Historic Lighthouse Preservation:

IRON

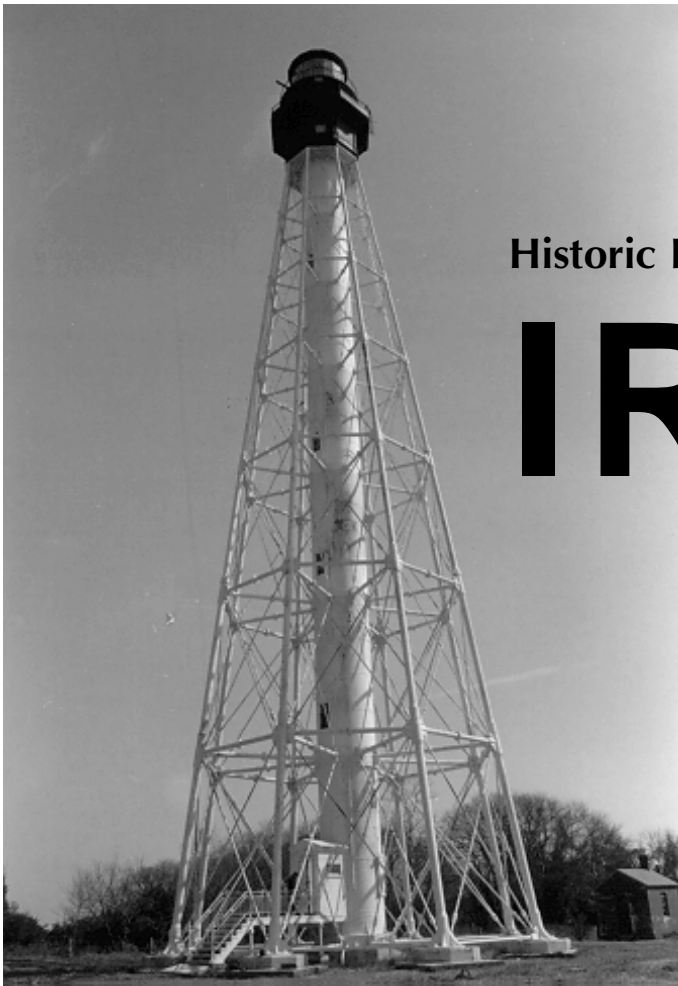
Figure 1. Cast-iron-and-steel skeletal 191-foot-tall tower at Cape Charles, Virginia

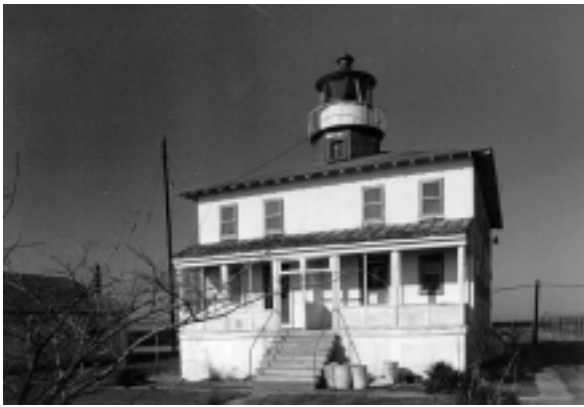
Figure 2. Example of a keeper's quarters fitted with a prefabricated cast-iron-and-steel lantern.

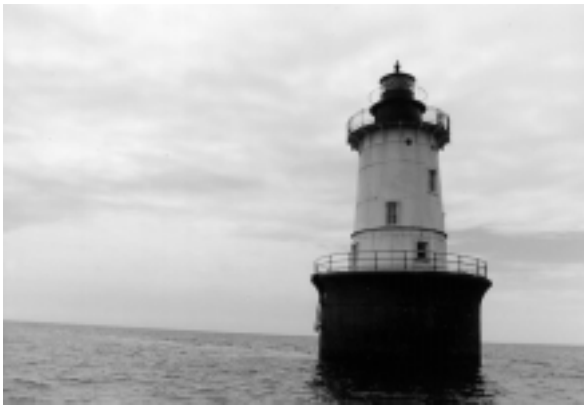
Figure 3. Example of an all-cast-iron construction "sparkplug" caisson-style lighthouse.

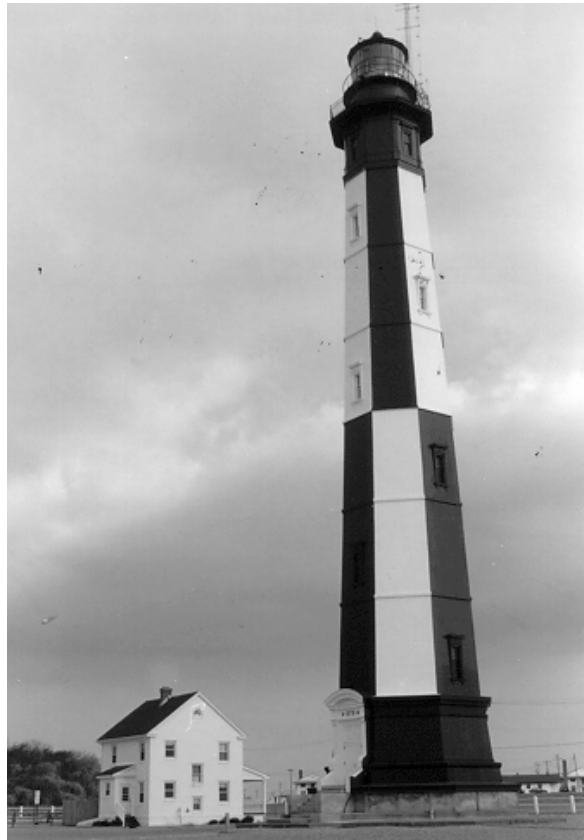
Figure 4. Double-wall, cast-iron, first-order 163-foot-tall coastal tower at Cape Henry, Virginia.

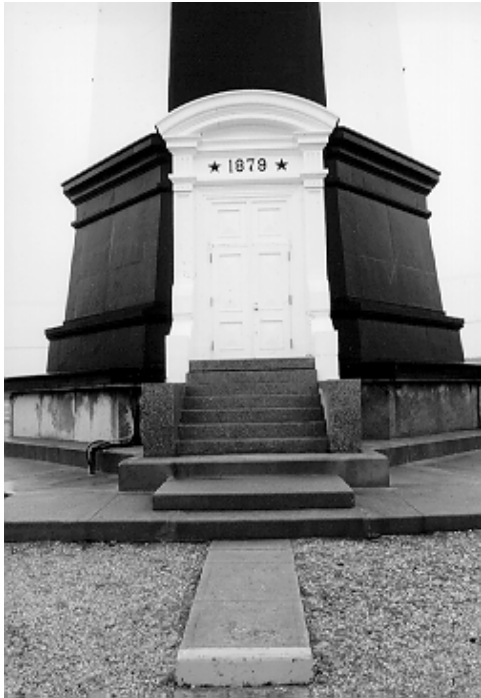
Figure 8. An example of the level of detail achieved with cast-iron construction.

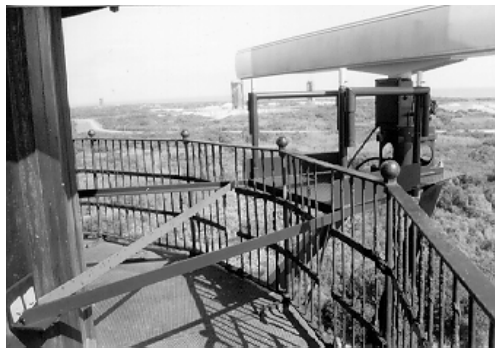
Figure 9. A modern range finder attached to the gallery deck using modern steel members.

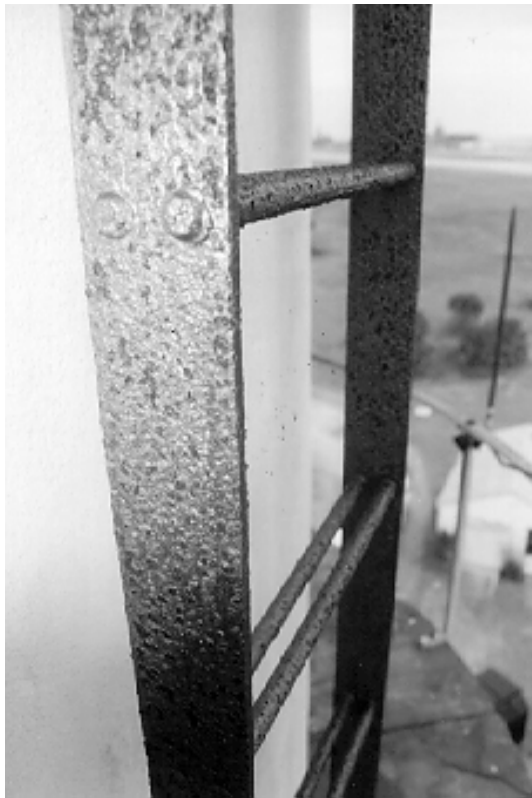
Figure 11. Detail view of a steel ladder that has been uniformly attacked by corrosion.

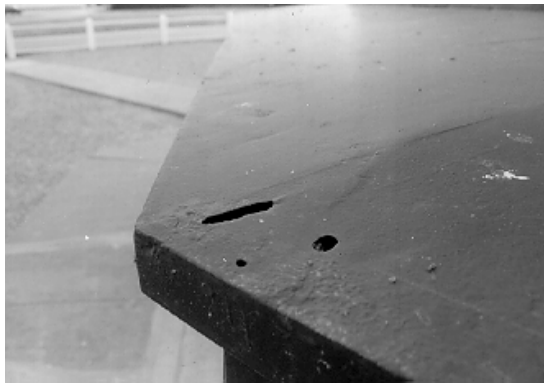
Figure 12. Close-up of localized corrosion or pitting where the corrosion has eaten through the cast iron.

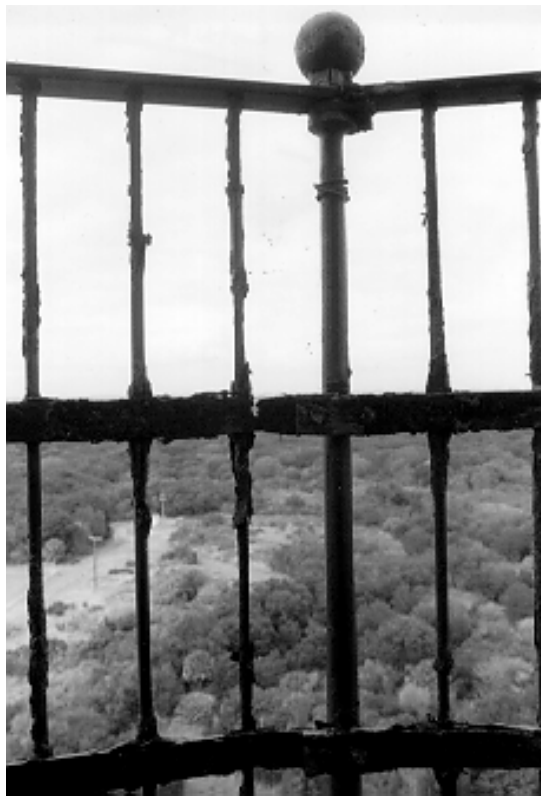
Figure 13. View of a steel railing where corrosion has occurred in distinct locations either because of variations in composition or localized failure of the coating system.

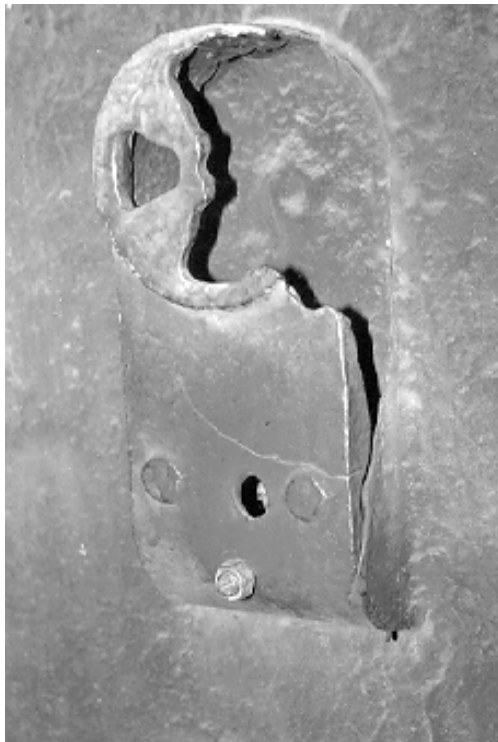
Figure 14. Nearly 30% of this ventilation shroud has been lost to two forms of abrasion: first, sand or grit blasting abraded away a majority of the material; second, human touch has smoothed the once rough surface.

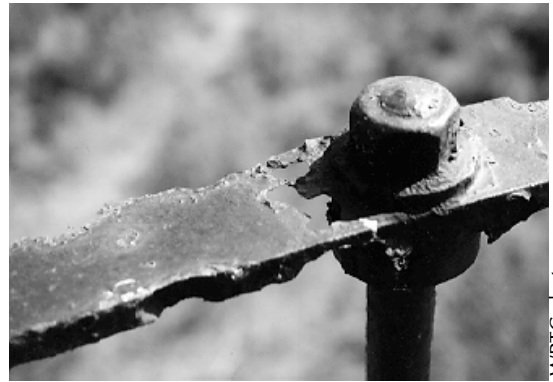
Figure 15. As corrosion attacked this steel handrail, wind and airborne sand eroded the loose and flaking surface rust.

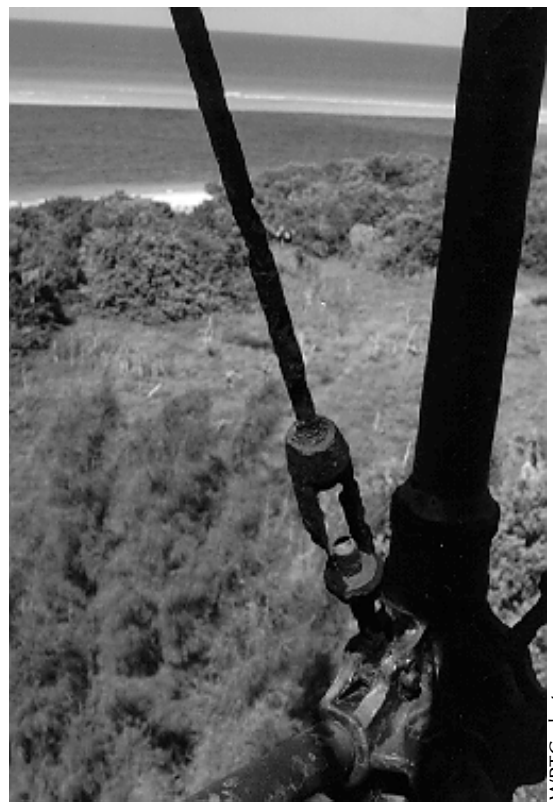
Figure 16. As corrosion attacked this steel turnbuckle, wind and airborne sand eroded away the flaking rust.

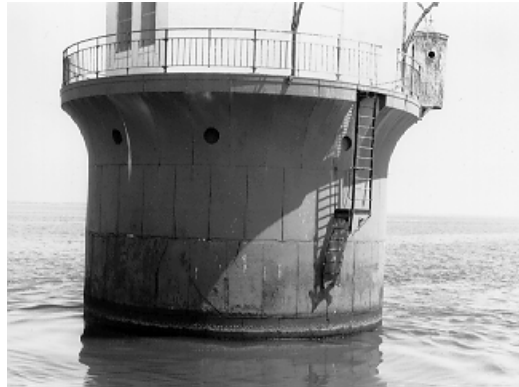
Figure 17. The cyclic pressure of the different rates of expansion and contraction of the exterior cast-iron plates and the interior brick lining of the caisson-style lighthouse has caused the cast-iron plates to fatigue and crack.

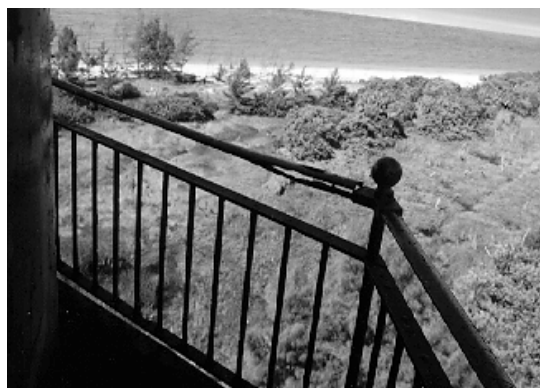
Figure 19. This handrail has been damaged by rust-jacking; rusting began between the two pieces of flat bar stock that formed the rail.
