CULTURAL LANDSCAPE REPORT

MARTIN VAN BUREN

NATIONAL HISTORIC SITE

Site History, Existing Conditions, and Analysis

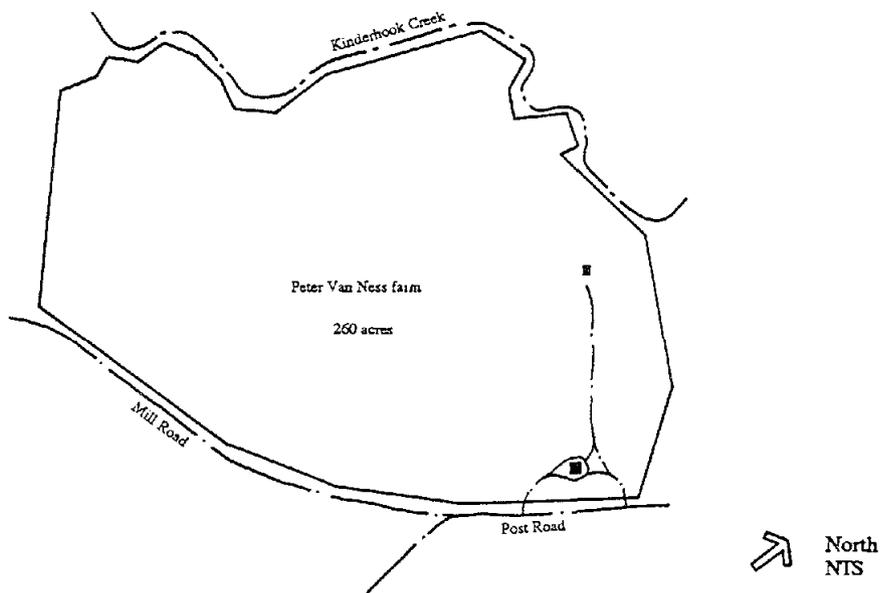
Figure 1.4: Kleinrood: 1780-1805, Peter Van Ness farm (Uschold, 1993. SUNY CESF).

The 260-acre property Peter Van Ness purchased consisted of farmland and the Van Alstyne stone house. Peter Van Ness owned other property in addition to this farm, including property on the opposite side of Post Road.²² Following his purchase of the 260 acres, Peter Van Ness and his family lived in the stone house until 1797 when a new, main house was completed, giving the farm one of the larger and more impressive houses of the Kinderhook area (fig. 1.4).

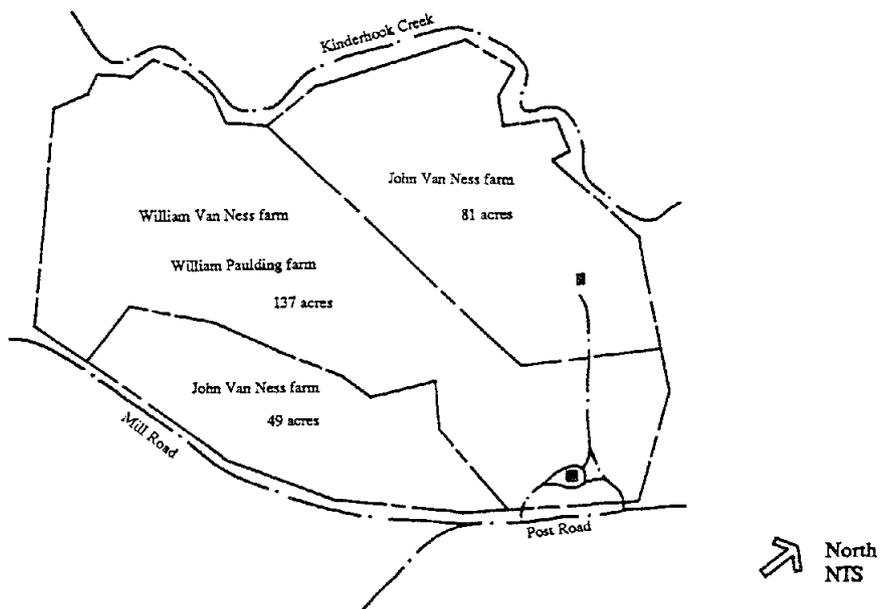
Figure 1.5: Kleinrood: 1805-1839, John Van Ness farm and William Van Ness/William Paulding farm (Uschold, 1993. SUNY CESF).

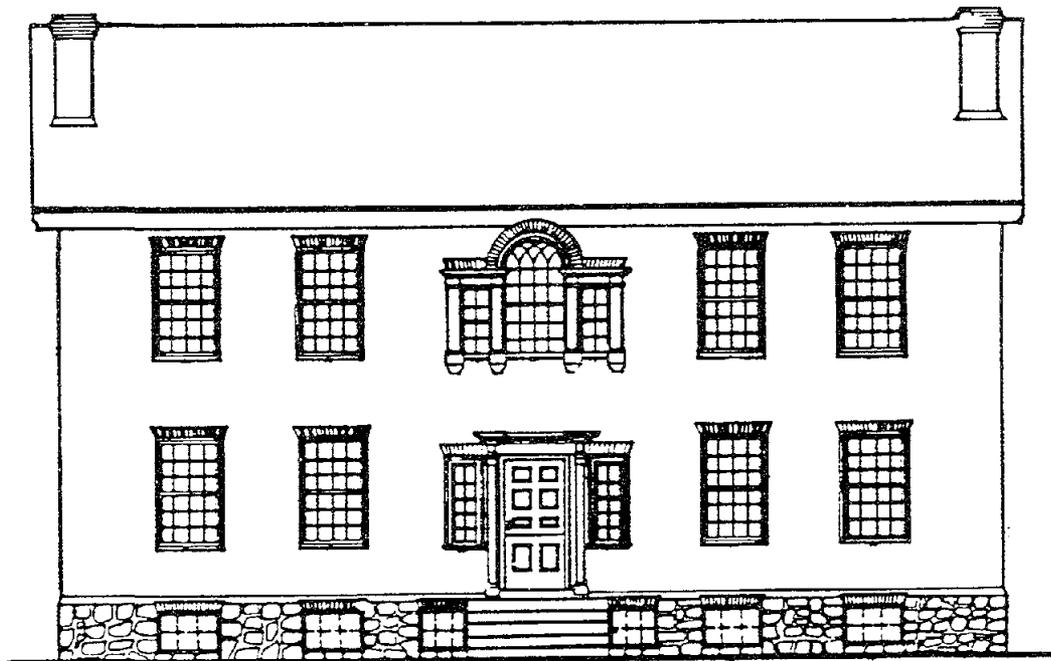
Figure 1.6: 1797 Peter Van Ness house (DSC, National Park Service, n.d.).

Several buildings and structures existed on the property during the Van Ness Period: the stone house, main house, carriage barn, and farm office. Other support buildings and structures existed but cannot be adequately documented.³⁴ The Van Alstynes had constructed at least two houses on the property: the stone house on the second terrace and another house on the first terrace east of the current house lot.³⁵ After purchasing the property, Peter Van Ness resided in the Van Alstyne stone house for approximately twenty years; he moved his family into the new house he built in 1797. The new main house was a simple, Late Georgian/Early Federal brick house (fig. 1.6), much larger and more formal in design than the stone house.³⁶ The new, main house was a rectangular block with two chimneys on each end, four main rooms and a central hall on the first floor, and five rooms around a smaller central hall on the second floor.

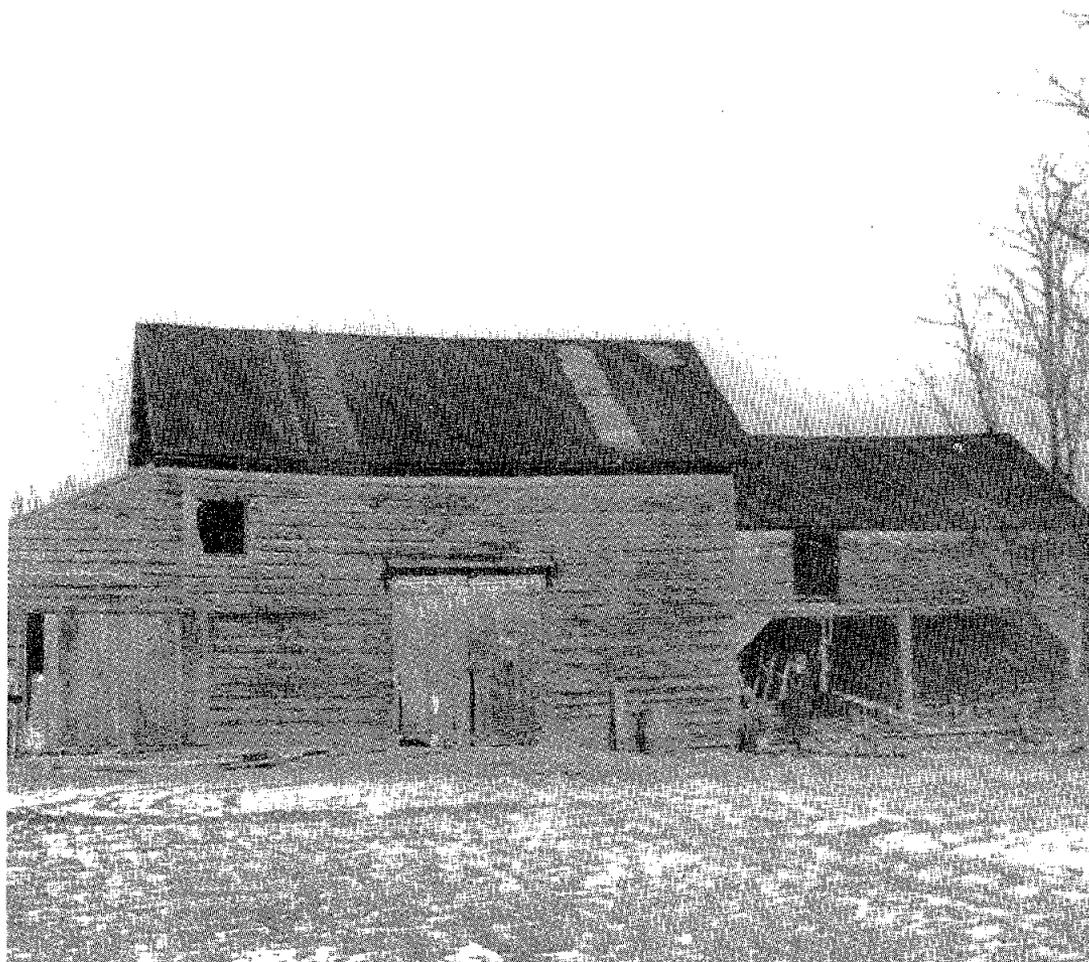
Figure 1.7: Carriage barn, 1937 (Photo # CLR-403. On file, MVB NHS).

The carriage barn (fig. 1.7) was located northwest of the house. The size of the carriage barn was approximately thirty feet wide and sixty-five feet long.³⁷ It was a wood-frame building with clapboard siding and a gable roof.

Several buildings and structures were existing on the property when Van Buren purchased it in 1839. The main house, built by Peter Van Ness in 1797, stood at the center of the house lot facing Post Road. Also on the house lot were the carriage barn, northwest of the main house (fig. 1.7), and the farm office, at the northeast corner of the garden (fig. 1.8).⁵⁹ The use of the farm office, during this period, is unclear, but during later periods it was used for storage. Its location within the garden suggests it was associated with the garden, but the use is unknown. The condition, or existence, of the stone house cannot be documented after the Van Ness Period. Ruins of the building remained into the deProsse Period (1917–1973), but whether the stone house was intact or in ruins during the Van Buren Period is unknown.⁶⁰ The stone house may have been occupied by Van Buren's farm foreman during the first few years of his tenure on the property.

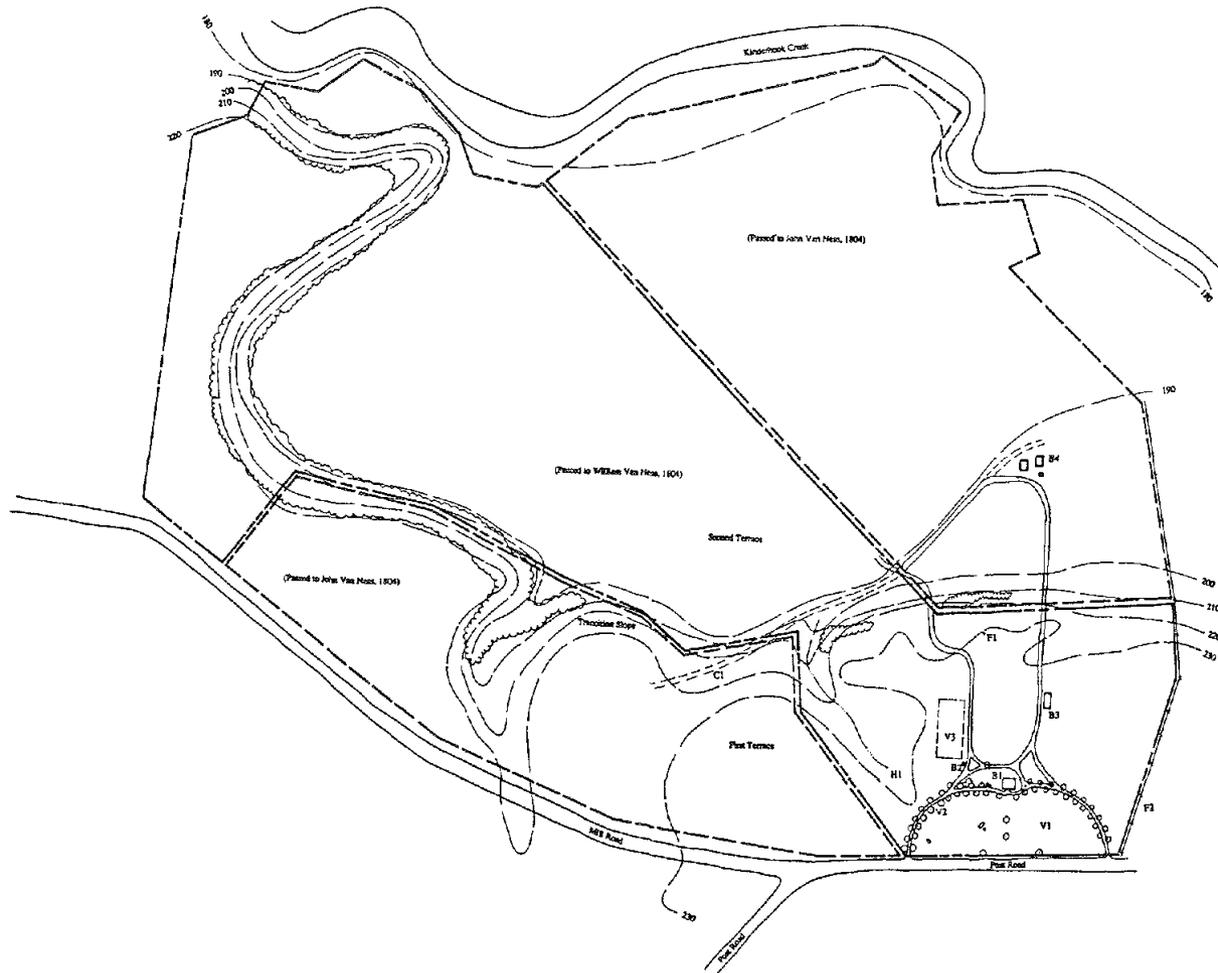
Symbol Key	
	Property Line
	Conservation Easement
	Overstory Vegetation
	Understory Vegetation
	Wood Land
	Tie-In
	Topographic Contour

Label	Feature
H1	Spring
B1	Main House
B2	Farm Office
B3	Cartage Barn
B4	Stone House
V1	Front Lawn
V2	Rear Lawn
V3	Garden
F1	Original Post Road
F2	Van Ness Grave Site
F3	Carpenter Fence

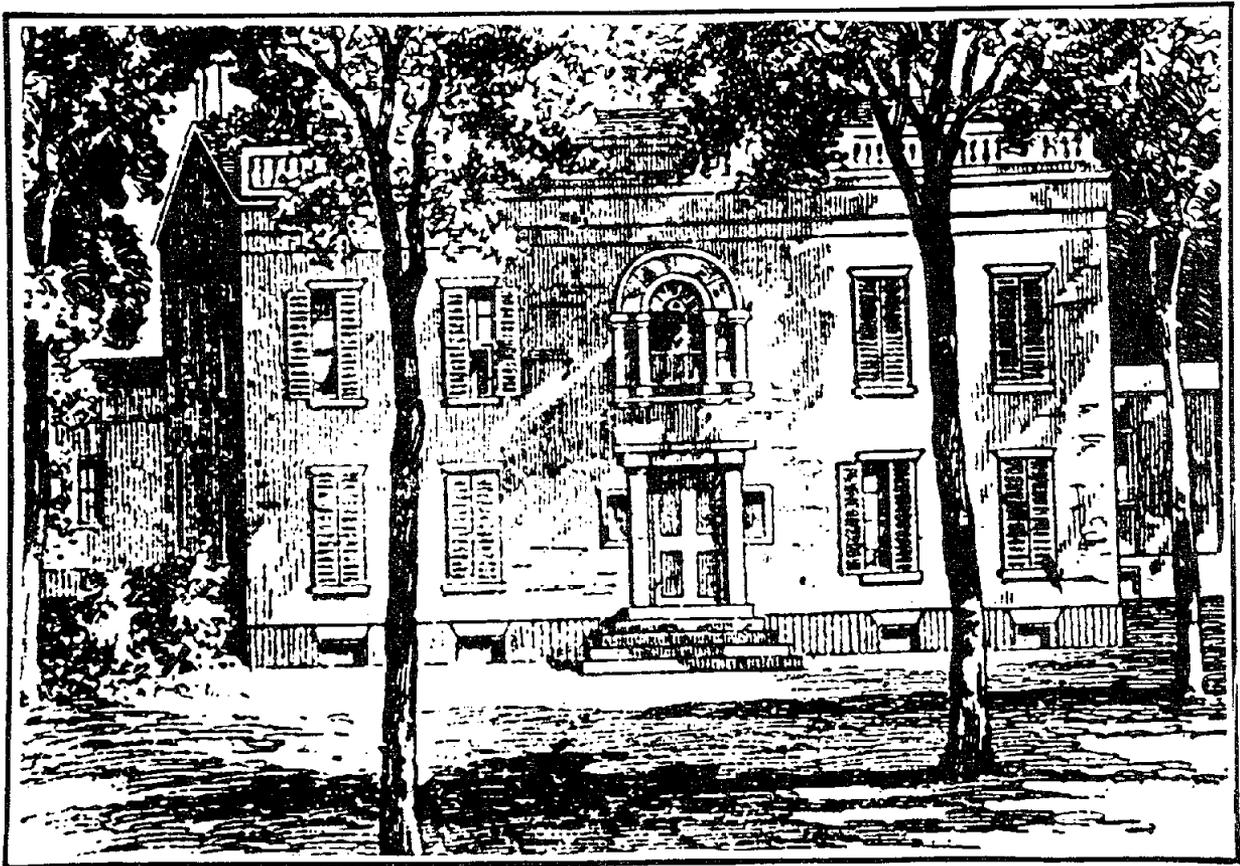
Figure 2.5: c.1843 sketch of Lindenwald main house (Photo # CLR-201, photographic copy. On file, MVB NHS).

Additional work was undertaken in 1841 on ". . . stables [wing on house], wood houses, etc."⁶² The stables mentioned may be part of the wings added to the rear of the main house, seen in figure 2.5, a circa 1843 sketch of the main house.⁶³ The wood houses referred to are otherwise undocumented. They also may have been part of this rear wing on the main house.

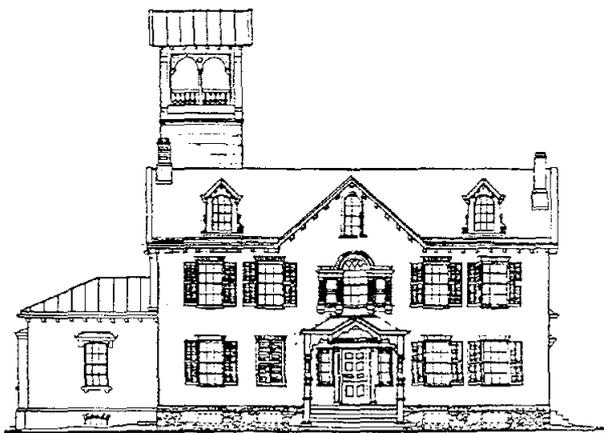
Figure 2.9: Lindenwald main house, post-1850 (DSC, National Park Service, n.d.).

In 1849, the final two years of major improvements began on the property. These last improvements were to accommodate Smith Thompson and his family as they moved onto Lindenwald. The alterations, designed and supervised by well-known architect Richard Upjohn, began that year and were completed in 1850. The purpose of the alterations was to enlarge the main house, but much more was done. The simple rectangular Van Ness house was increased greatly in size by a large addition along the rear, a south and a west wing, and a four story tower. To accommodate these changes, the stable wings were removed. Along with this tremendous increase in size, the exterior of the main house was transformed from the original Late Georgian/Early Federal style to Italianate. Ornamentation was added to the exterior including a small, finely detailed porch at the front entrance, a large gable and dormers on the front facade, and ornamentation on the overhangs of the roof. The simple Van Ness farm house was transformed into a large and elaborate mansion (fig. 2.8 and 2.9).

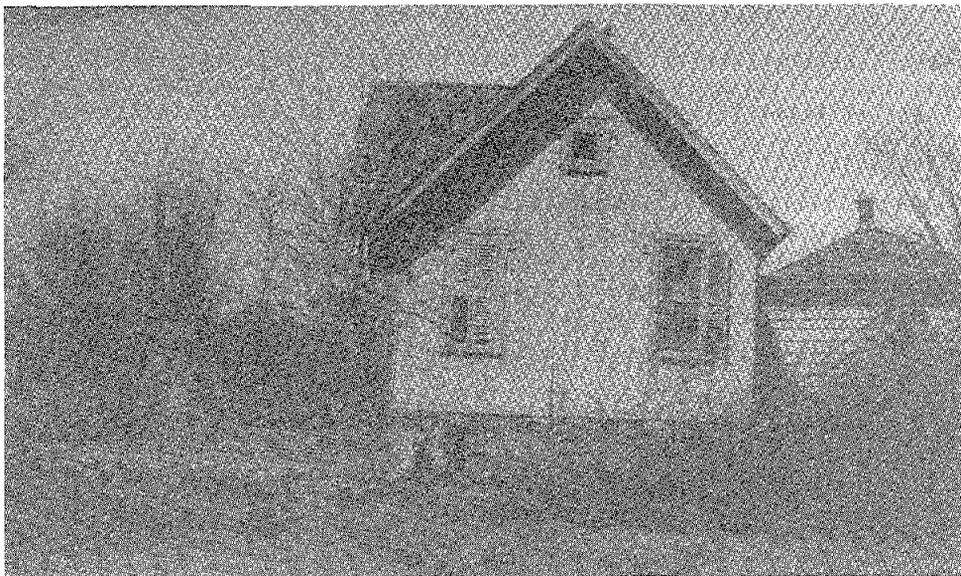
Figure 2.11: North gate house, c.1945 (Photo # CLR-426. On file, MVB NHS).

In addition to the alterations on the main house, two gate houses were constructed as part of the Upjohn plan, one at each entrance to the drive. The two buildings were sixteen feet by twenty-three feet and were mirror images of one another, except for the dormer in the south side of the north gate house. They were small, one and one-half story board and batten buildings with a wood-shingle, gable roof, field stone foundation, and full basement (fig. 2.10 and 2.11).⁶⁶

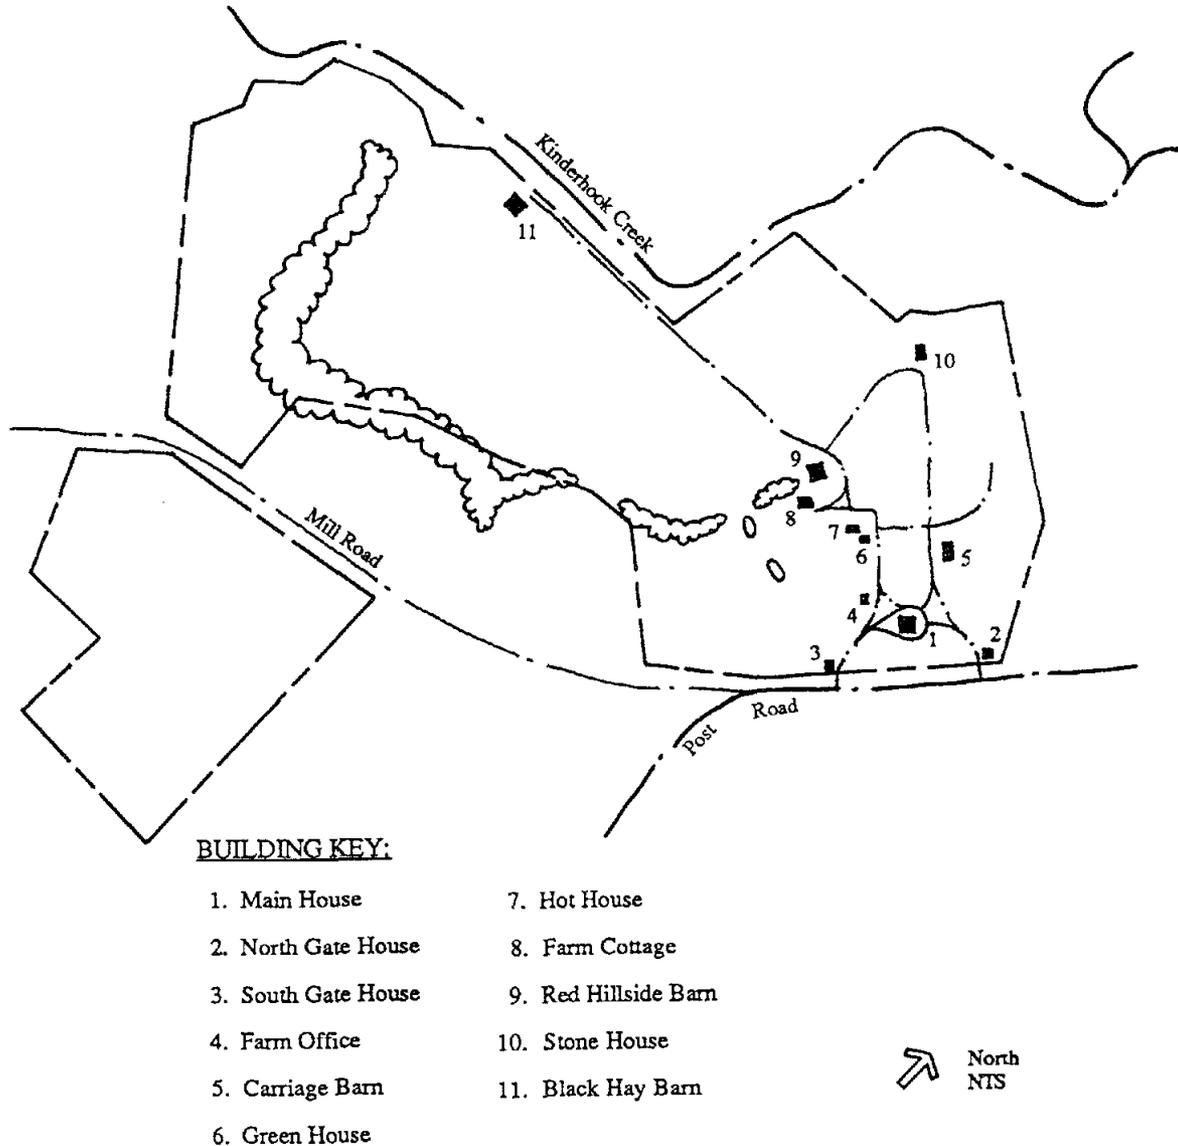
Figure 2.12: Buildings and Structures: Van Buren Period (Uschold, 1993. SUNY CESF).

The buildings and structures of Lindenwald during the Van Buren Period were in a constant state of change. From the modest beginnings of the Van Ness farm, Lindenwald experienced an eleven-year time span characterized by construction and renovation, ending in 1850. At the completion of these improvements, the property had been transformed from a simple country home into a substantial and successful working farm. The buildings and structures on the property at this time remained throughout the period. They included the main house, north gate house, south gate house, farm cottage, carriage barn, farm office, hothouse, greenhouse, red hillside barn, black hay barn, and stone house. Figure 2.12 illustrates the buildings and structures for the Van Buren Period.

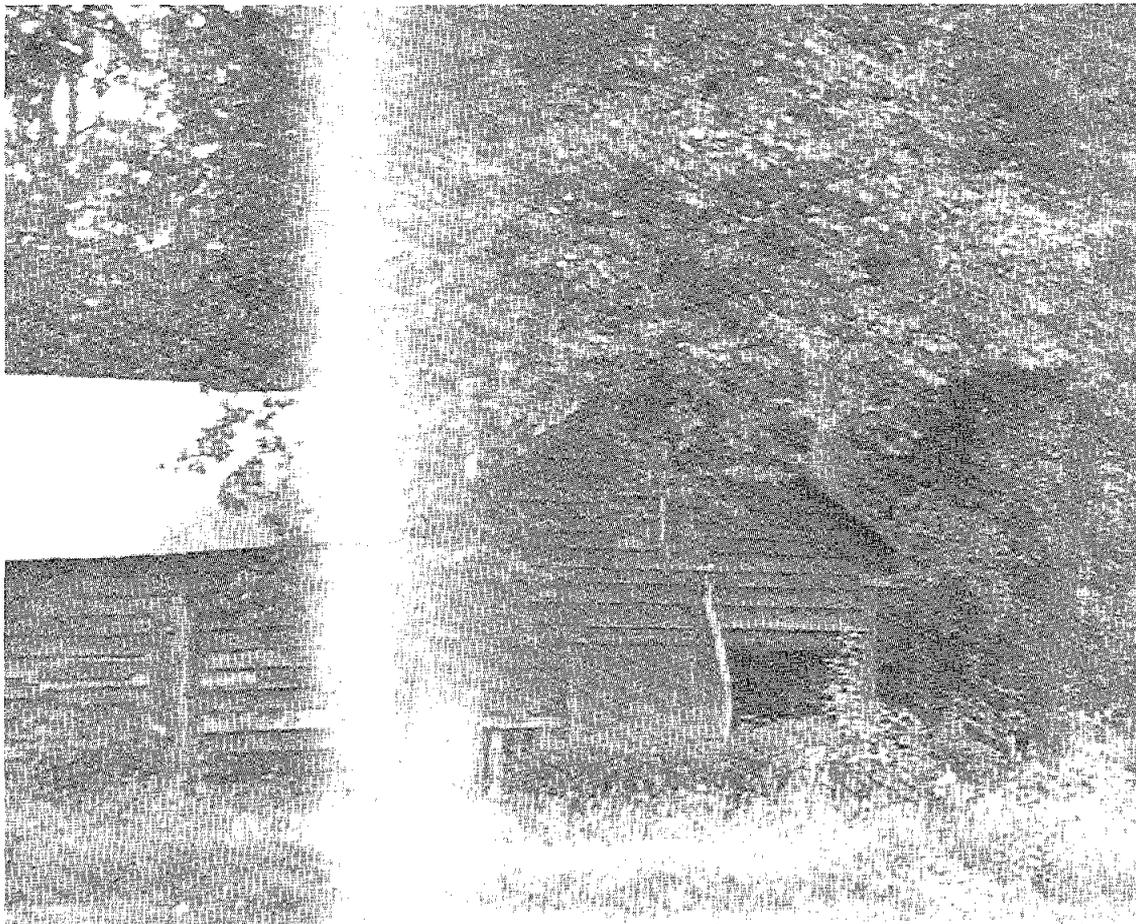
Figure 3.4: Wood shed, c.1900 (Photo # CLR-004. On file, MVB NHS).

Two buildings were also located behind the main house across the drive: a wood shed and garage. Like the well house, these buildings are first documented by their appearance in several photographs from the Wagoner Period. The wood shed, as it was known later, was a one and one-half story wood frame building approximately thirty-five feet by twenty-five feet (fig. 3.4 and 3.5). The origin of the wood shed is unclear. It may have existed from the Van Buren Period, or even the Van Ness. Its description as a wood shed originates from the following period, therefore, its use during the Wagoner Period is unknown. Its appearance and poor condition in the photographs suggest it was standing for a long time before the photos were taken. Its sturdy construction and lack of foundation suggest that it may have been moved. Archeological survey of the area suggests that it may have been rotated ninety degrees. The only documented use and detailed description does not appear until the deProsse Period.¹⁰¹

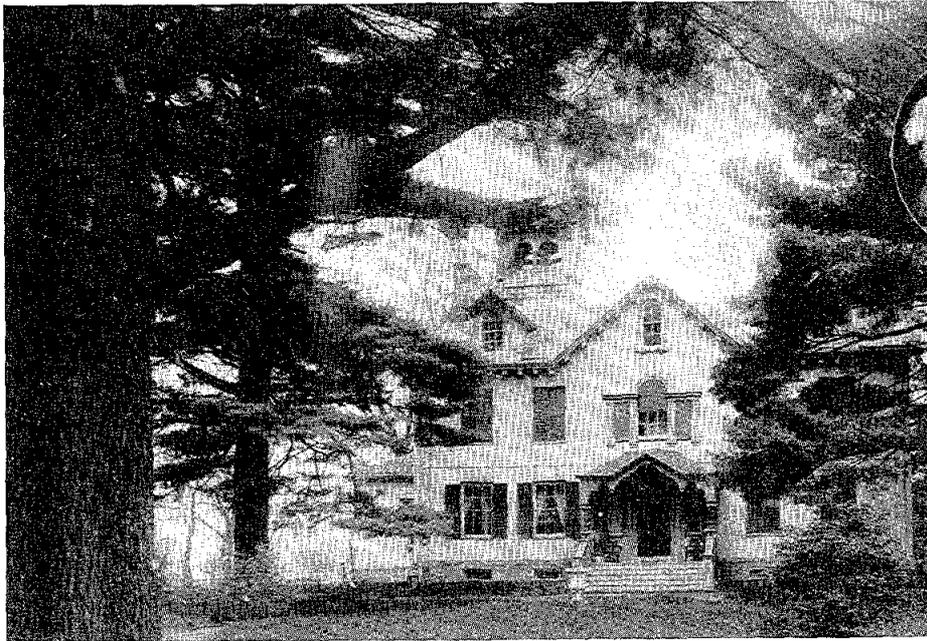
Figure 3.9: Front view of main house, showing curved trellis, c.1895 (Photo # CLR-312. On file, MVB NHS).

A trellis was located approximately ten feet from the front south corner of the main house. Two different trellises existed here during the Wagoner Period. In the early years a wood trellis approximately seven feet tall with a curved form, was in place. It appeared to have been painted a light color (fig 3.9). At the end of the Wagoner Period a less sturdy, rectangular-shaped, wood trellis was in the same location. It was approximately six feet tall and also appears to have been painted a light color (fig 3.10). Near the trellis, on the opposite side of the entry drive, was a lawn swing. The swing appears to have been stationary with two posts approximately ten feet tall with a cross member that held the swing. The entire swing appears to have been constructed of wood and does not appear to have been painted (fig 3.10). This swing is not in the earliest photos of the Wagoner Period, suggesting it was introduced later in this period.

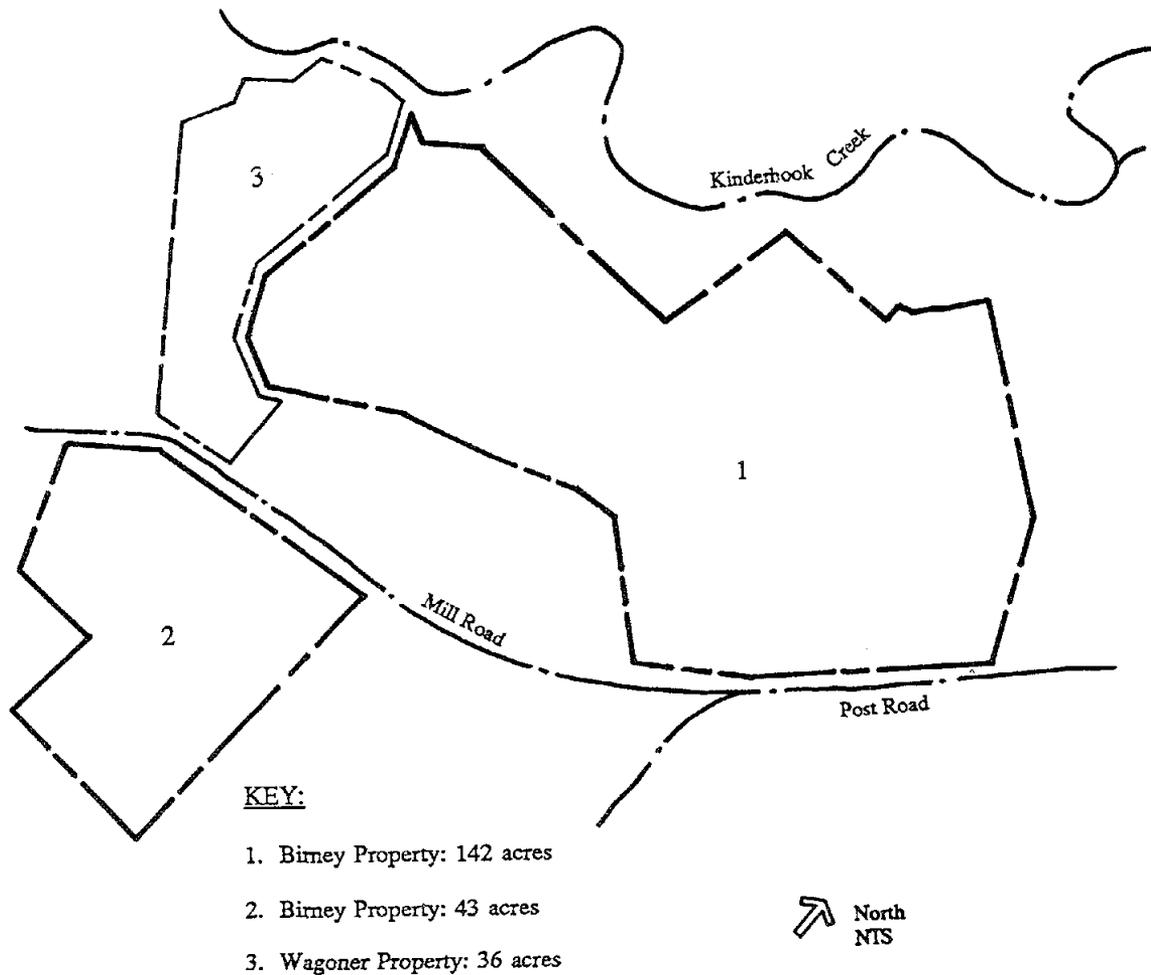
Figure 4.1: Setting: Birney (1917-1925) and deProsse (1925-1957) ownerships, deProsse Period, (Uschold, 1993. SUNY CESF).

of the grounds, which had decreased through the deProsse Period, was minimal during the Campbell ownership. The final few years of the Campbell ownership demonstrate almost no maintenance at all. For the final few years of his occupancy, Campbell lived in the south gate house, continuing to sell antiques. At the close of the deProsse Period in 1973, the National Park Foundation purchased the unmaintained and overgrown 12.8 acres. Figures 4.1 and 4.2 illustrate the parcels of Lindenwald during the deProsse Period.

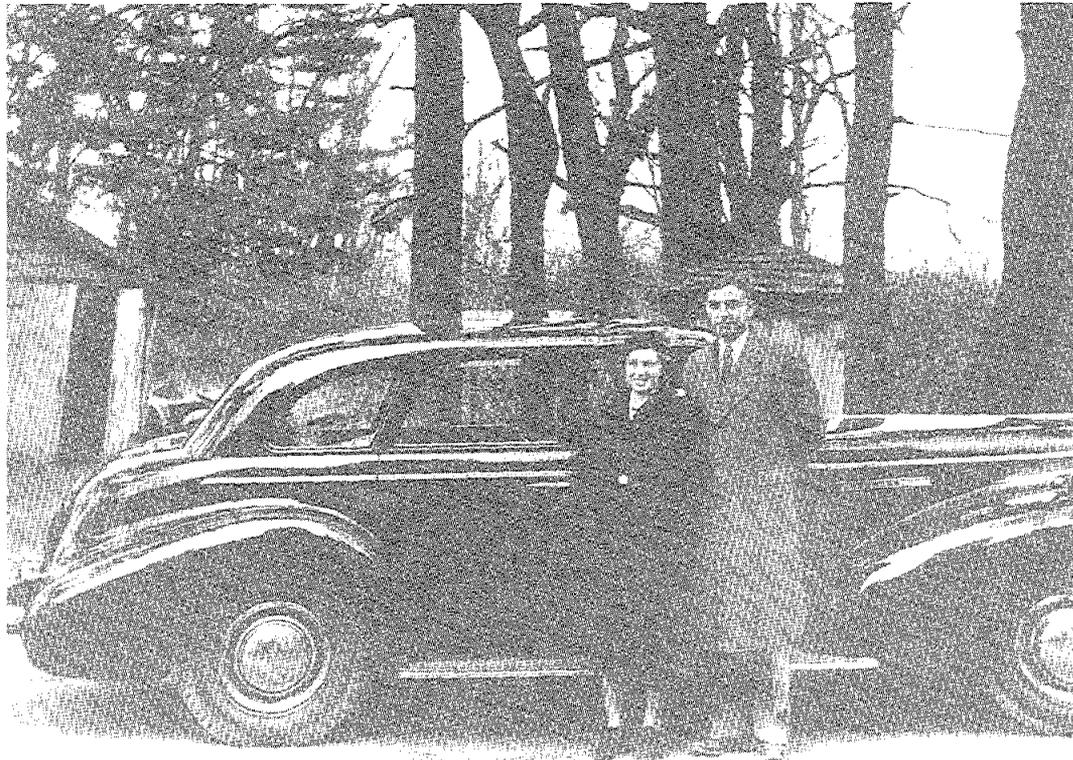
Figure 4.14: Slate shed in Wagoner garage and well house/play house, behind main house, c.1940 (Photo # CLR-407. On file, MVB NHS).

The well house, located on top of the well behind the main house during the Wagoner Period, was moved to the northeast corner of the Wagoner garage during the 1930s (fig. 4.13 and 4.14). Located in a grove of trees, it was converted to a play house for the deProsse children. It had either fallen down or been removed by the end of the deProsse Period, probably during the Campbell ownership.¹²⁴

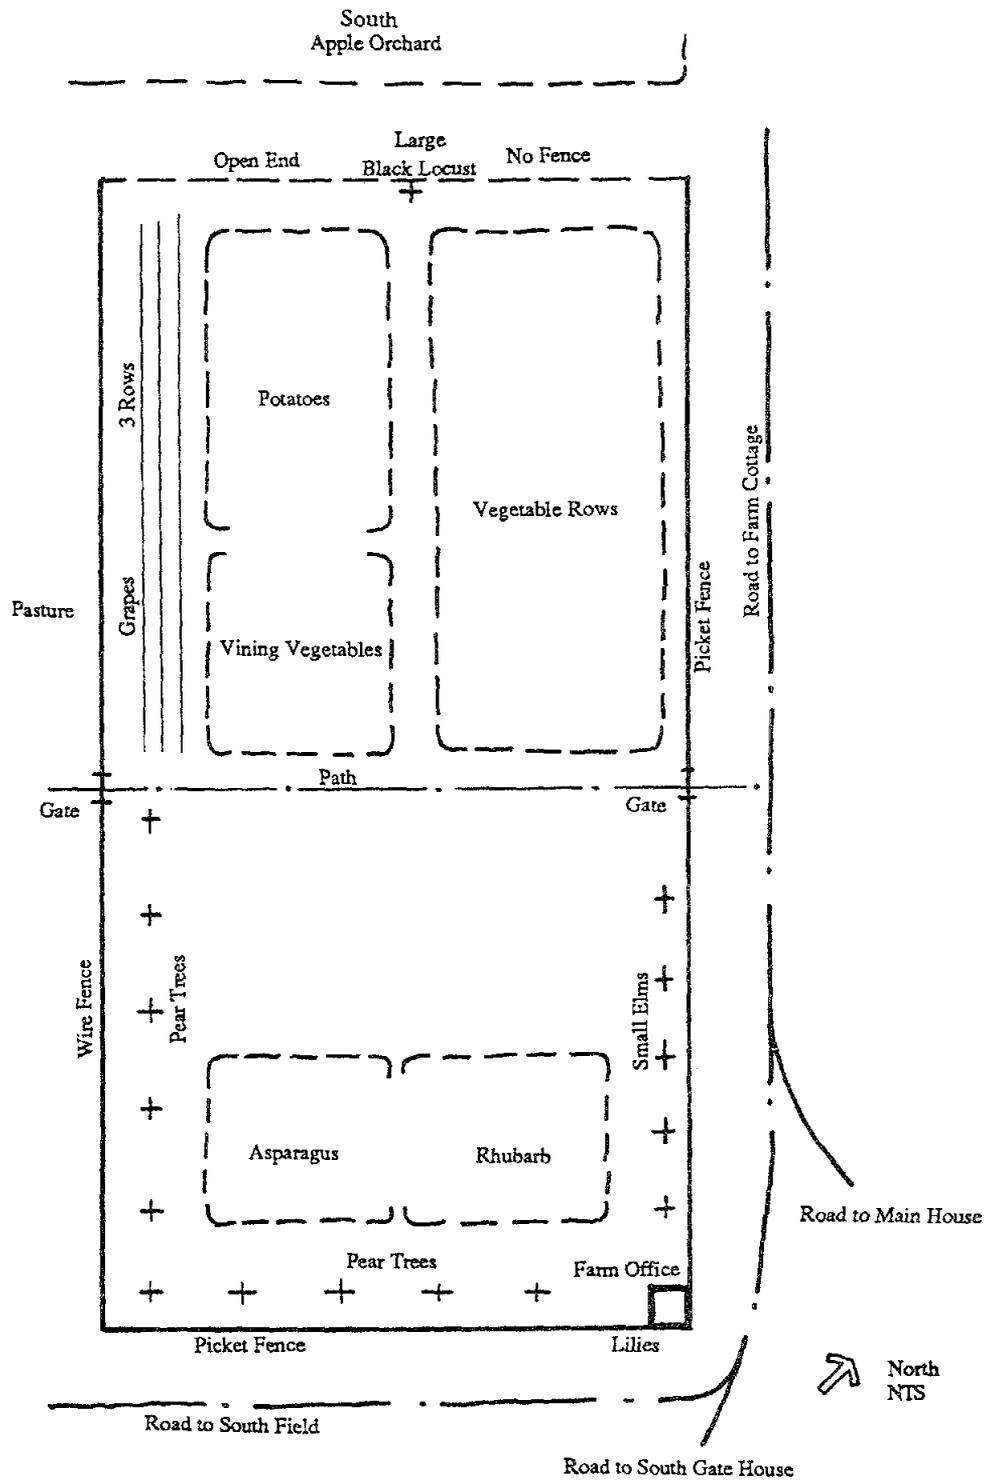
Figure 4.23: Detail of Lindenwald garden, c.1940 (William deProsse, 1993. Re-drawn by Uschold, 1993).

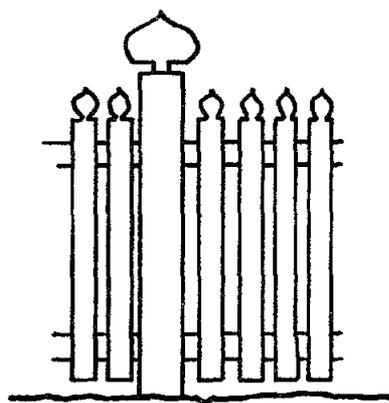
Figure 4.27: Detail of picket fence surrounding garden (William deProsse, 1993. Re-drawn by Uschold, 1993).

At the start of the deProsse Period, the garden had fences enclosing three of its sides. The north and east sides had an elaborate picket fence made of wood and painted white. The fence had posts approximately every six feet that were approximately five inches square. The pickets were spaced approximately one and one-half inches apart. The pickets had flat, onion dome shaped tops and the support posts had fully round tops of the same shape matching those of the front Victorian porch (fig. 4.26 and 4.27).¹³³

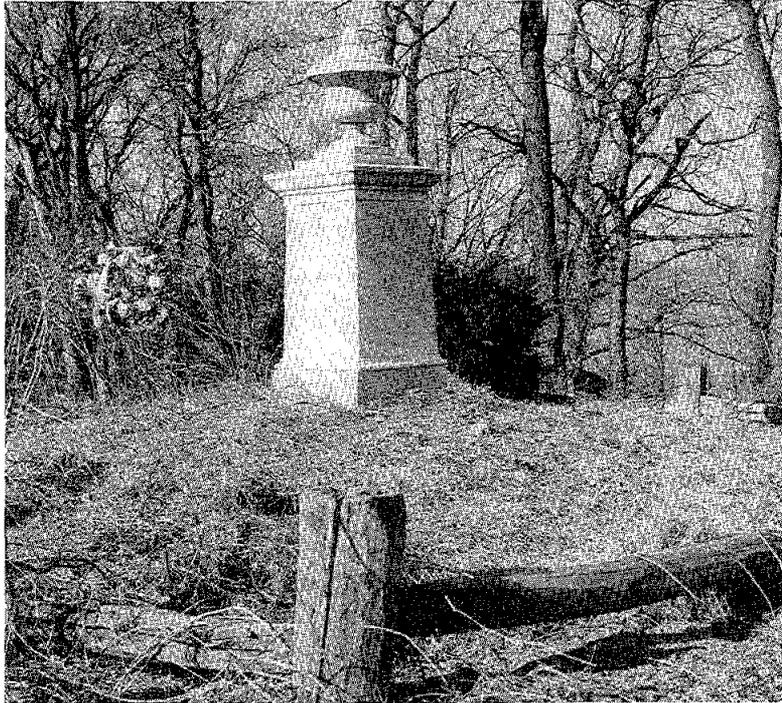
Figure 4.29: Fence around Van Ness grave, behind main house, c.1960 (Photo # CLR-010. On file, MVB NHS).

Several sections of fence were also added to the property during the Campbell ownership (fig. 4.28). The south and east sides of the Lilac grove south of the main house were fenced and both ends of the entry drive had gates. These fences were approximately four feet high, constructed of wood timbers, and painted white. The gates across the entry drives were white, wood gates of a simpler design than the gates recorded there previously. A fence also existed around the Peter Van Ness grave, behind the main house. This fence was constructed of large wood timbers and stood approximately one or two feet high. It surrounded a square area about twenty feet by twenty feet around the grave (fig. 4.29).

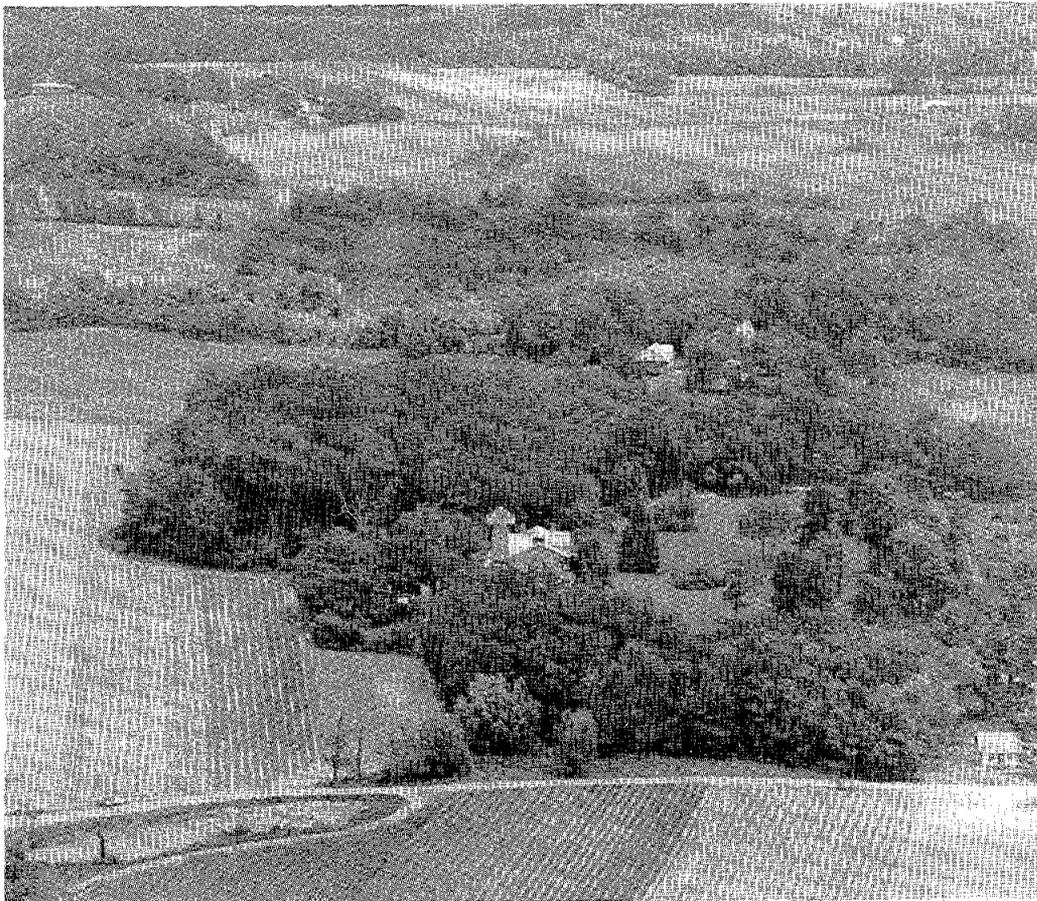
Figure 5.1: Martin Van Buren National Historic Site, aerial view from south, present park setting, 1978 (Photo # CLR-550. On file, MVB NHS).

The property boundaries have changed significantly but the visual setting of the current site has retained its overall character of the previous periods. All of the land adjacent to Lindenwald has remained in agriculture or, at least, undeveloped, maintaining the rural character (fig. 5.1 & 5.2).

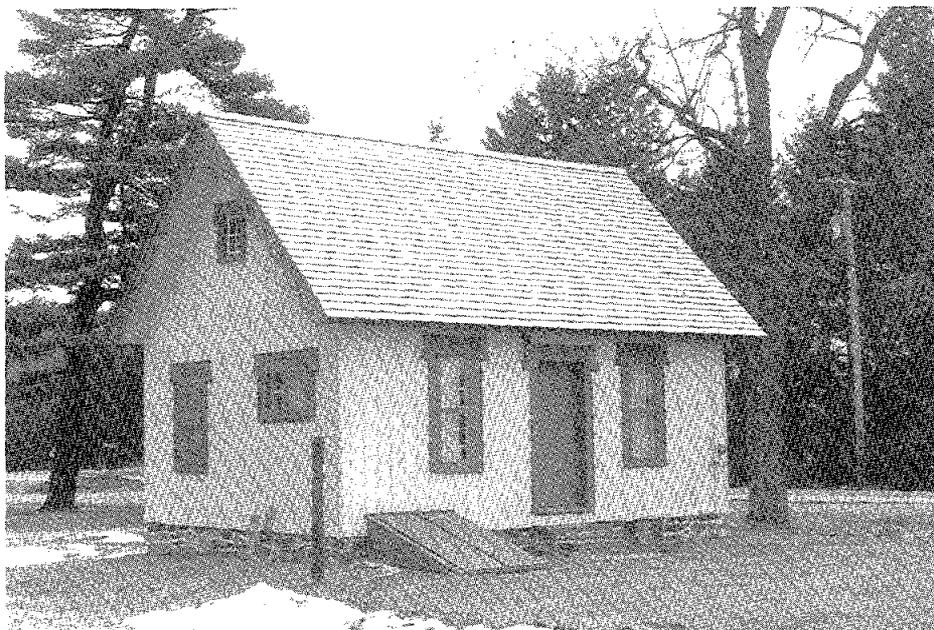
Figure 5.7: South gate house, 1993 (Photo # CLR-1316. Uschold, SUNY CESF).

The exterior of the south gate house was also restored, with the exception of the original chimney, which was left off because it was believed to be non-historic. The interior of the south gate house was repaired and is now used as storage space. The exterior of the south gate house has been painted to match the house (fig. 5.7). The interior has three rooms on the first level: a large room with a fireplace, once the living room, and two small rooms that served as the kitchen and bath. Stairs from the bathroom lead to the upper level. The basement is accessed by steps on the exterior of the building. The north gate house foundation was filled with debris in 1973. This fill was removed and the foundation was back-filled with soil to ground level to stabilize it from deterioration.¹³⁷ A one-foot high portion of the stone foundation remains above grade. The foundation is now threatened by several Black Cherry (*Prunus serotina*) trees that have grown up around it. (fig. 5.8). The farm office foundation, constructed of flat stones at grade level, is also extant. Since it is at grade level and located in an area maintained as lawn, it is becoming overgrown and covered with grass (fig. 5.9).

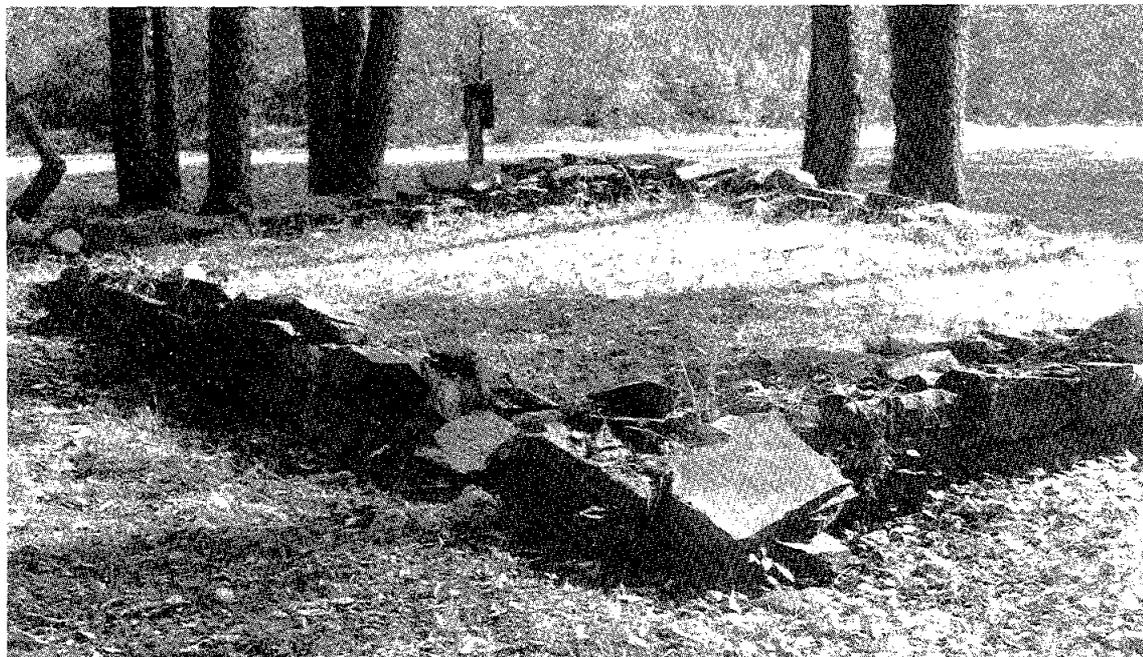
Figure 5.8: North gate house foundation, 1993 (Photo # CLR-1654. J. Harris, NPS).

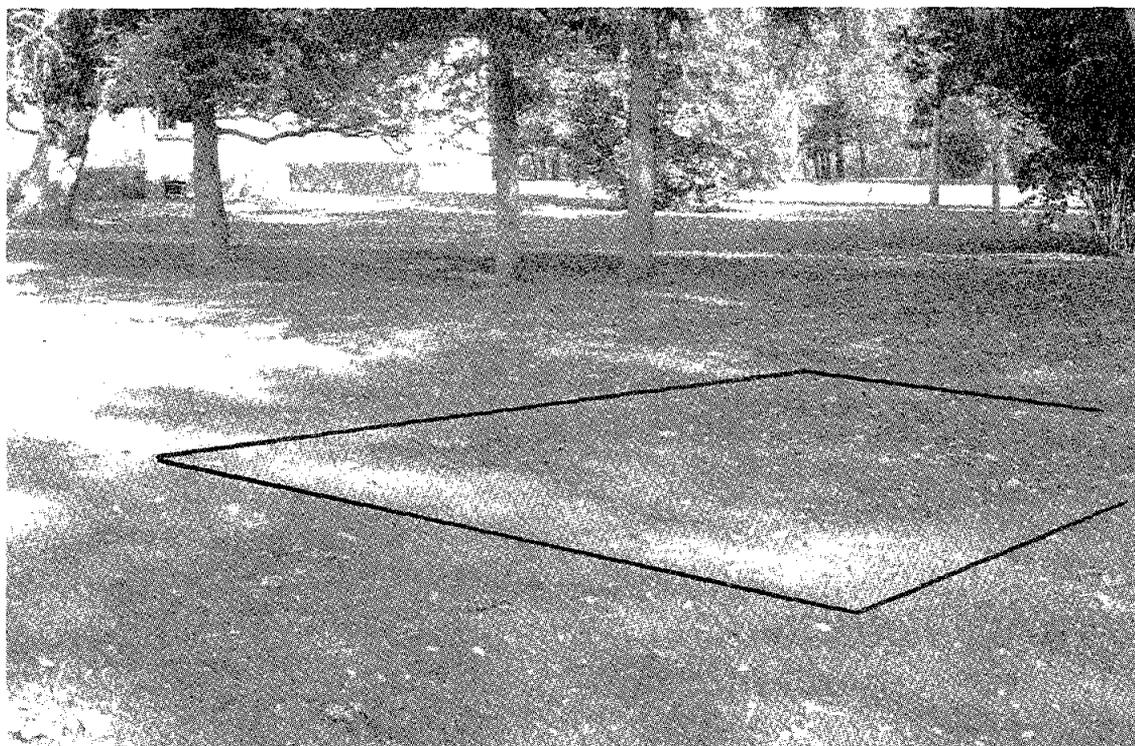
Figure 5.9: Farm office foundation, 1993 (Photo # CLR-1666. J. Harris, NPS).

Existing: A portion of the farm office foundation exists, but the building itself was removed circa 1960.

Analysis: Foundation elements existing, contributing.

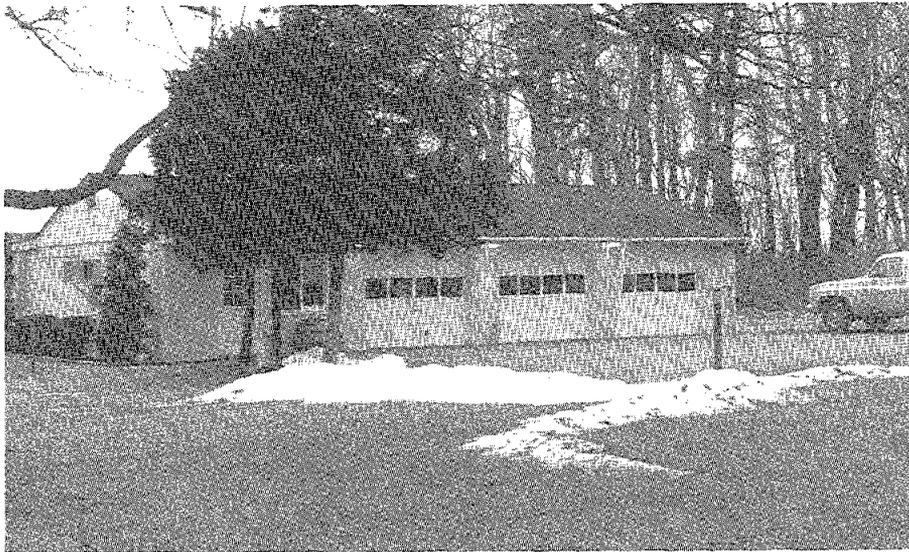
Figure 5.10: Campbell garage: maintenance garage, 1993 (Photo # CLR-1116. Uschold, SUNY CESF).

The Campbell garage was renovated for use as the maintenance shop for the Park in 1978. Three bays are used for work and storage space and the fourth is office space. This garage also has been painted yellow (fig. 5.10). The Wagoner garage collapsed in 1974 and the debris was removed from the property (fig. 5.11). Campbell's antique shop was removed from the property in 1981 due to its visually intrusive character and location (fig. 4.15).¹³⁸

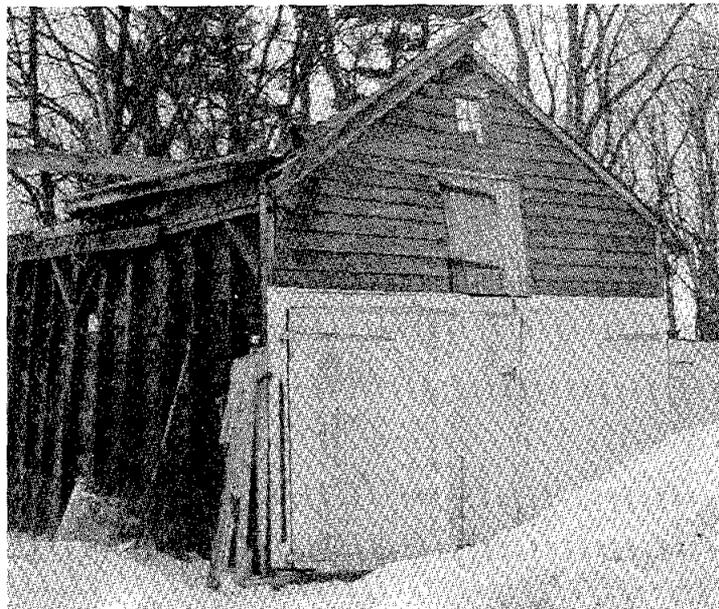
Figure 5.11: Wagoner garage, 1974 (Photo # CLR-501. On file, MVB NHS).

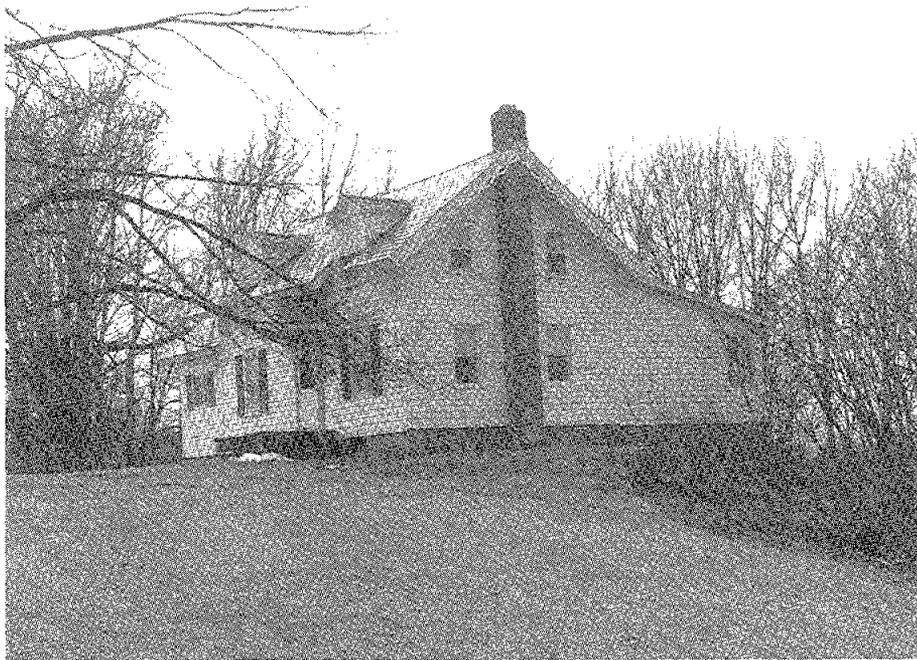
Figure 5.14: Farm cottage, 1993 (Photo # CLR-1112. Uschold, SUNY CESF).

The farmland, now owned by Meyer, had an extensive complex of buildings at the beginning of the period and more buildings have been added to it during this period. The farm cottage is extant, although it has been greatly altered. It has undergone a number of renovation and modernization efforts. Additions have been built on the west and north sides of the building. It is now being used as a residence (fig. 5.14). The farm complex also contains a ranch house built in 1985. In addition, there are three silos, one large barn, seven garages and sheds, one hothouse, and one greenhouse (fig. 5.15 & 5.16).

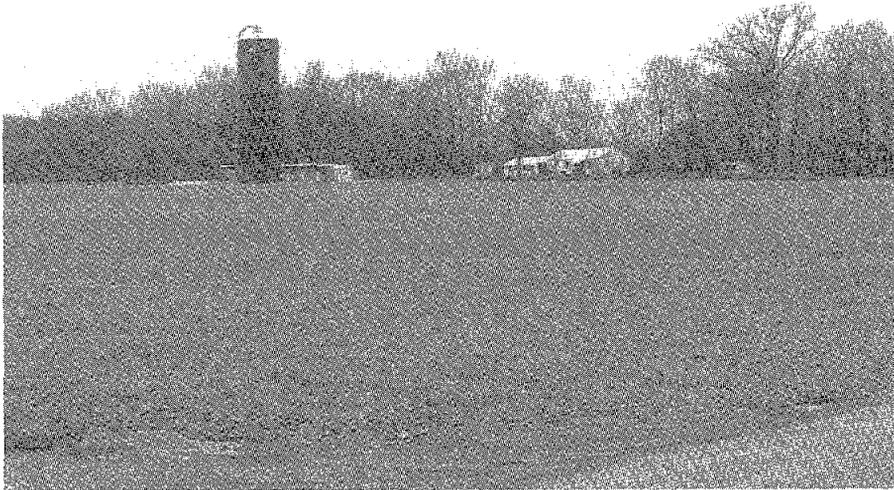
Figure 5.15: Meyer farm complex and 1985 ranch house, 1993 (Photo # CLR-1313. Uschold, SUNY CESF).
