CULTURAL LANDSCAPE REPORT

MARTIN VAN BUREN

NATIONAL HISTORIC SITE

Site History, Existing Conditions, and Analysis

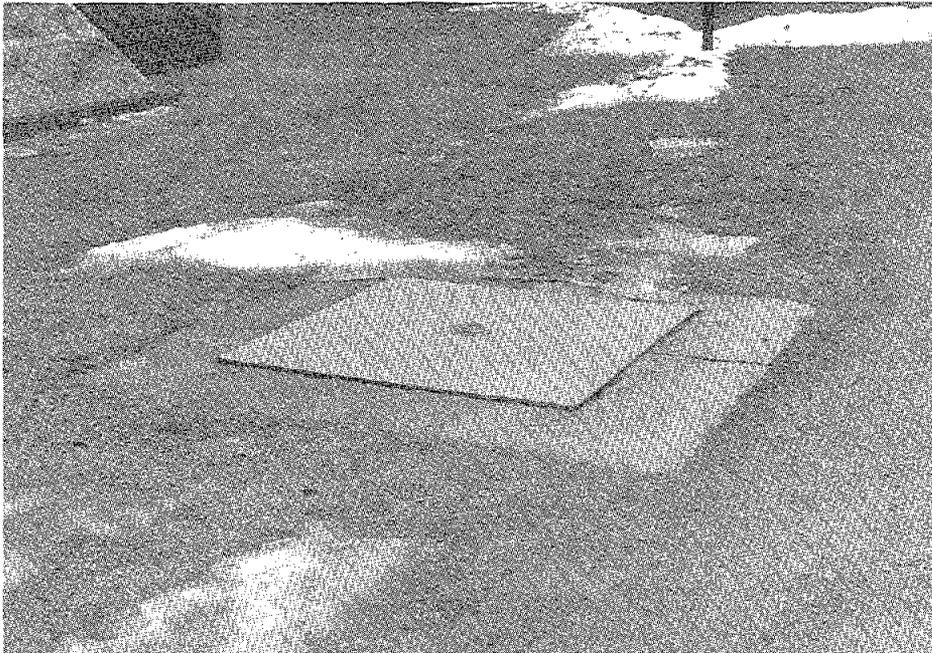
Figure 5.17: Historic well for main house, 1993 (Photo # CLR-1115. Uschold, SUNY CESF).

Water is provided to the Park by an underground well located behind the main house. This well was installed by the Park in 1978. The well provides the amount of water needed at the Park, however it is not dependable for drinking water. The historic well that served the main house still exists at the rear of the house (fig. 5.17). A steel cover has been placed over the well for protection. The sewage from the Park buildings is handled by a 1000-gallon septic tank which was placed underground in front of the pole barn. The septic system which served the main house and was implemented during the deProse Period, was removed as non-historic in 1984. Four leach tanks were added, located around the main house, and are used for disposal of the storm water run-off from the gutters of the house. These leach tanks are dry wells constructed of concrete. On the north side of the front lawn, a 10,000-gallon water tank was placed underground. It has no connections to the Park's other water supply and was added for the sole purpose of fire protection.

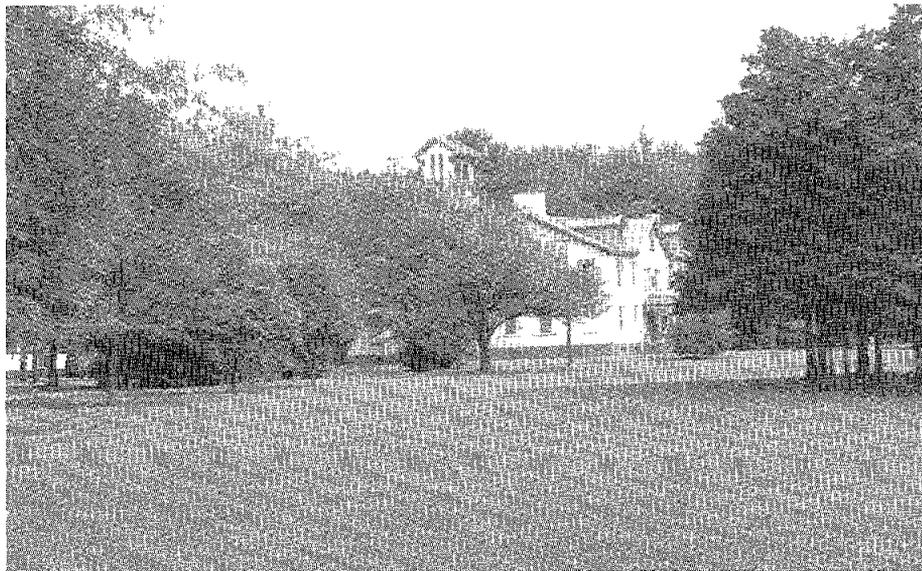
Figure 5.19: Front south lawn, 1993 (Photo # CLR-1421. Uschold, SUNY CESF).

Over a period of years, beginning in 1976, vegetation was cut back and cleared from the property. The lawn was cleared of all plants except the larger trees and shrubs. The pine row along the road was cleared, leaving only the larger trees, of various species, to maintain the row. The north and south wood lots were cut back a few feet from the entry drive and several feet from the south gate house, antique shop, and north gate house foundation, leaving the larger trees. The vegetation surrounding the garages was cleared completely and the north wood lot cut back on its south boundary. Upon completion of the clearing, lawn was established and maintained around all of these features (fig. 5.19–5.23).

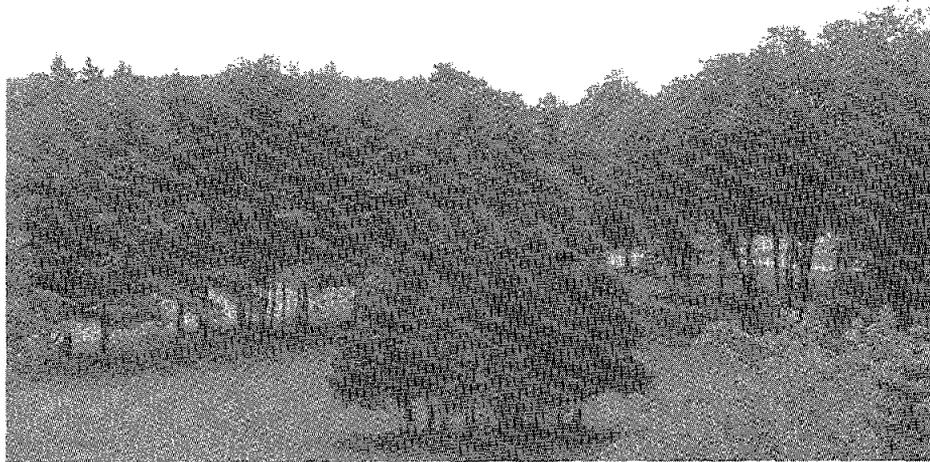
Figure 5.20: Front lawn, pine row, & south drive, 1993 (Photo # CLR-1520. Uschold, SUNY CESF).

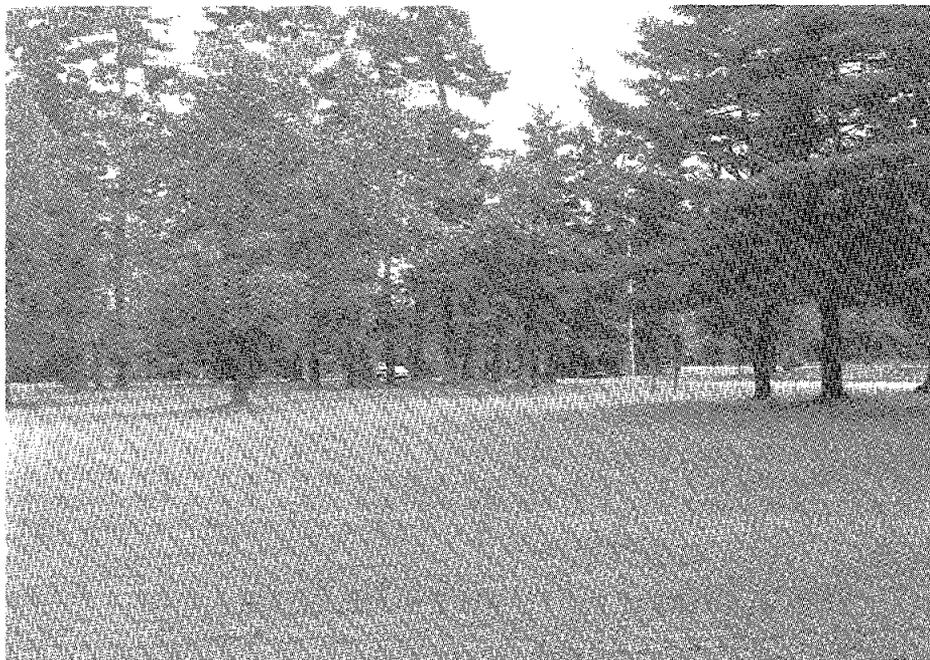
Figure 5.21: Pine row & front pine grove, 1993 (Photo # CLR-1423. Uschold, SUNY CESF).

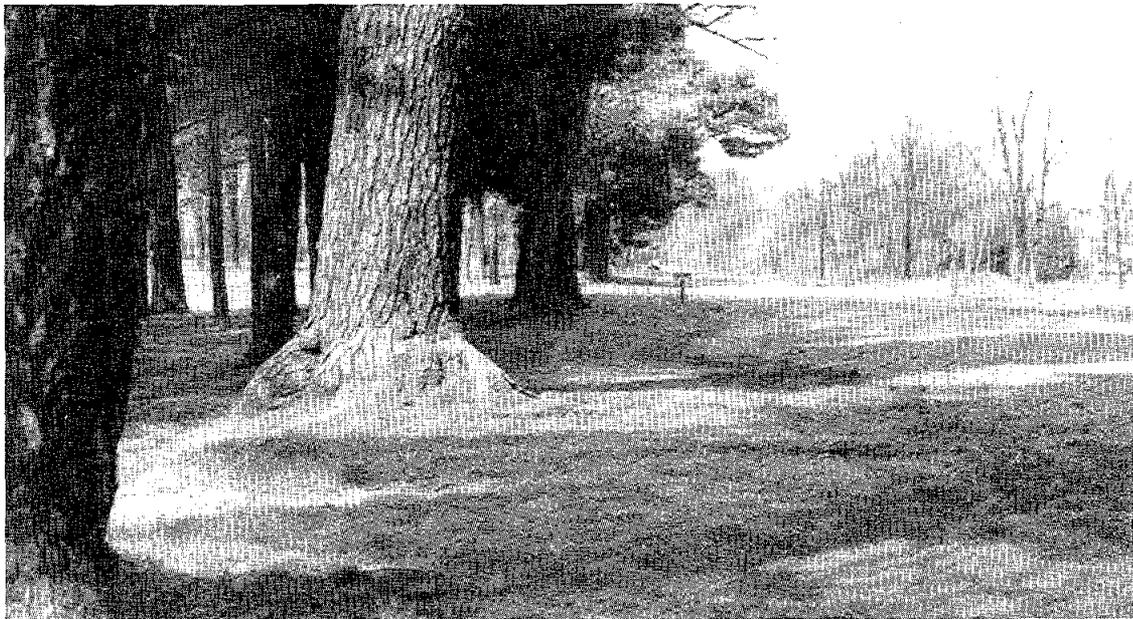
Figure 5.22: Pine row, 1993 (Photo # CLR-2061. Uschold, SUNY CESF).

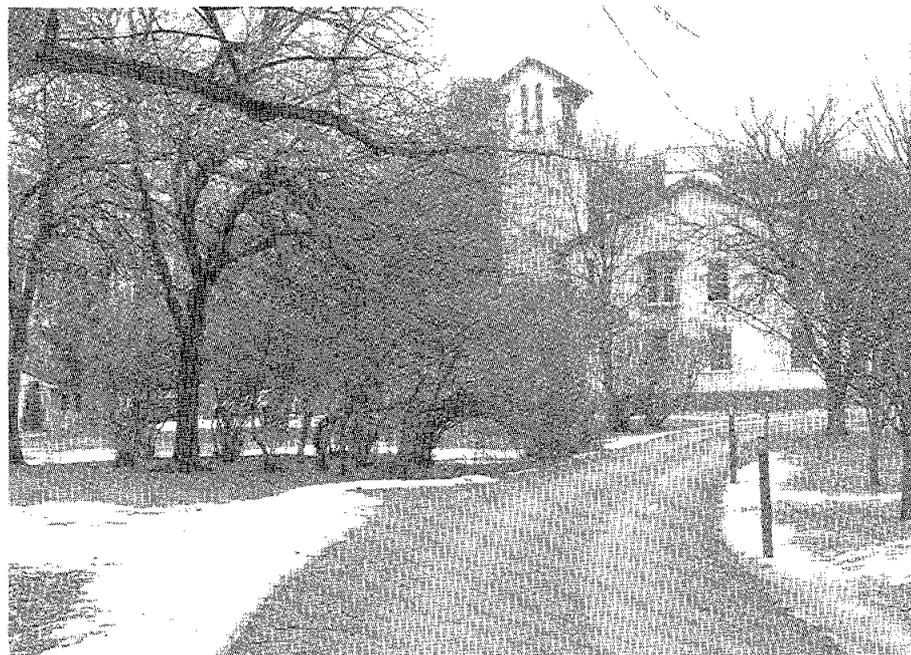
Figure 5.23: Vegetation south of main house, 1993 (Photo # CLR-1308. Uschold, SUNY CESF).

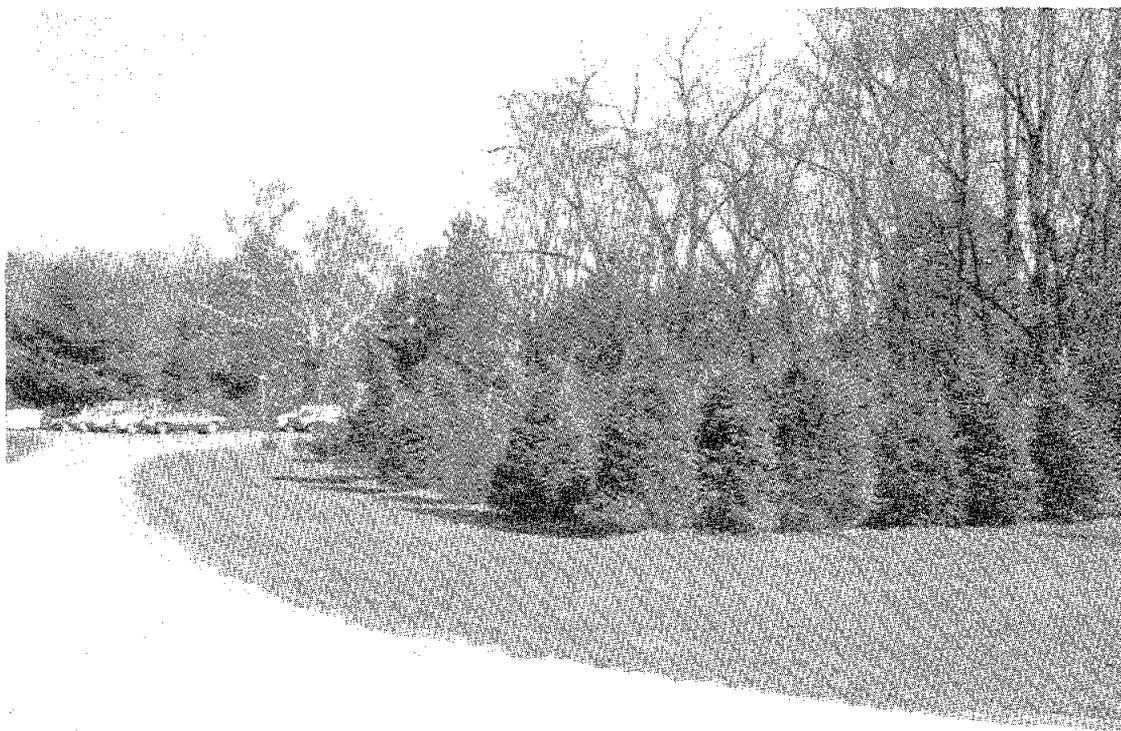
Figure 5.24: Nursery at rear of site, 1993 (Photo # CLR-3002. Uschold, SUNY CESF).

The vegetation today is finely manicured by the Park staff. The lawn is regularly cut to a height of approximately two inches, and the trees and shrubs are continuously trimmed of dead limbs and low hanging branches. Several historic trees have been replaced in kind and various new plantings have been added. The boundaries of the wood lots are maintained, but there is no other maintenance. The north wood lot often is used by the maintenance staff as a discreet storage area and Black Cherry trees are often cut for fire wood and used in the wood burning stoves in the maintenance garage. A small nursery is maintained behind the south wood lot. It holds small conifers used for replacement and screening efforts in preparation for the proposed visitor center north of the historic core. The nursery includes Canadian Hemlock (*Tsuga canadensis*), Japanese Black Pine (*Pinus thunbergii*), Douglas-fir (*Pseudotsuga menziesii*), and White Spruce (*Picea glauca*) (fig. 5.24).

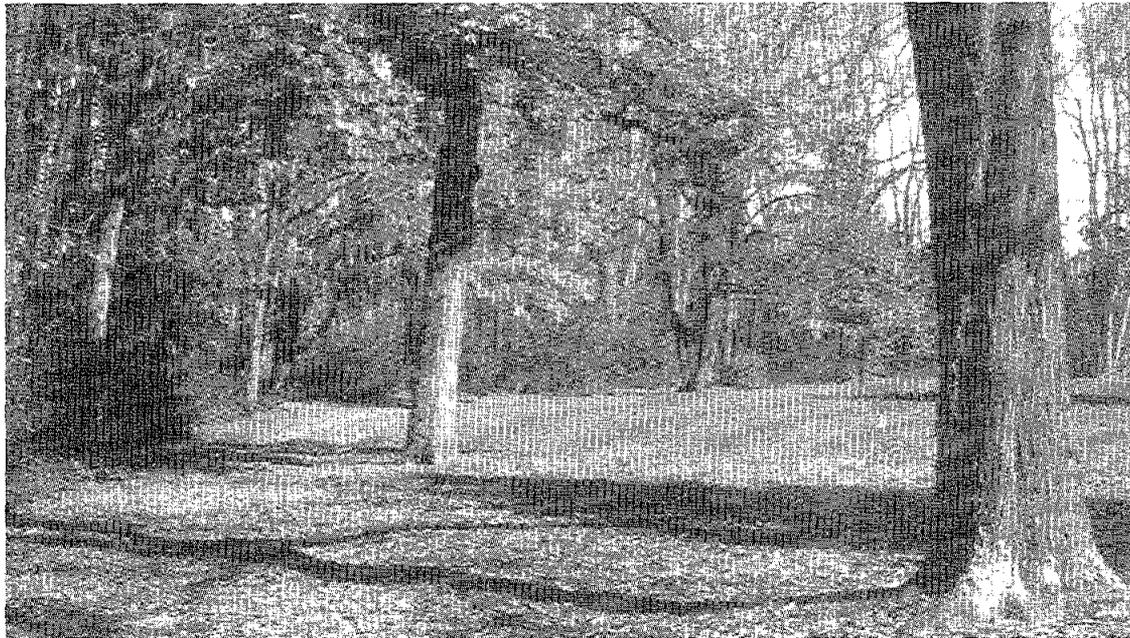
Figure 5.30: North drive, 1993 (Photo # CLR-1604. Uschold, SUNY CESF).

A number of changes and additions to the circulation systems occurred during this period. The entry drive, overgrown with vegetation at the start of the period, was re-established. Previously composed of compacted soil, crushed stone was added to the south portion of the drive, while the north remains compacted soil. The south drive is used regularly by the Park maintenance staff; the north is rarely traveled on (fig. 5.29 & 5.30). The farm road, accessing the Meyer farm complex behind the Park, was compacted soil at the start of the period. In 1989 the farm road was paved with asphalt (fig. 5.31). In the location of the garden, a temporary employee parking area has been constructed. It is composed of compacted soil and stone, accommodates approximately thirty cars, and is accessed by a road of the same materials extending from the farm road, at the intersection with the upper fish pond (fig. 5.32). A series of asphalt paths were constructed, connecting the parking, maintenance garage, mobile homes, and pole barn. Two paths were cut through the vegetation of the north wood lot. They provide the maintenance staff access to their storage areas, visitor access to the visitor rest rooms, and visitor nature walks.

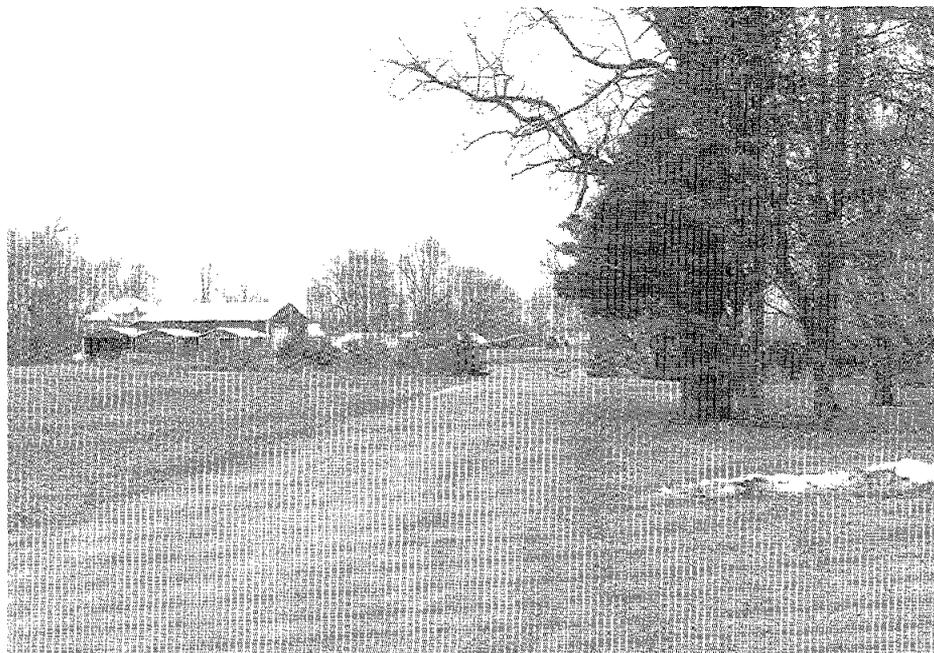
Figure 5.31: Farm road, from Rt. 9h, 1993 (Photo # CLR-1312. Uschold, SUNY CESF).

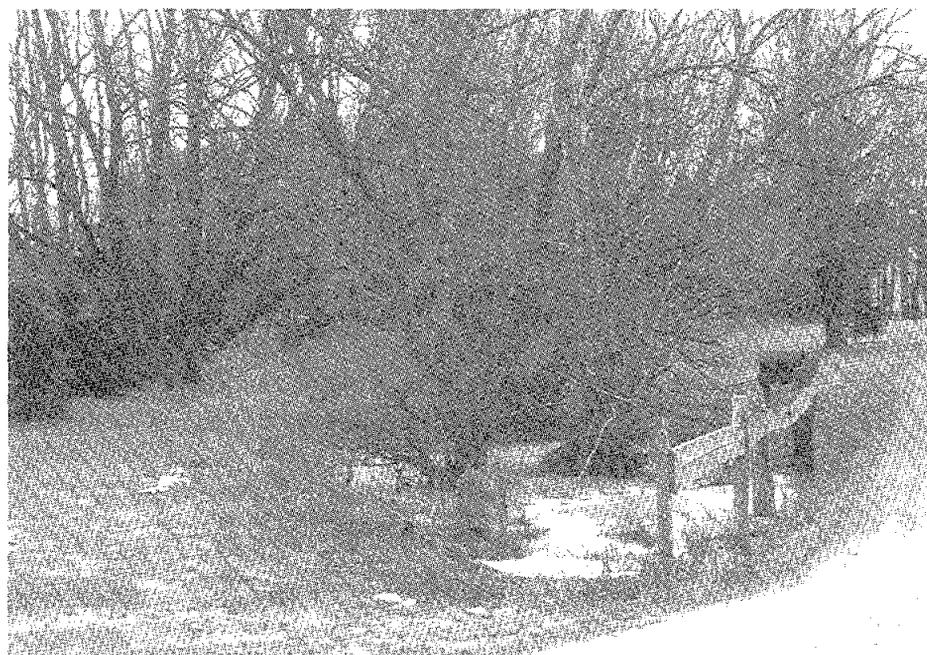
The only designed water feature within Park control is the upper fish pond. It abuts the farm road and is located on a conservation easement controlled by the Park. The pond, enlarged by Meyer during the deProsse Period, currently is used for irrigation purposes on his farm. On the opposite side of the farm road is a small pond created as a result of the farm road's construction. This small shallow pond has formed by the fill for this road. A culvert runs underneath the farm road, connecting this small pond with the upper fish pond. This pond fluctuates greatly depending on the season. It is almost non-existent during the dry summer months (fig. 5.36–5.38).

Figure 5.38: Small pond adjacent to farm road, 1993 (Photo # CLR-1319. Uschold, SUNY CESF).

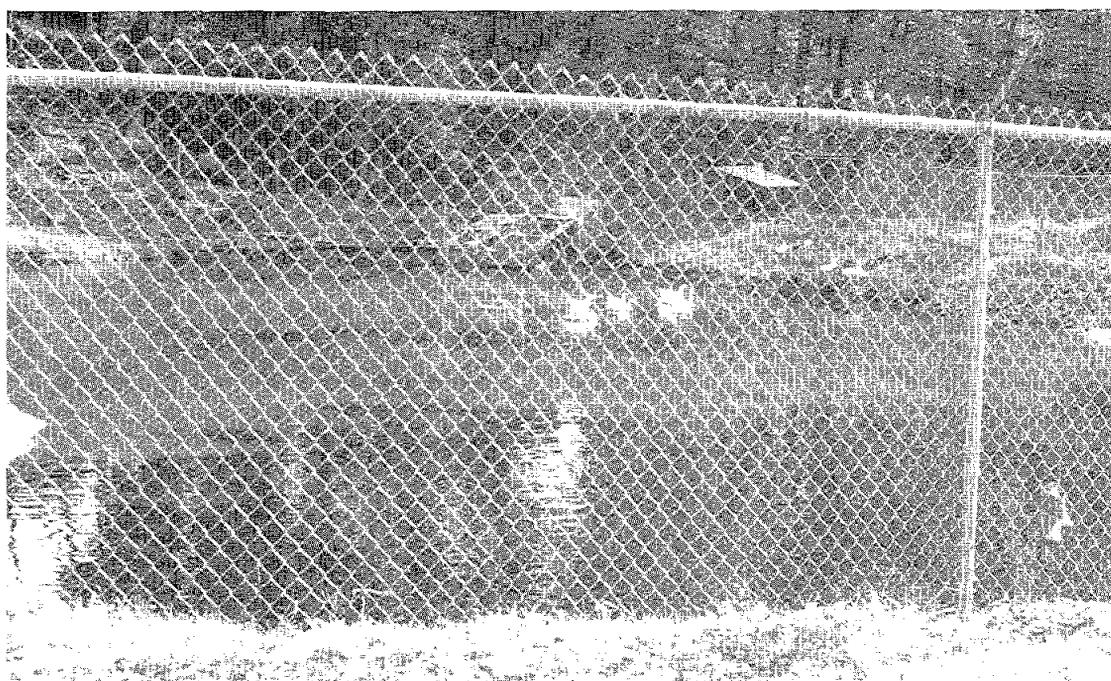
Meyer also altered the existing pond on the second terrace at the bottom of the transition slope and constructed four additional ponds on the farm. The pond at the bottom of the slope was redefined and is now also used for irrigation on the farm. Meyer constructed two additional ponds at the southwest end of this existing pond. These three ponds directly abut the bottom of the slope (fig. 5.39–5.41). Two smaller ponds were constructed within the slope between the first and second terraces. A southern one located behind the farm complex and northern adjacent to the farm road leading to the second terrace (fig. 5.42 and 5.43).¹⁴³

Figure 5.41: Southern Meyer pond at base of slope, 1993 (Photo # CLR-1671. J. Harris, NPS).

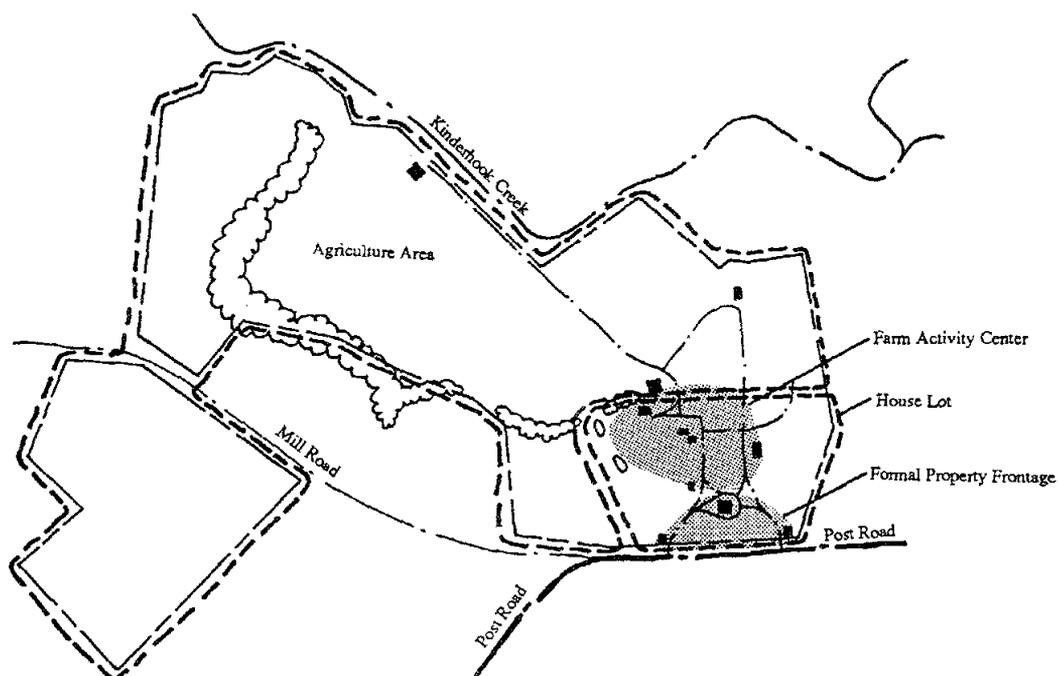
While many of the elements that created the formal character of the front of the property have been lost, much of the character has been retained. The north and south wood lots have maintained the sense of enclosure, although more dense, once defined by the locust allee. The symmetry created by the combination of the gate houses, entry drive, locust allee, and front pine row is not as strong but is still evident. The lawn has a more manicured character today, but the form remains.

Figure 6.1: Spatial Organization of Lindenwald Farm, Van Buren Period (Uschold, 1993. SUNY CESF).

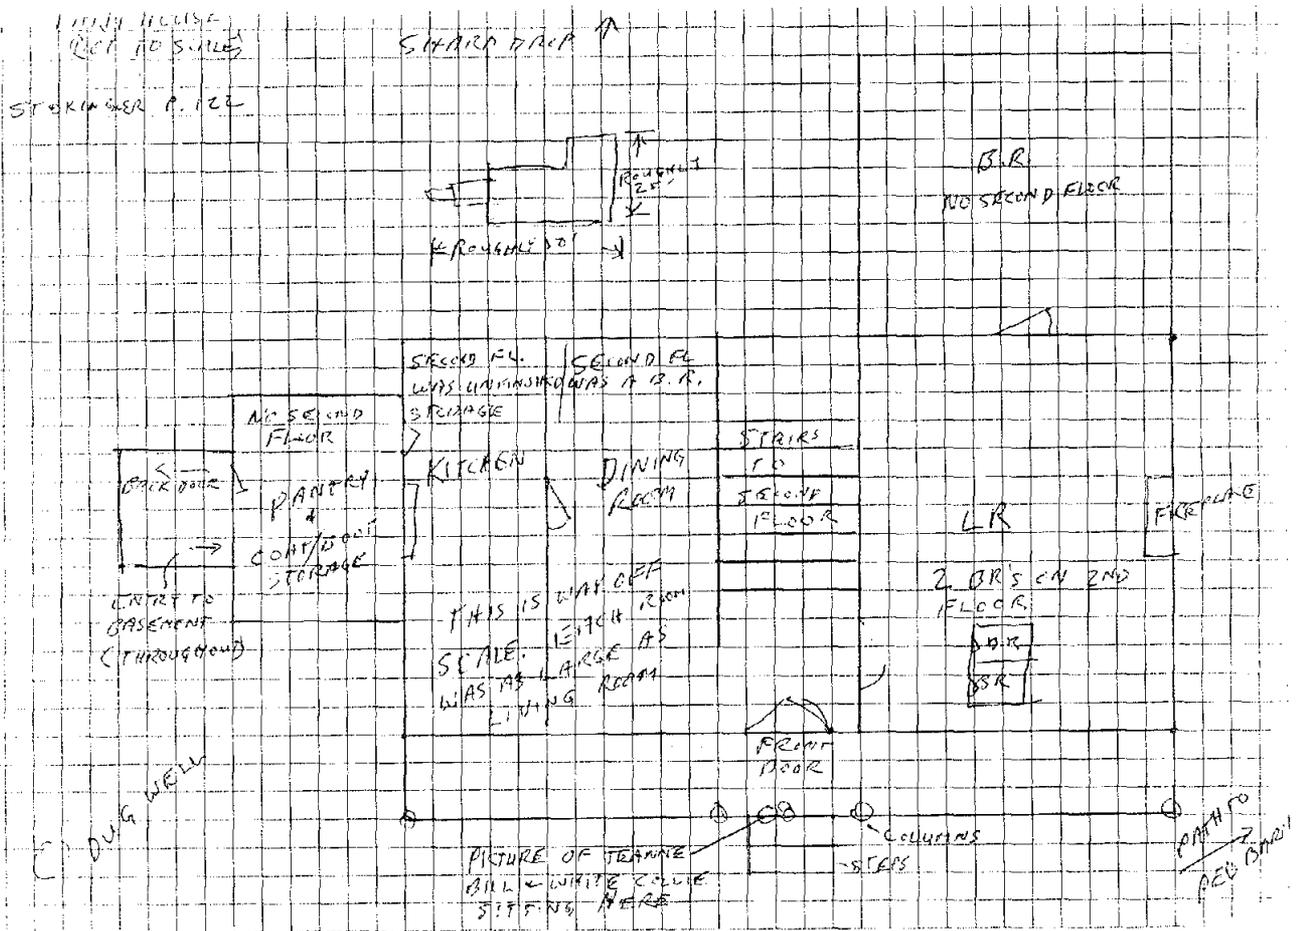
Figure F5: Farm cottage floor plan (William deProse Jr., 1993).

The farm cottage was a substantial building for a nineteenth century farm employee residence. Its existence and interpretation are integral to understanding how important and valuable the farm was to Van Buren. Recognizing the many changes the farm cottage has undergone, the location and spatial mass of the building still contribute to the historic character of the property. Further alterations may damage its ability to contribute to the historic character of the property and, therefore, it is priority for treatment.
