National Register of Historic Places
Registration Form

historic name Howard Lodge

other names HO-13

street & number 12301 Howard Lodge Road not for publication

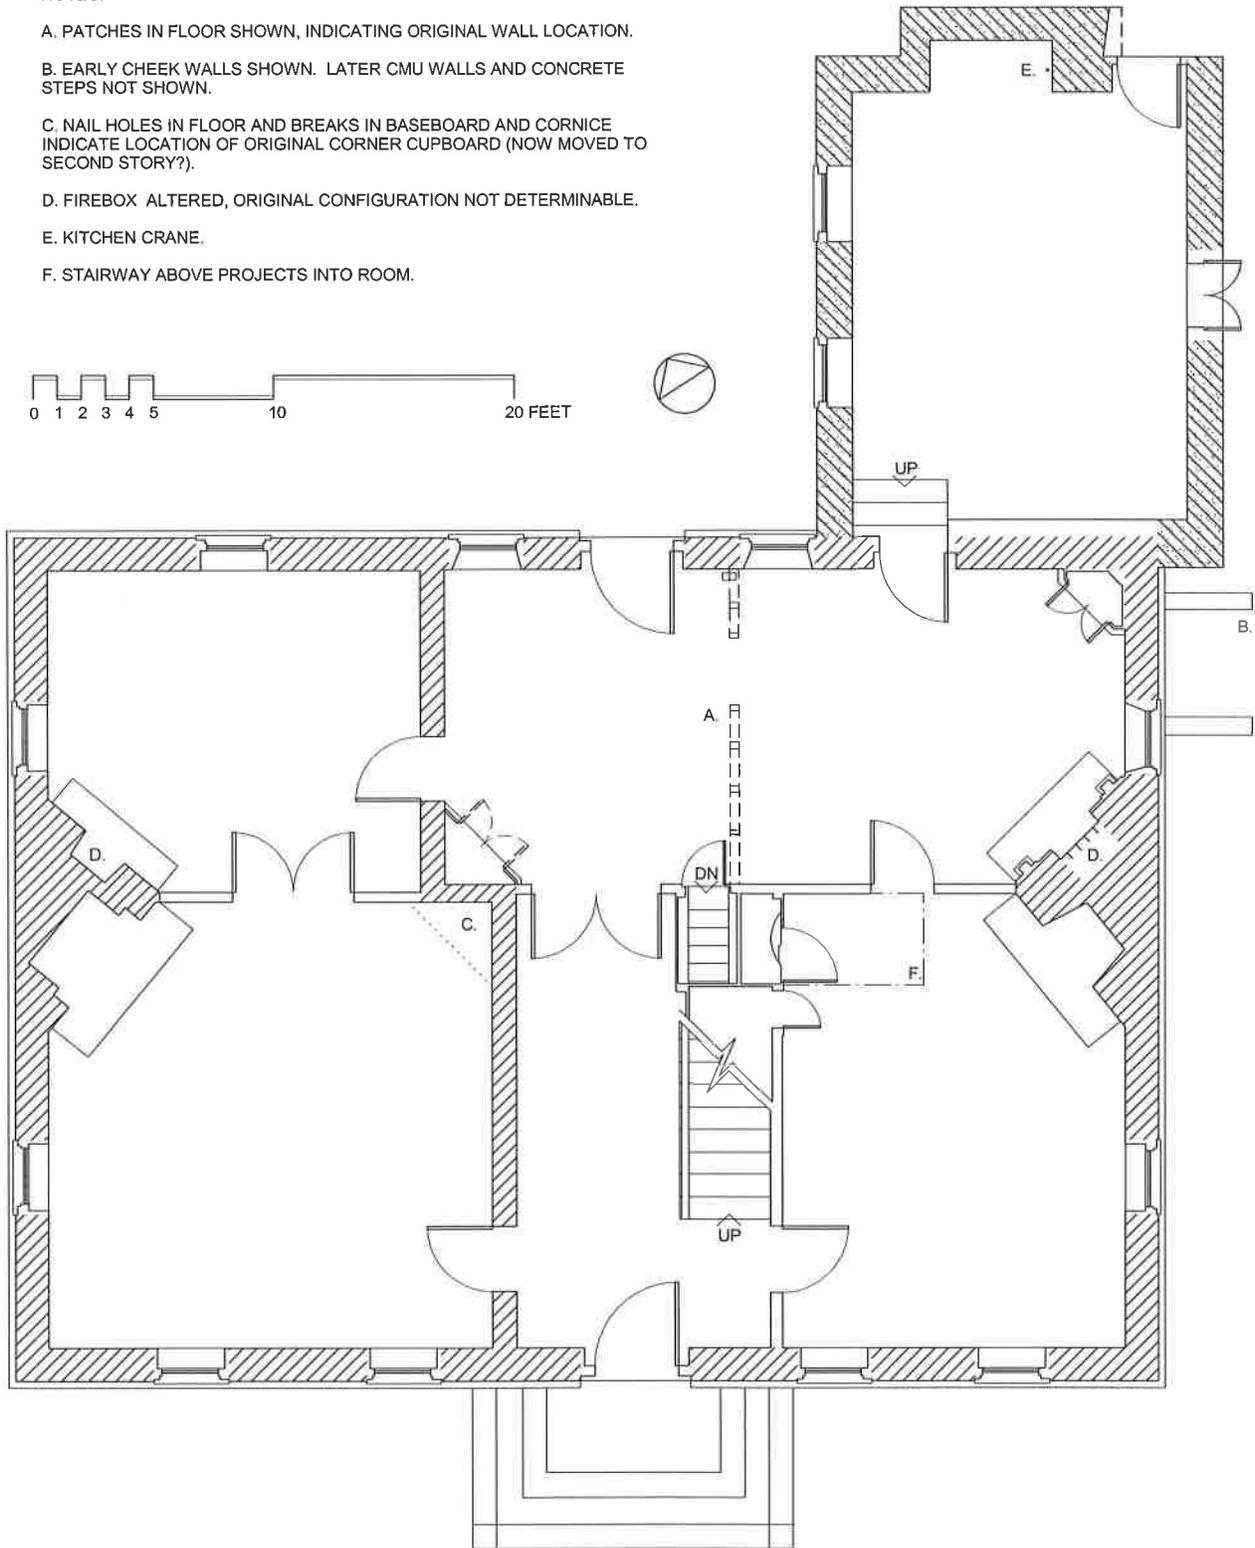
E. KITCHEN CRANE.

F. STAIRWAY ABOVE PROJECTS INTO ROOM.

HO-13 "HOWARD LODGE" 12301 HOWARD LODGE DRIVE

FIRST FLOOR PLAN -- MEASURED BY KEN SHORT, PETER KURTZE, & THOMAS RINEHART -- DRAWN BY KEN SHORT -- NOVEMBER 2010

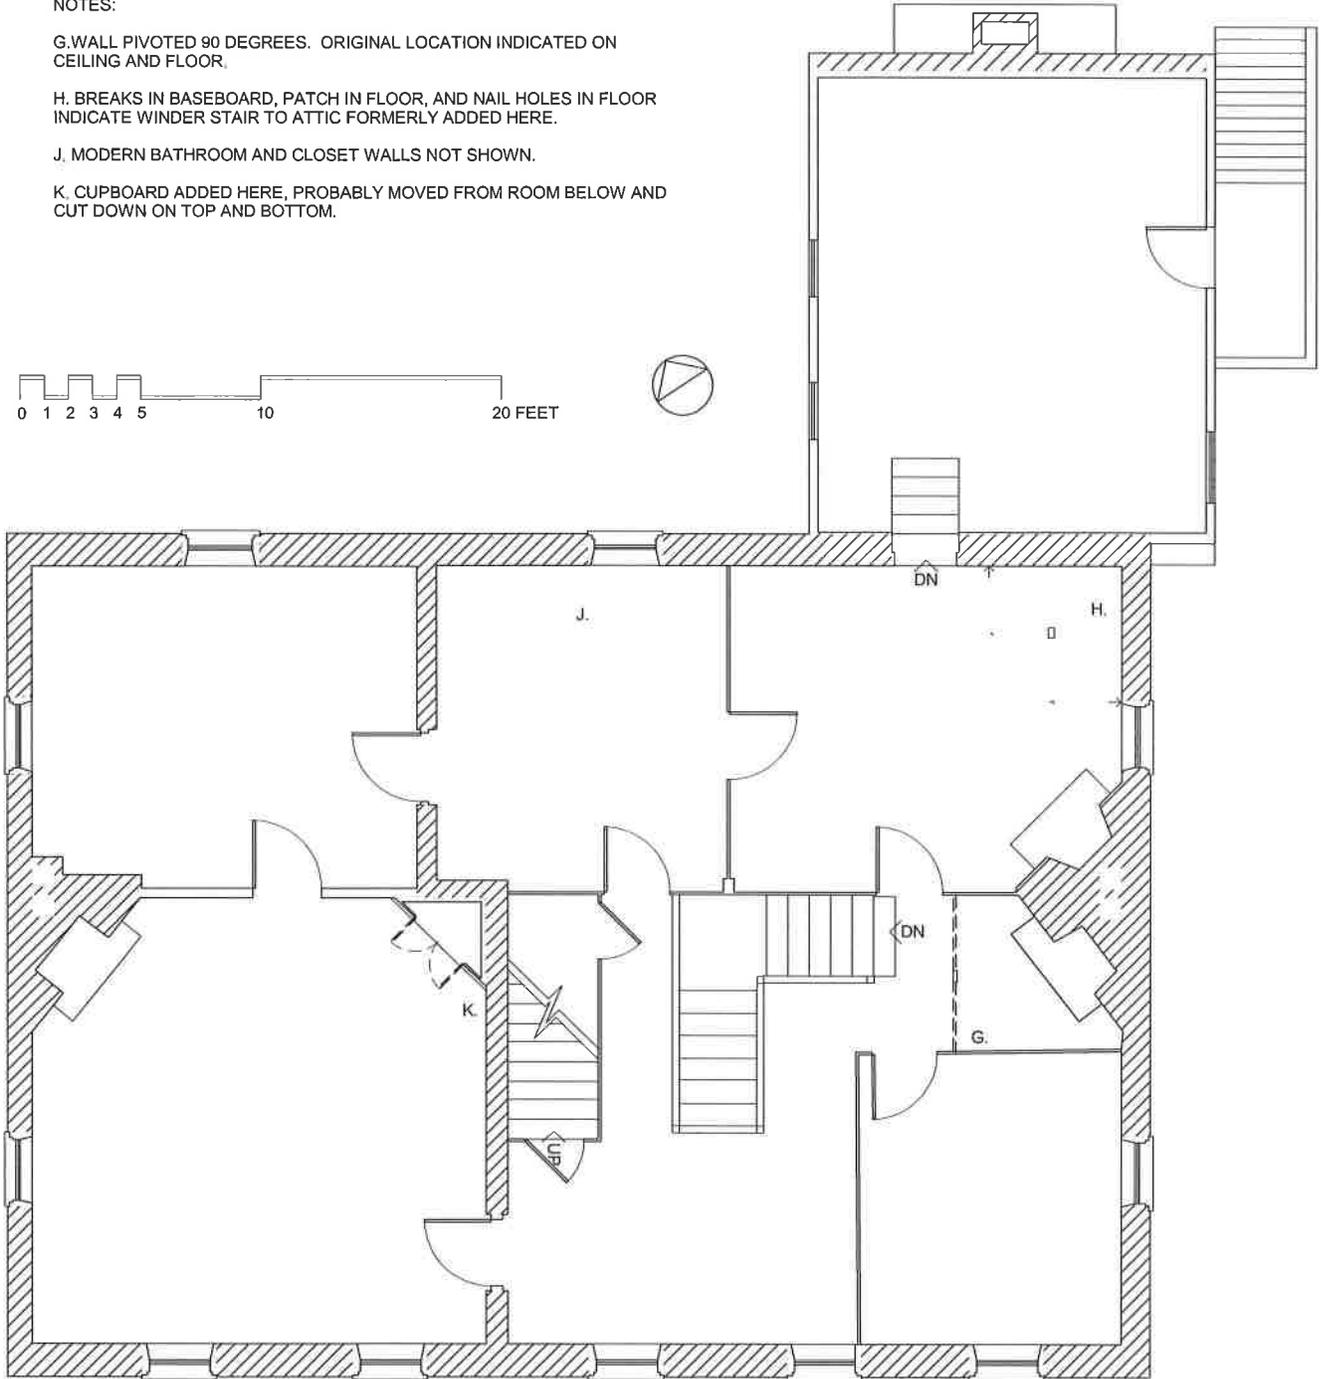
J. MODERN BATHROOM AND CLOSET WALLS NOT SHOWN.

K. CUPBOARD ADDED HERE, PROBABLY MOVED FROM ROOM BELOW AND CUT DOWN ON TOP AND BOTTOM.

HO-13 "HOWARD LODGE" 12301 HOWARD LODGE DRIVE

SECOND FLOOR PLAN -- MEASURED BY KEN SHORT, THOMAS RINEHART, & MARCIA MILLER -- DRAWN BY KEN SHORT -- NOVEMBER 2010
