Testing the Flood Resilience of Traditional Building Assemblies

How do materials used in flood-prone historic buildings in the United States fare when tested in a laboratory using modern methods and standards?

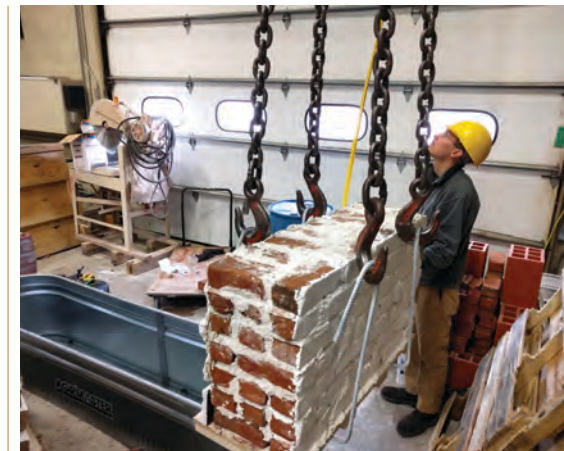
Fig. 3. Wall assemblies that were too heavy for two people to lift into and out of the immersion tank were hoisted by a crane. The wall assemblies were constructed on small wood platforms, and steel bars were used to create hooks with which to lift the samples. Courtesy of ERDC/CERL TR-19-8, 2019.

the flooding or the movement of the test specimens (Fig. 3).

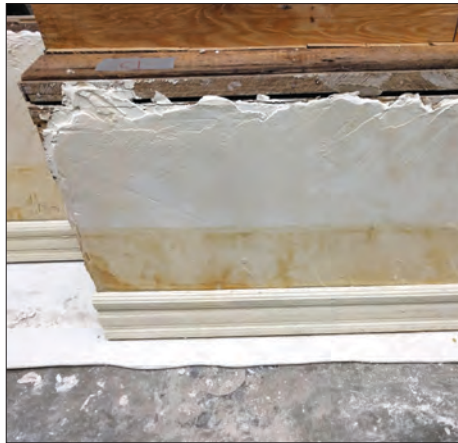
Fig. 4. The exterior of Wall A was an example of an assembly that performed well in the immersion test. Note that there is some loss of the lime mortar on the surface. Courtesy of ERDC/CERL TR-19-8, 2019.

shellac, tung oil, and floor wax on floors—there were some unforeseen outcomes. Surfaces covered with well-bonded lead-based paint performed well and seemed to resist biological growth consistent with known biocide properties, but there were some problems with paint flaking. This condition may have been the result of the wood swelling under the surface since the edges of the samples were not painted. On the floors, the shellac failed, becoming cloudy and discolored (Figs. 4–7).
