Interpreting The Secretary of the Interior's Standards for Rehabilitation

Subject: New Infill for Historic Garage Openings

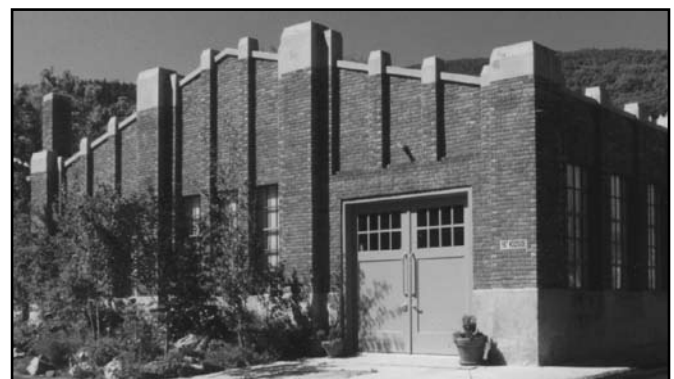
The owner chose to duplicate the original garage doors. The new doors preserved the industrial character of the historic building.

Application 1 (Compatible treatment): A "mechanical arts" building, built in 1936 as a WPA project, was recently converted from a high school industrial arts shop to a studio/office/shop. The rehabilitation of this individually listed property included the infill of an historic garage door opening on the front elevation. Historically, the garage door opening was infilled with an oversized pair of hinged wood doors, each divided into two segmented panels by intersecting stiles and rails. The top panels of each door were glazed with eight multi-paned, true-divided lights. At some point, the historic garage doors were replaced by a single roll-up wood door, divided into thirty segmented solid panels by intersecting stiles and rails. As a result of this earlier alteration, the owner had the option of preserving the existing doors, recreating a new unit based on historic photographs, or designing new compatible doors. The owner chose to recreate the doors shown in historic photographs. Fitted with handles, the new doors allow easy entrance while preserving the industrial character of the building.

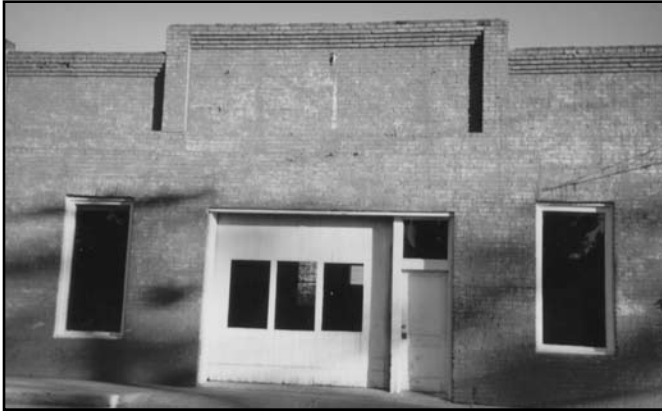
Before the work began, the original 1930 garage door opening had an operable garage door and a pedestrian door surmounted by a glazed transom installed as infill.

Application 2 (*Incompatible treatment*): A second example involves the conversion of a single story, 1930 building in a historic district, from light industrial use to office/residential use. Plans included infilling a large historic garage door opening on the principal elevation. Before rehabilitation, the opening contained an operable garage door and a pedestrian door surmounted by a glazed transom. During the rehabilitation, the owner removed the door units and installed an early-20th century style storefront in the opening, thereby creating a change incompatible with the building's historic character.

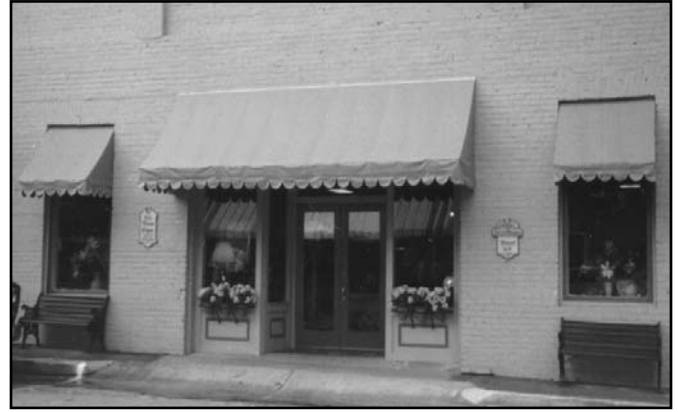
During rehabilitation the owner infilled the garage door opening with a storefront reminiscent of those used in the early-20th century, which is not in keeping with the historic character of the building.

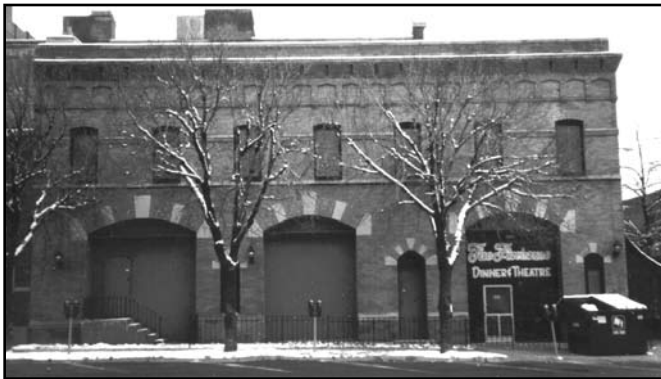
The south elevation of the 1903 firehouse is dominated by three large garage door openings. This photo was taken just prior to rehab and shows the existing infill treatments.

Application 3 (*Compatible treatment*): A 1903 firehouse, located within a historic district, was recently converted into a restaurant. The rehabilitation included infilling a series of three, segmental arched garage door openings. Historically, these openings contained firehouse doors. In 1972, these openings were infilled with concrete masonry. During the rehabilitation the current owner removed the inappropriate masonry infill and installed replacement garage doors with glazed transoms. The design of the new doors consists of multi-paned units, each divided into 16 segmented panels by intersecting stiles and rails. The panels are infilled with three rows of clear tempered glass and V-groove wood siding at the base. This compatible contemporary treatment of the replacement garage doors maintains the historic character of the building, while providing the openness sought by the new owner.

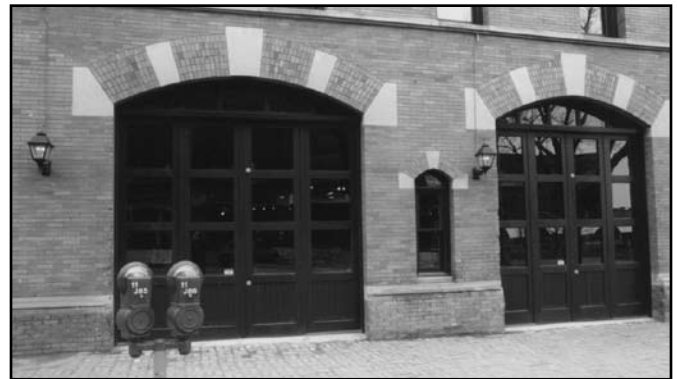
The design of the replacement doors is articulated with multi-paned units, maintaining the historic character of the building.
