ITS NUMBER 6

Interpreting The Secretary of the Interior's Standards for Rehabilitation

Subject: Preserving Historic Church Interiors

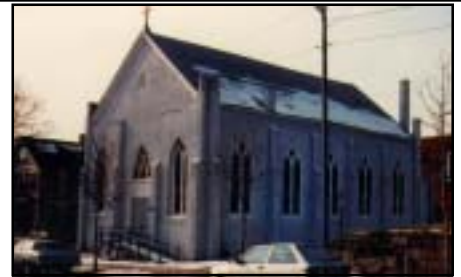
1858 Gothic Revival church building prior to rehabilitation.

Application 1 (*Incompatible treatment*): A simple Gothic Revival church constructed in 1858 was rehabilitated for combined office and residential apartment use. The interior still possessed a high degree of integrity before its rehabilitation with its tray ceiling, twelve large stained glass windows, choir loft, and the large, two-story space of the sanctuary itself. During the rehabilitation the choir loft was demolished, and the construction of a full second floor resulted in bisecting the two-story interior space horizontally. The combination of these treatments resulted in a loss of interior features and loss of the interior space itself in this historic church building. Inserting the new floor level removed the choir loft and, most importantly, resulted in the loss of the

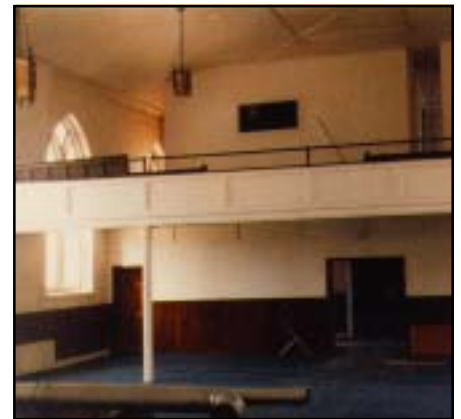
Sanctuary with choir loft prior to rehabilitation

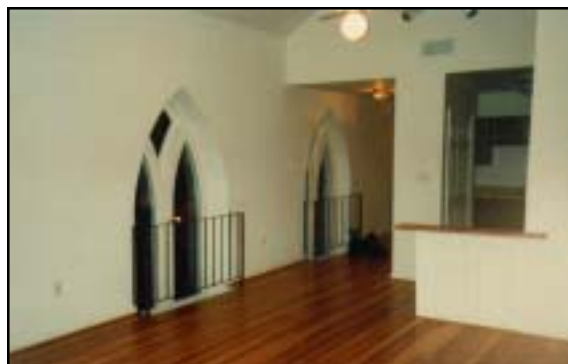
Sanctuary after rehabilitation with new floor and newly divided windows.

historic spatial volume so characteristic of church building interiors. The new second floor also negatively impacted the tall Gothic-arched windows by cutting across them, effectively reportioning them and reducing their appearance to smaller segments. This rehabilitation, because it did not preserve the integrity and historic character of the church interior, did not meet Standards 1, 2, 5 and 10. Although this particular rehabilitation was not successful, some subdivision may have been possible if a sense of the historic interior space and volume had been preserved, as was achieved in the second example.

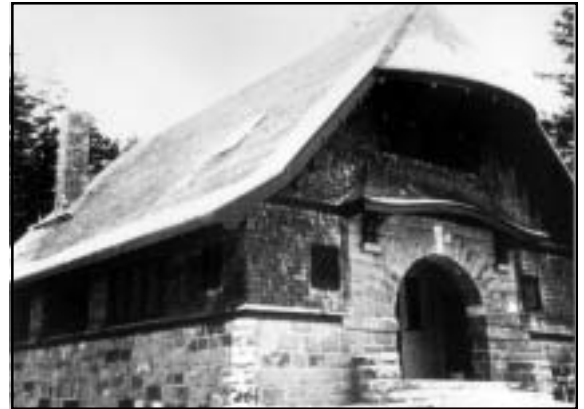
Shingle-Style church. North and east elevations after rehabilitation.

Application 2 (Compatible treatment): In another example, a small, two-story, rectangular Shingle-style church, built in the late-19th century, was rehabilitated into a single-family dwelling. Prior to rehabilitation, the interior historic finishes still remained intact, as did the sanctuary space itself lit by original clear glass casement windows. As part of the rehabilitation, approximately a third of the first floor sanctuary space was partitioned off at the rear and modified for use as two bedrooms. The remaining two thirds of the sanctuary was retained intact as the living room, and the apse became the dining area. The corner rooms (the cloakroom, vestry and rear entry vestibule) were kept in their historic configuration and converted into a bathroom, kitchen and mudroom, respectively. To permit more light into the interior, plaster panels at the back of the apse were removed and replaced with clear, single-paned glass windows. The existing stairway provided access to the choir loft which was converted into a master bedroom and bath with only a minimal amount of alteration, even allowing retention of the historic church organ. This rehabilitation successfully preserved the primary, character defining features, finishes and spaces of this historic church interior.

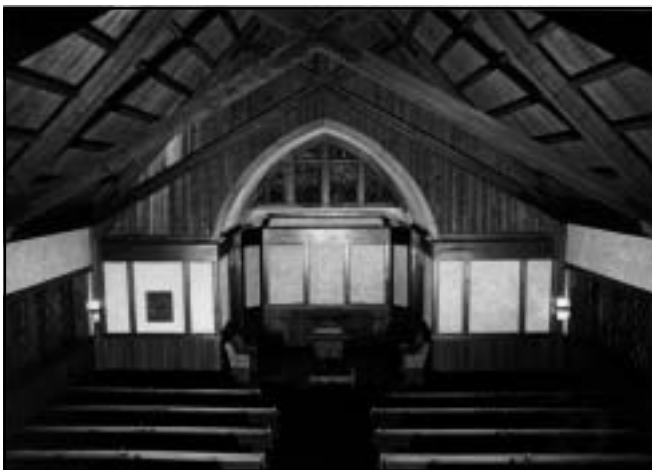
Sanctuary and apse before rehabilitation.

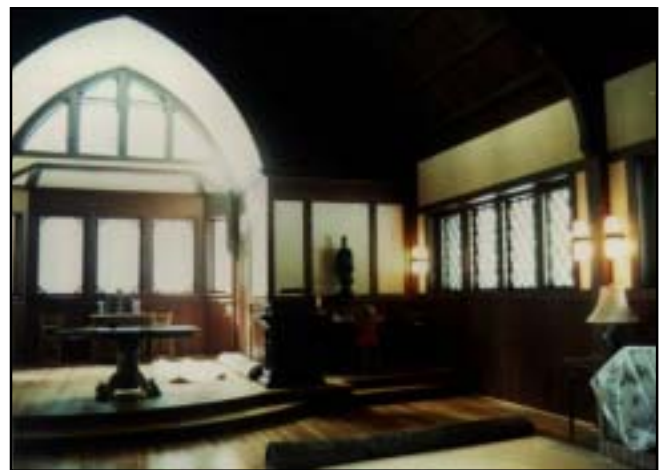
Sanctuary after rehabilitation. View toward kitchen and dining area from living space.
