Subject: Slate Roof Treatments

- Applicable Standards:**
- 2. Retention of Historic Character
 - 6. Repair/Replacement of Deteriorated or Missing Features Based on Evidence

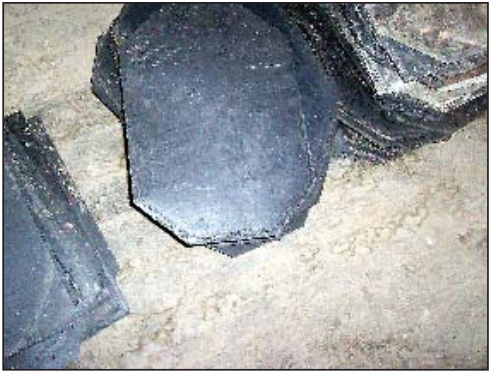
Right: New rubber slate (center; left) next to historic slate (right).

Application 1 (Compatible Treatment): After surveying approximately fifty buildings in this Colonial Revival-Style apartment complex, it was determined that the 80-year old slate roofing was in poor condition. As a result, the owner proposed that all the slate be removed and replaced with a polymer-based substitute. The most distinctive features of these simple 2-1/2 story brick garden apartments are their hipped and gabled slate roofs, which are very visible within the complex. Therefore, replacement with a substitute material was deemed incompatible and the owner agreed to use new slate from the original quarry. The new slate roofs, which require only seasonal maintenance, are a sound investment and historically appropriate.

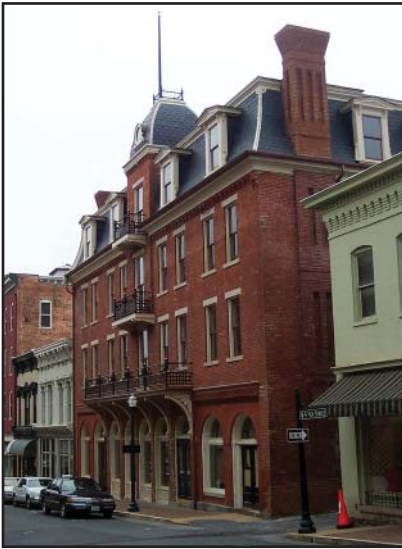
Left: Second Empire former hotel, built in 1894.

Application 2 (Compatible Treatment): This 1894 example of Second Empire architecture is “high style” with pedimented dormers, balconies, corbelled cornices, a dominant central tower, and a small mansard roof covered in slate. Prior to rehabilitation the property was in extremely deteriorated condition and although some of the slate on the mansard was still there, it was delaminating, fractured, and partially painted. Since the roof is only one of many decorative elements making up the primary façade and not the sole defining feature of the building, replacing the slate with a polymer-based substitute slate was an acceptable alternative. Although the replacement slate is visible,

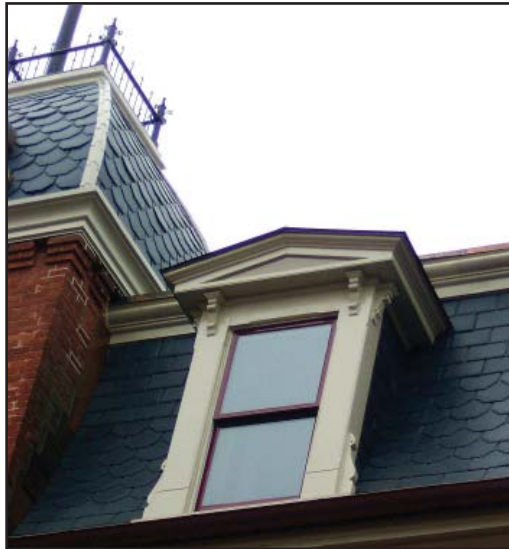
Right: Close-up of substitute slate after installation.

it replicates the decorative fish-scale pattern of the historic slate and, thus, has the same appearance as the original roof. Because the building is on a narrow street and is generally viewed at an angle rather than head on, the mansard roof is not the major focal point.
