## Interpreting The Secretary of the Interior's Standards for Rehabilitation

### Subject: Converting Fire Escapes into Balconies in Mill Complexes

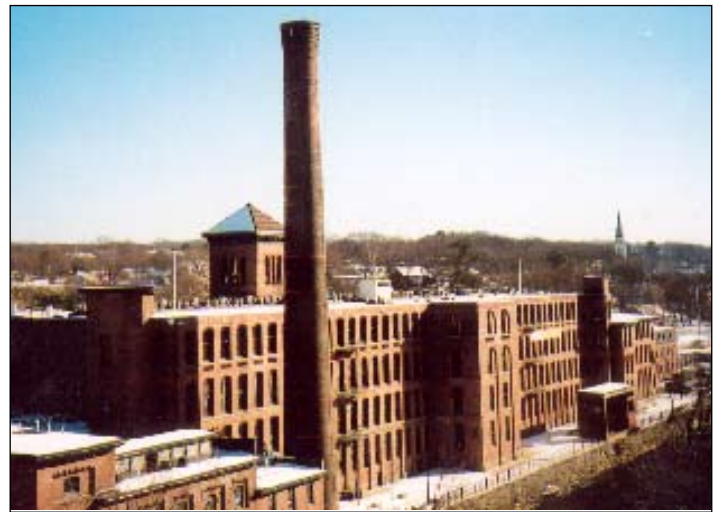
Many historic mill buildings that are being converted for residential use retain their historic fire escapes.

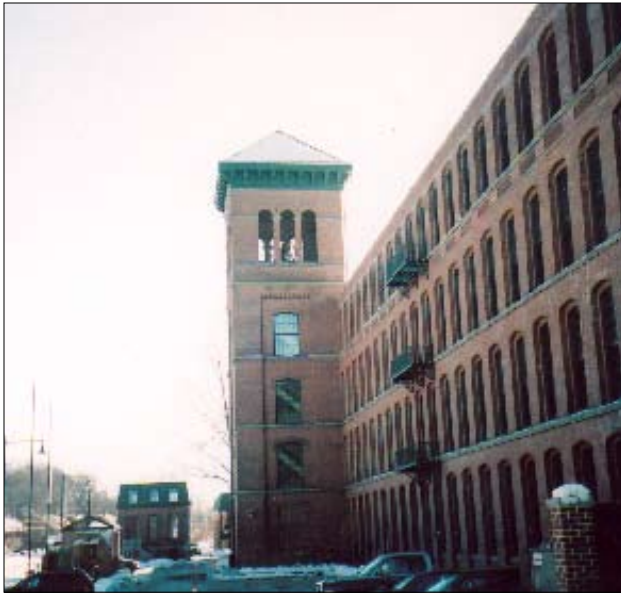
*Far left: Mill building with fire escape after rehabilitation. Left: Section detail of new balconies converted from historic fire escapes.*

**Application 1 (Compatible treatment):** A large, 1868 brick mill complex was recently converted to housing with 207 market-rate and 42 low- to moderate-income units using federal historic preservation tax credits. There were two sets of historic fire escapes on both the east and west elevations of the four-story main complex. As part of the rehabilitation, the fire escape landings and railings were retained and converted into balconies after they were sandblasted, primed and painted. The fire escape stairs were removed for safety and security reasons. This treatment meets the Standards.

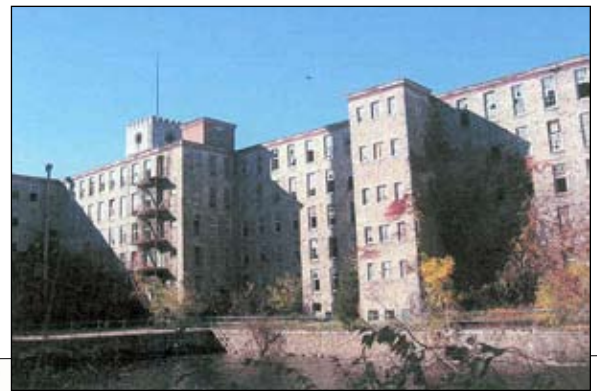
**Application 2 (*Incompatible treatment*):** This 1814 mill complex was planned to be converted for housing consisting of 273 market-rate units and related service areas. The five-story, 450 feet long, main building constructed of rubble stone has an irregular footprint with multiple stair towers and numerous ells. It also features several tiers of fire escapes. The developer proposed to adapt the existing fire escapes into balconies, but also to add multi-story columns of new balconies of a different height and much deeper than the fire escape landings. Adding these new balconies would have changed the historic appearance of the exterior of the mill building. But, equally important, because the new balconies would have been lower than the landings of the fire escapes, existing historic windows would have had to be lengthened into doors to access the balconies. The combination of adding new balconies and making so many windows into doors would have negatively impacted the character-defining fenestration that distinguished the mill building. This proposed treatment did not meet the Standards.
