Chapter 9:

District-wide Design and Management Guidelines

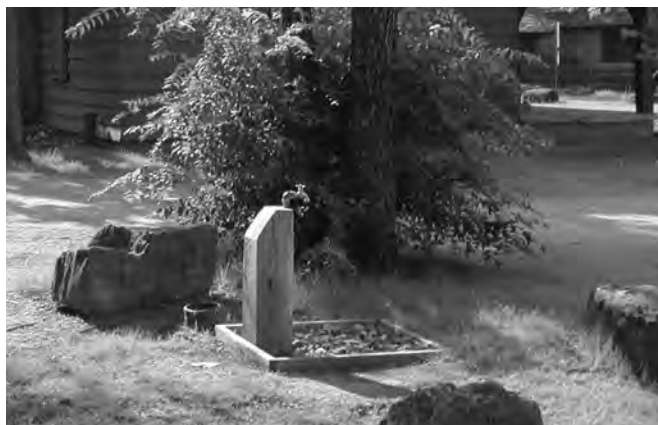
Figure 9-1. Existing hydrant type with stone drainage area at base in Cold Springs Campground.

A variety of hydrant styles (Figures 9-1 and 9-2) currently exist in the district. With the exception of the hydrants at the base of the rectangular stone trash and wood enclosures at Cold Springs Campground, most hydrants do not appear to be historic, and instead date to recent times. The current designs are functional, but wood supports are beginning to rot, and grey water drainage is often a problem at the base of heavily used hydrants.

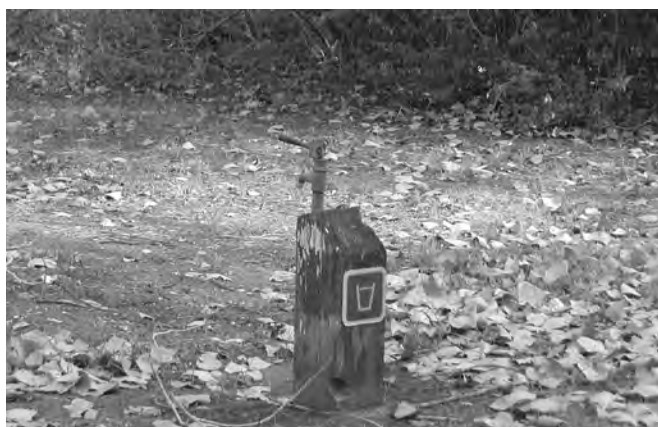
Figure 9-2. Existing hydrant in Walnut Grove.

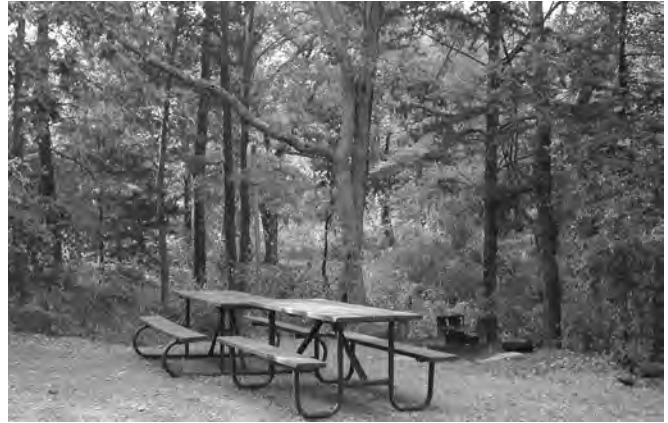
Figure 9-4. Standard picnic tables currently used in the district.

During the period of significance, picnic tables were generally of wood frame construction (see Figure 4-84). Some areas also had stone or concrete picnic tables (see Figures 4-90 and 5-65). The picnic table currently used throughout the park is a two-inch pipe frame with wood tops and seats that are stained with a brown (color “Spicewood”) solid-body stain by Sherwin Williams (Figure 9-4). This picnic table is functional and appropriate and its use should be continued.

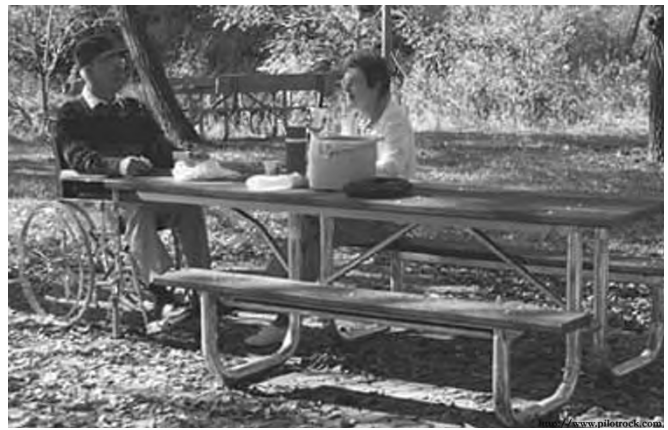
Figure 9-5. Accessible picnic table with extended end, as used throughout the district.

As picnic tables are replaced, however, it is suggested that at least twenty-five percent of tables have ends extended twenty-seven inches, to accommodate wheelchair access. An eight-foot long table with such an extended end (Figure 9-5) is currently used in the district because they are accessible, yet still easily moved. Although an accessible picnic area is recommended (see below) for each major picnic area, locating a number of accessible picnic tables throughout the park at undesigned sites may also help increase access.

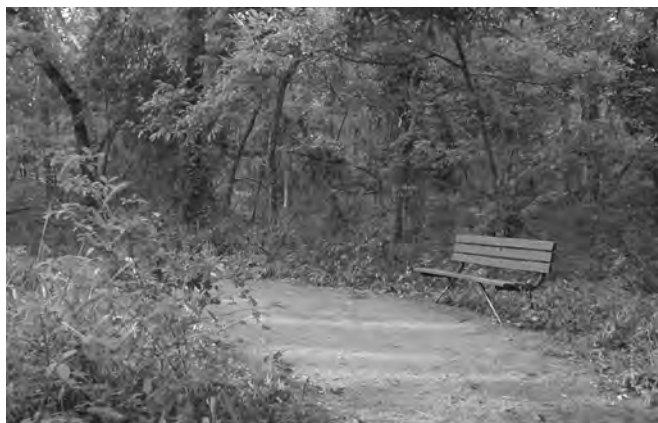
Figure 9-6. Typical bench used in the district. This one is located at Antelope Springs.

Today, a few benches exist in the park, along Veteran's Trail and Buffalo-Antelope Springs Trail (Figure 9-6). These benches are neither attractive nor in keeping with the park's historic appearance. However, they are useful in increasing the accessibility of these trails. According to ADA guidelines, accessible trails (those with slopes five percent or less) should provide seating every two hundred feet. Although fully accessible trails are not possible in much of the district due to steep slopes, providing benches along trails in some locations will increase accessibility.

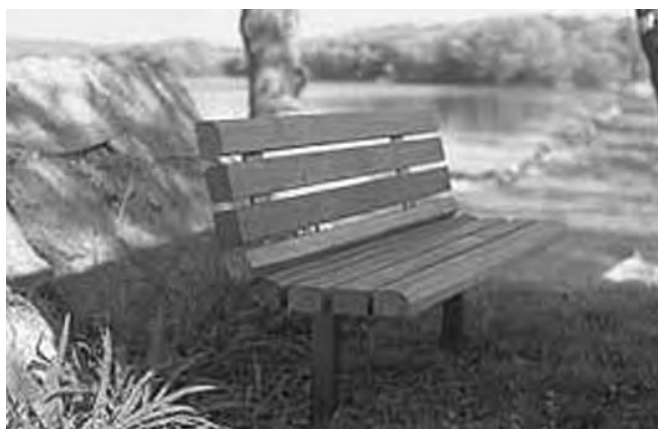
Figure 9-7. To project a consistent image, one bench design should be used throughout the district. This simple wood bench (a style available from many vendors) is one design alternative.

materials. Natural materials such as wood and stone may be preferable to plastic or metal, to be in keeping with the rustic nature of the rest of the district's structures and features. Different alternatives for the design are provided in Figures 9-7, 9-8 and 9-9; any single one of these options would work, or another design could be developed.

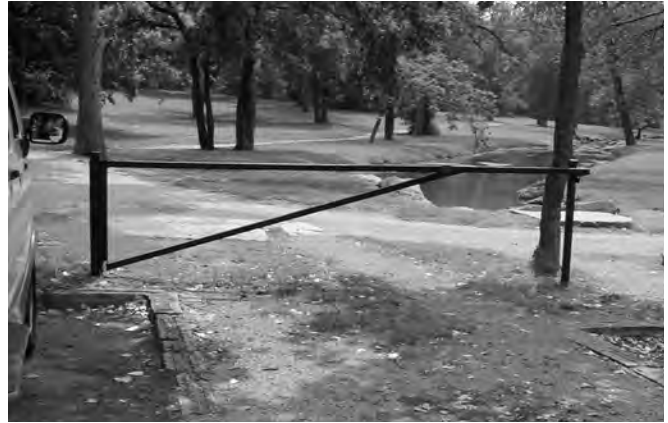
Figure 9-10. Typical metal gate used in the park is unattractive and should be replaced by gate in Figure 9-11. This gate, in Flower Park, was replaced in the summer of 2003.

Vehicle gates are located at Cold Springs, Rock Creek, and Central Campgrounds to close off portions of the campgrounds or the whole campground during the off season. These metal gates (Figure 9-10) are typically unattractive. When they deteriorate, they should be replaced with a gate more compatible with the district's historic setting. A gate (Figure 9-11) currently used at the Point Campground is a good model, and may be used singly or in pairs, depending on the width of the access route. The gates in all locations should be consistent with each other.

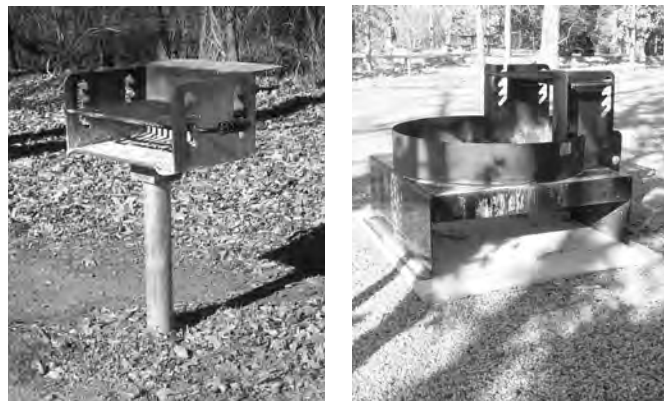
Figure 9-12. Pedestal grill (left) and fire ring grill (right) currently used in the park. The fire ring, on a concrete pad, has an ADA-accessible, adjustable grill.

The district's historic grills—stone masonry fire pits with metal grills (originally located at Cold Springs Campground, Walnut Grove, and Buffalo and Antelope Springs) and concrete grills (originally located at Rock Creek Campground)—are by-and-large no longer extant for use in the park. Replacing these historic structures is not recommended. Instead, use of the current two styles of grills—a pedestal grill and a combined metal grill and fire ring on a concrete slab (Figure 9-12)—should be utilized throughout the district. Both models of these grills currently being used in the park are ADA-compliant. To provide a consistent district appearance, upright grills should be used at all picnic areas and the circular metal grill and fire ring used at campgrounds.

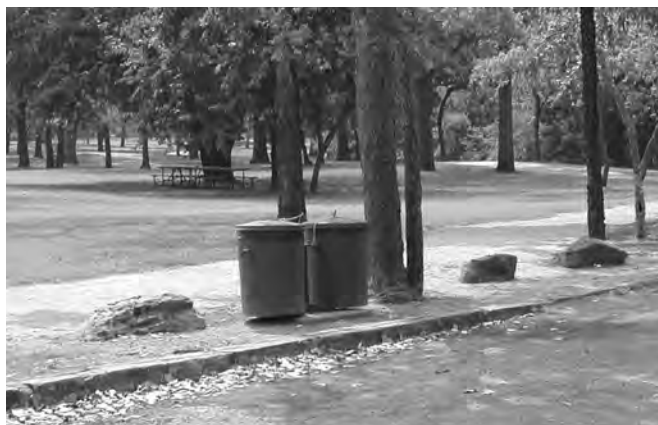
Figure 9-13. Thirty-gallon lidded trash receptacles currently used in the park.

Today, there are two main types of trash receptacles in the district: brown, round thirty-gallon lidded cans, often mounted in pairs on low, metal pole structures (Figure 9-13), and rectangular raccoon-proof cans bolted to a concrete pad (Figure 9-14). The round cans have been in use since the 1960s or 1970s, while the raccoon-proof receptacles date to the 1990s. While neither receptacle is attractive, the raccoon-proof bins are more obtrusive, in part because they are large and their shape is somewhat atypical. However, other raccoon-proof receptacles on the market are equally unattractive.

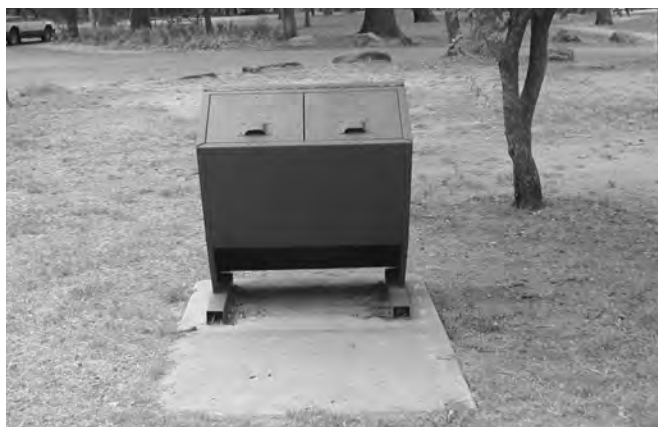
Figure 9-14. Raccoon-proof trash receptacles currently used in the park, such as in the Bromide area.

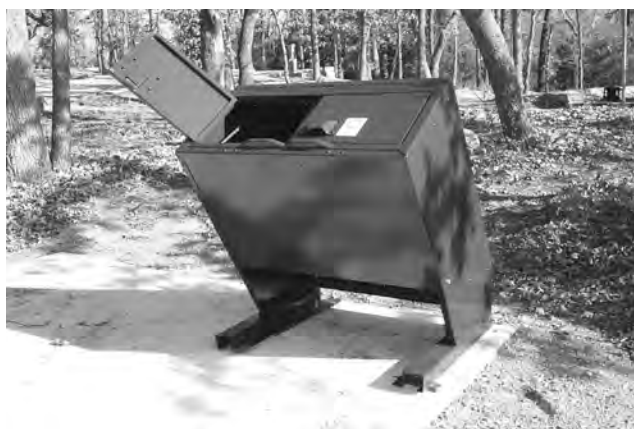
Figure 9-15. Accessible raccoon-proof trash receptacle, used elsewhere in the CNRA. The doors on this model open horizontally instead of vertically.

As a result, introducing a new type of receptacle is not recommended, as it would simply add more visual clutter to the landscape. Rather it is proposed that existing models be maintained. The need to add more raccoon-proof receptacles in the district, however, seems likely. To reduce their visual impact, a number of actions are recommended. First, they should be restricted to the current size (paired thirty-gallon bag holders) and should not be increased to the larger, sixty-gallon paired fixtures. Second, they should be painted a consistent color throughout the district. Third, when mounted on a concrete pad, these pads should be colorized or stained to make them less obtrusive in the landscape. Finally, an ADA-accessible model, one with doors that open horizontally (rather than vertically) should be considered, especially in ADA-accessible picnic areas or camping areas (Figure 9-15).

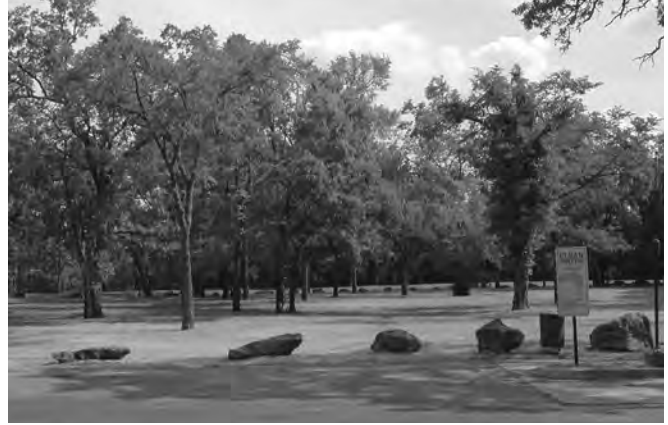
Figure 9-16. Boulder roadside barrier. Notice that recently installed boulders are placed at grade, and not embedded in the soil.

In most parts of the park, boulders delineate roads and parking areas and separate vehicles from pedestrians or natural areas. Much of this “boulder guardrail” (as it was then known) was installed in the 1930s and its use is clearly a character-defining feature of the Platt Historic District. However, original boulder locations were not documented in a detailed manner during the initial period of placement, although we do know that they were installed “along park roads.” Locations included the edges of the roads and parking areas of Bromide Springs and Travertine Island and Little Niagara Falls, as well as along roads and spurs in Cold Springs Campground. Since 1940, boulders have been installed in many more areas of the park and so it can be difficult to distinguish “historic” from “non-historic” boulders. Usually, more recently placed boulders are those placed simply at grade (Figure 9-16). Historic boulders were usually embedded in the soil with about one-third of the boulder below grade (Figure 9-17), and sometimes were placed on a concrete pad.

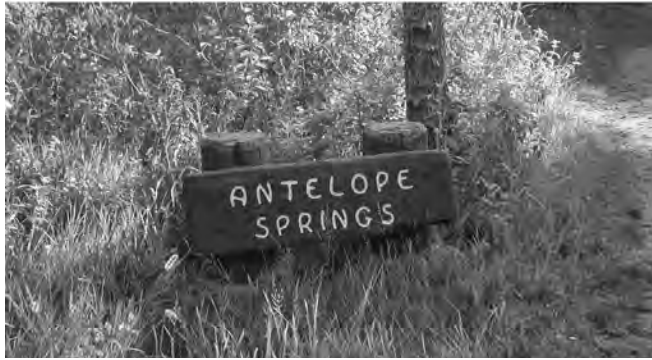
Figure 9-18. Half-log place name sign: proposed design from “Signs for General Park Area,” Drawing NP-PLA-8010 (top), and extant historic sign at Antelope Springs.

Half-log place name sign (Figure 9-18):

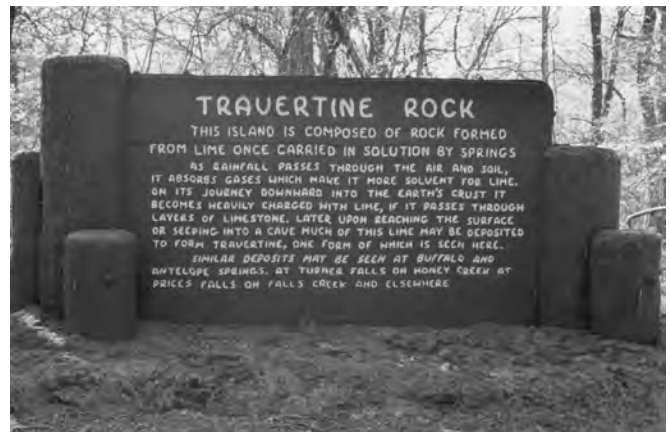
Figure 9-21. Extant historic interpretive sign at Travertine Island.

Historic Interpretive Signs (Figures 9-21 and 9-22):

The two remaining historic interpretive signs should be retained and replaced in kind. The one at Travertine Island is rapidly deteriorating and the one at Bromide is an inaccurate restoration. These signs are highlighted in Chapter 11 as individual projects. The mineral water composition signs at the Bromide and Pavilion Springs pavilions are also historic interpretive signs, and these should also be retained and preserved.

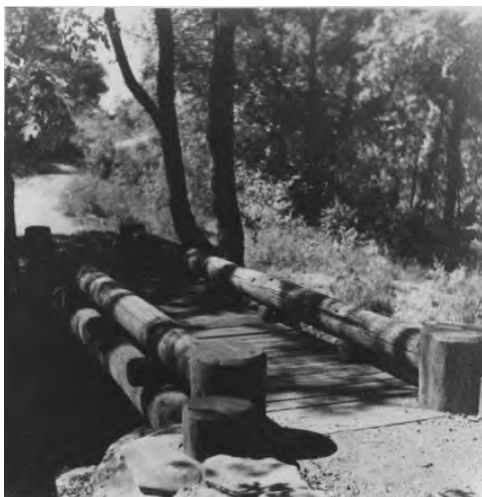
Figure 9-23. Historic bridge design, unknown location in park, circa 1935. Bridges were constructed of large, peeled, creosote-impregnated logs, atop stone abutments.

Historically, trail bridges were constructed of massive timbers, located atop stone abutments (Figure 9-23; see also Figures 4-14 and 4-17). Today, the trail bridges are more simply constructed. A pair of steel I-beams span the historic abutments and a wood plank deck sits atop the I-beams. Hand-railings, if present, are usually pipe railings (Figure 9-24). On some trails, such as the Buffalo Pasture Trails, bridges do not have railings. Although there are quite a few bridges along the district's trail system, these purely functional, low-profile structures do little to enhance the character of either the trails or the district.

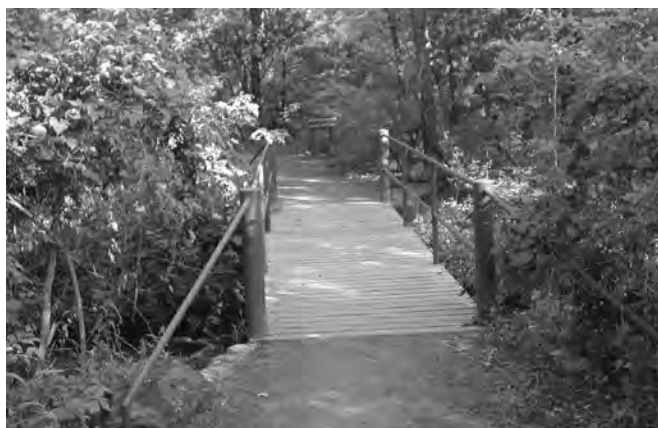
Figure 9-24. Existing trail bridge with pipe railing at Travertine Island. Such structures are functional, but do little to enhance the character of the district.

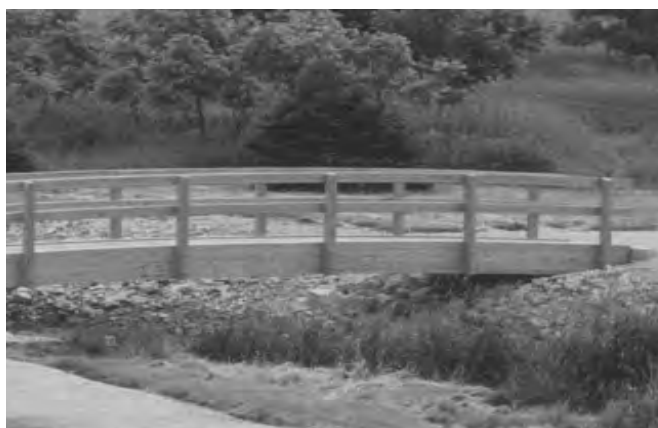
Figure 9-25. A potential new bridge design in a style readily available from a landscape structures vendor. A custom bridge design is another alternative.

Recreating the historic bridges is not recommended, since little documentation of them has been found. However, the bridges could and should reinforce the district's historic character. As they wear out, the existing, non-historic structures should be replaced with a consistent bridge design that is clearly contemporary, but more in keeping with the original historic form and massing of the original structures and with the historic character of the district. Such a design might have wood timber railings, such as supplied by a vendor (Figure 9-25), or it might be a custom design using the historic bridges as inspiration.

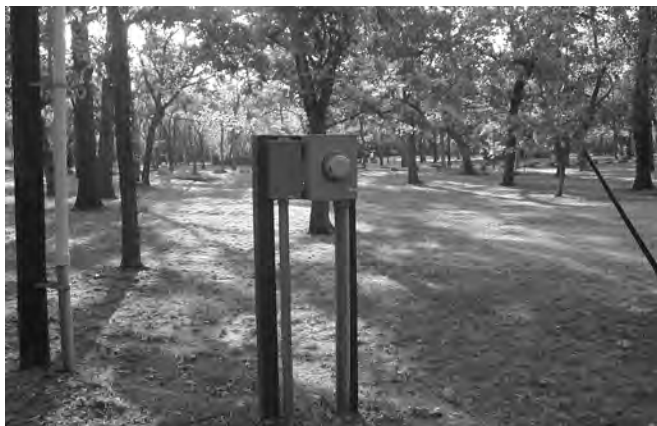
Figure 9-26. Utility box at Bromide. Such infrastructure could be eliminated by placing utilities underground.

In general, utility infrastructure should be made less visible (Figure 9-26). Phone and electrical boxes should be painted brown to blend in with surroundings, provided that the utility companies will permit this. The satellite dish at the Headquarters and Administration area should also be painted brown (see Project AH4 in

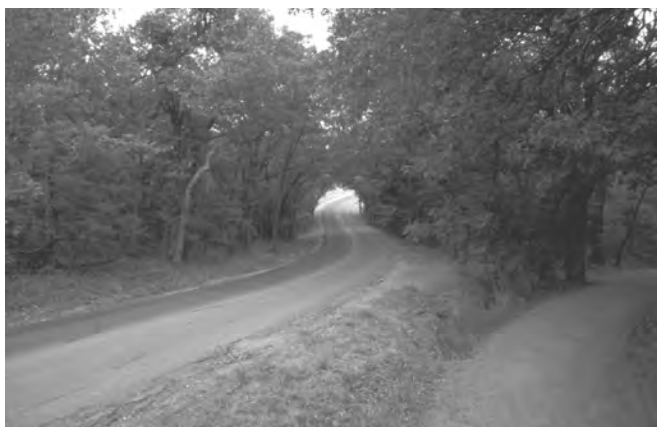
Figure 9-28. Tunnel-like character of the perimeter road between Bromide Hill and Highway 177, above, and elsewhere along the road is another character-defining feature that should be retained.

The tunnel-like quality of trees arching over the road on the south side of the perimeter road near Bromide Hill, along Rock Creek near Walnut Grove, and at other locations, should also be maintained (Figure 9-28). However, to reduce fire hazard in these areas, red cedar located in the understory along these stretches should be eliminated. Overhead road canopies may be thinned, but a quality of dappled shade on the road surface should be maintained.

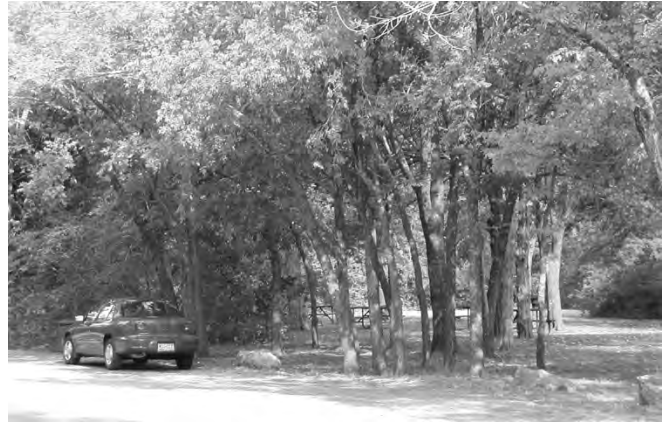
Figure 9-29. Parking area at Walnut Grove.

be maintained as is. Tree and understory vegetation around the parking areas should be maintained to provide shade and to reduce the visual impact of parking within the historic district (Figures 9-29 and 9-30).

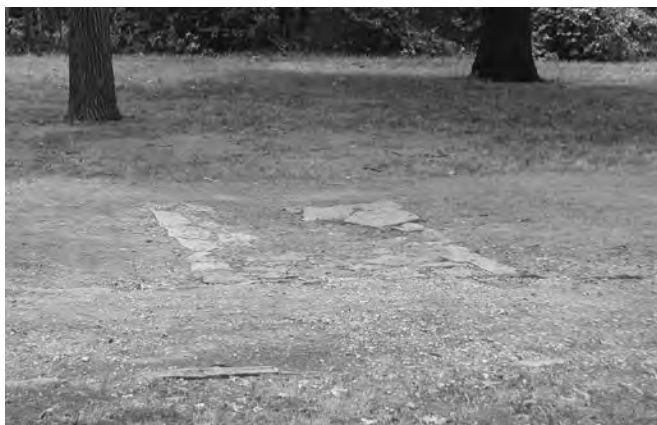
Figure 9-31. Drainage crossing at Flower Park, 2002. These will be redone as part of the trail reconstruction project in 2003 and 2004.

Concentrated drainage flows cause continual erosion in localized areas along most paths paved with compacted decomposed granite or gravel. Over time, many of these have been “hardened” using asphalt or flagstone (Figure 9-31) to prevent tripping hazards and eliminate continual surface repair. This is an appropriate treatment. However, the construction of these drainageways should be made more consistent throughout the district. We recommend that all such areas carrying cross drainage should be paved with flagstone. If flagstone is dry laid, joints should be as tight as possible, ¼” to ¾”. Where appropriate, flagstone may also be set in mortar with mortar joints (Figure 9-32). The flagstone surfaces should be kept as smooth as possible and the pavement ends should meet the existing trail at grade. An overall smooth and even transition with the trail is necessary, since pavement changes are a major part of reduced trail accessibility. Flagstone areas should be large enough to fully carry drainage, to prevent undermining at pavement edges and to help maintain smooth transitions.

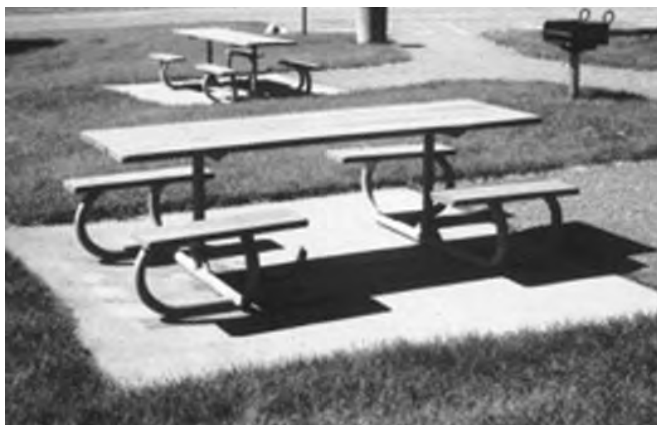
Figure 9-34. A typical, fully accessible picnic area requires hardened access and surface.

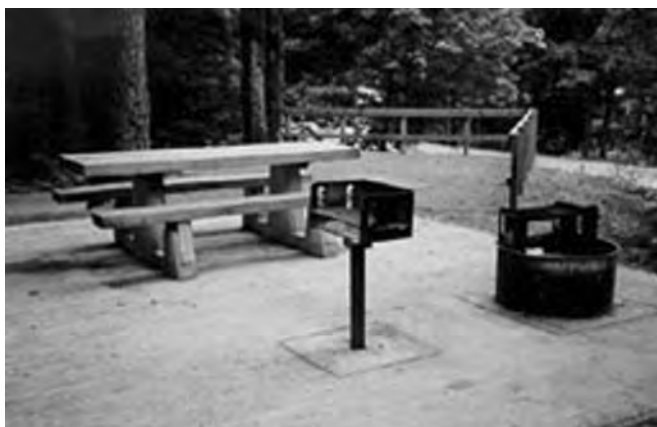
Figure 9-35. An accessible campsite must have accessible amenities and be located on an accessible route.

The three campgrounds in the Platt District have accessible comfort stations but do not have designated accessible sites. It is recommended that seven accessible individual campsites be provided at Rock Creek Campground and four individual accessible campsites be built at Cold Springs. As described in Chapter 11, these are located in close proximity to the comfort stations, and, like the picnic areas described above, will require hardened trail surfacing to and from the comfort stations. This could be done using decomposed granite, with a stabilizer, to create a hard surface that is less visually intrusive than white concrete.

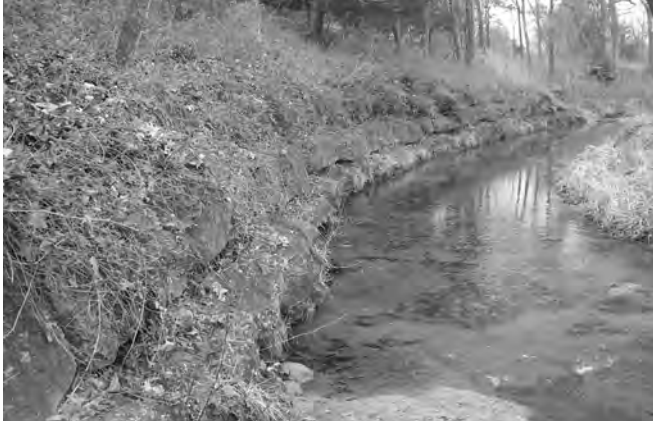
Figure 9-36. Recently constructed wall at Central Campground is an excellent example of new construction matching historic construction.

Where conditions are severe, stone revetment walls may be constructed. These dry-laid walls are in keeping with the historic means of preventing erosion, and there are excellent historic examples of such construction along the upper portions of Travertine Creek in the Environmental Study Area. More recent examples of revetment walls include those constructed along Travertine Creek in Central Campground (Figure 9-36). These walls, only a few years old, appear almost indistinguishable from historic stone work.

In general, new stone revetment walls should be constructed of large boulders, graduated in size from base to top, and with a 2:12 batter or a batter matching walls in adjacent areas. Vegetation such as Virginia creeper or catbriar may be placed in pockets of soil between stones to encourage revegetation of the walls to effect a natural appearance.
