HISTORIC AMERICAN BUILDINGS SURVEY

An
Architectural Study
of

F O R T M C H E N R Y

FORT MCHENRY NATIONAL MONUMENT AND HISTORIC SHRINE
Baltimore, Maryland

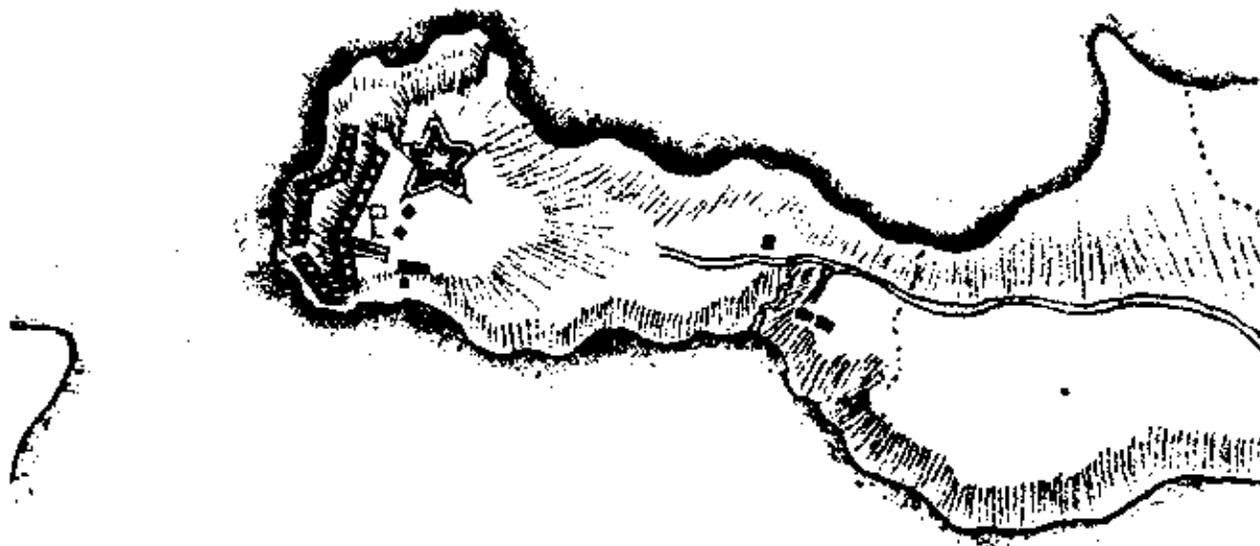
Illustration No. 1

Portion of "Rade et port de Baltimore," 12-15 September 1781, Papers of Louis-Alexandre Berthier, group 16, map 8, Princeton University Library. Map of Whetstone Point showing "star fort," shore-line batteries, and buildings.

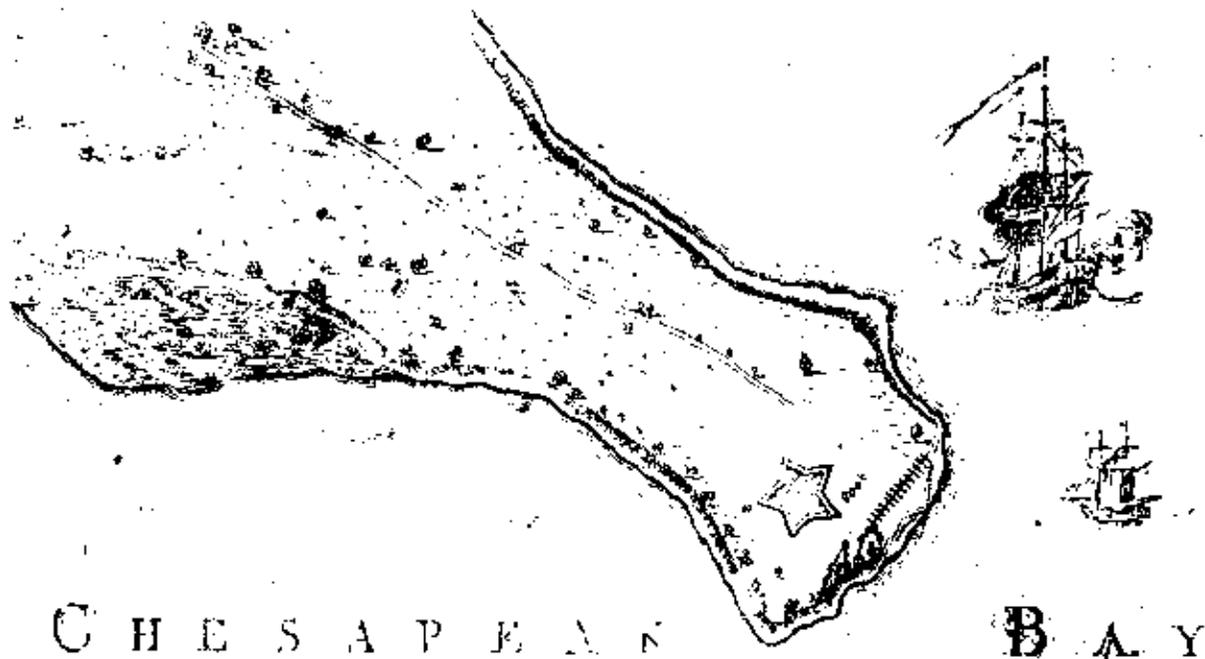
Illustration No. 2

Copied from a portion of a "Plan of the Town of Baltimore and its Environs," by A. P. Folie, French Geographer, 1792. Peale Museum, Baltimore. Map of Whetstone Point showing "star fort" and shore-line batteries.

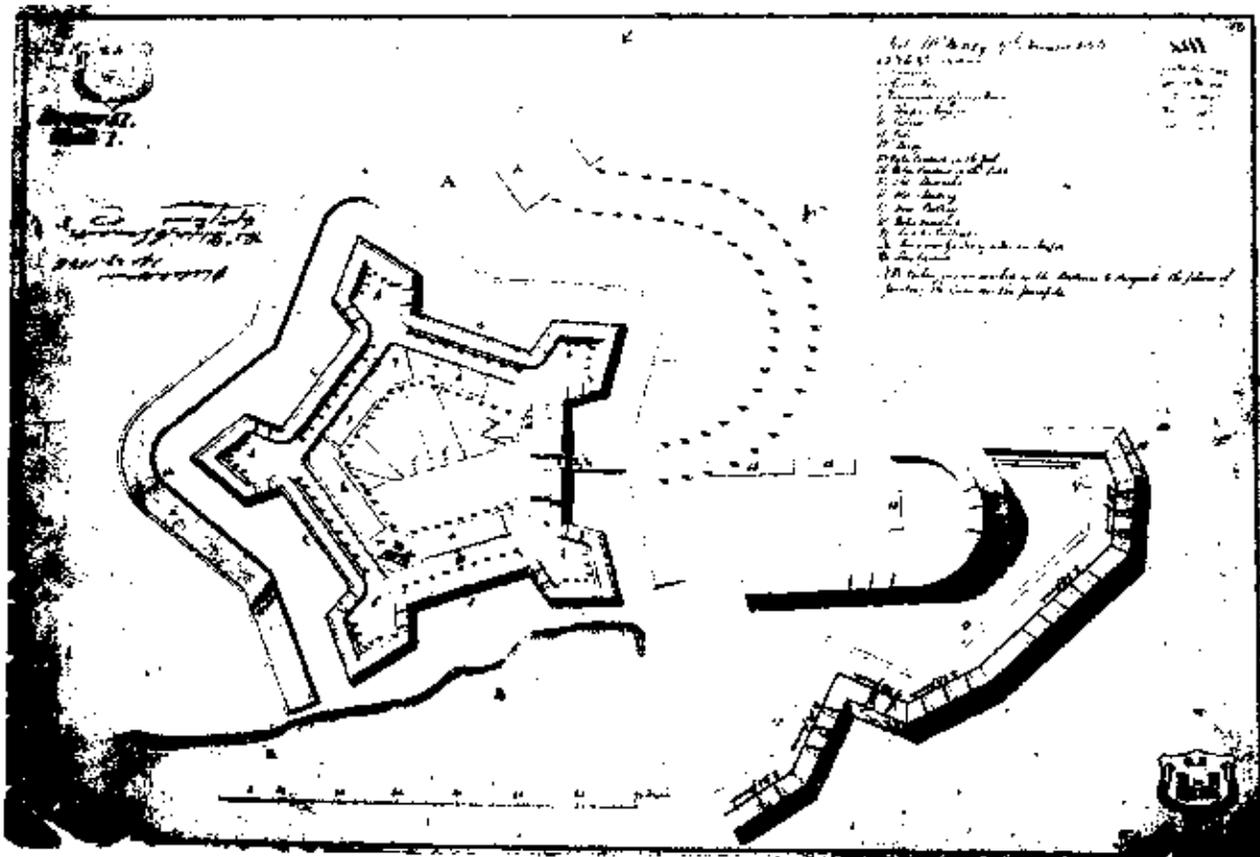
Illustration No. 3

Copy of plan of Fort M'Henry, November 9, 1803, author-
 ship unknown. National Archives, Records of the War
 Department, Cartographic Section, Record Group 77,
 drawer 51, sheet 1.

The 1803 plan shows a well-defined ditch around the land sides of the fort, but none along the southeast side, facing the harbor. This defect was later corrected. The width of the ditch varied from 35 feet at the bastions to 55 feet, from the brickfaced walls midway between bastions. The ditch was also drained at two points by "water conduits," which have since been obscured or obliterated. A conduit also opened through the rampart, centered along the southeast wall. The fort as originally built, probably had a master drainage system, similar to but less extensive than the one at Fort Washington, Maryland, but the evidence of such a system is not yet available.

The 1803 map is interesting also in that it shows trees planted upon bastions, terreplein, and the parade ground level. The plan shows 36 trees upon the terreplein level, 30 on the bastions (6 on each), and 38 around the parade ground. The function of such extensive planting is not clear, but it probably served several functions; as camouflage and as a ready supply of otherwise expensive firewood in the event of a siege. Old views of Fort McHenry seem to show Lombardy poplars, a tree widely planted in America and noted for its high absorption of ground water, a desirable feature in the earthen and sodded fort.

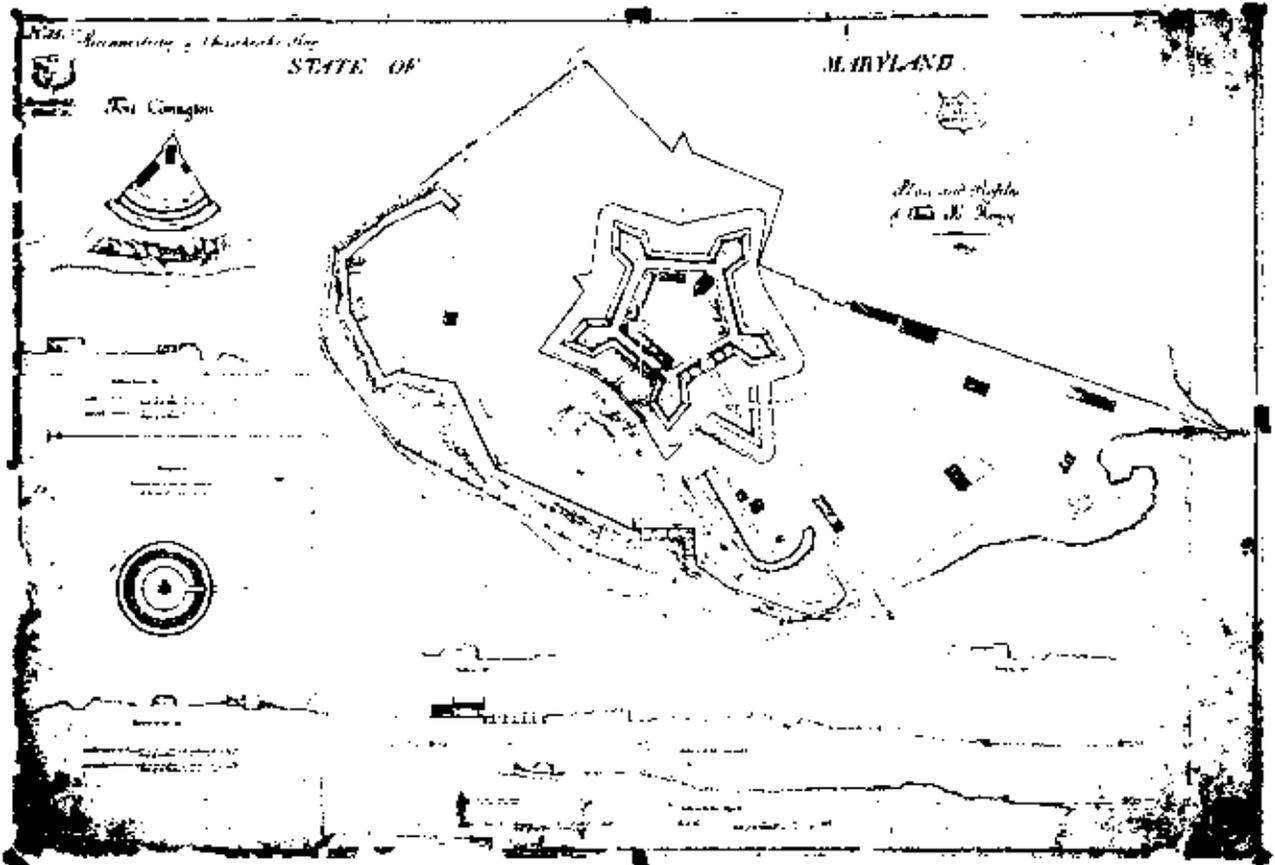
Illustration No. 5

Plan of Fort McHenry, by William Tell Poussin, 1819.
National Archives, Records of the War Department,
Cartographic Section, Record Group 77, drawer 51,
sheet 2.

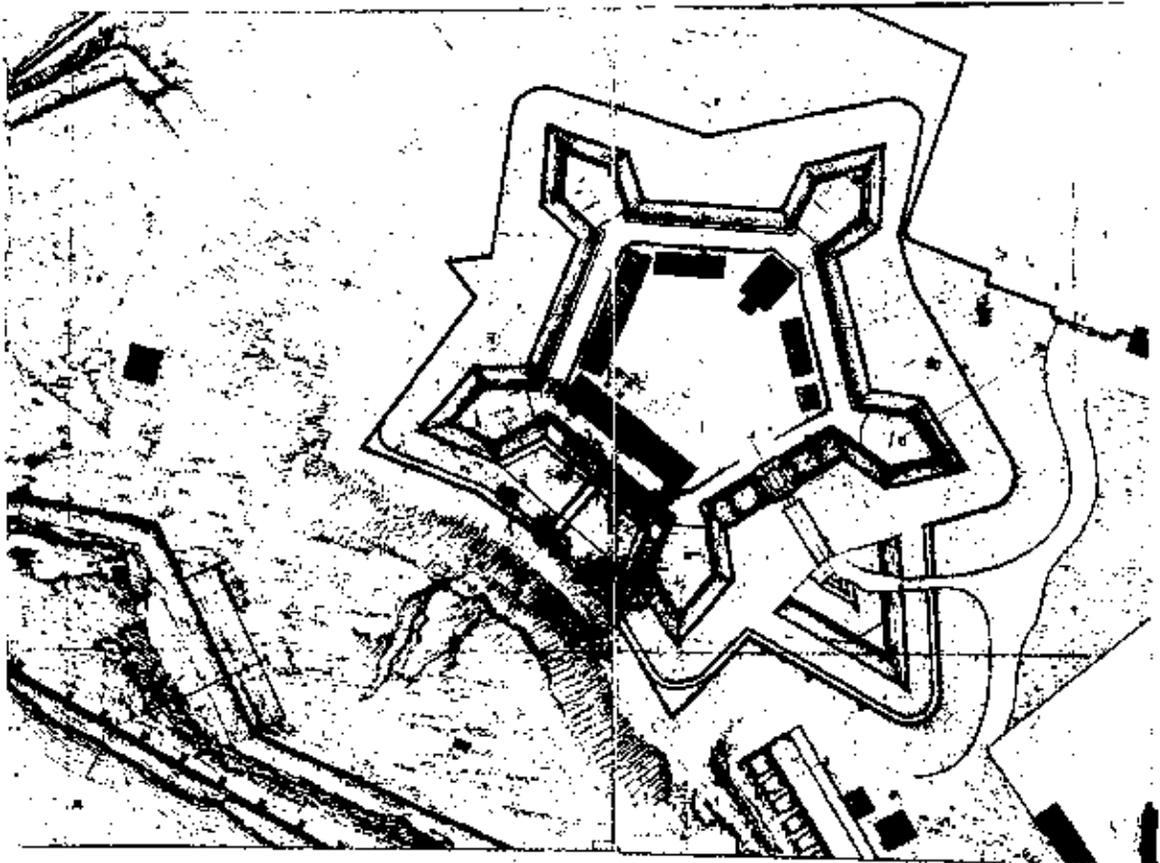
Illustration No. 6

Portion of a plan of Port McHenry, by William Tell
Poussin, 1819, National Archives, Records of the War
Department, Cartographic Section, Record Group 77,
drawer 51, sheet 2. Plan of fort and enclosed build-
ings.

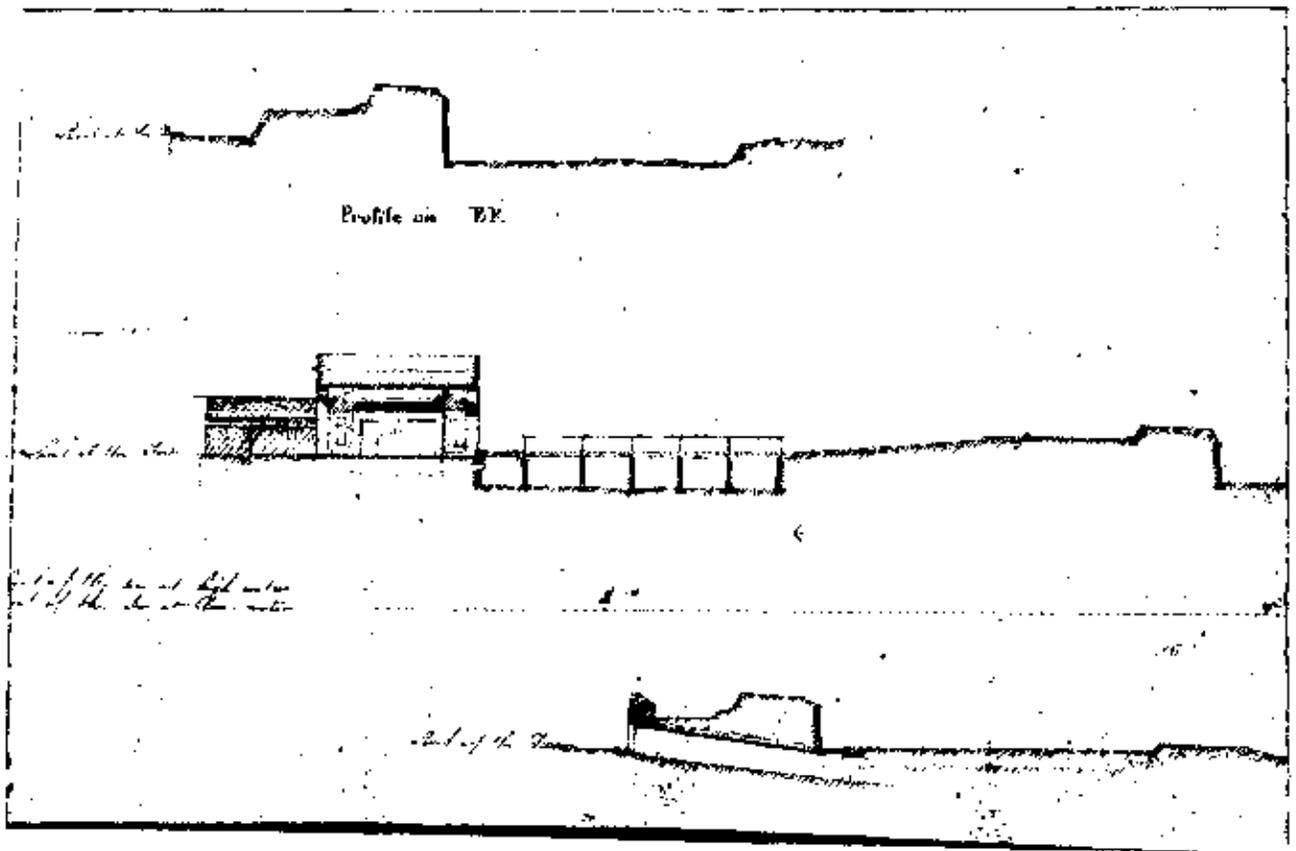
Illustration No. 7

Portion of a plan of Fort McHenry, by William Tell
Poussin, 1819. National Archives, Records of the War
Department, Cartographic Section, Record Group 77,
drawer 51, sheet 2. Sections through ramparts (top),
sally port and ravelin (middle), and postern (bottom).

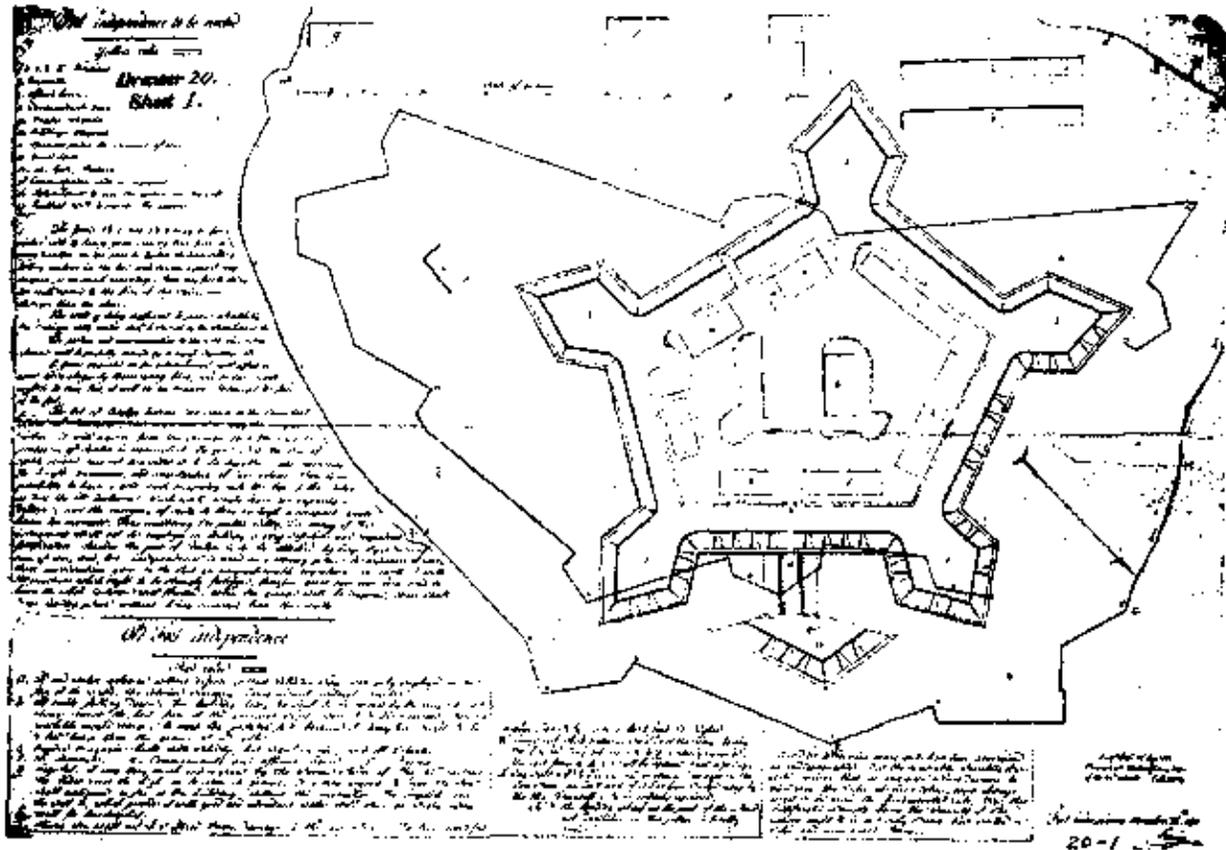
Illustration No. 9

"Fort Independence to be erected," November 24, 1800, by John Foncin, National Archives, Cartographic Section, Record Group No. 27, drawer 20, sheet 1. Marginal notes on this plan refer to the fortifications at Baltimore, see Appendix III.

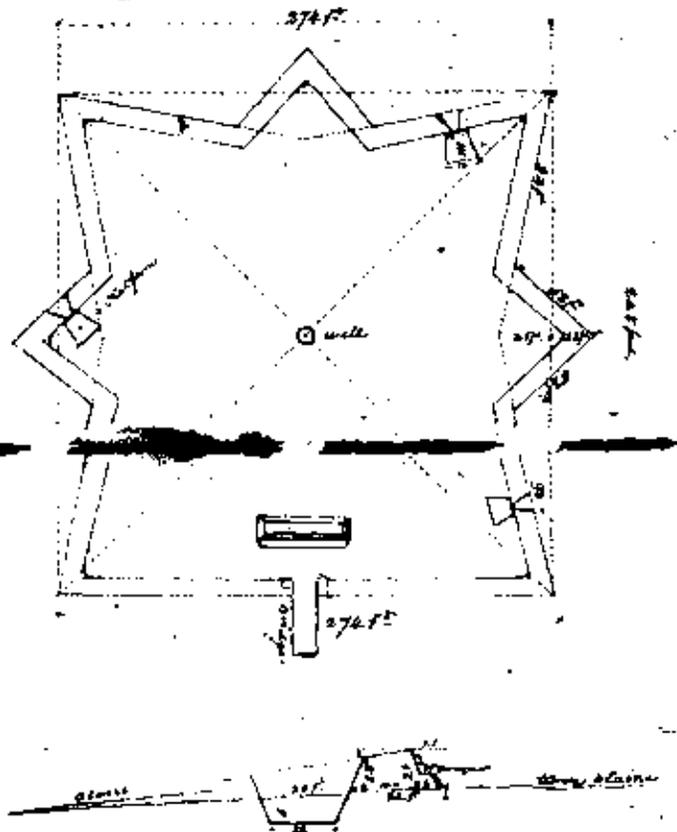
Illustration No. 11

Plan of the Parapet of Fort Hamilton,
1814. Drawing in the William Strick-
land account book, State Records Office,
Harrisburg, Pa.

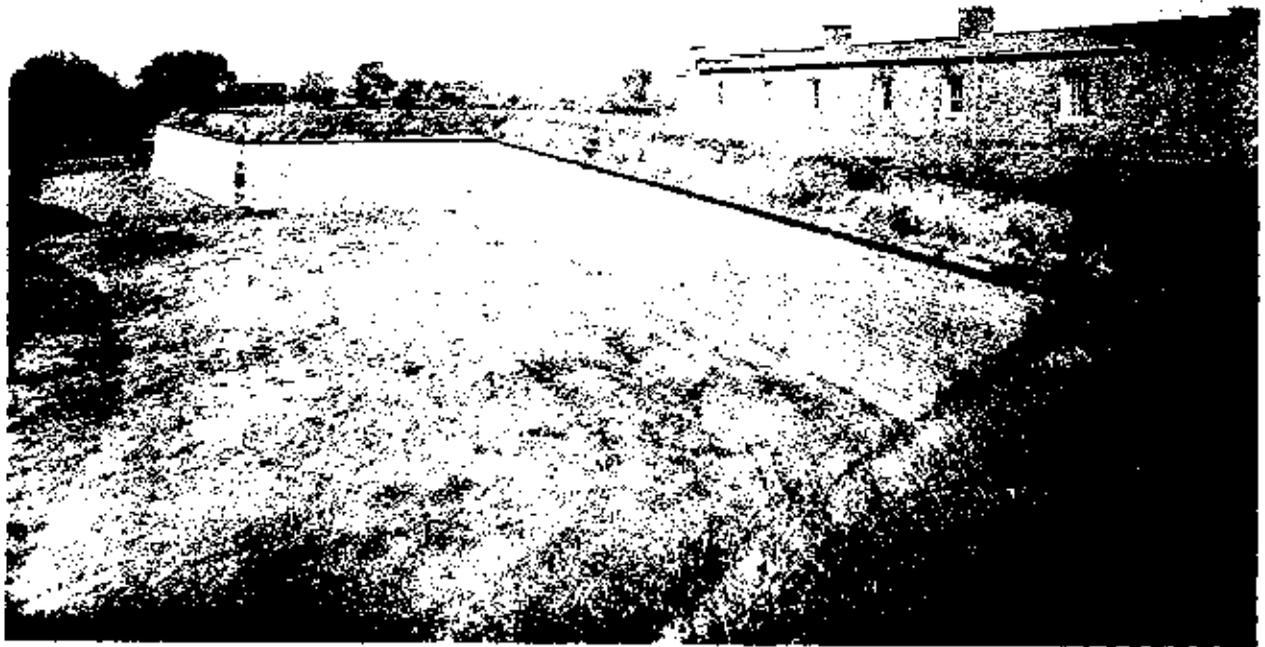
Illustration No. 12

Southwest bastion from south bastion. Rear of No. 1
Soldiers' Barracks (Building D) at right. Photographer:
Jack E. Boucher, October 1958.

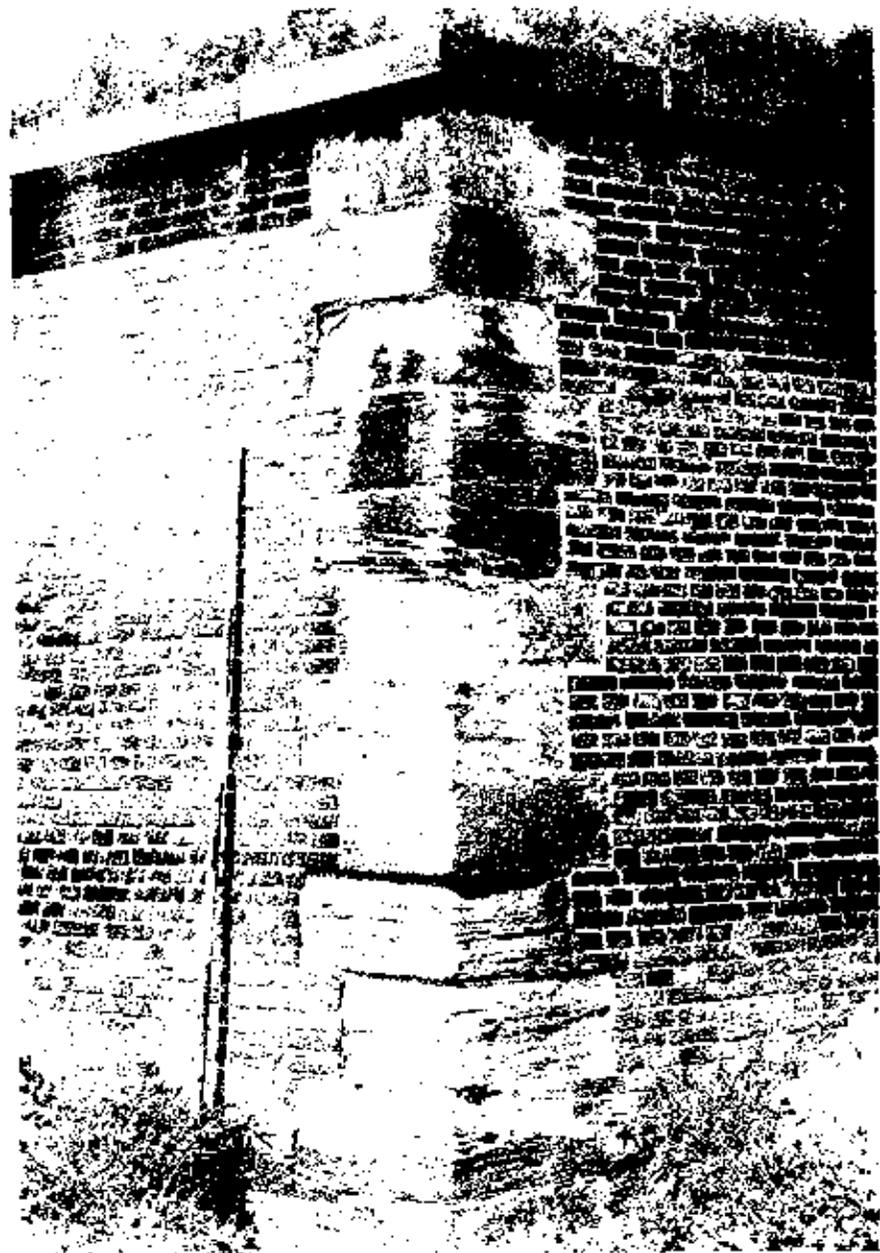
Illustration No. 13

Detail of typical stone quoining at
an outside corner of a bastion.
Photographer: Jack E. Boucher, July
1958.

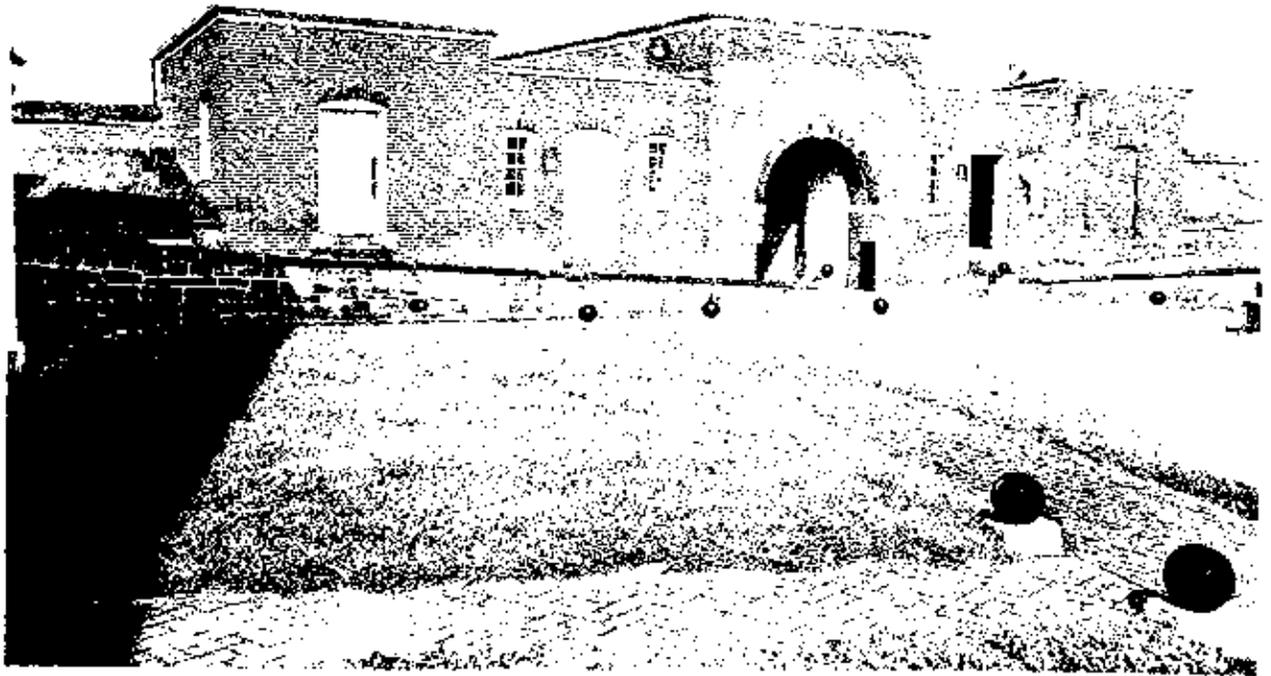
Illustration No. 15

View of sally port and guard rooms from parade ground.
Photographer: Jack E. Boucher, July 1958.

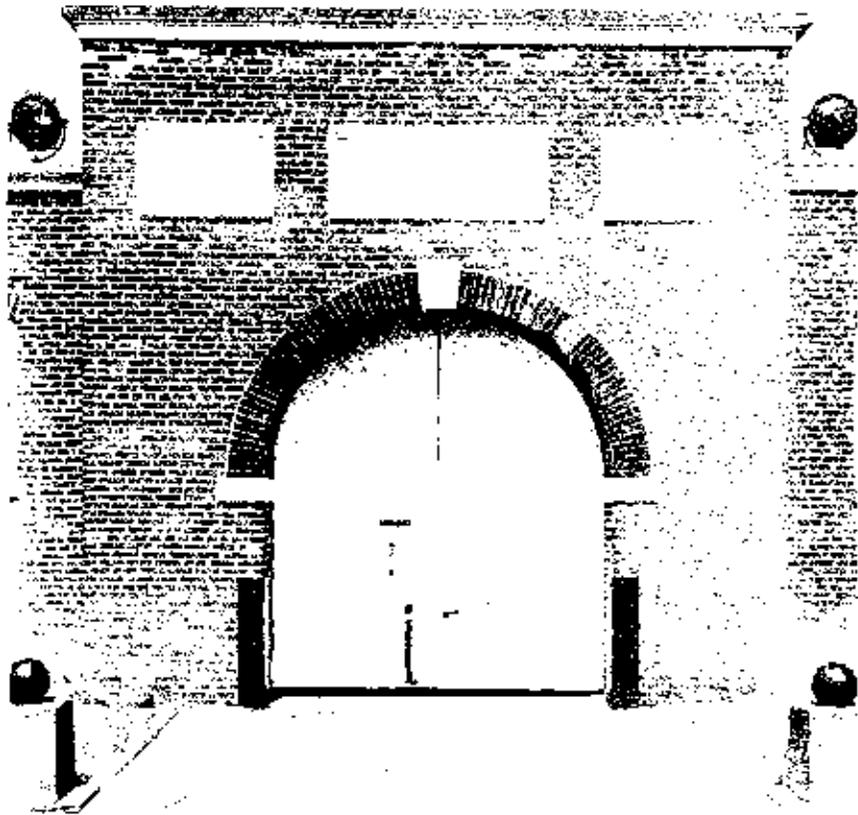
Illustration No. 16

Interior elevation of sally port,
with doors closed. Photographer:
Jack E. Boucher, July 1958.

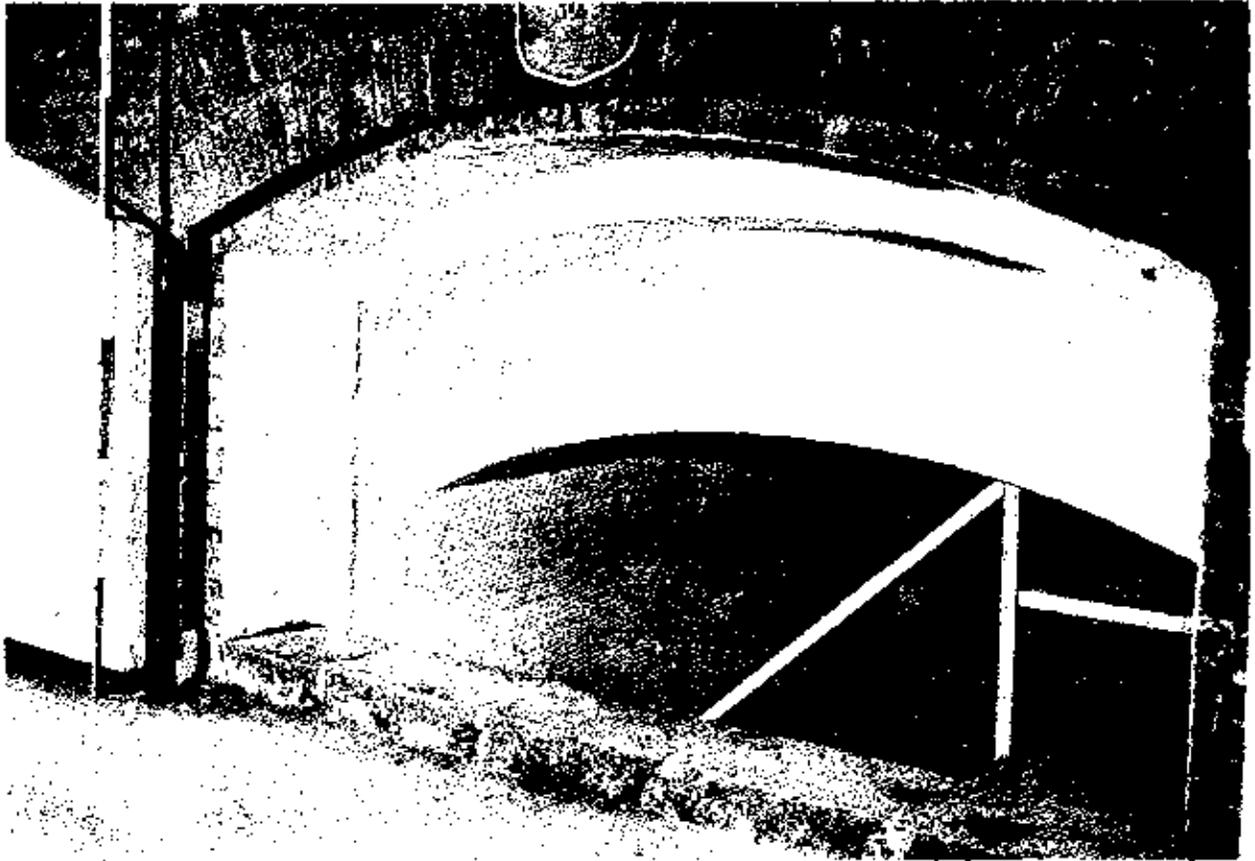
Illustration No. 17

Arched entrance to small casemate room looking south
from inside sally port. Photographer: Jack E. Boucher,
July 1958.

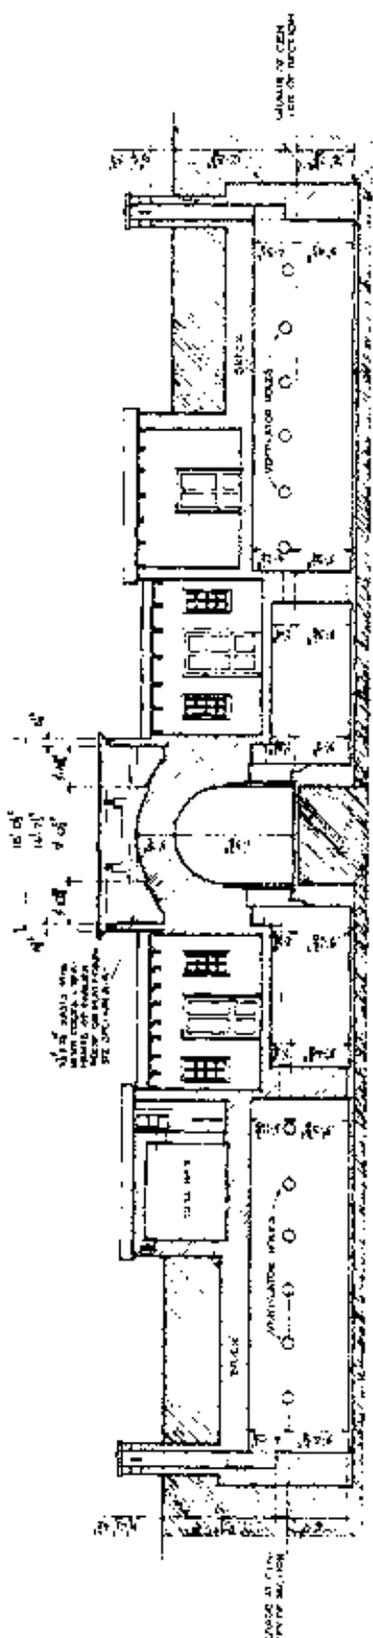
SECTION D-D - LOOKING WEST
SCALE: 1/8" = 1'-0"

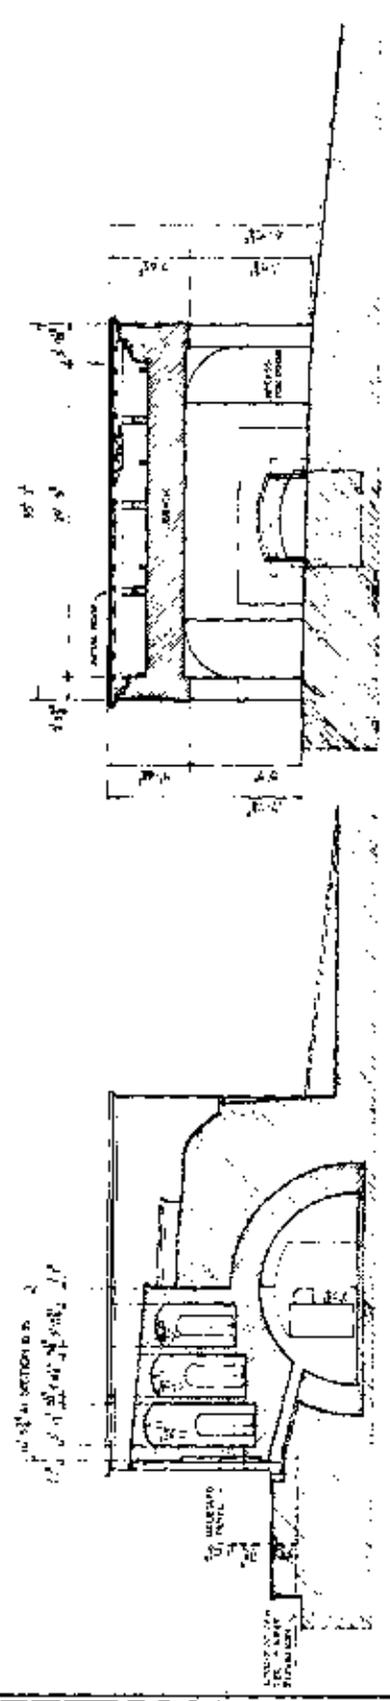
SECTION A-A - LOOKING NORTH
SCALE: 1/8" = 1'-0"

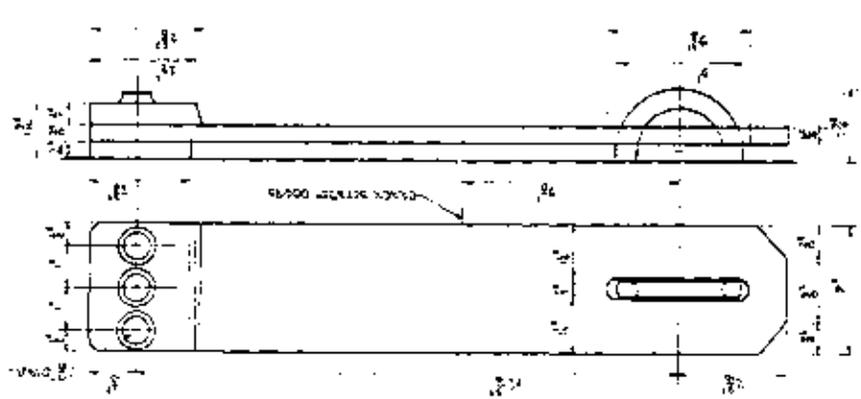
DOOR PLAN - DUNGLON N°1
(CASEWELL)
SCALE: 1/4" = 1'-0"

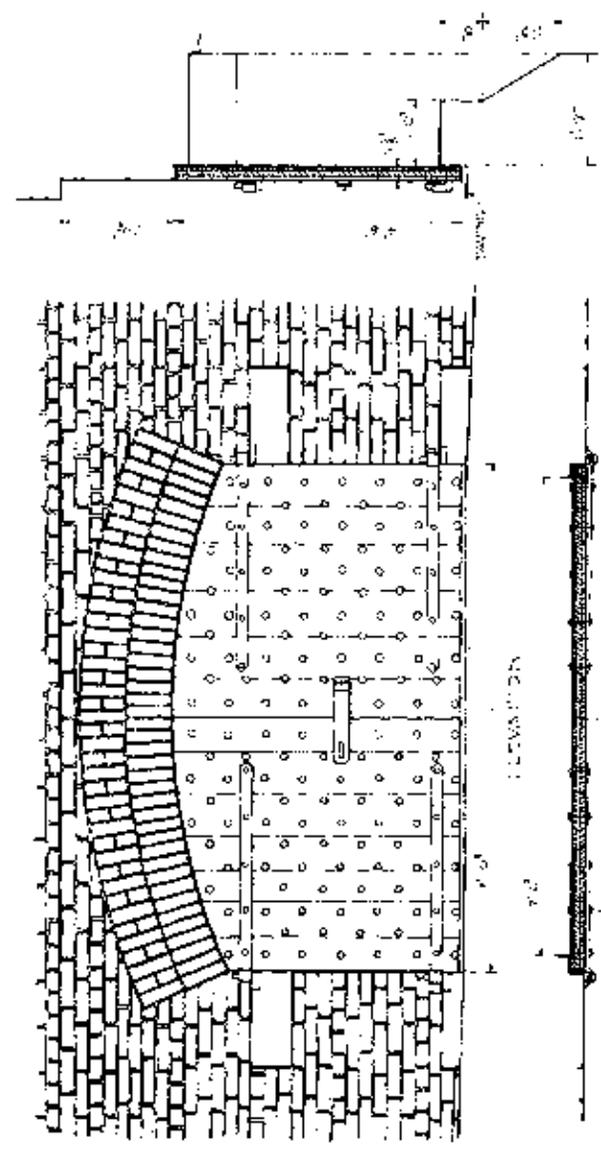
ELEVATION
DUNGLON N°1 (CASEWELL)
SCALE: 1/4" = 1'-0"

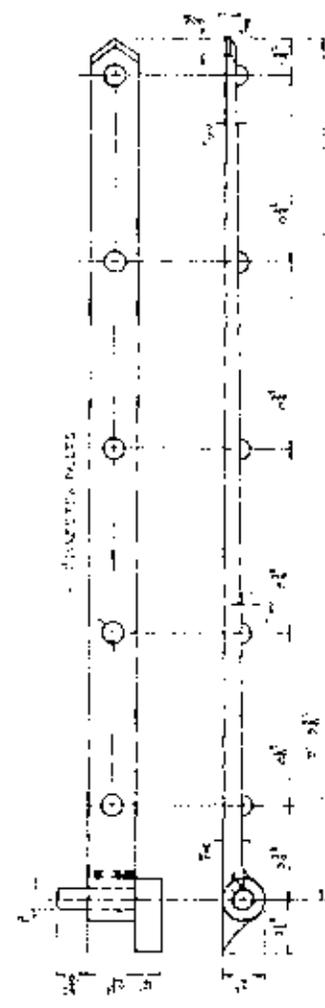
WINDOW PLAN - DUNGLON N°1 (CASEWELL)
SCALE: 1/4" = 1'-0"

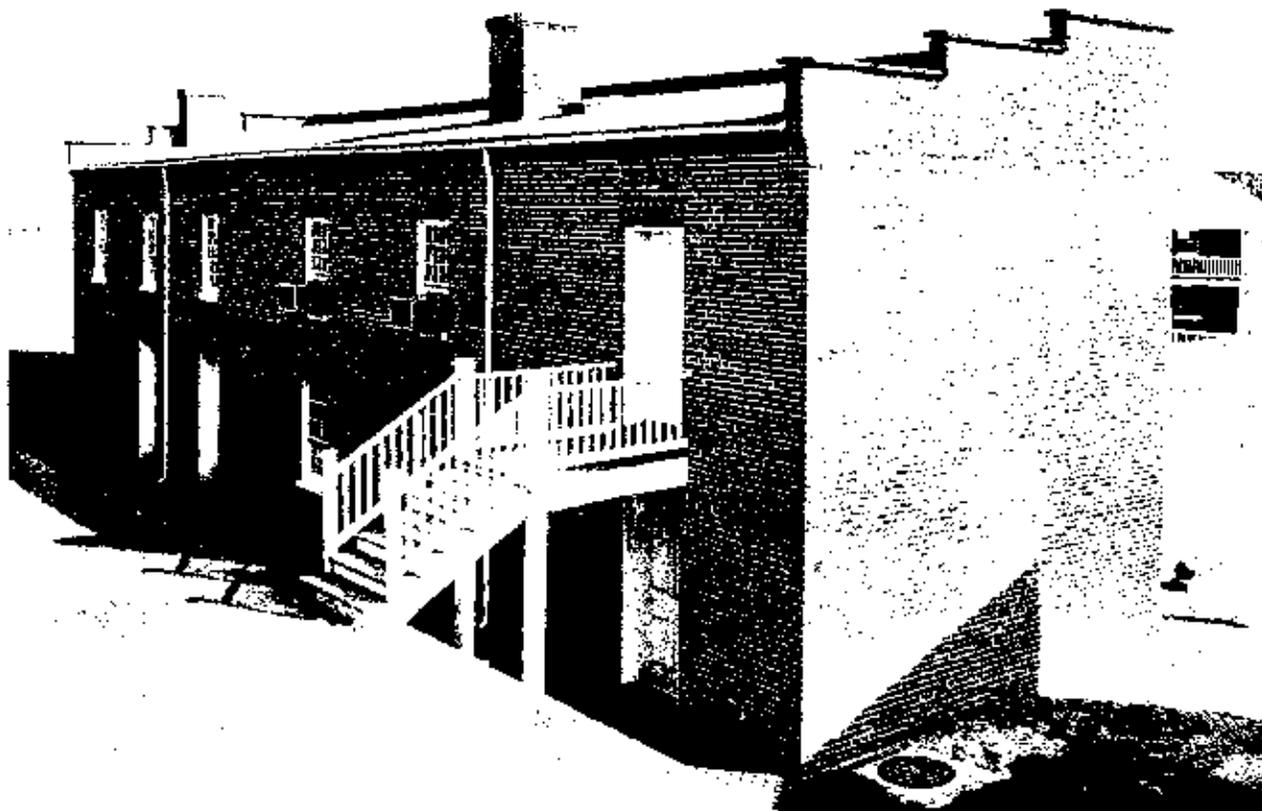
Illustration No. 20

Commanding Officer's Office and Quarters (Building A).
Rear wall and west end-wall. Photographer: Jack E.
Boucher, October 1958.

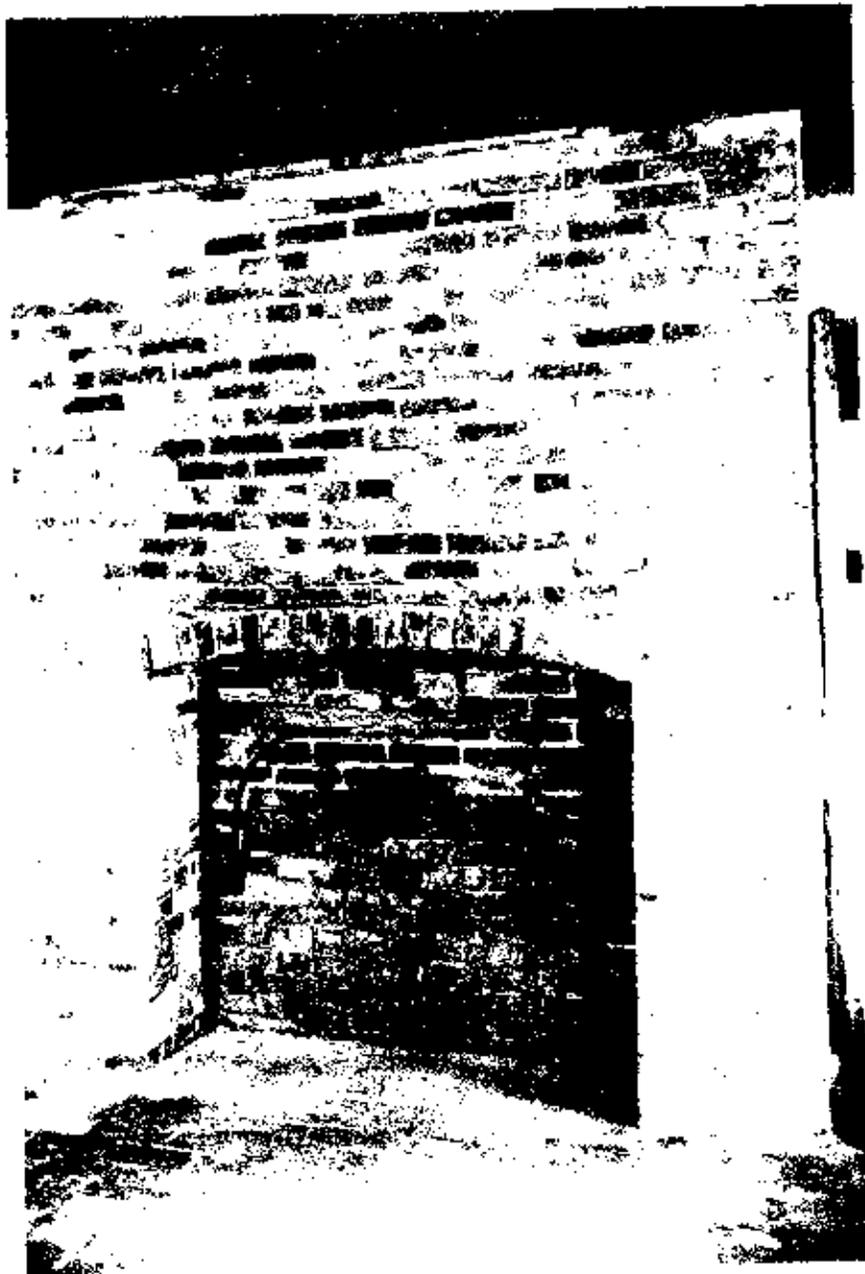
Illustration No. 21

Commanding Officer's Office and Quarters (Building A). Fireplace in eastern-most room. This fireplace was sealed off sometime in the nineteenth century, and reopened during the War Department restoration of 1929-30. At that time, the old cooking crane was discovered. Photographer: Jack E. Boucher, October 1958.

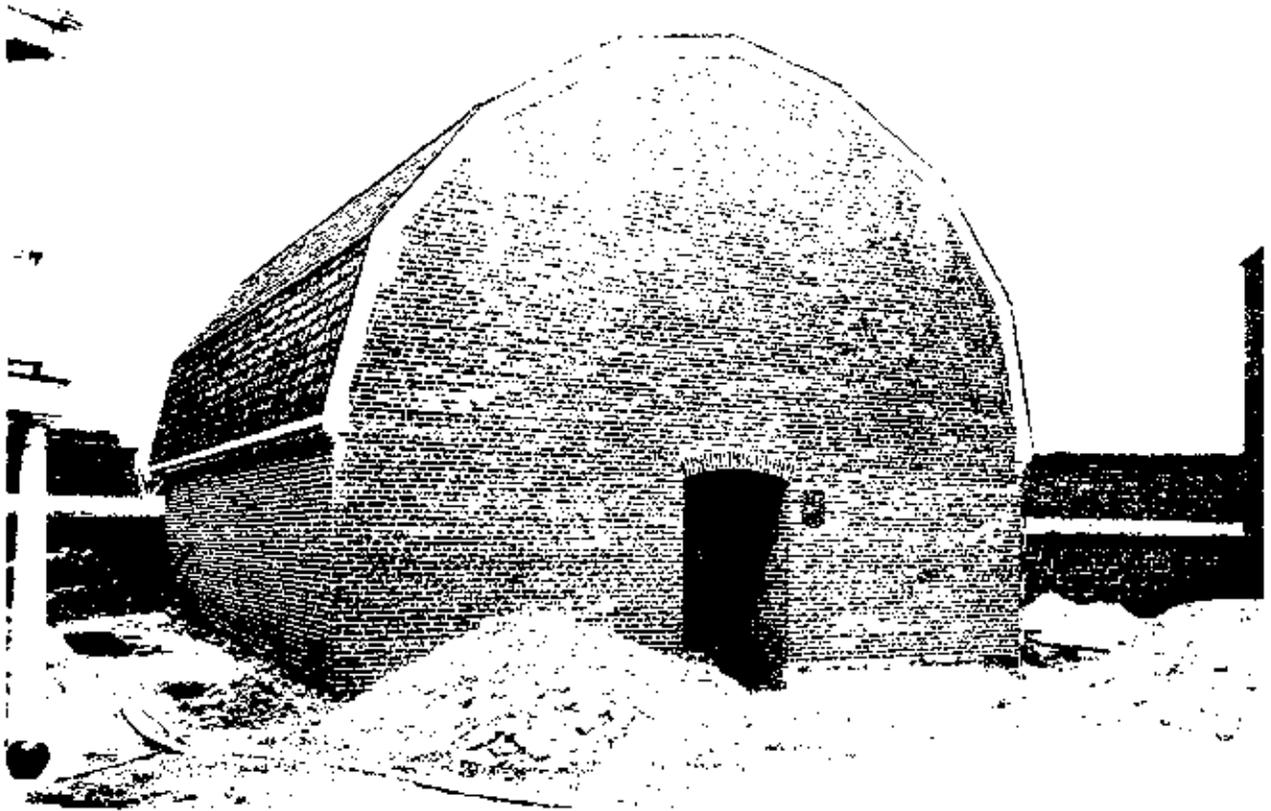
Illustration No. 23

The Powder Magazine, facade and west side. Photographer:
Jack E. Boucher, July 1958.

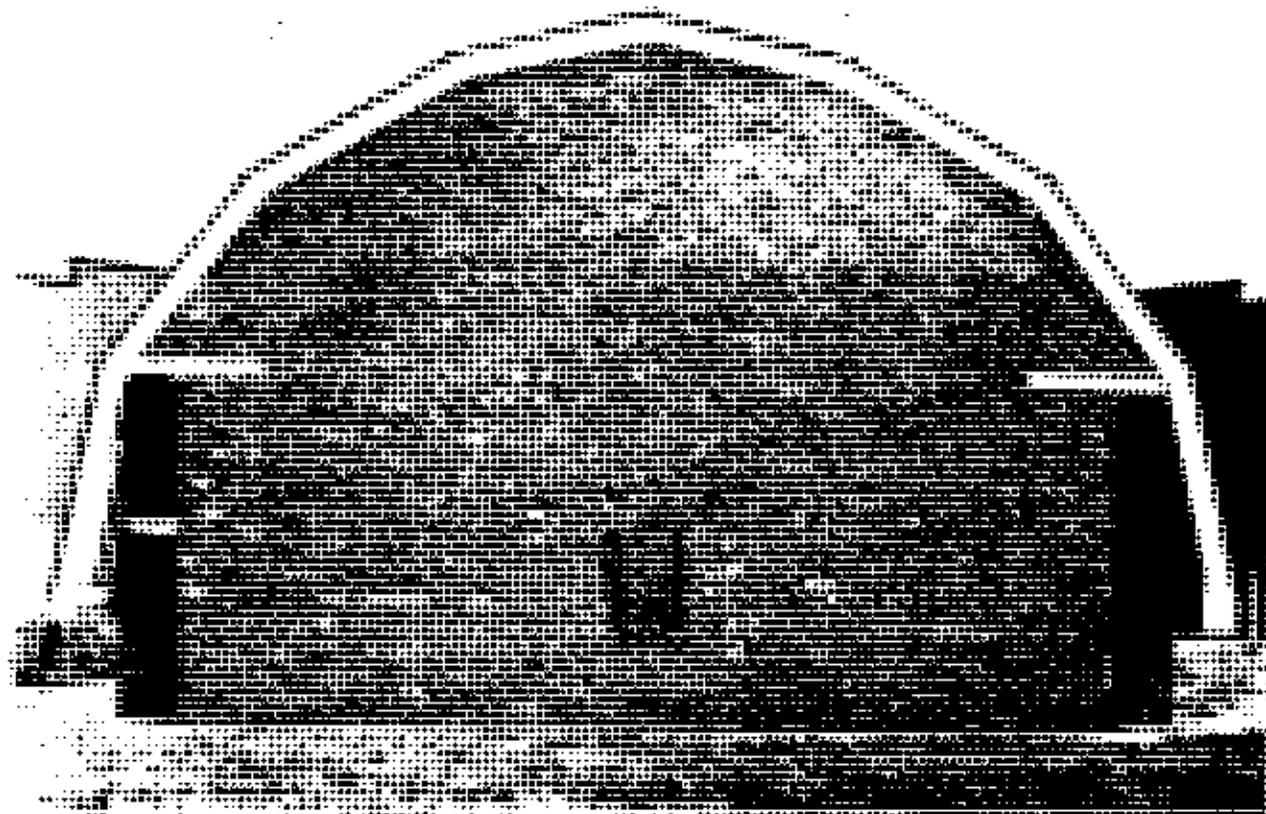
Illustration No. 24

The Powder Magazine, rear view. Photographer: Jack E. Boucher, July 1958.

On October 22, 1839, Captain Thompson was ordered to repair the rear window of the magazine with a shutter on the outside and a row of 7/8 inch diameter iron bars, set in the opening one foot inside the walls, with a "wire gauze" screen installed on the inside.²⁸

While other minor repairs have been made at various times, such as bricking up the rear window, reworking the doors, and raising the ground level to provide better drainage, the powder magazine has not undergone any significant changes. It was used as a coal shed in the 1880's, and generally has never been entirely useful or satisfactory as to its original function. It was never adequate as to size, nor was it conveniently located with respect to the guns in the fort. Altogether, the magazine never served its function efficiently, and ultimately it was discovered that to render the outer batteries effective, several service magazines, contiguous with the battery, were a more satisfactory solution.

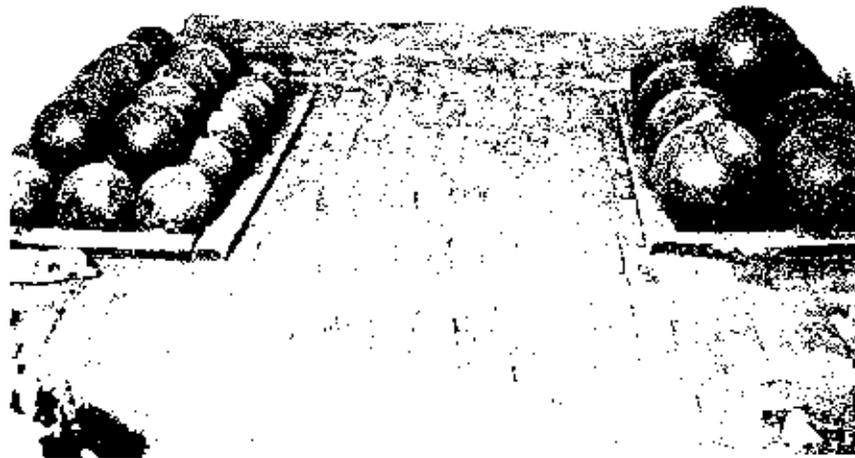
Illustration No. 25

The Powder Magazine, interior view.
Photographer: Jack E. Boucher, July
1958.

2. Flooring. Brick, two layers thick, laid in mortar without any consistent pattern, except for cross bands of brick laid end to end, on approximately two foot centers. The original surface was probably of wooden floor boarding supported by floor joists which rested upon the stone foundation ledge. There was probably a shallow cellar space for circulation of air, but that was filled about 1837.

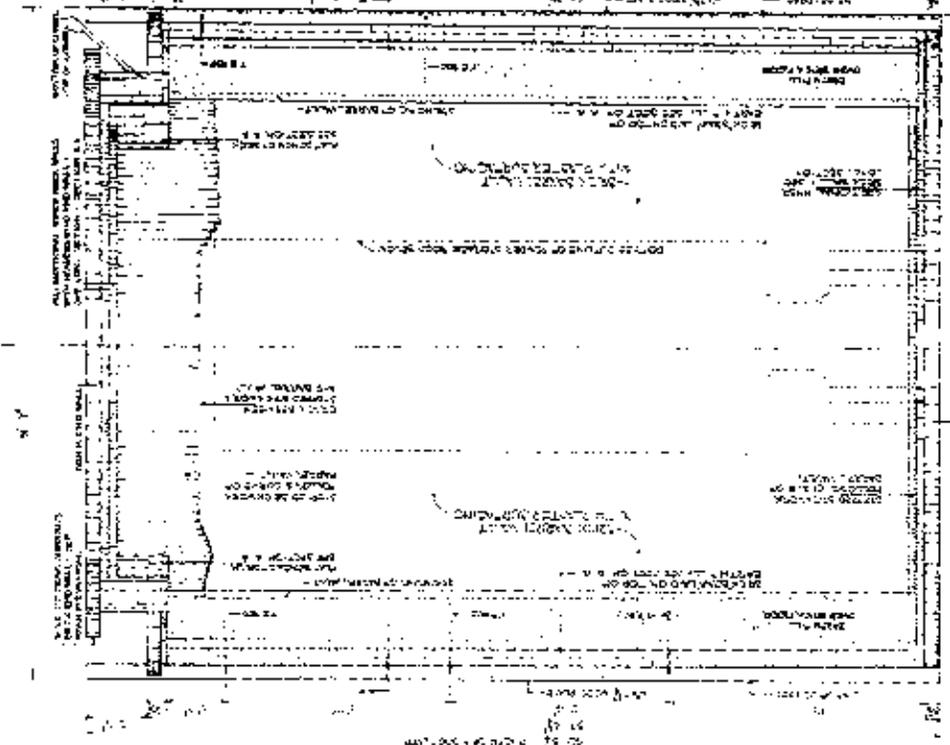
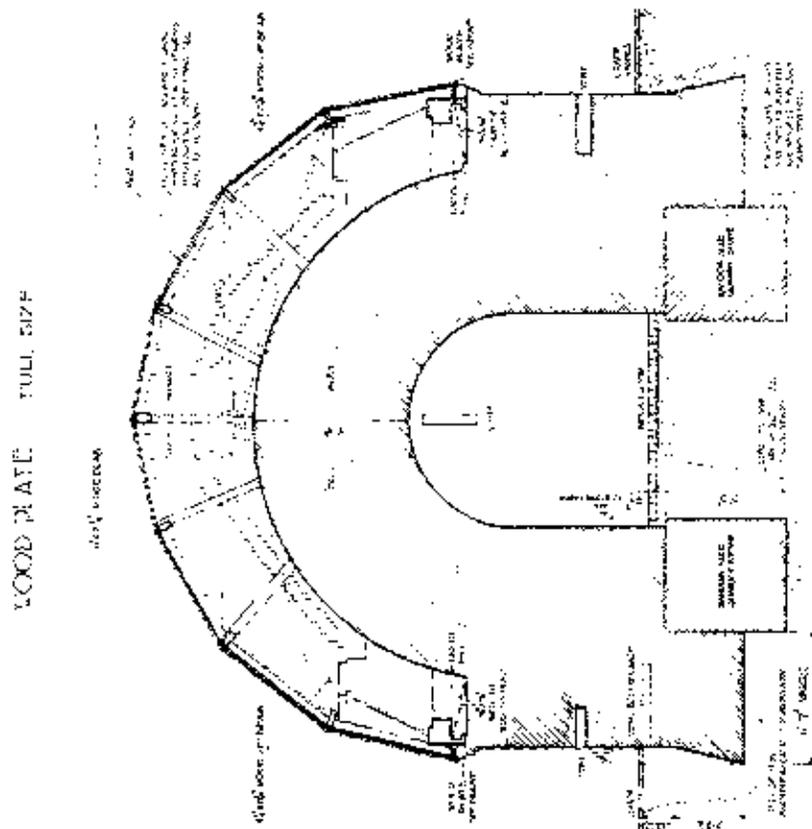
ATTIC PLAN, SHOWN WITH ROOF REMOVED
SCALE: 1/8" = 1'-0"

SECTION A-A
SCALE: 1/8" = 1'-0"

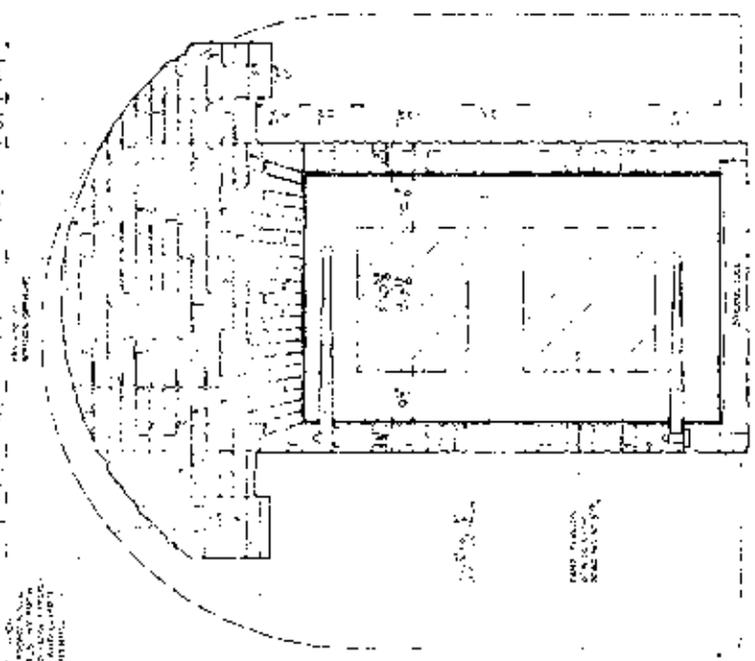
SECTION 3-6 - OUTER DOOR SCALE 1/4\"/>

SEE PLAN FOR DOOR SWELL
