HISTORIC AMERICAN BUILDINGS SURVEY

An
Architectural Study
of

F O R T M C H E N R Y

FORT MCHENRY NATIONAL MONUMENT AND HISTORIC SHRINE
Baltimore, Maryland

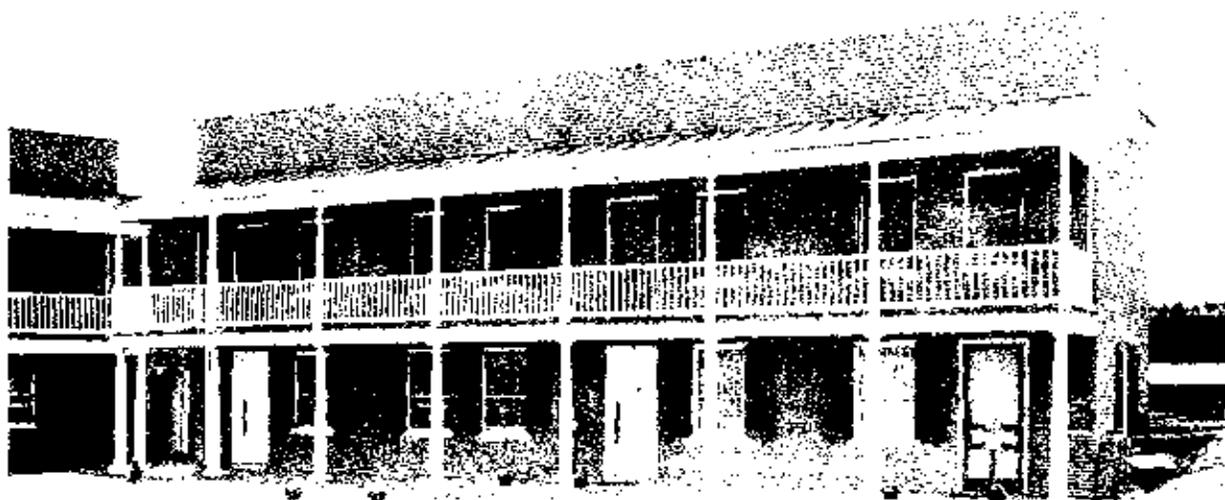
Illustration No. 27

Officers' Quarters (Building C). Facade and north end-wall. Photographer: Jack E. Boucher, July 1958.

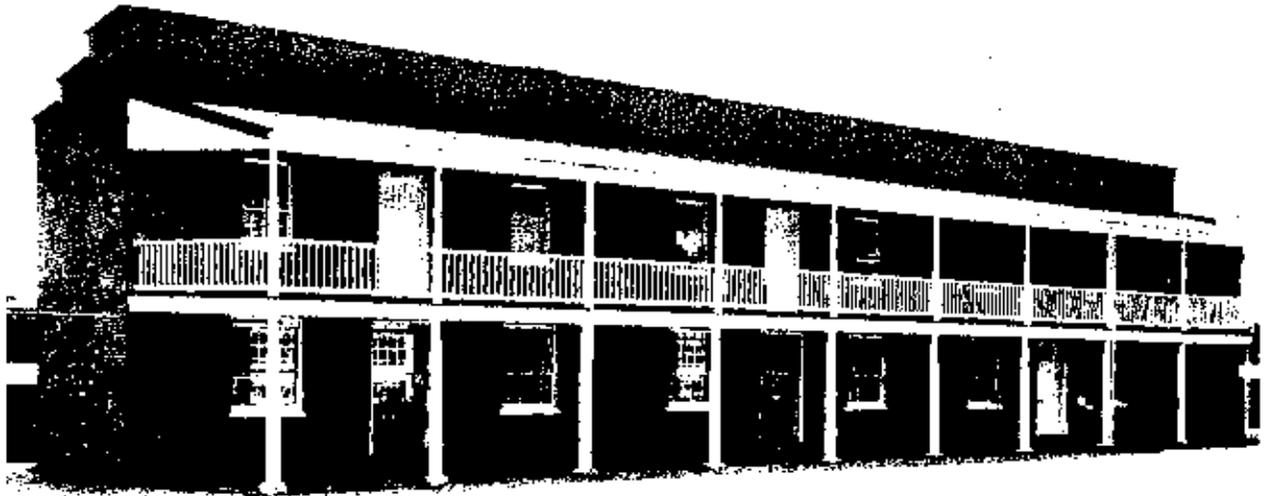
Illustration No. 30

No. 1 Soldiers' Barracks (Building D). Facade and southeast end-wall. This was the only building which retained its ca. 1829 "piazza," when the fort was restored by the War Department in 1929-30. Photographer: Jack E. Boucher, July 1958.

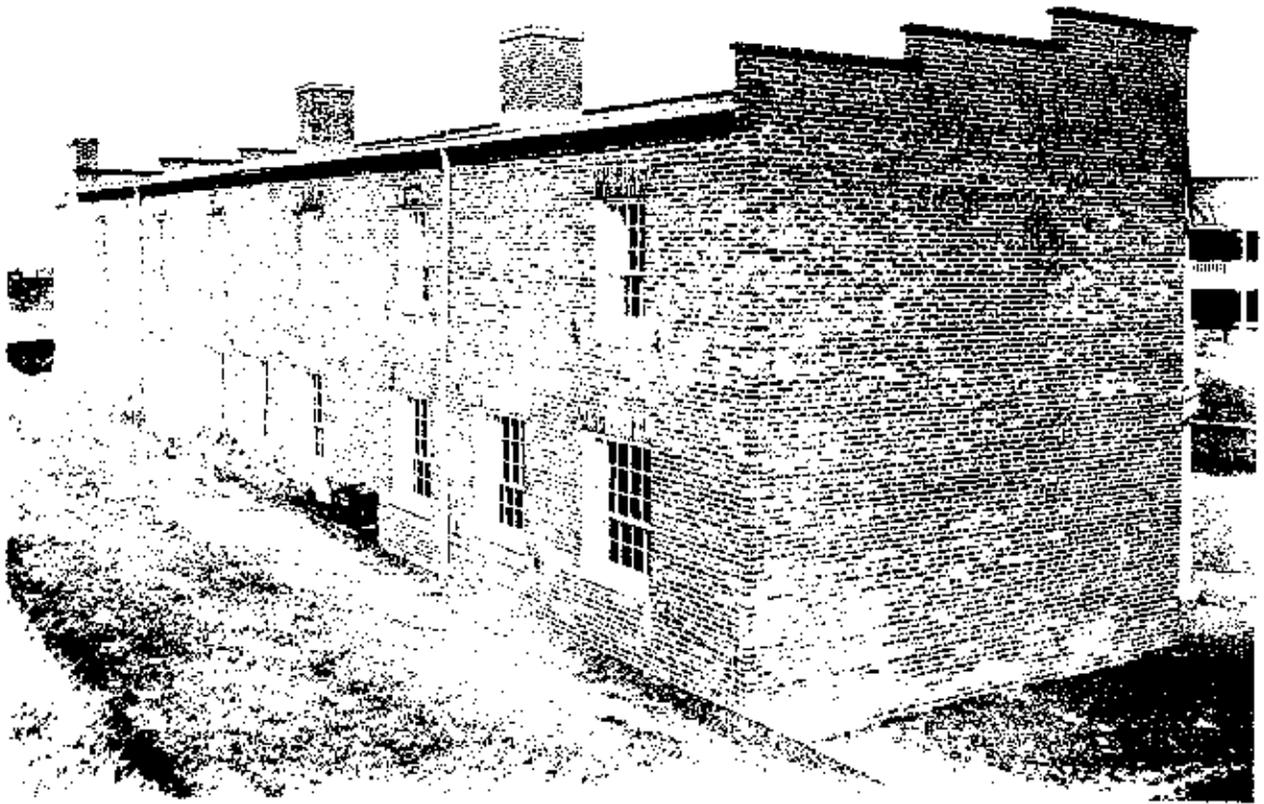
Illustration No. 31

No. 1 Soldiers' Barracks (Building D). Rear wall and southeast end-wall. Brick patchwork on end wall indicates a nineteenth century (not original) window opening. Photographer: Jack E. Boucher, October 1958.

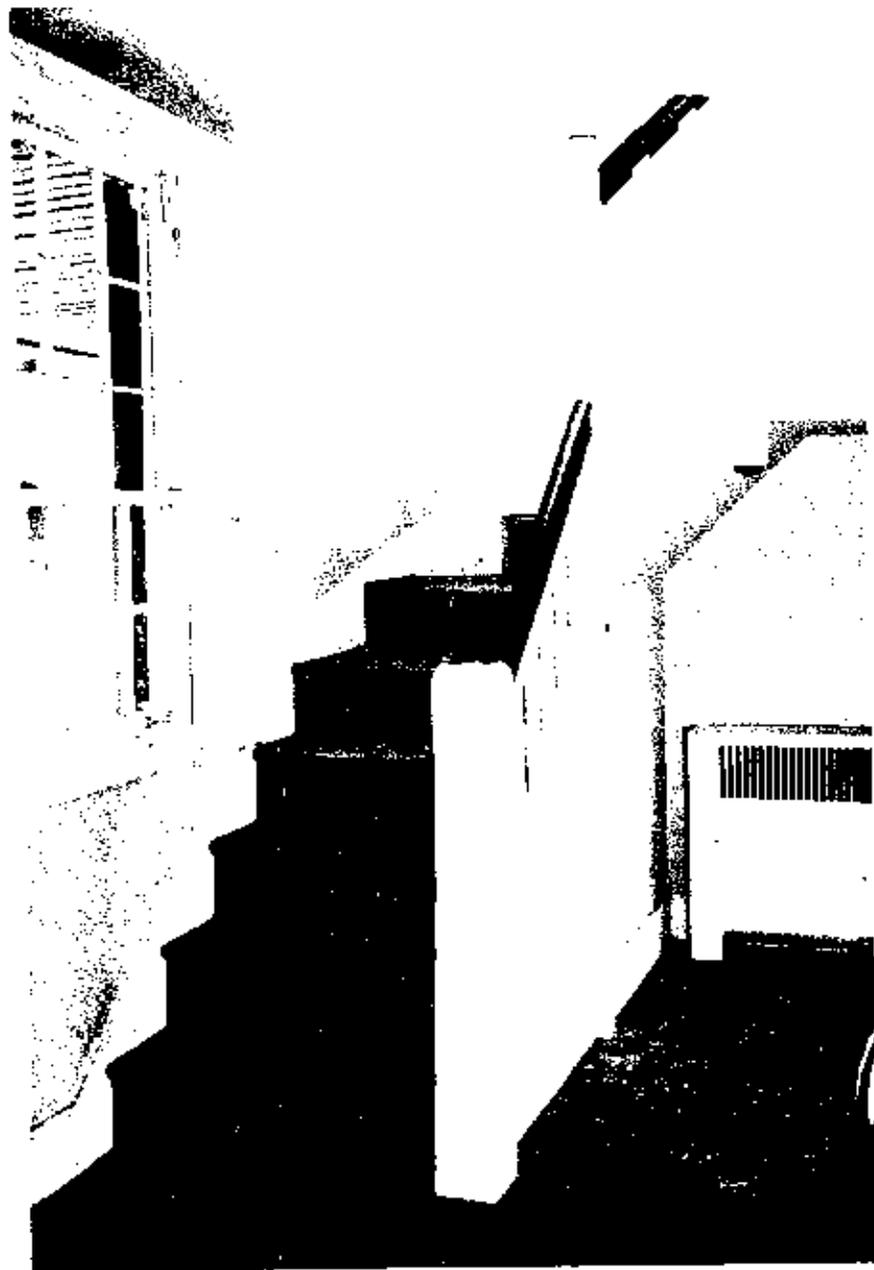
Illustration No. 32

No. 1 Soldiers' Barracks (Building D).
View of stairway in center room, first
floor, restored 1929-30 by the War
Department. Photographer: Jack E.
Boucher, October 1958.

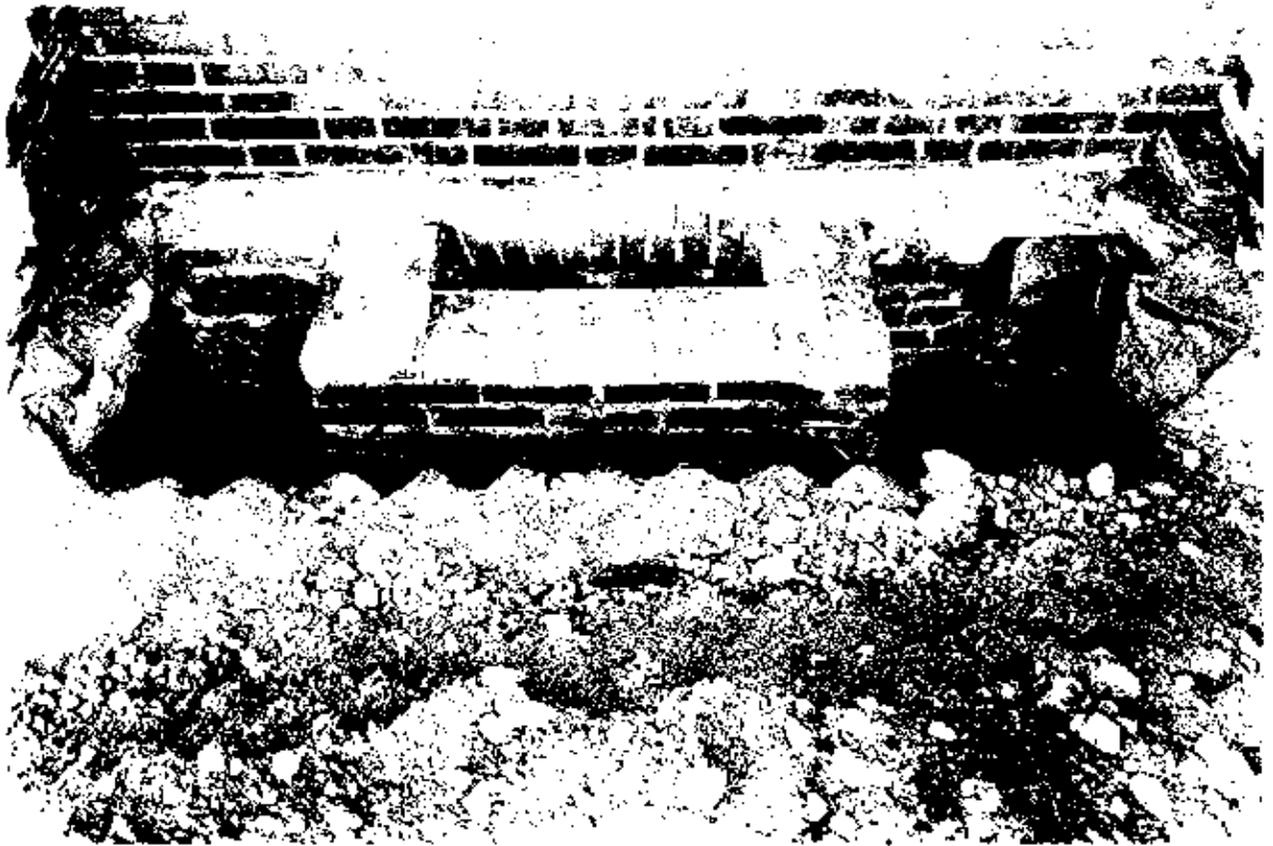
Illustration No. 33

No. 1 Soldiers' Barracks (Building D). View of bricked-up cellar window, and altered brick light-well on front wall. Photographer: Jack E. Boucher, October 1958.

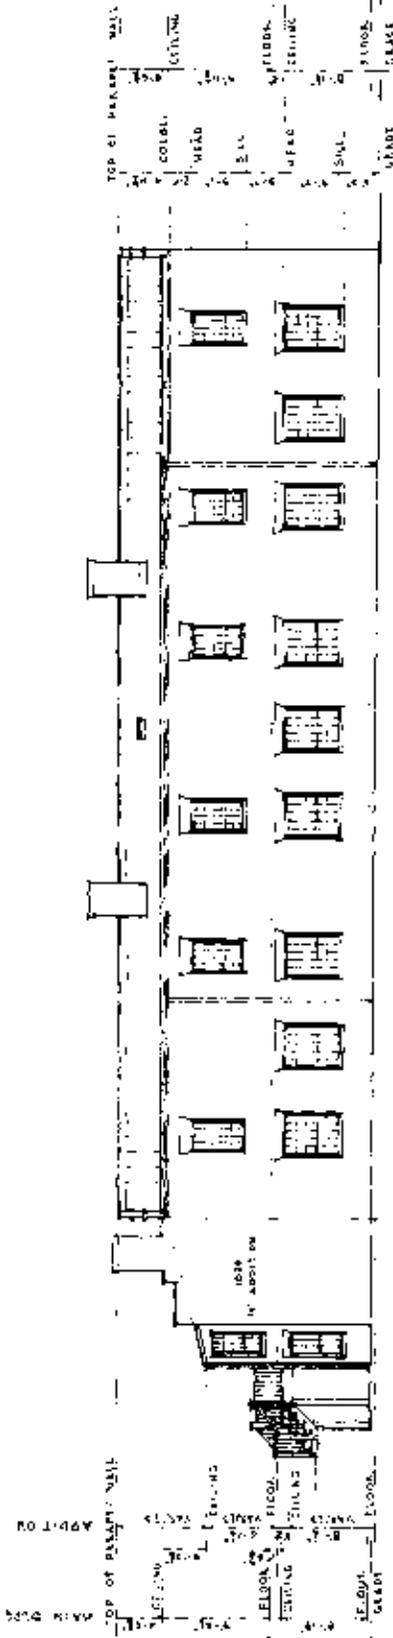
REAR (SOUTHWEST) ELEVATION
SCALE: 1/8" = ONE FOOT

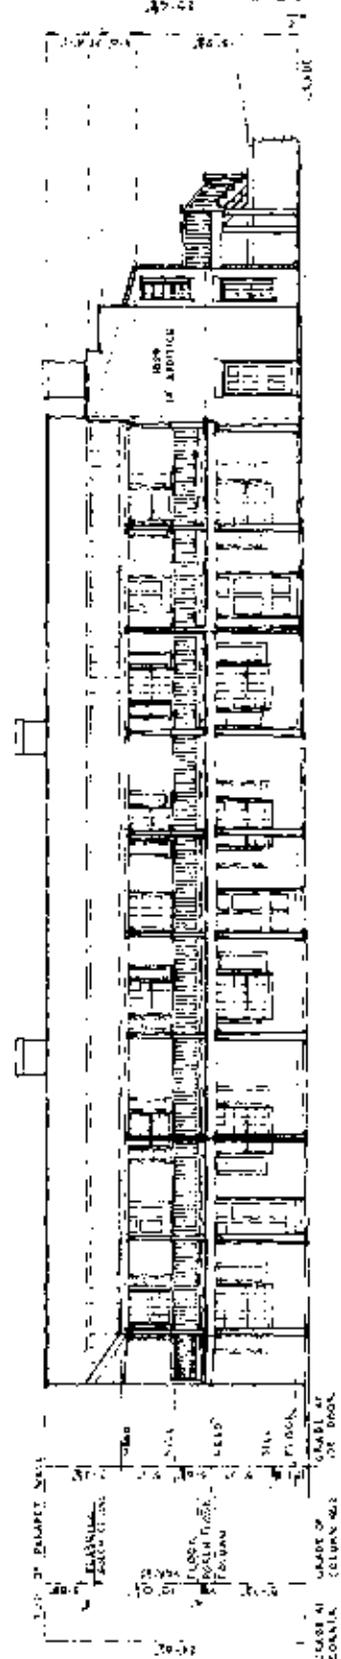
FRONT (NORTHEAST) ELEVATION
SCALE: 1/8" = ONE FOOT

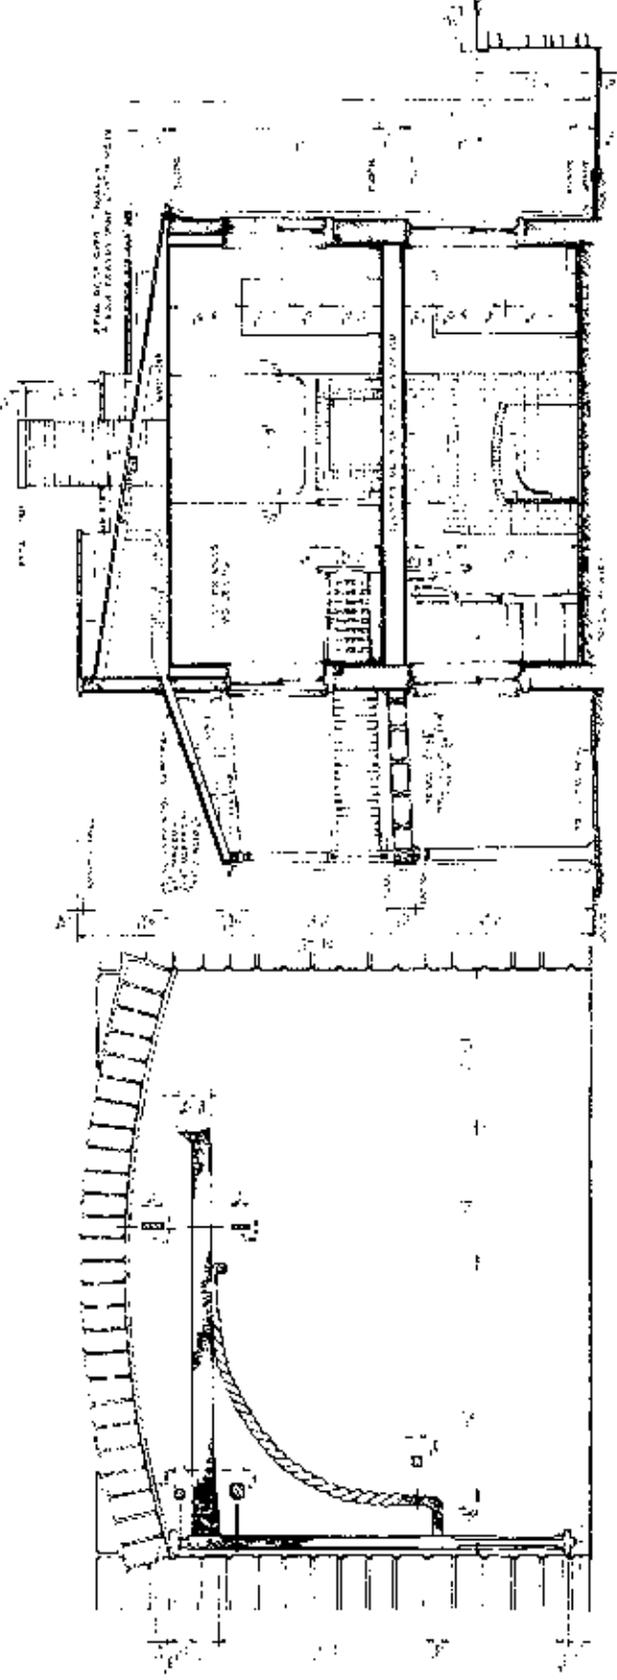
SECTION
SCALE 1/4" = 1'-0"

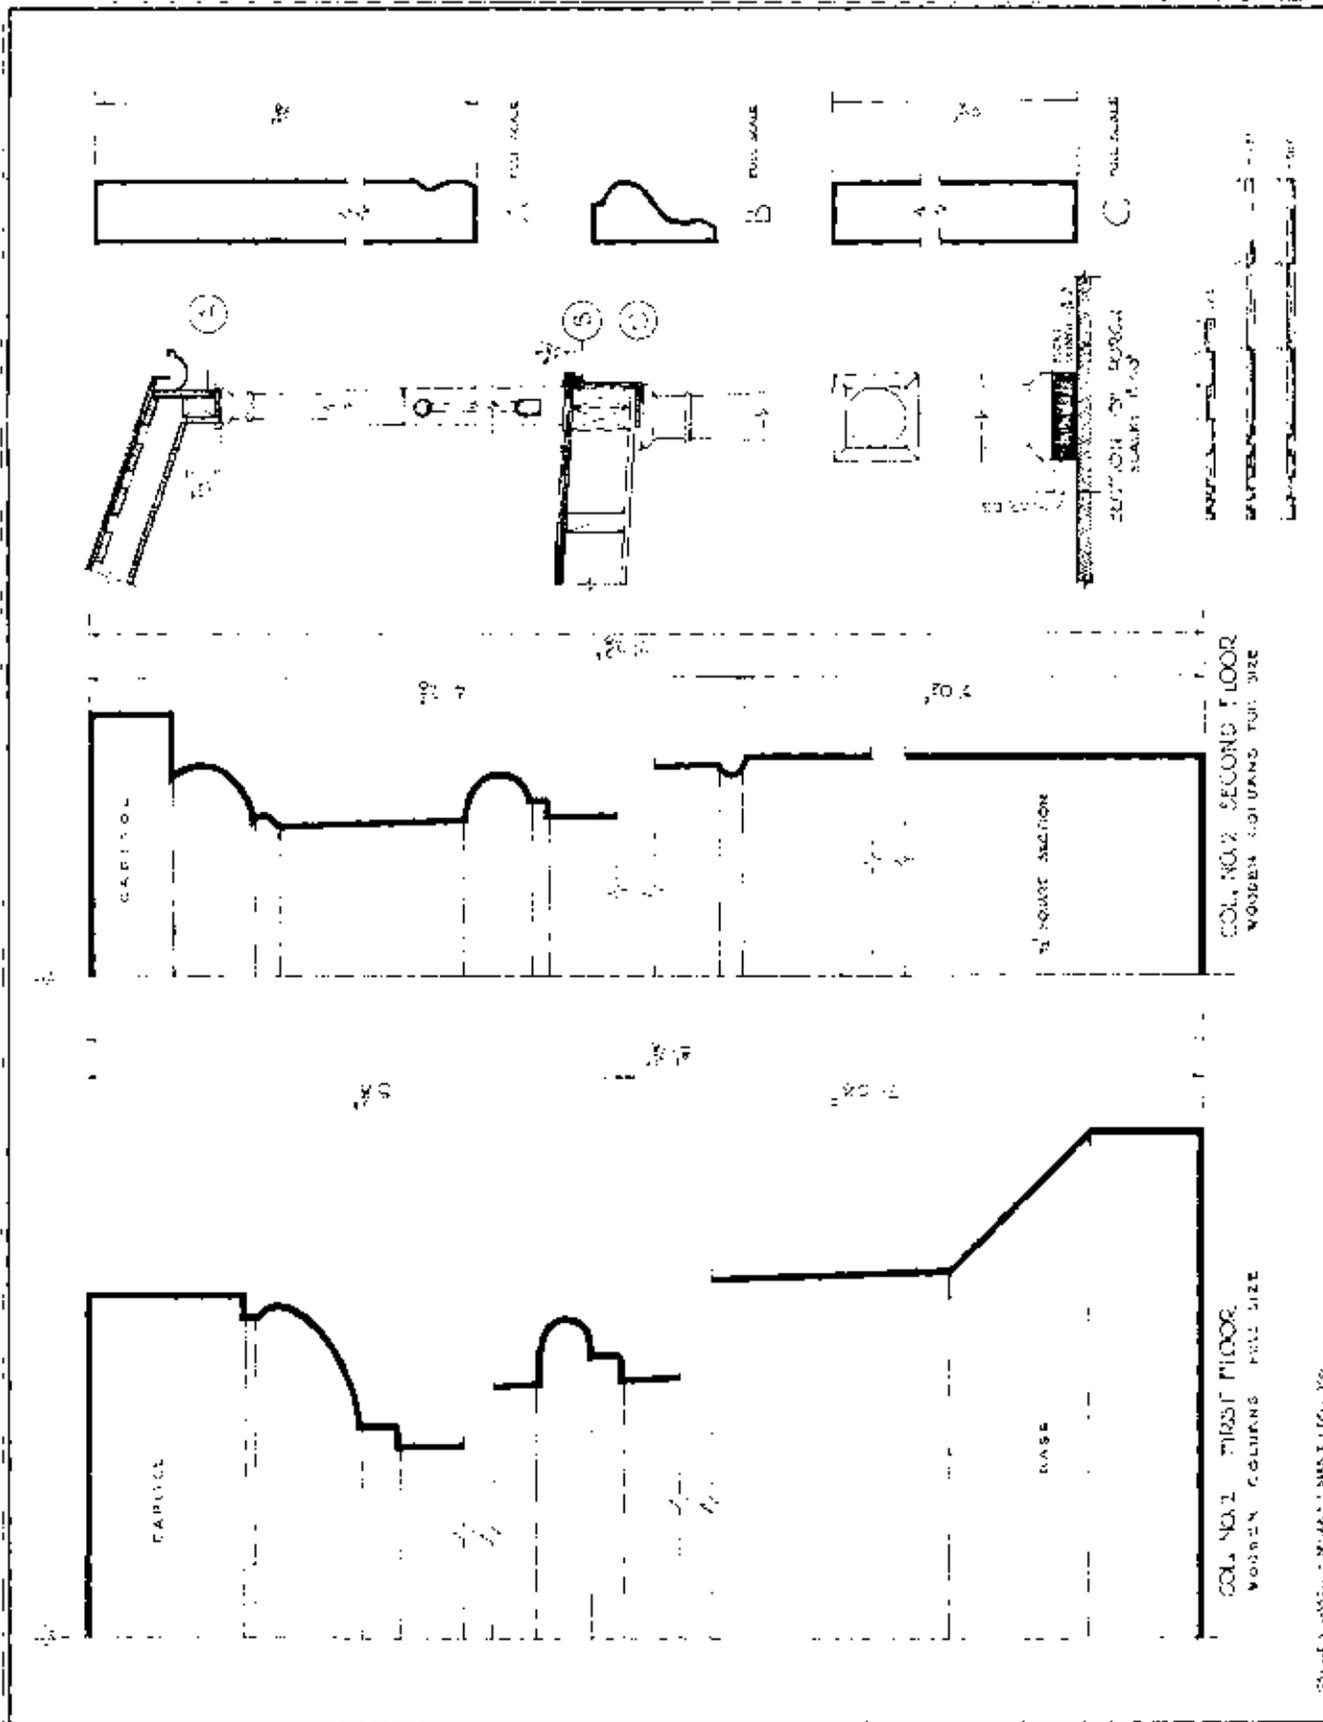
COL. NO. 1 FIRST FLOOR
 WOODEN COLUMNS FULL SIZE

COL. NO. 2 SECOND FLOOR
 WOODEN COLUMN FULL SIZE

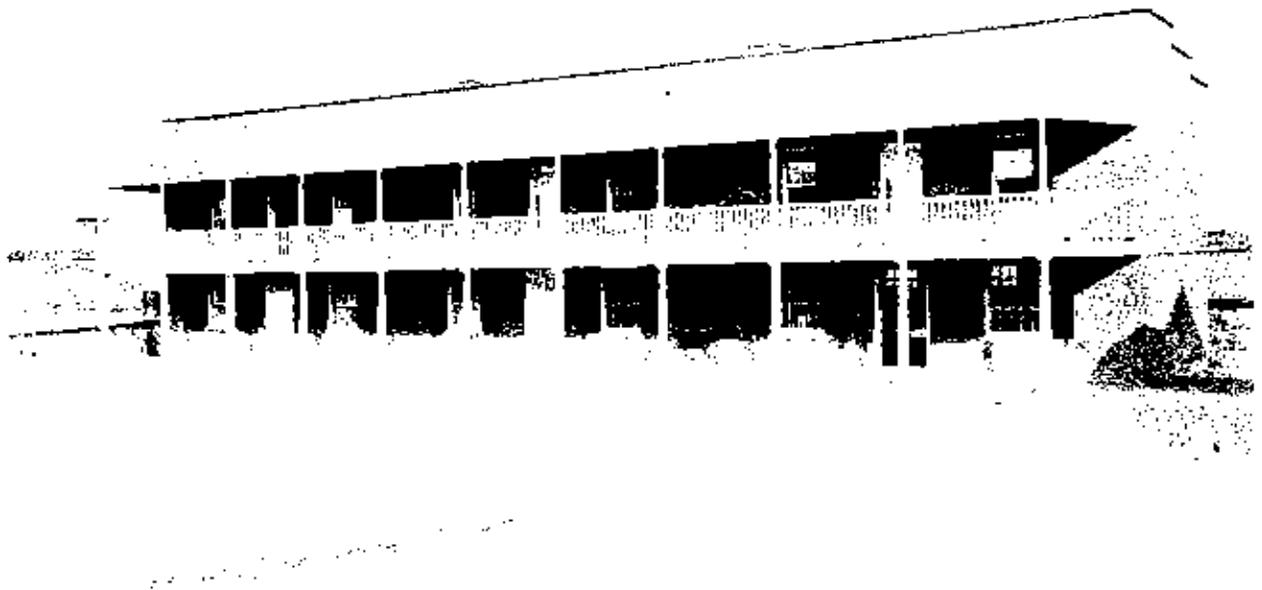
Illustration No. 35

No. 2 Soldiers' Barracks (Building E). Facade and southwest end-wall. Photographer: Jack E. Boucher, July 1958.

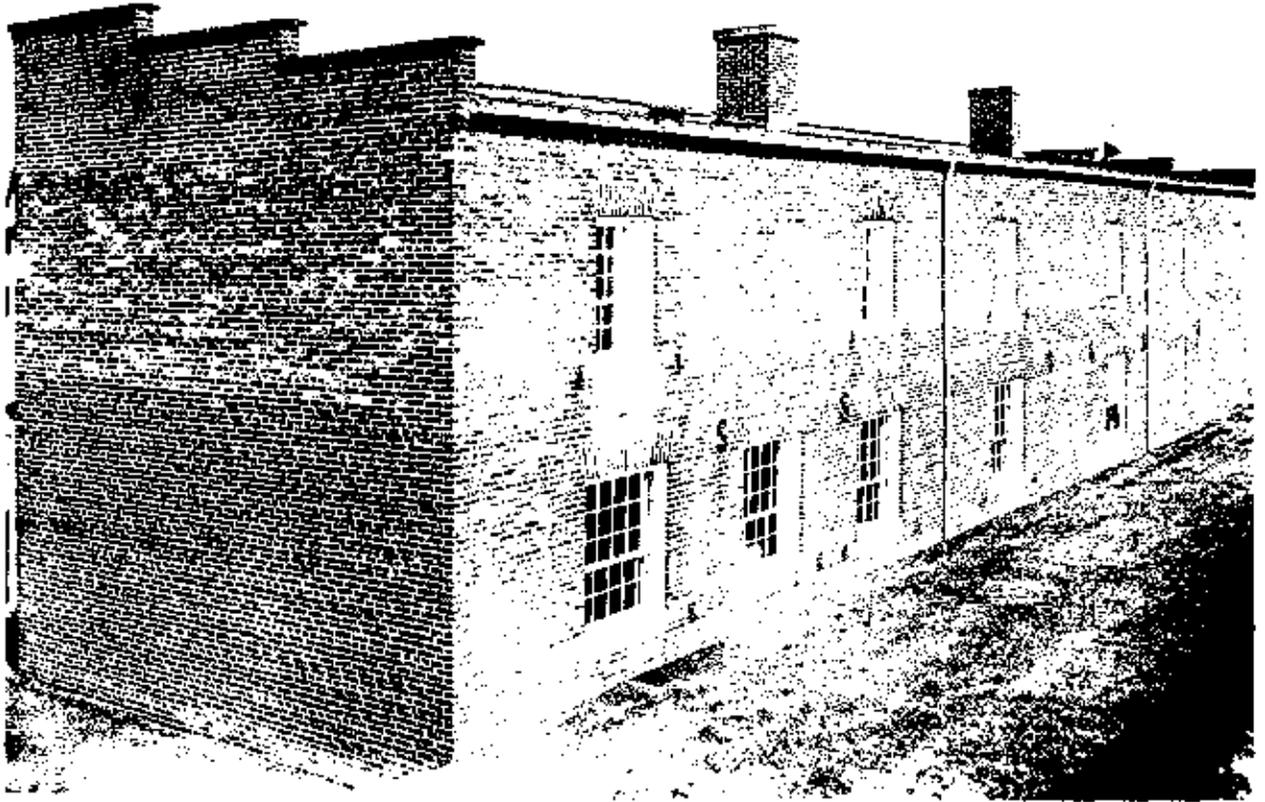
Illustration No. 36

No. 2 Soldiers' Barracks (Building E). Rear wall and southwest end wall. Photographer: Jack E. Boucher, October 1958.

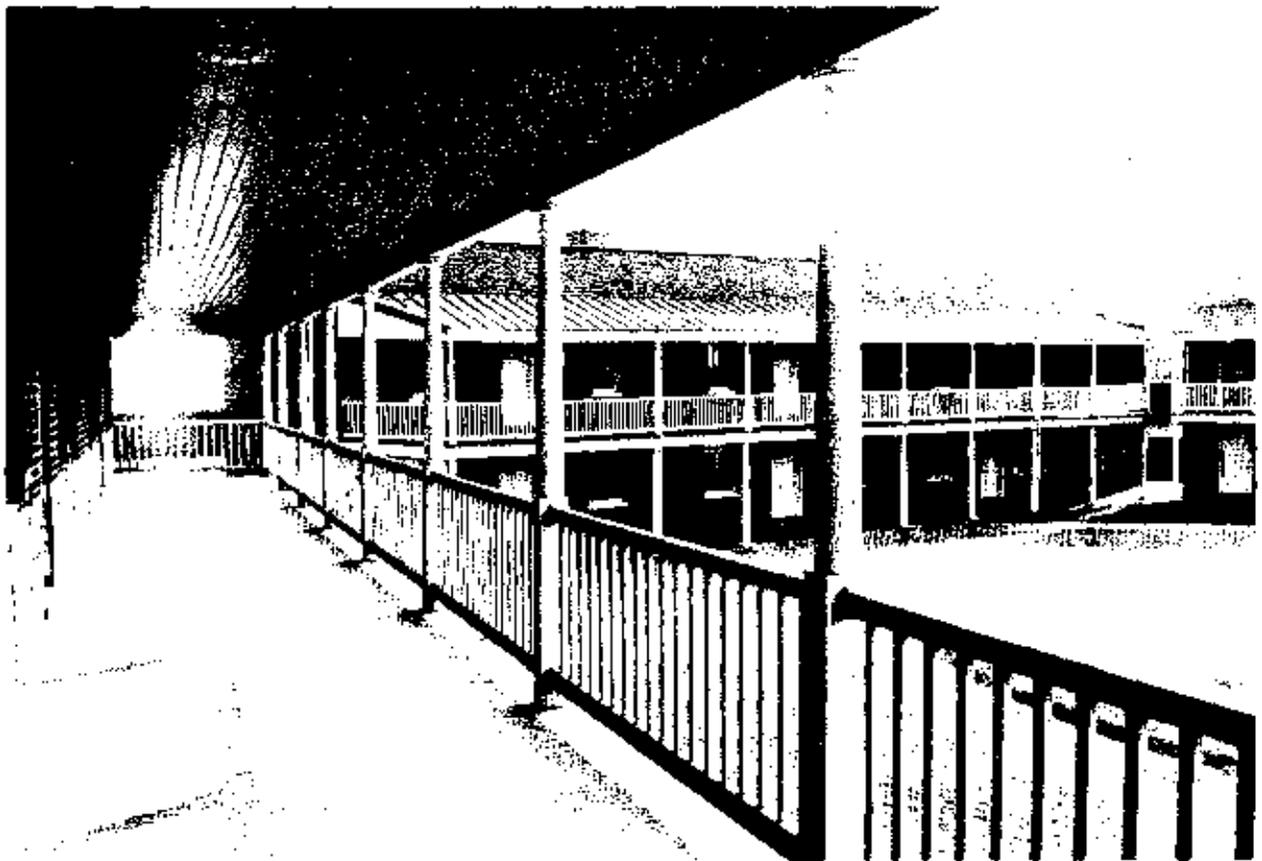
Illustration No. 37

No. 2 Soldiers' Barracks (Building E). Second floor level of "piazza," reconstructed in 1929-30 by the War Department, using Building D as a prototype. Photographer: Jack E. Boucher, July 1958.

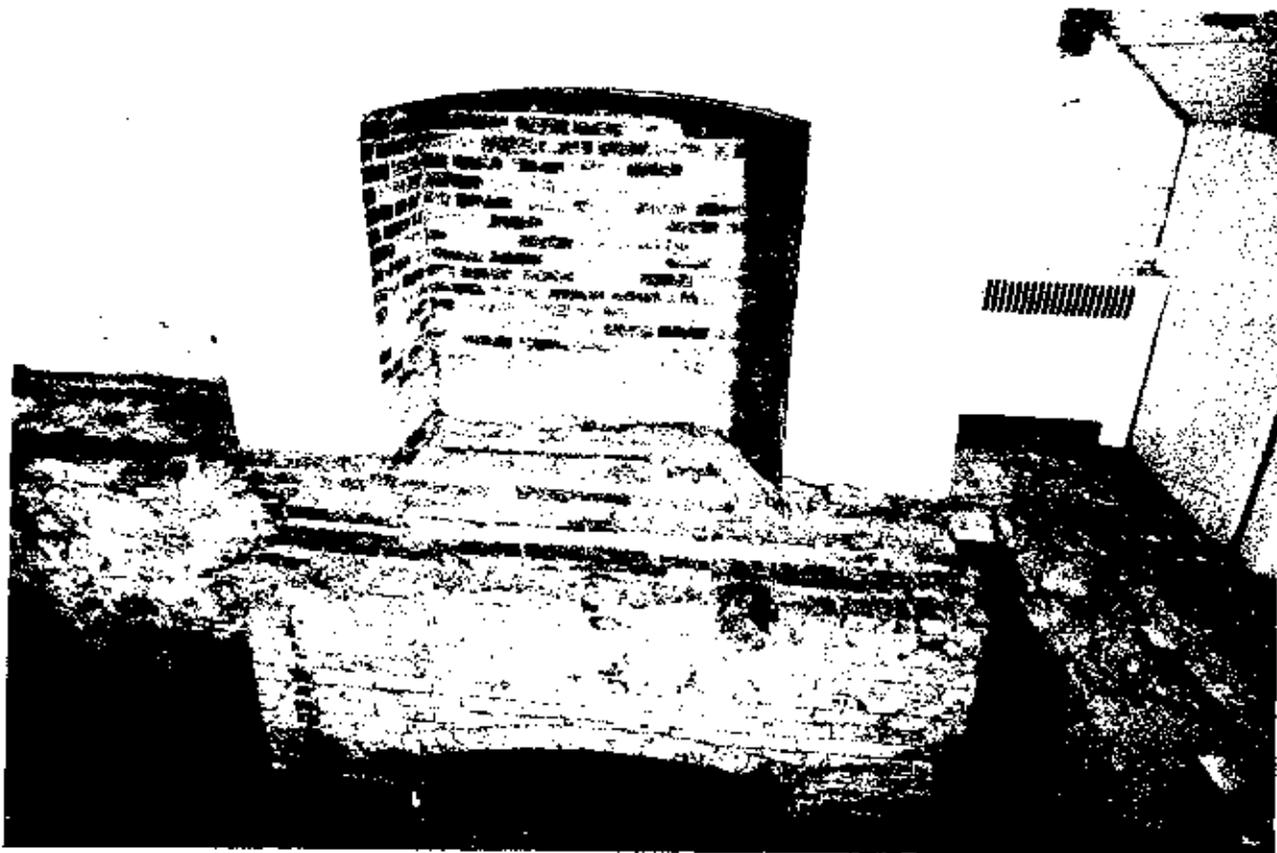
Illustration No. 38

No. 2 Soldiers' Barracks (Building E). Partial excavation of cellar fireplace under northeast room, first floor. Photographer: Jack E. Boucher, October 1958.

8. Heating, modern steam radiators. Originally, heat was furnished by fireplace, one in each room. Fireplaces, and chimneys, restored in 1930, are located at the center of the crosswalls, two of the fireplaces being back to back. First floor fireplaces have no shelves or mantel pieces, openings are arched with header bricks, supported by iron lintel bars, rectangular in cross section. The cellar fireplace is similar to those on first floor, except that it is whitewashed. Second floor fireplaces are smaller, with flat arch brick lintels. The mantel shelf and pilaster boards are 1930 replacements, similar in design to those shown on the 1834 drawing by Lt. Thomas J. Lee.

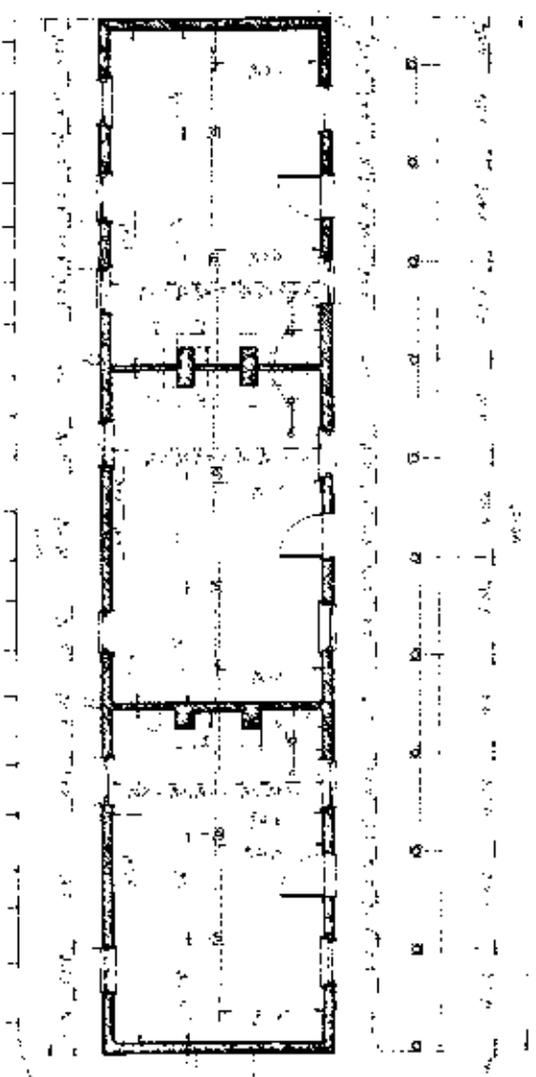
SECOND FLOOR PLAN
Scale 1/8" = 1'-0"

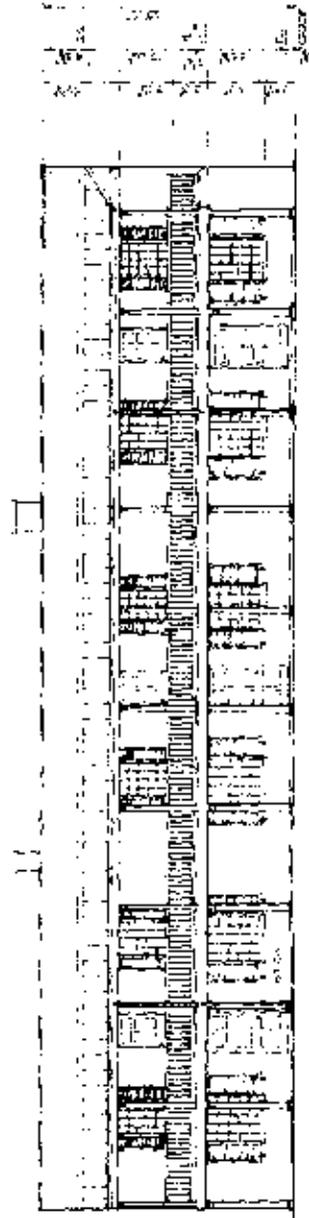
REAR (SOUTHEAST) ELEVATION
SCALE 1/8" = ONE FOOT

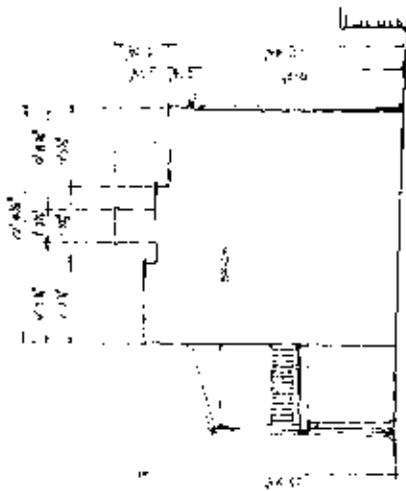
FRONT (NORTHERN) ELEVATION
SCALE 1/8" = ONE FOOT

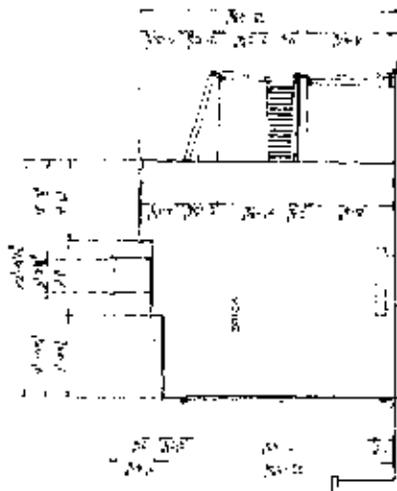
SOUTH ELEVATION
SCALE 1/8" = ONE FOOT

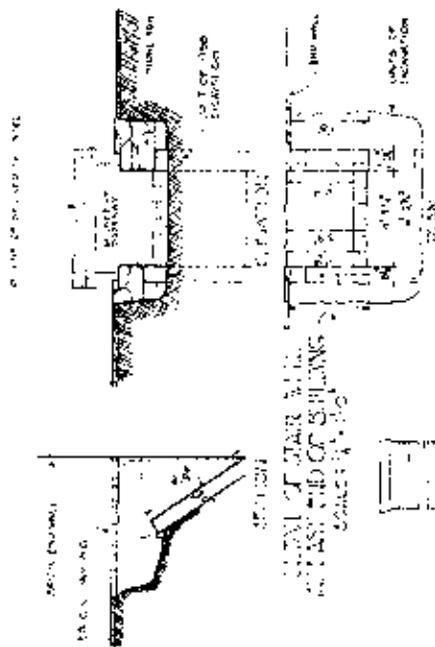
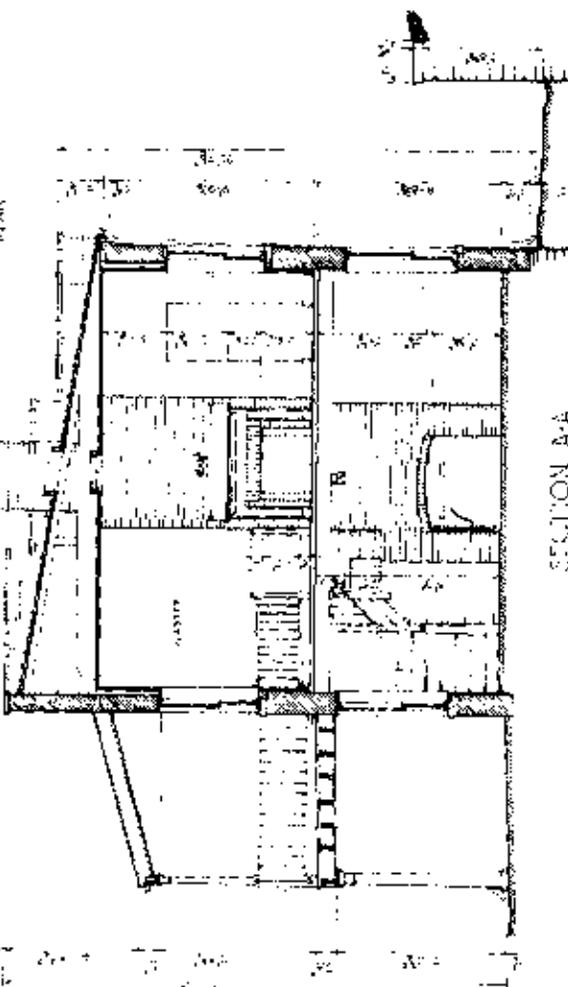
NORTH ELEVATION
SCALE 1/8" = ONE FOOT

SECTION A-A
SCALE 1/4" = ONE FOOT

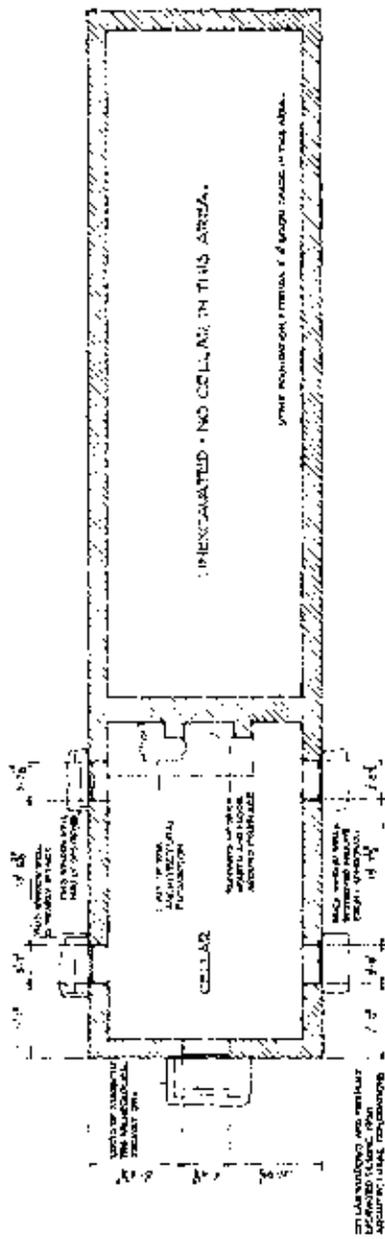
FOUNDATION PLAN SCALE: 1/8" = 1'-0"

2. Foundations. Random quarry stone foundation walls, which extend about three feet below grade, except at easternmost end of building, where stone walls extend nearly eight feet below grade to accommodate a cellar kitchen that was filled with earth about 1837.

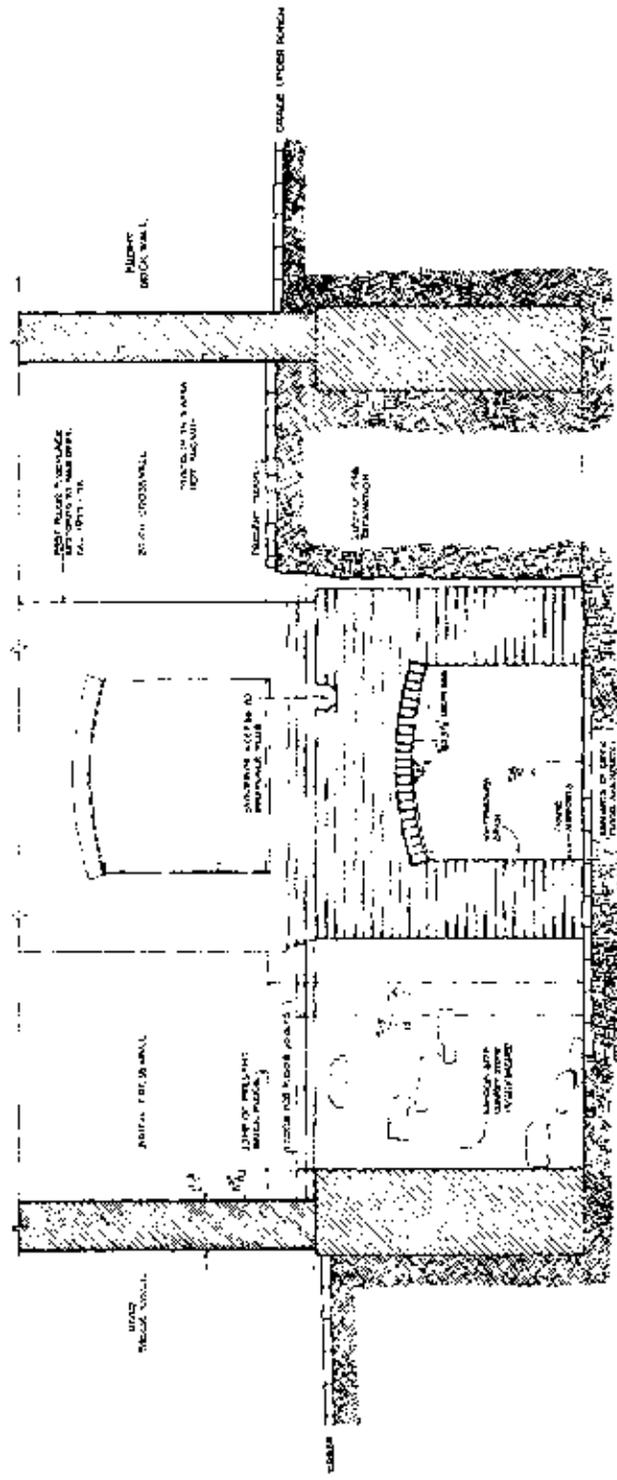
CELLAR FIREPROOF SCALE: 1/8" = 1'-0"

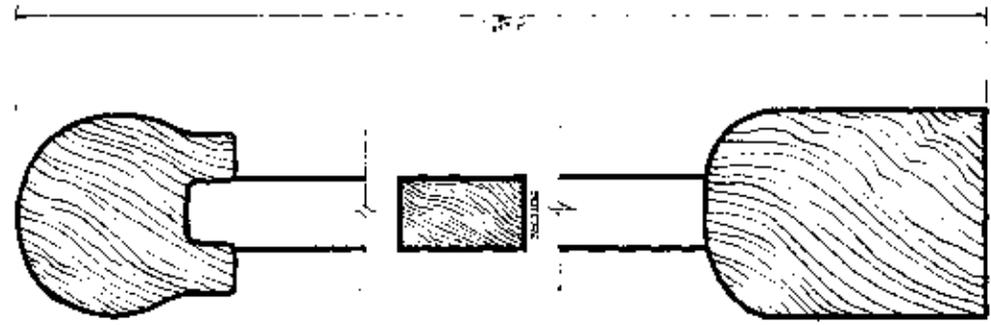
BALUSTRADE DETAIL
FULL SCALE

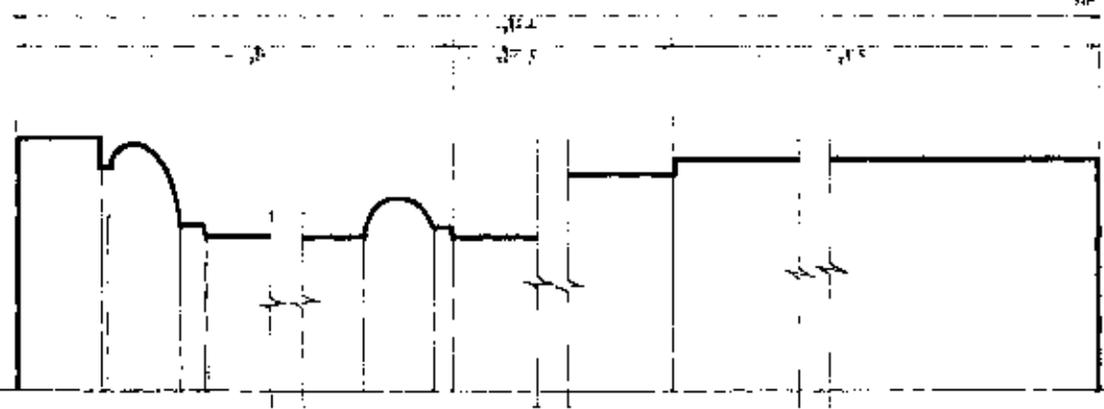
SECOND FLOOR PORCH COLUMN
FULL SCALE

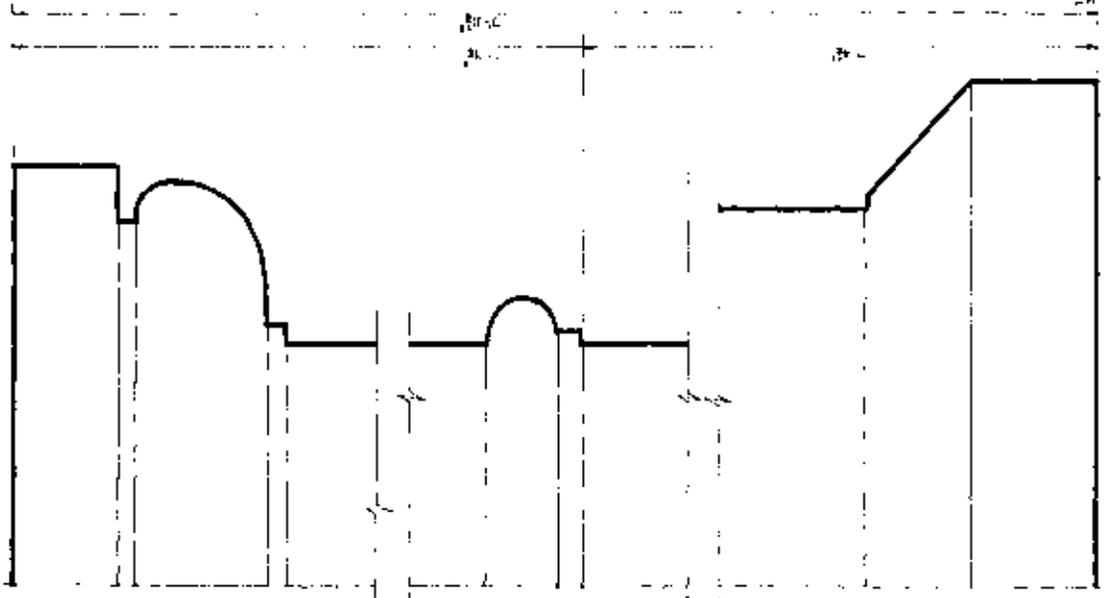
FIRST FLOOR PORCH COLUMN
FULL SCALE

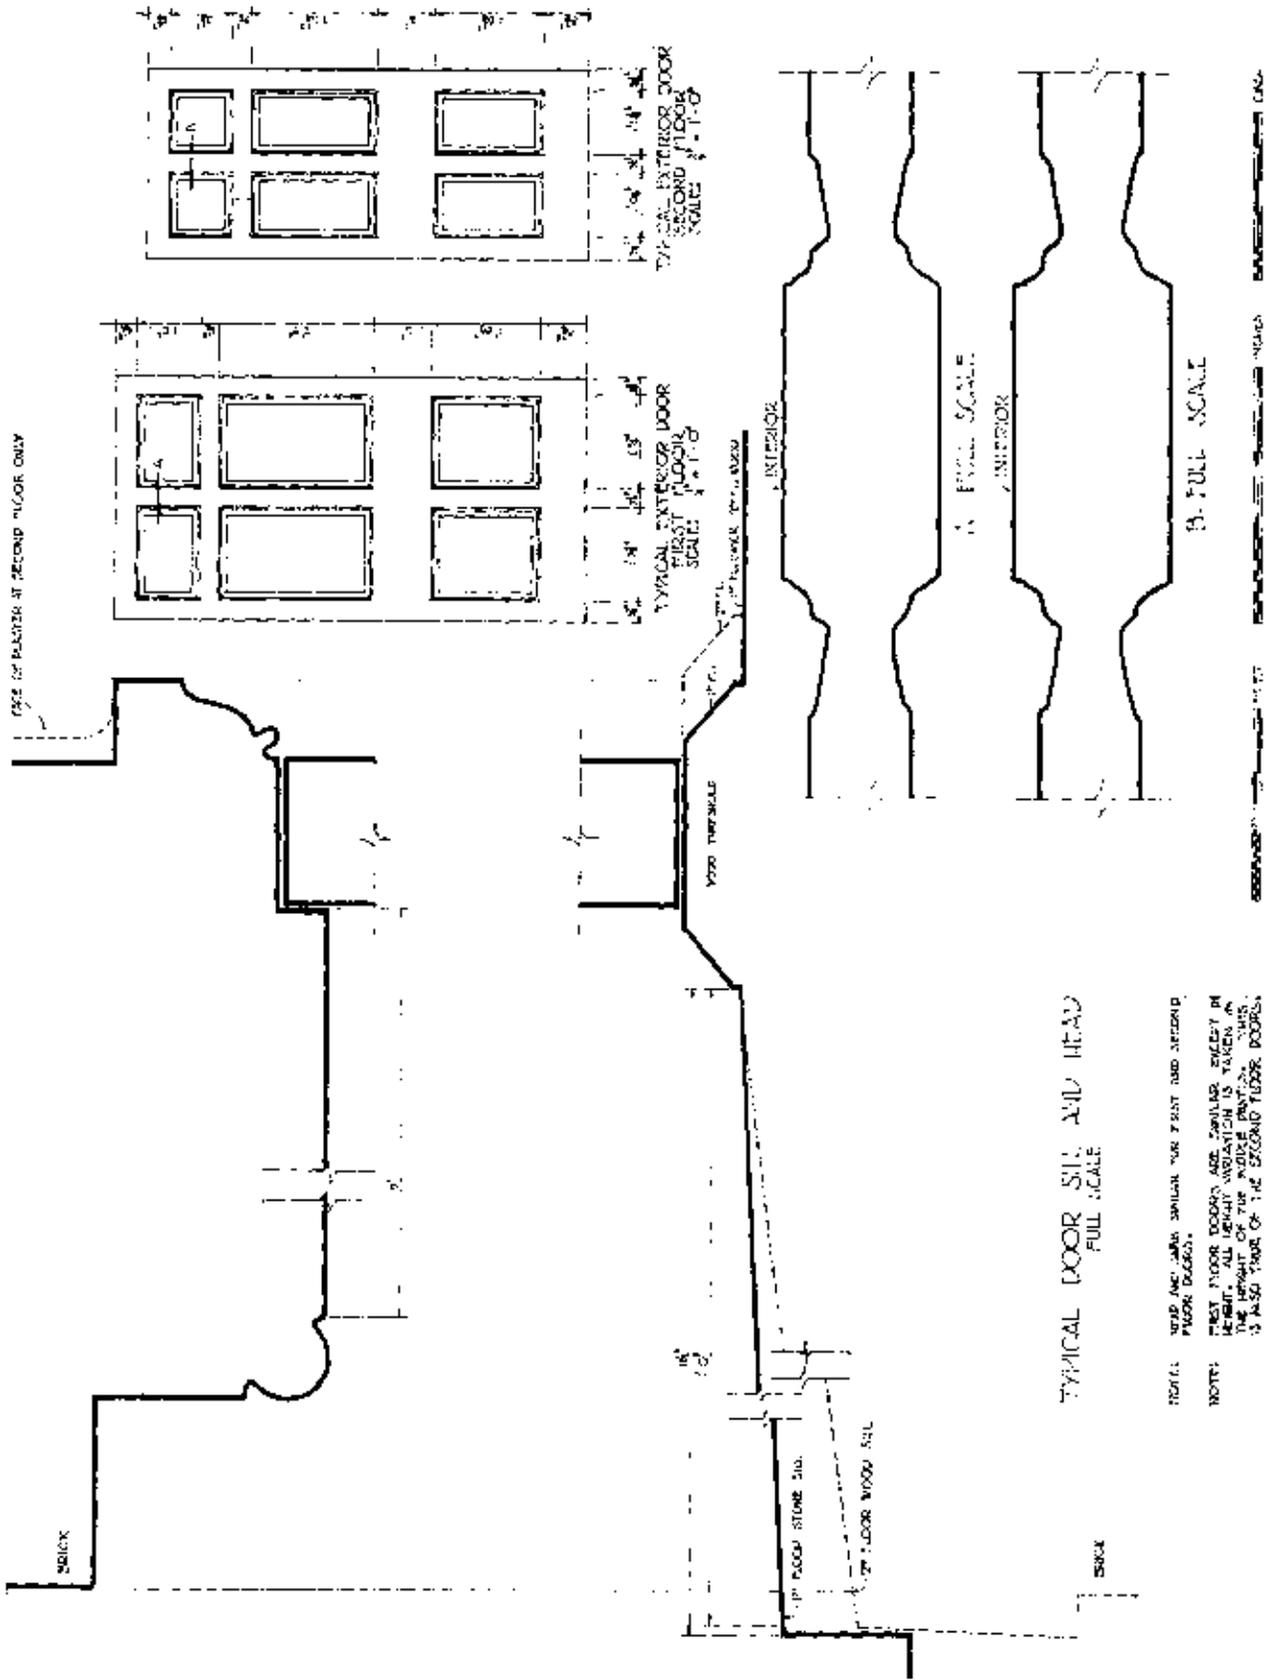
TYPICAL DOOR SILL AND HEAD
FULL SCALE

a. Doors. Are all replacements, original design unknown. Millwork details are all 1930 as to design and construction. Door sills are probably original, being of a dressed, granite-like stone.
