OFFICERS CLUB BUILDING No. 114

HISTORIC STRUCTURE REPORT

**Sandy Hook Unit
Gateway National Recreation Area**

James J. Lee III
Architectural Conservator

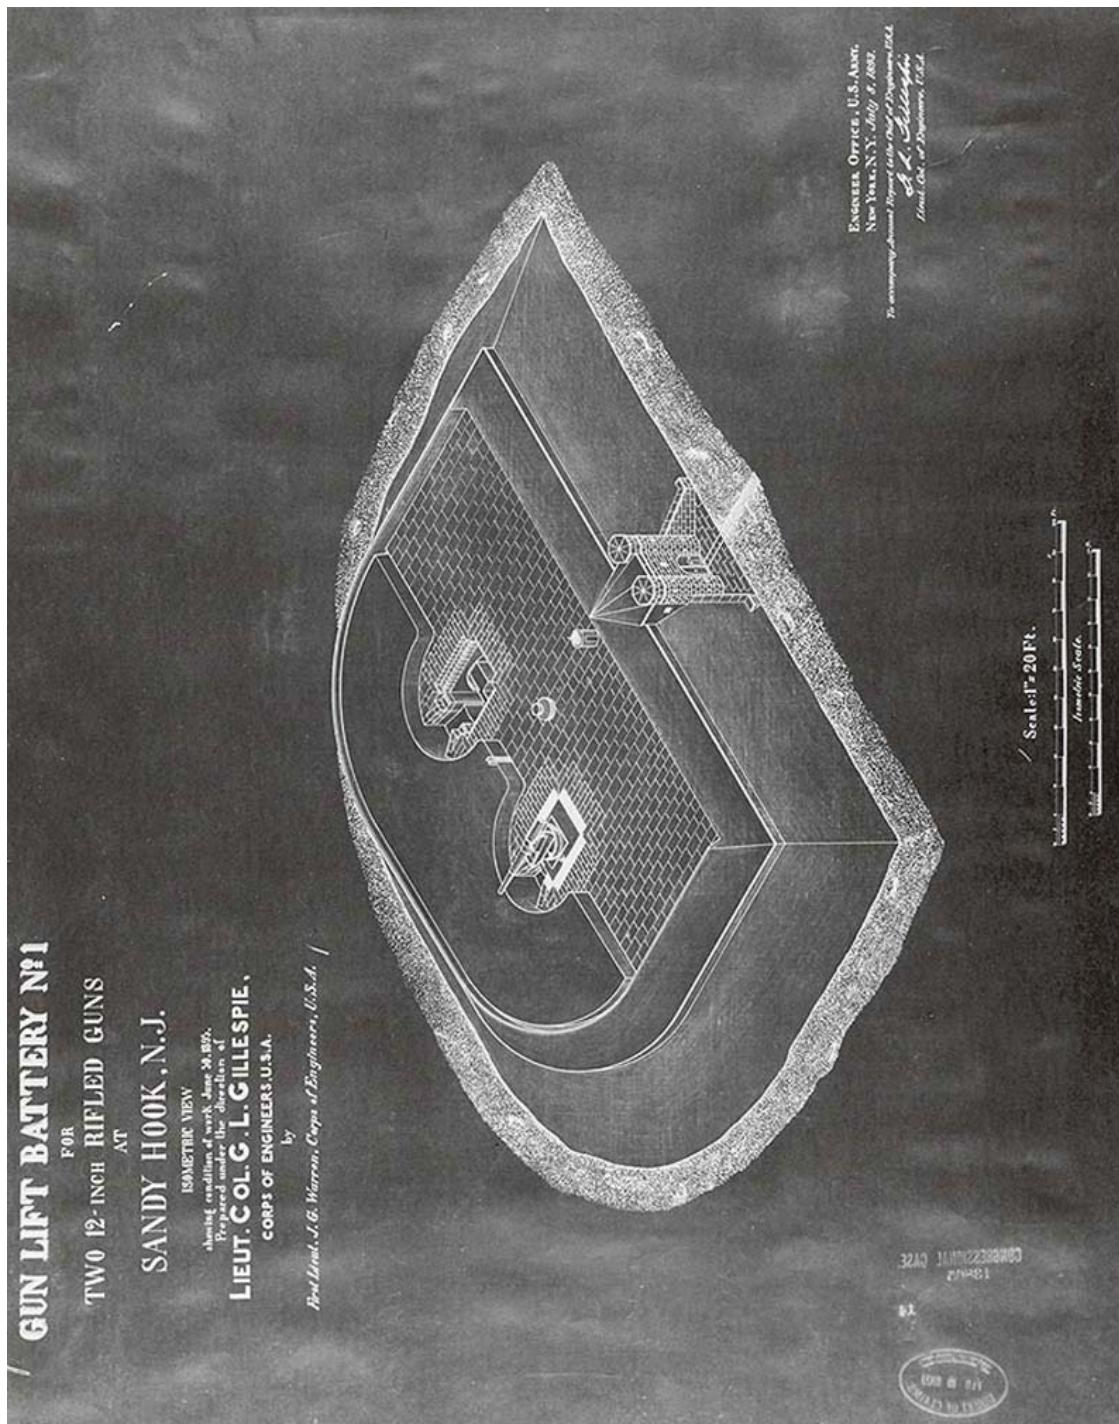
Figure 6. “Gun Lift Battery No. 1” (Battery Potter), Isometric View, June 30, 1893.

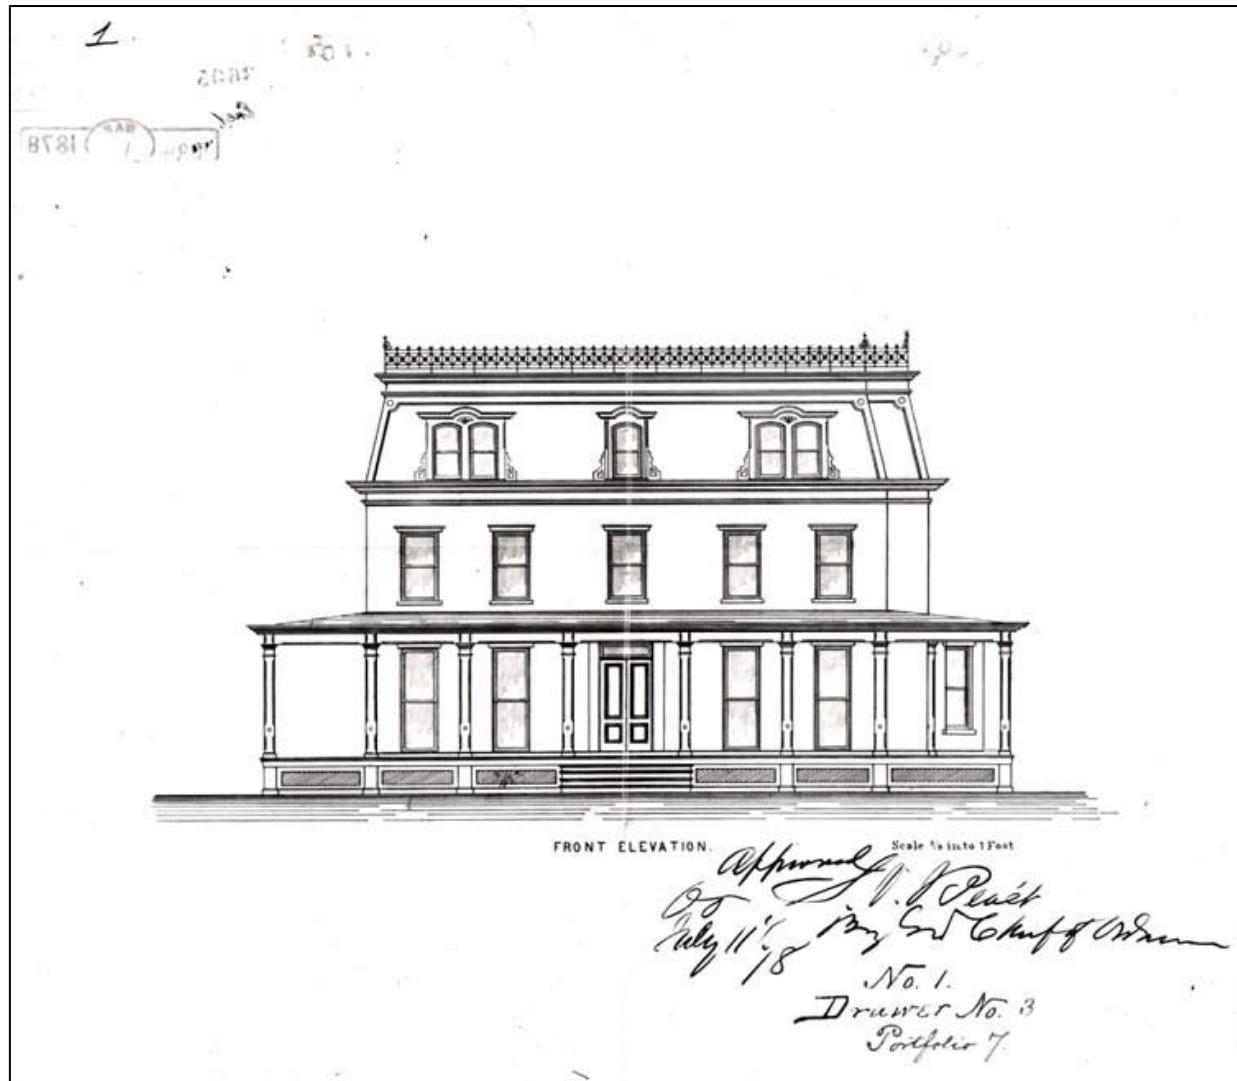
Figure 11. "Officers' Quarters," proposed front elevation plan, July 1878.

The placement of doorway and window openings in the building figures prominently in the Victorian design. This is illustrated in the drawing of the "Front Elevation" (fig. 11). Though the doorway and window details were not executed exactly as drawn, and the placement of some openings deviates from the proposed plan, the overall intent for the façade was implemented. Many of the building's original openings are extant and continue to convey the intent of the original design, and they also provide evidence of original details and finishes.

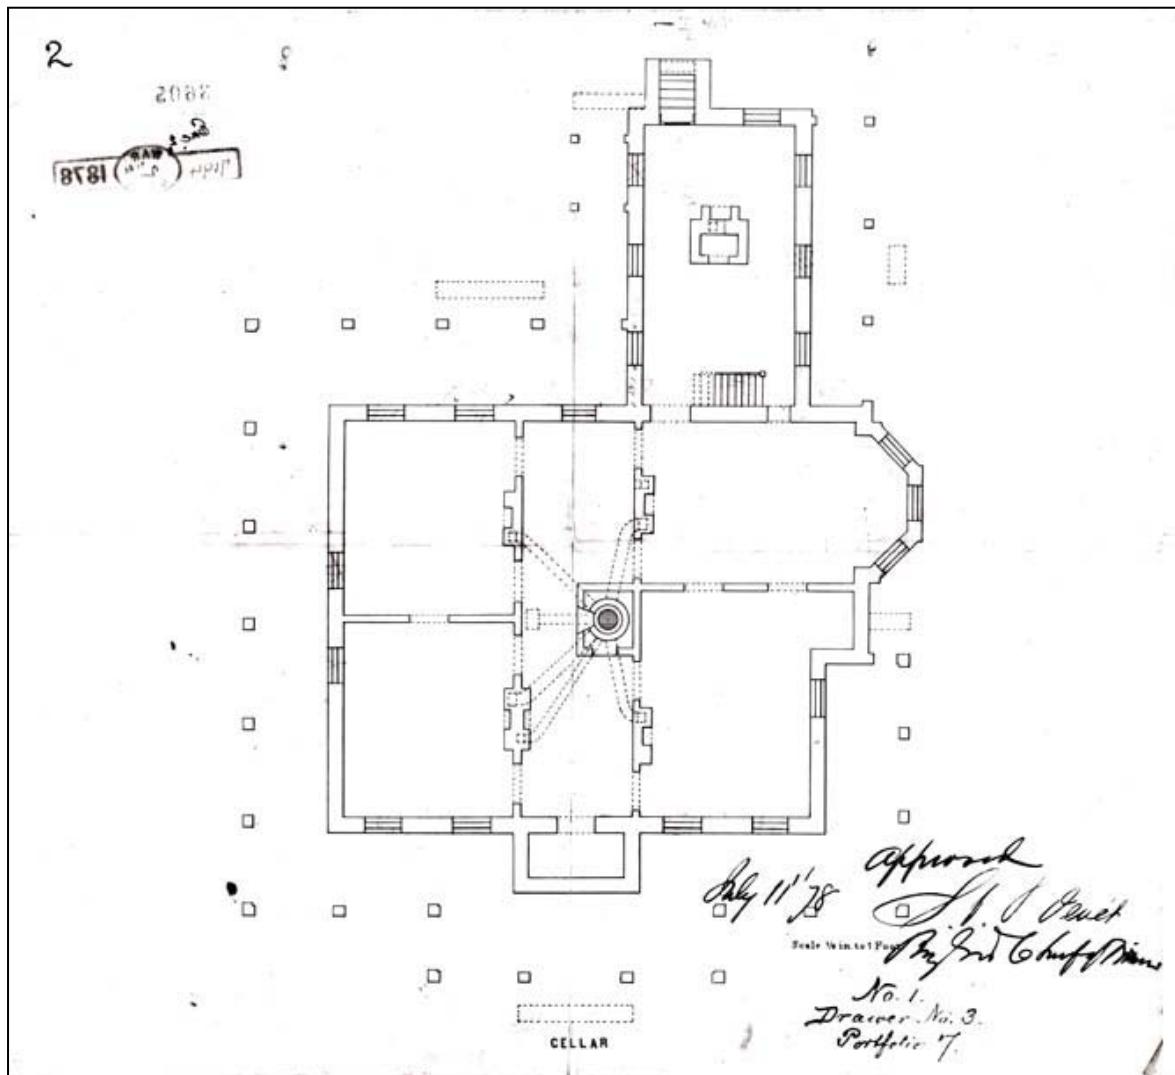
Figure 12. “Officers’ Quarters,” proposed cellar plan, July 1878.

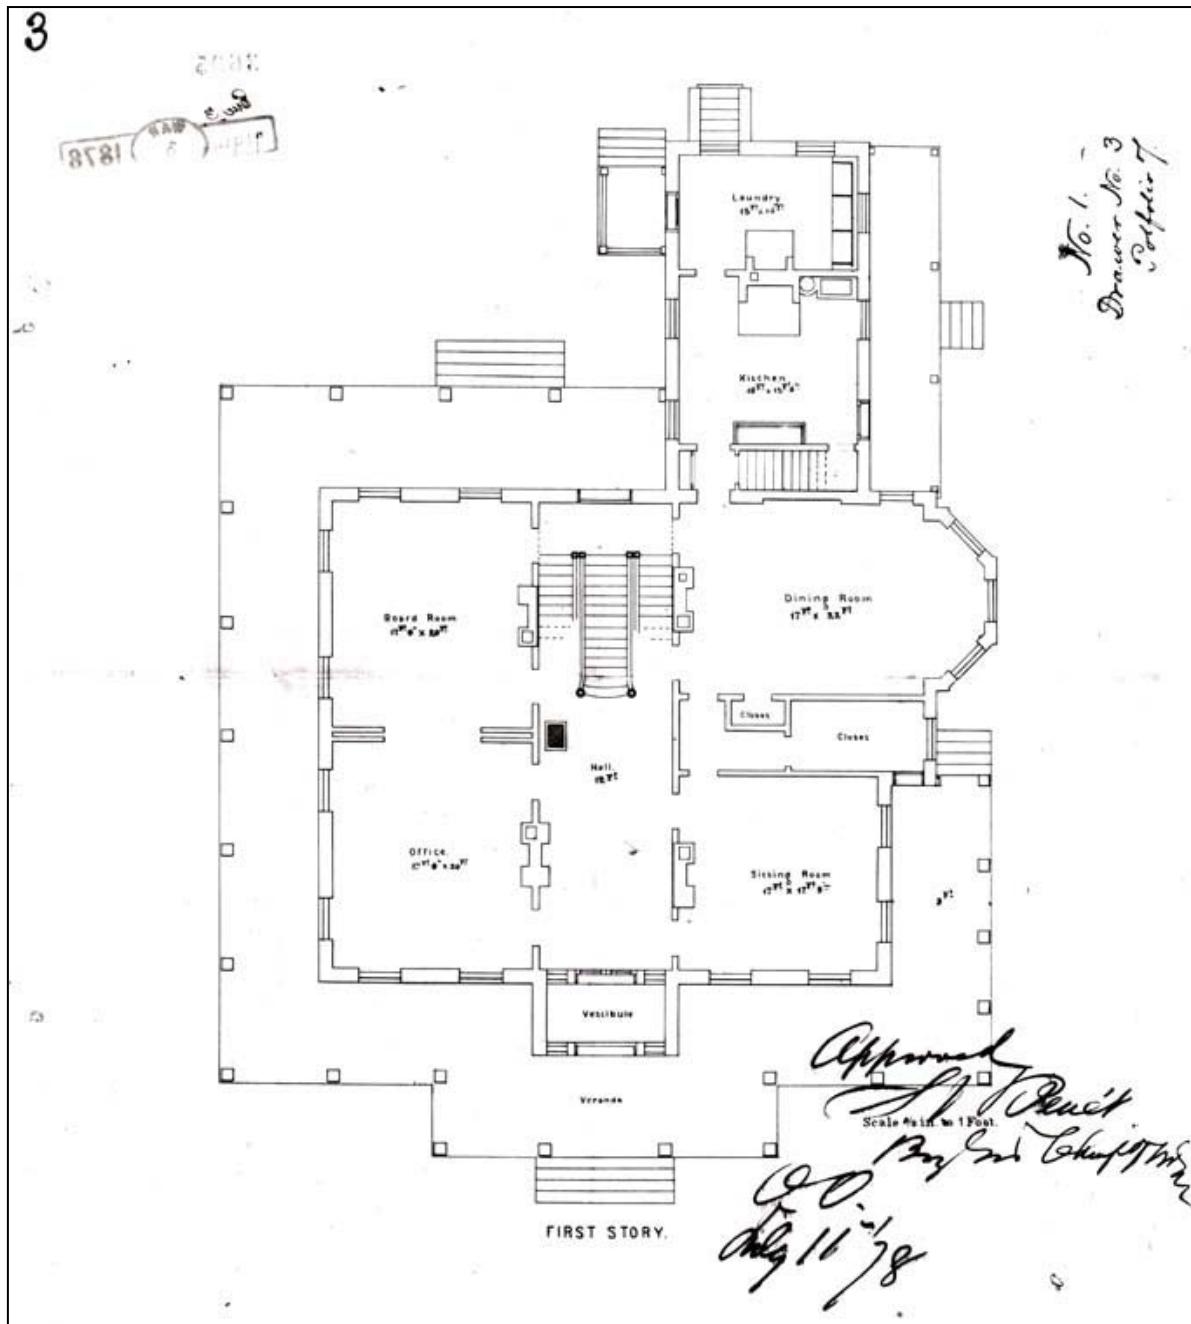
Figure 13. "Officers' Quarters," proposed first-story plan, July 1878.

The typical window openings at the second- story level measured 44 inches wide by 82 inches high and had double- hung, one- over- one sashes (fig. 25). The second story also featured some atypical openings. Based on examination of the earliest photographs, the center bay of the front elevation was an elongated opening that contained double- hung sashes and a smaller two- light sash above (fig. 19). Tall window openings were also constructed on the north elevation above the bay window. In this location the sashes were paired to create a larger opening. This configuration is evident in both the plans and the early photograph (figs. 13, 18, and 27).

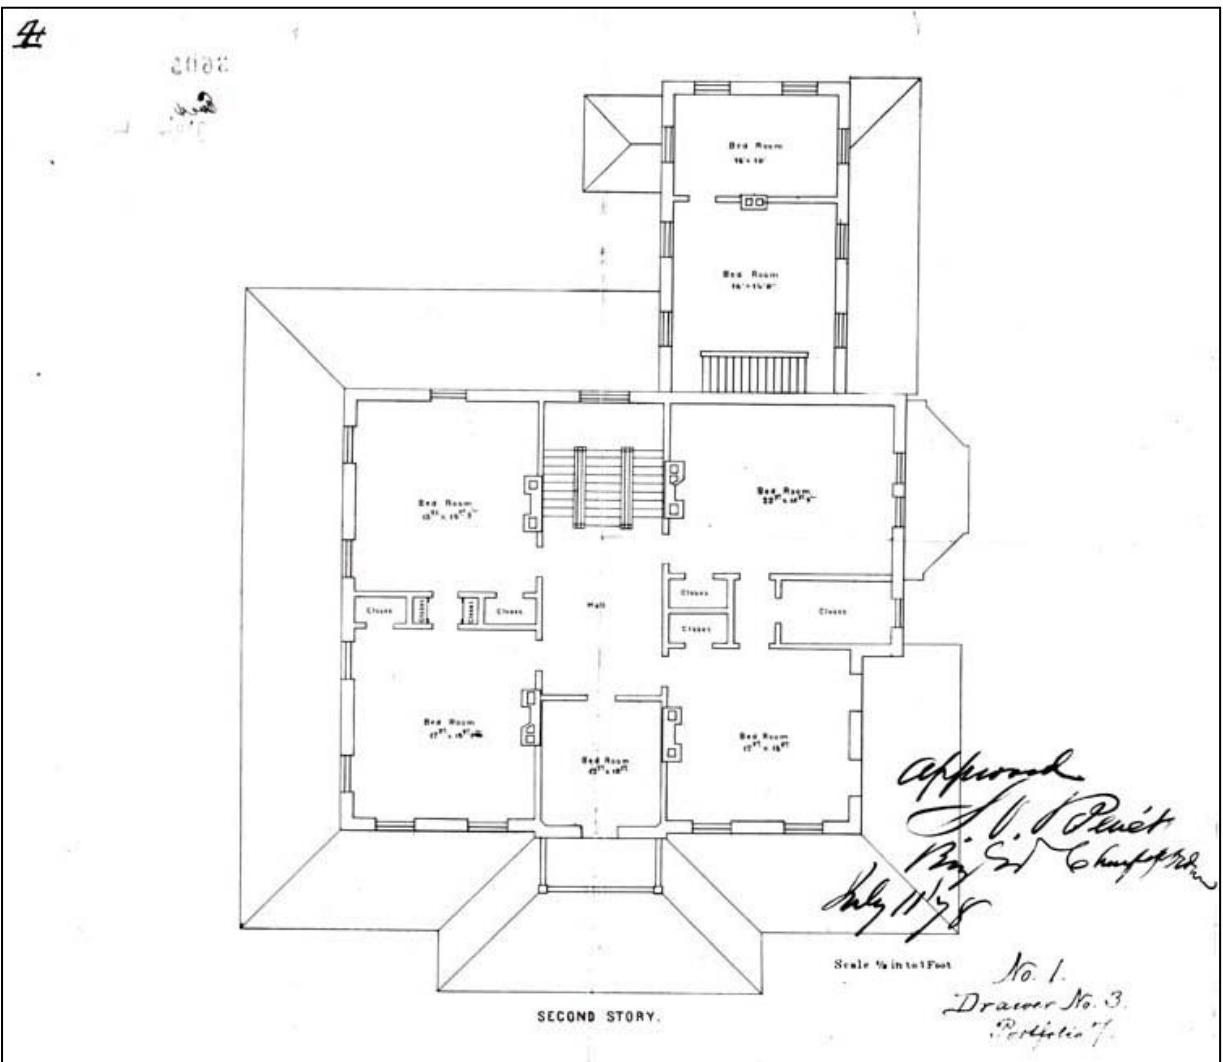
Figure 14. “Officers’ Quarters,” proposed second-story plan, July 1878.

The second story of the west elevation of the main block was designed with two windows: one centered in the wall of the southwest bedroom (Room 215), and a wide window at the landing of the main stairway to the second story (fig. 14). Two apparently original windows are extant in this elevation today: one at the extreme south end of the elevation (W223), and the narrow northwest- corner window just described (W210). The offset location of the southwest window suggests that Room 215 may have had two windows in this wall prior to the enlargement of the ell ca. 1905. This arrangement that would have mirrored that of the east elevation, but it cannot be confirmed without further destructive investigation. The interior casing of the original landing window appears to be intact, but nothing else of that window is visible.

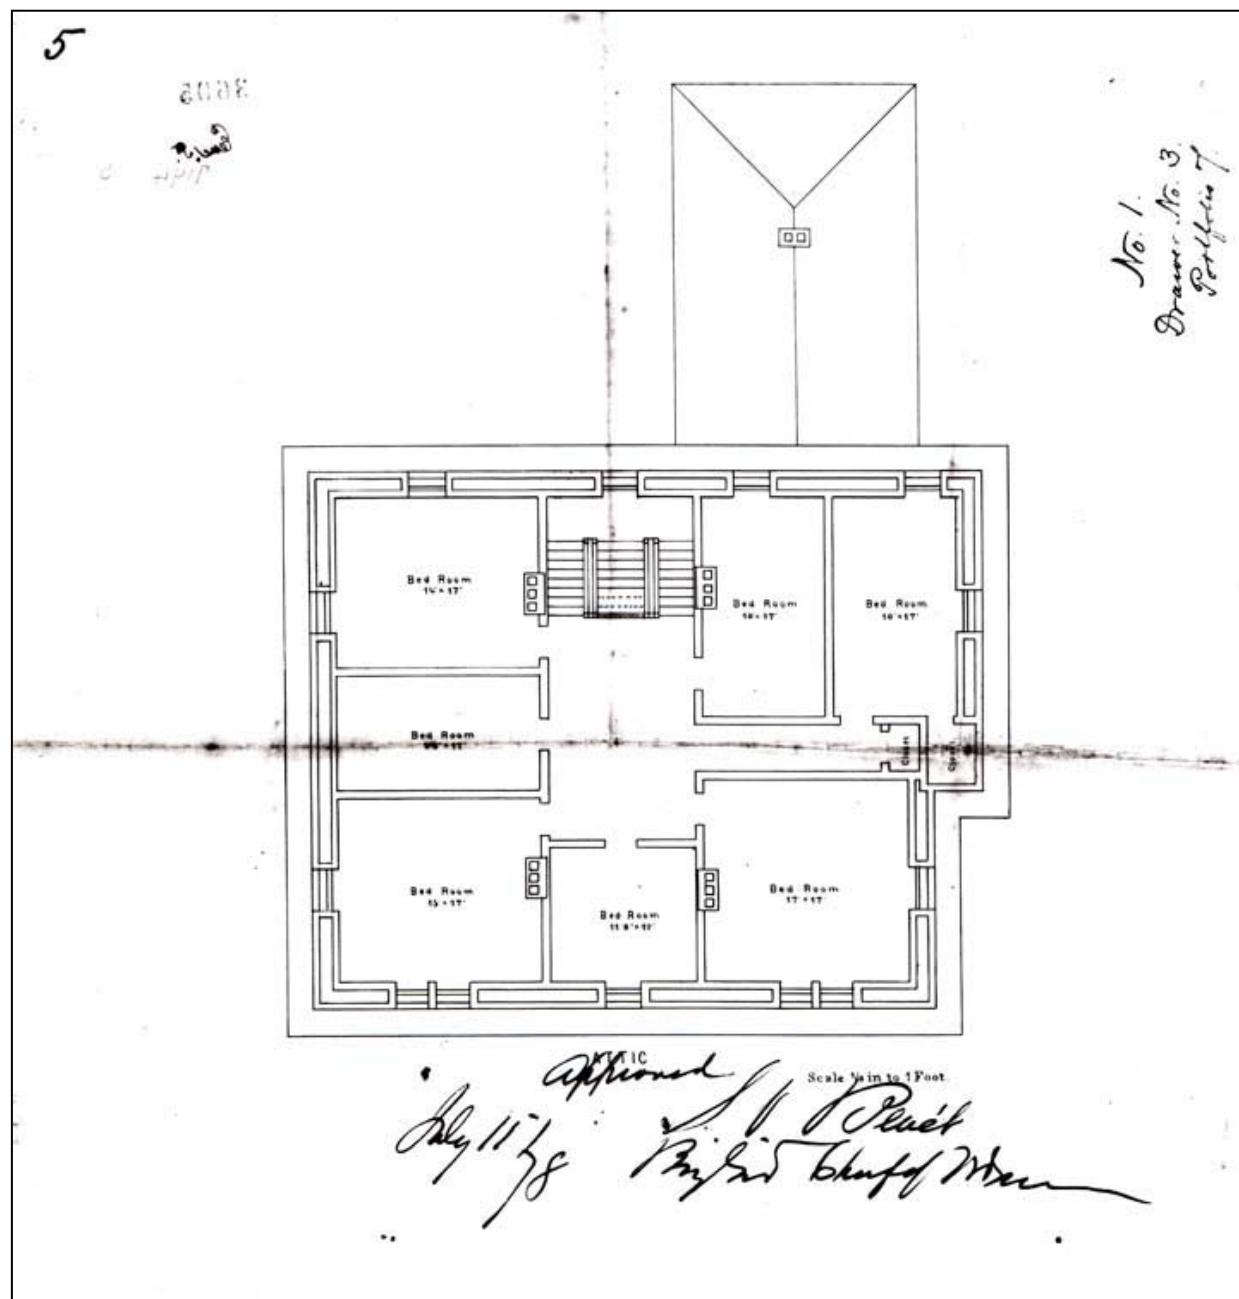
Figure 15. "Officers' Quarters," proposed attic plan, July 1878.

At the attic level, the east façade had five windows similar to the stories below, but they were grouped into three dormers: a center dormer with one window was flanked by two dormers with paired windows. This arrangement was echoed on the west elevation, contrary to the proposed attic plan (fig. 15). The north and south elevations each had three dormers, rather than the two shown on the proposed attic plan. These were symmetrically placed and had a single window each.

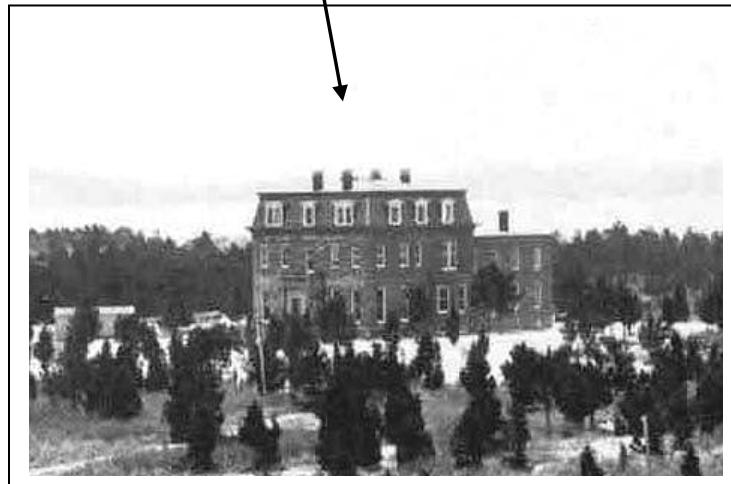
Figure 18. Detail of the Officers Club, north and east elevations; note the absence of the piazza.

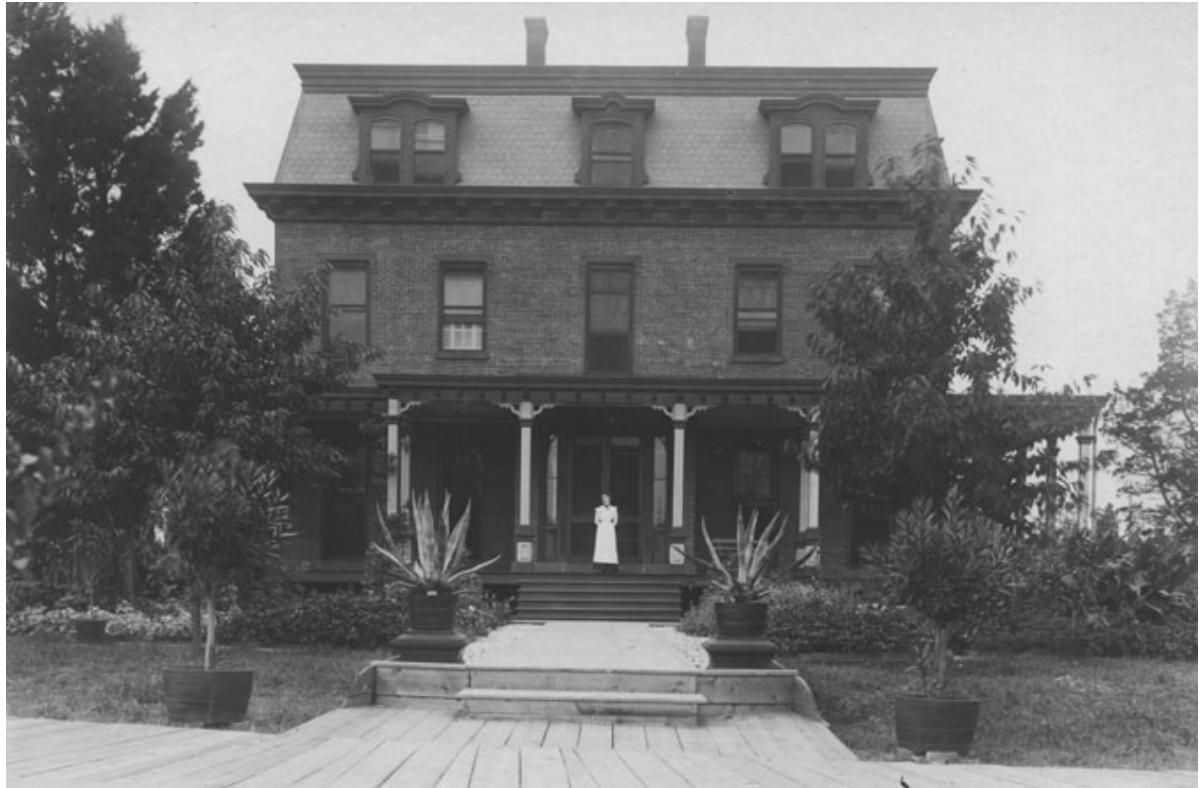
Figure 19. Officers Club, east/front facade, ca. 1900.

The author relied on the proposed plans for the “Officer’s Quarters” for the overall intent of the original design, for the general organization of the interior spaces, and as confirmation of pieces of physical evidence. Physical and documentary evidence was used to corroborate the original appearance. In particular, a ca.- 1900 photograph of the east/front elevation (fig. 19) provided the earliest detailed view of the Officers Club.

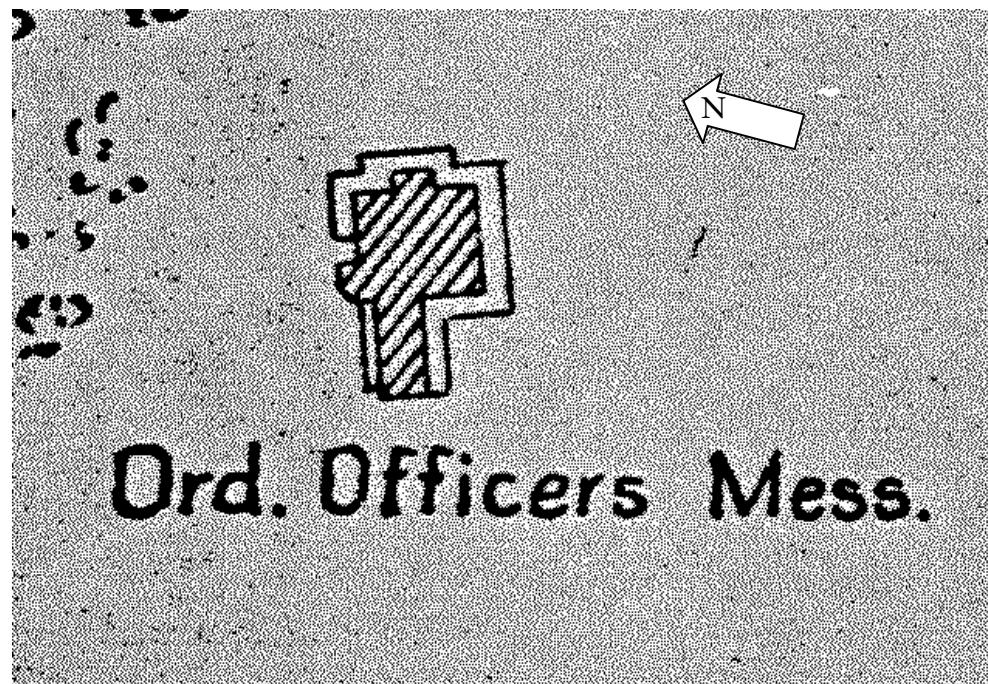
Figure 21. "Ordnance Officers Mess," 1901. Note the delineation of porches.

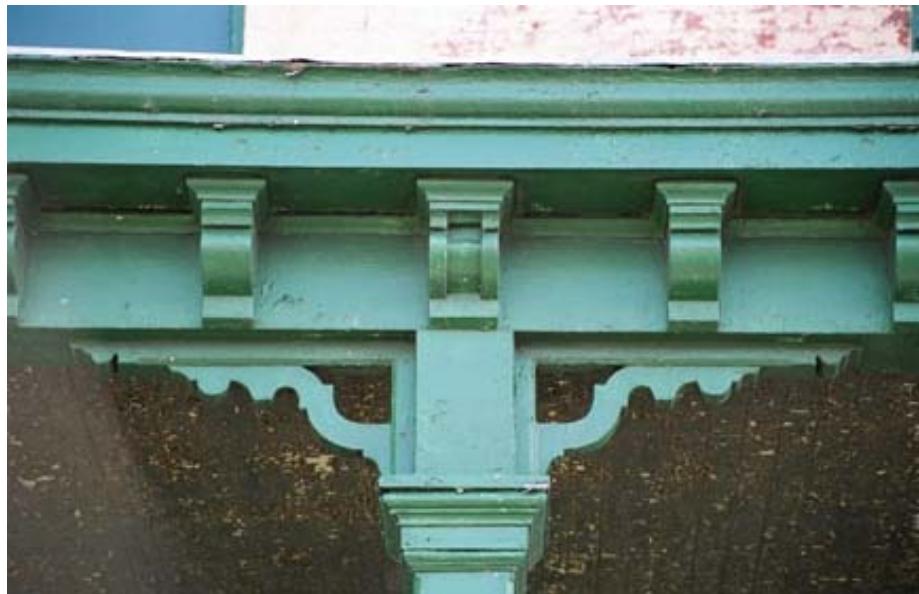
Figure 22. Officers Club, north elevation, piazza brackets, 2005.

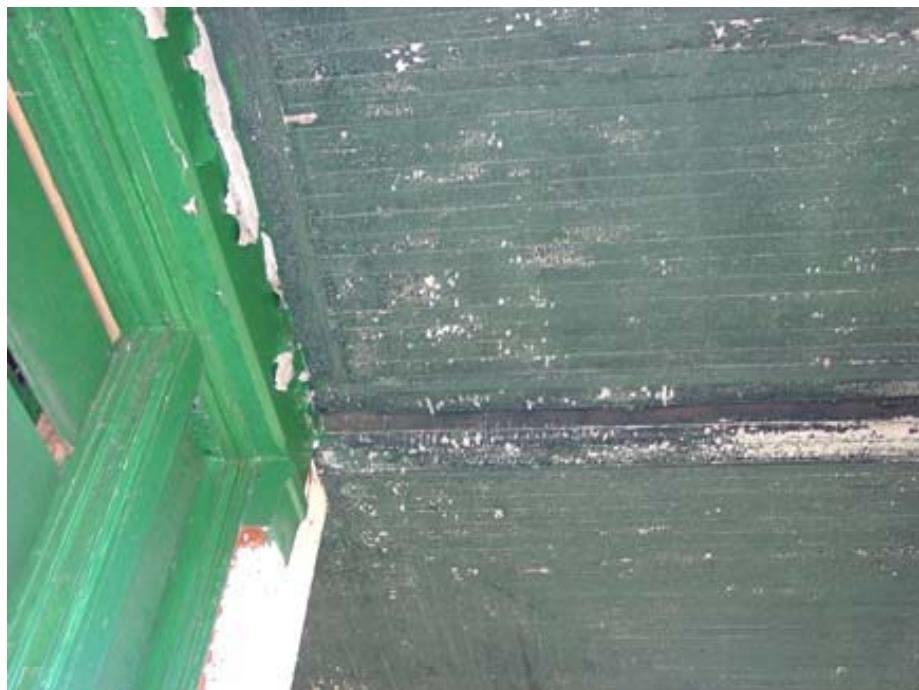
Figure 23. Officers Club, east façade , piazza ceiling, 2005.

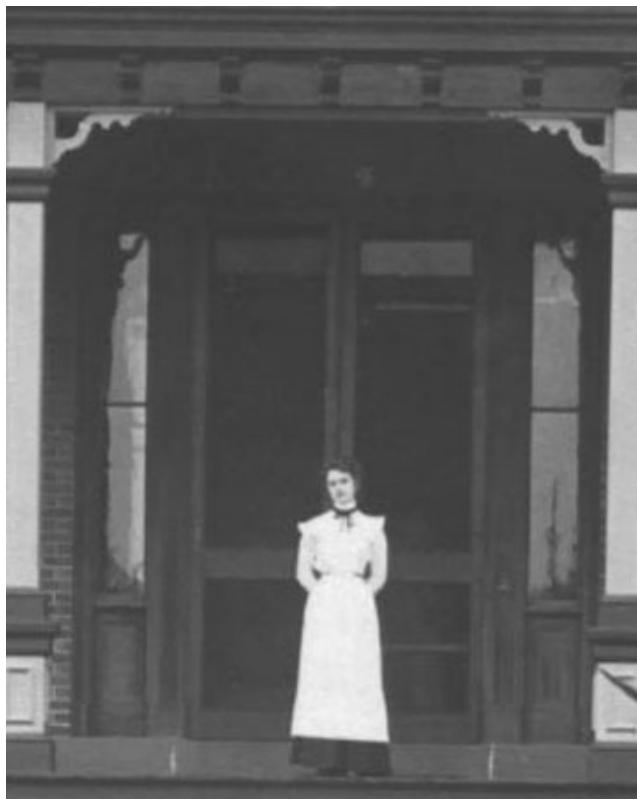
Figure 24. Officers Club, east façade, showing front entrance, ca. 1900.

The center bay of the east/front façade featured a projecting entry vestibule that identified the main entrance to the building. The doorway here was an inviting set of double doors with a brownstone lintel and sill (fig. 24). The lintel was constructed with shallow brackets at either end, and was dressed with beveled outside edges, a chamfered lower edge, and a shallow cyma profile on the brackets of the lintel. Each door had eight lights in the upper half and one small wooden panel below. These were framed by decorative molding. A transom light extended above the double doors. The entry was surrounded with a plain wood casing and flanked by sidelights.

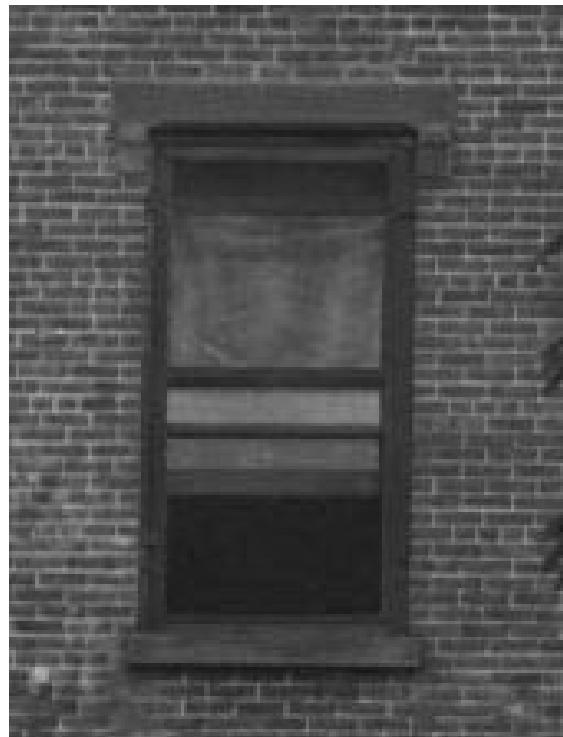
Figure 25. Officers Club, east façade, second story, showing typical window elements, ca. 1900.

In plan, the trim elements of the first- and second- story windows were plain, capped elements. However, they received a more decorative design as built. The windows were faced with brownstone lintels and sills, similar to the front entry (fig. 25). The lintels protruded from the masonry wall 1 $\frac{1}{2}$ inches, the outside edges were beveled, the lower edge was chamfered, and the ears of the lintel had a shallow cyma profile. The brownstone sills had a shallow pitch, but were otherwise unadorned. The horns of the brownstone sills extended 1 $\frac{1}{2}$ inches beyond the rough opening.

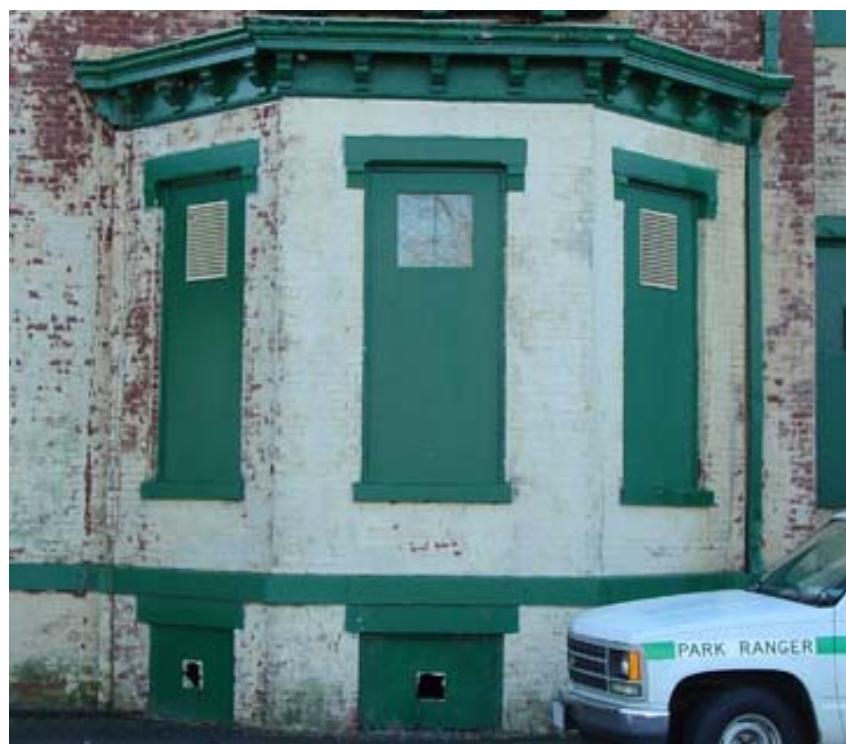
Figure 26. Officers Club, north elevation, bay window, 2005.

As part of the original design and construction, the main block of the building had a one- story bay window on the north elevation (fig. 26). The bay window had angled sides; its three windows contained double- hung, two- over- two sashes measuring 42 $\frac{1}{4}$ inches wide by 94

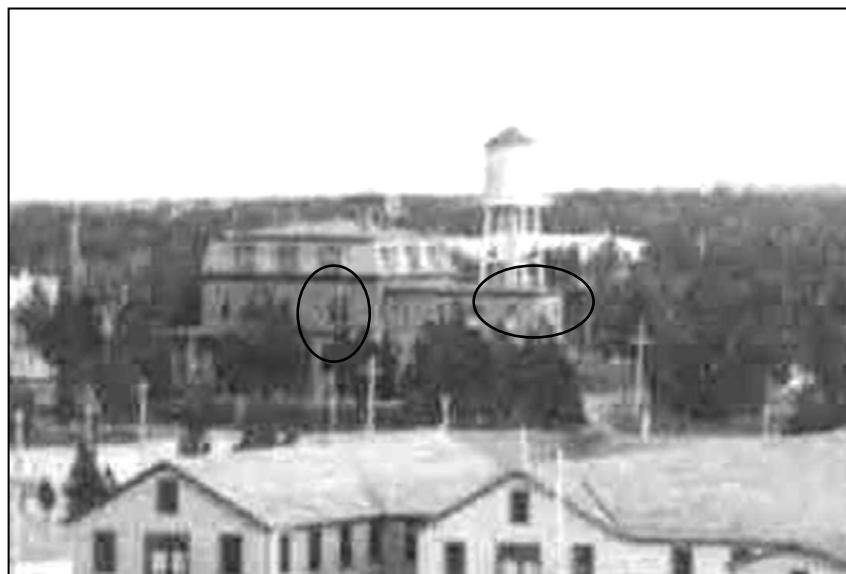
Figure 27. Officers Club, showing window openings, ca. 1904.

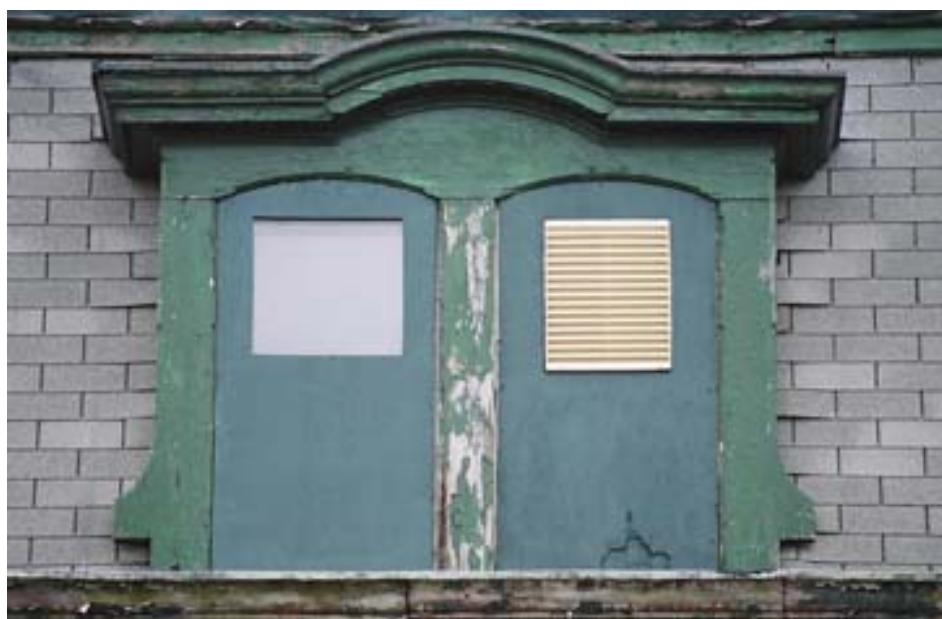
Figure 28. Officers Club, east elevation of mansard roof, showing dormer with paired windows, 2005.

All of the dormer windows in the mansard roof were framed in wood. All window openings had a segmentally arch head (fig. 28). The dormer casings were detailed with an applied fillet molding, chamfering on the outer and inner edges and on the segmental arch of the window opening, and they were flared at the base. Many of these details matched the proposed plans, but the flared bases were less elaborate than planned. The typical dormer cornice had an arch in the center, and the arched crown over the double window was extenuated and segmental in shape.

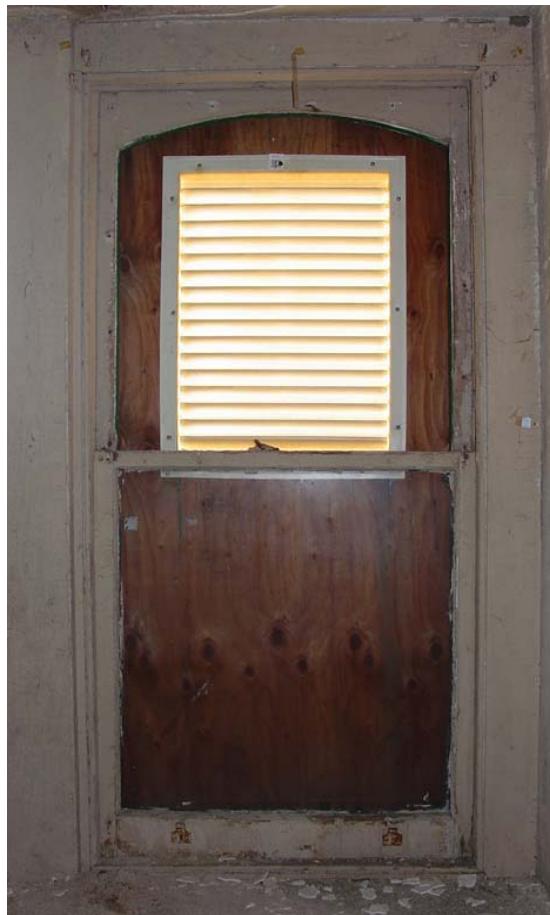
Figure 29. Officers Club, interior side of dormer sashes with arched top rail, 2005.

The typical opening of the single dormers was 38 $\frac{3}{4}$ inches wide by 66 $\frac{3}{4}$ inches high. The paired windows were set within the same casing and separated by a mullion. Overall the double- window opening measured 81 inches wide by 66 $\frac{3}{4}$ inches high, and the individual openings were 32 $\frac{1}{2}$ inches wide by 62 $\frac{1}{4}$ inches high. All windows at this level had double- hung, one- over- one sashes. The top rail of the top sash was segmentally arched to match the window opening (fig. 29).

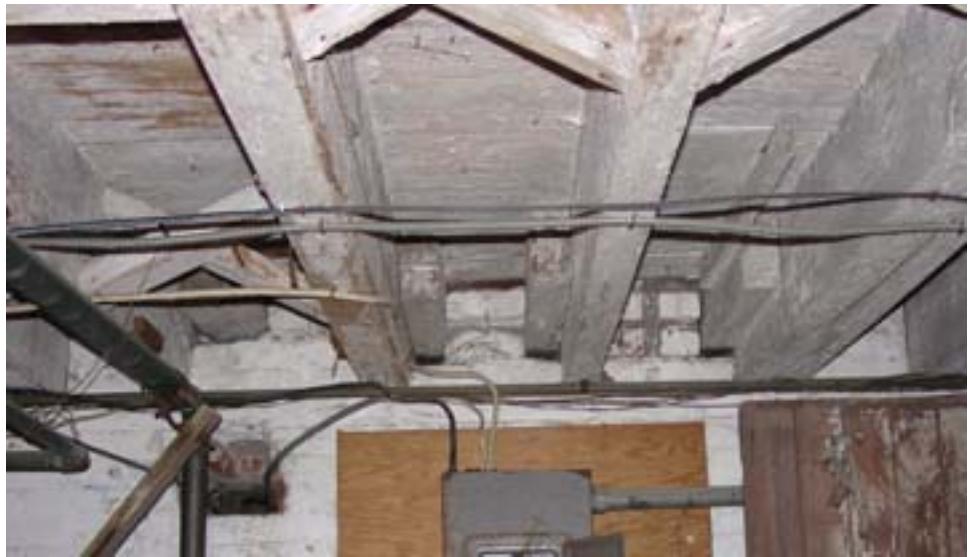
Figure 30. Officers Club, basement of rear ell, south wall, showing extant framing and brick infill that is evidence of earlier opening, 2005.

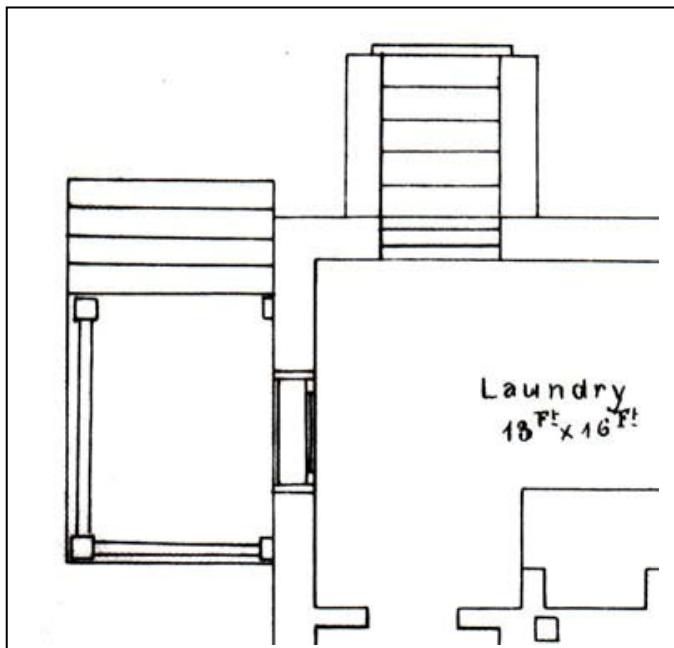
Figure 31. Officers Club, south- elevation entry to rear ell, 1878.

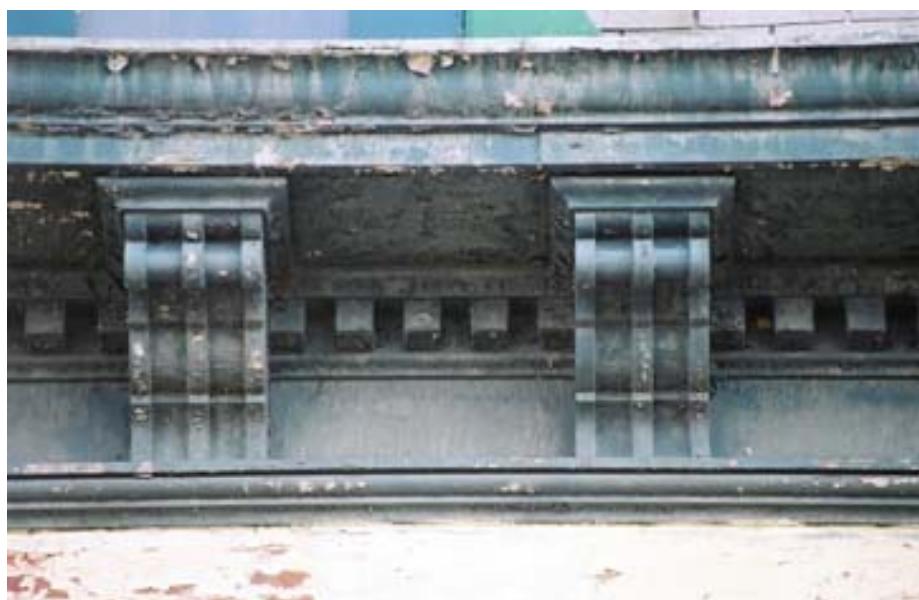
Figure 32. Officers Club, mansard roof, lower cornice brackets, 2005.

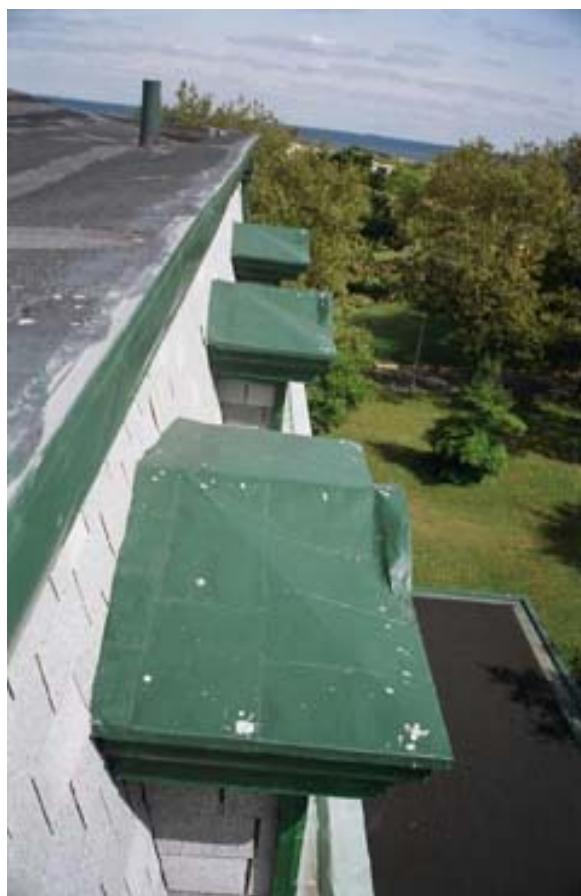
Figure 33. Officers Club, mansard roof, dormer roofing material, 1992.

The roofs of the dormers were also covered with flat- seam metal pans (fig. 33). They were constructed with a complex ridge/hip/valley combination, which allowed water to shed around the arched crown.

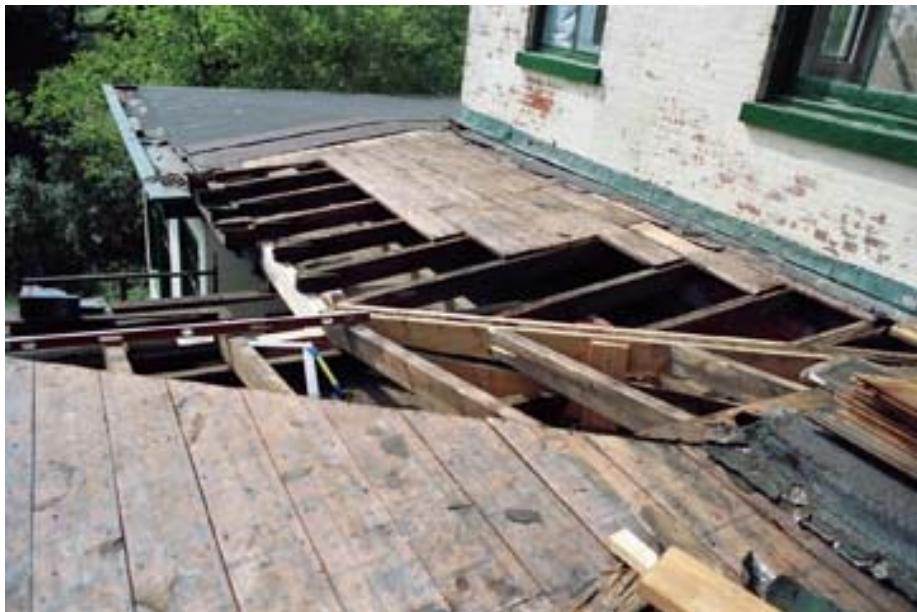
Figure 34. Officers Club, east façade, piazza roof, showing original framing and repairs, 1991.

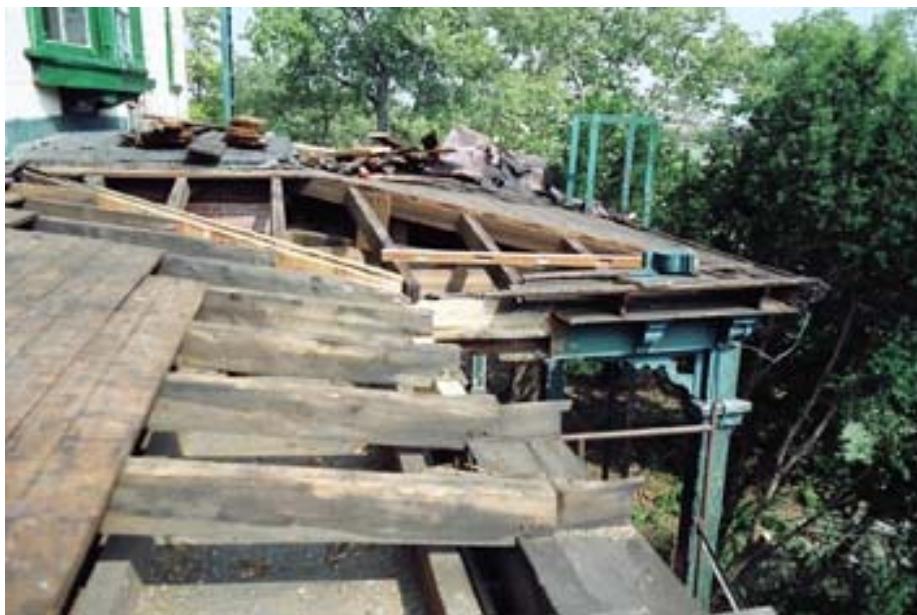
Figure 35. Officers Club, east facade, piazza roof, showing original framing with extended rafters for integral gutters.

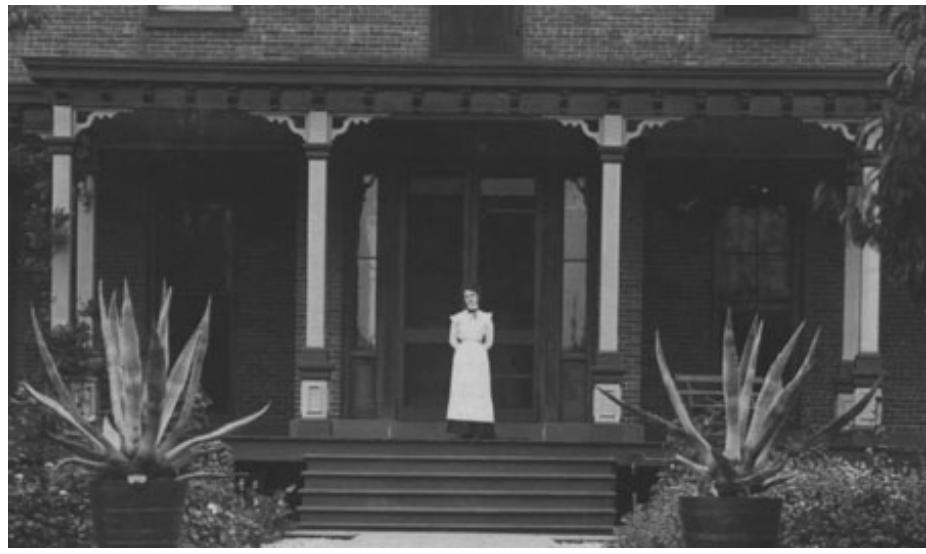
Figure 36. Officers Club, east- facade piazza, showing period paint scheme, ca. 1900.

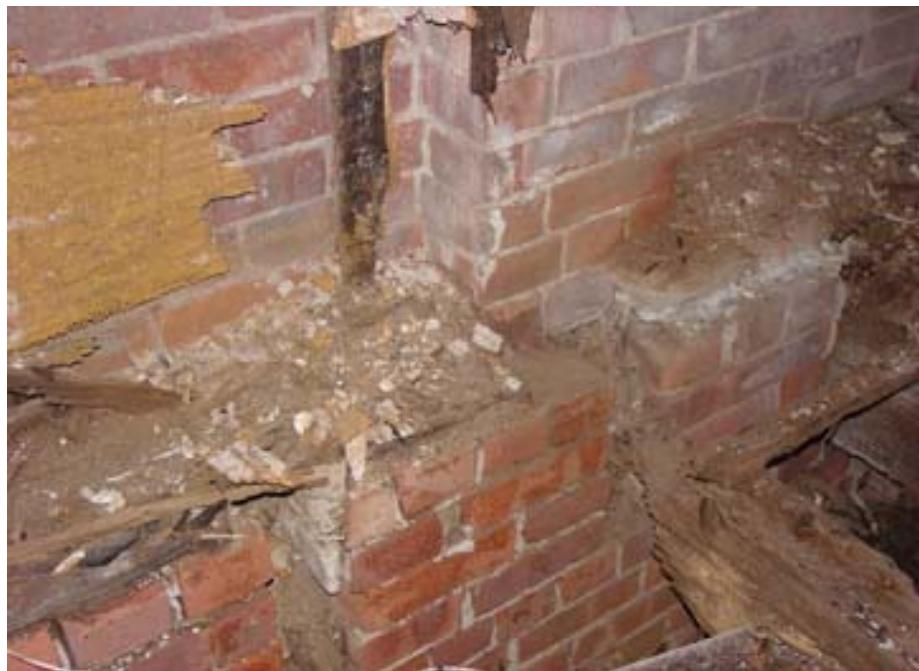
Figure 38. Officers Club, showing exterior bearing- wall construction at transition from first story to second story; also shows pockets in masonry for framing, 2005.

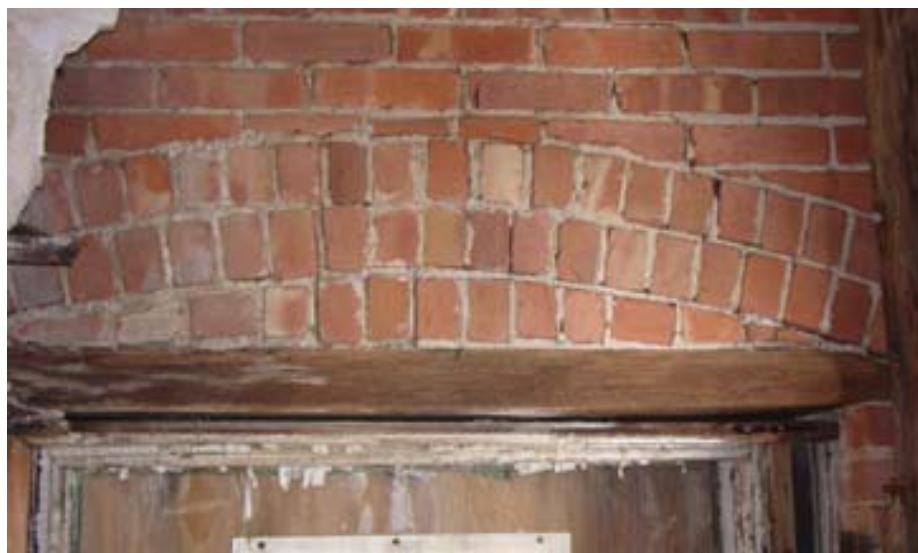
Figure 39. Officers Club, typical brick relieving arch above window opening, as seen from Ladies' Lounge (Room 103), 2005.

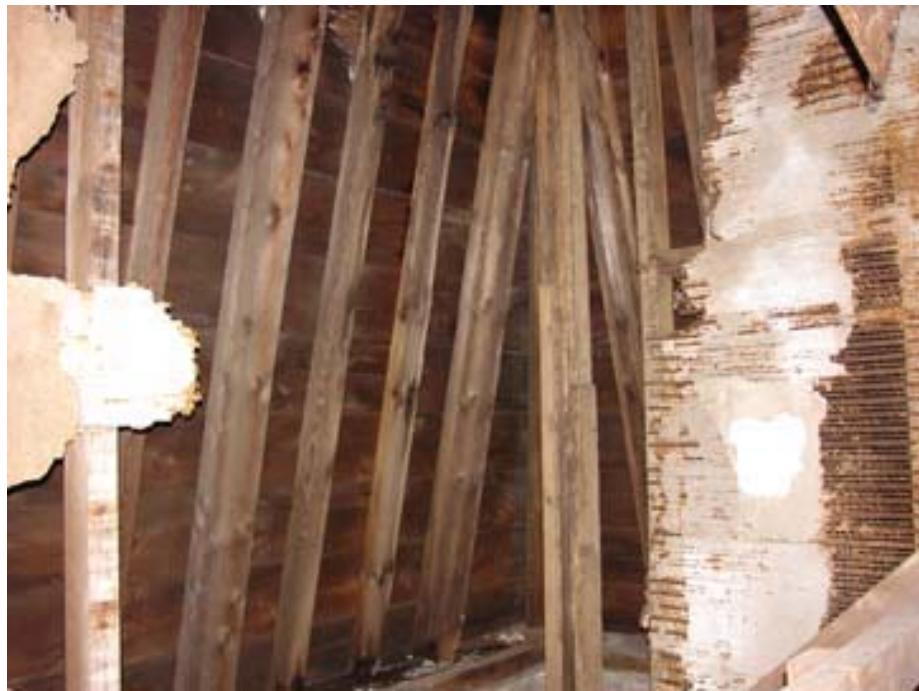
Figure 40. Officers Club, attic, showing framing of lower slope of mansard roof with alternating jack rafters, 2005.
