OFFICERS CLUB BUILDING No. 114

HISTORIC STRUCTURE REPORT

**Sandy Hook Unit
Gateway National Recreation Area**

James J. Lee III
Architectural Conservator

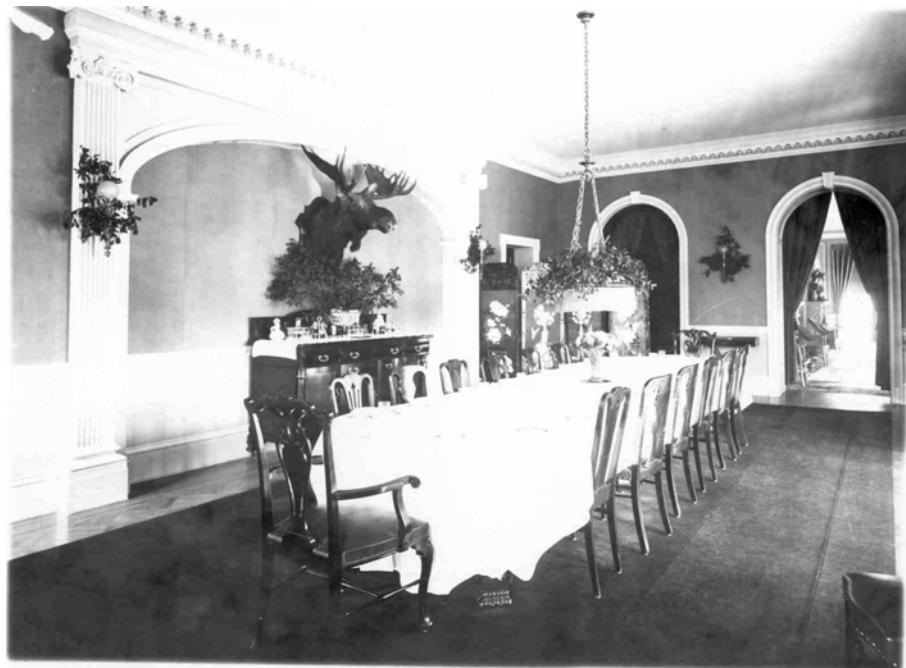
Figure 56. Officers Club, Dining Room (Room 106), view of south and west walls, ca. 1905.

The brief description of the addition by Major Smith, which included the orientation and style of the Dining Room (Room 106), is supported by the earliest photographs of the room (figs. 56 - 57). They were most likely taken soon after the completion of the Dining Room, and they reveal several aspects of the room's initial appearance. Among these are the outline of the original south- elevation bay window, the early mantelpiece and overmantel, the period trim and decorative schemes, the plaster ceiling, early lighting fixtures, and the original fenestration. All reflect the Colonial Revival style, and clearly illustrate the stylistic change from the period of original construction to the period of the addition.

Upon close examination, one photograph reveals the outlines of a large bay window facing south (fig. 56). This is supported by the shape of the ca.- 1905 foundation, which was constructed with a three- sided projection on the south elevation (fig. 55). The bay was designed to take full advantage of the southern exposure of the Dining Room (Room 106). The bay- window opening was framed with a classical archway composed of a large segmental arch with Composite- order pilasters and entablature. The archway was balanced by a symmetrically placed arch on the north wall, which framed a niche for a sideboard and, at the time of the photograph, a moose head.

As noted in the previous section, the Officers Club was wired for electricity in 1897. The note submitted to the Appropriations Committee with the funding request on June 30, 1903, stated that the new addition would include electrical work.⁸⁶ The ca.- 1905 photographs of the room show wall sconces and a chandelier, which most likely dated from the construction of the addition (figs. 56- 57). The same wall sconces were visible in photographs through the 1960's.

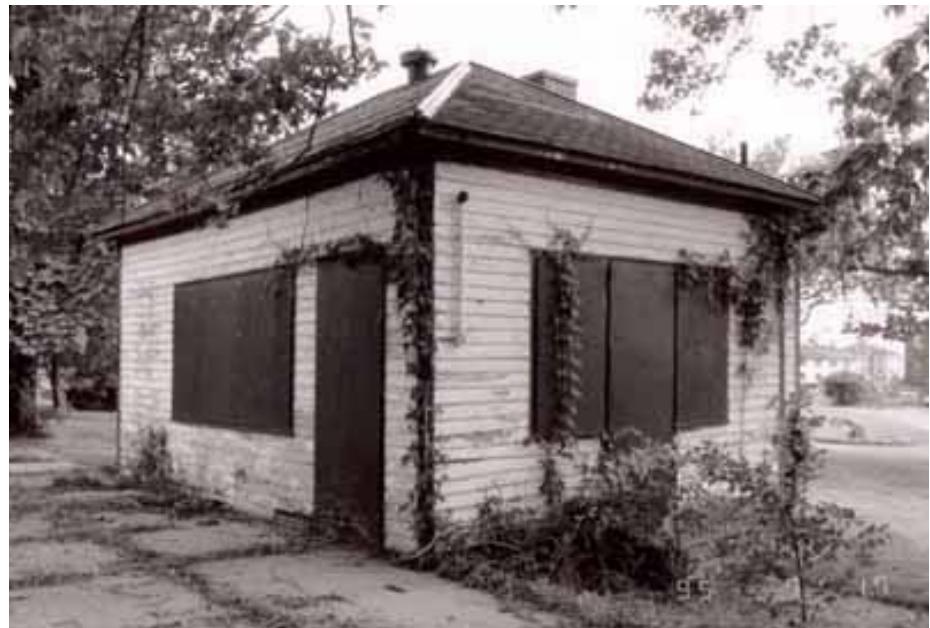
Figure 81. Laundry/Caddy House, Building No. 113, 1995.

Building No. 113 (figs. 80- 81) was constructed in 1905 just west of the Officers Club (fig. 48), to serve as a laundry for the officers of the Ordnance Department.¹¹⁸ It was a one- story wood-framed structure built on a poured concrete foundation. The building had a hip roof, which was covered with green asphalt shingles at the time of research was performed for this report. Building No. 113 was clad with clapboards and had wooden double- hung sashes. The structure had triple sets of windows on both its south and east elevations. The center window in both sets had double- hung, eight- over- eight sashes, which were flanked by double- hung, six- over- six sashes. Other windows on the building had double- hung, six- over- six sashes.

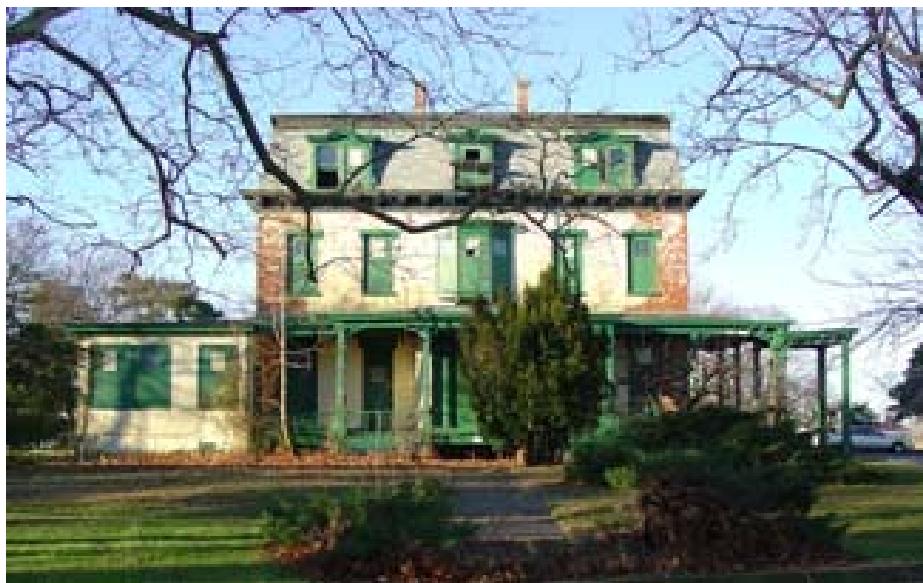
Figure 82. Officers Club, east façade, 2004.

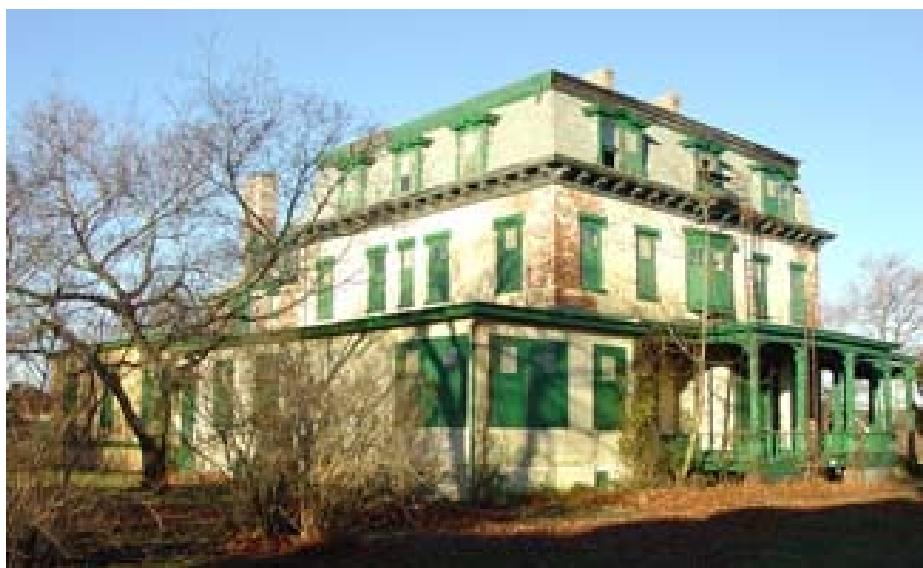
Figure 83. Officers Club, east façade and south elevation, 2004.

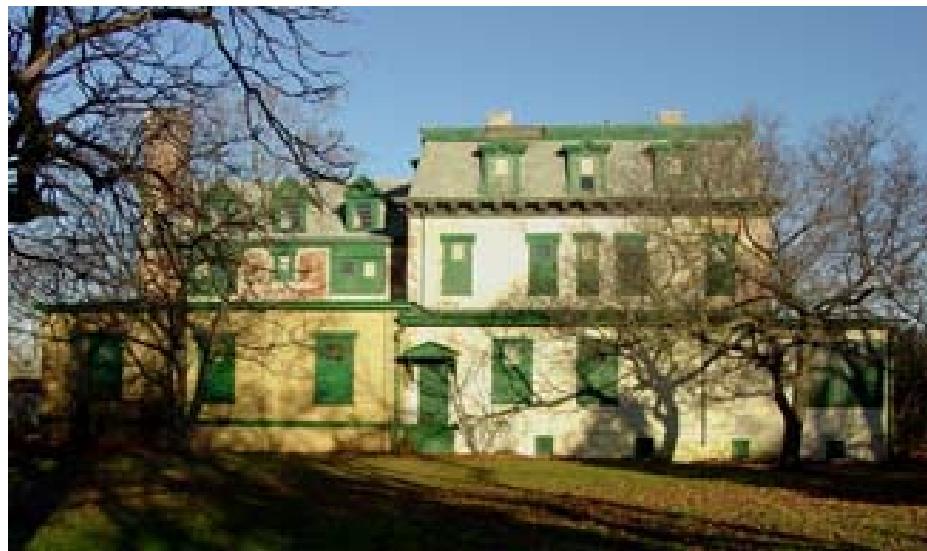
Figure 84. Officers Club, south elevation, 2004.

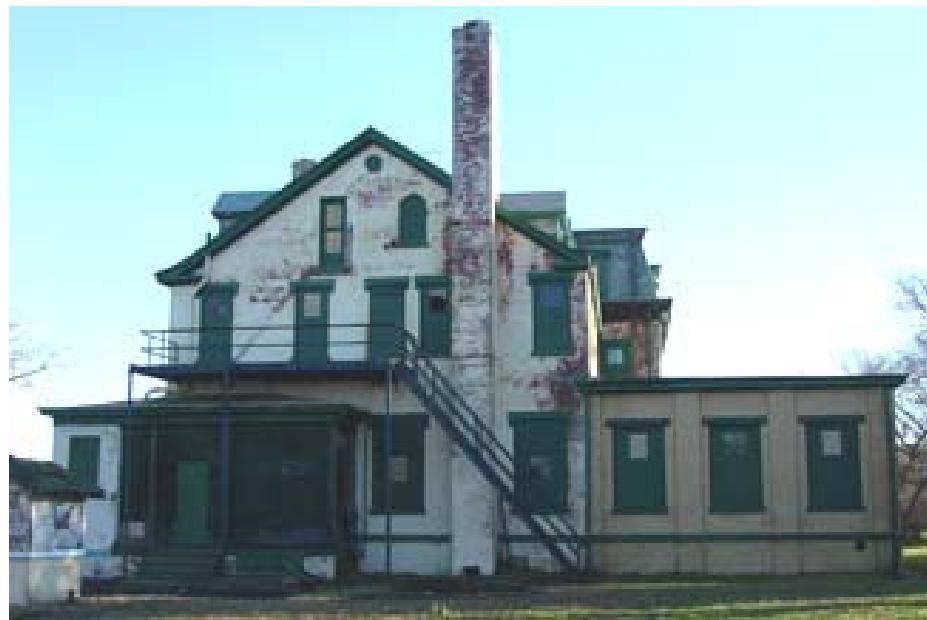
Figure 85. Officers Club, west elevation, 2004.

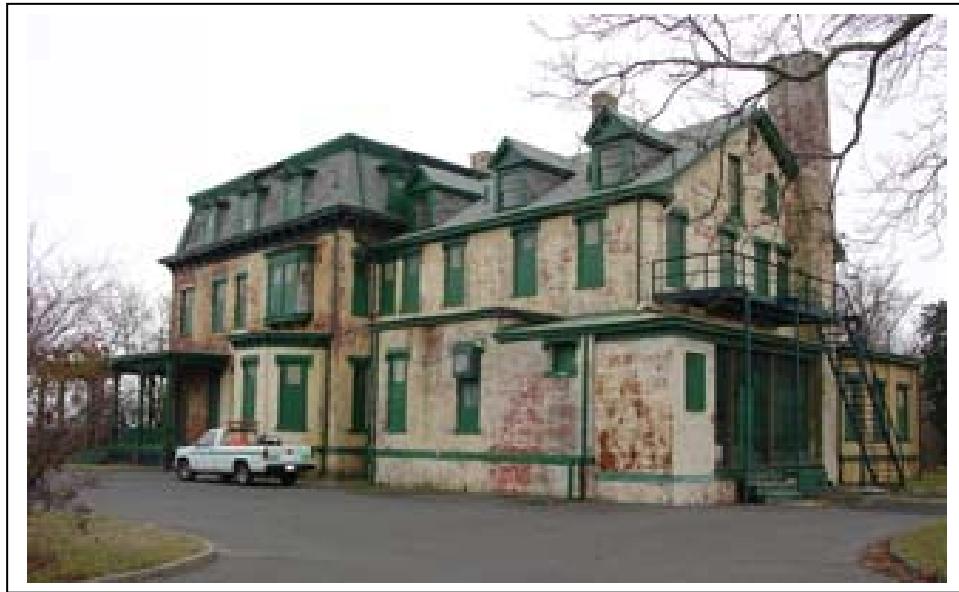
Figure 86. Officers Club, north and west elevations, 2004.

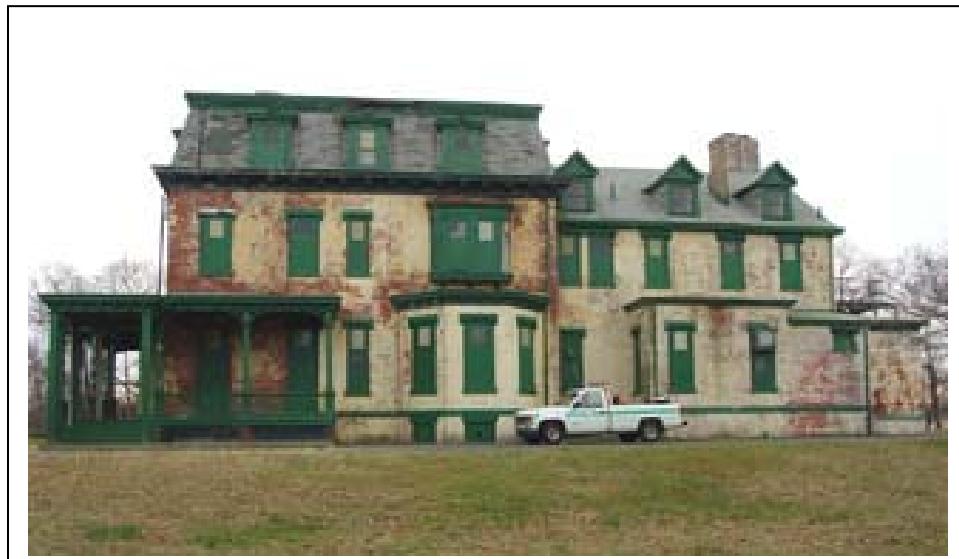
Figure 87. Officers Club, north elevation, 2004.

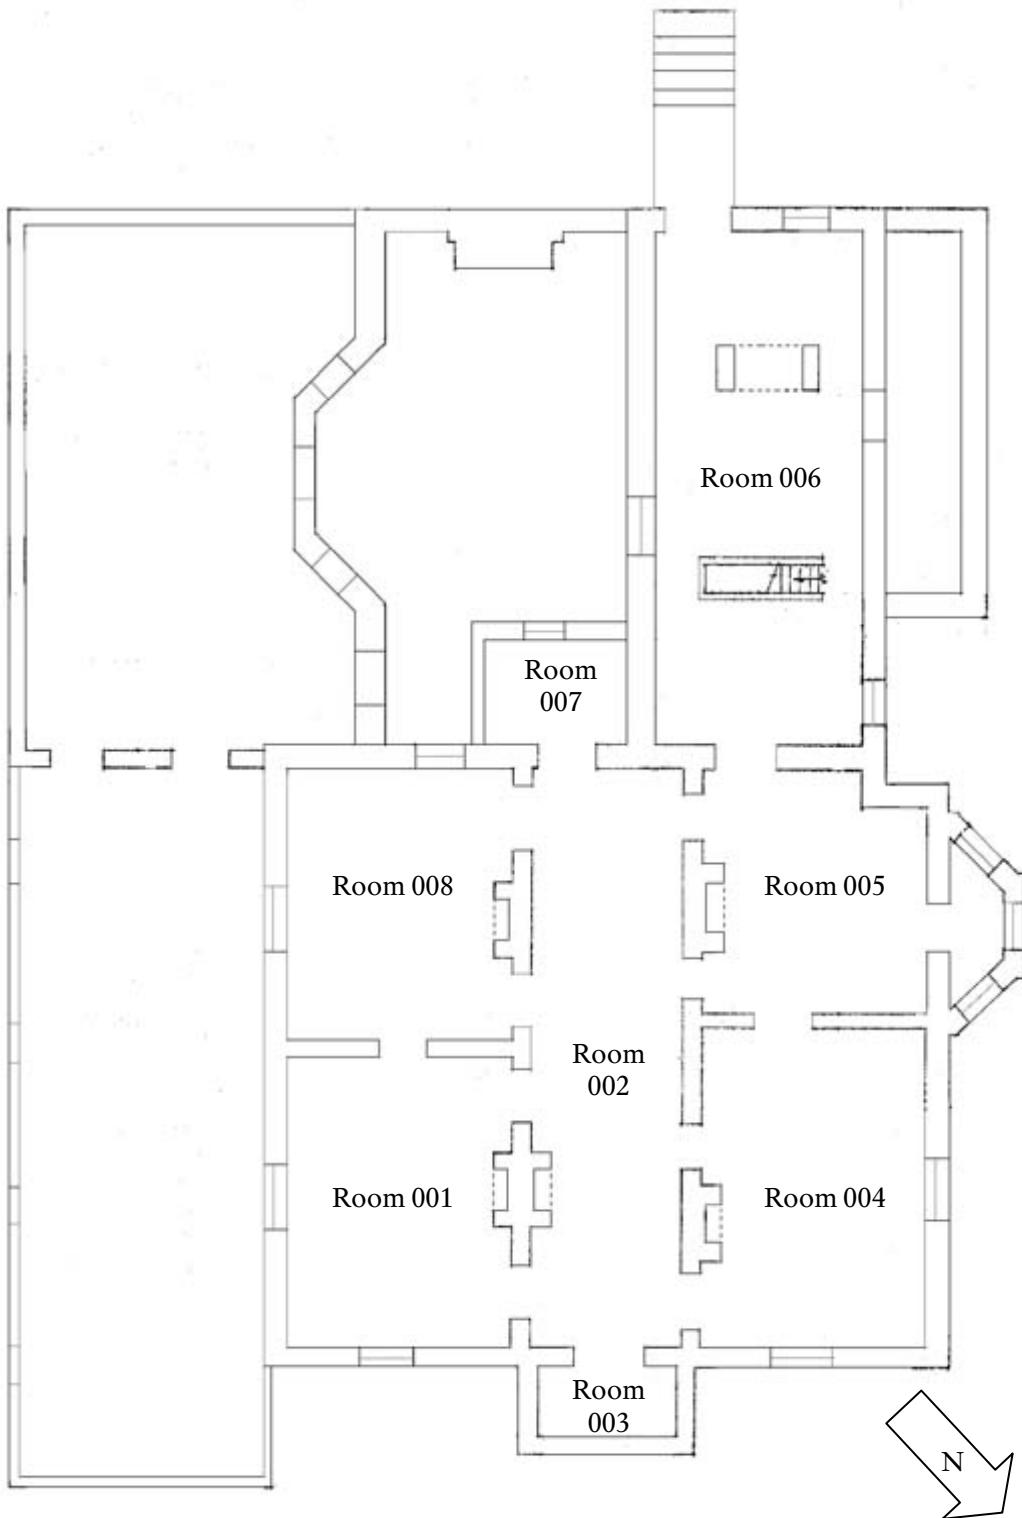
Figure 88. Officers Club, basement plan annotated with room numbers (not to scale).

The current exterior appearance of the Officers Club reflects the evolution of the building throughout its association with the military presence at Sandy Hook. The current structure communicates the original form of the building, as well as later additions and alterations (Appendix A, figs. 88- 91).

There is a full basement under the original sections of the building and crawlspaces under the additions (fig. 55 and Appendix A, fig. 88). The original stairway from the basement to the first story of the rear ell has been removed. Thus, the only access to the basement is through the west- elevation bulkhead. Several of the doorways in the brick bearing walls and partitions of the basement are sealed off with cinderblocks. Some of the original basement windows are closed off with brick, and the windows facing the exterior are covered with plywood. As previously mentioned, a large portion of the exposed framing was charred by fire. In Room 001, some of the framing has been strengthened by the addition of support posts and extra joists. The ceiling in the center hallway, Room 002, appears to be composed of fireproof asbestos panels. The basement floors are covered with cement, except in Room 008, which is paved with pieces of brick.

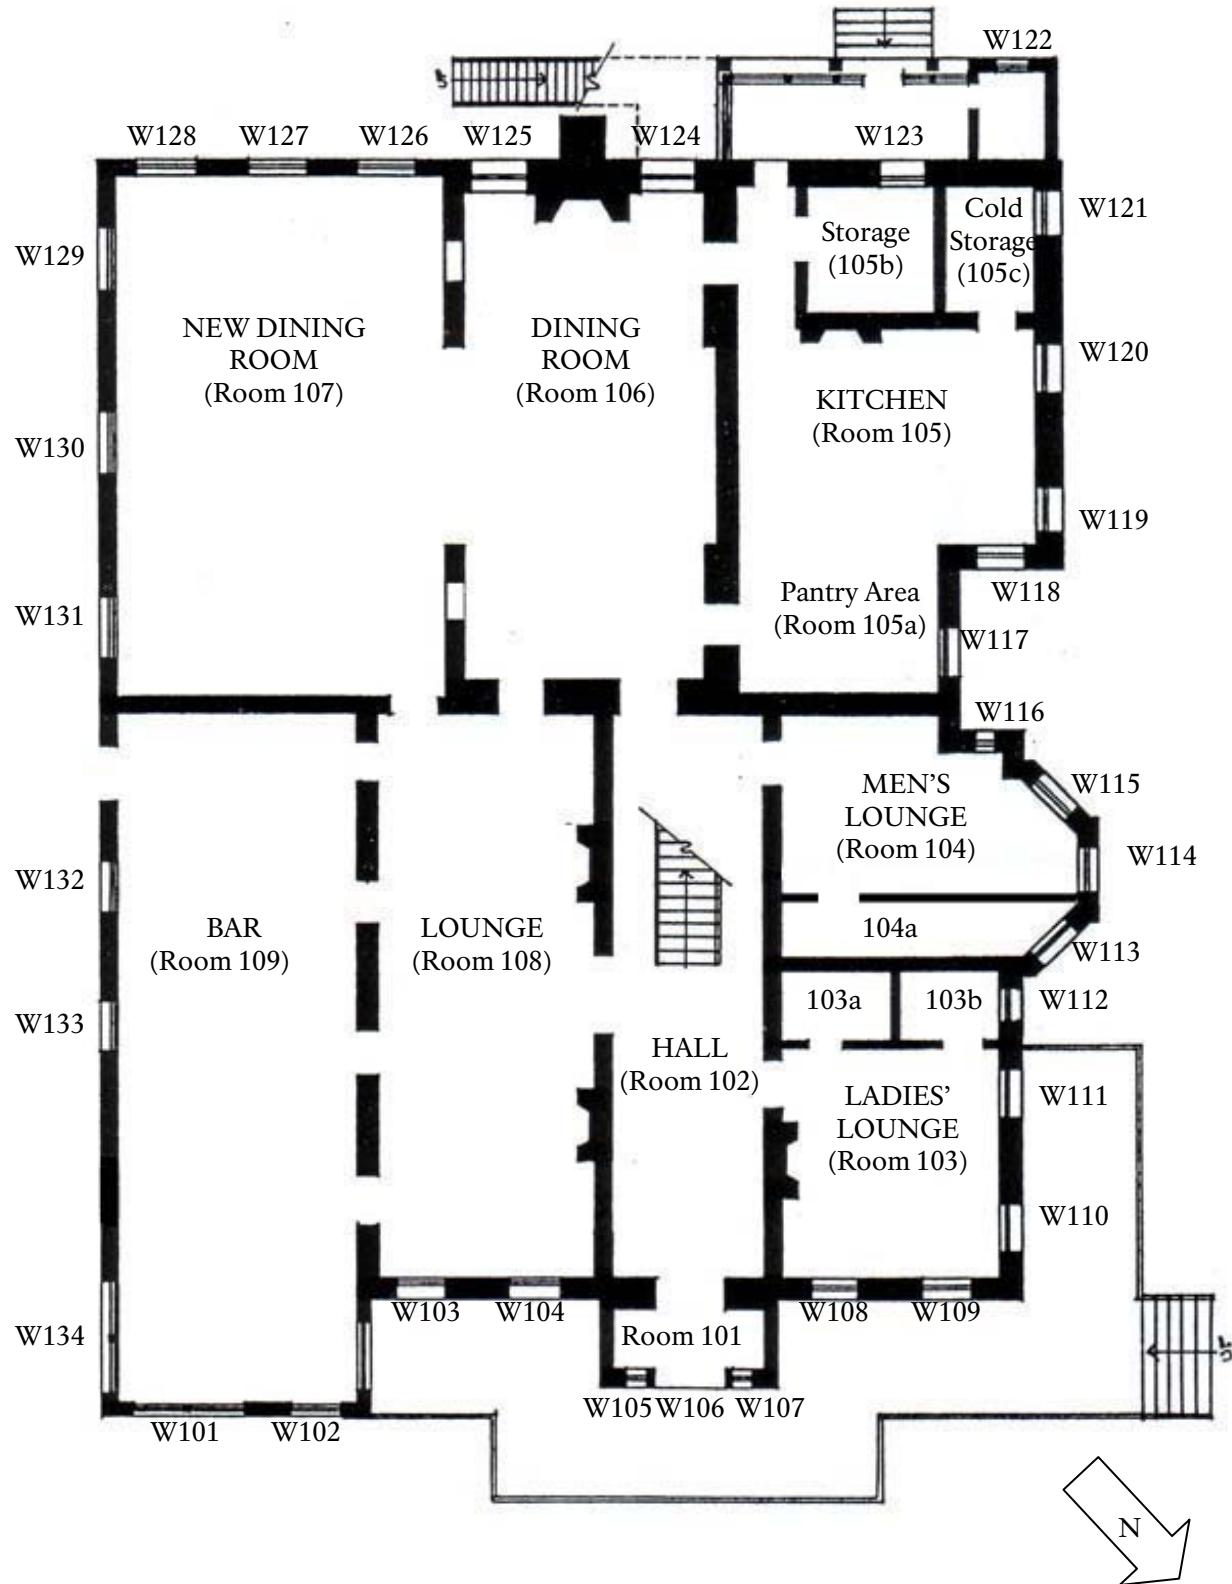
Figure 89. Officers Club, first- story plan, annotated with 1959 room names and room and window numbers (not to scale).

The current plan of the first story appears to be relatively unchanged from the military usage of the Officers Club (Appendix A, fig. 89). The front entrance and vestibule, leading to the east-west center hallway, remain important features of the plan. The primary rooms on first story flank the center hallway, as they did historically. The demolition of the rear stairway and partitions in the Kitchen area (Room 105) has created a much larger service area that does not reflect the historic appearance. However, this does not adversely affect the interpretation of the first story.

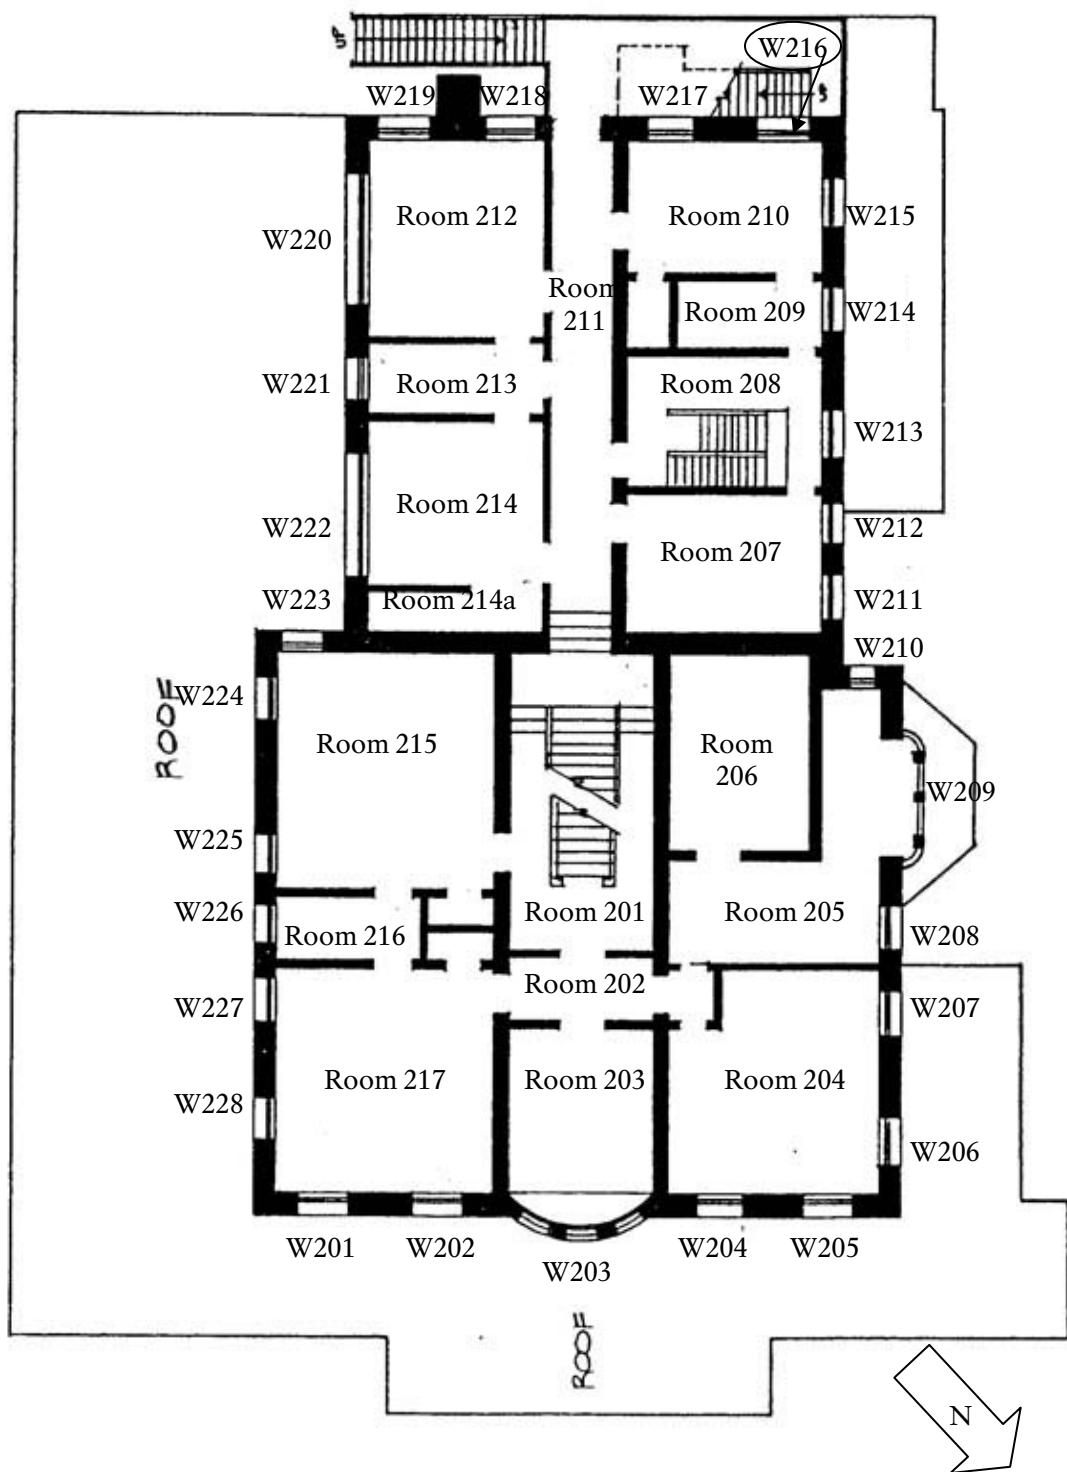
Figure 90. Officers Club, second-story plan, annotated with room and window numbers (not to scale).

The east- west interior bearing walls of the main block extended through the second story, maintaining a center corridor flanked by rooms to the north and south. As planned and constructed, there were five “Bed Rooms” at this level of the main block (figs. 14, 74, and Appendix A, fig. 90). All of the bedrooms opened off the center hallway. Adjoining closets separated the bedrooms on both sides of the hallway.

The current floor plan of the second story has not been dramatically changed from the historic layout (Appendix A, fig. 90). The 1920's room list provides a useful tool for determining the number, size, and use of rooms. The room list does not include Room 202, a small connecting hallway that was apparently created after the 1920's. Also evident from that list was the removal of one bathroom, which was corroborated by the physical evidence. This bathroom was located

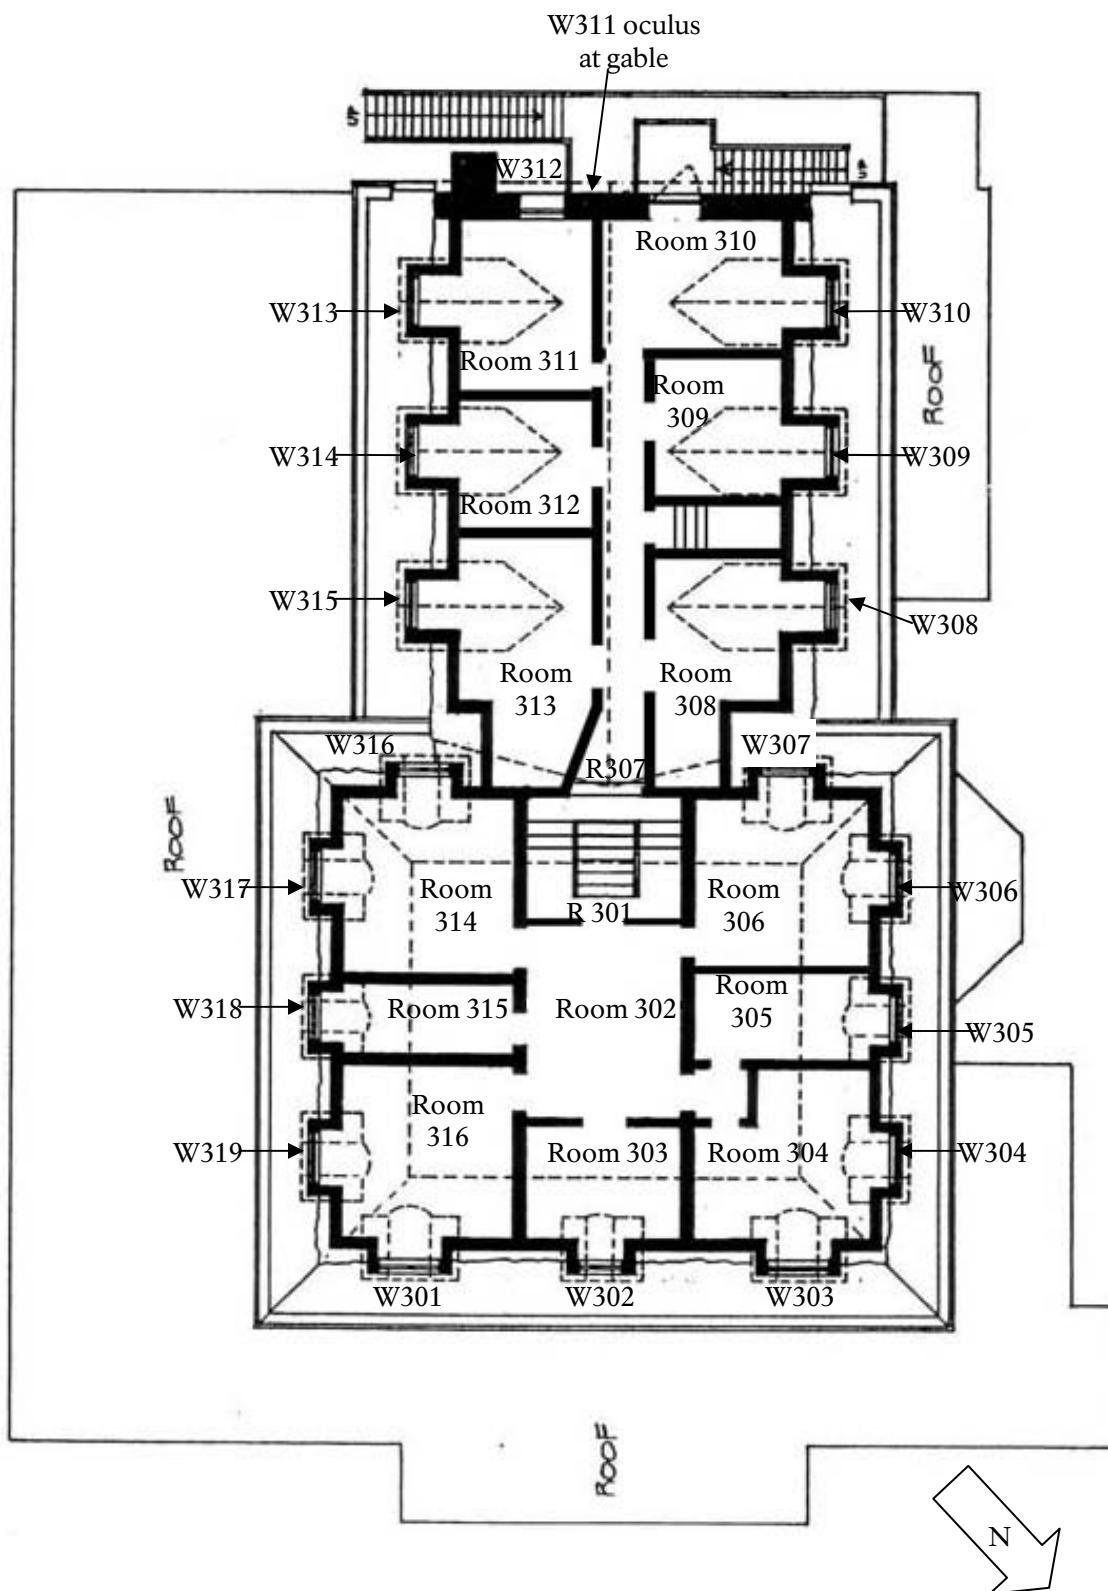
Figure 91. Officers Club, attic plan, annotated with room and window numbers (not to scale).

The extant building materials in the attic of the Officers Club indicate that the current room plan of the main block is similar to the original 1878 layout (Appendix A, fig. 91). The bearing walls that delineate the east- west center hallway continue at the attic level, with rooms flanking the hallway. The list of room names and sizes from the 1920's supports the physical evidence. Apparently one bathroom has been removed since then, which may have been located between Rooms 304 and 305. A partition was added across the center hallway (Room 301) to restrict access from the second story to the attic- story rooms. This created an ancillary cross hallway (Room 302). In the rear ell, the attic is divided into five bedrooms and one bathroom. This is also similar to the layout described in the 1920's records.
