CHARACTERISTICS OF THE DEVELOPED AREAS

INTRODUCTION

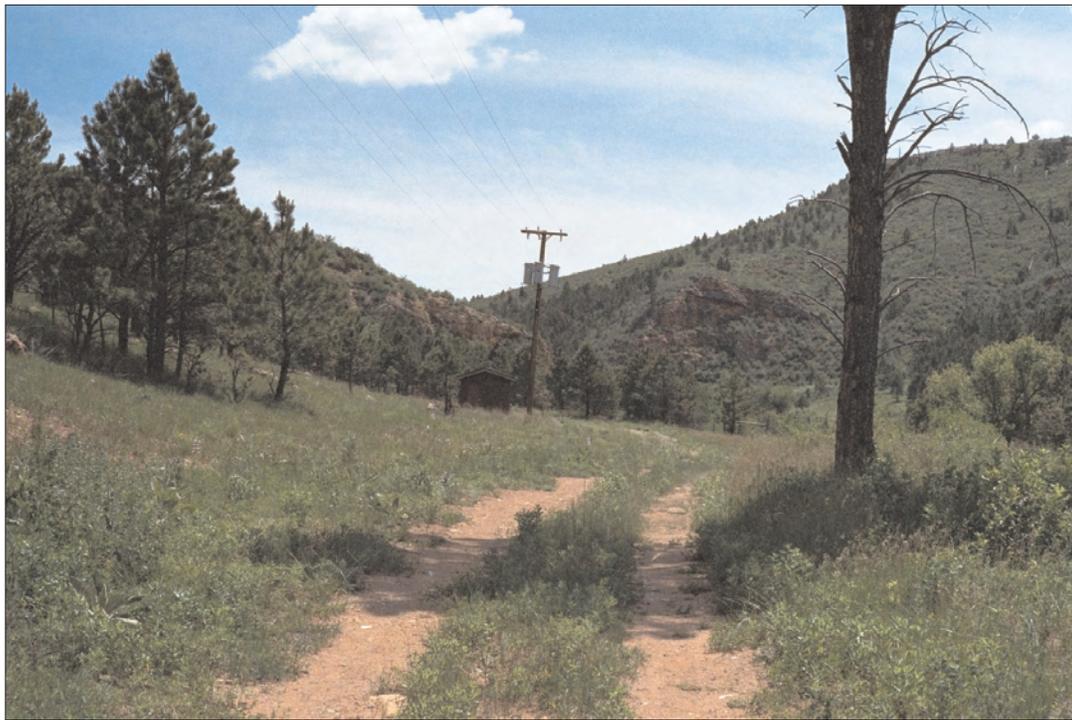
Figure 3-27
(2N-10) View east along Wind Cave Canyon Trail to Pump House.

The pump house is a rectangular building clad in vertical wood board-and-batten siding with a gable roof covered in standing-seam metal. The eaves overhang the building edges about one foot on all sides. The pump house has no windows and a single brown-painted metal door in the center of one long side. The pump house appears to be in good condition.

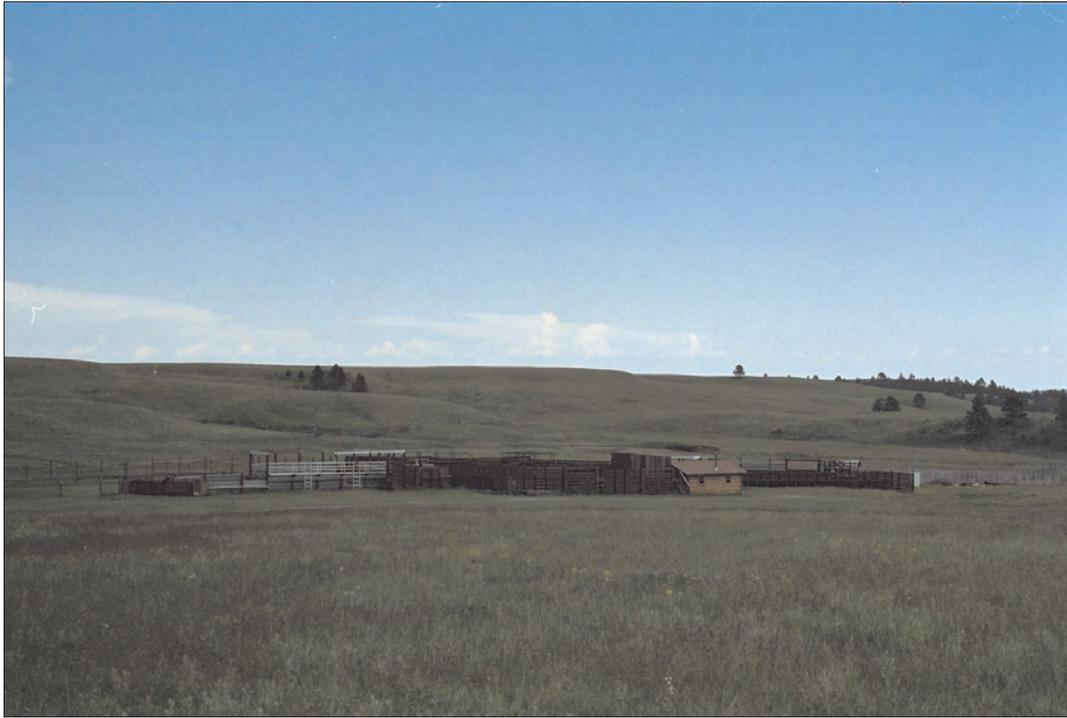
Figure 3-30
(2F-23) A small hill screens the Wildlife Handling Facility from NPS Route 5.

Figure 3-31
(2G-04) Corrals and chutes at Wildlife Handling Facility.

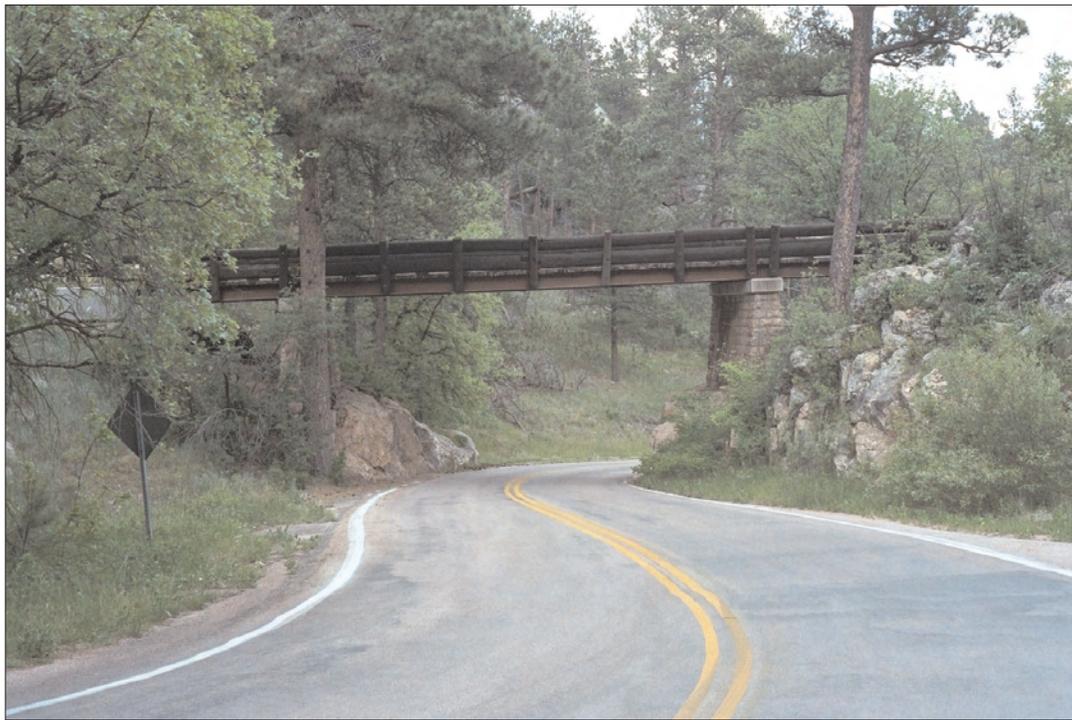
Figure 3-50
(2P-21) Beaver Creek Bridge along SD 87.

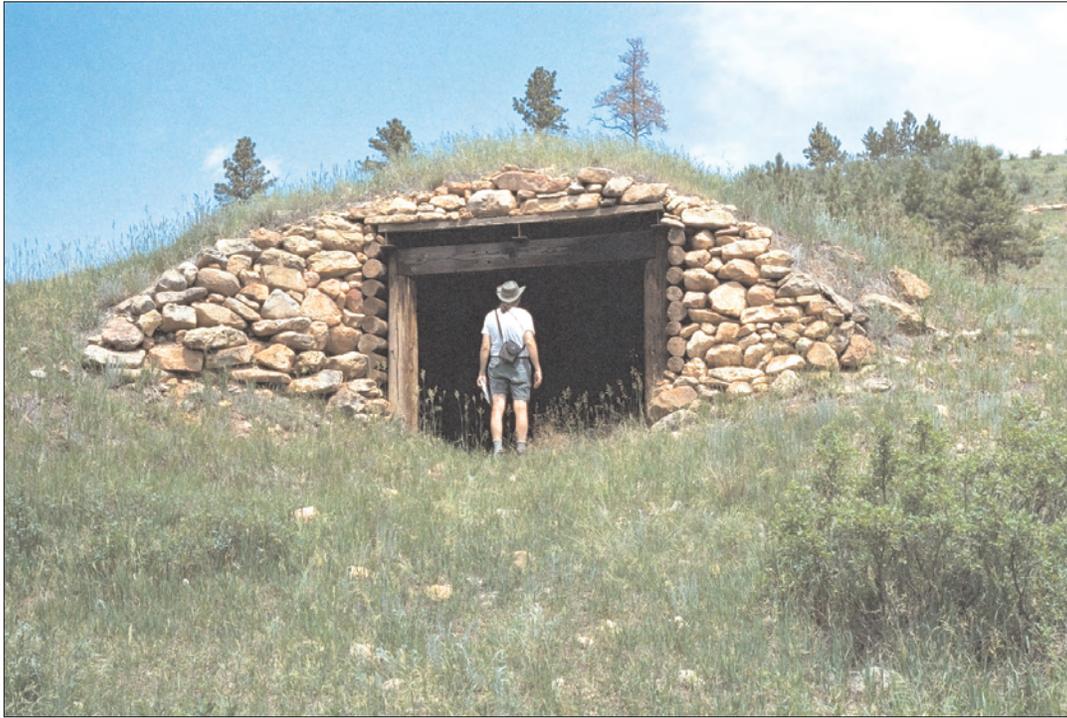
Figure 3-53
(2N-11) Pump House at end of Wind Cave Canyon Trail.

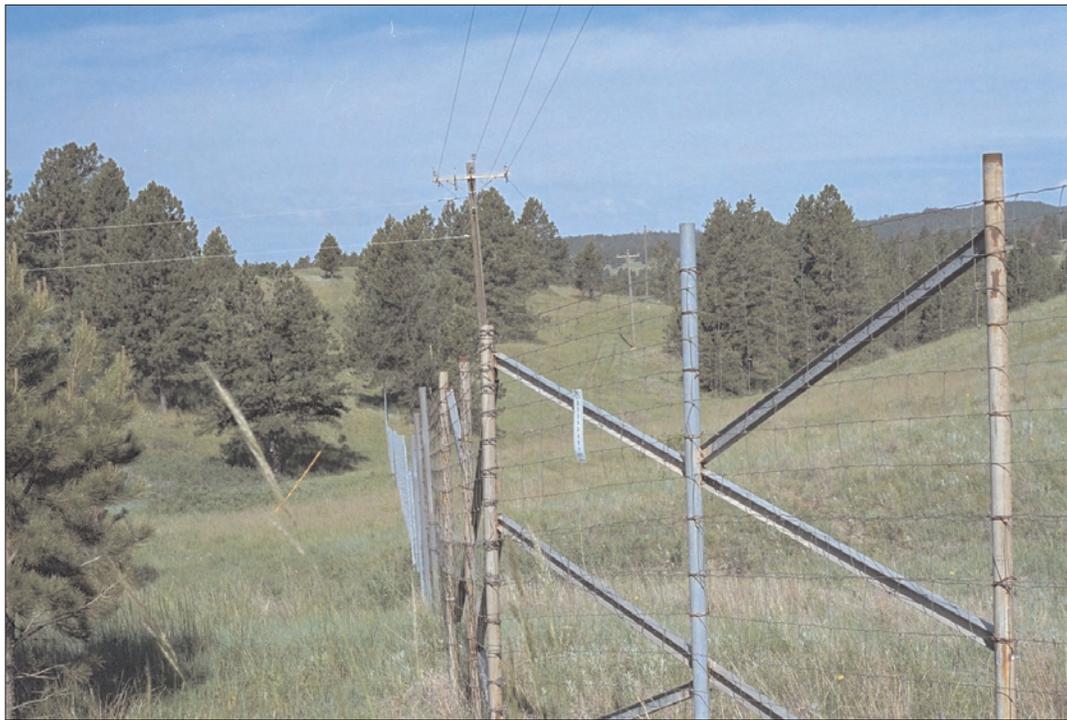
Figure 3-62
(2A-03) Woven-wire perimeter fencing and cattle guard at park's boundary at NPS 5.

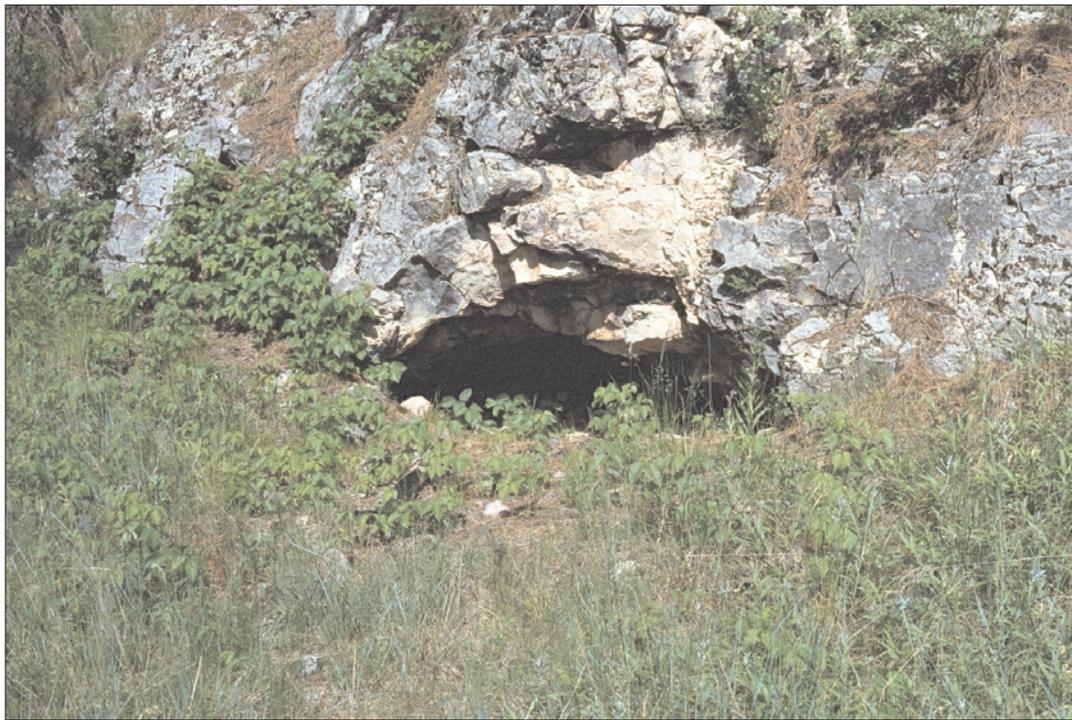
Figure 3-66
(CC-21) Cave excavation for trail.

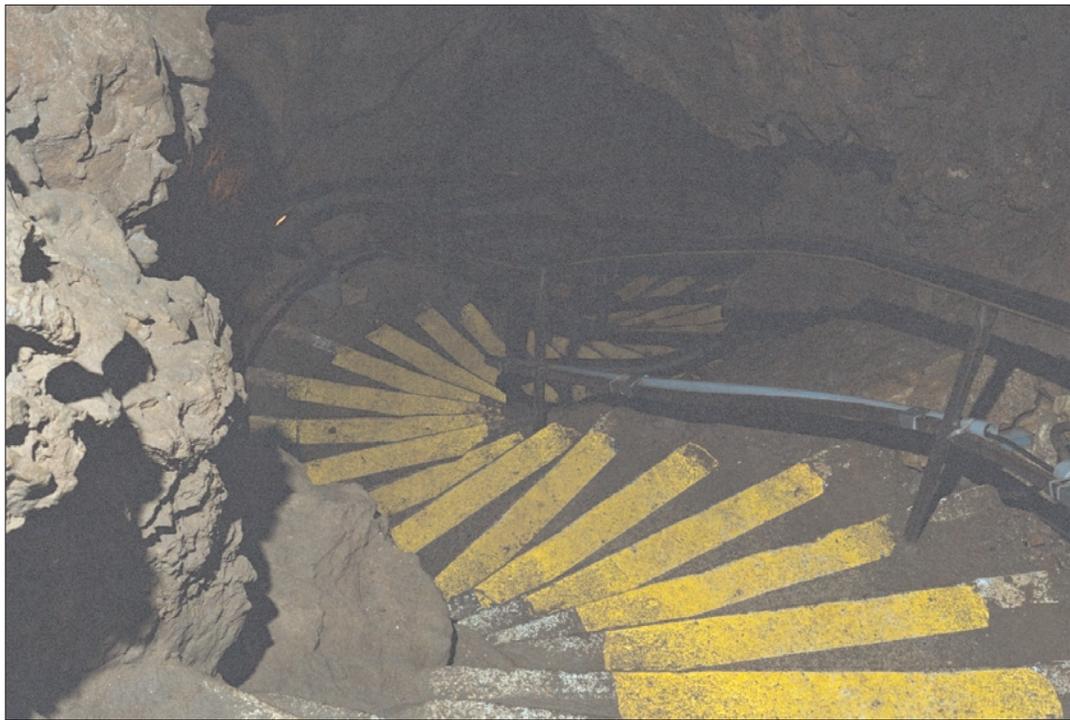
Figure 3-70
(CA-03) Stairs leading into cave.

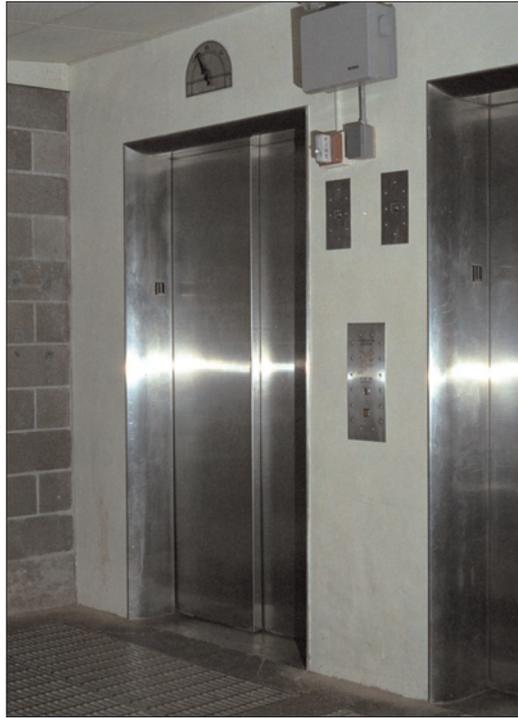
Figure 3-79
(CB-16) Cave antechamber housing elevator.

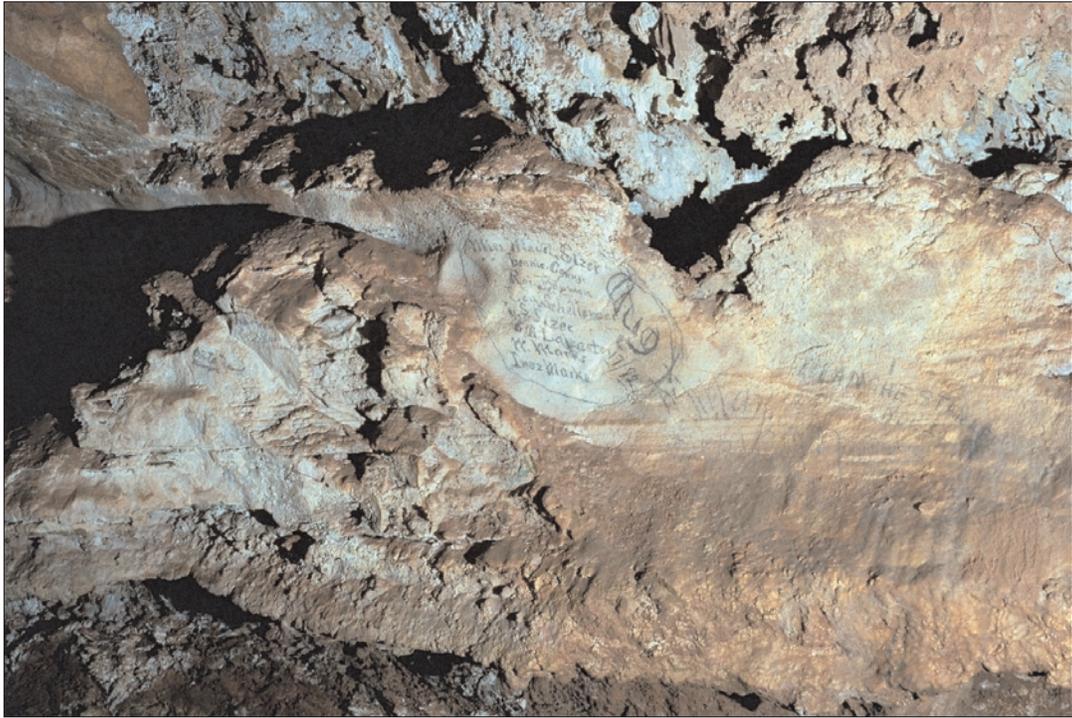
Figure 3-87
(CB-12) Painted survey station from 1902.

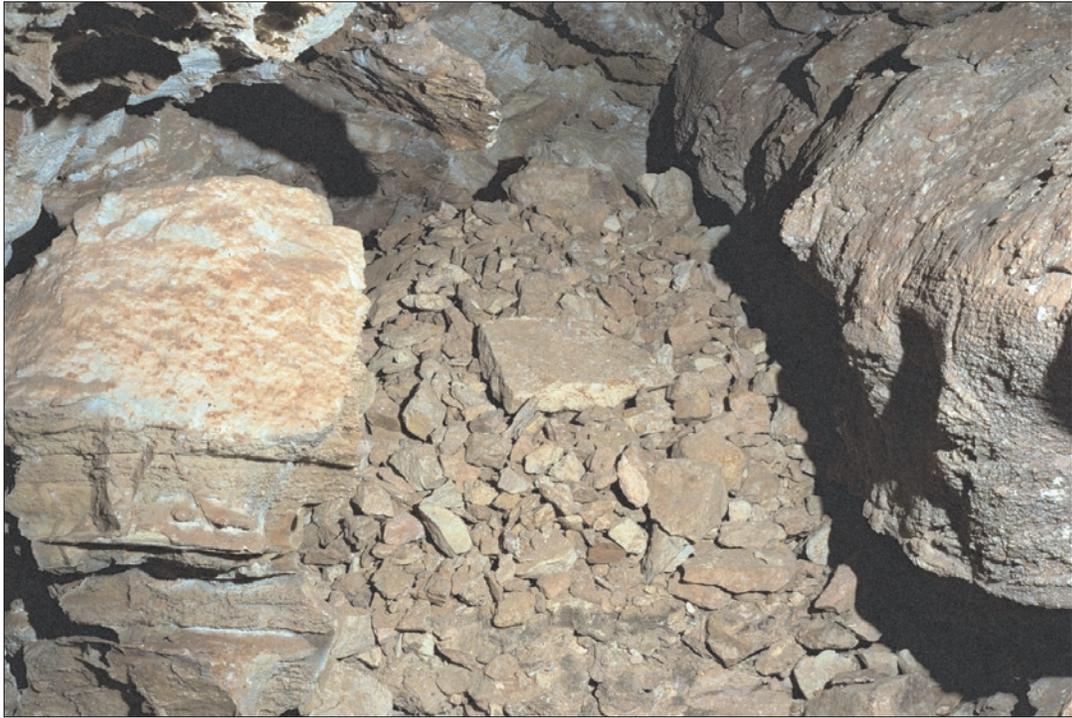
Figure 3-89
(CC-03) USGS survey marker.

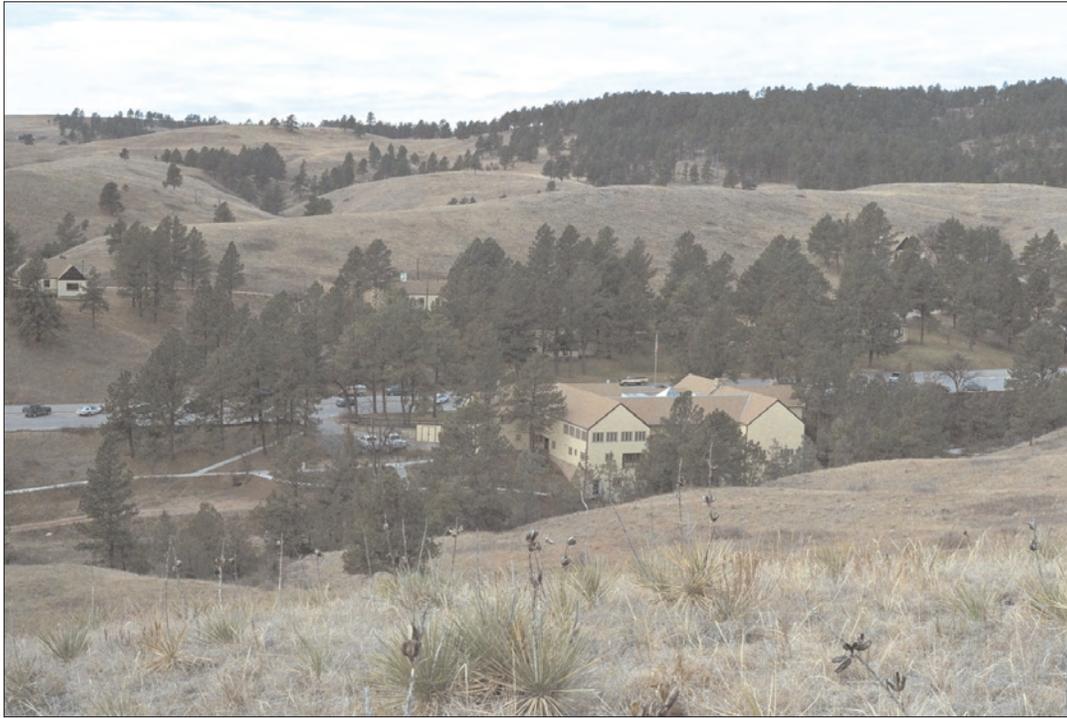
Figure 3-101
(E-19) View north of stone and timber bridge and trail to Walk-in Entrance and Visitor Center.

This footbridge connects the lower level of the Administration Building with the walkway to the cave entrance (*Figure 3-101 /E-19*). The footbridge was probably built by the CCC. It crosses the usually dry Wind Cave Canyon Creek. It is approximately seven feet wide and forty feet long. The bridge abutments are of ashlar-patterned rustic cut and mortared masonry, with the top blocks stepping down slightly on the outward ends. They project out as end walls roughly three feet high and six feet long on either end of the bridge. The bridge structure is of wood, with brown-painted wooden plank railings on the sides and wood plank treads. It appears to be in good condition.

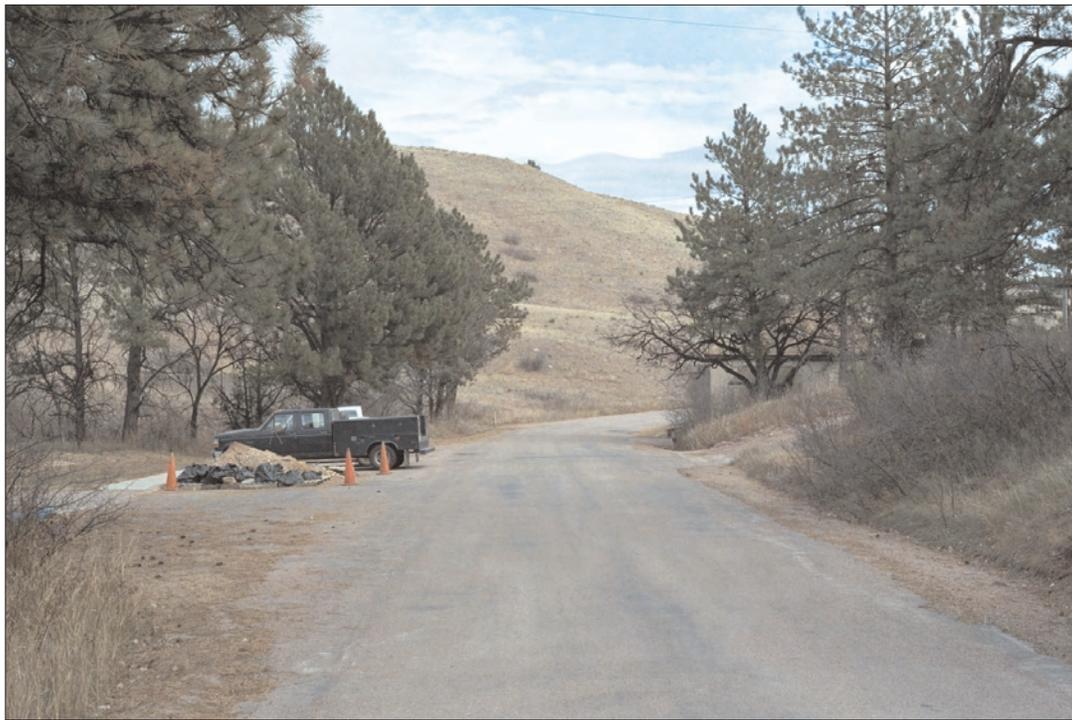
Figure 3-104
(2W-09) Picnic area access road.

An oval parking area with a planted island lies on the east side of the Headquarters Road north of the main parking lot. Just to the north of this parking area, a short paved drive allows access to a picnic loop with crushed stone spaces for parking (*see Figure 3-104 /2W-09*).

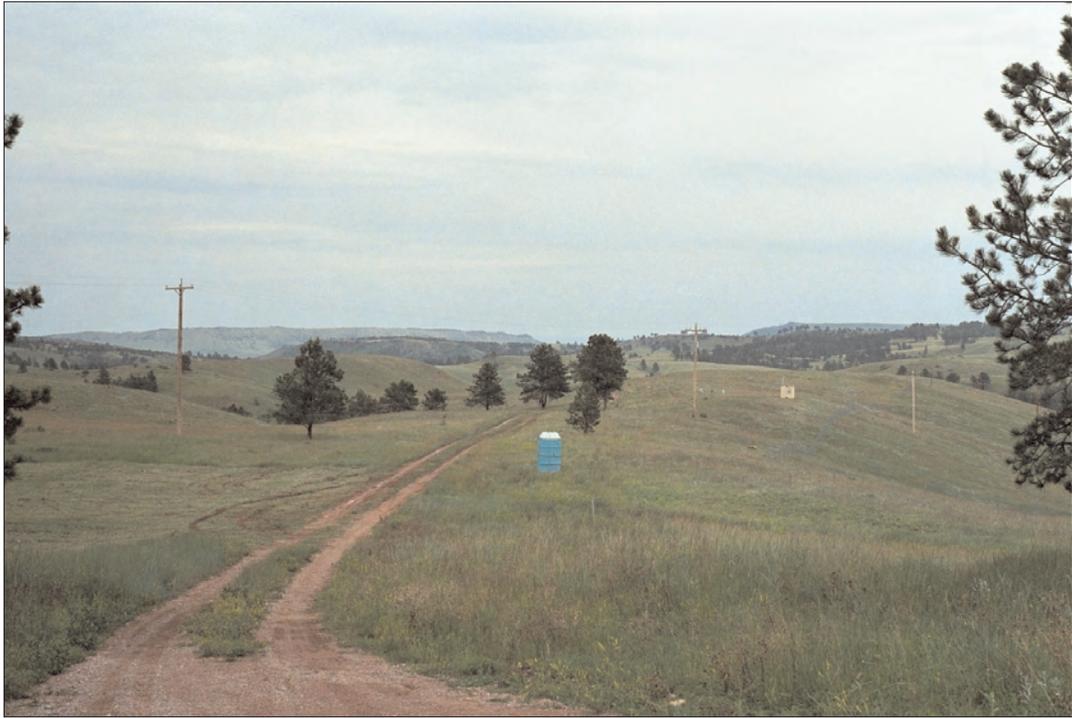
Figure 3-107
(2S-24) View of Maintenance Area from the west.

The Maintenance Area small-scale features include gas pumps, a propane tank, a large water pump, trashcans, and a dumpster (*Figure 3-107*). There are several miscellaneous storage bins and a metal retaining wall at the Mixing Circle, along with a portable toilet and various debris piles.

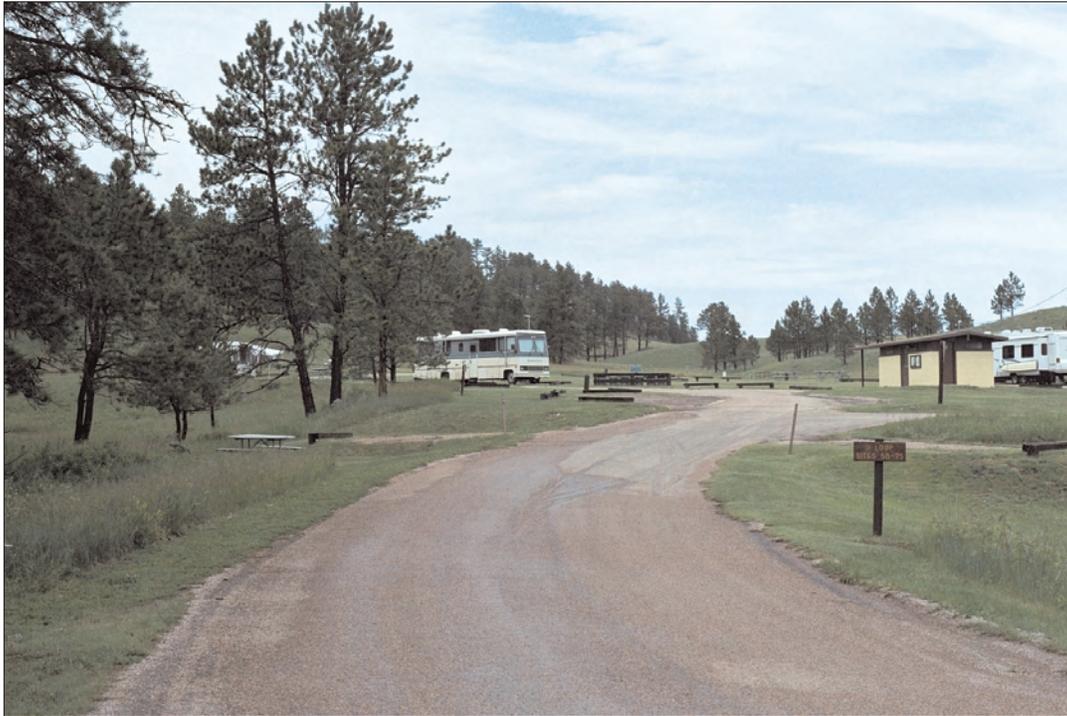
Figure 3-109
(2U-07) Entrance to campground looking west.

The access road to Elk Mountain Campground originates along the Headquarters Road approximately one-half mile north of the Headquarters Area. This unstriped, two-lane paved road connects to four paved loop roads accessing campsites and a parking lot at the amphitheater (*Figures 3-109 /2U-07 and 3-110 /2V-20*).

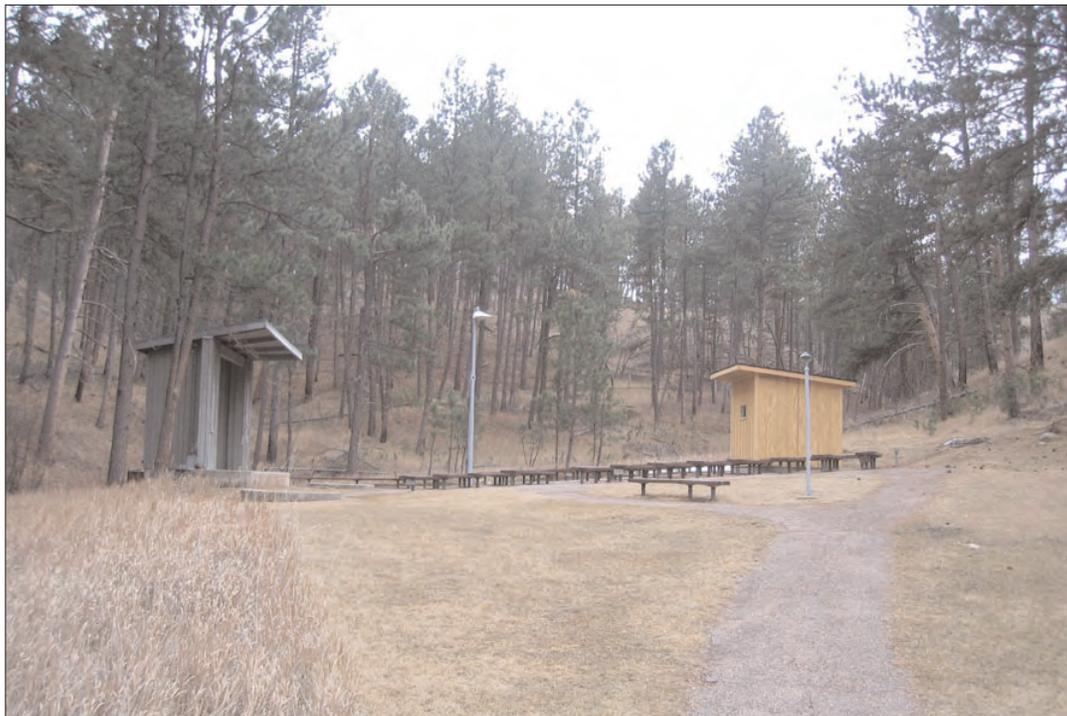
Figure 3-110
(2V-20) View of campground loop looking west.

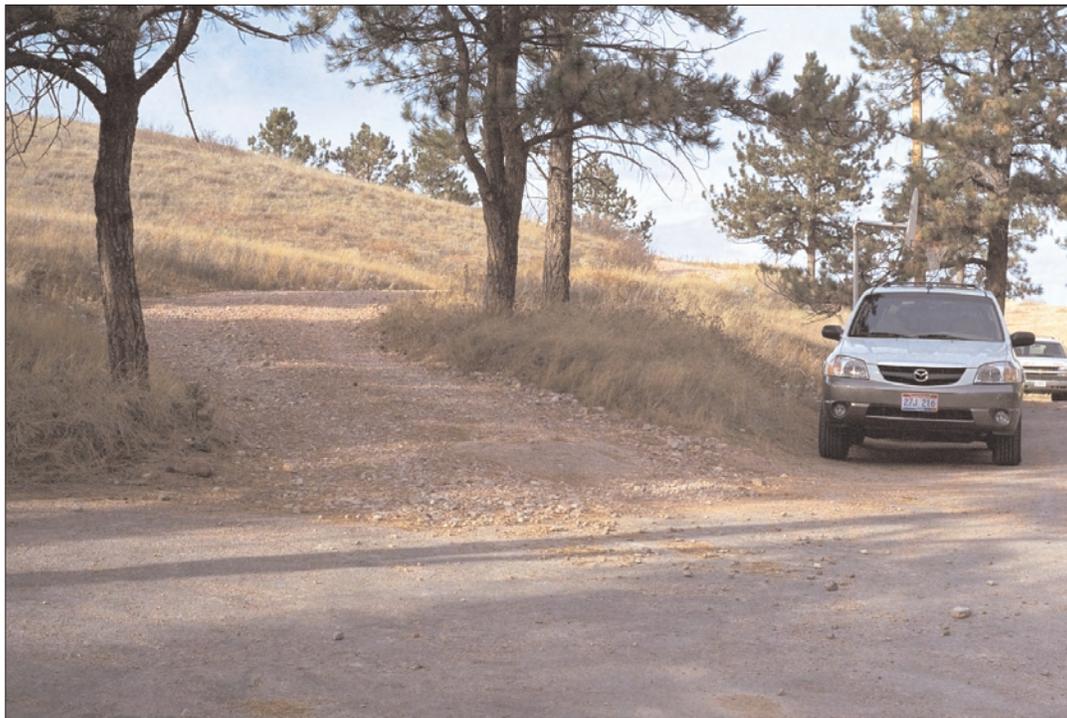
Figure 3-116
(J-23) Upper-level road through Historic Housing Area looking northwest.

A narrow, chip-and-seal surfaced drive runs west from the Headquarters Road across from the Administration Building, accessing the Historic Housing Area. This access road curves to the south and splits into two parallel segments. The eastern, 450-foot-long segment accesses three residences and ends in front of a two-story garage (*Figure 3-115 /L-04*). The western segment, 675 feet long, accesses a storage building, a second garage, and the upper level of the first garage, then ends at a residence (*Figure 3-116 /J-23*). Portions of both drives have stone curbing.

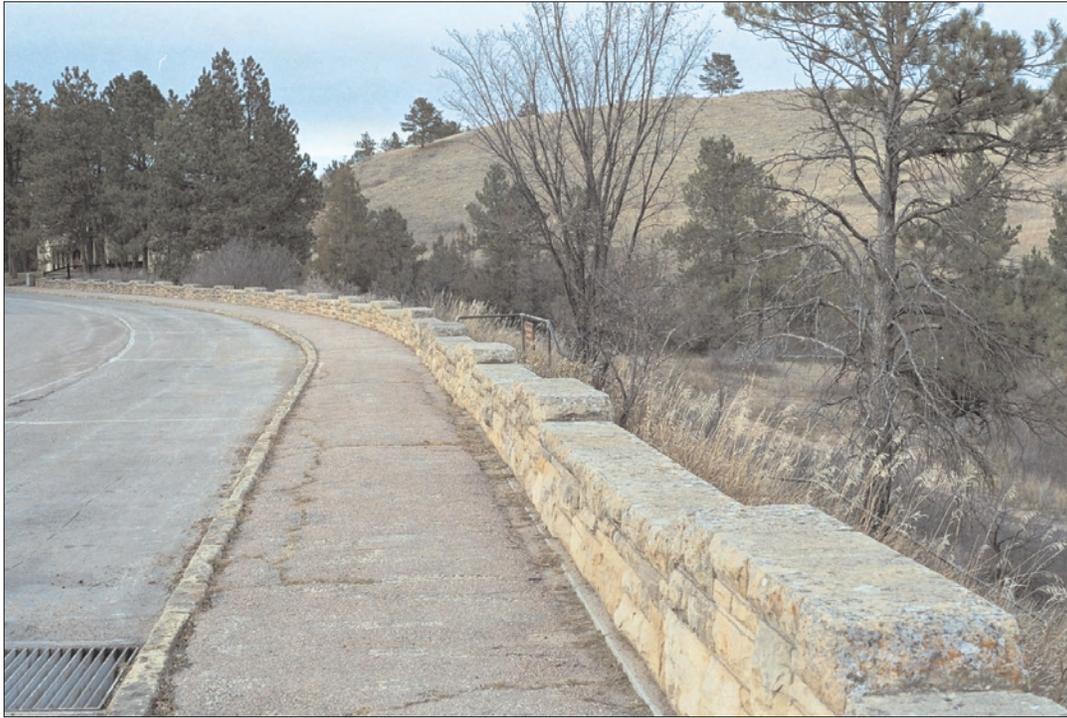
Figure 3-117
(I-17) Service road to underground tanks looking northwest.

A crushed stone and hard packed earth road originates along this drive at the curve, continuing west. This road curves, first north, then back to the west, and continues uphill for another quarter mile, ending at a pump house and underground water tanks on the flank of Elk Mountain (*Figure 3-117 /I-17*).

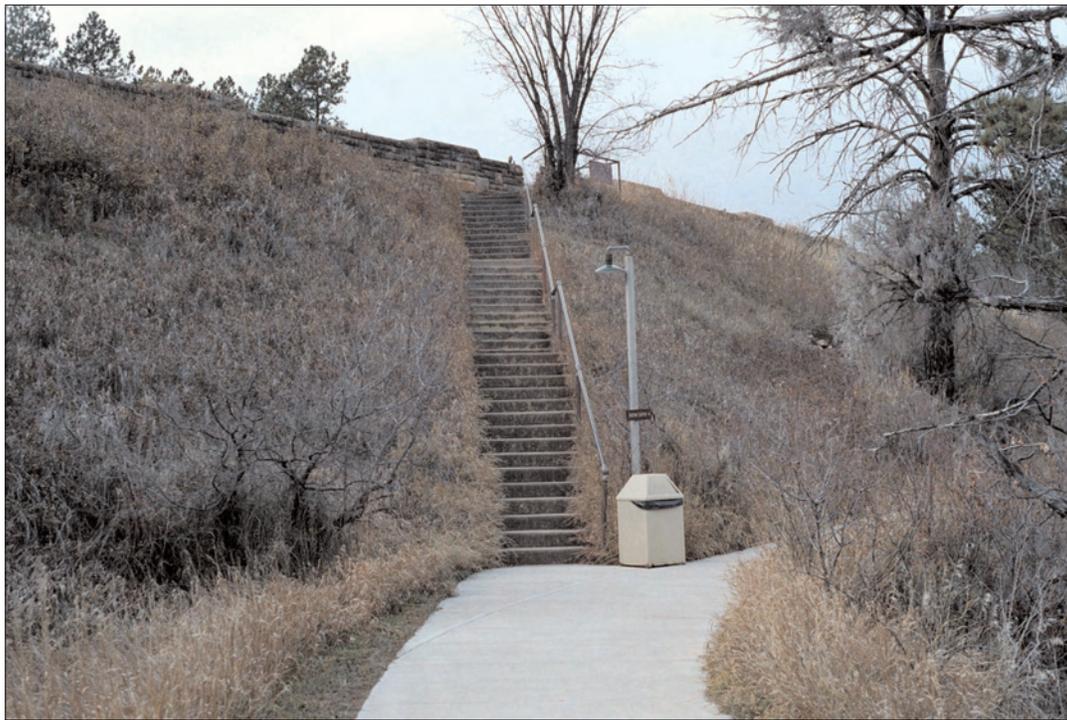
Figure 3-118
(D-07) Visitor Center sidewalk and Stone Barrier Walls (HS-94) along east edge of parking lot south of Visitor Center.

There is a large stone retaining wall supporting the parking lot (*Figures 3-118 /D-07, 3-193 /A-20*). Other stone walls occur in front of ponderosa pine plantings, along the parking lot, and around the Elevator Building courtyard (*Figures 3-194 /B-23 and 3-195 /F-19*).

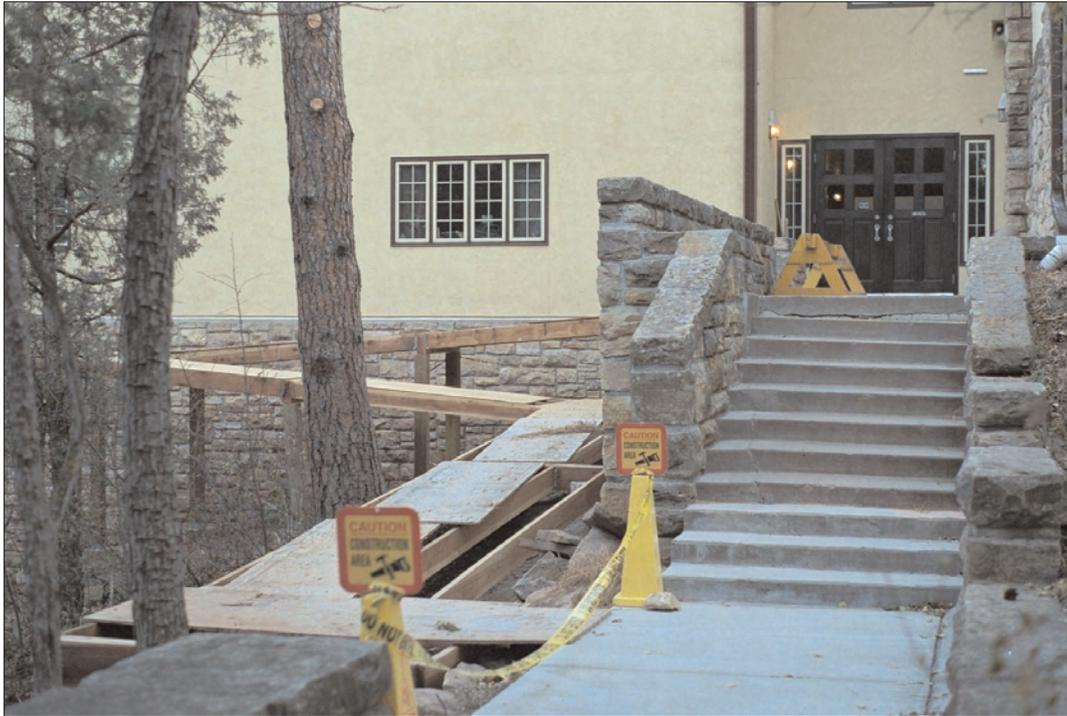
Figure 3-119
(D-17) Concrete steps connect lower-level sidewalk and south end of Visitor Center parking lot.

Due to the slope of the terrain, there are numerous steps and ramps in the Headquarters Area. Concrete steps connect the parking lot sidewalk to the sidewalk behind the Administration Building (*Figure 3-119 /D-17*). A ramp (photographed while under construction) provides wheelchair access to the sidewalk behind the Administration Building (*Figure 3-120 /E-16*). Circulation-related small-scale features associated with the Headquarters Area include handrails on steps and lighting (*see Small-scale Features section below*).

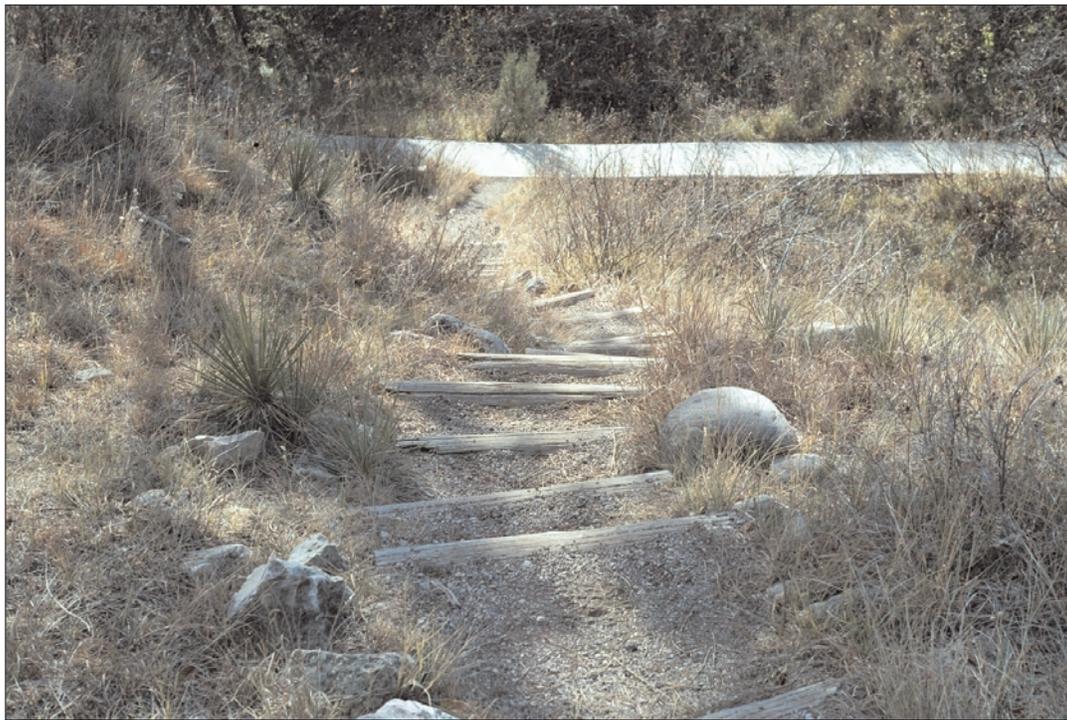
Figure 3-120
(E-16) Wheel chair accessible ramp at north end of Visitor Center during construction.

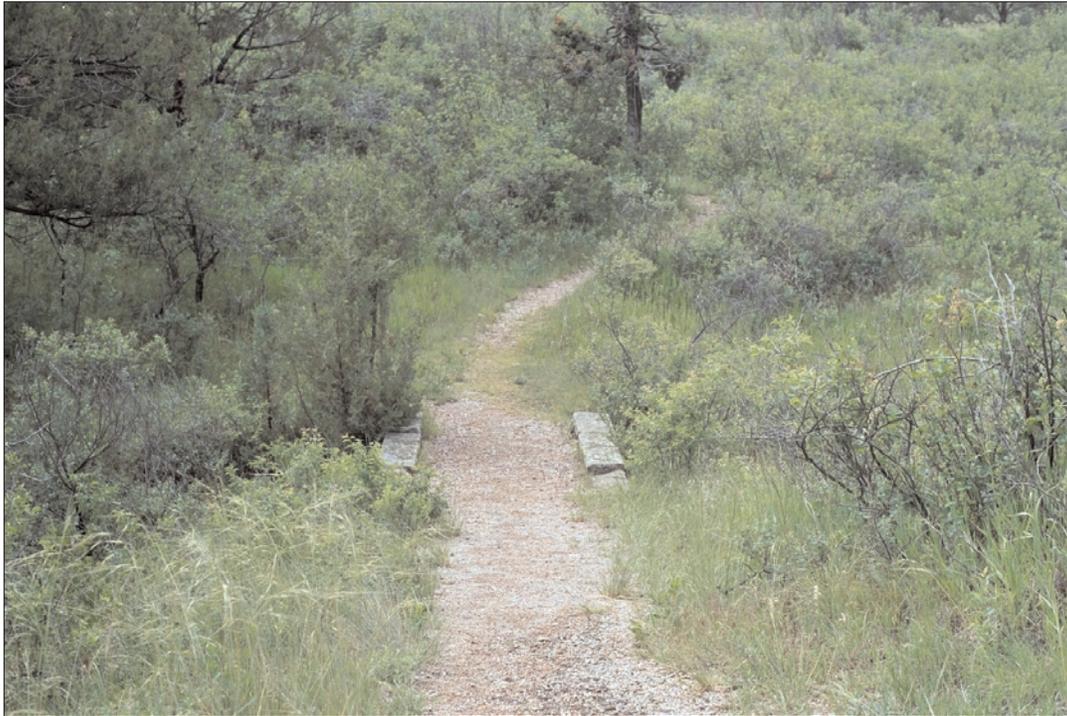
Figure 3-121
(H-15) Prairie Vista Trail path with log steps and gravel surface.

In addition, there are some earthen paths, including the Prairie Vista Trail with timber steps leading up from the cave entrance (*Figure 3-121 /H-15*). Leading from the picnic area up to the parking lot is a crushed stone path that crosses over a stone bridge and ascends timber stairs. Another gravel path leads from the picnic area to the upper-level vehicle turnaround (*Figure 3-122 /2W-14*).

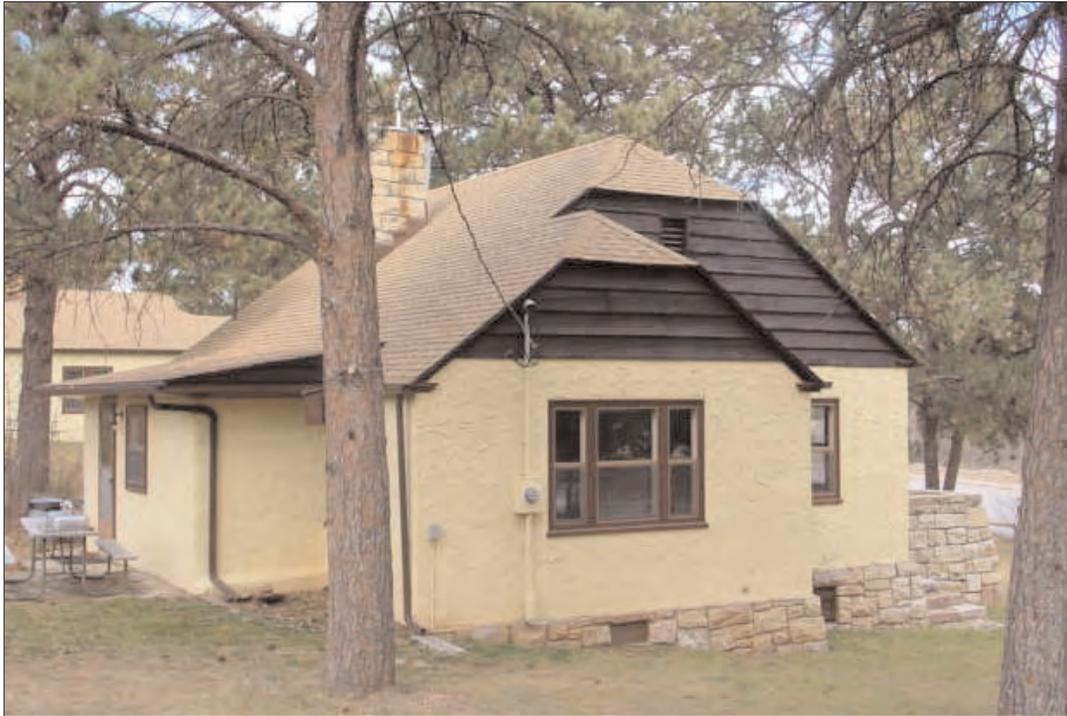
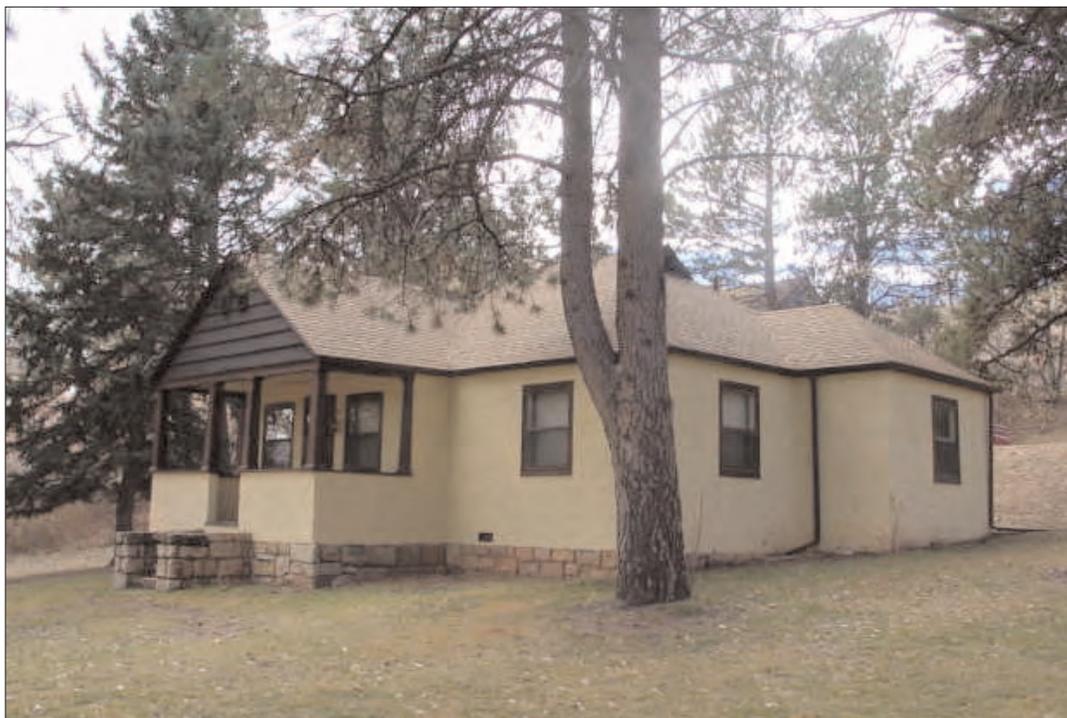
Figure 3-141
(BVH-17) Residence (HS-6) looking northwest.

Figure 3-142
(BVH-18) Residence (HS-6) looking northeast.

This residence was constructed in 1934 (*Figures 3-141 /BVH-17, 3-142 /BVH-18*). The hipped gable roof consists of asphalt shingles that appear to be recently installed and are in good condition, with new K-style aluminum gutters and rectangular downspouts, all in pre-finished

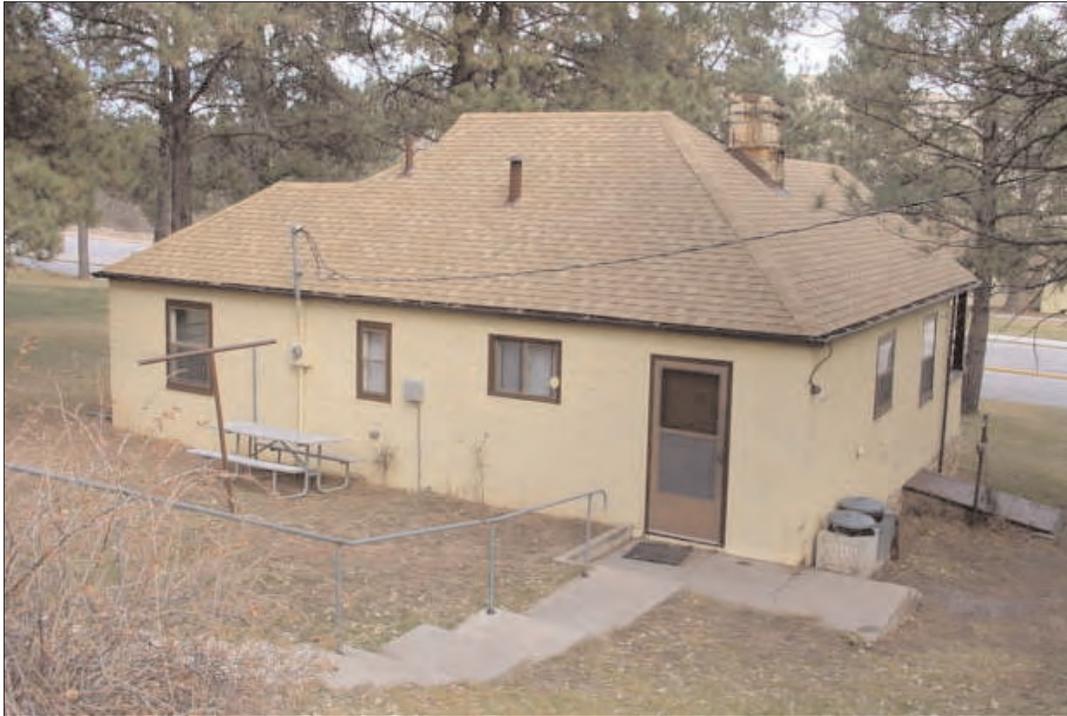
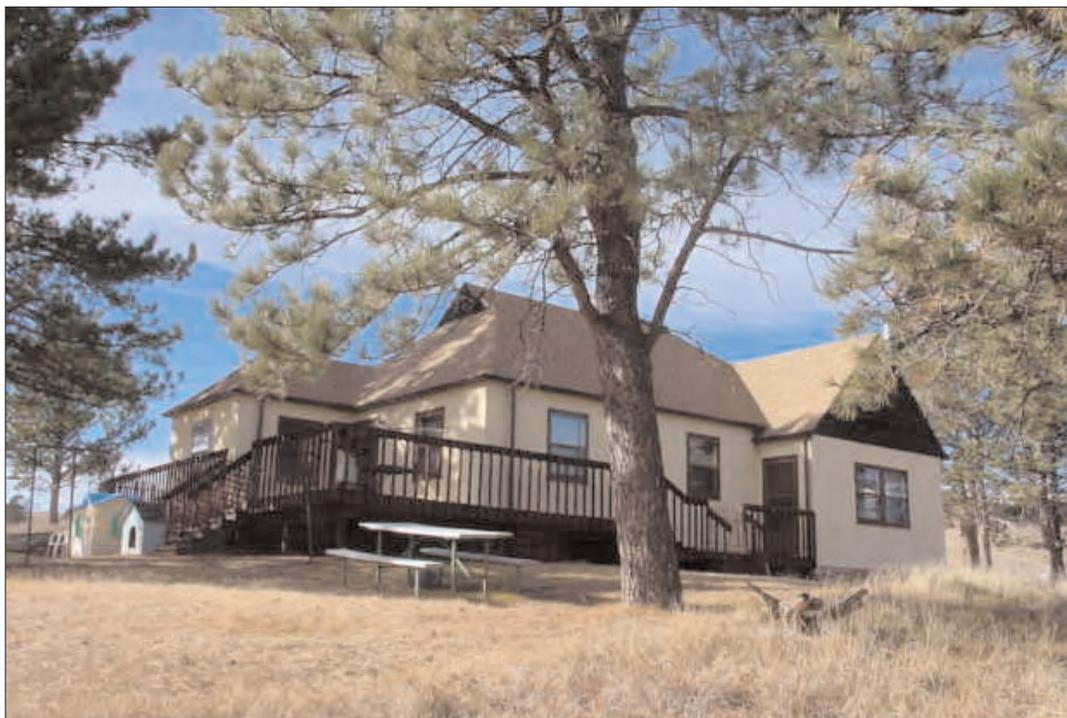
Figure 3-143
(BVH-19) Residence (HS-7) looking southwest.

Figure 3-144
(BVH-20) Residence (HS-7) looking east.

This residence was constructed in 1932 (*Figures 3-143 /BVH-19, 3-144 /BVH-20*). The hipped roof consists of asphalt shingles that appear to be recently installed and are in good condition, with new K-style aluminum gutters and rectangular downspouts, all in pre-finished brown metal. The gutters and downspouts are in good condition. At the roof edges and in the gable of the front porch is wood trim and lap siding at the roof gable ends. The trim and gable end are in good to fair condition. The wood is either painted or stained with a dark seed-oil stain mixture. Walls of the residence consist of heavily textured plaster stucco with a limestone rubble base. The plaster is painted and is in good condition with very few cracks. The limestone base is also in good condition. Mortar joints are solid, and the stone is in good condition. There are a couple of minor cracks which occur at the porch area where some settlement may have occurred. The stone wing walls at the porch entrance stair are also heavily covered with algal growth, but appear to be in fair condition.

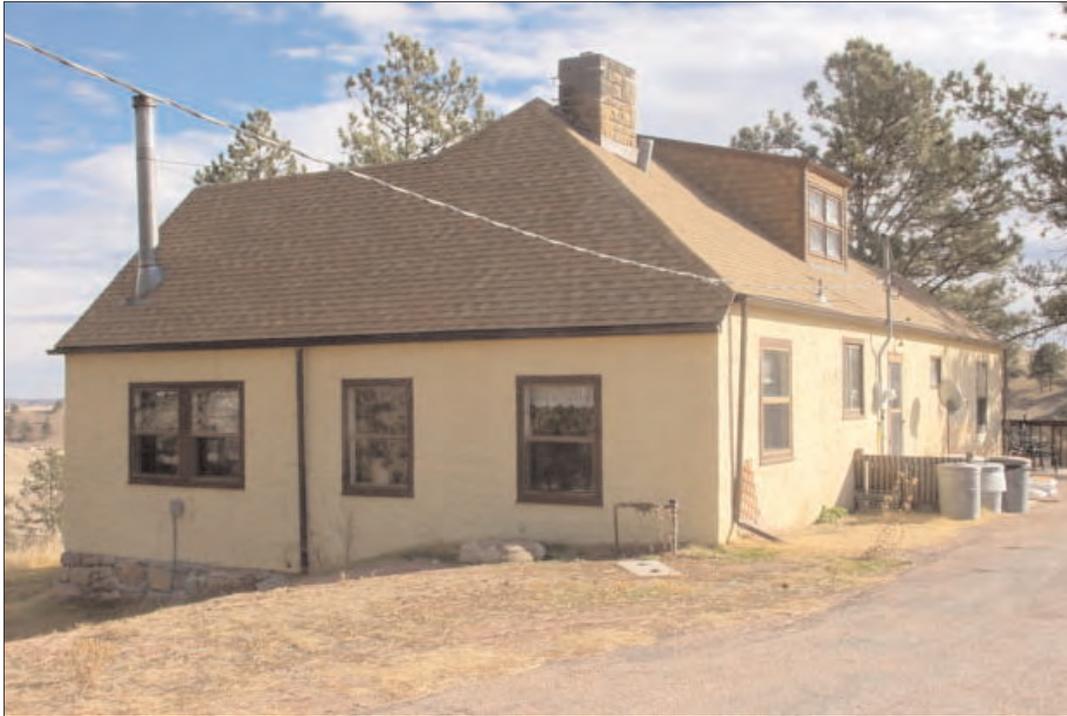
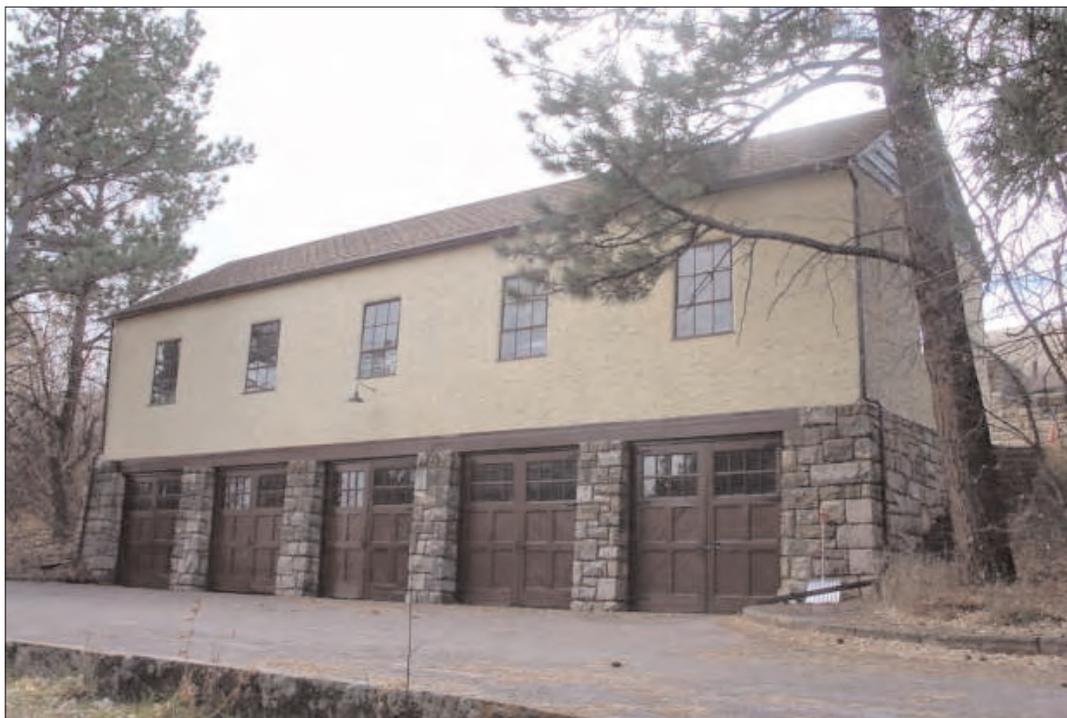
Figure 3-145
(BVH-21) Residence (HS-8) looking northwest.

Figure 3-146
(BVH-22) Residence (HS-8) looking southeast.

The one and a half story Ranger's Dormitory and Mess House was constructed in 1931 (*Figures 3-145 /BVH-21, 3-146 /BVH-22*). The house sits on a slope that falls away from back to front, and the foundation is not visible at the back. The building's hipped roof consists of asphalt shingles with K-style aluminum gutters and rectangular downspouts all constructed of pre-finished aluminum. The asphalt roof is in good condition and appears to be recently installed. The gutters and downspouts are also in good condition and appear to have been recently installed. The building's wall surfaces consist of heavily textured stucco with a random limestone finish below the main floor level. The stucco wall surfaces are in fair condition. There were several cracks noted around the perimeter of the building, particularly under windows that span from the windowsill to the stone base. The paint finish on the stucco is in good condition. The stone base appears to be in good condition. The sill areas have been recently tuck-pointed with a contrasting mortar material that does not match the original mortar. The stones themselves appear to be in good condition.
