CHARACTERISTICS OF THE DEVELOPED AREAS

INTRODUCTION

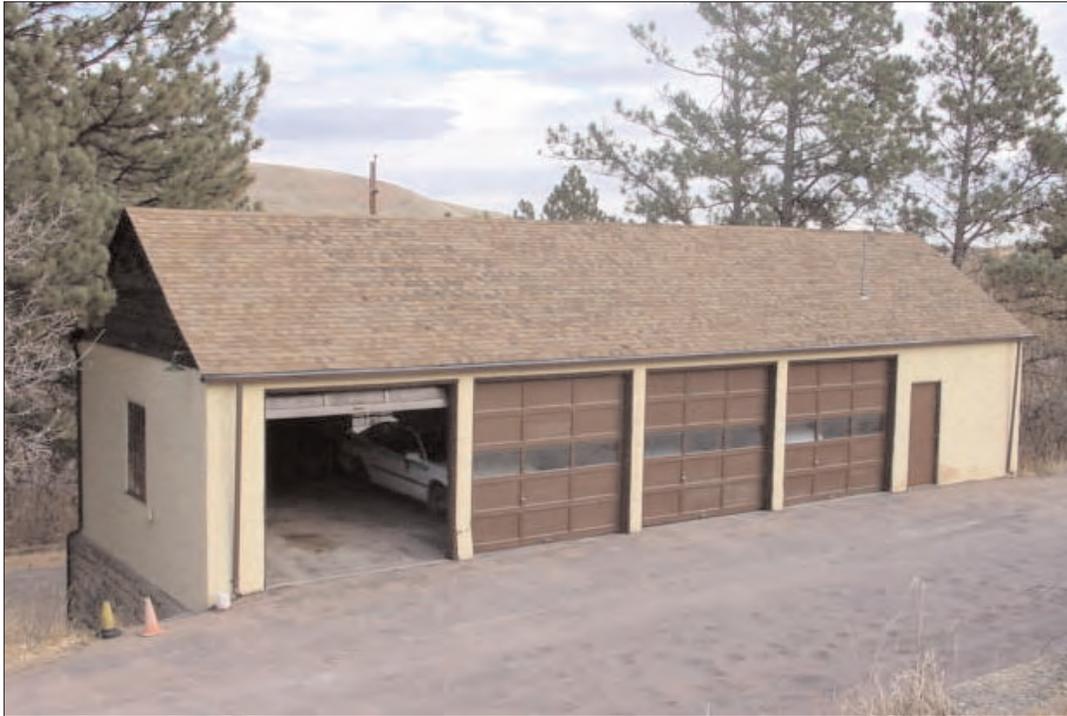
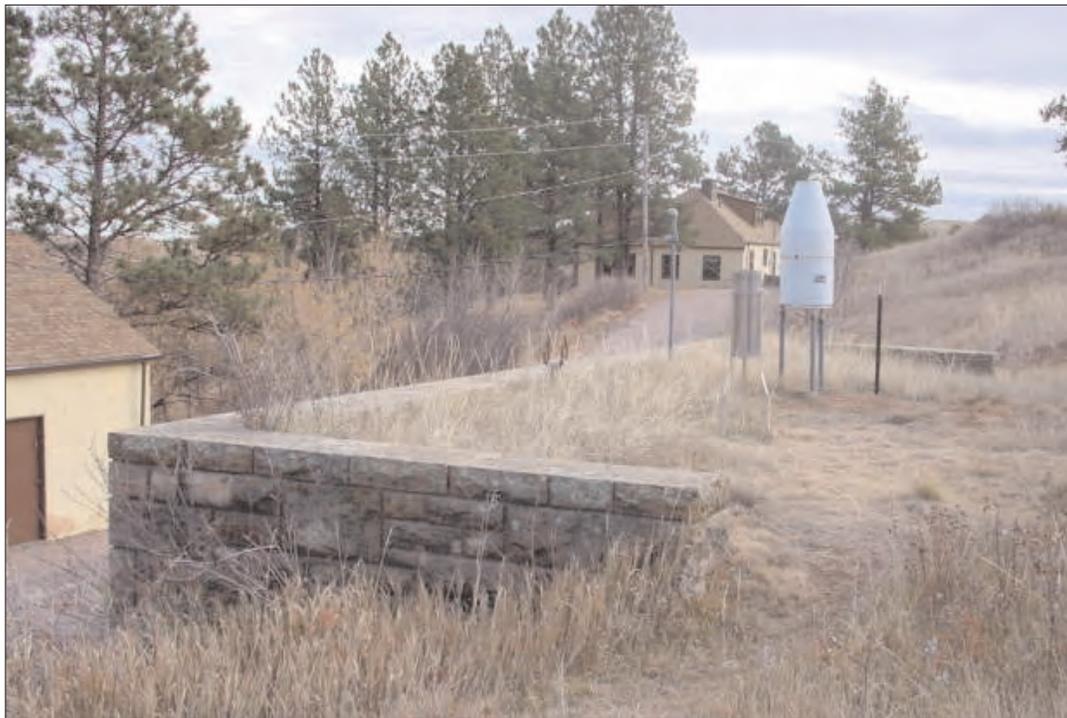
Figure 3-147
(BVH-23) Garage (HS-11) looking southwest.

Figure 3-148
(BVH-24) Garage (HS-11) looking southeast.

The Machine Shop Shed was constructed in 1934 (*Figures 3-147 /BVH-23, 3-148 /BVH-24*). The roof of the building consists of asphalt shingles with pre-finished aluminum K-style gutters and rectangular downspouts. The asphalt roof is in fair to poor condition. Several areas at the interior of the roof contain deteriorated shingles. Shingles have cupped and warped and there are several areas of uplifted tabs. The downspouts and gutters are in good condition and appear to have been recently installed. The garage's wall surfaces consist of heavily textured stucco plaster on the upper level with a limestone base. The stucco is in good condition. The painted surface is sound, and the stucco walls contain few areas of cracks. The limestone base of the building is in good to fair condition. There are several stones at the base of the building, mostly located at the lower garage door areas, which are deteriorated. Deterioration could be linked to vehicle abuse and also freeze/thaw intervals at the lower areas of the garage doors. The building's windows are of steel sash construction. The windows are in good to fair condition. The upper sashes tilt, allowing ventilation. The paint finish of the windows is in fair condition. The lower level garage doors consist of five pairs of wood doors, which contain upper divided light vision panels with lower inset diagonal wood panels. The doors are painted and are in fair condition. The doors exhibit some signs of sagging and misalignment. Door hardware, consisting of strap hinges and simple latches, are in fair condition. Some lower door panels exhibit signs of deteriorated or rotted wood.

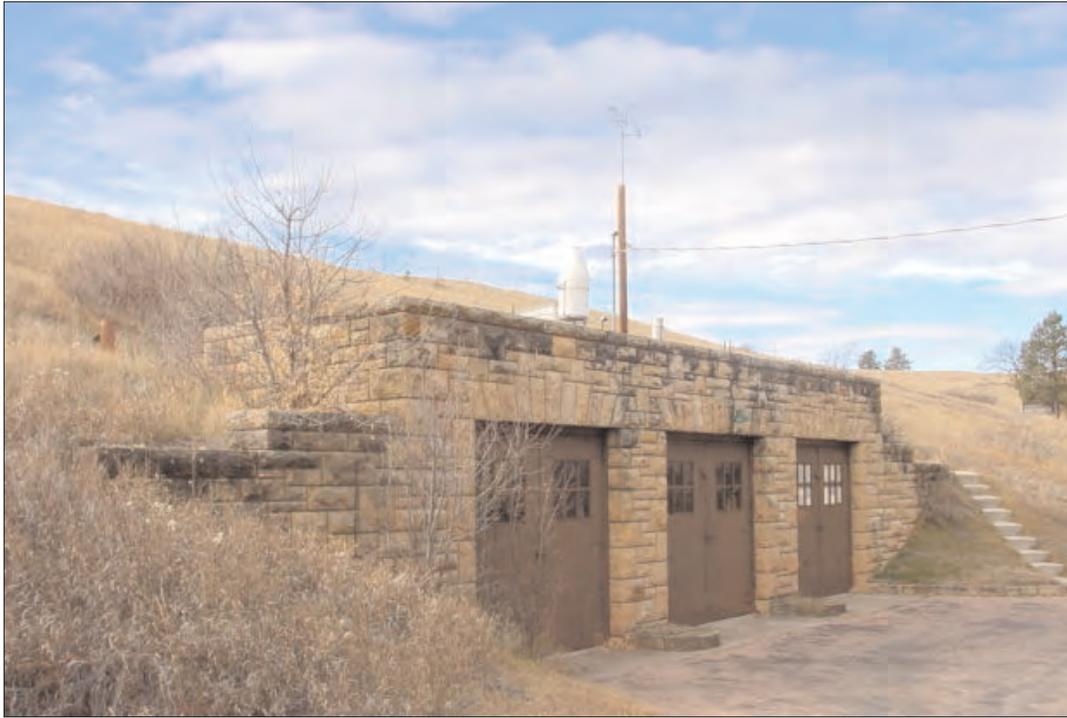
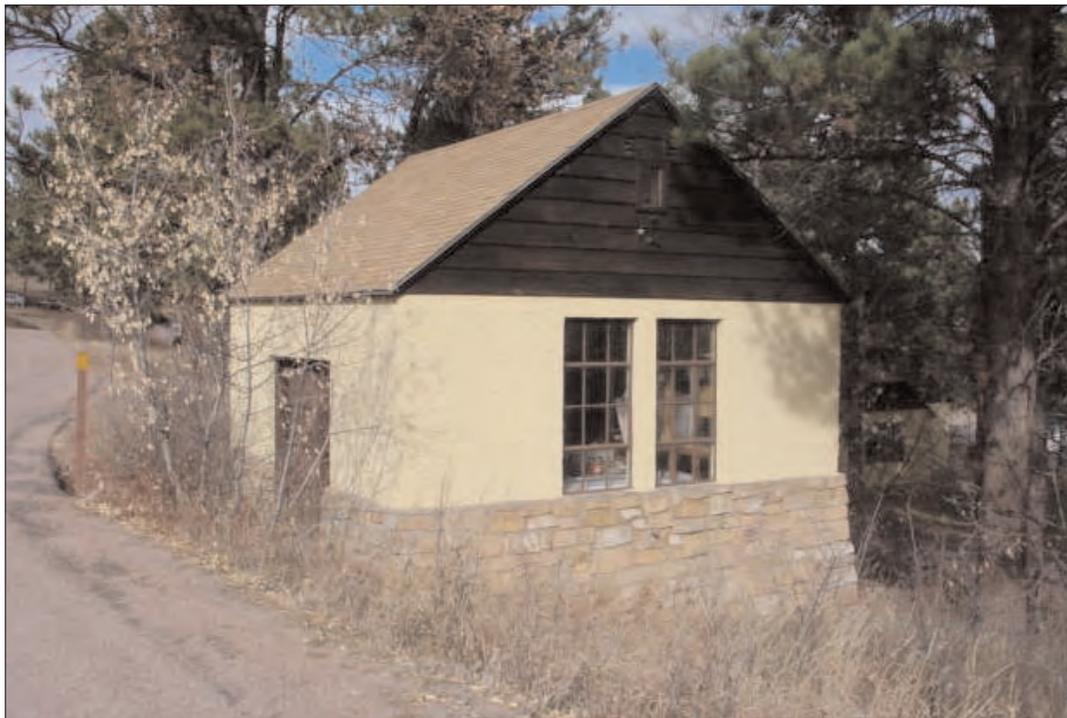
Figure 3-149
(BVH-25) Top of garage (HS-12) looking southeast.

Figure 3-150
(BVH-26) Garage looking northwest.

Constructed in 1937, the Fire Cache Building is partially underground with an eastern exposure of three main doors (*Figures 3-149 /BVH-25, 3-150 /BVH-26*). The roof of the building is covered with sod. The roof condition is unknown. The stone parapets at the roof are in fair condition. There are a few open joints at the copings allowing moisture penetration, and there is some vegetation growth occurring at the open joints. Also on the sod roof there are some instrumentation pieces for moisture and meteorological measurements.

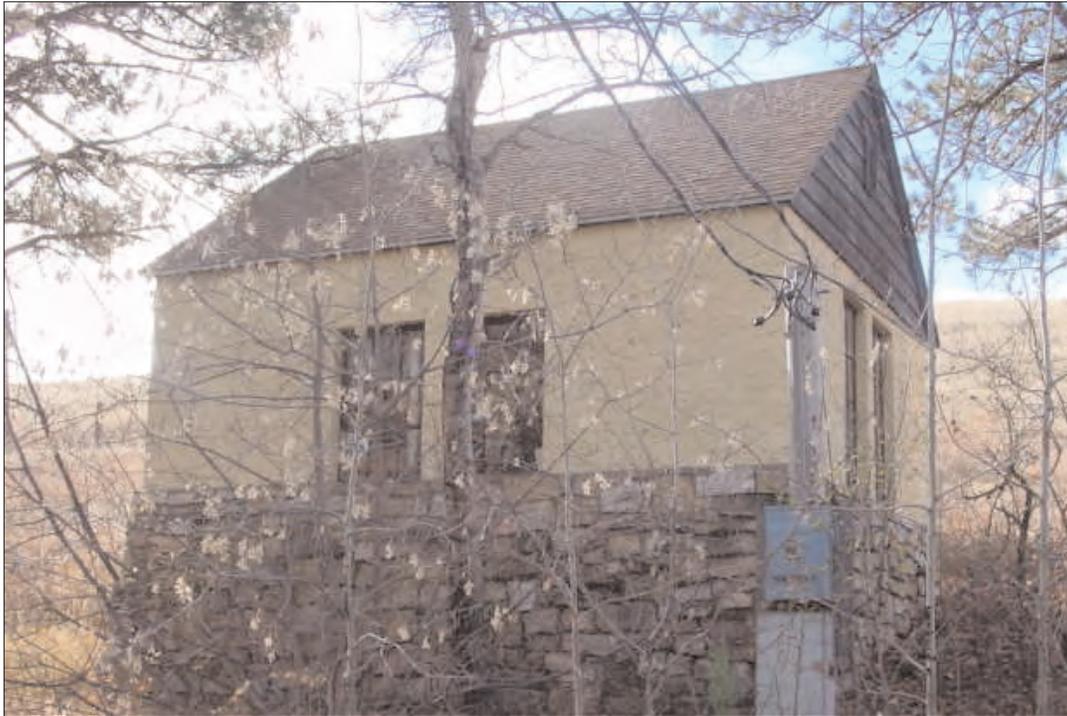
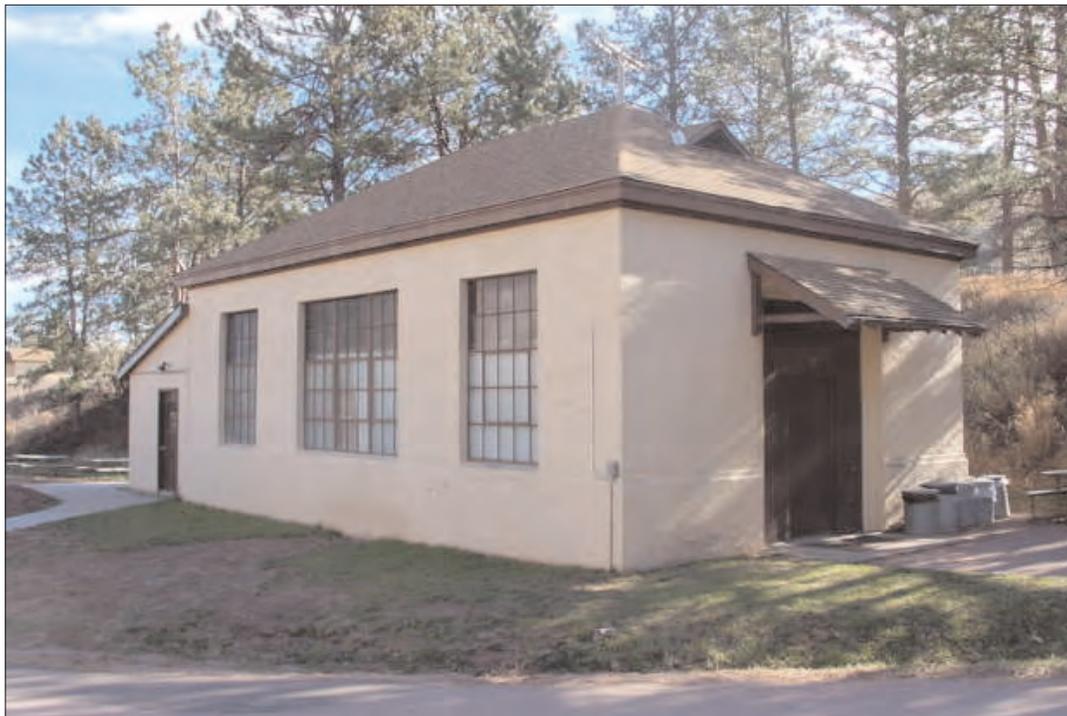
Figure 3-151
(BVH-27) Storage Building (HS-13) looking northeast.

Figure 3-152
(BVH-28) Storage Building looking west.

The Power House was constructed in 1931 (*Figures 3-151 /BVH-27, 3-152 /BVH-28*). The equipment was removed between 1939 and 1942, and the building has been used as a storage shed since. The roof consists of asphalt shingles that are in good condition and appear to be

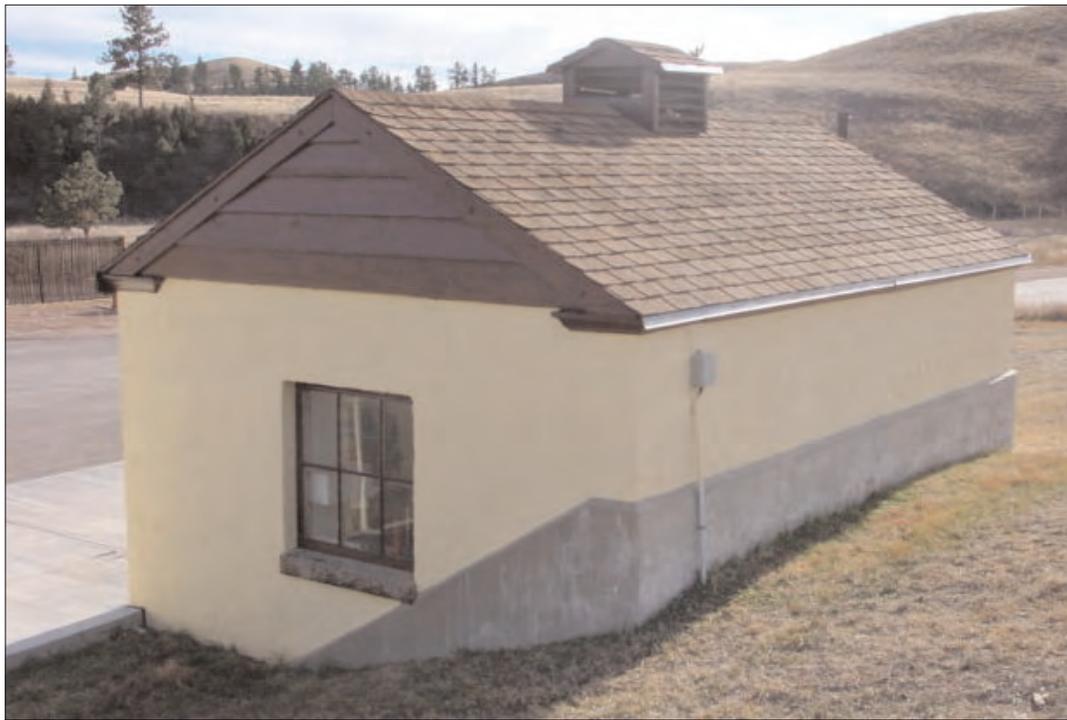
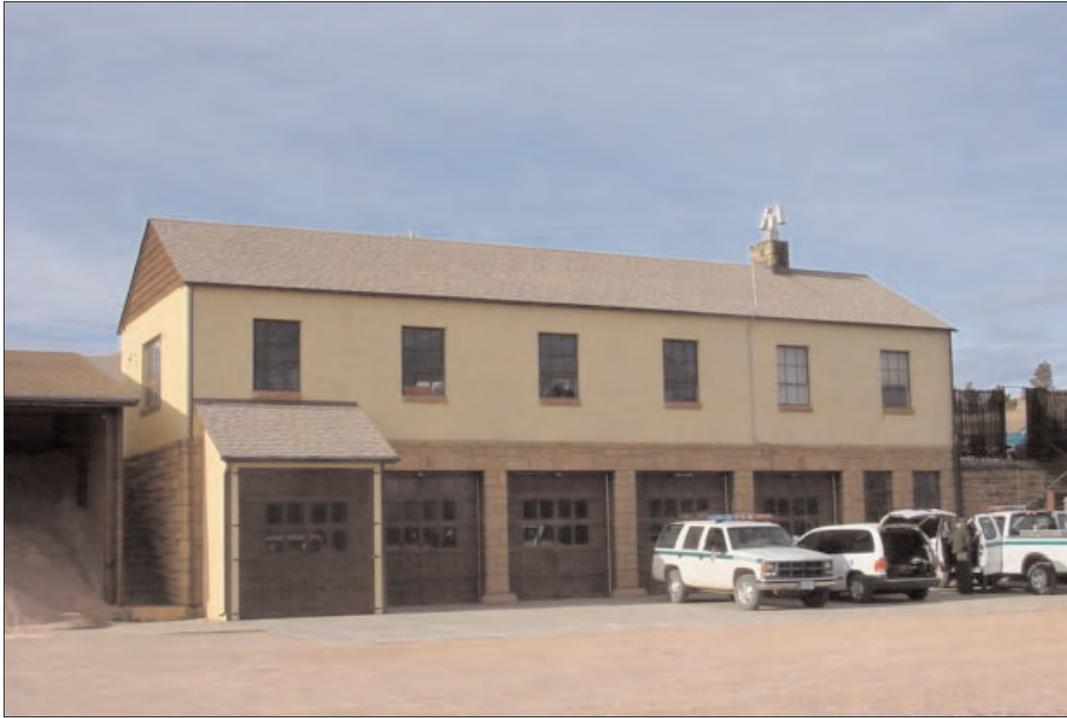
Figure 3-156
(BVH-32) Gas Station (HS-16) looking north.

Figure 3-157
(BVH-33) Gas Station (HS-16) looking south.

This building, constructed in 1940, is a simple rectangular building with a gable roof (*Figures 3-156 /BVH-32, 3-157 /BVH-33*). The roof contains asphalt shingles with gable ends in-filled with lath wood siding. Gable ends also contain dimension-wood fascias. The asphalt roof appears to

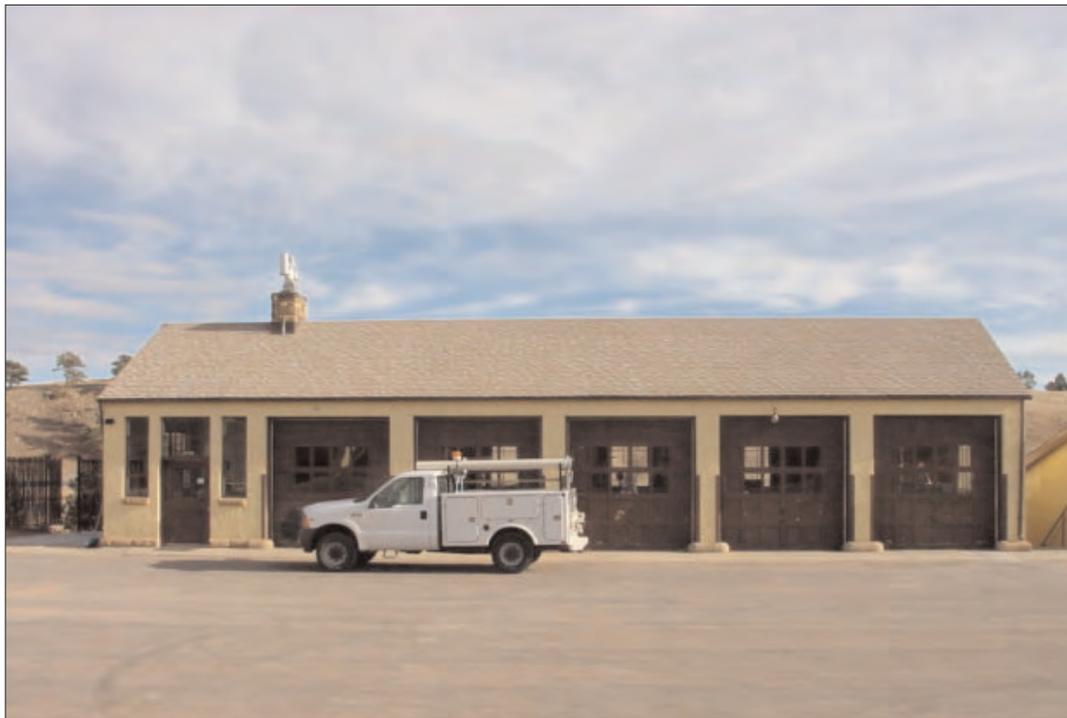
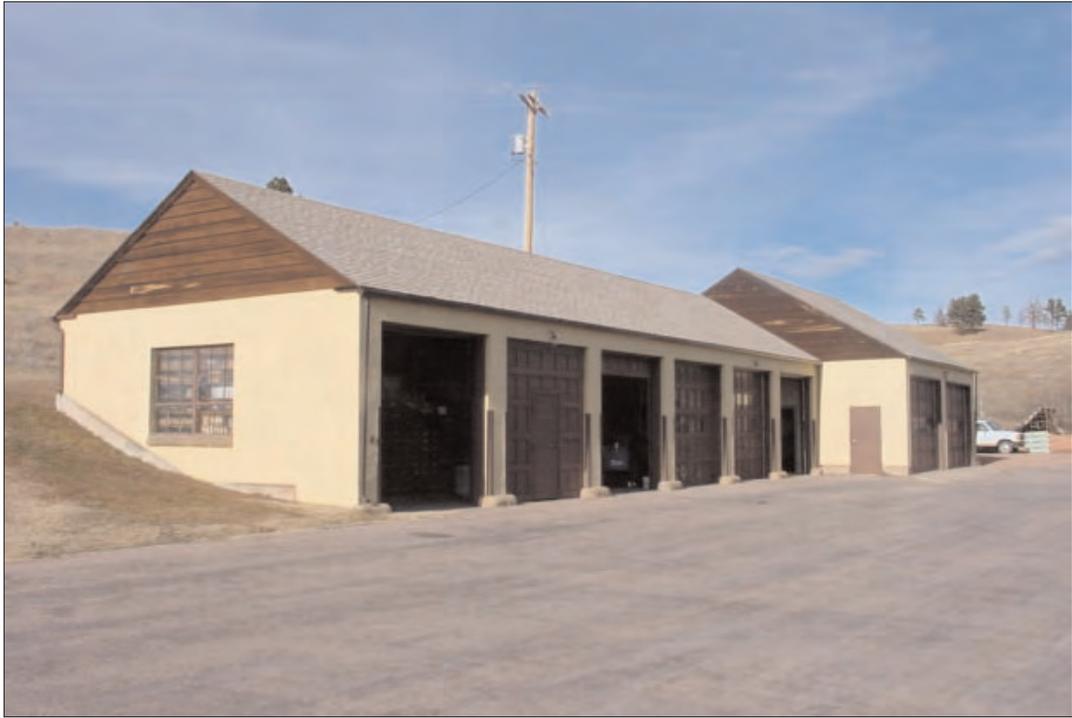
Figure 3-158
(BVH-34) Garage A (HS-17) looking northwest.

Figure 3-159
(BVH-35) Garage A looking southeast.

This garage, built in 1939, is a two-story structure built into a hillside with garage service bays at both levels (*Figures 3-158 /BVH-34, 3-159 /BVH-35*). The upper level is accessed from the northwest and the lower garage bays are entered from the southeast. Both the upper and lower levels of the garage contain five-garage bays. The simple gabled roof of the garage consists of asphalt shingles with K-style pre-finished aluminum downspouts and gutters. The asphalt roof appears to be in good condition, as do the gutters and downspouts, both recently installed.

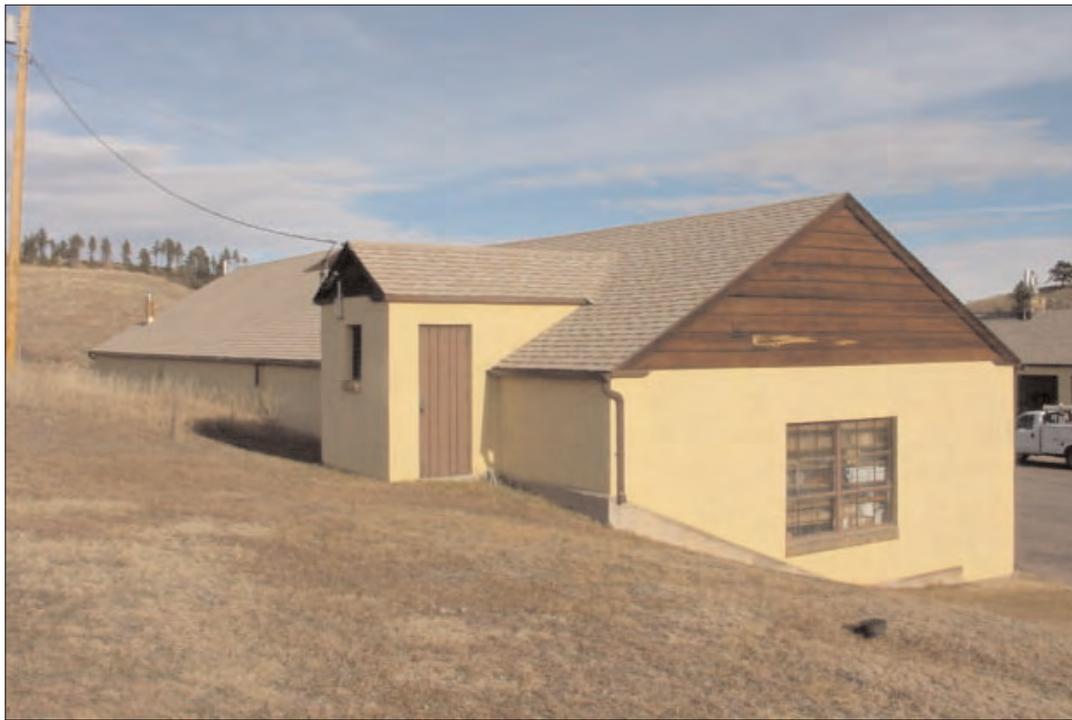
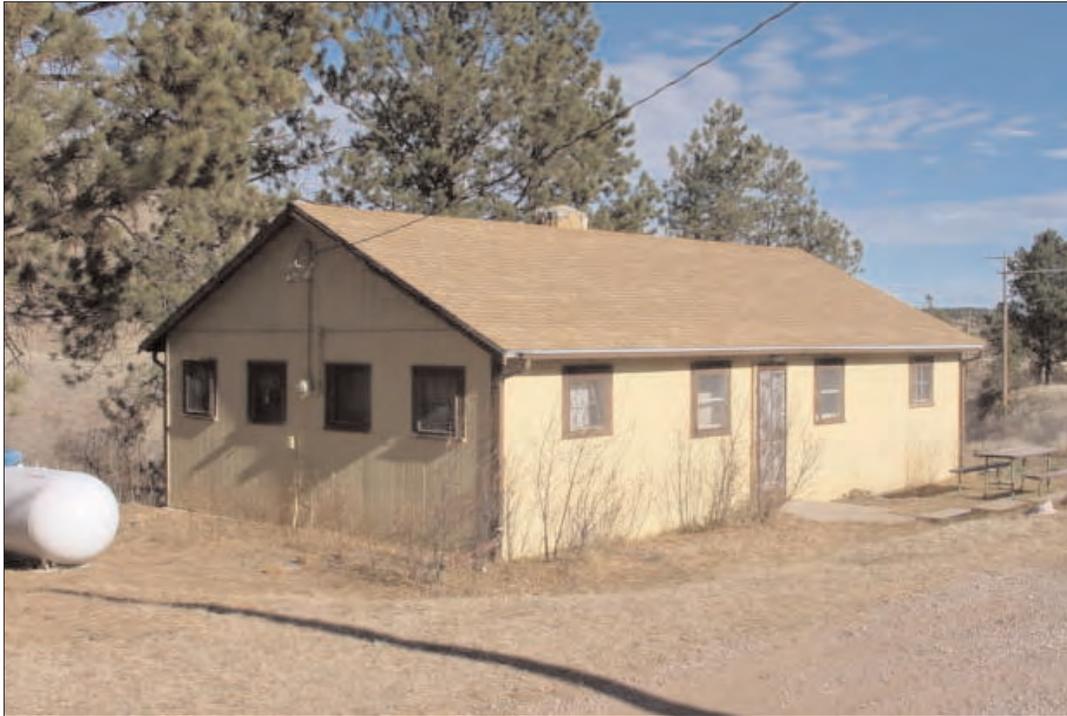
Figure 3-160
(BVH-36) Garage C (HS-18) looking north.

Figure 3-161
(BVH-37) Garage C looking southeast.

The original six-bay section of Garage C was constructed in 1939 (*Figures 3-160 /BVH-36, 3-161 /BVH-37*). The two-bay addition at the northeast end was added in 1974. The Maintenance Shop has a simple gable roof form with asphalt shingles and K-style pre-finished aluminum downspouts and gutters. The asphalt shingles appear to be in fair condition. There are some asphalt shingles that have uplifted at the roof edges. The edge of the roof contains wood fascias with wood lath siding gable in-fills. The wood is either painted at the eaves, or stained at the gable in-fill areas. It appears to be in fair condition.

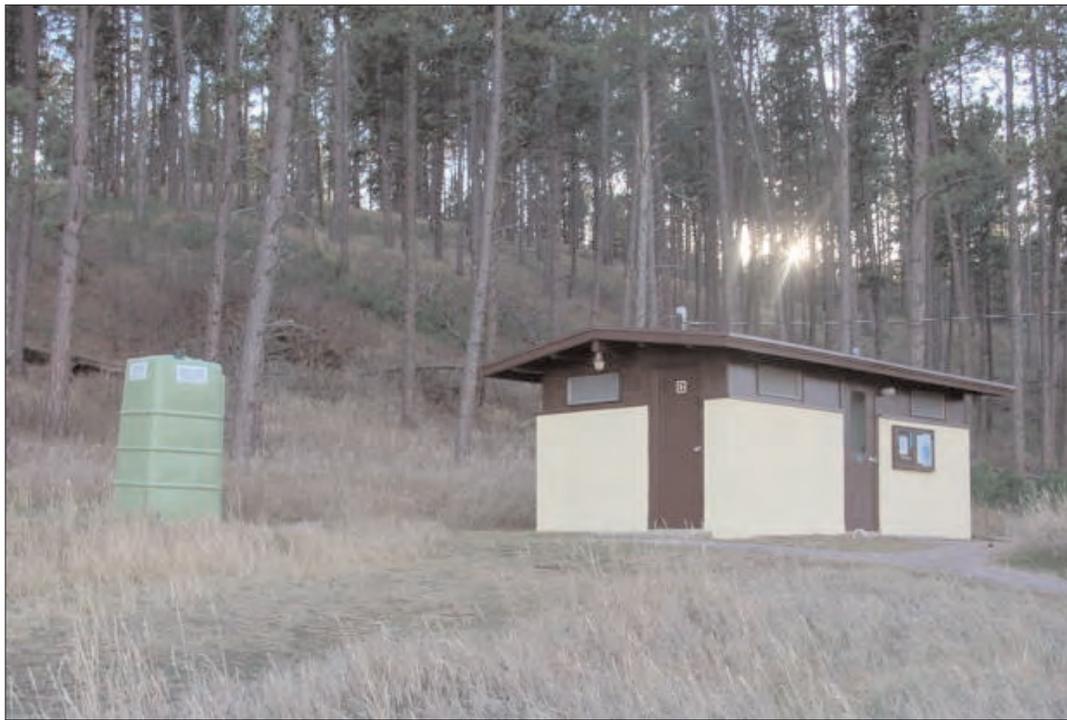
Figure 3-178
(BVH-54) Campground Comfort Station looking southwest.

Like the other comfort stations, this building is a simple rectangular building containing men's and women's restrooms, a small utility room, and an accessible restroom (*Figure 3-178 /BVH-54*). It has the same roof, windows, walls, doors, and paint colors as the campground comfort station described above. The masonry and paint appear to be in good condition. The plywood top wall areas are painted a dark brown color and appear to be in good to fair condition. The windows, doors, and hardware appear to be in working order and are in fair condition. Roofs appear to be in fair condition.

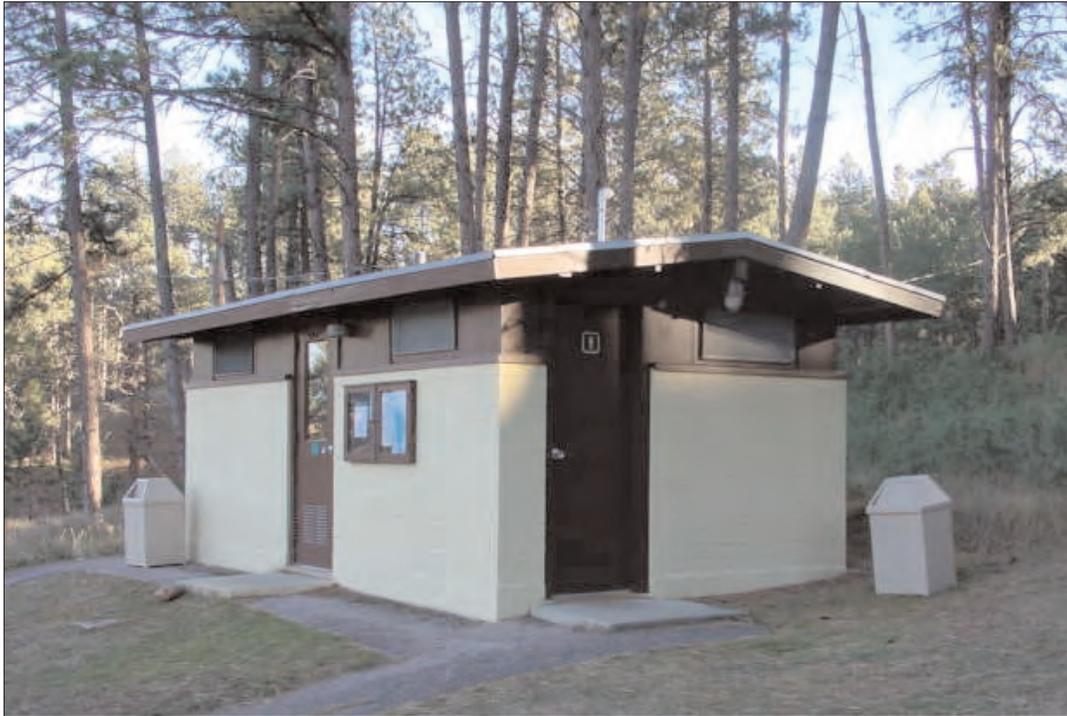
Figure 3-179
(BVH-55) Campground Comfort Station looking southwest.

This simple rectangular building, much like the two previous comfort stations, contains men's and women's restrooms, a small utility room, and an accessible portable toilet (*Figure 3-179 /BVH-55*). It has the same roof, walls, windows, doors, and paint colors. The stack bond masonry is in good condition. The paint is also in good condition. The plywood top wall areas appear to be in good to fair condition. Windows, doors and hardware appear to be in functioning or working order and are in fair condition. The roof structure is composed of a central laminated beam with smaller beams twelve pitch. Roof decking is composed of by six dimension lumber with 2 x 6 fascias and edges. There are no gutters or downspouts at the roof edges. Roofs appear to be in fair condition. This building does not contain ADA accessible restrooms.

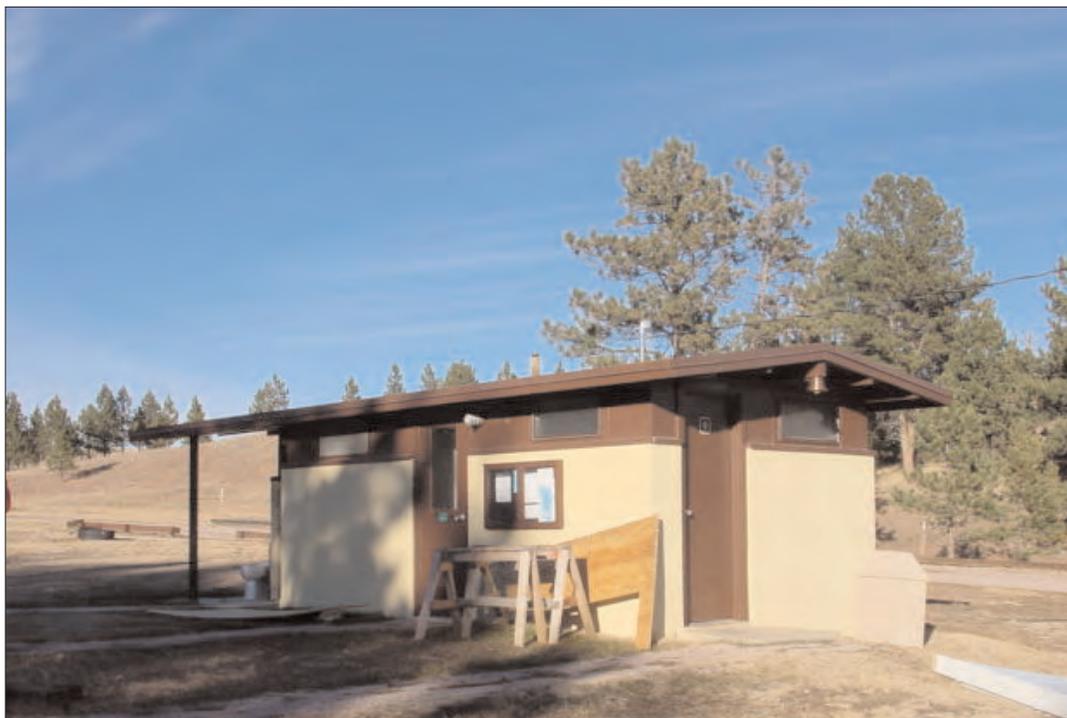
Figure 3-180
(BVH-56) Campground Comfort Station looking southeast.

This simple rectangular building contains men's and women's restrooms, a small utility room, and a handicap accessible restroom (*Figure 3-180 /BVH-56*). It has the same roof, walls, windows, doors, and paint colors. The stack bond masonry is in good condition. The paint is also in good condition. The plywood top wall areas appear to be in good to fair condition. The windows appear to be in functioning or working order and are in fair condition. Doors and hardware all appear to be in fair condition. The roof structure is composed of a central laminated beam with smaller beams twelve pitch. Roof decking is composed of by six dimension lumber with 2 x 6 fascias and edges. There are no gutters or downspouts at the roof edges. Roofs appear to be in fair condition. This building does not contain ADA accessible restrooms.

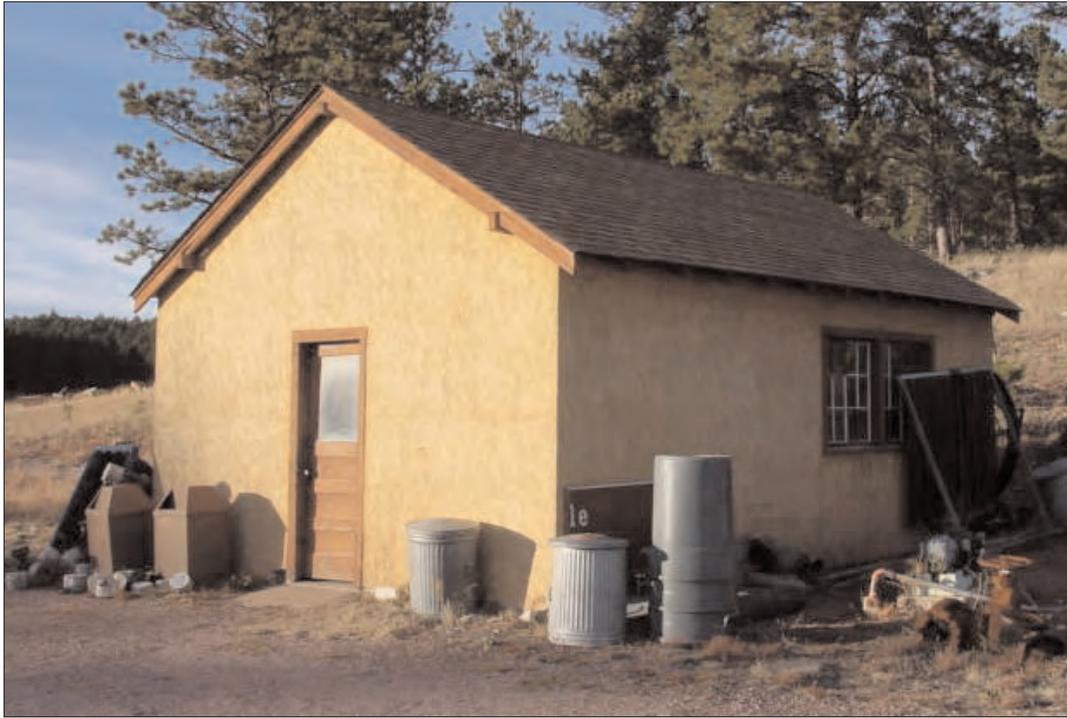
Figure 3-181
(BVH-57) Campground Comfort Station looking northeast.

This simple rectangular building contains men's and women's restrooms, a small utility room, and a handicap accessible restroom (*Figure 3-181 /BVH-57*). It has a very shallow sloping, simple gable roof covered with rolled asphalt roofing material. The exterior walls are composed of stack bond masonry up to approximately five feet. Above that are plywood panels interspersed with operable vent windows. The stack bond masonry is painted and in good condition. The paint is also in good condition. The plywood top wall areas are painted a dark brown color and appear to be in good to fair condition. The windows located within the plywood wall area are aluminum hopper units with single-pane glass and exterior screens. These units appear to be in functioning or working order and are in fair condition. Doors leading to men's and women's restrooms and the utility room are flush steel doors set in hollow metal frames. The doors are painted, and the doors and hardware all appear to be in fair condition. The roof structure is composed of a central laminated beam with smaller beams twelve pitch. Roof decking is composed of by six dimension lumber with 2 x 6 fascias and edges. There are no gutters or downspouts at the roof edges. Roofs appear to be in fair condition. This building contains ADA accessible restrooms.

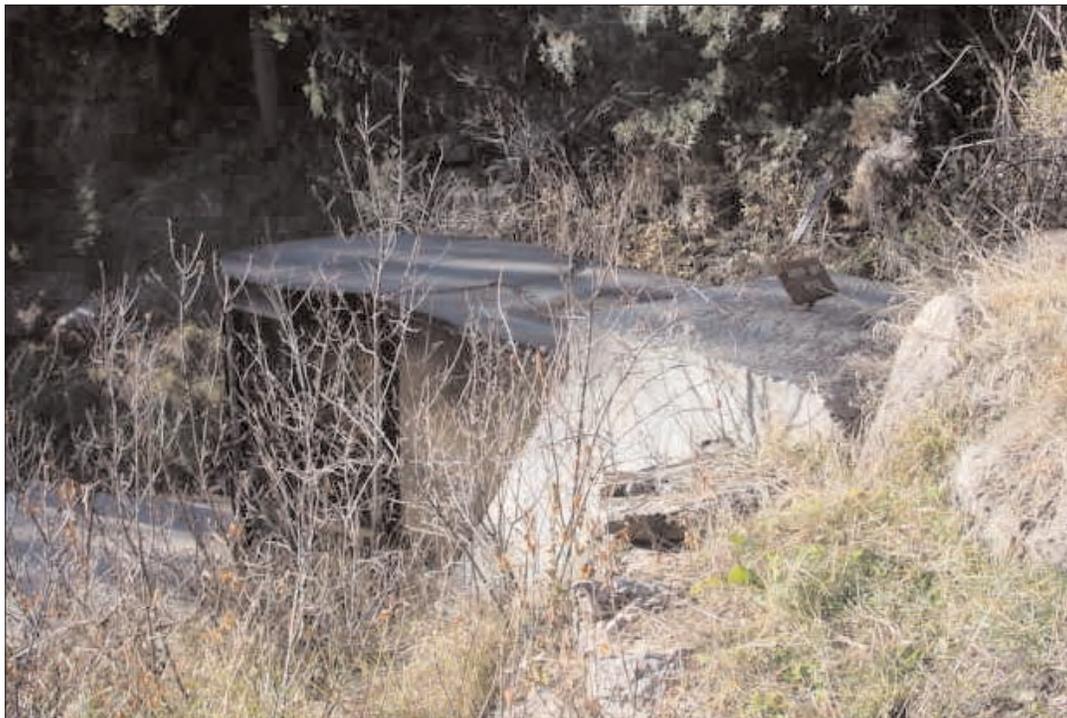
Figure 3-186
(BVH-62) Cave Walk-in Entrance revolving door.

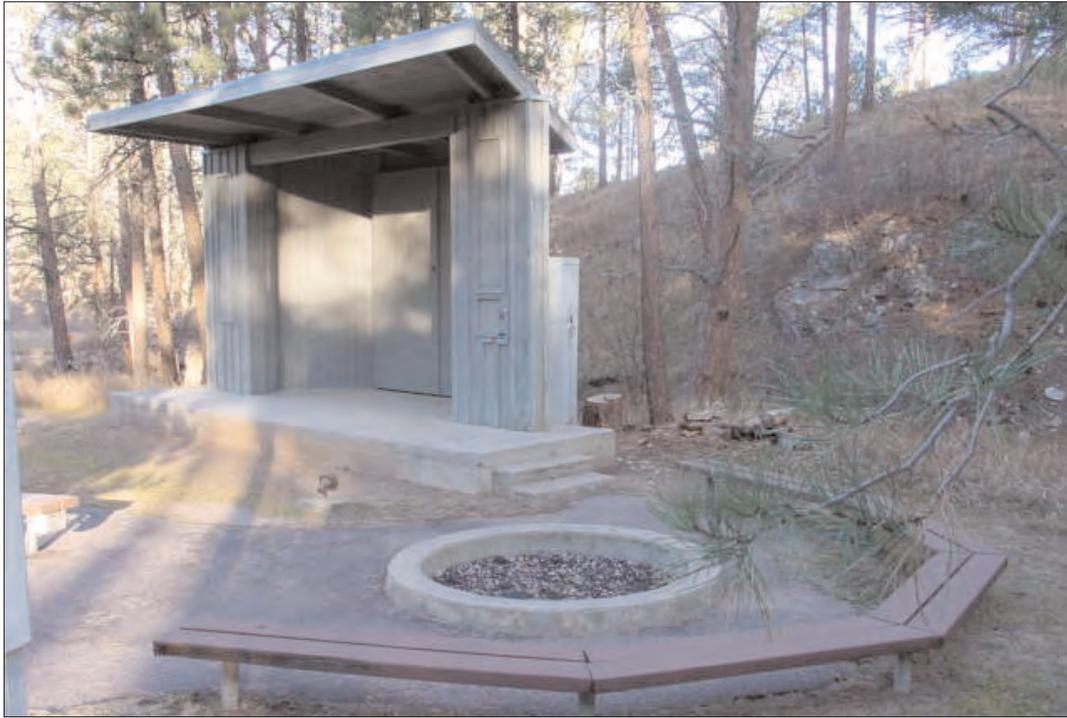
Figure 3-187
(BVH-63) Cave Walk-in Entrance revolving door roof looking southeast.

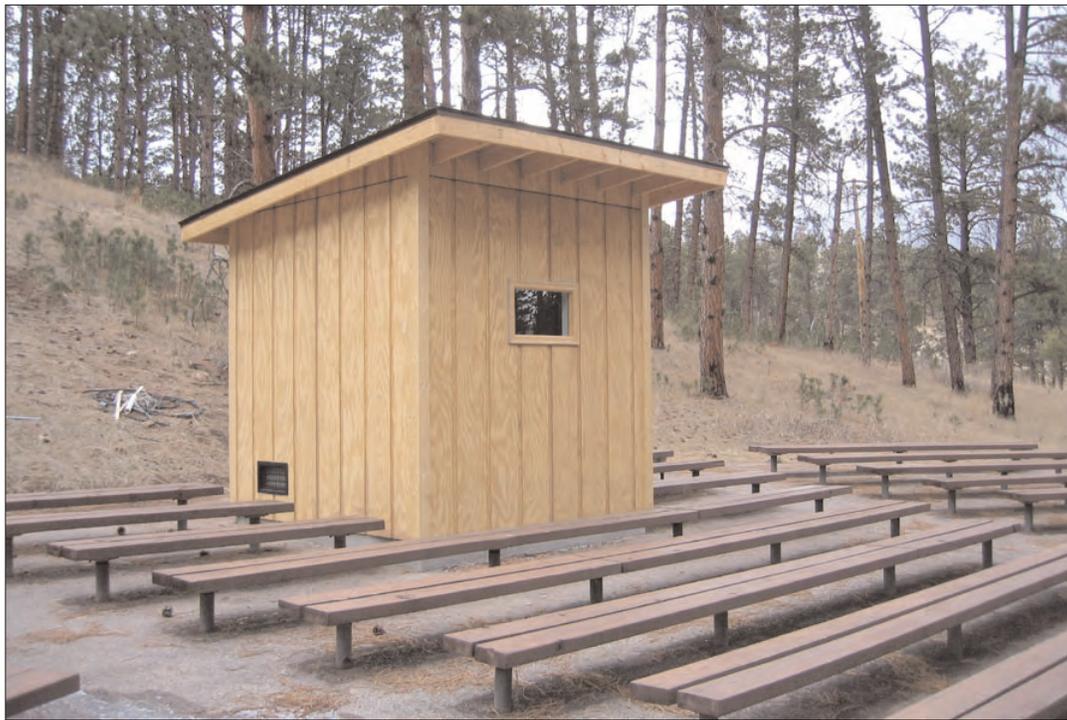
Figure 3-188
(BVH-62) Amphitheater stage and campfire pit.

The Amphitheater consists of a small stage platform constructed of concrete with a wood-framed stage cover (*Figure 3-188 /BVH-62*). The amphitheater also contains a series of wood benches

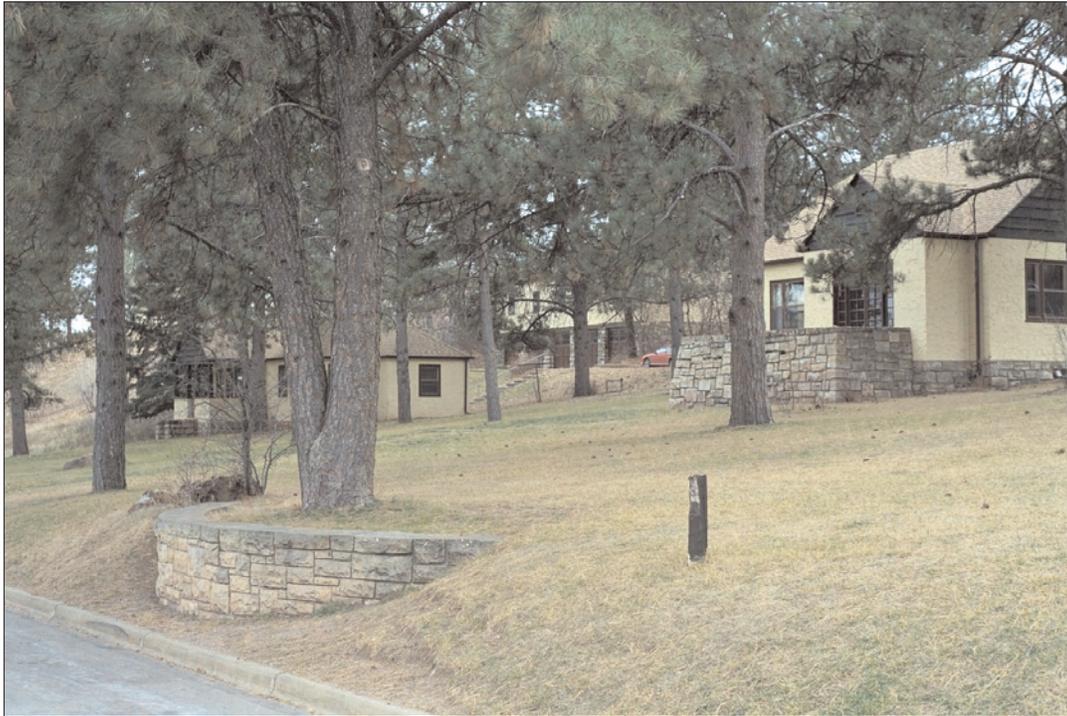
Figure 3-193
(A-20) Barrier Wall (HS-94) at Visitor Center parking lot looking northwest.

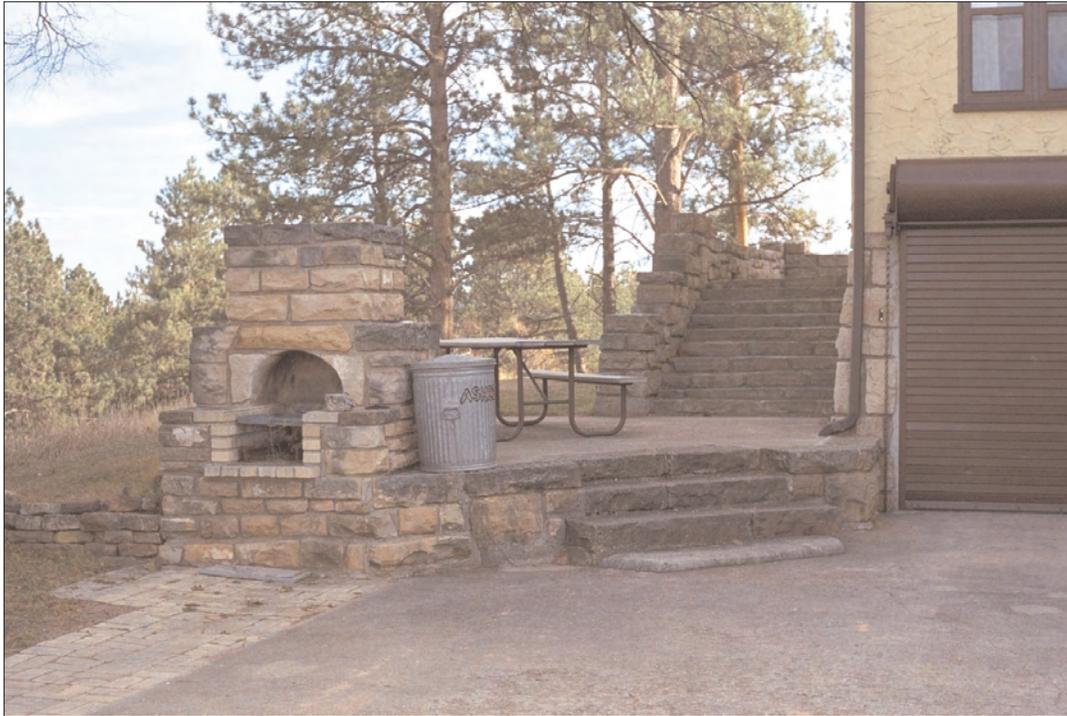
Figure 3-195
(F-19) Retaining wall at Elevator Building courtyard.

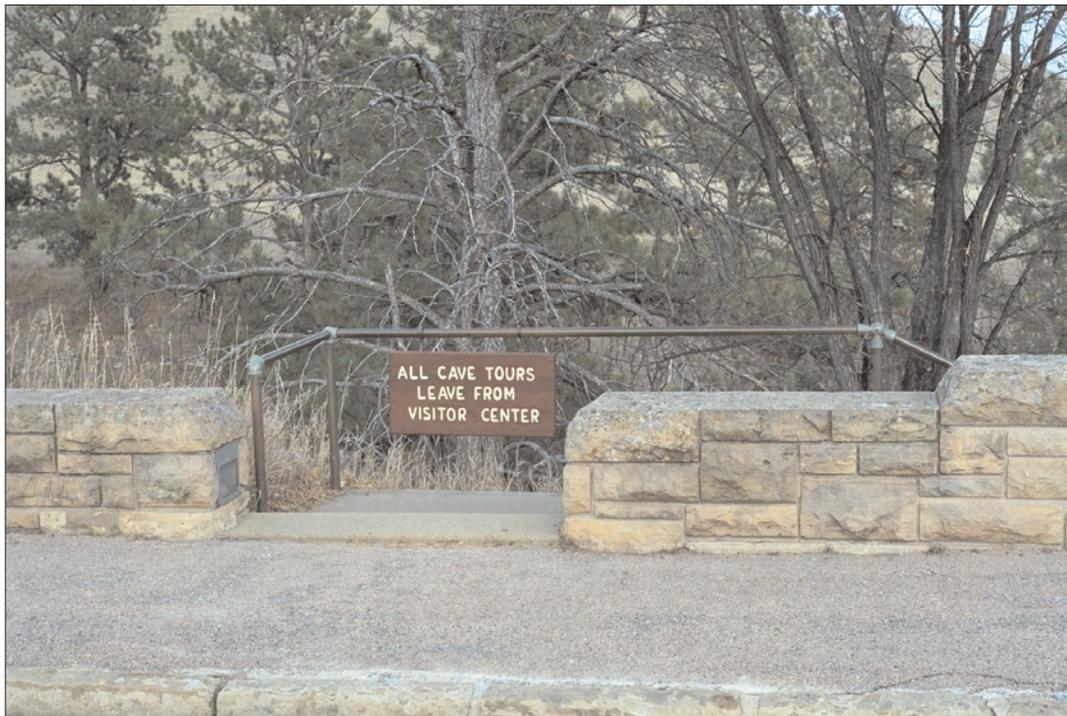
Figure 3-196
(I-24) Furnishings at Superintendent's Residence.

Small-scale features in the Headquarters Area include picnic tables, clotheslines, a propane tank, and a basketball hoop. There is terracing and a stone grill at the Superintendent's Residence and a fire ring with picnic tables in the Historic Housing Area. Signage includes painted wood and metal regulatory, directional, interpretation, and informational signage. There are also standard metal traffic signs. The park headquarters sign is timber with a stone base. Small-scale utility features include lampposts, utility poles, fire hydrants, pole-mounted overhead lighting that illuminates the parking area and sidewalk leading to the Administration Building (*Figures 3-196 /I-24, 3-197 /D-05, 3-95, 3-96, and 3-98*).

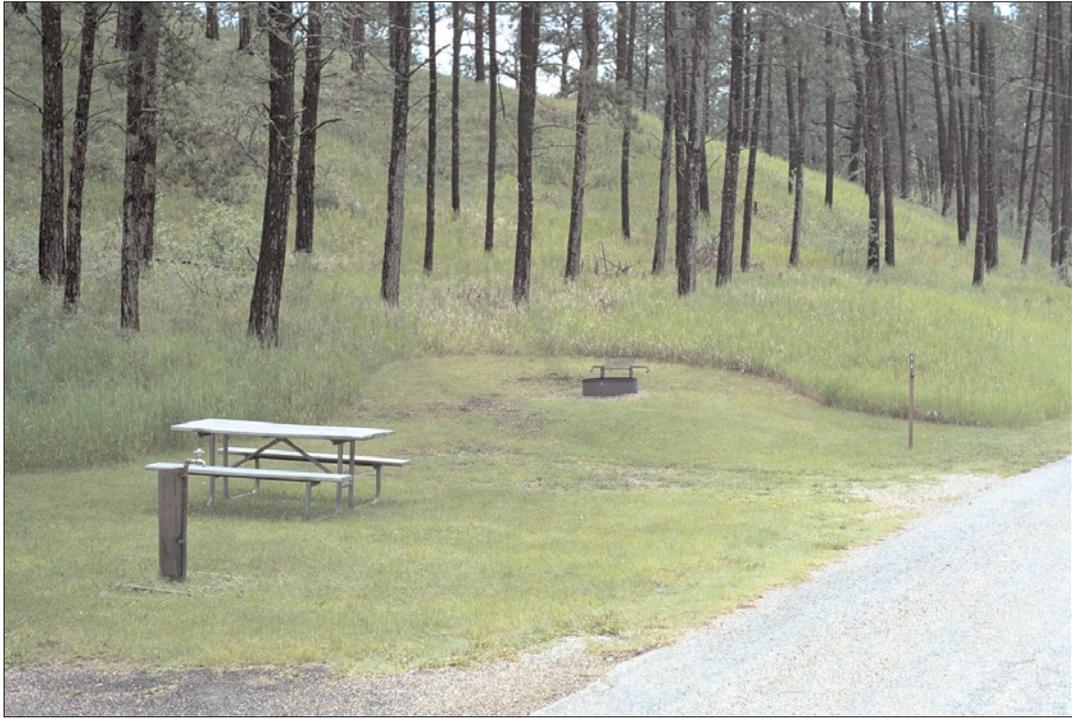
Figure 3-203
(H-12) Alvin McDonald's grave site.

There are numerous culverts located throughout the Headquarters Area. Some examples are a stone culvert beneath the sidewalk near the Administration Building, a stone and metal culvert beneath the sidewalk near the elevator building, a metal culvert under the service road to the Historic Housing Area, and a stone culvert in the Maintenance Area (*Figure 3-200 /E-08*). Other small-scale features in this area include a weather station, the Alvin McDonald Memorial, and a survey marker (*Figures 3-201 /K-06 and 3-202 /I-06*). The Alvin McDonald Memorial is a marker composed of a plaque attached to a large boulder, signage, and small boulders edging the trail (*Figure 3-203 /H-12*).

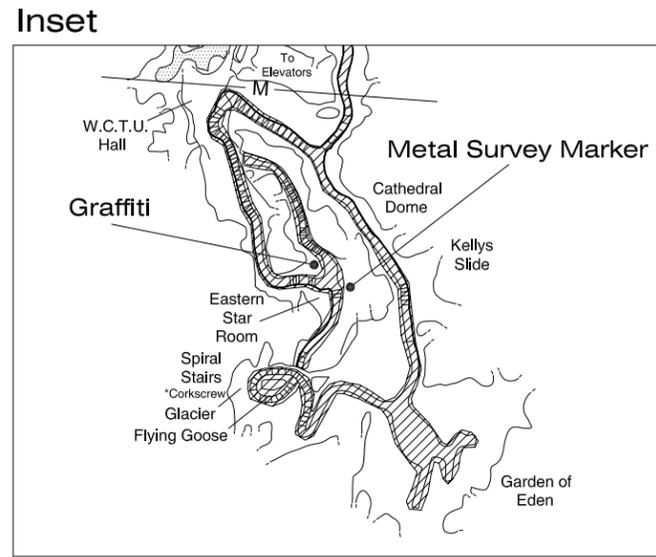
Lights, electrical cabling, handrails, and early explorer artifacts are found throughout the Cave.
