CHARACTERISTICS OF THE DEVELOPED AREAS

INTRODUCTION

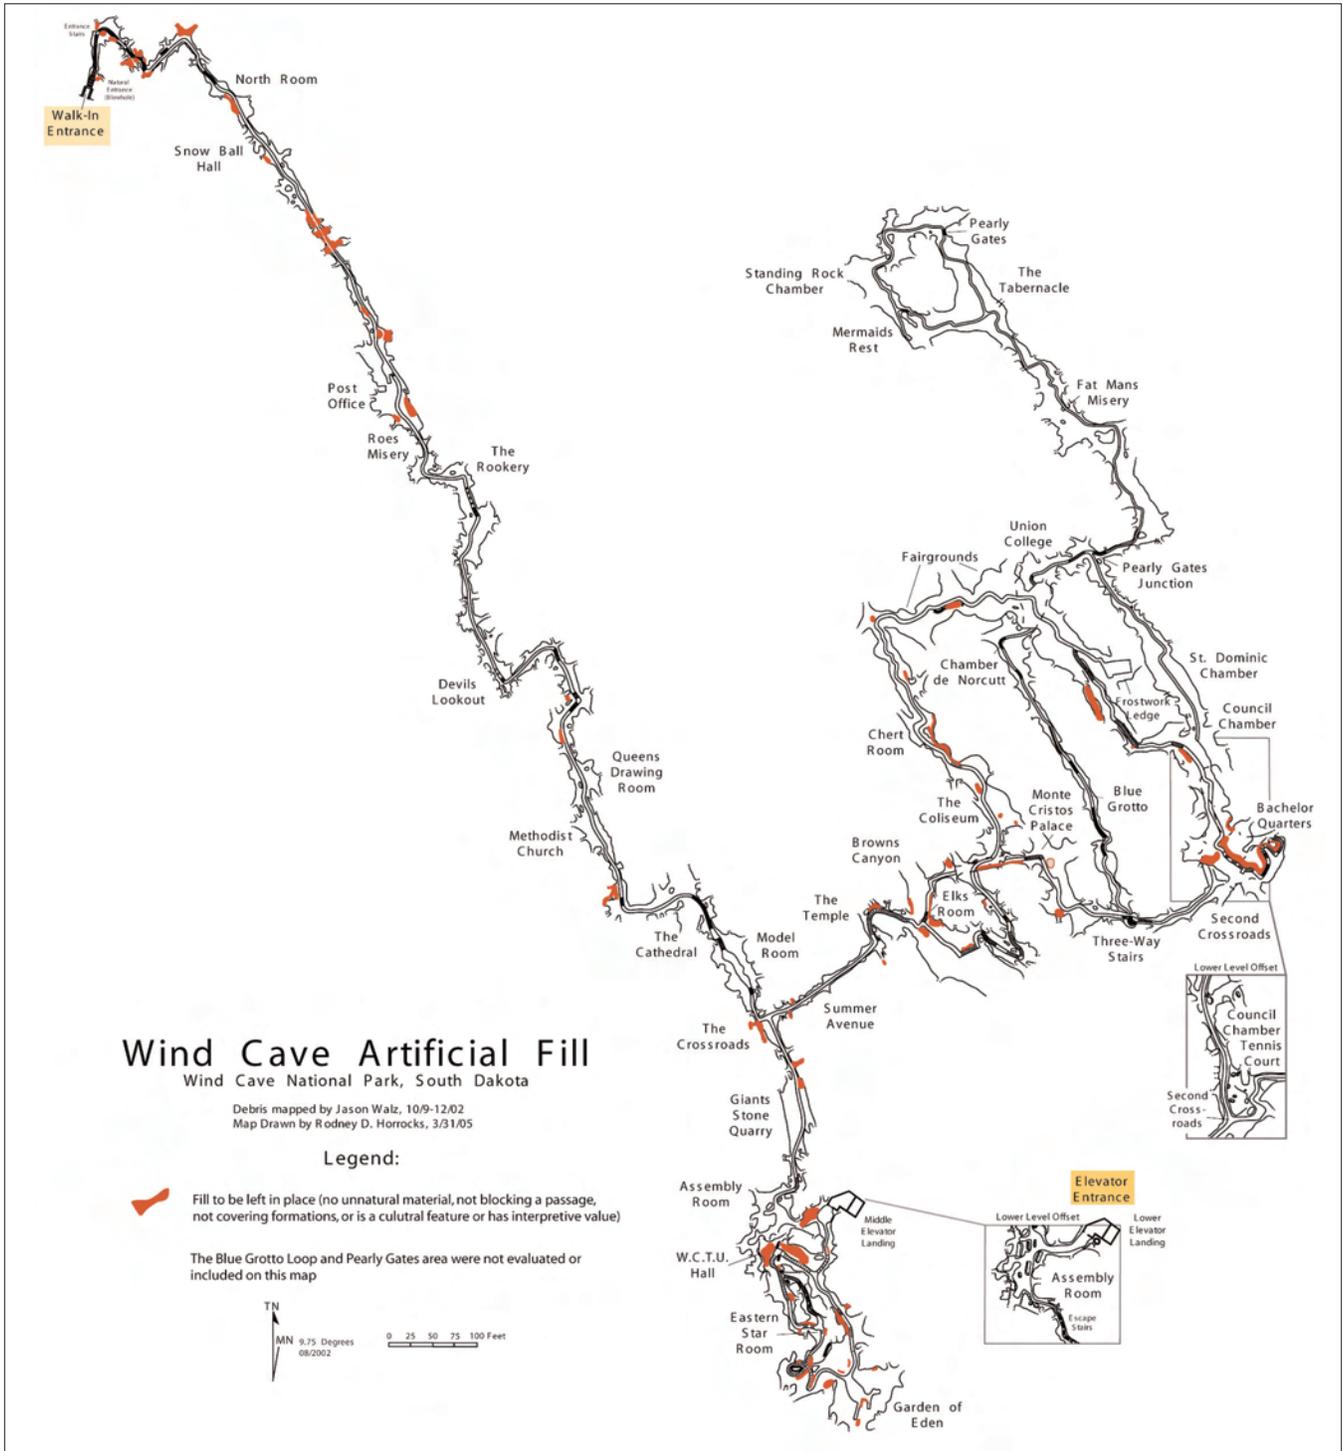
Figure 5-1
Wind Cave Artificial Fill.

- Protect existing **physical modifications** of the passages along the tour routes including blasted and chiseled-out trails (*see Figure 5-1 Wind Cave Artificial Fill at the end of this chapter*). Remove trail construction debris if it: 1) includes foreign material such as asphalt, concrete, gravel, crushed stone aggregate, pea gravel, and sand; 2) covers speleothems such as popcorn or moonmilk, but not boxwork which is a speleogem; 3) is a safety hazard; or 4) it blocks a passage that has evidence of a post-1940 era disturbance. Leave trail construction debris if: 1) it is a constructed cultural feature such as walls, path edging, or path surfaces; 2) would cause damage to the cave if removed; or 3) it has interpretive value. Before beginning any major restoration projects Cave Resource Management Staff and Cultural Resource Management Staff should conduct a site inspection to confirm the work to be accomplished. Minimize new physical modification to those only required to ensure visitor and staff safety. Continue to undertake measures to educate visitors concerning the sensitivity of cave resources.

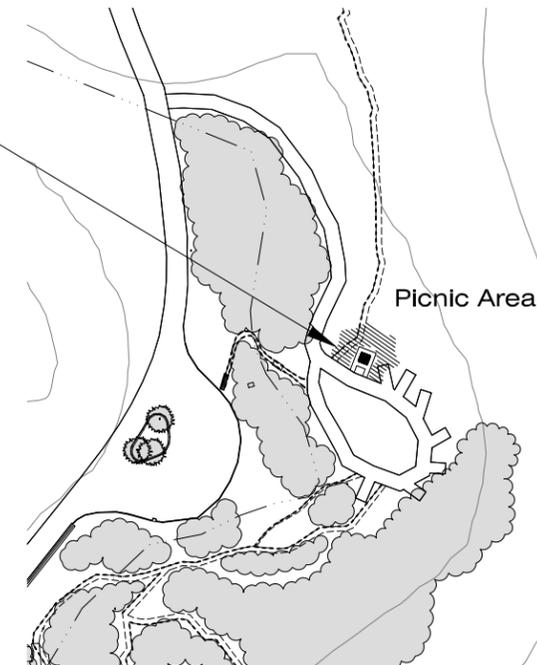
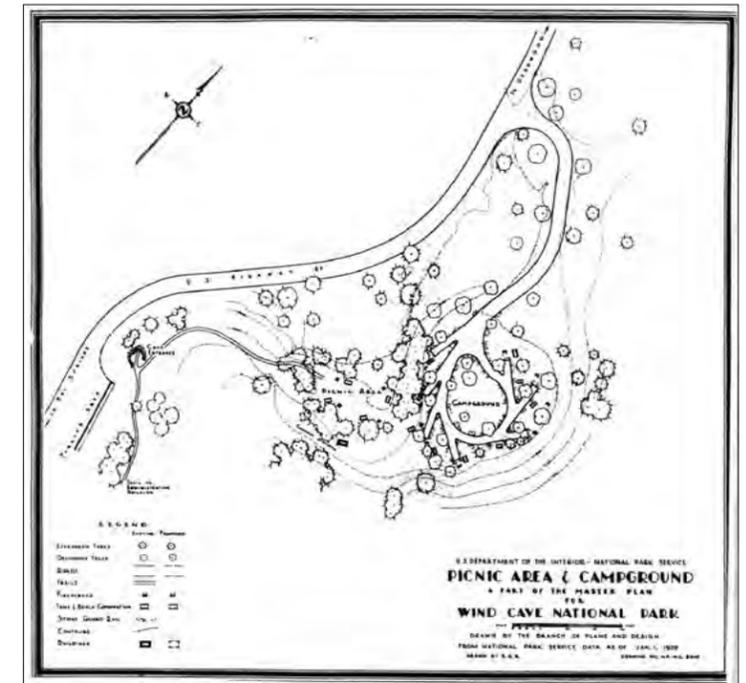
Plan of Campground (now Picnic Area), 1939.
(Wind Cave National Park Archives)

- Add native trees and shrubs to **screen views** of the picnic area comfort station.
- Restore and maintain the historic character of the **Picnic Area**. Retain the informal groves of trees around the former campsite loop. Replace in-kind any trees that are removed. Remove or reduce shrub masses to promote infiltration of surface water into the groundwater system.
- Rehabilitate the **buffer of trees** between the Administration Building parking area and the historic housing area.
- Maintain existing tree plantings of ponderosa pine and deciduous species in an open grove arrangement at the **Historic Housing Area**.
- Consider integrating new plantings in public areas into an **interpretive program**.

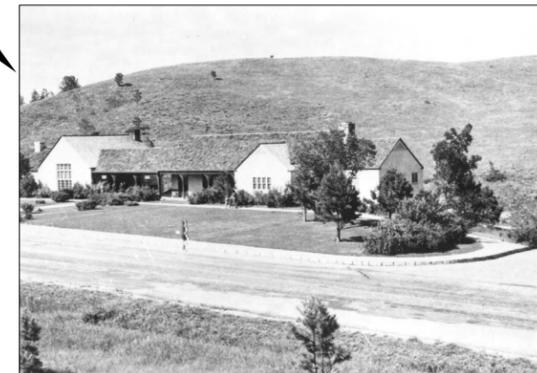
Administration Building, 1939, just after planting.

Retain the **symmetrical, formal character of planting** in the space in front of the historic **Administration Building/Visitor Center**.

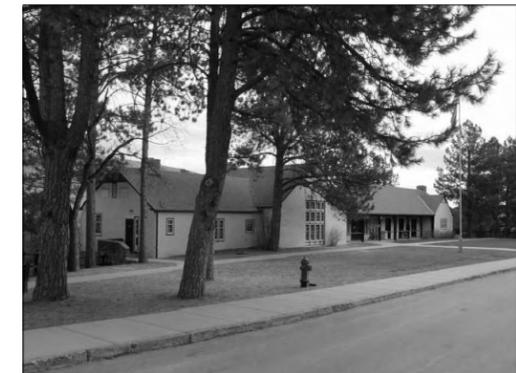
Administration Building, 2003.

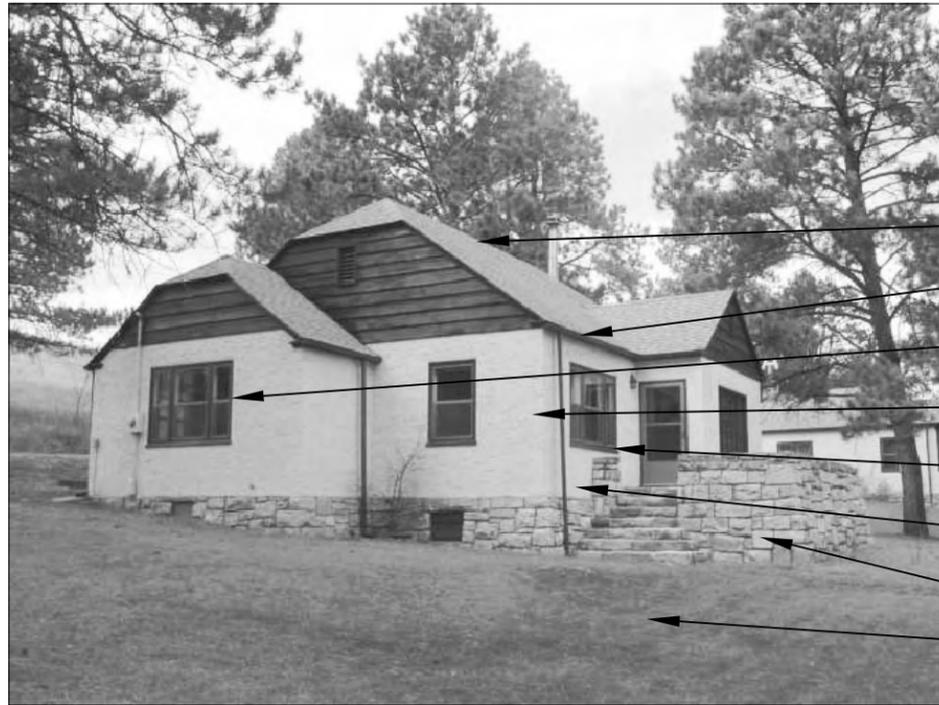
The majority of the buildings are from the CCC era (1933-1941). The **established architectural language** makes use of natural materials and disturbs the natural experience as little as possible. These characteristics can be used to guide future building to fit in with the historic setting. The residence at left illustrates some of the **defining characteristics** that uphold the harmonious and aesthetic atmosphere of the park:

- Consistent medium-sloped roof with dark-stained clapboard peaks
- Simple cornice and narrow overhang
- Simple operable double-hung windows with this proportion
- Exterior walls in rough finished stucco
- Simple lintels and sills on windows
- Consistent color scheme of earth tones found in the surrounding environment (browns, yellows)
- Field stone or ashlar foundations and porches
- Set among trees, in natural green settings whenever possible

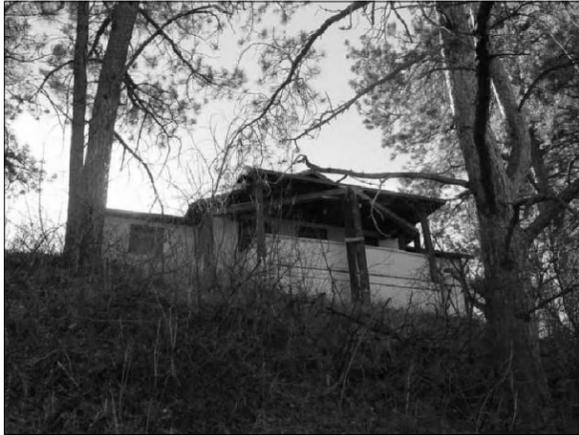
- Undertake investigations to determine the structural condition of the **Seasonal Residence (CCC Bunkhouse)** and the feasibility of retaining and adaptively reusing this building. Due to the compromised integrity of the architecture, deterioration of the fabric as well as its subsidence down the slope of the hill, a geotechnical analysis of the building foundation and site is necessary to determine the stability and salvagability of this structure. These findings will determine the appropriate treatment. If investigations indicate that the building cannot be saved, then it should be documented and demolished. If demolished, a new building of similar character and size could be sited in this location.

- Complete the treatment of the Seasonal Residence (CCC Bunkhouse) based on a completed HSR;
- Repair Pig Tail Bridge;
- **Repair the terrace pavements and replace plantings at the Elevator Building;**

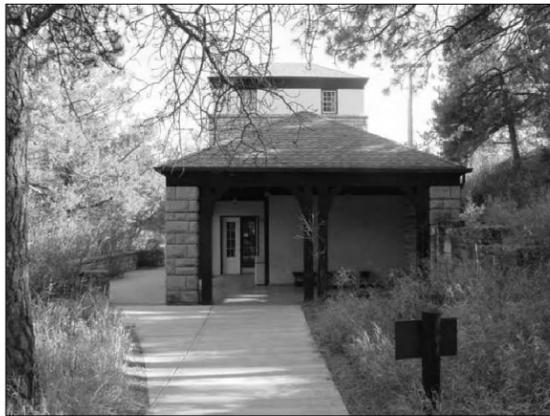
Elevator Building.

ARCHITECTURE CONCEPT A: The aesthetics of the entry can take clues from existing architecture within the park. It is not advisable to try to copy a style of the past, but to emulate with the use of similar materials in a contemporary fashion. The east end of the Elevator Building has a loggia of heavy timber and ashlar limestone that terminates into the slope to the right in this photograph. As another entrance to the caves, elements of this building would be appropriate to use for architectural inspiration for a new cave entrance.

This project involves the rehabilitation of the Elevator Building terrace including repair of the masonry walls, replacement of the concrete pavements, repair of the concrete pavement under roof, and replacement of plantings in accordance to guidance in an HSR. The project may also include new and/or repaired site furnishing such as benches and signs. Cracking and spalling of the concrete pavement was observed particularly in areas that are exposed to weather elements and poor drainage. The concrete pavement under the roof appeared in good condition and may only need minor repairs. Existing pavement identified for replacement and repair should be documented with measured drawings prior to any action being taken. The new concrete sections should be based on measured drawings in order to ensure that the new concrete matches the historic materials and joint patterns. The existing shrubs have outgrown their planters and should be replaced with native shrubs that will be smaller in size at maturity in order to prolong the need for their replacement in the future. Replacement shrubs should match the existing in habit and form, and could be a dwarf or smaller forms of the existing native plant, if available.

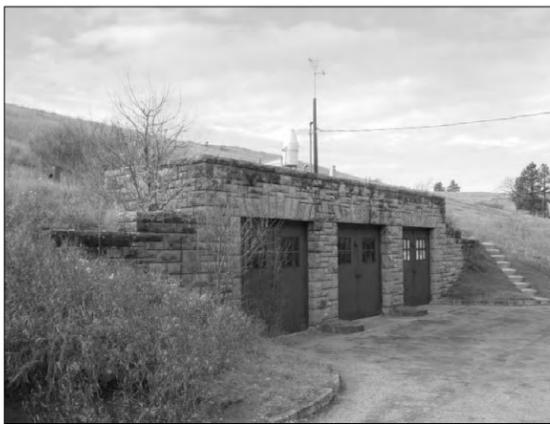
Fire Cache.

ARCHITECTURE CONCEPT B: The Fire Cache is partially underground and faced with random cut ashlar limestone. The roof is sod and blends into the landscape. This option could allow for a dark lobby area that would help the eyes of the visitor to start to adjust to the light levels inside the cave, as they begin the tour experience.

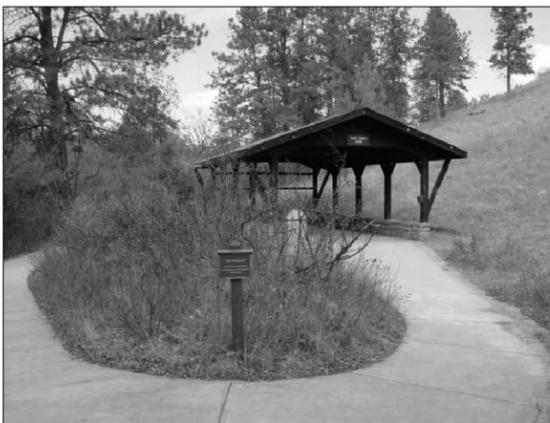
Cave Tour Queue Pavilion.

ARCHITECTURE CONCEPT C: The Cave Tour Queue Pavilion is located between the Administration Building and the Walk-in Cave Entrance. Its purpose is for protection of tourists from the elements when waiting for a tour of the caves. It has been recently constructed, using heavy timber construction reminiscent of other buildings in the park. A smaller version of this building enclosed in glass may be appropriate for the new cave entrance as the building would become semi-transparent which would help to minimize its impact on the natural surroundings.

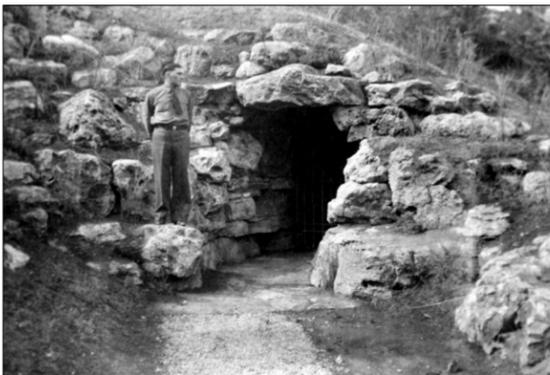
CCC-constructed rustic cave entrance.

LANDSCAPE ARCHITECTURE CONCEPT D: This concept involves creating a themed entrance with the appearance of natural stone outcrops. This scheme takes its inspiration from the original CCC-constructed entrance, but would not be a restoration of the original stacked-stone and wood door design.

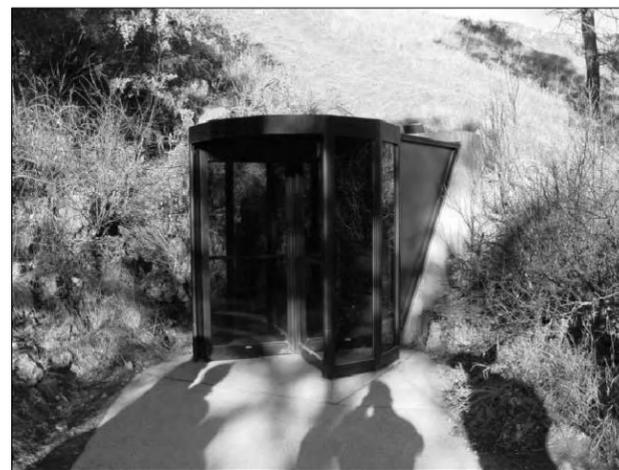
Existing cave entrance with revolving door.

- PROGRAM CONCEPT A: An enclosed and airtight vestibule or lobby is to be constructed. It has been suggested that this lobby be large enough to hold up to 40 people, which is a large tour group size. The purpose would be to gather, introduce, and interpret the historic door and entrance to the cave, as well as orientation to the cave itself, before descending into the earth.
- PROGRAM CONCEPT B: The current urban revolving door and assembly can be replaced with an entry of the same basic size, in a more appropriate style and efficient construction.
- PROGRAM CONCEPT C: Similar to concept B with an exterior enclosure for minimal protection from weather when gathering to enter the cave. The current Cave Tour Queue Pavilion serves a similar purpose, however is separated from the cave entrance by several yards.

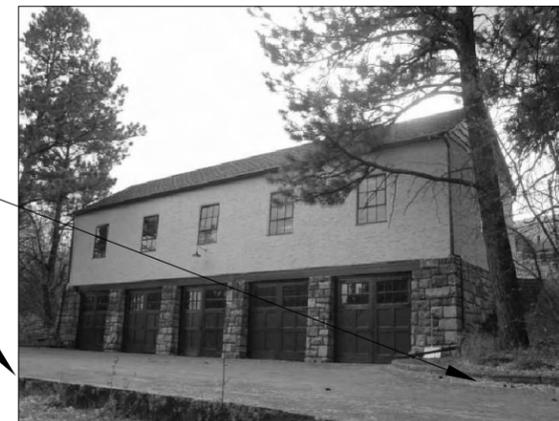
Stone curbing at the Garage.

- Bury all remaining **overhead power and telephone lines and poles.**
- Retain and repair all remaining **stone curbing.**
- Avoid constructing **new fencing** within the Headquarters Area. Retain the perimeter grazing control fencing.

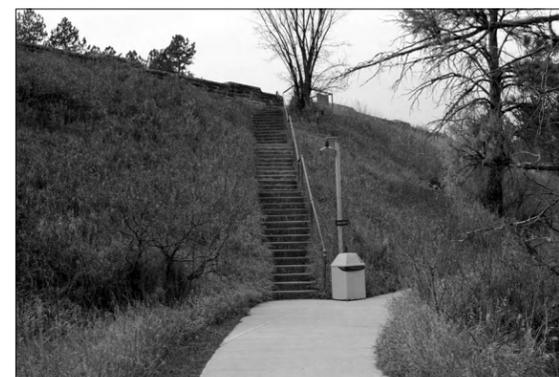
Example of existing light fixture, handrail, and trash receptacle.

- Retain and maintain any remaining **rustic features** such as log benches.
- Establish consistent design standards for **site furnishings** including benches, trash receptacles, and related features. Appropriate materials include painted wood, painted metal, weathering steel. Avoid galvanized and other bright materials and finishes. The designs should be contemporary and simple in form.

- Implement consistent design standards for **site lighting.** All lighting should have shielded light sources, not over-illuminate areas, be oriented downward, and all fixtures should be dark in color.

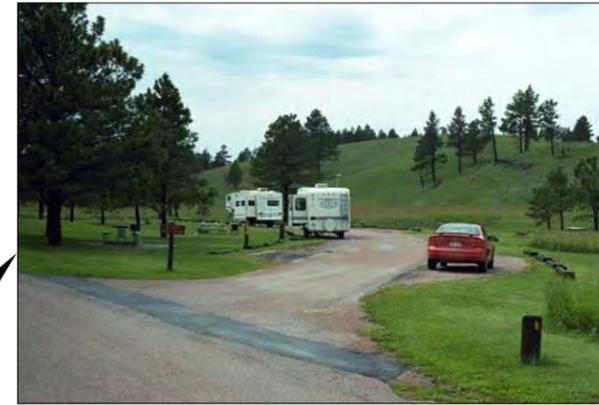
Retain and maintain the **campground loop roads** using guidelines for the road corridor.

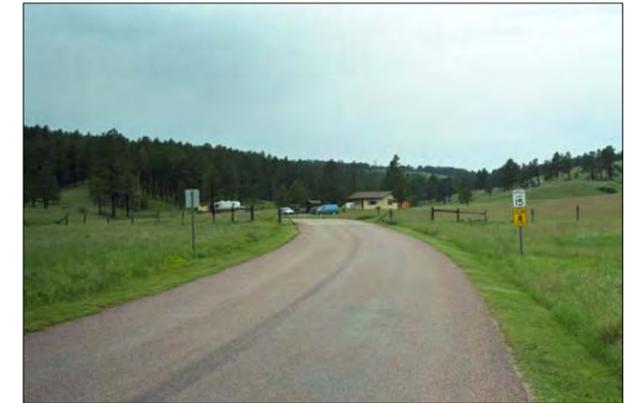
Retain and maintain the **existing campground road corridor**. Avoid alterations to the width and horizontal and vertical alignments. Avoid adding any new drives, parking spaces, or curbing. Do not allow vehicles to create parking areas within lawn or other planted areas.

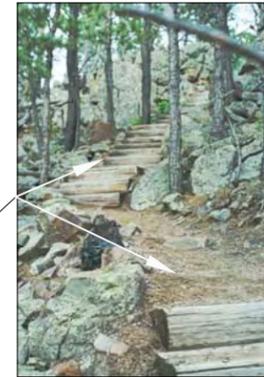
Timber steps along Rankin Ridge Trail.

- Repair **trails**, including limited drainage improvements and repair of hazardous surfaces. Use compacted crushed local stone or soil cement surfaces. If new trails are required, link them to existing trailheads. Retain and repair steps. New water bars should be local stone, wood timbers, or milled round wood posts.

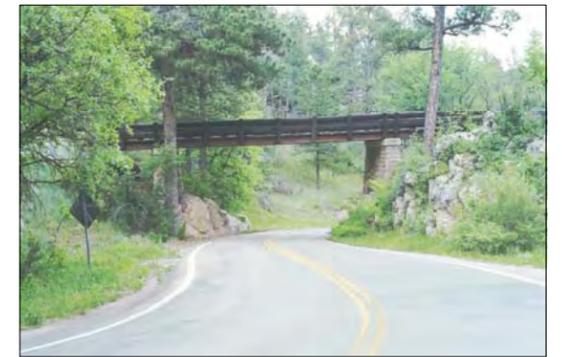
Pig Tail Bridge.

- Maintain the location and design of the bridge, and the alignment and widths of the approaches.
- Retain masonry materials and joint patterns when repairs are necessary.
- Minimize major new constructed features when stabilizing eroding areas at abutments, piers, and footings.
- Retain the timber guardrail features. Repair as required, matching existing design.
- Match existing design when replacing timber decking and rails.
- Minimize the attachment of safety markers and reflectors.
- Retain road alignment of the approaches unless dictated by safety requirements.
- Retain and repair round timber guardrails extending from the bridge rails.
- Minimize striping and match color of bridge wearing surface with the road wearing surface asphalt.

- Match existing forms and design when repairing delaminated, spalled and cracked, and missing sections of concrete bridge deck, barriers, and lower curbs.

- Minimize new construction when stabilizing eroding areas at abutments, piers, and footings. Repairs should approximate a natural condition of boulders and vegetation. In locations of stacked stone, repair or reconstruct these features matching the original wall patterns and materials.

- Remove vegetation growing in the stacked stone retaining walls.
- Replace missing curb stones.
- Minimize safety markers and reflectors.
- Avoid altering the road alignment of the approaches unless dictated by safety requirements. Avoid constructing ditches or other structures or measures that require demolition and removal of bridge components such as barriers and curbing. In addition, avoid constructing ditches or swales that are lined with riprap. Consider lining ditches with local stone with fitted joints.

- Consider replacing the w-section weather steel and wood post guardrails with rough-sawn wood timbers backed by steel and mounted on rough-sawn wood timber posts.

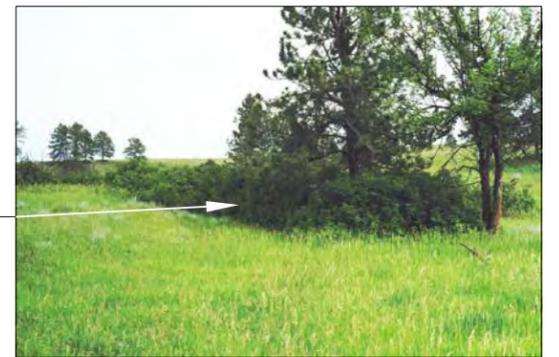
Former Game Preserve Headquarters exotic vegetation.

- At the Game Preserve Headquarters site undertake documentation and removal of **non-native species**. This site does not retain integrity so the retention of the last vestiges of developed area plantings is not critical to the historic integrity of the proposed Historic District. Mitigate the removal of introduced plantings by augmenting the documentation contained in this CLR. Establish native plant cover.

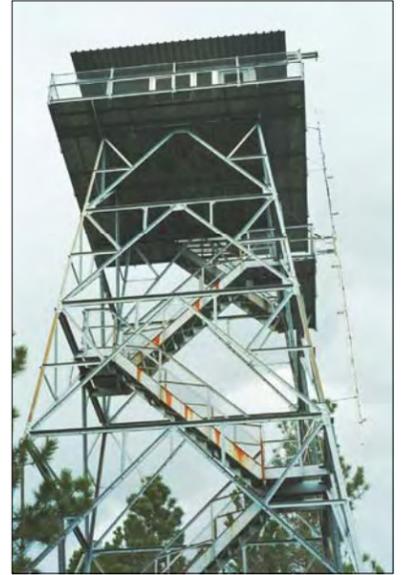
Rankin Ridge Fire Tower.

- Rankin Ridge Fire Tower
- Manage the **Rankin Ridge Fire Tower** as a historic resource, though constructed at the beginning of the Mission 66 program in 1956.
