CULTURAL LANDSCAPE REPORT

KENNECOTT MILL TOWN

WRANGELL-ST. ELIAS
NATIONAL PARK AND PRESERVE
ALASKA

2001

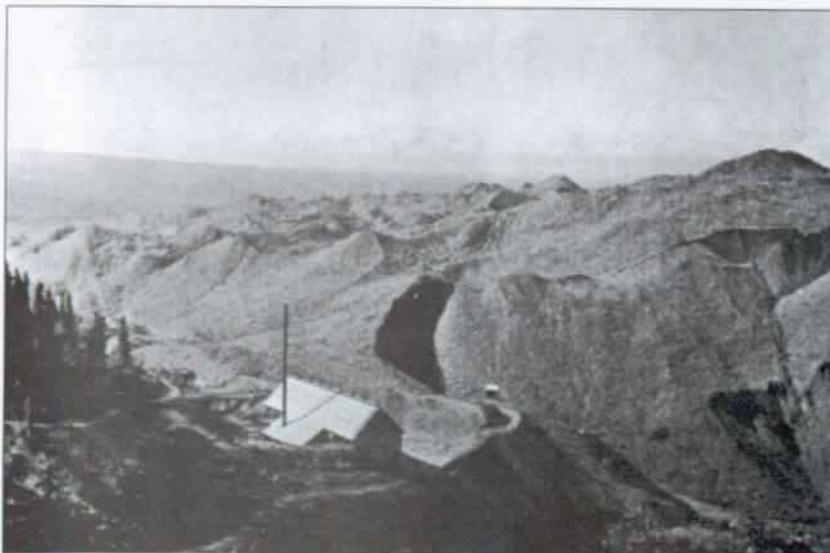
Figure 8. Kennecott mill town, circa 1908. View looking south with the sawmill in the foreground. (Photo courtesy of the Anchorage Museum of History and Art.)

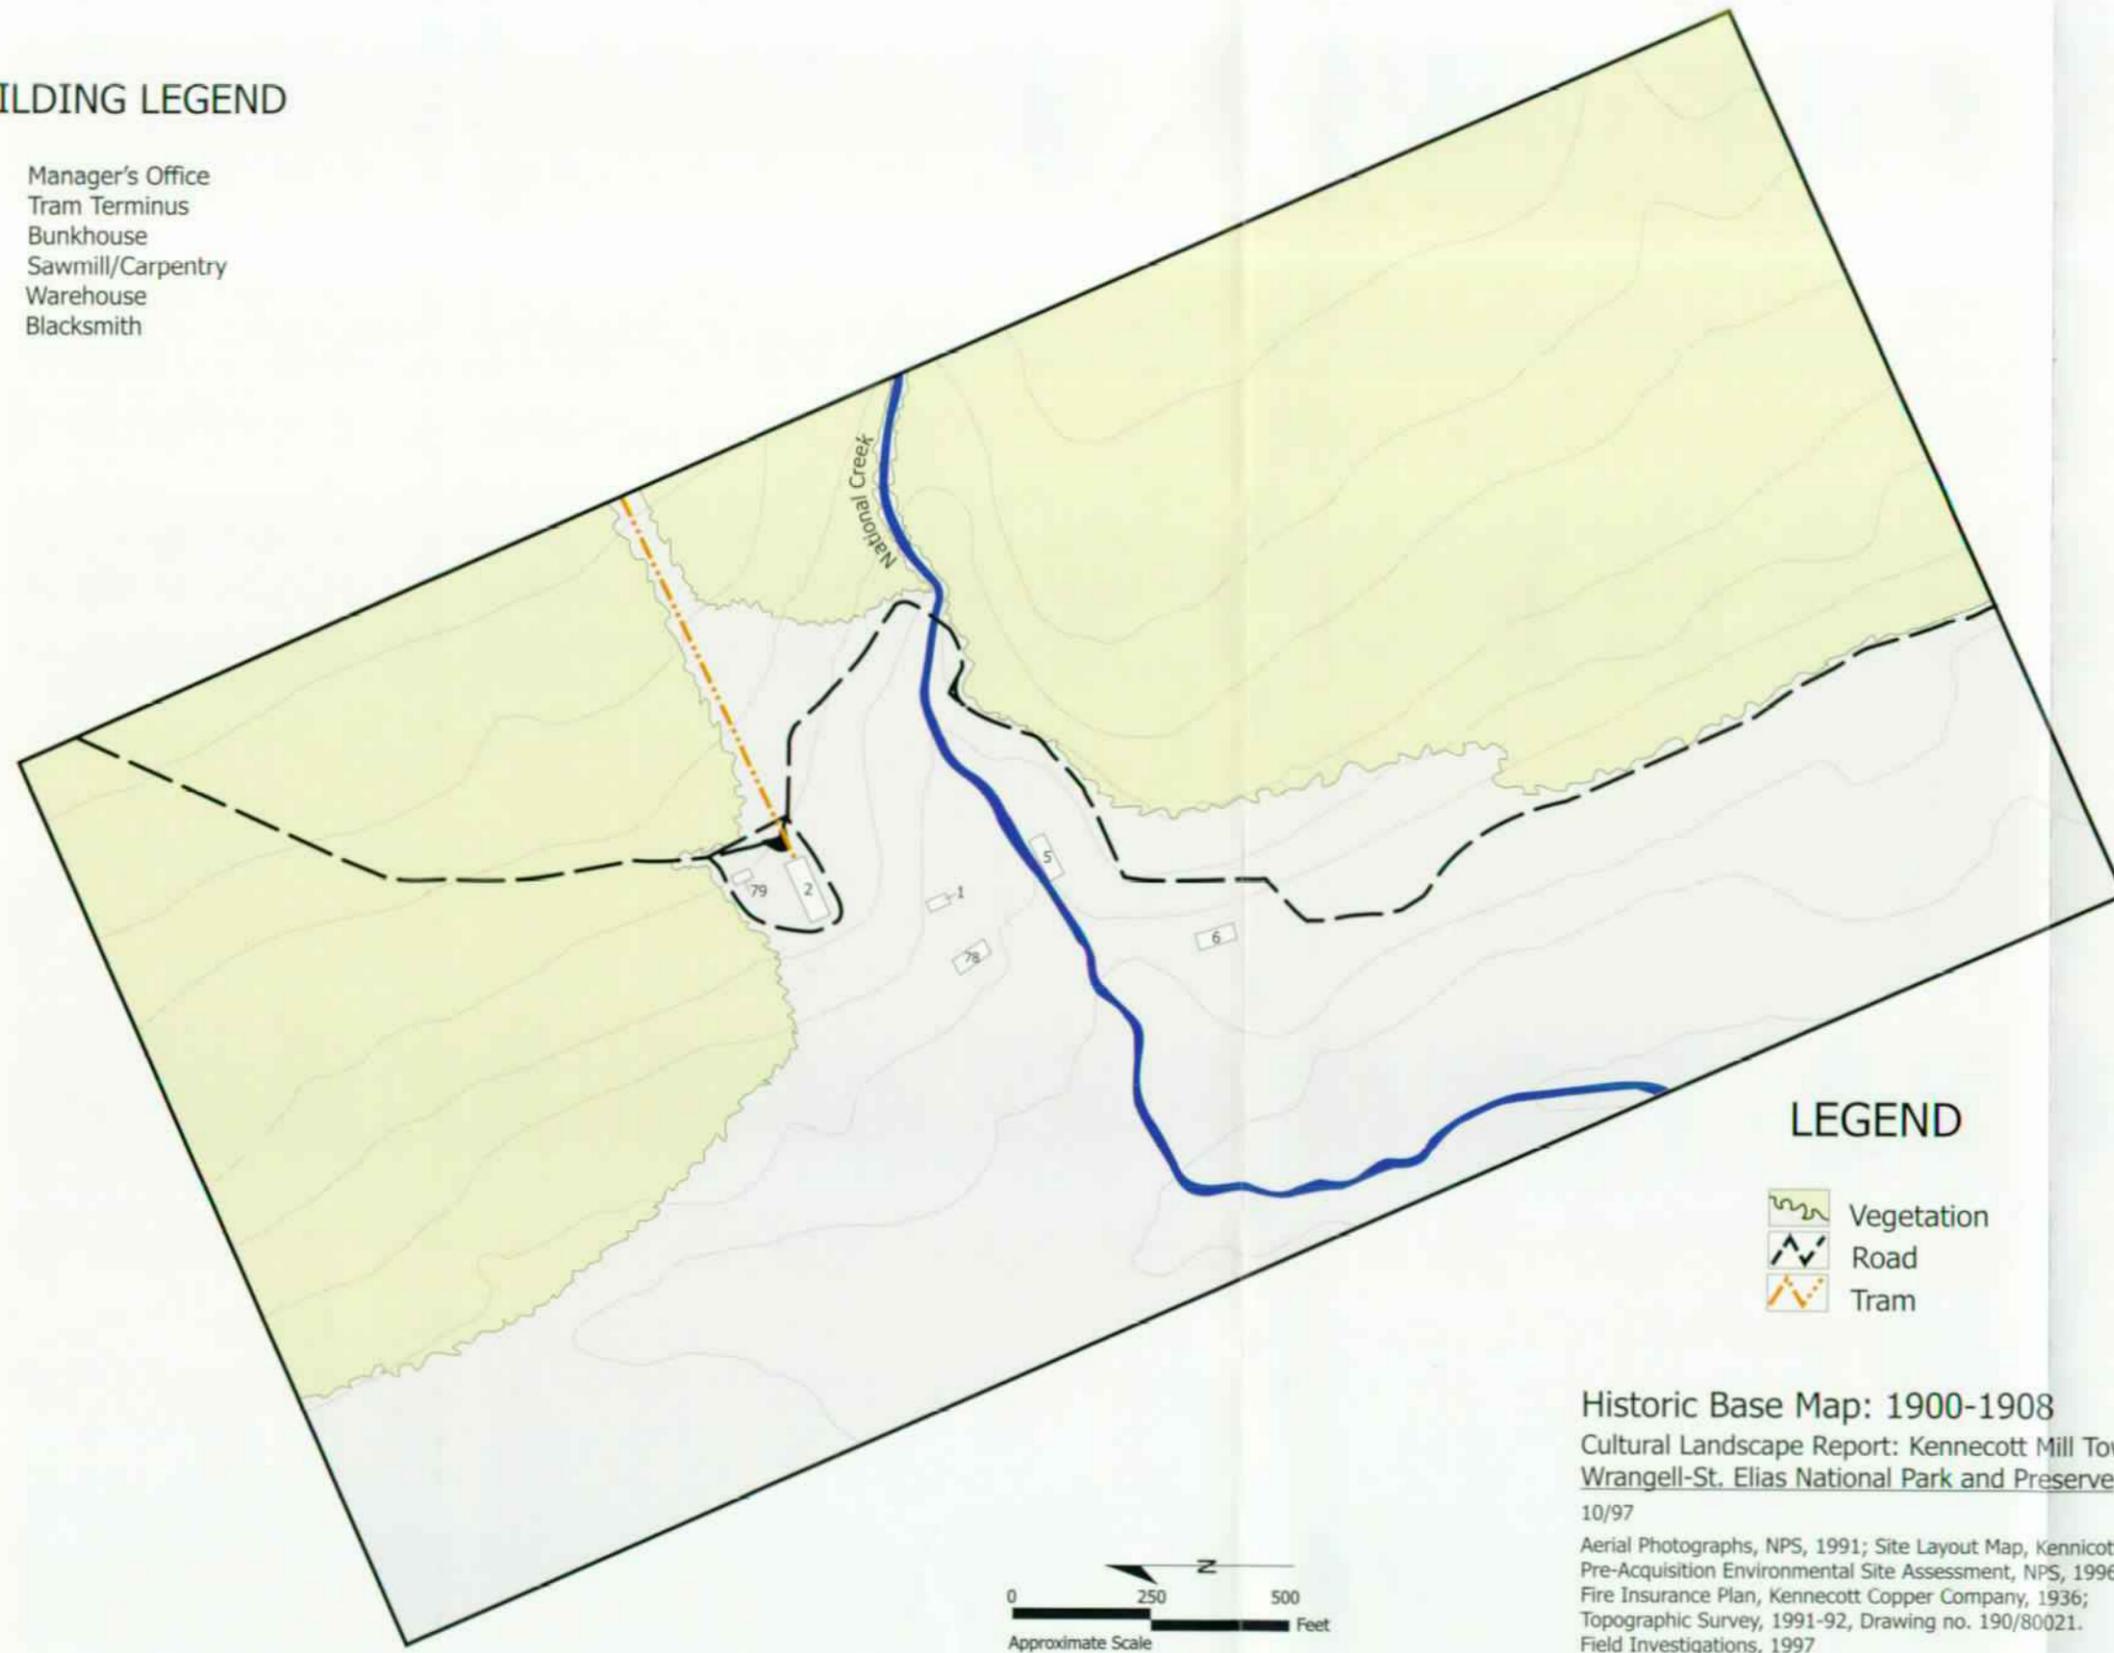
- 1 Manager's Office
- 2 Tram Terminus
- 5 Bunkhouse
- 6 Sawmill/Carpentry
- 78 Warehouse
- 79 Blacksmith

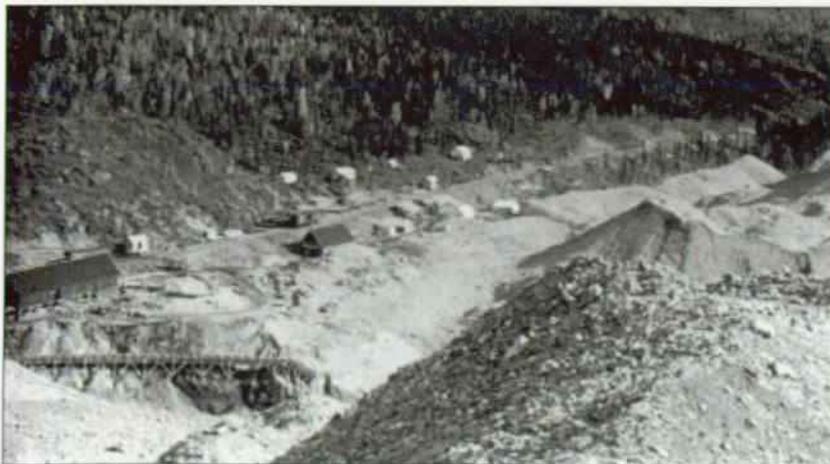
Figure 12b. Panorama of Lower Kennecott mill town, circa 1913. (Mears Collection, Rasmuson Library, University of Alaska, Fairbanks Alaska.)

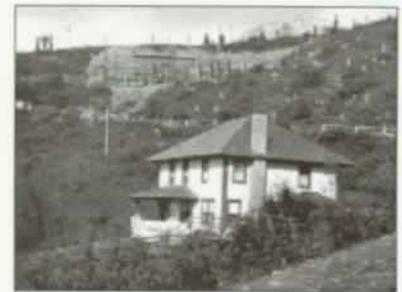
Figure 14. Built in 1916, Stephen Birch’s residence was situated near the Bonanza Mine ore bin and Jumbo aerial tramway tower, visible in the background. Photograph circa 1919. (USGS photo library, Moffit 754.)

Developments in 1916 also included substantial improvements to staff and managerial residences. Immediately north of the National Creek dam, a two-story residence built for manager Stephen Birch (painted white) sat perched on the rise of the slope, affording views to the concentrator, other National Creek structures, and the glacial moraine beyond (figure 14). Because Birch’s residence occupied the space once used for the community garden, management allocated space for a new garden, measuring 100 feet by 160 feet, on the north side of the National Creek dam reservoir. New accommodations for staff were constructed at the north and south ends of the mill town. At the north end, three cottages were constructed next to the power plant alongside those built the previous year. Due to the steep drop-off on the west side of the rail grade, these cottages included lined basements and catwalks connected each cottage with a privy.⁷⁶ Toward the south end of the mill town an apartment house containing five, four-room apartments and farther south, four, six-room cottages

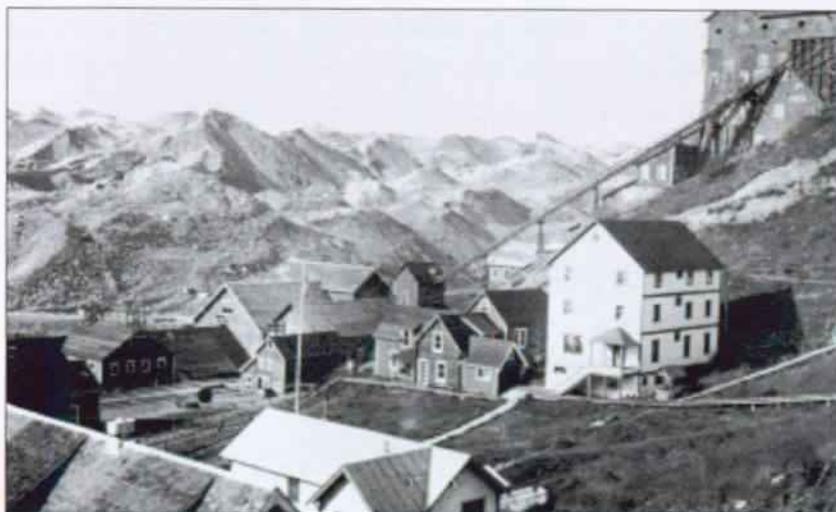
Figure 15. Administrative center of Kennecott showing the mill and industrial buildings, hospital (center foreground), staff house (right), and manager's office (center). Note the well, flagpole, picket fence, and boardwalks (center foreground). Photograph circa 1919. (USGS Photo Library, Moffit 753.)

Improvements at the mill town also continued. The powerhouse received an extension to accommodate a diesel engine and additions were made to the east side of the hospital. Both bunkhouses on National Creek were renovated to accommodate more workers (figure 15).⁹¹ The second bunkhouse (circa 1910) included a toilet, shower and laundry facilities, a poolroom, reading room, and locker room.

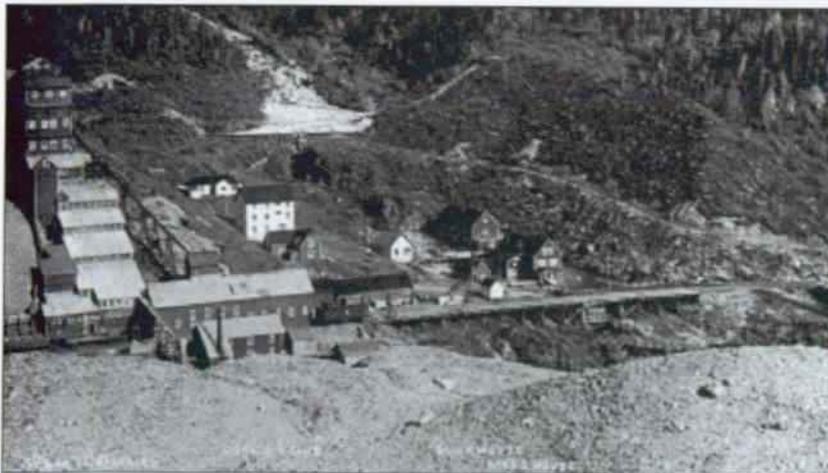
Figure 25. Railroad trestle through the mill town was the primary link to outside markets and supplies. Note the wagon road extending up the hill, south of the bunkhouse buildings. Photograph circa 1913. (Mears Collection, Rasmuson Library, University of Alaska, Fairbanks, Alaska.)

Between 1908–1915, core circulation systems were established that would influence virtually all future development at Kennecott. Key to this circulation system was the rail line connecting the mill town with Cordova, about 196 miles away (figure 25). In 1908, the Copper River and Northwest Railway crossed the Copper River at Flag Point near Cordova. After many physical and political obstacles, the railroad finally reached the Kennecott mines in the spring of 1911.

The track entered the site from the south on an alignment just east of the existing wagon road. Extending north, the track crossed National Creek on a 256-foot trestle bridge and ended at the ore bins at the base of the concentration mill. Completion of the railroad had a dramatic effect on construction at Kennecott. First, it provided a reliable source of supplies and a transportation system for the ore. Second, the railroad established a strong linear framework for both the structural and functional development of the mill town.

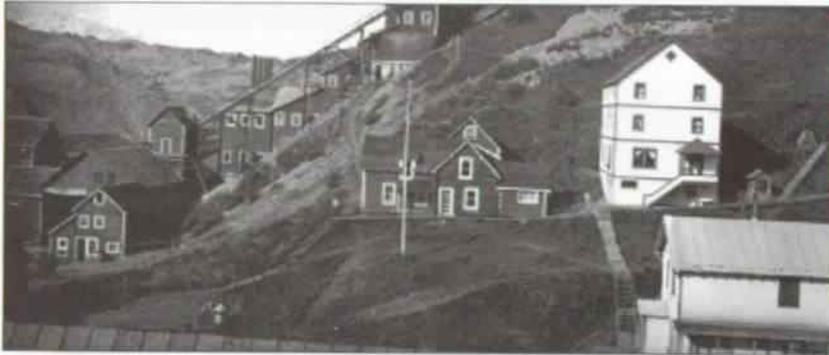
Figure 26. Wood boardwalks and foot paths through the administrative area of the mill town, linking primary buildings, circa 1919. (Photo courtesy of F.H. Moffit, USGS.)

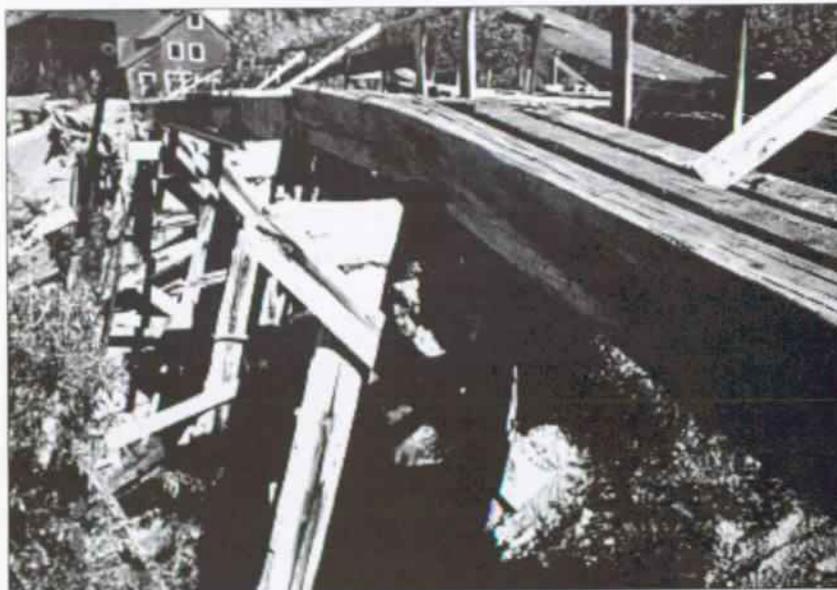
Figure 29. Railroad trestle structure as it looks today. (NPS, photo file, WRST, 1998.)

The Copper River and Northwest Railway reached Kennecott from the Port of Cordova in 1911. The rail line entered the mill town from the south, crossing a 250-foot trestle and terminating at the concentrator (figure 29). The railway and associated trestle became the dominant circulation structure in the town, defining the overall industrial infrastructure and building complex. The trestle originally served two pairs of tracks, one pair on the west and one on the east. The rail bed was constructed of pressure-treated beams, cribbing, and railroad ties. The posts supporting the bed structure are a combination of pressure-treated round poles and untreated spruce trees.

The railroad trestle is an important historic structure and although it is in poor condition, is still an important contributing feature of the Kennecott mill town.

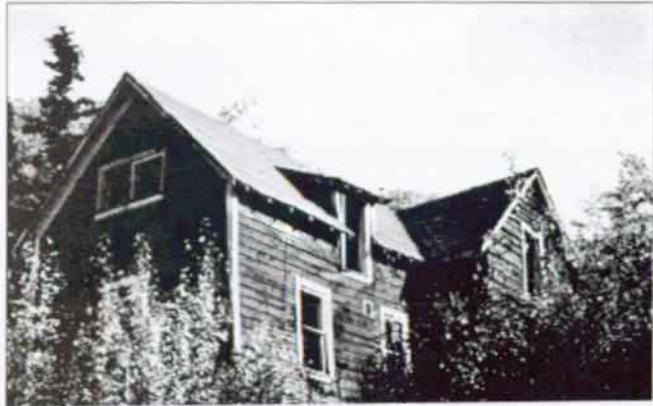
Figure 31. Manager's office, 1998. (NPS photo file, WRST.)

Description: Built in stages, the original portion of the manager's office is a one-and-a-half-story, saddle-notched log structure with sill log foundation. The main door and two windows are on the south façade. One-over-one, double-hung windows are in the gable end above the first floor. An addition is set back on the west side of the log structure and has a roof line running perpendicular to the original roof. A small one-story office wing was also constructed on the east side. And on the rear of the log structure, a large two-story wing was constructed.

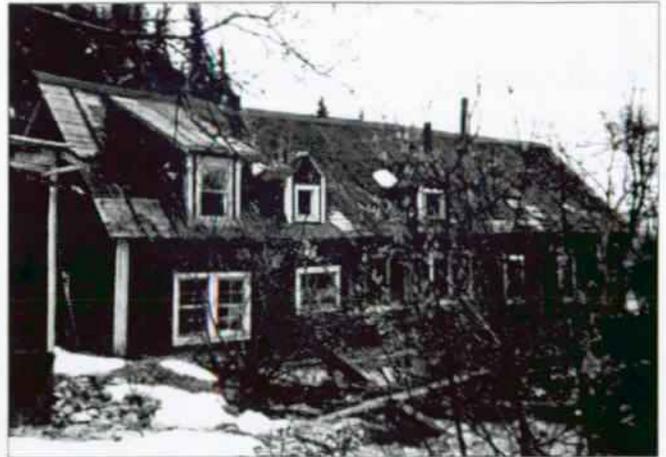
Figure 34. Bunkhouse along National Creek. (NPS photo file, WRST, 1998.)

Description: Sited along National Creek, this bunkhouse is a rectangular, one-and-a-half-story structure with a gable roof, and shed roof dormer on the south side. Two gable roof dormers provide additional light and space to the north and south side rooms. A shed-roofed porch is on the south side of the building, extending the length of the structure. The boardwalk on the north side of the building has been buried by flood rubble. Gable and verge overhangs are detailed with a narrow fascia board.

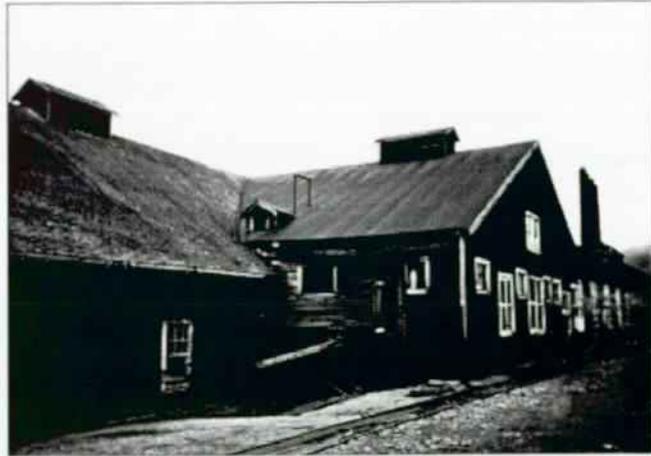
Figure 37. Leaching plant, east elevation. (NPS photo file, WRST, 1998.)

Description: The leaching plant is on the west side of the railroad bed, north of National Creek. A one-and-a-half story, wood frame structure with a basement opening to the rear (west) grade, the building is utilitarian in nature. Having little ornamentation, the plant is characterized by varying rooflines reflecting periods of growth and development in the mining operations in Kennecott. The original portion of the structure (now collapsed) contains the leaching tanks and is one story below grade, with a central gabled wing extending to the roadway. Six-over-six, double-hung windows are common on the first floor, and six light windows are on the second floor. A two-story addition on the north end of the structure has a central pavilion, with double doors opening toward a loading dock at the side elevation.

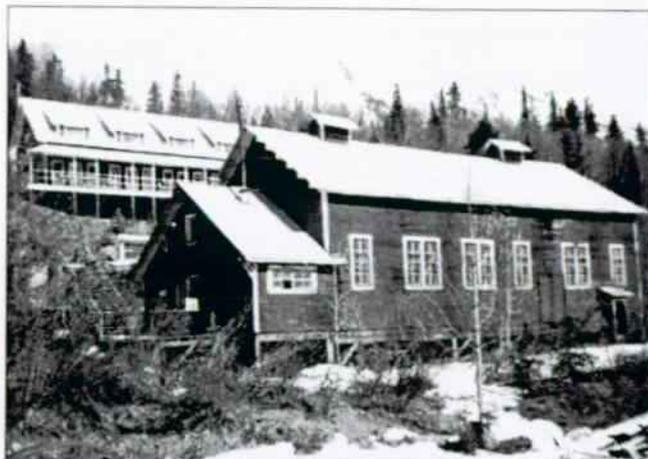
Figure 38. Recreation hall, west elevation. (NPS photo file, WRST, 1991.)

Description: The recreation hall is located on the west side of the railroad corridor south of National Creek. A two-story, balloon frame structure, the hall is rectangular in shape and set on 6x6 wood post foundations. Two louvered cupolas provide ventilation at the ridge of the gable roof. Windows are four-over-four, double-hung sash.

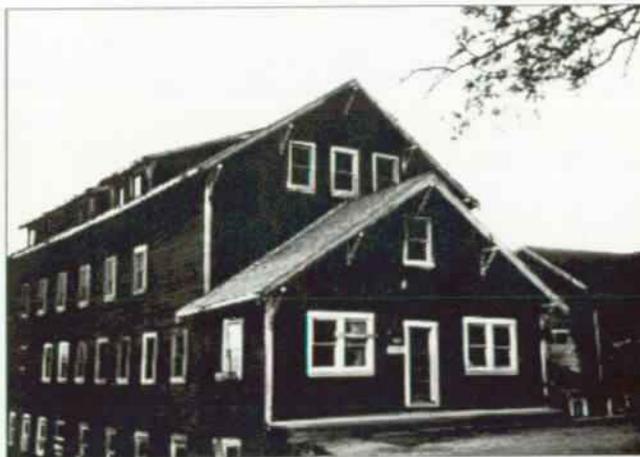
Figure 39. West bunkhouse. (NPS photo file, WRST, 1998.)

Description: The west bunkhouse is a rectangular, balloon-frame, four-story structure, oriented perpendicular to the west side of the main road, south of National Creek. The foundation is wood post on pier. There is a gable roof over the structure with three dormers on each side of the gable. Windows are double-hung single light sashes. The ground floor is approximately nine feet below the grade of the railroad line, with timber cribbing retaining the adjacent bank.

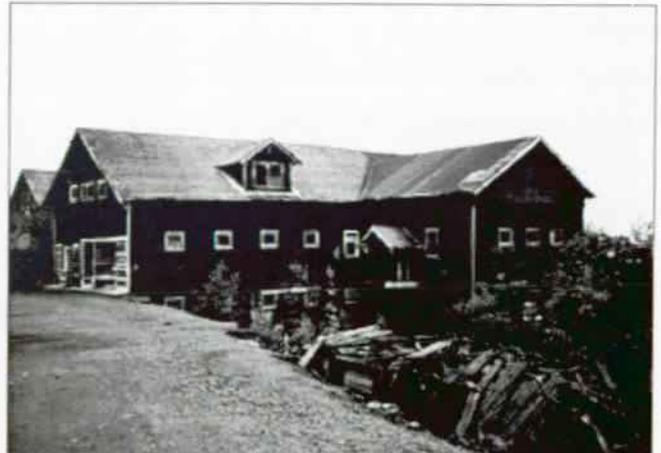
Figure 40. View southward to the store and warehouse. (NPS photo file, 1998.)

Description: One-and-a-half story, T-shaped, wood commercial building with gabled store facade and recessed entrance with bracketed verge overhangs, exposed eave rafter ends, and double-hung and fixed sash. Catwalks extend to the warehouse entrances on each side wing of the rear warehouse structure. Gable roof porches are at each entry above a full-height basement containing additional storage rooms. A receiving area, complete with a conveyor, is located on the west half of the structure.

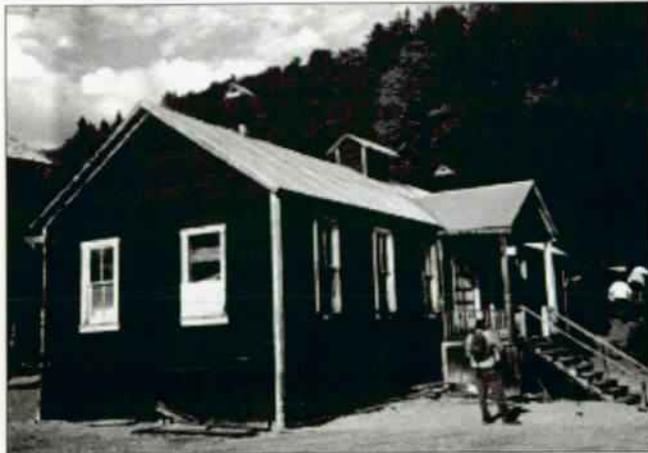
Figure 41. View eastward toward the schoolhouse. (NPS photo file, 1998.)

Description: The schoolhouse is a rectangular, wood frame, gable roofed structure, located on the west side of the main road into the mill town. Four-over-four and two-over-two, double-hung windows are on the north and south facades. A central louvered cupola is located on the ridge of the gable, which is flanked by two small chimneys. Grounds surrounding the structure were used for sporting activities and recreation.

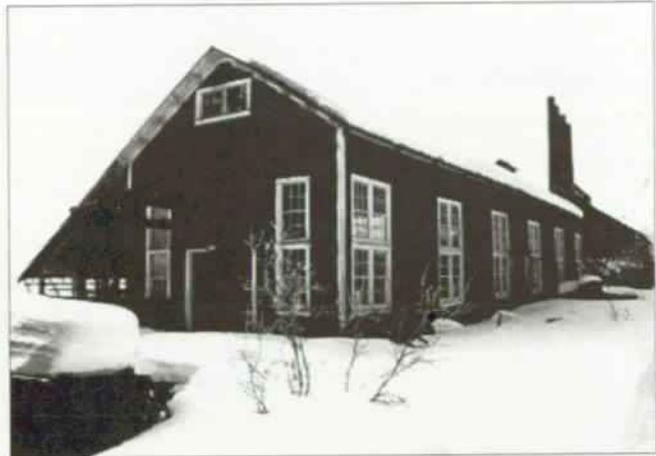
Figure 43. View northwest to the machine shop, constructed in 1916. (NPS photo file, WRST, 1998.)

Description: The machine shop is located on the west side of the main road, north of the leaching plant and south of the power plant. Rectangular in plan, the wood frame structure has six front bays of six-over-six, double-hung sash. The front elevation faces east and is parallel to the main road. The roof is gabled in three sections: aluminum to the south, and center and tarpaper on the north section. Large double doors are set in the south, east, and north sides of the structure. An overhead hoist enters the building above a door on the south end of the structure. The grade falls away to the west, with storage for machinery, tools, fittings, and gears stored under the building.

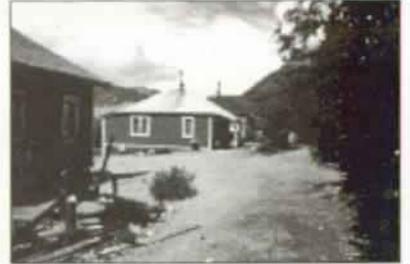
Figure 49. Restored staff cottage (13f) north of the power plant. (NPS photo file, WRST.)

The west row of four cottages fronts the rail grade (figure 49). Constructed on a hillside, these cottages include lined basements. Historically, catwalks extended from the rail grade level to privies west of the cottages. Two privies from this system are currently extant. The rail grade separating the rows of cottages continued north as a wagon road to the Erie Mine, with a spur leading around the eastern extent of the mill town. Both roads are extant, although the route to Erie Mine eventually narrows to a walking trail.

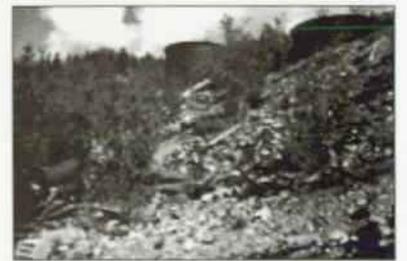
Figure 50. Dump west of power house and staff cottages. Oil tanks 4b and 4c at terrace scarp. First power plant remains at left middle distance. (MTU field documentation, 1997.)

An extensive discard area (a) lies down the terrace scarp, southwest of the cottages (figure 50). This scatter extends south to the power plant. Materials asso-

ciated with the first power plant (destroyed in 1924) are found at the bottom of the scarp, including firebricks from the furnaces and furnace stacks from the flues. Modern domestic artifacts are intermixed with industrial detritus in the vicinity of the oil storage tank (4c).

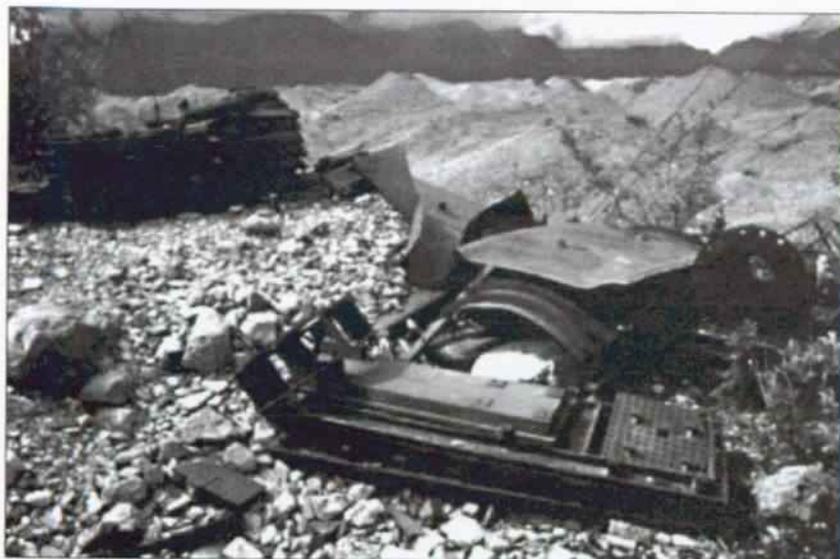
Figure 54. Power plant fixtures, including furnace latches and braces (background), stacked during asbestos removal in 1995. View looking south. (MTU field documentation, 1997.)

Immediately south of the oil house are stacks of furnace latches, braces, metal plate, and ceramic blocks (a, b, d). These artifacts derive from the powerhouse, perhaps salvaged by the company after the 1924 power plant fire (figure 54). The remnants of a boardwalk lie between the power plant and oil house. A second boardwalk, farther south connected the power plant with the machine shop dump (figure 55). Extensive dumps (k, l) west of the terrace scarp contain predominantly industrial and construction-related materials (barrels, concrete, and firebricks), although domestic artifacts are also present.

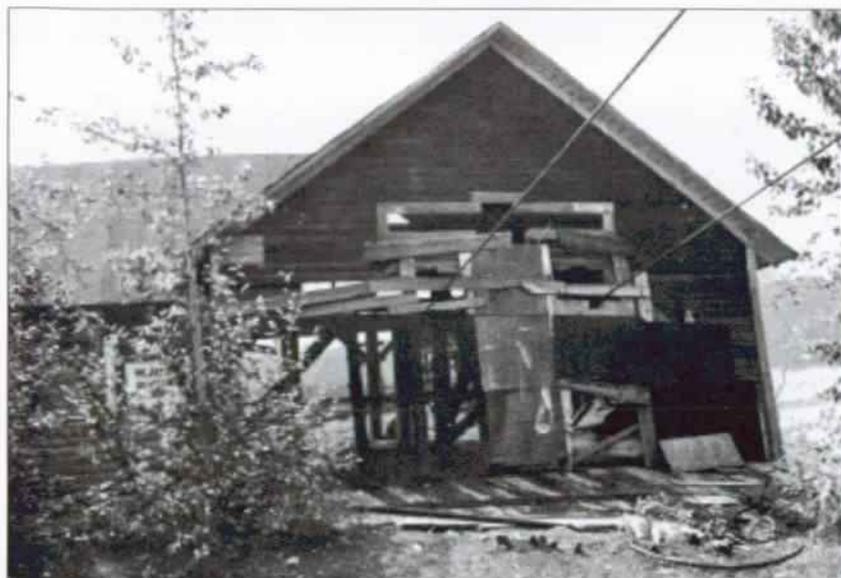
Figure 62. Tram terminus (2) for the Jumbo Mine aerial tramway. (NPS photo file, WRST.)

Description: The concentrator tram terminus (2) extends west from the top of a hill scarp above the rail grade. Decks around the concentrator, as well as their contents, are for the most part well preserved (see c and d, and figure 62). Together with the track incline system connecting the tram terminus with the crushing unit of the concentration mill and machine shop, these features illustrate the system by which concentrator machinery was installed, repaired, and temporarily stored.

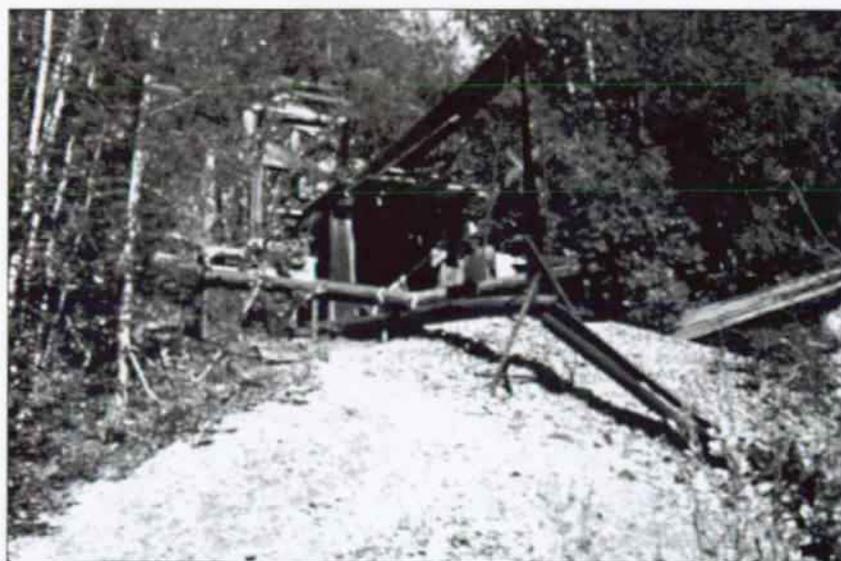
Figure 63. Wrangell Consolidated operations (64). View northeast from tailings toward shaking and crushing machinery. A shed (63) once behind the manager's house, circa 1910, is at middle right. (MTU field documentation, 1997.)

During the 1960s, Consolidated Wrangell operated a concentration mill southeast of the tram terminus (figure 63). Remains of Wrangell workings include an ore chute, storage basin, conveyor, crushing machinery, and a storage shed (63, 64). Tailings from Wrangell operations were directed west of the crushing machinery. This eventually covered areas formerly occupied by the manager's residence and staff office building (removed 5–10 years prior), two sites having potential archeological value.

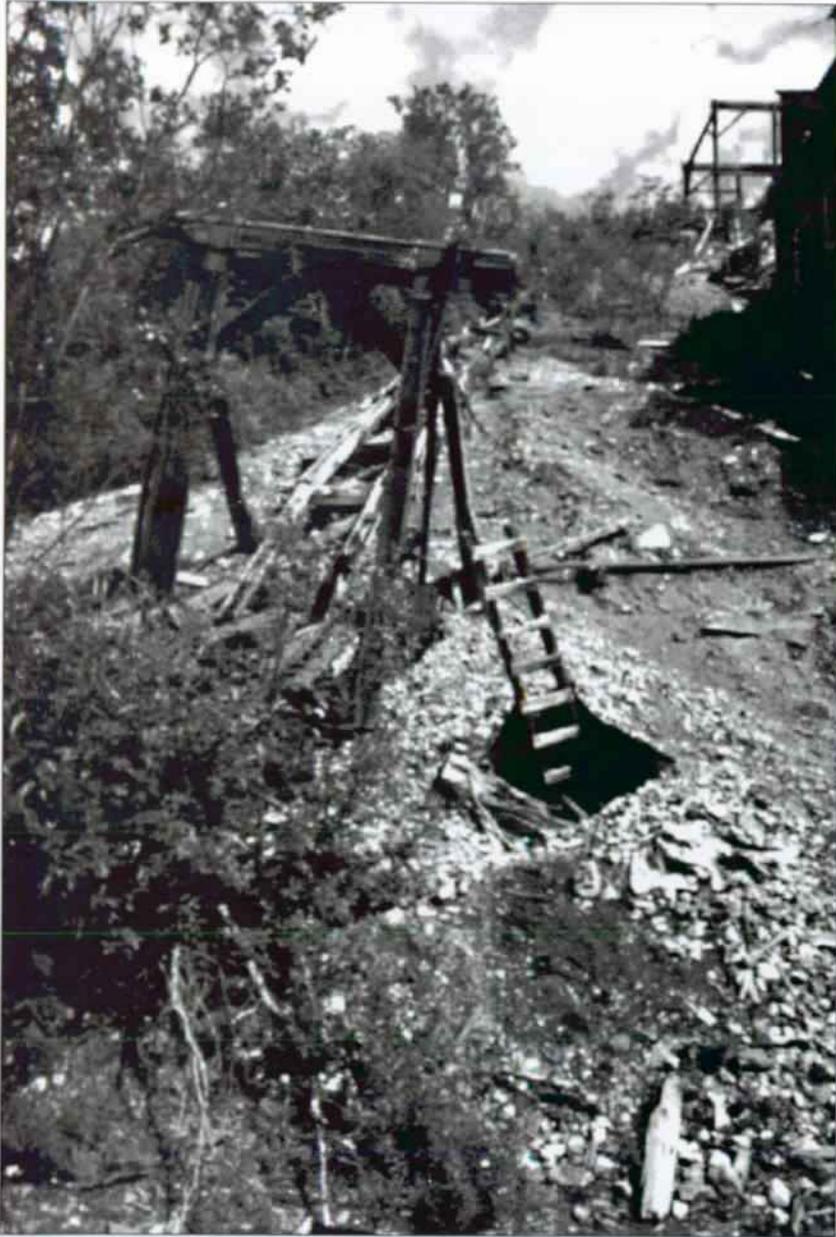
Figure 65. Drawbridge of service tram between tram terminus (2) and machine shop (36). (MTU field documentation, 1997.)

remain, powered a drawbridge that raised and lowered the tracks of a service tram line between the concentrator and machine shop (also see Section 5b, o).

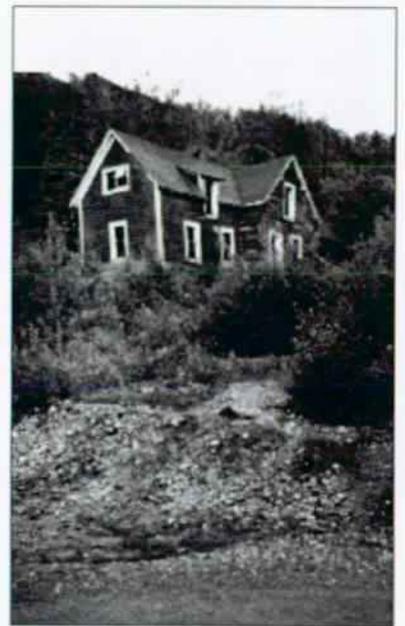
Figure 67. Manager's office building. Vegetation between the building and the tram terminus (upper left) occurred after Kennecott's closure. (NPS photo file, WRST.)

Although the rail grade provided general access to the concentration mill, boardwalks indicate pedestrian circulation traversed the hillside. A boardwalk between the manager's office (1) and the concentrator is the only substantial survival of a once well-defined pedestrian circulation in the National Creek area (figure 67).

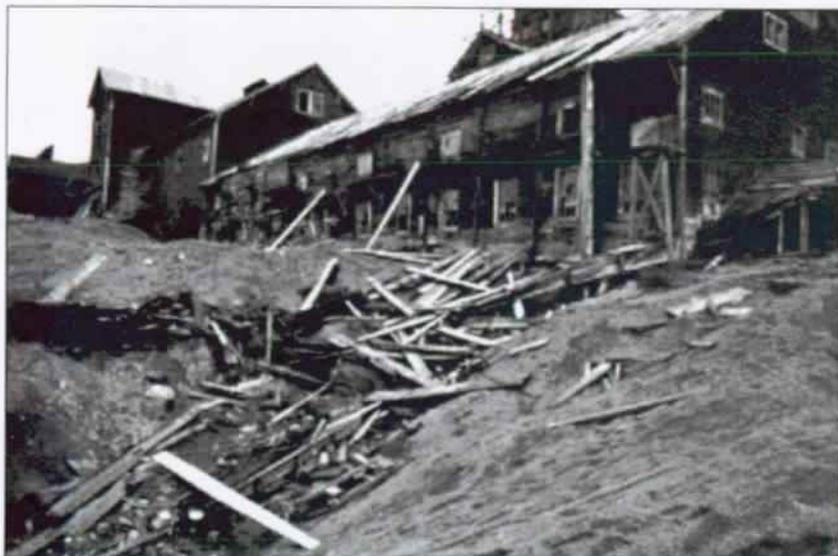
Figure 70. Ammonia leaching plant (15), looking northeast. Flumes and pipes for waste removal in foreground. (MTU field documentation, 1997.)

Flumes and pipes south and west of the leaching plant directed both tailings and wastewater toward National Creek. A cluster of flumes (l) extended from the southwest corner of the leaching plant (figure 70). The southern part of the leaching plant sustained significant damage during the flooding of National

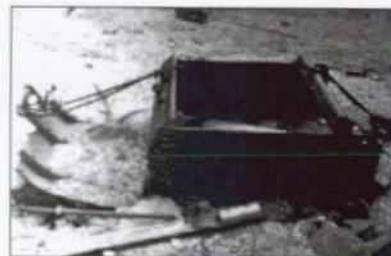
Figure 69. Scraper used in landscaping tailings, located west of leaching plant (15). (MTU field documentation, 1997.)

Tailings around the plant primarily derive from the concentration mill and were likely deposited prior to construction of the flotation plant. A tailings launder, at least in place by 1917, directed mill tailings (including fines that the leaching process could not treat) toward the glacial moraine. Finely stratified tailings are exposed beneath a conveyor shed at the southern end of the plant. The conveyor shed distributed leaching plant tailings across National Creek and aided the creation of construction space in the southern mill town (see Section 11). A hoist house (21), crib (f), and scraper (g) on the west side of the leaching plant indicate additional methods used by Kennecott to disperse leached tailings (figure 69).

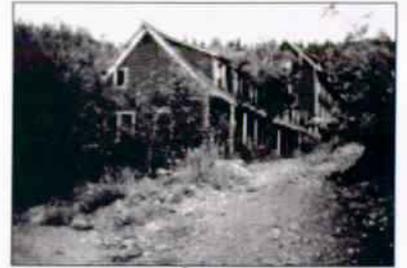
Figure 73. View east with 1908 bunkhouse (5) in foreground and 1910 bunkhouse (7) in background. The road is on the right is built on gravel brought in during the 1980 and 1983 National Creek floods. (NPS photo file, WRST.)

example, are almost entirely absent (with exception of a small area abutting the west side of the hospital). Floods likely removed a storage shed that had been located south of the 1908 bunkhouse (5) (figure 73). A firehouse (h) abutting the west side of this bunkhouse is still extant, but at least two others were once in the area (between the two bunkhouses and north of the assay shed).

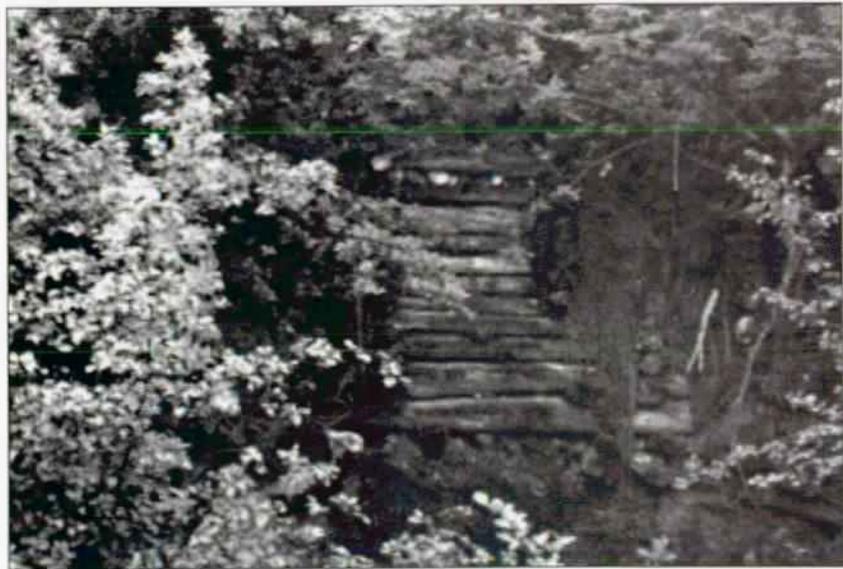
Figure 75. Detail of west face of National Creek Dam (33), built circa 1911. (NPS photo file, WRST.)

In spite of major breaches in 1980 and 1983, the National Creek Dam (33) retains a high level of structural integrity (figure 75). Cribbing, facing boards and a spillway are extant.

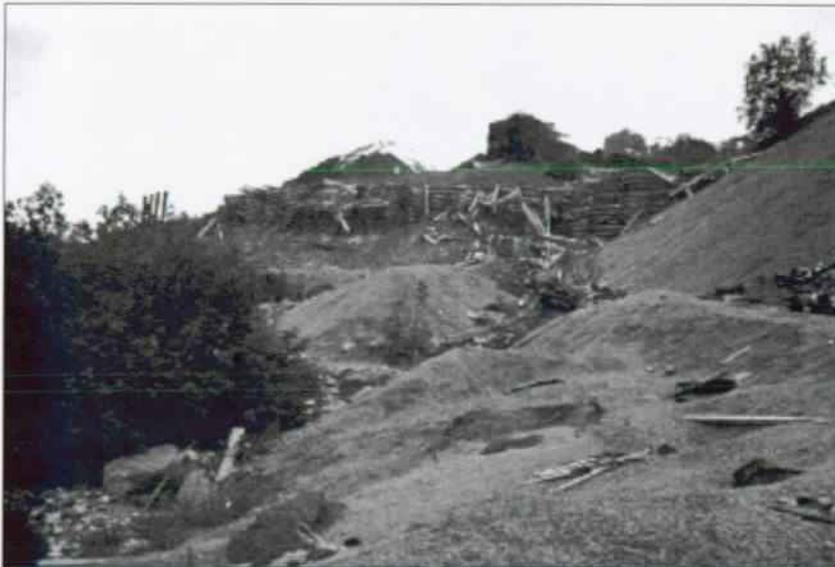
Figure 80. Tailings cribbing (45) looking northeast. (NPS photo file, WRST.)

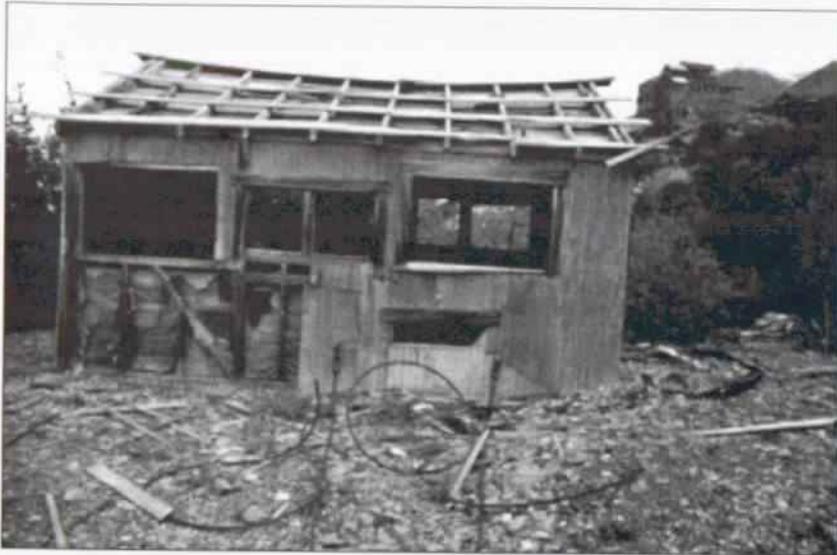
Figure 83. Detail of hoist house (44), looking north. Concentration mill in background. (MTU field documentation, 1997.)

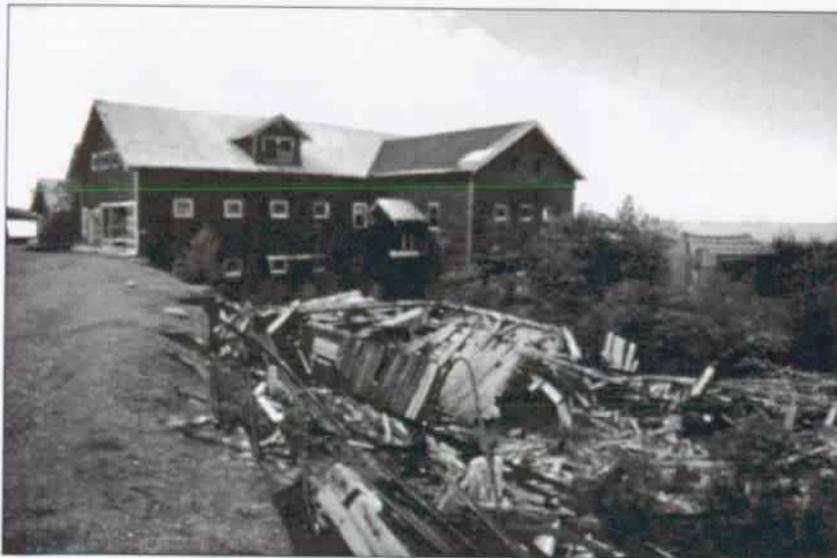
Figure 84. View south toward store and warehouse (19). Remains of carpentry shop (6) in foreground. Hoist house (44) appears at right background. (MTU field documentation, 1997.)

The carpentry building north of the warehouse has almost entirely collapsed (figure 84). Of the few wall sections remaining, all lack stability. Some standing walls may belong to the paint shop (51) or to a later extension of the carpentry. Artifacts in the wood scatter include a workbench (a), an edging machine (c), and flywheels (e and f), and clearly relate to work activities in the shop.

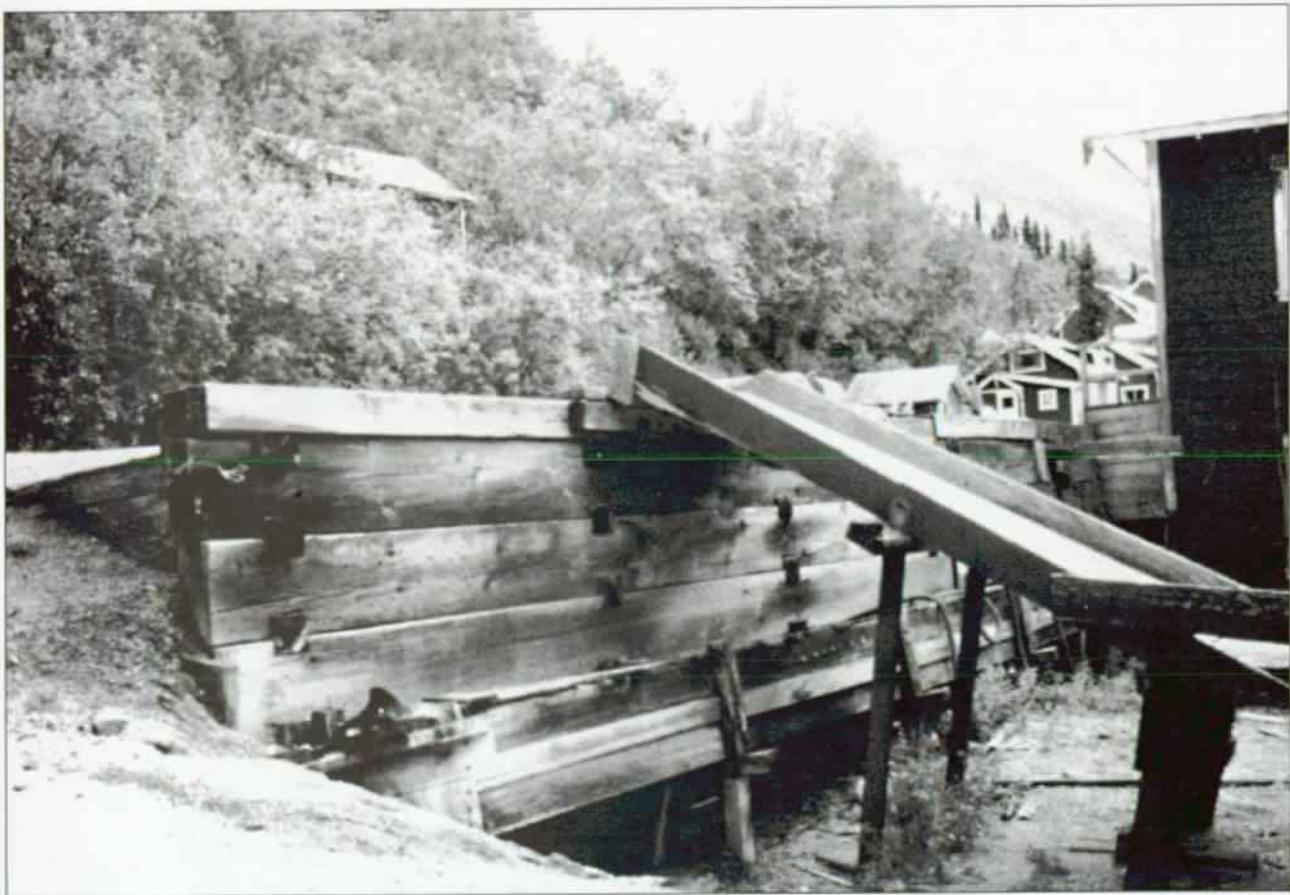
Figure 86. Retaining wall and covered utilidor east of the refrigeration plant (48). View looking southeast. (NPS photo file, WRST.)

The surrounding area is largely devoid of artifacts and small-scale features. Utilidors, conveying water, steam, and sewage lines parallel the retaining wall and connect between the bunkhouse and schoolhouse. A smaller utilidor, probably conveying water and steam lines, connects the bunkhouse and refrigeration plant (figure 86). A wooden platform and chute on the north side of the refrigeration plant aided the delivery of meat carcasses to the building from the rail grade (figure 87).

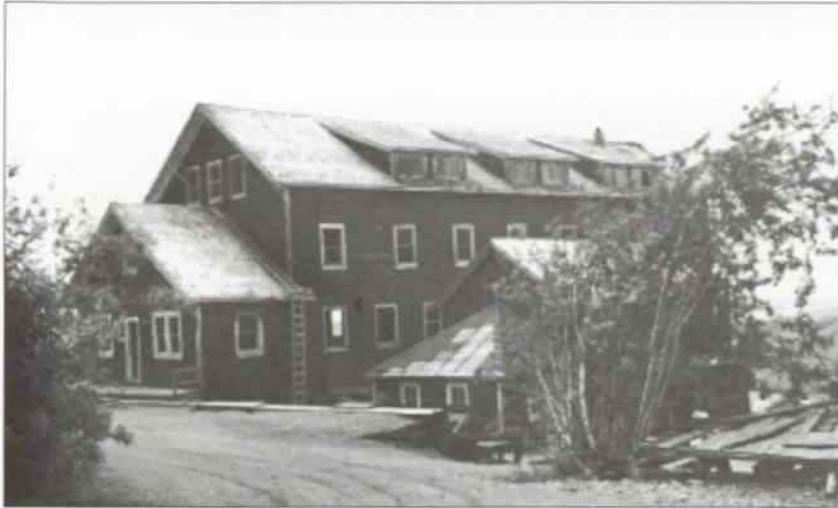
Figure 87. View showing refrigeration plant (48) with west bunkhouse (20) in background. (NPS photo file, WRST.)

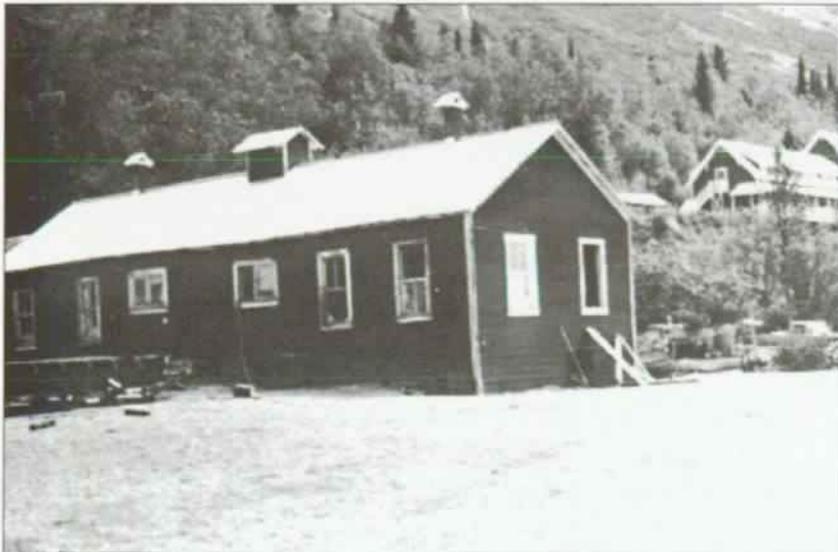
Figure 88. Looking southeast toward the schoolhouse (23). Conveyor and remains of handball court can be seen in center left. (NPS photo file, WRST.)

A small area of wood planking and joists (c) between the bunkhouse and schoolhouse constitute the remnants of the handball court (figure 88). A scatter of stove parts (a) immediately outside the bunkhouse was likely deposited after Kennecott operations. The location of an ore conveyor (b) west of the handball

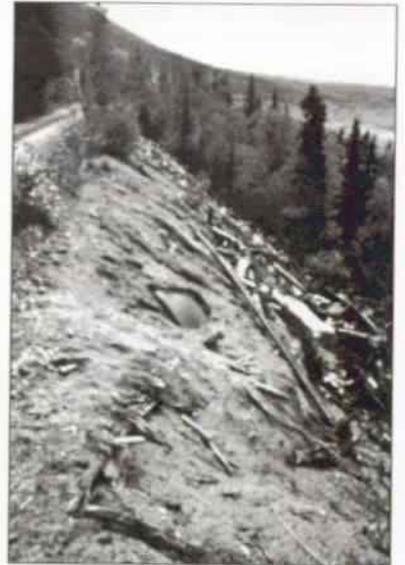
Figure 93. Industrial dump located at south entrance to the mill town. View southeast with rail grade at left. (MTU field documentation, 1997.)

A dispersed dump, containing both modern and Kennecott-era materials, extends north of the dairy barn. A second and more concentrated refuse dump west of the rail grade at the southern extent of the mill town primarily contains industrial artifacts (such as link belts, screens, and machinery). This area is less disturbed by modern refuse and retains high archeological significance (figure 93). Isolated artifacts located in the scrub between the cottage (26) and the former wagon road includes a concrete mixer, washer, and water heater. These were, in all likelihood, used during Kennecott's operation.

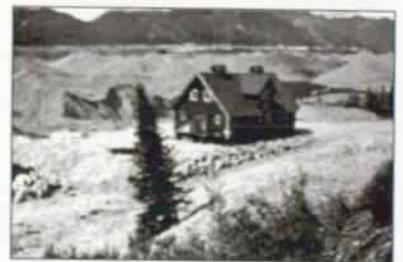
Figure 94. Looking northwest toward the dairy barn (28). Landscaping around the barn is a recent disturbance. (MTU field documentation, 1997.)

Numerous modifications occurred in this area after the closure of Kennecott. A modern road between the northern cottage and recent commercial facility provides vehicle access from the rail grade to the former McCarthy wagon road. Recent landscaping around the dairy barn has destroyed its surrounding context (figure 94). Decking extending east from the dairy barn to the rail grade is no longer present.

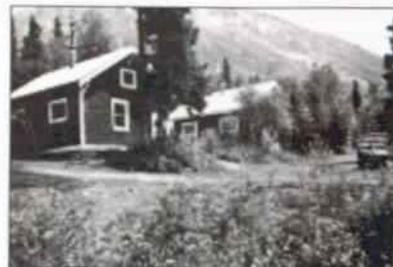
Figure 96. South cluster of cottages built in 1916 on Silk Stocking Loop road. (NPS photo file, WRST.)

The southern cluster, built in 1916, includes a row of three, freestanding wood frame cottages (30 a–c, figure 96). The cottages sit to the east of Silk Stocking Loop. Two collapsed chicken coops (31 a–b) are located west of the cottages on the other side of the dirt road. A utilidor carried water and steam lines to a firehouse between the chicken coops. Utility lines were not conveyed into the cottages and privies were built to the rear.

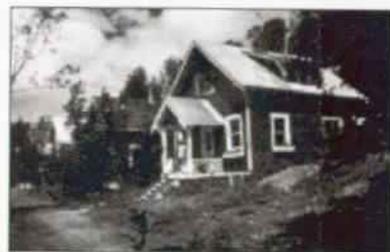
Figure 97. North cluster of cottages (32 b–d) built in 1918 on Silk Stocking Loop road. (NPS photo file, WRST.)

In 1918, the company constructed a second cluster of four cottages (32 a–d) 300 feet north of the first group (figure 97). Although of similar design and orderliness to the southern cluster, the northern cottages were fitted with water, steam, and sewage lines. Remnants of the utilidor between the west bunkhouse (20) and cottage 32d are found down the hillside. It is likely that the firehouse, water, and steam lines conveyed to the southern cluster of cottages occurred during the construction of the 1918 cottages. Pipes between the building clusters follow the west side of Silk Stocking Loop. A collapsed garage (72)
