CULTURAL LANDSCAPE REPORT

KENNECOTT MILL TOWN

WRANGELL-ST. ELIAS
NATIONAL PARK AND PRESERVE
ALASKA

2001

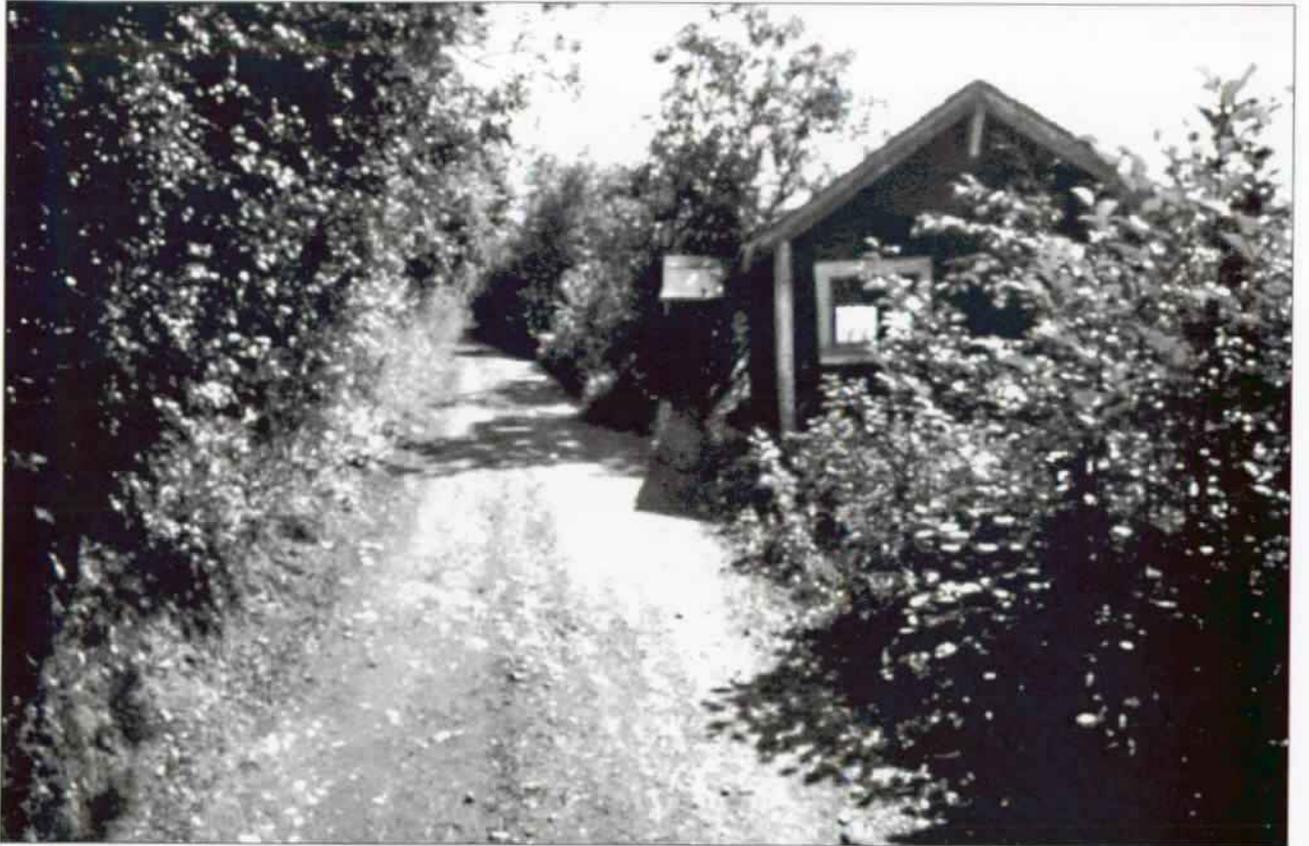
Figure 99. Bathhouse (47) seen from Silk Stocking Loop road, looking southeast. (MTU field documentation, 1997.)

Description: This section of the mill town predominantly served storage and transportation functions. Structures positioned close to the rail grade included a tool shed (46), oil storage building, and open-air lumber storage. Although the tool shed remains intact, a small wood scatter and leveled ground testify to the presence of the one-story oil warehouse to the south. Artifacts in the vicinity, including pipe bends, relate to the tool shed. Extant decking south of the oil storage building contains gears, sections of pipe, and corrugated iron. The latter likely derived from the roof of the oil storage building or an abutting shed. An extant bathhouse, southwest and up the hillside from the deck, probably served families living in the south mill town not connected to a water supply (figure 99).

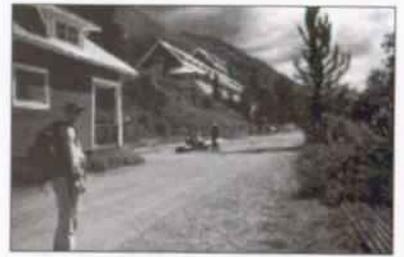
Figure 101. Looking south along rail grade in south mill town area. The cottage (29 c) in foreground was moved during renovations of the Kennicott Glacier Lodge (17) seen in the background. (NPS photo file, WRST.)

Post-Kennecott-era disturbances occurred close to the rail grade and around the apartment building. In the late 1970s, the apartment building became refurbished as the Kennicott Glacier Lodge. After a fire in 1983, the lodge was rebuilt in keeping with its original form. In 1992–1993, in order to allow for a southern extension to the building, two staff cottages (29 c–d) were moved down to the rail grade level (see Section 15 and figure 101). Modern landscaping around the guest lodge includes a southern entrance driveway and grass lawn. The current steps leading up to the lodges were probably remodeled after the 1983 fire. At the rail grade level, management has built an information sign and planted berry shrubs on the hill slope.

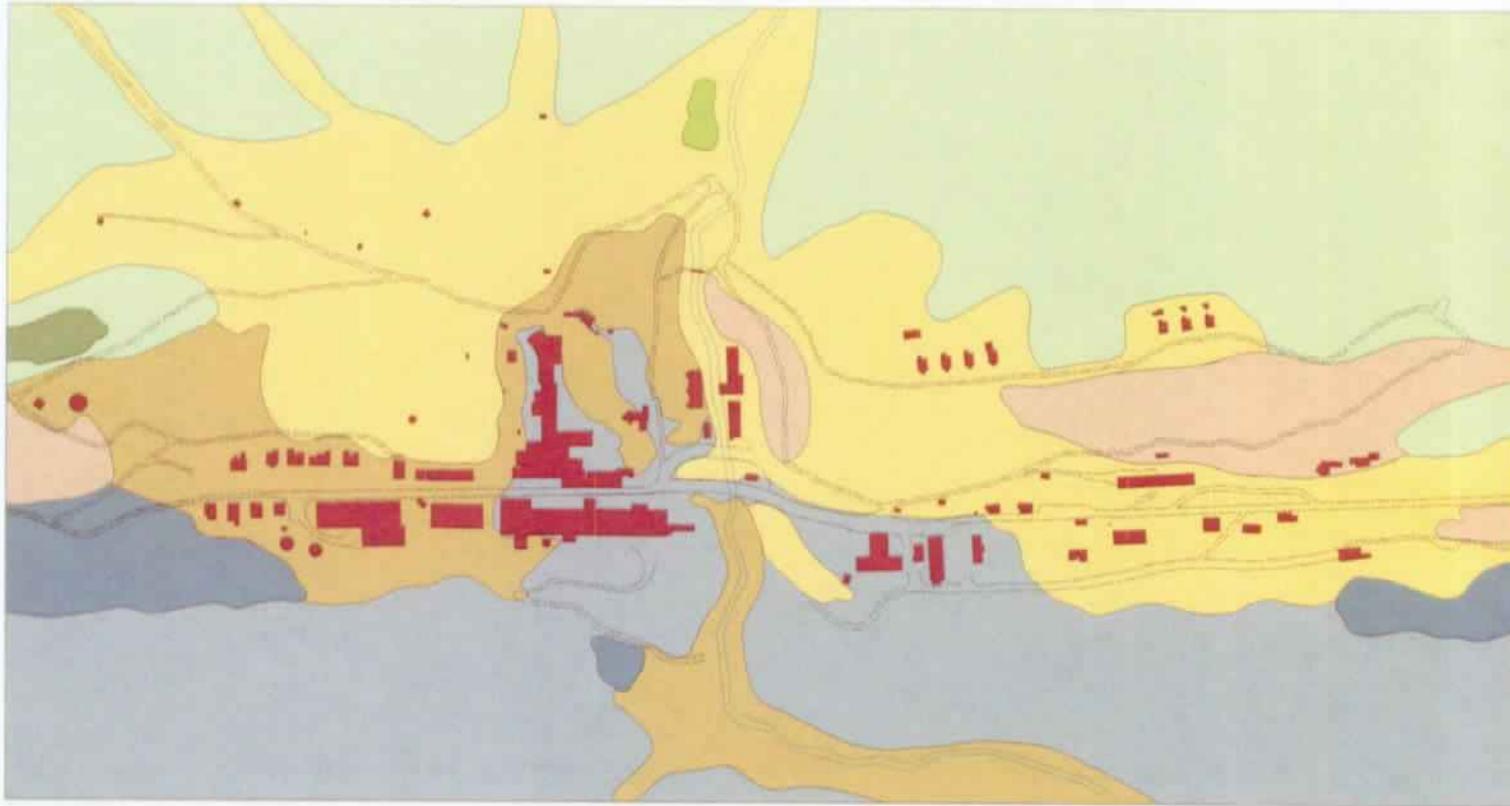
Existing Conditions
Vegetation Documentation
for Cultural Landscape Report:
Kennecott Townsite, 1998

Vegetation Types

- III.B.1.a. Seral Herbs
- II.B.2.a Open Tall Willow Shrub
- I.A.2.e. Open White Spruce Forest
- I.A.1.j. Closed White Spruce Forest
- II.B.1.d. Closed Tall Alder-Willow Shrub
- II.B.2.d. Open Tall Alder-Willow Shrub
- II.B.2.e. Open Tall Birch-Willow Shrub

There is more total vegetation cover today than at any time since the start of the mining era. This is due primarily to the ongoing retreat of the Kennicott Glacier and the consequent colonization of its abandoned lateral moraines. Virtually all of the land cleared during the mining era has revegetated to some degree, and most roadways and trails have either disappeared or become narrow paths through a tunnel of encroaching alder and willow. With the exception of privately-owned property (the Kennicott Glacier Lodge, Silk Stocking

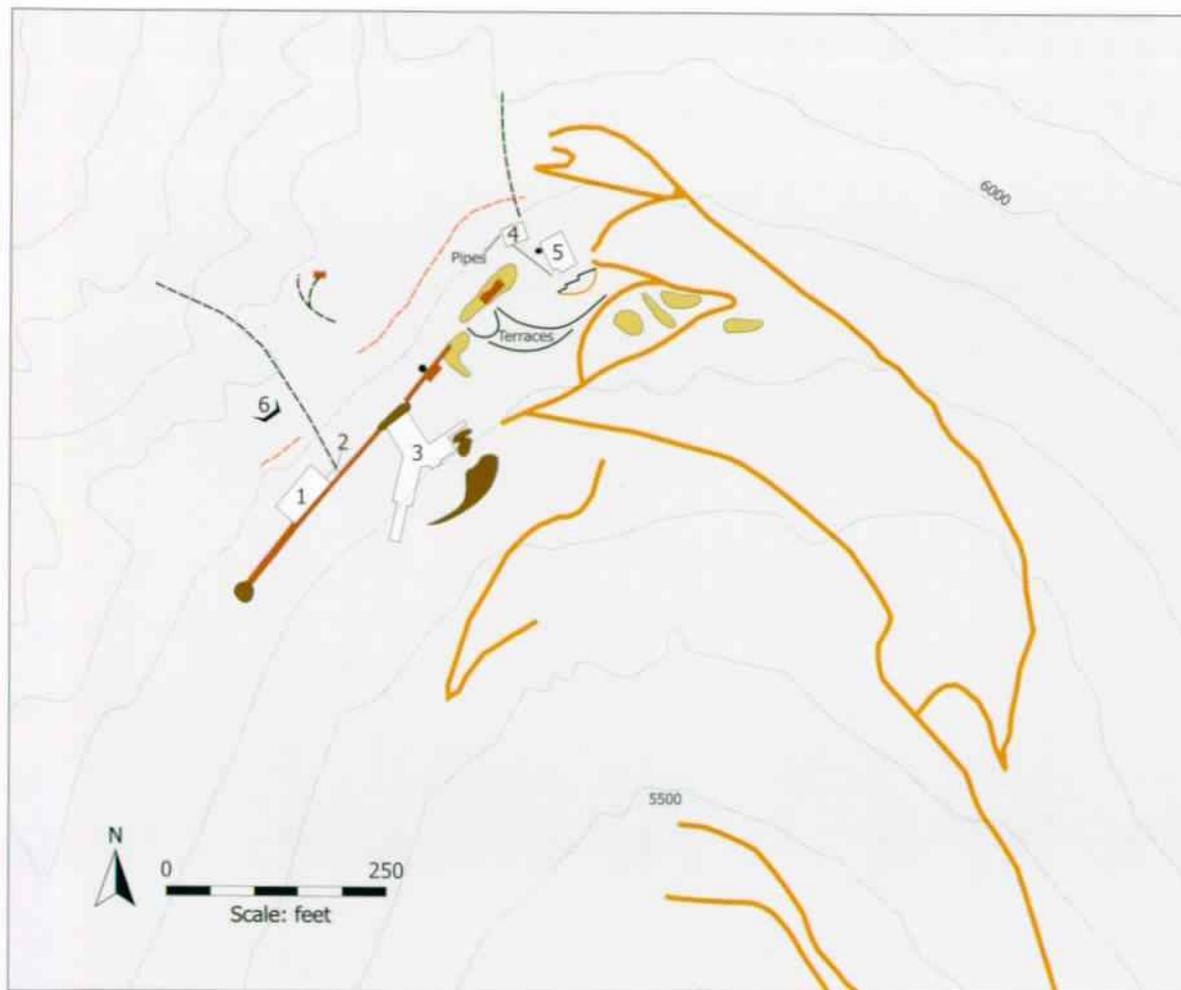
Bonanza Mine
Existing Conditions

LEGEND

- Adit
- Wood Scatter
- Dump
- Decking
- Telephone Line (fallen)
- Cable
- Trail

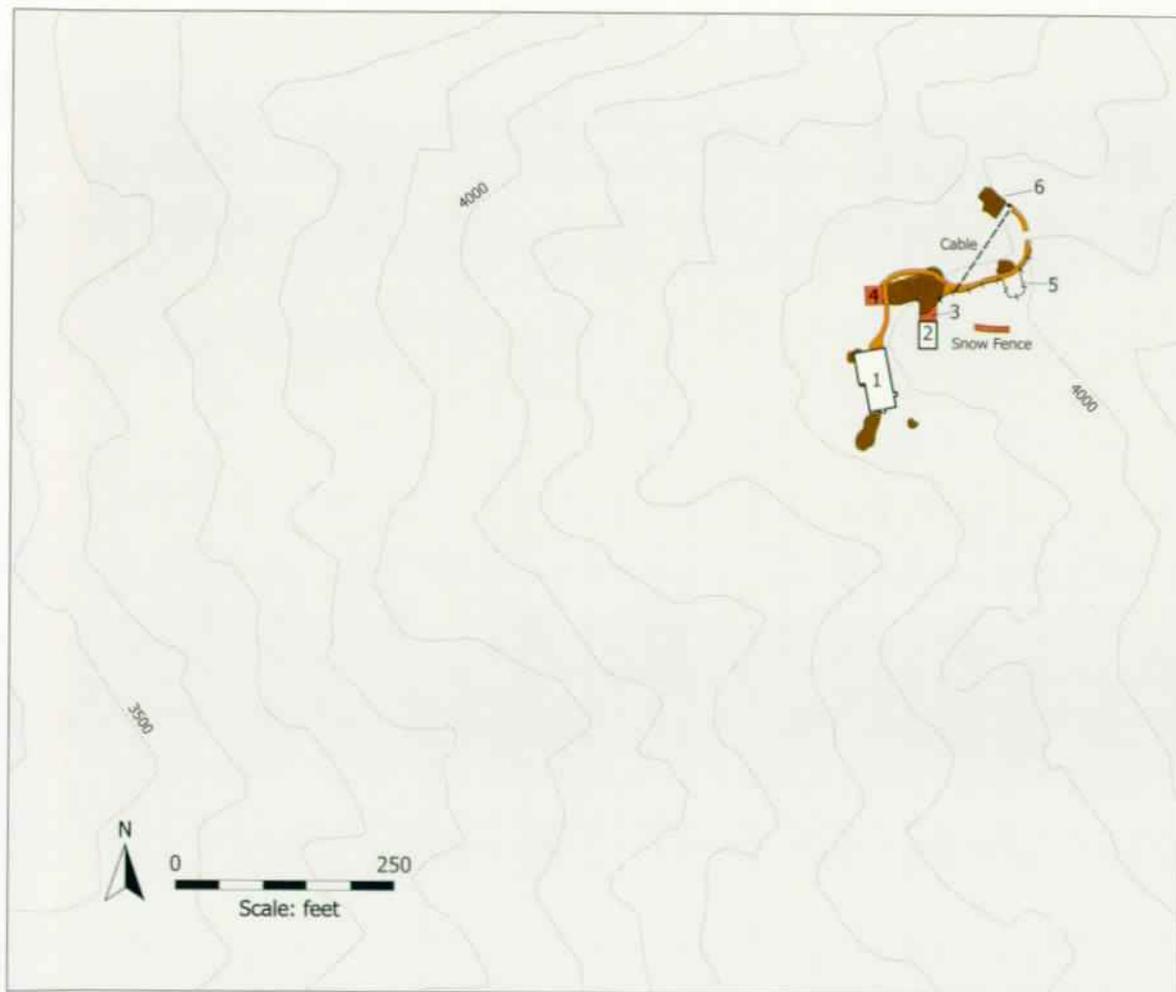
Erie Mine
Existing Conditions

LEGEND

- Ruin
- Adit
- Wood Scatter
- Trail
- Scarp

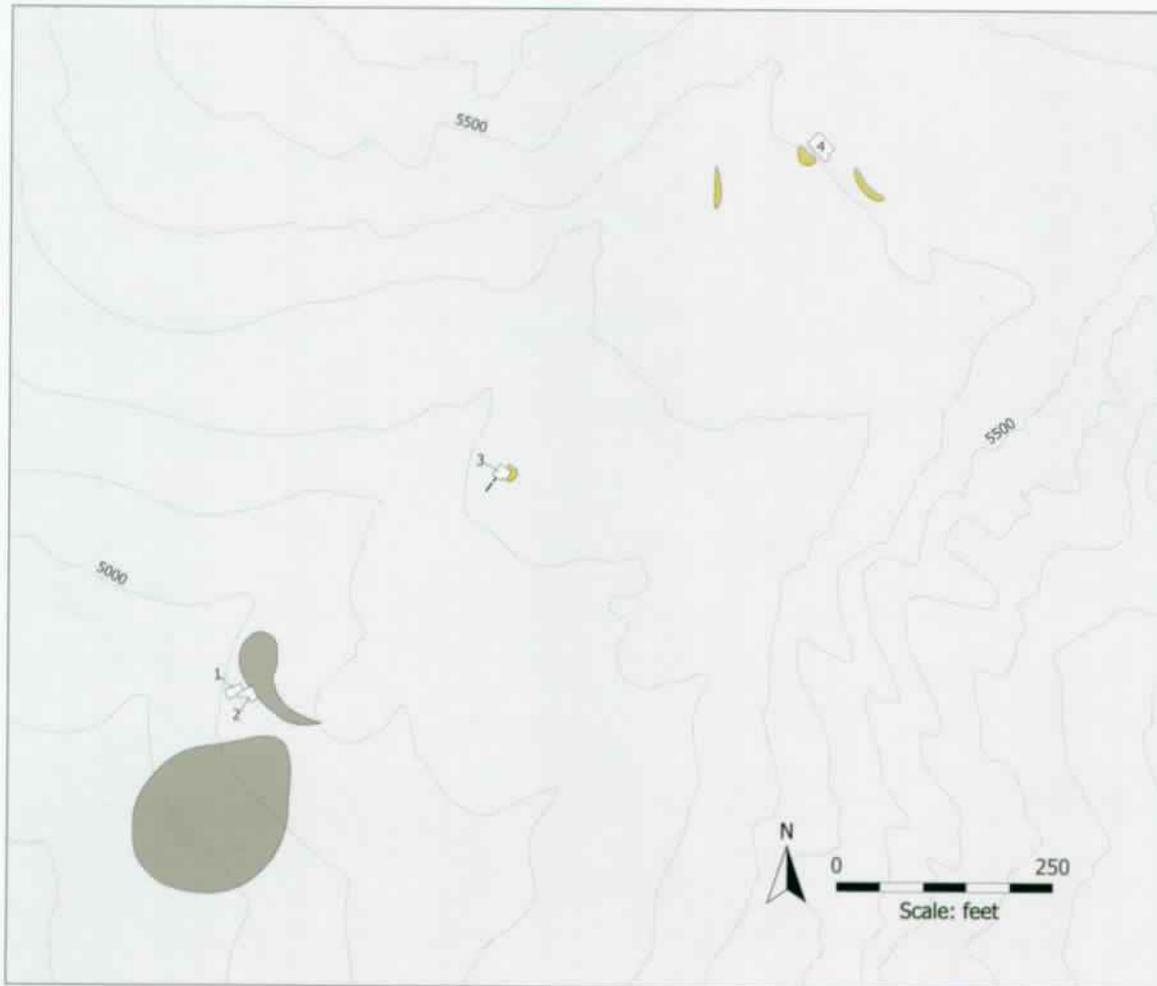
LEGEND

- Dump
- Tailing
- Cable

Kennecott last produced ore from the Glacier mine in 1928. Over the nine seasons it operated the Glacier Mine shipped a little over 160,000 tons of ore containing a total of 3,526 tons of copper.⁴⁷ From the first to the last, the Glacier was an unusual operation: a placer mine on a glacier high in the mountains of Alaska.
