## United States Department of the Interior

NATIONAL PARK SERVICE  
Point Reyes National Seashore  
Point Reyes, California 94956

Subject : Coastal Consistency Determination and Project Description for the Drakes Estero Restoration Project

**NATIONAL PARK SERVICE  
POINT REYES NATIONAL SEASHORE**

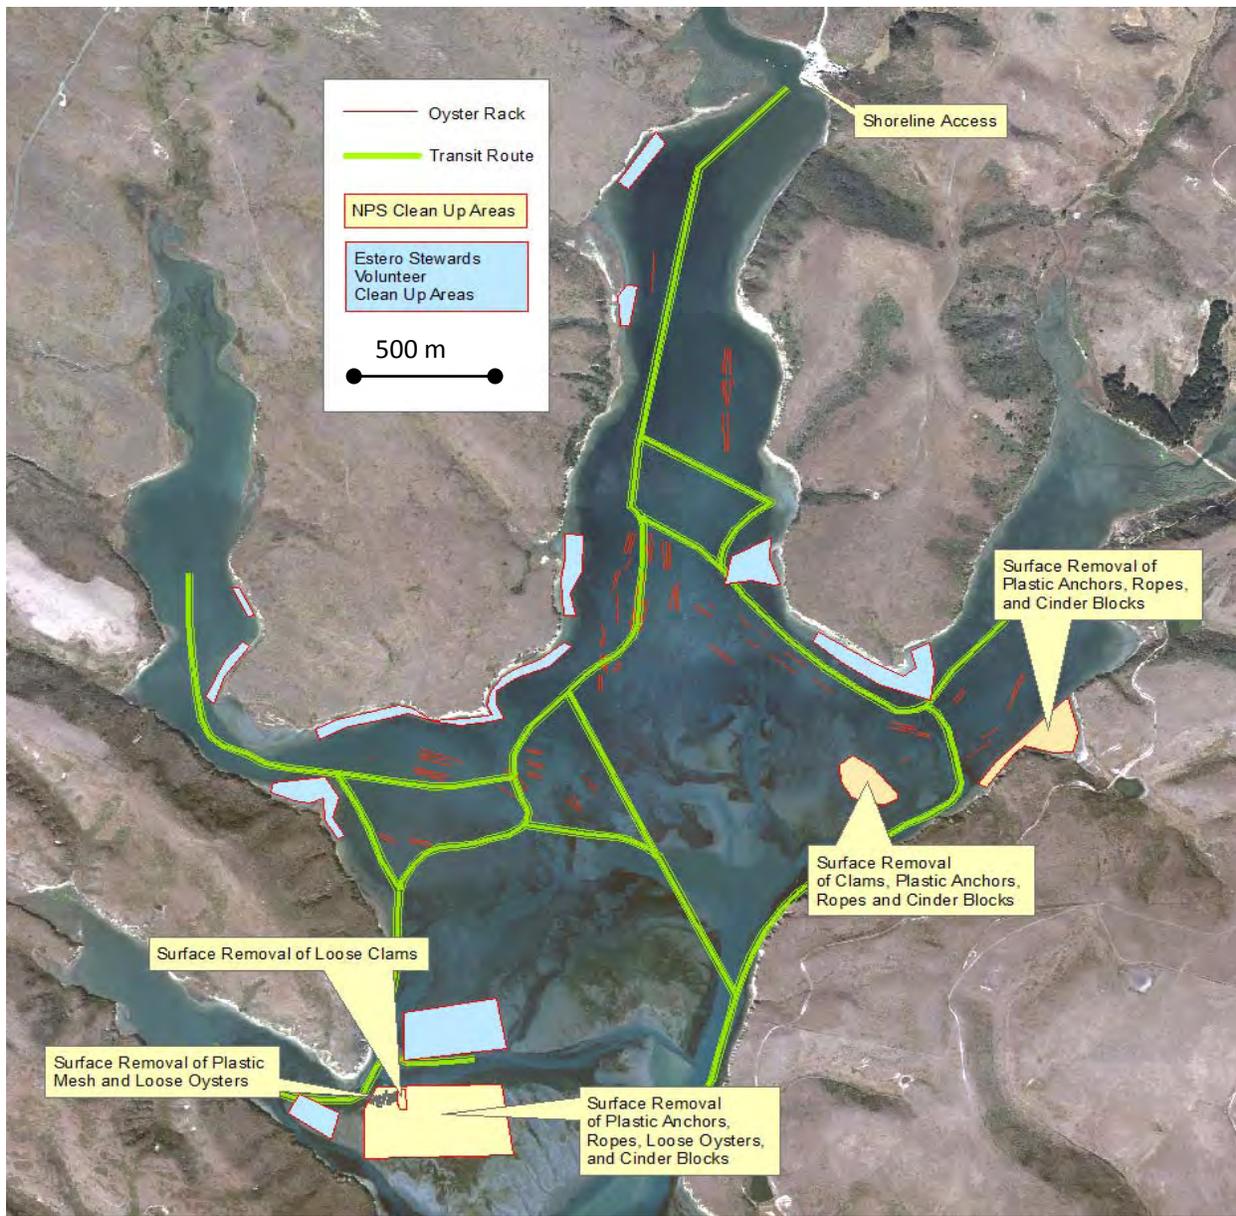
**Figure 2:** Project Treatment Areas, and primary vessel transit routes within Drakes Estero

The NPS has collected and analyzed aerial imagery and underwater video of more than 70 racks within Drakes Estero to identify planning assumptions for this project. The more detailed description of how estimates were derived is included as Appendix A. The Project Area is represented by the offshore and onshore areas of the former commercial oyster operation with Drakes Estero. There are a number of specific areas within the restoration project area where the NPS plans to implement removal and restoration activities (Figure 2). Barge and boat traffic associated with the demolition and restoration activities will follow established vessel transit corridors.

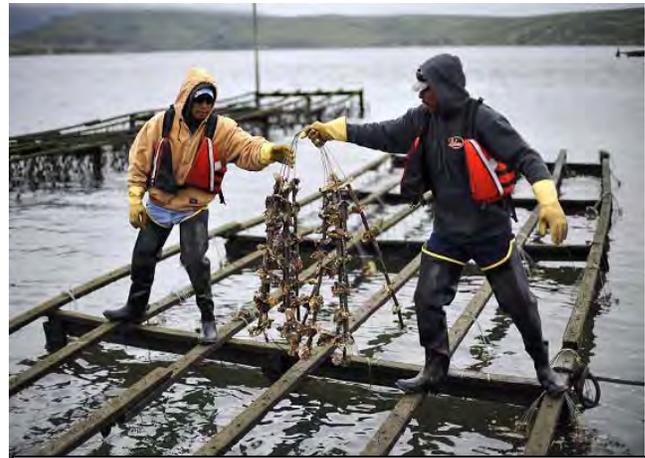
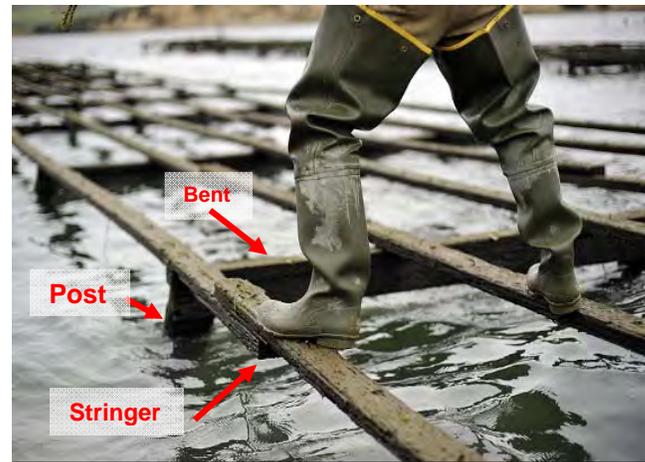
Figure 3: Typical Oyster Rack in Drakes Estero (Photo Source: [www.sfweekly.com](http://www.sfweekly.com))

Figure 4: Typical Oyster Rack in Drakes Estero (Photo Source: [www.sfweekly.com](http://www.sfweekly.com))

The 95 oyster racks comprise approximately 7.07 acres of area (308,000 square feet), and if lined up end to end are more than 5 miles long. Materials used to construct the racks typically consisted of 2 in. x 4 in. and/or 2 in. x 6 in. milled lumber (see Figure 3 and Figure 4 for typical condition). Some oyster racks appear to have been constructed using pressure treated lumber. DBOC was not permitted to construct or add new lumber to the oyster racks for the last ten years. Therefore, it is assumed that all lumber in the Estero has been in-place for at least 10 years.

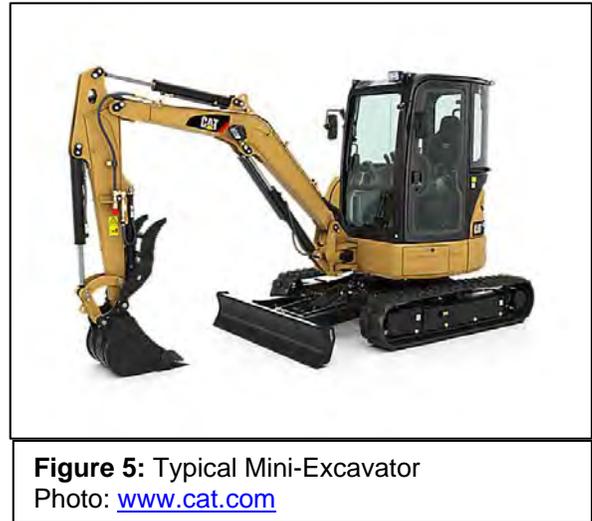
The mini-excavator, a small tracked excavator, is proposed as the primary equipment for rack removal. Figure 5 shows a typical mini-excavator. Generally, mini-excavators have a lifting capability of over 4,000 lbs and less than 10,000 lbs which is consistent with the assumed project requirements. The operating weight of the mini-excavator, from 3 to 5.5 tons is considered another important advantage. The Estero is a shallow water body. Lighter equipment has the advantage of increasing the duration of operation within the Estero through tidal fluctuations. The machine features independent boom swing with interchangeable attachments depending upon the application of the machine.

The mini-excavator will likely operate with a grapple-claw for the grabbing of debris material and depositing it into a debris container on the same barge or a hydraulic scissor to cut stringers and other boards as necessary for safe and easy removal from the site. The hydraulic scissor may be used above and below water, and is intended to cut the lumber and will not produce any saw dust that could be released into the estero. The use of the mini-excavator will also allow for a more consistent force to be applied on each post and is expected to reduce potential for post breakage. The mini-excavator will also increase the flexibility of conducting demolition activities and will be able to operate from various work platform rack orientations.

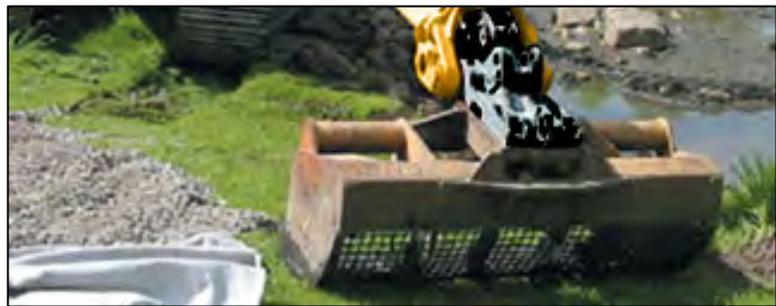
An excavator using a clamshell or equivalent dredge bucket type will access and remove accumulated aquaculture debris (bags, strings, and tubes) from the bottom surface (See Figure 6). Operators would be instructed to minimize disturbance to the bed and not digging deep into native sediment. Debris will be placed directly into debris boxes on a barge for transport to shore and proper disposal. This method will also result in collection of some additional free oyster shell as part of the removal.

**Figure 6:** Dredge Bucket (Photo:<http://www.gradall.com>)

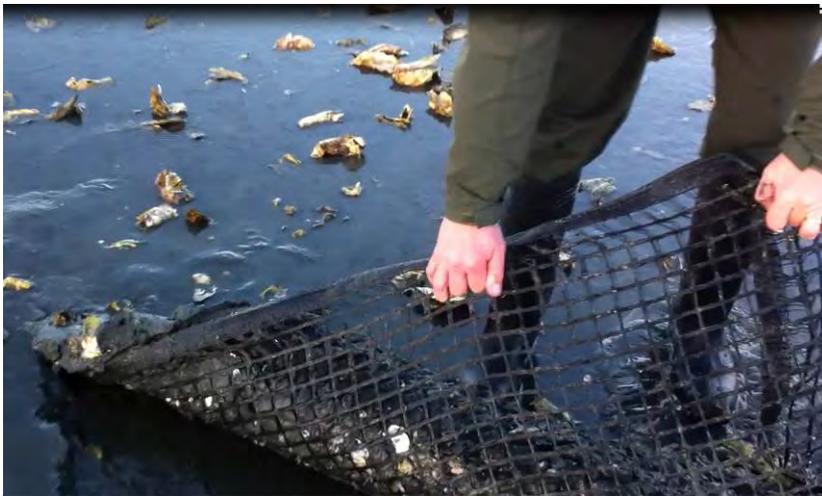
It appears that between 2009 and 2014 DBOC rolled out plastic mesh mats that were used to grow oysters outside of bags or containment (Figure 7).

**Figure 7:** Plastic Mesh Fabric Oyster Mat

The NPS has documented through review of recent aerial photos the presence of approximately 15 sections of this 12 foot wide mat, ranging in length from 50 to 100 feet on the western portions of the sandbar near bed 17, but not in bed 17 (Figure 8). The total area covered by these mats is approximately 16,900 SF (0.39 acres). These mats are covered by 2-6 inches of sand and a large number of uncontained live large pacific oysters (see left portion of Figure 7).

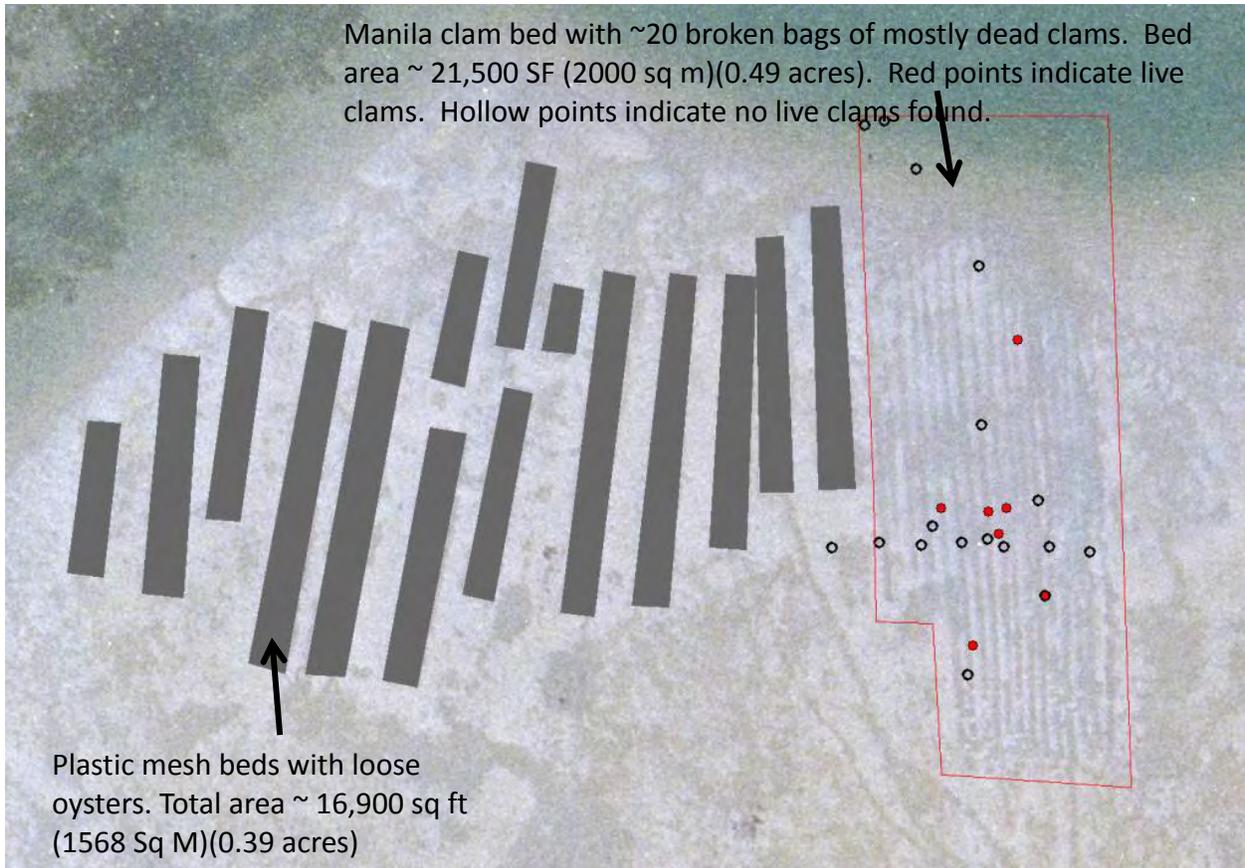
**Figure 8:** Locations of mesh mats (n = 15) and former Manila clam bed with broken bags and live clams in the sediment. See Figure 2 (Project Map) for location with project area.

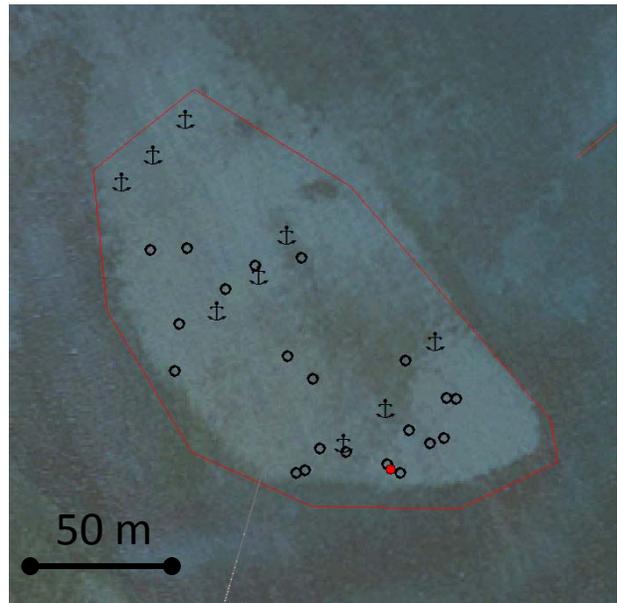
**Figure 9:** Former manila clam bed (Bed 7) with ~10 broken bags of dead clams. Bed area = approx. 20,000 sq m. (4.94 acres). Red points indicate live clams. Hollow points indicate no live clams found. Anchor symbols are plastic anchors.

DBOC provided GPS locations of more than 30 plastic anchors that would be left at the close of their operations in areas of Bed 17 (Figure 10), Bed 7 (Figure 9), and Bed 39 (Figure 11). The NPS has observed that these anchors still include a network of connected lines. Additional infrastructure, including cinder block anchors and many other lines will be removed as they are encountered (See Figure 12).

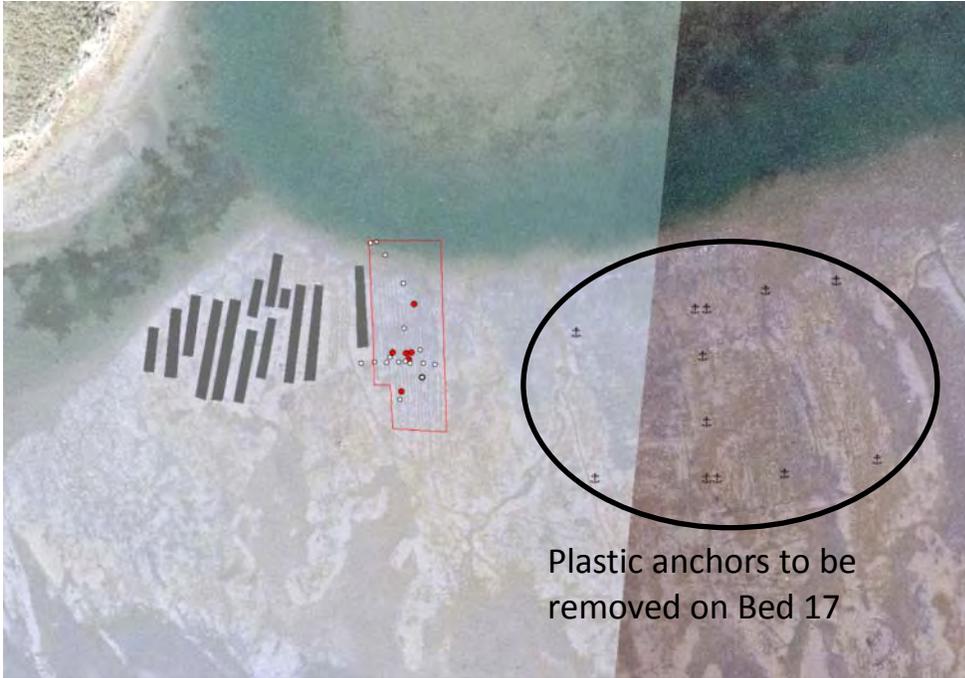
**Figure 10:** Plastic anchors to be removed on Bed 17.

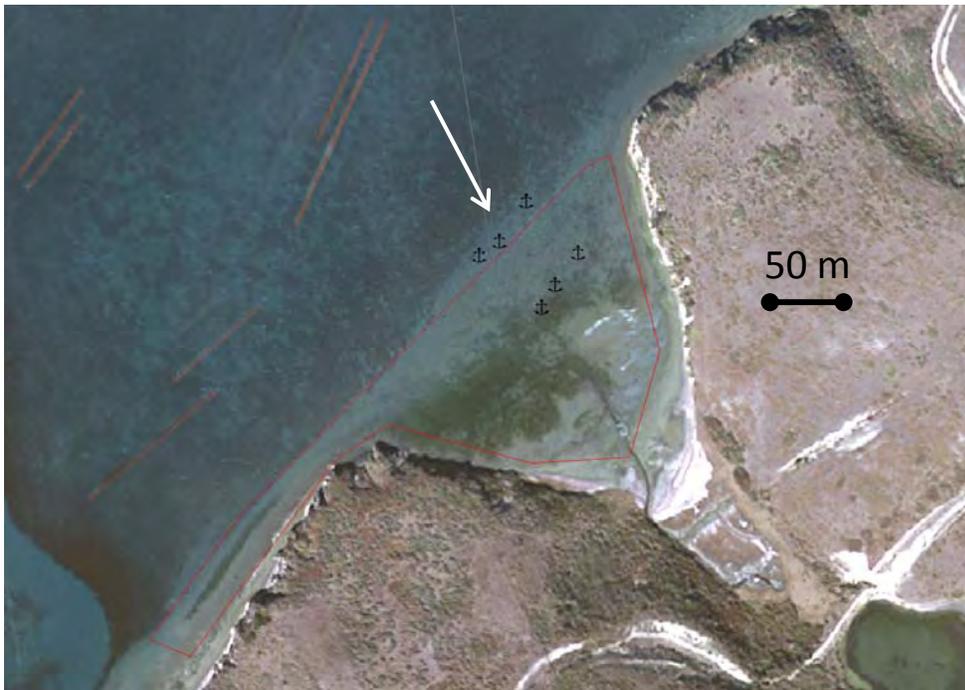
**Figure 11:** Plastic anchors to be removed on Bed 39.

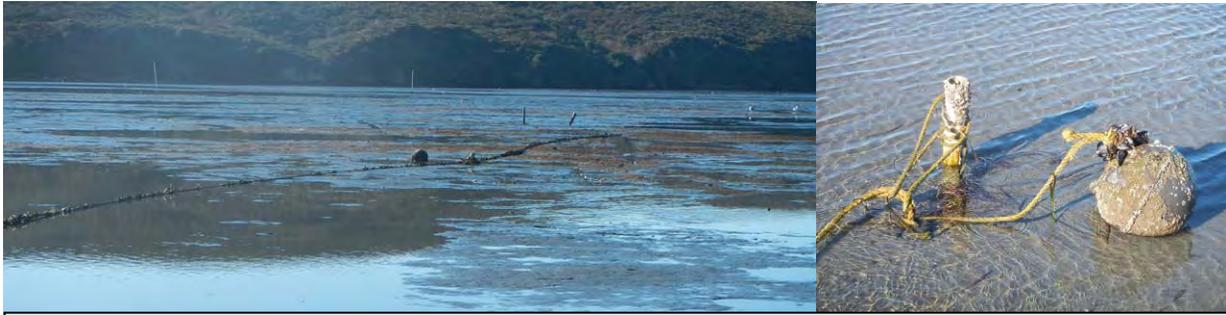
**Figure 12:** Examples of screw anchors and lines on Bed 17.

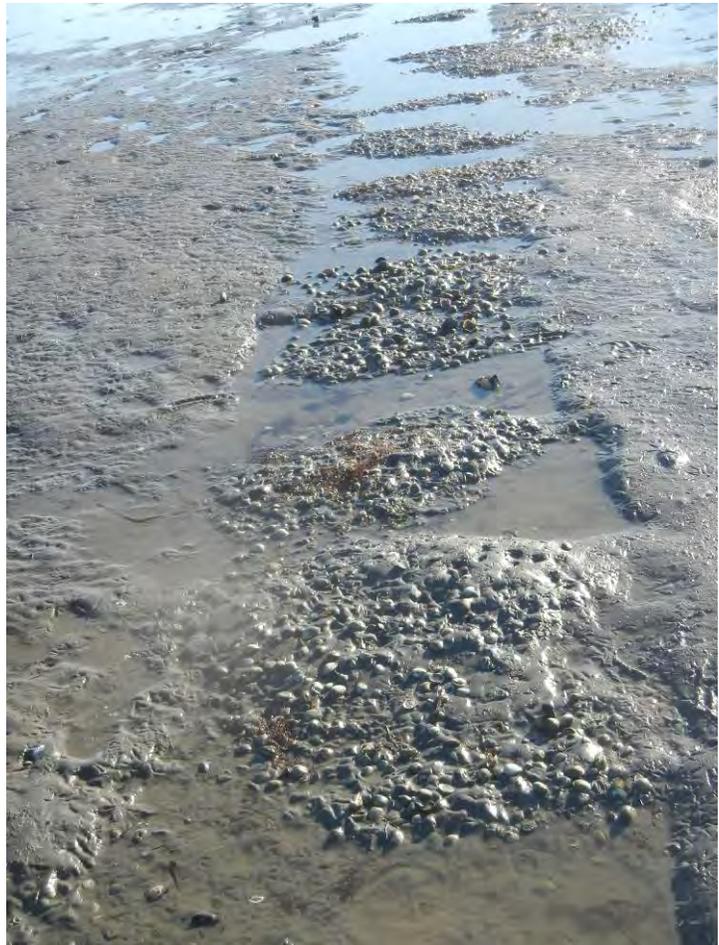
**Figure 13:** Remains of dead and live manila clams from spilled clam bags near bed 17. January 2015. See Figures 8 and 10 for location.

As part of reconnaissance surveys in early January 2015, the NPS identified specific areas where bags of manila clam had broken, with most clams distributed on the sandbar (Figure 13). An attempt to remove these was made by contractors in January, but at that time it was documented that the clams were far more broadly spread than the 10 bags that were initially observed.

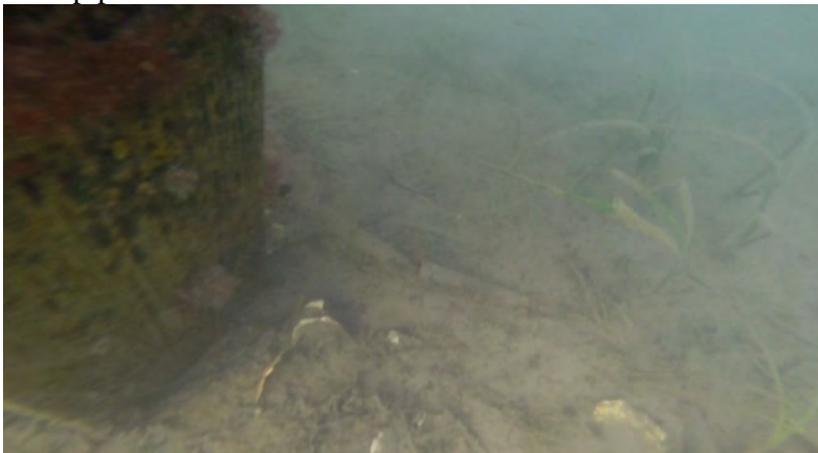
**Low Debris** is defined as covering less than <25% of the visible estero floor. This generally consisted of scattered oyster shells under racks, but also may include small amounts of wire and PVC pipe.

*Minor debris by post under rack 22D on 1/30/2015. Note plastic spacer tubes with wire and scattered oyster shell.*

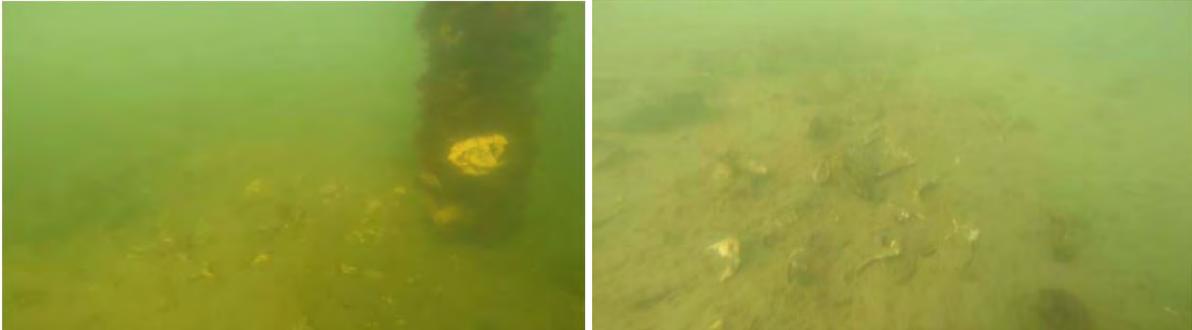
**Moderate Debris** is defined as covering approximately 25-75% of the visible estero floor. This generally consisted of numerous oyster shells under racks, but also wire and PVC pipe. Eelgrass is rarely in the moderate debris areas.

*Moderate shell debris under rack 9C on 1/1/2015.*

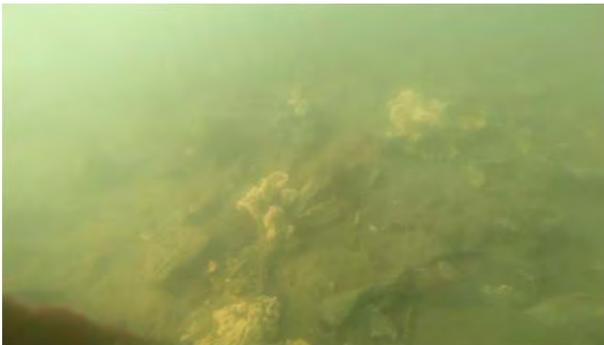
*Upper end of moderate class of debris under rack 9C on 1/29/2015*

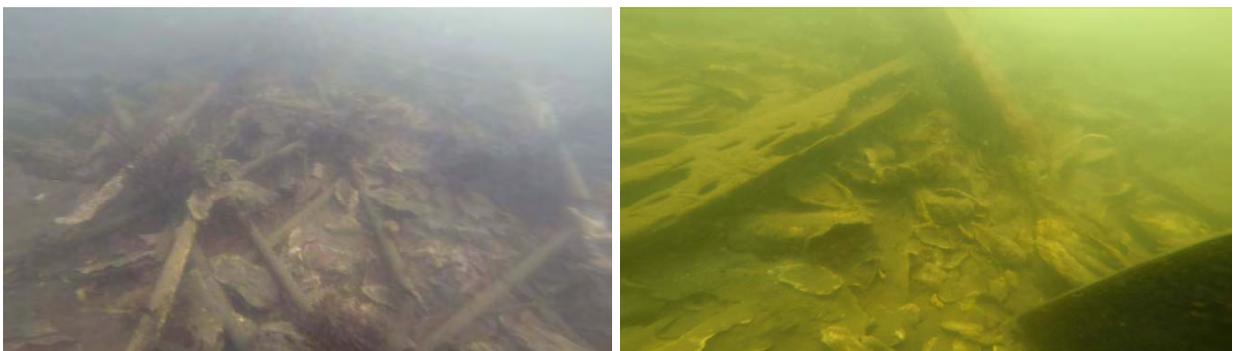
**Heavy Debris** is generally defined as having >75% cover, precluding eelgrass growth and covering most of the estero floor under a rack. This periodically includes large piles of oyster bags or French tubes that have fallen from the rack and almost always includes complete bottom coverage of oyster shell. It is unknown how deep into the sediment this debris may be.

*Examples of heavy debris: (Left) oyster shell and French tubes under rack 6B on 1/29/2015, (Right) oyster shell under rack 22B on 1/30/2015.*

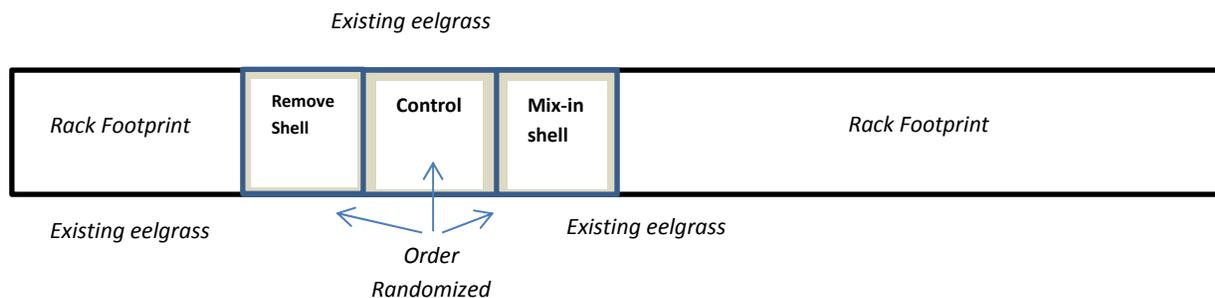
All treatment plots will be conducted in a split plot design in groups of 3 (removal/mixing/control) to minimize location effects. The linear order of the treatments will be randomized and in no case be at the end of a rack, since the ends of racks could have existing eelgrass on 3 sides of the plot, whereas non-end plots would have pre-experiment eelgrass at most on two sides of the plot. Racks suitable for treatment 1, treatment 2, and control split plots are listed in Table 1. There are 11 potential racks that meet the needs for a heavy shell treatments, and 10 potential racks that meet the needs of the moderate shell treatments. Note that there is some variation in shell coverage classes under single racks, meaning that a heavy treatment may occur in one section of a rack, and a moderate in another section. Each plot will have the 4 corners marked with white ¾” PVC pipe that protrudes approximately 40 cm above and 100 cm below the bay floor to ensure easy and accurate relocation of plots. The top of the pipe marker will still be ~60 cm below the water surface at most low tides. WAAS GPS will also be used to record all plot locations for relocation.

**Figure 1.** Experimental design showing treatments within the footprint of an oyster rack surrounded by existing eelgrass. Racks are 12' wide and each plot will be 12'x12'. This design will be replicated 10 times each in in areas of heavy and moderate oyster shell coverage.

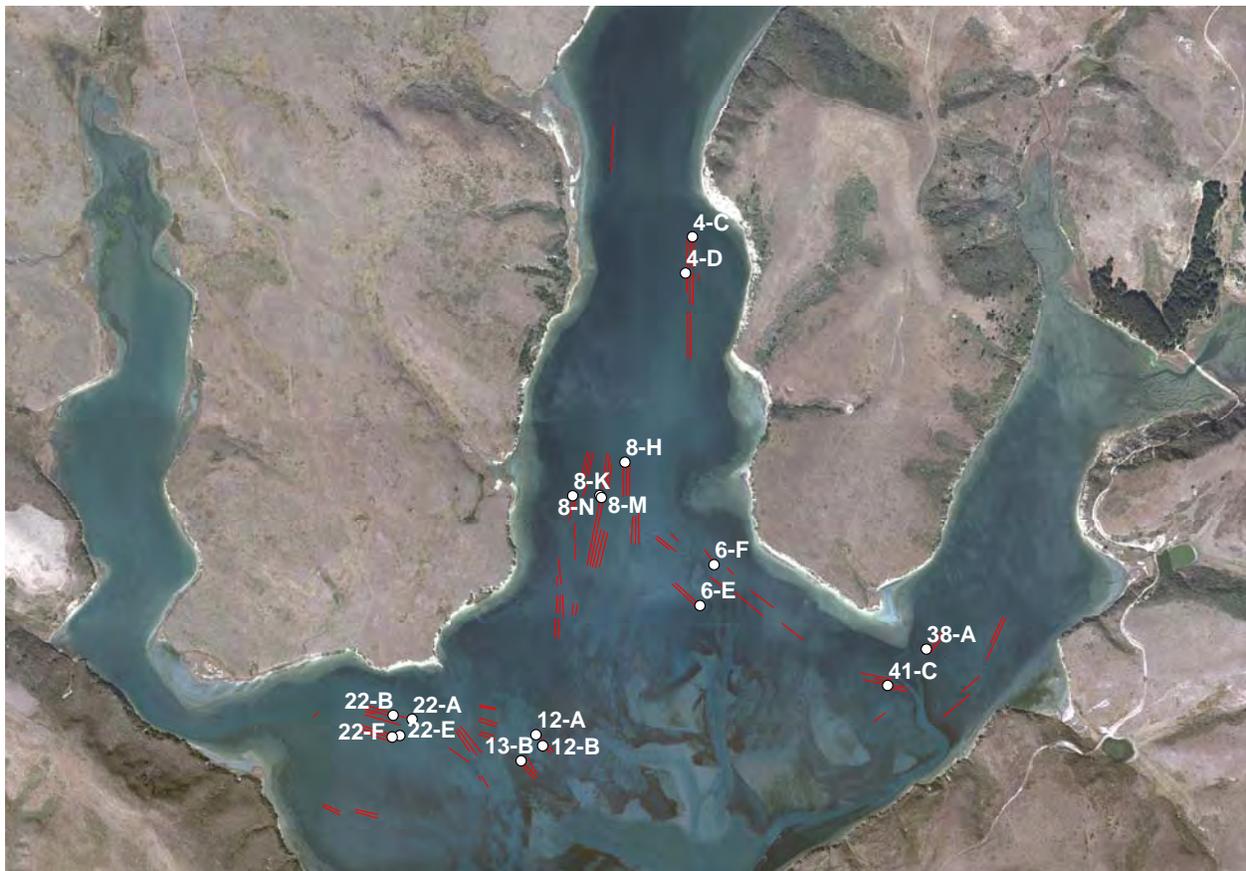
**Figure 2:** Rack Locations suitable (shell debris under racks and eelgrass growing adjacent) for experimental shell removal, shell mixing and controls. We anticipate using all of these racks. See Table 1 and text for details.
