Drakes Estero Restoration Project

Removal of Oyster Racks and Aquacultural Debris from Subtidal Lands of Drakes Estero

PROJECT DESCRIPTION April 2015

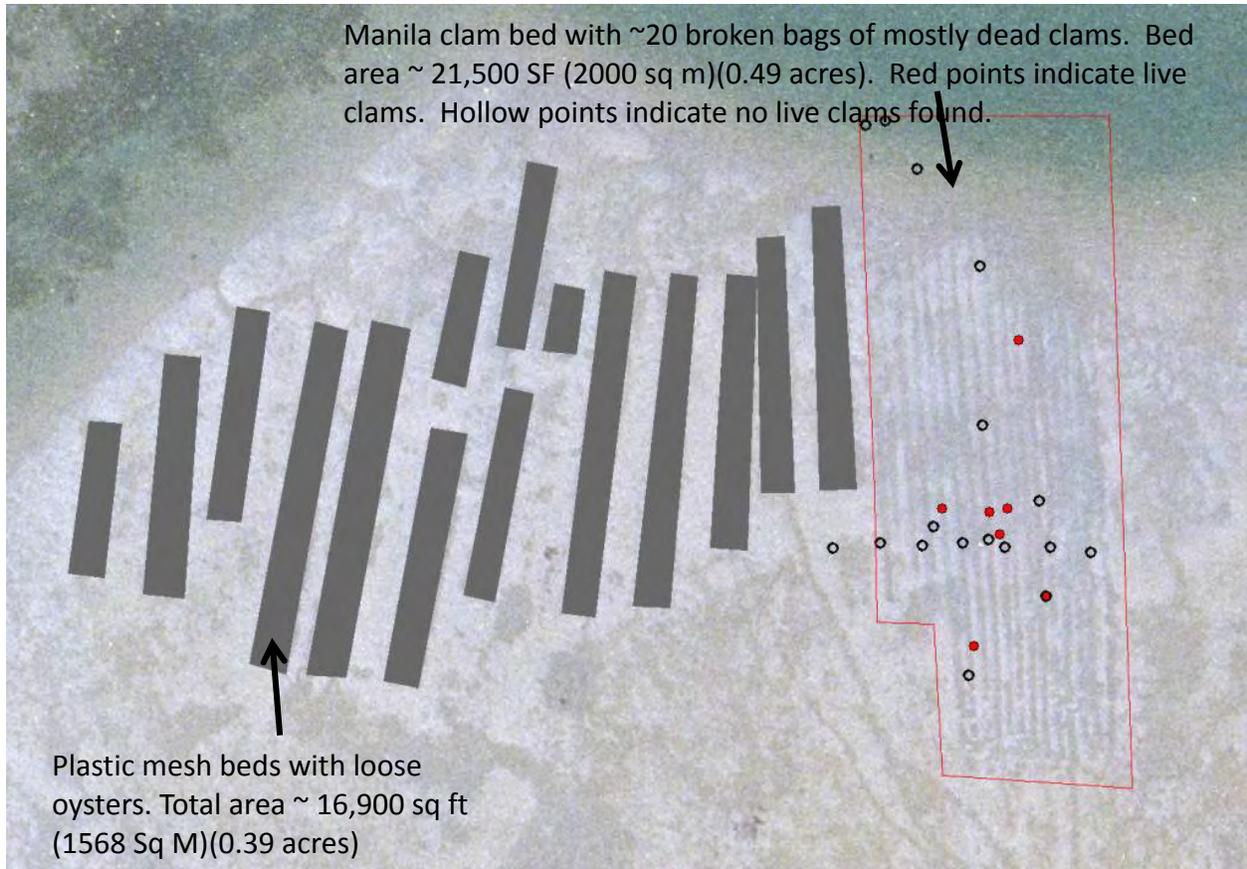
Figure 8: Locations of mesh mats (n = 15) and former Manila clam bed with broken bags and live clams in the sediment near bed 17. See Figure 2 (Project Map) for location with project area.

The NPS has documented, through review of recent aerial photos and field inspection, the presence of approximately 15 sections of this 12 foot wide mat, ranging in length from 50 to 100 feet on the western portions of the sandbar near bed 17 (see Figure 8). The total area covered by these mats is approximately 16,900 SF (0.39 acres). These mats are covered by 2-6 inches of sand and a large number of uncontained live large pacific oysters (see left portion of Figure 7).

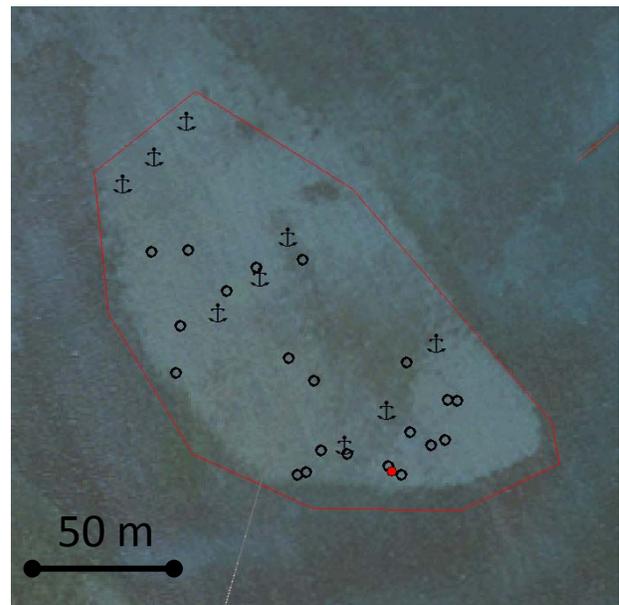
Figure 9: Former manila clam bed (Bed 7) with ~10 broken bags of dead clams. Bed area = approx. 20,000 sq m. (4.94 acres). Red points indicate live clams. Hollow points indicate no live clams found. Anchor symbols are plastic anchors.

DBOC provided GPS locations of more than 30 plastic anchors that would be left at the close of their operations in areas of Bed 17 (Figure 10), Bed 7 (Figure 9), and Bed 39 (Figure 11). The NPS has observed that these anchors still include a network of connected lines. Additional infrastructure, including cinder block anchors

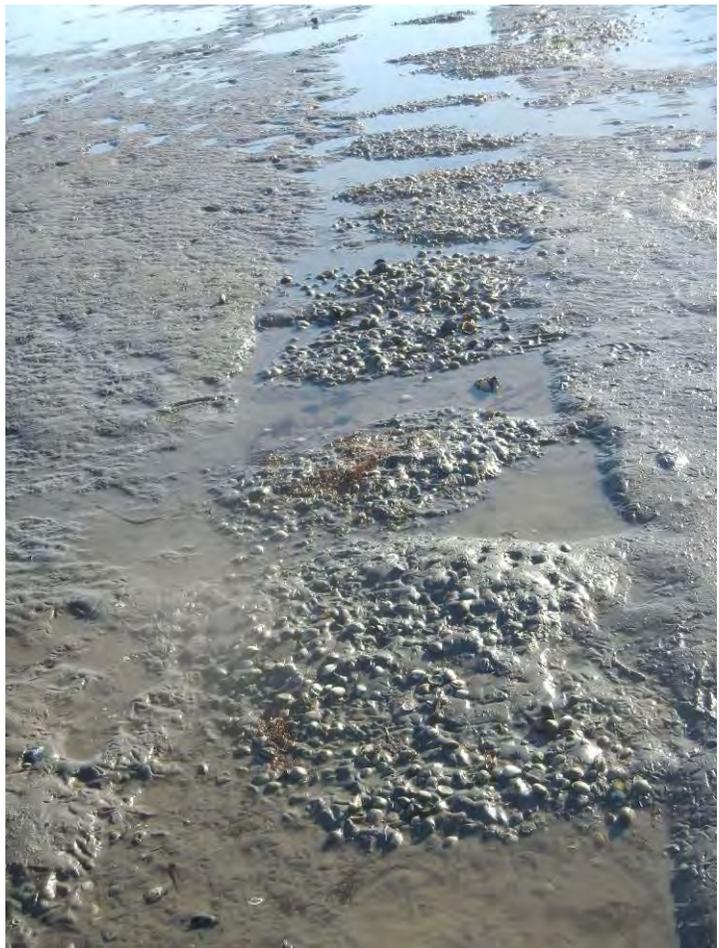
Figure 13: Remains of dead and live manila clams from spilled clam bags near bed 17. January 2015. See Figures 8 and 10 for location.

As part of reconnaissance surveys in early January 2015, the NPS identified specific areas where bags of manila clam had broken, with most clams distributed on the sandbar (Figure 13). An attempt to remove these was made by contractors in January, but at that time it was documented that the clams were far more broadly spread than the 10 bags that were initially observed.

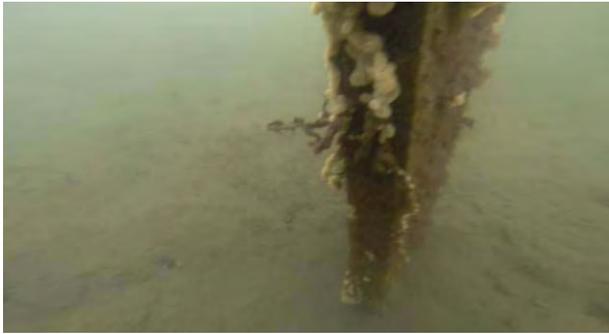
No eelgrass. Rack 6E on 1/29/2015

Field evaluations, including snorkel and side-boat video collection has informed our base of information regarding presence/absence and potential effects of rack and debris removal on eelgrass within Drakes Estero. From video, we placed areas under racks into one of 5 broad cover classes estimated visually without the aid of test points: 0, <5%, 5-25%, 25-75%, and >75%. It was not feasible to assess shoot density. For reproducibility, cover was always estimated in conditions where eelgrass was floating in low current conditions. Below are examples of each eelgrass coverage class.

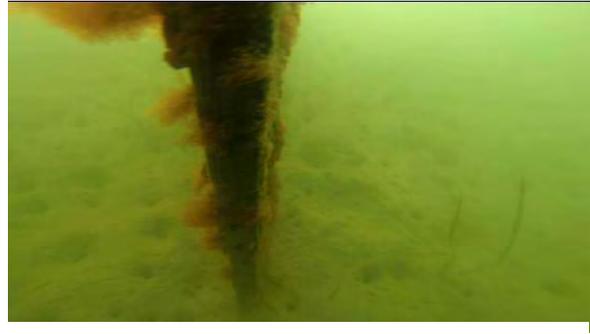
Very Low (<5%) eelgrass coverage. Post in sediment on Rack 11I on 1/30/2015. Note single eelgrass plant approximately 18" from post.

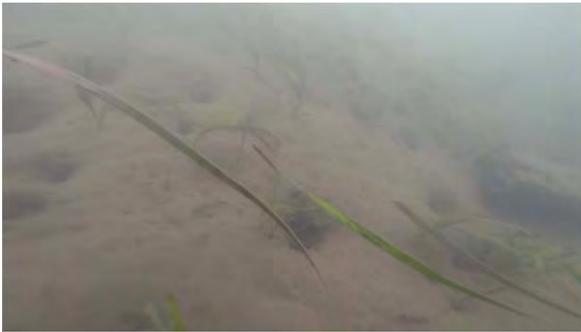
Light (5-25%) eelgrass coverage under rack 11H on 1/30/2015

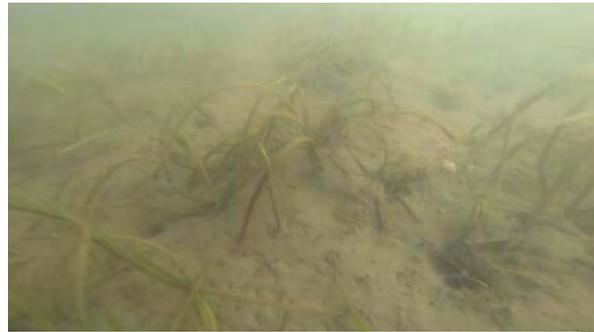
Moderate (25-75%) eelgrass coverage under rack 8P on 01/28/2015.

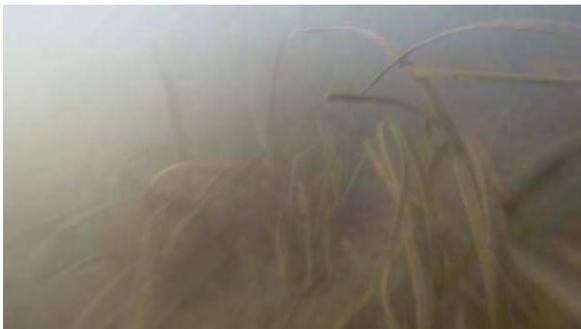
Dense (>75% cover) eelgrass. This density only occurred under part of rack 41. All other racks surveyed were <75%, but racks 22E and 22F are close to 75%.

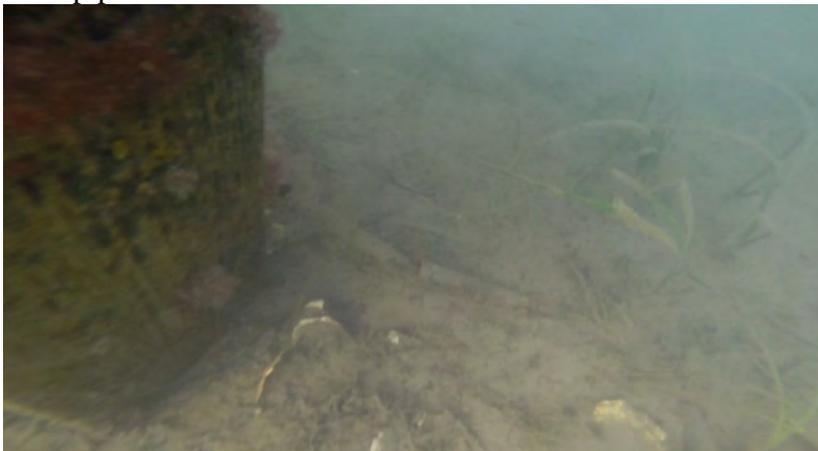
Low Debris is defined as covering less than <25% of the visible estero floor. This generally consisted of scattered oyster shells under racks, but also may include small amounts of wire and PVC pipe.

Minor debris by post under rack 22D on 1/30/2015. Note plastic spacer tubes with wire and scattered oyster shell.

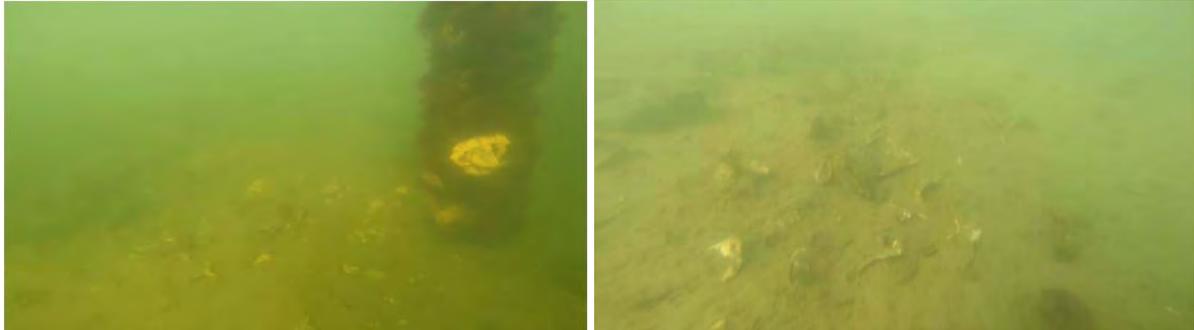
Moderate Debris is defined as covering approximately 25-75% of the visible estero floor. This generally consisted of numerous oyster shells under racks, but also wire and PVC pipe. Eelgrass is rarely in the moderate debris areas.

Moderate shell debris under rack 9C on 1/1/2015.

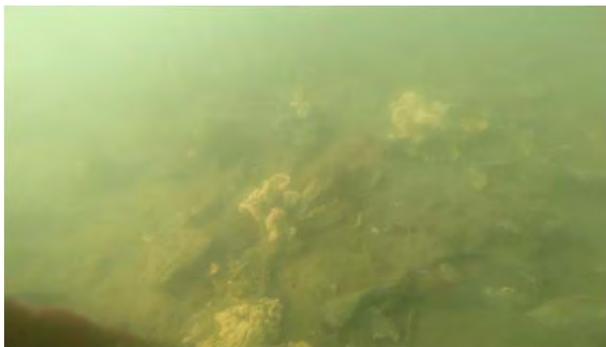
Upper end of moderate class of debris under rack 9C on 1/29/2015

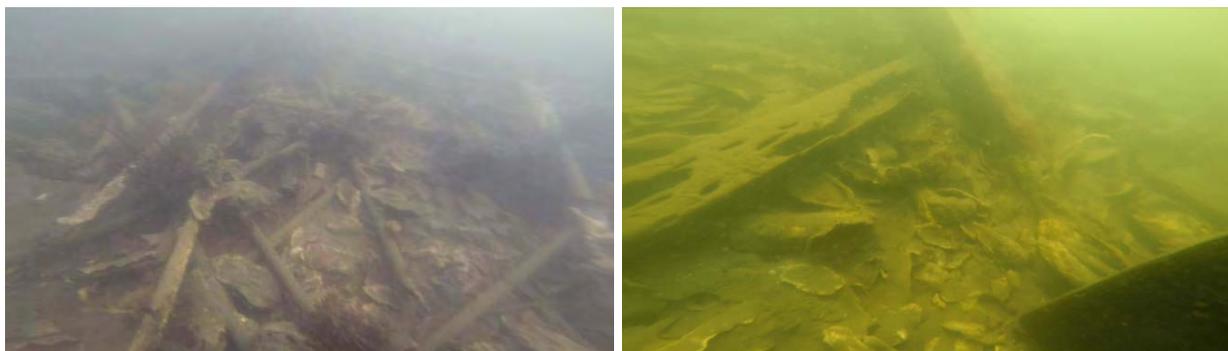
Heavy Debris is generally defined as having >75% cover, precluding eelgrass growth and covering most of the estero floor under a rack. This periodically includes large piles of oyster bags or French tubes that have fallen from the rack and almost always includes complete bottom coverage of oyster shell. It is unknown how deep into the sediment this debris may be.

Examples of heavy debris: (Left) oyster shell and French tubes under rack 6B on 1/29/2015, (Right) oyster shell under rack 22B on 1/30/2015.

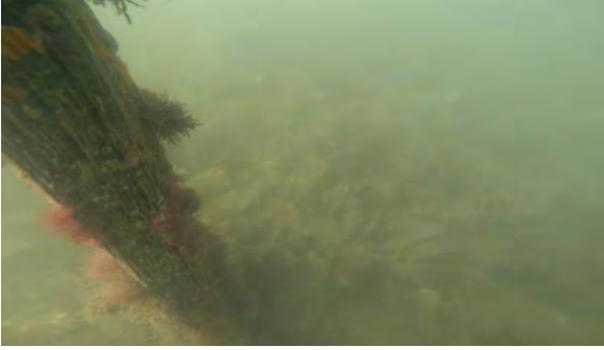
Heavy debris on rack 9C on 1/29/2015.

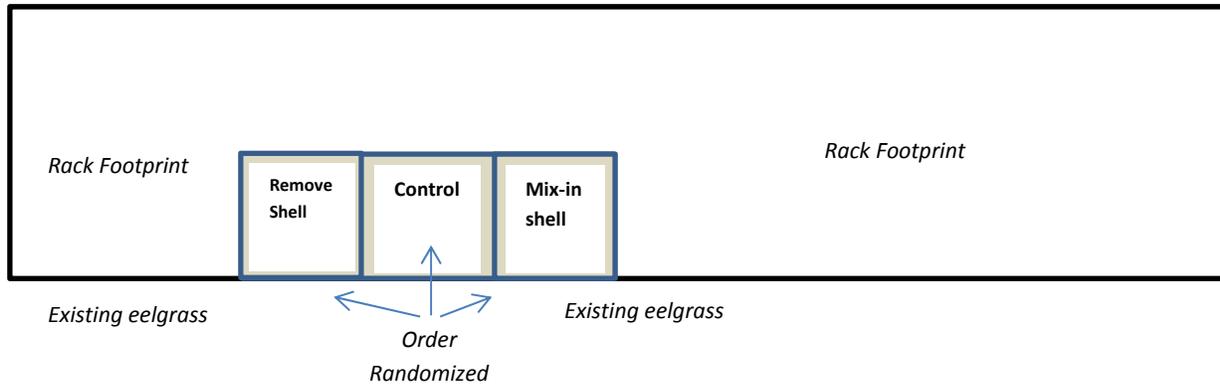
Figure 1. Experimental design showing treatments within the footprint of an oyster rack surrounded by existing eelgrass. Racks are 12' wide and each plot will be 3'X3" (Not to scale). This design will be replicated 10 times each in in areas of heavy and moderate oyster shell coverage.

All treatment plots will be conducted in a split plot design in groups of 3 (removal/mixing/control) to minimize location effects. The linear order of the treatments will be randomized and in no case be at the end of a rack, since the ends of racks could have existing eelgrass on 3 sides of the plot, whereas non-end plots would have pre-experiment eelgrass at most on two sides of the plot. Racks suitable for treatment 1, treatment 2, and control split plots are listed in Table 1. There are 11 potential racks that meet the needs for a heavy shell treatments, and 10 potential racks that meet the needs of the moderate shell treatments. Note that there is some variation in shell coverage classes under single racks, meaning that a heavy treatment may occur in one section of a rack, and a moderate in another section. Each plot will have the 4 corners marked with white ¾” PVC pipe that protrudes approximately 1.5 feet above and 3 feet below the bay floor to ensure easy and accurate relocation of plots. The top of the pipe marker will still be 2 feet below the water surface at most low tides. WAAS GPS will also be used to record all plot locations for relocation.

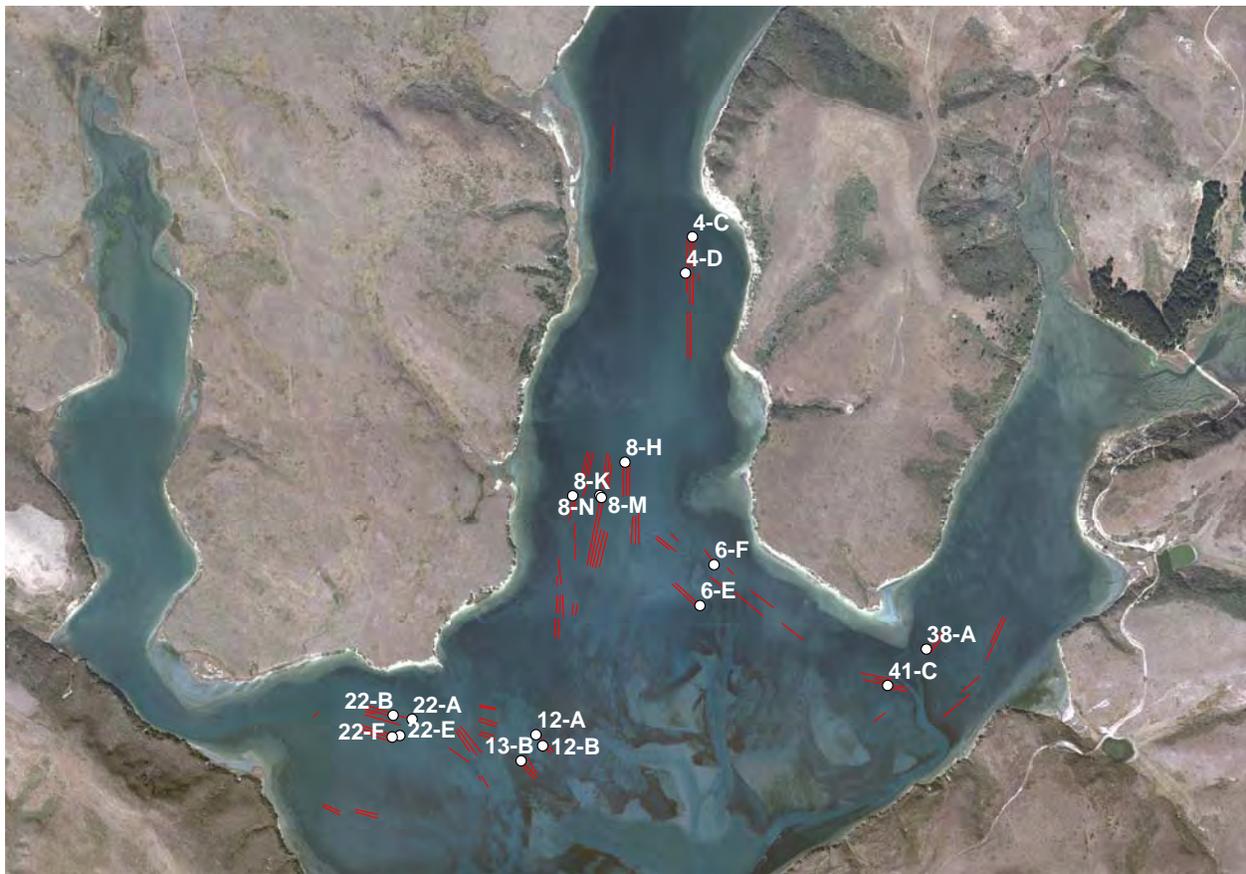
Figure 2: Rack Locations suitable (shell debris under racks and eelgrass growing adjacent) for potential experimental shell removal, shell mixing and controls. See Table 1 and text for details.

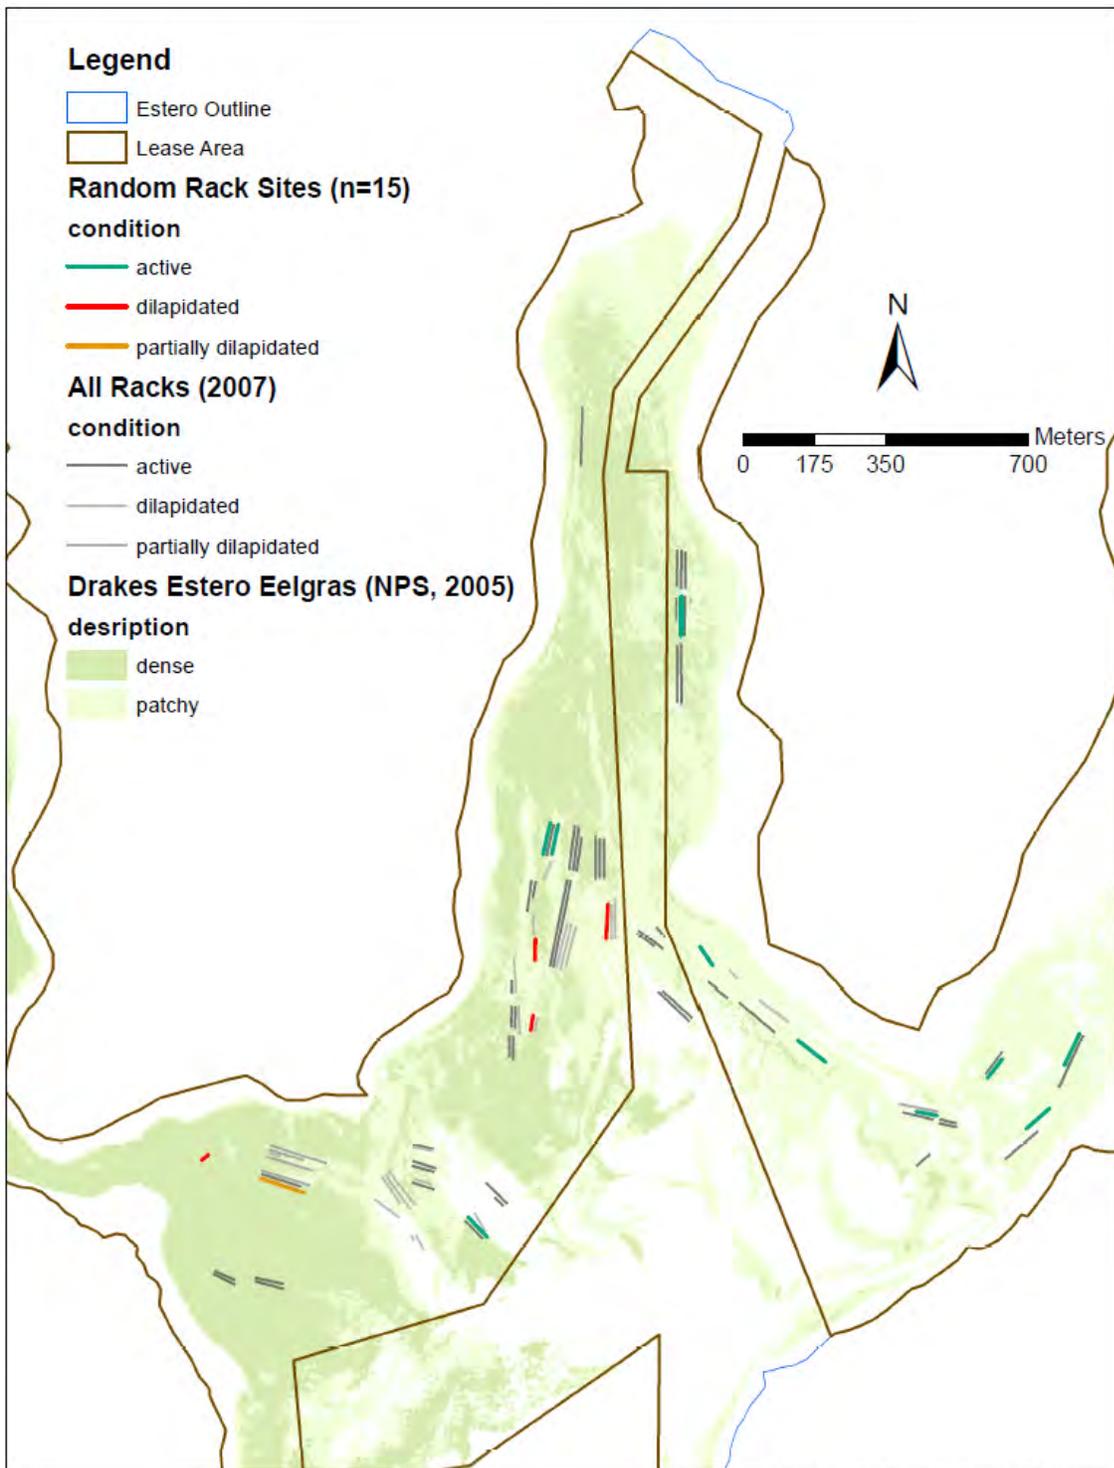
Figure 1. An example of 15 randomly selected survey sites including racks in good (Green) and poor (Red) conditions. Control sites will be randomly placed near treatment racks to ensure a valid comparison.

An example of a selection of oyster racks for survey is in Figure 1.
