Gray Cottage

Sagamore Hill National Historic Site
Oyster Bay, New York

Historic Structure Report

**James J. Lee III
Architectural Conservator
Historic Architecture Program
Northeast Region, National Park Service
Lowell, Massachusetts**

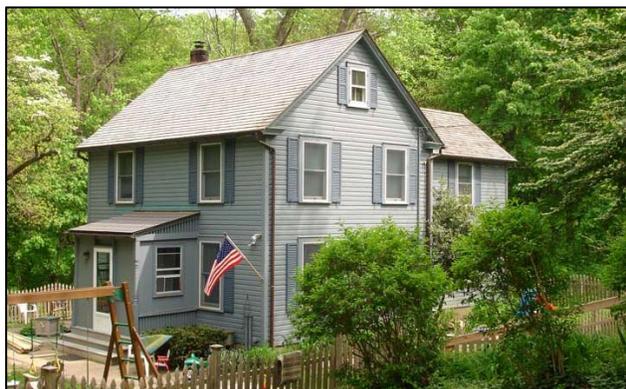
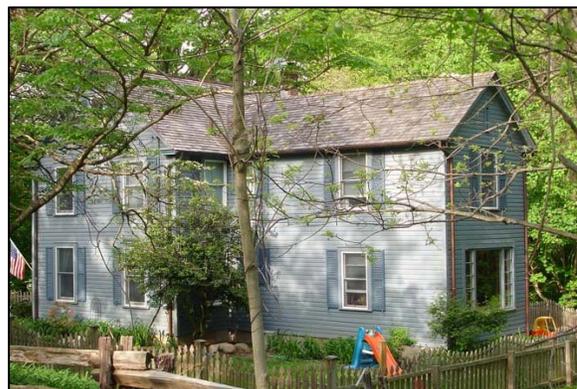
Figure 3. Gray Cottage looking southeast, 2009.

Figure 4. Gray Cottage looking northeast, 2009.

The current views of Gray Cottage depict the main/north block and south ell/1964 addition of the building (figs. 3 and 4). Gray Cottage is situated approximately 800 feet southeast of the main house in a low lying wooded lot. The following information is selected and cited from the current LCS data for Gray Cottage.¹⁵

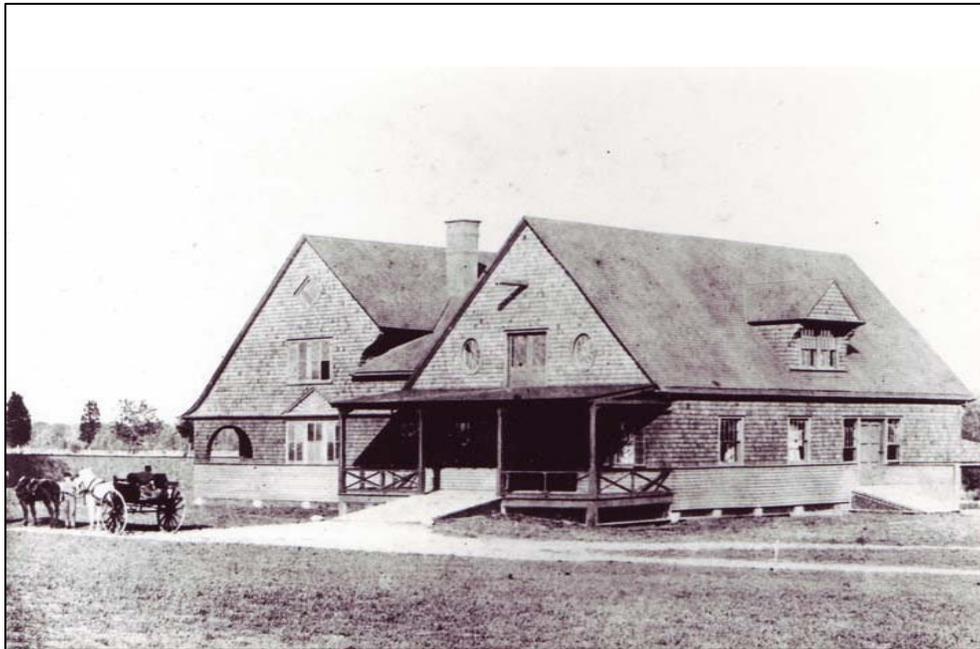
Figure 10. The west elevation of the Stable and Lodge at Sagamore Hill, circa 1905.

Theodore Roosevelt hired the architectural firm of Hugo Lamb and Charles A. Rich to design a stable and lodge for the property, which was designed in the popular Queen Anne-style of the Victorian period. Local builders, John A. Wood & Son, were contracted to build the Stable and Lodge in 1883 (fig. 10).³²

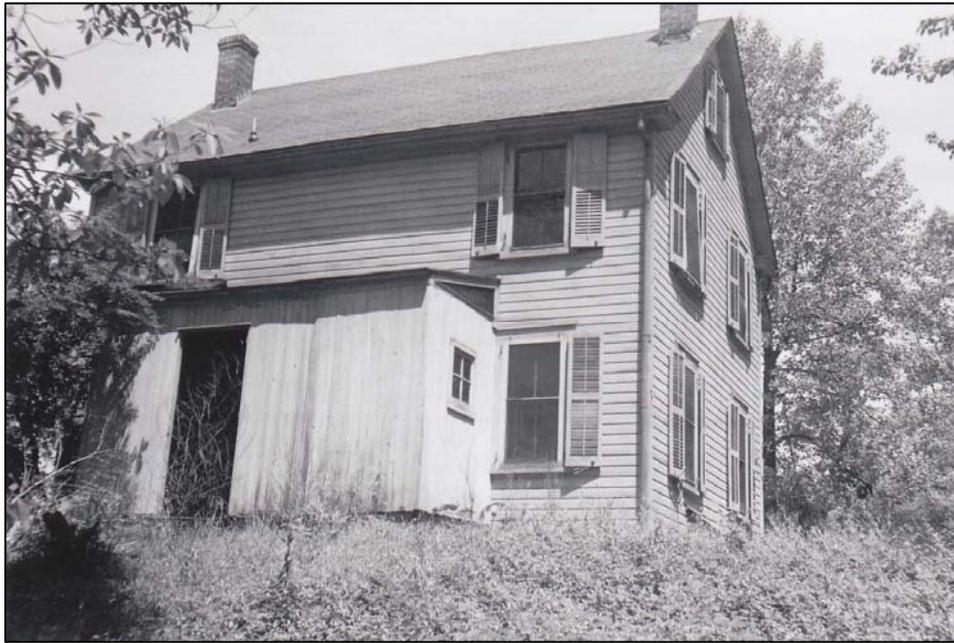
Figure 18. Gray Cottage, south and east elevations, 1950. The photograph depicts Gray Cottage prior to alterations by the TRA in the early 1950s, and is the earliest known photograph of the building.

Gray Cottage was not extensively documented when constructed or during the Roosevelt period. This was not unusual since the building was staff housing and was remotely located. The earliest known historic photograph was taken in 1950 for the Great American Insurance Company report prepared for Sagamore Hill (fig. 18). That photograph recorded portions of the south and east elevations of the historic structure. Another photograph taken in 1963 by the Historic American Buildings Survey (HABS) recorded the north and west elevations of Gray Cottage prior to NPS rehabilitation in 1964 (fig. 19). In addition to the historic photographs, HABS surveyed the building in December 1963, and prepared three pages of measured drawings of Gray Cottage in January 1964 (figs. 22, 23, and 24). Though this occurred after some renovations by the TRA the plans provide some information regarding the historic appearance. These documents, and descriptions of the building from appraisals, insurance reports, oral histories, and the 1964 *Historic Structures Report, Part I, The Gray Cottage*, by John A. Townsley and John B. Lukens, were helpful in determining the original

Both the 1950 insurance photograph and description indicated that there was an enclosed porch on the south elevation at that time (fig. 18). The porch was later removed by the TRA and no further documentation of the south porch exists. The south porch was probably constructed as an open porch and enclosed when the front porch was enclosed. However, there was no extant evidence of that porch to determine the original configuration.

The earliest known documentation of the upper-story window openings is the 1950 historic photograph (fig. 18). That photograph depicts the window openings with double-hung, two-over-two sashes. The window openings including the attic windows had flat board casings,

Enclosing the front porch appeared to be the most significant exterior change during the historic period. The 1950 insurance photograph indicated that the back porch was also enclosed (fig. 18). That was evident from the presence of shutter hardware but the absence of the shutter on the first-story window opening (W104). The alterations to the back porch may have coincided with the work on the front porch. Paint evidence indicated that Gray Cottage was routinely painted on a schedule that probably coincided with the painting of other buildings on site (Appendix A, Exterior Paint Analysis). The physical evidence suggested that there were no other significant alterations to the exterior of Gray Cottage during the Roosevelt period.

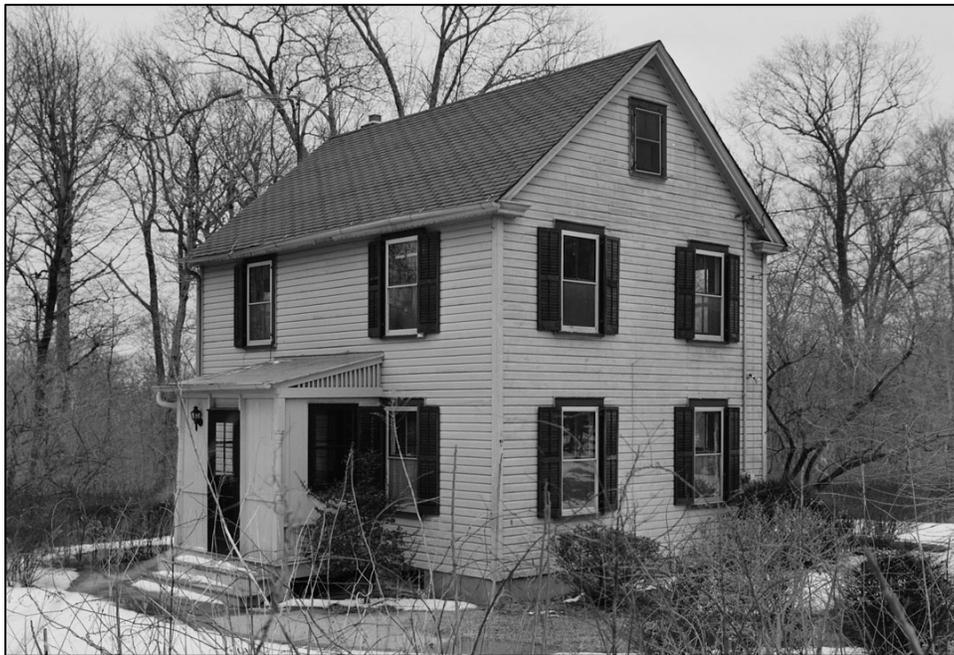
Figure 19. Gray Cottage, north and west elevations, 1963. The photograph depicts the original two-story, side-gabled structure with some alterations.

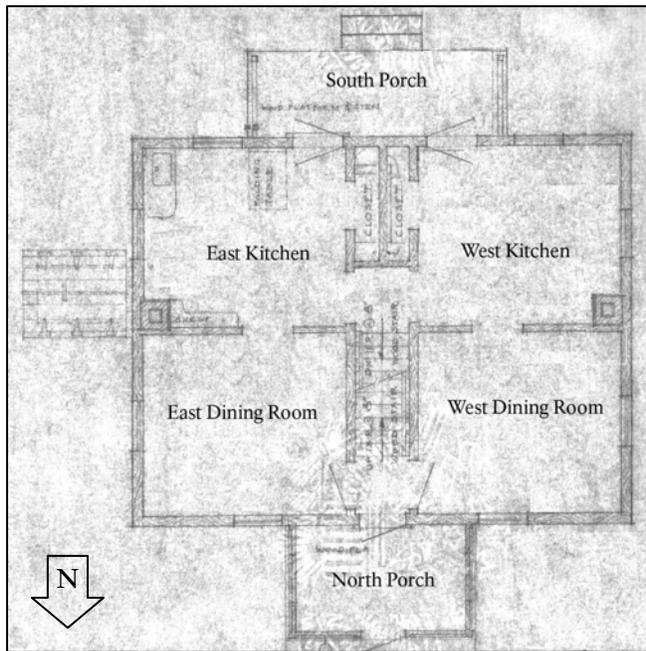
Figure 20. Gray Cottage, conjectural historic plan of first story.

Historical accounts and some physical evidence suggested that the first story of Gray Cottage was configured for two apartments. The front doorway (D102) opened into a small foyer that had a doorway on the east wall (D105), and one on the west wall leading to the respective apartments. The foyer also had access to the center staircase that ascended to the second-story hallway.

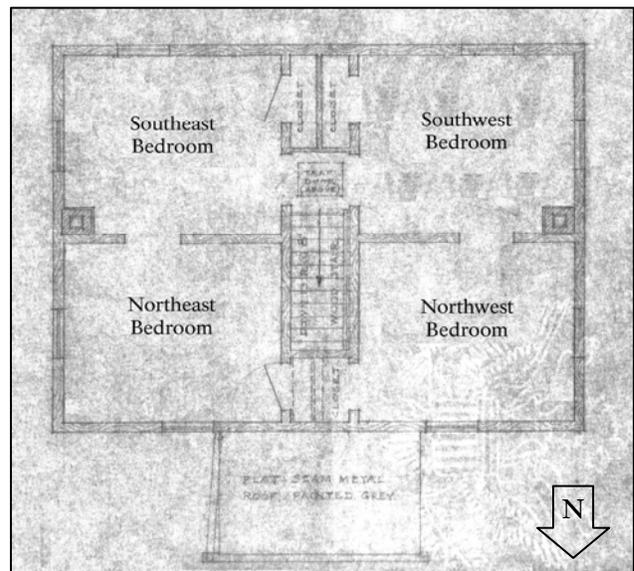
Figure 21. Gray Cottage, conjectural historic plan of second story, depicting a common hallway and staircase with separate bedrooms.

According to Lukens's description of the second story, the west side of the building retained the original two rooms with the addition of a bathroom in the southeast corner of the southwest room (fig. 21). The bathroom and associated partitions were added during the historic period, and were recorded in the 1950 and 1963 documents. The extant physical evidence indicated that the original layout of the west side rooms included a closet doorway in the northeast corner that accessed a common closet (D205). It was conjectured that the east and west sides of the second story had a similar plan when first constructed, which was supported by Lukens's observations. However, the configuration of the living space on the second story was not documented prior to 1950.

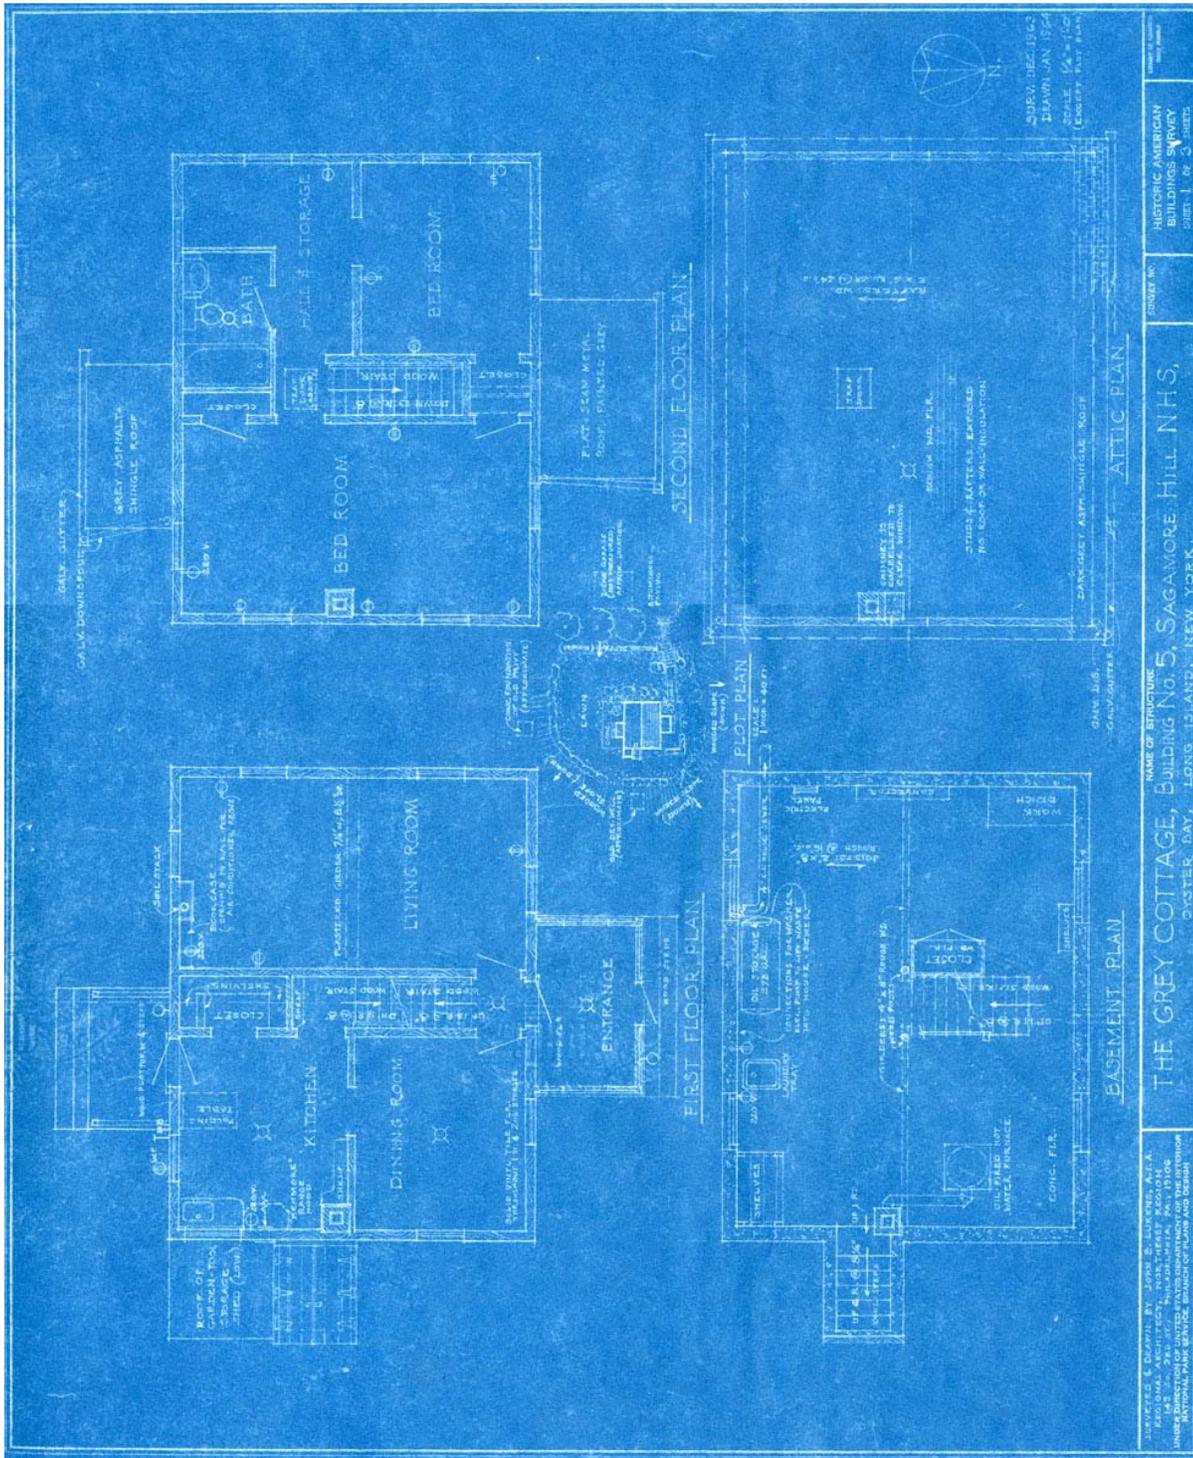
Figure 22. The Grey Cottage, Building No. 5, Sagamore Hill NHS, Historic American Buildings Survey, Sheet 1 of 3 sheets. Reproduced from full-size blue print, not to scale.

The plan of the first story as a single-family residence was documented by the HABS drawings (fig. 22). The 1950 insurance description provided documentation of the building during the historic period and described a single-family home.⁹¹

The description of the building in 1950 does not vary significantly from the building depicted in the 1963/64 HABS plans. Thus it seemed likely that the floor plans depicted in the HABS drawings were similar to the historic layout after the earlier alteration of Gray Cottage from a two family to a single-family residence. The HABS drawings and photograph documented the existing building when the NPS established Sagamore Hill NHS.

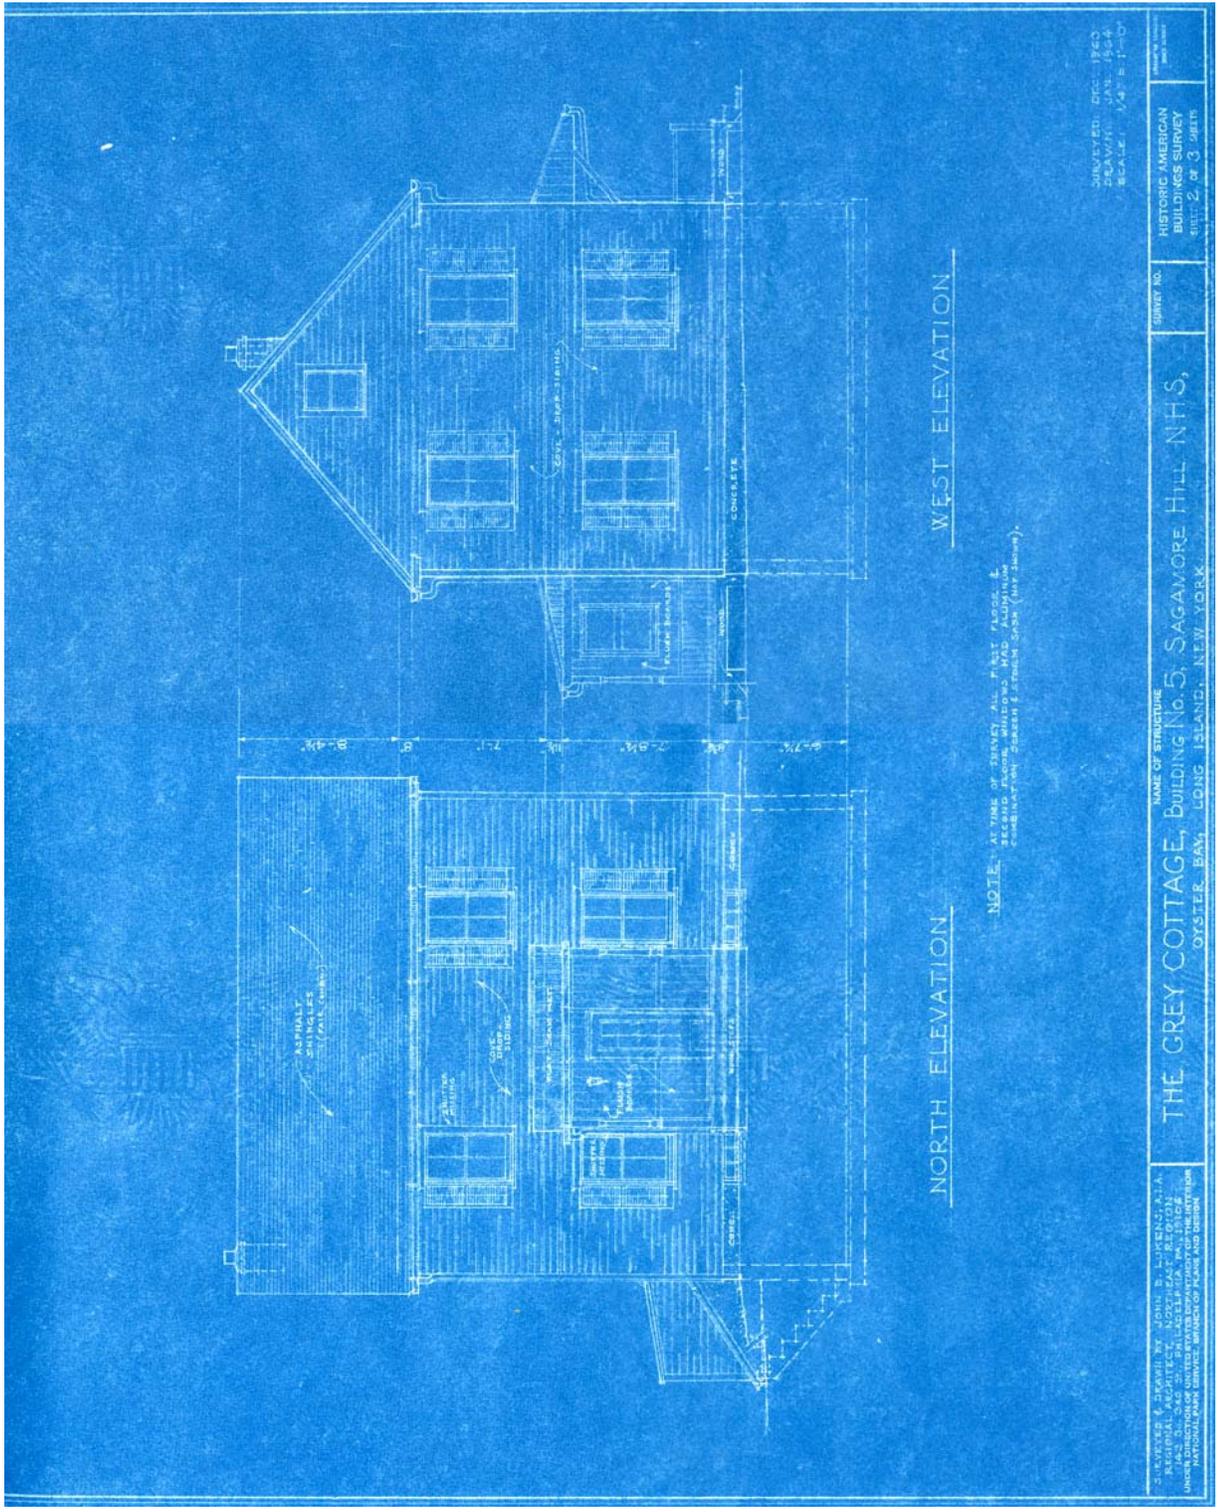
Figure 23. The Grey Cottage, Building No. 5, Sagamore Hill N.H.S., Historic American Buildings Survey, Sheet 2 of 3 sheets. Reproduced from full-size blue print, not to scale.

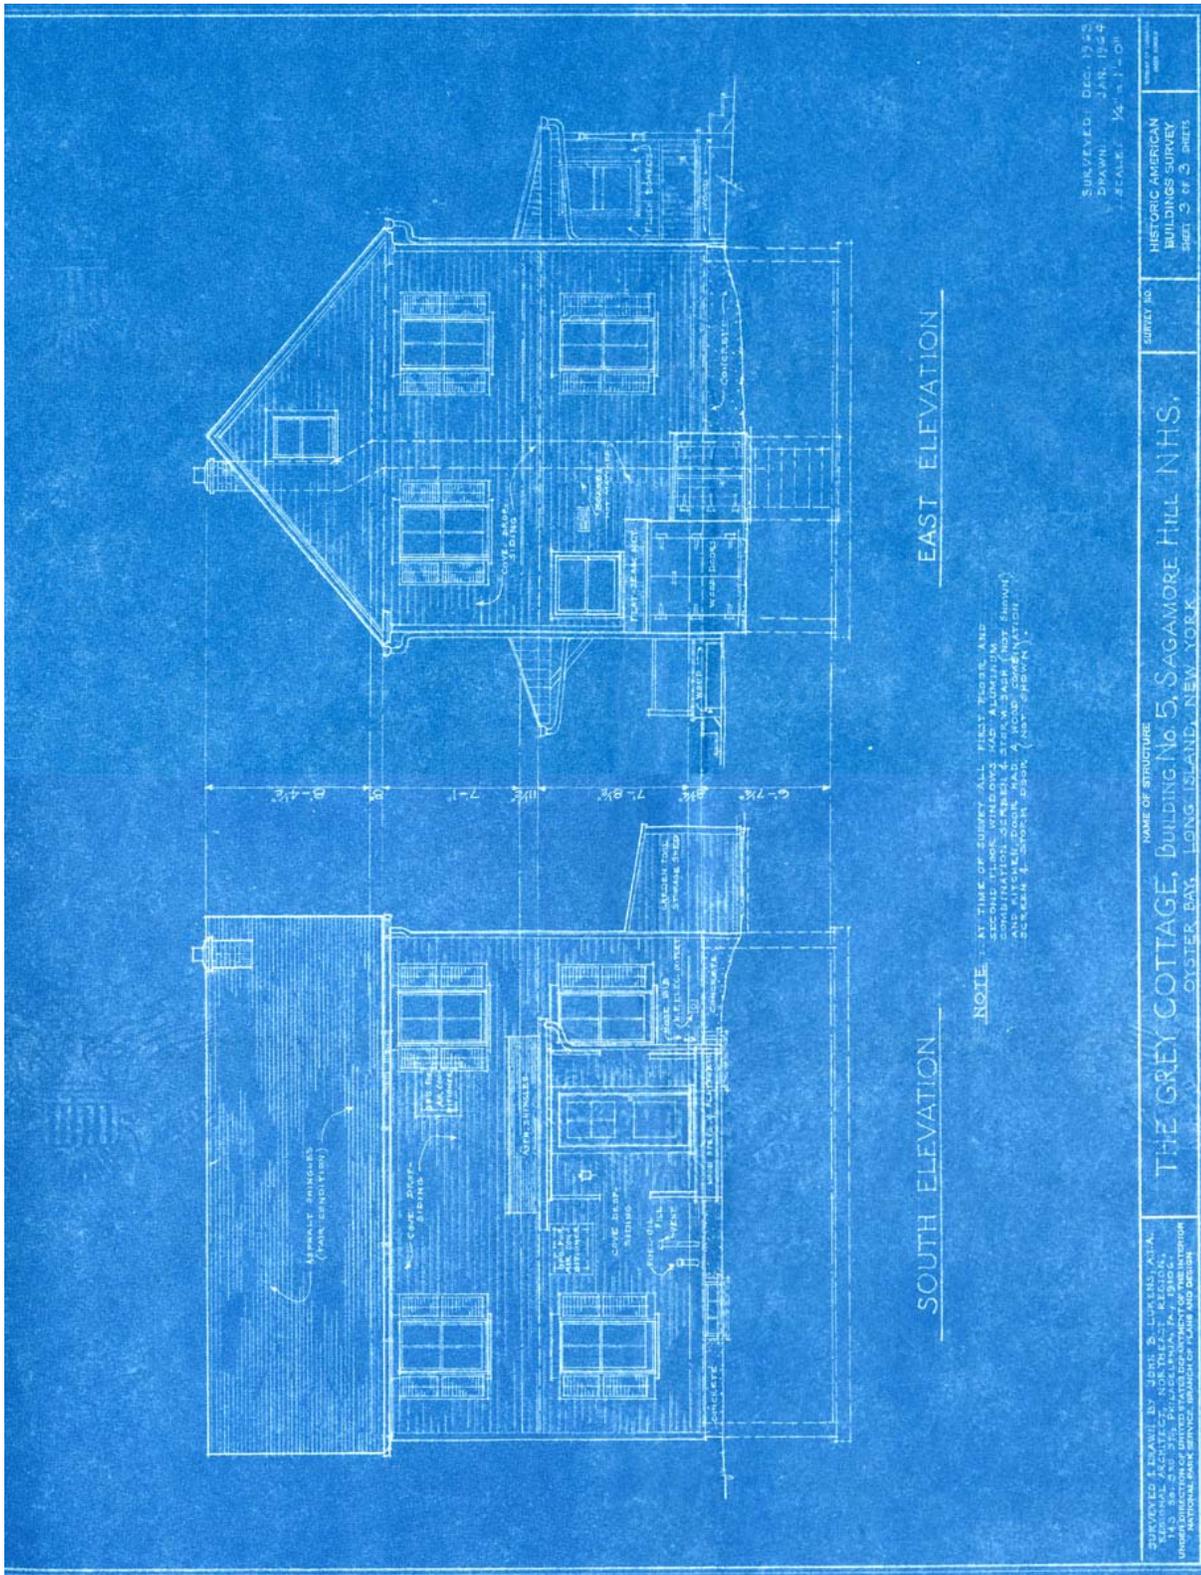
Figure 24. The Grey Cottage, Building No. 5, Sagamore Hill NHS, Historic American Buildings Survey, Sheet 3 of 3 sheets. Reproduced from full-size blue print, not to scale.

The east side of the first story had two rooms that were described in the 1950 insurance report and documented in 1963/64 drawings (fig. 24). The same documents indicated that the historic use of the two rooms was as a dining room in the northeast room and a kitchen in the southeast room. It was conjectured that the historic use of the rooms as described in 1950 had not changed significantly from the original construction of the separate apartments. The northeast room was possibly used as both a dining room and sitting room when there were two separate apartments in Gray Cottage.

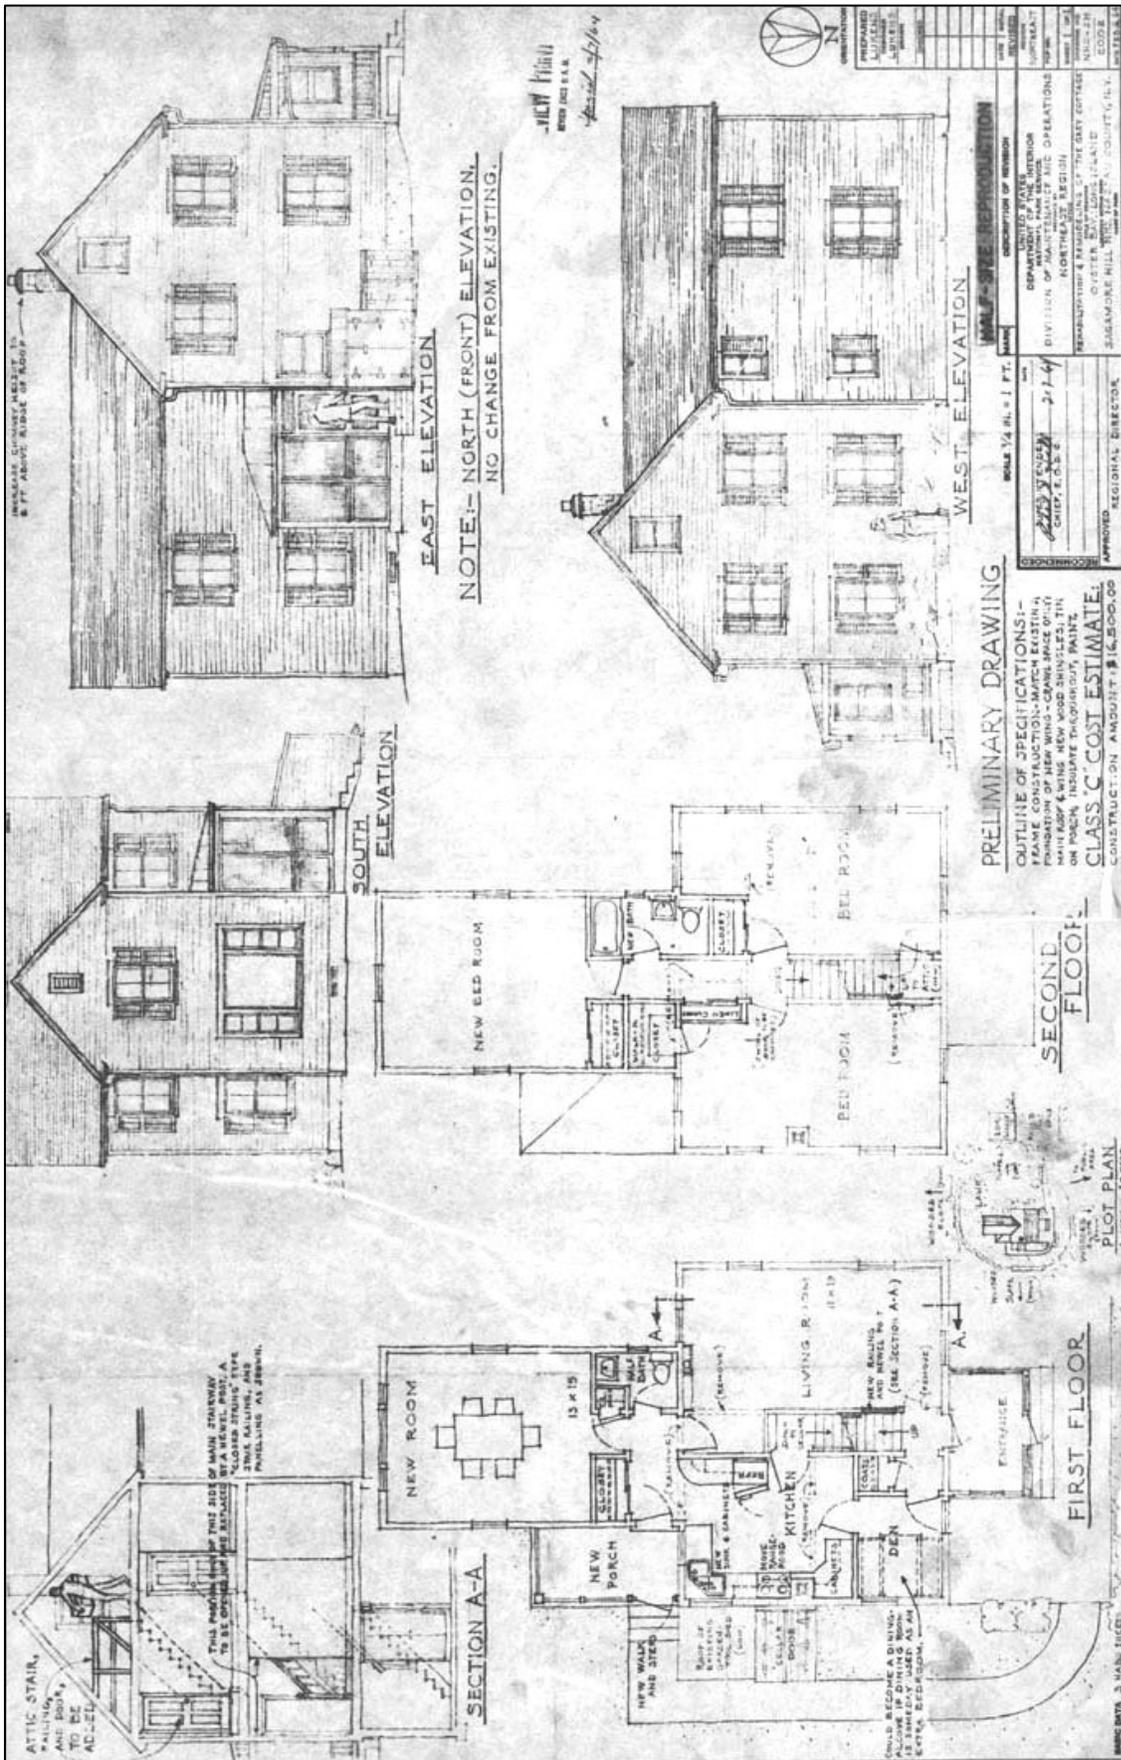
Figure 25. Preliminary drawings of Gray Cottage rehabilitation by John Lukens, NPS Architect, February 1964. Reproduced from half-size reproduction, not to scale.

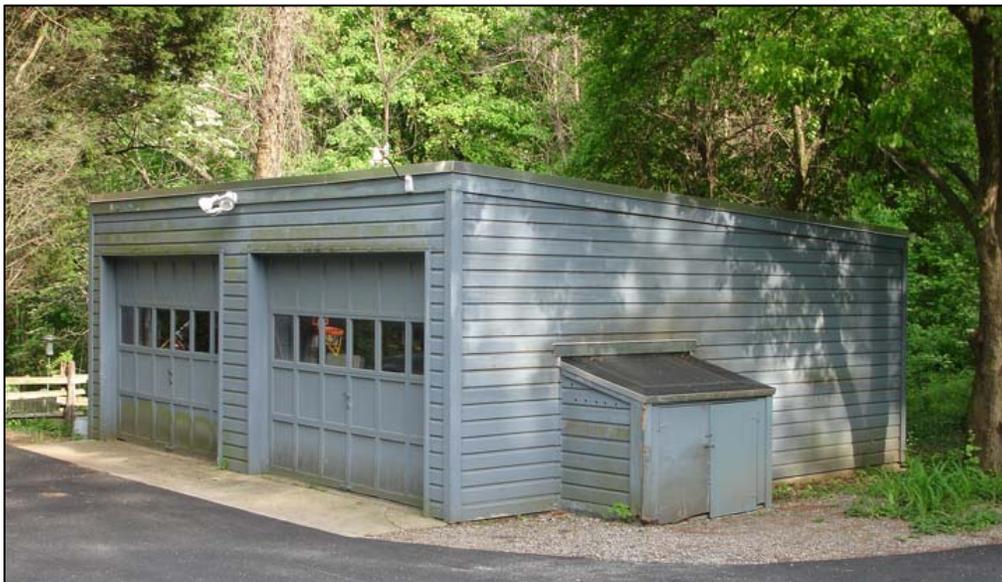
Figure 32. Gray Cottage Garage, looking southeast, 2009.

Approximately 50 feet west of Gray Cottage is a two car garage adjacent to the paved parking area. The garage was constructed by the TRA in the 1950s to serve the parking needs of the Gray Cottage residents. The garage is set on a concrete pad and measures 22 feet 3 inches wide (east-west) by 20 feet 3 inches long (north-south). It is sided with drop siding and has sections of replacement siding on the south and east elevations up to the southeast corner. The replacement siding is constructed with textured plywood (T111) designed to resemble vertical siding. The garage is trimmed with plain boards at the corners and along the roof line. It has a shallow pitched shed roof that is currently covered with membrane roofing material with an aluminum drip edge. Two overhead roll-up garage doors are located on the north elevation. These are four section doors with stiles and rails forming six panels in each section and one section of fixed glass panes. A small storage shed constructed with similar materials is appended to the west elevation of the garage in 1967.

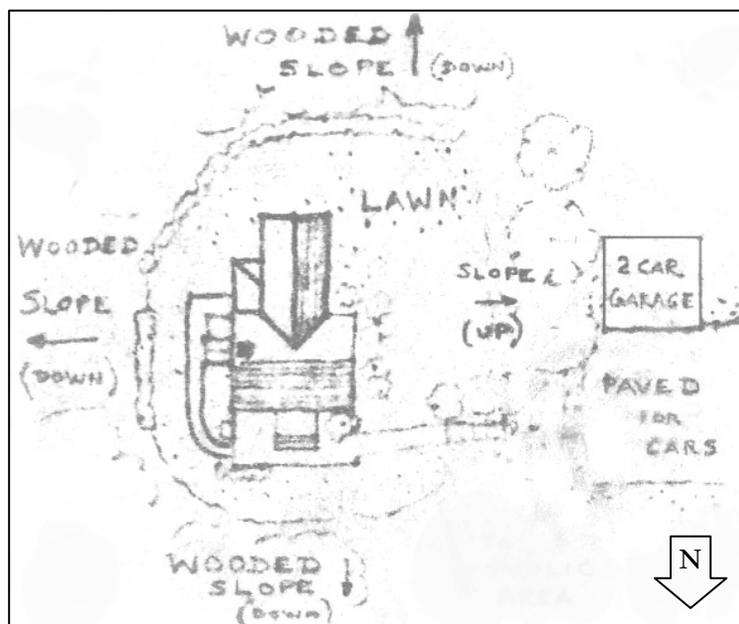
Figure 33. Gray Cottage plot plan depicting building, garage, paved parking area, and landscape features and slopes, 1964.

Gray Cottage is set on a low-lying wooded lot that slopes down from west to east. There is a paved approach driveway that leads east from the visitor parking lot to a level paved parking area west of the building. Concrete steps with a wooden railing along the south side lead down to a concrete walkway and the yard. The yard at Gray Cottage is enclosed by a wooden picket fence with a gate near the base of the steps. Proceeding through the double gate, the concrete walkway leads to the north elevation of the building. A wide concrete pad spans the entire length of north elevation of the building, and extends from the foundation about 12 feet north into the yard. On the east side of the concrete pad the concrete walkway continues around the east elevation of the building and leads to the east porch steps. A bluestone patio, portions of which are bordered by concrete curbing, is installed on the east side of the building.

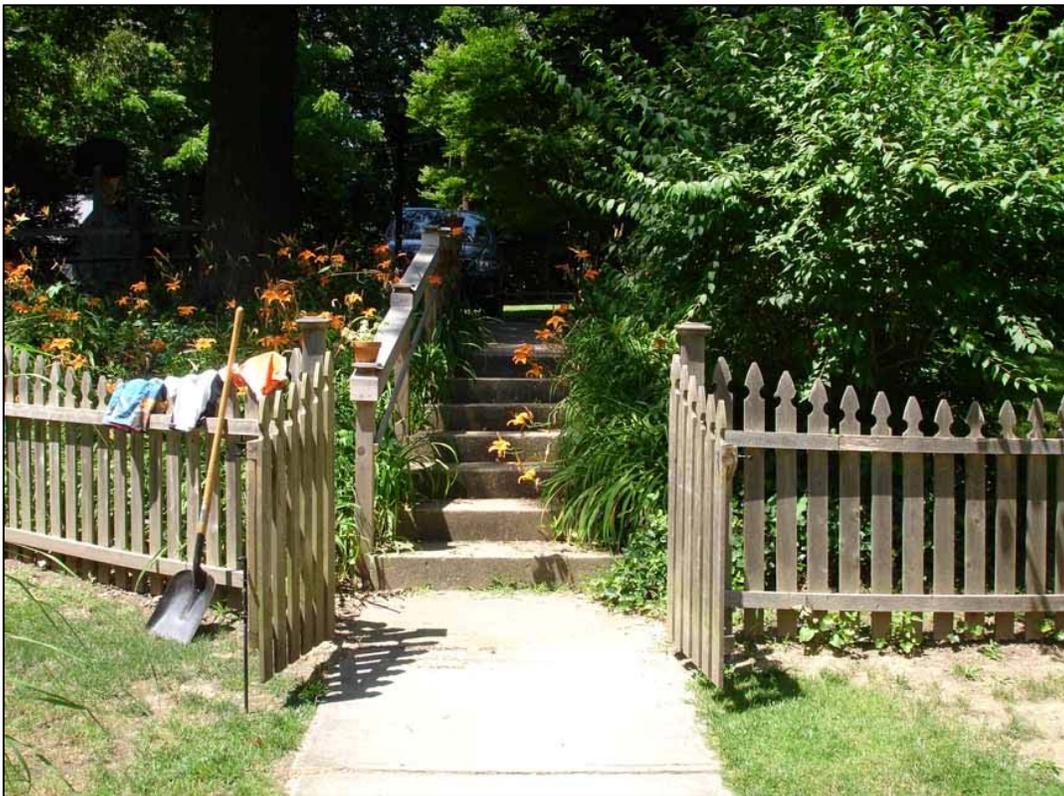
Beyond the fenced in yard the land slopes down on the south and east sides. In those areas there is dense ground vegetation and mature trees. The north side has a more gradual slope and is also wooded. West of the picket fence the land slopes up toward the parking area and is covered with dense ground vegetation. Grass and trees are planted on the north side of the driveway and approach steps. South of the steps a post-and-rail fence running north-south is installed at the top of the slope.

Figure 34. Gray Cottage, concrete walkway, steps, and wooden fences west of the building.

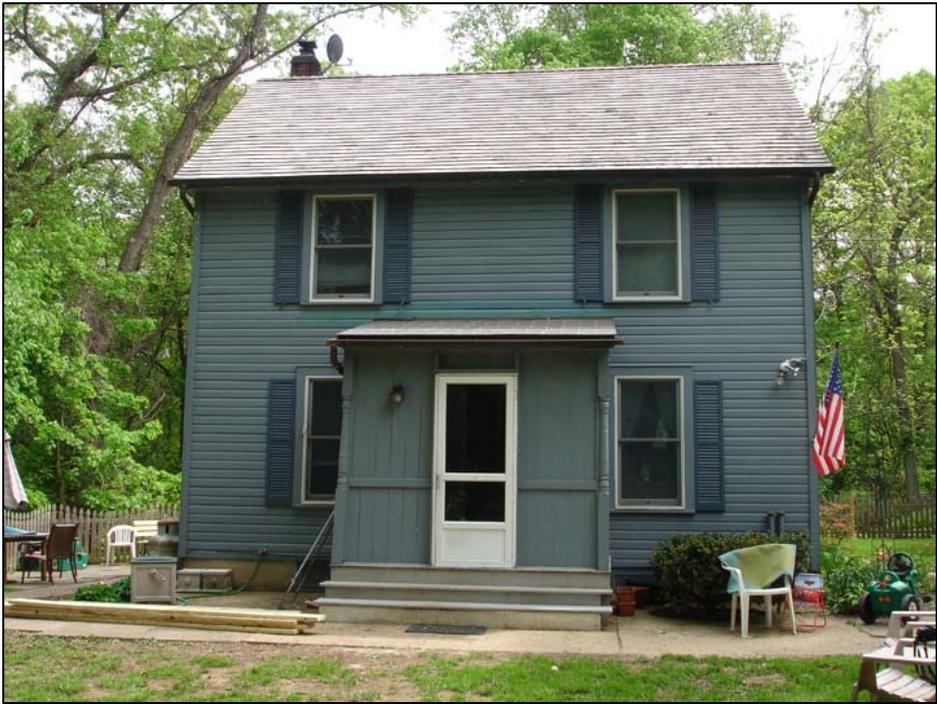
Figure 35. Gray Cottage, north elevation, 2009.

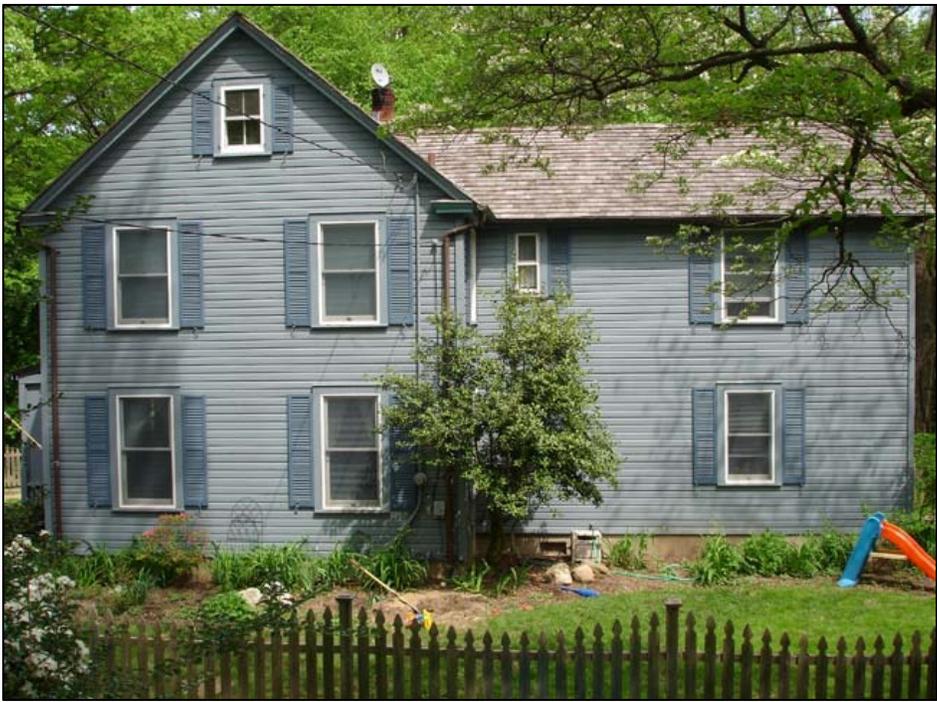
Figure 36. Gray Cottage, west elevation, 2009.

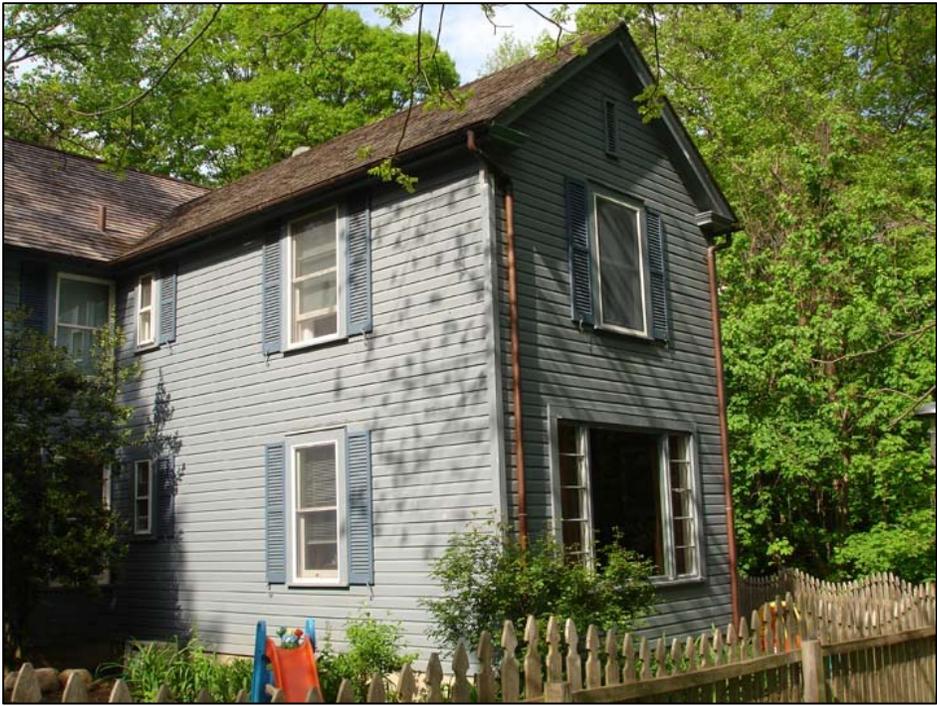
Figure 37. Gray Cottage, west and south elevations of ell, looking northeast, 2009.

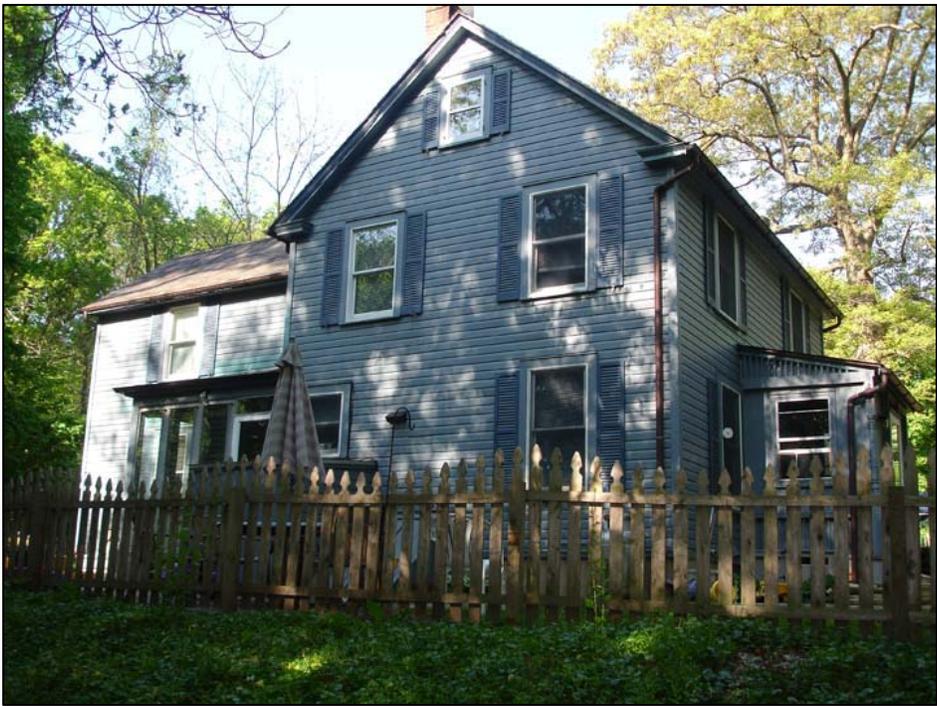
Figure 38. Gray Cottage, east elevation, 2009.

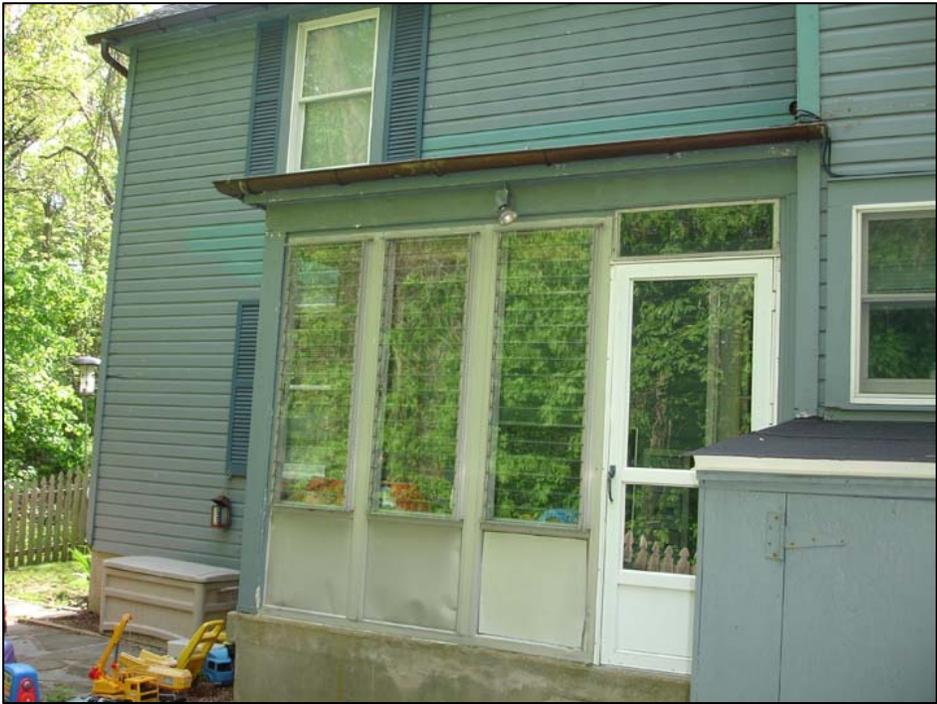
Figure 39. Gray Cottage, east elevation enclosed porch, 2009.

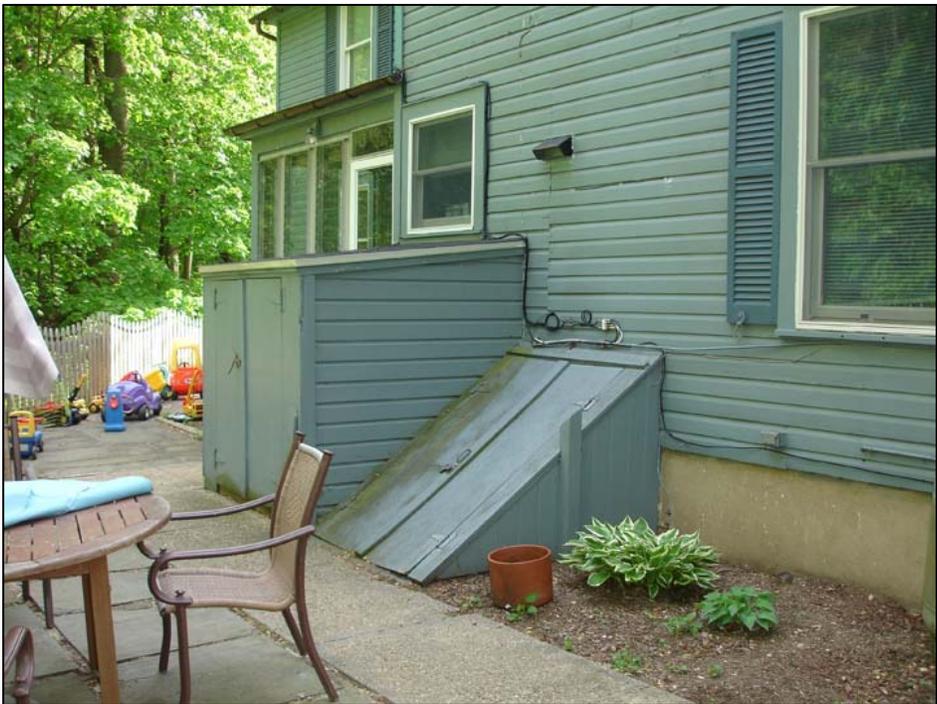
Figure 40. Gray Cottage, east elevation bulkhead and storage shed, 2009.

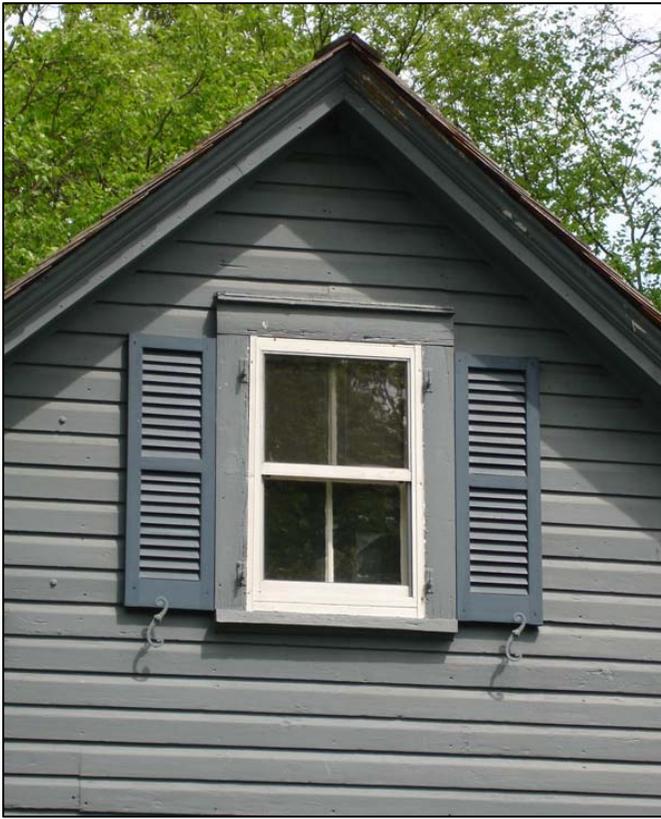
Figure 41. Gray Cottage, west elevation gable window opening, 2009.

Window Opening Number	Window Location and Description
W301 & W302	Location: main block, east and west gable ends, attic. Description: The window openings for the attic are 2 feet 2 inches wide by 3 feet 2 inches high. The exterior casings, heads, beveled caps, and sills of W301 and W302 are typical for the main block and both have cove moldings below the window sill (fig. 41). Both window openings have double-hung, two-over-two wood sashes with aluminum combination storm windows. Two louvered shutters with shutter dogs are fastened to the sides of each opening. The side casings have shutter pintles that are not used by the current shutters.
Vent Opening	Location: ell, south elevation gable, attic. Description: This is a narrow opening with a louvered wooden vent. The opening is framed with plain boards, a canted sill, and has a cap over the head.

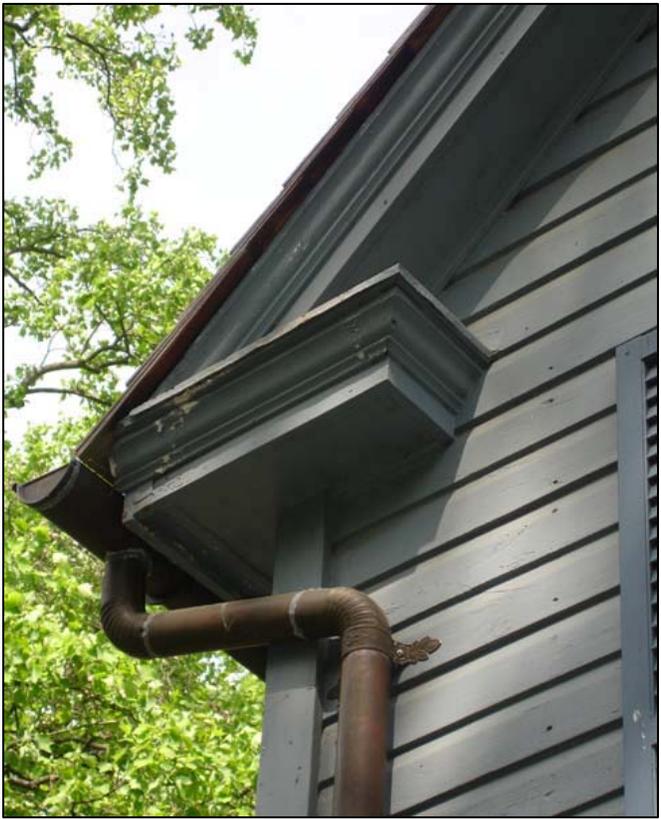
Figure 42. Gray Cottage, west elevation cornice return and molded rake board, 2009.
