Gray Cottage

Sagamore Hill National Historic Site
Oyster Bay, New York

Historic Structure Report

**James J. Lee III
Architectural Conservator
Historic Architecture Program
Northeast Region, National Park Service
Lowell, Massachusetts**

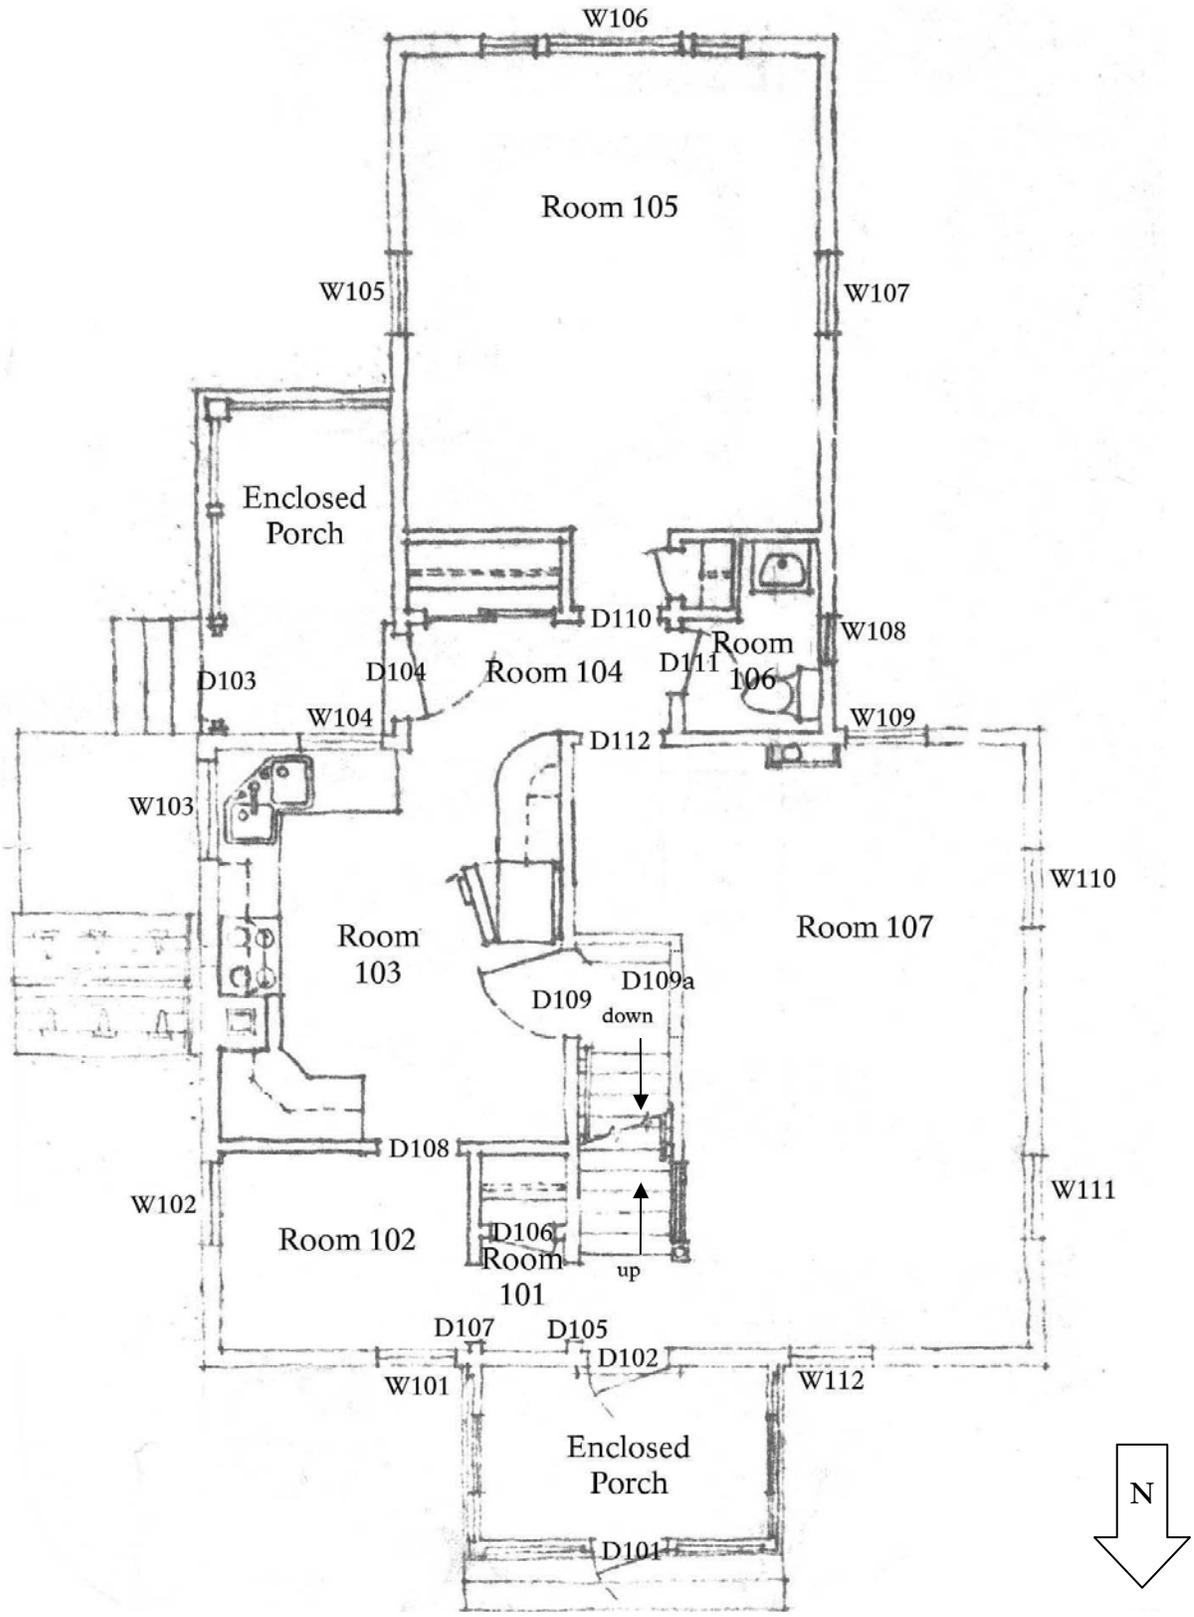
Figure 43. Gray Cottage, first-story floor plan with room, doorway and window opening numbers assigned for the current project.

The following descriptions make reference to some room, doorway, and window opening numbers that were assigned for the current project (figs. 43 and 44). The numbered drawings were based on the extant structure and are representative of the existing elements. The first and second story numbered plans are included in the “Current Physical Description.”

The layout of the kitchen is depicted in the current plans of Gray Cottage (fig. 43) and most of the built-in elements appear to date from the 1964 renovations. Base cabinets are installed along the north, east and west walls and at the south end of the west wall. The base cabinets are constructed with plywood and have plywood doors with brass handles and small butt hinges. The narrower doors in the northeast corner and at the south end are constructed with screened panels within stile and rail frames. Similar screened panels were installed at the west ends of the north and south base cabinets. At the south end of the west wall cabinets is curved open shelving. Formica counter tops with a Formica backsplash are installed on top of the base cabinets. In the northwest corner of the room is a more recently installed counter top with a dishwasher stored beneath it. Upper cabinets are installed above the counter tops except for the sections in the southeast corner near the window openings. The upper cabinets were also constructed with plywood. The upper cabinets along the west wall have glass doors and curved open shelves in the south corner. The tops of the upper cabinets are constructed with a molded trim with a fillet and cavetto profile. The upper cabinets do not extend to the ceiling and the gap to the ceiling is in-filled with gypsum board.

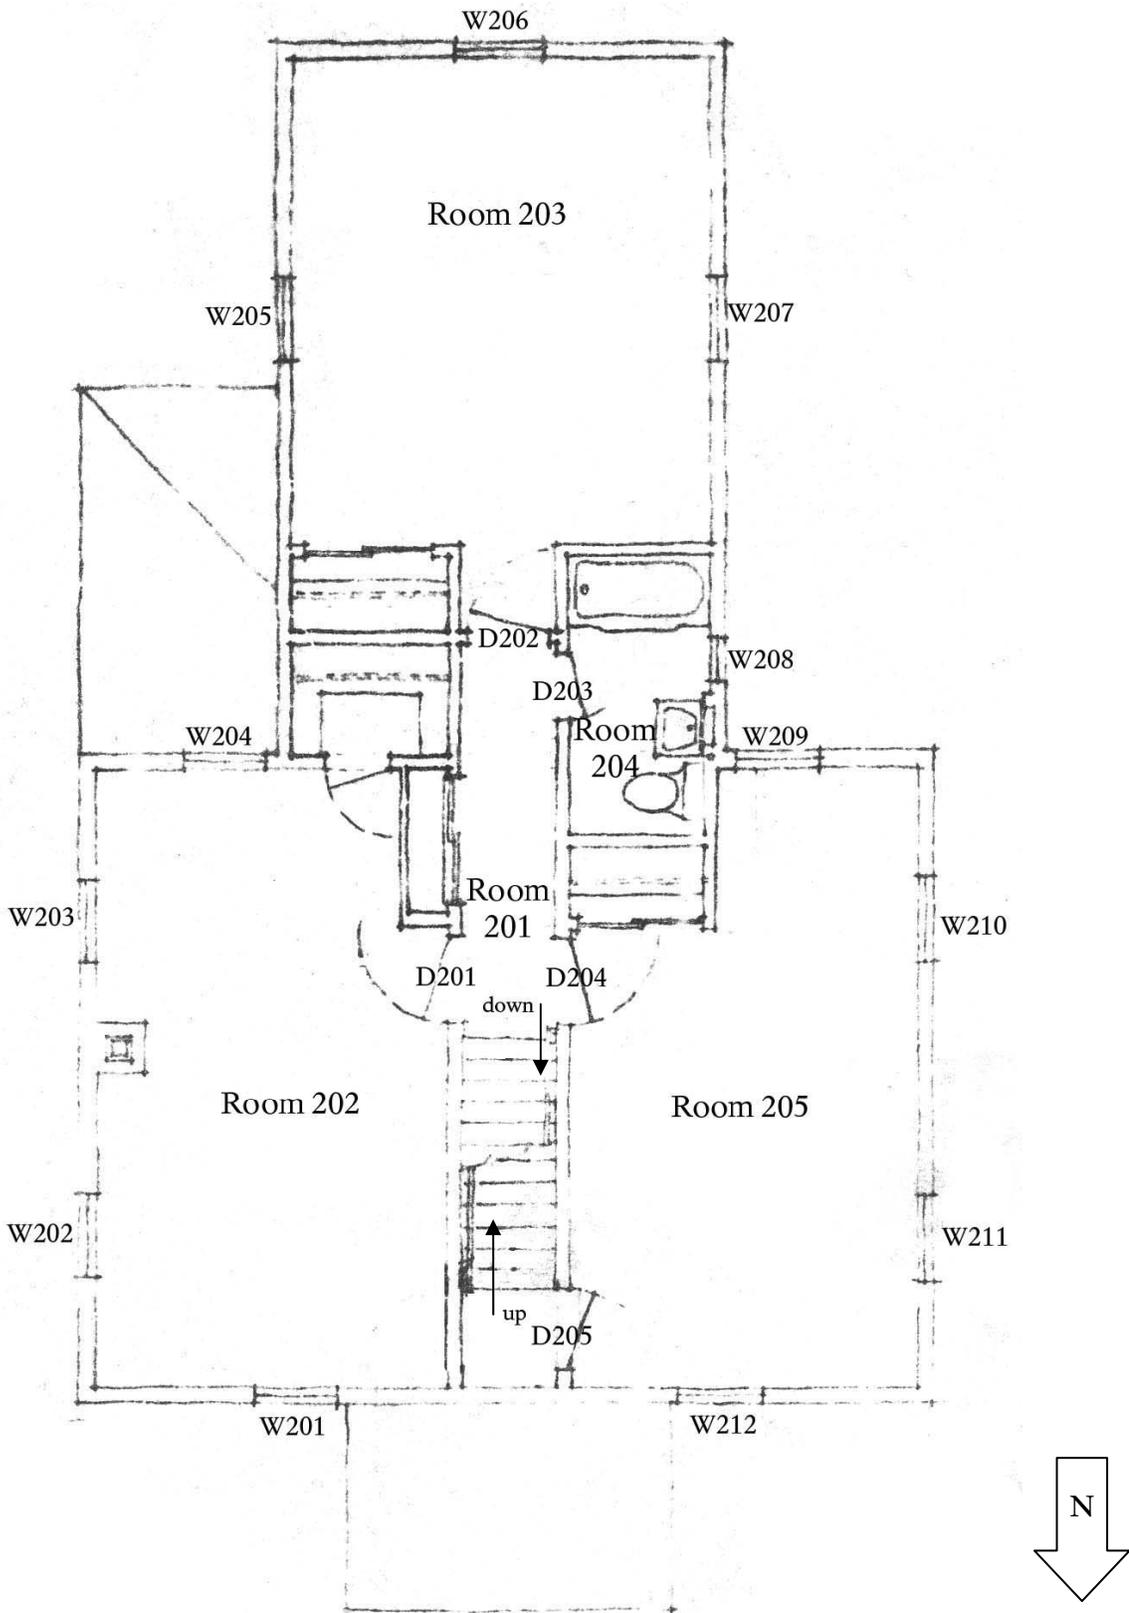
Figure 44. Gray Cottage, second-story floor plan with room, doorway and window opening numbers assigned for the current project.

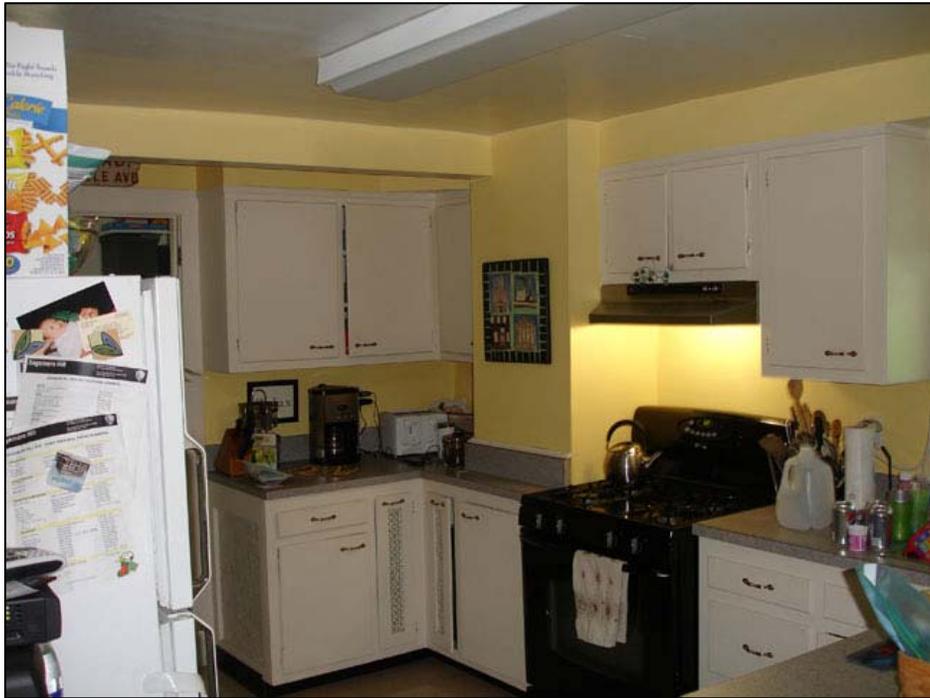
Figure 45. Gray Cottage, Room 103, kitchen, north and east elevations, 2009.

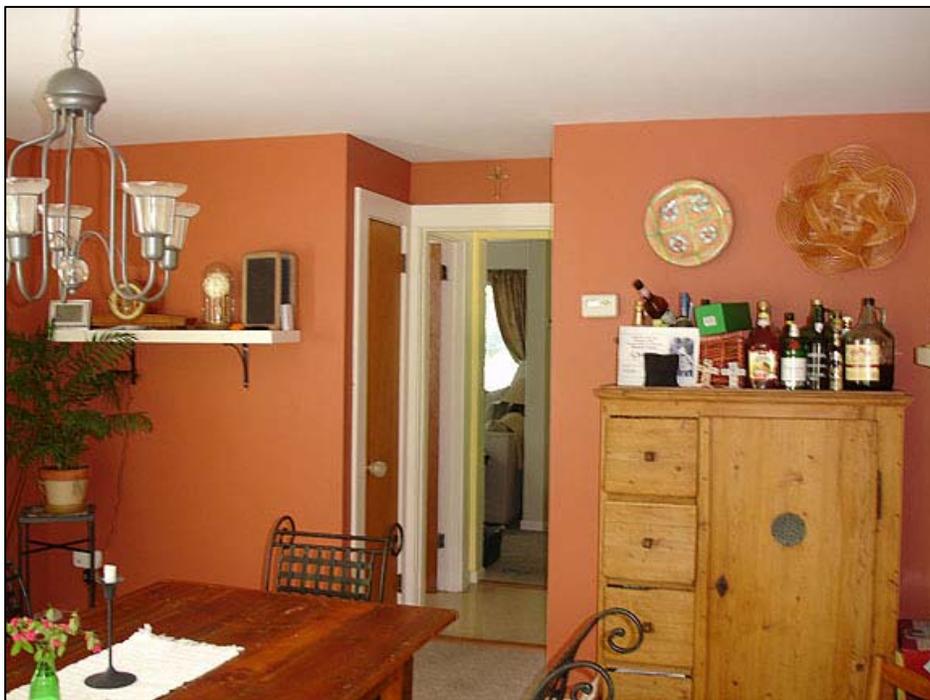
Figure 46. Gray Cottage, Room 105, dining room, north elevation, 2009.

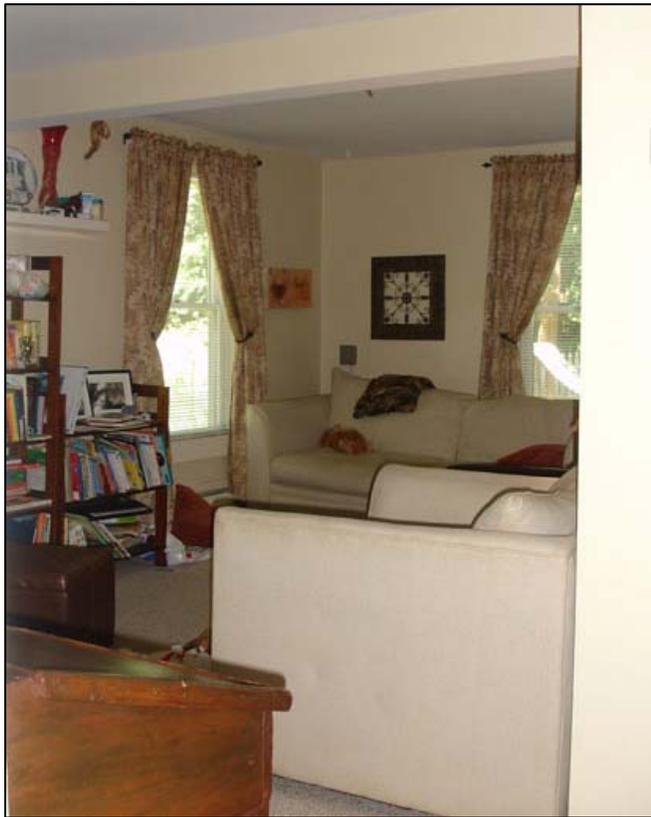
Figure 47. Gray Cottage, Room 107, living room, north and west elevations, 2009.

Room 107 has four window openings that have the typical vinyl-clad wooden replacement sashes. All of the window openings (W109, W110, W111, and W112) are trimmed with 4¾ inch casings, heads, and sills. W109 has a narrower 3 inch east casing that abuts the pipe chase.

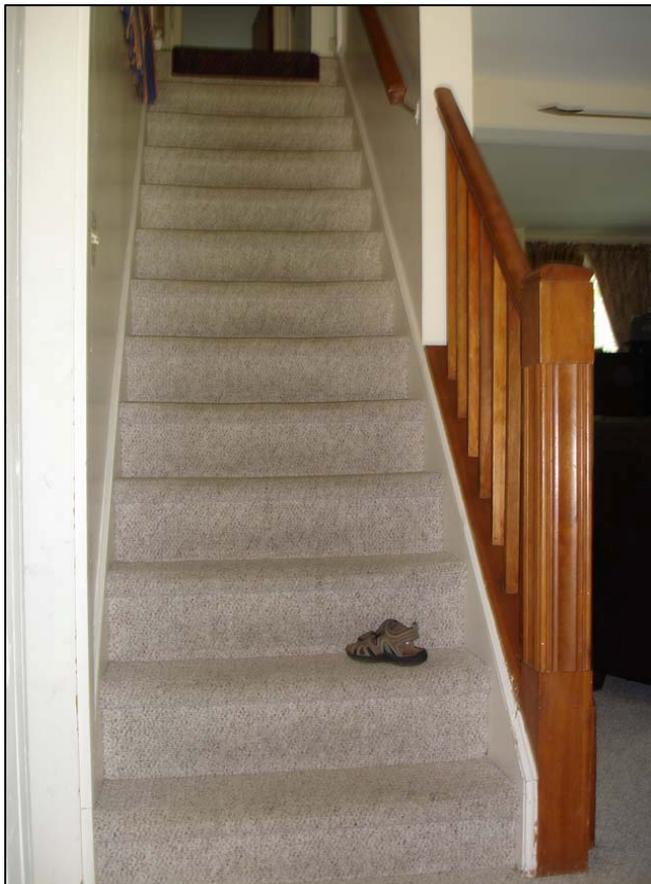
Figure 48. Gray Cottage, Room 107 staircase to second story, 2009.

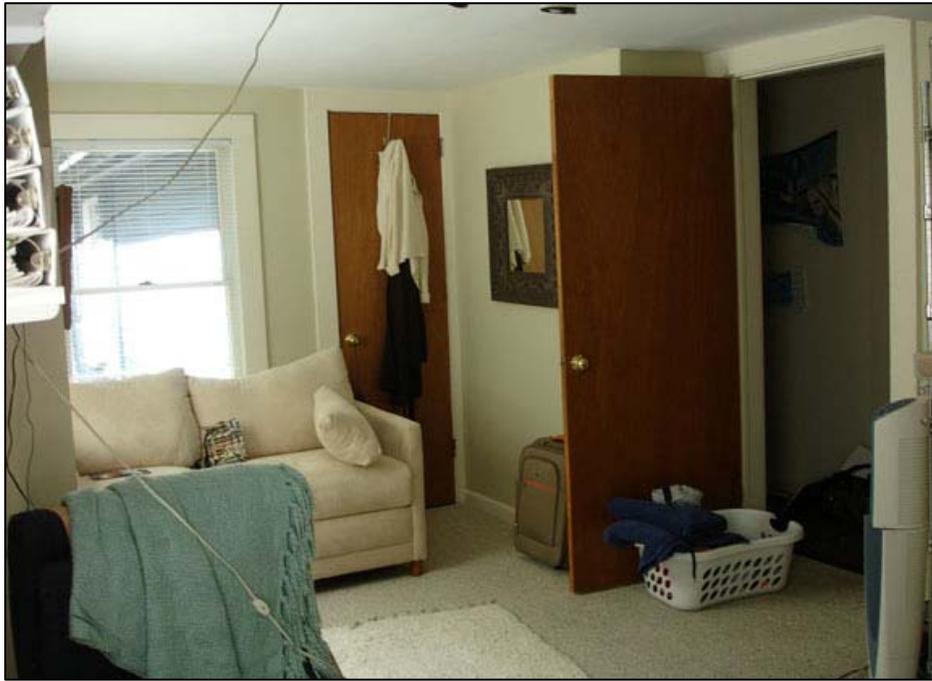
Figure 49. Gray Cottage, Room 202, south and west elevations, 2009.

There are four window openings (W201, W202, W203, and W204) in Room 202. All of the window openings have wooden vinyl-clad, one-over-one replacement sashes. The interior elements are constructed in the typical manner with 4¾ inch wide flat casings and 4 inch wide sill trim.

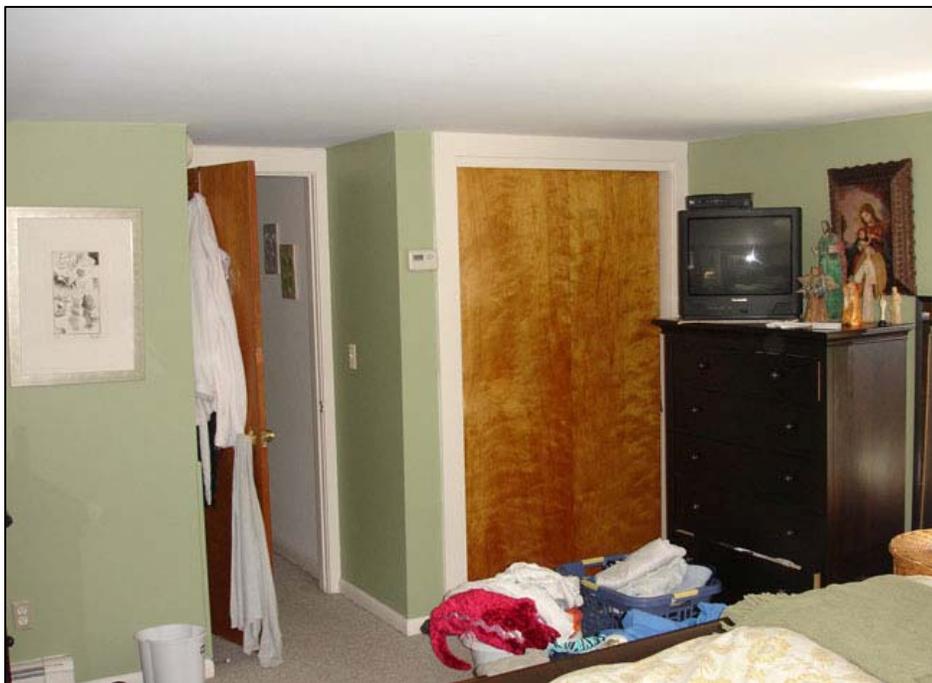
Figure 50. Gray Cottage, Room 203, north elevation, 2009.

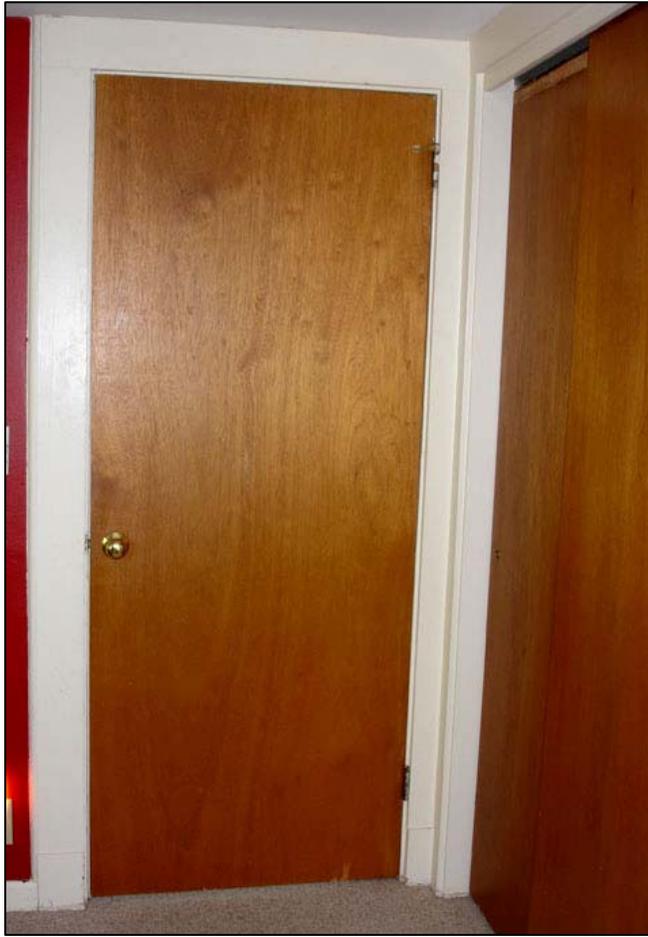
Figure 51. Gray Cottage, Room 205, D204 depicting historic trim and replacement door, 2009.

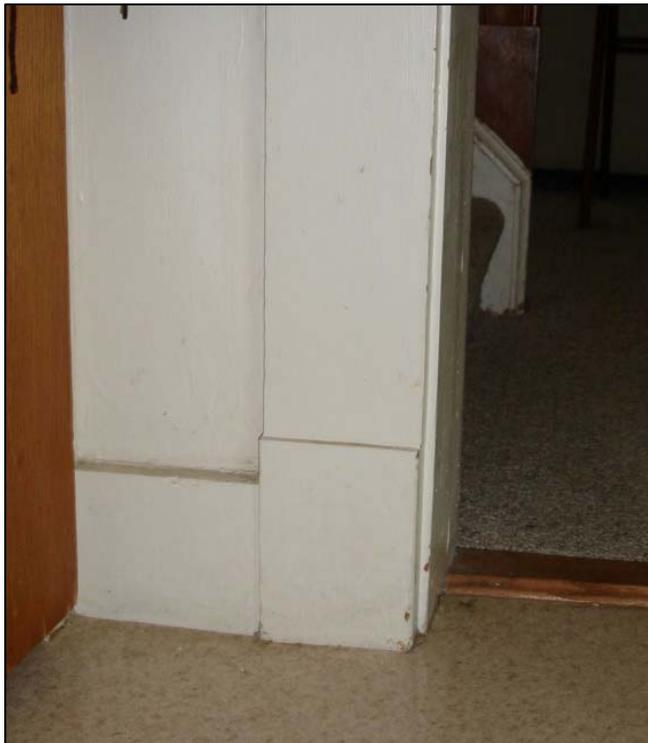
Figure 52. Gray Cottage, Room 101, D105 historic trim with plinth block at base, 2009.

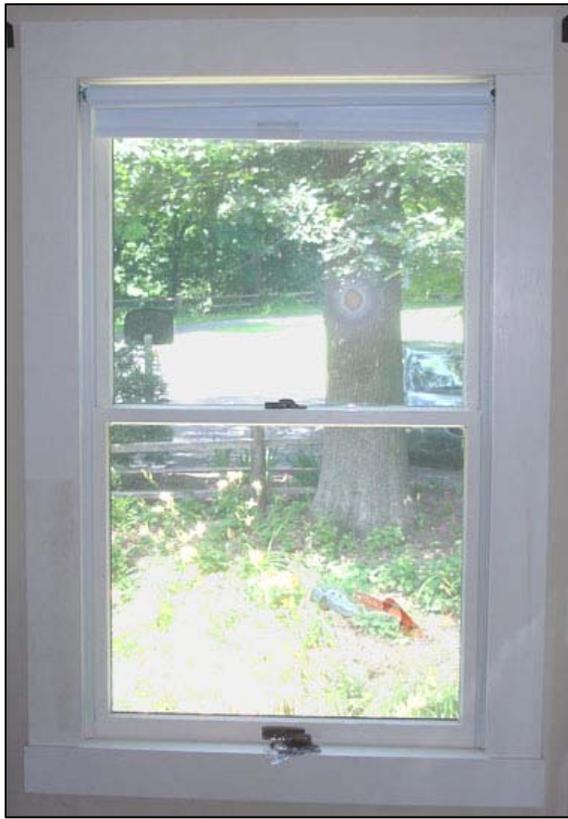
Figure 53. Gray Cottage, Room 205, W211 depicting interior elements and replacement sashes, 2009.

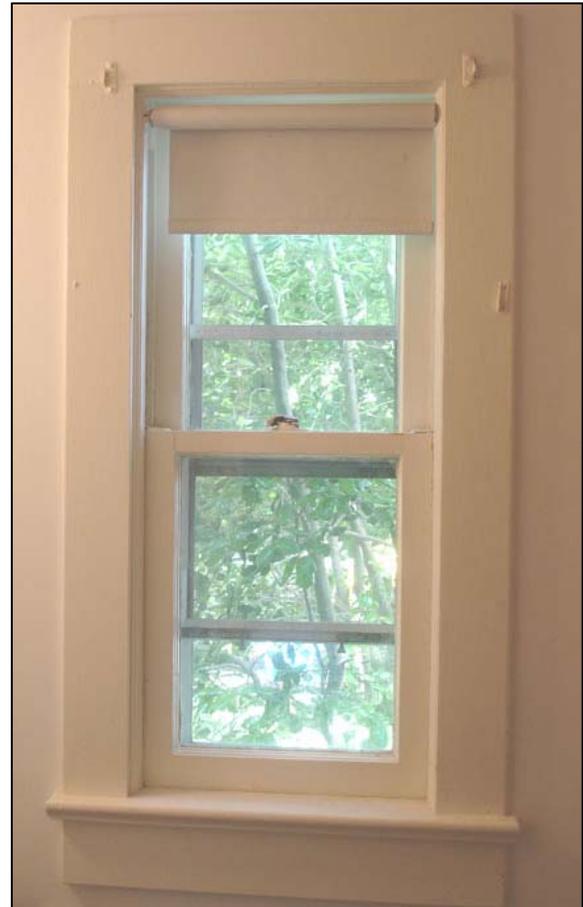
Figure 54. Gray Cottage, Room 106, W108 depicting elements typical of bathroom window openings, 2009.

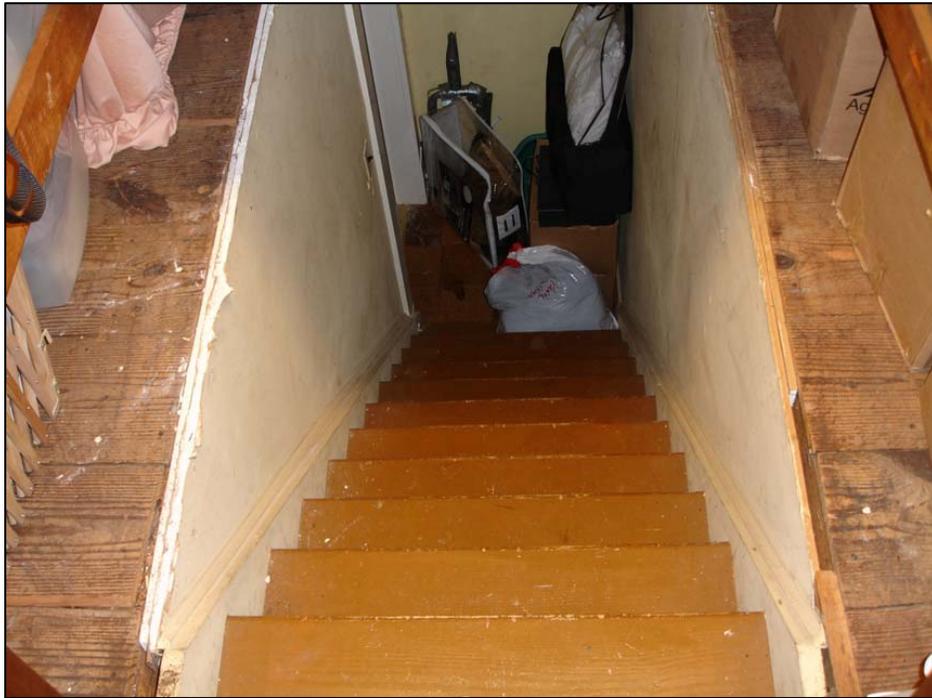
Figure 55. Gray Cottage, attic staircase added in 1964, 2009.

The attic is unfinished except for the staircase walls and trim, which are painted yellow, and the treads, which are painted brown. There were remnants of craft paper on the gable ends that was apparently used in the original construction. There is some evidence of yellow paint in the sash unit jambs and sills, but the interiors of the sashes are not painted.

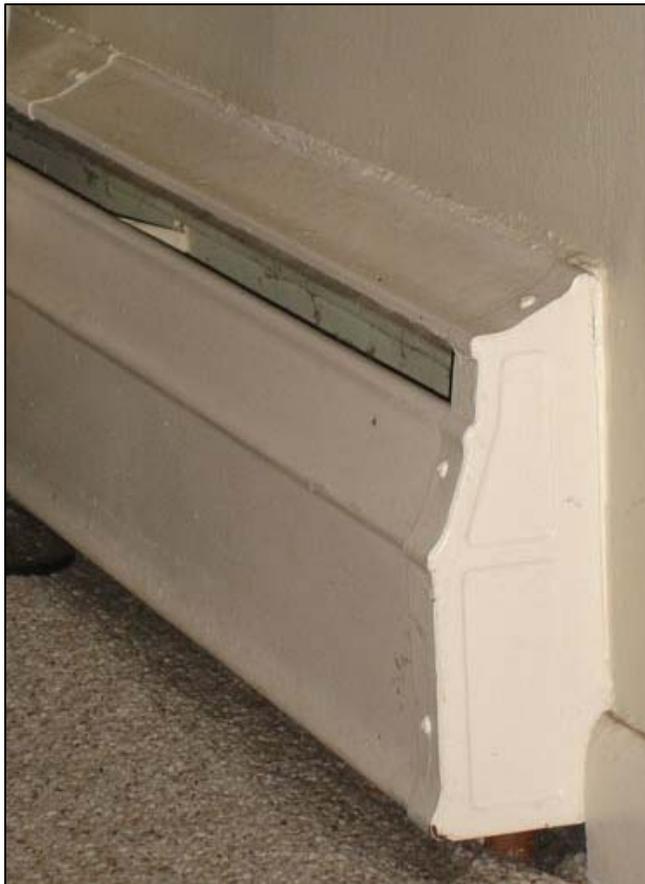
Figure 56. Gray Cottage, baseboard radiator added by the TRA in 1956, 2009.

metal fins that was covered with metal panels (see subsequent section “Current Physical Description,” fig. 56). The front panel of each section had a bead at the bottom edge, a flat section with a bead, and a coved section with a bead at the top edge. The top cover of the baseboard radiator was slanted with coved profile, a bead on the front lip, and a bead along the top edge. The sections of baseboard were connected with narrow pieces of panel that are screwed to the longer panels. The radiators were connected to an oil-fired hot-water furnace that was installed in the basement. The furnace was vented through the east chimney and an oil tank was installed along the south wall of the basement. When the baseboard heat was installed the air vents from the first story to the second story were covered over.

The baseboard radiator installed in Room 102 is typical of the older-style baseboard units in the building that were previously described (see previous section "Alterations"). The baseboard radiators with the decorative metal panels are installed on the north and east walls of Room 102, and are typically installed along the outside walls. This type of baseboard was observed throughout the main block of Gray Cottage and was evidently installed when the TRA renovated the building in the 1950s.

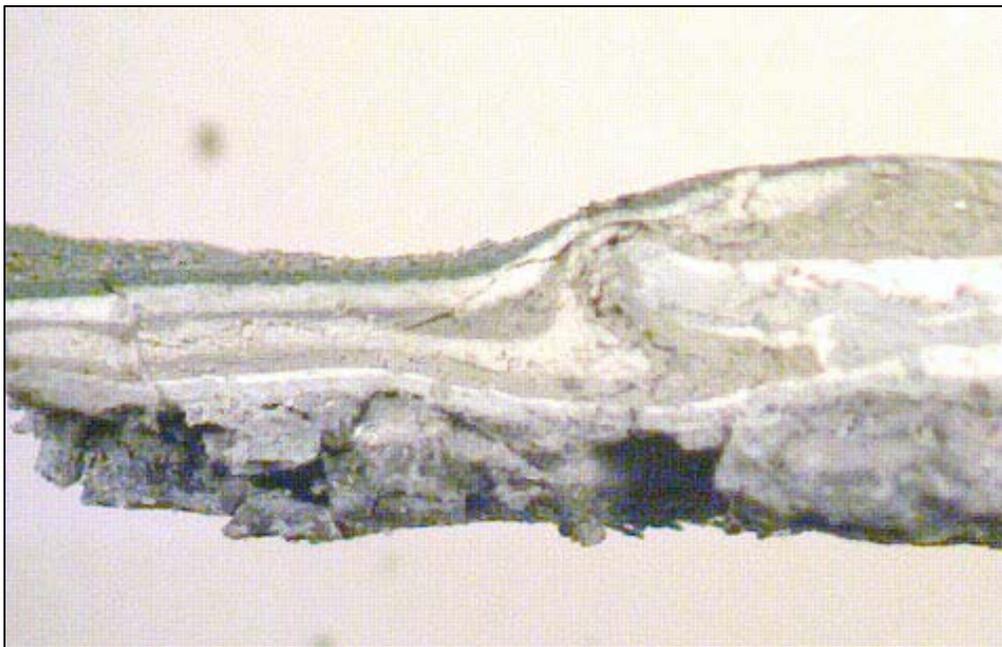
Figure 57. Gray Cottage, paint sample from horizontal drop siding (P016).

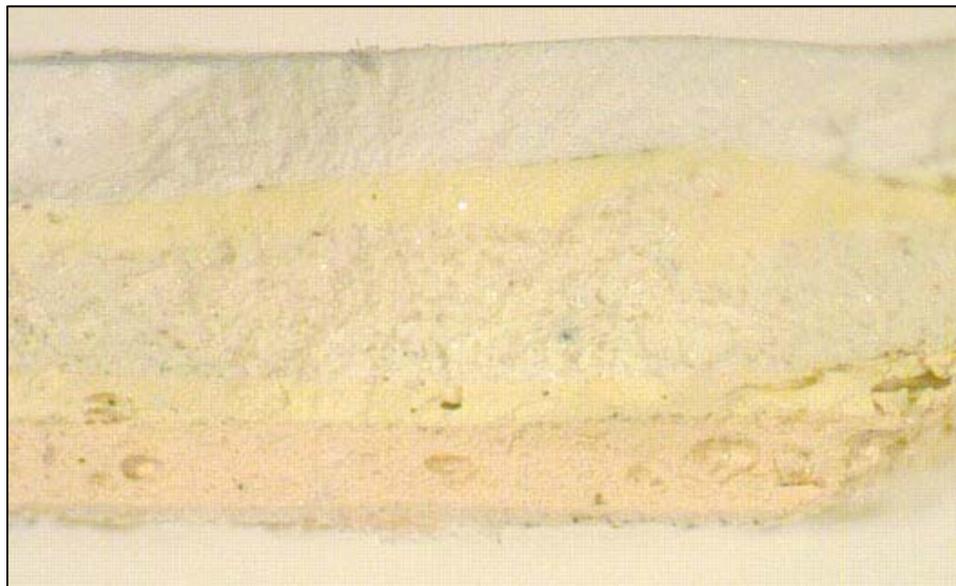
Figure 58. Gray Cottage, W108 window jamb added in 1964 (P002).

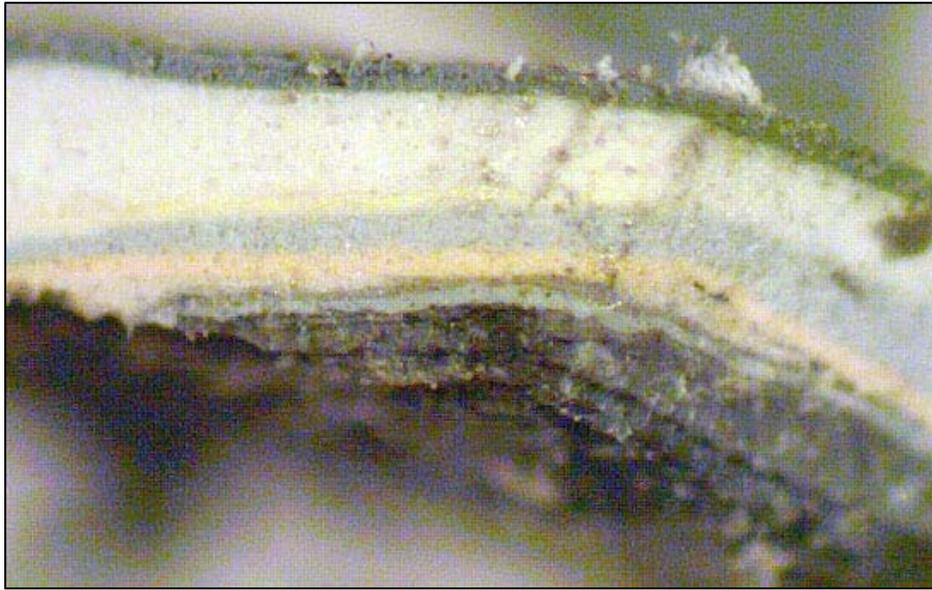
Figure 59. Gray Cottage, fascia below cornice (P026).

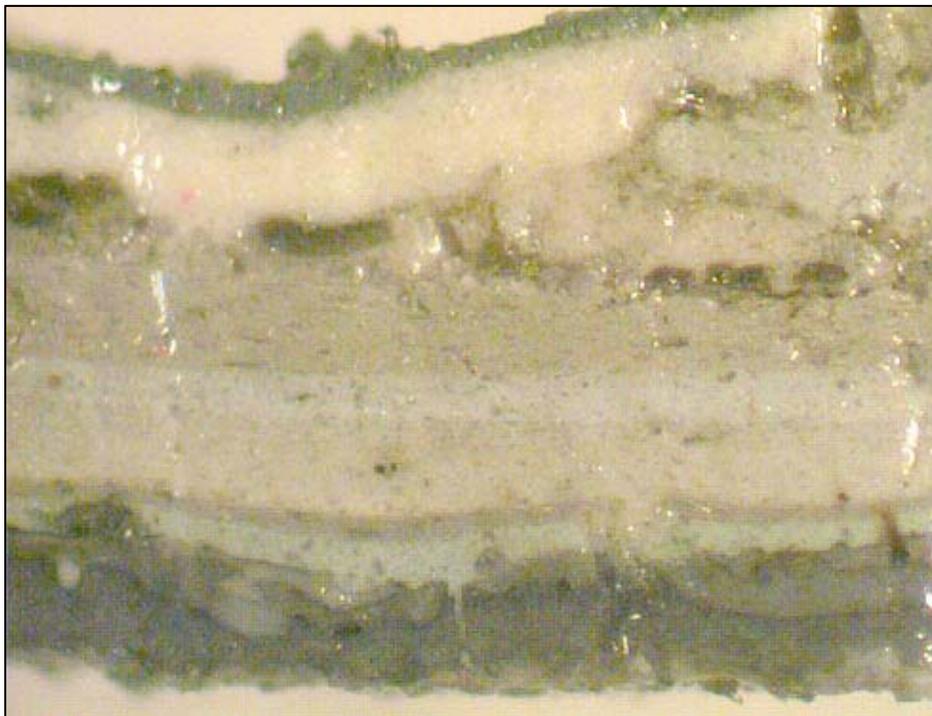
Figure 60. Gray Cottage, northeast corner board (P028).

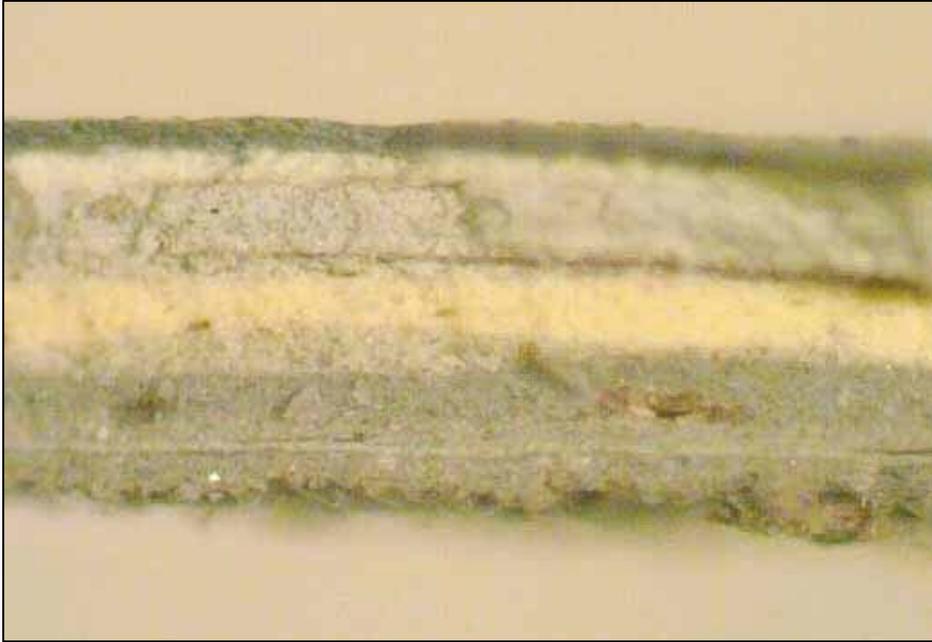
Figure 61. Gray Cottage, front porch, north elevation siding (P023).

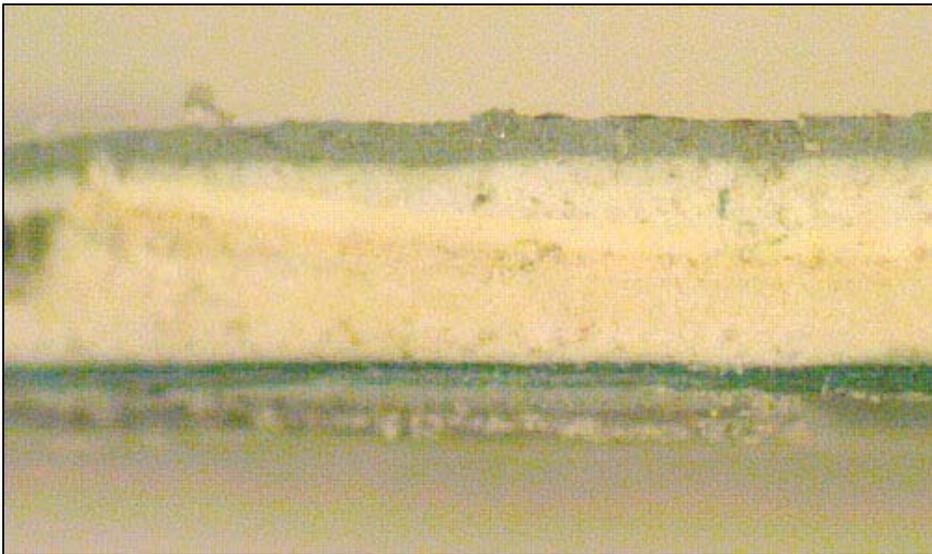
Figure 62. Gray Cottage, front porch, east elevation window trim (P025).
