Search for the Canals

William A. Griswold

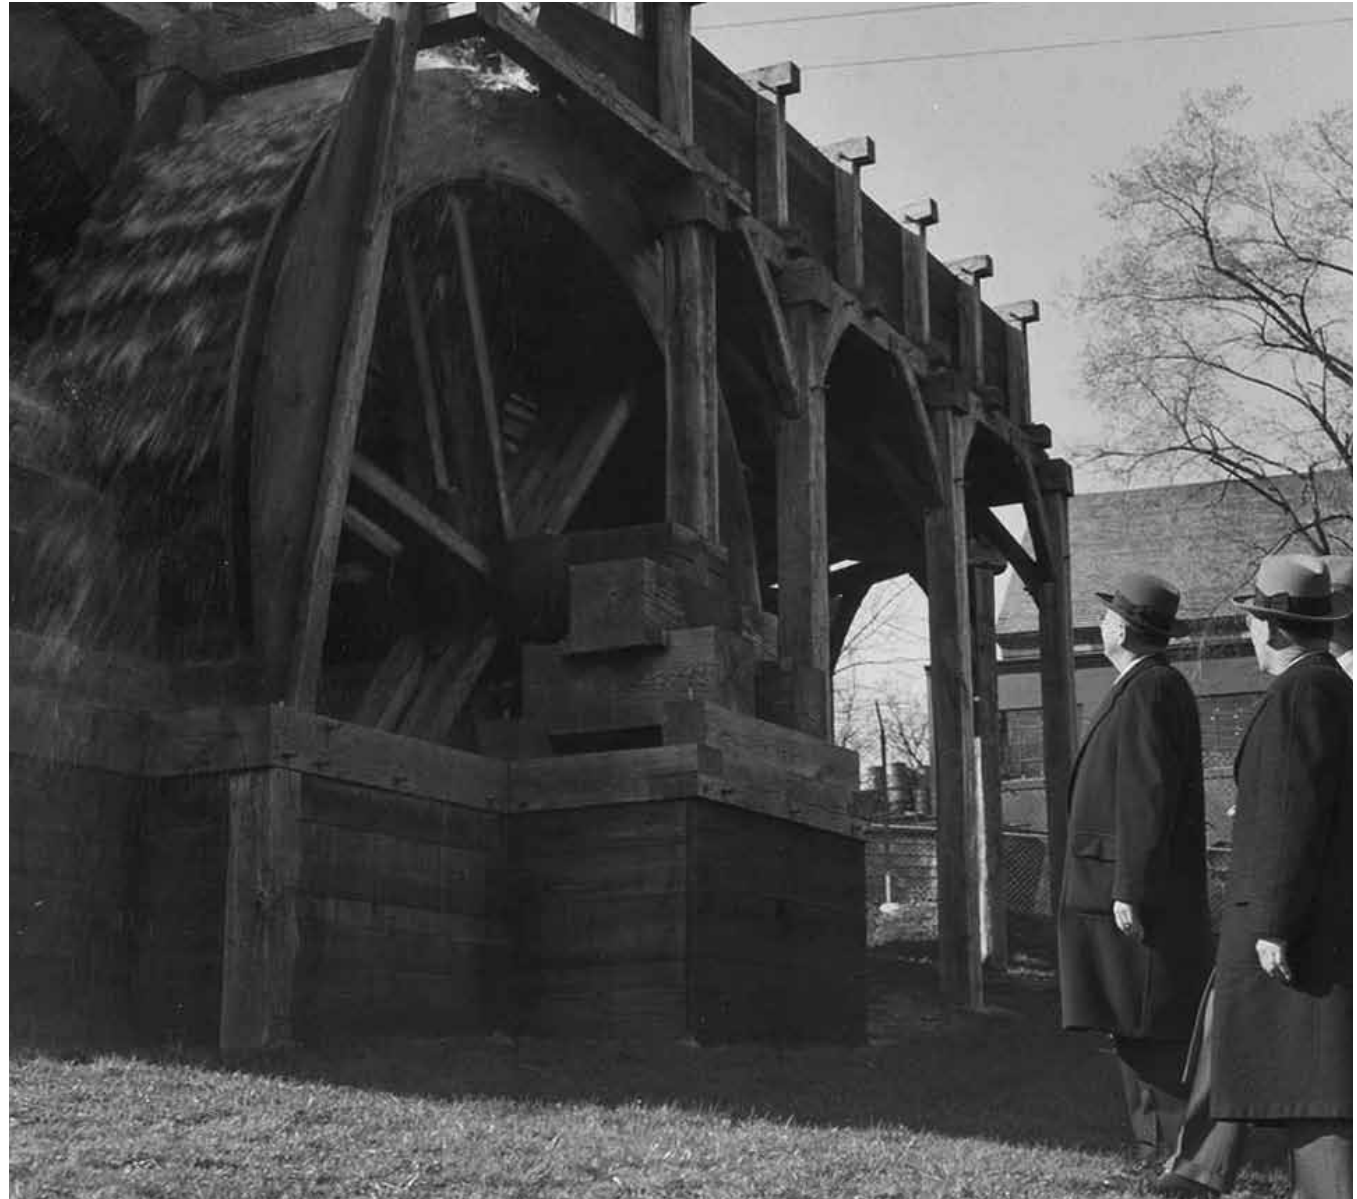
8.1 Photograph illustrating the power of water to move the waterwheels at the slitting mill. (Photograph 1400 by Richard Merrill, 1957.)

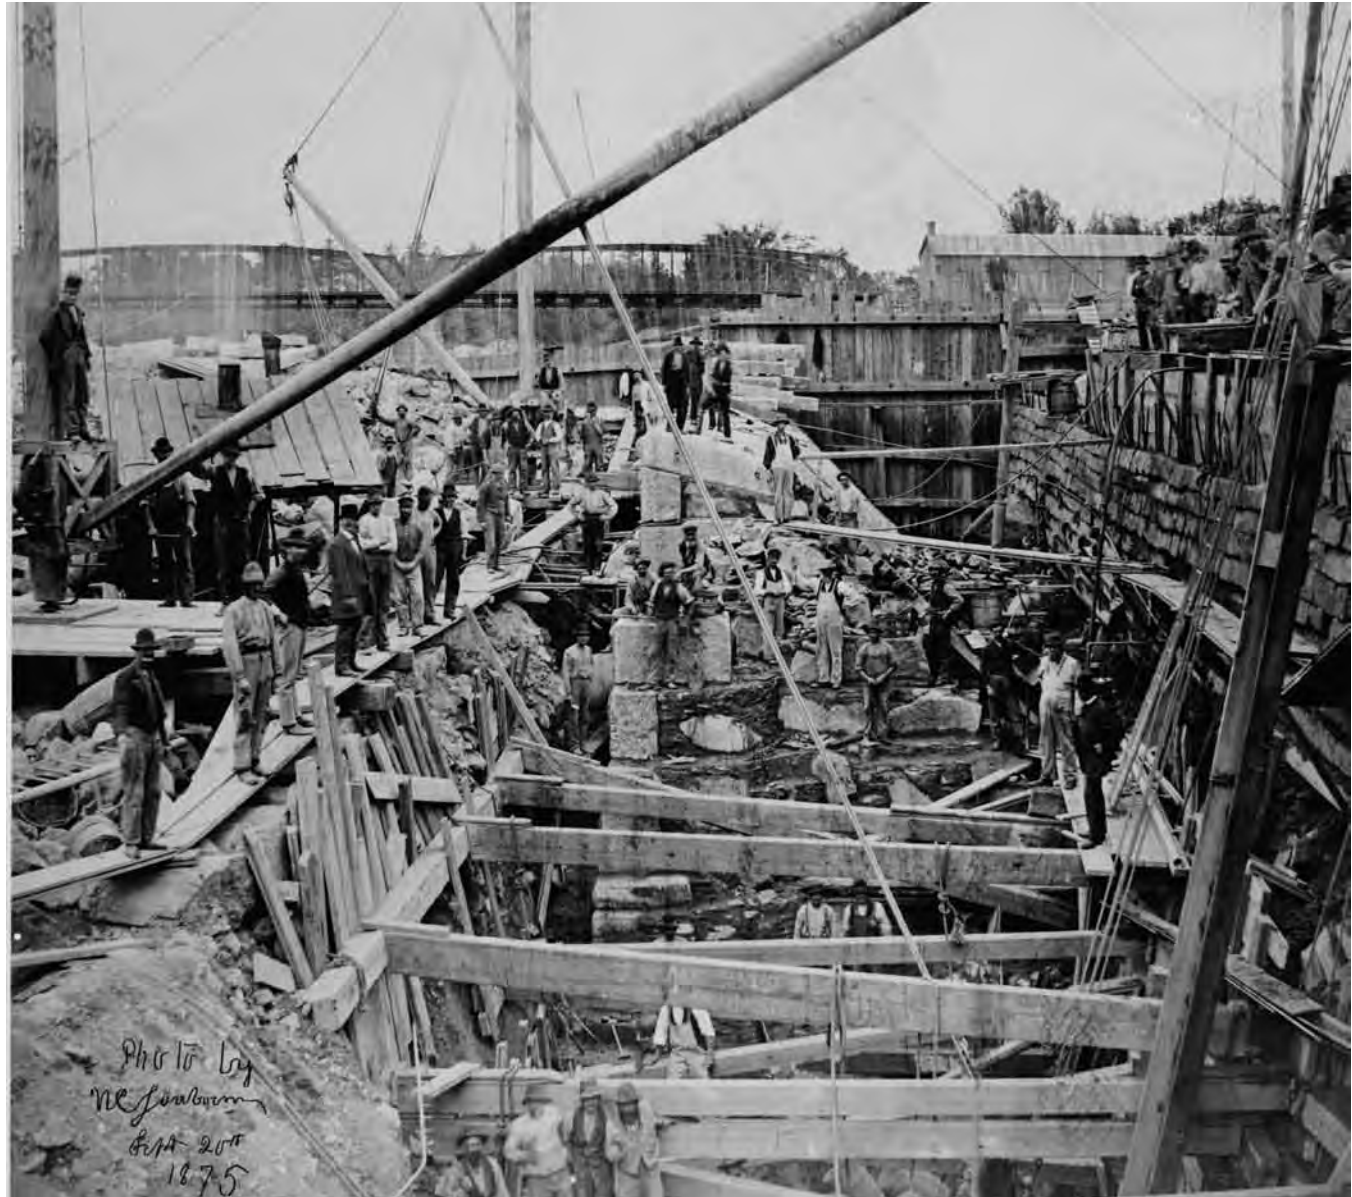
8.2 Dam at the Head of the Pawtucket Falls, Lowell, Massachusetts, September 20, 1875. This photograph illustrates the complexity of dam construction over two centuries after the construction of the dam at Saugus. (Photograph HAER MASS, 9-LOW, 8A-1 from the Library of Congress.)

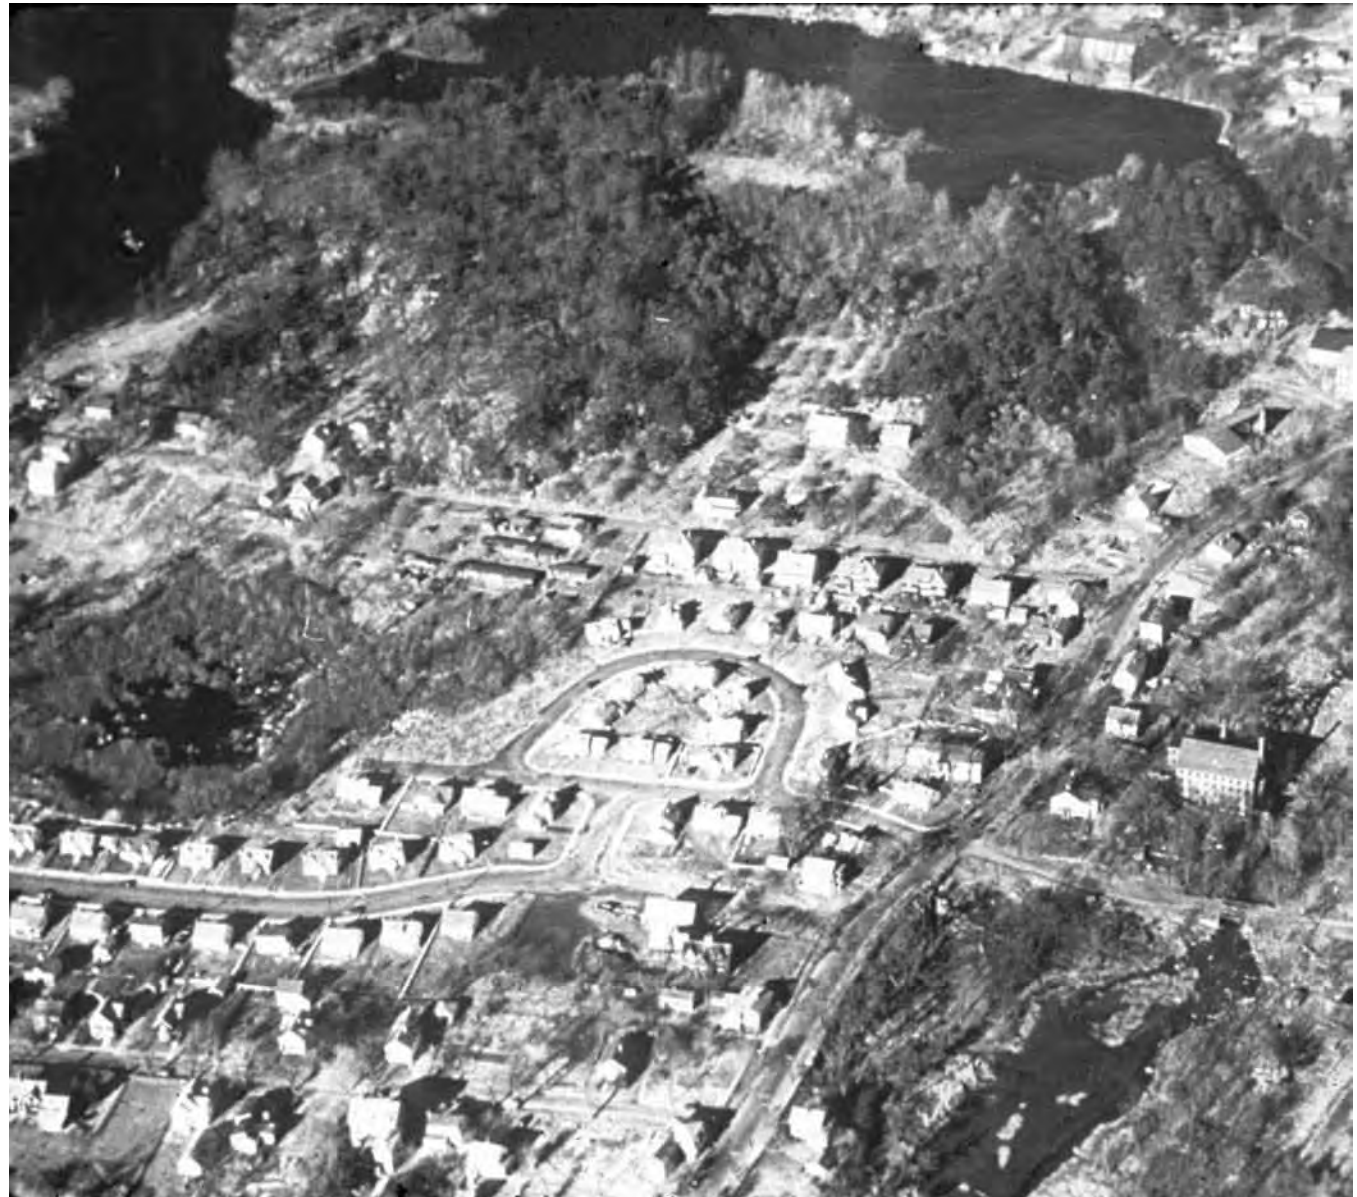
8.3 This 1949 aerial photograph shows the location of the ironworks (bottom right), Pranker's Pond (top center), and the cranberry bog (left center). Notice how developed the area was in 1949. (Photograph 1719 by Laurence Lowry, 1949.)
