**Subject: Exterior Stair/Elevator Tower Additions**

- Applicable Standards:**
- 9. Compatible New Additions/Alterations
  - 10. Reversibility of New Additions/Alterations

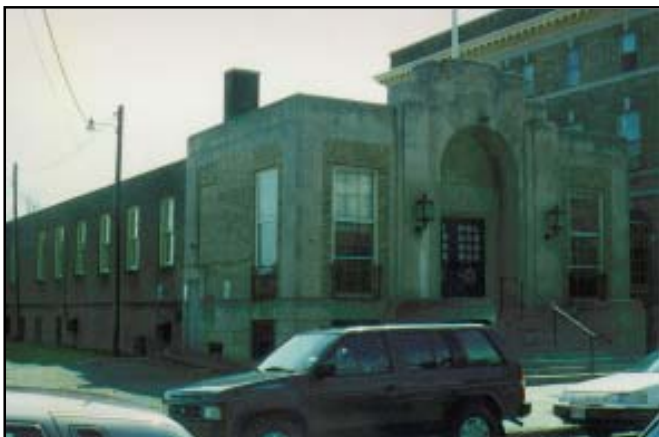
*Prior to rehabilitation. Note the symmetrical head house (1938) and later rear brick shed addition (1955).*

**Application 1** (*Incompatible addition*): A former American Legion Hall, built in 1938 in a simplified Art Deco style, was rehabilitated into commercial office space. The historic building includes a buff brick and stone "head house" with a distinctive stepped gable entrance facing the street, and a later red brick "shed" addition (c.1955) to the rear. The rehabilitation included the construction of an elevator tower adjacent to the front elevation. Although the design of the tower is appropriately simple in design, massing and scale, and is built with compatible materials, its location nearly flush with the building's façade is inappropriate. The addition in this

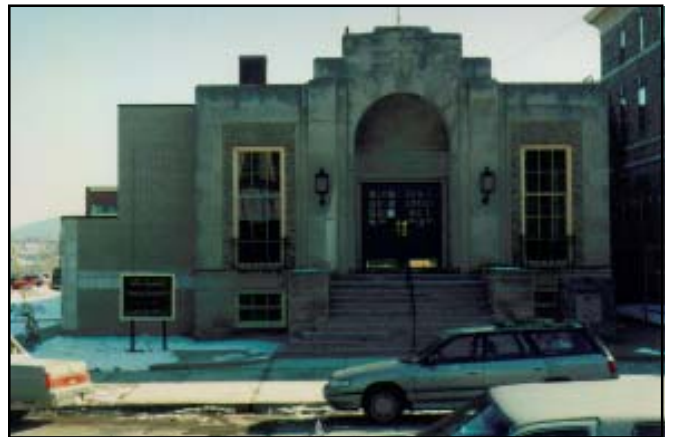
*After rehabilitation. The addition is located very close to the facade and, as a result, is highly visible, altering the symmetrical balance of the historic facade.*

location is a highly visible new element that markedly alters the building's appearance and character by destroying the balance found in the historic facade. A better approach would have been to construct the addition further toward the rear of the building where it would have been less obtrusive, and would have preserved the character of the historic building.

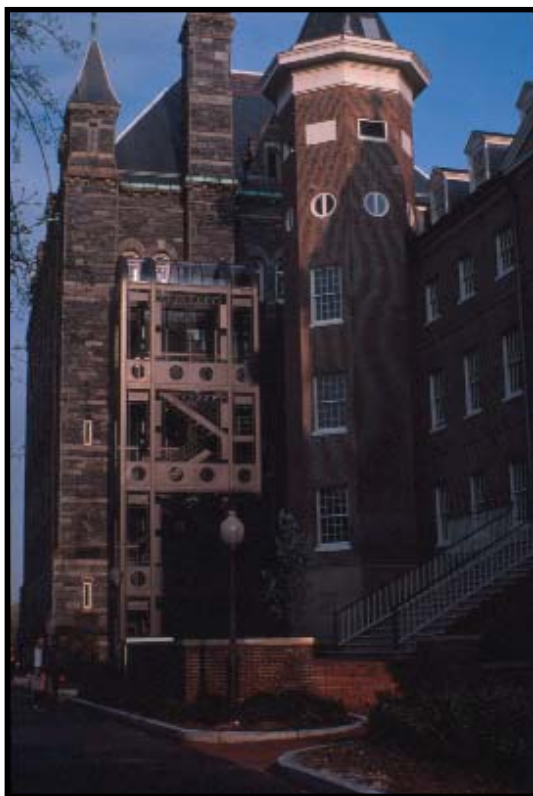
*This modern, metal stair tower addition located between an existing projecting tower and articulated corner is compatible with the character of the historic structure. It is also located on the rear elevation of the building, and is not visible from major public vantage points.*

**Application 2 (Compatible addition):** A second example involves a large university building, including a late-19th century stone Gothic Style historic structure with a later brick historic addition abutting it. A new stair to provide an additional means of egress was added to the rear elevation of the original structure, inconspicuously placed near the intersection with the later addition. The new stair is constructed in modern materials and is clearly differentiated from the old. Moreover, its simple, contemporary design is compatible with the historic building. Finally, the addition is not visible when looking at the building's primary elevation. Accordingly, this stair tower addition successfully conforms with the Secretary of the Interior's Standards for Rehabilitation.
