**WEIR FARM HISTORIC STRUCTURES REPORT
VOLUME II-A**

**Weir Farm National Historic Site
Wilton, Connecticut**

Weir Farm Outbuildings
Barn • Tack House
Rustic Wooden Fence • Ice House
Garden Tool Shed • Corn Crib • Chicken Coop
Well Houses • Wagon Shed

Maureen K. Phillips
Marie L. Carden

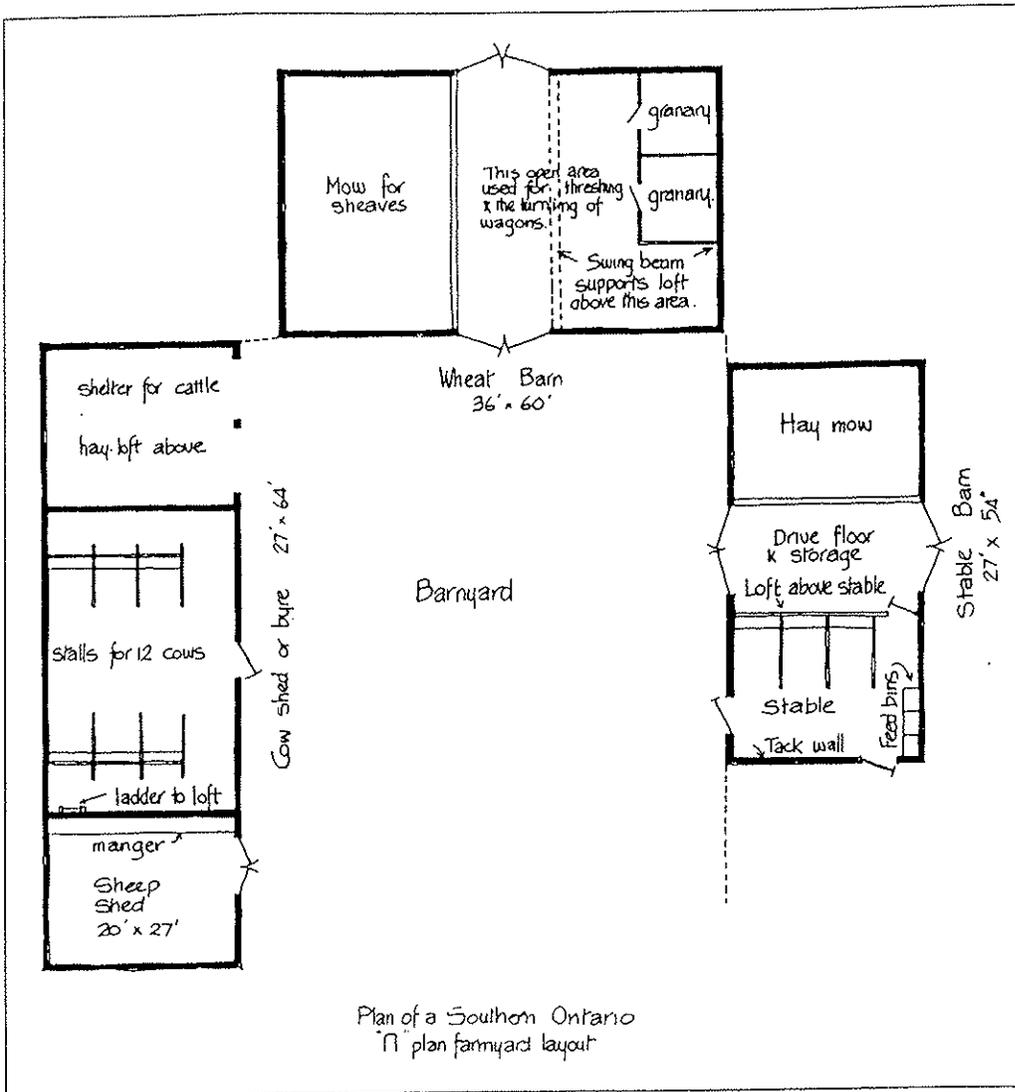
Figure 9. Plan of Mid-Nineteenth Century U-Plan Farmyard Layout.

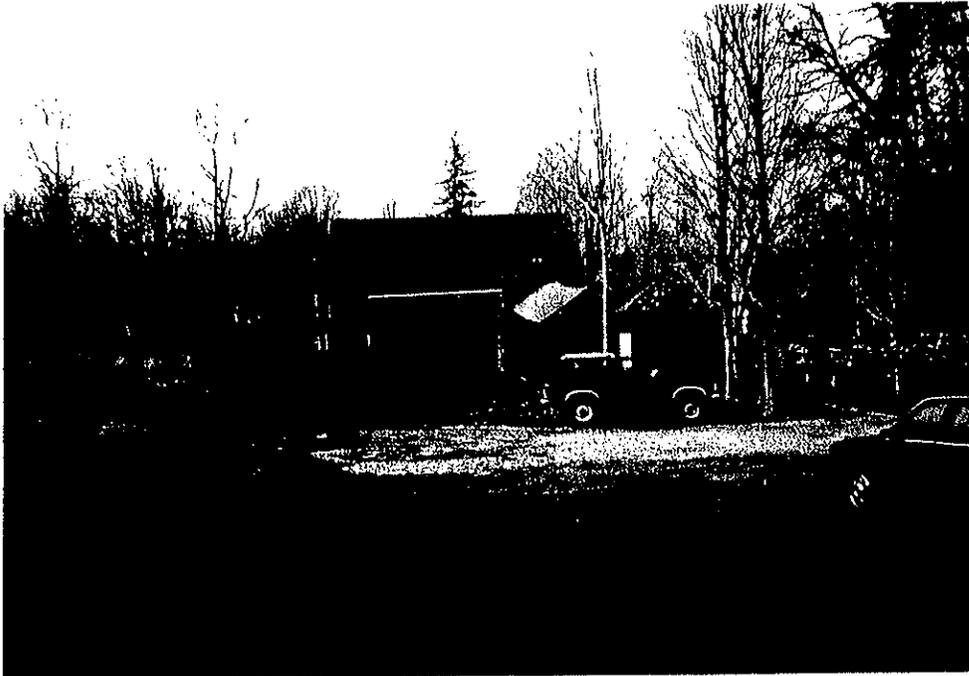
Figure 23. Weir Barn - View from the South (1995).

There is one window (W105) on the south facade of the main barn, located to the west of the main double doorway on the first story level (**fig. 23**). This opening measures 2 feet wide by 1 foot 8 inches high and is fitted with a fixed sixteen-light sash that has muntin profile Type A. The window is trimmed on the sides with a 4-inch-wide plain-board surround, with an asphalt roofing shingle nailed across the top. The wood-shingle siding was installed over the original surround, so that the window is slightly recessed from the wall plane.

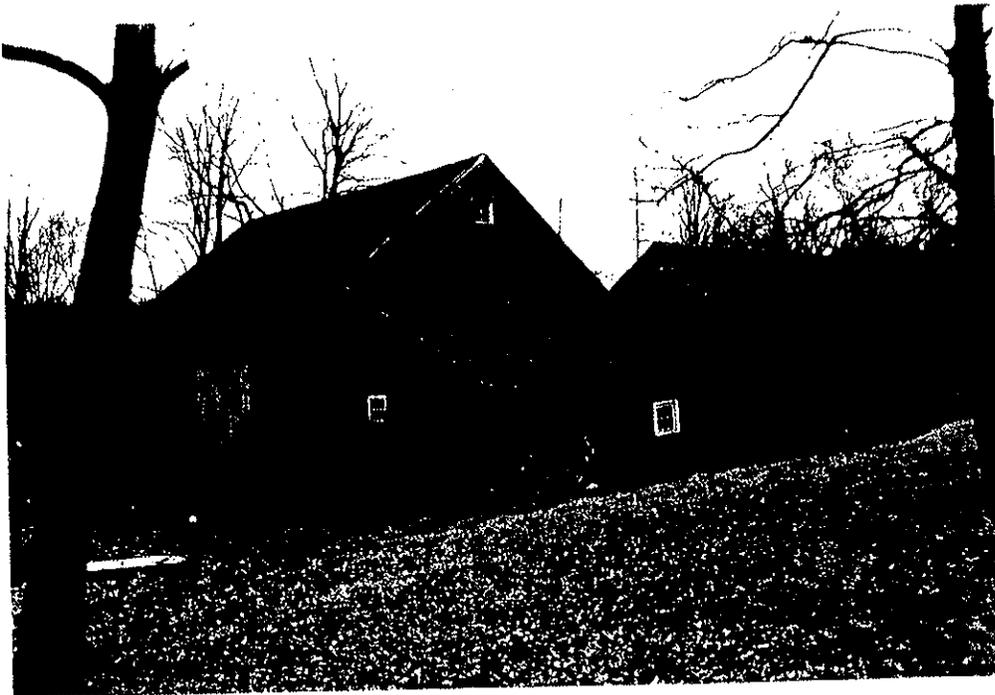
Figure 26. Weir Barn - North and West Aspects (1995).

There is one window (W121) on the west wall of the west wing, located at the south end of the wall at the first-story level (**fig. 26**). This opening measures 2 feet 3 inches wide by 2 feet high and is trimmed with a 3-inch-wide plain surround. The opening is fitted with a butt-edge board awning that is covered with wood shingles and is hung using hinges attached to top of the frame on the interior.

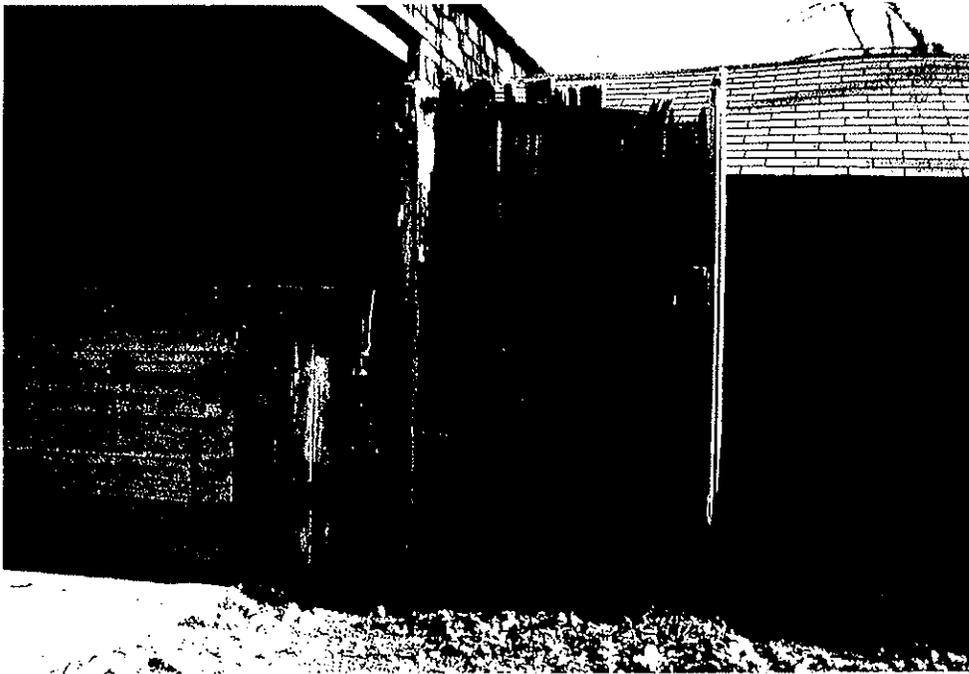
Figure 29. Weir Barn - Main Barn, South Façade, Doorway D105 (1993).

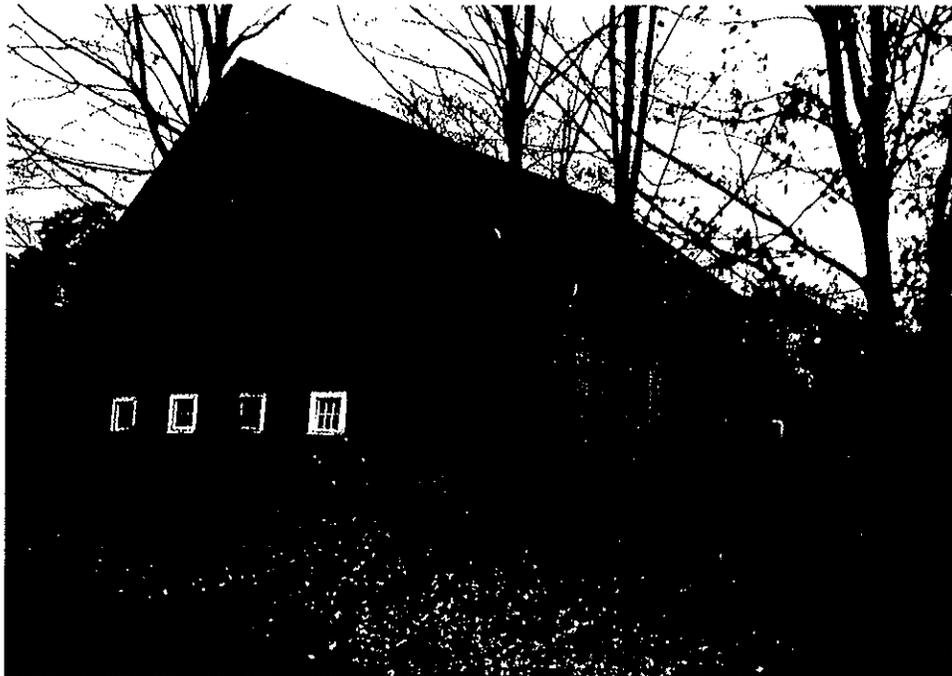
Figure 30. Weir Barn - Main Barn, North and East Walls (1993).

There is one window on the north wall of the east wing, located at the top west corner of the wall immediately under the roof eave (**fig. 30**). The opening (W115) measures 2 feet 3 inches wide by 1 foot high. It is fitted with a fixed three-light sash and has no surround.

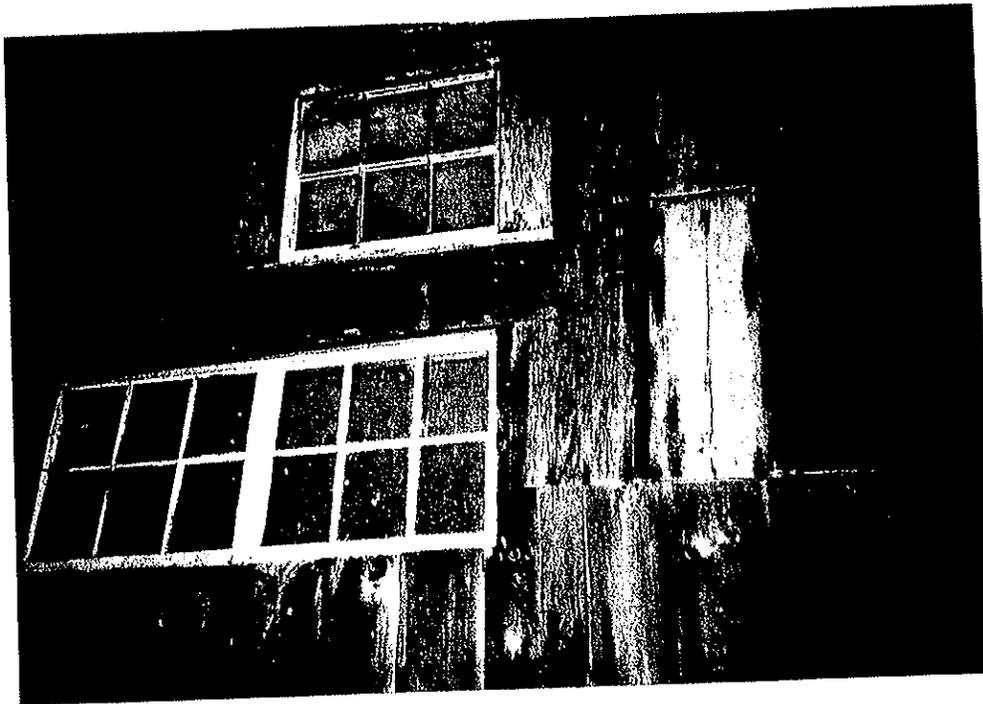
Figure 32. Weir Barn - East Wing, West Wall Recess, Windows W106-W107 and W108 (1994).

There are two windows on the west facade of the Weir barn's east wing, both located in the recessed area at the north end of the structure (**fig. 32**). One window (W106-W107) is located to the north (left) of doorway D107-D108 at the same level as the top of the doorway. This window measures 3 feet 11 inches wide by 1 foot 8 inches high, and is fitted with two, fixed, six-light sashes with muntin profile **Type B** that are installed side by side.

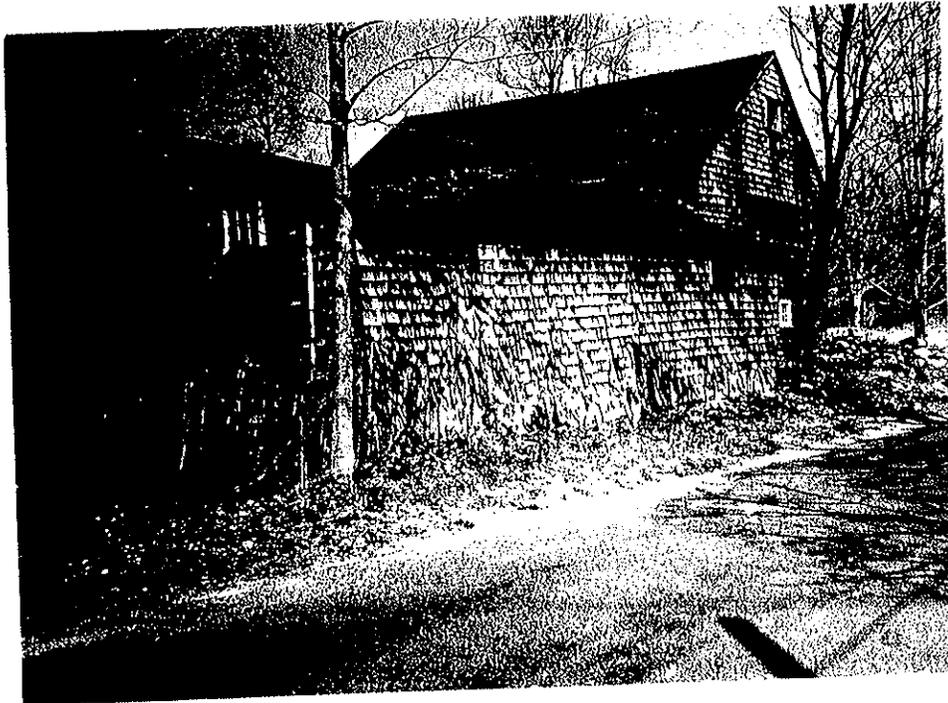
Figure 33. Weir Barn - East Wing, East and South Walls (1992).

There is one window (W109) on the south wall of the east wing, located at the east end of the wall immediately under the roof eave (**fig. 33**). The opening measures 2 feet wide by 1 foot 8 inches high. It is fitted with a fixed six-light sash with muntin profile **Type B**, and is trimmed with a 4-inch-wide plain surround.

There is one window (W110) on the east wall of the east wing of the barn, located at the north end of the wall immediately under the roof eave (**fig. 33**). The opening measures 3 feet wide by 1 foot high. It is fitted with a fixed sixteen-light sash with muntin profile **Type A**, and trimmed with a 3-inch-wide plain surround.

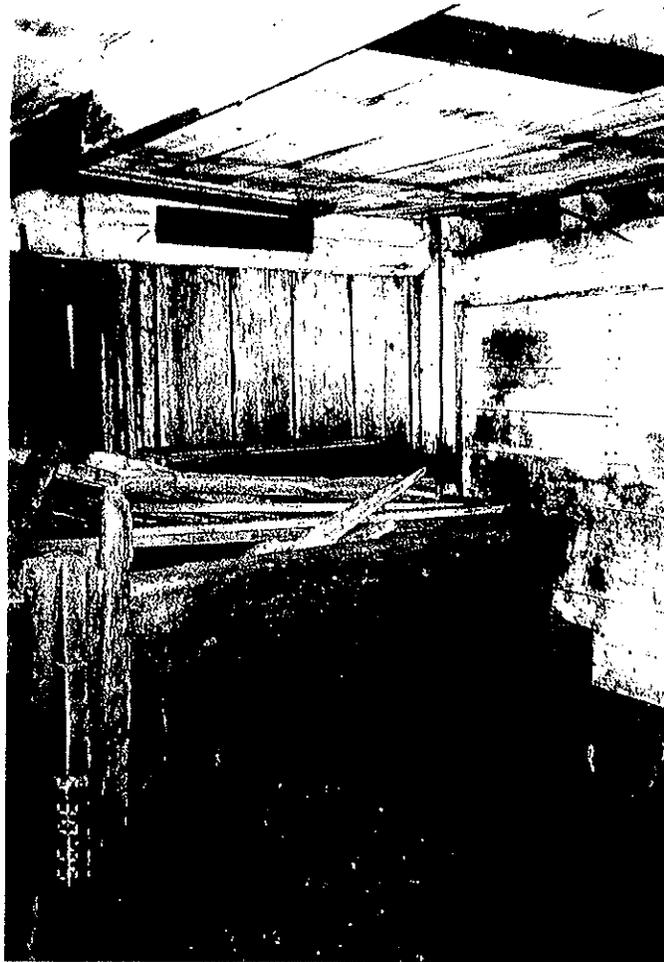
Figure 34. Weir Barn – Stable [Room 101], West Wall (1995).

The stable (**fig. 34**) is located at the south end of the west wing and measures approximately 11 feet square. The room is entered from the barn courtyard via a doorway on the east wall.

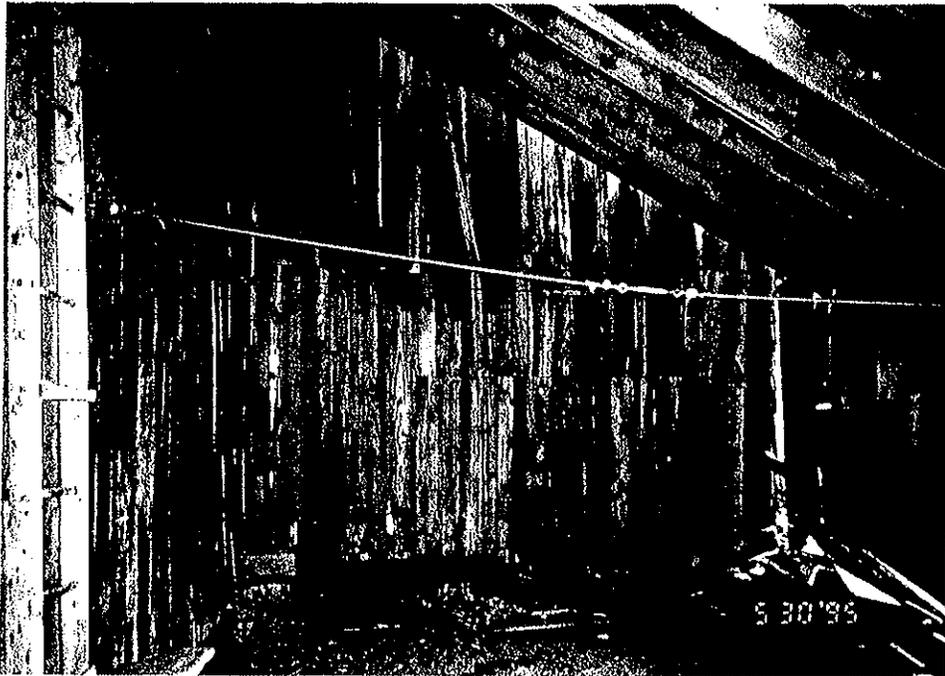
Figure 38. Weir Barn - Lean-To Shed [Room 104], South Wall (1995).

The upper portion of the shed's south wall is the early nineteenth-century exterior board-and-batten siding of the north wall of the west wing (**fig. 38**). The lower portion of the wall is covered with post-nineteenth century vertical boards.

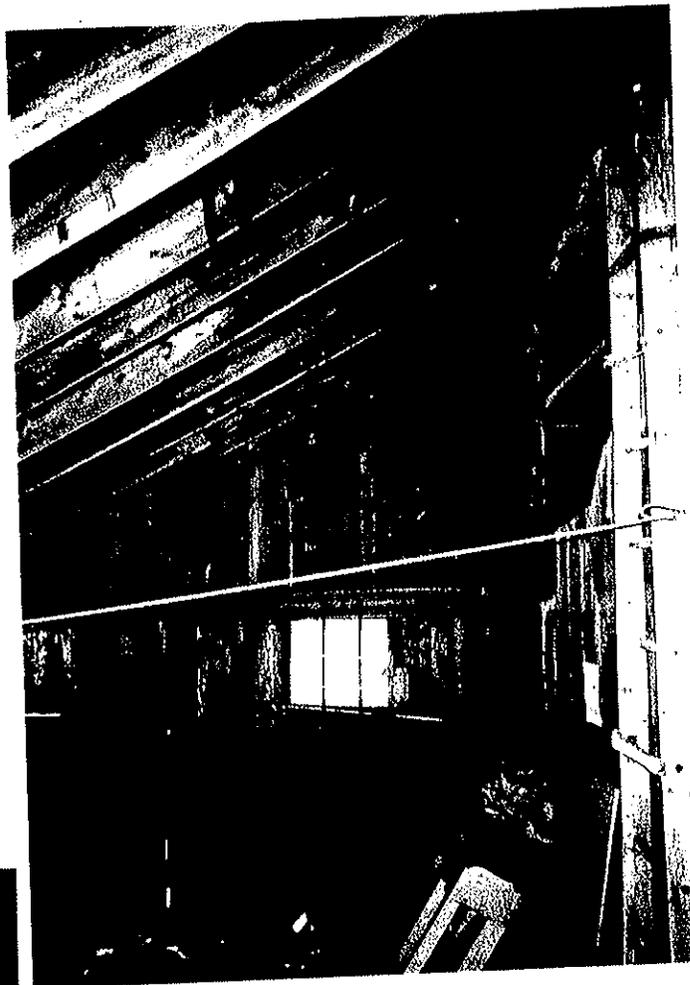
Figure 39. Weir Barn -Lean-To Shed [Room 104], North Wall (1995).

The west and north walls (**fig. 39**) of the shed are composed of the exposed interior side of the exterior vertical-board sheathing.

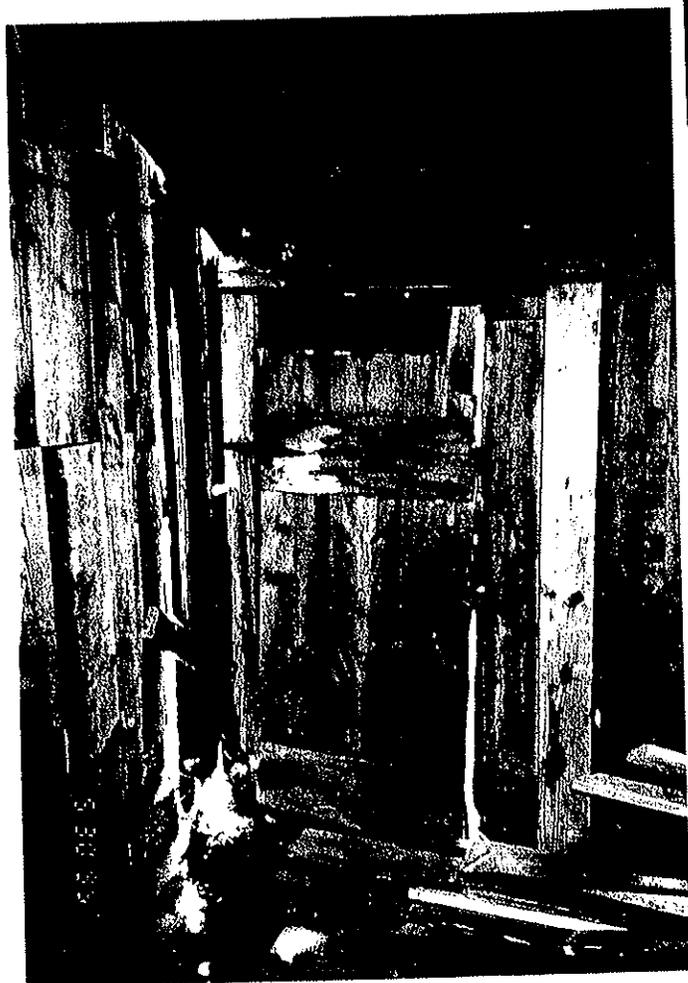
Figure 40. Weir Barn - Lean-to Shed [Room 104], West Wall, Doorway D116 (1995).

There are two exterior doorways in the lean-to shed, one doorway (D115) located in the center and the second doorway (D116) located at the south end of the shed's west wall (**fig. 40**). An interior doorway (D117) is located at the north end of the room's east wall and opens into a small storage room in the main barn. This opening measures 2 feet 2 inches wide by approximately 6 feet 9 inches high. It is fitted with a door composed of butt-edge vertical boards supported by several horizontal and cross braces, and is hung using a pair of wrought-iron double-strap hinges that are mounted on the post on the storage-room side of the door.

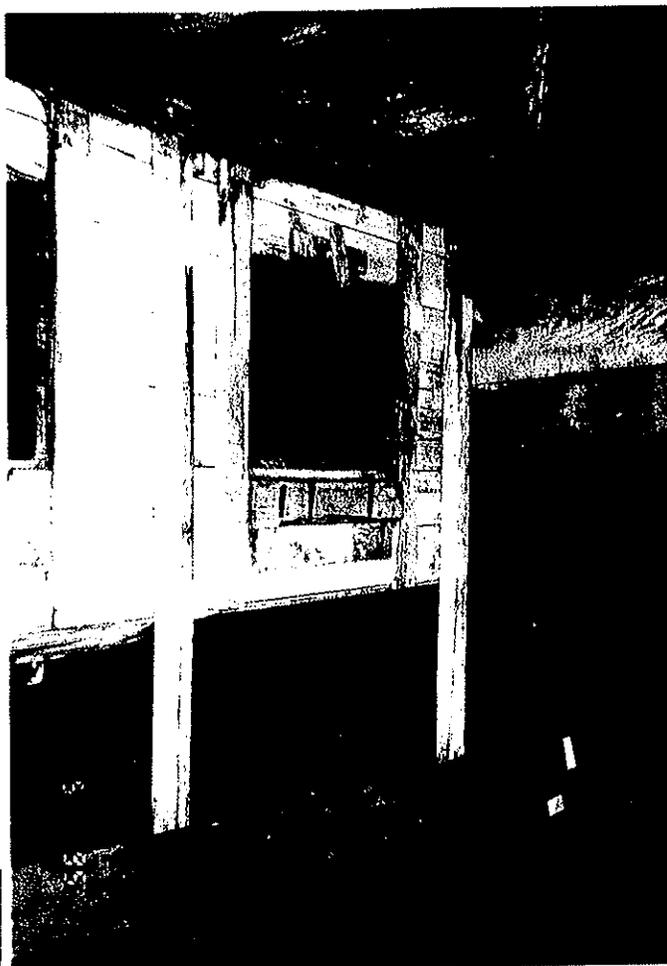
Figure 42. Weir Barn - Storage Room [Room 106], Looking Southwest (1995).

A storage room for livestock feed is located in the northwest corner of the main barn, occupying approximately 1/3 of the original hay mow (figs. 42 & 43). The room measures approximately 9 feet 9 inches by 11 feet 3 inches and approximately 6 feet high. There is a doorway on the east wall that opens to the threshing floor, and another doorway on the west wall that accesses the lean-to shed. One window is located on the north wall.

Two large openings are located on the room's south wall (**fig. 42**). These openings presumably were used to deliver feed into the oxen's stalls (Room 105) on the other side of the wall.

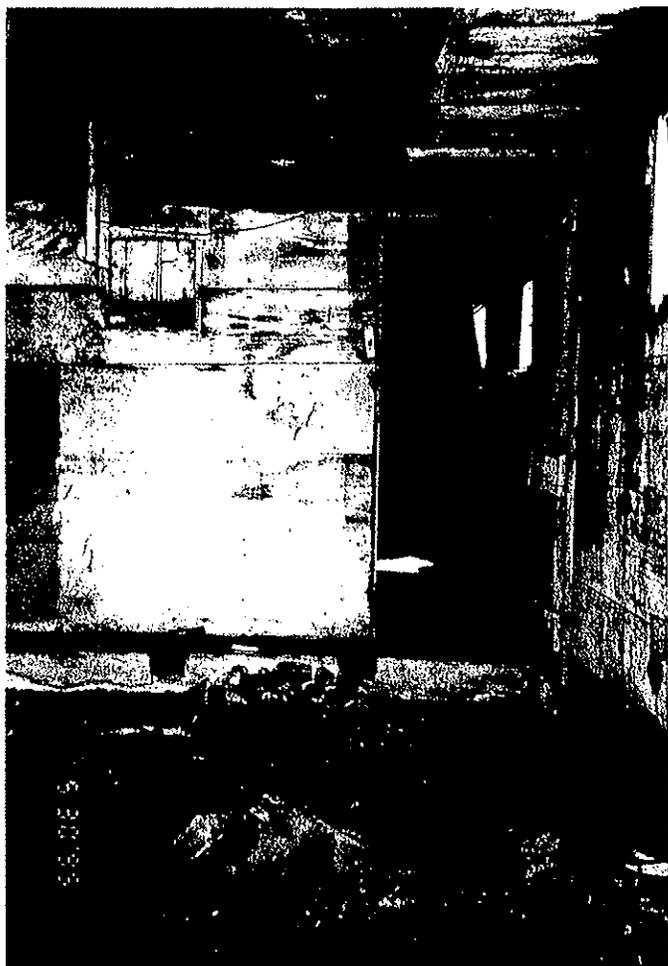
Figure 43. Weir Barn – Storage Room [Room 106], West Wall (1995).

The second door (D117) in the storage room is located at the north end of the west wall and leads to the lean-to shed (**fig. 43** - see **Room 104 - Lean-to Shed, "Doorways"**).

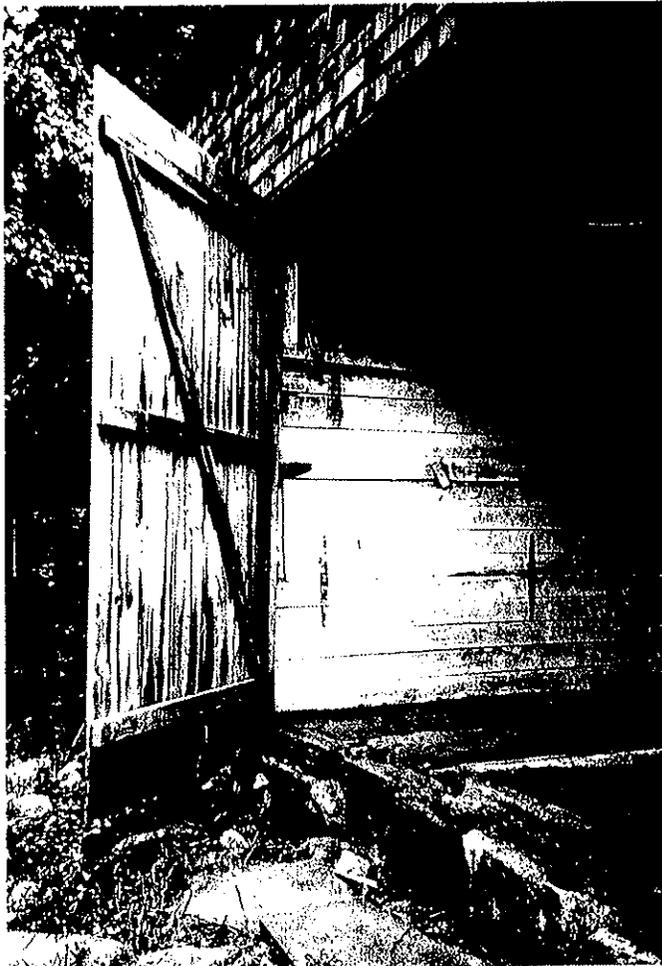
Figure 45. Weir Barn – Threshing Floor [Room 107], East Wall and Doorway D113 (1995).

Two horizontal hatch openings run the length of the room along the center of the east wall (**fig. 45**). The doors in the openings are covered with the same horizontal boards that line the lower east wall. Each door is hinged at the bottom with a pair of double-strap hinges, and a block of wood nailed at the top holds each hatch closed. The hatch openings were used to pass feed through to the cows in the milking room (Room 108) on the other side of the wall.

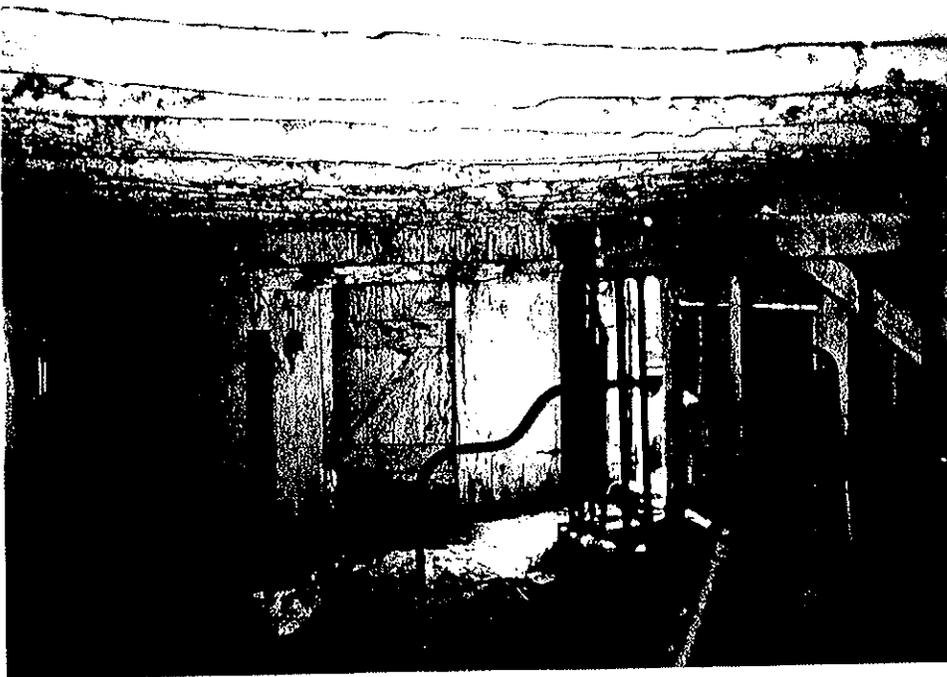
Figure 47. Weir Barn – Milking Room [Room 108], Looking South (1995).

The milking room (figs. 46 & 47) occupies the east end of the main barn. The room measures 12 feet 1 1/2 inches wide by 25 feet long and 6 feet 4 inches high. Exterior doorways are located on the north and south walls, and a doorway to the threshing floor is located on the west wall. The room retains some of the 1930s accoutrements for milking cows.

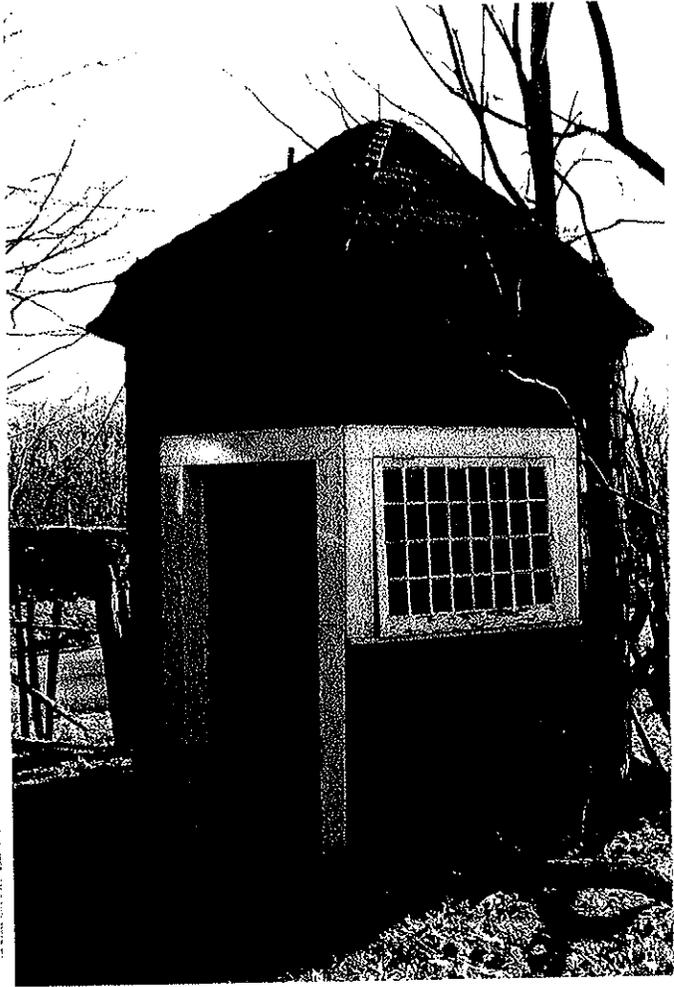
Figure 57. Weir Tack House - West and Northwest Walls (1993).

installed in the barn during the 1911-1914 work. However, an earlier window frame can be seen in an area under the extant sash on the west wall of the tack house where shingles have fallen off (**fig. 57**). Either the tack house was built before the barn remodeling and its west-wall window sash was replaced during the circa 1911-1914 remodeling of the barn with the multi-pane sash, or the tack house was built at the same time as the 1911-1914 remodeling of the barn and the multi-pane window was installed soon after.

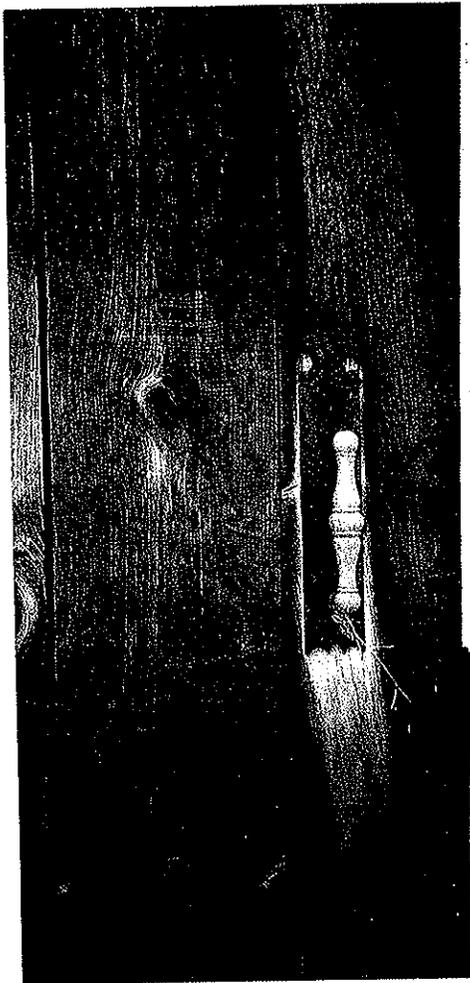
Figure 58. Weir Tack House -- Northwest Wall, Norfolk Latch on Door in Doorway D101 (1995).

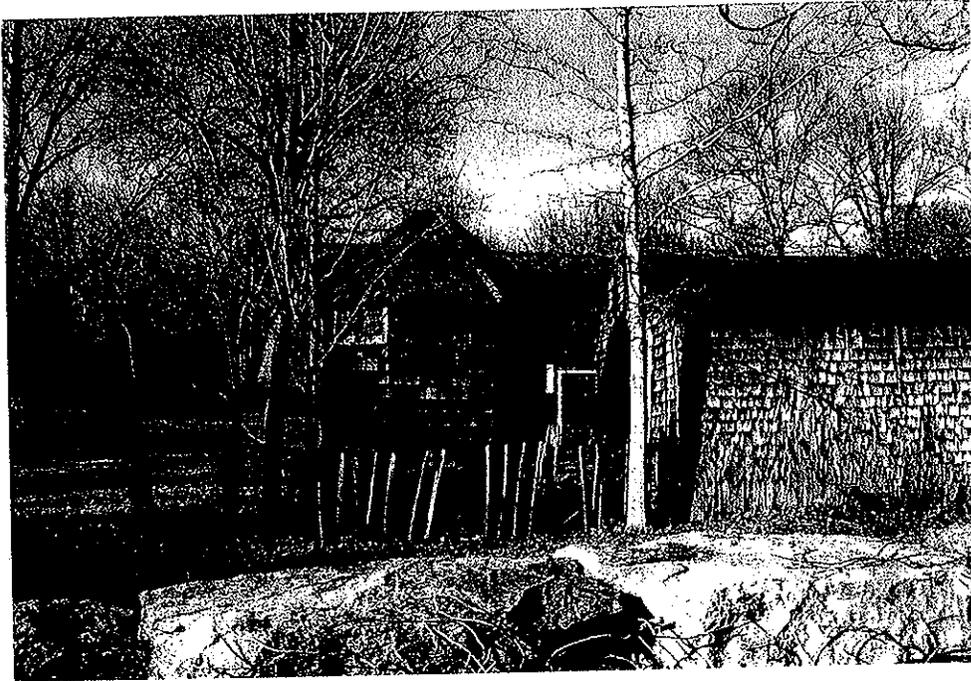
Figure 59. Weir Tack House - East and Southeast Walls (1994).

The second window on the tack house is located on the upper southeast wall immediately under the eave (**fig. 59**). This opening (W201) measures 3 feet 1 inch wide by 1 foot 6 inches high. It is fitted with a fixed sash of mortise and tenon construction that has sixteen lights and muntins with profile **Type A**. The opening is trimmed with a 2 1/2-inch-wide plain-board surround.

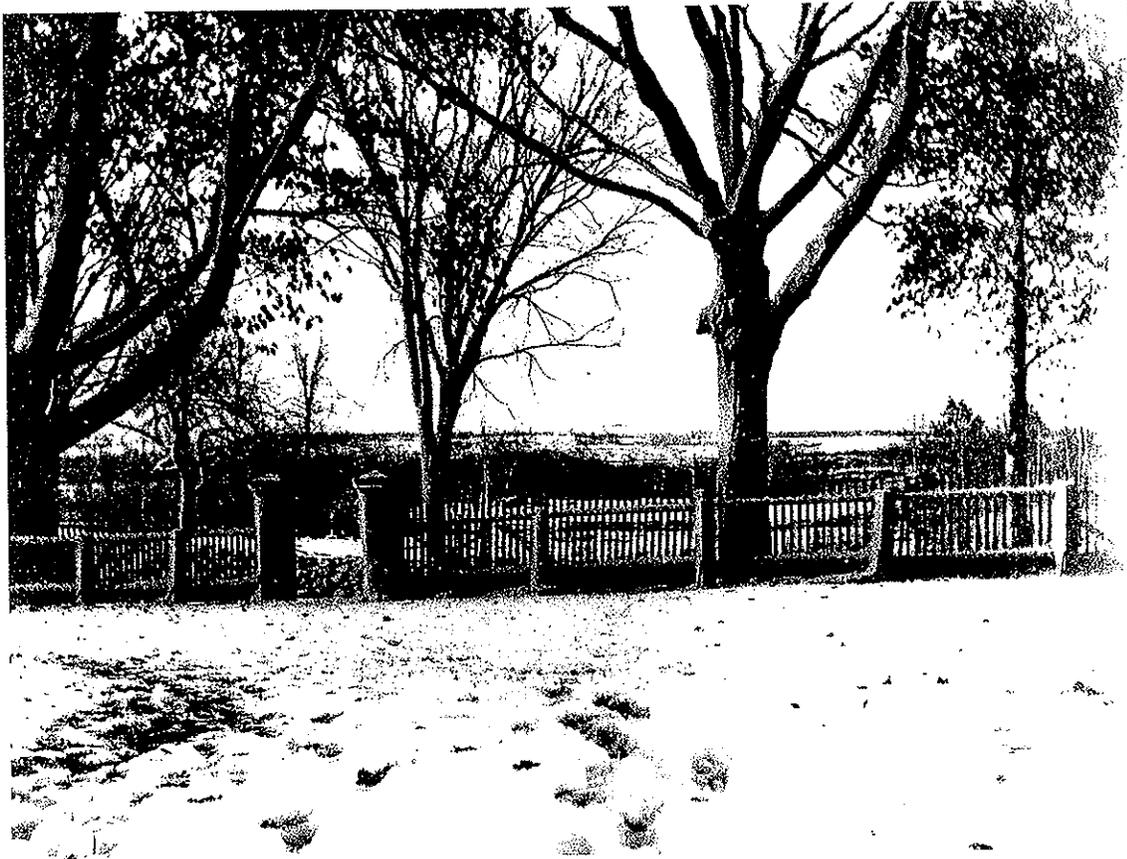
Figure 65. Weir Picket Fence - Looking East (Before 1900).

A good comparison between the earlier picket fence and the later rustic fence can be made by examining two additional historic pre-1900 photographs of Weir farm. One view (**fig. 65**) looks east from the east entrance to Weir house and shows the earlier picket fence and east gateway. In the second photograph (**fig. 66**) the view is from across Nod Hill Road towards the east entry of the house and shows the east face of the rustic fence. The east side of the rustic fence has no gate in line with the Weir house east entry, reflecting Weir's decision to relocate the primary entrance to the house to its south side. It is thought that a gate along the east span of the rustic fence was relocated closer to the barn and tack house to the north.

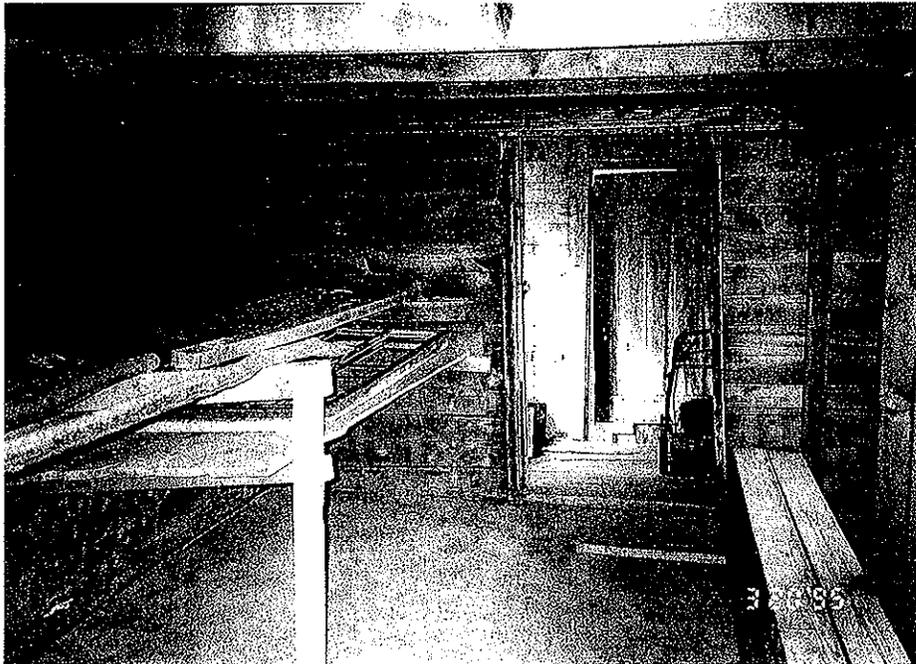
Figure 84. Weir Ice House – Chicken Coop [Room 101], Looking North into Lean-to Shed (1995).

There are two doorways in the chicken coop. The main entrance (D101) is centered on the south wall. The second doorway in the room is located on the north wall (D103) and accesses the lean-to storage shed (Room 102 - fig. 84). The opening is framed using circular-sawn 2-inch by 7-inch boards and measures approximately 3 feet 5 wide by 6 feet 4 inches high. There is no door in doorway D103.

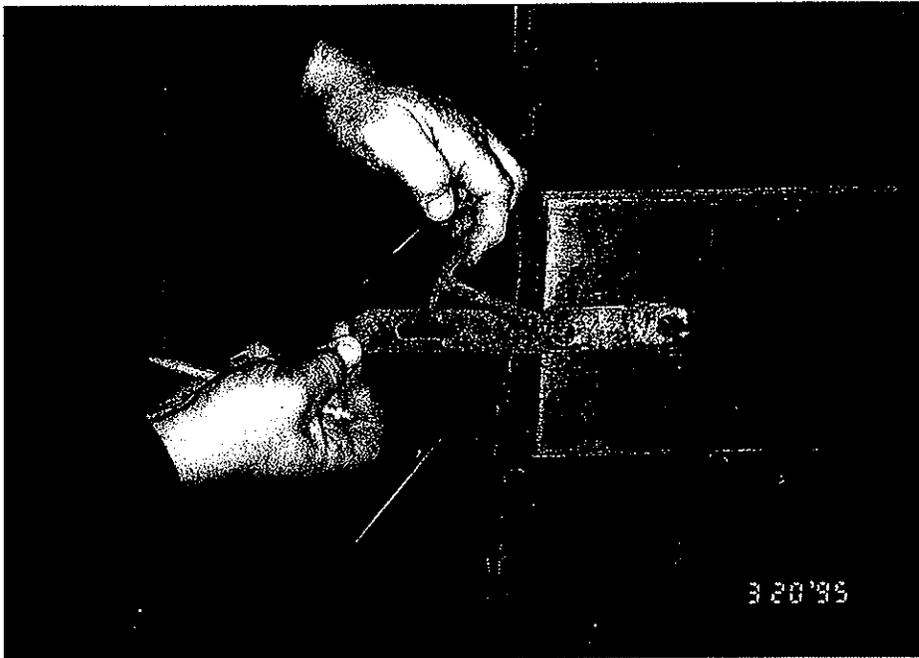
Figure 85. Weir Ice House – Lean-To Shed [Room 102],
Doorway D102 Hardware (1995).

There are two doorways in the lean-to shed. The rear exterior entrance (D102) is located on the north wall. A hand-wrought hook and latch have been attached to the interior side of the door in D102 using a bent-over wire nail (fig. 85). The second opening (D103) is located on the south wall and leads to the chicken coop. This opening has no door.

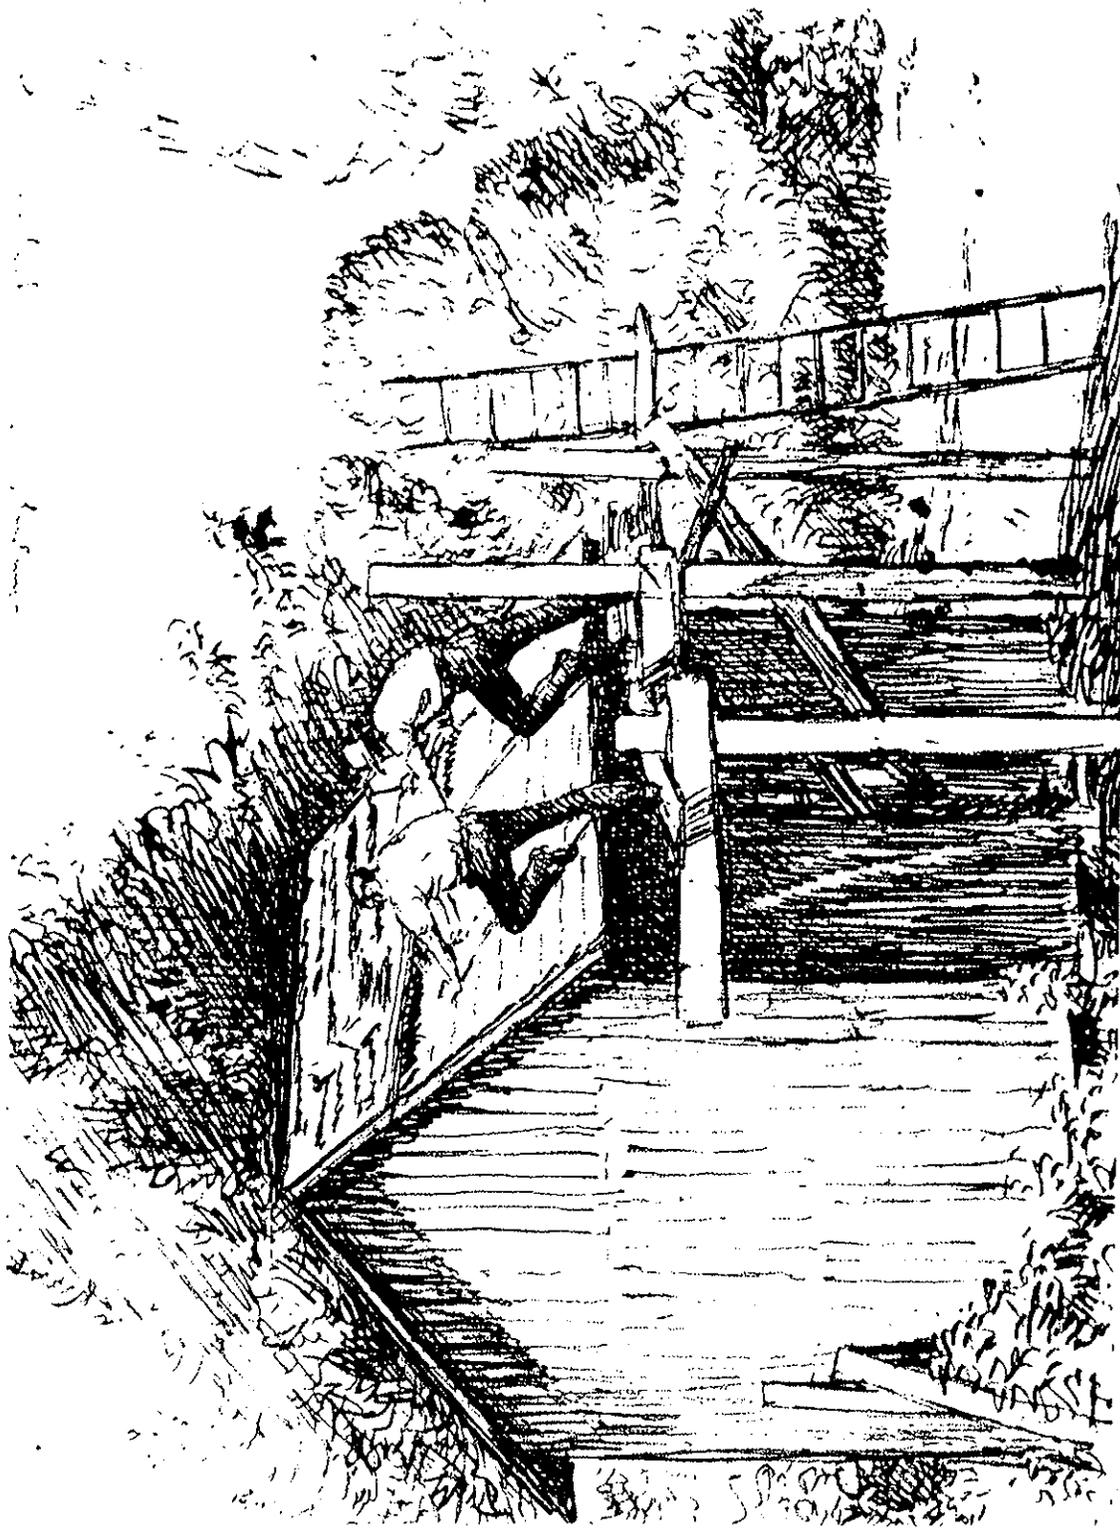
Figure 89. Mahomi Young, *Shingling the Corn Crib* (1932).

A 1932 Mahonri Young drawing entitled *Shingling the Corn Crib* depicts two men reshingling the corn crib roof and shows the east and south exterior walls of the building (fig. 89). It appears from the drawing that the east-wall doorway had been filled in by this date.

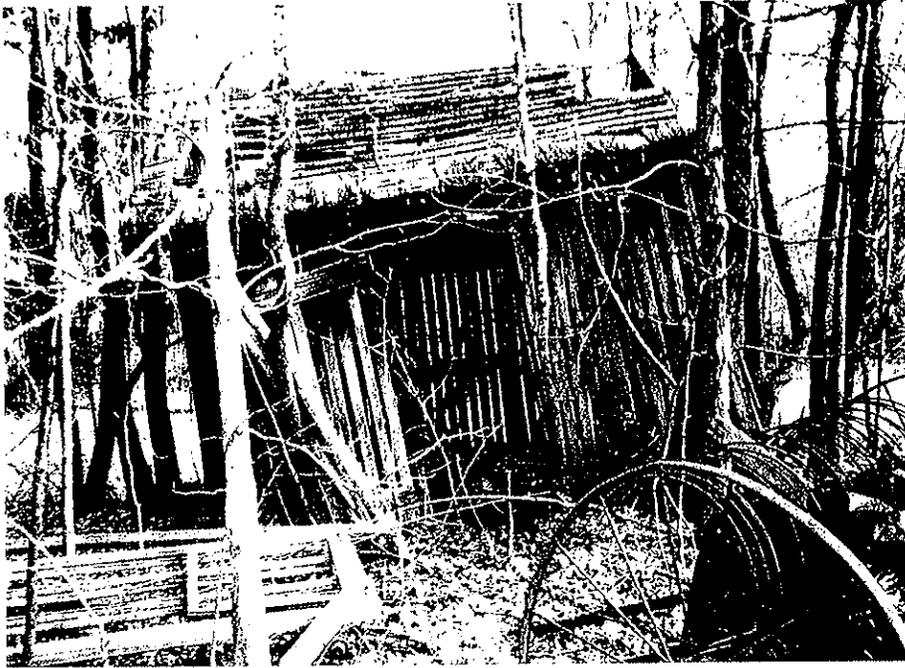
Figure 90. Weir Corn Crib - West Facade (1993).

The Weir corn crib (figs. 90 & 91) is located approximately 100 feet north of the Weir ice house and approximately 200 feet north of the Weir barn. The corn crib is a 1-story, rectangular, one-room building that measures 10 feet 1 inch deep by 12 feet wide. The wood-frame structure has a gable roof with the ridge running north/south. The surviving roofing is wood shingle and the siding is composed of open-slatted boards. One doorway is centered on the west wall.

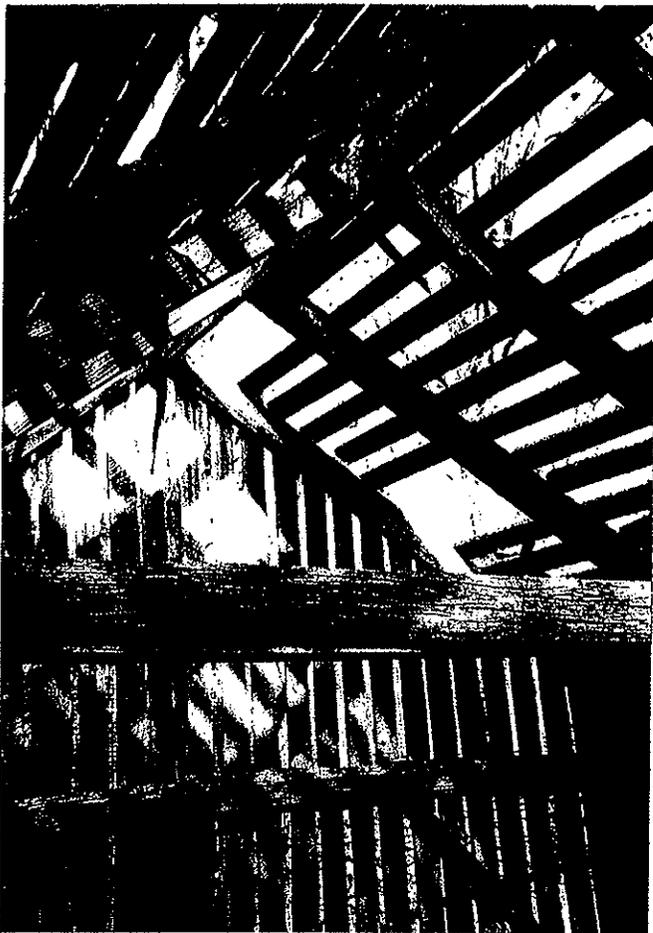
Figure 92. Weir Corn Crib -
Roof Framing, Interior (1993).

The framing of the corn crib is made up of hewn timbers assembled using mortise-and-tenon joinery and of milled timbers with their butt-joints toe-nailed with wire nails (figs. 92 & 93). There are four corner posts and four additional structural posts, each measuring 5 1/2 inches by 3 3/4 inches. Timbers of the same size are used as braces situated between the posts approximately 3 feet above the floor level and as wall plates. Rafters are 2-inch by 4-inch boards installed 2 feet on center, and are attached to a 3 foot 3/4 inch by 6 inch ridge board. One collar tie that is a 5 1/2-inch by 3 3/4-inch timber acts as a brace between the west and east wall plates.

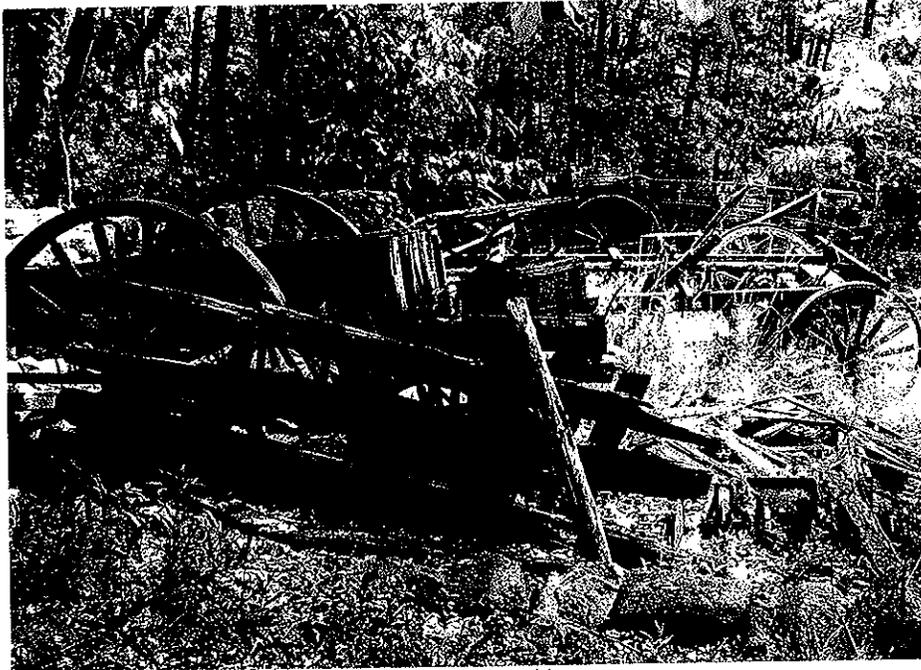
Figure 114. Weir Wagon Shed - Foundation and Building Remnants, View from the West (1992).

Only remnants of the wagon shed foundation and walls are extant, along with four wagons in deteriorated condition (**figs. 114 & 115**).
