**WEIR FARM HISTORIC STRUCTURES REPORT
VOLUME II-A**

**Weir Farm National Historic Site
Wilton, Connecticut**

Weir Farm Outbuildings
Barn • Tack House
Rustic Wooden Fence • Ice House
Garden Tool Shed • Corn Crib • Chicken Coop
Well Houses • Wagon Shed

Maureen K. Phillips
Marie L. Carden

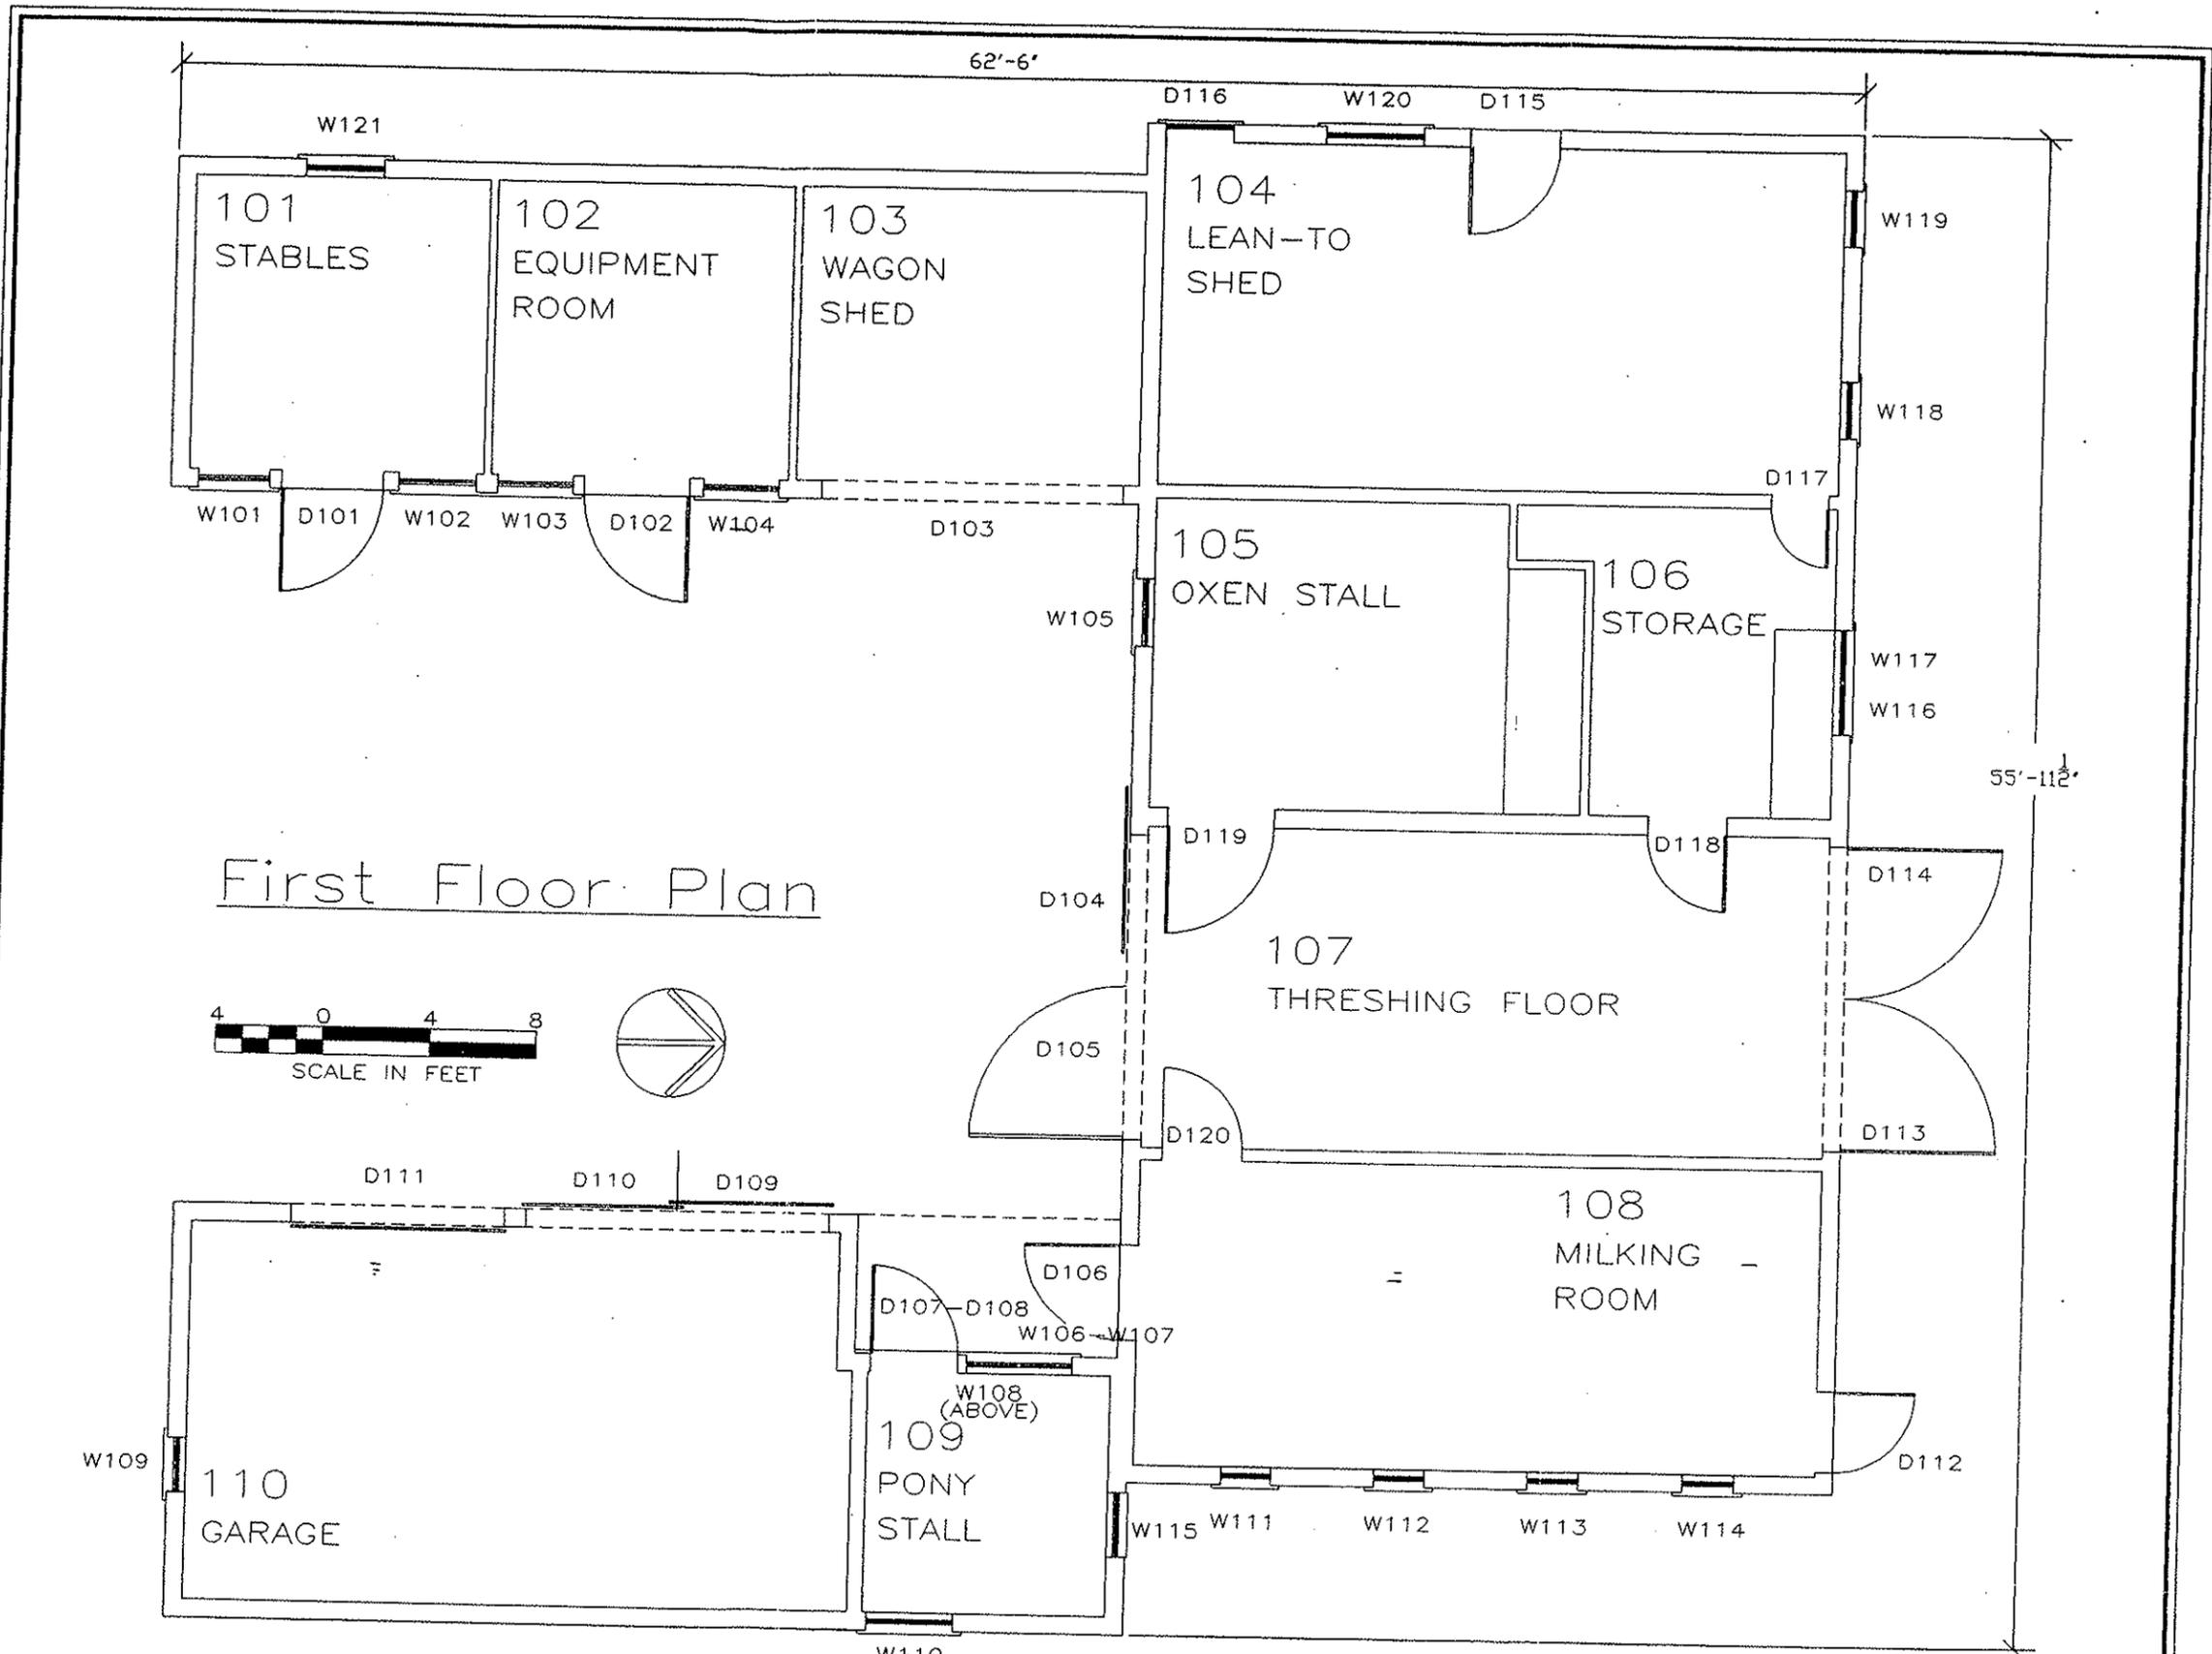
First Floor Plan

FLOOR PLAN BASED ON FIELD NOTES PROVIDED BY C. MCCOY, BCB/CRC
 DRAWN BY: BUILDING CONSERVATION BRANCH/CULTURAL RESOURCES CENTER, NESSO, 6/95

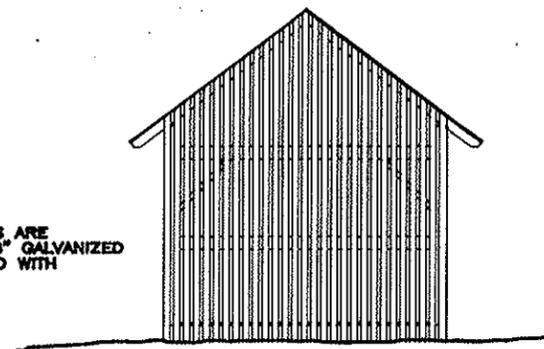
North Elevation

NOTE:
ALL EXTERIOR WALLS ARE
COVERED WITH 3/8" GALVANIZED
WIRE MESH SECURED WITH
ROOFING NAILS.
