**WEIR FARM
HISTORIC STRUCTURES REPORT**

**Weir Farm National Historic Site
Wilton, Connecticut**

Burlingham Complex

1995

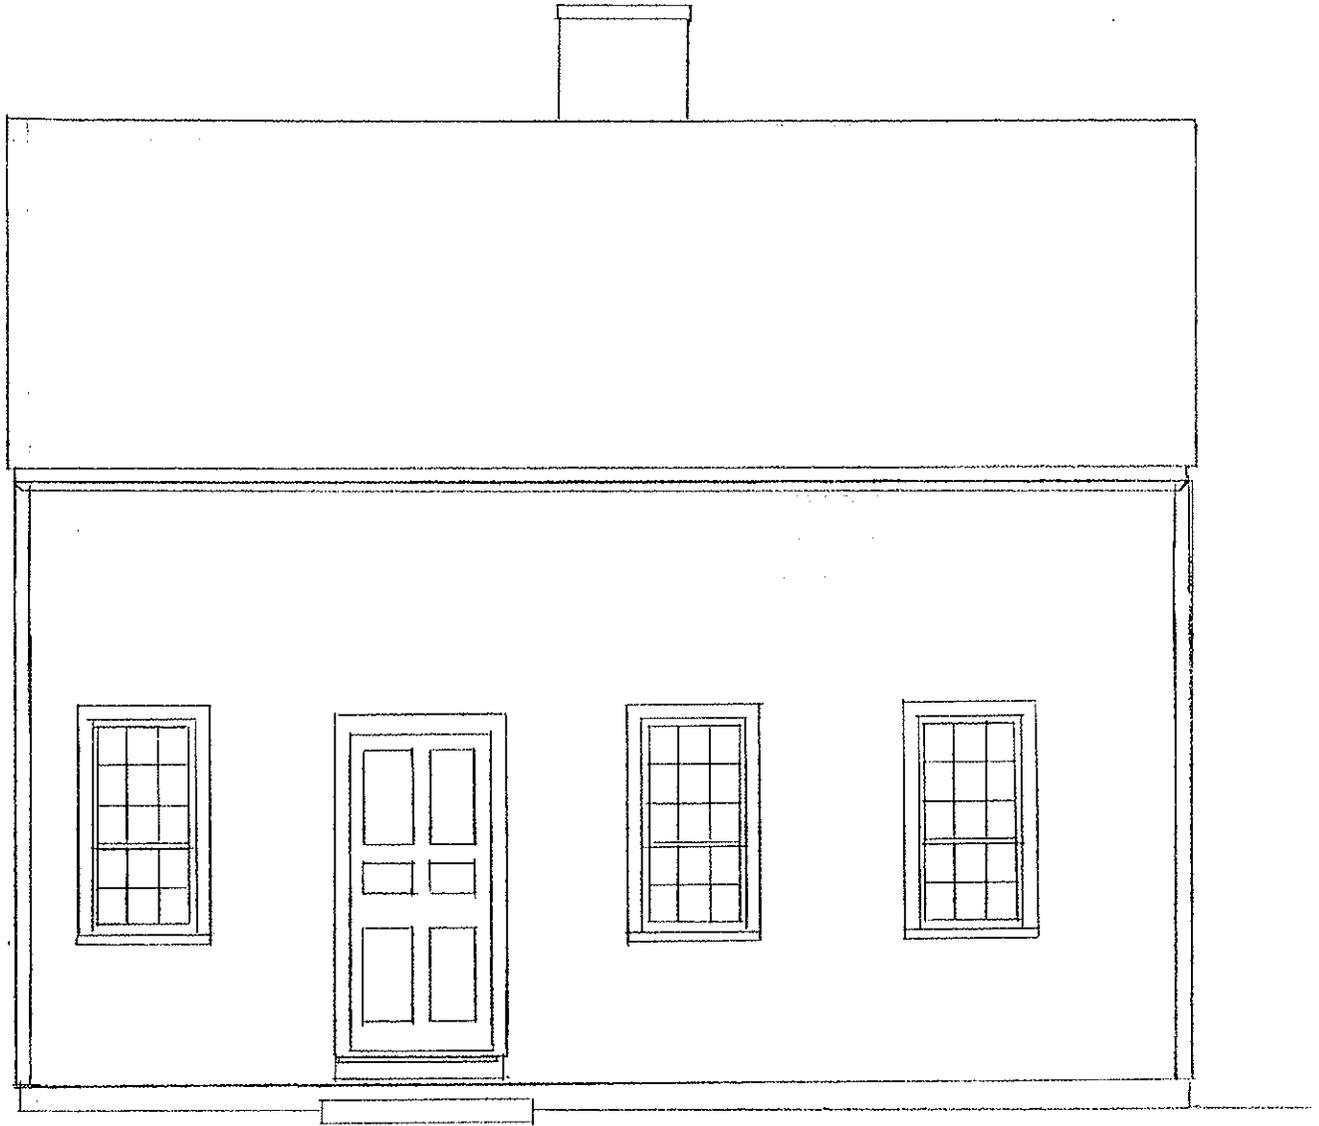
Figure 1. Webb-Burlingham House,
Conjectured Circa-1775 East Facade.

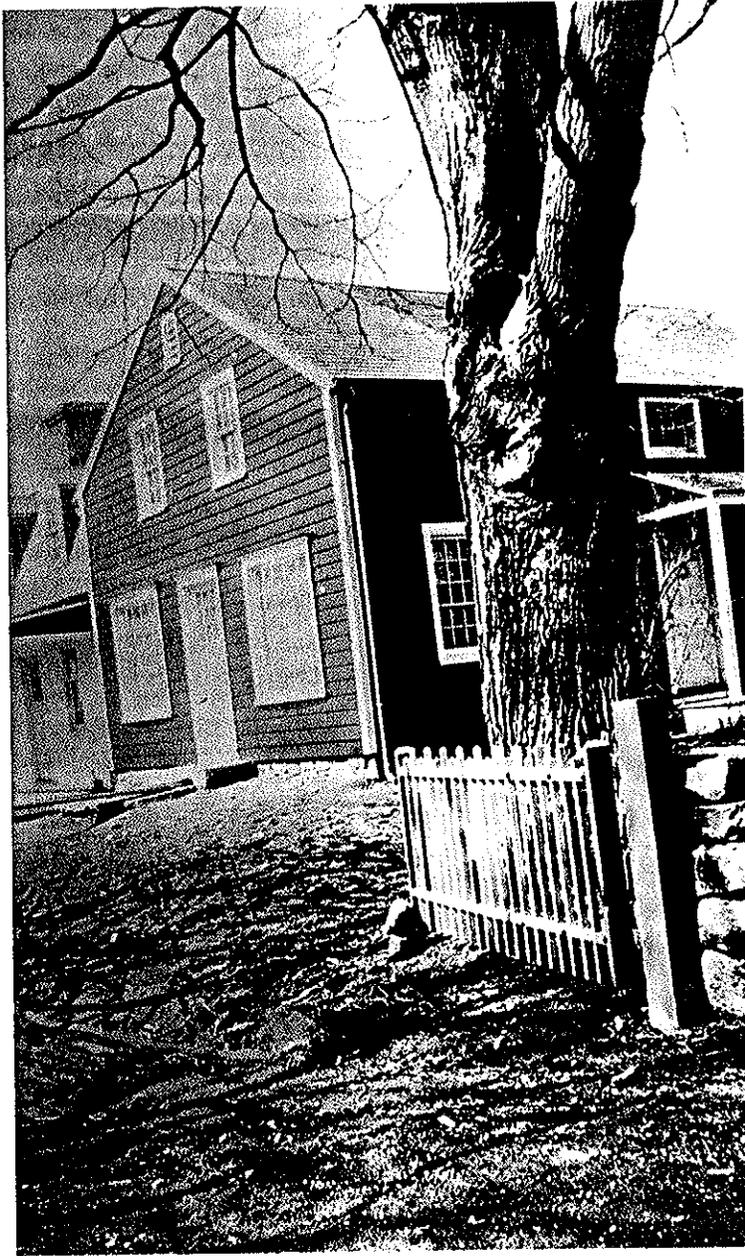
Figure 2. Webb-Burlingham House, Main House,
East Facade and West Wall (circa 1933).

the surround, if only by a few years. A photograph thought to date to circa 1932 shows the east entrance with the extant door but with a plain surround.²⁰ The view also shows that the entrance had a covered porch with a shed roof and wooden stoop, both of which were removed in 1938 (fig. 2).

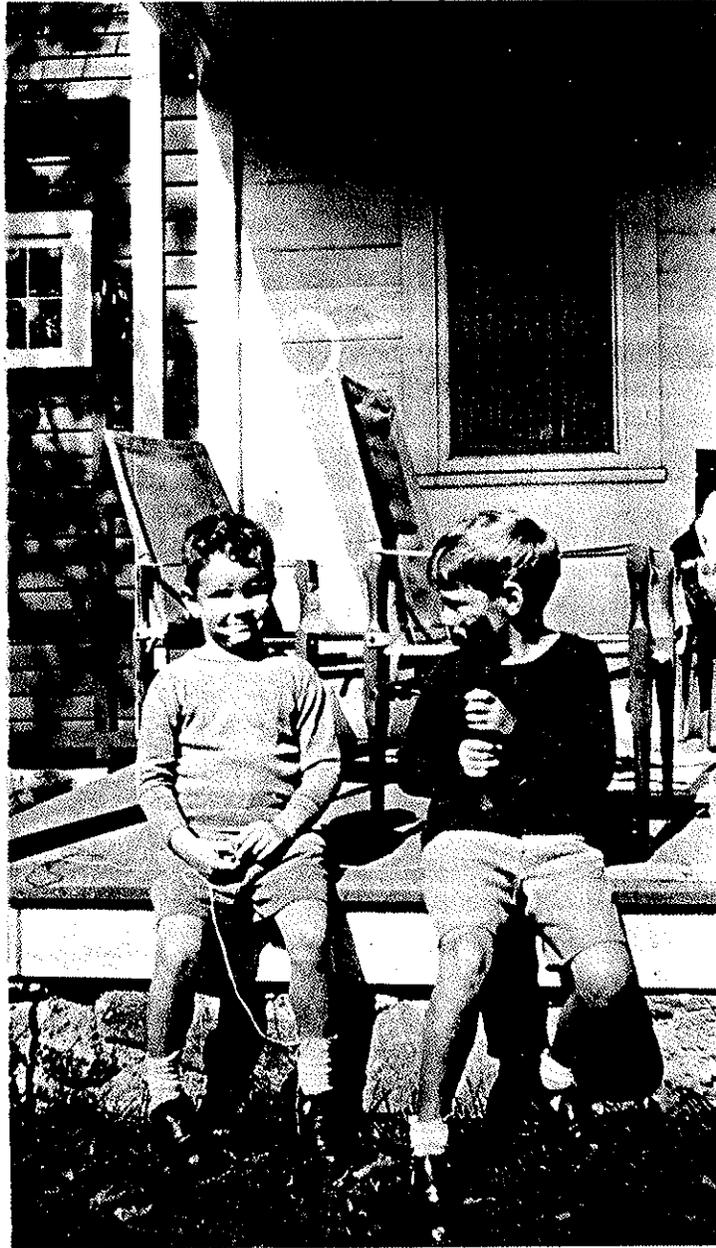
Figure 4. Webb-Burlingham House, South Porch (Circa 1933).

The extant dining room ell and the south porch can be seen in photographs of the house dating to circa 1933-1935 (figs. 4-6). The ell appears to have been built at the same time as the south addition to the main house. This is also evident in a shared basement foundation wall that, from the ell side, is continuous along the main house and the south addition. The ell was joined to

Figures 4 and 5 do not show the upper level of the ell. However, paint stratigraphies of the gables and window sashes and surrounds on the two extant dormers situated on the lower slope of the ell's gambrel roof are identical to those on the extant original features on the first story, and are therefore known to date to the circa-1932 construction of the ell.

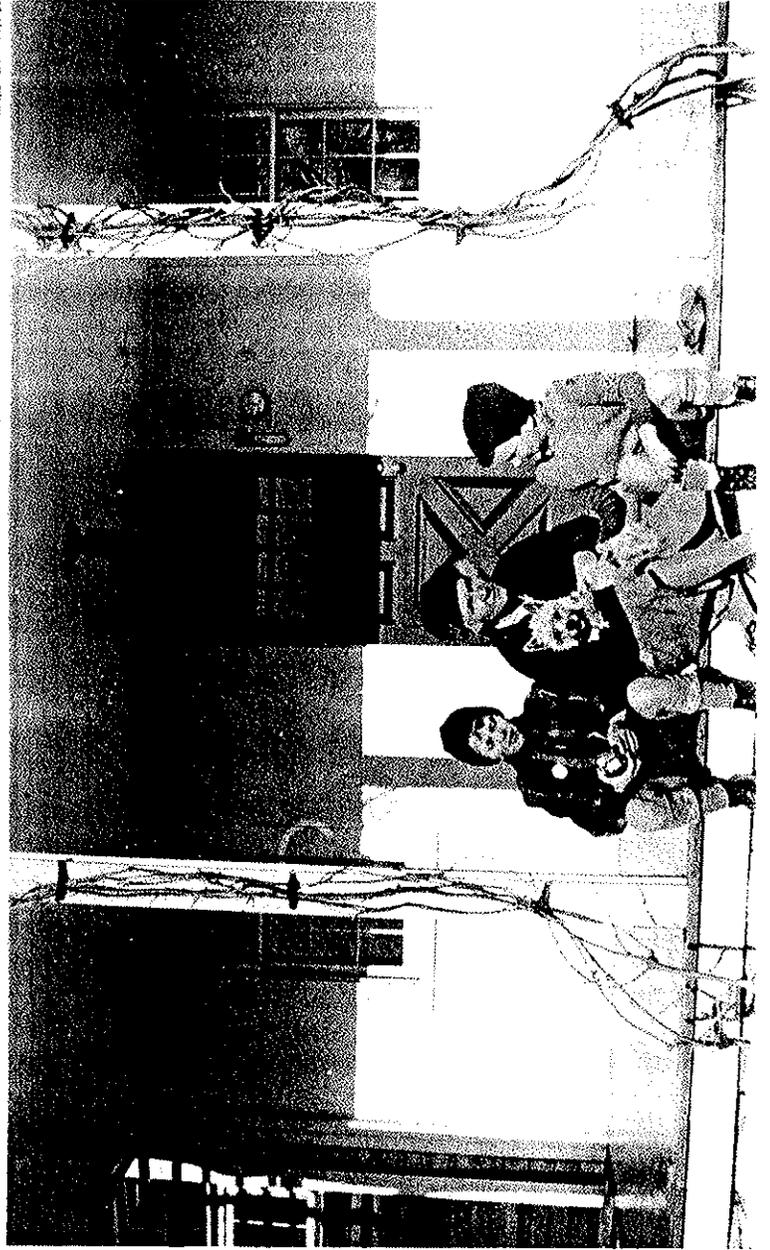
Figure 5. Webb-Burlingham House, South Wall Dining Room Ell (Circa 1937).

The south porch was built at the same time as the dining room ell. Analysis of mortar samples taken from the porch foundation shows that they are the same as mortar samples taken from the ell foundation, and paint histories of the porch elements match those of features on the ell's south wall. Burlingham family photographs from the mid-1930's show the porch as it appears today, with screens in place and vines growing up the posts in the summer months (figs. 5 & 6). The porch protected the entire south wall of

Photographs from the mid-1930s show that the exterior appearance of the south and west walls of the kitchen ell has changed since it was first built (figs. 4, 6, & 9-11). Figures 3, 5 and 9 show that the first-story south wall originally had two small 6-pane windows. A trellis is set against the wall shaded by a rustic pergola. The rear (west) wall of the kitchen ell can be seen in the background in figure 10, taken before 1940.¹⁷ The rear porch and upper-story windows are visible and appear much as they do today. A back doorway, which is extant, was located under the rear porch. A post blocks the view of the porch door in the photograph, but the steps lead up to the same point as they do today, and the interior paint stratigraphy of the door is

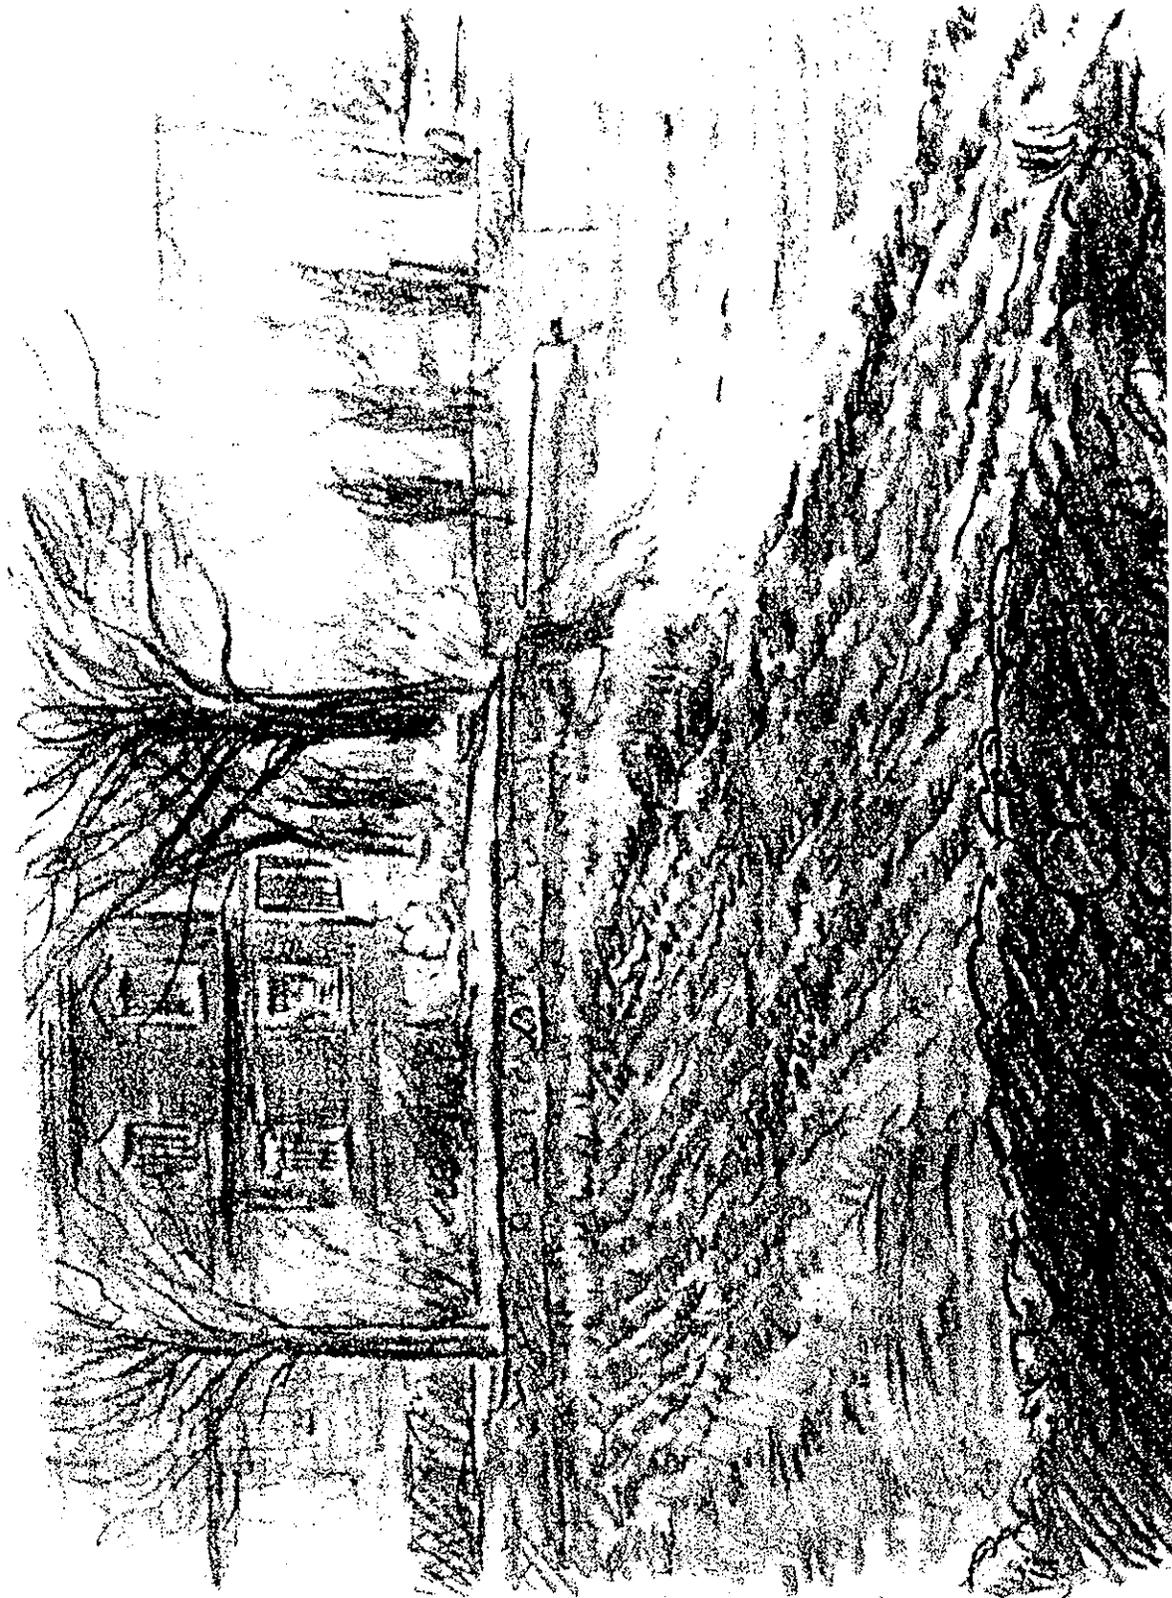
Figure 7. Mahonri Young, Plowed Garden (1939), Showing North Aspect of Webb-Burlingham House.

There are no known circa-1930's photographs of the north wall of the dining room ell, but there are two Mahonri Young drawings of the north side of the kitchen and dining room ells that date to 1939 and circa 1942 (figs. 7 & 8). From the drawings it can be seen that the dining room ell's original appearance has not changed, with the main feature at the first story the extant bay with tripartite windows. The foundation for this bay is integral with the rest of the ell foundation wall, and is thus known to be original to the ell. This is confirmed by analysis of the paint on the sashes and surrounds of the bay and basement windows, which shows stratigraphies similar or identical to those on circa-1932 features on the ell's south wall.

There were also originally two gable dormers on the lower north slope of the dining room ell's gambrel roof. These dormers appear in Young's drawings, and are identical to the extant dormers on the ell's south roof slope. There was also originally a doorway

The north side of the kitchen ell is thought to have appeared in 1935 as it does today. Paint analysis of the interior indicates that the two extant window sashes on the first story were installed with the original circa-1932 construction of the ell. The upper stories of the north and south sides of the ell are not visible in any of the photographs, but the north kitchen ell was depicted in the 1939 and circa-1942 Mahonri Young drawings (fig. 7 & 8). The drawing shows a gambrel roof and two dormers that appear the same as they do today.

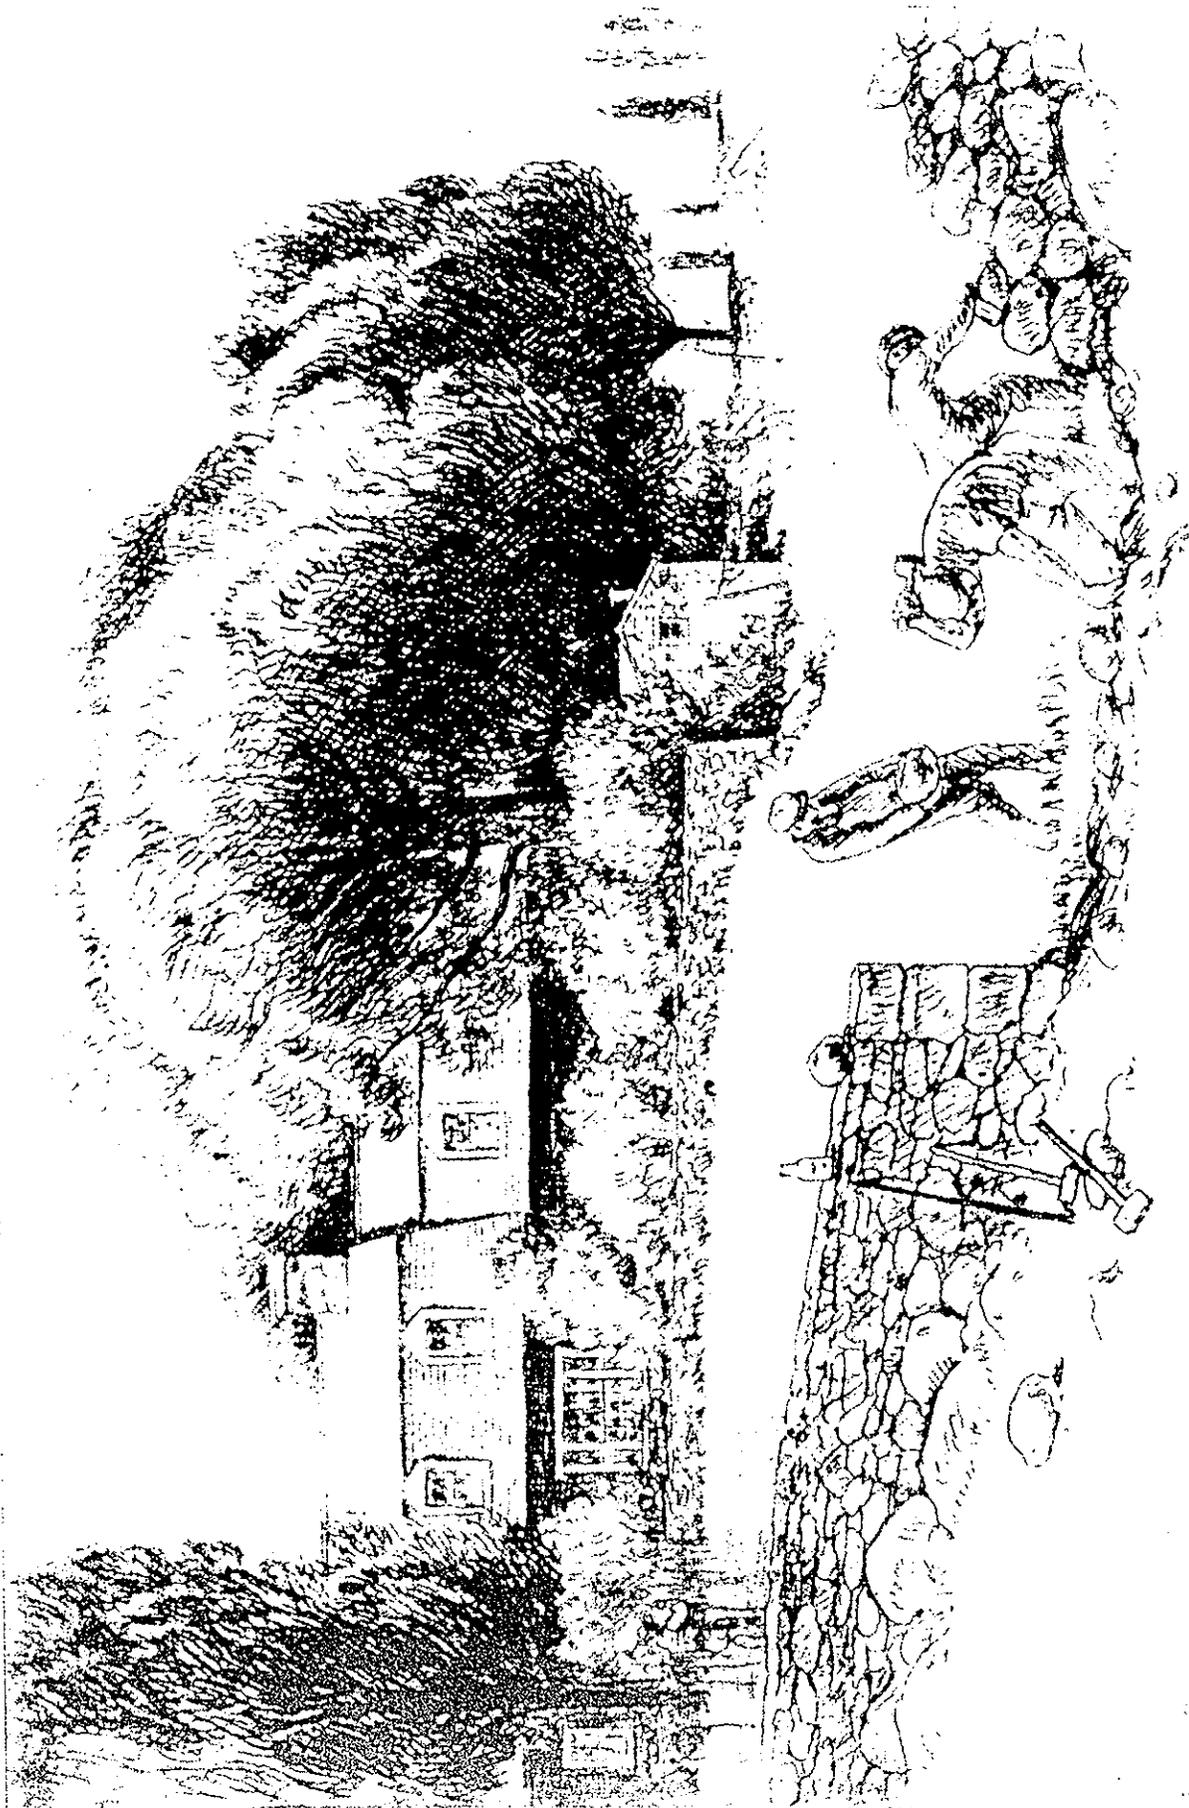
Figure 8. Mahonri Young, Joe Knoche Builds a Wall (Circa 1942), Showing North Aspect of Webb-Burlingham House and Burlingham Tool House.

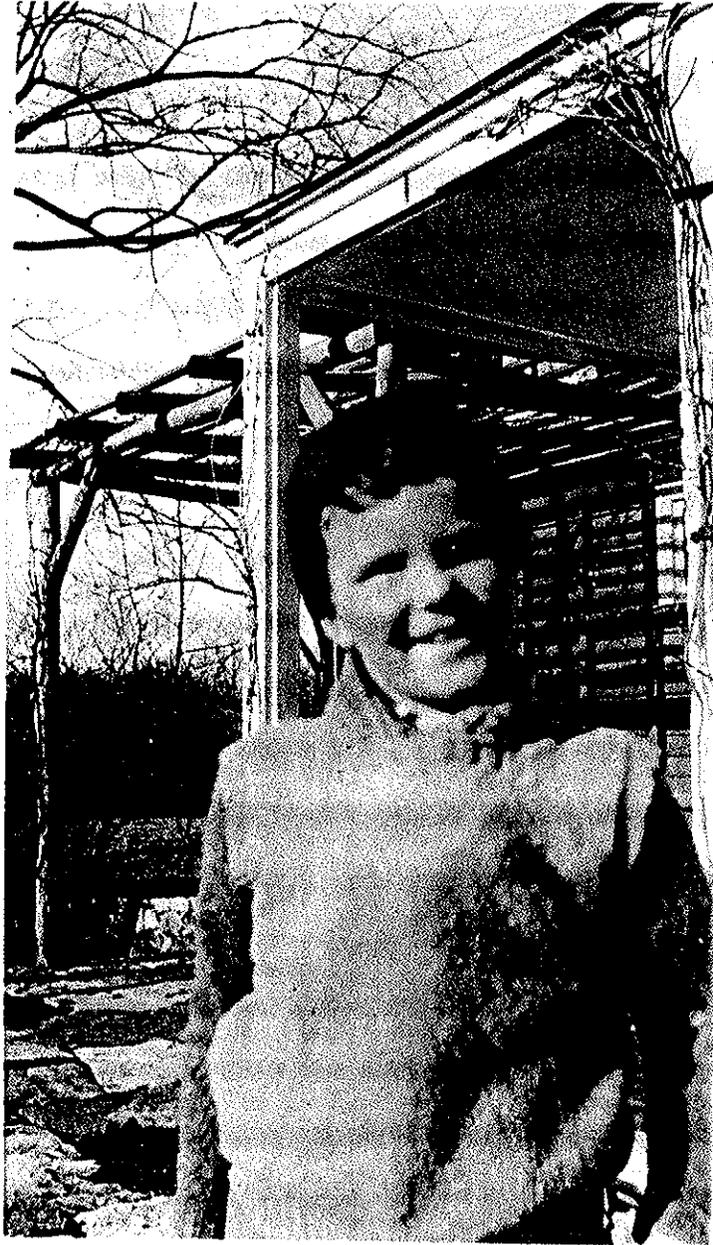
Figure 9. Webb-Burlingham House, South Wall,
Kitchen Ell and Pergola (circa 1937).

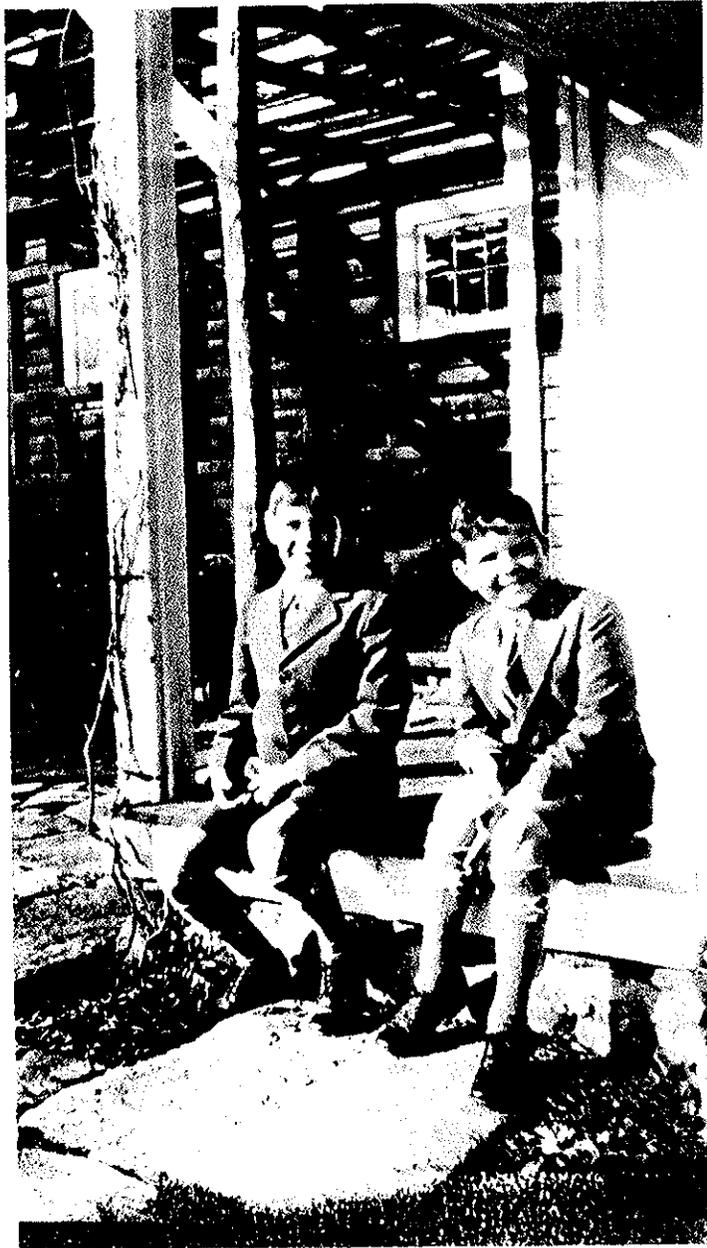
Figure 10. Webb-Burlingham House, South Aspect, Kitchen Ell and South Porch (Circa 1937).

Notations on plans for a 1938 greenhouse built on the south kitchen wall (see following section) indicate that the greenhouse used the extant stone terrace for its foundation and flooring. This terrace is thought to have been installed sometime after 1932. A family photograph shows Cora Burlingham's two sons, Charlie and Bill, sitting on the edge of the south porch in front of the kitchen and dining room ells. Charlie is approximately 3 to 4 years old in the photo, which would date it to circa 1933-1934. Both boys' feet are resting on grass where the terrace would exist (fig. 3). A later photograph, taken before the 1938 greenhouse was installed, shows the (somewhat older) boys in a similar pose, with their feet resting on the terrace stone (fig. 10).

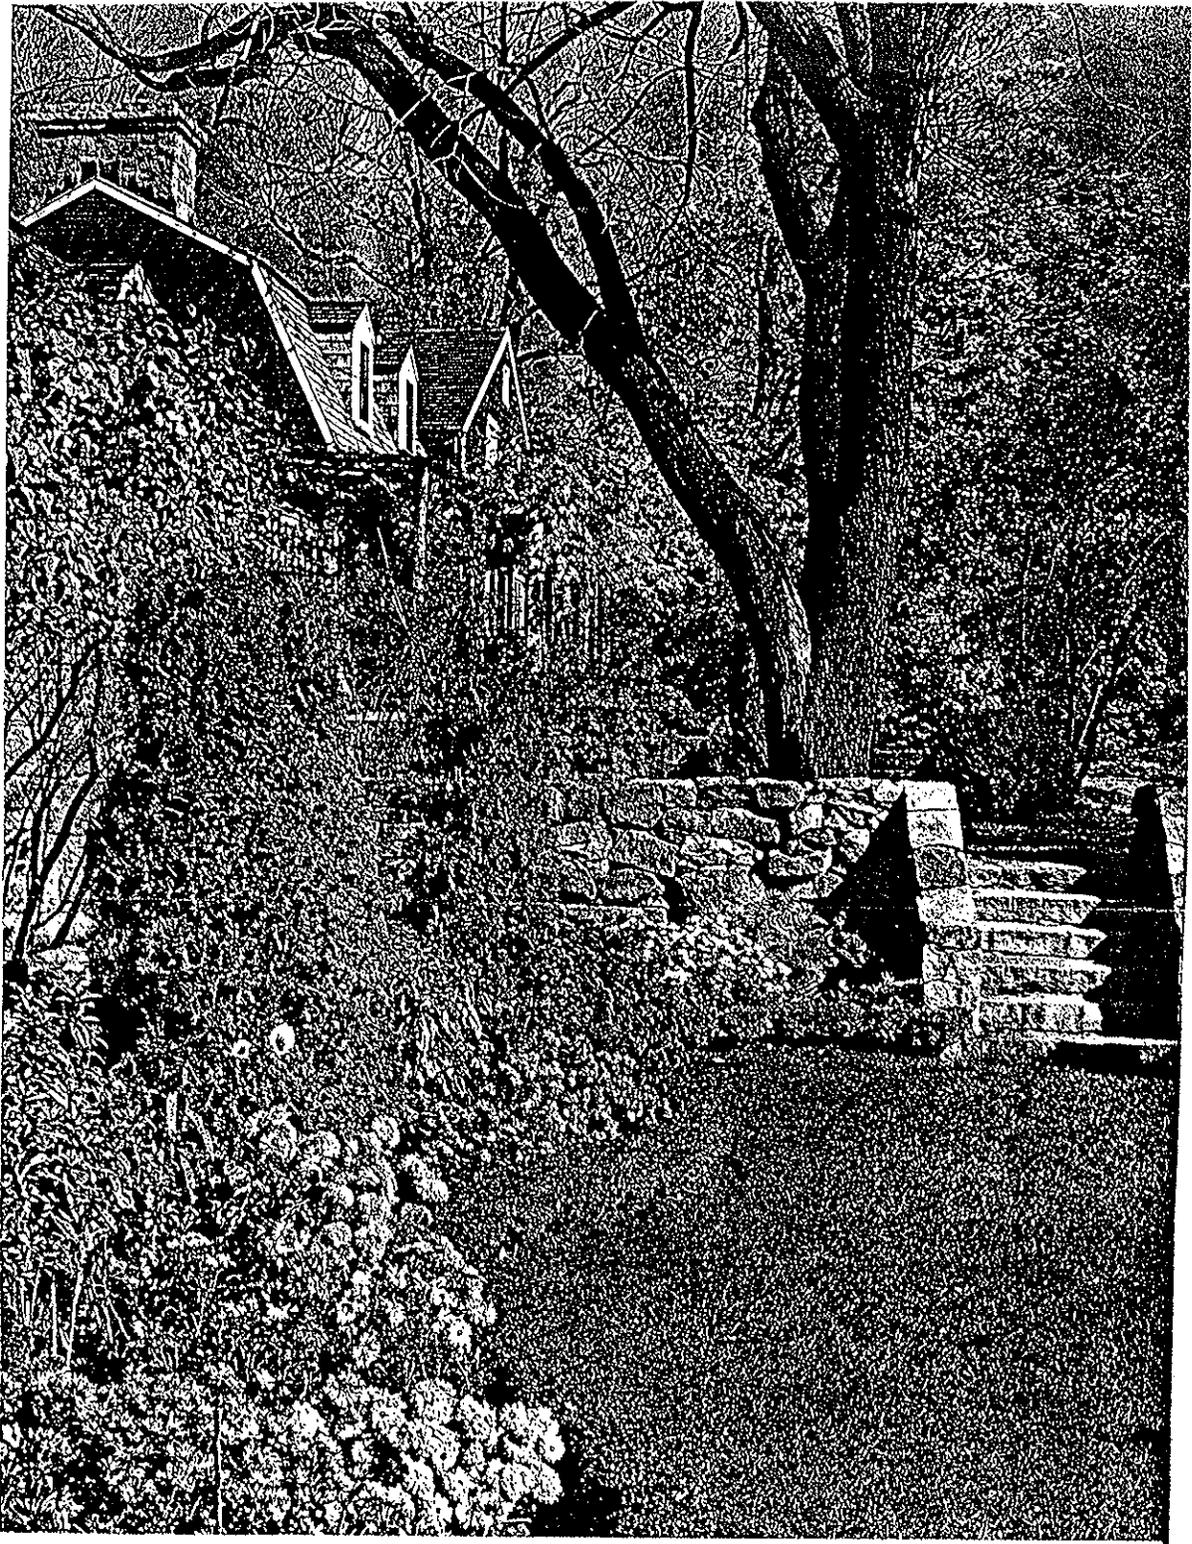
Figure 12. Webb-Burlingham House, View From Sunken Garden (1956).

In 1938 a greenhouse designed by F. Nelson Breed was built along the south kitchen ell wall. A Dutch doorway was installed on the short west wall of the dining room ell, replacing a window. This doorway led from the dining room to a wood platform step in the greenhouse that now blocked a basement window on the west foundation wall of the dining room ell. Breed's surviving 1938 architectural drawings for the structure show that it was built as planned, with glazing on the upper half of the exterior west and south walls as well as on the shed roof.¹⁸ A 1956 photograph of the house in a national magazine taken from the sunken garden shows that the pergola was retained when the greenhouse was built (fig. 12).

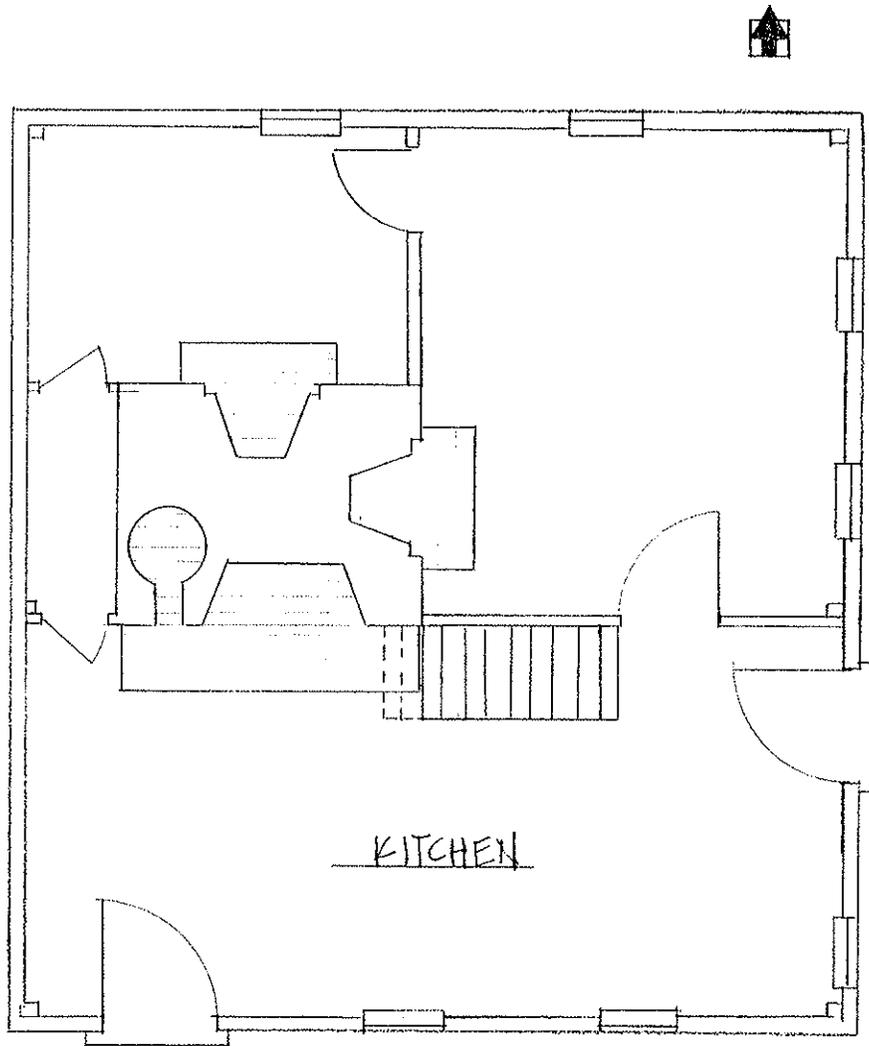
Figure 14. Webb-Burlingham House,
Conjectured Circa-1775 First-Floor Plan.

The ridge pole of the original roof of the house ran parallel to the road, as was typical in 18th century vernacular Connecticut houses.²⁴ On the first floor, the placement of the chimney stack slightly off-center and behind the ridge line indicates that, although circulation in the original house revolved around the chimney mass, the house did not have the center chimney plan that was more common for the region. The house was built as a one-and-a-half story structure, in which one would usually find either an entry and a second-floor staircase in front of the chimney stack, or (less frequently) an entry in front of the chimney with the stairs behind. Apparently the original Webb-Burlingham house had no such entry or staircase. As can be seen in the conjectured plan

(fig. 14), the chimney stack was placed off-center front-to-rear. The area to the front of the chimney stack was too large to have been used for an entry alone or even for the entry and staircase typical of 18th century Connecticut houses. In addition, a fireplace was located on the front face of the stack, and analysis of the mortar in its extant firebox in the current study indicates that this is an original feature of the house. The area at the rear of the stack was too narrow to accommodate a staircase.

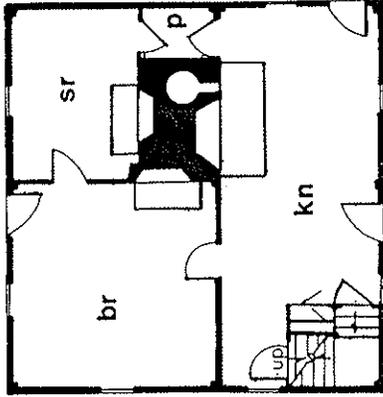
Fig. 3. Plan of Bixby house, as originally constructed by Nathan and Rufus Hemenway. Kn = kitchen; p = passage; br = best room; sr = sitting room. In all the drawings, stippling indicates a first addition; hatching indicates subsequent additions; a dashed line indicates a wall or structure removed. (Drawing, Myron O. Stachtiv)

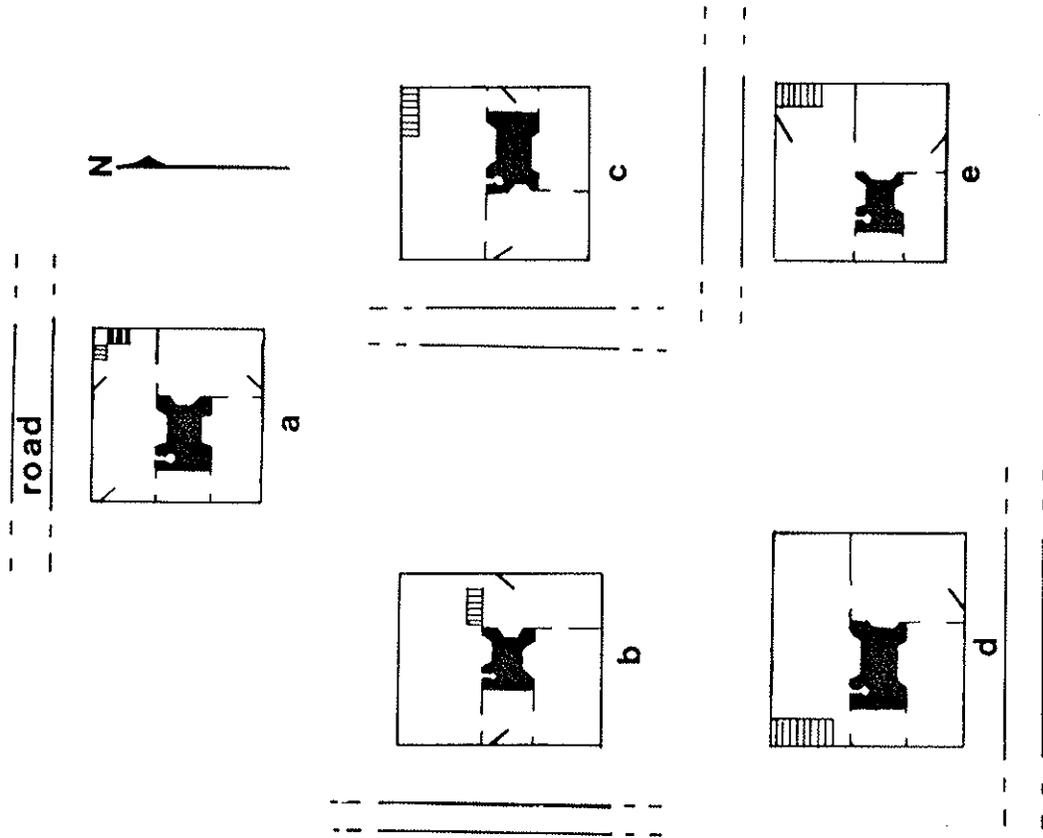
Figure 15. Reconstructed Plans of the Five Hemenway-Plan Houses.

Fig. 4. Reconstructed plans of the five Hemenway-plan houses located: (a) Bixby house, (b) Aaron Gates house, (c) Joseph Underwood house, (d) Amos Hemenway house, (e) Joab Holland house. Not to scale. (Drawing, Nora Pat Small)

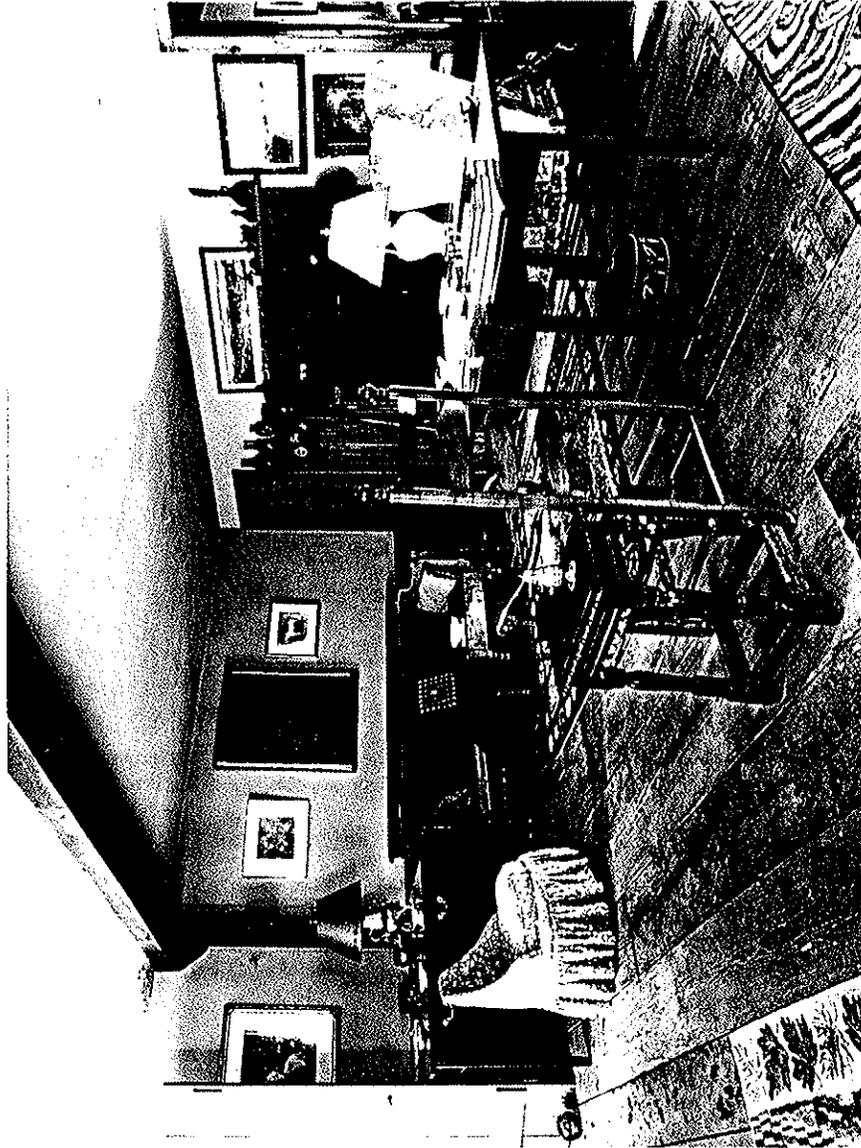
Figure 16. Webb-Burlingham House Living Room (Room 108), Looking Northwest (circa 1940s).

The first phase of the circa-1932 remodeling of the Webb-Burlingham house made by the Burlinghams shortly after Cora Burlingham took possession of the property was the extension of the main house by 8 feet to the south. This work resulted in a larger living room on the south end of the first floor (fig. 16), and the creation of a master suite on the south end of the second floor. The hopper windows on the east wall of the new master bedroom and the northeast bedroom were probably installed at this time. These rooms are essentially unchanged from circa 1932 to today (see section PHYSICAL DESCRIPTION - INTERIOR ELEMENTS, following).

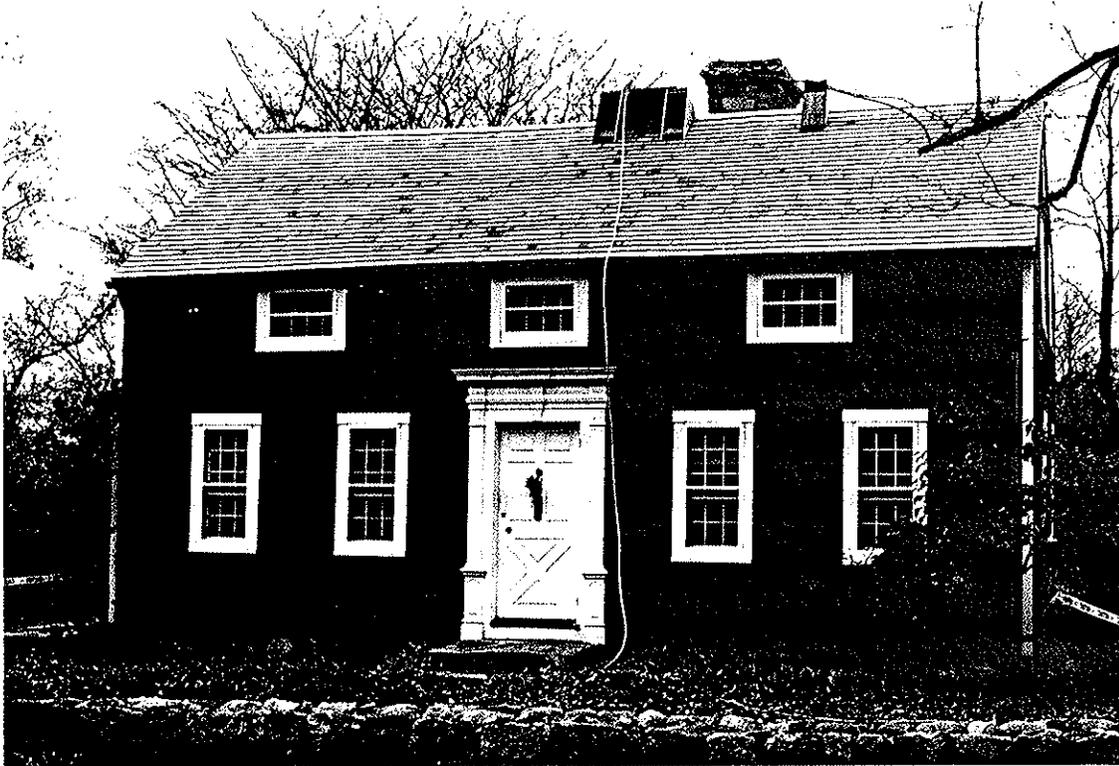
Figure 17. Webb-Burlingham House, Main House East Facade (1994).

The Webb-Burlingham house (fig. 17) is located on the west side of Nod Hill Road, and consists of the main house, which is set back approximately 20 feet from the road, and two ells extending from the main house in a line to the west. The main, or front, portion of the house is a rectangular, gable-roof, wood-frame structure measuring 32 feet 6 inches wide by 22 feet 6 inches deep and 1 1/2 stories high. It is set on a fieldstone foundation, and has a wood-shingle gable roof, with a stone chimney located off-center behind (west of) the ridge line. An unpaved driveway, which parallels the south side of the house, leads down from the road to the outbuildings to the west.

The front of the main house faces Nod Hill Road to the east. The east (front) facade is five bays wide, with two sash windows symmetrically placed on either side of a center entrance doorway at the first story, and three hopper windows tucked up under the eaves at the upper half-story (fig. 17).⁴⁶ A basement window is located in the foundation wall to the south of the doorway.

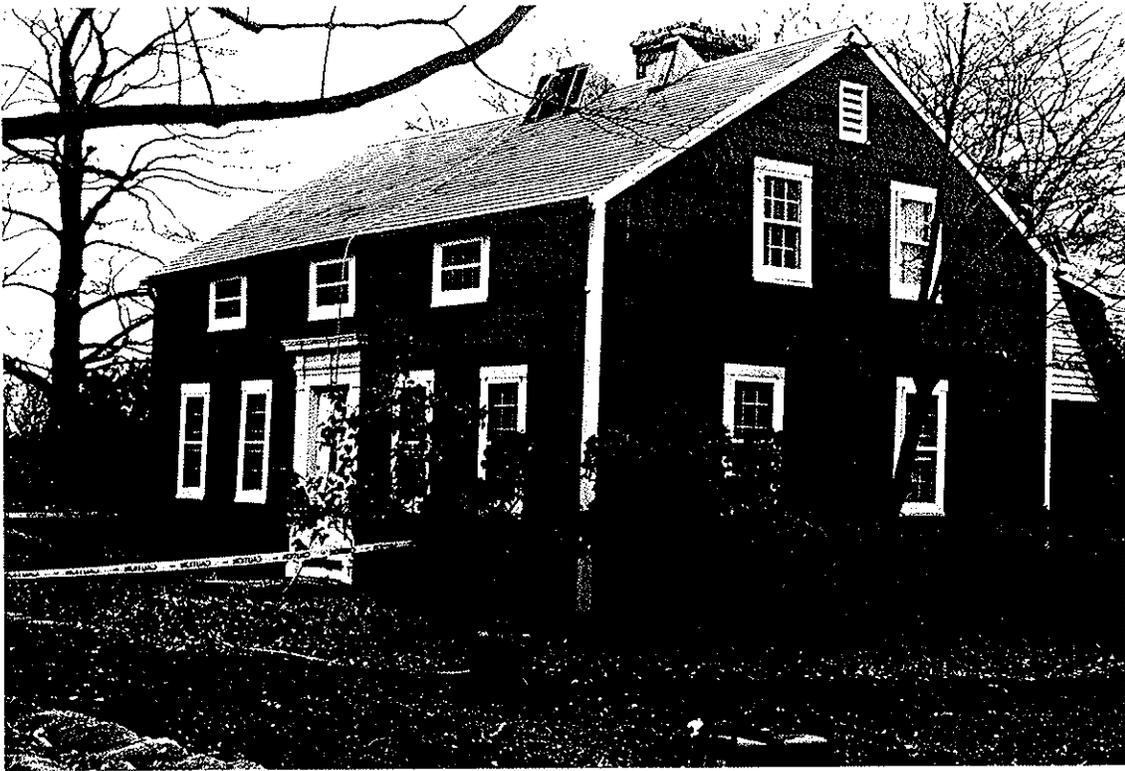
Figure 18. Webb-Burlingham House,
Main House East Facade and North Wall (1993).

The **north gable end** of the main house has one basement window, four sash windows (two at the first-story level and two at the upper-story level) and an attic vent under the gable (**fig. 18**). The **south gable end** has two fixed bow windows flanking a center doorway with a half-glass dutch door, two sash windows at the upper level, and an attic vent under the gable (**fig. 19**).

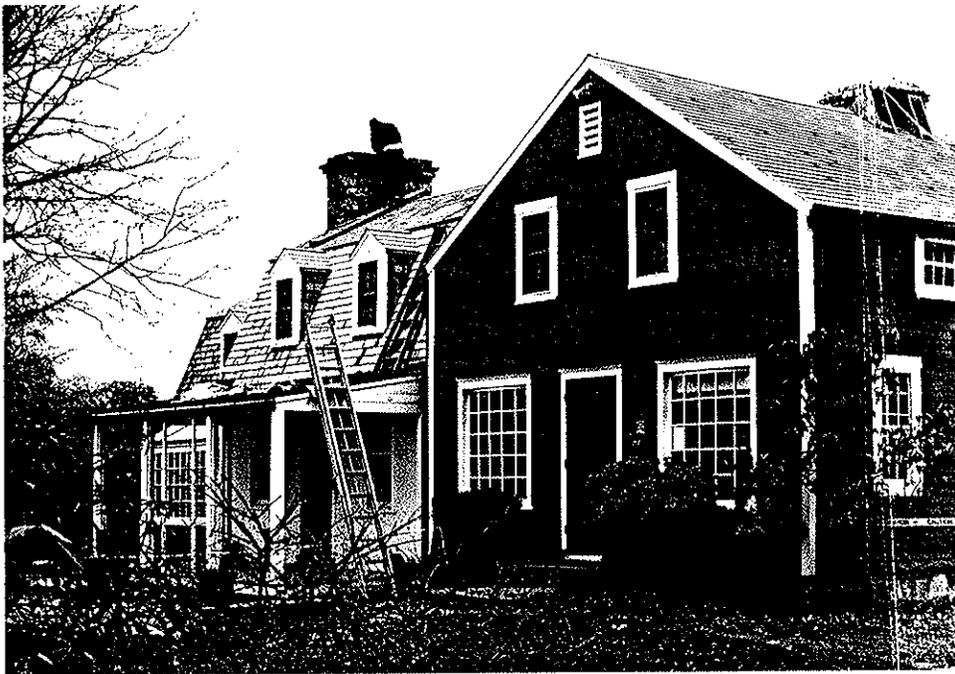
Figure 19. Webb-Burlingham House, Main House and
Dining Room Ell, South Aspect (1993).

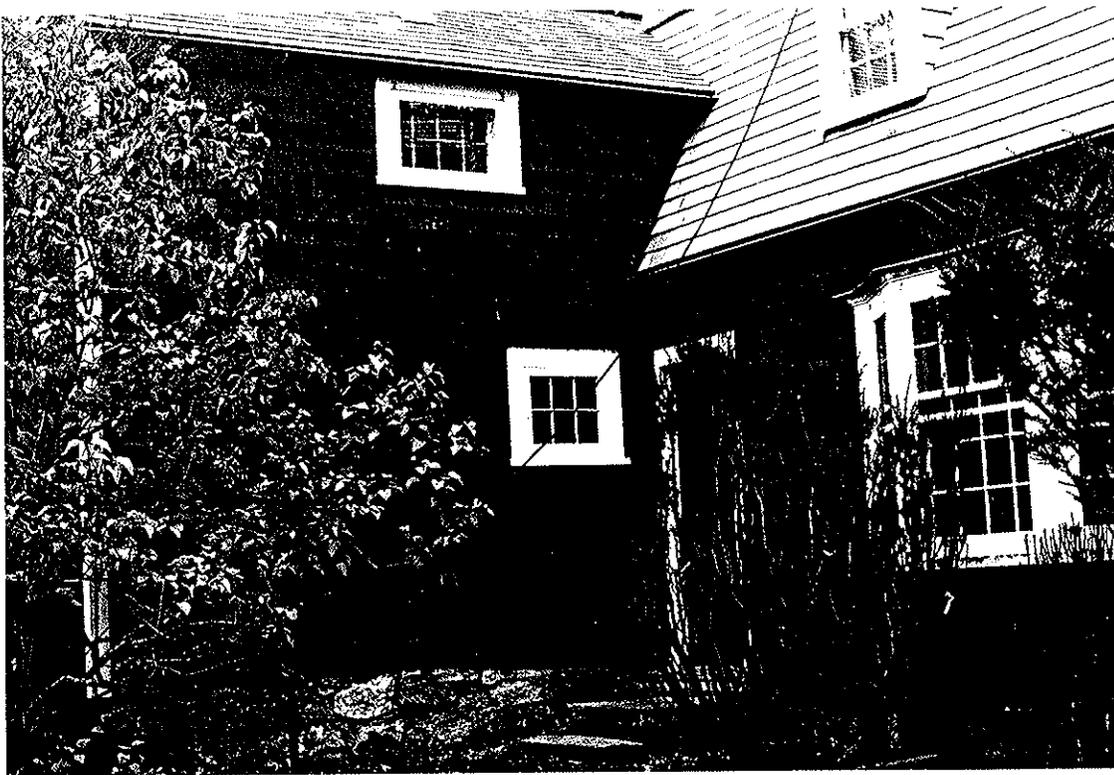
Figure 20. Webb-Burlingham House, Main House and Dining Room Ell, West and North Walls (1993).

The **rear (west) wall** of the house is interrupted at its south end by an ell. A small **casement** window has been installed on the upper story at the extreme south end of the wall under the eaves where the ell's gambrel roof intersects with the main house roof. The north end of the west wall has a small casement window on the first story near the ell, and a hopper window centered on the exposed wall at the upper story (**fig. 20**).

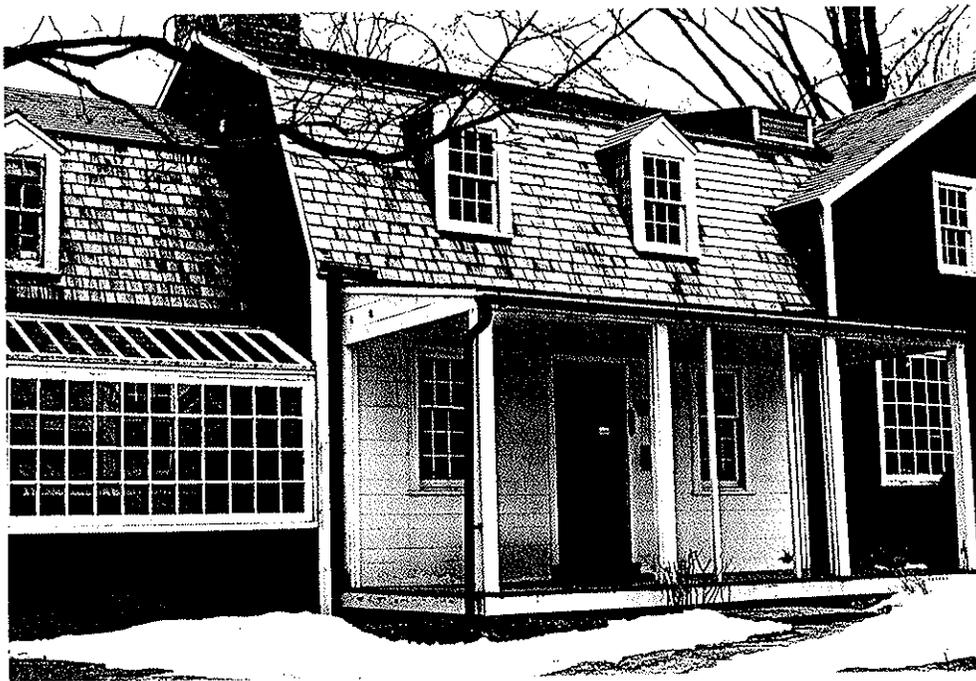
Figure 21. Webb-Burlingham House, Dining Room Ell, South Wall (1993).

Two wood-frame ells are located in a line to the west of the main house. The first of the ells (the "dining room ell") is connected to the south end of the west wall of the main house. The ell measures 22 feet wide by approximately 17 feet deep, and is 1 1/2 stories high. It is set on a fieldstone foundation, and has a wood-shingle gambrel roof with a stone chimney at its west end (**fig. 21**).

The dining room ell's **south wall** is recessed from the south wall of the main house, and in turn projects from the kitchen ell south wall to its west (**fig. 21**). The dining room ell's south wall has a center doorway with a half-glass door that is flanked by two

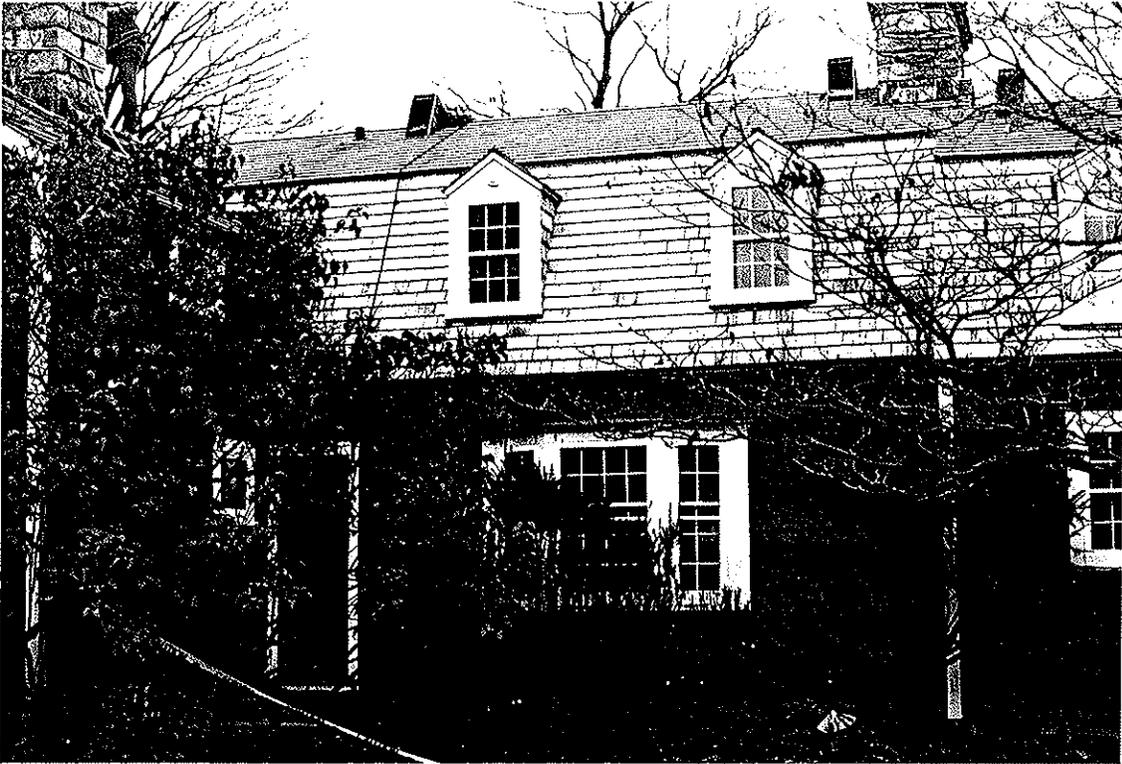
Figure 22. Webb-Burlingham House, Dining Room Ell, North Wall (1993).

The dining room ell's **north wall** is recessed from the north wall of the kitchen ell to the west. A doorway is located at its east end at the junction with the west wall of the main house. This doorway is fitted with a half-glass door and is approached using two steps made from granite slabs. A bay with three windows is centered on the wall (**fig. 22**), and one basement window is located in the bay foundation. Two dormers pierce the lower north slope of the ell's gambrel roof.
