**WEIR FARM
HISTORIC STRUCTURES REPORT**

**Weir Farm National Historic Site
Wilton, Connecticut**

Burlingham Complex

1995

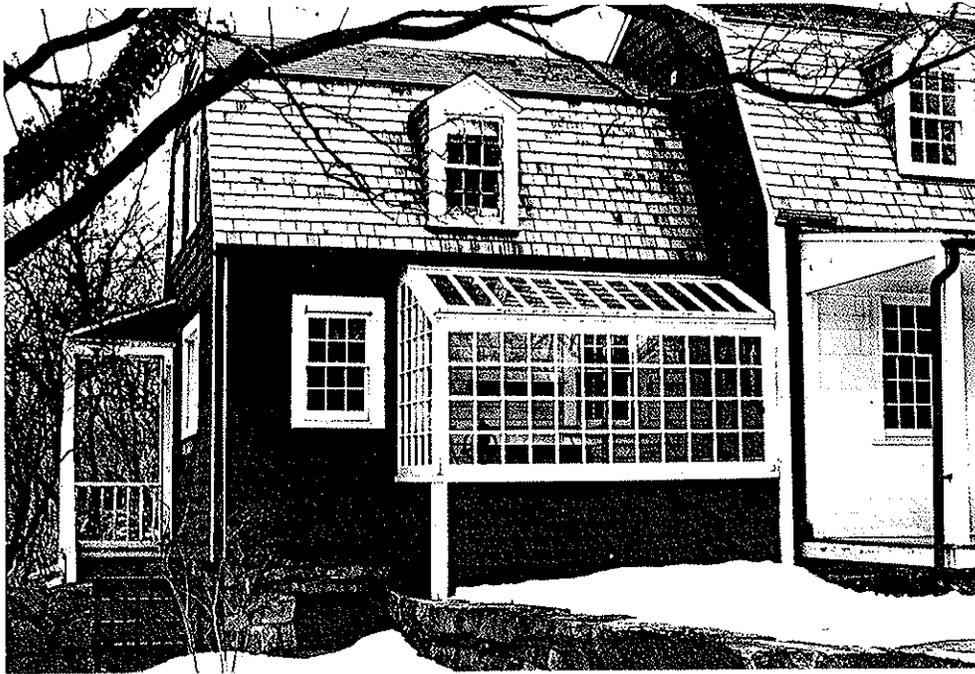
Figure 23. Webb-Burlingham House, Kitchen Ell, South Wall (1993).

The second of the two ells ("the kitchen ell") is connected to the west wall of the dining room ell (**fig. 23**). The kitchen ell measures 16 feet 6 inches wide by 18 feet deep and is 1 1/2 stories

One of the first-story windows on the south wall of the kitchen ell opens into the interior of a **greenhouse** that is located in the recess at the intersection of the dining room ell and the kitchen ell (**fig. 23**). The greenhouse, which rests on the retaining wall and the stone terrace, is glazed on the upper half of its south and west walls and on its shed roof.

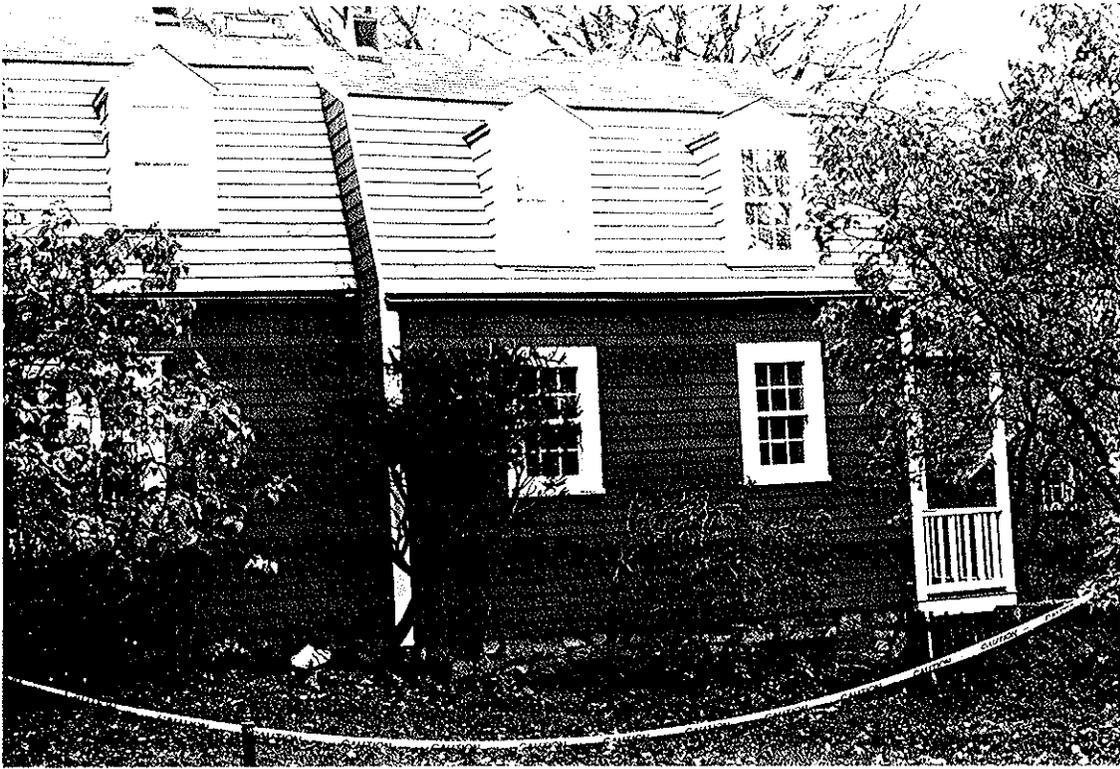
Figure 24. Webb-Burlingham House, Kitchen Ell, North Wall (1993).

The **north wall** of the kitchen ell projects from the north wall of the dining room ell. There are two sash windows on the first story, two dormer windows on the lower north slope of the gambrel roof, and a basement window at the west end of the foundation wall (**fig. 24**). A short **east wall** projects from the north wall of the dining room ell.

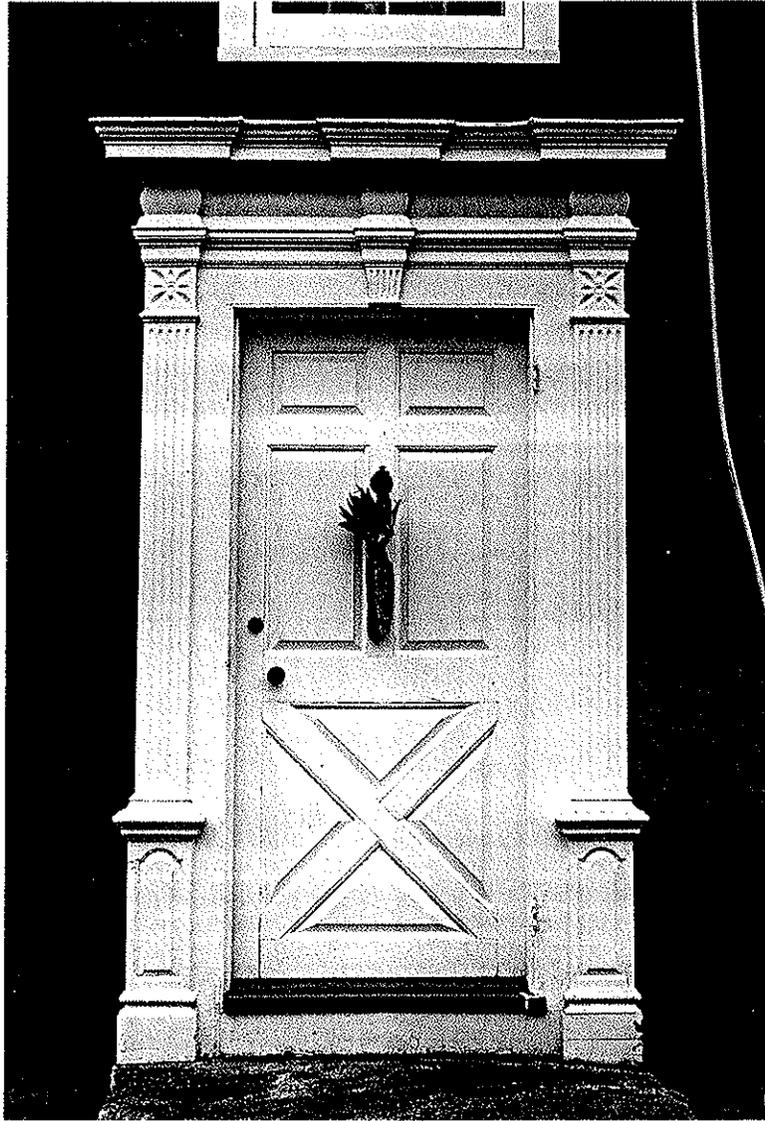
Figure 26. Webb-Burlingham House, Main House
East Facade, Main Entrance (D103) (1993).

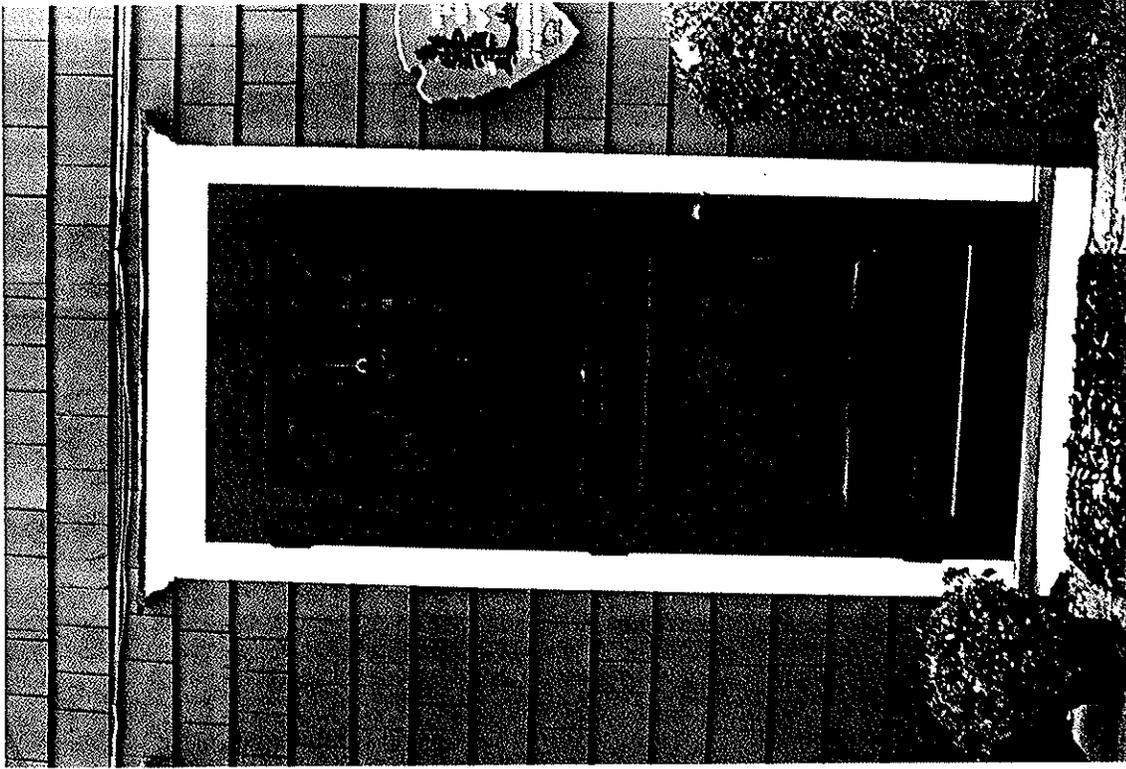
Figure 28. Webb-Burlingham House, Main House South Wall, Doorway D102 (1993).

The second doorway on the south aspect of the house is a circa-1932 doorway that is centered on the south wall of the main house (D102 - fig. 28). This doorway is approached via two steps composed of large granite slabs, and opens into the living room. The opening measures 3 feet wide by 6 feet 7 1/2 inches high, and

has a half-glass dutch door with a cross-panel on the bottom half and a glazed upper half with 9 lights. The opening is fitted with a screen door (D102a). The door and screen door have 2-inch-wide brass knobs and plates that are original to both doors. The main door has a recently installed brass dead-bolt lock. The doorway has a plain 4-inch-wide surround, with a slightly more elaborate ogee cornice than on D101.

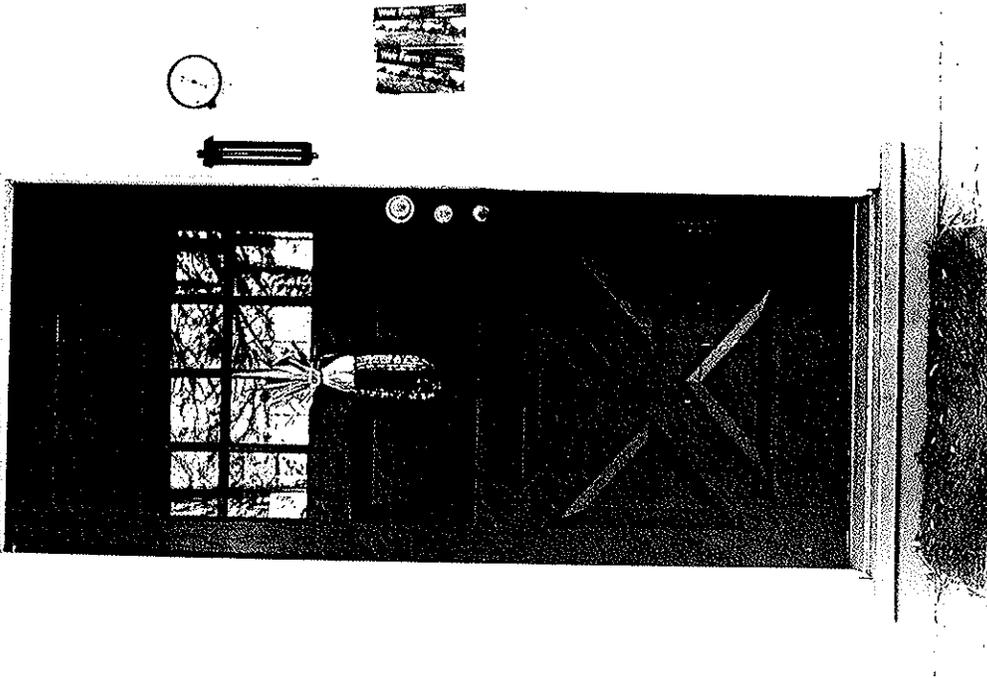
Figure 27. Webb-Burlingham House, Dining Room Ell South Wall, Doorway D101 (1993).

There are two doorways along the south aspect of the house. A circa-1932 doorway with a half-glass door is centered on the south wall of the dining room ell. This doorway is approached from the south porch, and opens into the dining room (D101 - fig. 27), and measures 3 feet wide by 6 feet 7 1/2 inches high. The door in the opening has a cross panel on its lower third, two small square panels in the middle, and 12 lights on the top third of the door. There is a 2-inch-wide brass knob and plate, original to the door, and two recently-installed dead-bolt locks. The doorway has a plain 4-inch-wide surround with a quarter-round molding cornice.

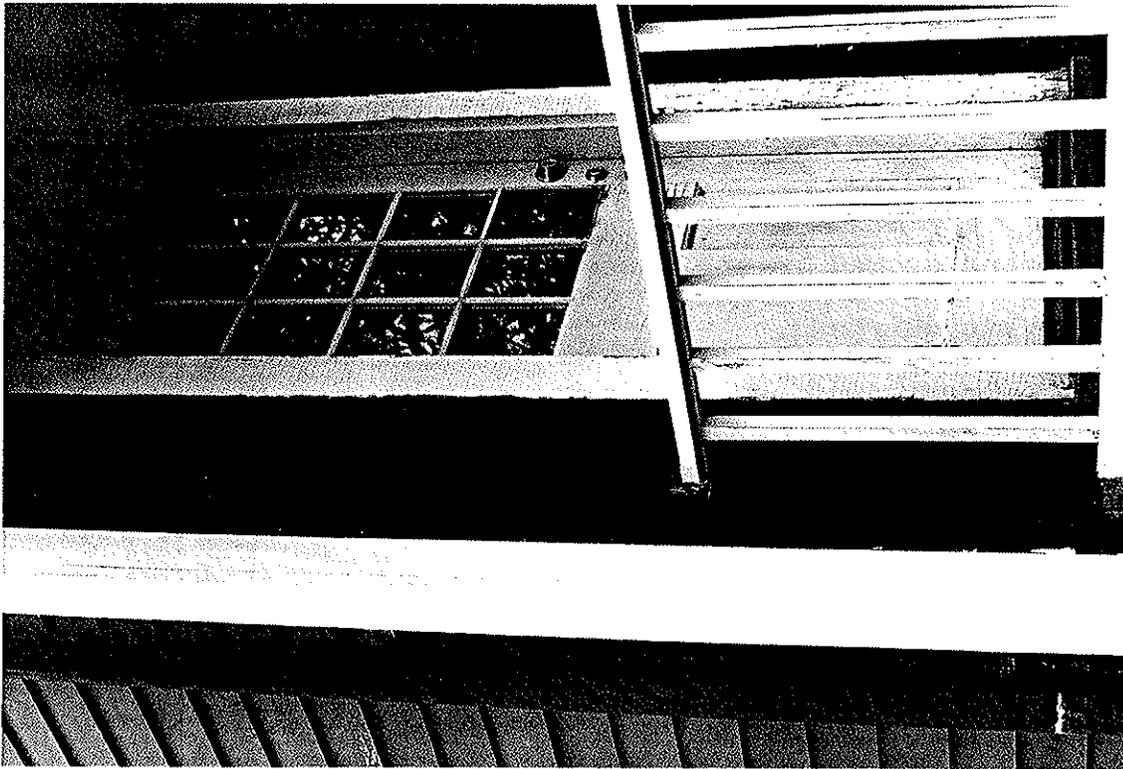
Figure 29. Webb-Burlingham House, Kitchen
Ell West Wall, Doorway D105 (1993).

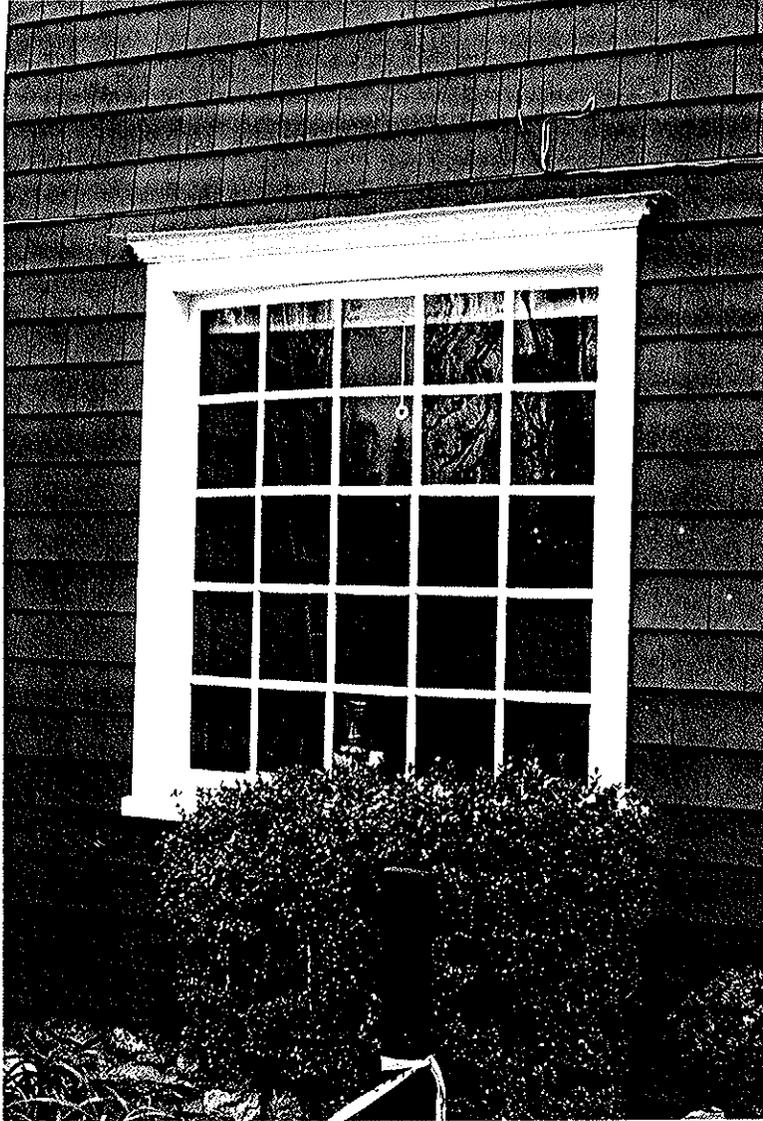
Figure 31. Webb-Burlingham House, Main House
South Wall, Window W107 (1993).

There are four circa-1932 windows on the south wall of the main house, two on the first story and two on the upper level. The two windows on the **first story** (W107 & W108) are bow windows that flank the center entrance (fig. 31). Each window measures 54 inches wide by 57 3/4 inches high, and has a fixed convex sash with 25 lights (five-over-five). Each is trimmed with a 3 1/2-inch wide plain surround with the same ogee cornice found on doorway D102.

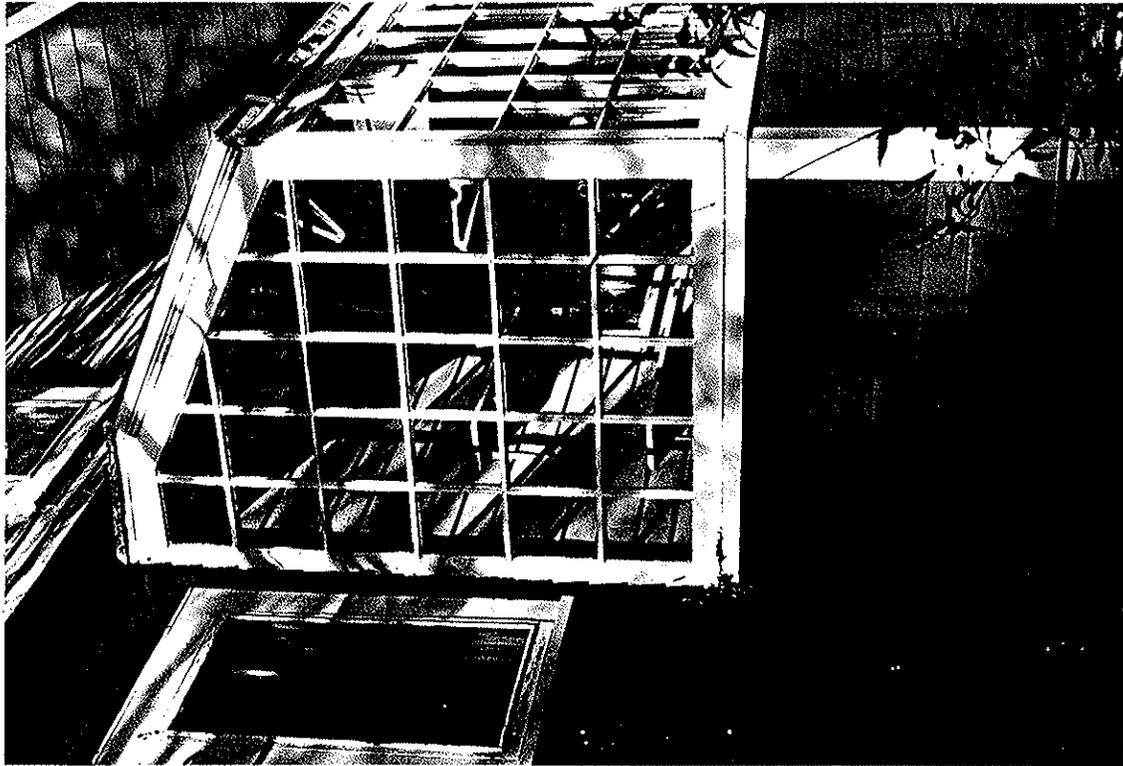
Figure 33. Webb-Burlingham House,
Greenhouse West Wall (1993).

The upper half of the greenhouse's west and south walls are glazed (fig. 33). The west wall has a single fixed glazed sash (W103) in the shape of a rectangle with the right top edge cut off by the slope of the shed roof. It measures $49 \frac{3}{4}$ inches wide by $57 \frac{1}{4}$ inches at its highest point. The sash has 24 full lights each measuring $8 \frac{3}{4}$ inches by $10 \frac{1}{4}$ inches, and 5 partial lights.

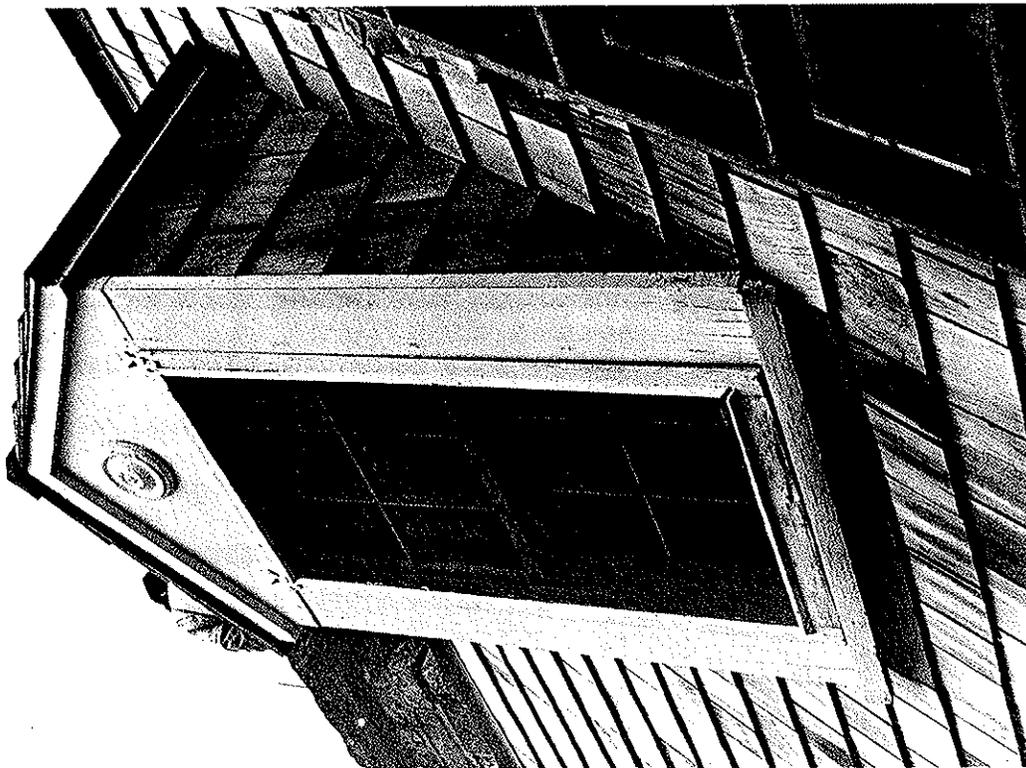
Figure 32. Webb-Burlingham House, Dining
Room Ell South Wall, Dormer Window W203 (1993).

The two dormer windows are located at the **upper story** on the lower south slope of the ell's gambrel roof (W202 & W203 - fig. 32). The dormers have gable roofs and shingled cheeks. Each dormer window has a double-hung sash with 12 lights that measures 24 inches wide by 40 1/2 inches high. The window is trimmed with a plain 6-inch-wide surround, and a raised wooden circular medallion or patera is centered on each dormer pediment.

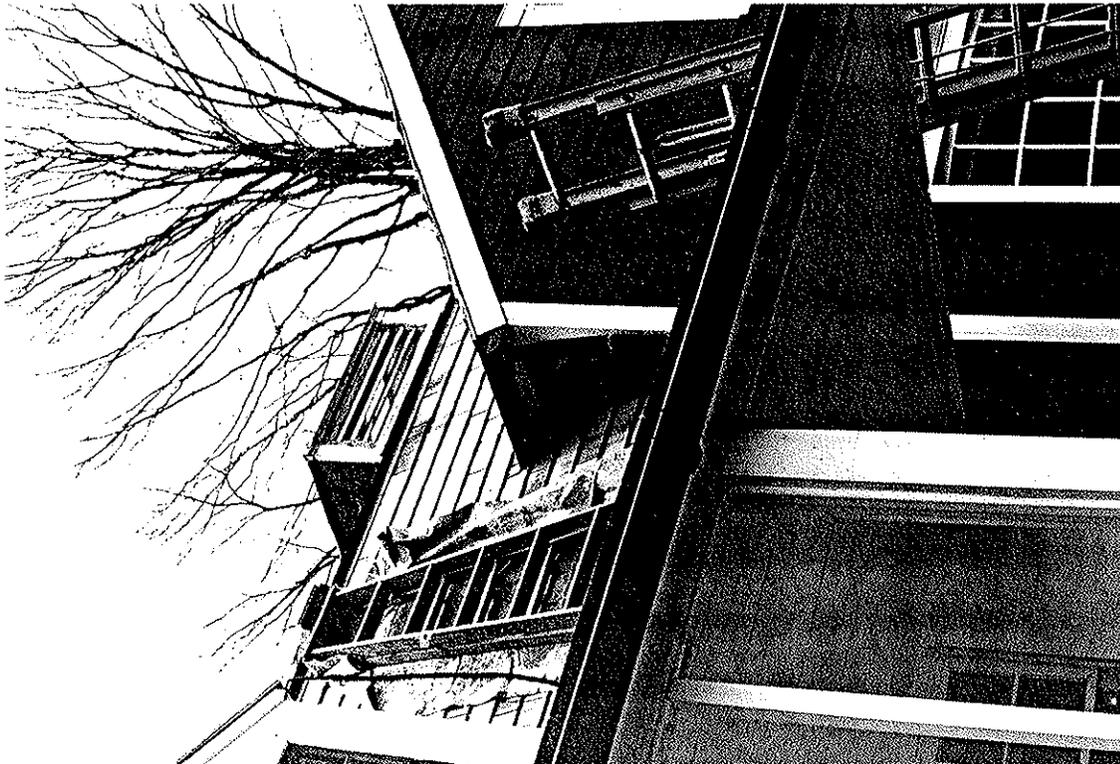
Figure 34. Webb-Burlingham House, South
Aspect, Junction of Dining Room Ell Roof (1993).

The third window on the main house west wall is located to the south of the dining room ell roof. This circa-1932 opening (W218) is situated on the **upper story** of the west wall in a small area above the intersection of the two roofs (fig. 34). The window is trapezoidal, measures 1 foot 6 inches high by 1 foot 2 inches at its widest, and has a casement sash with a single light.

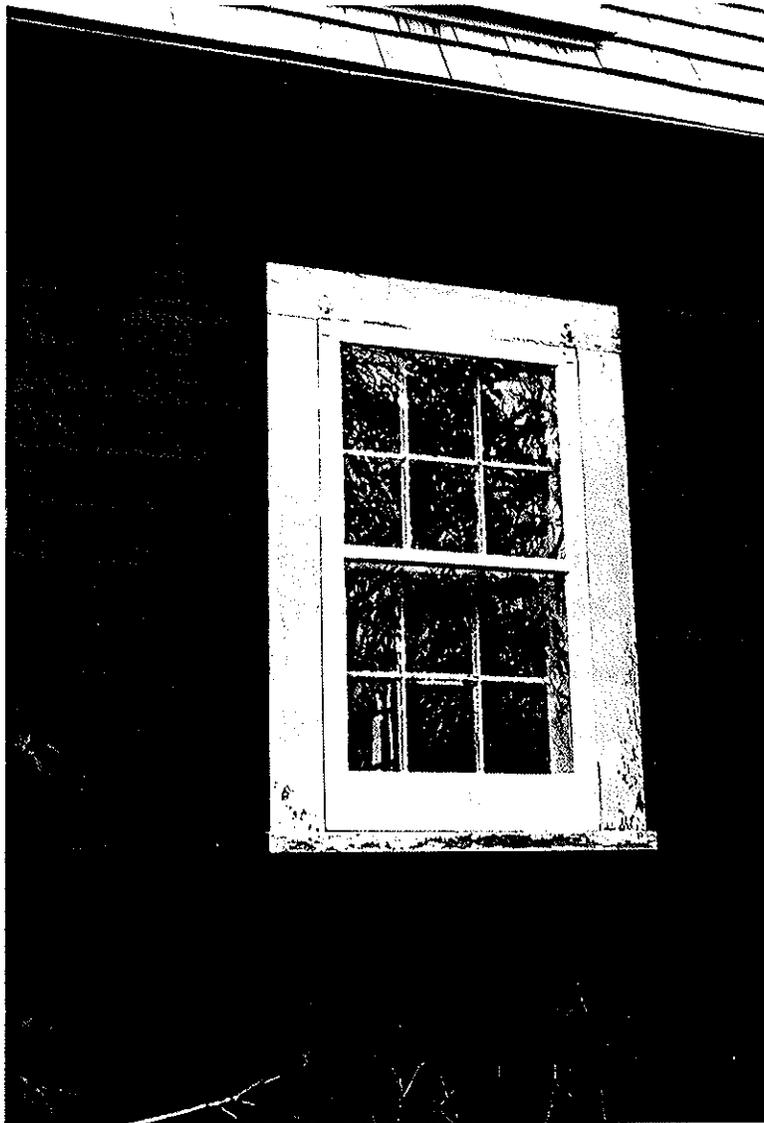
Figure 36. Webb-Burlingham House, Kitchen
E11 North Wall, Window W118 (1993).

Each of the two sash windows on the **first story** (W117 & W118) measures 24 inches wide by 40 1/2 inches high, has a double-hung sash with 12 lights (twelve-over-twelve), and a plain 4 1/2-inch-wide surround (fig. 36).

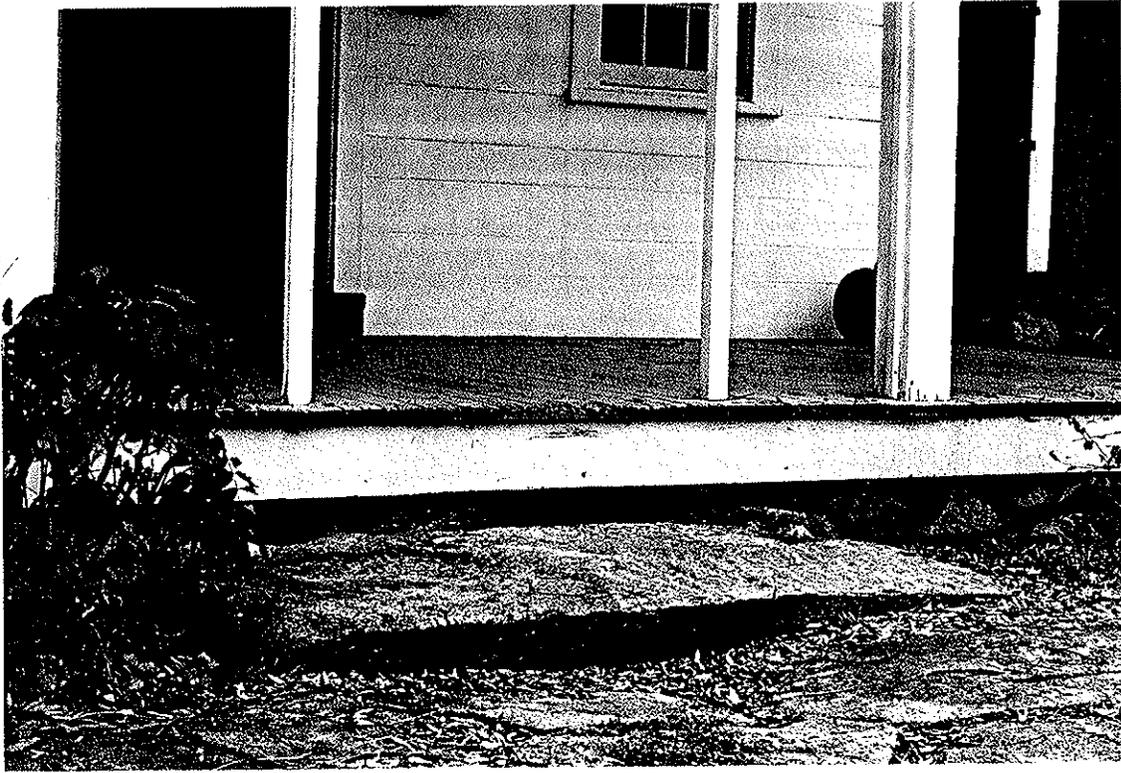
Figure 37. Webb-Burlingham House,
Dining Room Ell, South Porch Foundation (1993).

A circa-1932 one-story porch is located along the south wall of the dining room ell and protects the ell's south entrance (D101). The porch extends almost the entire length of the ell's south wall, measuring 19 feet 6 inches wide by 8 feet deep, and sits on a mortared fieldstone foundation (figs. 21 & 37). It is approached from a stone terrace to the south of the house. A large granite slab at the center of the south side of the porch is slightly raised from the level of the terrace and acts as steps to the porch floor.

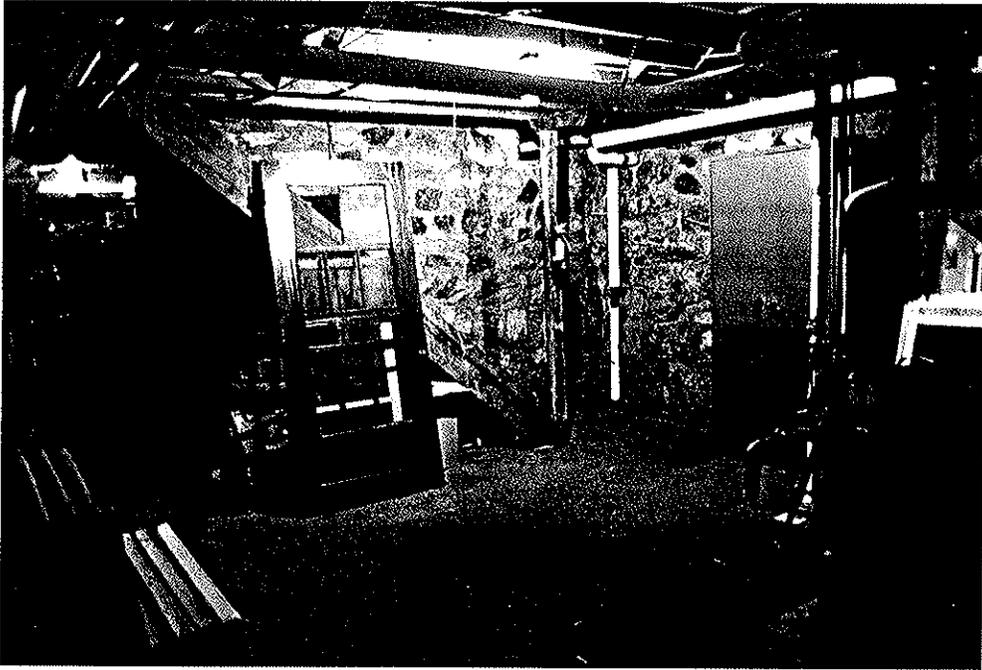
Figure 38. Webb-Burlingham House, Room 001 - Basement, Looking East (1994).

The staircase from the first floor is located along the east wall of the dining room basement, and runs from the north down to the southeast corner of the room. The staircase has an open-stair construction with no handrail (fig. 38)

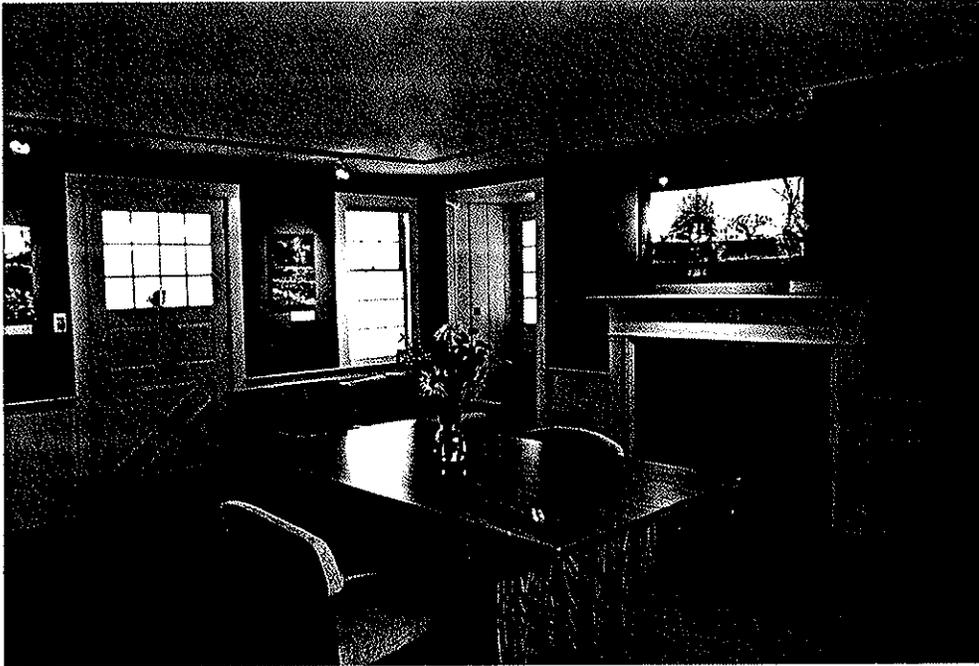
Figure 42. Webb-Burlingham House,
Room 102 - Dining Room, Looking Southwest (1994).

The dining room occupies most of the first floor of the dining room ell that was built circa-1932 (figs. 42 & 43). The room is located in the center of the east/west axis of the house, and measures approximately 15 feet wide by 18 feet deep. Two steps lead down from the stairhall and living room to the east, and the kitchen is located to the west. All features in the room, except

There are five doorways in the dining room. An exterior entrance doorway (D101) is centered on the south wall of the room (**fig. 42**). This opening is fitted with a half-glass door.

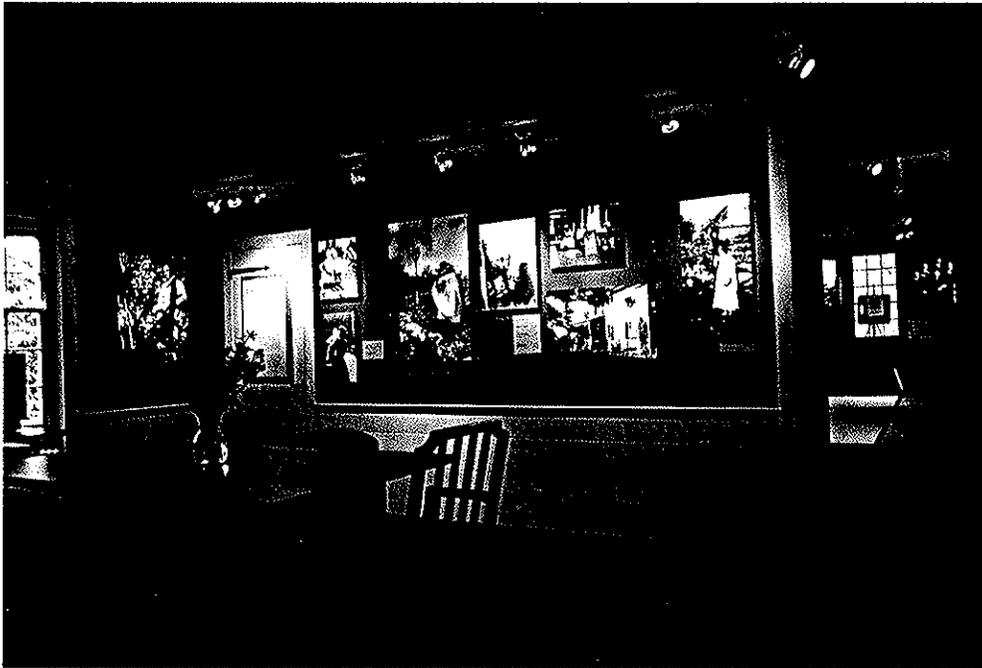
Figure 43. Webb-Burlingham House,
Room 102 - Dining Room, Looking Northeast (1994).

Two doorways are located on the east wall of the room: one at the south end of the wall (D109), which leads from the stair landing and has no door; and a second located at the north end of the wall (D108) that opens into a back hall (**fig. 43**). Doorway D108 measures 2 feet 6 inches wide by 6 feet 5 1/2 inches high, and is fitted with a door constructed of tongue-and-groove pine boards approximately 11 inches wide each. These boards are mounted vertically using two horizontal pine boards as support on the back hall side of the door. This is the standard-style door used throughout the house, and replicates what are thought to be original

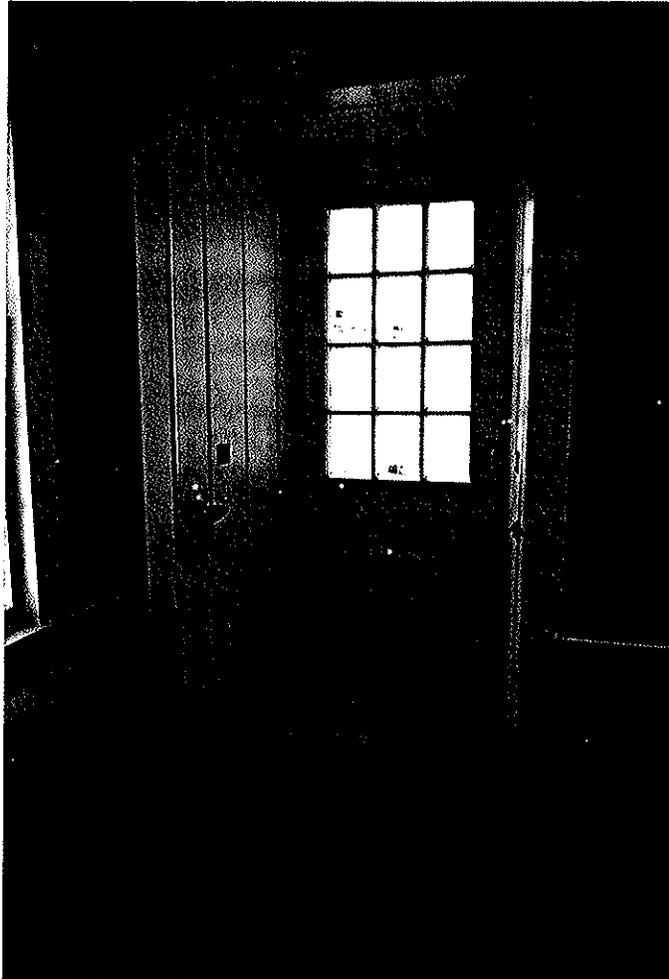
Figure 44. Webb-Burlingham House,
Room 102 - Dining Room, West Wall Alcove (1994).

A 2-foot-deep alcove is located at the south end of the west wall of the dining room, to the left of the fireplace (fig. 44). The alcove contains the doorway to the greenhouse (D106) and shallow cupboards on its north and south walls.

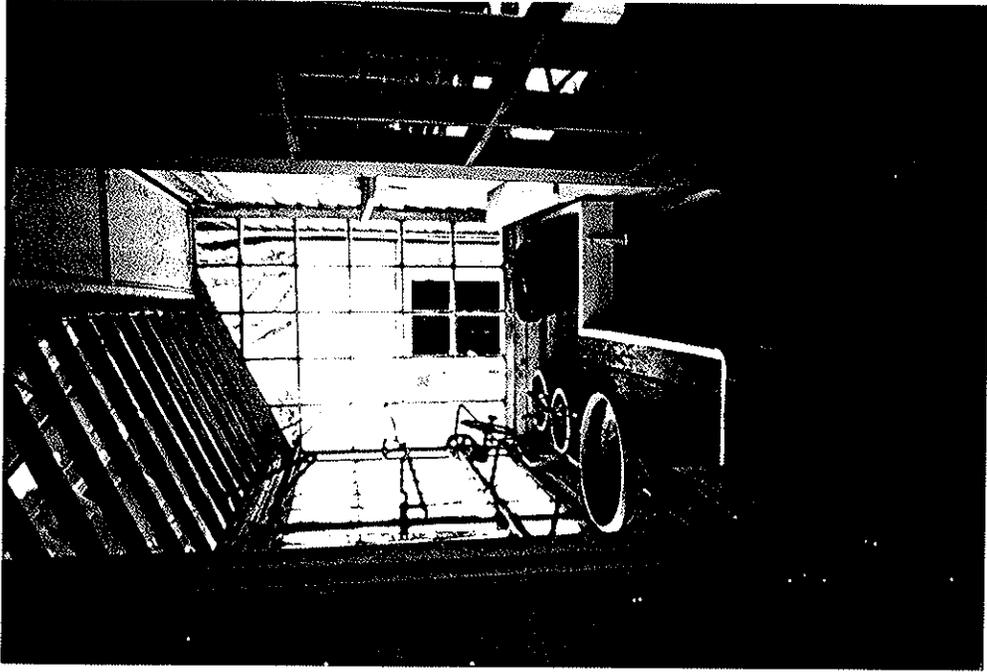
Figure 46. Webb-Burlingham House,
Room 103 - Greenhouse, Looking West (1994).

The upper half of the west and south walls of the greenhouse are fully glazed (fig. 46).

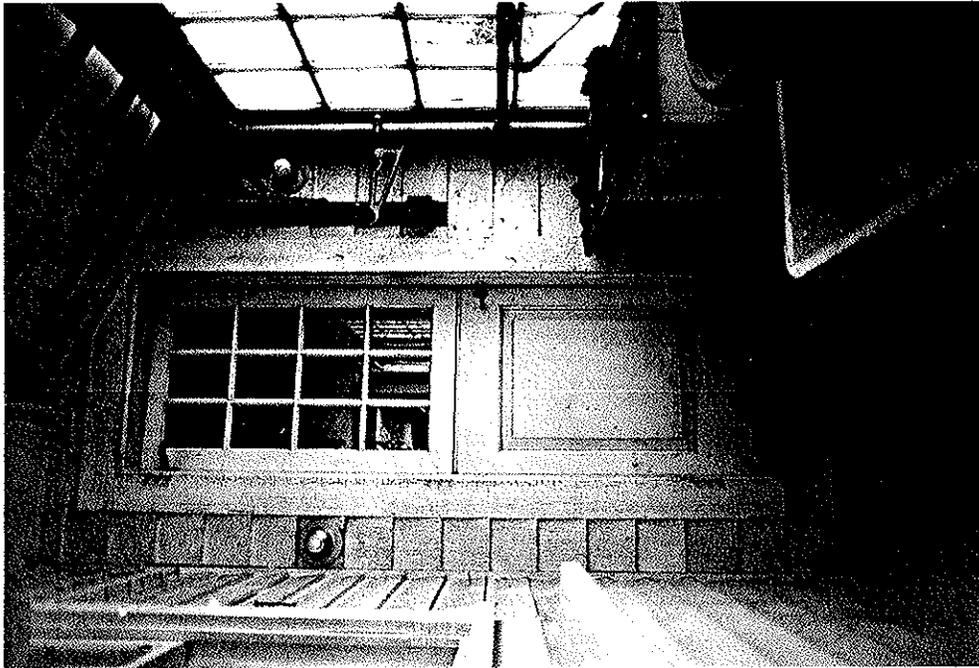
Figure 45. Webb-Burlingham House,
Room 103 - Greenhouse, Looking East (1994).

east wall and leading from the dining room (see subsection "Doorways" in section "Room 102 - Dining Room, above). The door has a brass hand latch, and hardware for a non-extant screen door is mounted on the surround (fig. 45).

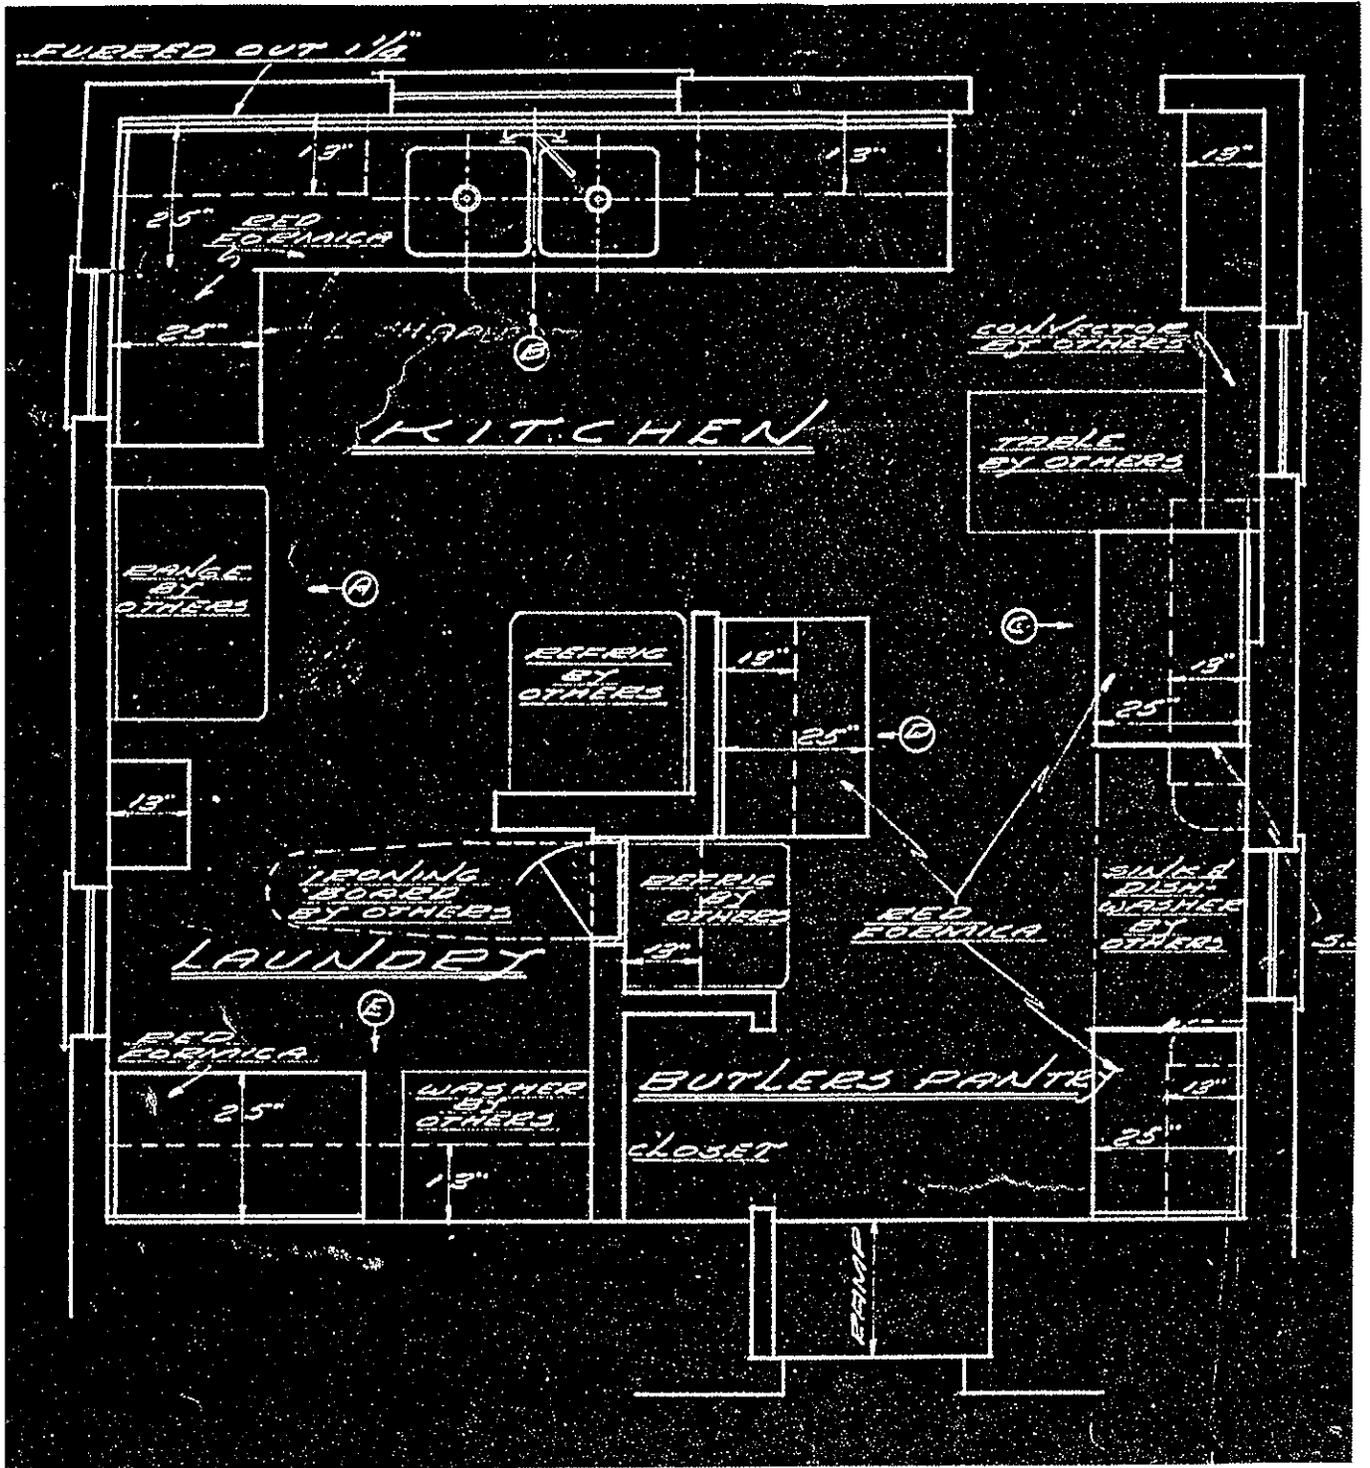
Figure 47. Portion of Drawing of Altered Kitchen Layout for Webb-Burlingham House Dated 11/7/47, Marked "Approved as Noted - F. N. Breed - 11/25/47".

The kitchen is divided into three areas around an east/west partition that runs from the east wall to the center of the room, as can be seen on F. Nelson Breed's 1947-1948 plans (fig. 46a).⁵¹ The first area is on the north side of the room and is referred to on the plans as the butler's pantry (fig. 47). Doorway D107 from the dining room, on the pantry's east wall, is the only interior access to the kitchen. The butler's pantry contains a closet, cupboards, sink, dishwasher, and spaces for a refrigerator and a table. The west side of the room is the cooking and preparation

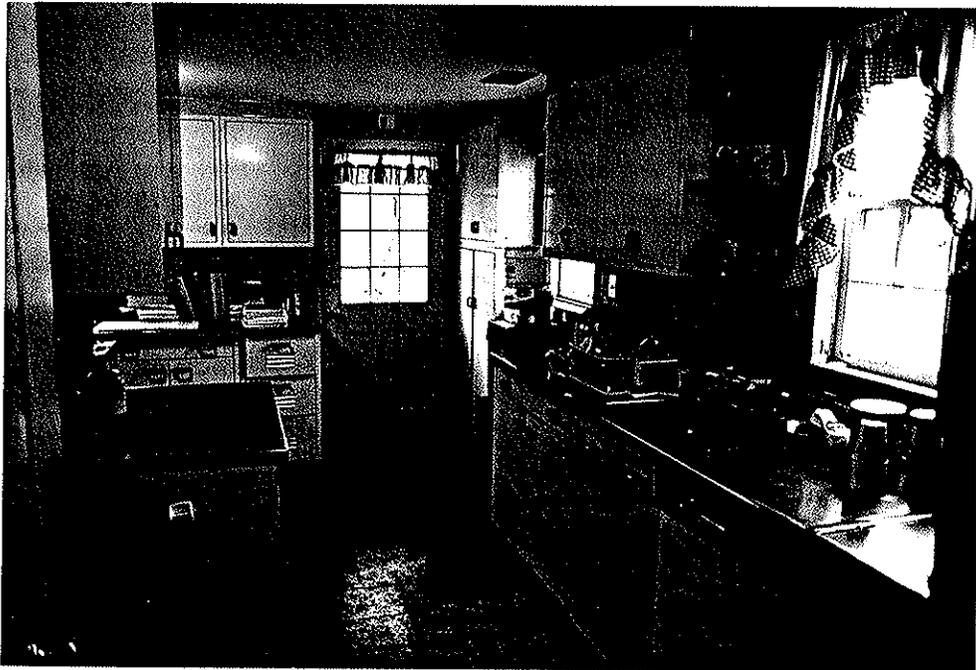
Figure 48. Webb-Burlingham House, Room 104 - Kitchen,
Looking West, Butler's Pantry (1994).

area, in which is found additional cupboards, a second sink, and a stovetop and ovens (fig. 48). The southeast corner of the room is referred to on Breed's plans as the laundry area, and contains cupboards, a pull-down ironing board, and space for a washing machine (fig. 49).

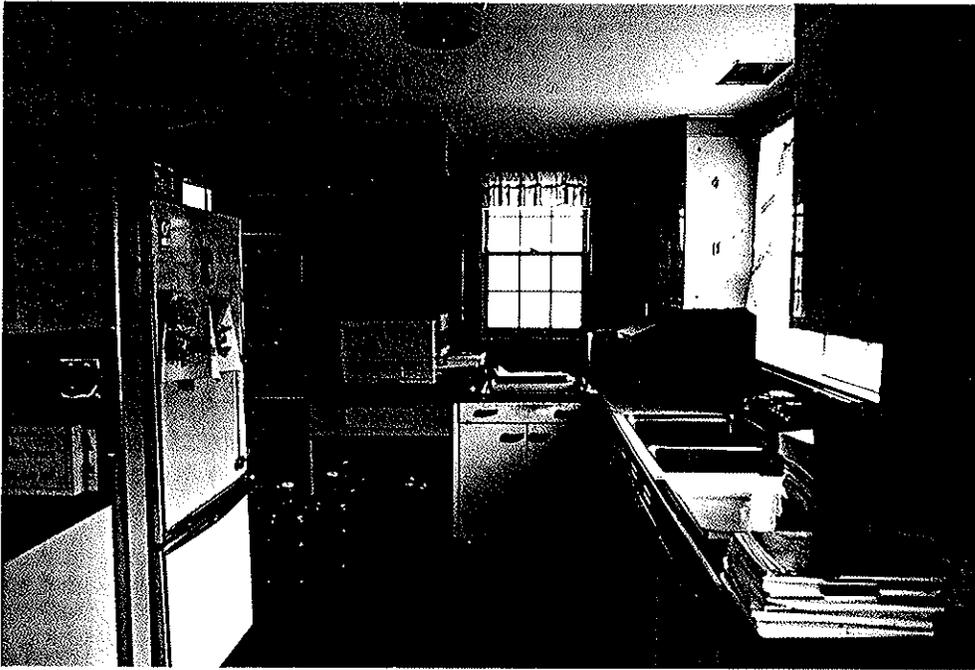
Figure 49. Webb-Burlingham House, Room 104 - Kitchen,
Looking South, Kitchen Area (1994).

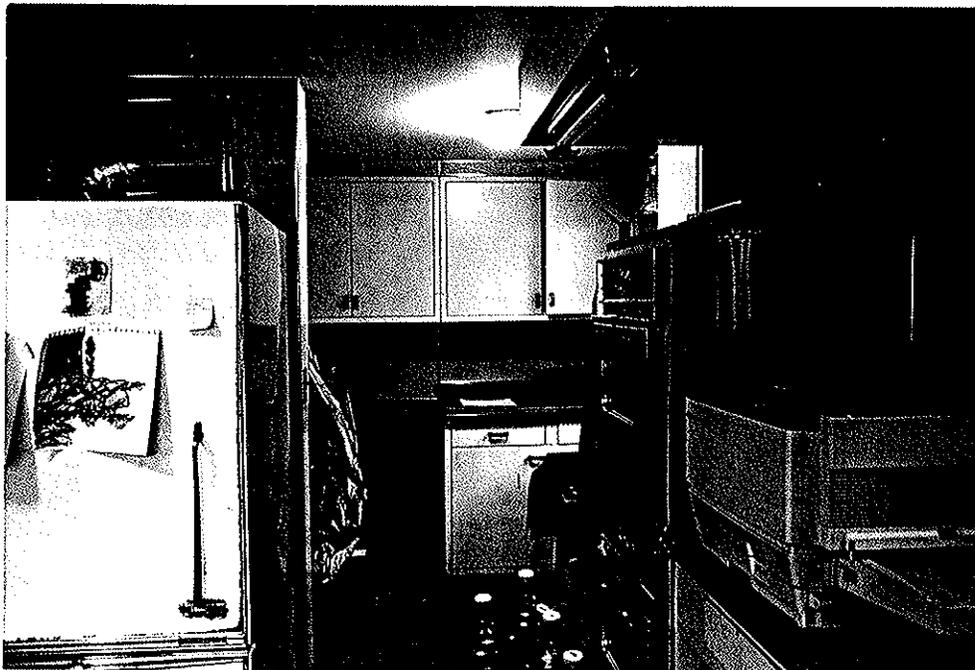
Figure 50. Webb-Burlingham House, Room 104 - Kitchen,
Looking East, Laundry Area (1994).

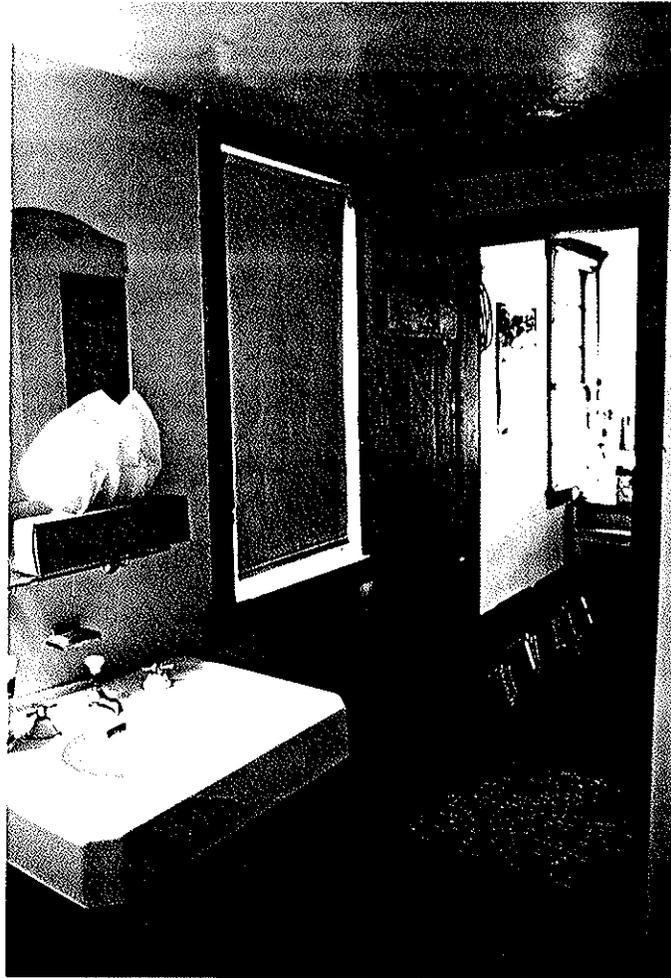
Figure 51. Webb-Burlingham House,
Room 106 - Bathroom, Looking East (1994).

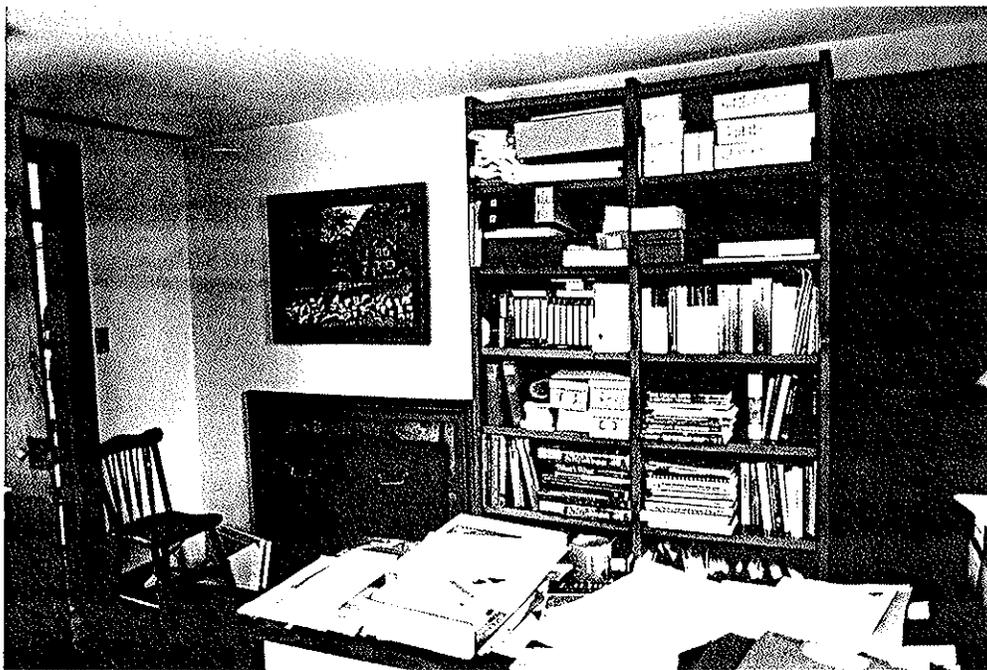
Figure 52. Webb-Burlingham House,
Room 107 - Study, West Wall (1994).

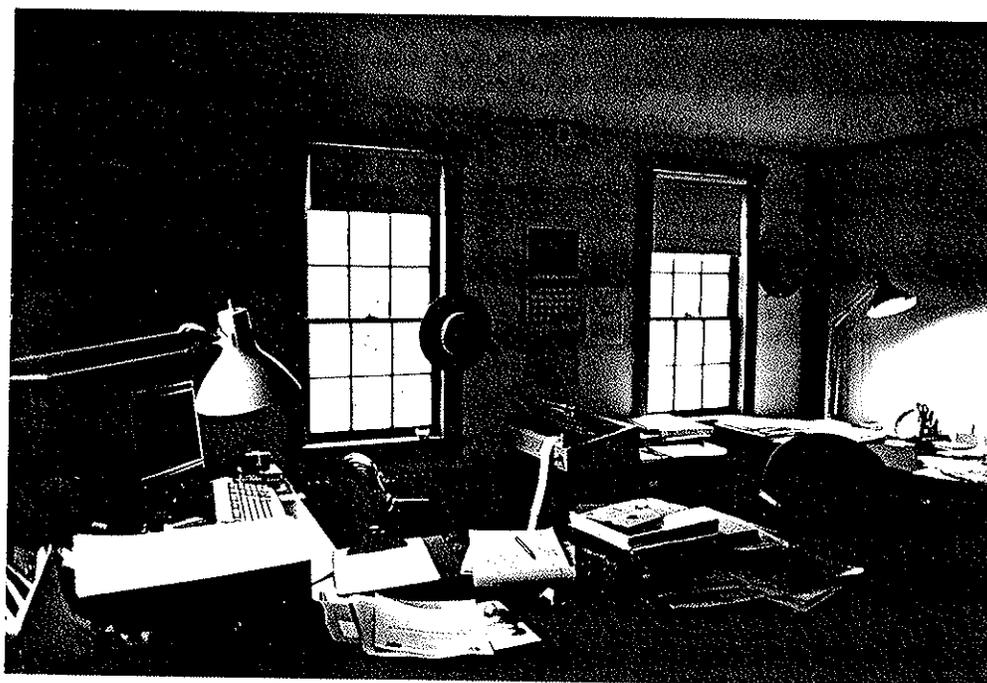
Figure 53. Webb-Burlingham House,
Room 107 - Study, East Wall (1994).
