**WEIR FARM
HISTORIC STRUCTURES REPORT**

**Weir Farm National Historic Site
Wilton, Connecticut**

Burlingham Complex

1995

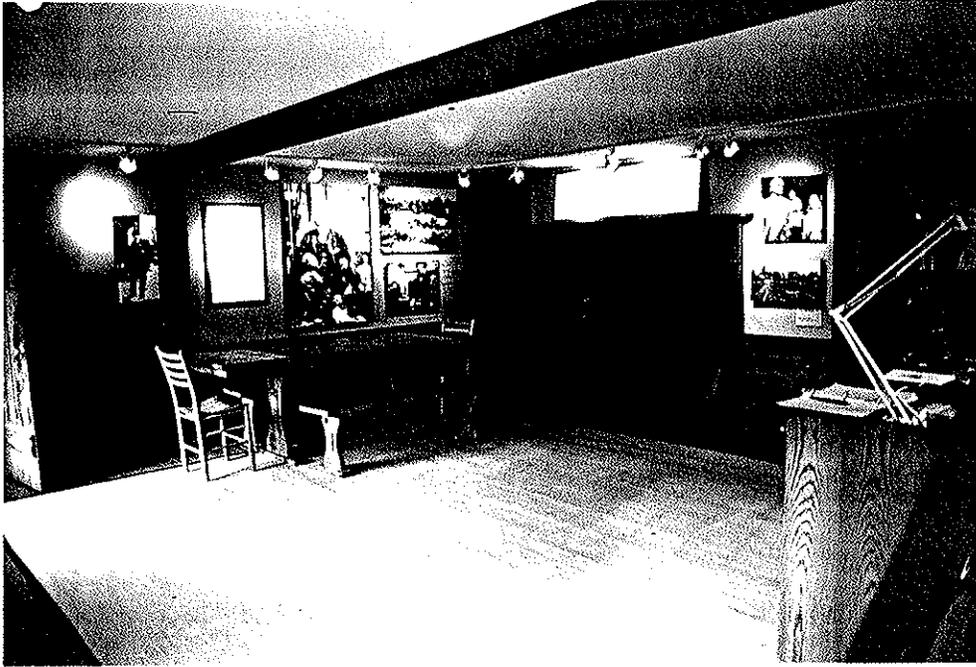
Figure 54. Webb-Burlingham House,
Room 108 - Living Room, Looking Northwest (1994).

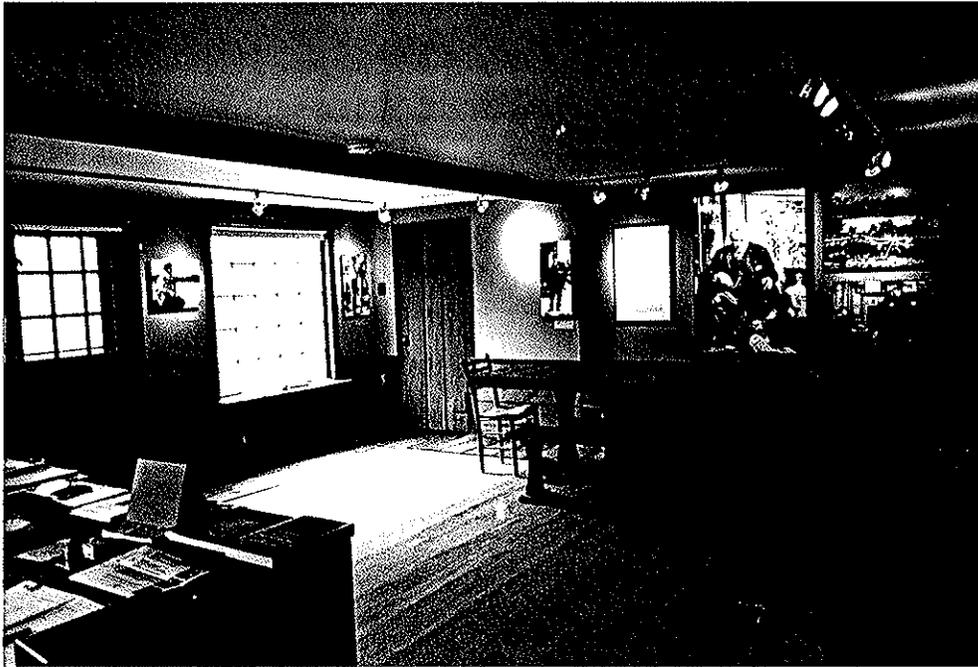
Figure 55. Webb-Burlingham House,
Room 108 - Living Room, Looking Southwest (1994).

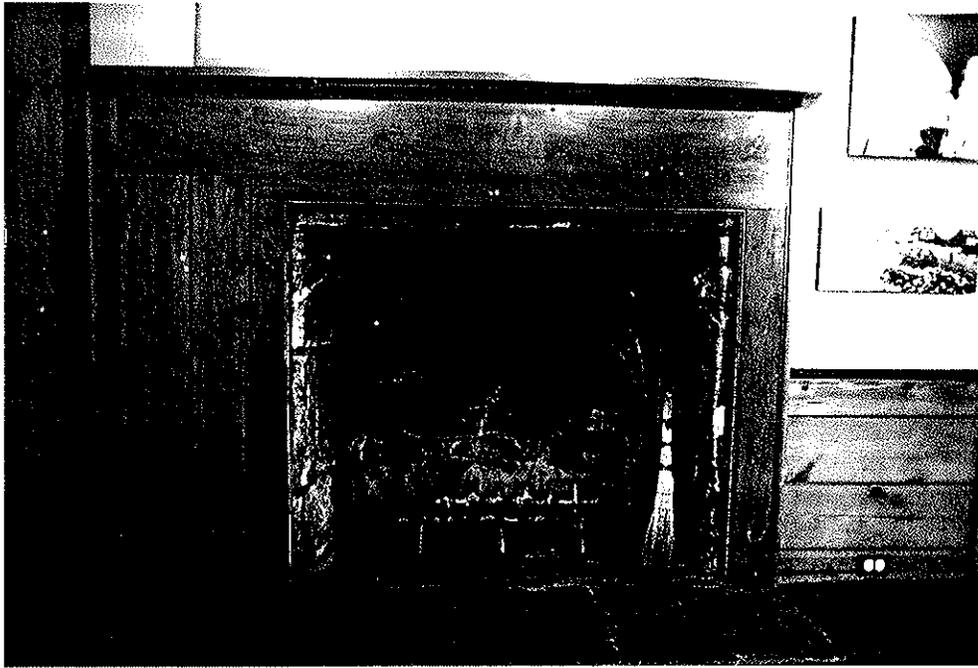
Figure 56. Webb-Burlingham House, Room 108 -
Living Room, North Wall Fireplace (1994).

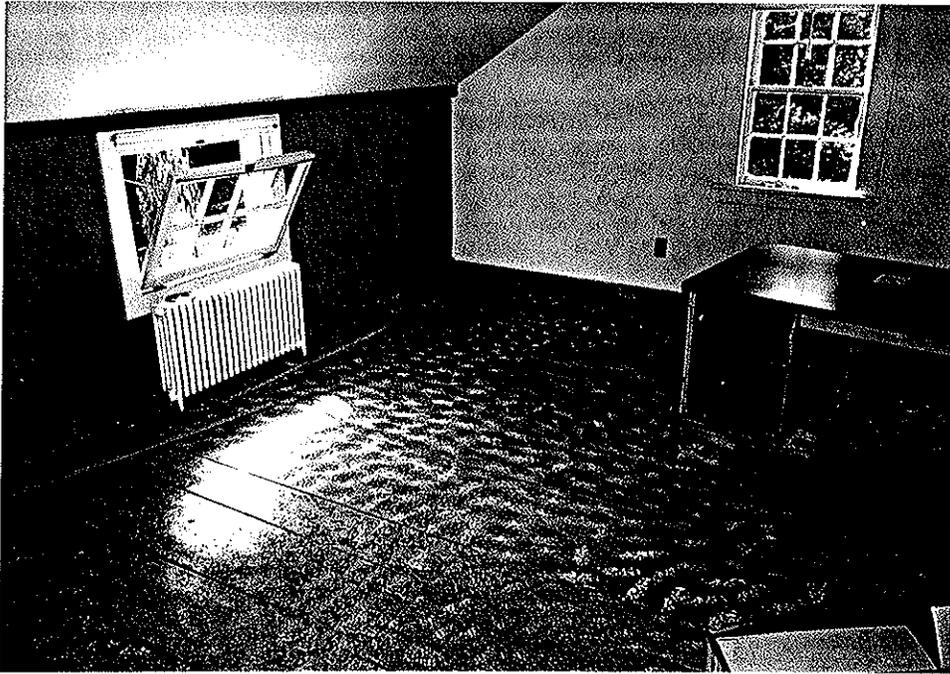
Figure 57. Webb-Burlingham House, Room 210 -
Master Bedroom, Floor With Decorative "Scrambled" Painting (1992).

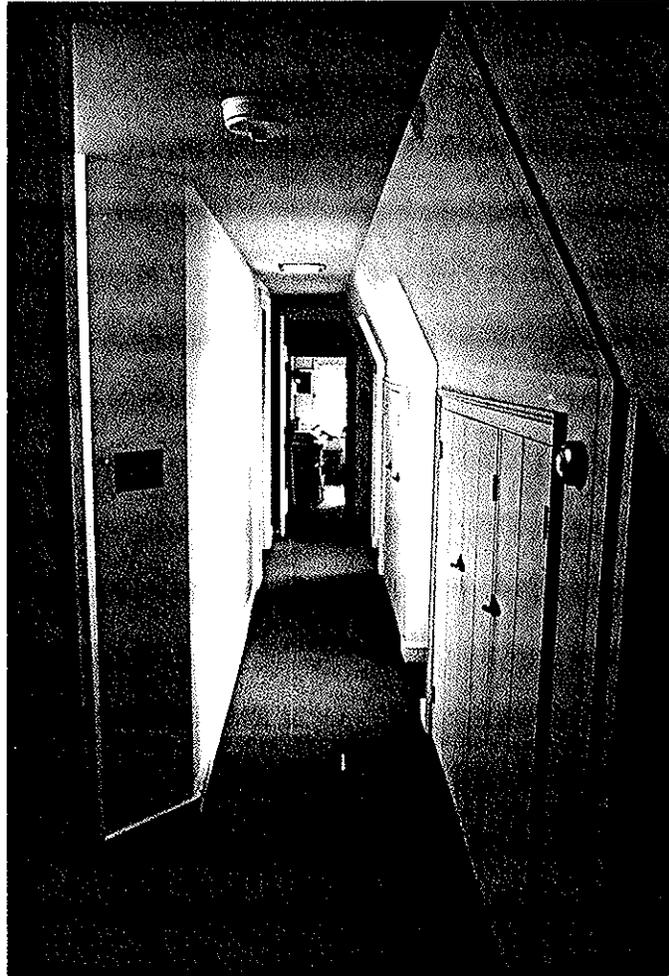
Figure 58. Webb-Burlingham House,
Room 201 - Center Hall, Looking West (1994).

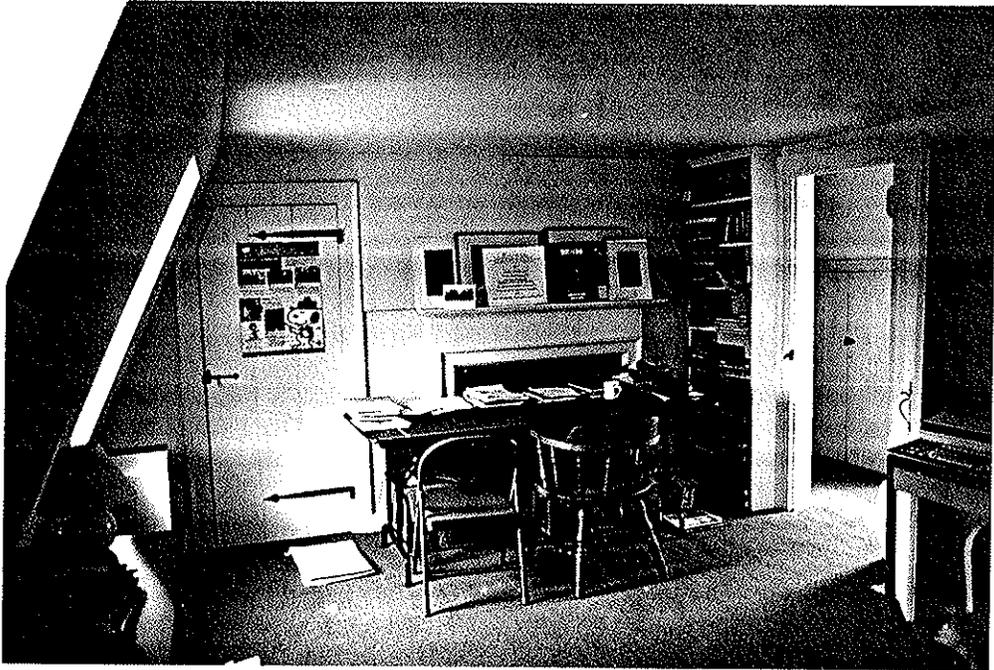
Figure 59. Webb-Burlingham House,
Room 202 - South Bedroom, West Wall (1994).

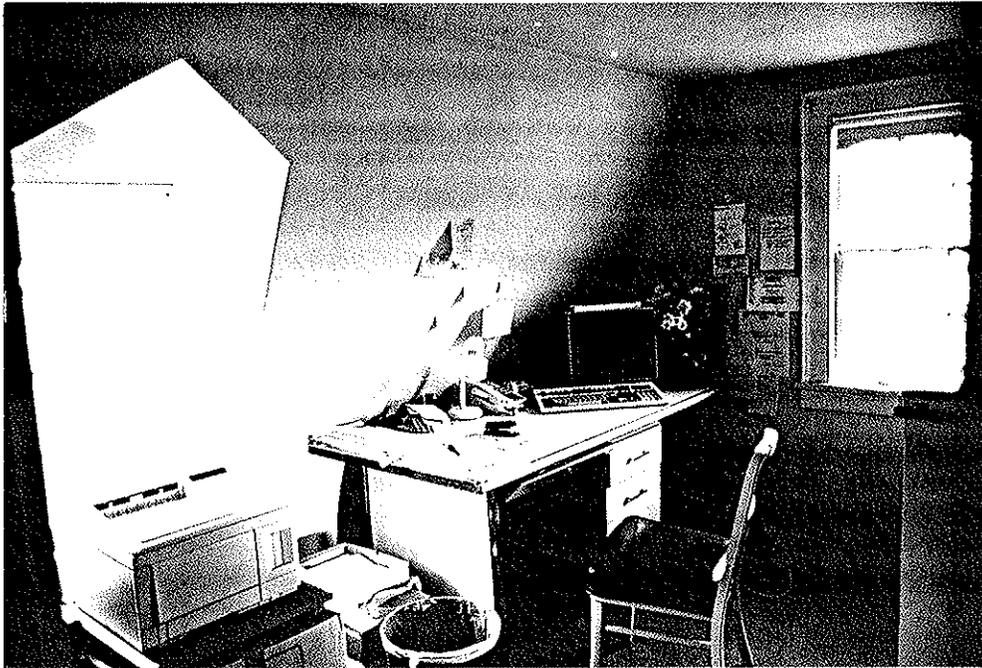
Figure 60. Webb-Burlingham House,
Room 203 - Southwest Bedroom, Looking Southwest (1994).

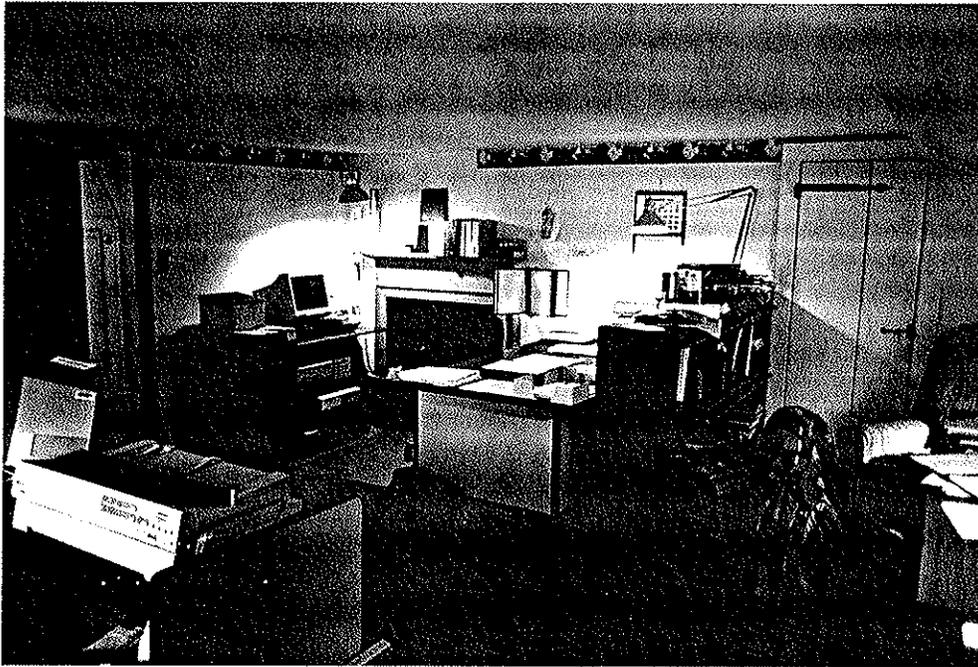
Figure 63. Webb-Burlingham House,
Room 210 - Master Bedroom, Looking Northwest (1994).

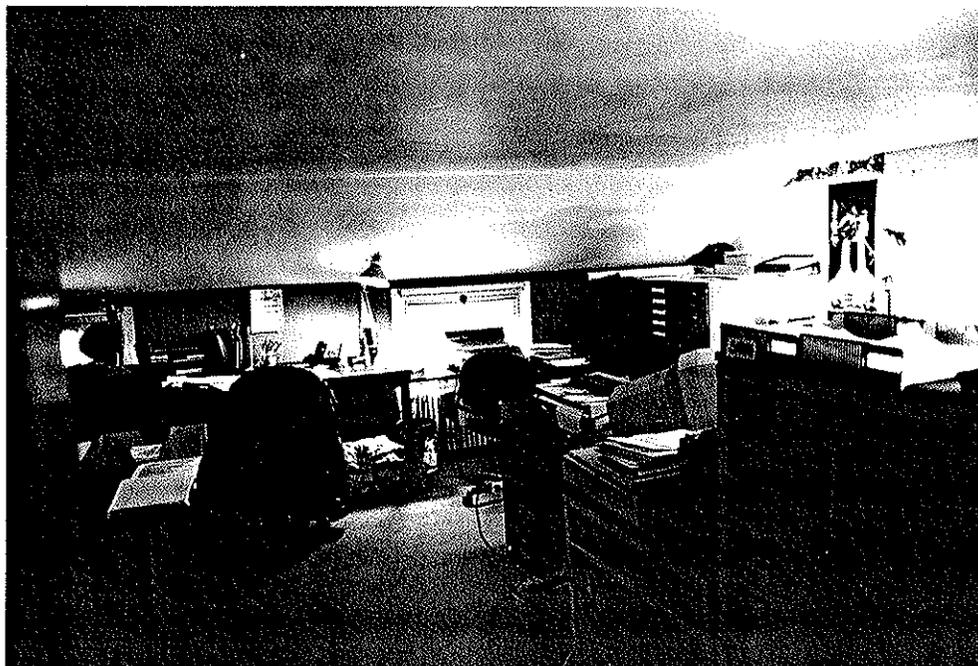
Figure 64. Webb-Burlingham House,
Room 210 - Master Bedroom, Looking Southeast (1994).

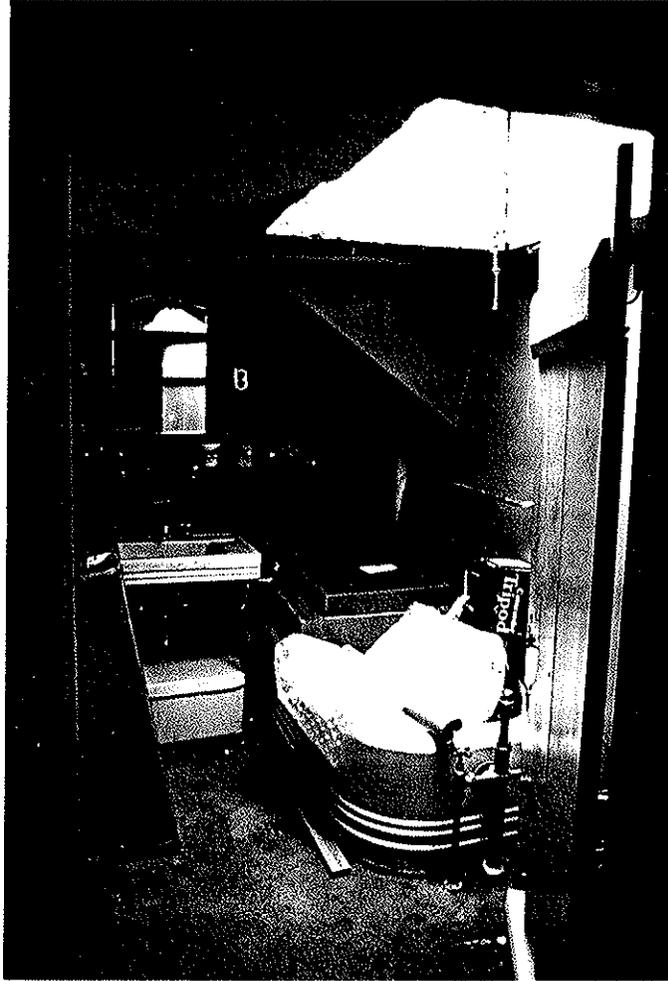
Figure 65. Webb-Burlingham House, Room 211 - Master Bathroom (1994).
(before 1994 rehabilitation)

There is one window in the master bathroom. This opening, located at the south end of the west wall, is trapezoidal in shape. It measures 1 foot 2 inches at its widest point by 1 foot 6 inches at its longest and is fitted with a one-light casement sash. The

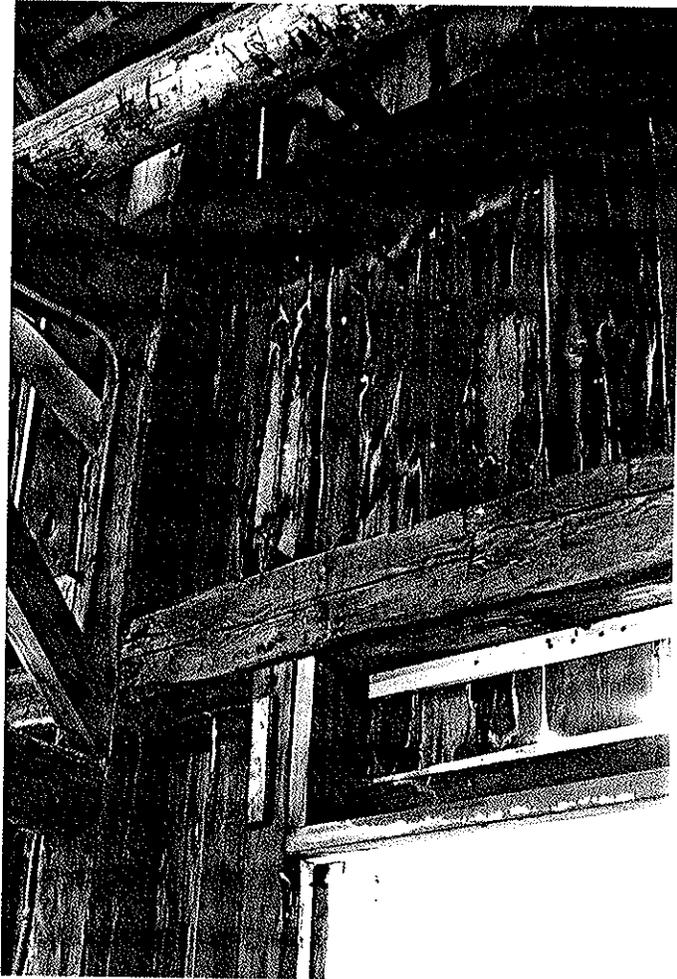
Figure 67. Webb-Burlingham Barn Interior,
South Wall Framing (1994).

An inspection of the extant framing confirms that there was originally only one doorway in the barn. This large doorway was centered on the south wall. The header for the original doorway is extant over the existing center doorway on the south wall (see fig. 66). Extant original posts on the south wall on either side of the

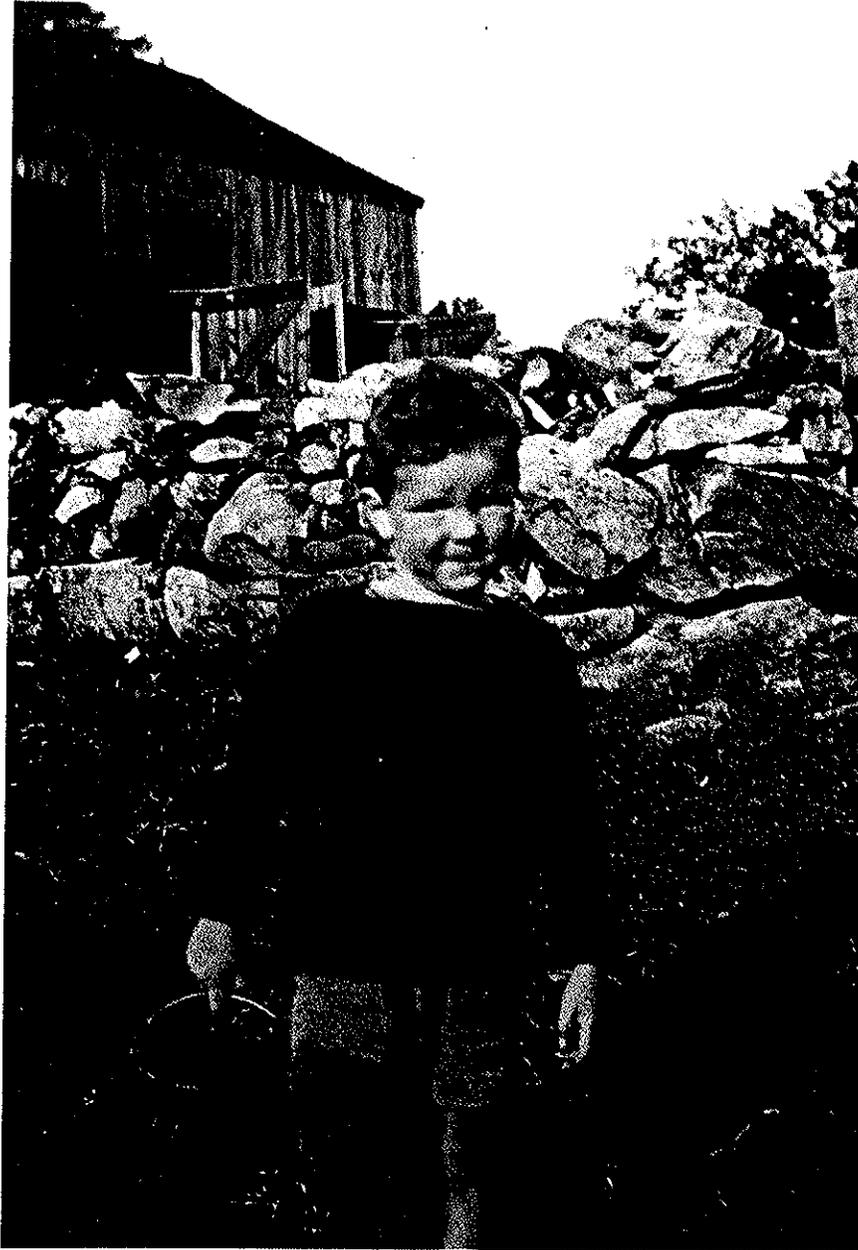
Figure 68. Webb-Burlingham Barn, South Facade,
from Paddock West of Barn (Circa 1933).

The original south facade doorway measured approximately 10 feet wide and was 12 feet high, several feet higher than the extant door. This high doorway can be seen in the Weir drawing (**fig. 65**) and in a Burlingham family photograph taken circa-1933, which shows the exterior south wall of the barn (**fig. 67**). By the time the photograph was taken, the door had been altered and two flanking doorways had been installed on the south wall. However, patching in the siding that is visible over the center opening shows that there had previously been a higher doorway in this location.

The Burlinghams "fixed up" the barn soon after they took over the property in 1931.⁵⁶ Except for the south facade, it is thought that the appearance of the barn and shed after the remodeling is much the same as it is today. The circa-1933 photograph (fig. 67) shows doorways flanking the original doorway on the south wall of the barn, and patching over the center doorway indicates that the height of this opening had been lowered. These changes were probably made by the Burlinghams. The new doorways were created by raising the original 4-foot-high front-wall girts to act as headers for the new openings. The remainder of the framing consisted of planed lumber generally available after the mid-1920s.

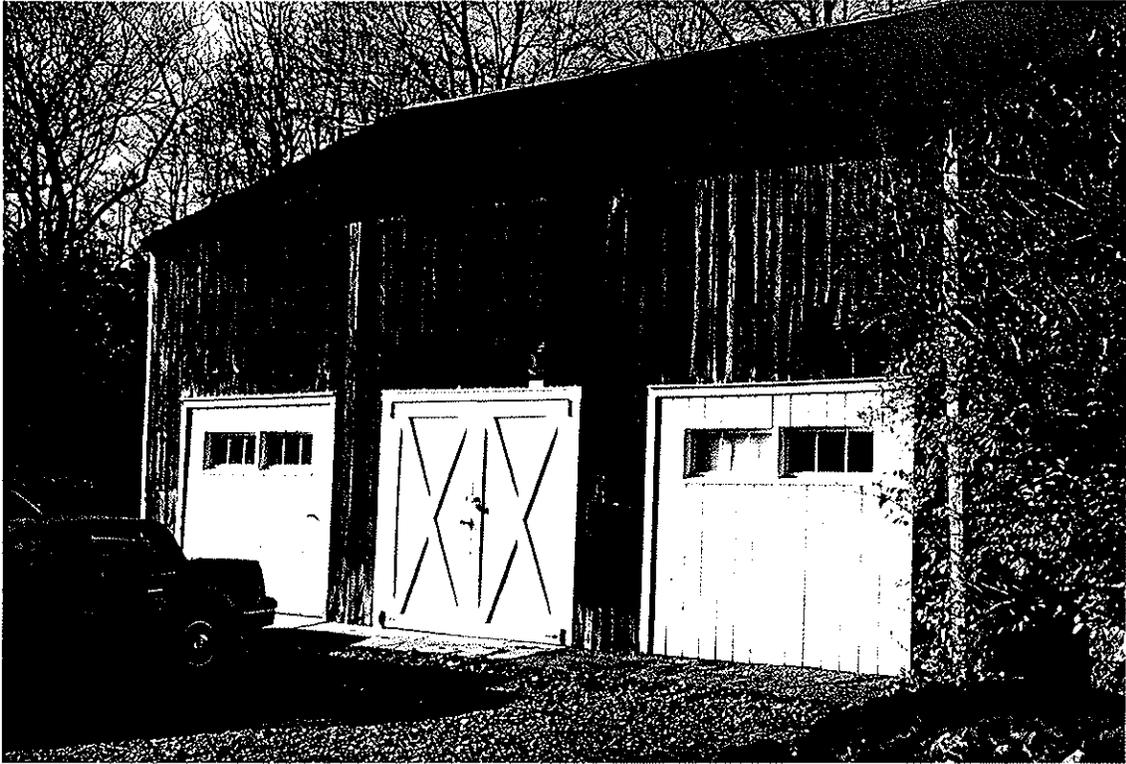
Figure 70. Webb-Burlingham Barn, South Facade (1994).

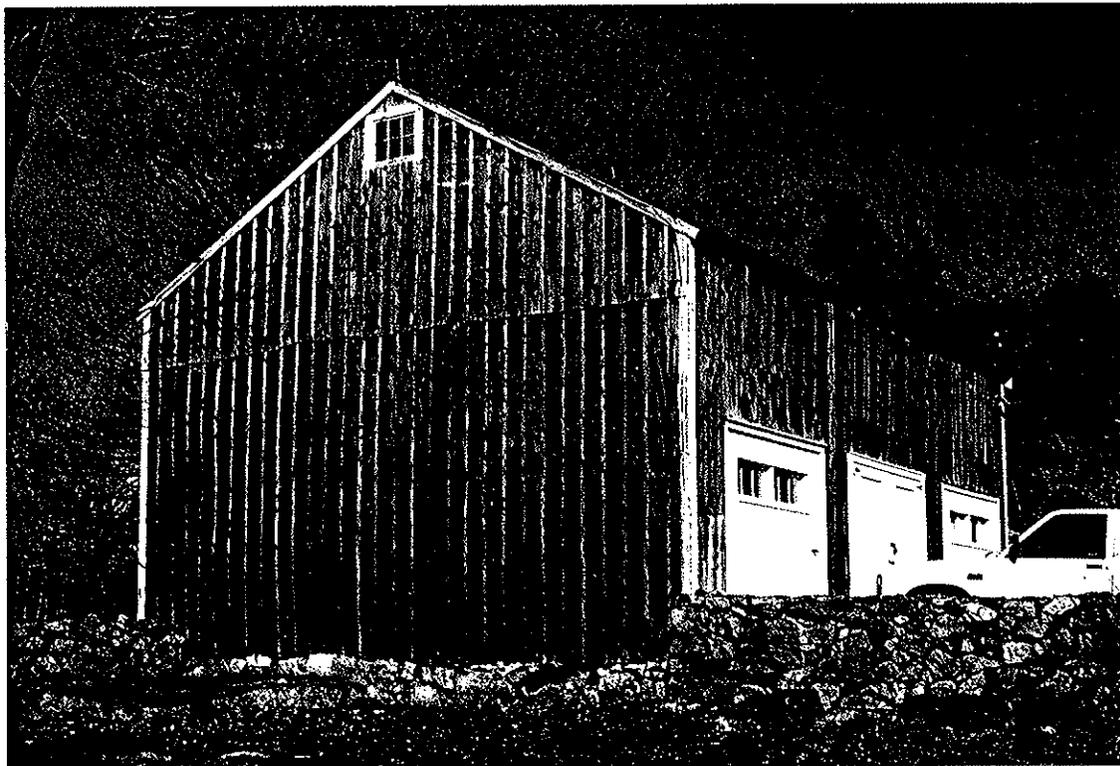
Figure 72. Webb-Burlingham Barn, West Wall (1994).

The boards on the **west wall** are 7 1/2 inches wide. These are installed vertically in the same manner as the east gable end: boards of uniform length cover the wall to just under the bottom edge of the gable, with a second level of boards in the gable that overlap the lower boards. Although the boards are also tongue-and-groove, there are 1/2- to 1-inch-wide gaps between the boards that have been covered with 2-inch-wide battens (fig. 71). This may have been a purposeful detail of construction. However, since this feature is not used on the other barn walls, it is possible that weathering on this side of the building caused the boards to

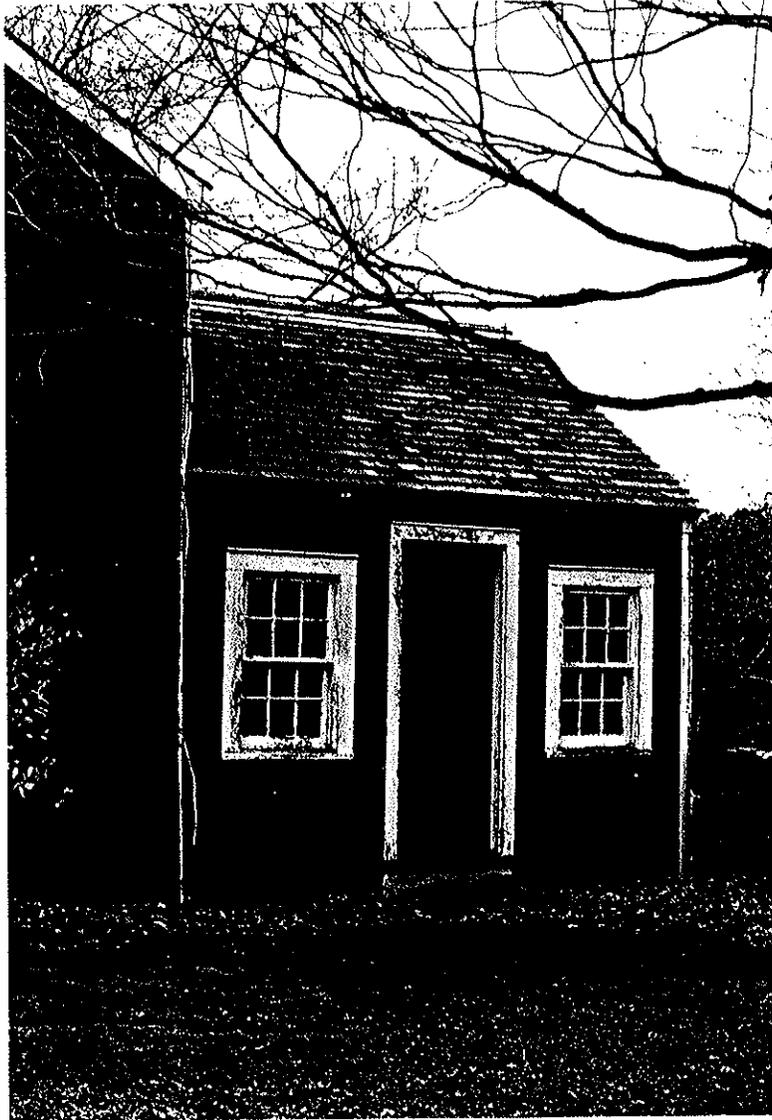
Figure 73. Webb-Burlingham Barn,
Attached Shed, East Facade (1994).

The entrance into the shed is located on the east facade of the attached shed (D102 - fig. 72). The opening is fitted with a

half-glass door that has 2-over-2 lights on the top half and three horizontal recessed panels on the bottom half. The door is hung using butt hinges, and has a 2 1/4-inch wide brass knob with a rectangular brass escutcheon plate. The doorway is trimmed with a plain 4-inch-wide surround.

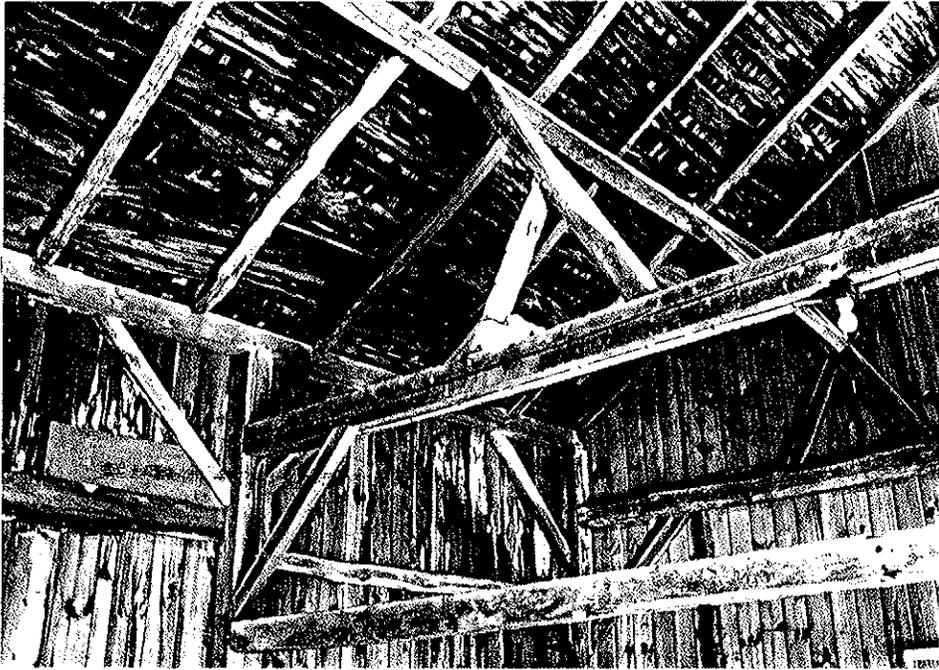
Figure 74. Webb-Burlingham Barn
Interior, Looking Northeast (1992).

The interior of the barn has no finished walls or ceiling, and the interior of the structural framing and exterior siding is exposed (fig. 73).

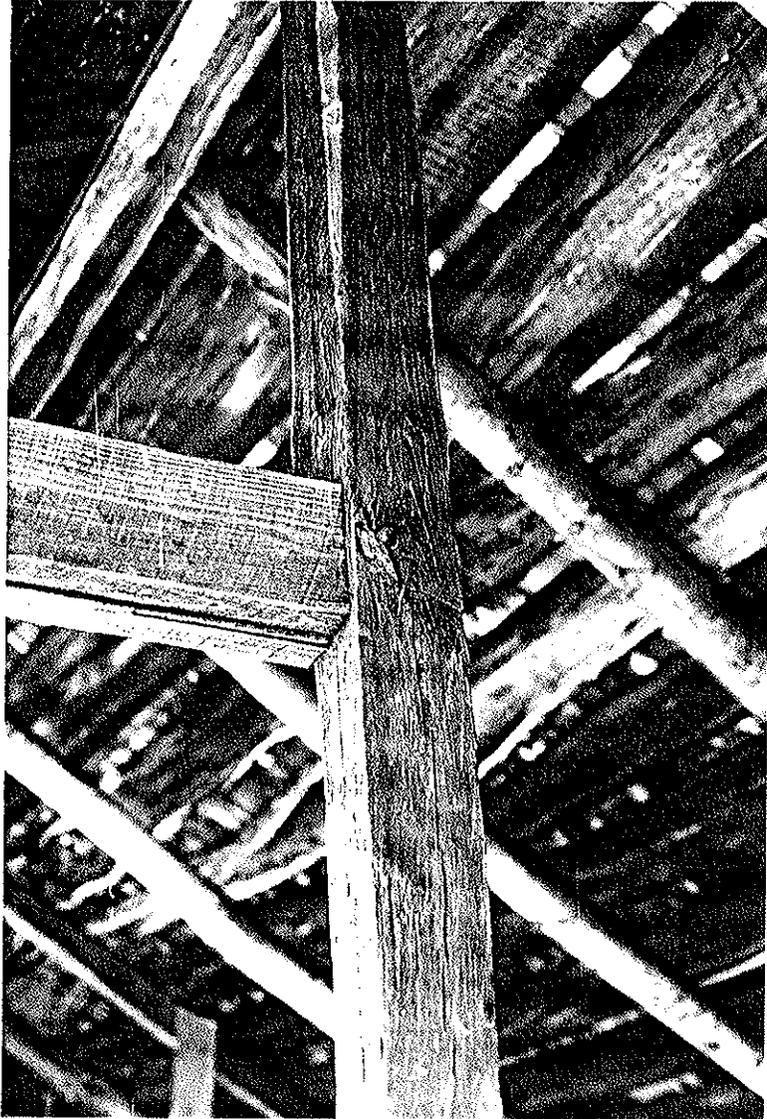
Figure 75. Webb-Burlingham Woodshed,
Interior Framing (1994).

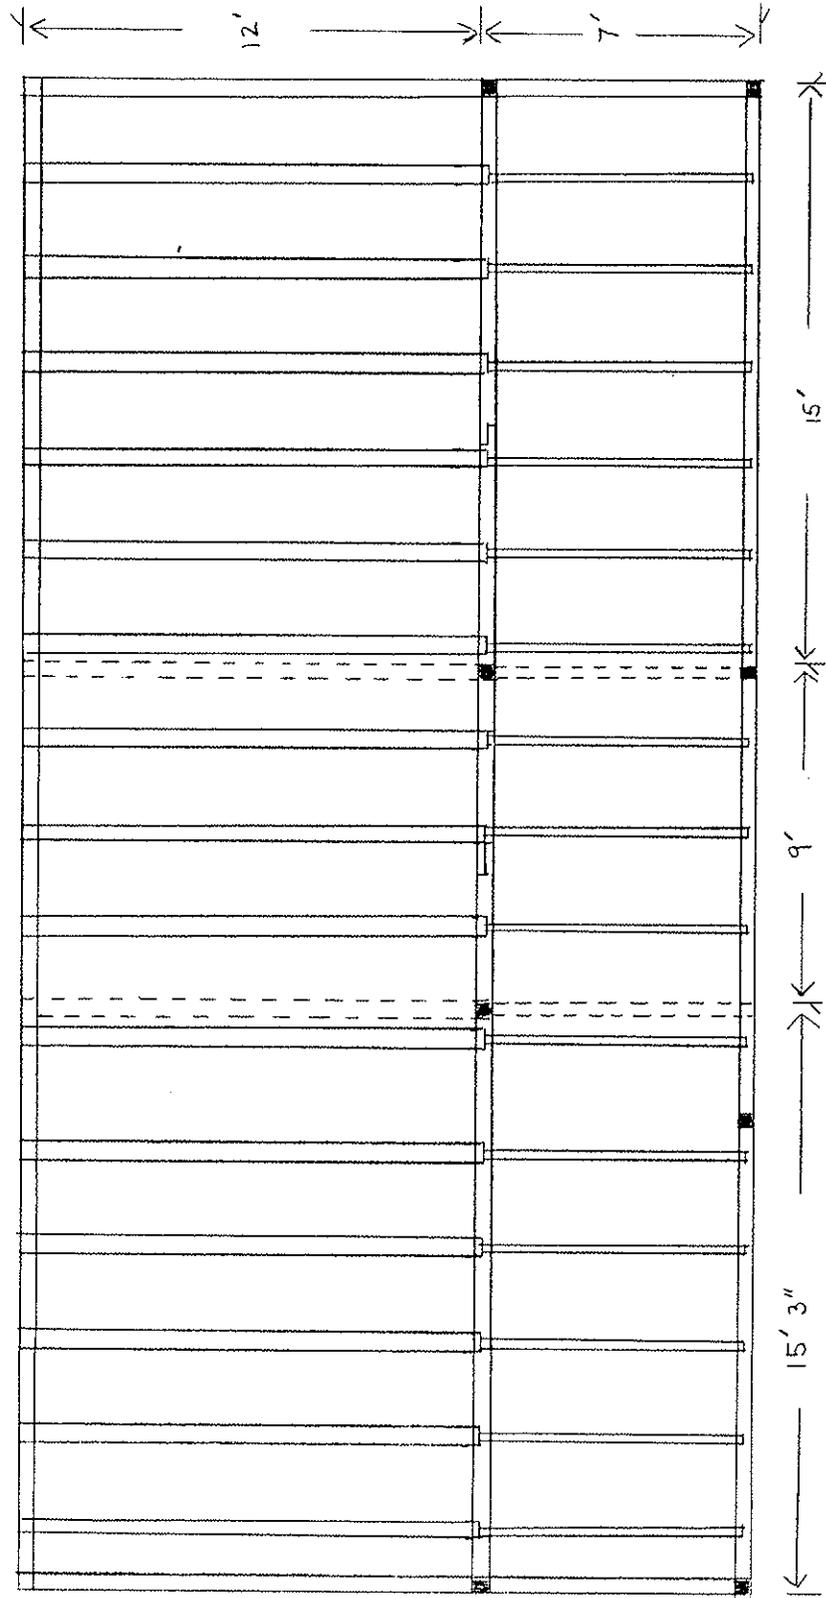
Figure 76. Webb-Burlingham Woodshed, Plan of Roof Framing (1994).

The extant framing of the front (south) slope of the woodshed roof is noticeably different from that in the rear (north) slope (see plan of roof framing - fig. 75). The rear roof has rafters and a ridge pole that are debarked tree-trunk, while the front roof has circular-sawn rafters and front plates. This at first suggests that the front section of the building is a later addition. However, the framing of the front and rear sections of the east end wall and the sole partition wall appears to be integral, indicating that both sections of the building were built at the same time (see

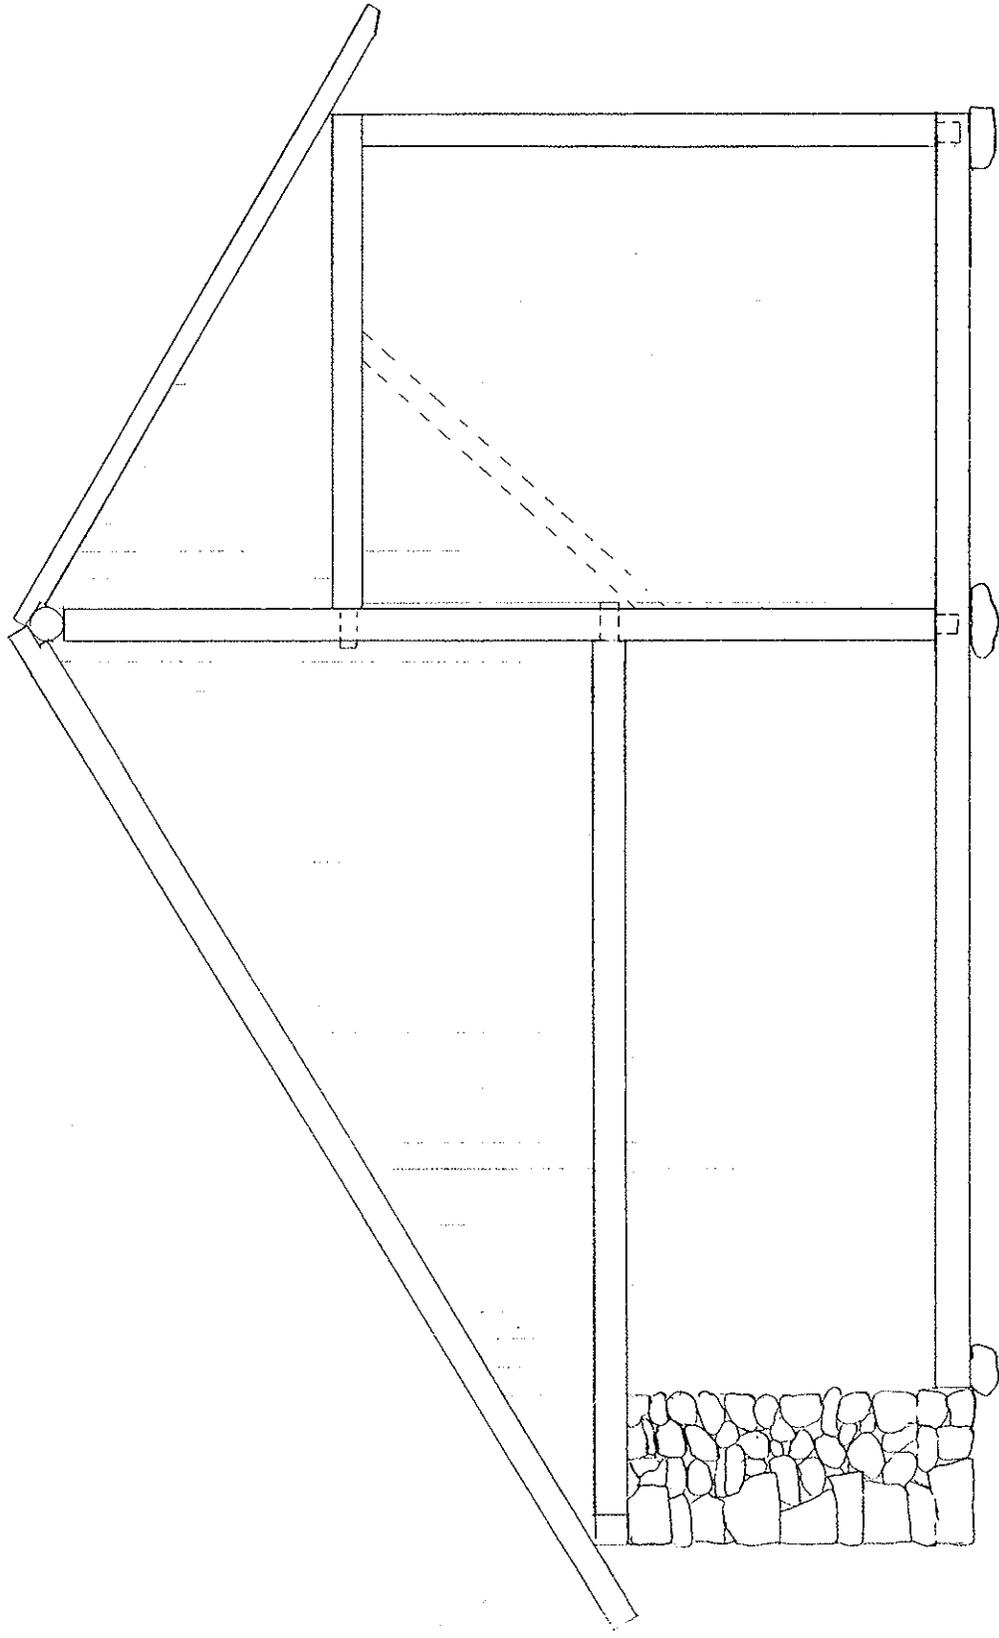
(not to scale)

Figure 77. Webb-Burlingham Woodshed, Section of Partition Wall and East, End Wall (1994).

section of wall framing - fig. 76). Therefore, it is assumed that the woodshed was originally built in its current configuration, and that the front roof slope was subsequently rebuilt.

A partition located 15 feet from the east end wall creates a room at the east end of the woodshed. Both the partition and the east end wall are framed in a similar manner (fig. 76). Rear girts run from the rear stone wall 4 feet above ground level to the ridge-pole post, and front girts run from the ridge-pole post to the south wall plate approximately 8 feet above ground level. The girts are connected to the post using pegged mortise and tenon joinery. On the partition wall, a circular-sawn 4-inch-square beam acts as a brace between the ridge pole post and the front transverse girt. Vertical boards are attached to the east side of the interior transverse girts and to the rafters to create the partition.

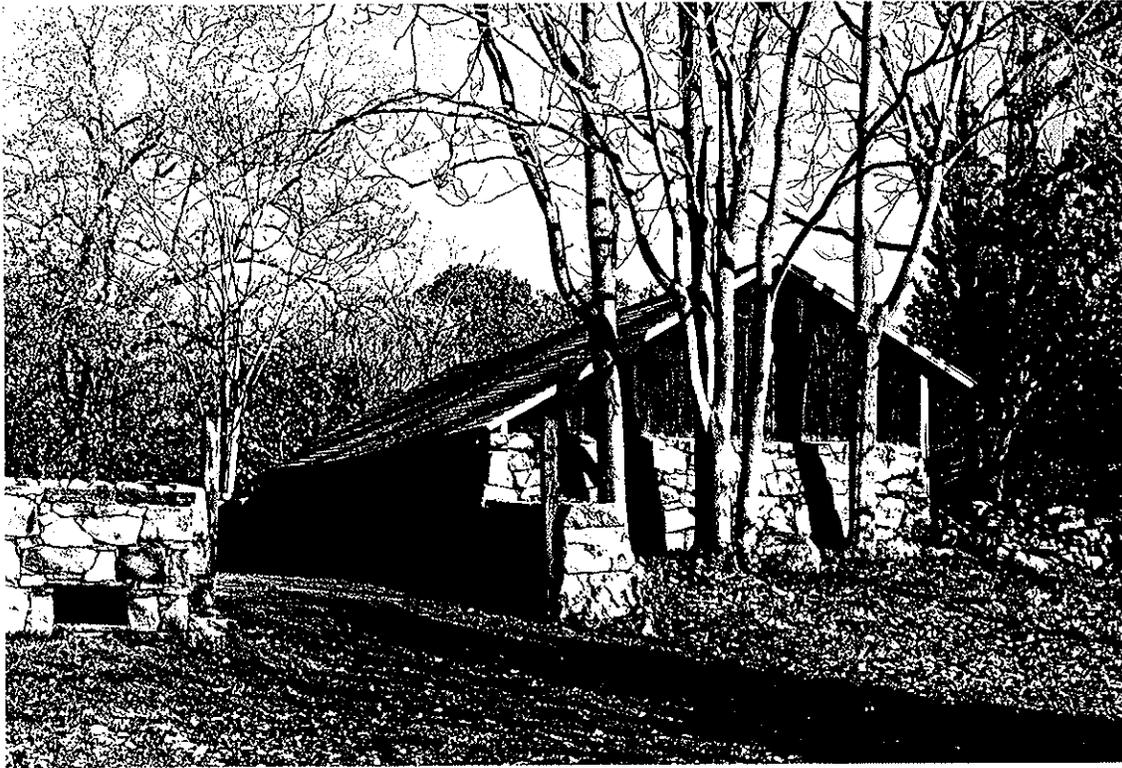
Figure 80. Webb-Burlingham Woodshed, View from West (1994).

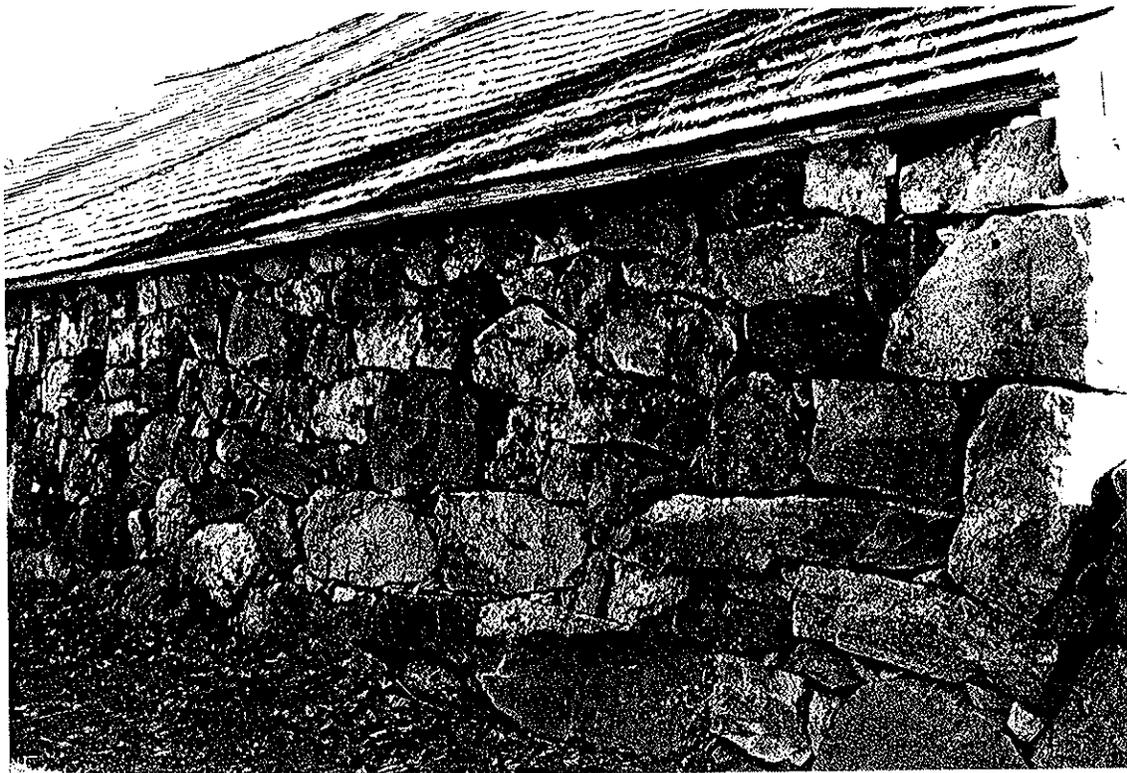
Figure 81. Webb-Burlingham Woodshed, North Wall (1994).

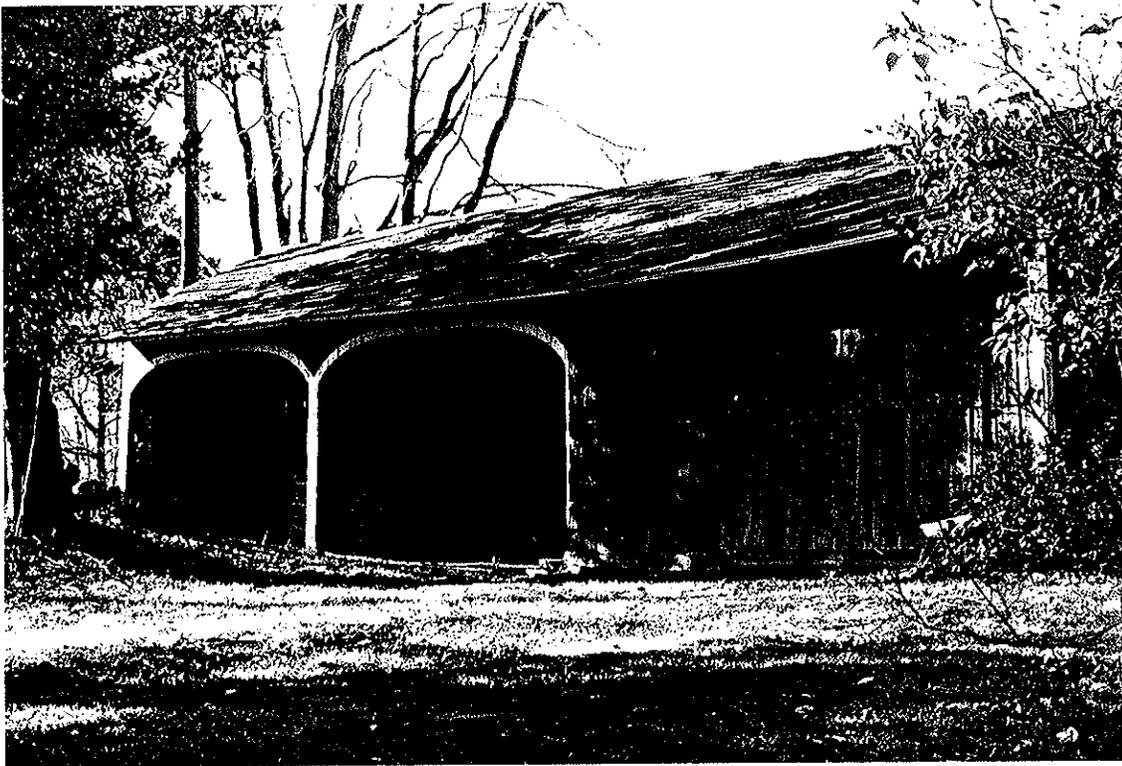
Figure 82. Webb-Burlingham Woodshed, South Facade (1994).

The siding on the woodshed is a combination of fieldstone and vertical tongue-and-groove pine boards. The siding on the **south facade** is vertical tongue-and-groove boards that are 7 1/2 inches wide. The siding on the **east wall** is vertical tongue-and-groove

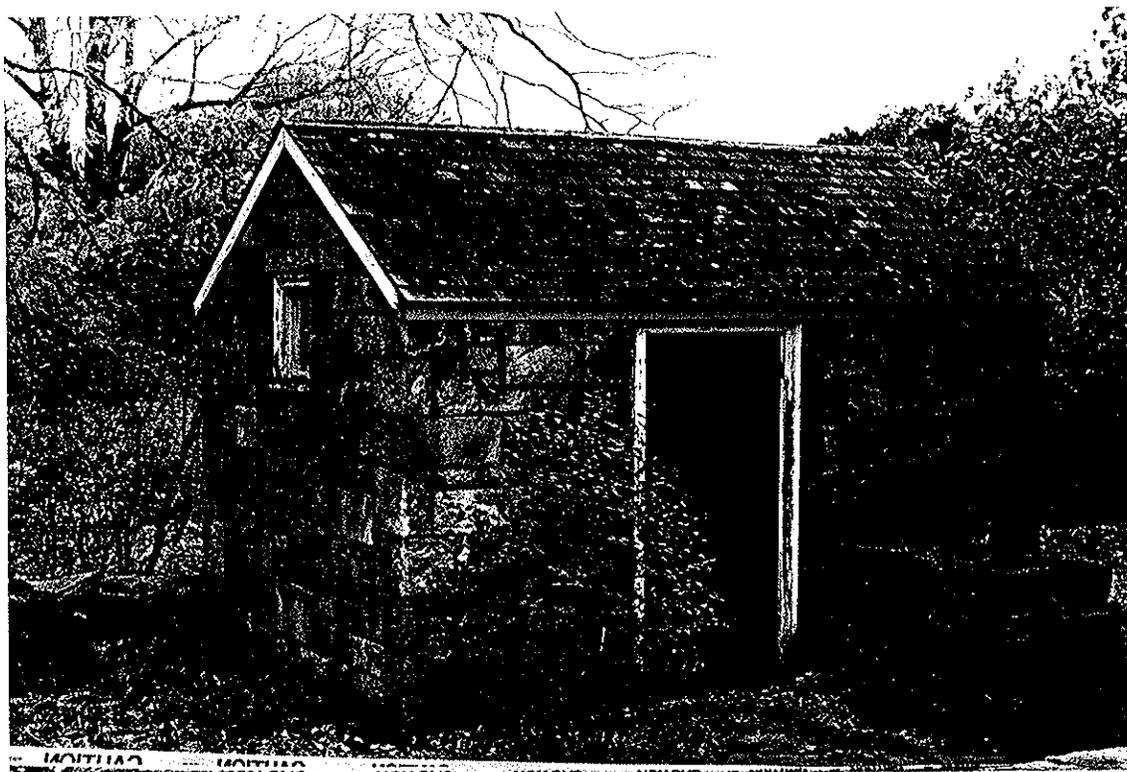
Figure 84. Burlingham Tool House, East Facade (1994).

There are two single-sash hopper windows in the tool house, one on the south gable end (W101 - fig. 84) and one on the north gable end (W103 - fig. 85). Each window measures approximately 1 foot 9 inches wide by 2 feet high, with two-over-two lights. Each opening is trimmed with a plain, 4-inch-wide surround.

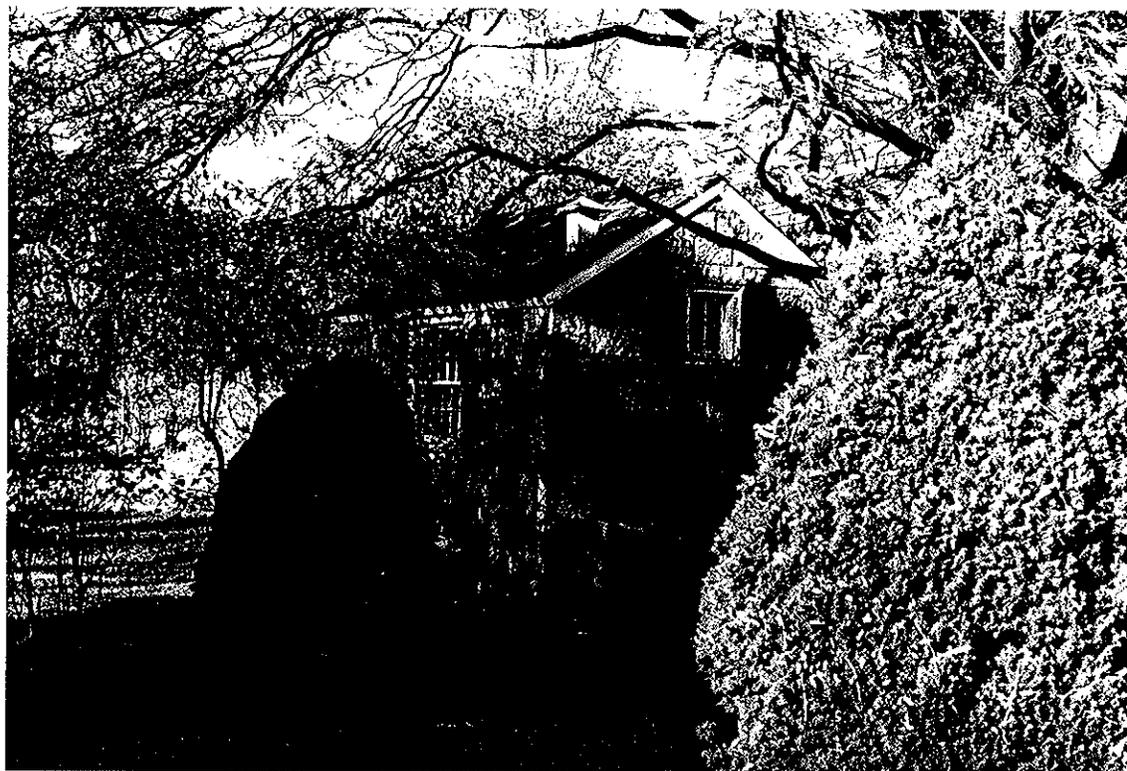
Figure 85. Burlingham Tool House, View from Southwest (1994).

A bulkhead doorway (D001) is centered at the basement level of the west wall of the building (fig. 85). The doorway measures approximately 4 feet 6 inches wide by 4 feet high, and is fitted with double doors. Each door measures 2 feet 3 inches wide and is constructed of 3 1/4-inch-wide tongue-and-groove boards mounted vertically on a Z-brace that faces the interior. The doors are hung using reproduction wrought-iron strap hinges. A chrome handle is located on the right-hand door.

Wood-boxed ventilation shafts are located in the southwest and northwest corners of the room. The shafts lead up through the first floor and through the west slope of the roof (figs. 84 & 85).

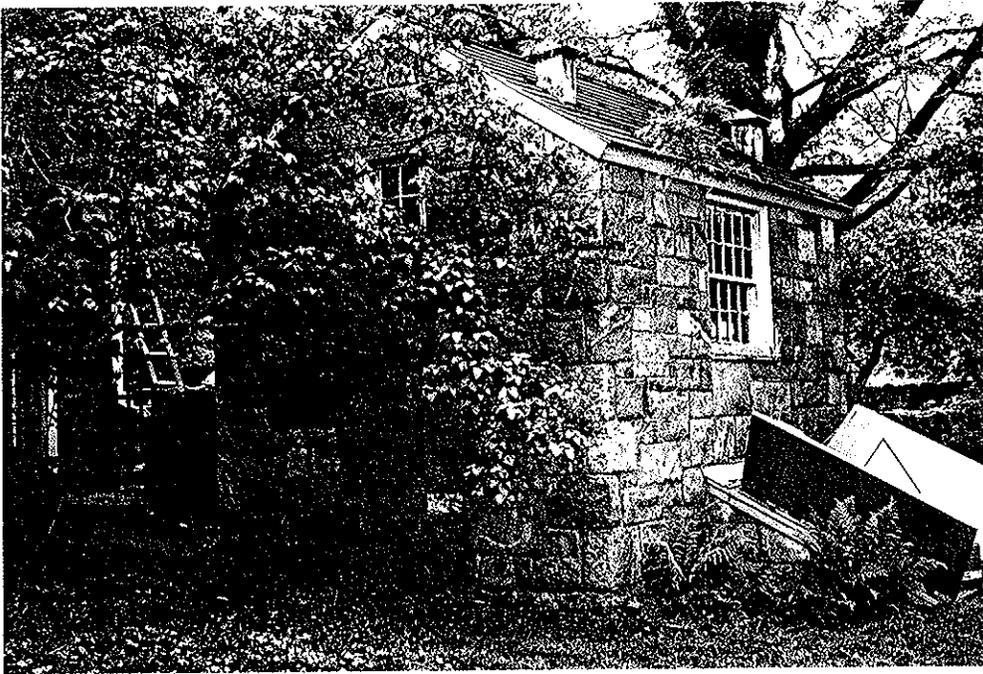
Figure 86. Burlingham Tool House, West and North Walls (1994).
