**WEIR FARM
HISTORIC STRUCTURES REPORT**

**Weir Farm National Historic Site
Wilton, Connecticut**

Burlingham Complex

1995

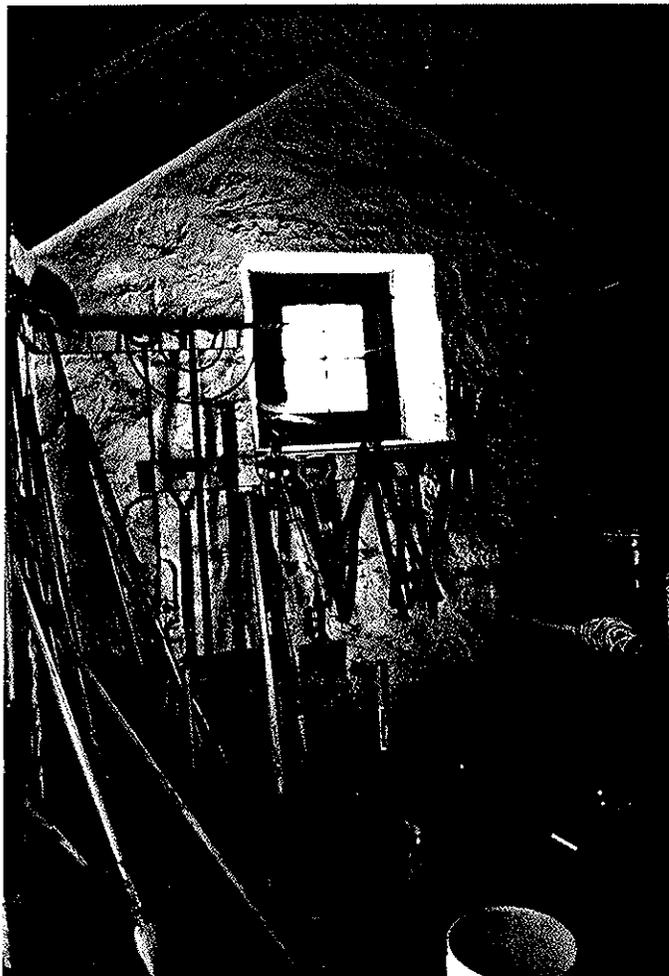
Figure 87. Burlingham Tool House, Potting Room South Wall (1994).

The first floor of the tool house is one room (the "potting room") that was used for potting plants and storing garden supplies and tools (figs. 86 & 87). The room measures approximately 11 feet 6 inches wide by 7 feet deep, and is accessed via an entrance on the east wall. Windows pierce the north and south gable end walls, and another window is centered on the west wall that looks toward the barn and fields to the west. Cupboards, work counters, storage spaces, and a sink line the interior walls.

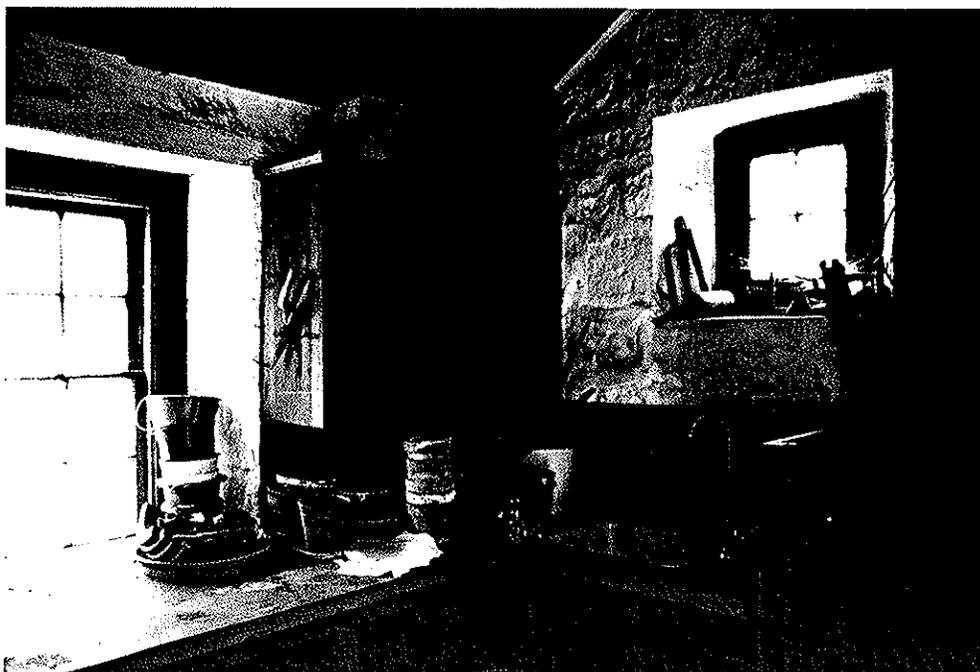
Figure 88. Burlingham Tool House, Potting Room Northwest Corner (1994).

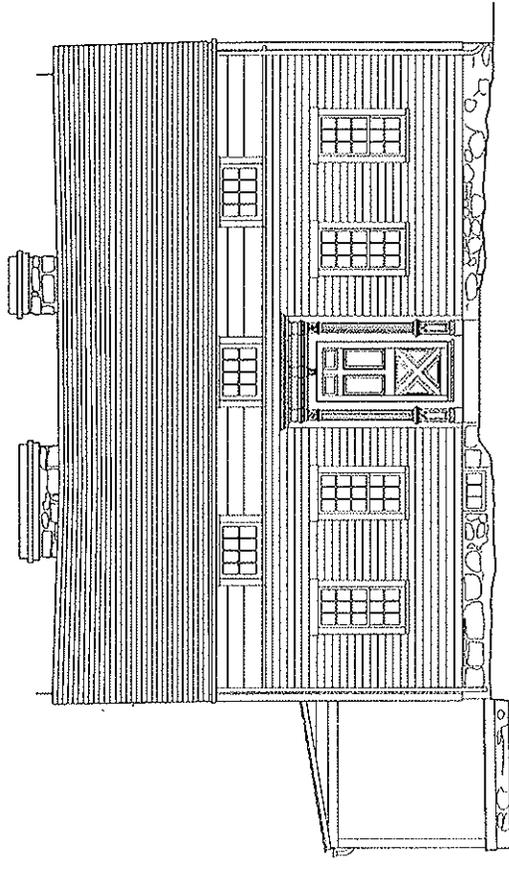
East Elevation

7'5" ————— 32'5.75"

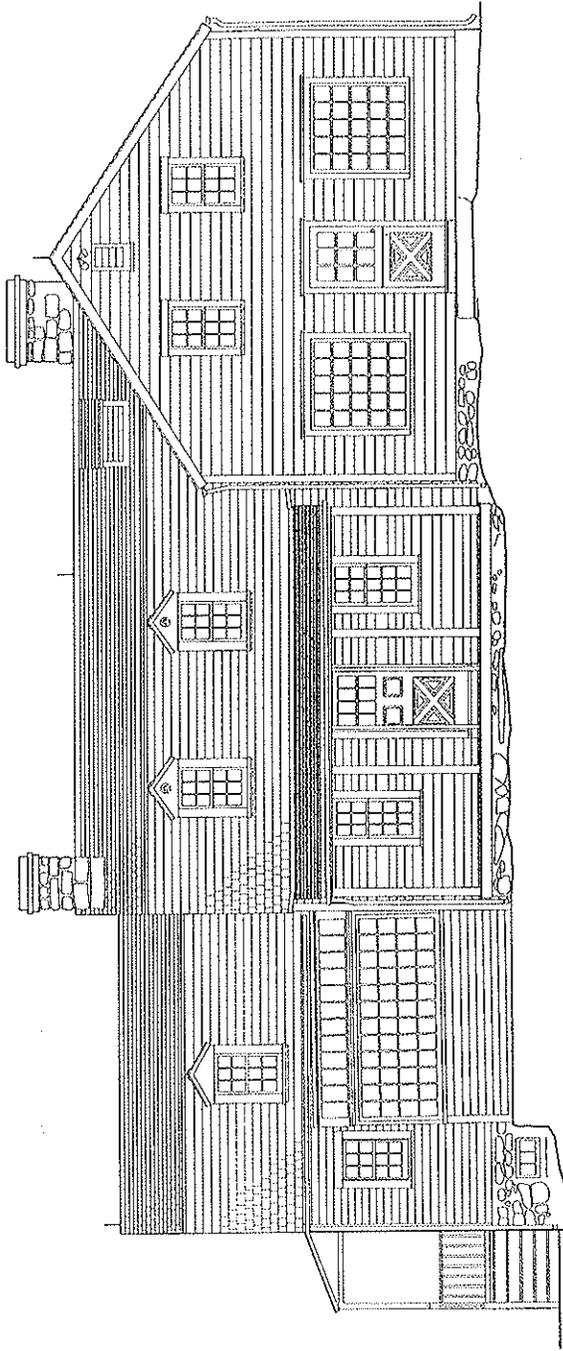
South Elevation

1/4" = 1'0"

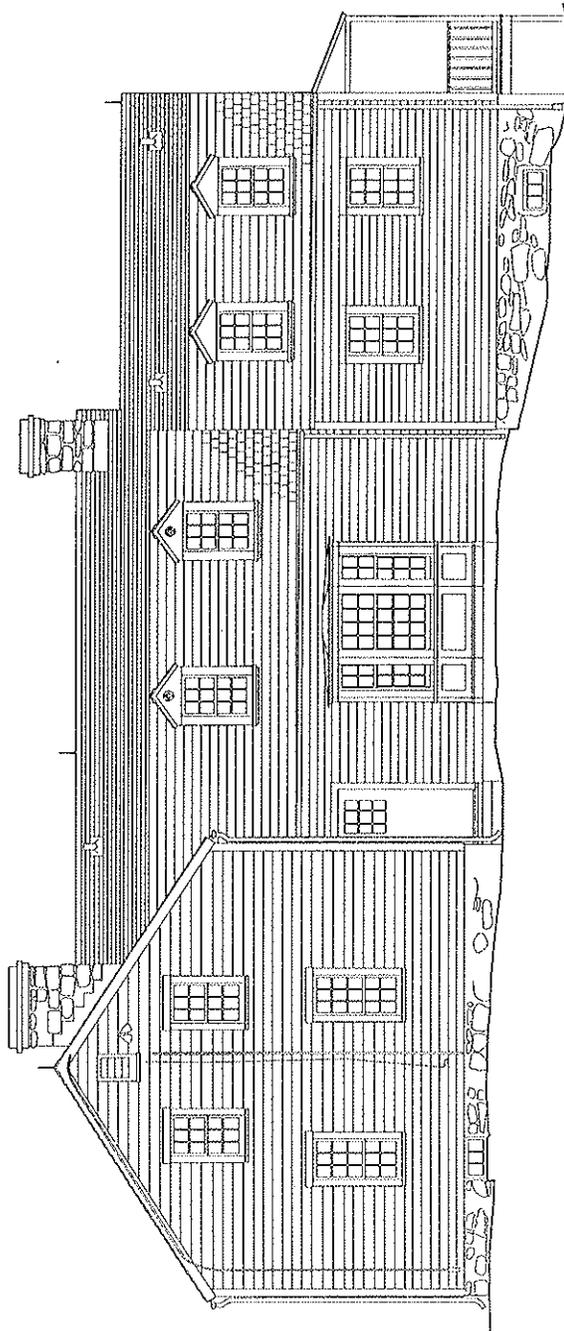
North Elevation

22'4.5" 20'4.5" 16'7.75" 3'10"

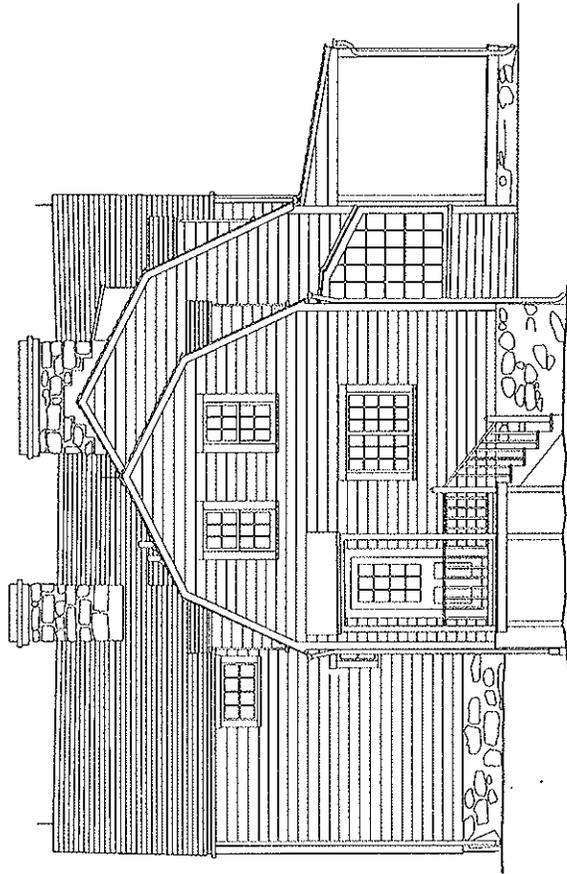
West Elevation

1/4" = 1'-0"

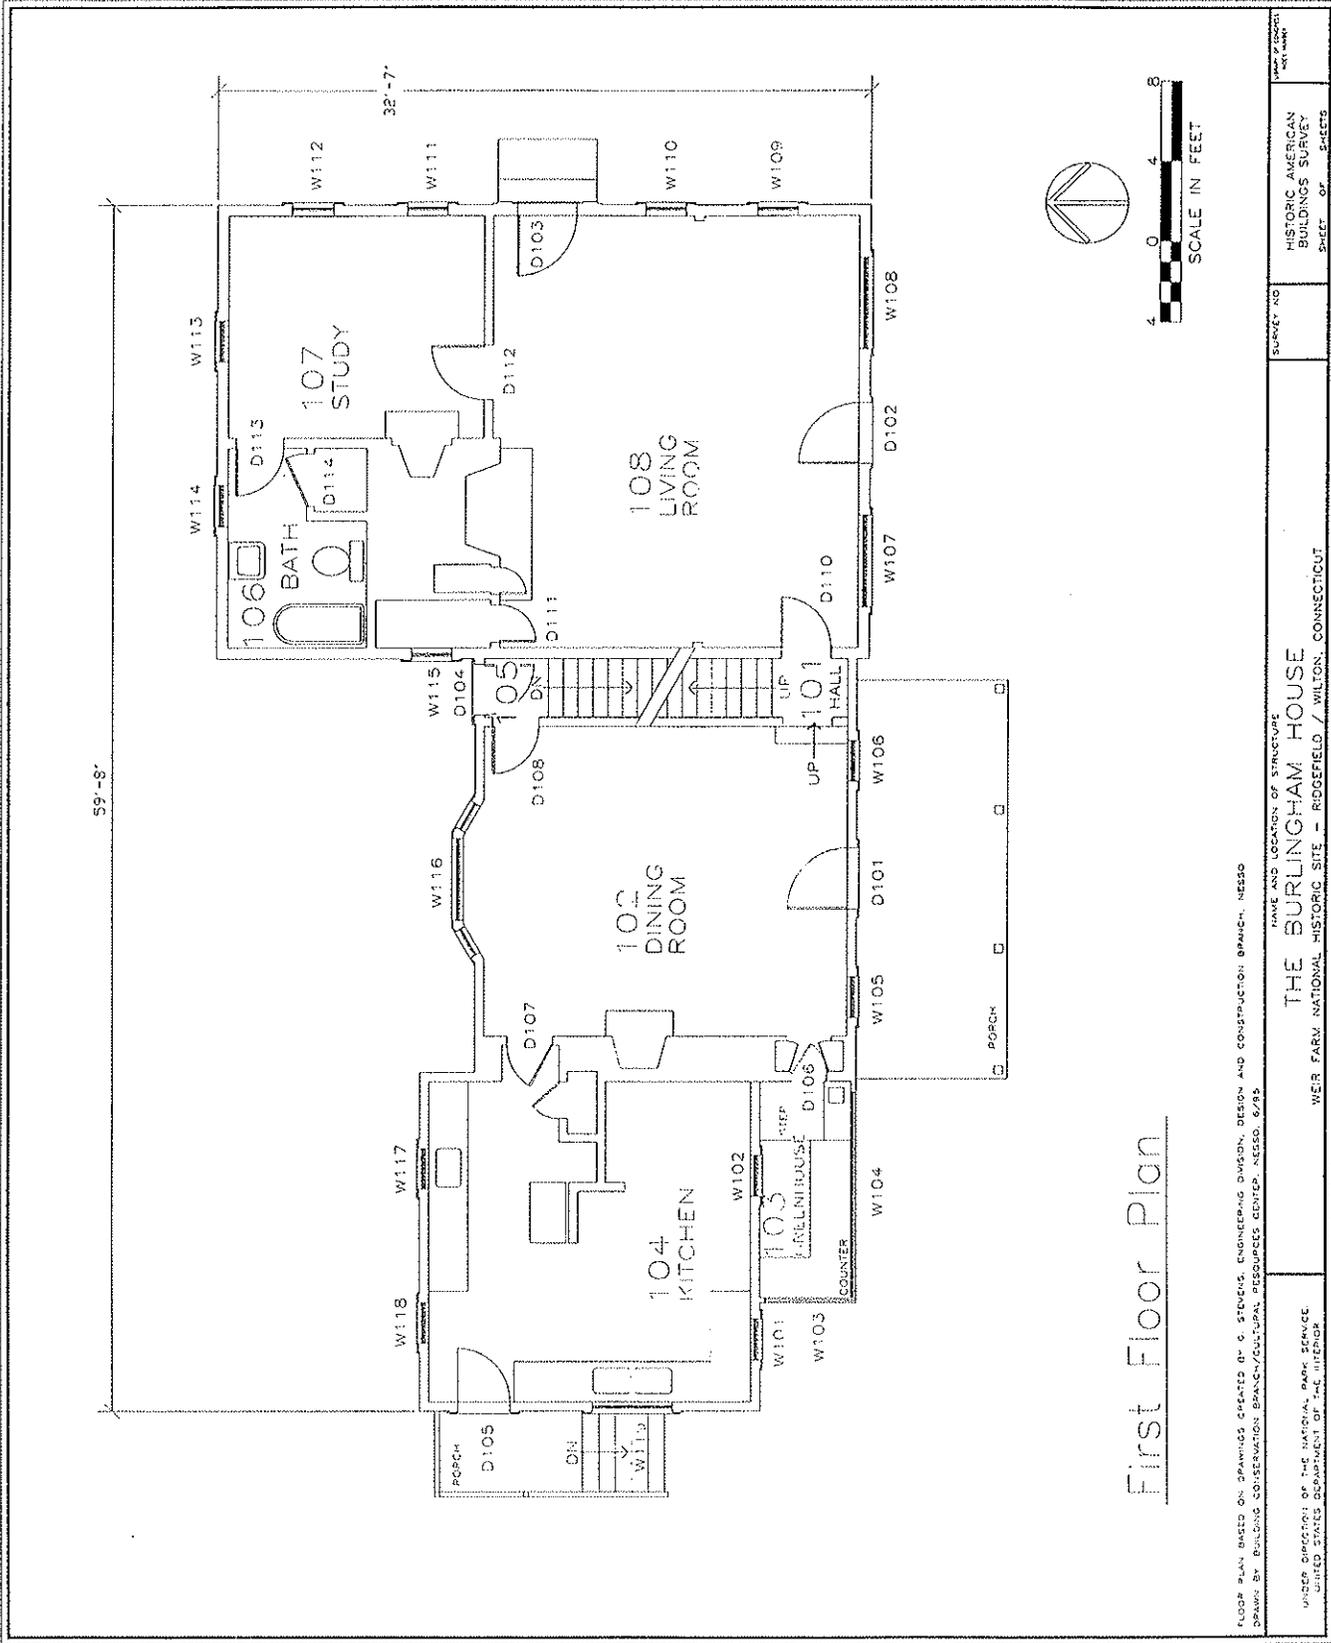
First Floor Plan

FLOOR PLAN BASED ON DRAWINGS CREATED BY G. STEVENS, ENGINEERING DIVISION, DESIGN AND CONSTRUCTION BRANCH, NESCO
 DRAWN BY BUILDING CONSERVATION BRANCH/CULTURAL RESOURCES CENTER, NESCO, 6/89
