CULTURAL LANDSCAPE REPORT

KENNECOTT MILL TOWN

WRANGELL-ST. ELIAS
NATIONAL PARK AND PRESERVE
ALASKA

2001

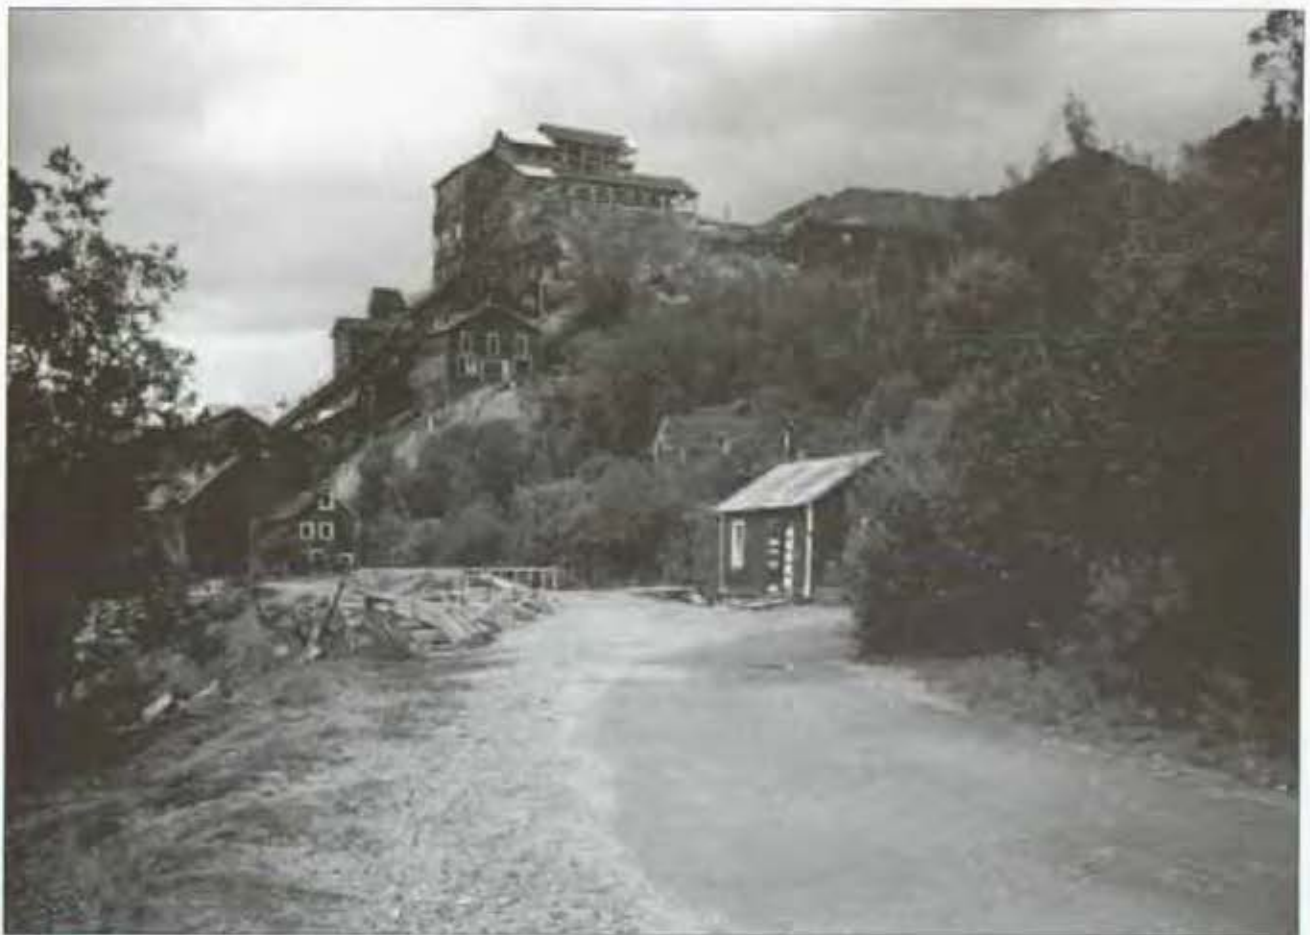
Figure 1. View north from the entry road to the lower Kennecott mill town, part of the National Historic Landmark District. (NPS park files, WRST, 1997.)

In June 1998, the National Park Service (NPS) acquired the land, mineral rights, and associated holdings of the Kennecott Copper Mines in south-central Alaska.¹ Located in the center of Wrangell-St. Elias National Park and Preserve, the area is a designated National Historic Landmark (NHL) District, encompassing 7,700 acres of public and private lands. The 2,839 acres purchased by the NPS includes property and structures in the historic mill town (figure 1), which was the center of operations between 1901–1938.

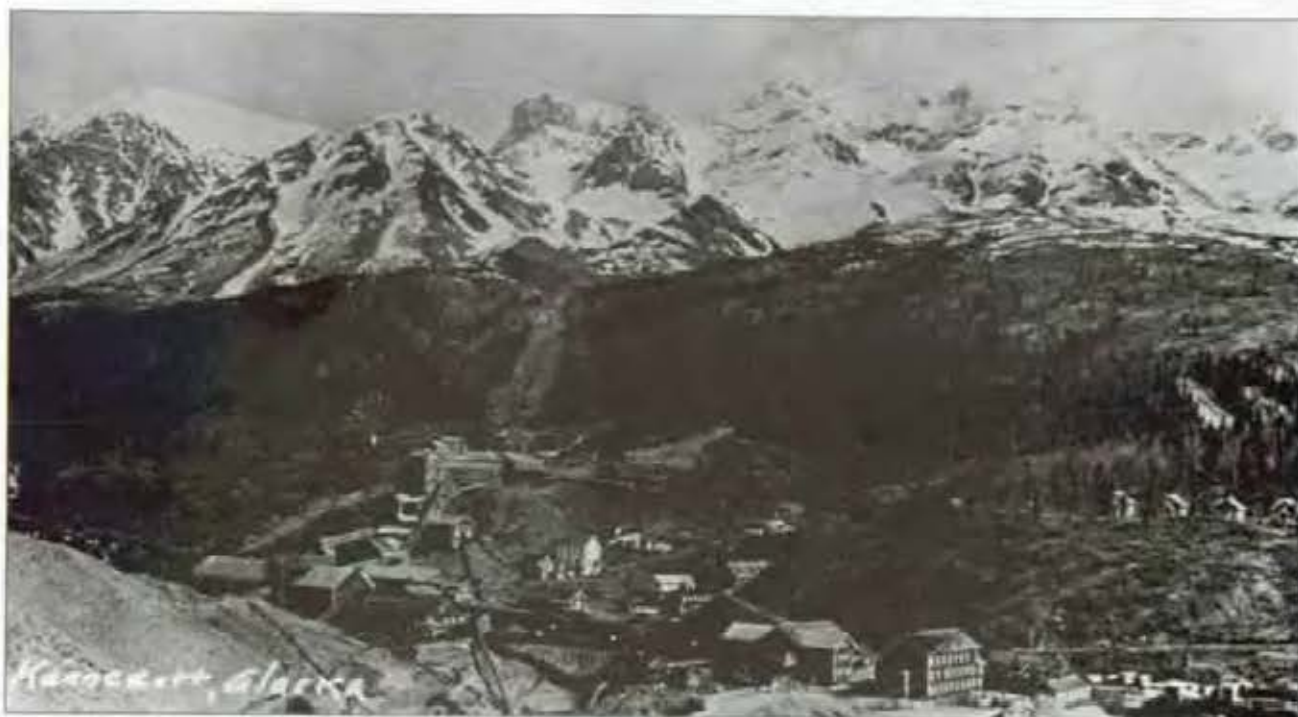
Figure 2. View of Kennecott, circa 1930, showing cleared vegetation, roads and trails, concentration mill, support structures, cottages, flumes, crib dam, and tramway up the hill. (Ervinne Sullivan, park files, WRST.)

Throughout the 1910s and 1920s, the mines continued to expand with new discoveries and increased investment (figure 2). Substantial facilities and infrastructure were established to advance the work and support the work force. Individual mine sites were self-sufficient camps, with structures for operating

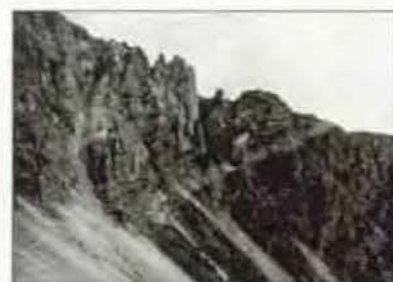
Figure 5. Location of the Bonanza claim, circa 1903. The rich chalcocite ore body is visible as the diagonal striations oriented toward the upper right of the photograph. (Mendenhall, 1905.)

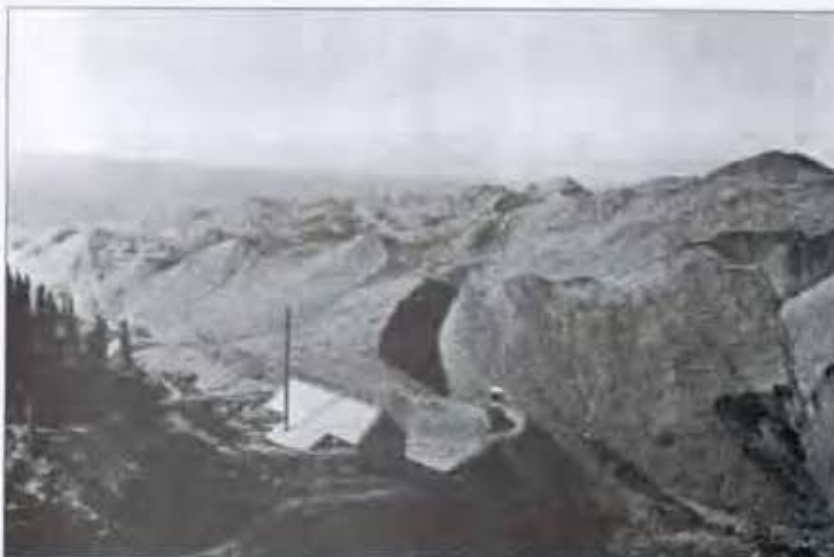
Figure 8. Kennecott mill town, circa 1908. View looking south with the sawmill in the foreground. (Photo courtesy of the Anchorage Museum of History and Art.)

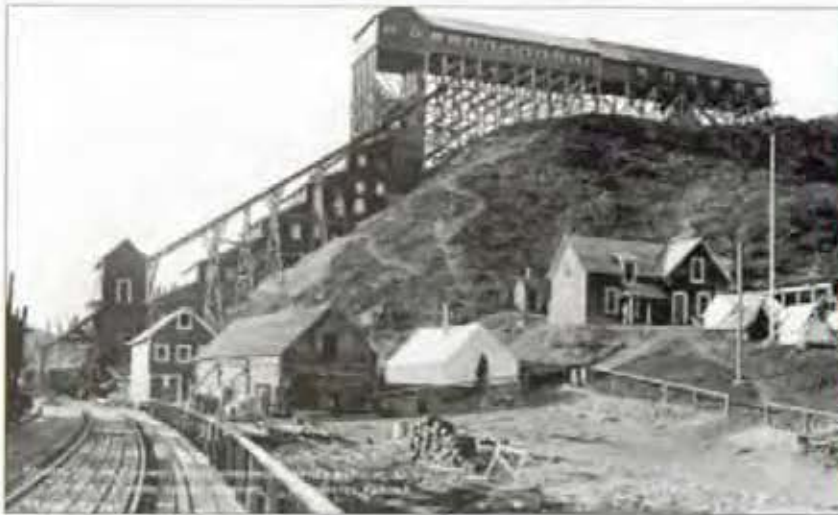
Figure 11. Concentration mill, circa 1912. Note the extensive crib work in front of the mill and the high-grade ore conveyor connecting the upper mill and the stacking shed. (Photo courtesy Alaska and Polar Regions Archives, Rasmuson Library, University of Alaska, Fairbanks, Alaska.)

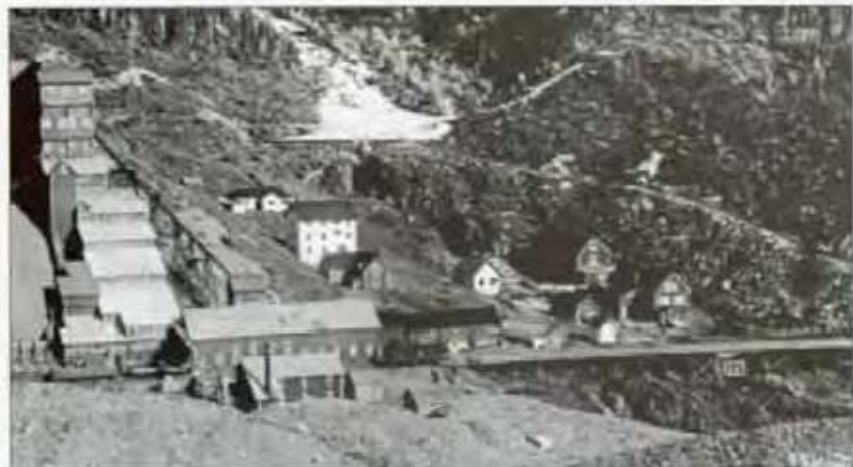
Figure 12a. Panorama of Lower Kennecott mill town, circa 1913. (Mears Collection, Rasmuson Library, University of Alaska, Fairbanks Alaska.)

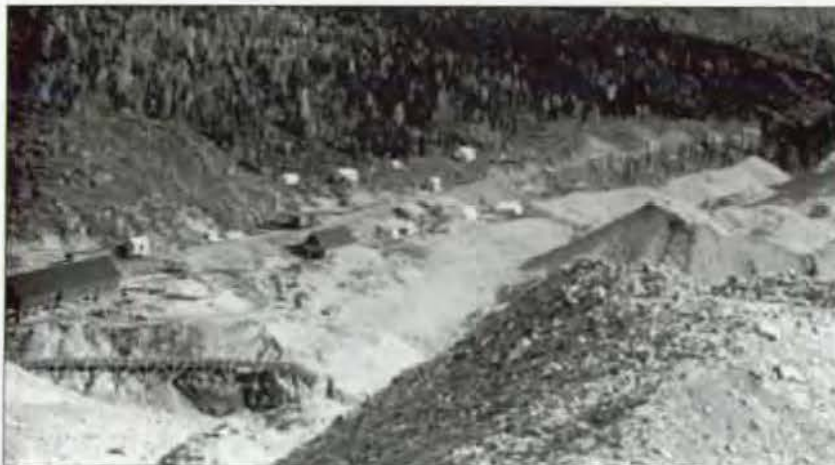
Figure 12b. Panorama of Lower Kennecott mill town, circa 1913. (Mears Collection, Rasmuson Library, University of Alaska, Fairbanks Alaska.)

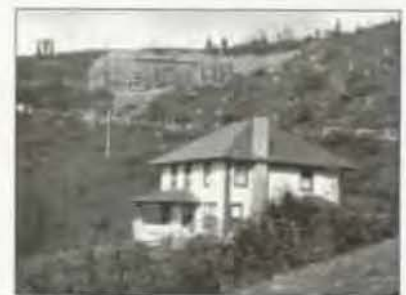
Figure 14. Built in 1916, Stephen Birch's residence was situated near the Bonanza Mine ore bin and Jumbo aerial tramway tower, visible in the background. Photograph circa 1919. (USGS photo library; Moffit 754.)

Developments in 1916 also included substantial improvements to staff and managerial residences. Immediately north of the National Creek dam, a two-story residence built for manager Stephen Birch (painted white) sat perched on the rise of the slope, affording views to the concentrator, other National Creek structures, and the glacial moraine beyond (figure 14). Because Birch's residence occupied the space once used for the community garden, management allocated space for a new garden, measuring 100 feet by 160 feet, on the north side of the National Creek dam reservoir. New accommodations for staff were constructed at the north and south ends of the mill town. At the north end, three cottages were constructed next to the power plant alongside those built the previous year. Due to the steep drop-off on the west side of the rail grade, these cottages included lined basements and catwalks connected each cottage with a privy.⁷⁶ Toward the south end of the mill town an apartment house containing five, four-room apartments and farther south, four, six-room cottages

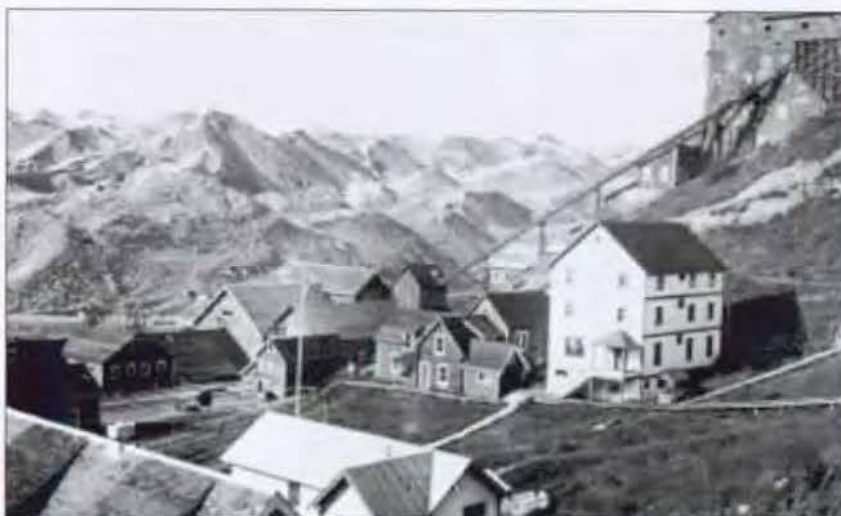
Figure 15. Administrative center of Kennecott showing the mill and industrial buildings, hospital (center foreground), staff house (right), and manager's office (center). Note the well, flagpole, picket fence, and boardwalks (center foreground). Photograph circa 1919. (USGS Photo Library, Moffit 753.)

Improvements at the mill town also continued. The powerhouse received an extension to accommodate a diesel engine and additions were made to the east side of the hospital. Both bunkhouses on National Creek were renovated to accommodate more workers (figure 15).⁹¹ The second bunkhouse (circa 1910) included a toilet, shower and laundry facilities, a poolroom, reading room, and locker room.

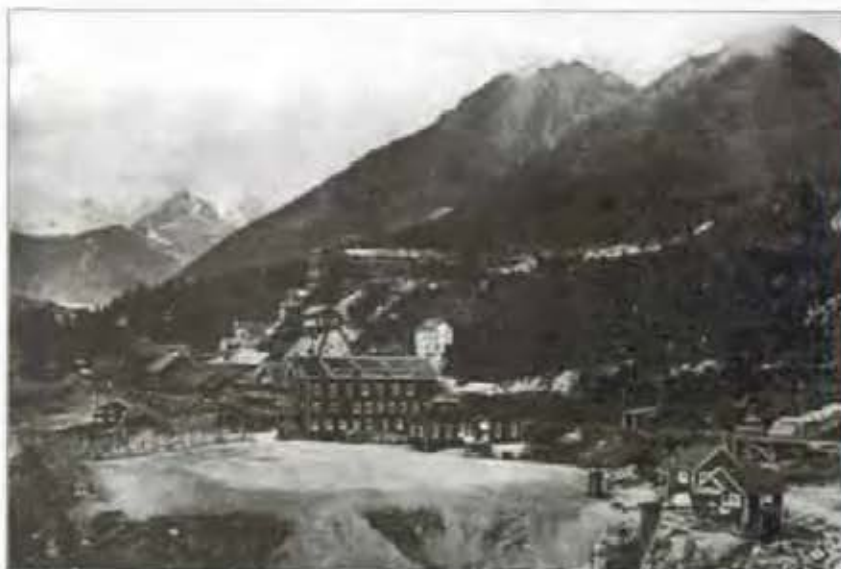
Figure 16. Kennecott mill complex in 1925. West bunkhouse is at center with the schoolhouse and baseball field in front. (Photo courtesy of the Alaska State Library.)

between the recreation hall and barn, and north of the recreation hall (for a coal bunker). The company also constructed two garage facilities south of the dairy barn. Lumber storage areas occupied space near the railroad, including areas between the apartment block and schoolhouse south of the recreation hall and east of the upper mill complex. Facilities for workers that were constructed by 1925 included a bathhouse east of the company store, two cottages north of the recreation hall, and a tent cottage at the south end of the complex (figure 16).

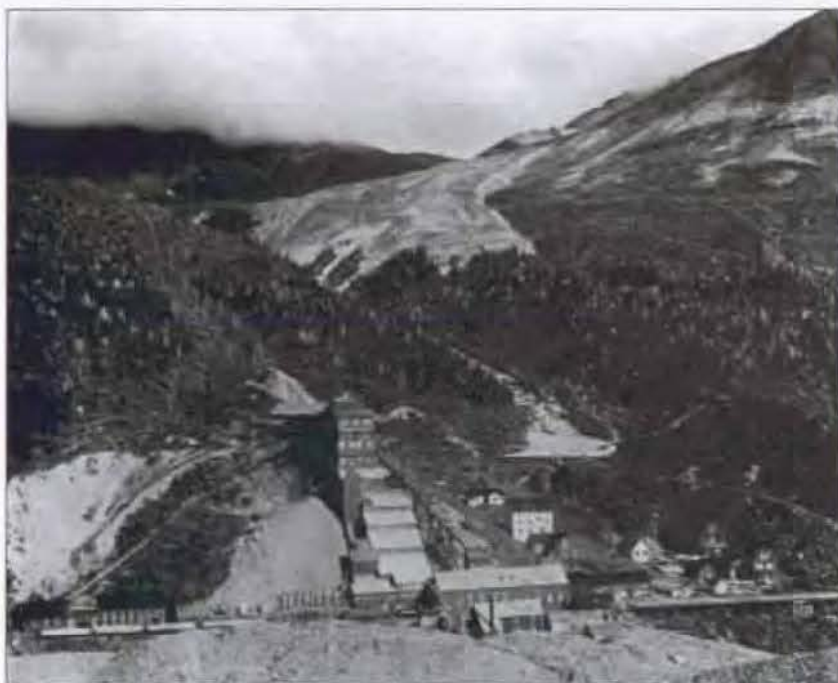
Figure 21. Kennecott, circa 1913, showing cleared vegetation, the complex of administration structures, and the concentration mill, tramway, crib dam, and railway along the bottom of the photograph. (Mears Collection, Rasmuson Library, University of Alaska, Fairbanks, Alaska.)

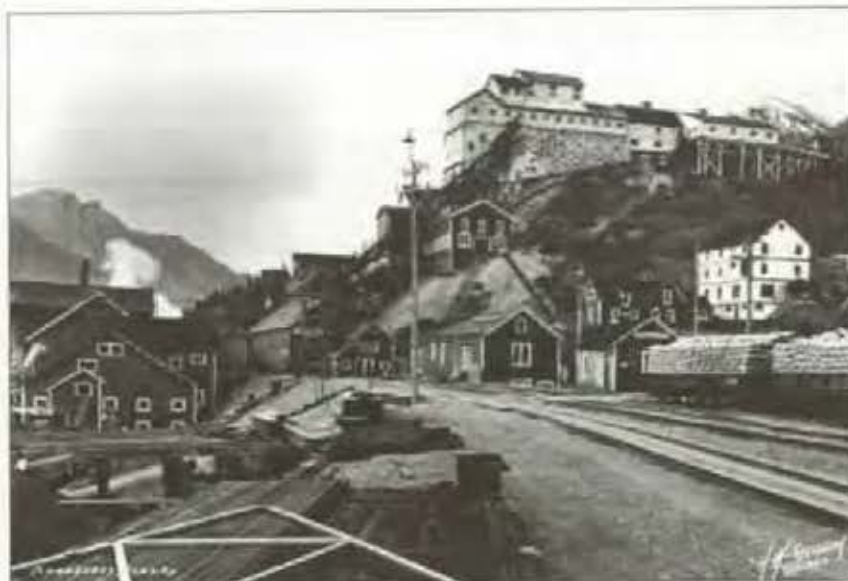
Figure 22. View northward from the railway line, circa 1927, showing the concentration mill and industrial area. (Mears Collection, Rasmuson Library, University of Alaska, Fairbanks, Alaska.)

The industrial core of Kennecott is most clearly reflected in the concentration mill, which grew between 1911–1938 into a structural complex stepping down the hill from the terminus of the tramlines coming from the Bonanza and Jumbo mines (figure 22). From the tram deck at the top of the concentrator, ore traveled through the crushing operation and the gravity concentrator to the flotation and ammonia leaching plants, and ended either in rail cars or piles of tailings. This remarkable structural complex was the heart of the industrial townscape. Many of the support structures for the concentrator, including the power plant, warehouses, machine shop, various small sheds and storage structures, and the rail system for transporting ore down the valley, were sited either directly adjacent to or very near the concentrator. At this scale of operation, circulation depended on the tramlines bringing the ore to the plants and rail line for transport to ports and markets. Other patterns of circulation focused on the internal system associated with the operation of machinery within the concentrator.

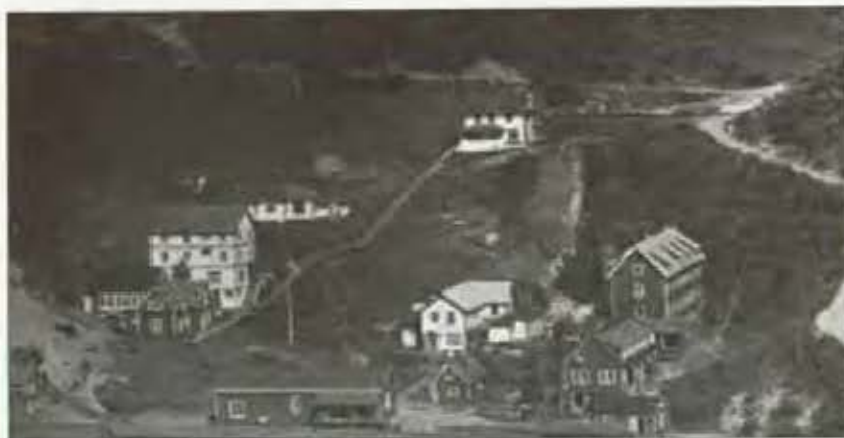
Figure 23. View of administrative core showing boardwalks, flag pole, and primary structures, including the manager's house, staff housing, hospital, and barracks buildings. Photograph circa 1930. (Evelyn Sullivan, photo files, WRST.)

Occupying the central area within the mill town, the manager's office and residence, the staff house, hospital, bunkhouses, assay shed, and community garden compose the administrative core (figure 23). Individual buildings were larger and more stylized than in other areas of the town. The manager's residence reflected a hierarchy and social status typical of other company towns. Constructed in 1916, the manager's house was a two-story structure, painted white, and sited on the highest portion of the mill town. Circulation through this area was somewhat formalized along boardwalks that linked key buildings stepping down the valley from the crib dam along National Creek and ending at the rail-

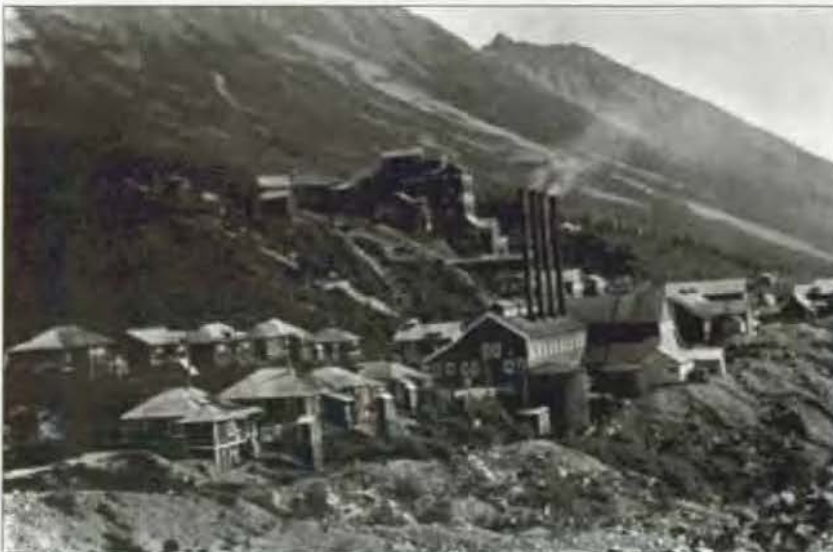
Figure 24. View of cottages in the north end of the mill town, circa 1930. (Jim McGavock, photo files, WRST.)

Two functionally related clusters of cottages and residential structures on the north and south sides of the mill town made up the housing core (figure 24). North of the concentrator, four individual cottages were constructed between 1908–1915 on the east side of the railroad tracks. These cottages were the first constructed in the mill town and they provided housing for families. As the town expanded between 1915–1938, four more cottages were built directly west. These cottages included lined basements and catwalks to individual privies. Collectively, these structures defined the northern edge of the mill town. Also during this period, seven cottages making up “Silk Stocking Row” were built on the hill south of the crib dam. These residences also had several associated out-buildings, including garages, chicken coops, outhouses, and gardens.

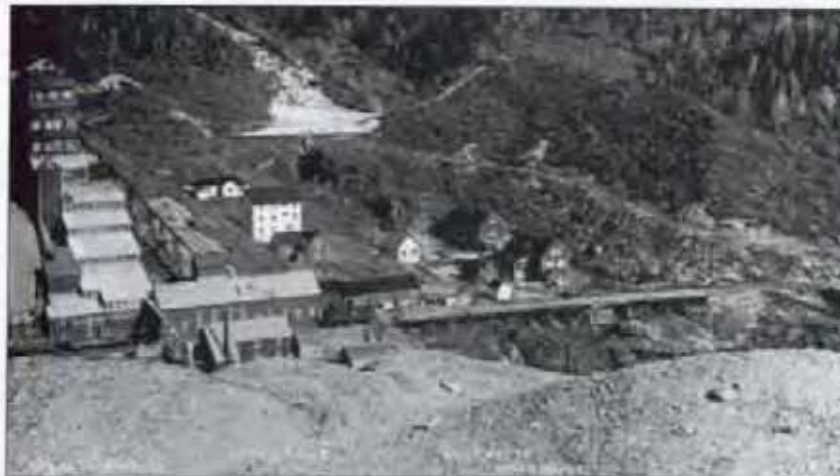
Figure 25. Railroad trestle through the mill town was the primary link to outside markets and supplies. Note the wagon road extending up the hill, south of the bunkhouse buildings. Photograph circa 1913. (Mears Collection, Rasmuson Library, University of Alaska, Fairbanks, Alaska.)

Between 1908–1915, core circulation systems were established that would influence virtually all future development at Kennecott. Key to this circulation system was the rail line connecting the mill town with Cordova, about 196 miles away (figure 25). In 1908, the Copper River and Northwest Railway crossed the Copper River at Flag Point near Cordova. After many physical and political obstacles, the railroad finally reached the Kennecott mines in the spring of 1911.

The track entered the site from the south on an alignment just east of the existing wagon road. Extending north, the track crossed National Creek on a 256-foot trestle bridge and ended at the ore bins at the base of the concentration mill. Completion of the railroad had a dramatic effect on construction at Kennecott. First, it provided a reliable source of supplies and a transportation system for the ore. Second, the railroad established a strong linear framework for both the structural and functional development of the mill town.

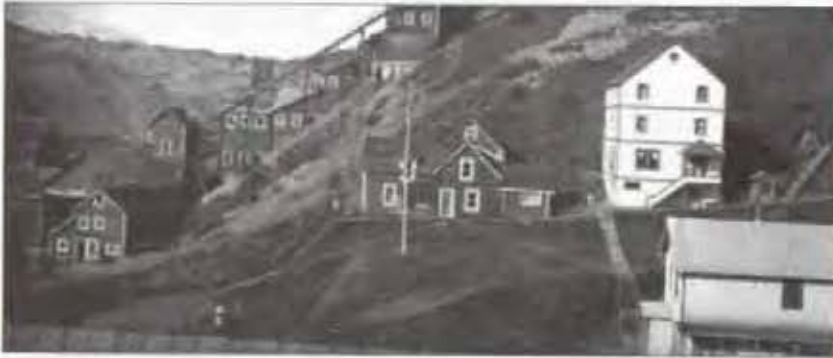
Figure 26. Wood boardwalks and foot paths through the administrative area of the mill town, linking primary buildings, circa 1919. (Photo courtesy of E.H. Moffit, USGS.)

Also during this period, wood plank boardwalks were constructed, linking primary residential structures (cottages and staff quarters) and service buildings (the hospital, manager's office, and assay office). While these boardwalks primarily served a functional purpose, they also served to formalize footpaths and provided some sense of domesticity in an otherwise industrial landscape (figure 26). In contrast, the paths between the industrial buildings were based on need and function, were informal in character, and did not follow straight lines and sharp angles.

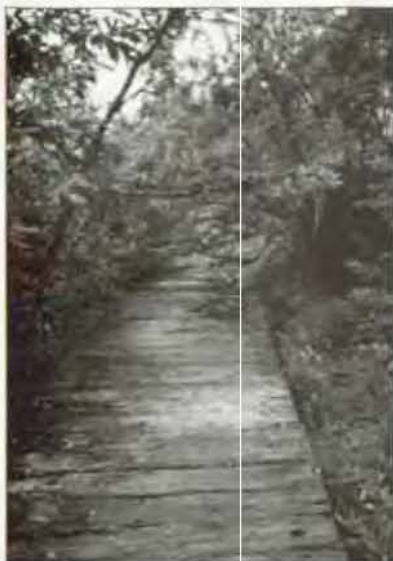
Figure 27. Remnant boardwalk section in front of cottages along the north end of the mill town. (NPS, photo file, WRST, 1997.)

features contribute as remnant features of circulation. These include the segment of boardwalk in front of cottages 13a–e, a portion of stairways, railing, and boardwalk in the National Creek area and below Silk Stocking Row (figure 27).

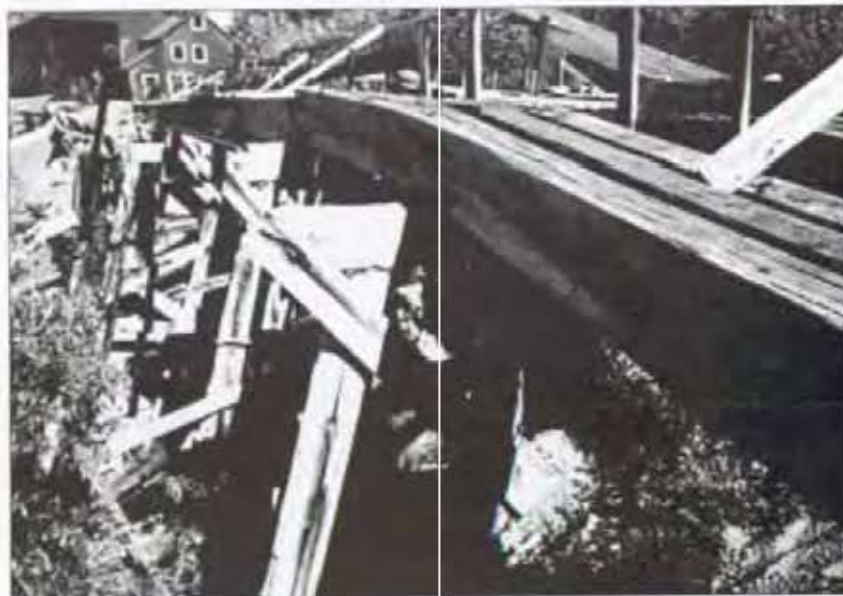
Figure 29. Railroad trestle structure as it looks today. (NPS, photo file, WRST, 1998.)

The Copper River and Northwest Railway reached Kennecott from the Port of Cordova in 1911. The rail line entered the mill town from the south, crossing a 250-foot trestle and terminating at the concentrator (figure 29). The railway and associated trestle became the dominant circulation structure in the town, defining the overall industrial infrastructure and building complex. The trestle originally served two pairs of tracks, one pair on the west and one on the east. The rail bed was constructed of pressure-treated beams, cribbing, and railroad ties. The posts supporting the bed structure are a combination of pressure-treated round poles and untreated spruce trees.

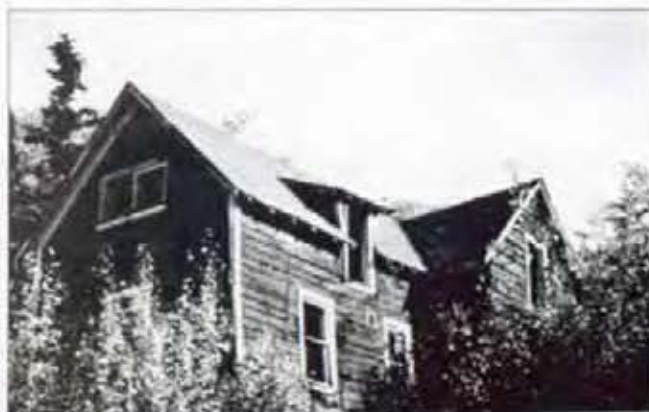
Figure 31: Manager's office, 1998. (NPS photo file, WRST.)

Description: Built in stages, the original portion of the manager's office is a one-and-a-half-story, saddle-notched log structure with sill log foundation. The main door and two windows are on the south façade. One-over-one, double-hung windows are in the gable end above the first floor. An addition is set back on the west side of the log structure and has a roof line running perpendicular to the original roof. A small one-story office wing was also constructed on the east side. And on the rear of the log structure, a large two-story wing was constructed.

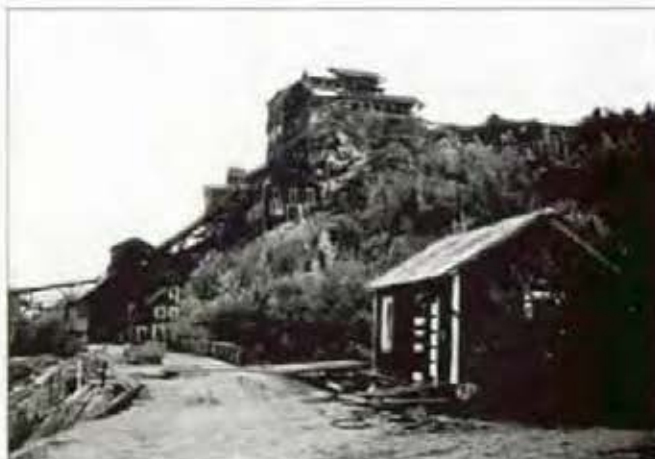
*Figure 32. Tram terminus viewed from the south side of National Creek, 1998.
(NPS, photo file, WRST.)*

Description: A large deck on the top portion of the concentration mill (Building 3), the structure served as the terminus for the tramway to the mines on Bonanza Ridge. Both the tram deck and the upper concentrator were covered by a long gable roof, with a cross gable over the first structural bay to the west. The entire upper level was constructed on a heavy timber post and beam framework, similar to the railroad trestle.

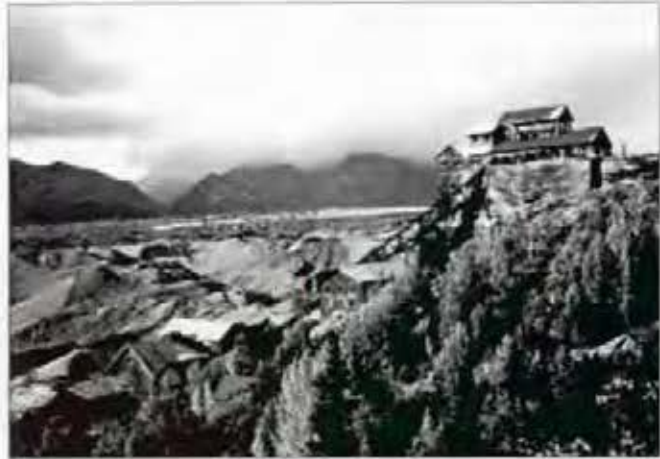
Figure 33. View northward toward the concentration mill, 1998. (NPS photo file, WRST.)

Description: The concentration mill is a 14-story, multi-gable, wood frame structure in the center of Kennecott. Easily the most impressive structure in the mill town, it is built on a series of terraces supported by timber cribbing, stepping 150 feet up the hill on the east side of the rail line. The concentration mill is the product of numerous building modifications, each reflecting change in the technology and expansion of the mining operation (figure 33). Additions to the original structure were constructed to house various support structures for operating the concentrator, water tanks, space for mechanical equipment, and storage. Windows throughout the building include double and single sash, randomly placed depending on interior requirements for lighting. Later additions have bracketed gable ends, although plain verge boards with exposed purlins are most common.

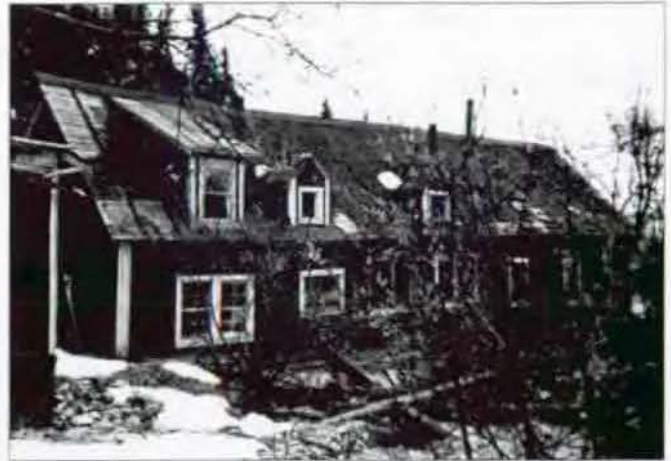
Figure 34. Bunkhouse along National Creek. (NPS photo file, WRST, 1998.)

Description: Sited along National Creek, this bunkhouse is a rectangular, one-and-a-half-story structure with a gable roof, and shed roof dormer on the south side. Two gable roof dormers provide additional light and space to the north and south side rooms. A shed-roofed porch is on the south side of the building, extending the length of the structure. The boardwalk on the north side of the building has been buried by flood rubble. Gable and verge overhangs are detailed with a narrow fascia board.

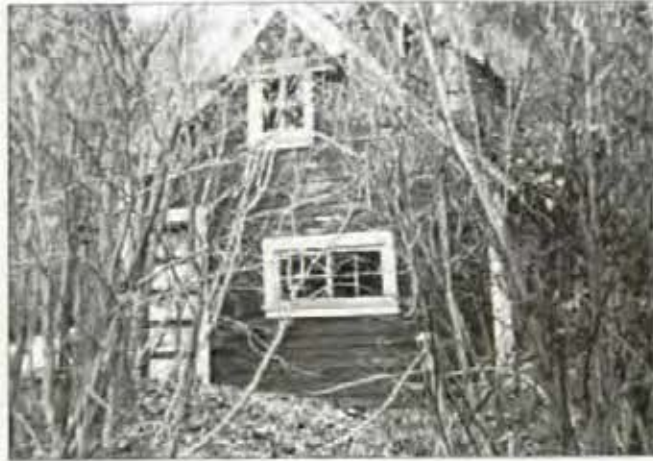
Figure 35. West façade of the assay office. (NPS photo file, WRST, 1998.)

Description: The assay office is a small, one-story, wood frame structure, located east of National Creek. Primarily a functional structure, there are few decorative features. Four-over-four, double-hung windows are located to provide light for interior work areas. A louvered ridge cupola provides ventilation to the attic.

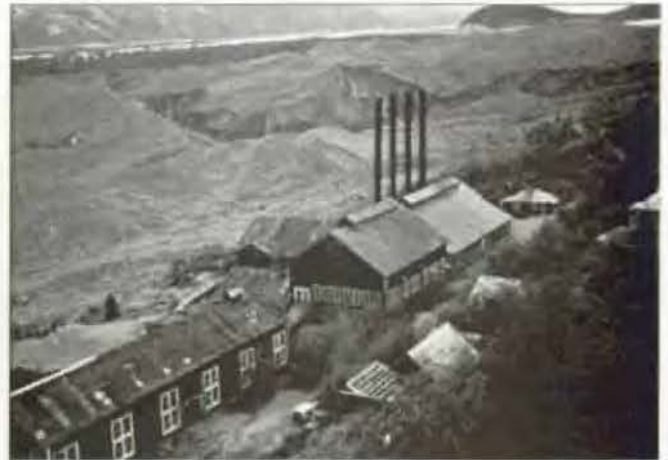
Figure 36. View northwest toward the power plant with four smokestacks. (NPS, photo file, WRST, 1998.)

Description: Characterized by four towering smoke stacks and constructed in three phases, the power plant is a three-story structure located north of the concentration mill on the west side of the railroad corridor. The south portion of the structure has a sheet metal gable roof and tall, nine-over-nine, double-hung windows. Paneled doors provide access to the south platform and front entrance of the structure. The north side of the building has an addition that includes a lower story with a central doorway and six-over-six, double-hung windows. A three-story west wing extends downhill from the rear of the south portion of the structure. One-story shed roofs flank this wing.

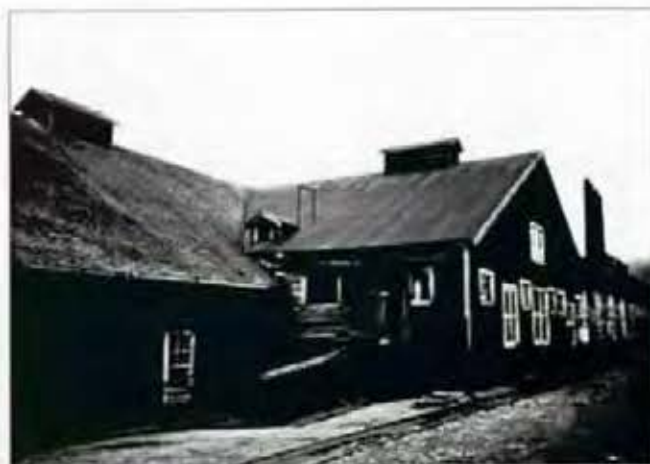
Figure 37. Leaching plant, east elevation. (NPS photo file, WRST, 1998.)

Description: The leaching plant is on the west side of the railroad bed, north of National Creek. A one-and-a-half story, wood frame structure with a basement opening to the rear (west) grade, the building is utilitarian in nature. Having little ornamentation, the plant is characterized by varying rooflines reflecting periods of growth and development in the mining operations in Kennecott. The original portion of the structure (now collapsed) contains the leaching tanks and is one story below grade, with a central gabled wing extending to the roadway. Six-over-six, double-hung windows are common on the first floor, and six light windows are on the second floor. A two-story addition on the north end of the structure has a central pavilion, with double doors opening toward a loading dock at the side elevation.

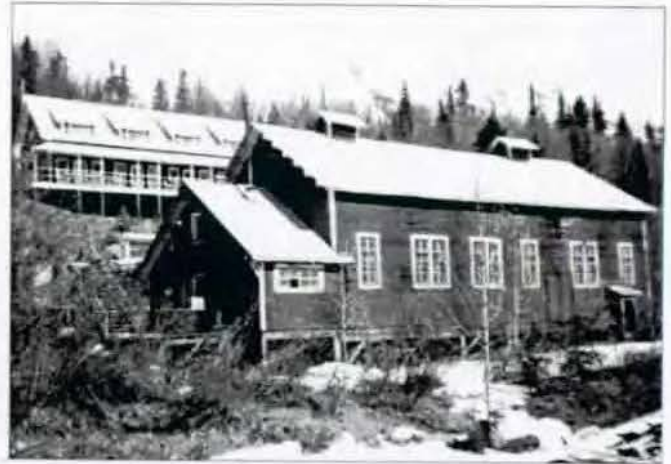
Figure 38. Recreation hall, west elevation. (NPS photo file, WRST, 1991.)

Description: The recreation hall is located on the west side of the railroad corridor south of National Creek. A two-story, balloon frame structure, the hall is rectangular in shape and set on 6x6 wood post foundations. Two louvered cupolas provide ventilation at the ridge of the gable roof. Windows are four-over-four, double-hung sash.

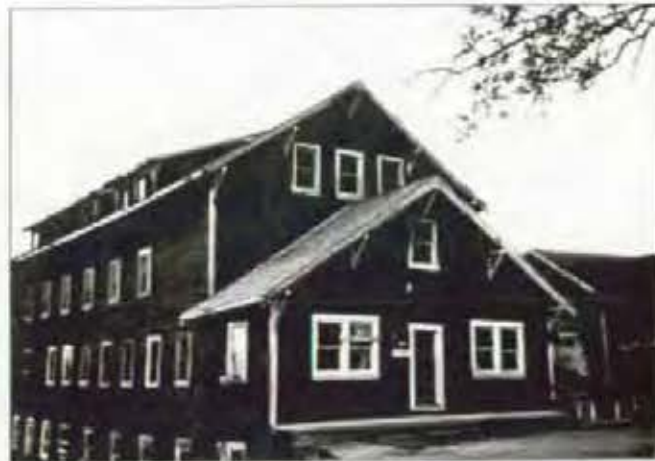
Figure 39. West bunkhouse. (NPS photo file, WRST, 1998.)

Description: The west bunkhouse is a rectangular, balloon-frame, four-story structure, oriented perpendicular to the west side of the main road, south of National Creek. The foundation is wood post on pier. There is a gable roof over the structure with three dormers on each side of the gable. Windows are double-hung single light sashes. The ground floor is approximately nine feet below the grade of the railroad line, with timber cribbing retaining the adjacent bank.

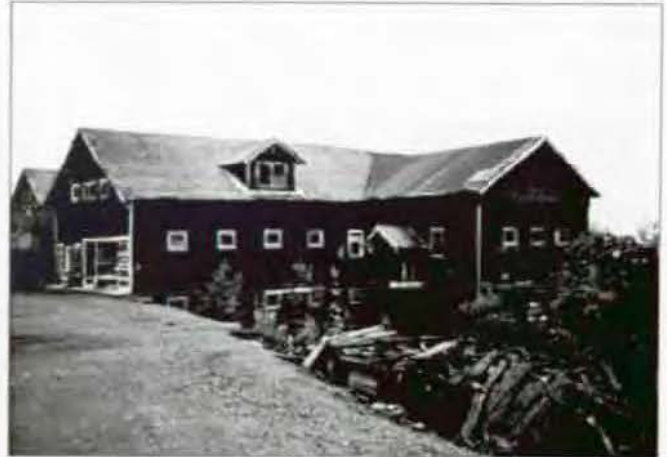
Figure 40. View southward to the store and warehouse. (NPS photo file, 1998.)

Description: One-and-a-half story, T-shaped, wood commercial building with gabled store facade and recessed entrance with bracketed verge overhangs, exposed eave rafter ends, and double-hung and fixed sash. Catwalks extend to the warehouse entrances on each side wing of the rear warehouse structure. Gable roof porches are at each entry above a full-height basement containing additional storage rooms. A receiving area, complete with a conveyor, is located on the west half of the structure.

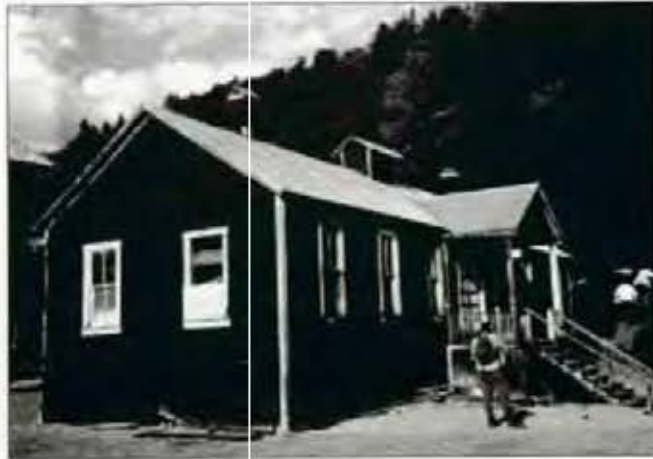
Figure 41. View eastward toward the schoolhouse. (NPS photo file, 1998.)

Description: The schoolhouse is a rectangular, wood frame, gable roofed structure, located on the west side of the main road into the mill town. Four-over-four and two-over-two, double-hung windows are on the north and south facades. A central louvered cupola is located on the ridge of the gable, which is flanked by two small chimneys. Grounds surrounding the structure were used for sporting activities and recreation.

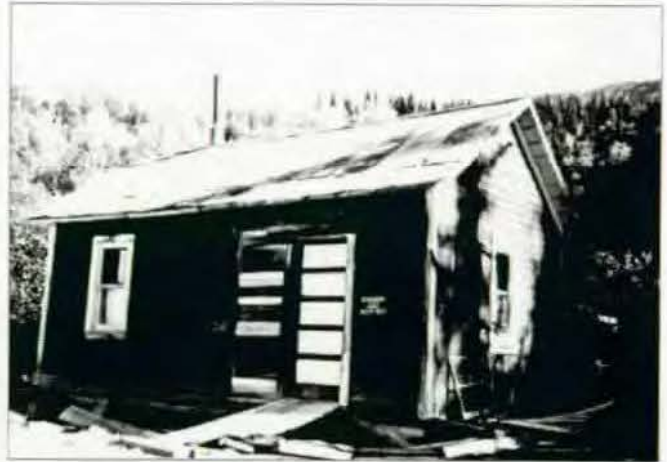
Figure 42. The station house, or depot, was constructed between 1910-1912. (NPS photo file, WRST, 1998.)

Description: Sited next to the rail bed, the station house is a small, one-story wood frame structure on post and sill foundation. The entrance vestibule has a shed roof and the windows are four-over-four, double-hung. A wood decking wraps around the north, west, and south sides of the building.

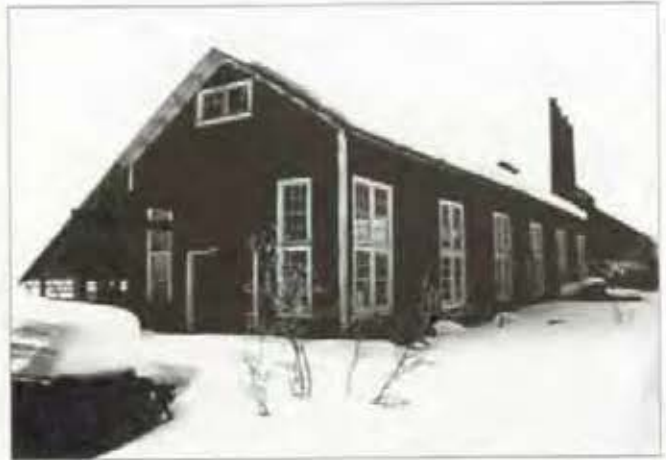
*Figure 43. View northwest to the machine shop, constructed in 1916
(NPS photo file, WRST, 1998.)*

Description: The machine shop is located on the west side of the main road, north of the leaching plant and south of the power plant. Rectangular in plan, the wood frame structure has six front bays of six-over-six, double-hung sash. The front elevation faces east and is parallel to the main road. The roof is gabled in three sections: aluminum to the south, and center and tarpaper on the north section. Large double doors are set in the south, east, and north sides of the structure. An overhead hoist enters the building above a door on the south end of the structure. The grade falls away to the west, with storage for machinery, tools, fittings, and gears stored under the building.

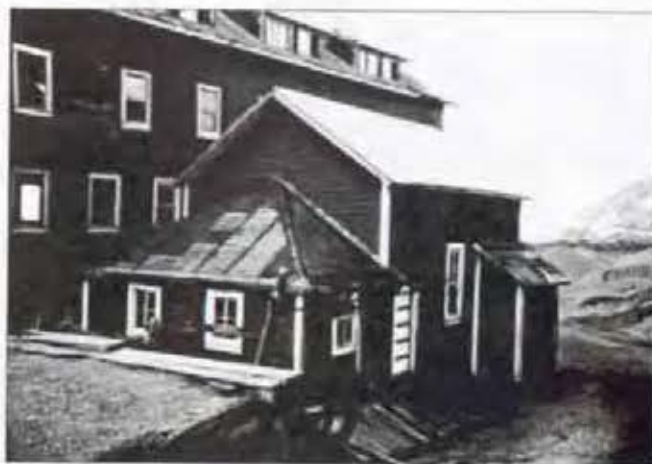
Figure 44. View westward to the refrigerator plant or meat cooler. (NPS photo file, WRST, 1998)

Description: The refrigerator plant is sited between the bunkhouse and the store and warehouse on the west side of the main road. Timber cribbing retains the railroad right of way, which is approximately seven feet above the level grade of the structure. Rectangular in shape, this structure is built around a large walk-in refrigerator. An exterior meat hoist extends around the front, above a platform and into the building above the main entry. Four-over-four, double-hung windows provide light into the refrigerator compartment.

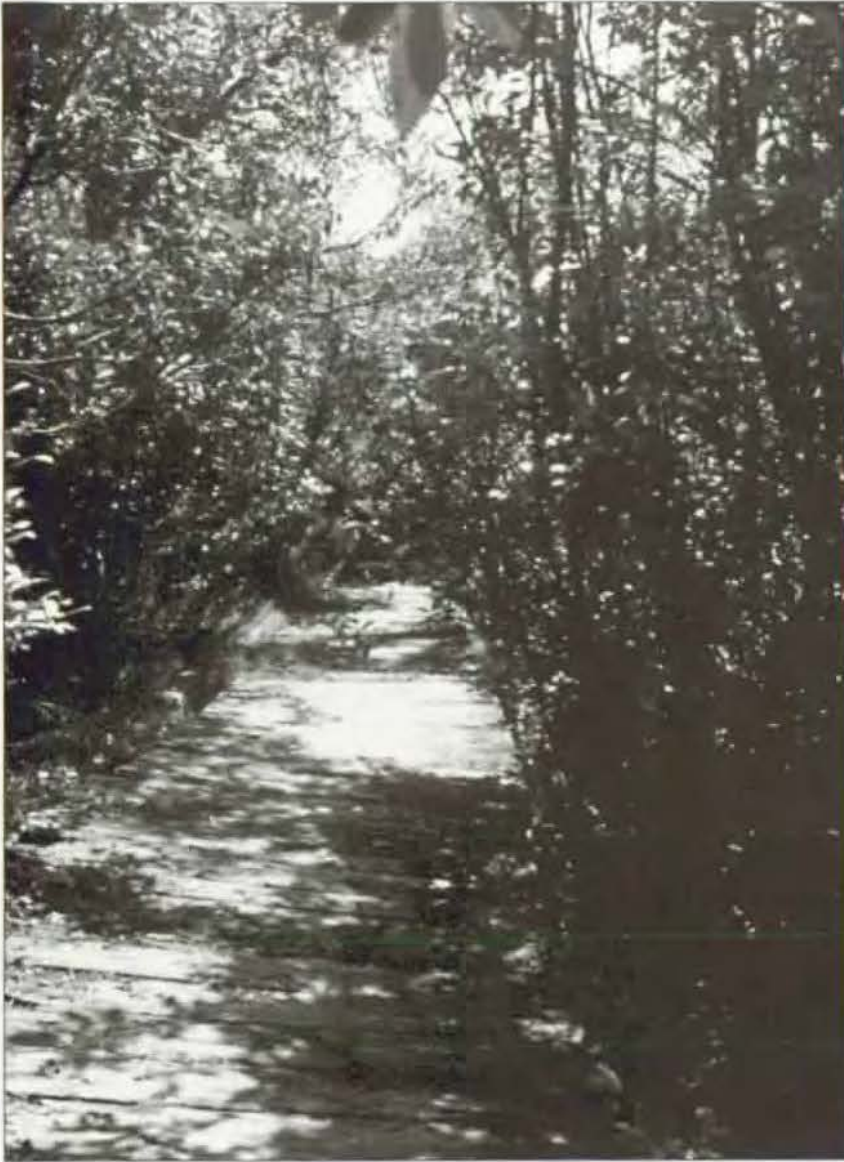
Figure 48. Boardwalk in front of staff cottage north of power plant and east of rail grade. (NPS photo file, WRST.)

The five cottages in the east row are set back from the rail grade and are currently obscured by vegetation (post-1938). Vegetation also obscures an access road to the rear of the cottages and evidence of Kennecott-era vegetable gardens. An extant boardwalk west of the cottages continues to define pedestrian circulation. A utilidor—conveying water, steam, and sewer pipes to the cottages—runs west of the boardwalk (figure 48). Firehouses are located south of structures 13a and 13d.

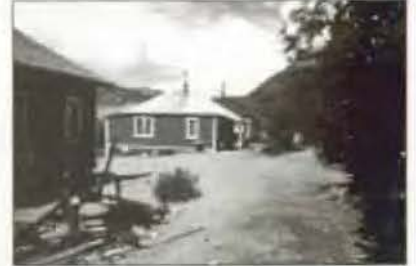
Figure 49. Restored staff cottage (13f) north of the power plant. (NPS photo file, WRST.)

The west row of four cottages fronts the rail grade (figure 49). Constructed on a hillside, these cottages include lined basements. Historically, catwalks extended from the rail grade level to privies west of the cottages. Two privies from this system are currently extant. The rail grade separating the rows of cottages continued north as a wagon road to the Erie Mine, with a spur leading around the eastern extent of the mill town. Both roads are extant, although the route to Erie Mine eventually narrows to a walking trail.

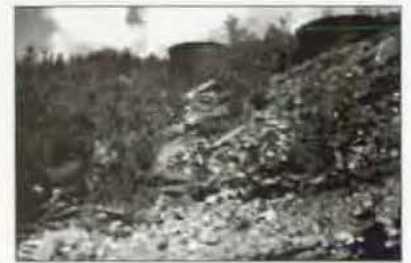
Figure 50. Dump west of power house and staff cottages. Oil tanks 4b and 4c at terrace scarp. First power plant remains at left middle distance. (MTU field documentation, 1997.)

An extensive discard area (a) lies down the terrace scarp, southwest of the cottages (figure 50). This scatter extends south to the power plant. Materials asso-

ciated with the first power plant (destroyed in 1924) are found at the bottom of the scarp, including firebricks from the furnaces and furnace stacks from the flues. Modern domestic artifacts are intermixed with industrial detritus in the vicinity of the oil storage tank (4c).

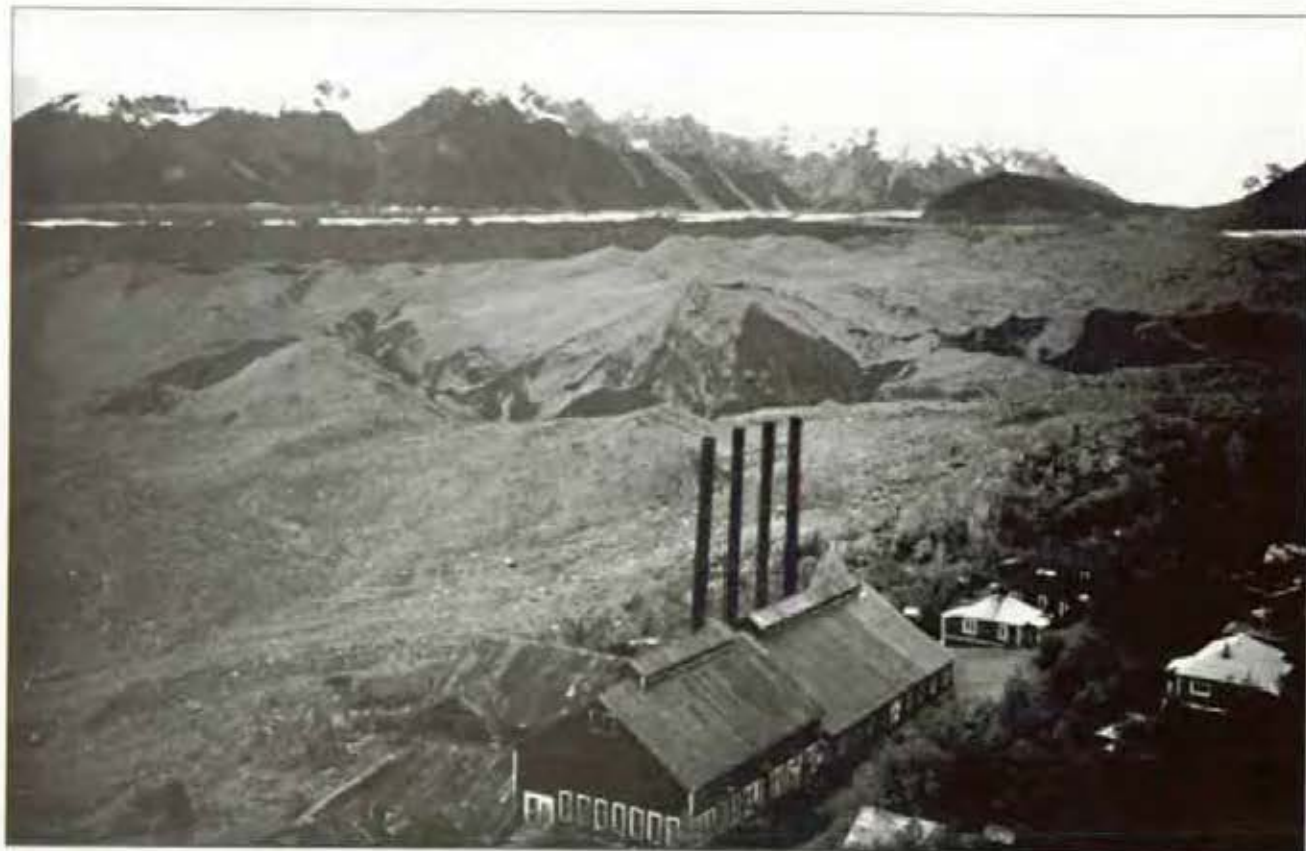
Figure 52. View north from tram terminus over section 2. Power plant (9) on left, and staff cottages in middle distance. (NPS photo file, WRST.)

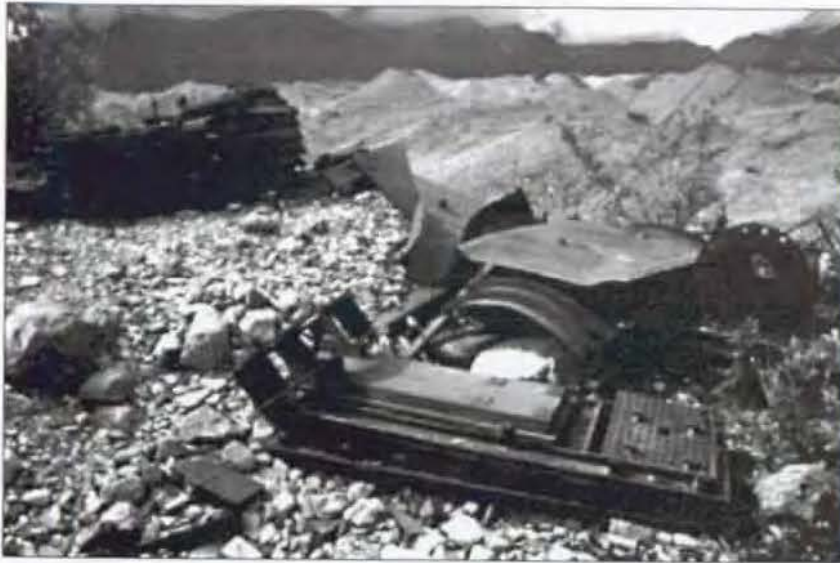
Figure 54. Power plant fixtures, including furnace latches and braces (background), stacked during asbestos removal in 1995. View looking south. (MTU field documentation, 1997.)

Immediately south of the oil house are stacks of furnace latches, braces, metal plate, and ceramic blocks (a, b, d). These artifacts derive from the powerhouse, perhaps salvaged by the company after the 1924 power plant fire (figure 54). The remnants of a boardwalk lie between the power plant and oil house. A second boardwalk, farther south connected the power plant with the machine shop dump (figure 55). Extensive dumps (k, l) west of the terrace scarp contain predominantly industrial and construction-related materials (barrels, concrete, and firebricks), although domestic artifacts are also present.

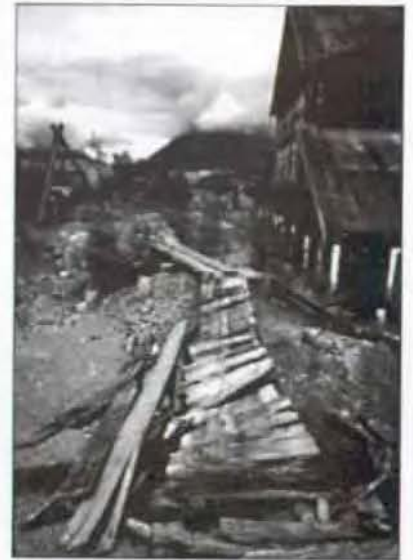
Figure 55. View north at boardwalk connecting between power plant (right) to machine shop dump. Trig post (middle left) marked the upper terminus of a stub tram bringing sand up from the glacial moraine. (MTU field documentation, 1997.)

Kennecott did not use the slope between the terrace and glacial moraine solely for waste disposal. A small wood crib (g) probably housed the hoist for a stub tram that brought sand from the glacial moraine to the power plant. (The sand likely found use for construction and blacksmithing activities at the concentrator and mines). This structure has moved approximately 80 feet down the slope from its original location. A wooden trig post (f) at the top of the terrace functioned as the upper terminus for the tram.
