CULTURAL LANDSCAPE REPORT

KENNECOTT MILL TOWN

WRANGELL-ST. ELIAS
NATIONAL PARK AND PRESERVE
ALASKA

2001

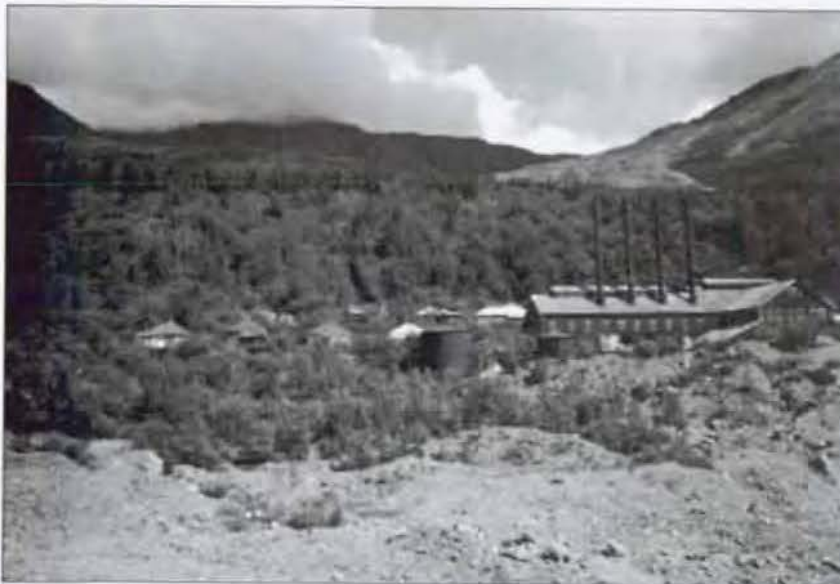
Figure 56. West side of the power plant (9), looking toward the oil tanks and platforms. (NPS photo file, WRST.)

An oil intake platform (i) and two other decks are the only features east of the power plant (figure 56). The oil intake platform suffered heavy damage during 1995 asbestos removal procedures. The two decks likely served as temporary storage for machinery loaded off the railroad.

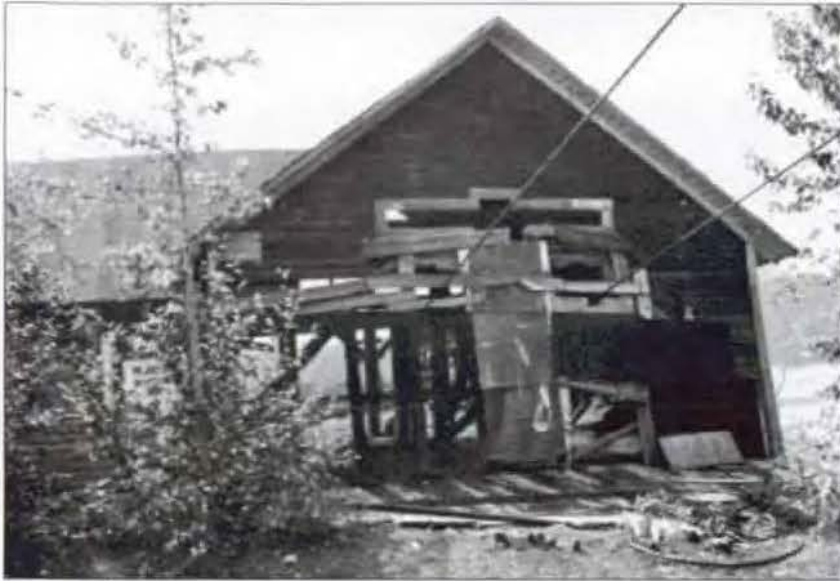
Figure 62. Tram terminus (2) for the Jumbo Mine aerial tramway. (NPS photo file, WRST.)

Description: The concentrator tram terminus (2) extends west from the top of a hill scarp above the rail grade. Decks around the concentrator, as well as their contents, are for the most part well preserved (see c and d, and figure 62). Together with the track incline system connecting the tram terminus with the crushing unit of the concentration mill and machine shop, these features illustrate the system by which concentrator machinery was installed, repaired, and temporarily stored.

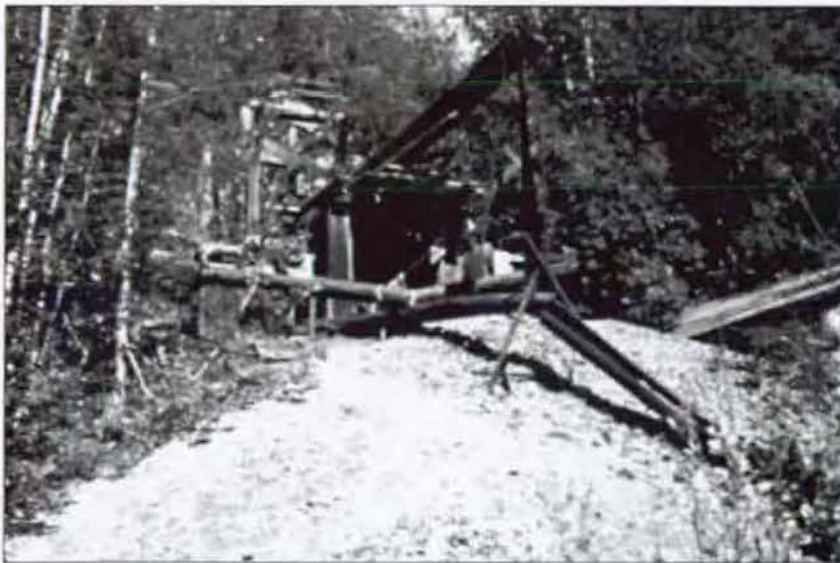
Figure 63. Wrangell Consolidated operations (64). View northeast from tailings toward shaking and crushing machinery. A shed (63) once behind the manager's house, circa 1910, is at middle right. (MTU field documentation, 1997.)

During the 1960s, Consolidated Wrangell operated a concentration mill southeast of the tram terminus (figure 63). Remains of Wrangell workings include an ore chute, storage basin, conveyor, crushing machinery, and a storage shed (63, 64). Tailings from Wrangell operations were directed west of the crushing machinery. This eventually covered areas formerly occupied by the manager's residence and staff office building (removed 5–10 years prior), two sites having potential archeological value.

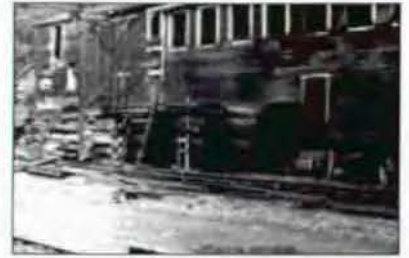
Figure 66. West wall of concentration mill (3) showing three generations of foundation cribbing. (MTU field documentation, 1997.)

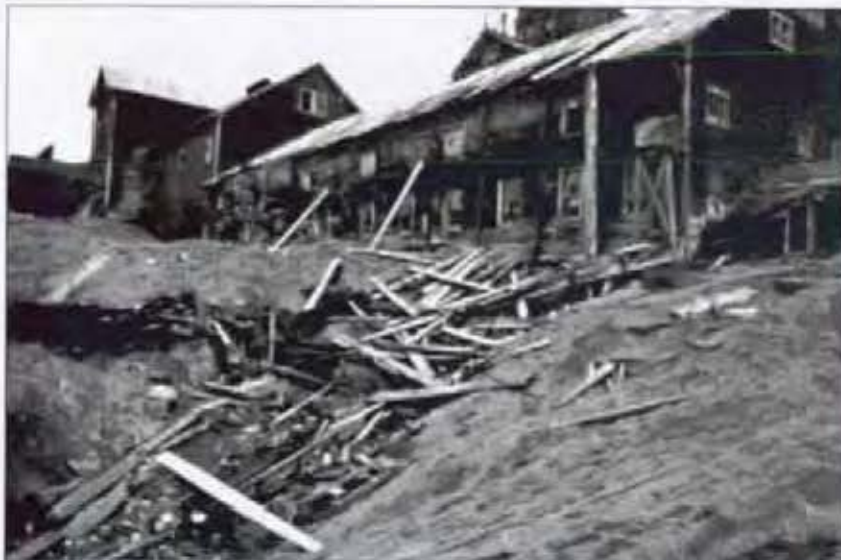
Figure 70. Ammonia leaching plant (15), looking northeast. Flumes and pipes for waste removal in foreground. (MTU field documentation, 1997.)

Flumes and pipes south and west of the leaching plant directed both tailings and wastewater toward National Creek. A cluster of flumes (l) extended from the southwest corner of the leaching plant (figure 70). The southern part of the leaching plant sustained significant damage during the flooding of National

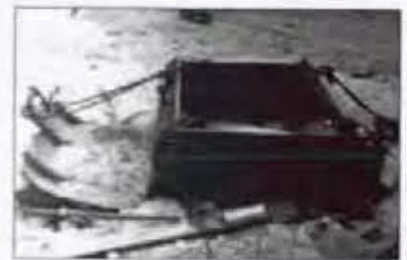
Figure 69. Scraper used in landscaping tailings, located west of leaching plant (15). (MTU field documentation, 1997.)

Tailings around the plant primarily derive from the concentration mill and were likely deposited prior to construction of the flotation plant. A tailings launder, at least in place by 1917, directed mill tailings (including fines that the leaching process could not treat) toward the glacial moraine. Finely stratified tailings are exposed beneath a conveyor shed at the southern end of the plant. The conveyor shed distributed leaching plant tailings across National Creek and aided the creation of construction space in the southern mill town (see Section 11). A hoist house (21), crib (f), and scraper (g) on the west side of the leaching plant indicate additional methods used by Kennecott to disperse leached tailings (figure 69).

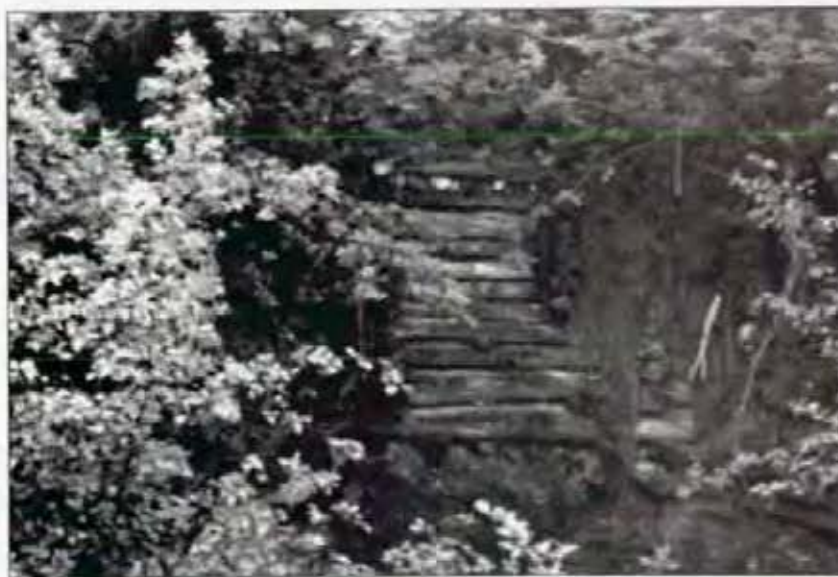
Figure 75. Detail of west face of National Creek Dam (33), built circa 1911. (NPS photo file, WRST.)

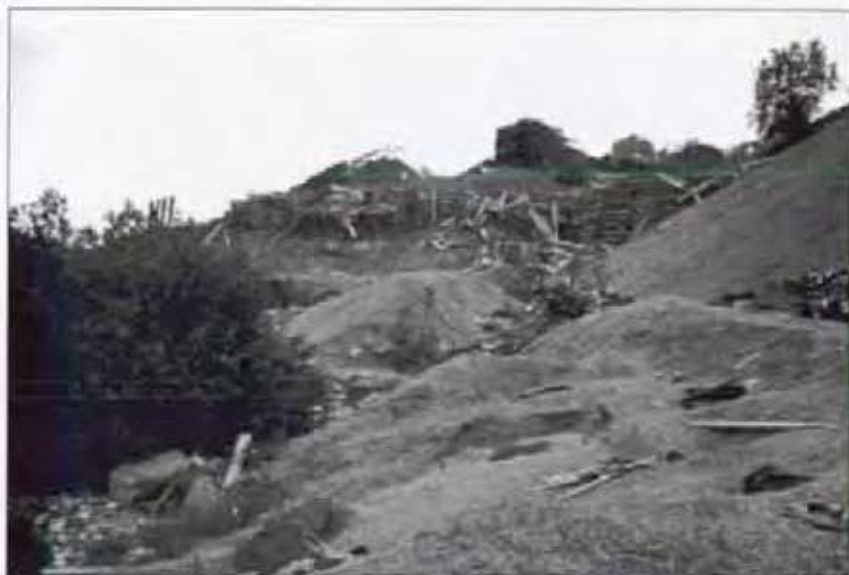
Figure 80. Tailings cribbing (45) looking northeast. (NPS photo file, WRST.)

Flooding of National Creek in 1980 and 1983 damaged the north section of the crib and carried off a substantial portion of the stored tailings (figure 80). Floods additionally undermined and removed numerous waste water pipes. Pipe and flume sections are found west of the rail bridge (a), on the west face of the crib dam, and approximately 50 feet northeast of the dam. The orientation of several pipe sections undoubtedly differs from original positions.

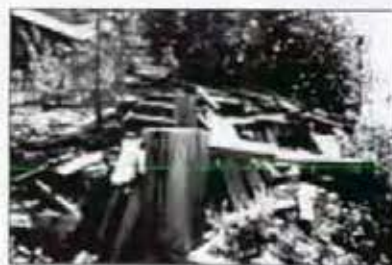
Figure 81. Looking southeast toward laundry remains, including corner post (center) and rock wall (left). Warehouse (19) appears in upper left. (MTU field documentation, 1997.)

A terrace southeast of the tailings dam extended along the southern extent of the mill town and provided space for the construction of mill facilities (see Sections 10–13). Remains of a company laundry (built by 1925) occupy the northwest corner of the terrace (figure 81). This one-story, wood frame structure has entirely collapsed (apparently destroyed as a potential hazard in the late 1970s),

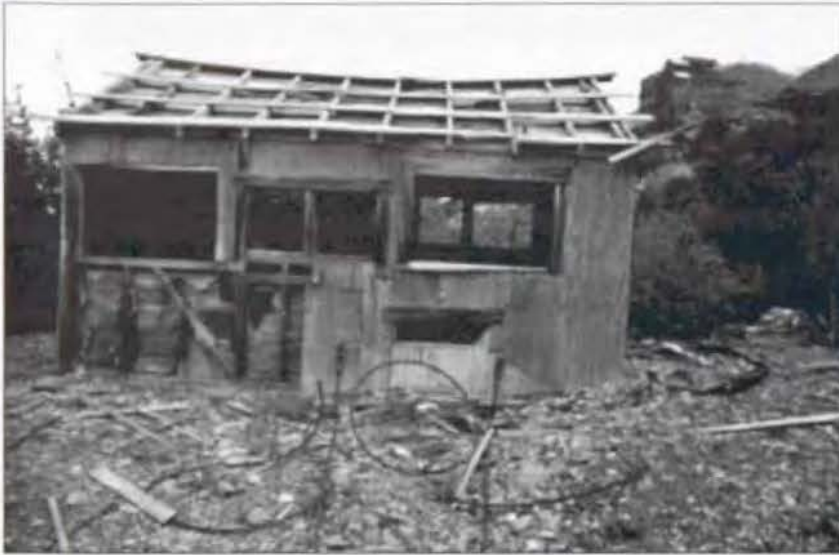
Figure 83. Detail of hoist house (44), looking north. Concentration mill in background. (MTU field documentation, 1997.)

Description: The mill town contained two structures important to its operation: the warehouse and the carpentry building. The warehouse (19) not only stored machinery and parts, but also included a general store and post office. North of the warehouse, the carpentry building supplied sawn lumber and furnishings for the mill town and mines. Constructed on a terrace 6–8 feet below the level of the rail grade, the buildings were accessed by boardwalks and steps. A wood crib supporting the west wall of the rail grade continues south for the entire extent of the mill town. A utilidor from the power plant follows the line of a crib wall. To maintain a level surface, the south part of the terrace was built up with tailings. A hoist house (44) is located northwest of the warehouse (figure 83).

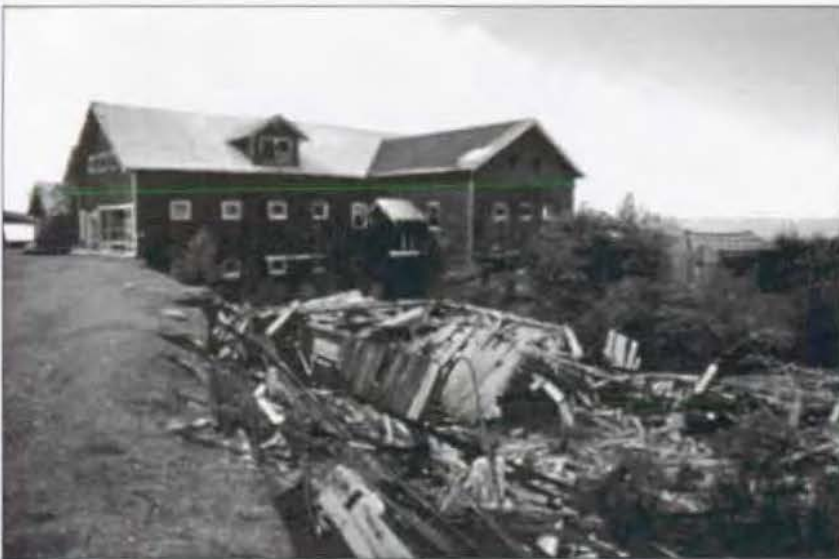
Figure 84. View south toward store and warehouse (19). Remains of carpentry shop (6) in foreground. Hoist house (44) appears at right background. (MTU field documentation, 1997.)

The carpentry building north of the warehouse has almost entirely collapsed (figure 84). Of the few wall sections remaining, all lack stability. Some standing walls may belong to the paint shop (51) or to a later extension of the carpentry. Artifacts in the wood scatter include a workbench (a), an edging machine (c), and flywheels (e and f), and clearly relate to work activities in the shop.

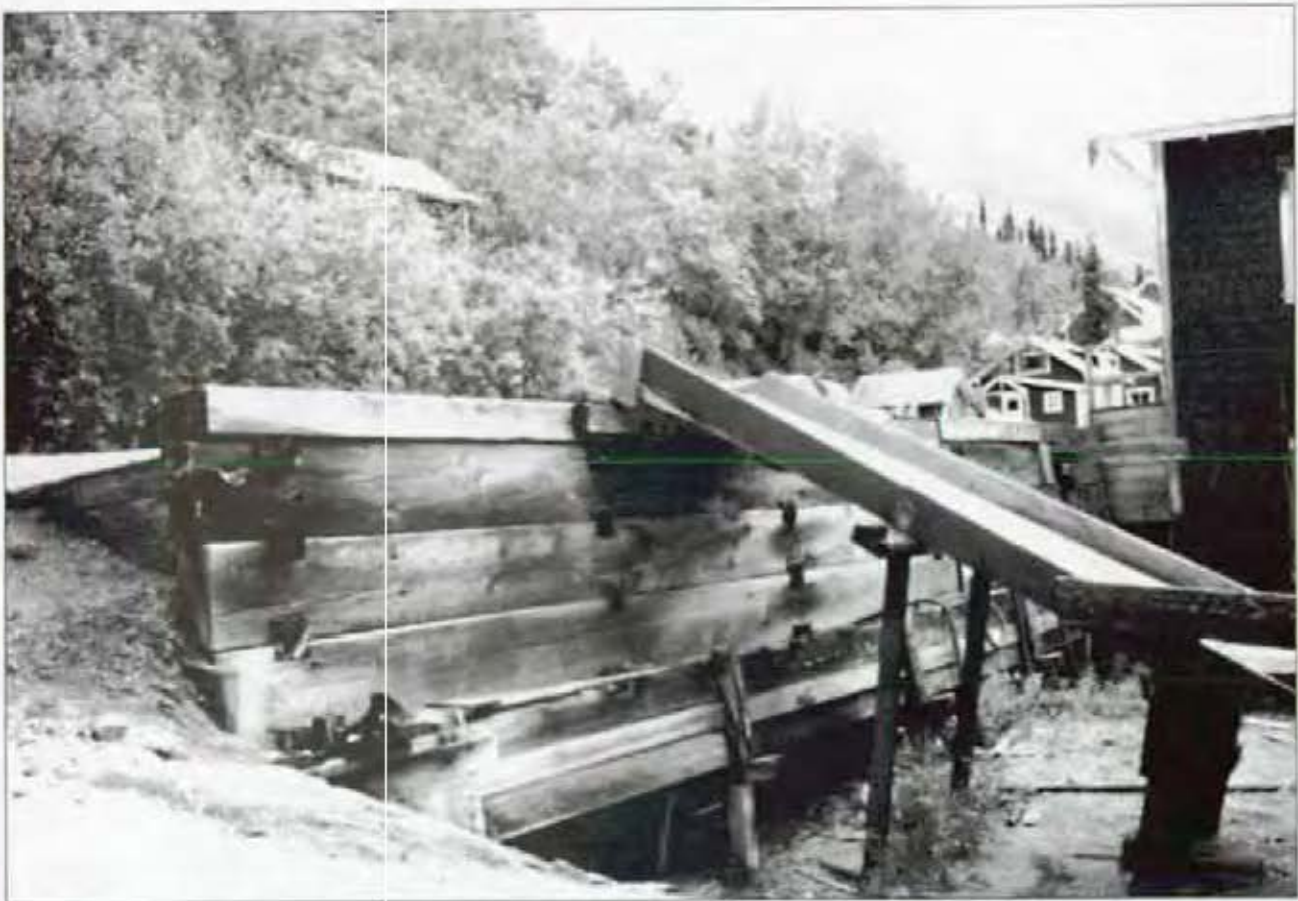
Figure 86. Retaining wall and covered utilidor east of the refrigeration plant (48). View looking southeast. (NPS photo file, WRST.)

The surrounding area is largely devoid of artifacts and small-scale features. Utilidors, conveying water, steam, and sewage lines parallel the retaining wall and connect between the bunkhouse and schoolhouse. A smaller utilidor, probably conveying water and steam lines, connects the bunkhouse and refrigeration plant (figure 86). A wooden platform and chute on the north side of the refrigeration plant aided the delivery of meat carcasses to the building from the rail grade (figure 87).

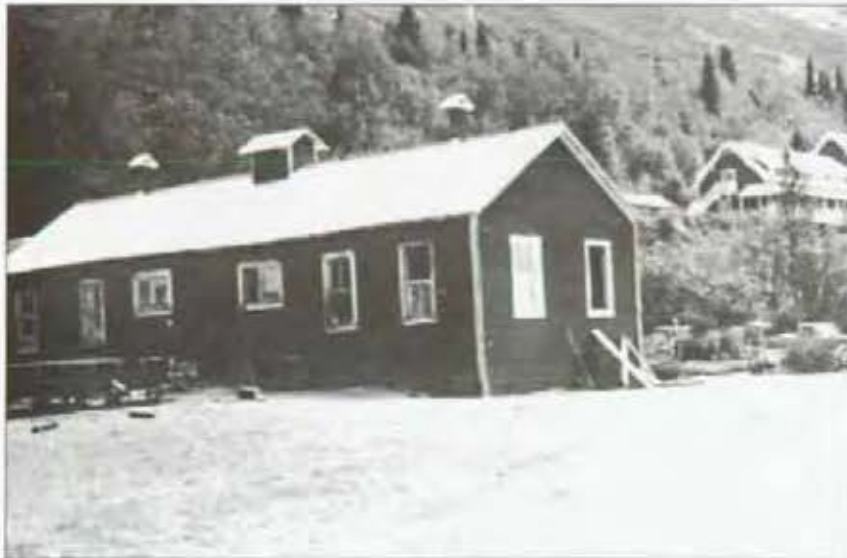
Figure 88. Looking southeast toward the schoolhouse (23). Conveyor and remains of handball court can be seen in center left. (NPS photo file, WRST.)

A small area of wood planking and joists (c) between the bunkhouse and schoolhouse constitute the remnants of the handball court (figure 88). A scatter of stove parts (a) immediately outside the bunkhouse was likely deposited after Kennecott operations. The location of an ore conveyor (b) west of the handball

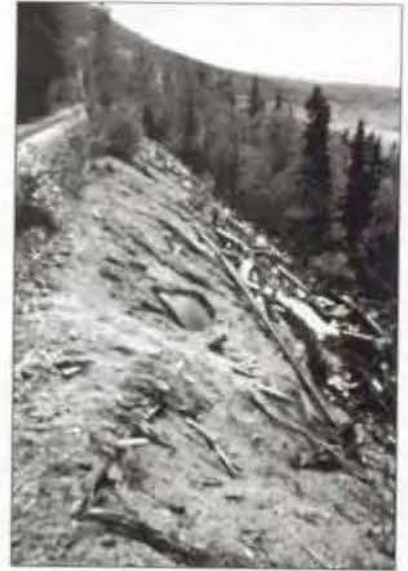
Figure 93. Industrial dump located at south entrance to the mill town. View southeast with rail grade at left. (MTU field documentation, 1997.)

A dispersed dump, containing both modern and Kennecott-era materials, extends north of the dairy barn. A second and more concentrated refuse dump west of the rail grade at the southern extent of the mill town primarily contains industrial artifacts (such as link belts, screens, and machinery). This area is less disturbed by modern refuse and retains high archeological significance (figure 93). Isolated artifacts located in the scrub between the cottage (26) and the former wagon road includes a concrete mixer, washer, and water heater. These were, in all likelihood, used during Kennecott's operation.

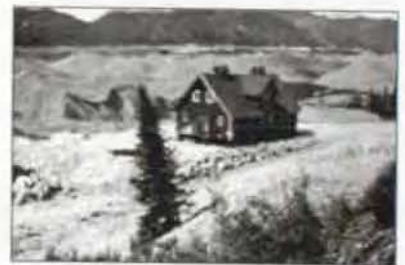
Figure 94. Looking northwest toward the dairy barn (28). Landscaping around the barn is a recent disturbance. (MTU field documentation, 1997.)

Numerous modifications occurred in this area after the closure of Kennecott. A modern road between the northern cottage and recent commercial facility provides vehicle access from the rail grade to the former McCarthy wagon road. Recent landscaping around the dairy barn has destroyed its surrounding context (figure 94). Decking extending east from the dairy barn to the rail grade is no longer present.

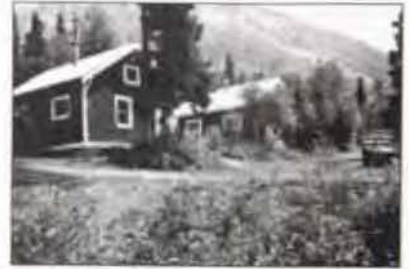
Figure 96. South cluster of cottages built in 1916 on Silk Stocking Loop road. (NPS photo file, WRST.)

The southern cluster, built in 1916, includes a row of three, freestanding wood frame cottages (30 a–c, figure 96). The cottages sit to the east of Silk Stocking Loop. Two collapsed chicken coops (31 a–b) are located west of the cottages on the other side of the dirt road. A utilidor carried water and steam lines to a firehouse between the chicken coops. Utility lines were not conveyed into the cottages and privies were built to the rear.

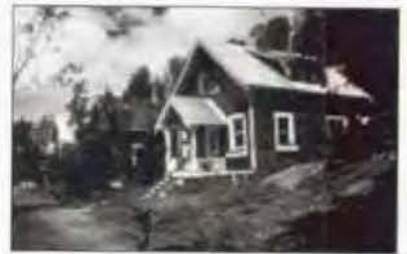
Figure 97. North cluster of cottages (32 b–d) built in 1918 on Silk Stocking Loop road. (NPS photo file, WRST.)

In 1918, the company constructed a second cluster of four cottages (32 a–d) 300 feet north of the first group (figure 97). Although of similar design and orderliness to the southern cluster, the northern cottages were fitted with water, steam, and sewage lines. Remnants of the utilidor between the west bunkhouse (20) and cottage 32d are found down the hillside. It is likely that the firehouse, water, and steam lines conveyed to the southern cluster of cottages occurred during the construction of the 1918 cottages. Pipes between the building clusters follow the west side of Silk Stocking Loop. A collapsed garage (72)

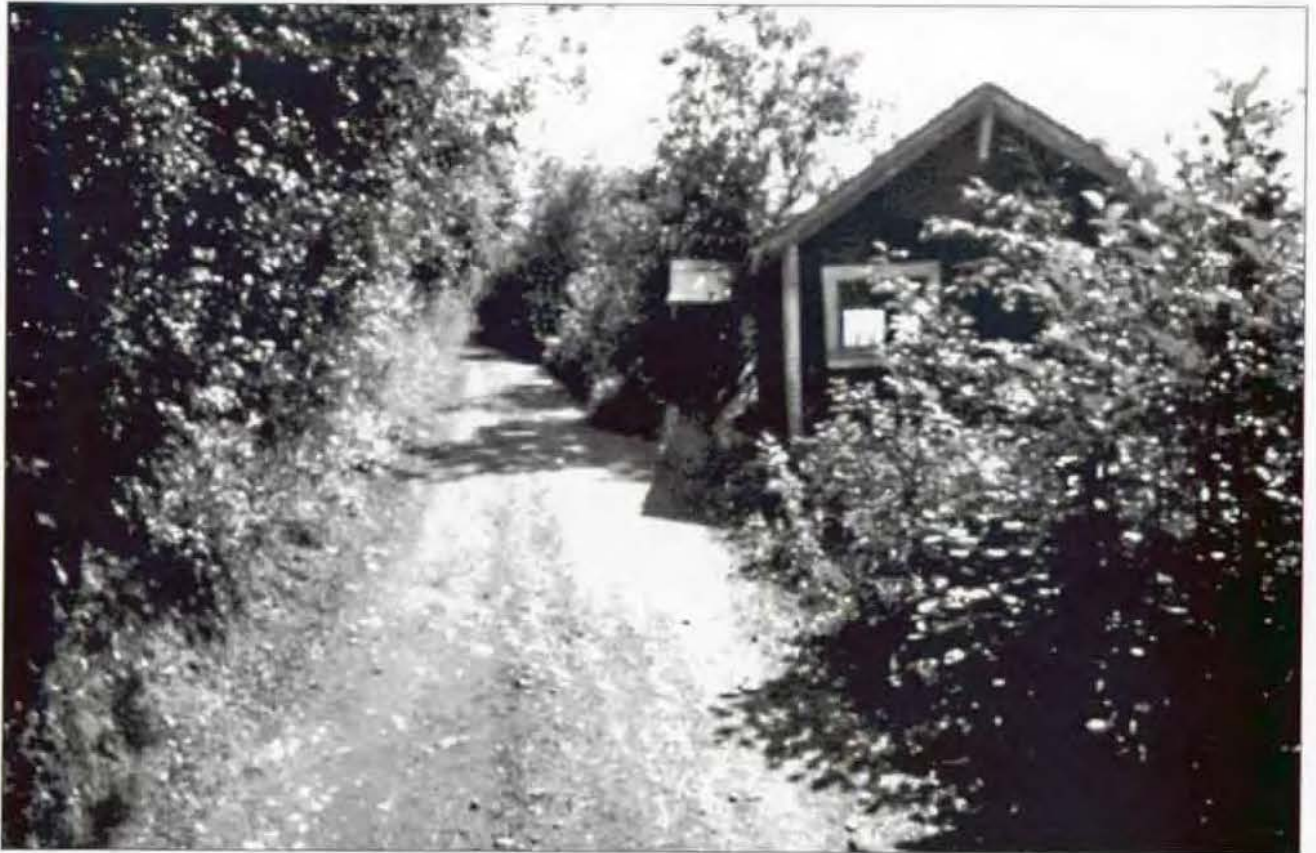
Figure 99. Bathhouse (47) seen from Silk Stocking Loop road, looking southeast. (MTU field documentation, 1997.)

Description: This section of the mill town predominantly served storage and transportation functions. Structures positioned close to the rail grade included a tool shed (46), oil storage building, and open-air lumber storage. Although the tool shed remains intact, a small wood scatter and leveled ground testify to the presence of the one-story oil warehouse to the south. Artifacts in the vicinity, including pipe bends, relate to the tool shed. Extant decking south of the oil storage building contains gears, sections of pipe, and corrugated iron. The latter likely derived from the roof of the oil storage building or an abutting shed. An extant bathhouse, southwest and up the hillside from the deck, probably served families living in the south mill town not connected to a water supply (figure 99).

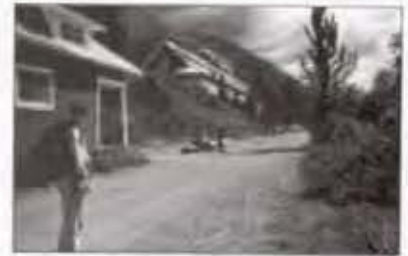
Figure 101. Looking south along rail grade in south mill town area. The cottage (29 c) in foreground was moved during renovations of the Kennicott Glacier Lodge (17) seen in the background. (NPS photo file, WRST.)
