CHAPTER NINE

Miscellaneous Features and Structures

William A. Griswold

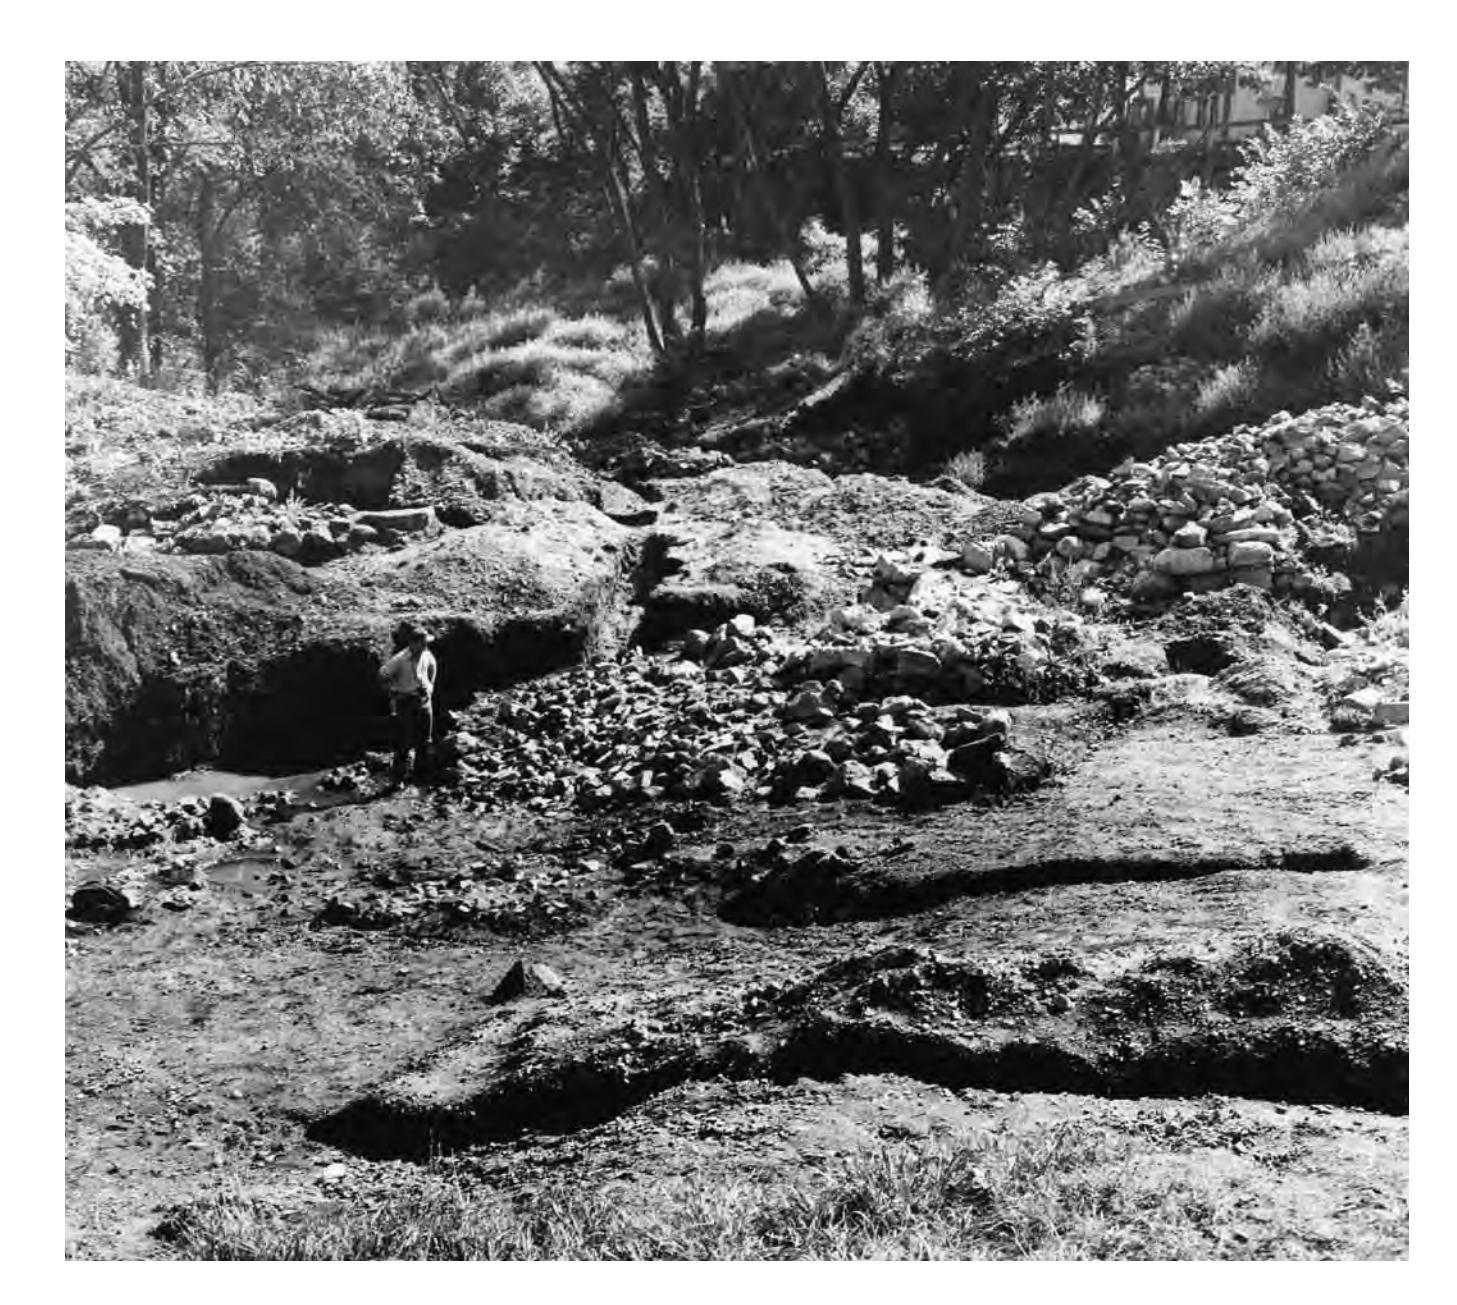
9.1 South view illustrating work to the south of the blast furnace, September 2, 1949. (Photograph 103 by Richard Merrill, 1949.)

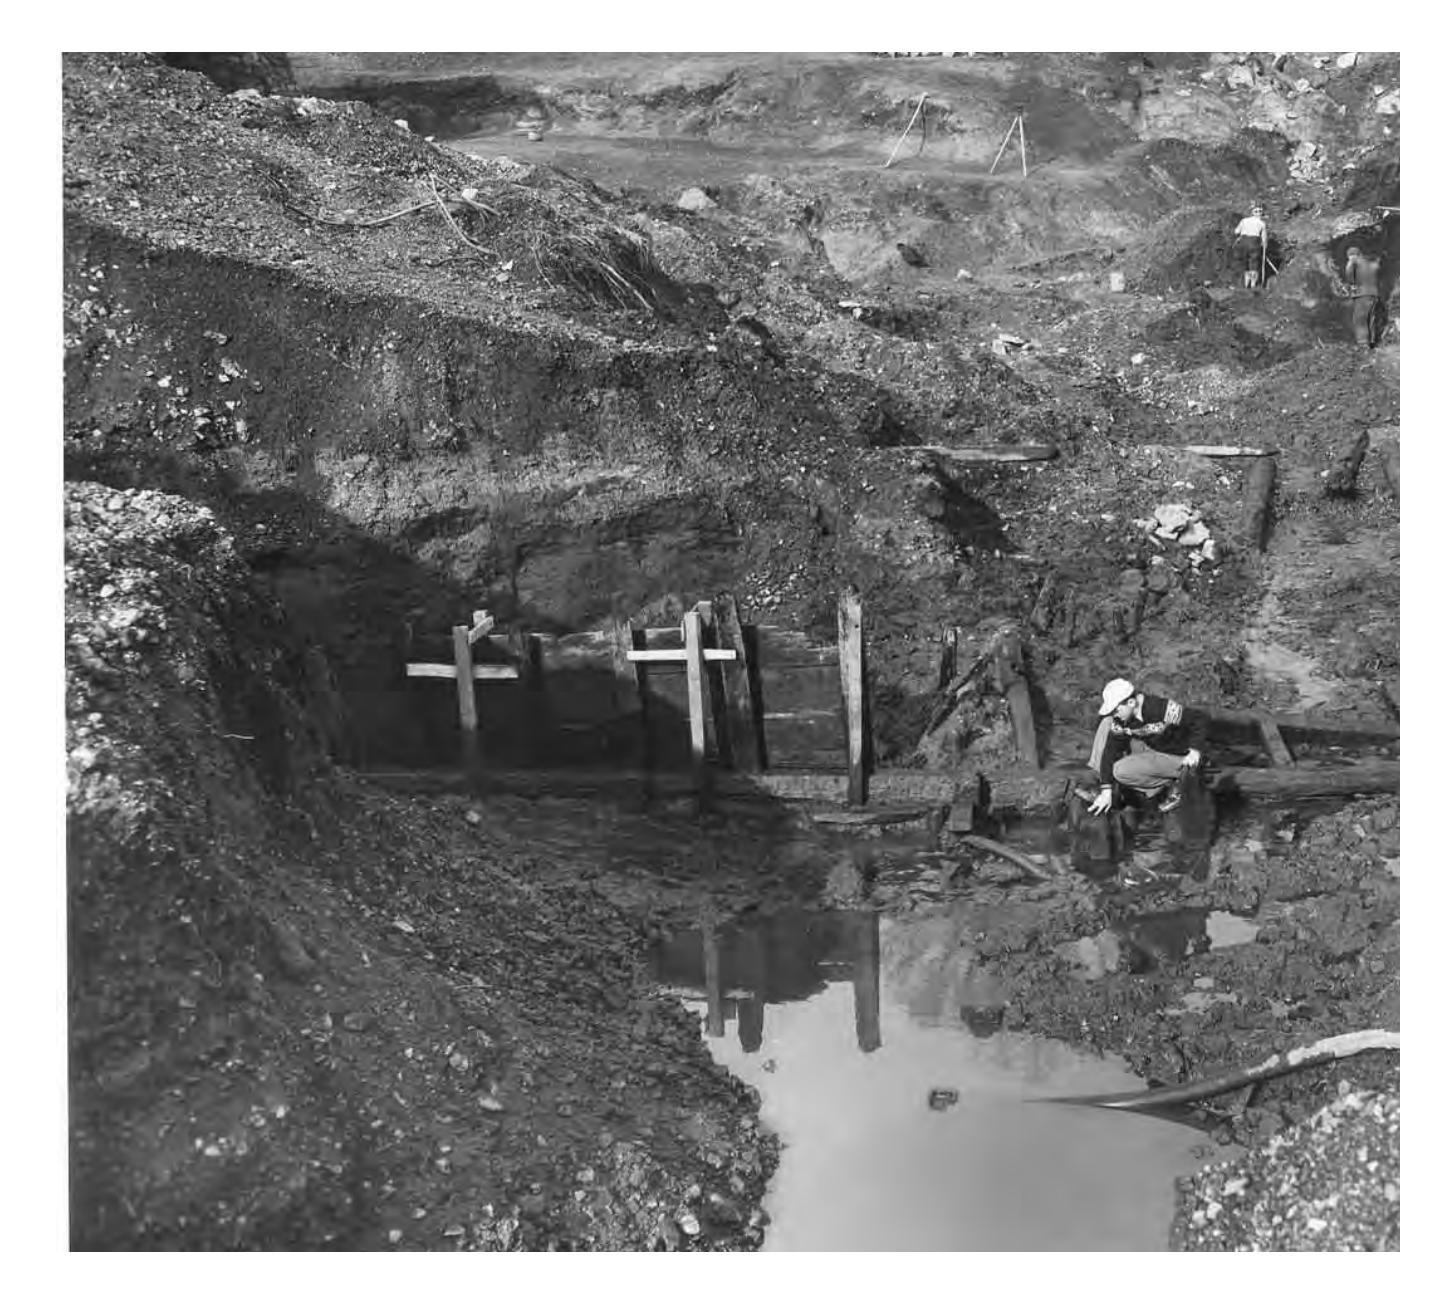
9.3 Robbins at the wharf. Notice the sheathing and deadmen still intact. (Photograph 531 by Richard Merrill, 1951.) the nature of these stones when found because of the black stain upon them. During the past several months, their exposure to the weather elements removed the black stain, revealing their identity.¹³

Behind the uprights were oak planks stacked on top of each other to form a sheathing for the wharf to contain the fill. Robbins describes some of these uprights as being preserved to a height of approximately seven feet above the base sill.⁸ Steve Whittlesey, Robbins' assistant who succeeded him after his resignation, notes on a September 10, 1953, sketch that at least a couple of the tenons from the uprights that had been sheared off in the base sill mortises still had one and a quarter inch dowels securing the tenons to the base sill.⁹ While remnants of a top sill capping the uprights were not found by Robbins, they would have been part of the original wharf construction. Robbins believed that the uprights and sheathing maintained a height of approximately seven feet until they reached the western side of the forge's western tailrace.¹⁰

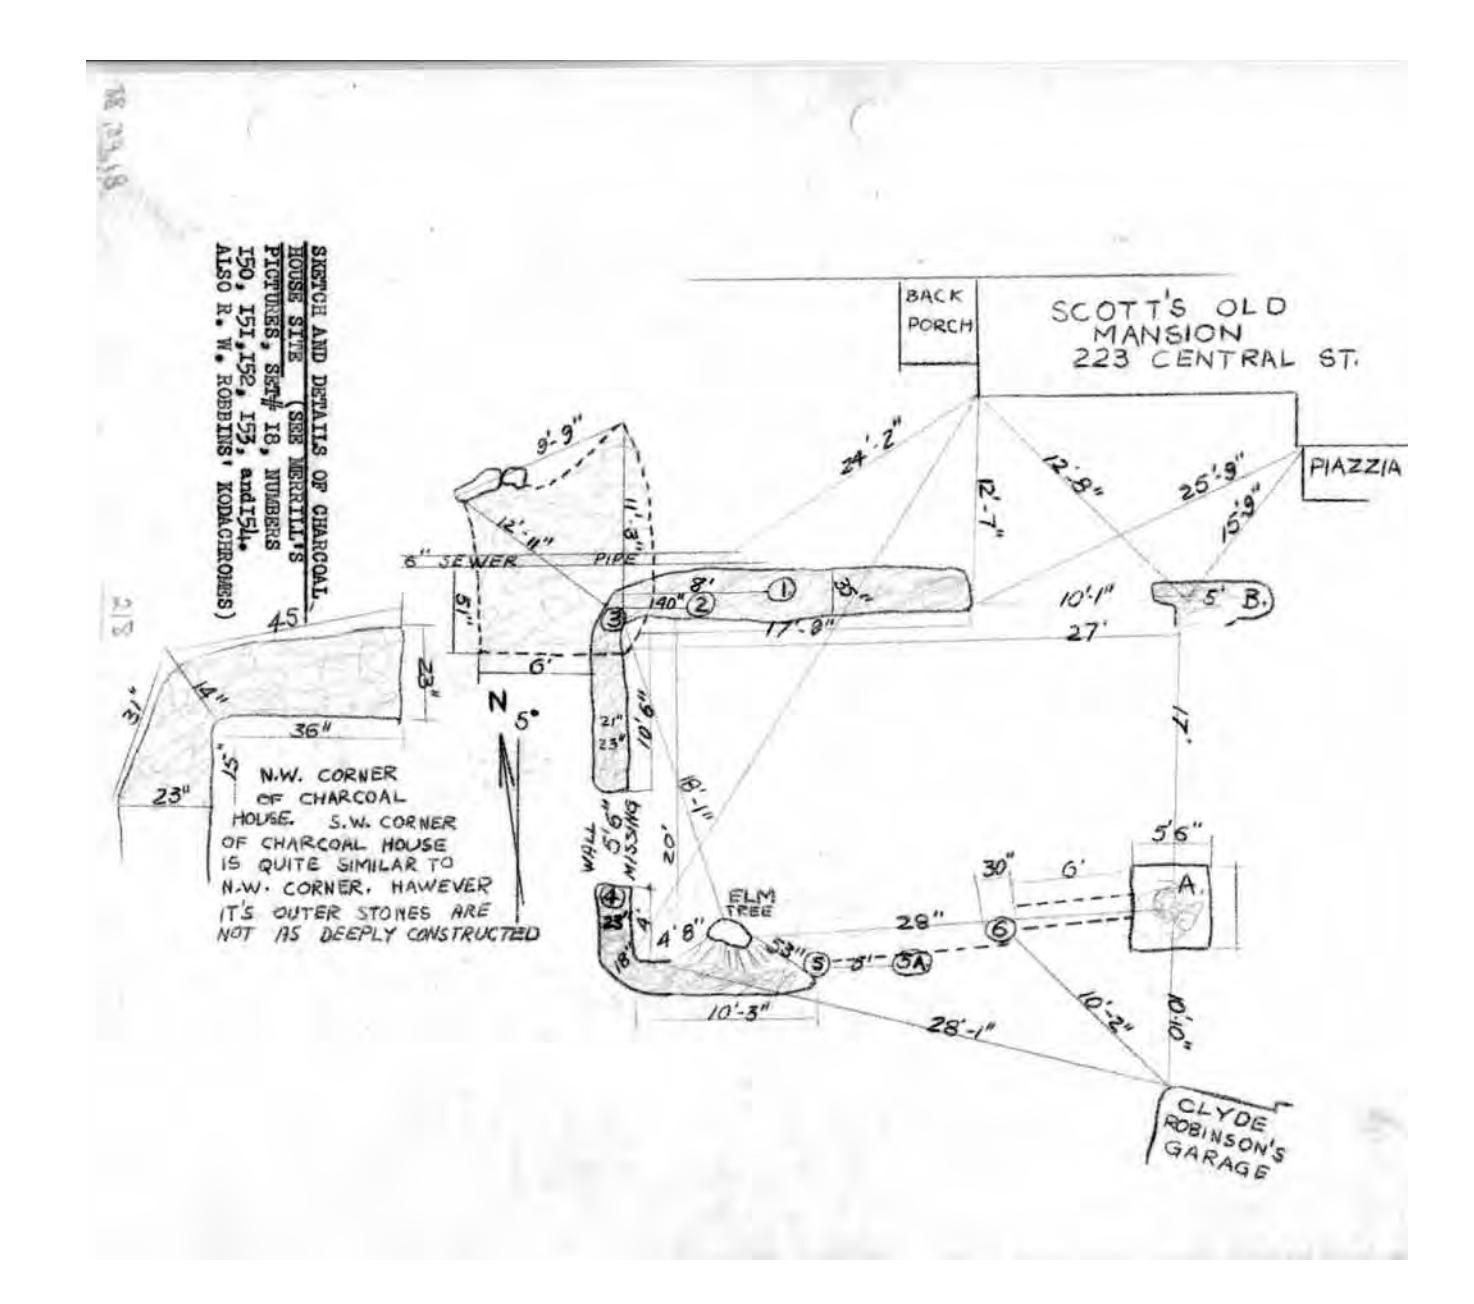
9.5 Sketch of the charcoal house foundation by Robbins recorded in his October 31, 1950, daily log.

Overall, Robbins estimated the structure to have been 27 feet long. He never mentions a width, but the sketch map that he included with the description shows it to be about 20 feet wide. Below the charcoal in the northern portion of the building, Robbins found a sandstone spike. This spike was similar in appearance to ones found at the furnace. It had a glaze on it indicating the likelihood that it had been used in the furnace. Robbins notes that its position below the charcoal suggests that the furnace had been in operation long enough to produce a burned lining before the remaining charcoal was stored here, or before it was used as a charcoal house.²³

Undoubtedly the area about the easterly end of the charcoal house, as well as along a section of the easterly end of the charcoal house southerly wall, had been disturbed by a later generation—and to a depth exceeding the elevation of the easterly end of the charcoal house. The coal and cinders and the fact Scott owned this property would suggest that Scott may have created the disturbance. To properly evaluate who disturbed what and when would necessitate more extensive excavations. We would have to carry away much of the excavated soil to permit proper working conditions. This work cannot be done under present arrangement with owners and tenants. All artifacts found in excavations at test holes A will be found under relics for this date.

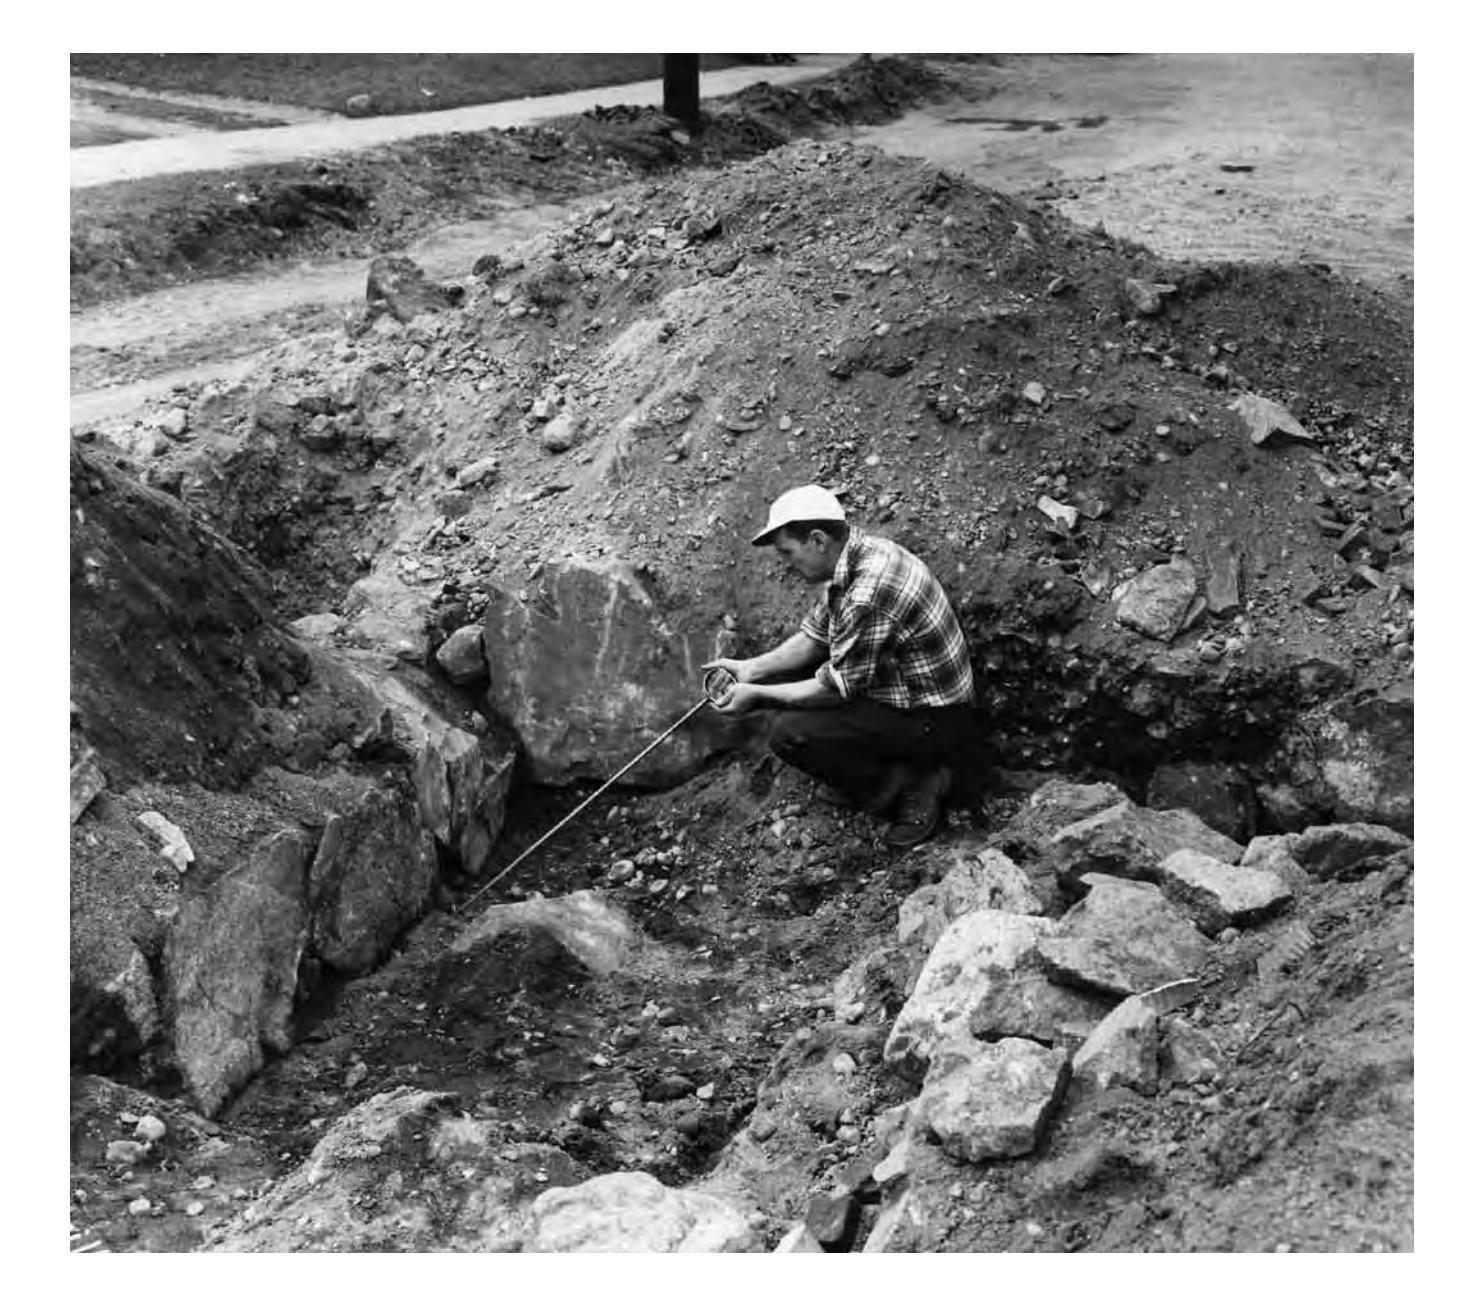
9.6 Robbins examining the building foundation discovered below Marion Street, September 27, 1950. (Photograph 233 by Richard Merrill, 1950.)

Evidently the contractor had cut through the west wall of the building and had torn out a considerable amount of the south wall. The stones in the foundation are described as quite large and mortared. Brick, plaster, and nails were found within the foundation; it appeared to Robbins that the bricks and nails and the robust construction of the foundation would make it of a later date, rather than being associated with the ironworks period, unless the original remains had been reworked at a later time.²⁶

It is very difficult to evaluate Robbins' conclusions about this foundation from the available evidence. Several photographs, a sketch map or two, and a brief description certainly do not qualify as adequate documentation. The stones used in the foundation do appear quite large in his illustrations. Based on the placement of the east and west fragments of wall, Robbins estimated the building to be about 32 feet long; no width is given.²⁷ There remain two possible interpretations for the building. First, that Robbins was correct and that the building dates to later than the ironworks period, or second, that the building dates to the ironworks period and was reused at a later time. If the remains were originally part of the ironworks and later reused, it may be one of several missing buildings from a theoretical ironworks land-scape, perhaps an office, barn, or storage shed. Unless additional excavations are undertaken, one may never know the date or function of the building.

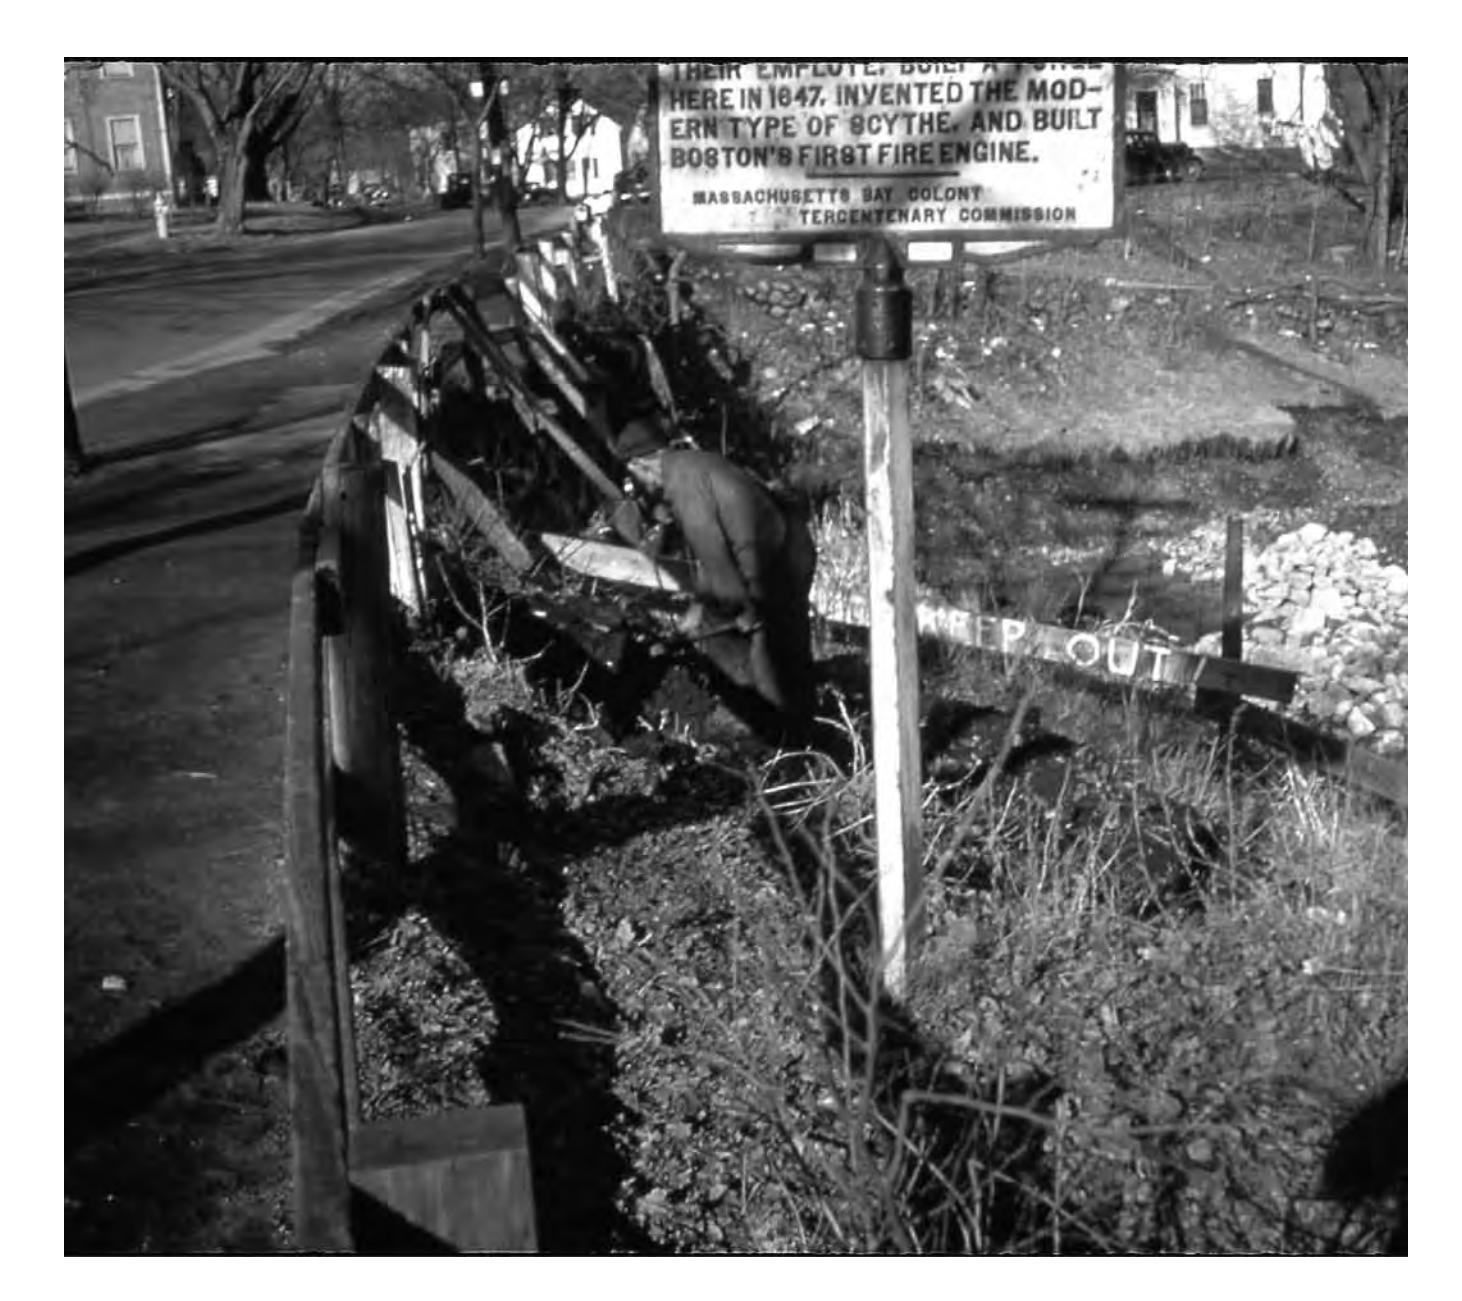
9.7 The location of the controversial forge/furnace findings adjacent to the tercentenary sign, late January 1950. (Photograph 328 by Richard Merrill, 1950.)

Friday, Jan 27 [1950] Found a considerable amount of iron rock evidence. There appeared to be a number of different types of iron rock. It will be interesting to learn if this is the case—and just where these ores were available. I found one-half a nail barrel load of coral, some pieces of good size. A few pieces of clam shells were also found. A large section of sow 37" long was found amid the stone and ore rubble. In the same rubble was found clay and charcoal evidence. The clay evidence had turned red by heat, apparently, must have been within forge or similar firing activity. I don't believe it was from furnace activity, no burned sandstone etc. or red clay packing pieces. Fact is the clay evidence found today was granulated. The diggings today were but several feet southerly of I.W. sign.

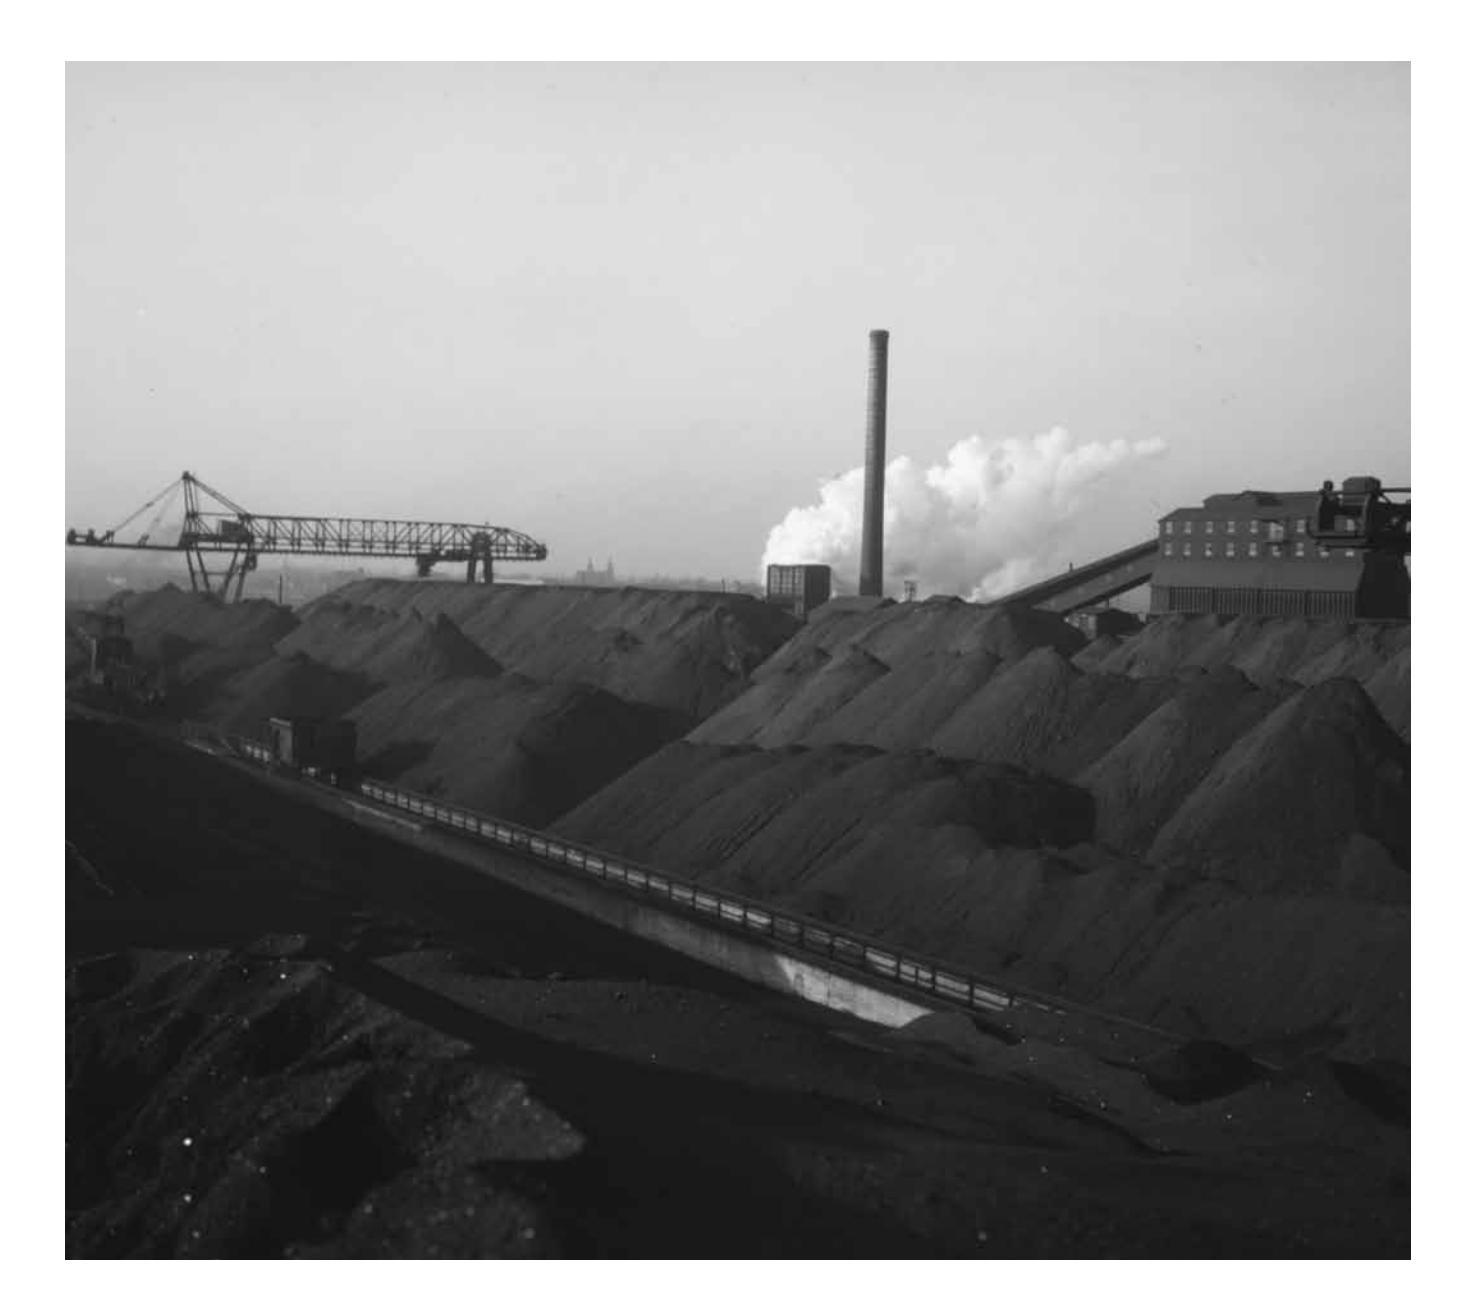
9.8 November 1942 photograph of the stockpiles of coal and iron ore for the Hanna furnaces of the Great Lakes Steel Corporation. (Photograph by Arthur Siegal. Library of Congress, Prints and Photographs Division, LC USW3-011208-C [P & P.])

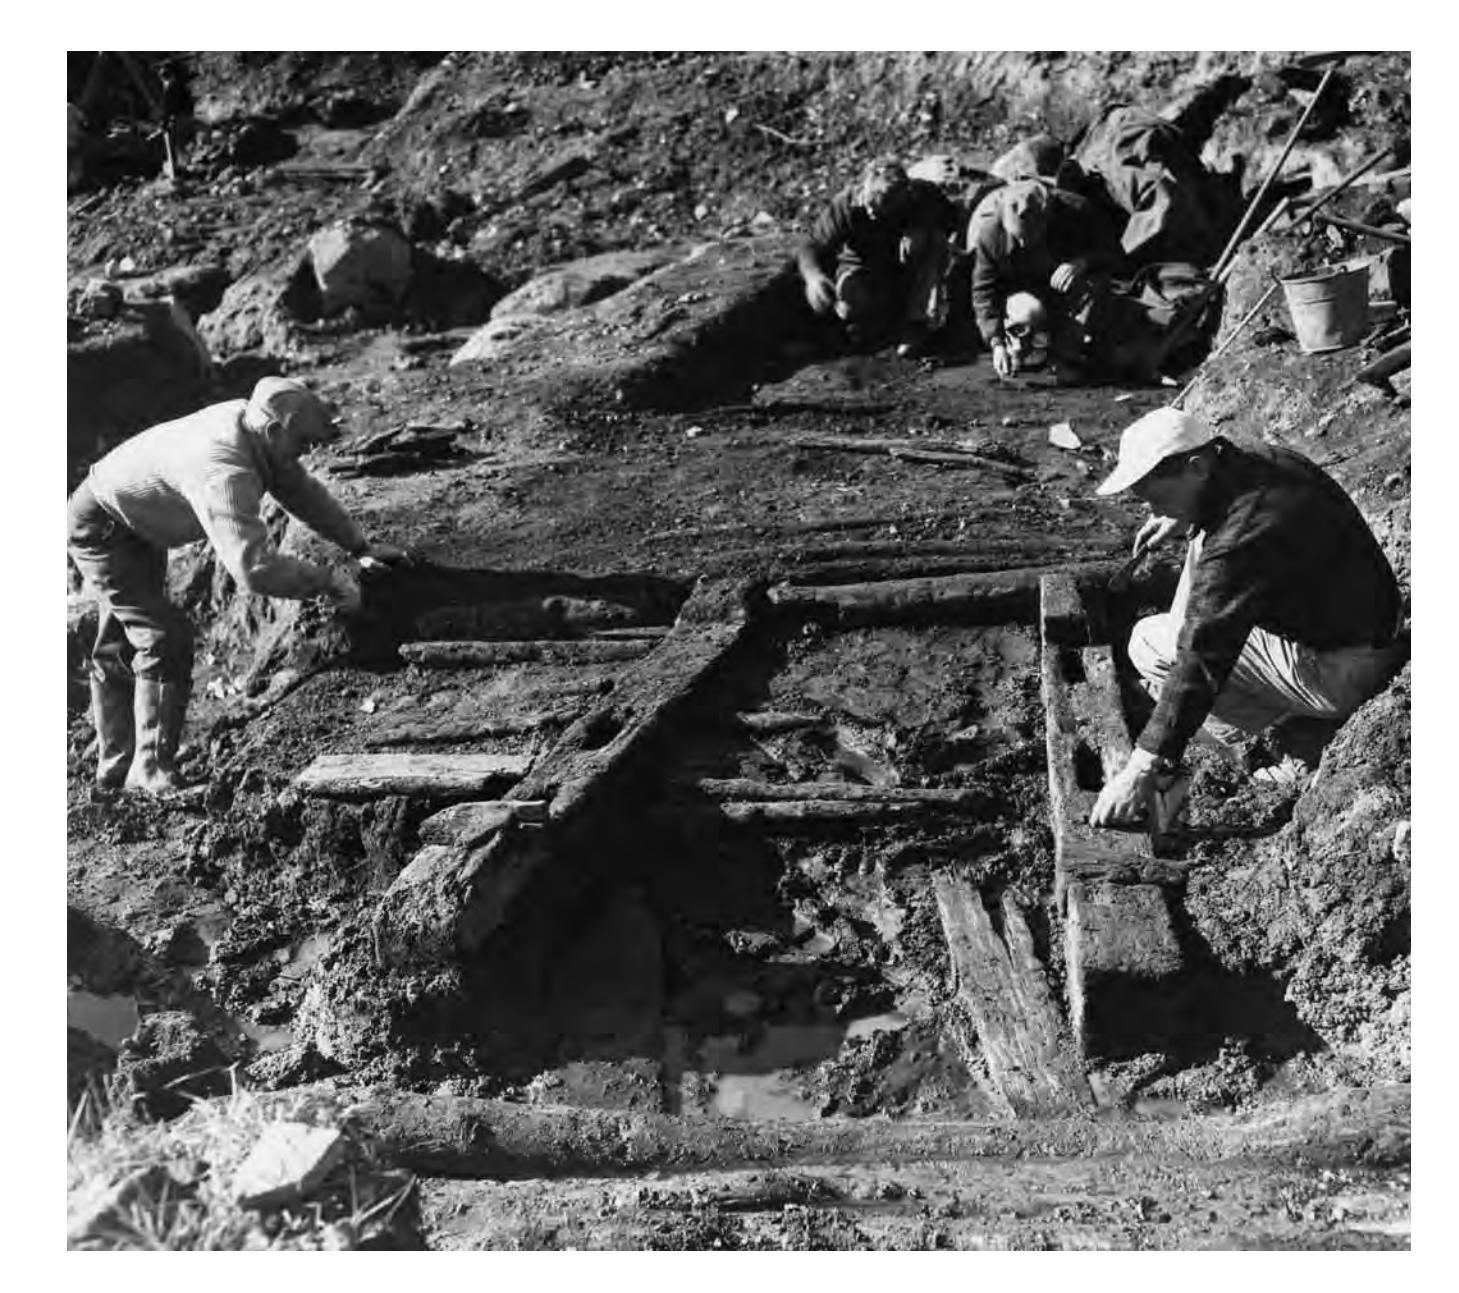
9.11 The excavation of the corduroy road timbers and associated bridge, November 11, 1952. (Photograph 746 by Richard Merrill, 1952.)

Another miscellaneous feature that Robbins discovered east of the blast furnace was the so-called corduroy road. This log feature, located just to the south and in front of the slitting mill, is briefly mentioned in the May 19, 1952, log entry. It may have been used to stabilize a roadway adjacent to a spring located just to the north of the road.

While the road is a prominent reconstructed feature at the Saugus Iron Works, it is barely mentioned by Robbins in his log. Even though he indicates that the corduroy road had stones over it, the reconstructed road lacks the stonework.
