2016 Preservation Technology and Training Grant Federal Grant Number: P16AP00194

PROTECTIVE TREATMENTS FOR WESTERN REDCEDAR SHINGLE AND SHAKE ROOFS

REPORT

Washington State Parks & Recreation Commission

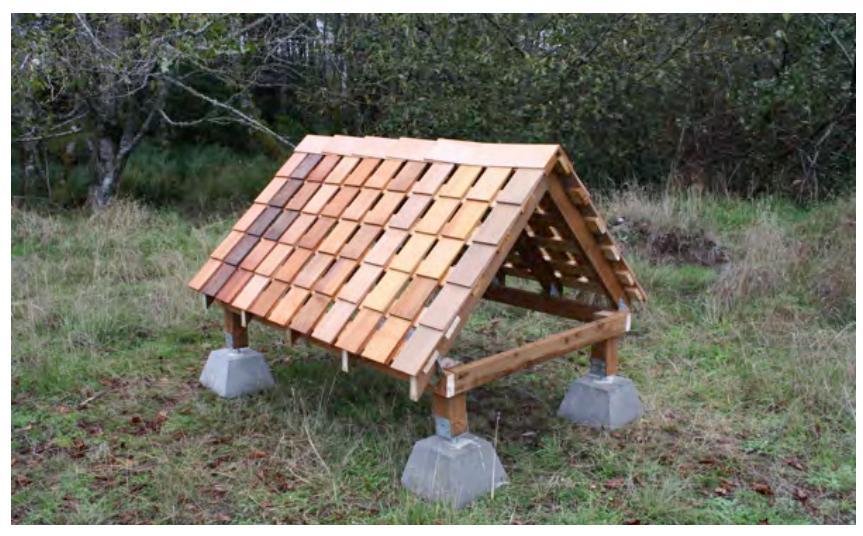
Figure 4. Experimental set up at Cape Disappointment State Park. Oceanic exposure.

The same layout of treated shingles was repeated on each slope, containing eleven treatment groups in vertical rows with a 1" gap between the groups. Each treatment group, as well as an untreated control group comprised five replicate samples on each exposure. Shingles were nailed with standard stainless steel ringshank roofing nails overlapping at half their length. The base structure was constructed of pressure treated 2 x 4 lumber, with 4 x 4 posts on pier blocks with galvanized brackets. The shingle nailers were utility grade cedar to prevent contact between tested products and wood preservative components in pressure treated lumber of the frame. Untreated shingles were used both as a "starter" course and for a ridge cap, simulating a typical assembly of this roofing type. Simpson ties were used for rafter connections.

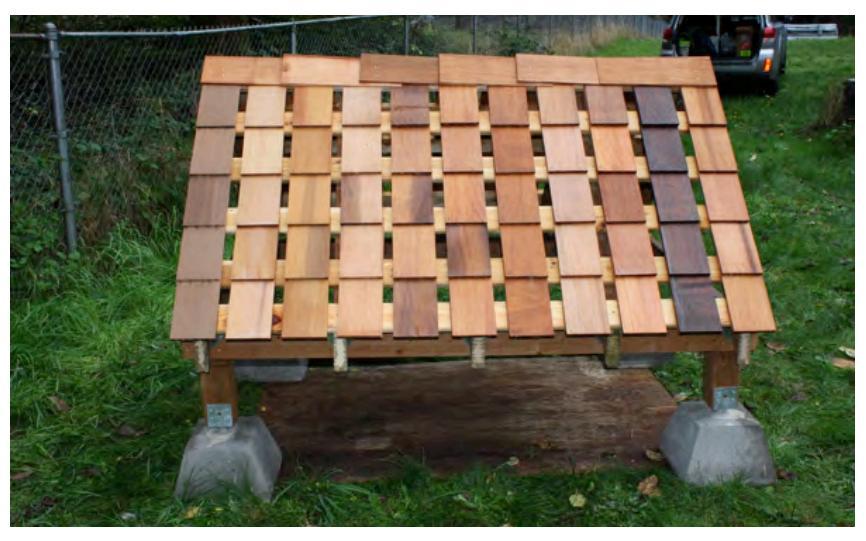
Figure 5. Experimental set up at Beacon Rock State Park. Maritime exposure.

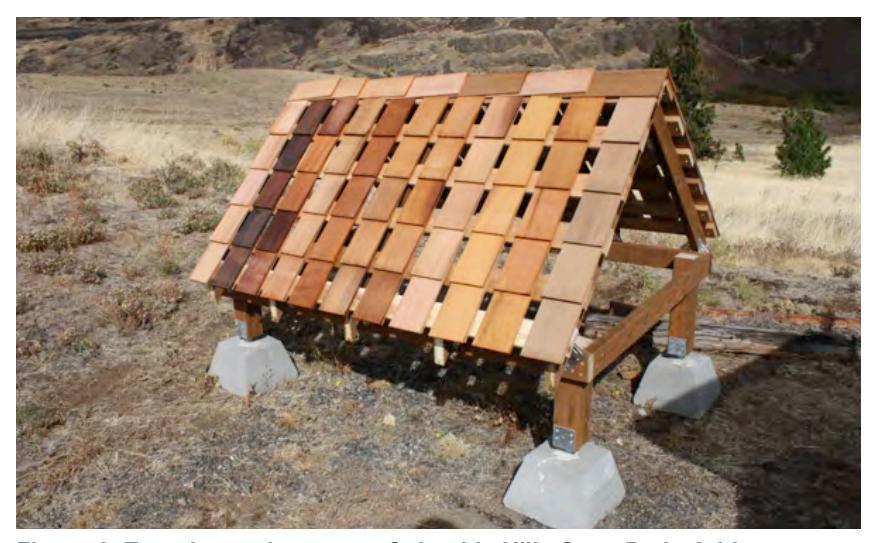
Figure 6. Experimental set up at Columbia Hills State Park. Arid exposure.

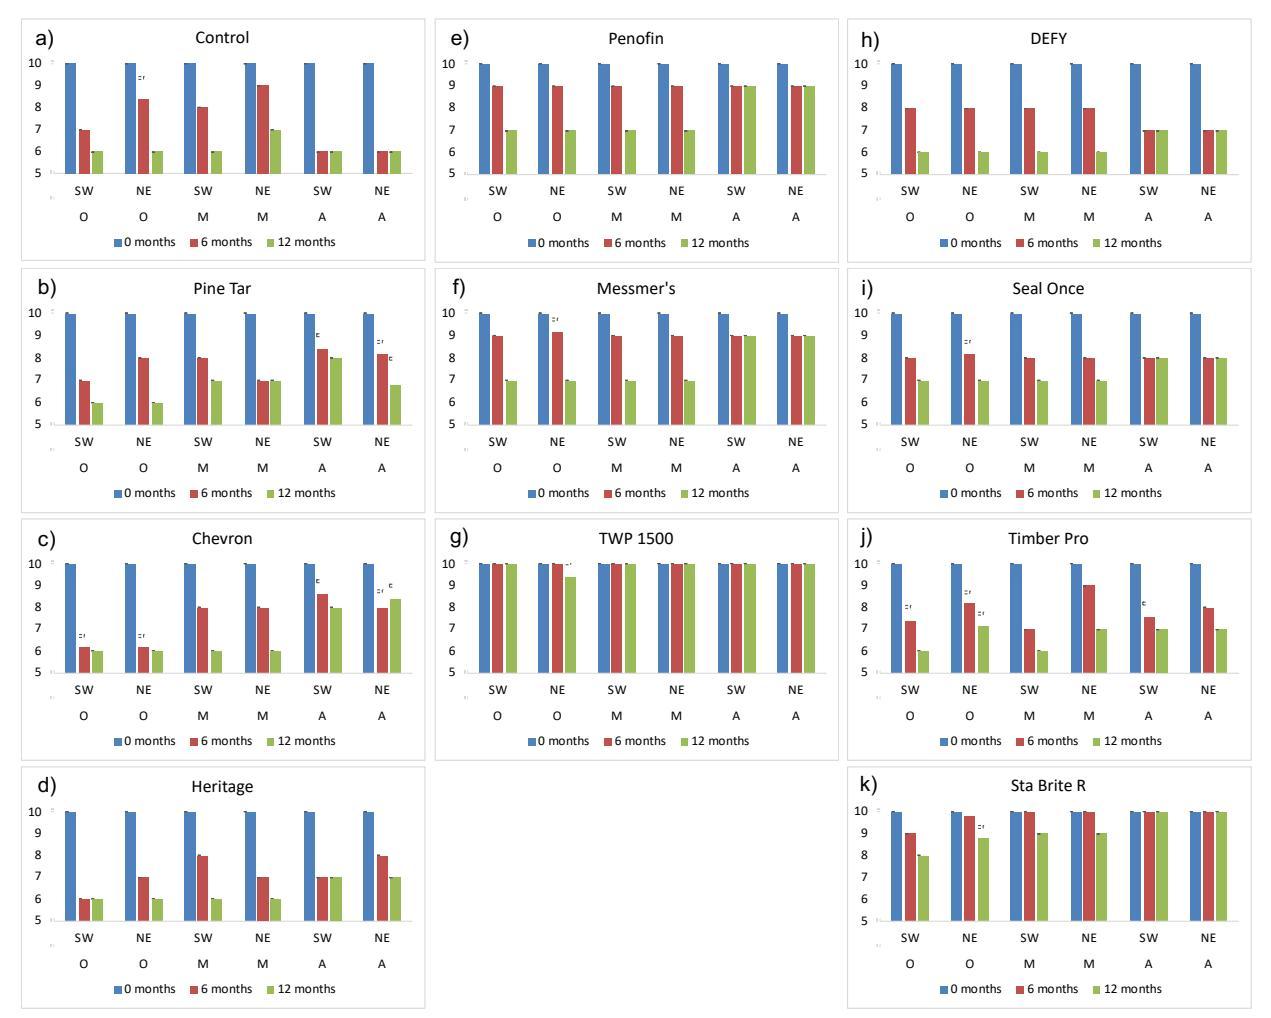
Figure 7. Average ratings and standard deviation (SD) for color change for individual test groups for Oceanic (O), Maritime (M), and Arid (A) exposures for SW and NE elevations.

Most rapid color loss was observed in untreated control groups (Figure 8.). They completely lost the natural color of western redcedar after six months of weathering (1st phase) at Arid exposure, followed by Maritime and Oceanic exposures where the color ratings were higher at the end of the 1st phase, but further decreased over the 2nd phase to near complete loss (Figure 7a).

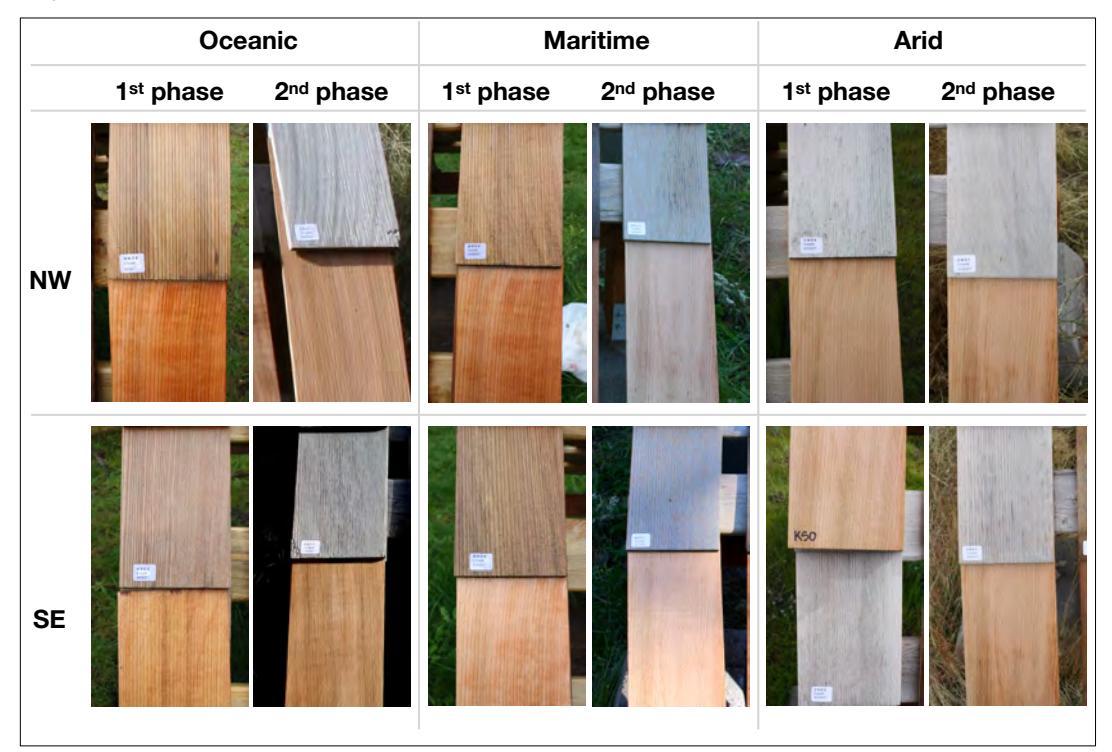
Figure 8. Comparisons for color and graying between uncoated control shingles (white label) and unweathered control following 1st and 2nd outdoor exposure phases for NW and SE exposures at three testing sites.

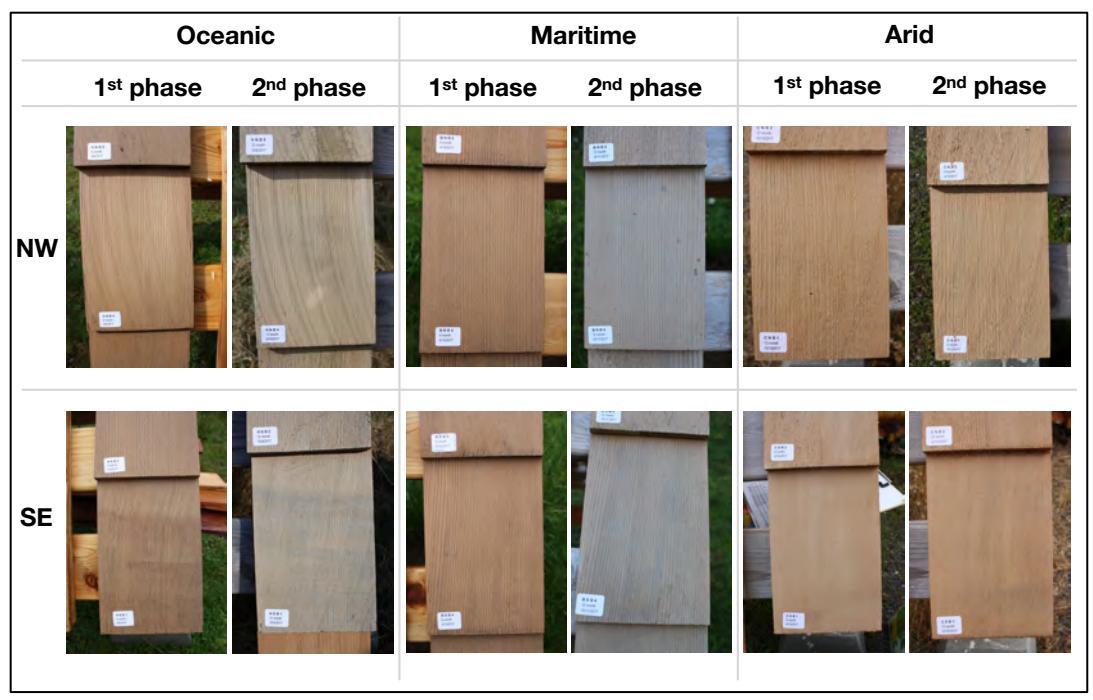
Figure 9. Test shingles coated with Sta Brite R at NW and SE elevations at three testing sites following the 1st and 2nd phase of outdoor exposure.

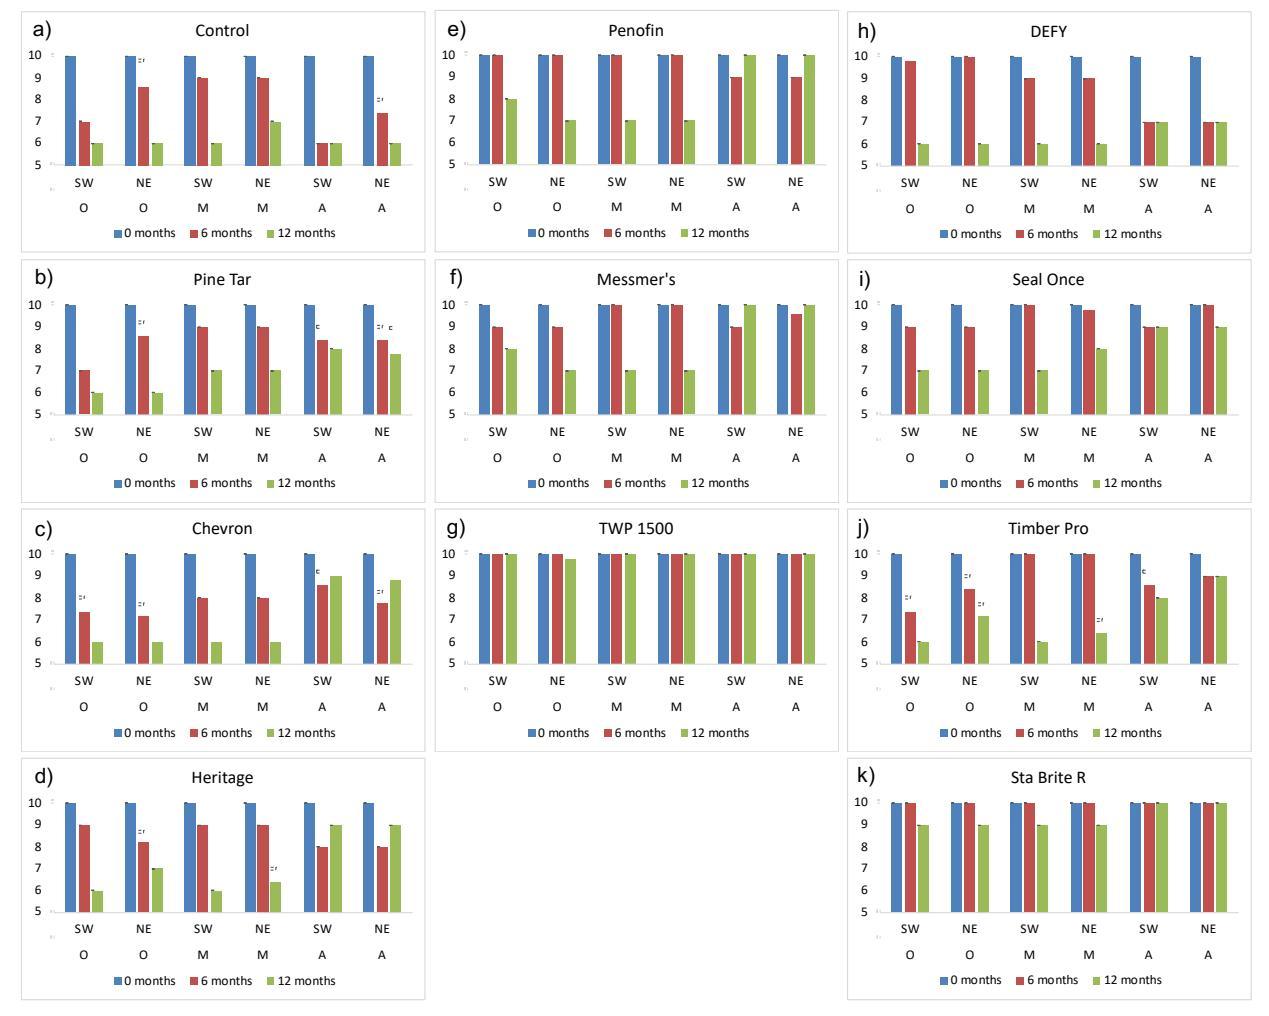
Figure 10. Average ratings and standard deviation (SD) for graying of the shingle surface for individual test groups for Oceanic (O), Maritime (M), and Arid (A) exposures for SW and NE elevations.

with the most severe graying at the Maritime exposure, followed by Oceanic exposure and no apparent graying at Arid exposure following the 2nd phase, and with no apparent graying following the 1st phase at either site (Figure 10 e, f). TWP 1500 retained the maximum rating of 10, indicating no graying of the surface for any test groups on all three testing sites. TWP 1500 had the best performance of all investigated treatments (Figure 10 g).

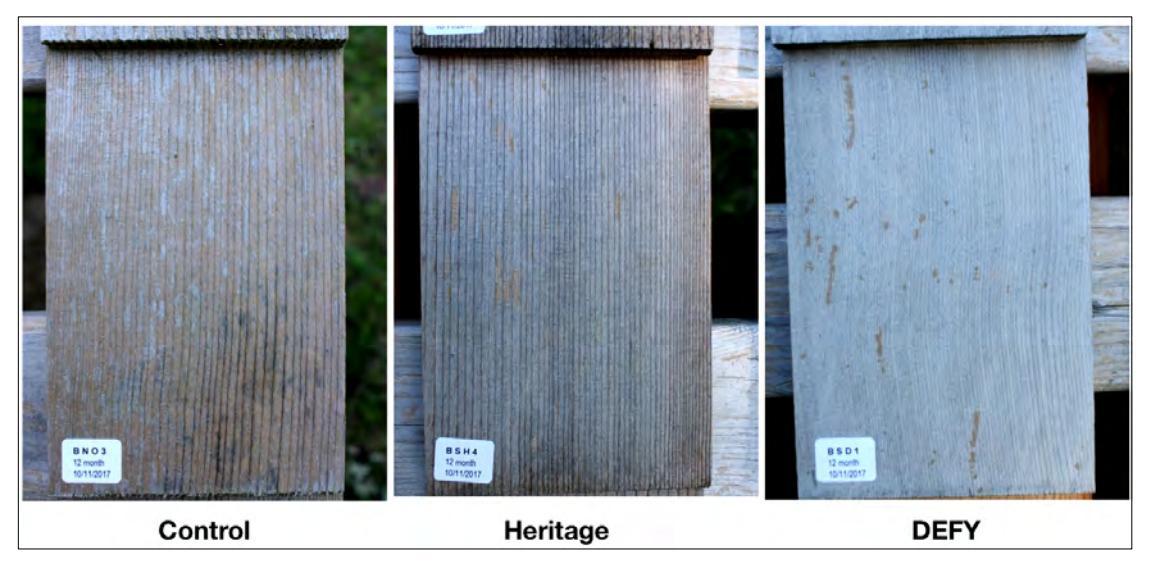
Figure 11. Surface erosion on uncoated control and Heritage and DEFY coated shingle. Maritime site after 12month outdoor exposure.

Surface erosion on uncoated control shingles resulted from weathering of wood caused by the combined action of UV radiation, precipitation, and wind (Schniewind, 1963). In contrast, erosion observed on samples coated with oil-borne coatings resulted from the failure of coatings caused by similar environmental factors to those responsible for weathering of wood that was, in some instances, followed by the weathering of unprotected wood. The erosion pattern was somewhat different on surfaces coated with water-borne coatings appearing to be caused by mechanical action.

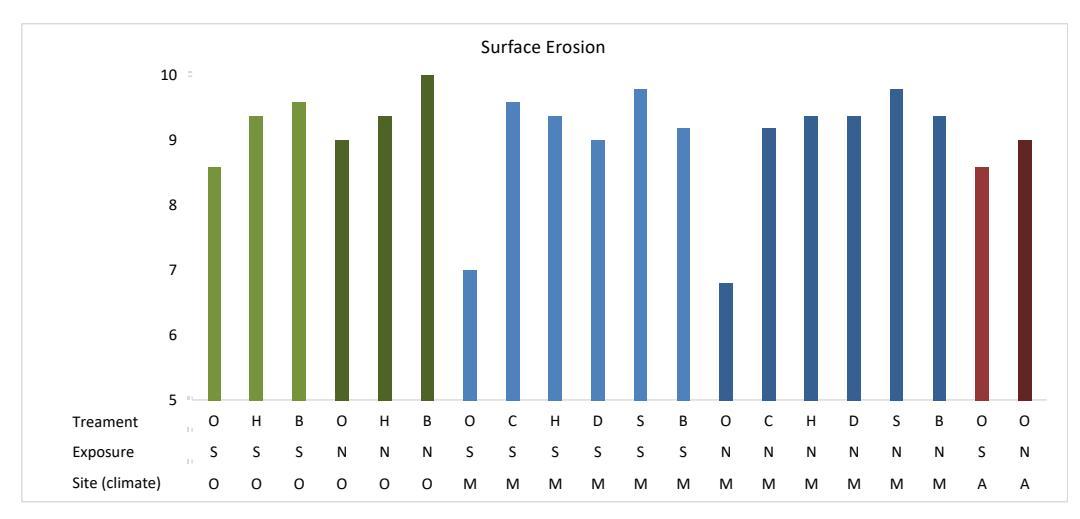
Figure 12. Mean ratings and standard deviation (SD) for surface erosion for control (O), Chevron (C), Heritage (H), DEFY (D), Seal Once (S), and Sta Brite R (B) (first row of category labels on X axis) following 12-month outdoor weathering for southwest (S) and northeast (N) exposure (second row of category labels on X axis) at Oceanic (O), Maritime (M) and Arid (A) sites (third row of category labels on X axis).

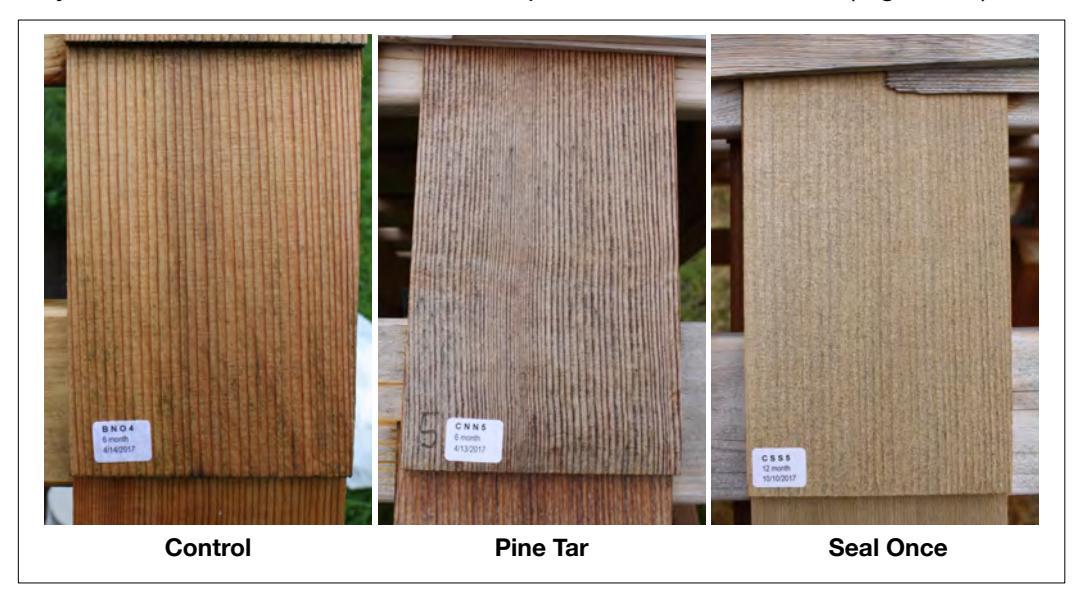
Figure 13. Appearance of green growth on the surface of uncoated control shingles and of black mold on shingles coated with Pine Tar and Seal Once.

Surface growth was observed on some, but not all, treatments following the 1st and 2nd phase of outdoor exposure. Two general types of surface growth were distinguished. The first type appears to be black mold and was the most frequently observed form of surface growth. The second type was the green growth that is usually associated with algae and mildew and was only observed on uncoated control samples at the Maritime site (Figure 13).

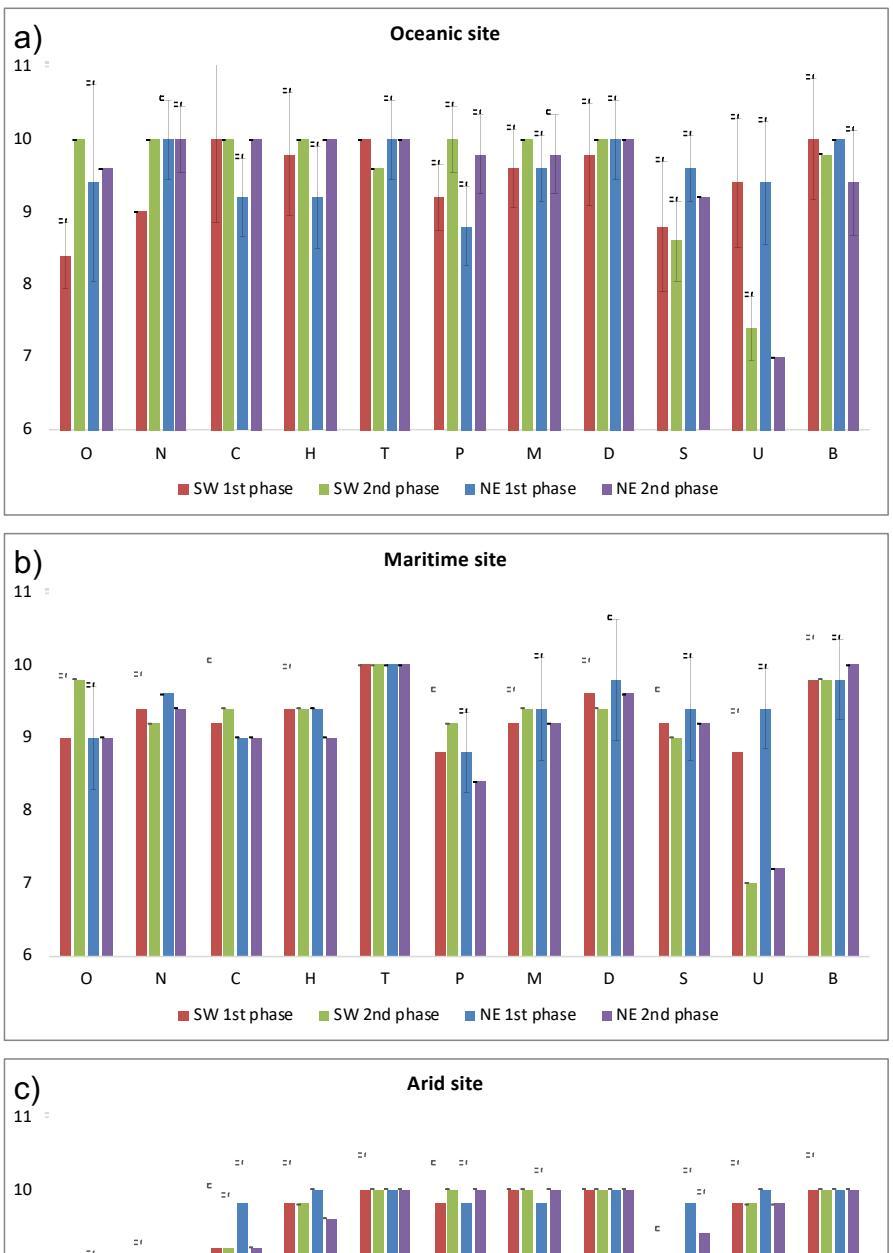
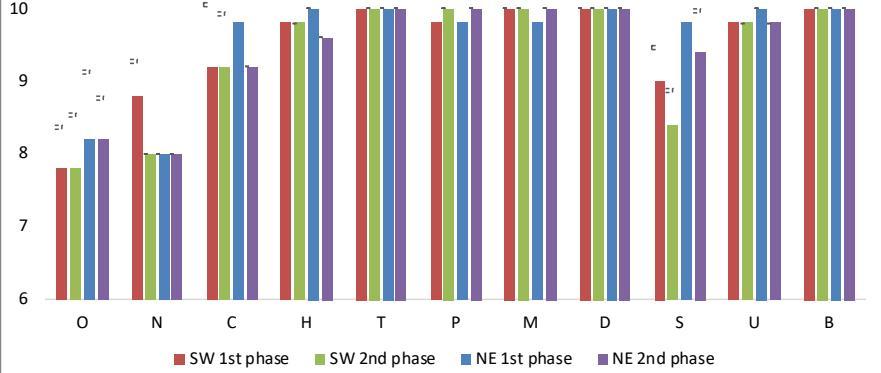
Figure 14. Average values and SD for surface growth on three testing sites for uncoated control (O), Pine Tar (N), Chevron (C), Heritage (H), TWP 1500 (T), DEFY (D), Seal Once (S), Timber Pro (U), and Sta Brite R (B).

The results for all three test sites are presented in Figure 14. In many instances, the amount of surface growth decreased over the 2nd phase from the 1st phase. This can be explained by generally less favorable conditions for the biological growth during warm and dry summer months, depletion of soluble nutrients from wood and oils in coatings required for the mold growth, and by the effect of weathering which seemed to cause removal of mold along with

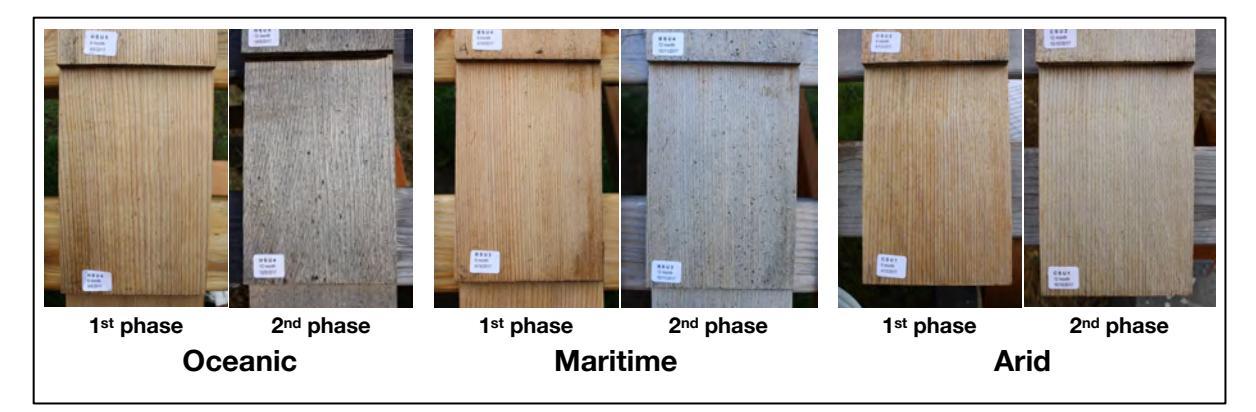
Figure 15. Surface growth on shingles coated with Timber Pro after 1st and 2nd testing phase respectively for three exposures.

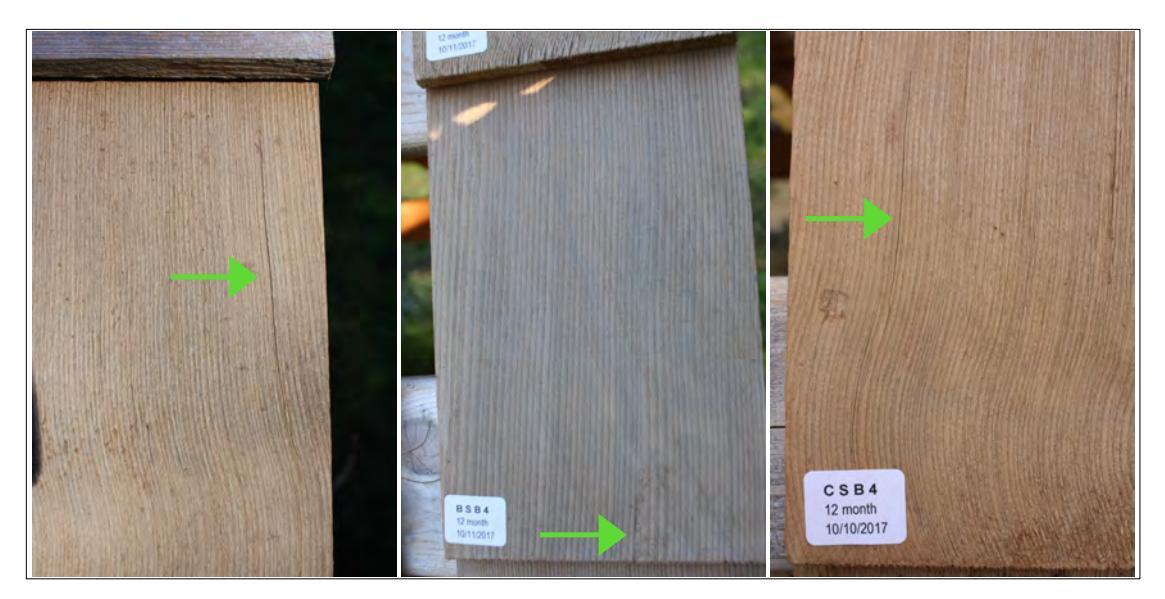
Figure 16. Examples of surface checking following 12-month outdoor exposure.

First occurrences of surface checking on tested shingles were observed after 12 months of outdoor exposure. Most checks appeared as hairline checks (Figure 16) of different lengths along the grain. The largest number of test groups that developed checks was observed at the Oceanic site (DEFY, Seal Once, Sta Brite R, Pine Tar, and Chevron), followed by the Maritime site, where checking was observed on test groups coated with DEFY and Sta Brite R, and the Arid site, where checking was observed on Timber Pro and Sta Brite R coated test groups (Figure 17). Many of the test groups had checking develop only on one out of five samples.

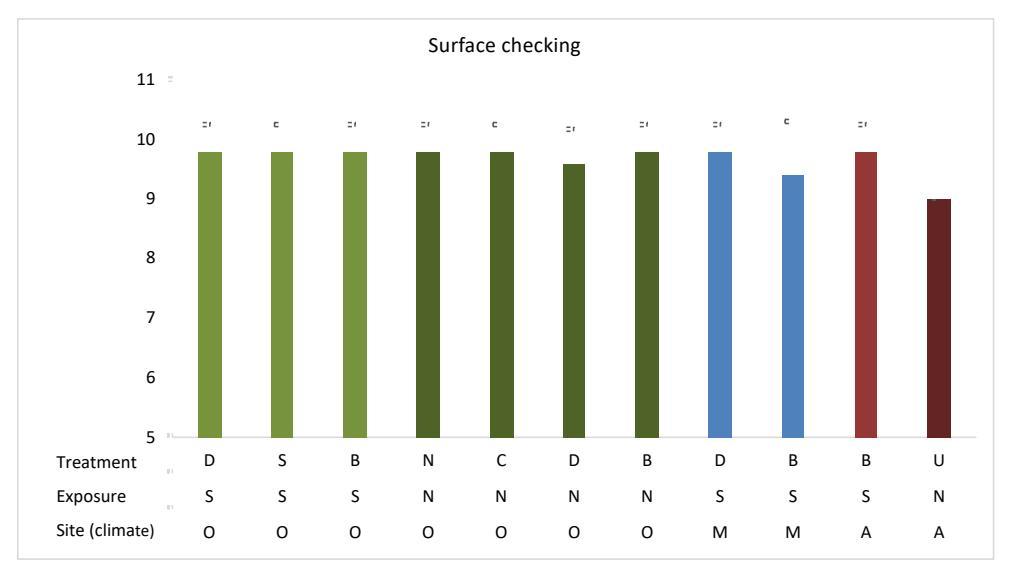
Figure 17. Mean ratings and standard deviation for surface checking following 12-month outdoor exposure at Oceanic (O), Maritime (M) and Arid (A) site, for southwest (S) and northeast (N) exposure for DEFY (D), Seal Once (S), Sta Brite R (B) Pine Tar (N), Chevron (C), and Timber Pro (U).

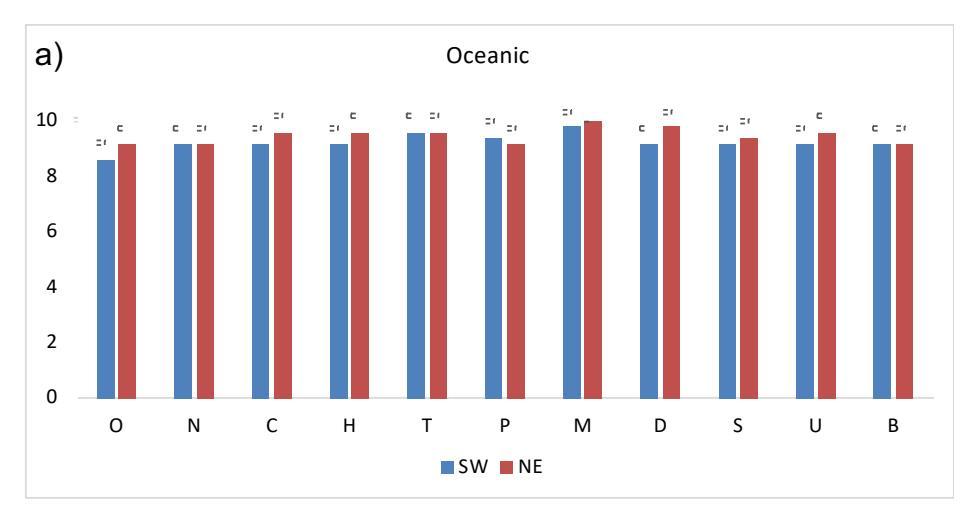
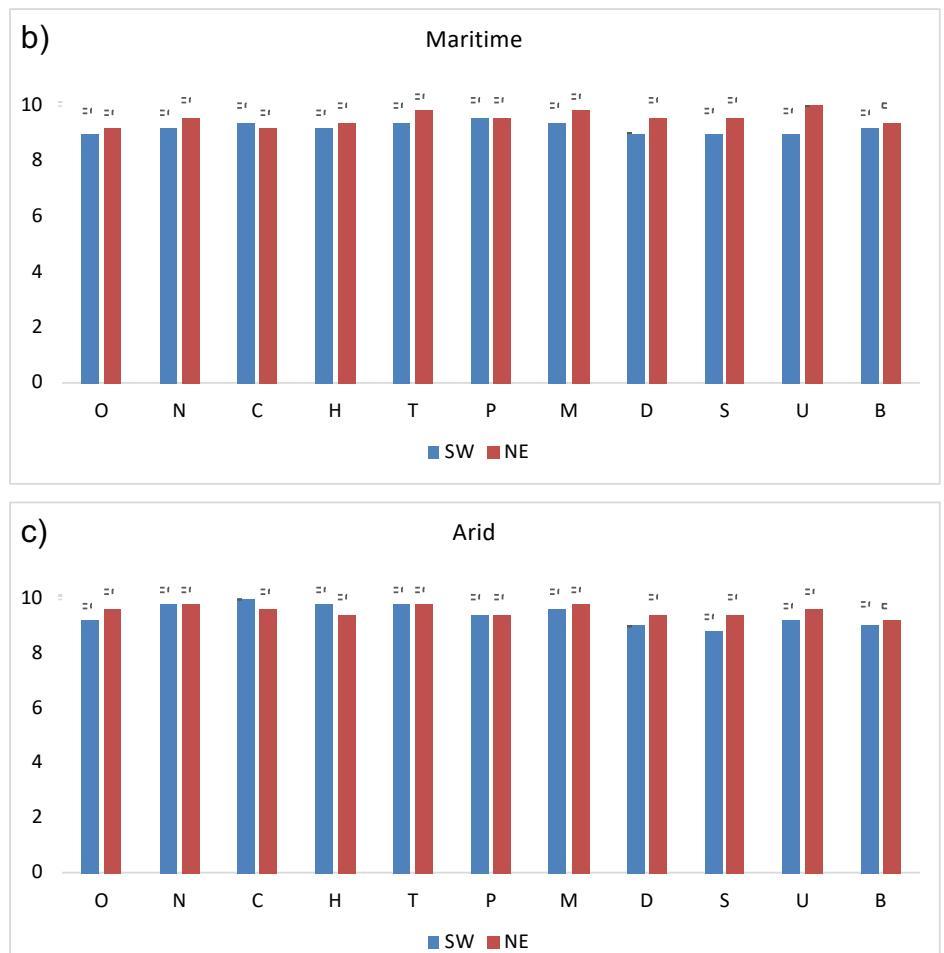
Figure 18. Mean ratings and standard deviation for cupping of shingles following 12-month outdoor exposure for a) Oceanic, b) Maritime, and c) Arid site, for southwest (SW) and northeast (NE) exposure for uncoated control (O), Pine Tar (N), Chevron (C), Heritage (H), TWP 1500 (T), Penofin (P), Messmer's (M), DEFY (D), Seal Once (S), Timber Pro (U), and Sta Brite R (B).

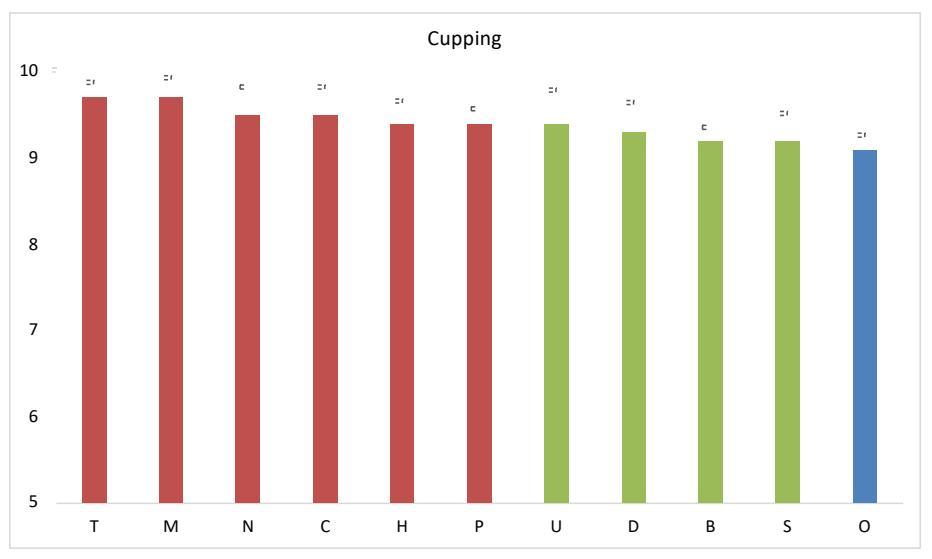
Figure 19. Mean cupping ratings and SD for samples from all test groups (three sites and two elevations). TWP 1500 (T), Messmer's (M), Pine Tar (N), Chevron (C), Heritage (H), Penofin (P), Timber Pro (U), DEFY (D), Sta Brite R (B), Seal Once (S), and Control (O).

No consistent effects of testing site and elevation were observed among individual coatings, although the analysis of the mean ratings for all samples with cupping from all three sites suggests that in general, oil-borne coatings had less cupping than water-borne coatings. TWP 1500 and Messmer's consistently had the least cupping regardless of the exposure conditions (Figure 19).

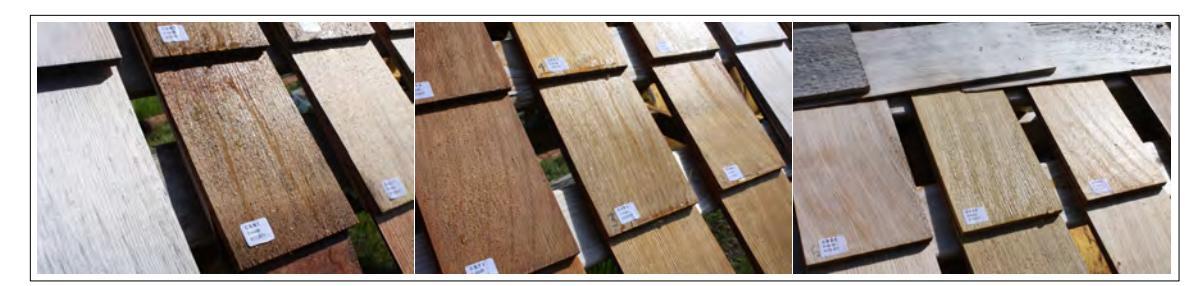
Figure 20. Examples of water beading on shingles during the field testing.

Results for water repellency of test groups based on field evaluation (Figure 20) are presented in Figure 21. There was very little variability in water repellent properties within each test group over the course of data collection. Uncoated control and Sta Brite R coated groups had no water beading on the shingle surface and were assigned the lowest rating of 6 at the time of installation with no subsequent change during the 12-month outdoor exposure.

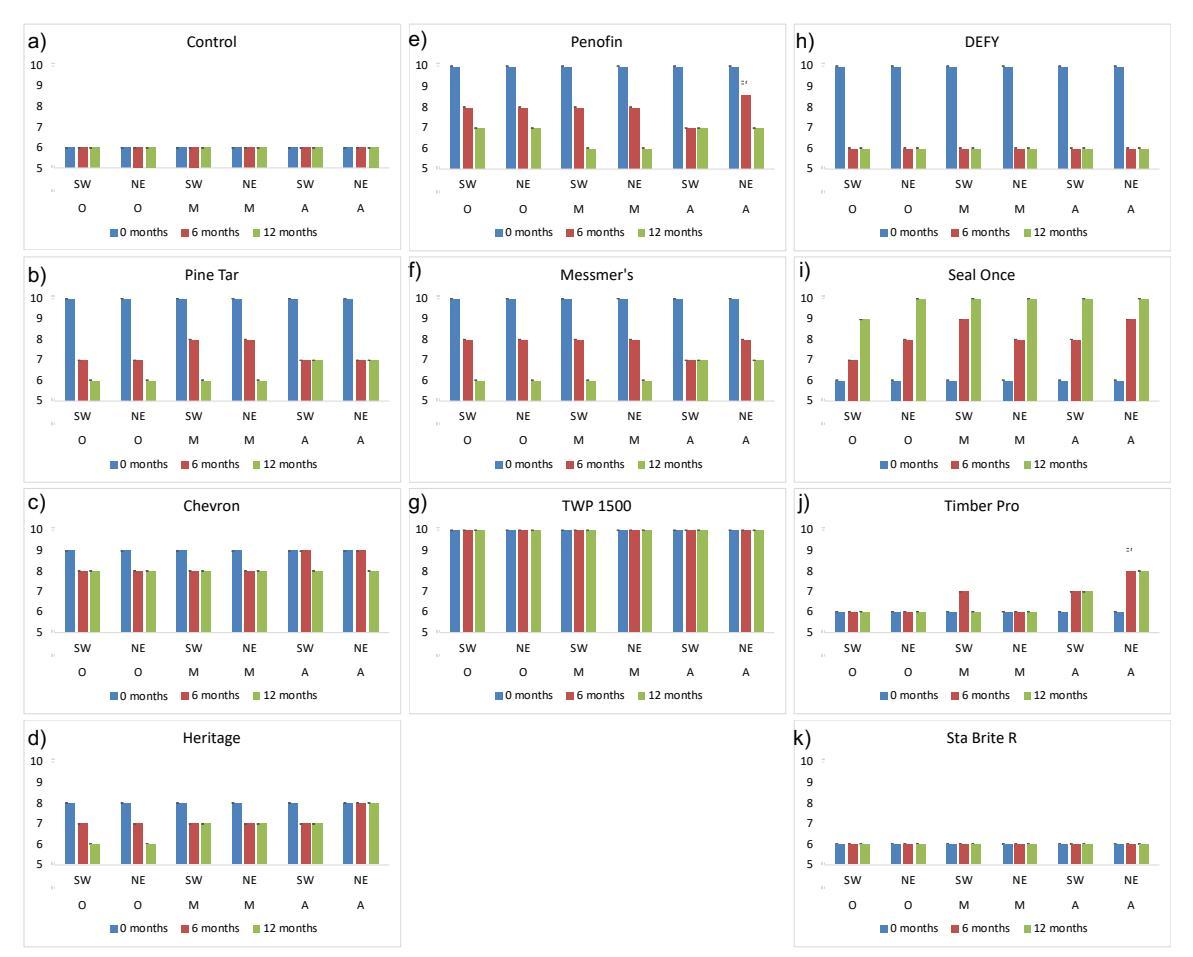
Figure 21. Average water repellency and SD for individual test groups based on on-site evaluation of water beading for SW and NE exposures for Oceanic (O), Maritime (M), and Arid (A) sites.

Water repellency of oil-borne coatings decreased progressively to different extents over time: Pine Tar, Penofin, and Messmer's, which initially had maximum water repellency ratings, deteriorated to very low values of 6 or 7 over a 12-month outdoor exposure, with overall higher residual water repellent properties at the Arid site than at the Oceanic and Maritime sites. Water repellency of Chevron coating was initially 9 and decreased only slightly to 8 at all sites. For Heritage, water repellency decreased from the initial rating of 8 to the raing of 6 at the Oceanic site, the rating of 7 at the Maritime site, and remained between the ratings of 7 and 8 at the Arid site. TWP 1500 had the best retention of water repellency, which remained at initial maximum of 10 for all sites.

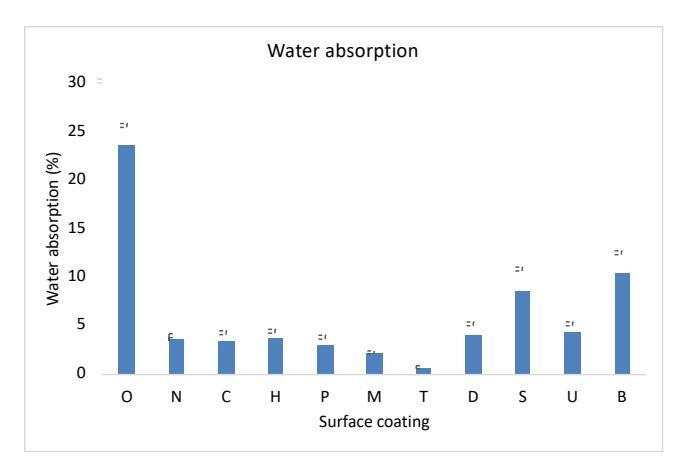
Figure 22. Average water absorption (%) and standard deviation (%) for coated shingles and controls following the laboratory testing. Uncoated control (O), Pine Tar (N), Chevron (C), Heritage (H), TWP 1500 (T), Penofin (P), Messmer's (M), DEFY (D), Seal Once (S), Timber Pro (U), and Sta Brite R (B).

Results for laboratory tests of water absorption and water repellent effectiveness of investigated coatings in shown in Figure 22, Figure 23, and Table 3. For coated groups, average water absorption over 30 minutes of water immersion ranged from 0.7% for TWP 1500 to 10.4% for Sta Brite R, compared to 23.5% for the control group. All coatings significantly reduced water absorption of WRC shingles compared to uncoated controls. Water repellent efficiency, which represents the ability of coating to prevent water absorption relative to uncoated controls, ranged from 55.8% for Sta Brite R to 97.1% for TWP 1500.

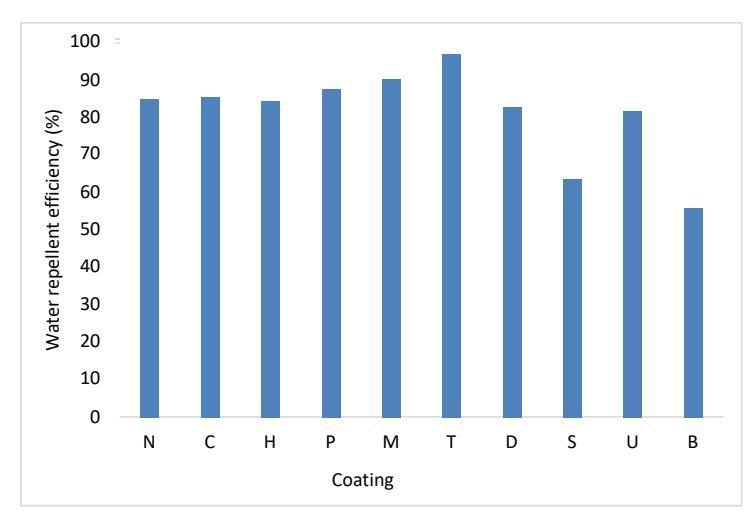
Figure 23. Water repellent efficiency relative to uncoated control samples for laboratory tested water absorption. Uncoated control (O), Pine Tar (N), Chevron (C), Heritage (H), TWP 1500 (T), Penofin (P), Messmer's (M), DEFY (D), Seal Once (S), Timber Pro (U), and Sta Brite R (B).

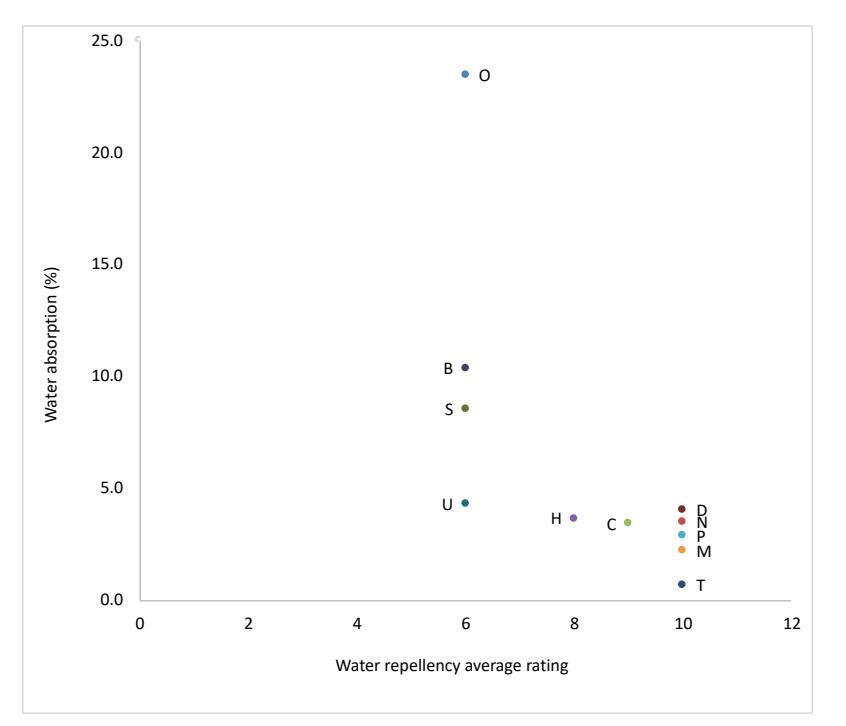
Figure 24. Comparison of water absorption (%) determined by laboratory testing and ranking of water repellency determined in field before the weathering exposure. Uncoated control (O), Pine Tar (N), Chevron (C), Heritage (H), TWP 1500 (T), Penofin (P), Messmer's (M), DEFY (D), Seal Once (S), Timber Pro (U), and Sta Brite R (B).

Figure 24 shows the comparison of water absorption determined by laboratory testing and ranking of water repellency determined in the field before the weathering exposure. As seen in the graph, overall there was a good correlation between laboratory and field results for all coatings with the exception of Timber Pro, which had low water absorption comparable to DEFY in laboratory testing but was rated at 6 as having no apparent water beading during field testing of water repellency.

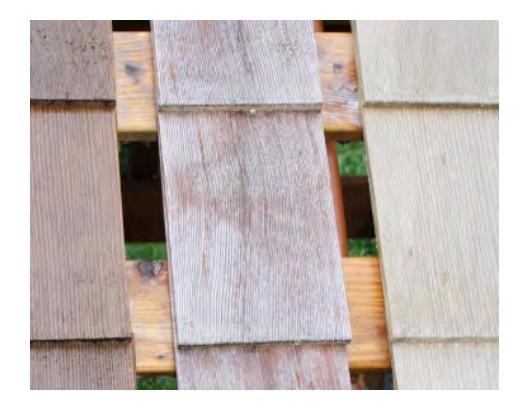
Figure 25. Whitish appearance of wet DEFY coated shingles

In terms of the aesthetic appearance, the most desirable coatings are those that resemble either the original or the weathered color of western redcedar. Heritage and Chevron coated shingles had the closest color to weathered control group after a 12 months exposure at the Maritime and Oceanic sites. The color of other oil-borne coatings Pine tar, Penofin and Messmer's shifted towards natural western redcedar color over the course of the 1st testing phase, and attained considerably darker tones when compared to weathered western redcedar at advanced stages of color loss after 12 months. TWP 1500 retained its original color over the whole year of outdoor exposure, closely resembling the color of unweathered western redcedar heartwood. Water-borne coating DEFY also weathered to a similar appearance as the weathered western redcedar when dry, but a milky white film appeared on the surface when the coating was wet (Figure 25).

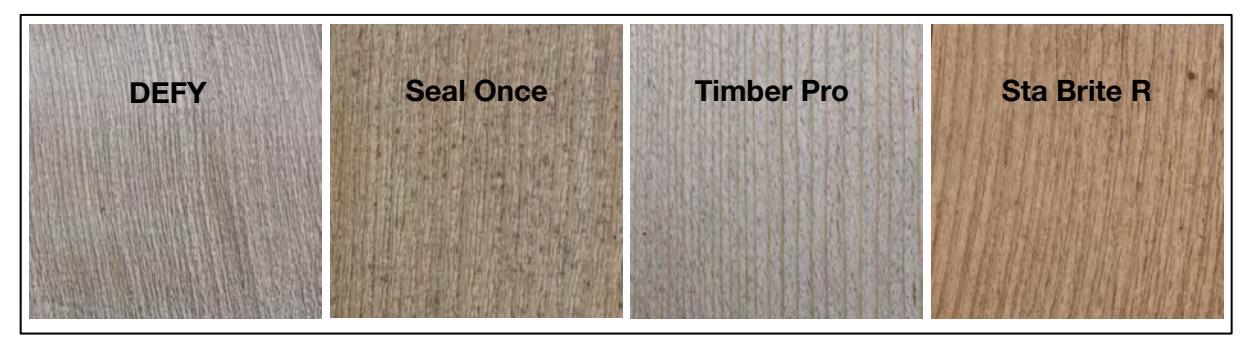
Figure 26. Micro checks on water-borne coatings.

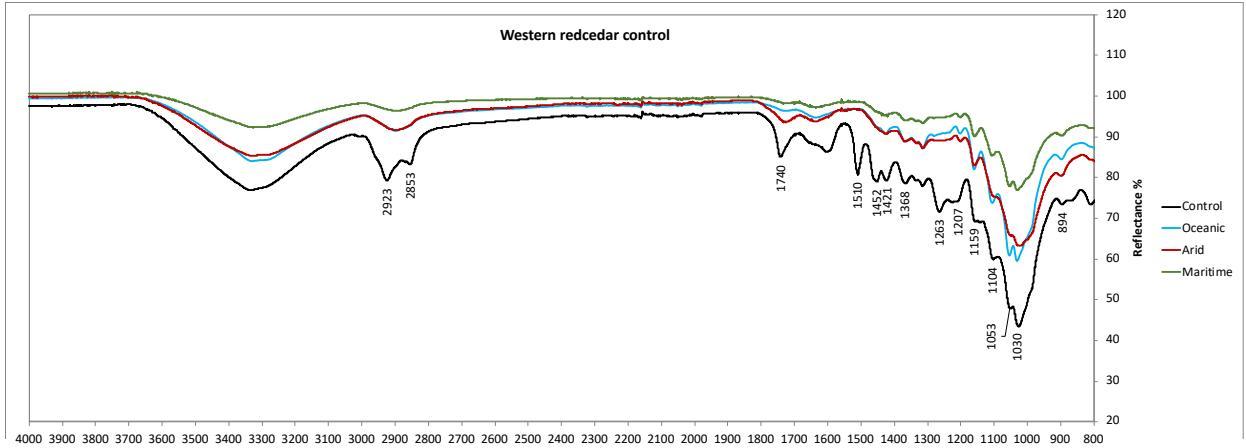
Figure A 1. FTIR spectra of uncoated western redcedar control before weathering and following the weathering at three exposures.

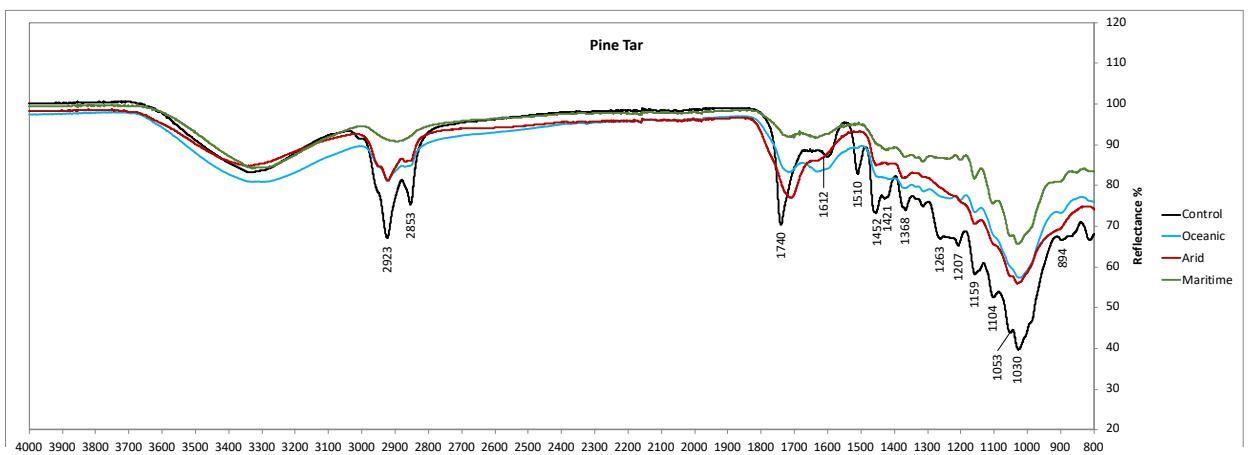
Figure A 2. FTIR spectra of Pine Tar coated wood before weathering (Control) and following the weathering at three exposures.

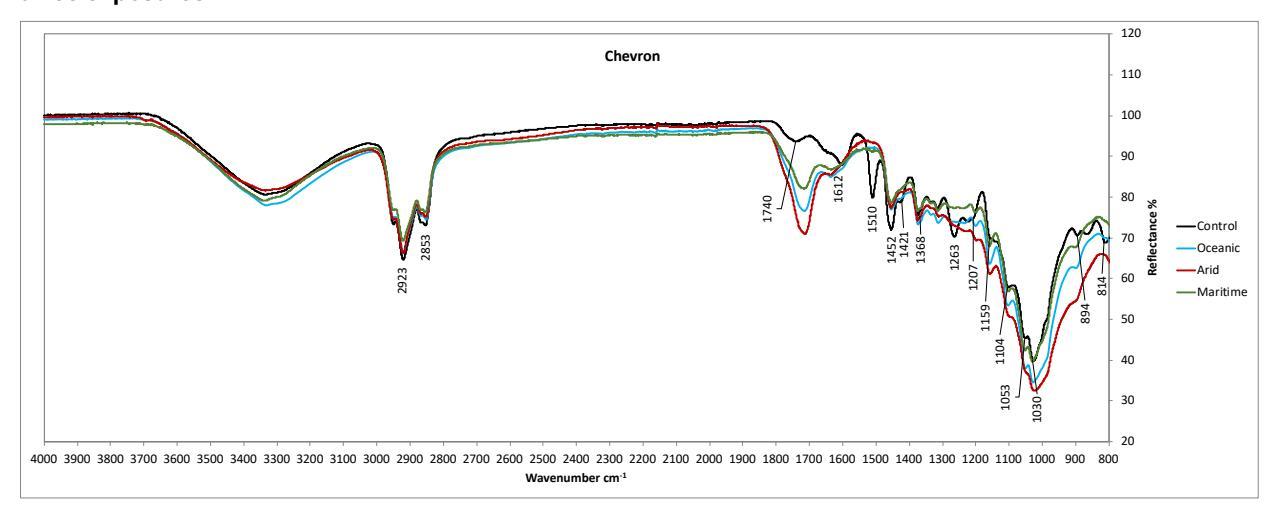
Figure A 3. FTIR spectra of Chevron coated wood before weathering (Control) and following the weathering at three exposures.

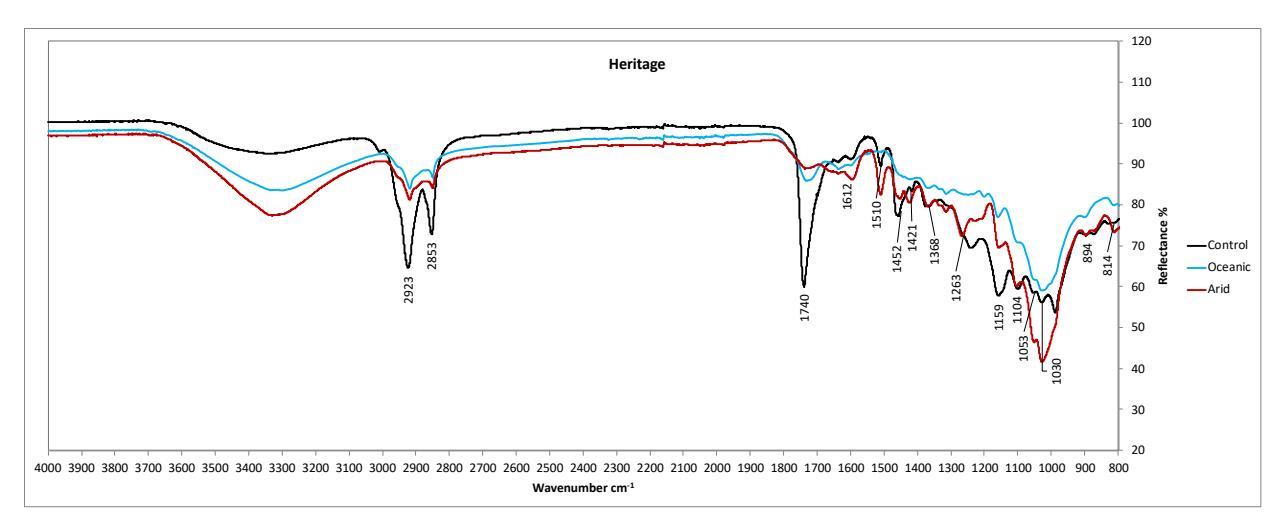
Figure A 4. FTIR spectra of Heritage coated wood before weathering (Control) and following the weathering at three exposures.

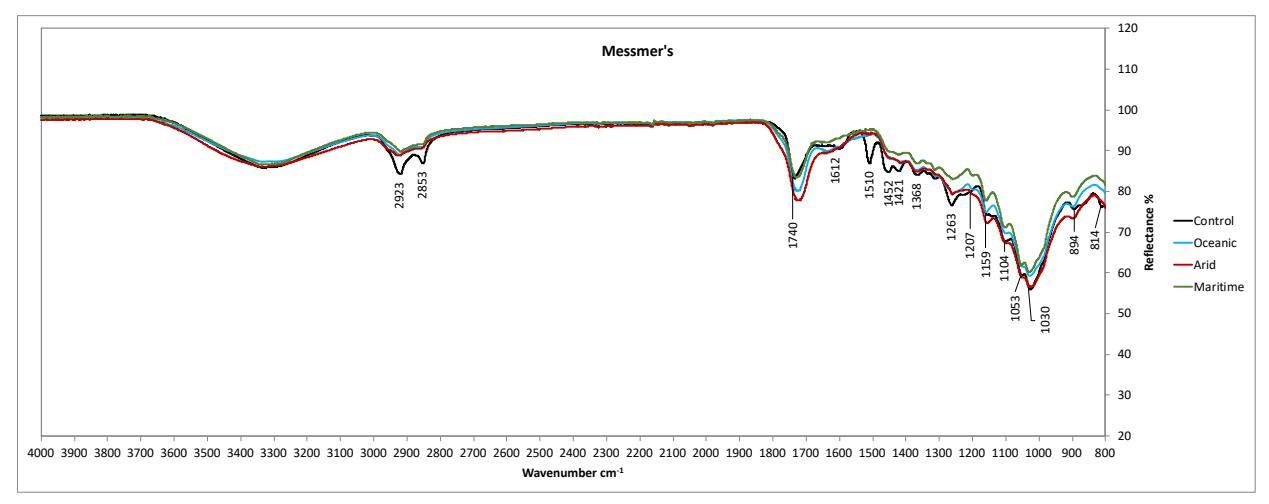
Figure A 5. FTIR spectra of Messmer's coated wood before weathering (Control) and following the weathering at three exposures.
