2016 Preservation Technology and Training Grant Federal Grant Number: P16AP00194

PROTECTIVE TREATMENTS FOR WESTERN REDCEDAR SHINGLE AND SHAKE ROOFS

REPORT

Washington State Parks & Recreation Commission

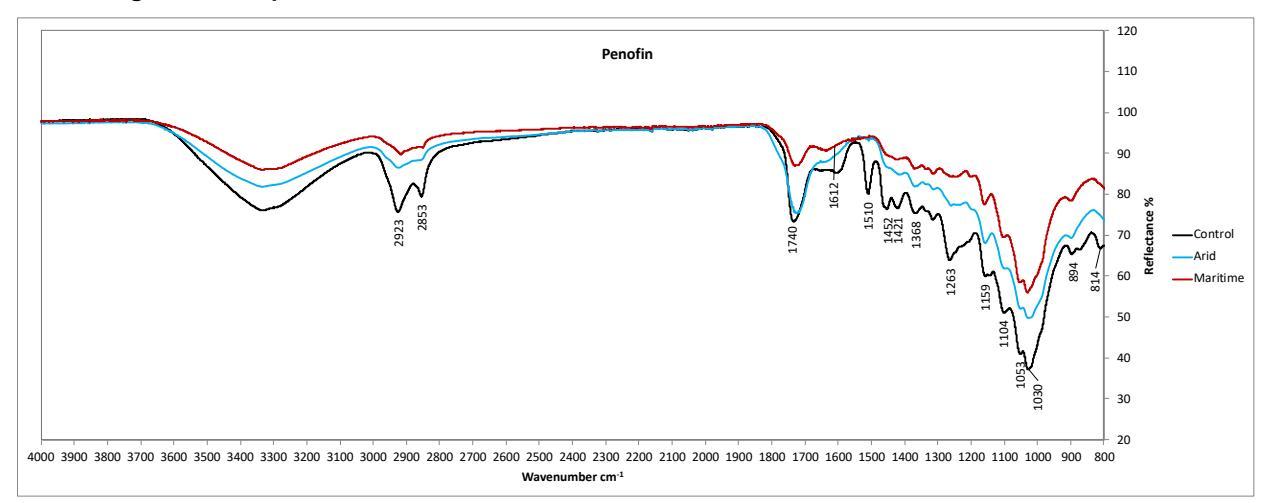
Figure A 6. FTIR spectra of Penofin coated wood before weathering (Control) and following the weathering at Arid and Maritime exposures.

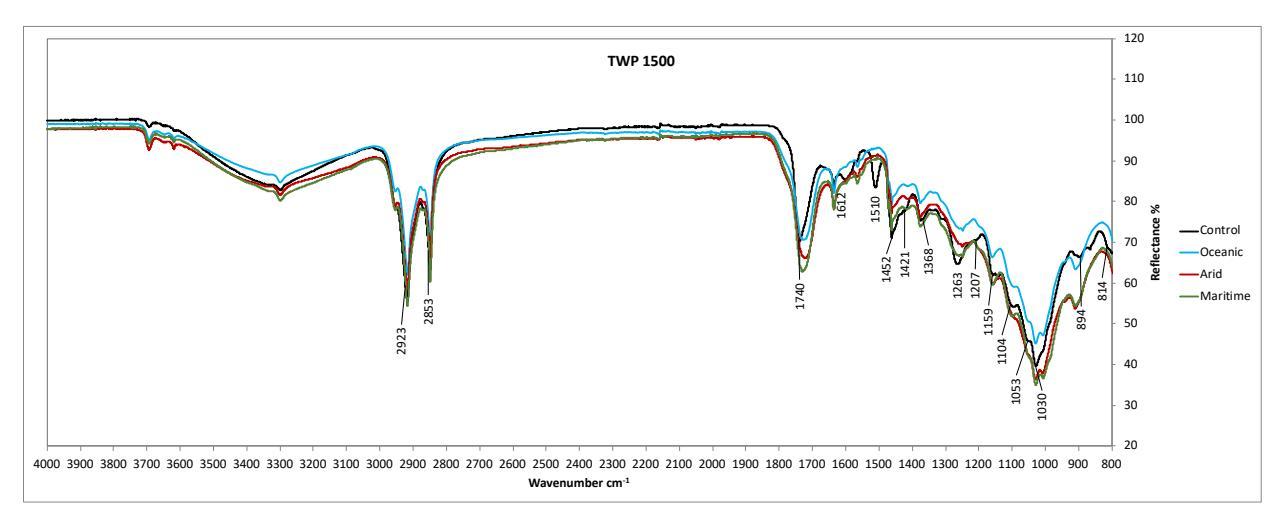
Figure A 7. FTIR spectra of TWP 1500 coated wood before weathering (Control) and following the weathering at three exposures.

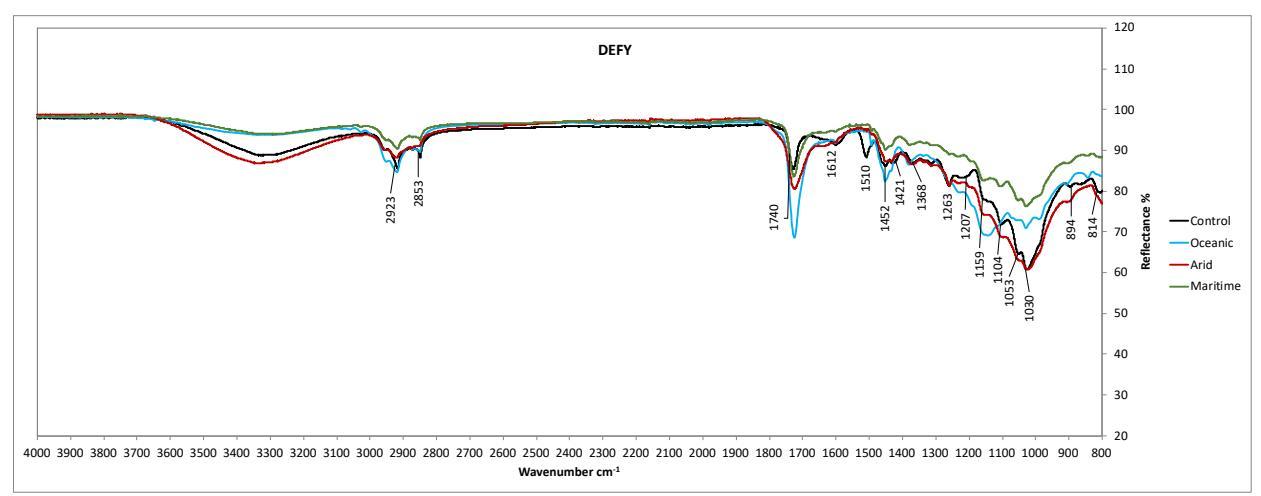
Figure A 8. FTIR spectra of DEFY coated wood before weathering (Control) and following the weathering at three exposures.

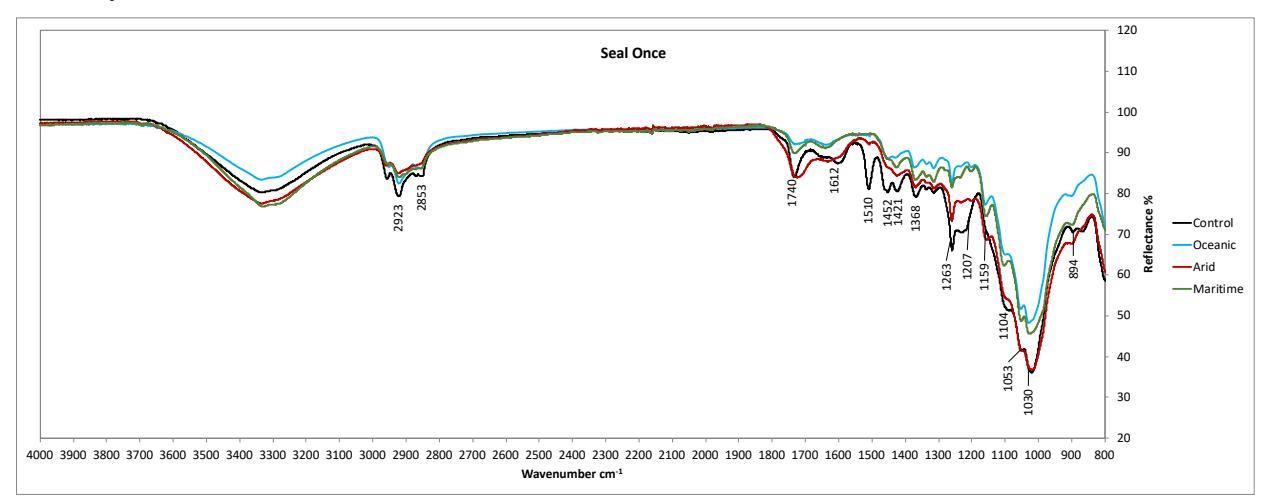
Figure A 9. FTIR spectra of Seal Once coated wood before weathering (Control) and following the weathering at three exposures.

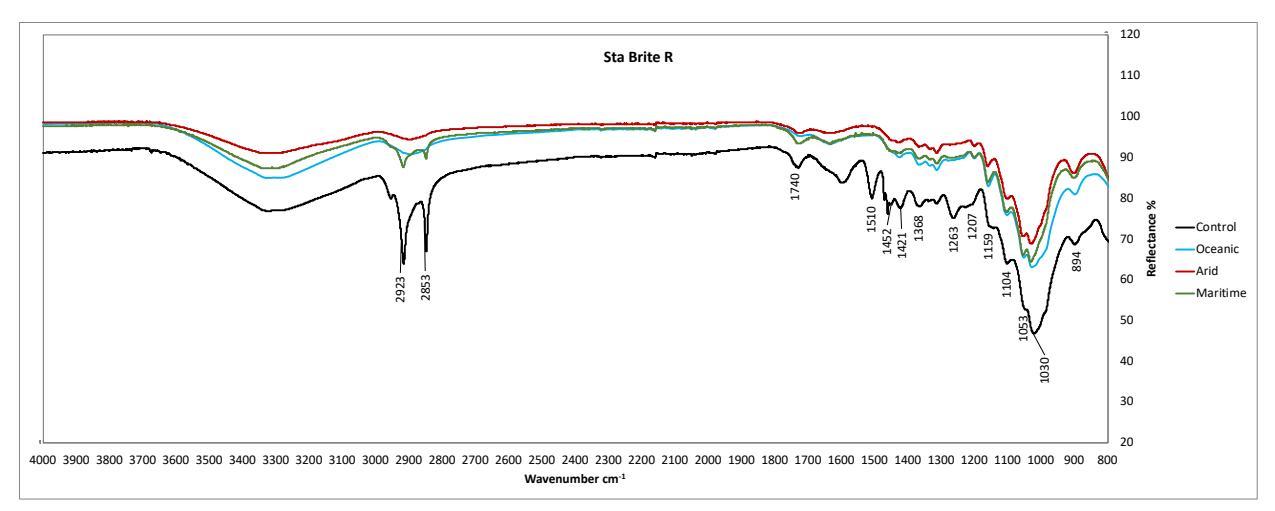
Figure A 10. FTIR spectra of Sta Brite R coated wood before weathering (Control) and following the weathering at three exposures.
