The Significance of Magnolia Plantation

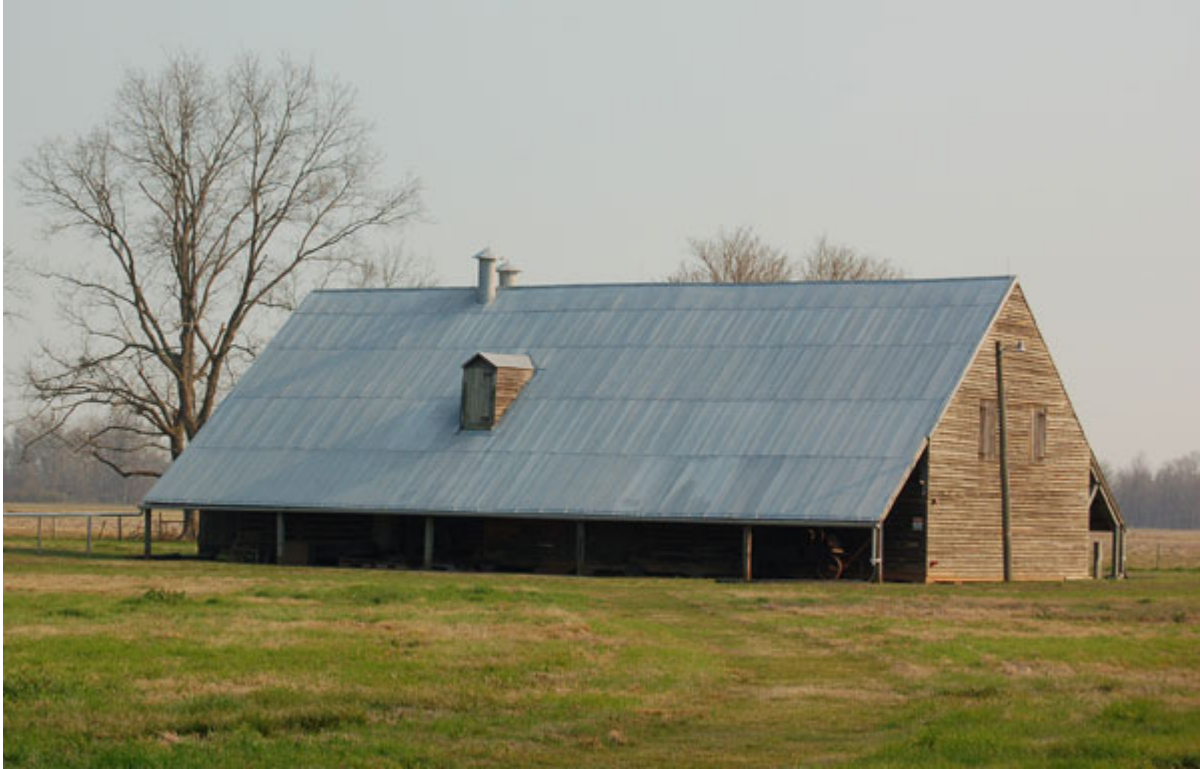
slave quarters cabins, a plantation store, a corn crib, a blacksmith shop, a pigeonier, and a cotton press-gin building.

The cotton press-gin building contains a rare cotton press and two types of gins. These remnants of a working plantation are invaluable in understanding southern antebellum agricultural practices. The unusually large overseer's house is a hip-roof, raised Acadian cottage, which is almost completely surrounded by square post galleries. This structure served as the family residence after the Civil War to the reconstruction of the large plantation house. Modifications to the overseer's house include the tin roof and the interior, which is much reworked. The transom, doors, windows, and

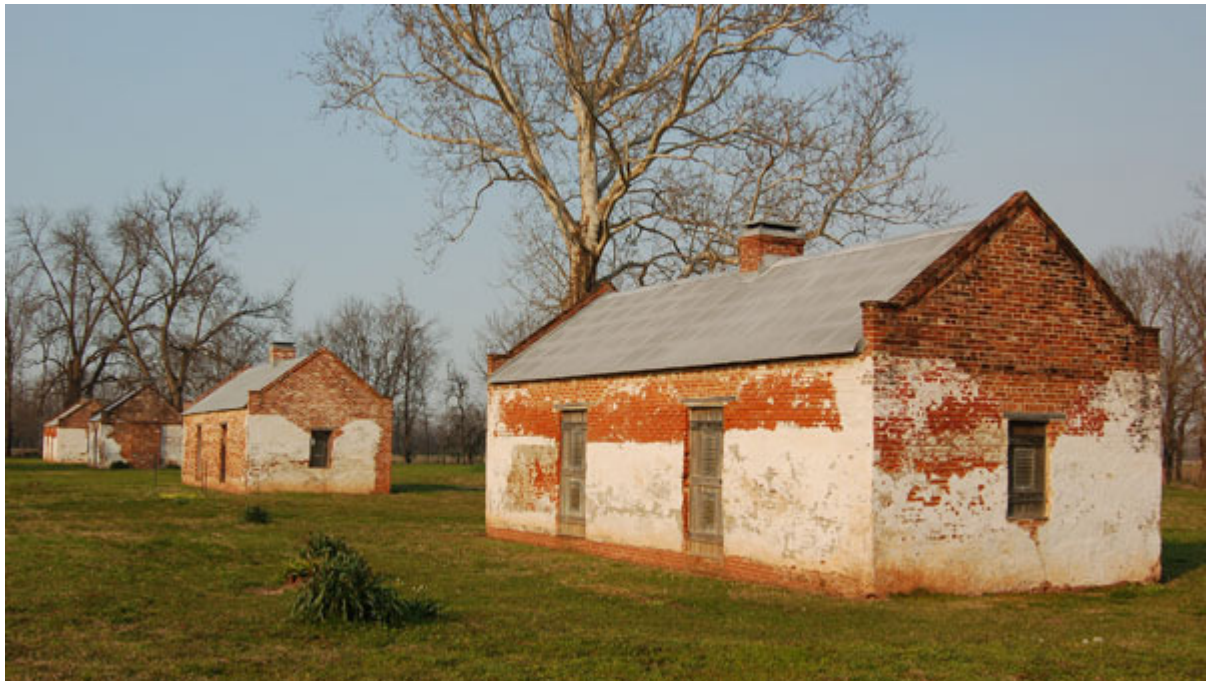
Of the original slave dwellings, eight remain in a double row in the southeast portion of the plantation.

These are brick, two-room, galleried houses with central chimneys and gable parapets - unusually high quality construction for slave cabins. Each fireplace has an iron lintel. There has been some deterioration, including the loss of several parapets, chimney tops, windows, and doors. In addition, some gallery roofs have collapsed. The cotton press dates back to ca. 1830 and is one of about five or six
