**CASTILLO DE SAN MARCOS
NATIONAL MONUMENT
HISTORIC RESOURCE STUDY**

March 1997

Jennifer D. Brown

National Park Service
Southeast Region
Atlanta, Georgia

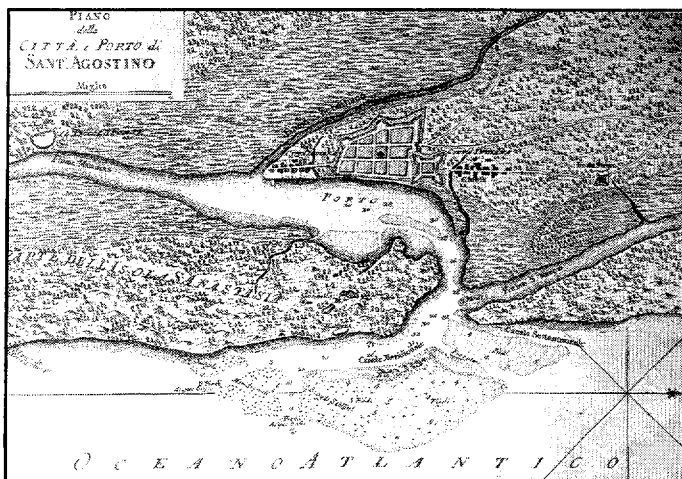
Figure 3. Plan of St. Augustine, 1660

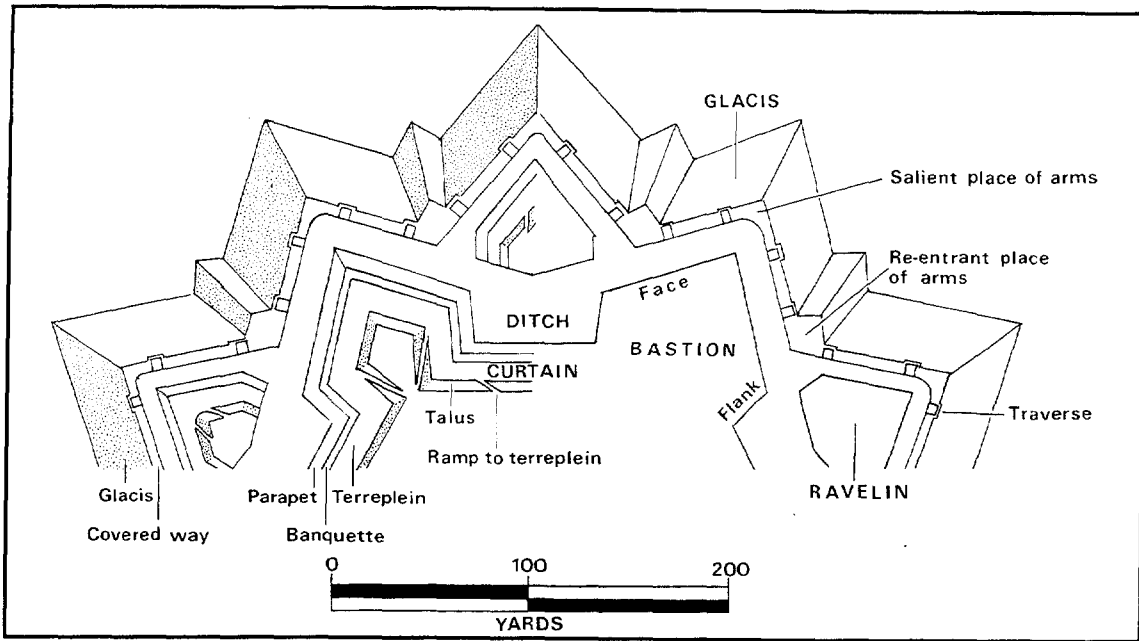
Figure 4. Plan of a simple bastioned fort

fortress and allowed the defenders to move farther into the landscape against the enemy. As a complete defensive fortification, the bastioned fort and its outer defenses provided a great deal of security to its occupants during a siege, although a persistent enemy might breach the walls given sufficient time and manpower.¹³

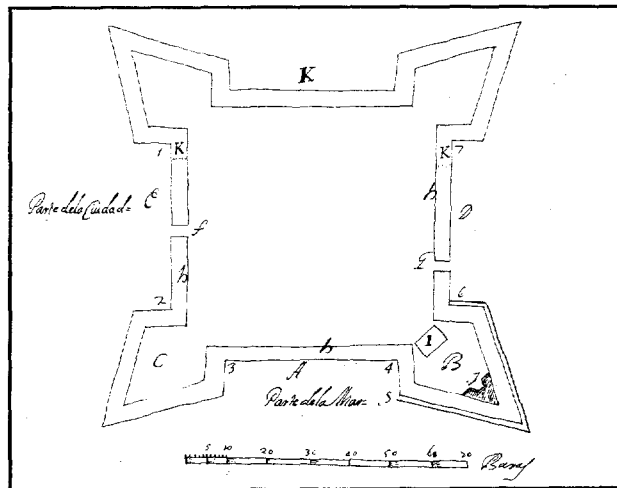
Figure 5. Plan of Castillo, 1675

Local Indians, convicts, African-American slaves, and occasionally Spanish soldiers labored alongside the skilled workers imported from Cuba. Work progressed at a steady rate on the fortress, although funding shortages and disease epidemics occasionally slowed construction. By 1686, the main block of the Castillo was complete. At that time, the outer curtain walls and bastions of the fort were coquina, while the interior walls and roof were wood; the terreplein was made of tabby, a cement made of lime and seashells, laid on top of wood planks. The fort housed troop quarters, a chapel, and a number of storerooms for the garrison. Ten years later, the moat and seawall were finished, thus enhancing the Castillo's defenses.¹⁷

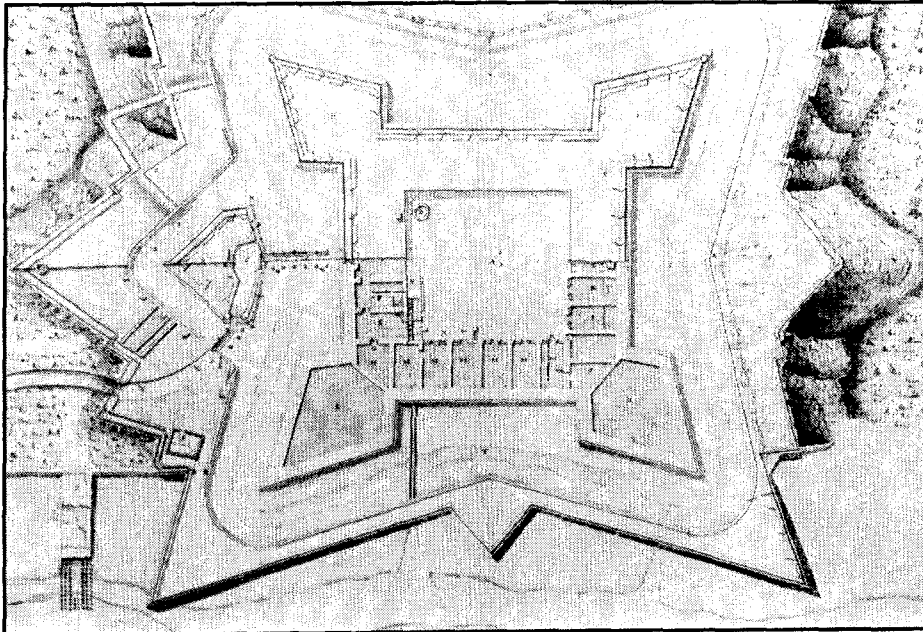
Figure 6. Plan of Castillo, 1763

the fortress walls and improved outer defense works. By 1739, the eight vaults along the east curtain wall were completed, increasing the total height of the wall five feet. The outbreak of war between England and Spain the same year slowed construction, however, and completion of the project was postponed until the end of the war.²²

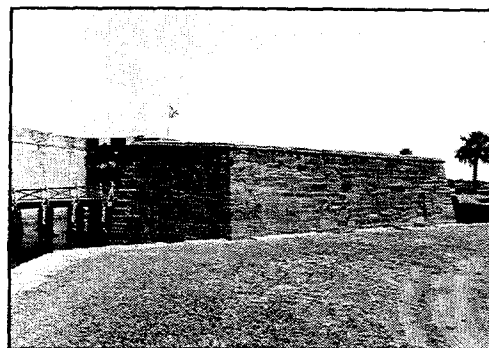
Figure 7. Ravelin viewed from west, 1995

In 1762 the Spanish undertook the last of their construction projects at the Castillo. Town residents volunteered their labor to enlarge the covered way by five feet, and masons constructed a six-foot-high stone parapet on top. Construction of the glacis was also completed at this time. Engineers determined that the original ravelin was inadequate to the defense of the fort's entrance; therefore, a new, larger ravelin, capable of housing five cannon and an underground powder magazine, was built by the end of the year.²⁴

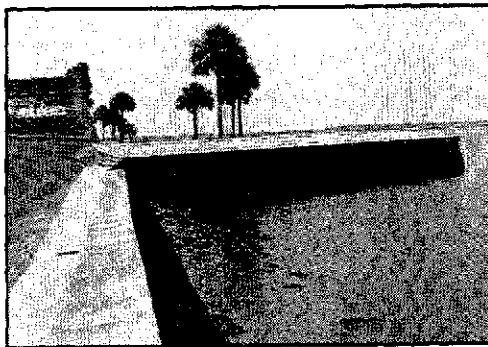
Figure 11. View of seawall from south, 1991

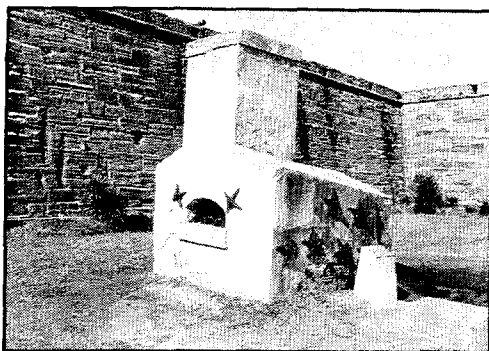
Figure 12. View of hot shot furnace from south, 1995

The completion of the water battery and hot shot furnace in 1844 ended construction projects at Fort Marion. The fort's defenses were updated sufficiently to be included as part of the nation's coastal defense system. Like many of the contemporary fortifications along the American coastline, however, the fort lacked one ingredient key to its defense: a garrison to man its guns. When Confederate troops came to take over Fort Marion in 1861, they found only one elderly caretaker occupying the fortress.⁴⁸

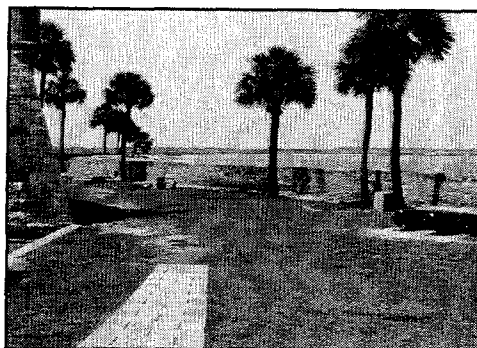
Figure 13. View of water battery from south, 1991

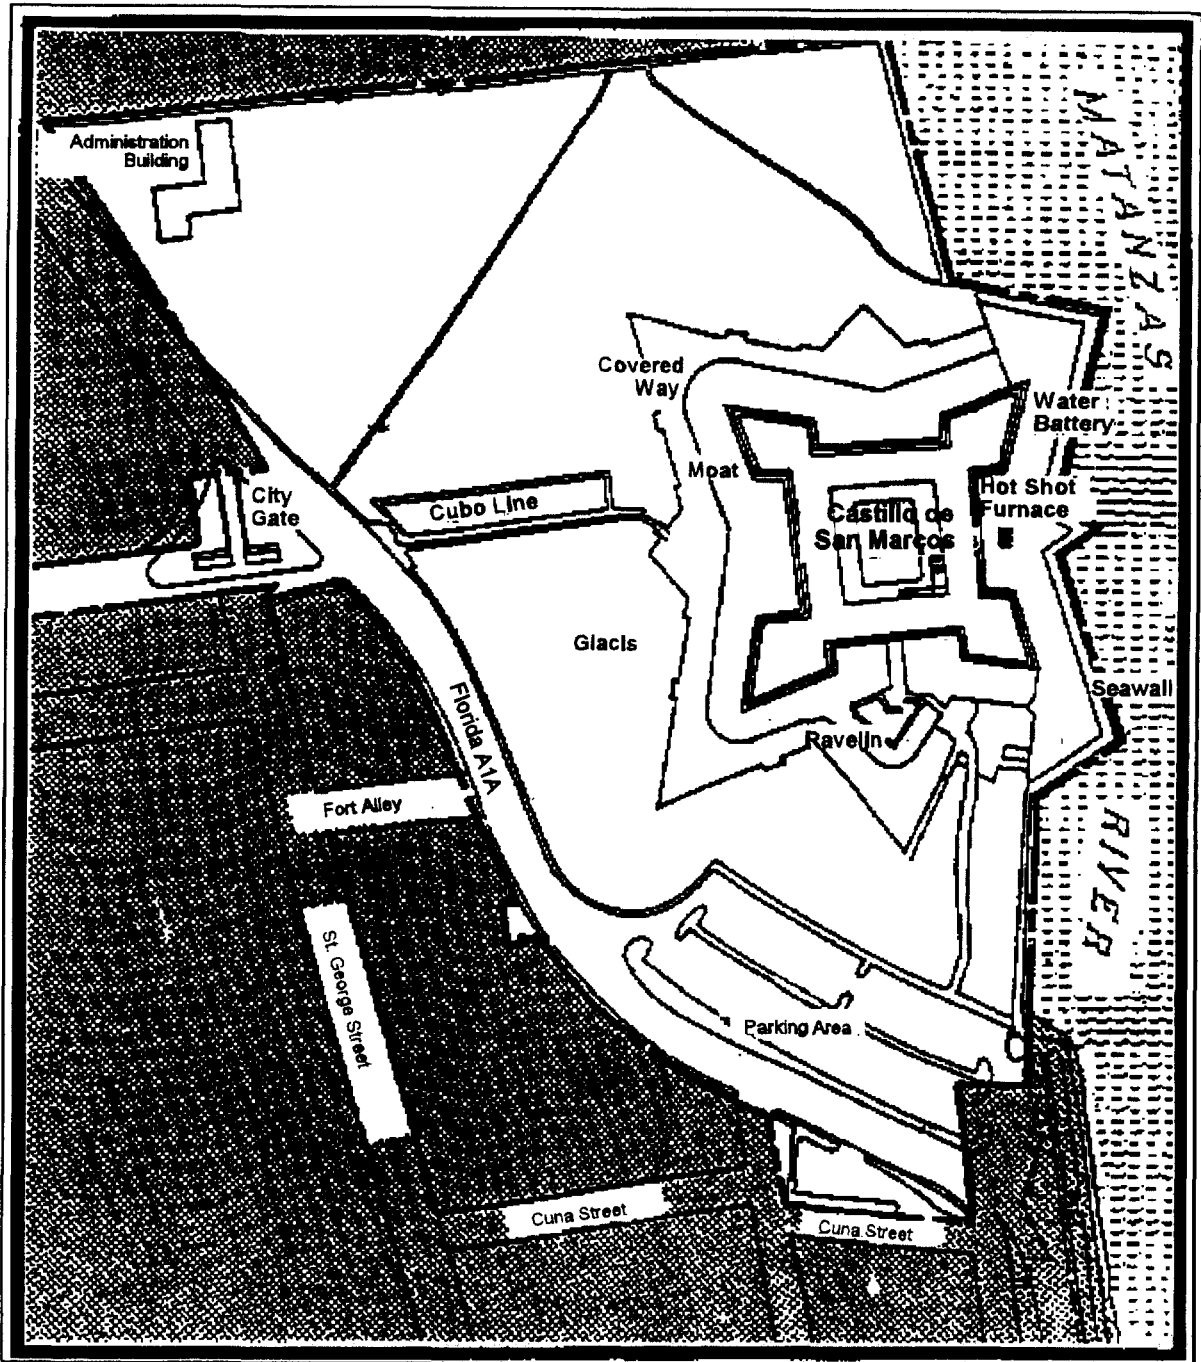
Castillo de San Marcos National Monument
Historical Base Map

The historical base map (Appendix B) depicts the existing historic resources within the park that are documented in this study. The map shows the Park boundaries, nearby bodies of water, and major area highways. National Park Service maps prepared by the Denver Service Center for the Park's General Management Plan served as the basis for the maps included in this study. The historical base map does not attempt to depict a historic scene or identify nonextant historic structures.
