SAUGUS IRON WORKS
IRONMASTER'S HOUSE

NATIONAL HISTORIC SITE / MASSACHUSETTS

HISTORIC STRUCTURE REPORT
IRONMASTER'S HOUSE
HISTORICAL AND ARCHITECTURAL DATA
AND
A HISTORY OF OWNERSHIP
SAUGUS IRON WORKS NATIONAL HISTORIC SITE
MASSACHUSETTS

November 1977

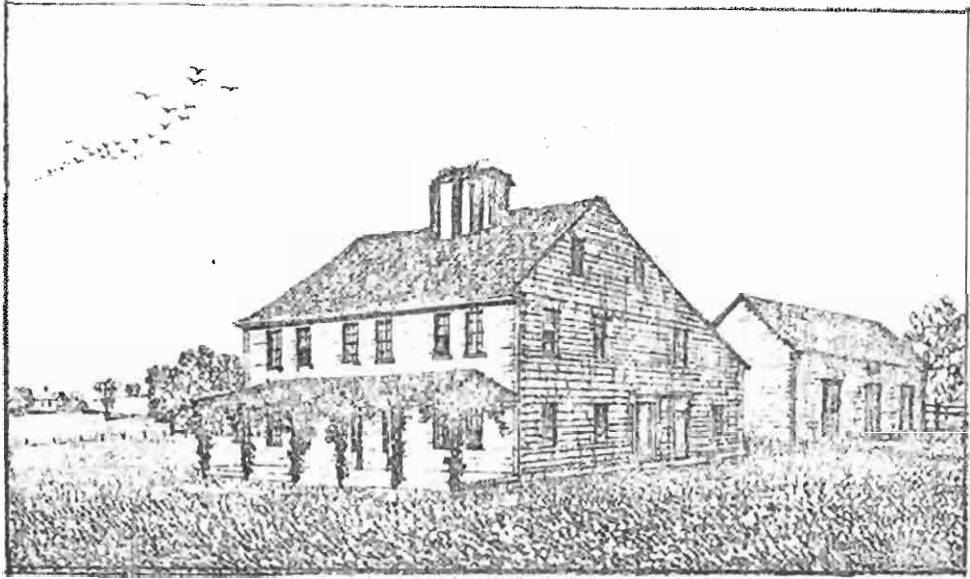
The Iron Works House, Saugus.

This house was built by the Ironworks who here commenced the manufacture of iron, about 1643. One of the boathouses removed is the neighborhood of Saugus. The business was carried on here for 100 years afterwards. The chimney at this house is of immense size, and is probably the largest in N. England. The exterior has been somewhat modernized.

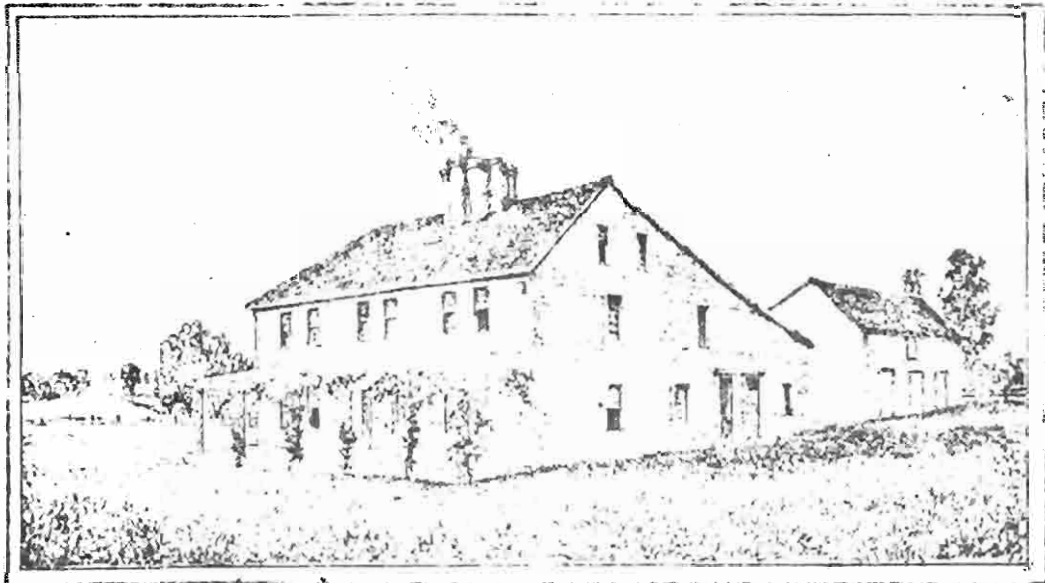
The Old Iron Works House.

This was built in 1643, but has been somewhat modernized, the piazza having been added about 1830. The chimney is of enormous size, and is probably the largest in N. England. It derives its name from the fact that the man who built it commenced the manufacture of iron in 1643. It continued to be made for 100 years afterwards.

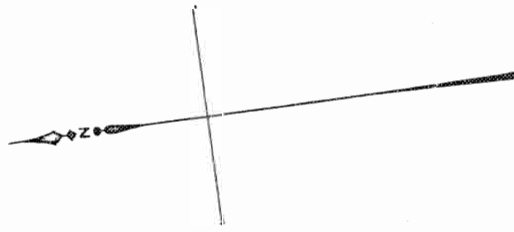
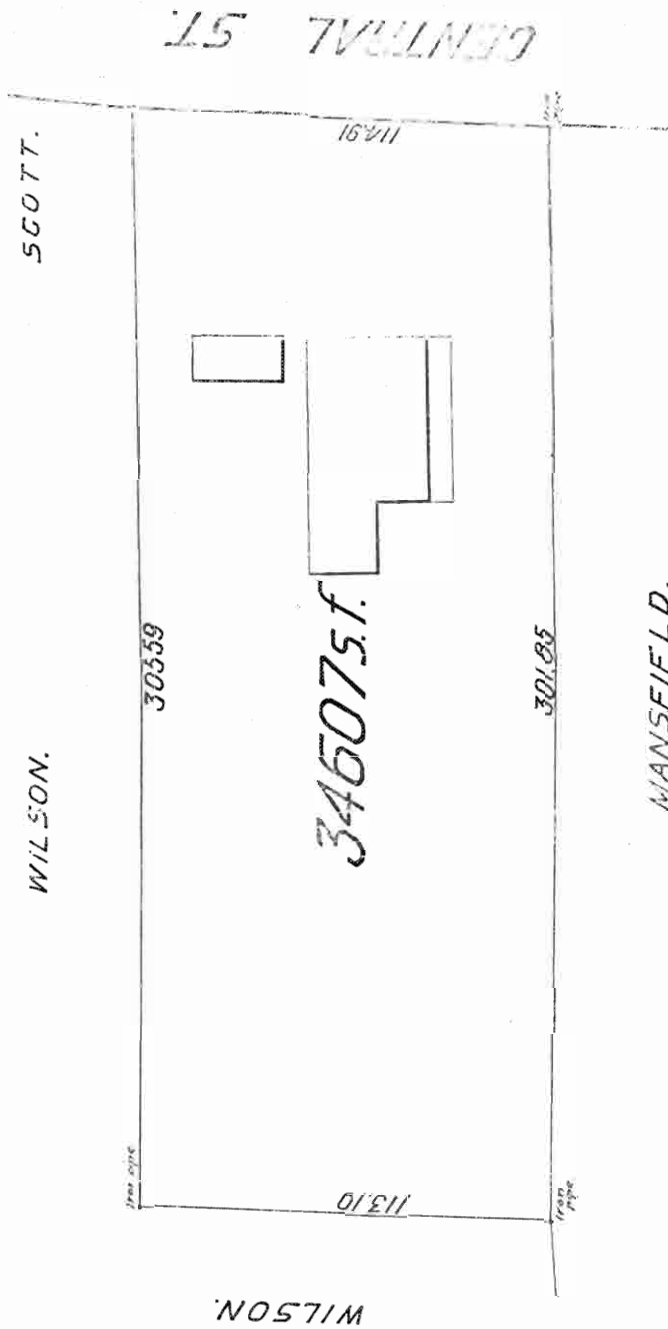
Illustration 19.

Plat accompanying the deed of sale from George Niven to Wallace Nutting, dated 1915, Essex County Deed Book 2287, p. 364.

Saugus, Mass.
 Eastman & Bradford,
 Civil Engineers,
 38 Exchange St.
 LYNN, MASS.
 Scale, 1 inch = 40 feet,
 Feb. 15, 1915.

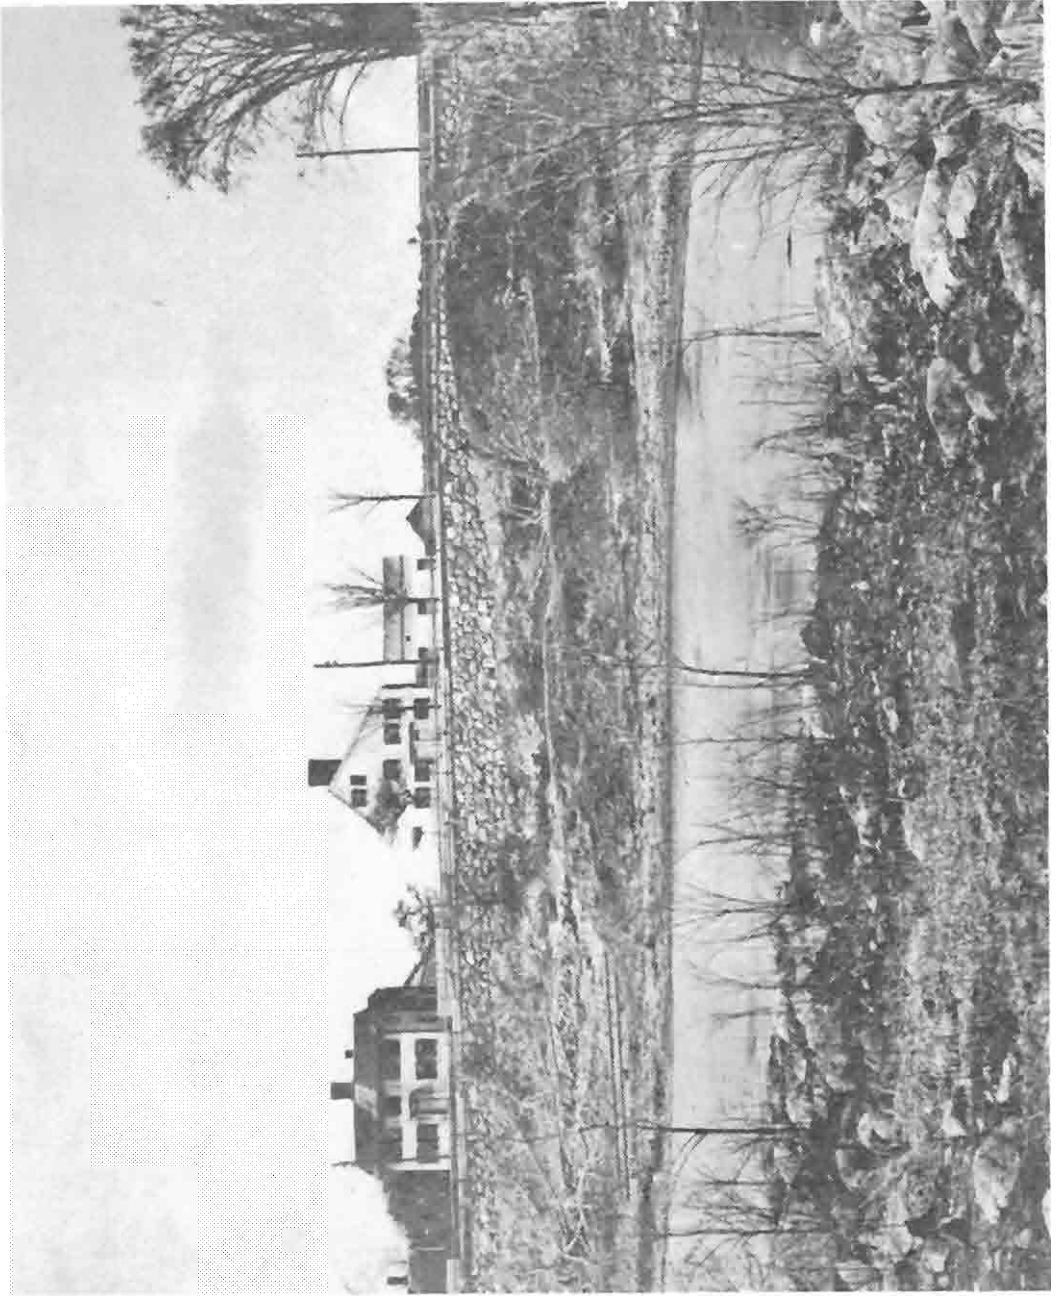
Photograph by George Bliss, 1899. It shows the structure essentially as Whitefield sketched it in 1879 and as Dean drew it in 1908. The ironworks ruins lay under the street and the stone wall.

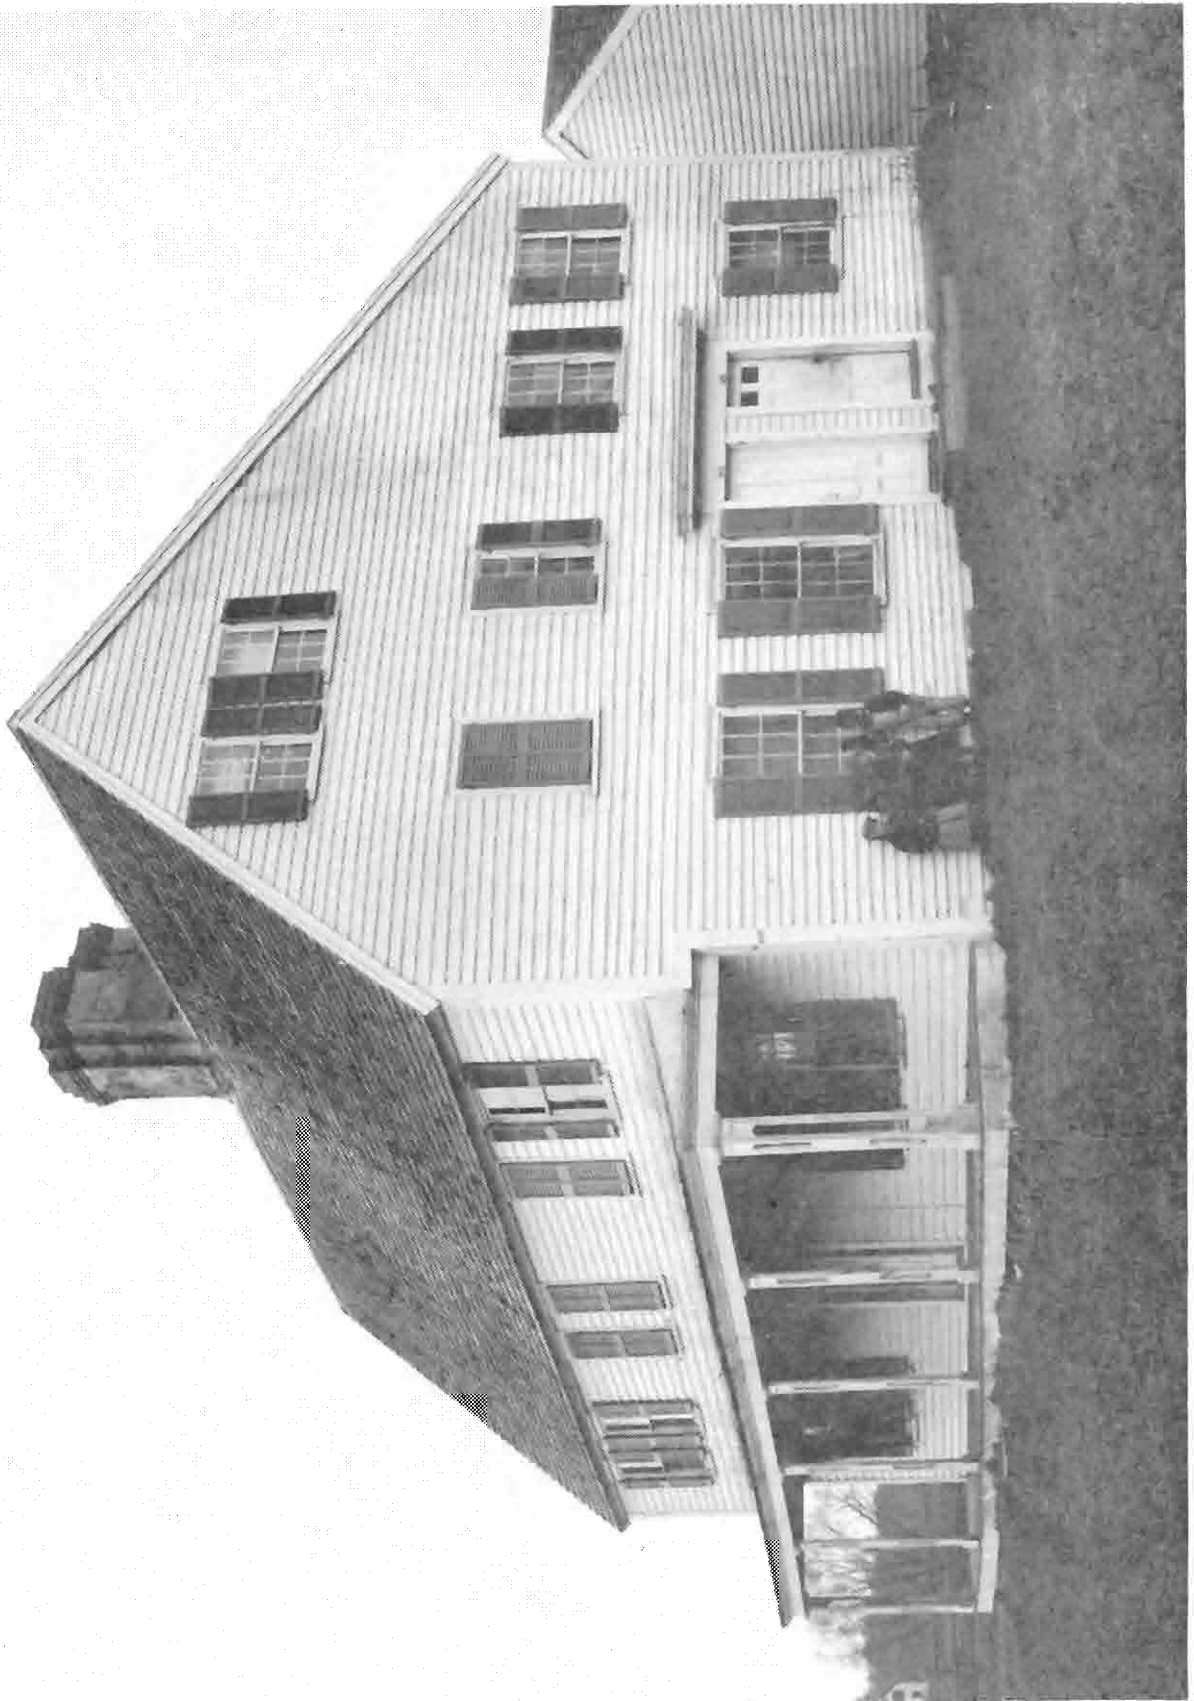
Illustration 22.

Fall or winter 1915, by Henry C. Dean. The house shows a great deal of disrepair in comparison with earlier photographs and illustrations.

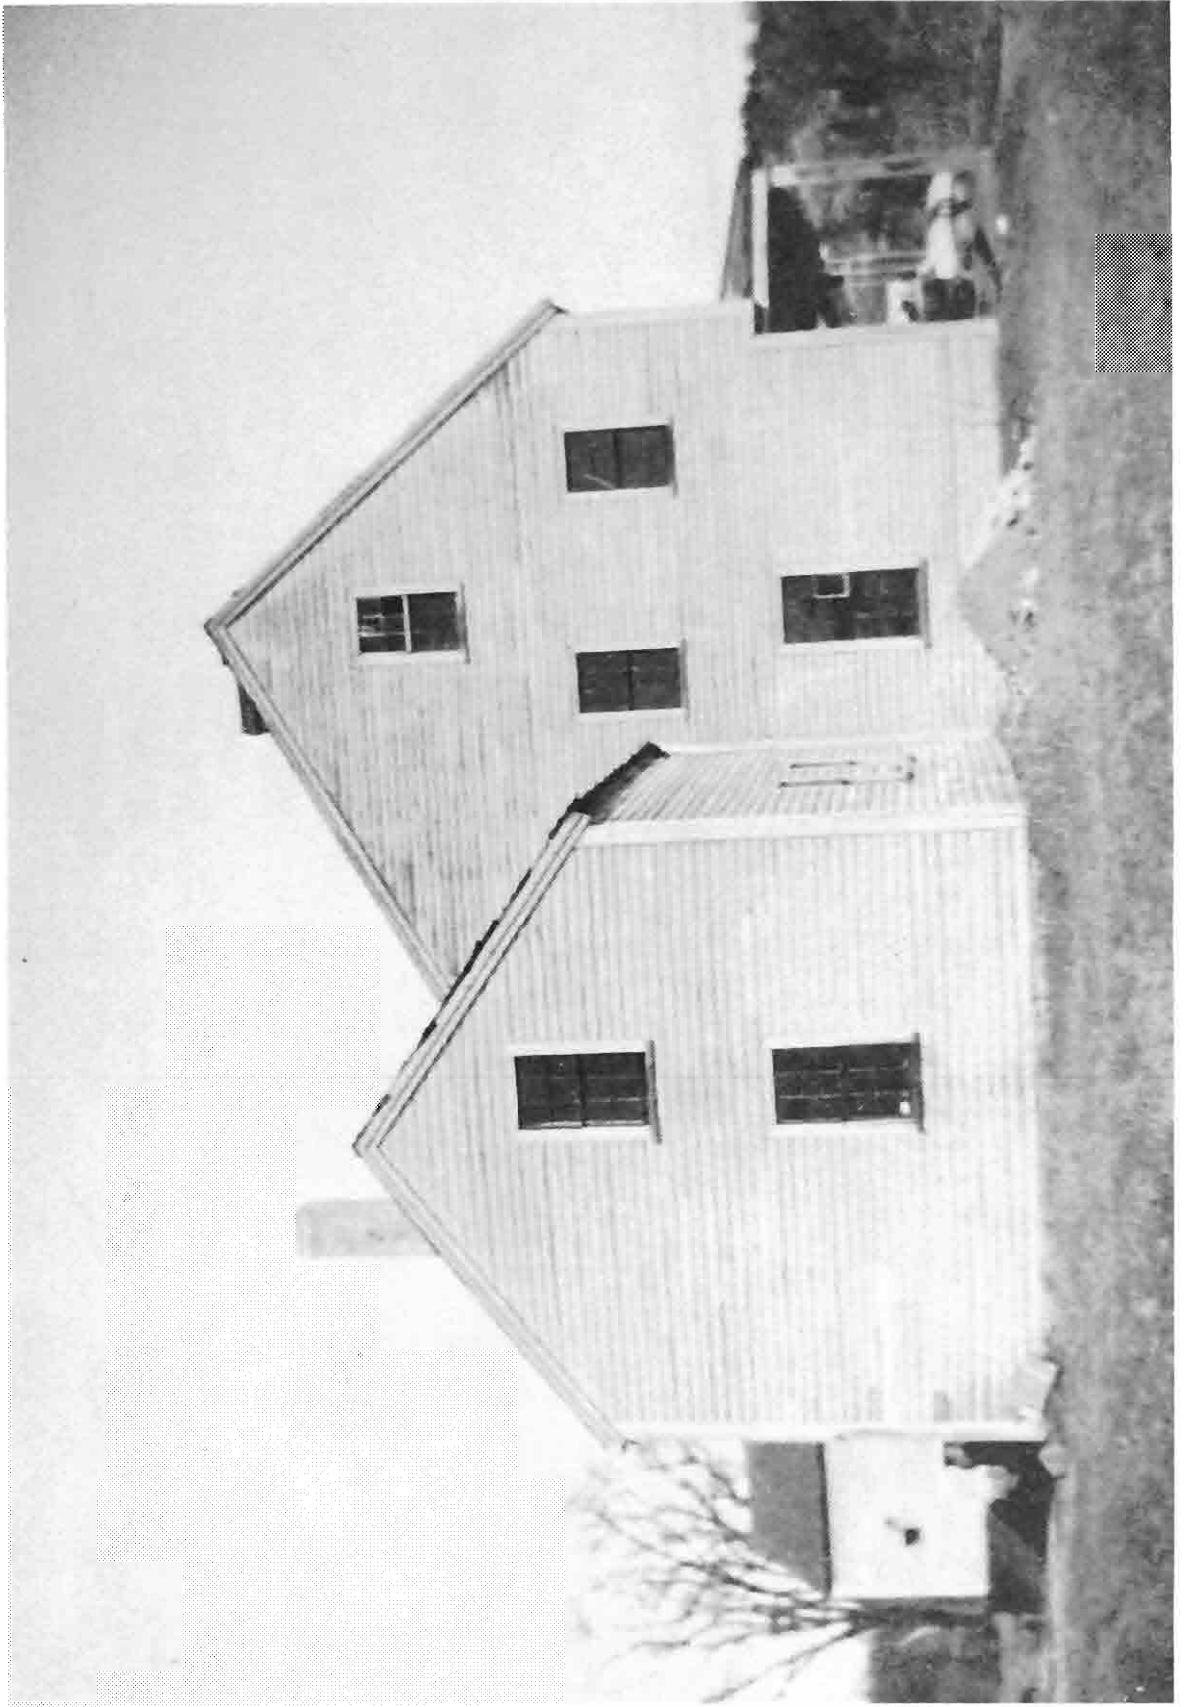
Illustration 25.

Photograph by Henry C. Dean, 1915.

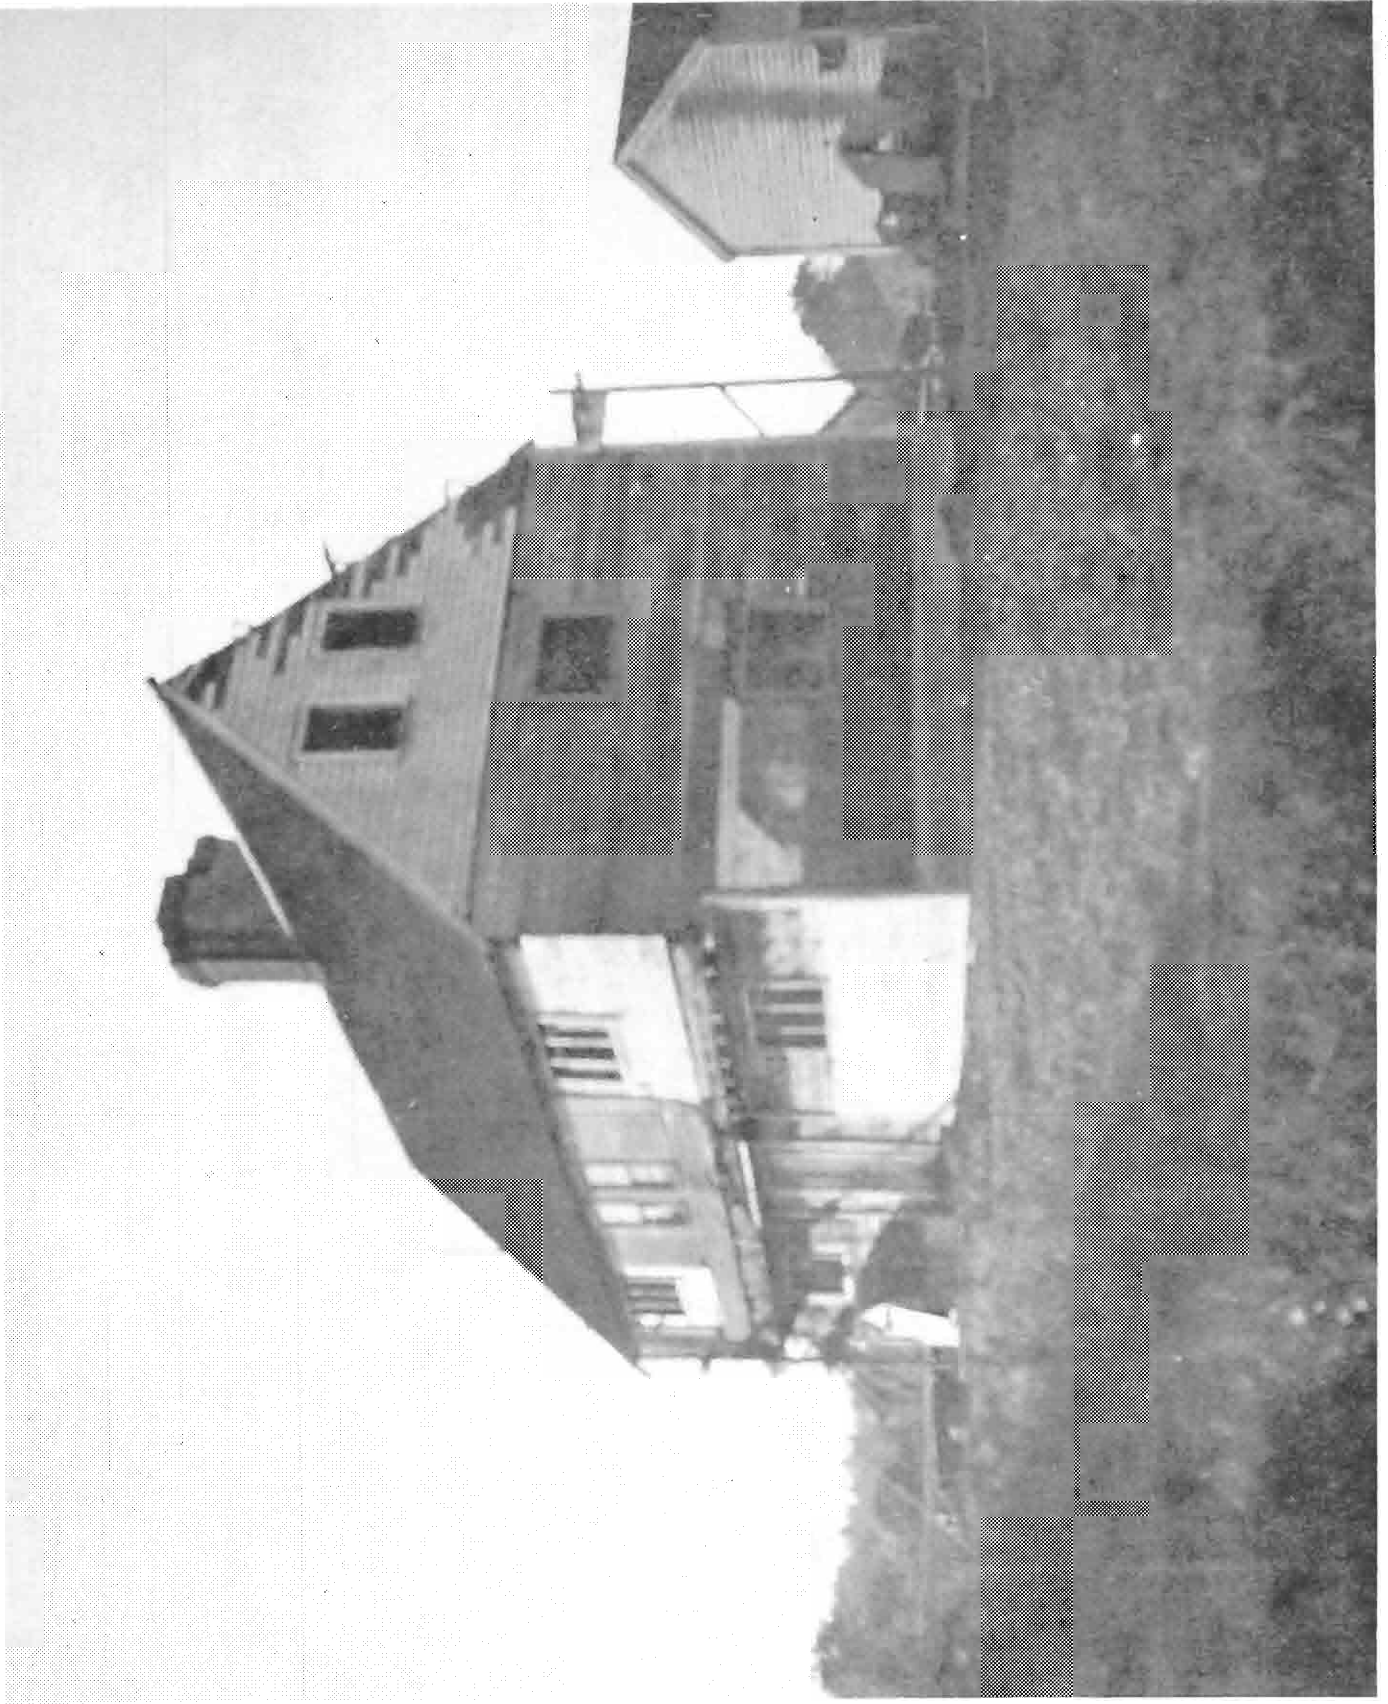
Illustration 26.

Photograph by William S. Appleton, 20 September 1915.
Restoration is obviously well under way.

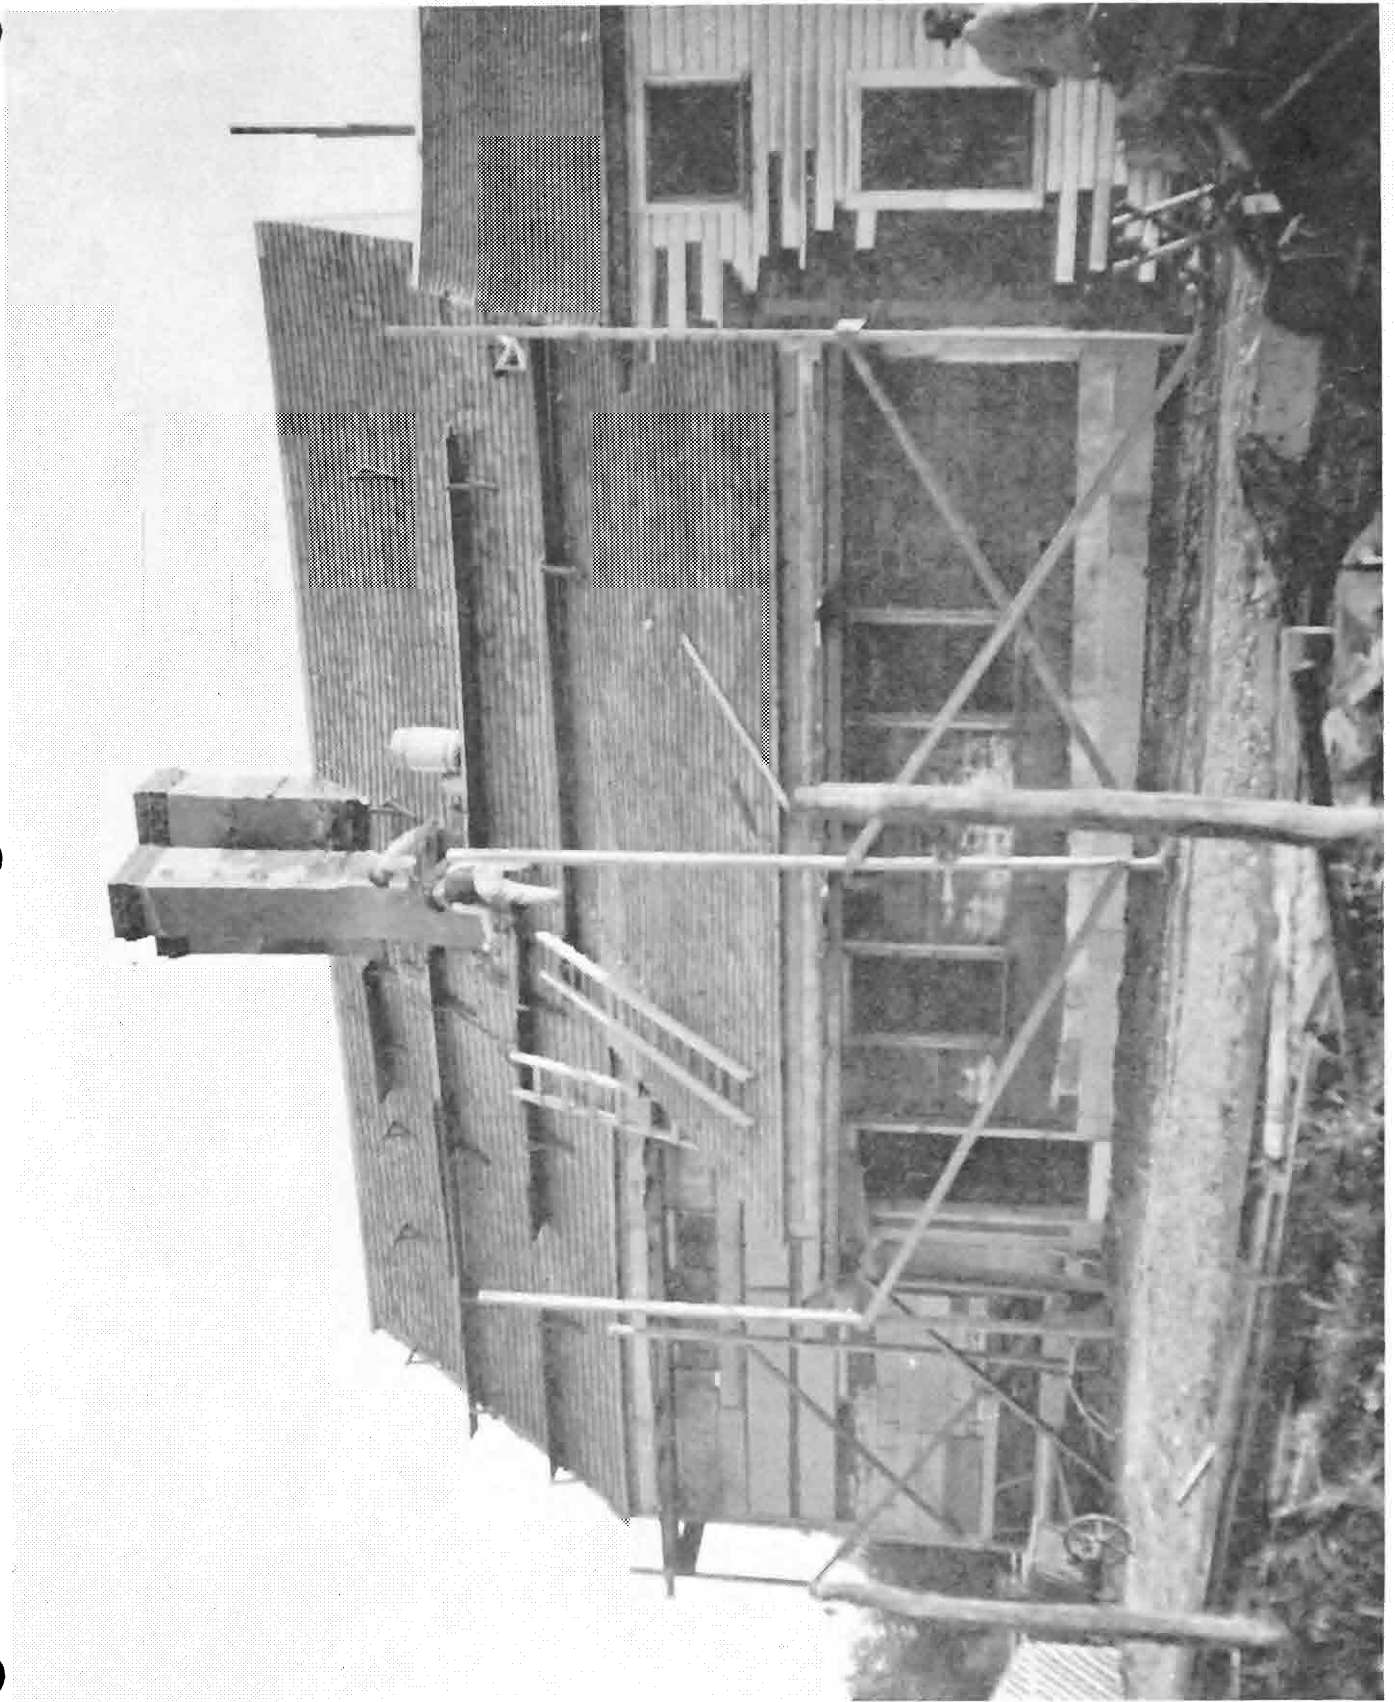
Illustration 28.

Photograph by William S. Appleton, 26 October 1915.
Detail of house front.

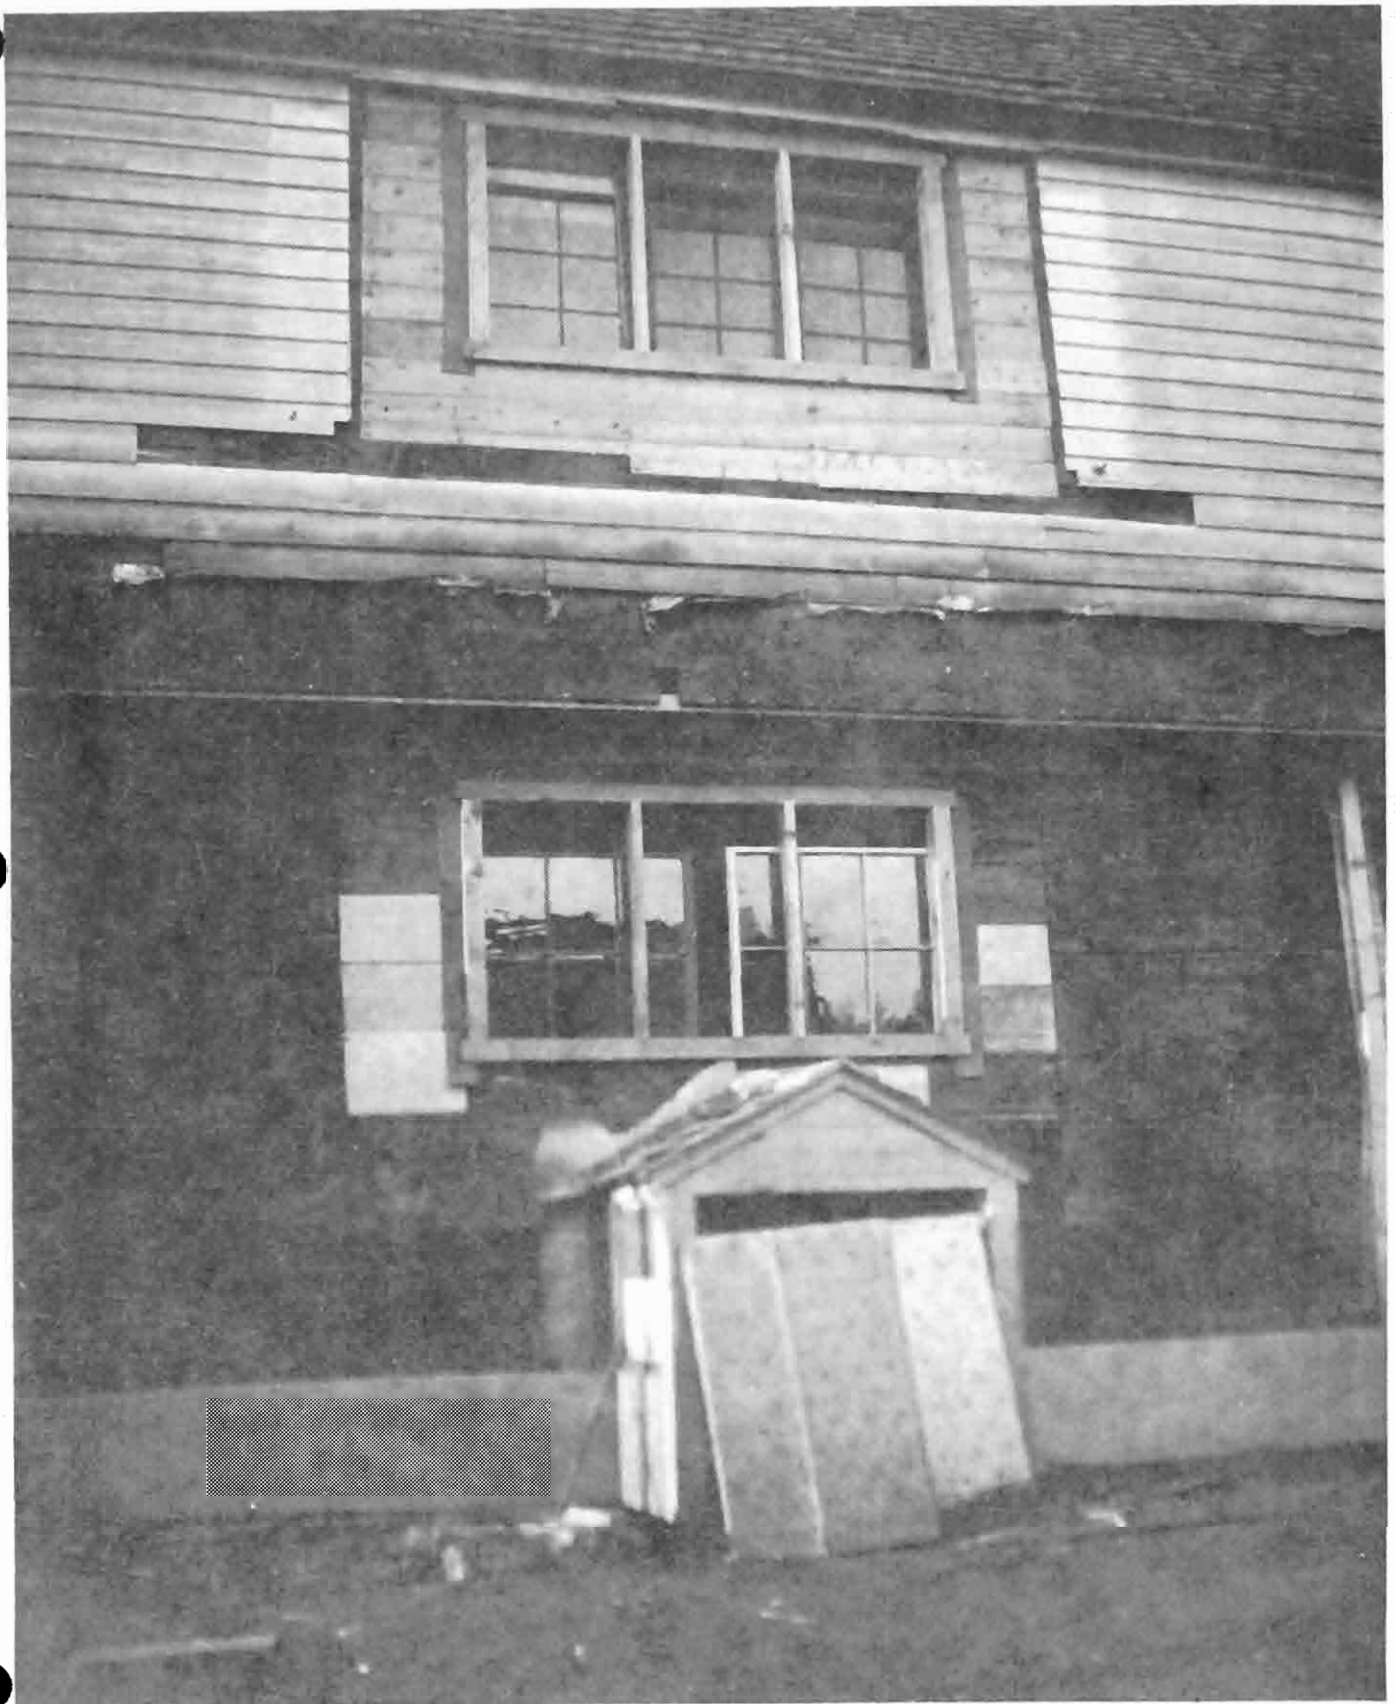
Illustration 29.

Late fall 1915 or early 1916, by Henry C. Dean.
External restoration appears complete on north and
west.

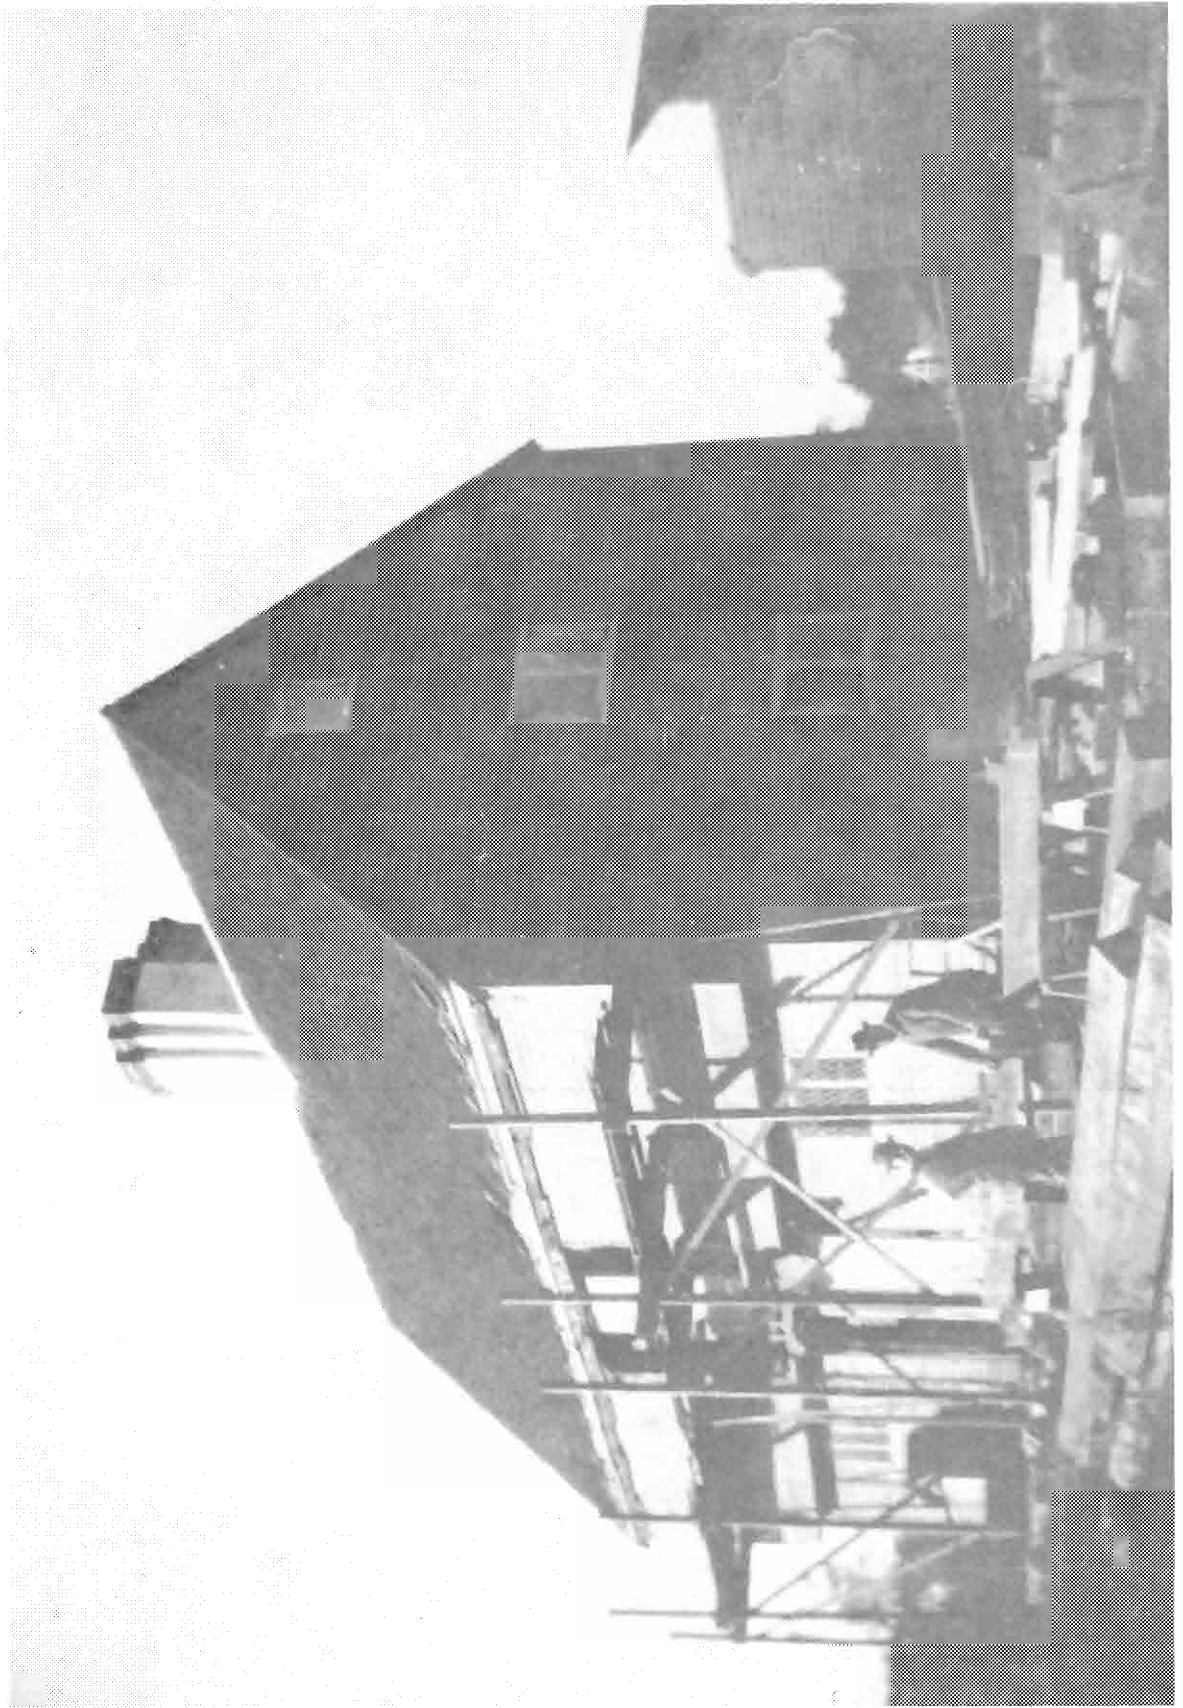
Illustration 30.

Late fall 1915 or early 1916, by Henry C. Dean. View from southeast showing front restoration virtually complete except for front porch (entrance hall).

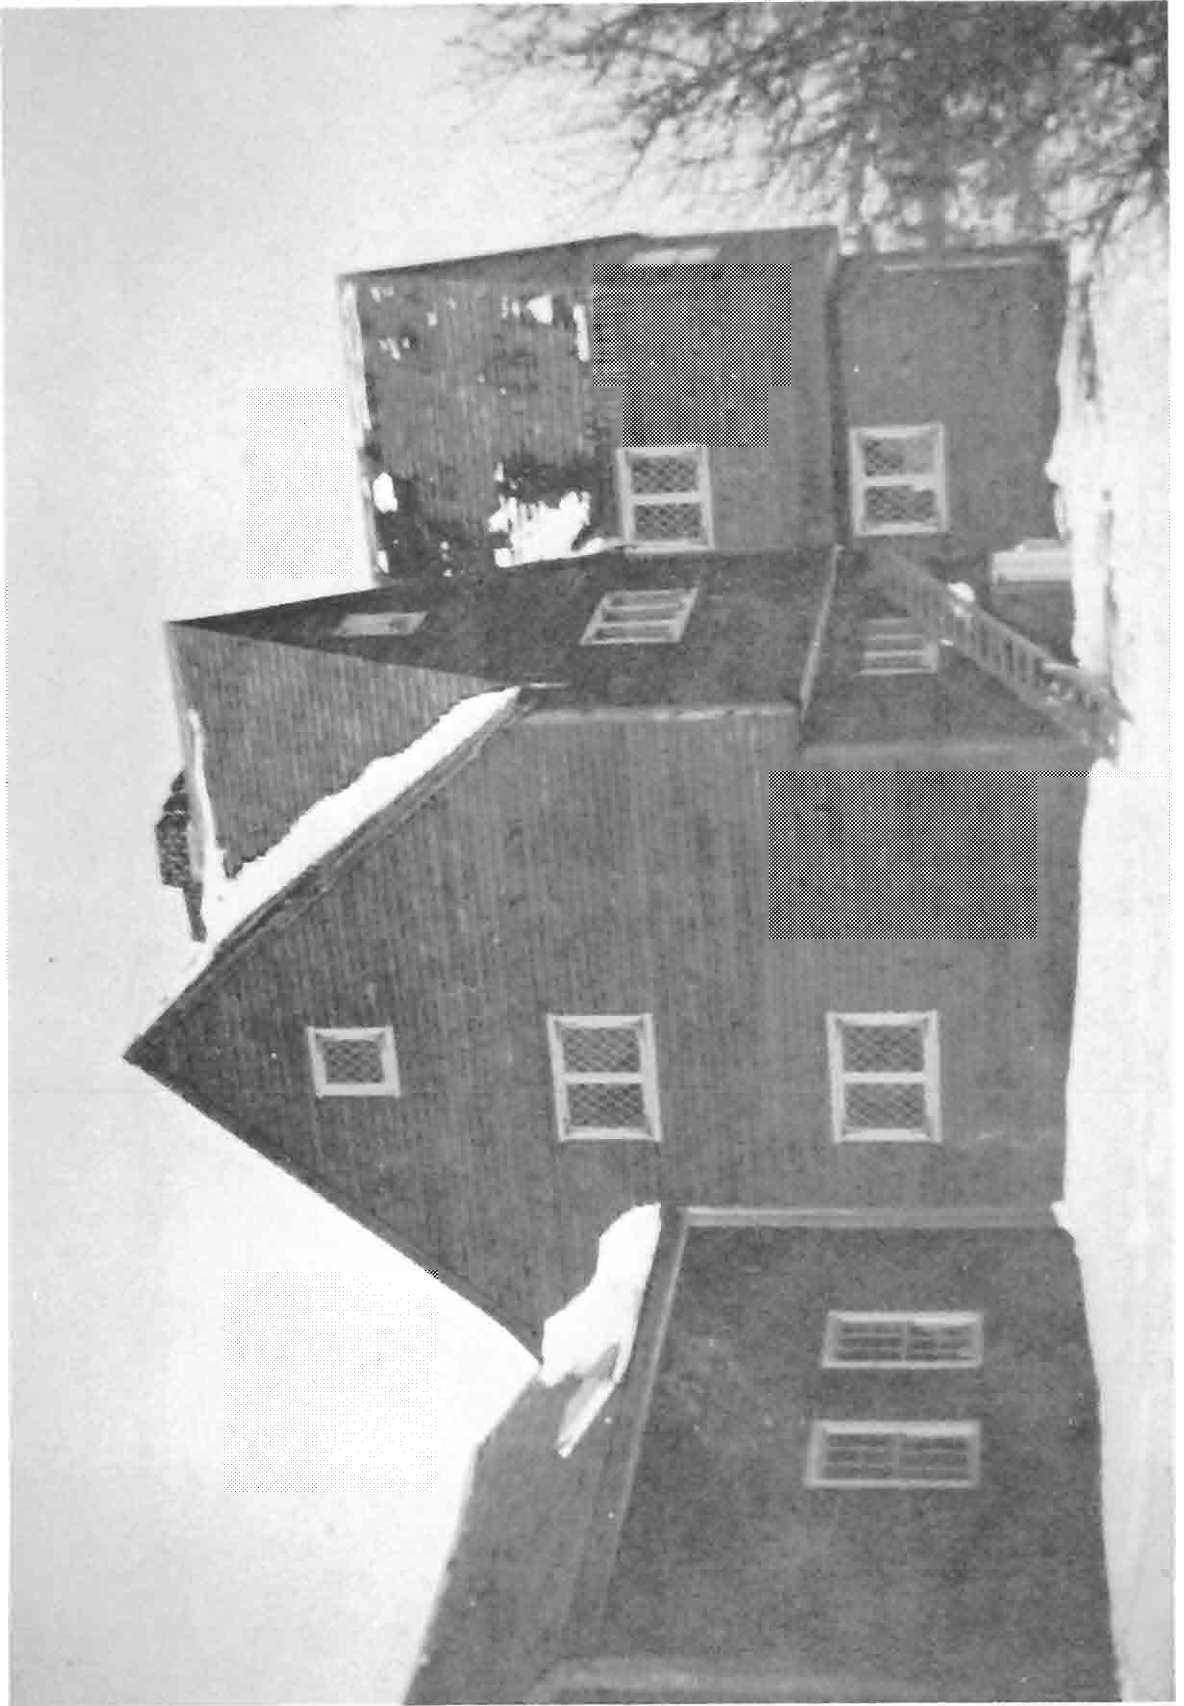
Illustration 31.

Late fall 1915 or early 1916, by Henry C. Dean.
External restoration is virtually complete.

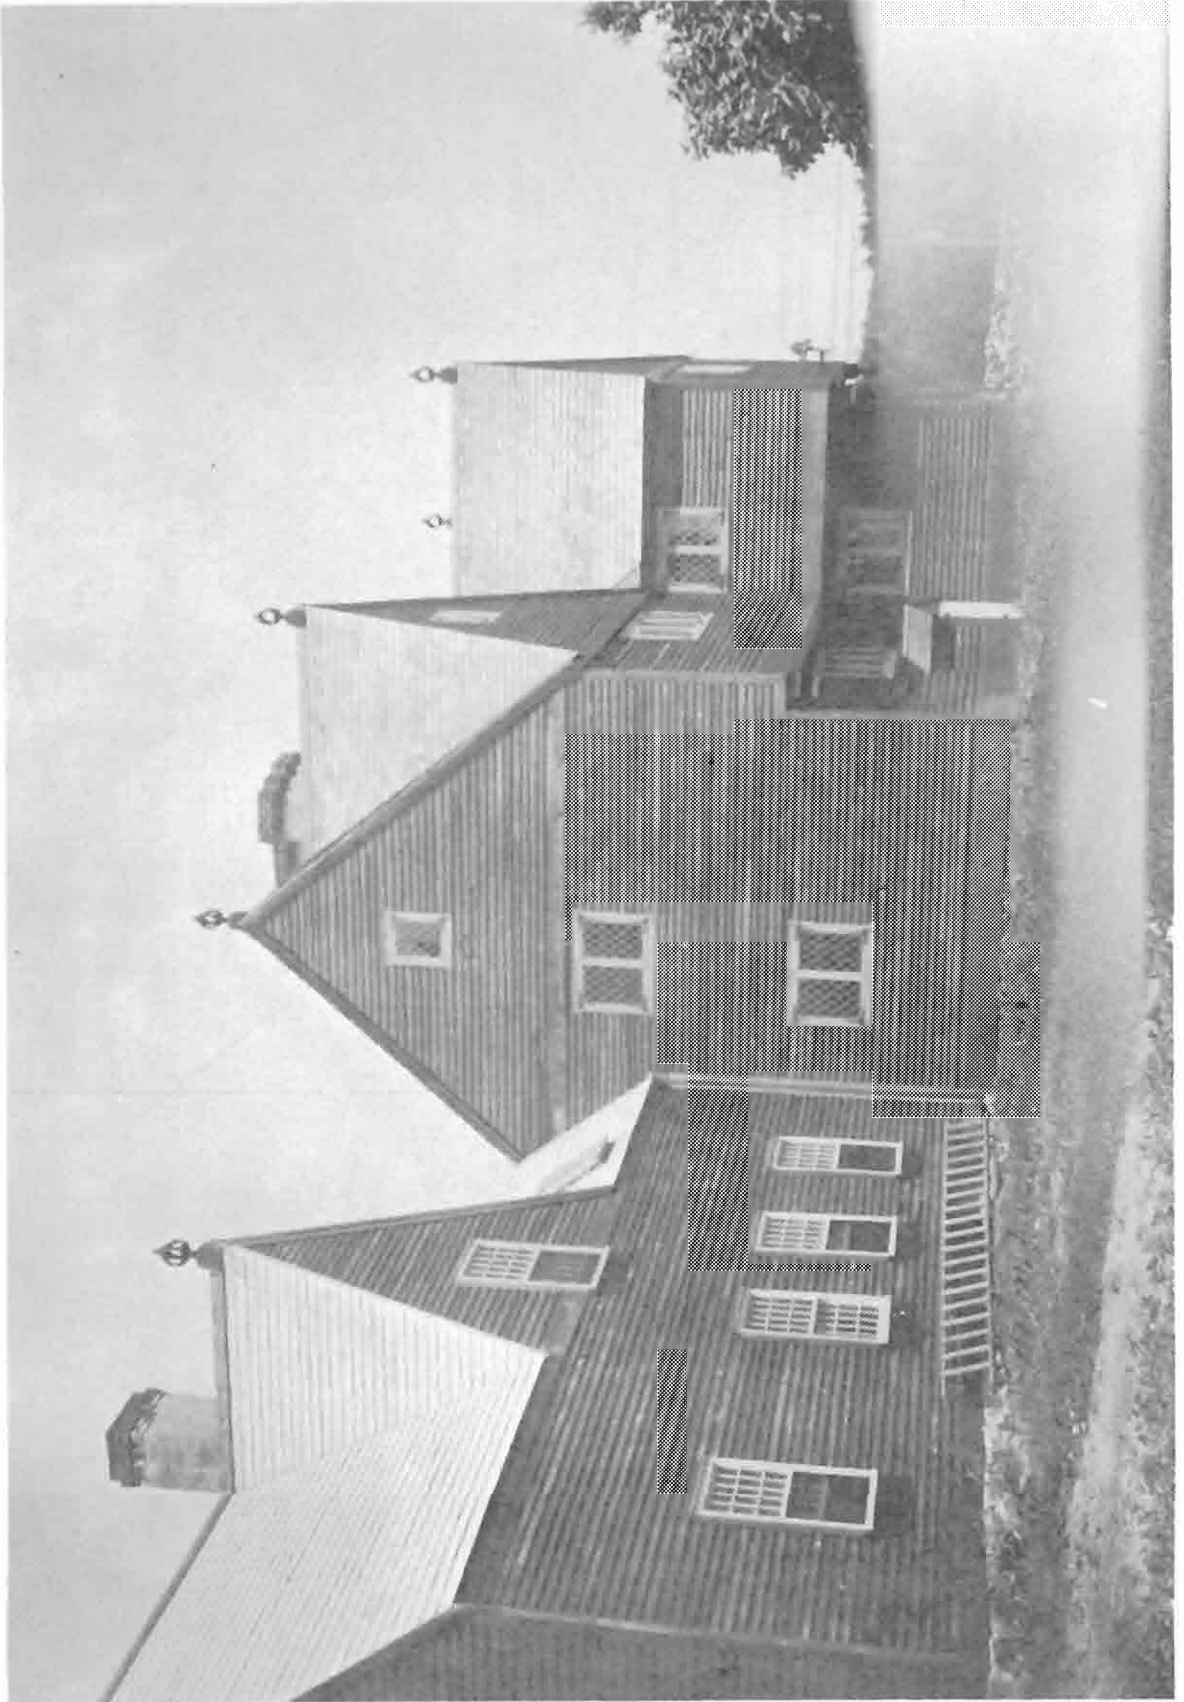
Illustration 32.

Summer 1917, by William S. Appleton. The ell has been extended and raised from its post-restoration original size.
