SAUGUS IRON WORKS
IRONMASTER'S HOUSE

NATIONAL HISTORIC SITE / MASSACHUSETTS

HISTORIC STRUCTURE REPORT
IRONMASTER'S HOUSE
HISTORICAL AND ARCHITECTURAL DATA
AND
A HISTORY OF OWNERSHIP
SAUGUS IRON WORKS NATIONAL HISTORIC SITE
MASSACHUSETTS

November 1977

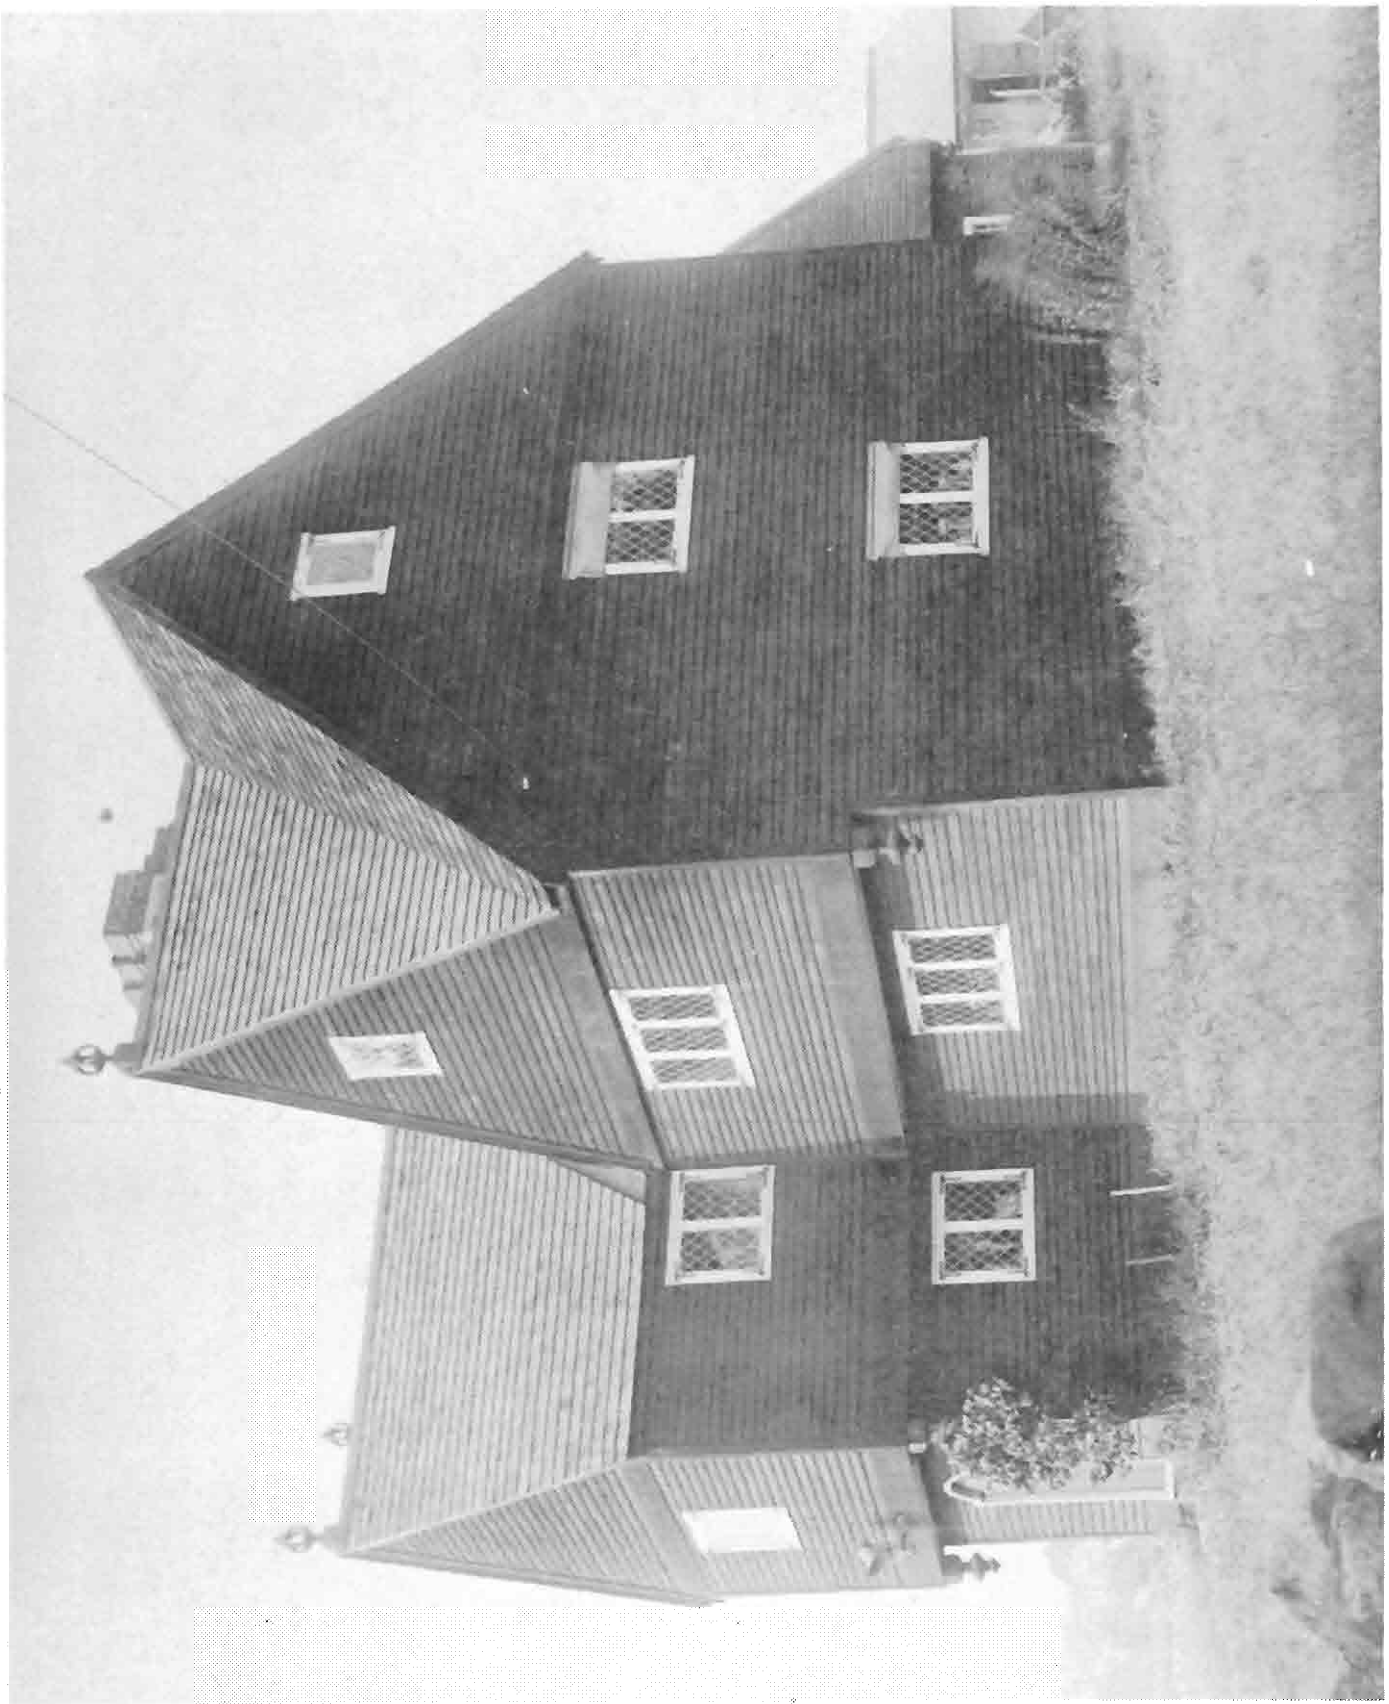
Illustration 33.

Photograph by C. Park Pressey, 12 October 1923. The house received no further major attention or external work until the FIWA took over its maintenance in 1947.

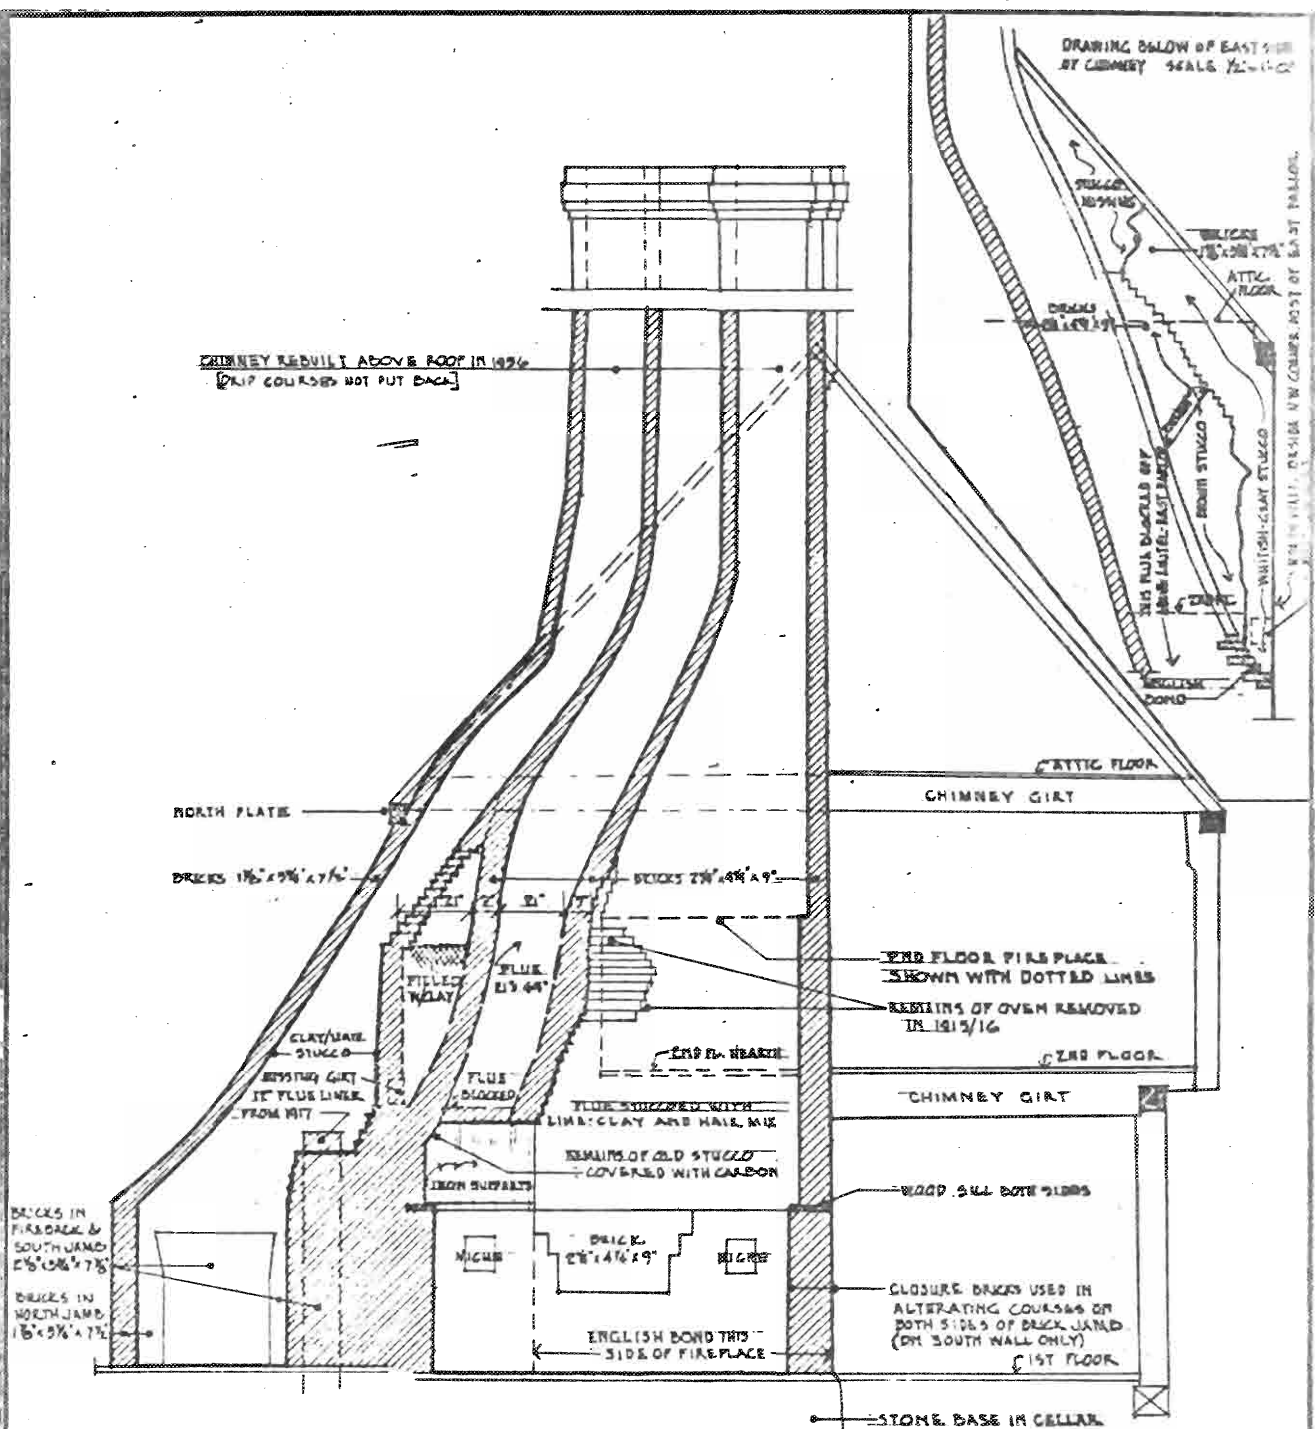
DRAWING BELOW OF EAST SIDE
BY CHIMNEY SCALE 1/2"=1'-0"

CHIMNEY REBUILT ABOVE ROOF IN 1926
[PAIP COURSES NOT PUT BACK]

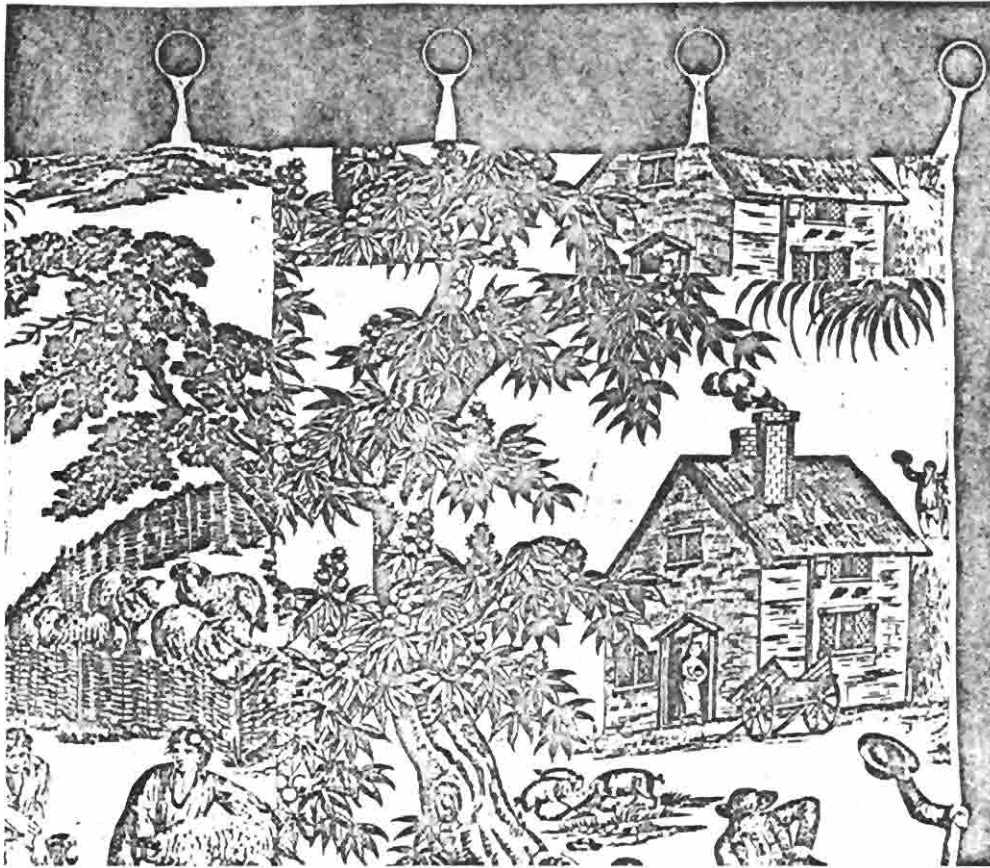
Fig. 1

Note arrangement of the casement hung windows

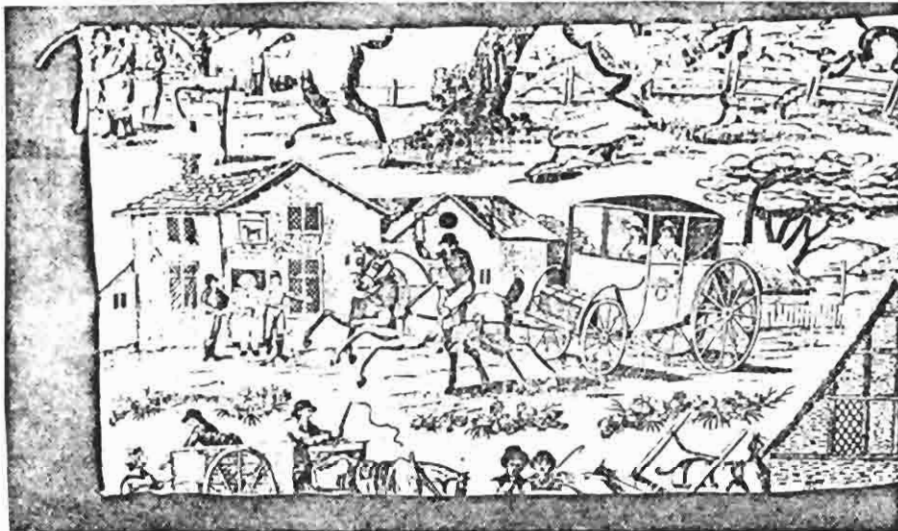
Fig. 4

Notice arrangement of casement hung windows:

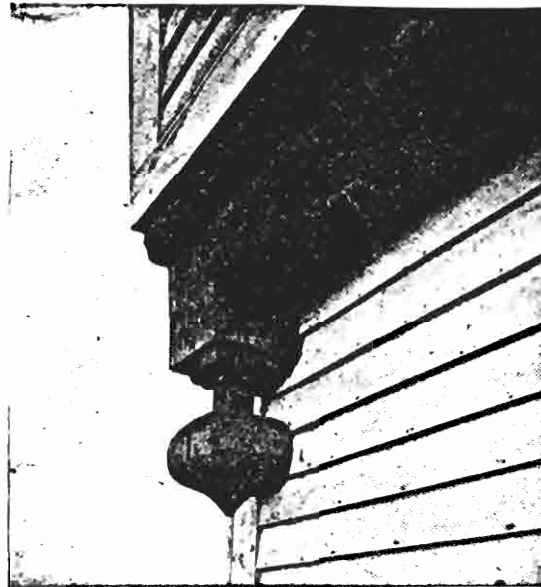
Fig. 12

The overhang is unusual in being a framed end showing end-girt molded and chamfered. This is a fine type of "drop" ornament depending from the posts framed into the projecting second end-girt.

"Drop ornament" possible precedent
or use at the Ironmaster's House,
1915/16

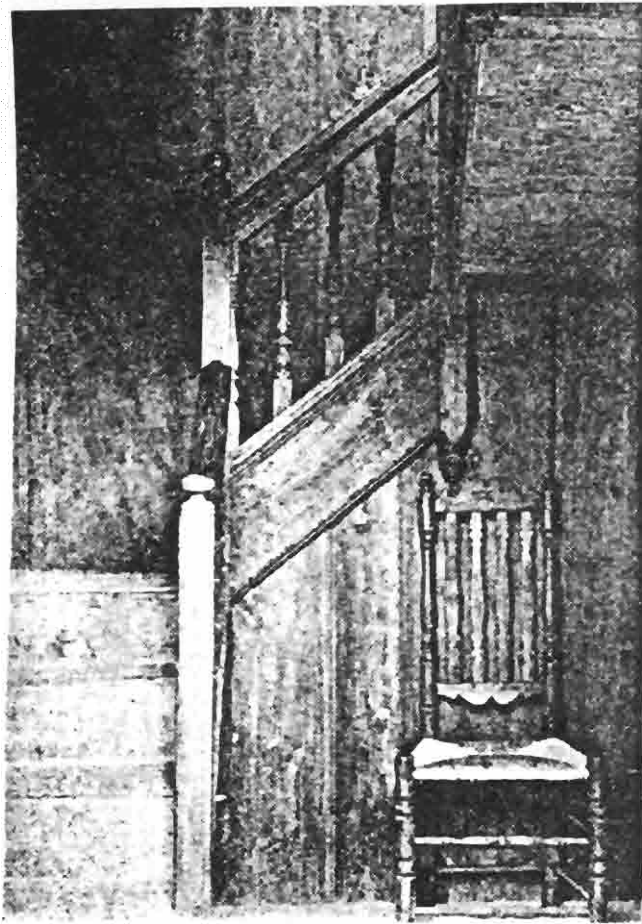
Fig. 13

SEVENTEENTH-CENTURY HALLWAY, GOULDING HOUSE
Courtesy Wallace Nutting

Stairway possible precedent for use at the
 Ironmaster's House, 1915/16

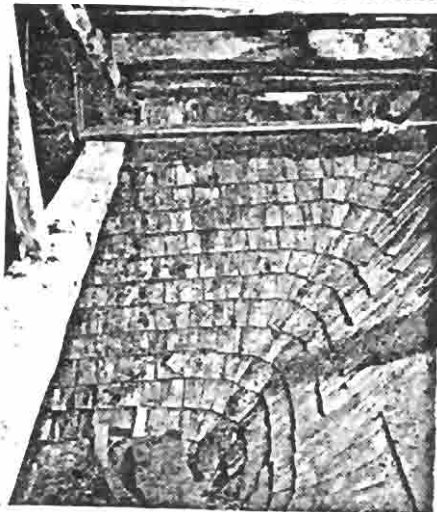
Fig. 14

An example of a shingled gutter or a valley with "swirled"
 shingles. The word gutter is a colonial term.

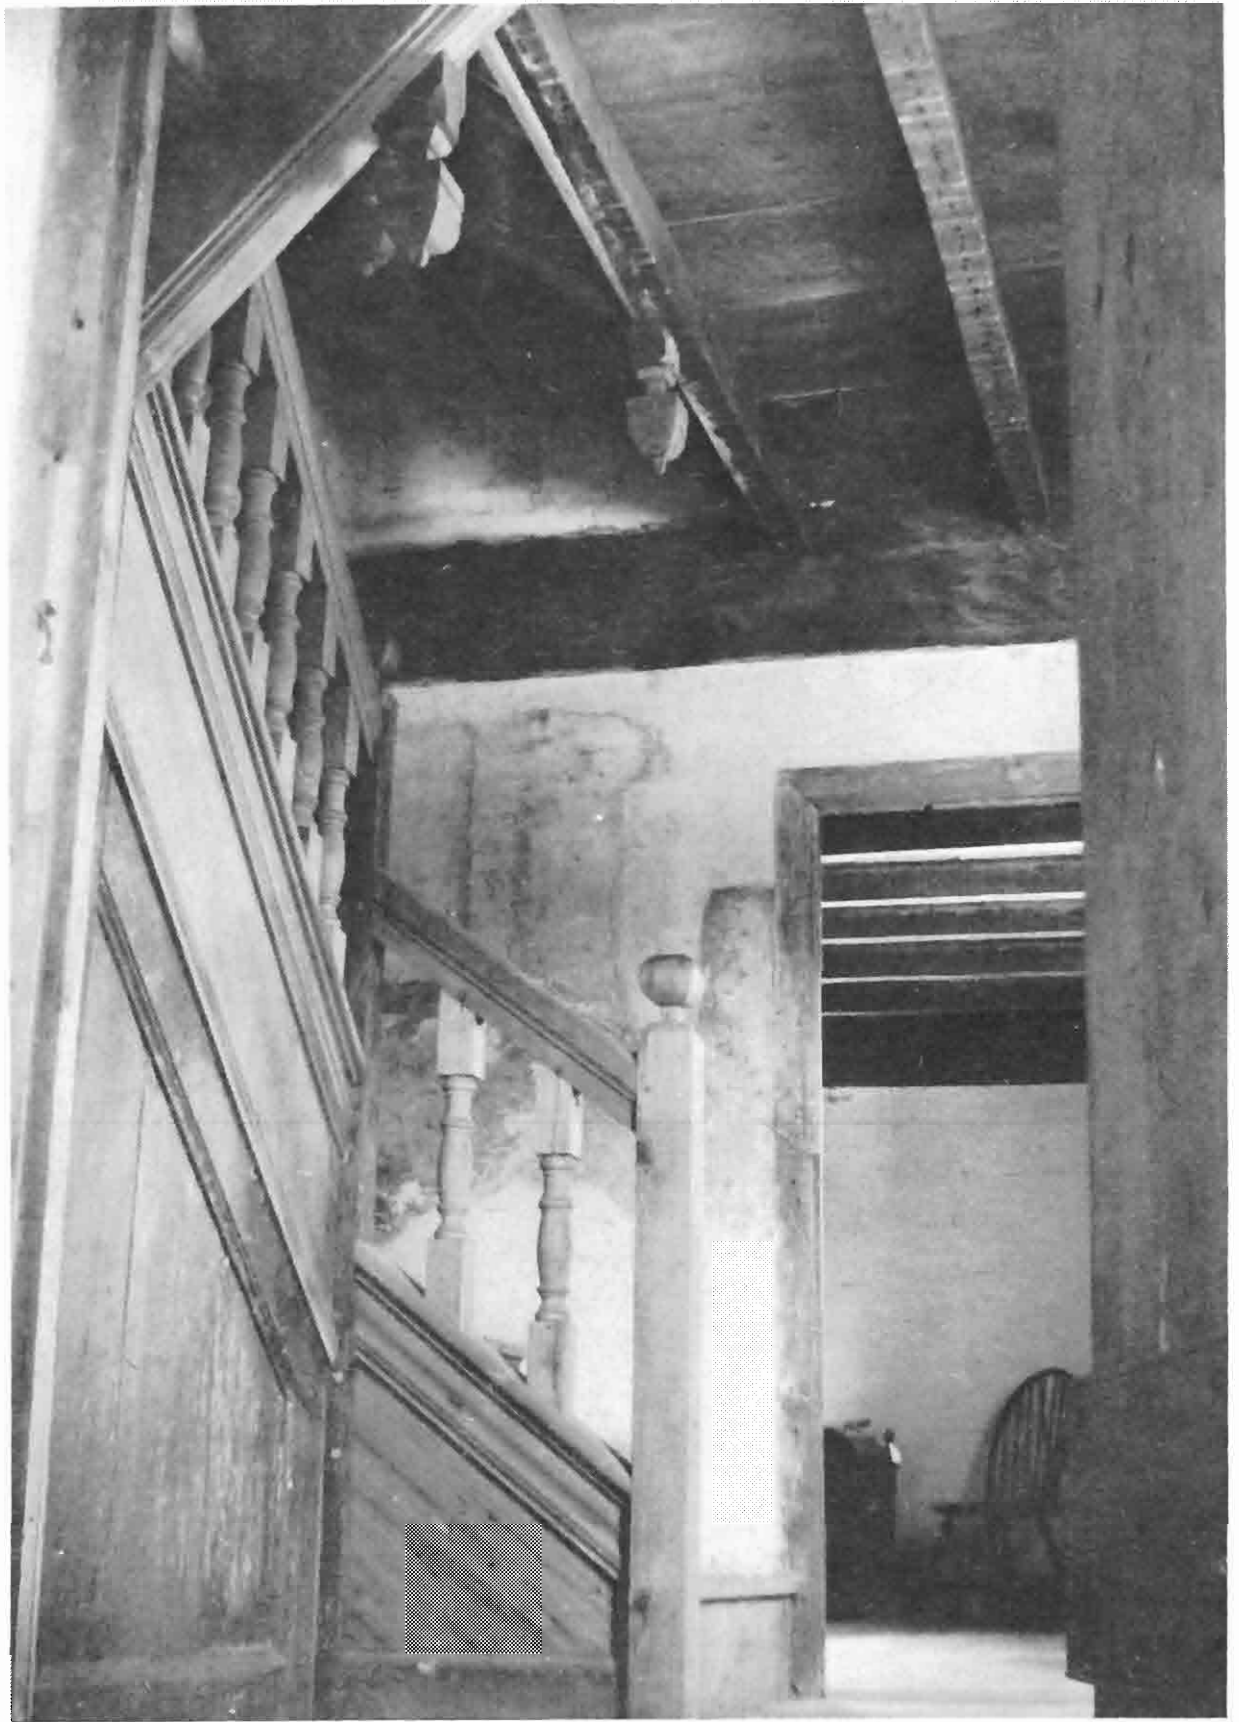
Illustration No. 5

View of the northeast corner of the West Chamber, second floor, after restoration work of 1915/16 was completed. The extent of the plasterwork can be seen in this view as the lighter wall areas. Compare this photograph with architectural drawing, Sheet No. 7, which shows the extent of the new plaster. From the Henry C. Dean drawings of ca. 1908 we know that an oven was removed from this room in 1915/16. Evidence of the oven occurs in the form of a squinch-like projection remaining in the flue. Also the outline of an oven appears in the plaster patch of the closet to the left of the fireplace. The mantel breastwork, including the closet, dates from 1915/16. The door opening in the north wall still retains the door frame and trim on the garret side. The existing door opening was simply reduced in height with new trim and door installed on the chamber side. All of the floor joists and floorboards above date from 1915/16 when the entire floor system was changed to its present-day appearance. Notice the 2" x 8-1/2" x 8-1/2" clay tiles laid in the fireplace ready to be installed as part of the hearth. According to Mr. Edward Guy, these tiles were removed from the cellar floor.

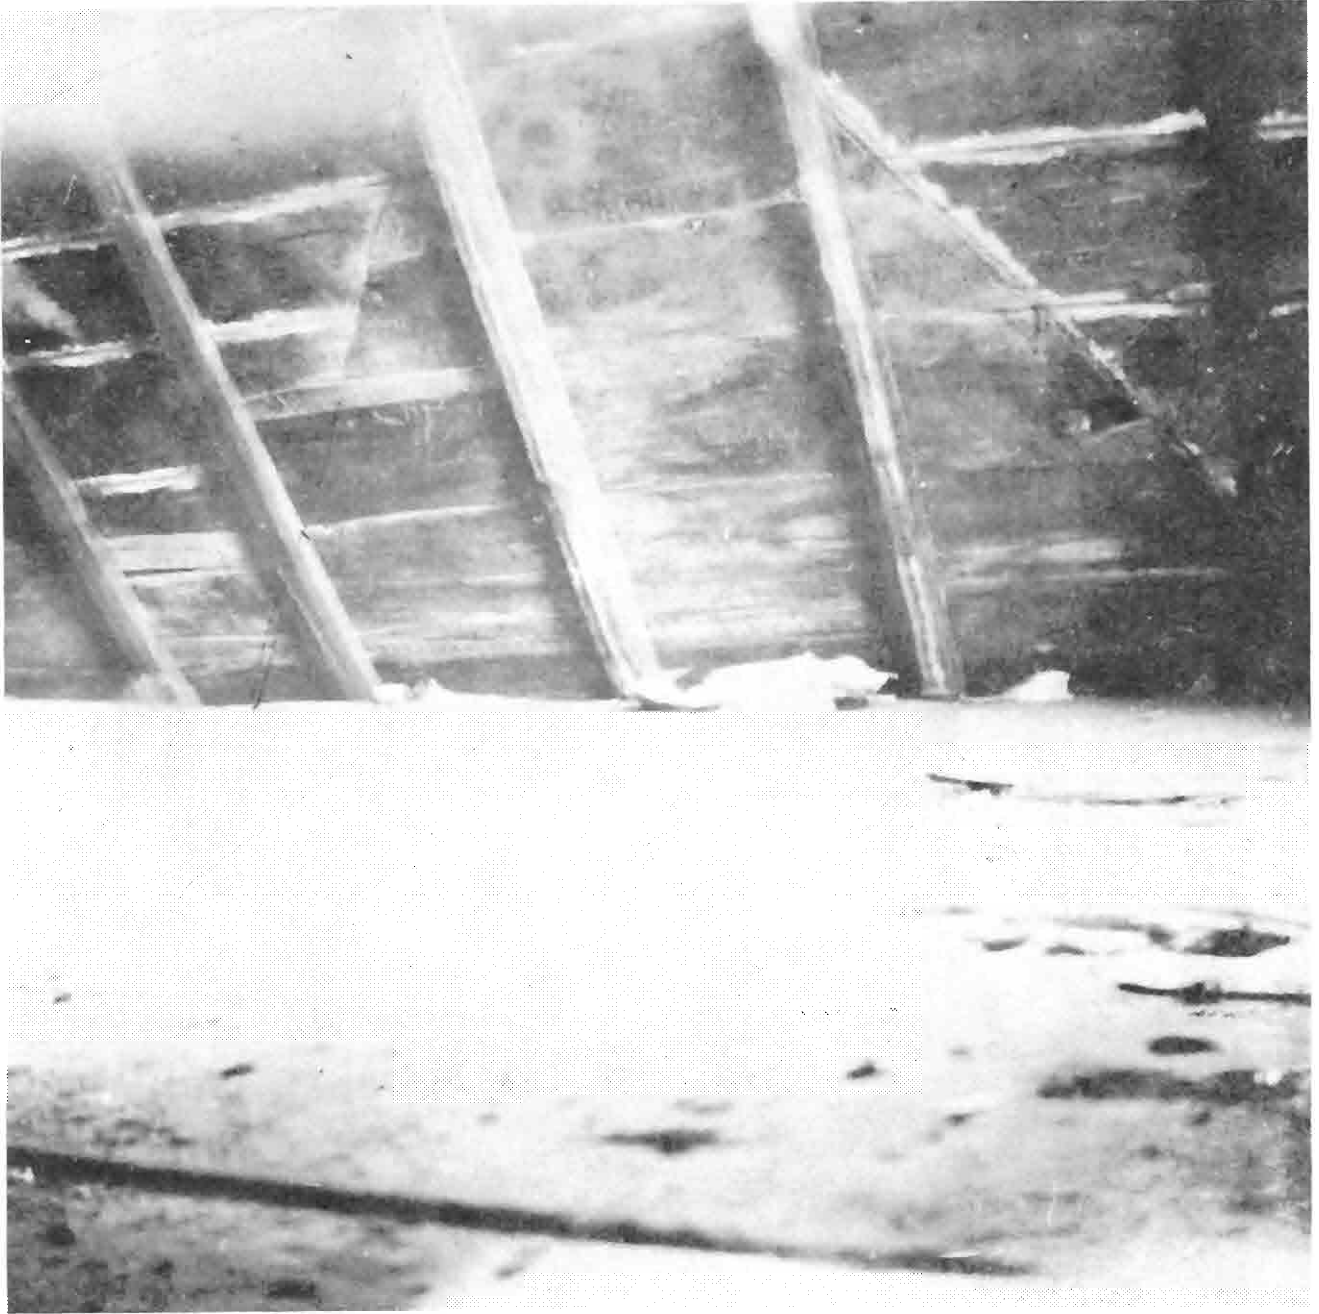
Illustration No. 6

View of south roof slope at west end in attic prior to restoration work of 1915/16. Compare this view with Illustration No. 47 taken from similar location in 1975. Cuts in roof sheathing supposedly represent location of west roof dormer. The upper and lower lines on diagonal cut to the left are from a pen line drawn on original photograph from which this is a copy. Notice whitish stain on horizontal cracks of roof boards, which writer attributes to mortar chinking, a form of weather stripping. Compare extent of roof boards in this view with architectural drawing, Sheet No. 7, which shows extent of possible original roof boards remaining in 1975.

This view and Illustration No. 48 below were taken of the west dormer in the south roof. Compare Illustration No. 47 with No. 6 taken 60 years earlier from the same location and notice the amount of roof boards cut away. The rafter framing in the south roof slope is unusual in that the rafters vary in size and number below and above the purlins (see architectural drawing, Sheet No. 4). The roof boards to the right are thought to be original and the white mortar stains along the cracks of the boards are thought to be an early form of weather stripping.

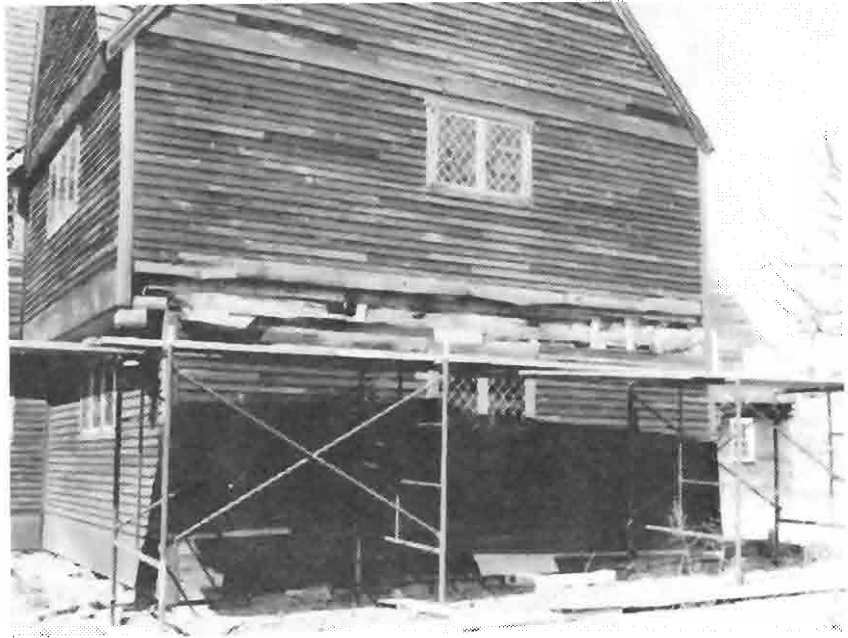
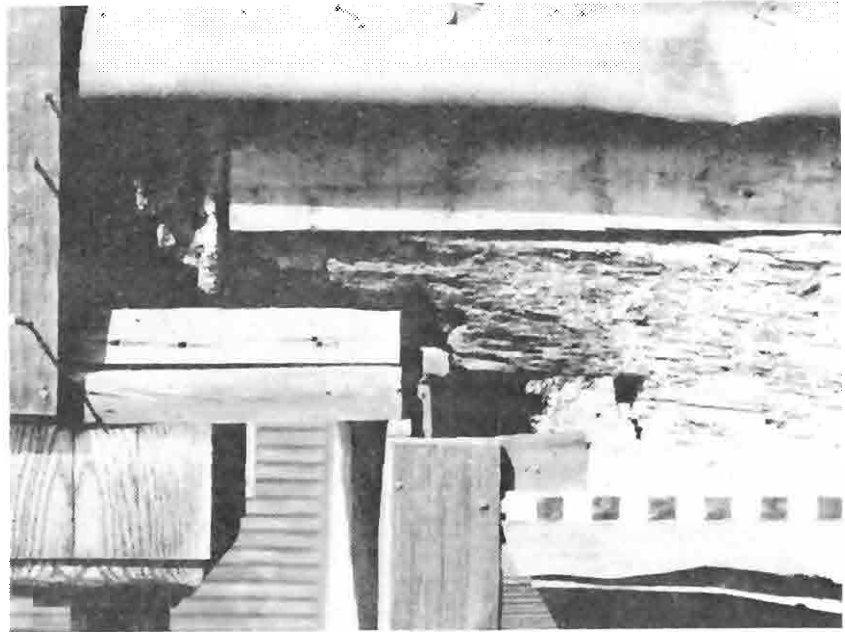
Illustration No. 9

View of east wall girt of East Parlor at north end of wall showing extent of rot occurring only at locations of braces and studding. This condition confirmed the results obtained with the X-ray machine photos. All carpentry work in this photograph dates from 1915/16. The window sashes in the lower left view are the second set since 1915/16.

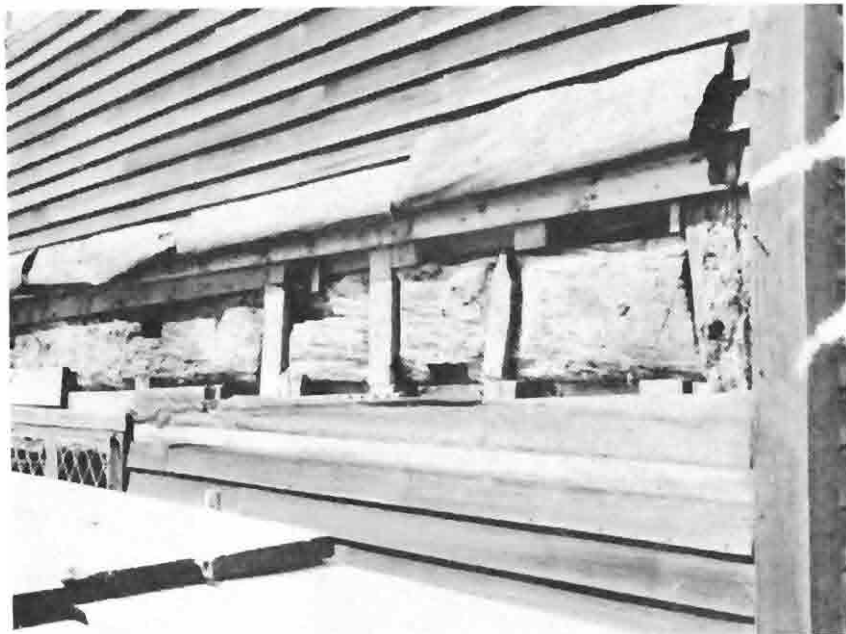
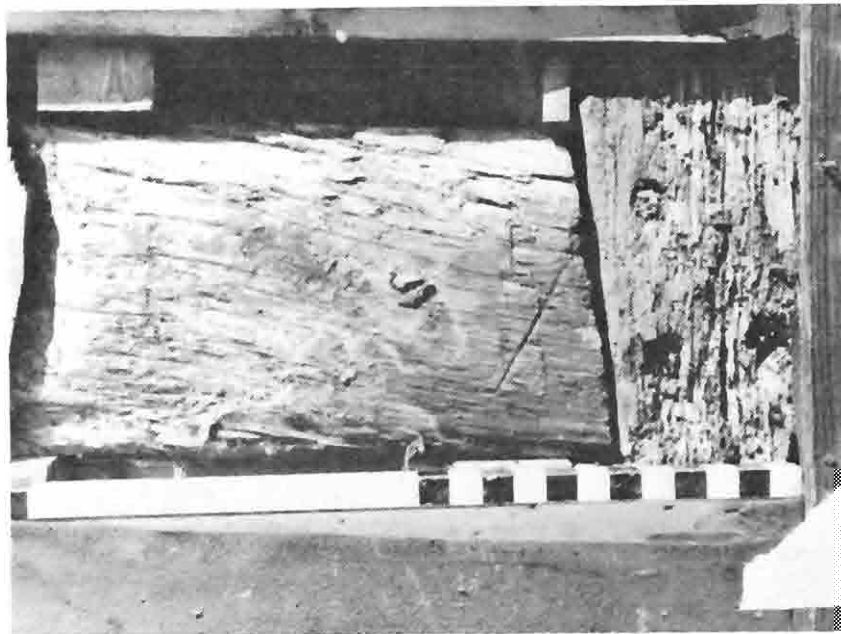
Illustration No. 11

View of north wall girt of East Parlor. The condition of this framing member is very good. Below the girt can be seen three original oak studs. Four original studs remain below the girt and three above out of twelve studs in this section of wall. See architectural drawing of north wall, Sheet No. 6.

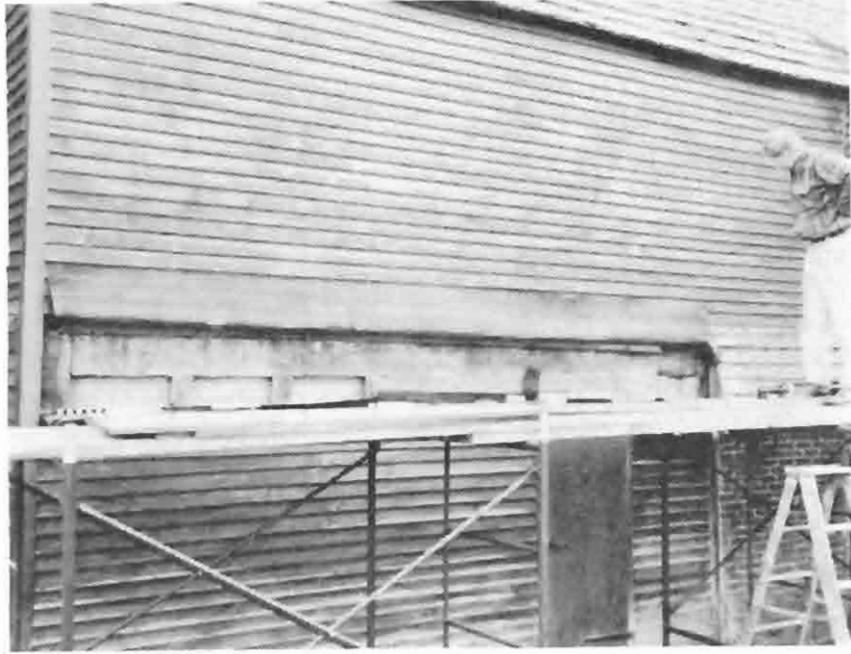
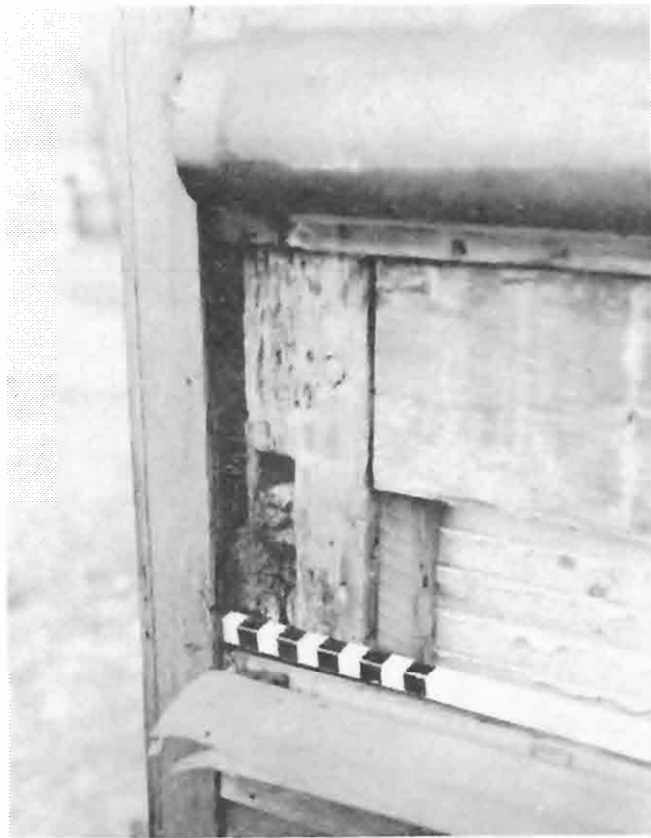
Illustration No. 13

Two mortices are visible in this view of the north side of the post, second floor level, northwest corner post of the East Parlor. Post can be partially seen in Illustration No. 11. The upper mortice probably was cut to support an interior girt for the two-story lean-to and the lower mortice for the girt of the original lean-to. A third mortice on the west side of the post was probably for the missing girt spanning the two chimney posts. See architectural drawing, Sheet No. 6.

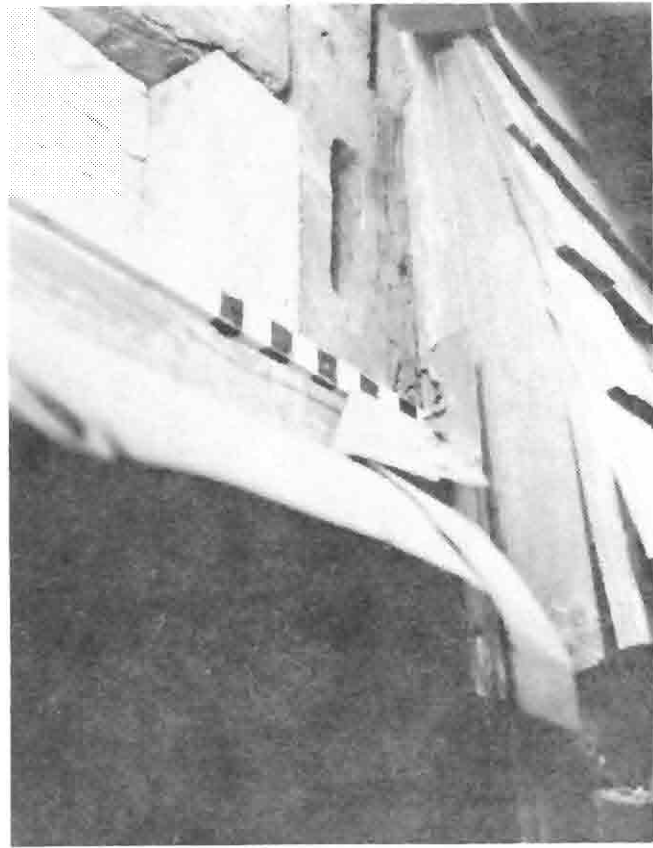
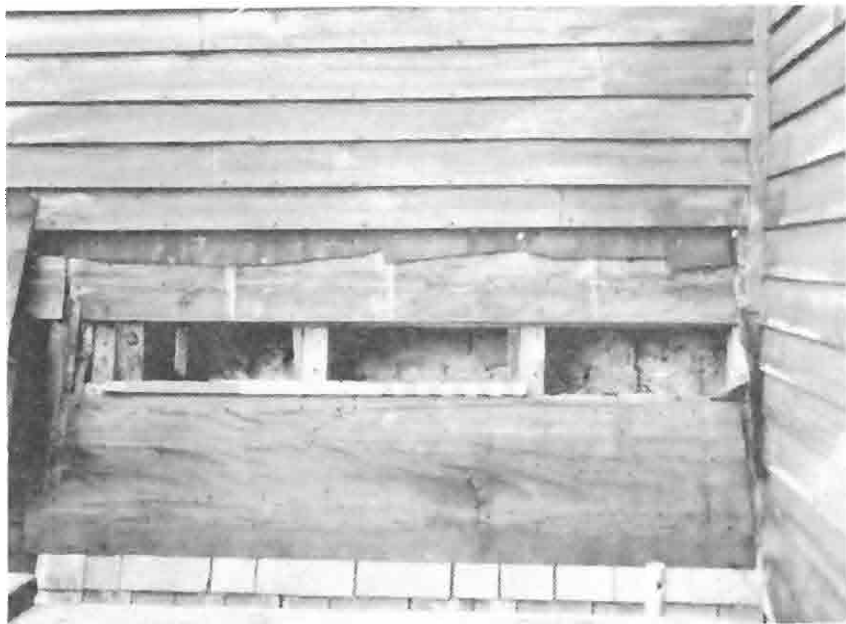
Illustration No. 15

Changes to the south wall of the West Parlor are reflected in this view. This wall was repaired after the removal of the 1915/16 cellar bulkhead in 1952. The arrows and string outline the extent of the new clapboards and water table. See architectural drawing, Sheet No. 8.

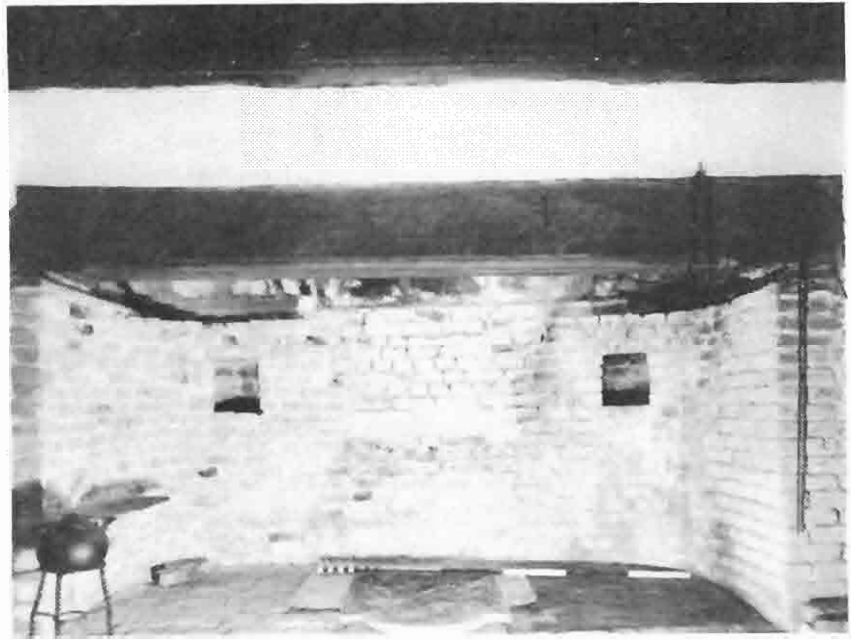
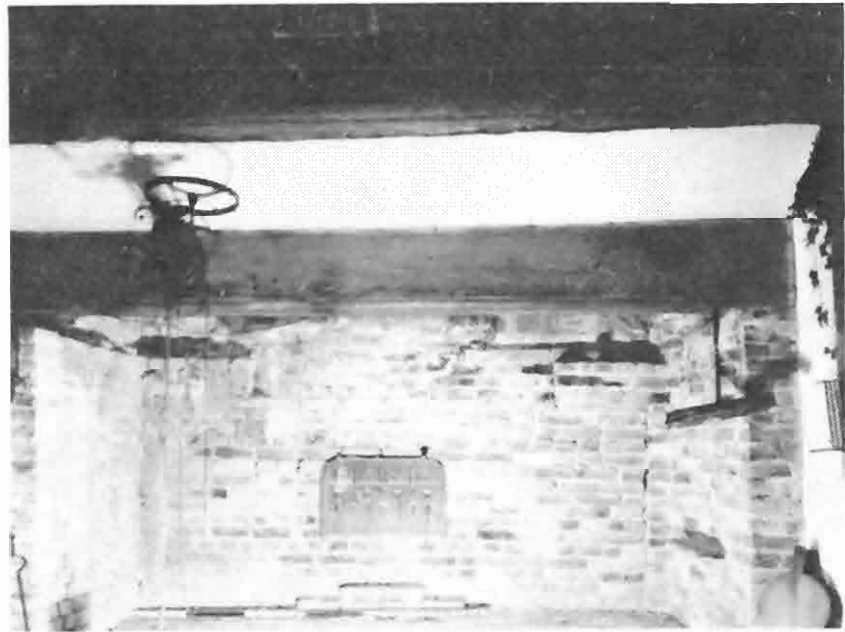
Illustration No. 19

Inside the West Parlor fireplace looking north at masonry work supported by iron bars installed in 1915/16. At left can be seen English bond brickwork extending to scale stick, which corresponds to old stuccowork directly above in flue. It is thought original fireplace extended only this far. At the extreme upper left can be seen old stucco covered with carbon, which may have been part of fireplace throat related to the original lean-to kitchen fireplace.

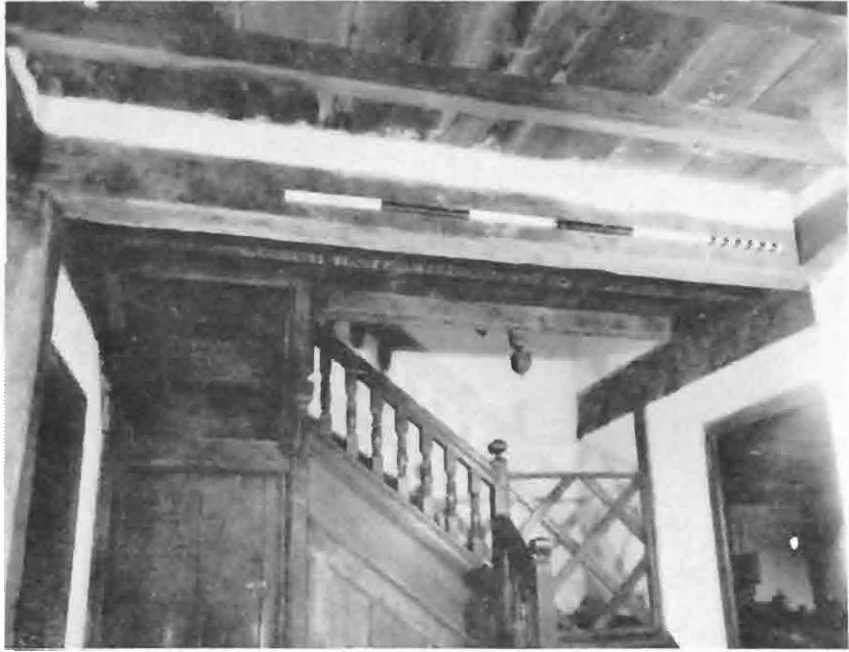
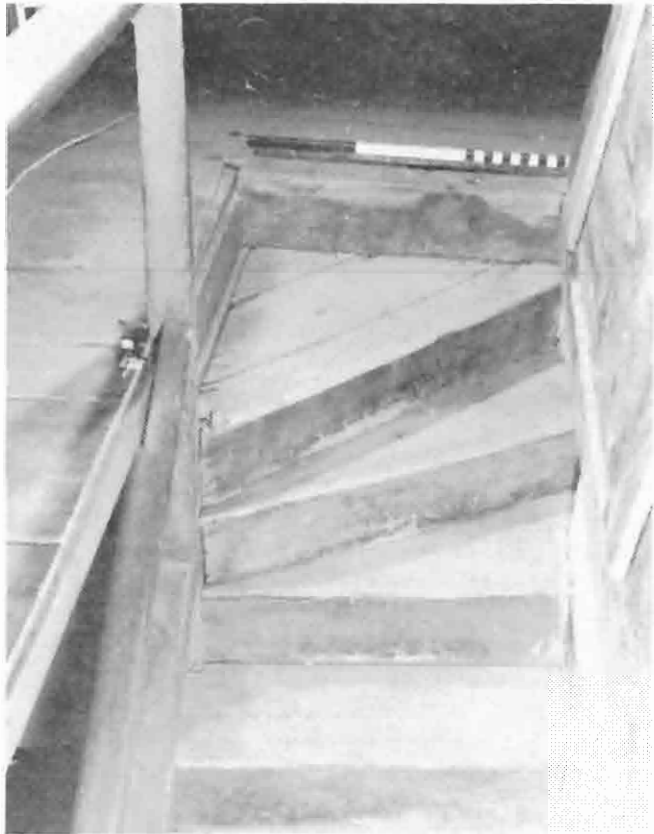
Illustration No. 23

View of the central stairway at the second floor level. The Henry Charles Dean drawings ca. 1908 explain why the newel posts seen at arrows nos. 1 and 2 were cut off at this height. When the main house was divided into two living units, two stairways to the attic were built. Hence the newel posts were cut off to provide space for one narrow and one wide stairs to the attic. The two steps and platform at the lower right were left intact inside a low closet prior to 1915/16. Note the absence of balusters on the upper handrails.

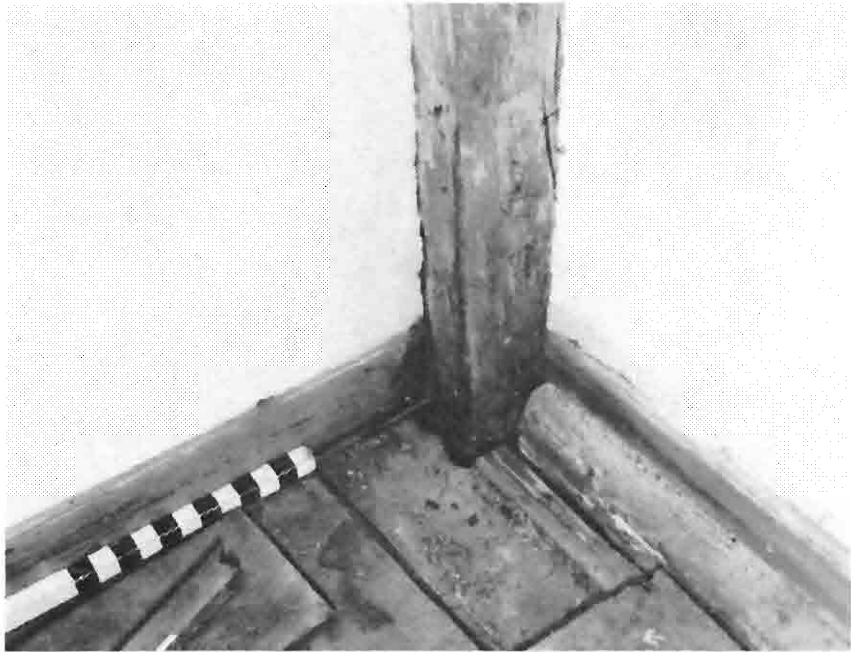
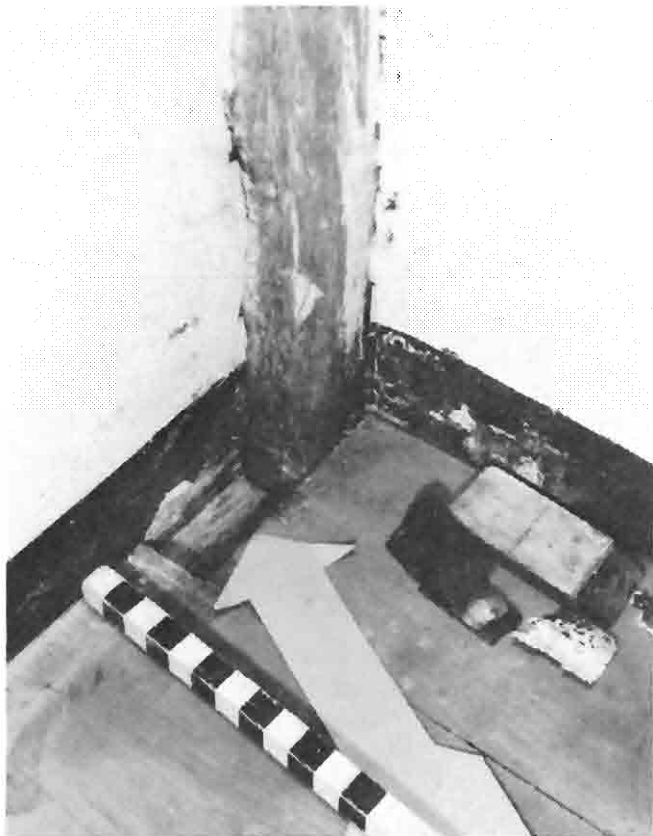
Illustration No. 27

Corner post in southwest corner of East Chamber at overhang of second floor. The upper girt that projects into the room at floor level passes under this corner post. Originally the girt ran as far as the southwest corner post in the hallway beyond where it tenoned into the post as seen in Illustration No. 28.

Corner post in southwest corner of the stairhall, second floor. This post is opposite the one seen in Illustration No. 27. Near the floor can be seen the post mortice that received the tenon from the upper girt of the overhang (now missing). Reason for the upper mortice is not known. Doorway at left is to the 1915/16 porch chamber.

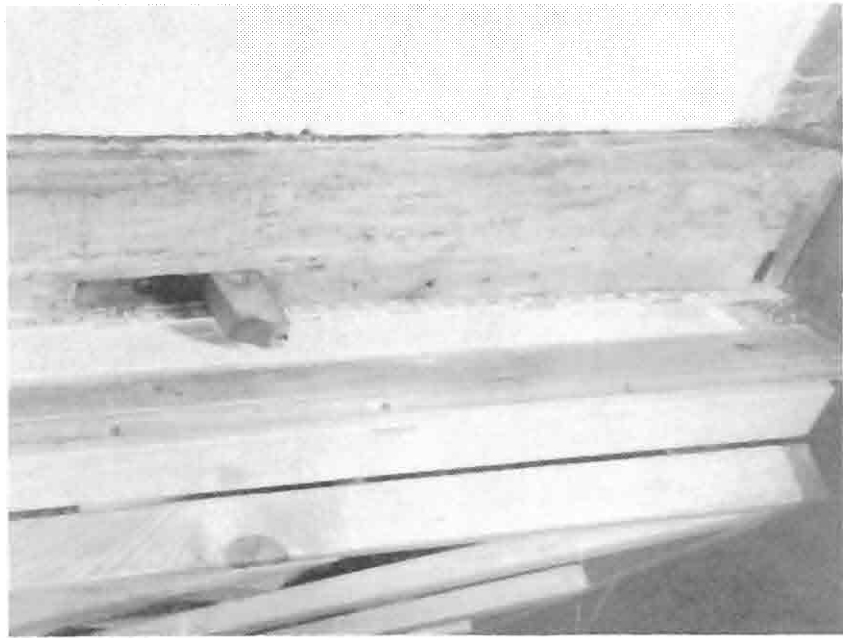
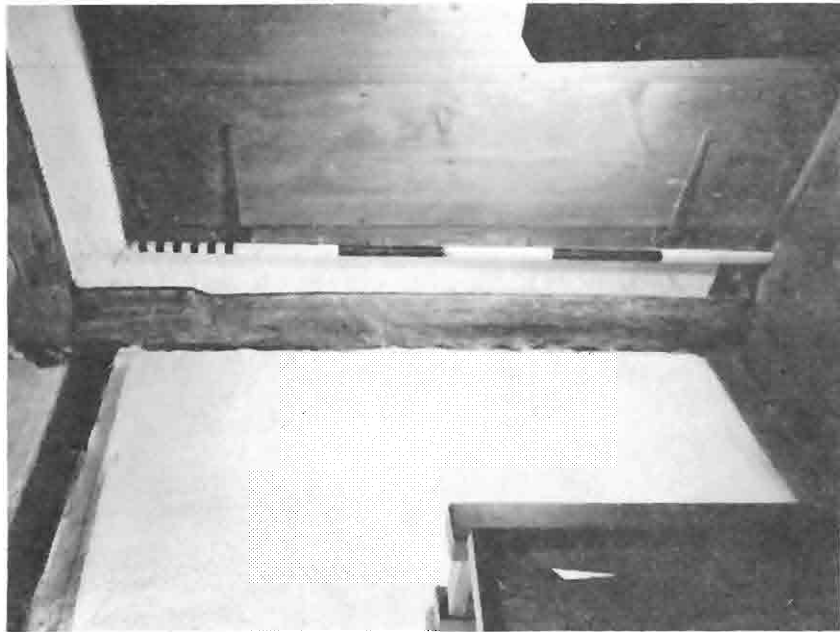
Illustration No. 29

Splice joint at the east end of the south foundation sill as seen from the crawl space under the porch. The mill-sawn sill to the right was installed in 1915/16, but the left sill seems to be from the original construction. The stonework under the porch dates from 1915/16.

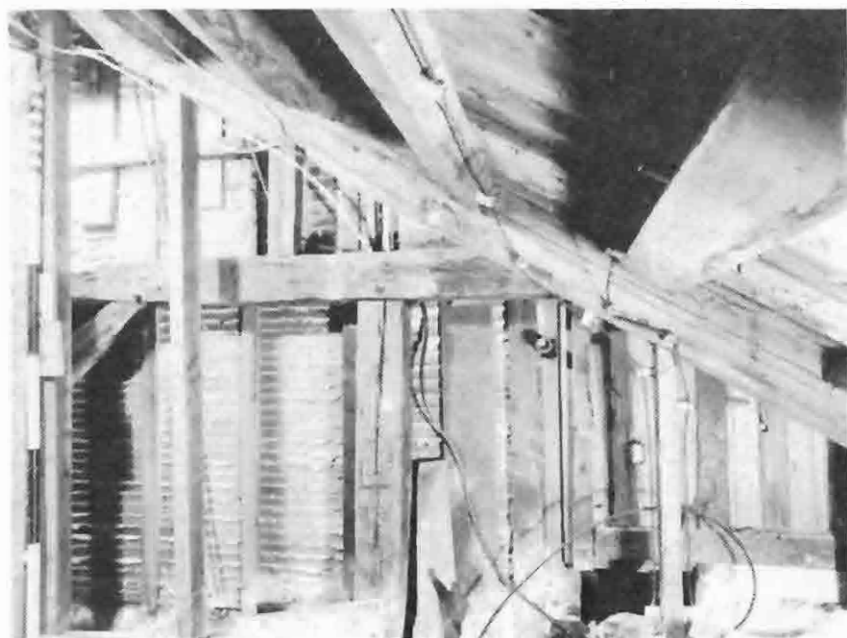
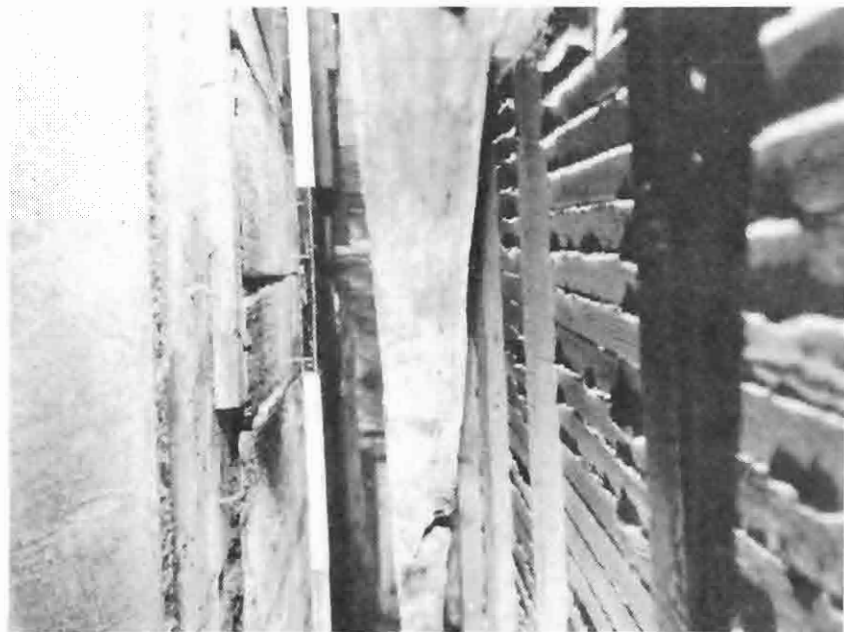
Illustration No. 37

Additional evidence is presented in this view to show that the original chimney was built as a T-shape above the roof but with an additional flue below the roof that possibly went to a second floor fireplace in the lean-to chamber. The first masonry projection represents the line of four flues for the first and second fireplaces. The first joint seen in the T-stem beyond represents the outside wall of the flue that went to the fireplace/oven on the first floor of the lean-to kitchen. The second joint of the rear stem seen starting above the floorboards is for an unknown flue, possibly for a fireplace in the lean-to garret. The last flue seen built against the roof boards is for the fireplace/oven located in the existing lean-to, possibly dating from the late 18th century.
