SAUGUS IRON WORKS
IRONMASTER'S HOUSE

NATIONAL HISTORIC SITE / MASSACHUSETTS

HISTORIC STRUCTURE REPORT
IRONMASTER'S HOUSE
HISTORICAL AND ARCHITECTURAL DATA
AND
A HISTORY OF OWNERSHIP
SAUGUS IRON WORKS NATIONAL HISTORIC SITE
MASSACHUSETTS

November 1977

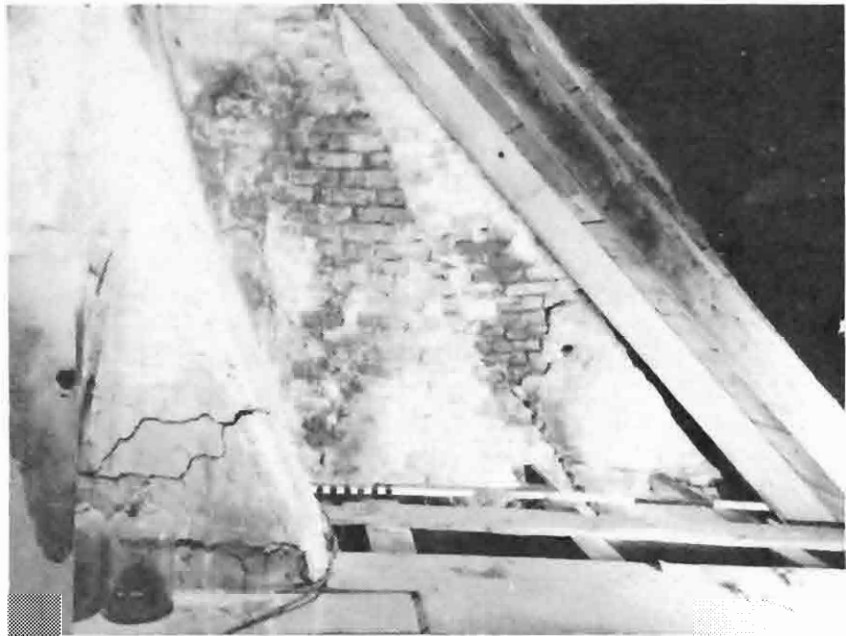
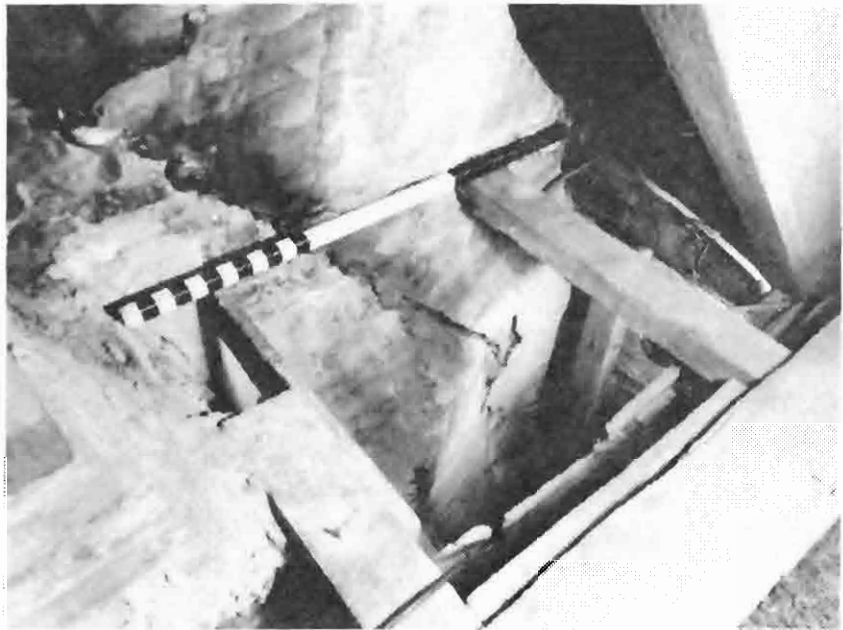
Illustration No. 39

Looking at the north roof frame at the east end of the attic. Notice the dropped purlin that allows the common rafters to rest on it above. A diagonal wind brace running from purlin to principal rafter no. 1 at the east end of the house is seen at right. At some time in the past the four common rafters were cut off and replaced below the sawn purlin (where scale stick rests). All of the roof boards in this view date from 1915/16. Peg holes for the old lean-to rafters were found in principal rafters nos. 2 and 3 seen in this photo.

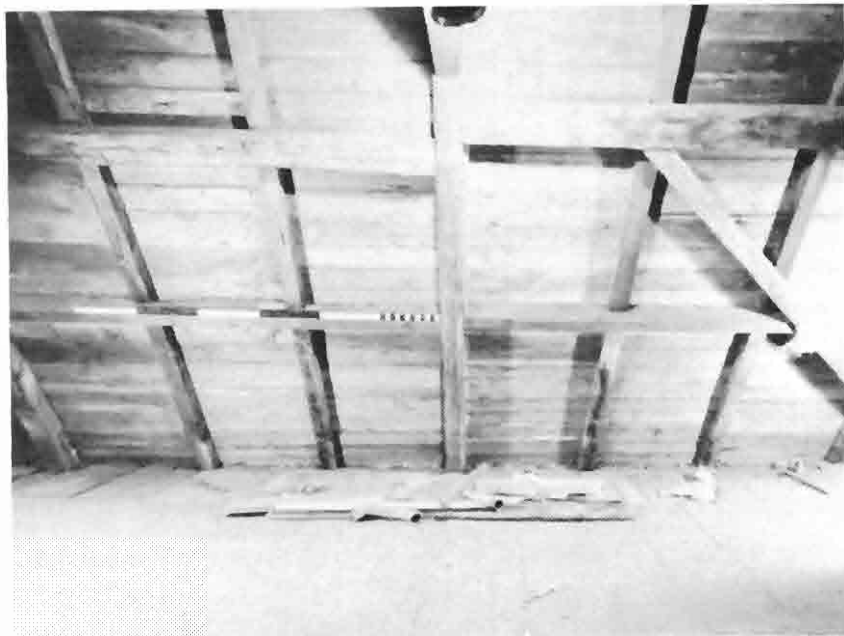
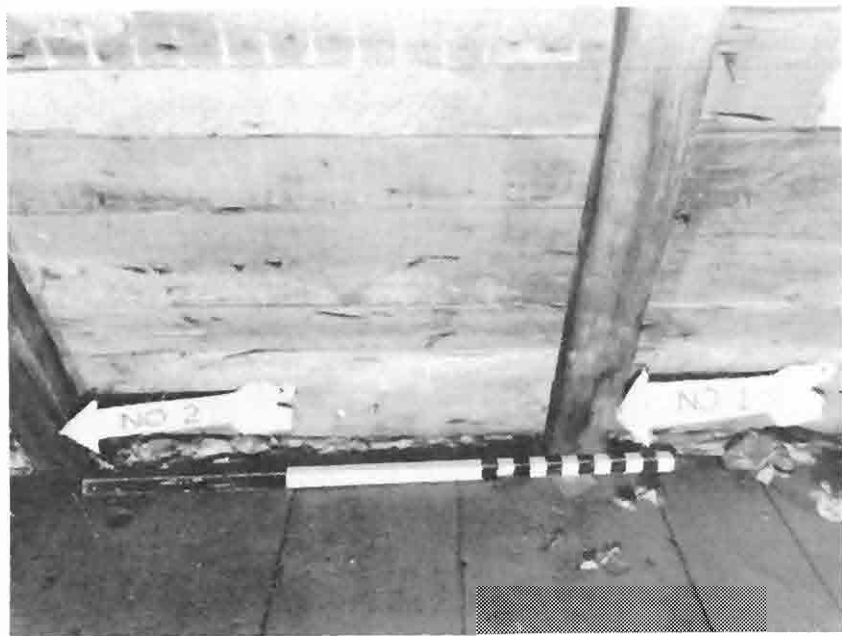
Illustration No. 41

View of west gable end in attic. Of particular interest are the two methods employed for framing the roof. To the left in the south roof slope the purlin is full depth of the rafter. This depth permitted the common rafters to be either morticed or let into the purlin (see architectural drawings, Sheets Nos. 3 and 4). On the north side the purlin has less thickness, permitting the 2-1/2"-deep common rafters to rest on top of the purlin. All common rafters run full-length, approximately 16'-6" from peak to plate, on the north roof slope. All the studs in the end wall are original oak members. The studding to the right of the window has been cut and moved. Between the first and second studs at the left, up near the purlin, can be seen a small pencil drawing for the proposed roof of the Ironmaster's House probably dating from ca. 1915 (see Illustration No. 42).

A pencil drawing found on the plaster wall in the west gable end of the attic (refer to Illustration No. 41). This sketch has to be a drawing for the proposed roof of the Ironmaster's House done prior to the 1915/16 restoration work.

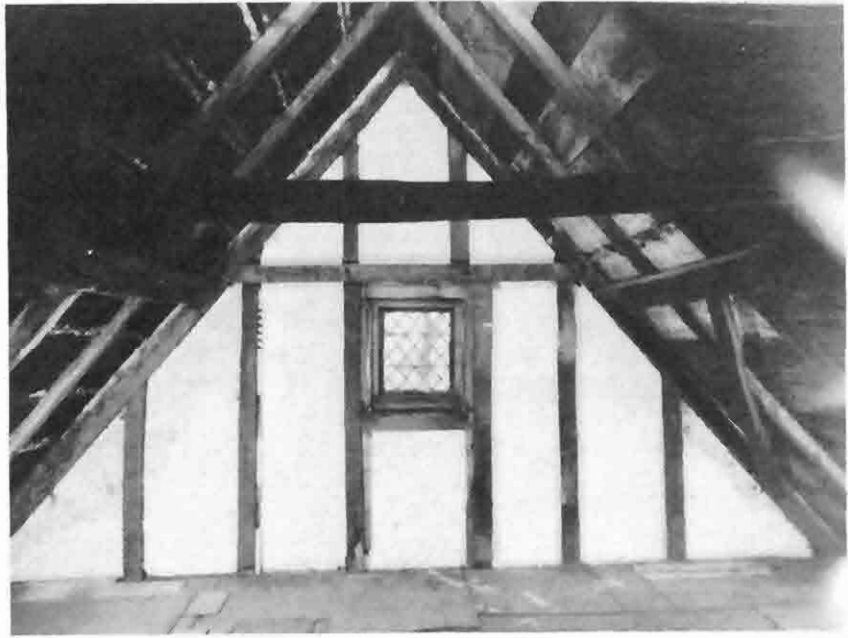
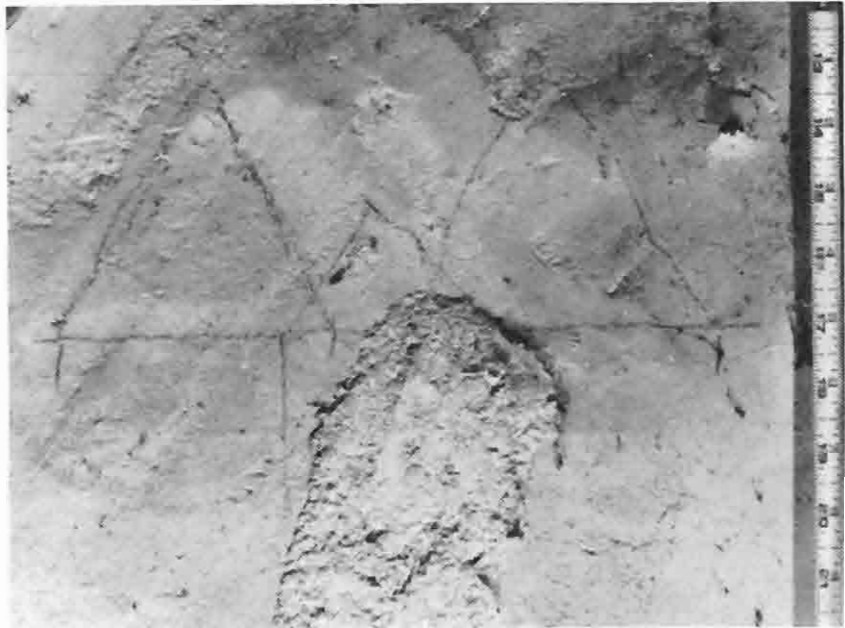
Illustration No. 43

A view of the existing roof framing in the south roof opposite the central porch. Above the purlin only two common rafters existed in the original roof structure. Below the purlin only the valley rafters were framed into the space between the two principal rafters. Seven extra pieces have been introduced into this area since the house was built. Notice the chamfer on the lower edge of the purlin and on the lower edges of the principal rafters. The floorboards and joists and porch structure to the right date from 1915/16.

A photograph of the main roof where the existing 1915/16 porch rafters intersect. Compare this view with Illustrations Nos. 43 and 44 taken from the interior side. The upper roof boards are thought to be original. The rotted portions of the roof boards suggest that the porch dormer was once at a lower elevation than the existing roof, although a lower pitched roof would complicate the shingling process. This view is looking north from the porch attic.

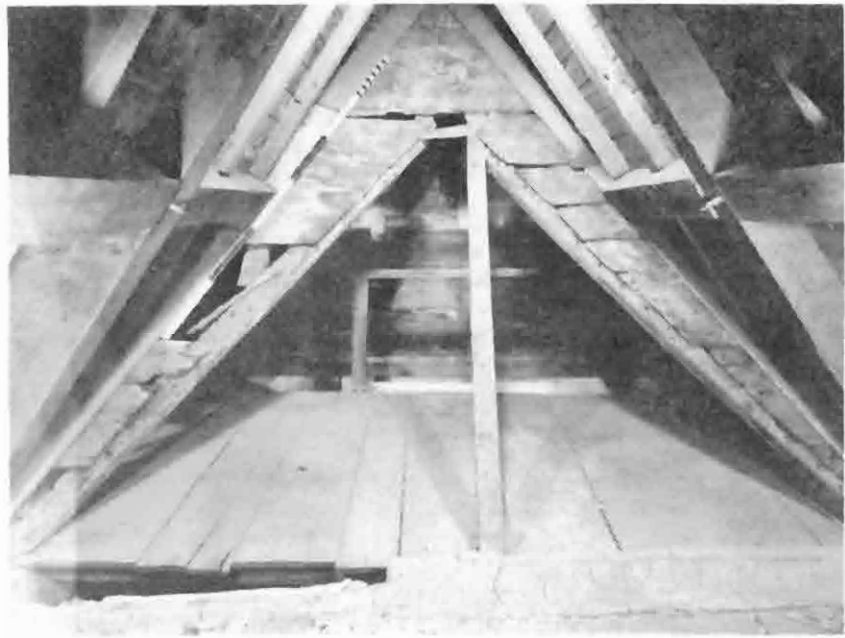
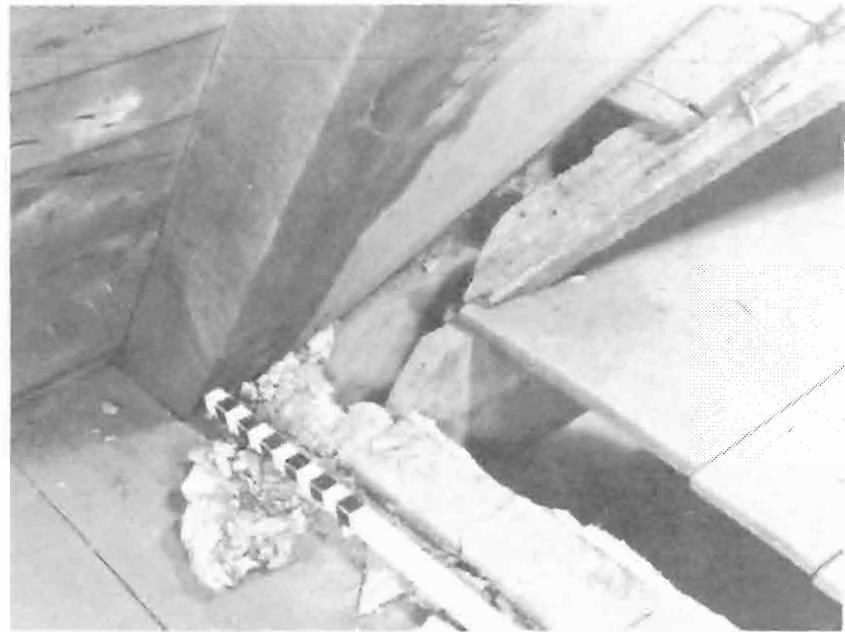
This view and Illustration No. 48 below were taken of the west dormer in the south roof. Compare Illustration No. 47 with No. 6 taken 60 years earlier from the same location and notice the amount of roof boards cut away. The rafter framing in the south roof slope is unusual in that the rafters vary in size and number below and above the purlins (see architectural drawing, Sheet No. 4). The roof boards to the right are thought to be original and the white mortar stains along the cracks of the boards are thought to be an early form of weather stripping.

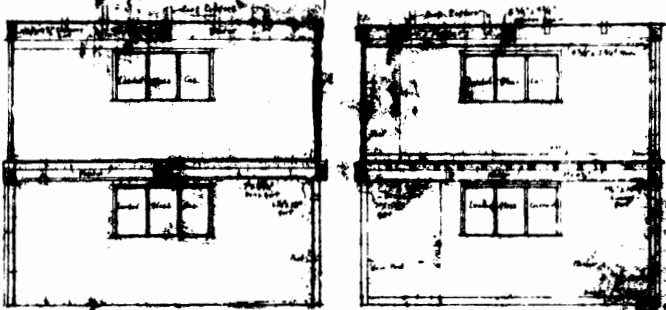
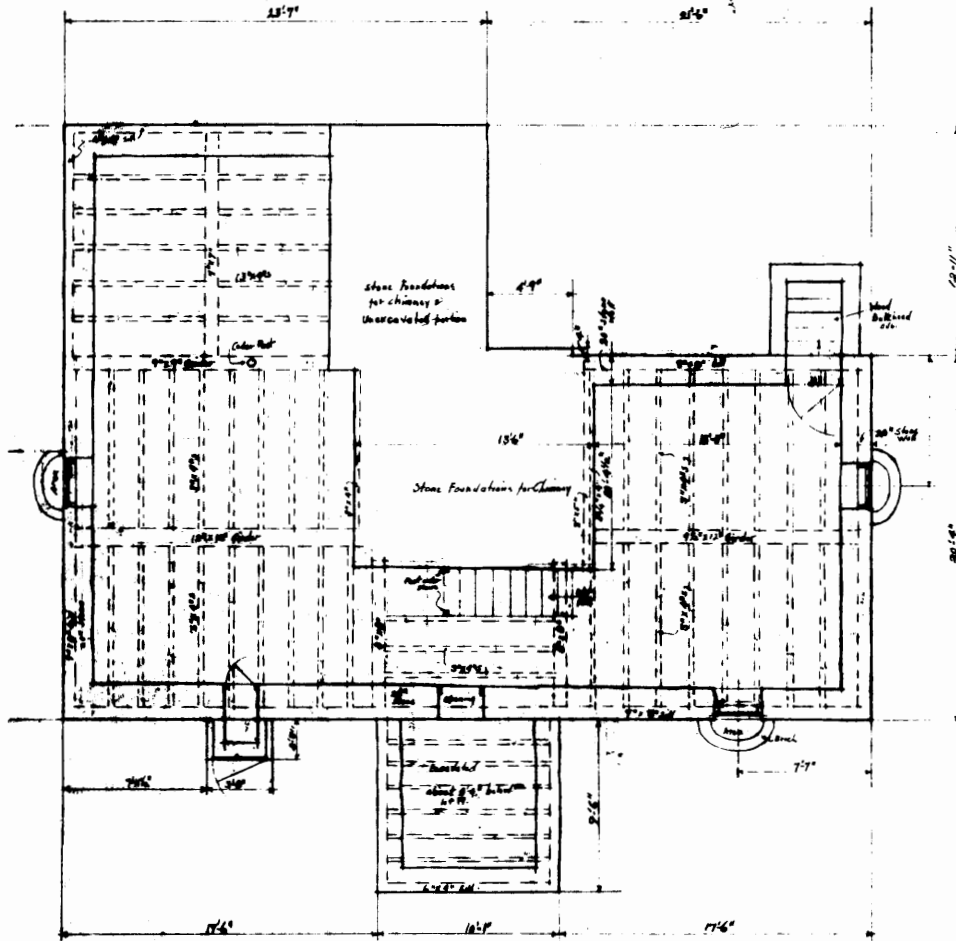
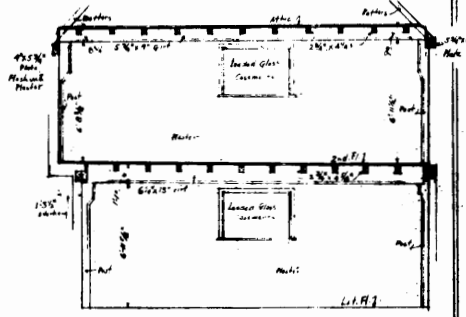
Sheet 1.

Cellar Plan and Interior Elevations.

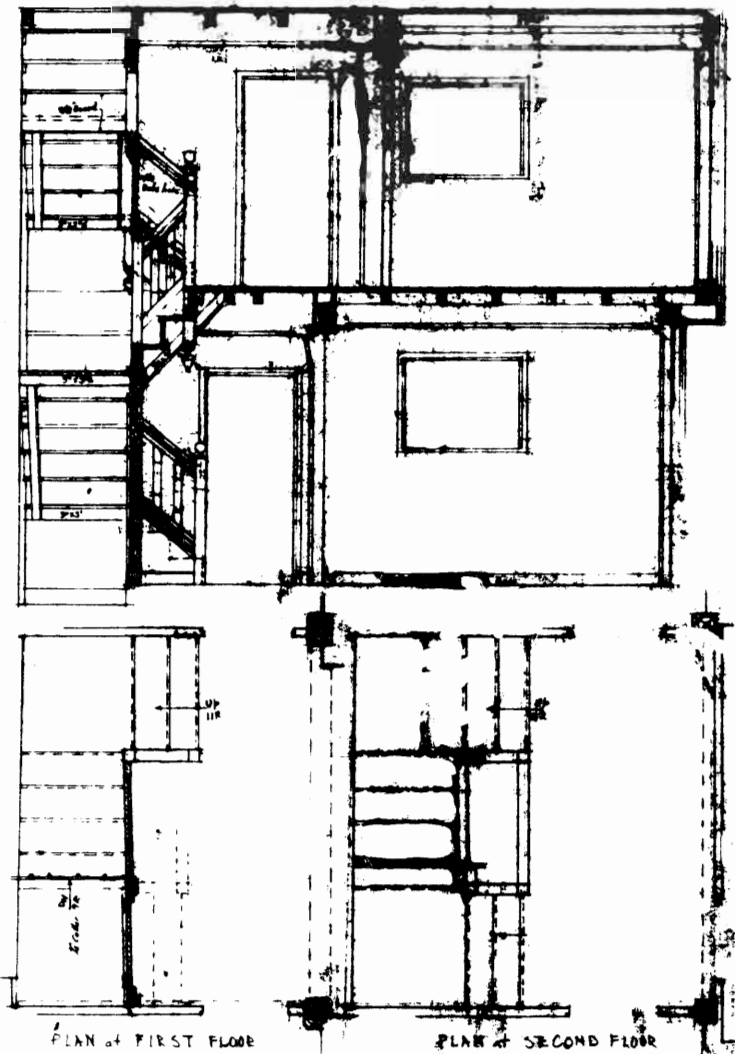
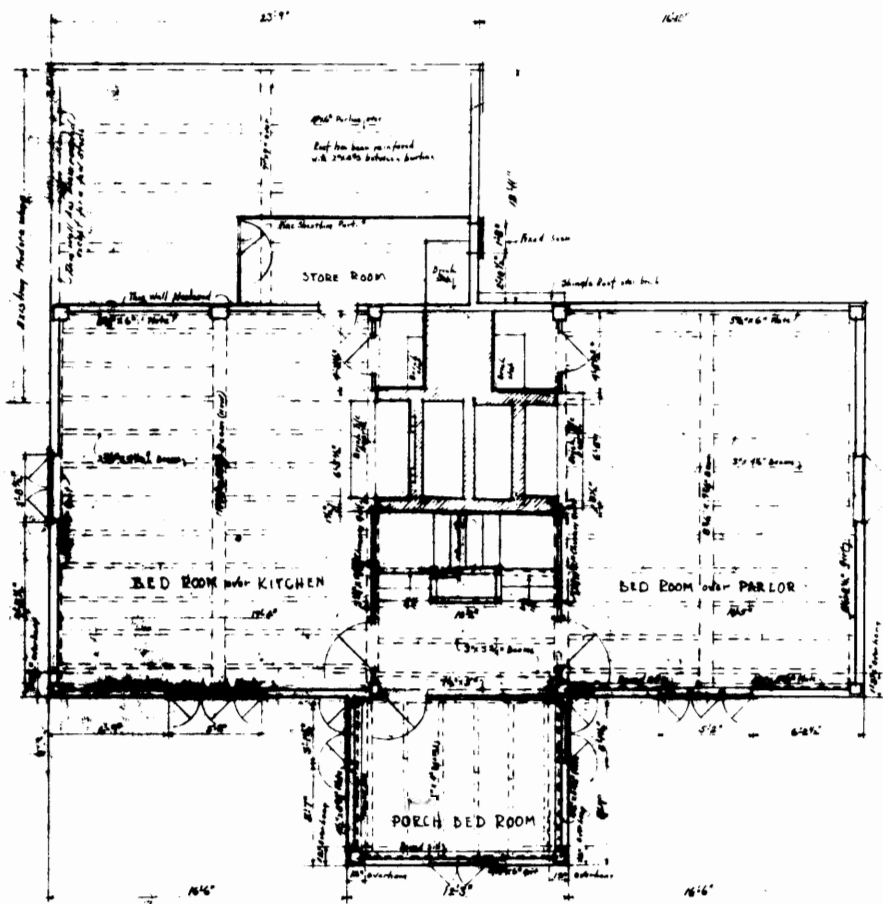
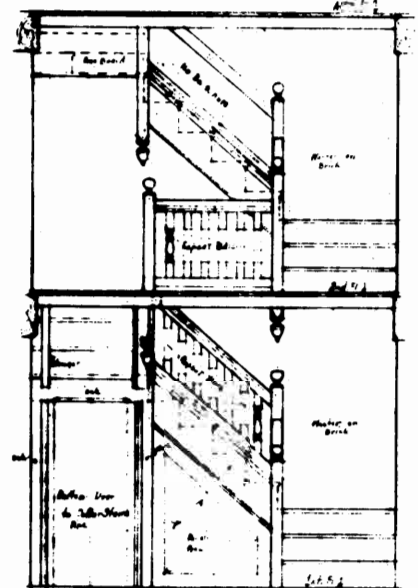
Sheet 3.

Second Floor Plan and Details.

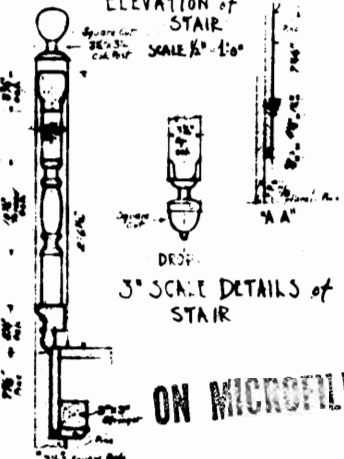
ELEVATION of STAIR
 SCALE 1/2" = 1'-0"

3/4" SCALE DETAILS of STAIR

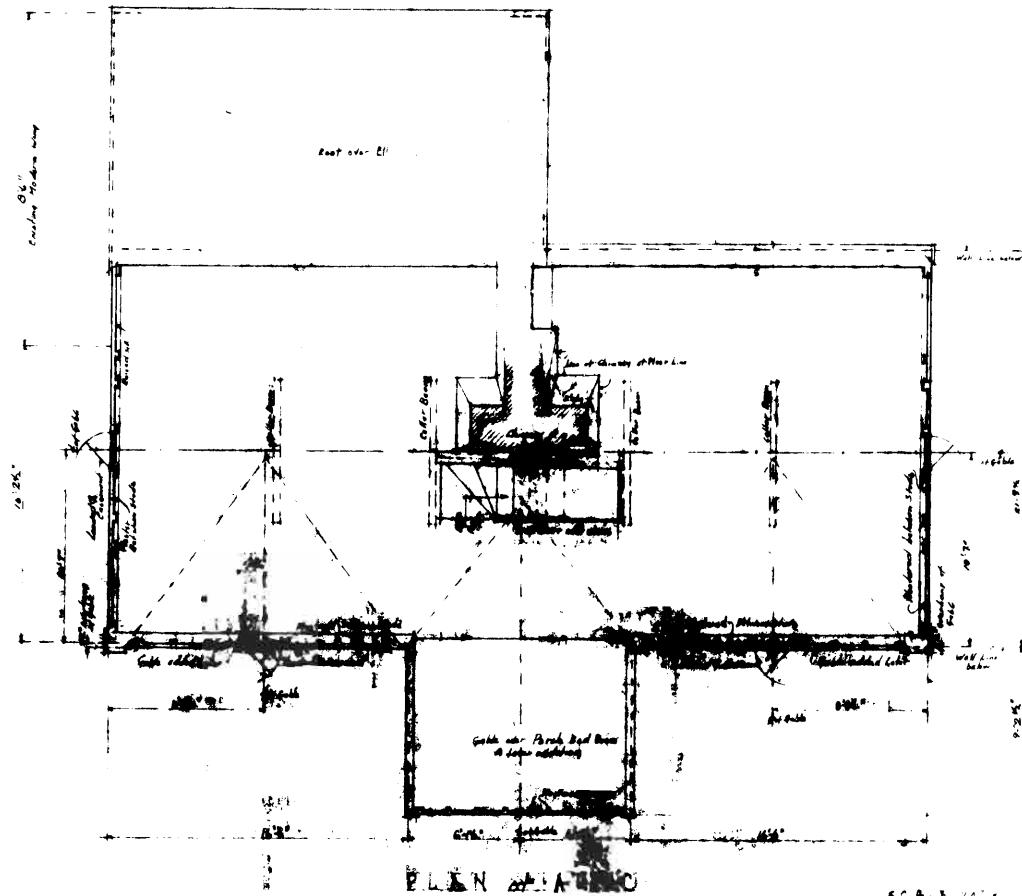
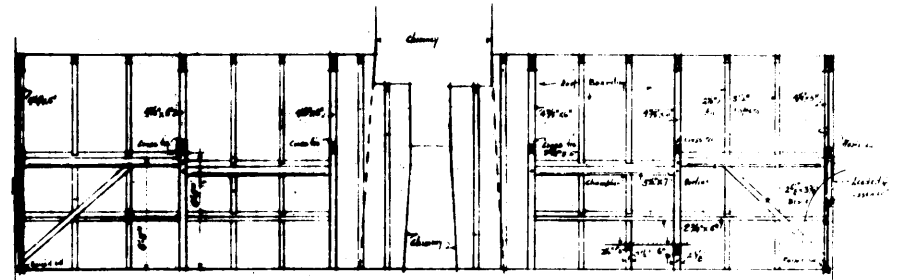
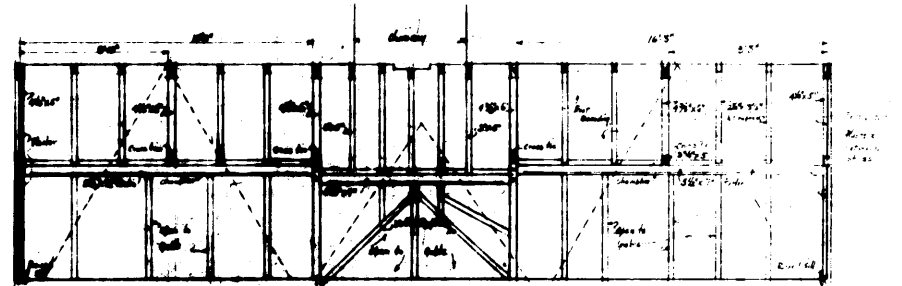
Sheet 4.

Attic Plan--Interior Frame Elev's.

PLAN - ATTIC

ELEVATION - WEST

ELEVATION - EAST

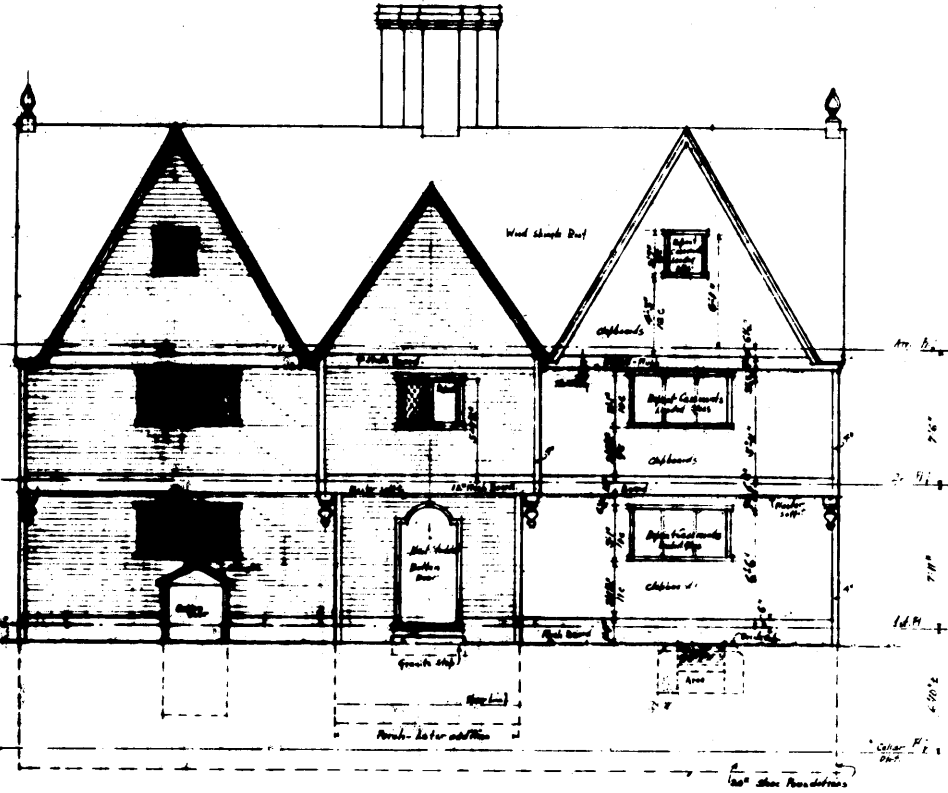
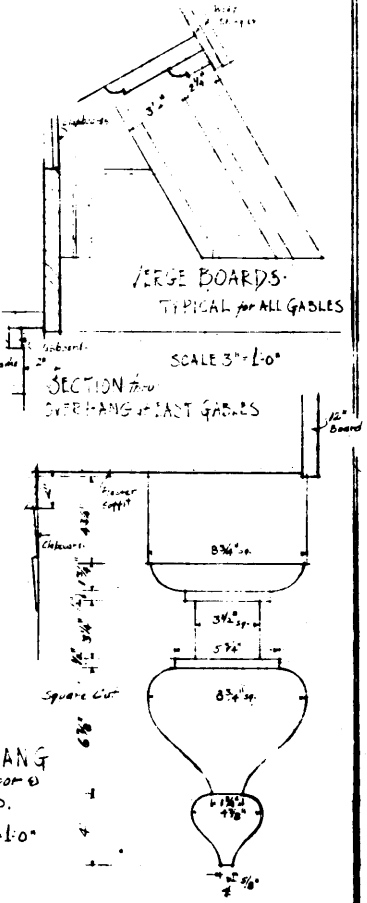
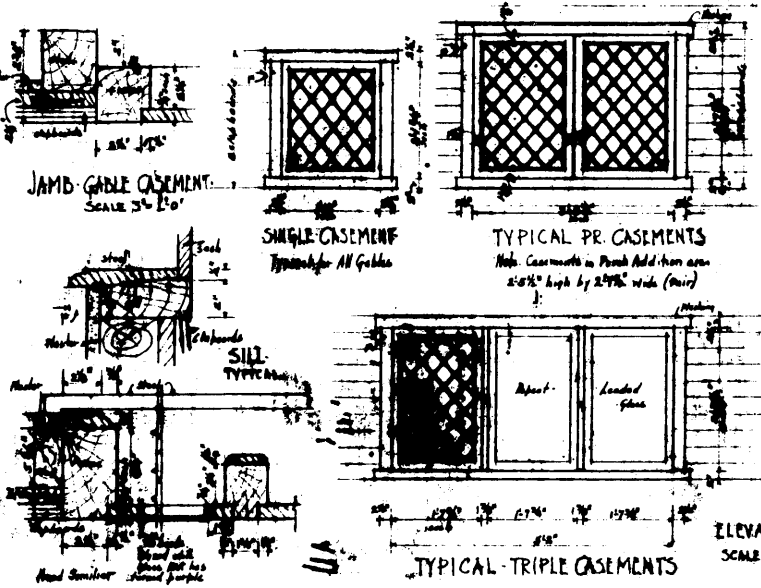
Sheet 5.

East Elevation and Details.

EAST ELEVATION
SCALE 1/4" = 1'-0"

OVERHANG
at 2nd Floor is
DROP.
SCALE 3" = 1'-0"

TYPICAL TRIPLE CASEMENTS

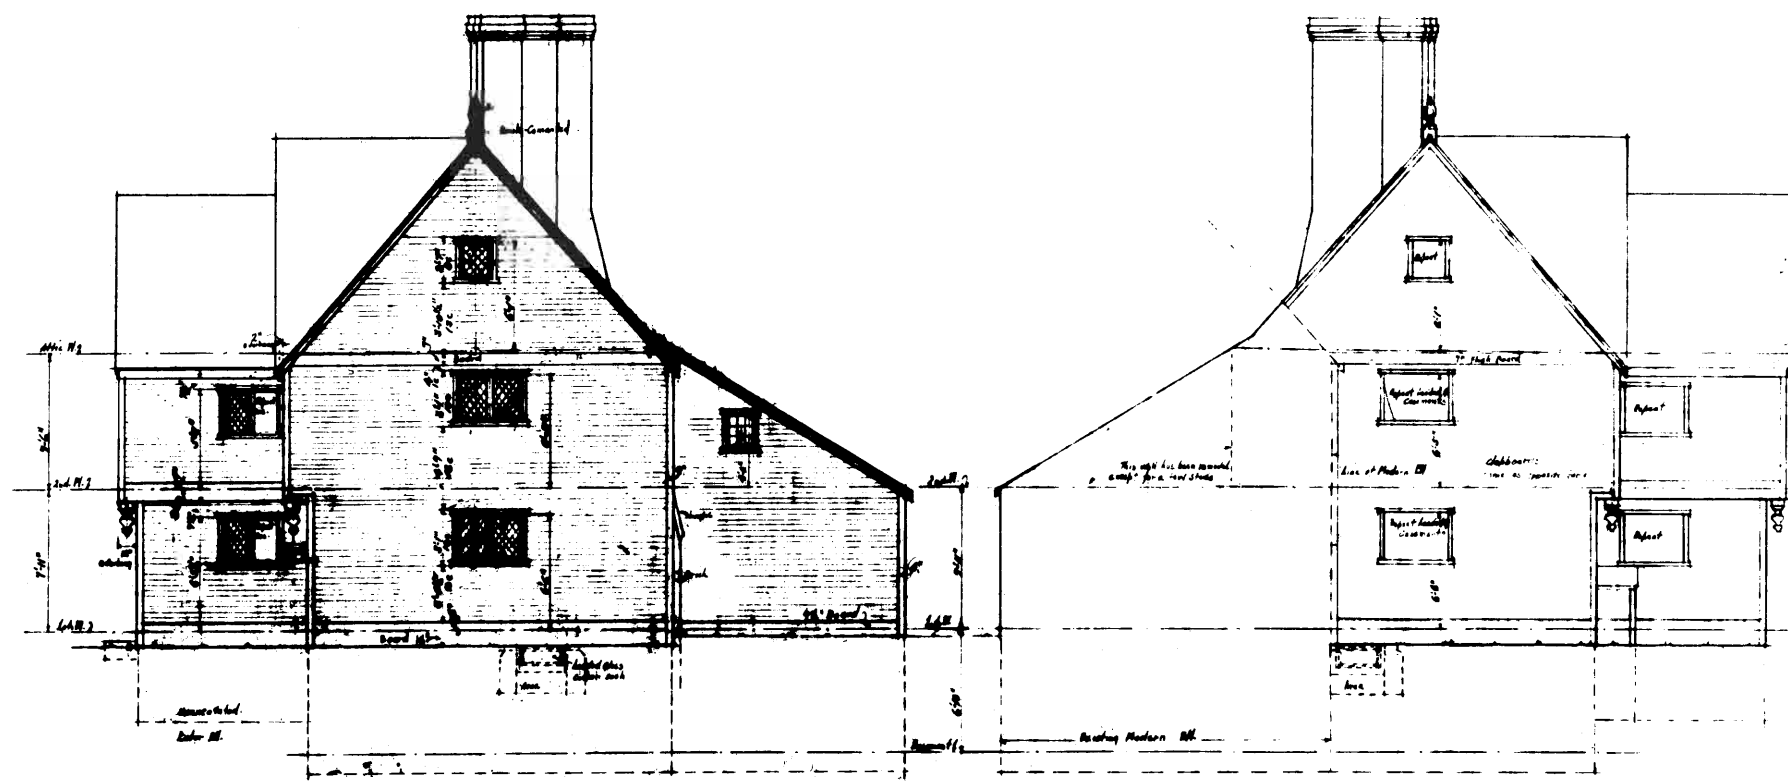
Sheet 6.

North and South Elevations.

NORTH ELEVATION

SOUTH ELEVATION

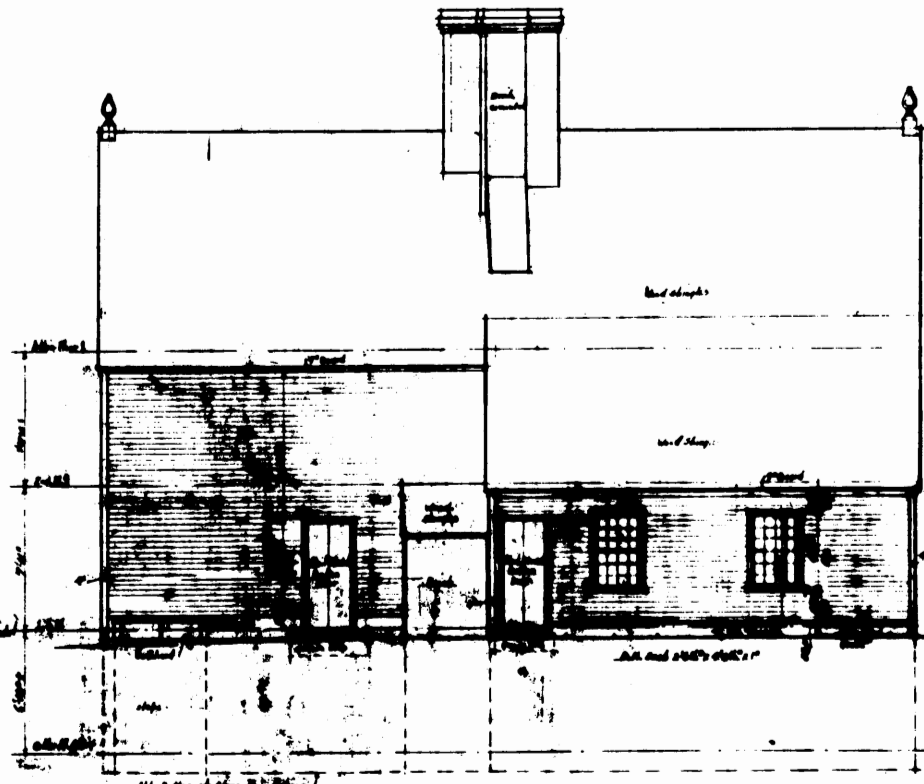
WEST ELEVATION

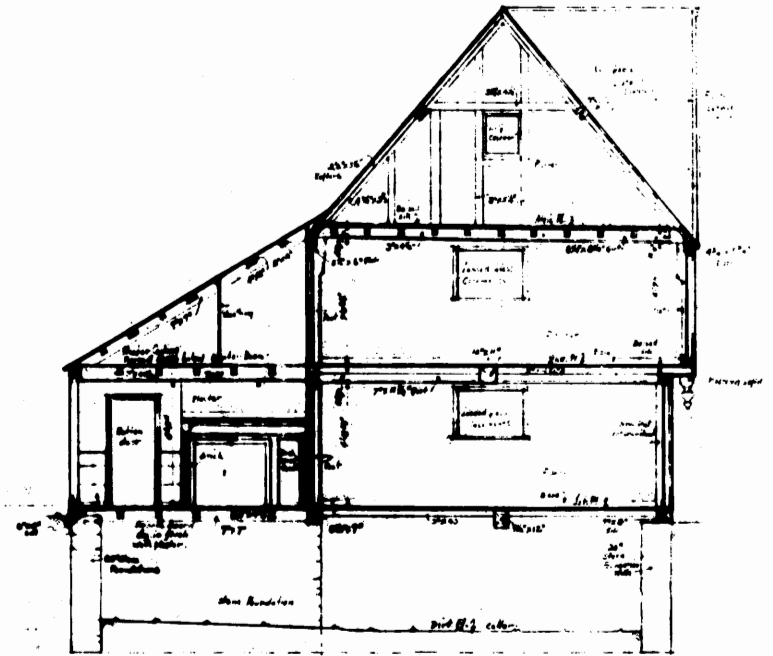
CROSS SECTION

thru Work Room, Parlor, & Parlor Bed Room
SCALE 1/4" = 1'-0"

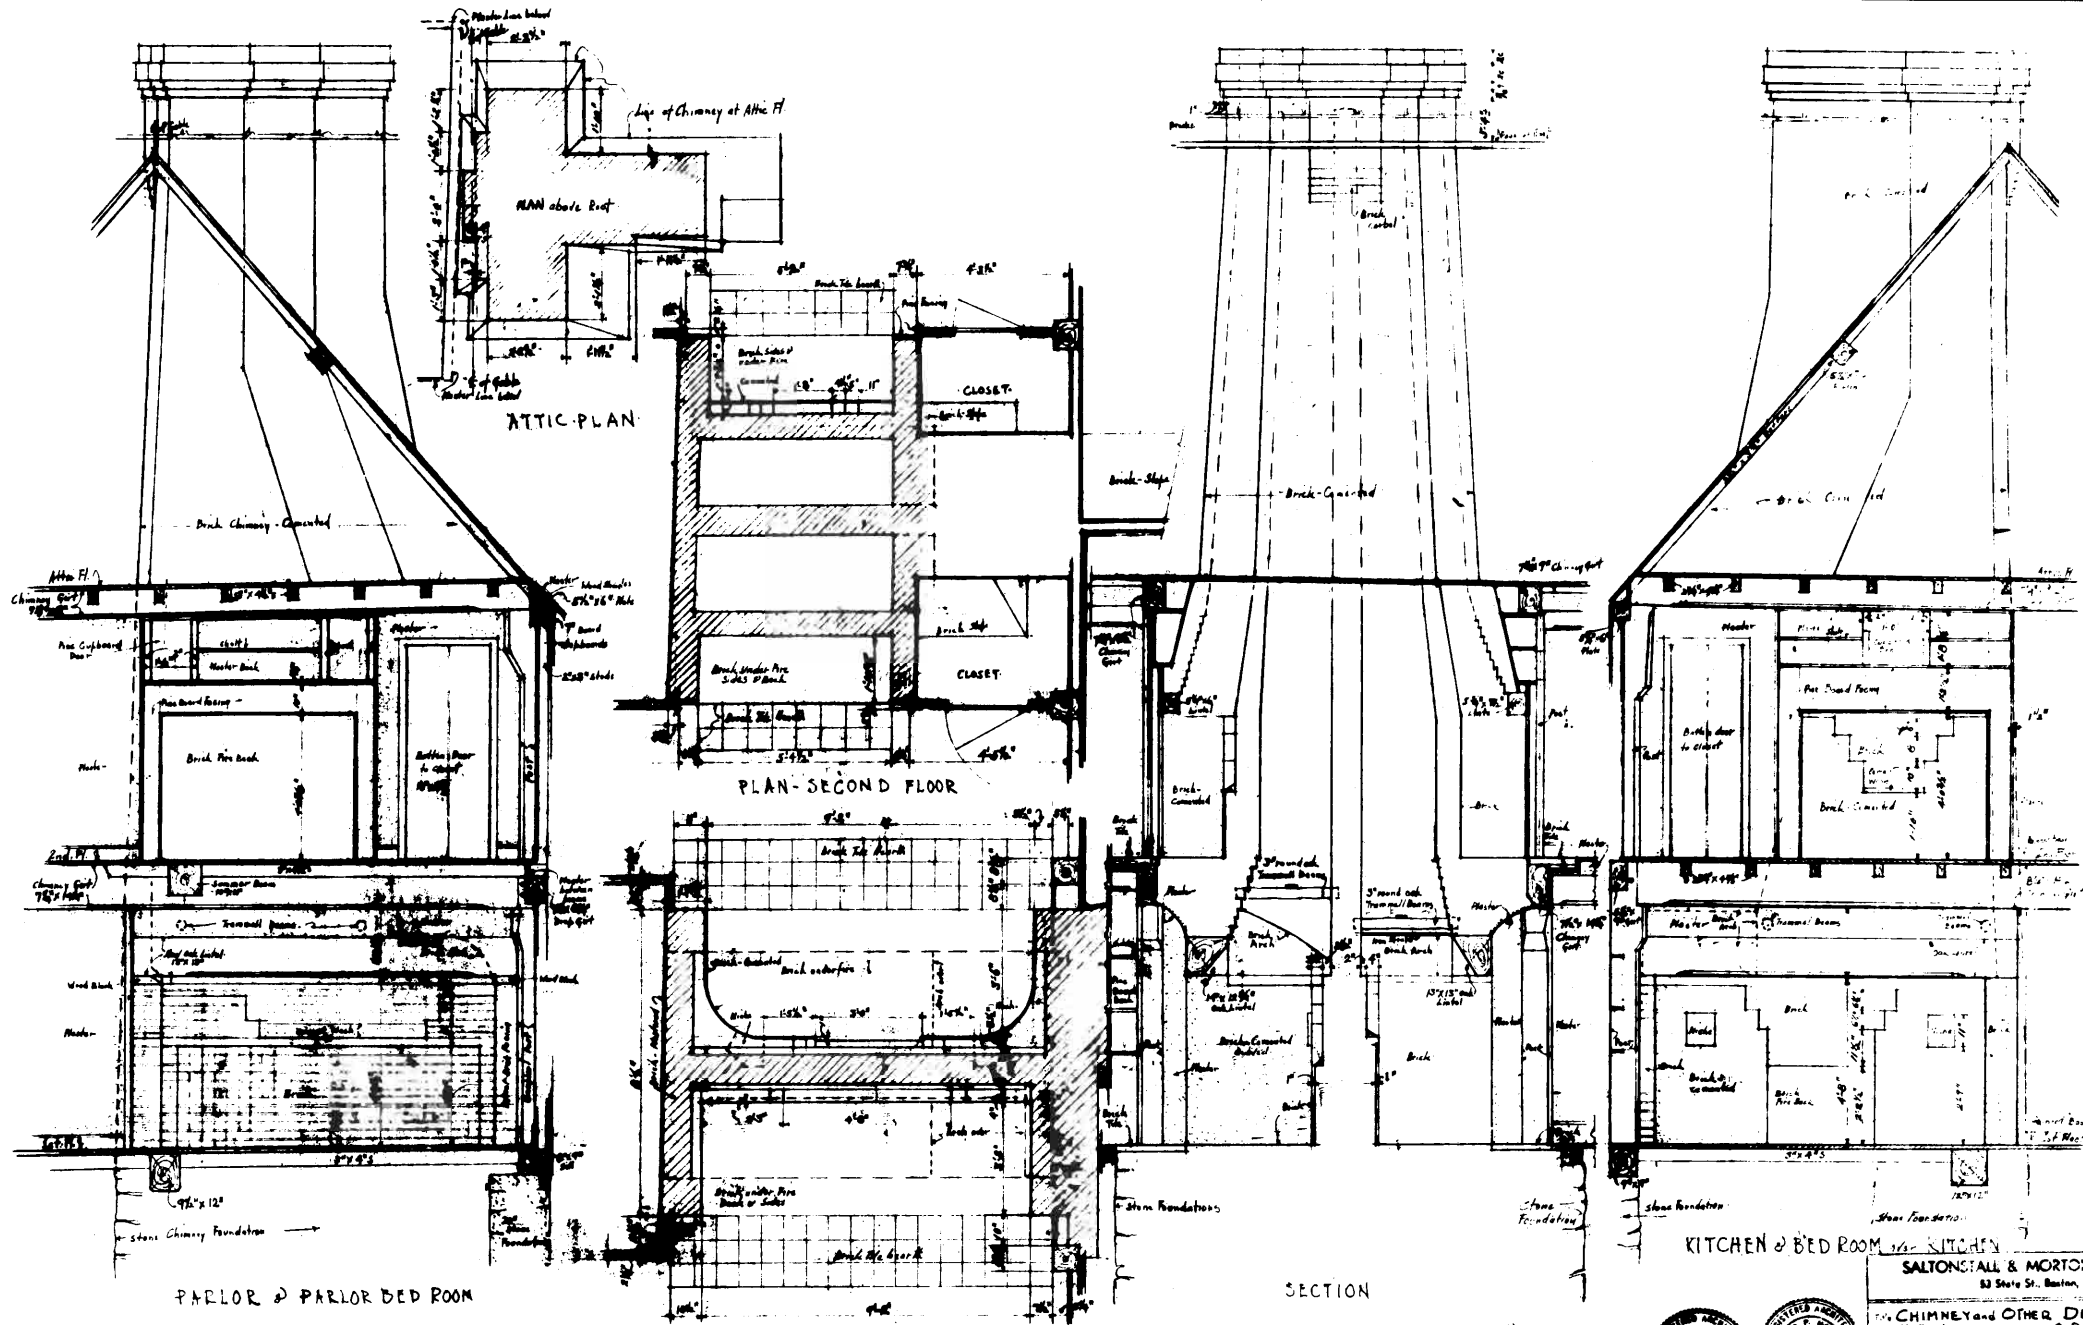
Sheet 8.

Chimney and Other Details.

CHIMNEY DETAIL ON MICROFILM
SCALE 1/2" = 1'-0"

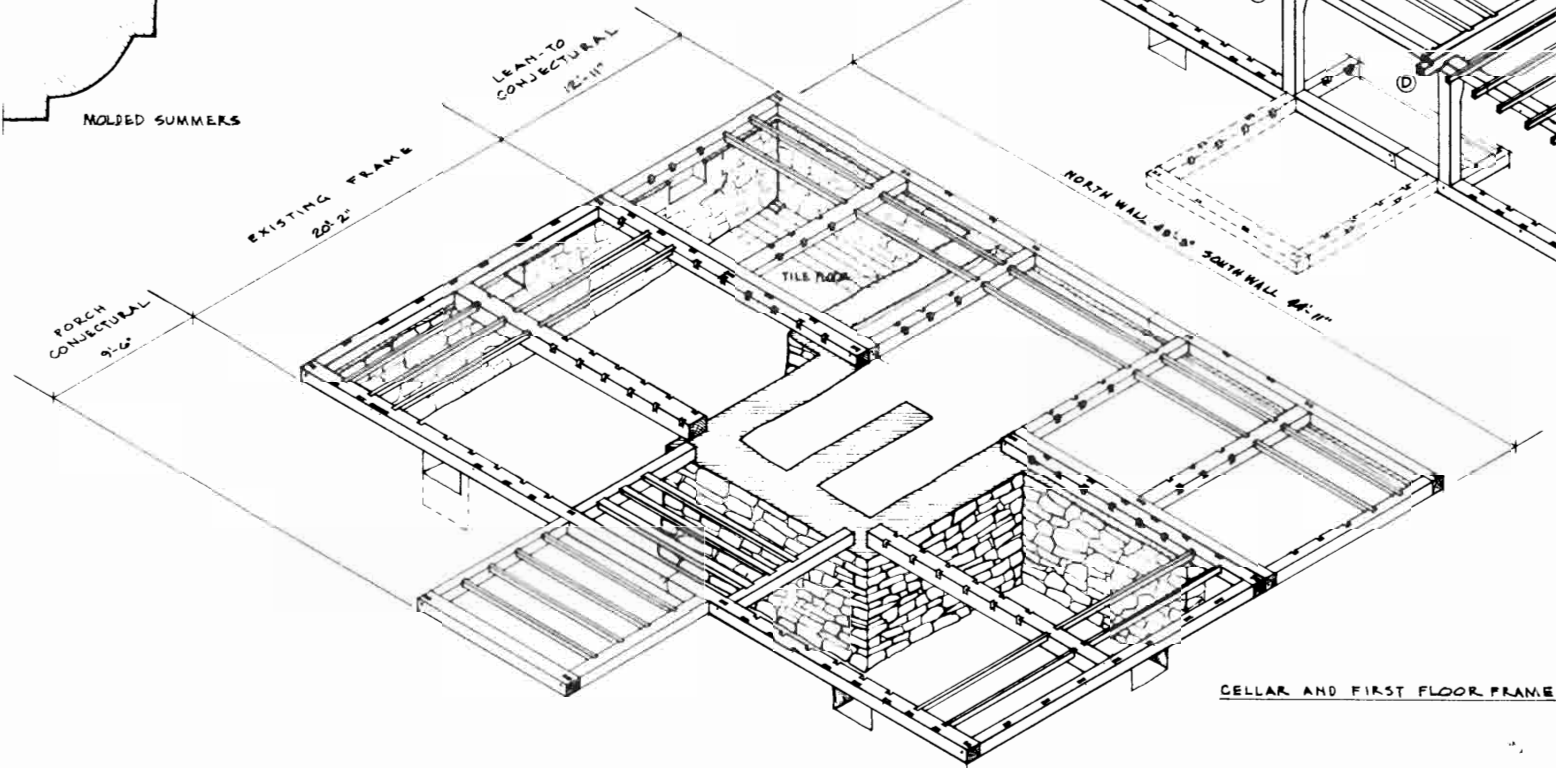
CELLAR AND FIRST FLOOR FRAME

ISOMETRIC VIEWS OF IRONMASTER'S HOUSE

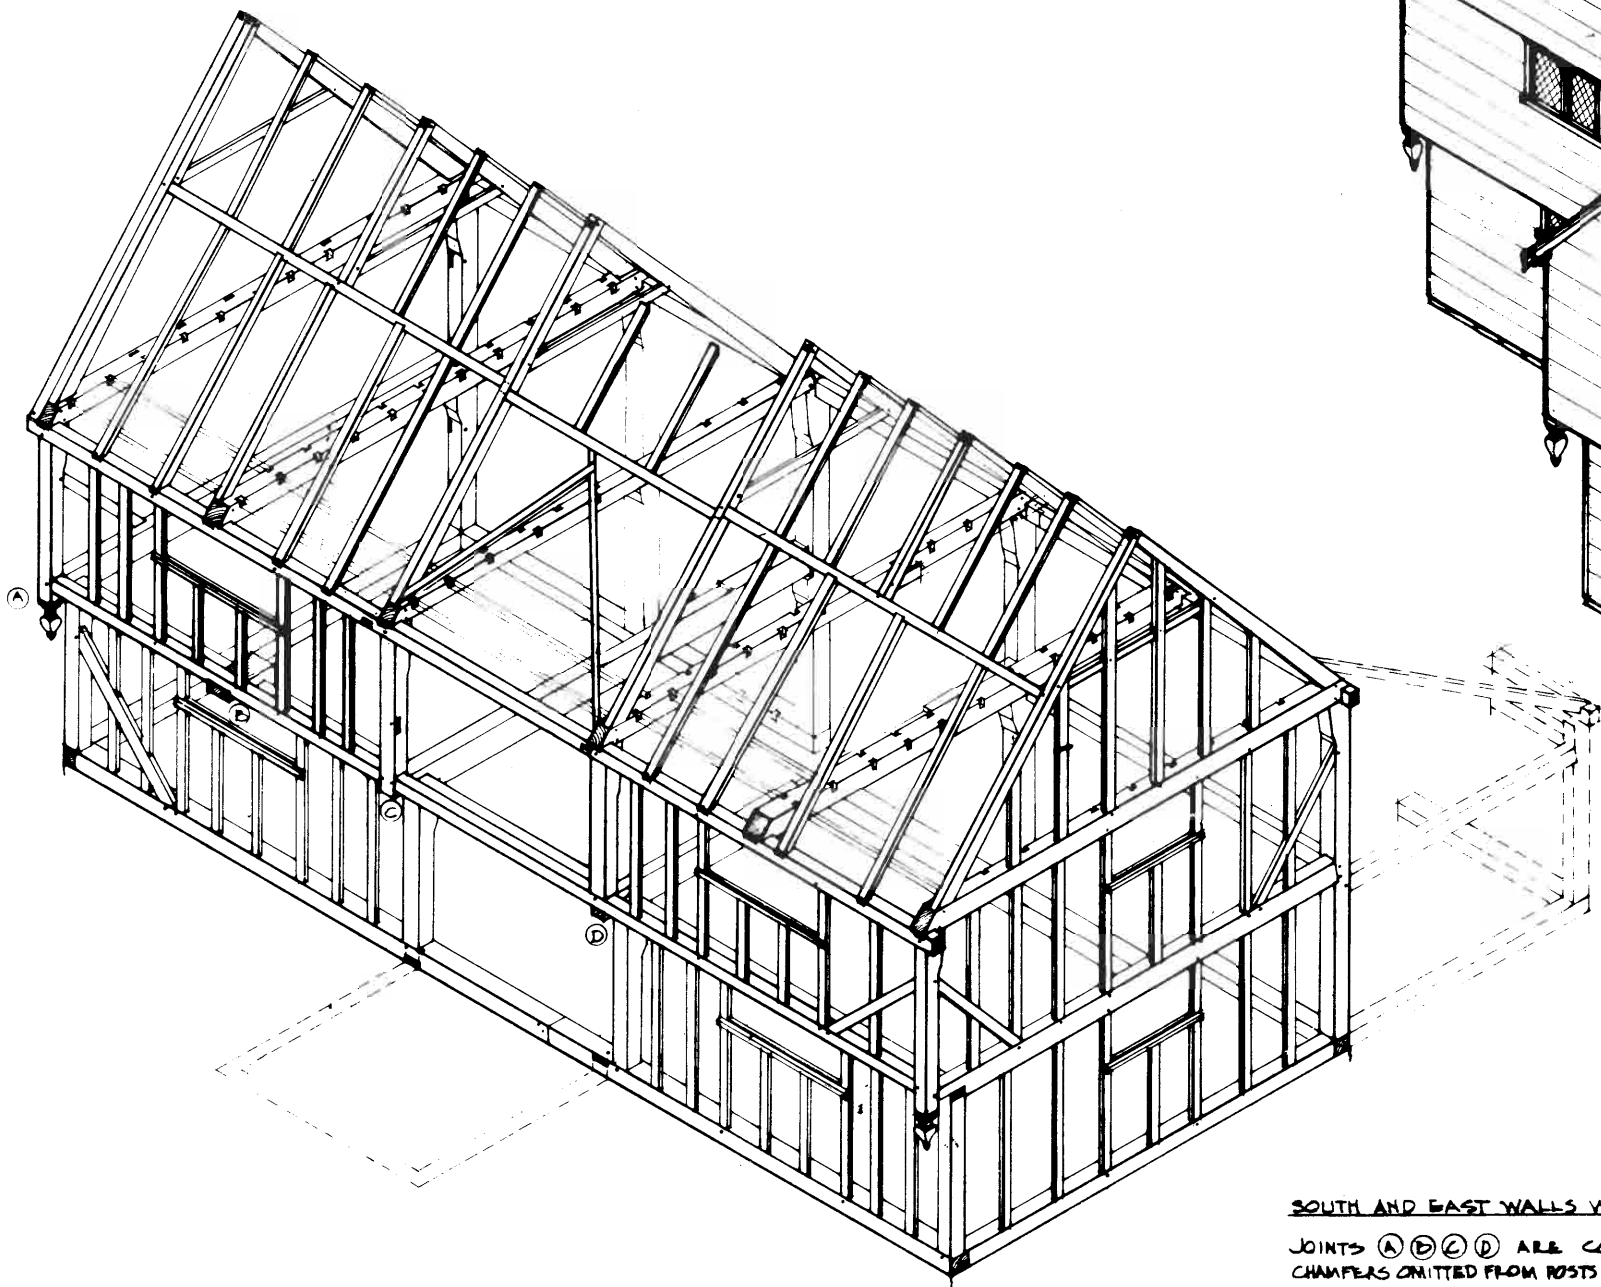
Sheet 3,

Isometric--2nd Floor & Roof.

SOUTH AND EAST WALLS WITH ROOF FRAME
 JOINTS A B C D ARE CONJECTURAL
 CHAMFERS OMITTED FROM POSTS GIRTS & BEAMS

LEAN-TO IS CONJECTURAL
 BUT BASED ON STRUCTURAL
 EVIDENCE FOUND IN FRAME

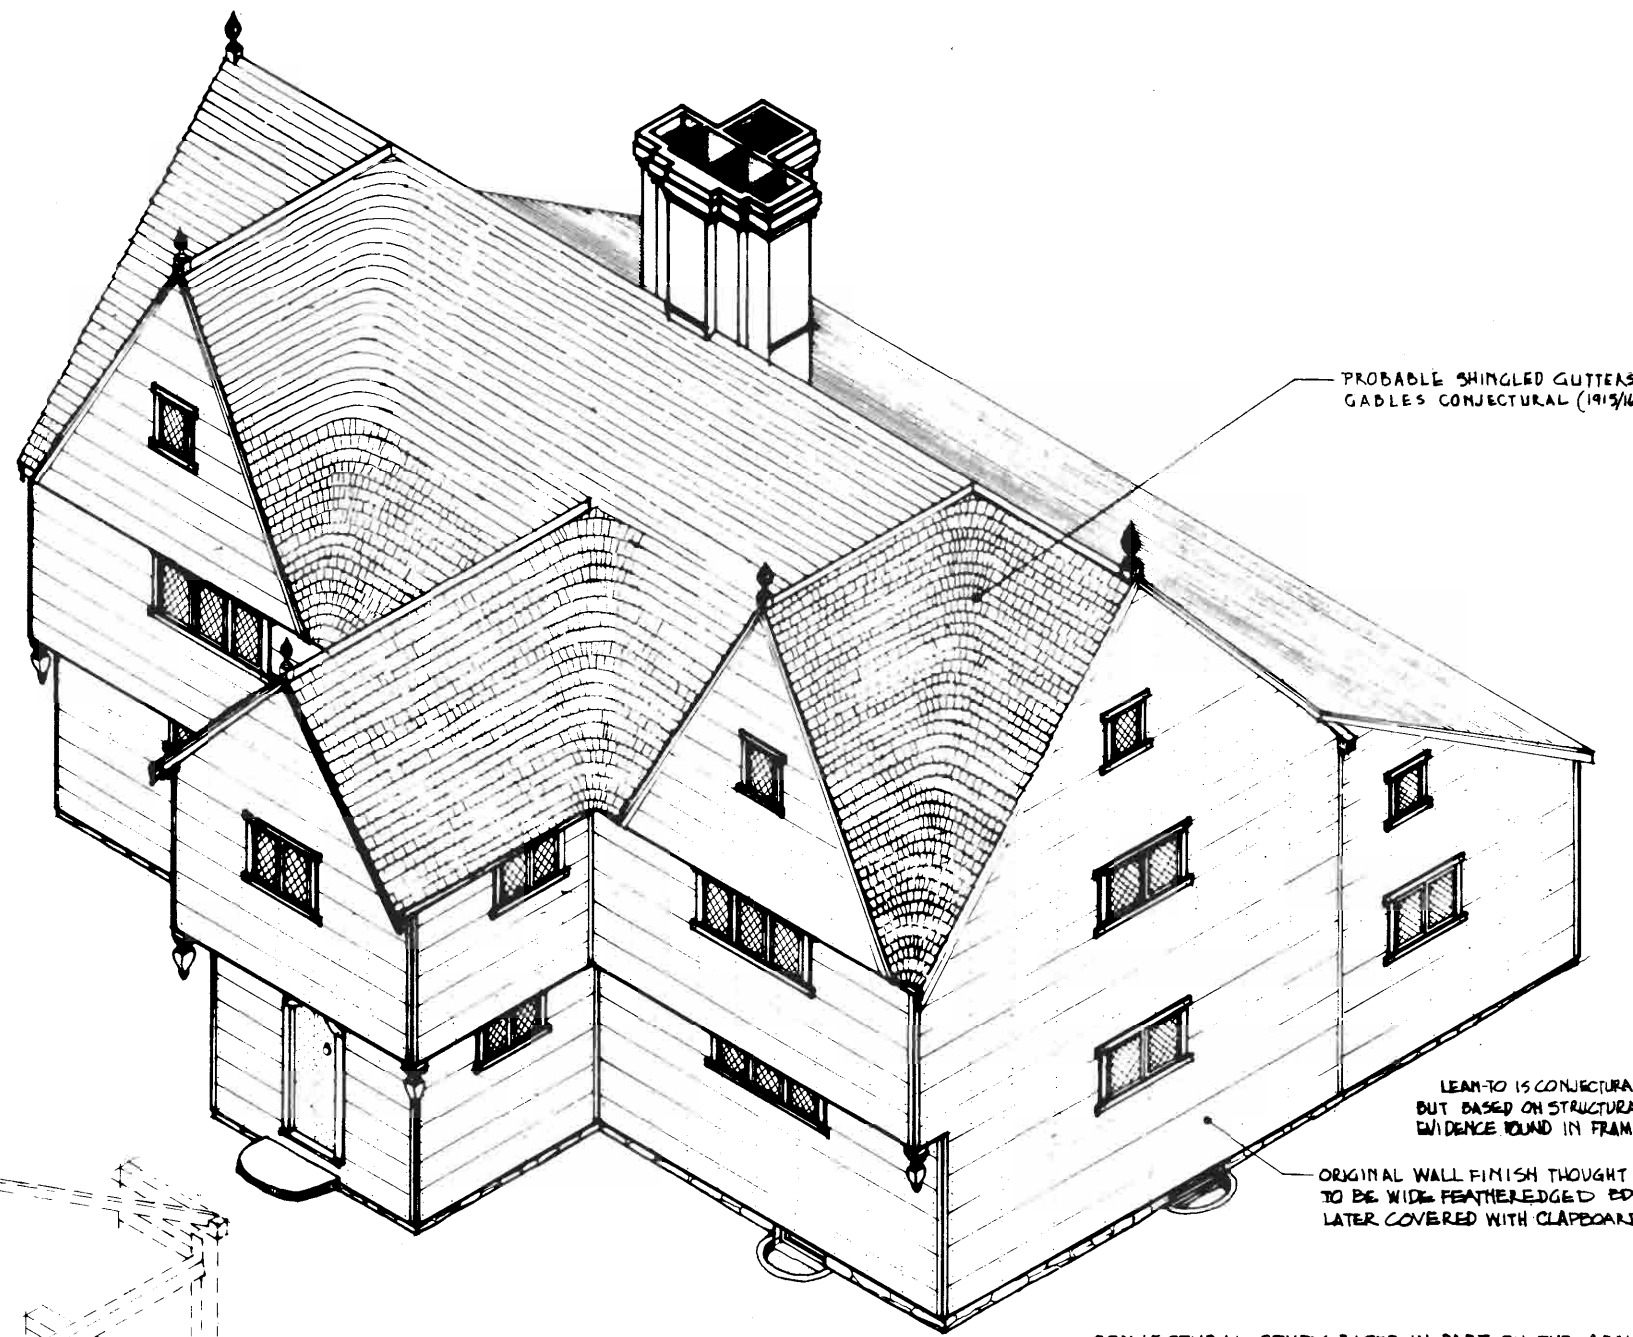
PROBABLE SHINGLED GUTTERS
 GABLES CONJECTURAL (1915/16)
