SAUGUS IRON WORKS
IRONMASTER'S HOUSE

NATIONAL HISTORIC SITE / MASSACHUSETTS

HISTORIC STRUCTURE REPORT
IRONMASTER'S HOUSE
HISTORICAL AND ARCHITECTURAL DATA
AND
A HISTORY OF OWNERSHIP
SAUGUS IRON WORKS NATIONAL HISTORIC SITE
MASSACHUSETTS

November 1977

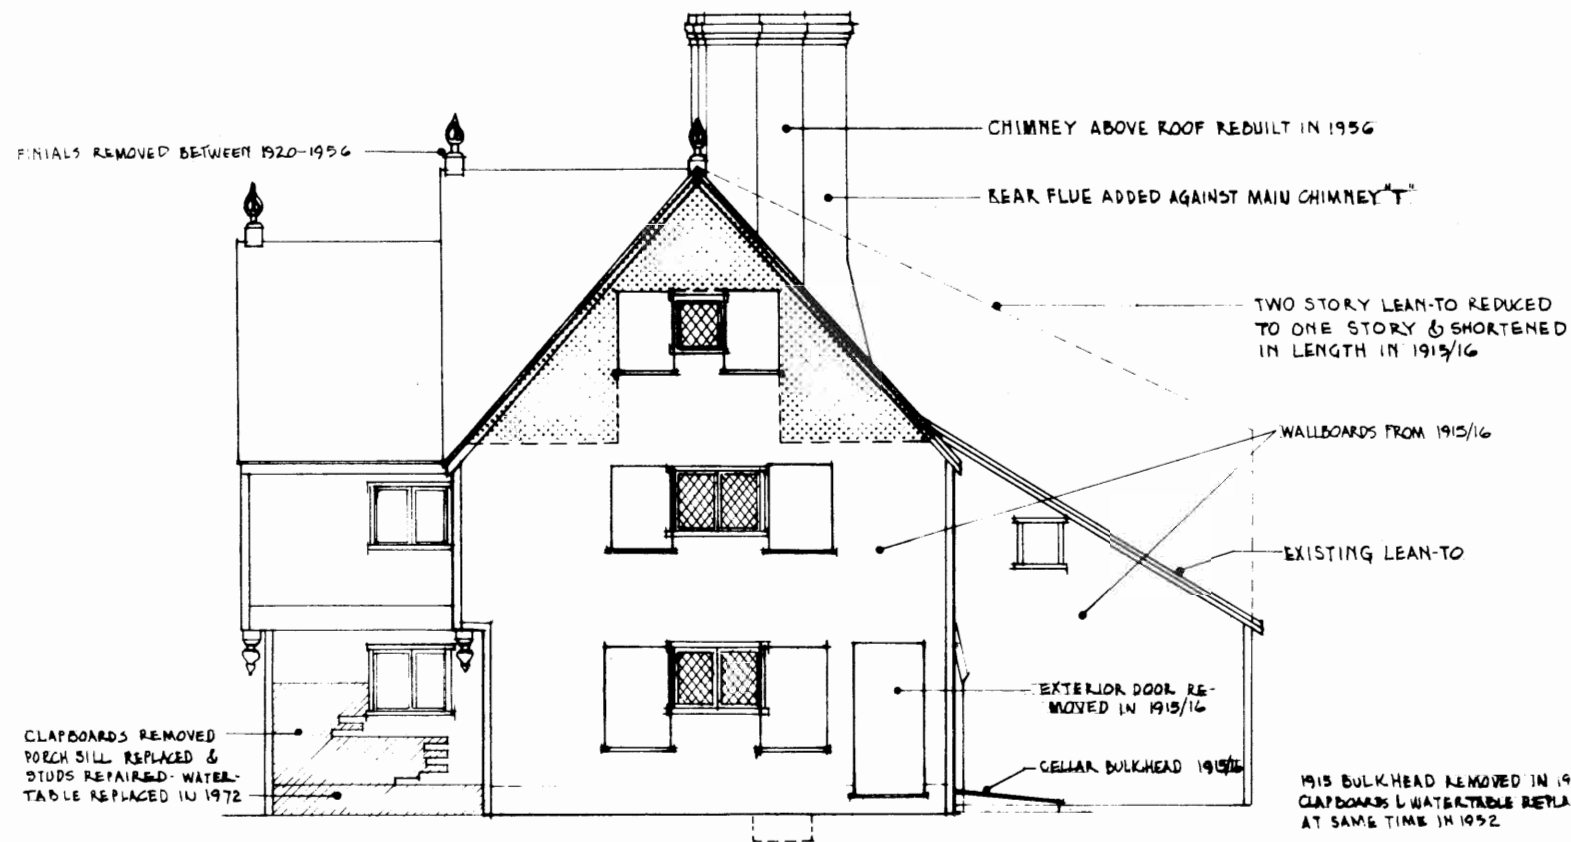
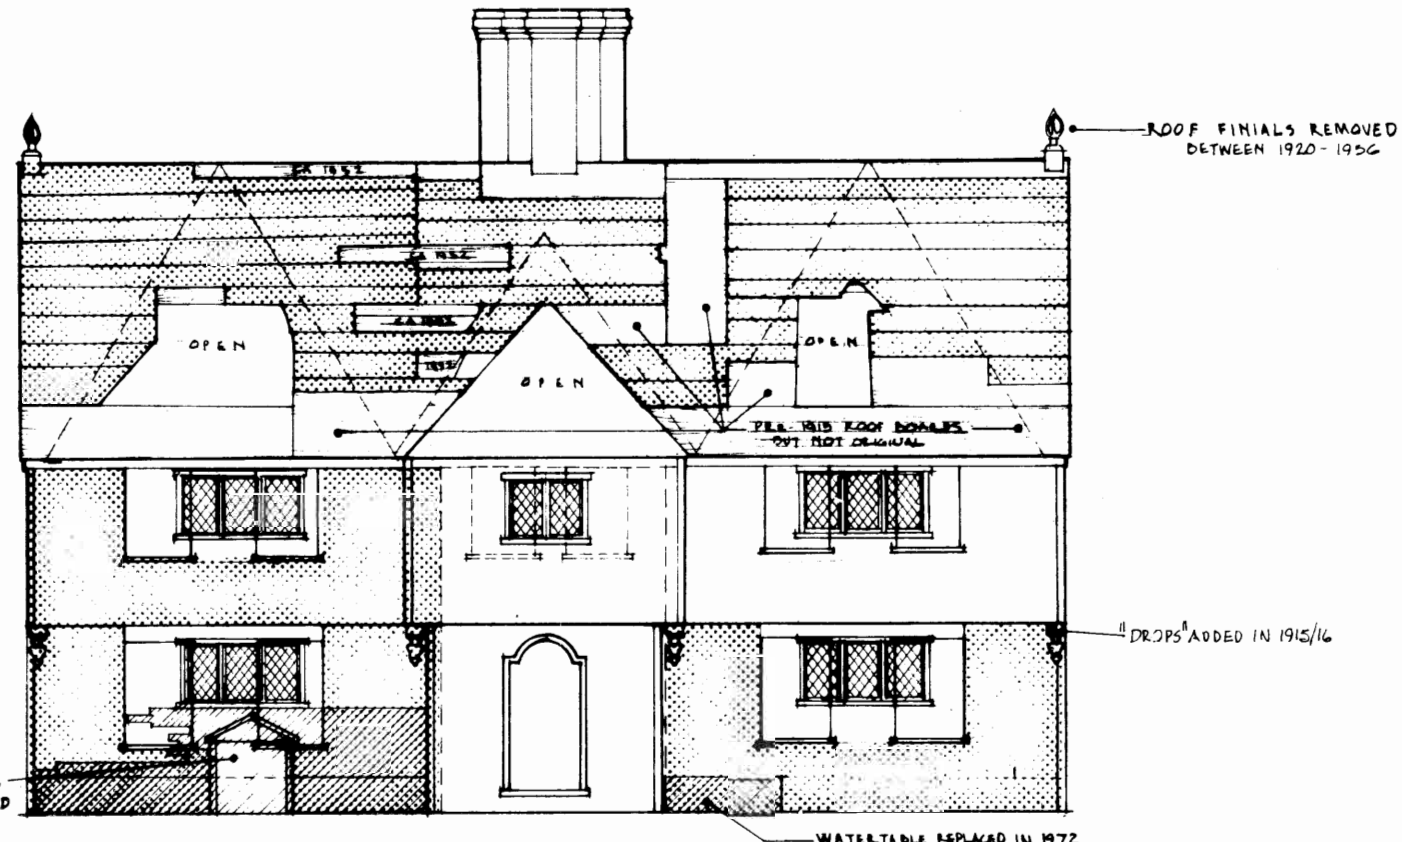
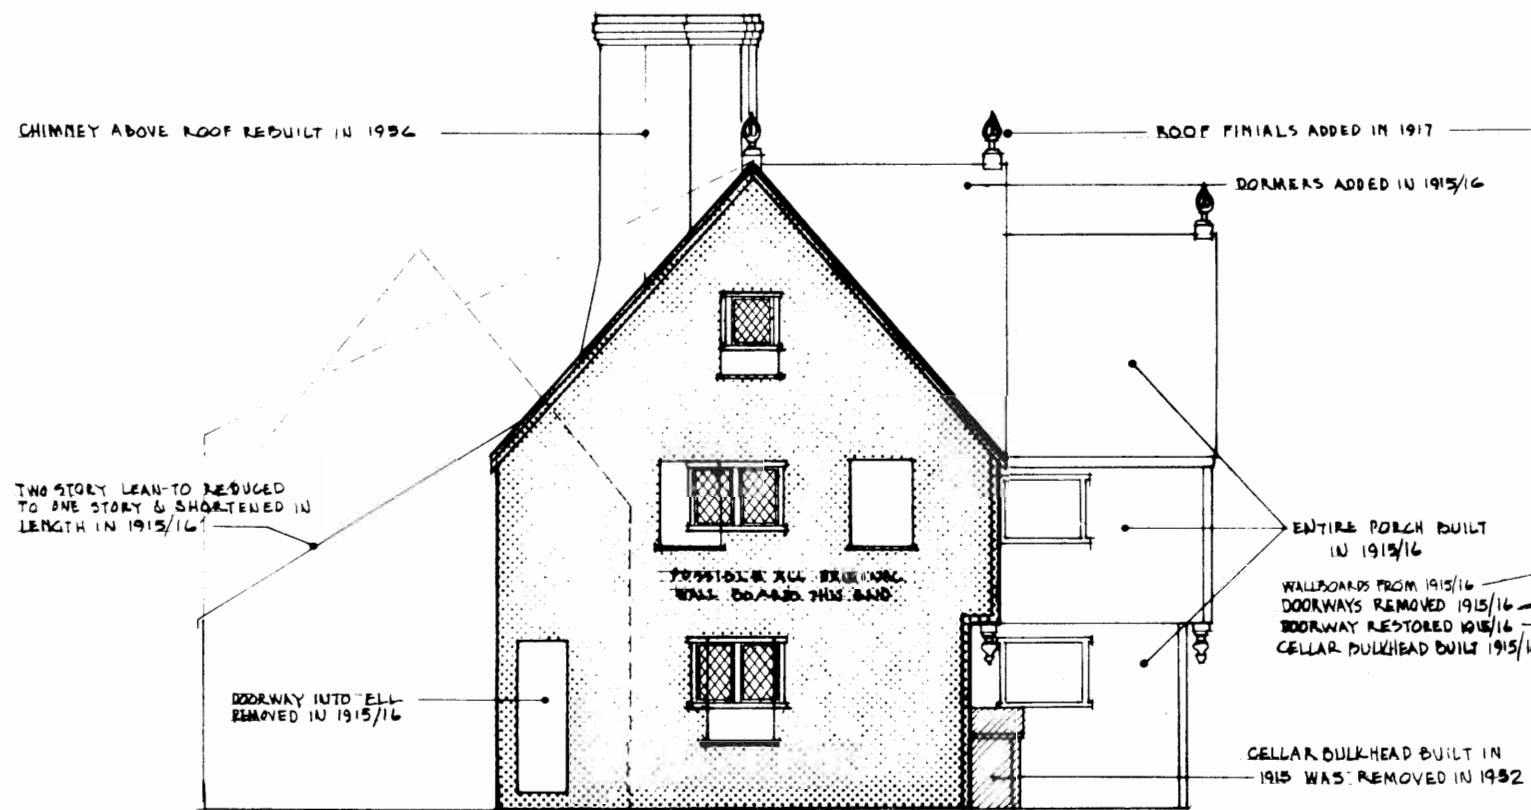
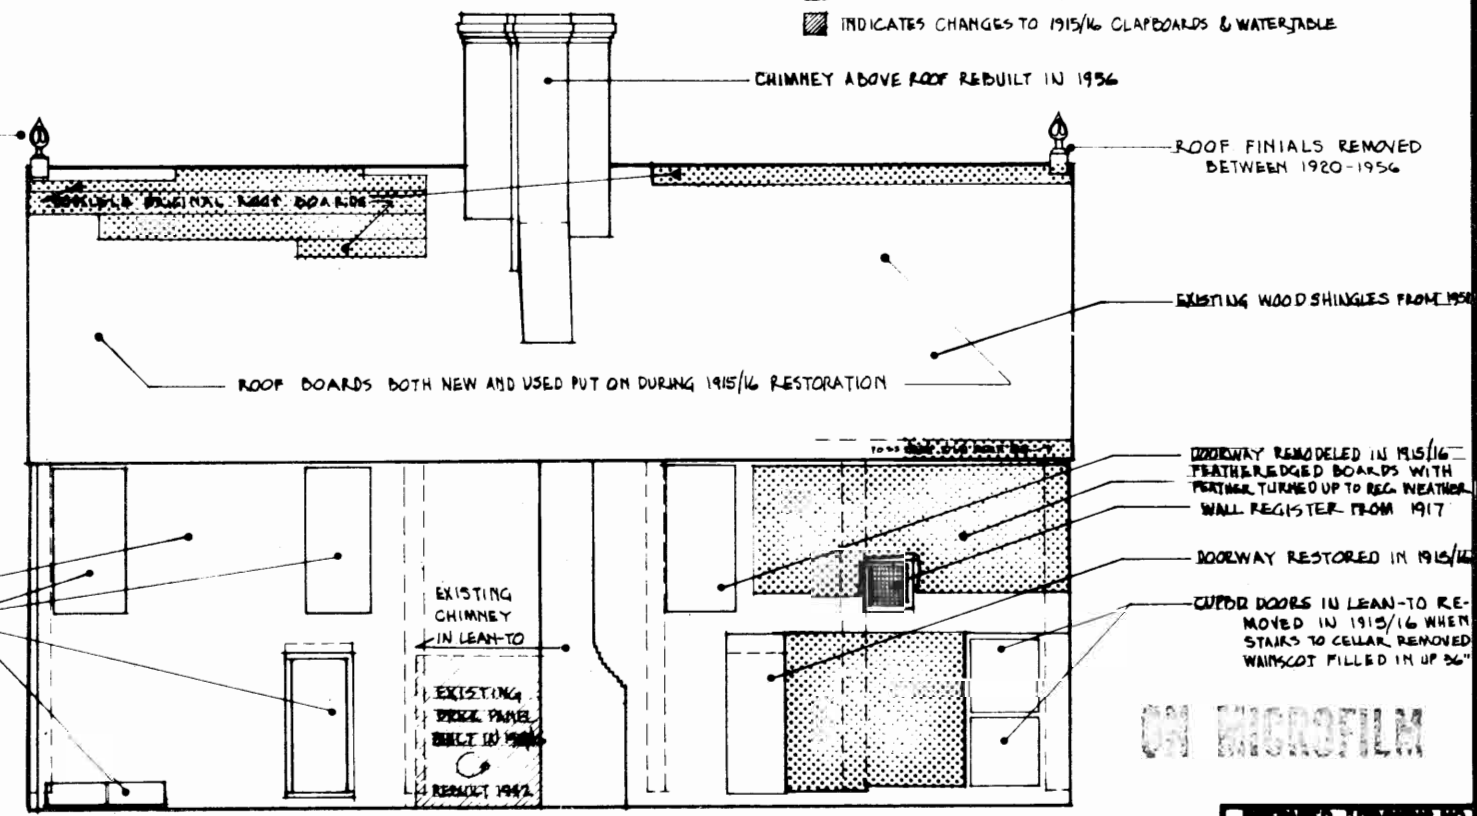
Exterior Wall & Roof Changes.

■ INDICATES POSSIBLE ORIGINAL ROOF BOARDING
 ▨ INDICATES CHANGES TO 1915/16 CLAPBOARDS & WATER-TABLE

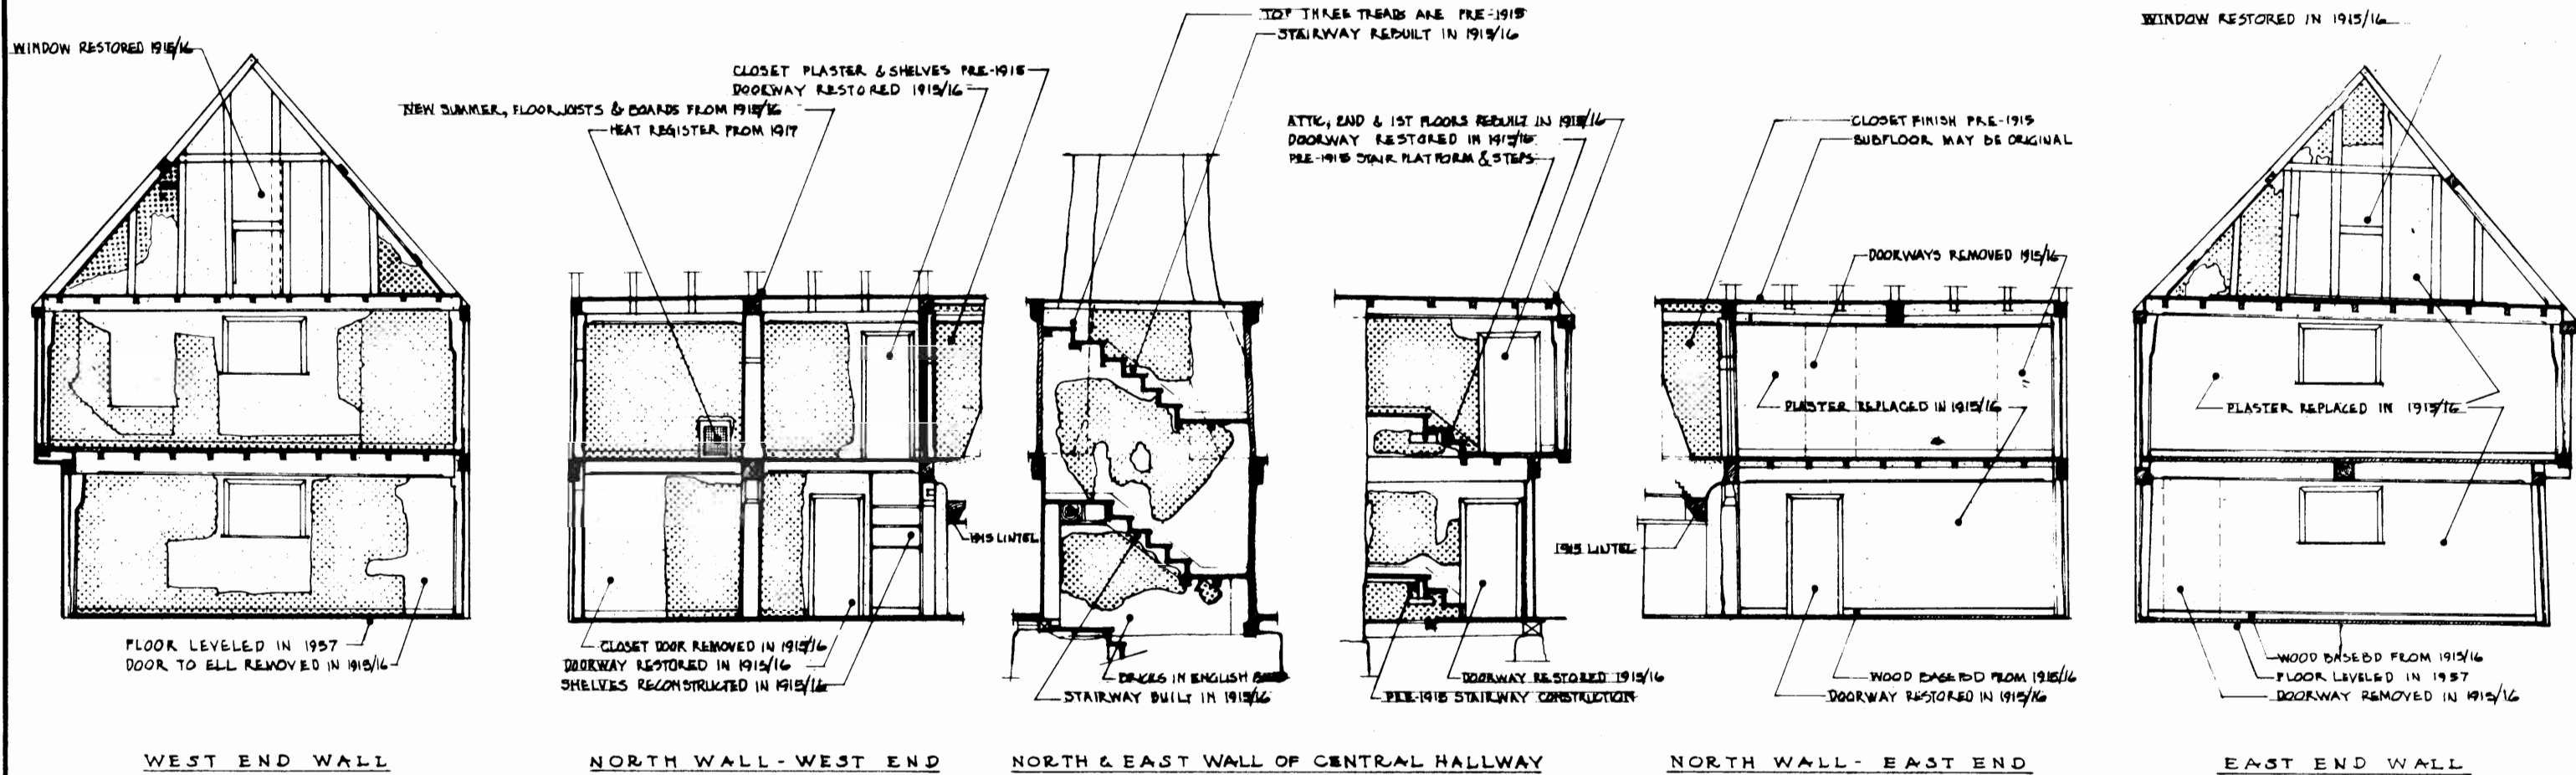
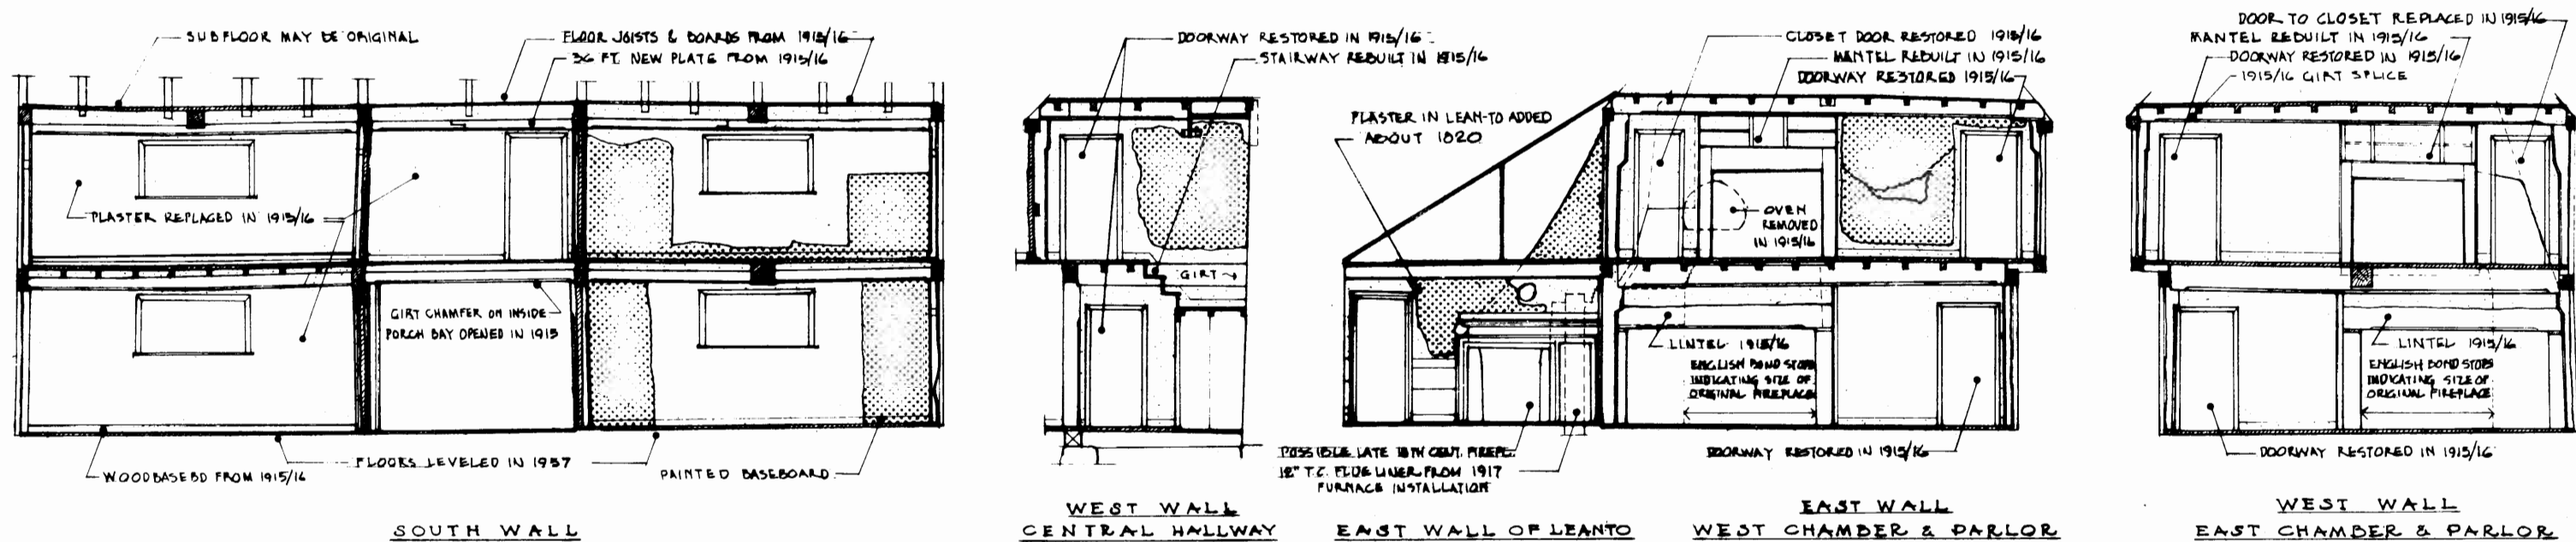
Sheet 8.

Interior Wall Changes.

INTERIOR CHANGES MADE TO WALL FINISHES OF IRONMASTER'S HOUSE

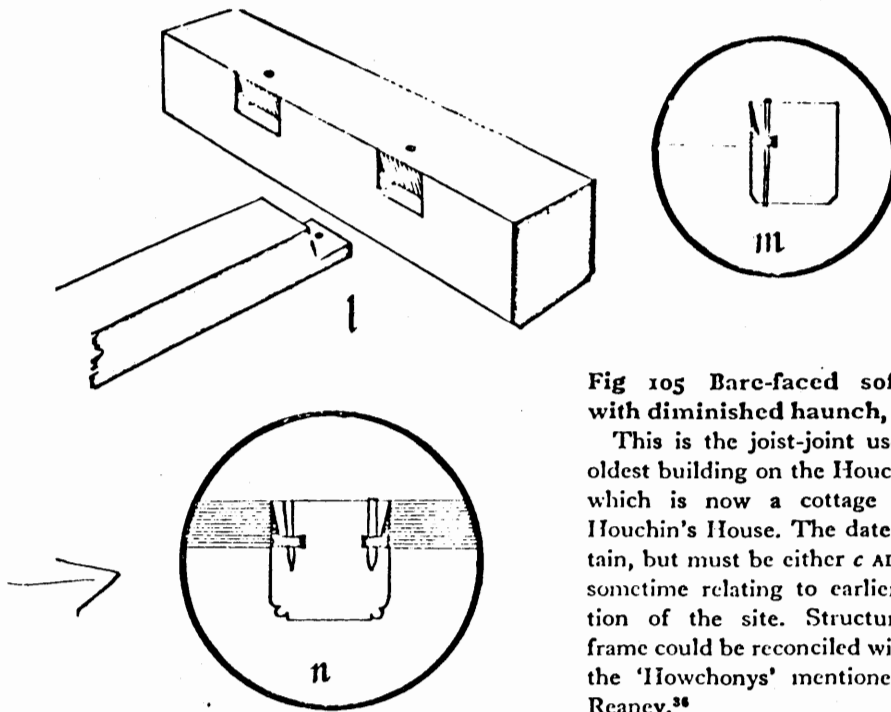
Fig 105 Bare-faced soffit-tenon with diminished haunch, and peg.

This is the joist-joint used in the oldest building on the Houchin's site, which is now a cottage adjoining Houchin's House. The date is uncertain, but must be either c AD 1560, or sometime relating to earlier occupation of the site. Structurally, the frame could be reconciled with c 1412, the 'Howchonys' mentioned by Dr Reaney.³⁶

15. Cecil A. Hewett, "The Development of Carpentry 1200-1700." See also Figs. A and B, taken from this book, relating to the development of joinery.

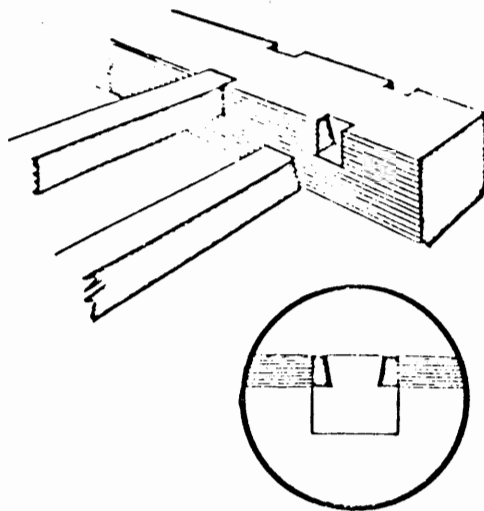
Fig 110 Butt-cogged flush with face.

This method has been recorded by Mason,³⁷ and exists at the Red Lion, Witham, Essex. It has nothing to recommend it and relies upon bridging-joists far stronger than are necessary. It would date from c 1650 and might extend to c AD 1800. It was certainly widely used in New England after c AD 1660.

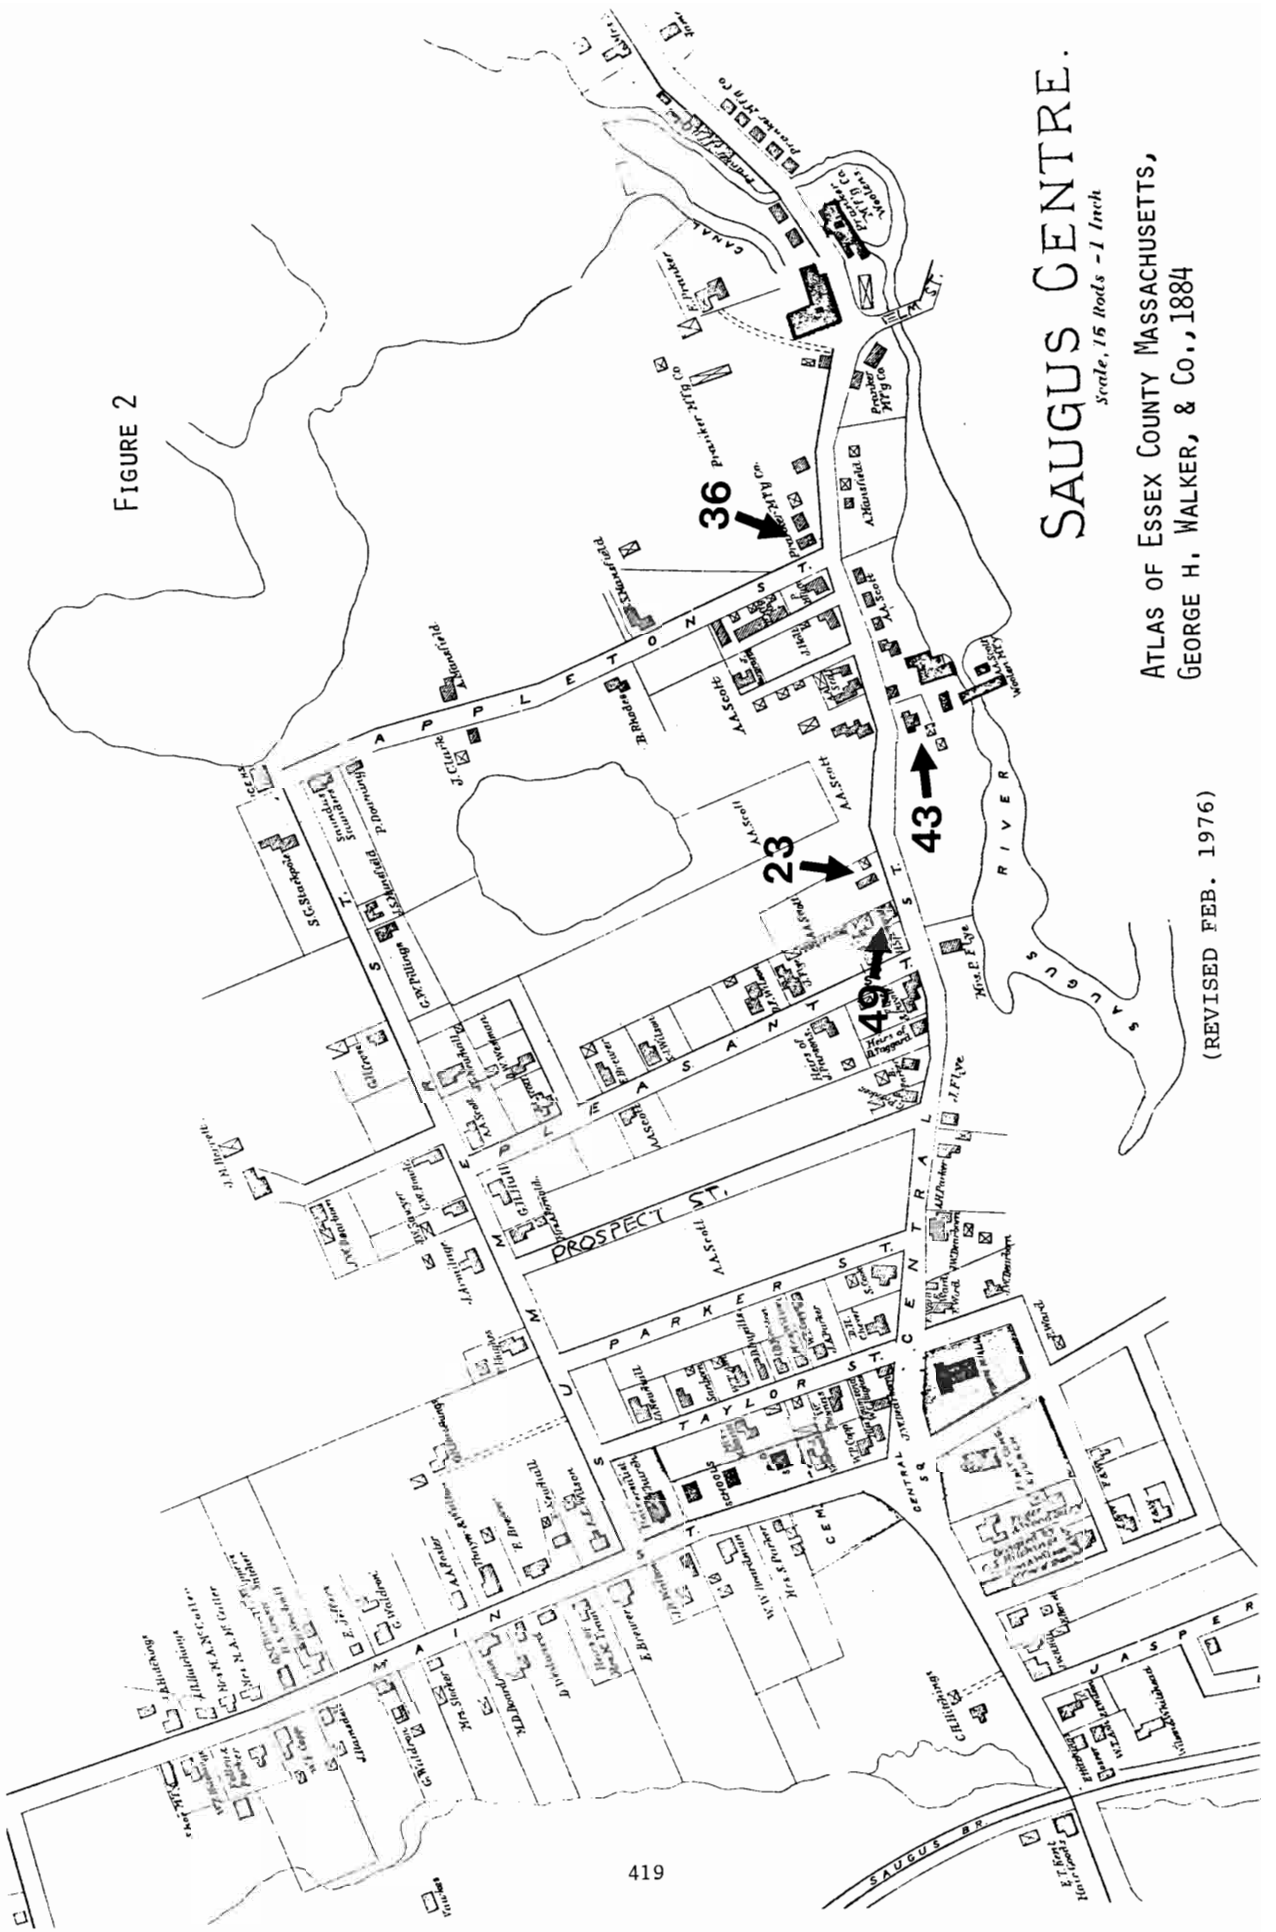
FIGURE 2

"Saugus Centre," from 1884 Atlas.

SAUGUS CENTRE.

It could be argued that the course of Central Street beyond Appleton, continuing into Elm Street (Fig. 2), may conceivably mark the course of the "Convenient Way" of 1724, for it is clear that the gristmill was near the middle or upper end of Abigail's lot. This we can determine for the following reasons: having acquired the thirteen and a quarter acres in Callamount Pasture, Daniel Mansfield conveyed this tract, described now as containing "a Dwelling House & Barns," to his son Thomas Mansfield, clothier, ten years later on January 3, 1753.¹⁶ The house, which we have designated the Thomas Mansfield I House (Str. #36), became Thomas's home and was built either by him or by Daniel for him.

the northeast where Elm Street now crosses the Saugus River (Fig. 2). Thomas Mansfield's inventory in 1758, taken the same year as that of his father's, mentions again the "Grist Mill" (Str. #26) appraised at £26 13s. 4d., together with "The Fulling Mill" (Str. #37) at £14 3s. 4d., "Dye house and Furnice" (Str. #39) at £6 13s. 4d., and "The Shop with the two presses" (Str. #38) at £20 13s. 4d.²⁰ In the division of Thomas's estate in 1760, "The Clothiers Shop, tools, & Teinters," "The Fulling Mill with the Conveniency of the Streams . . . [and] The Grist Mill" were set off to his son, Thomas Mansfield, Jr., together with the upper half of the "Homestead" on which all but the shop (as we shall see) were located.²¹

While the exact nature of the "Factory establishment" is not specified, one of the principals at this time, John Haskins of Saugus, is described as a "Bleacher and Calico Printer,"²⁶ and there is further reference during the same year (1826) to "the dyeing & Calico printing establishment" here on this site, to which by 1826 some two more acres had been added at the southern end,²⁷ and a professional survey had determined that the original six-and-a-half-acre lot was closer to nine acres in extent. By 1834 the deeds refer to "the large brick Factory & other factories & buildings" and the "Flannel Manufactory and the Bleaching, Dying & Printing works," and it is assumed that the gristmill and chocolate mill had by now given way to more modern buildings.²⁸ These mills (or their successors) form part of the extensive complex identified as Prankers Manufacturing Co. in the Atlas of 1884 (Fig. 2).

Some months later, on February 4, 1812, when Robert Emes conveyed all interest to Joseph Emes, there was now a "Morocco factory" (Str. #42) and "other buildings" standing on the first two of the three parcels.³³ By 1828 the property is described as containing, in addition to the Morocco factory and "other buildings," a dwelling house and two barns.³⁴ Nearly a decade later, in 1838, the deeds refer to the Brick Factory, Dye House, dwelling house, and barn here. Following purchase of the premises by Francis Scott of Salem, woolen manufacturer, the complex became known in 1847 as "Scotts Factory," and is so described in 1862 when Francis Scott's widow conveyed the property to Andrew A. Scott of Saugus, also called "Woollen Manufacturer."³⁵ The A. A. Scott Woolen Mf'y is clearly identified in the 1884 Atlas (Fig. 2), though we are not informed of the fate of the Morocco Factory.

He was still living in the Appleton/Taylor/Mansfield House in 1793, as will later appear, but had surely constructed the house in question before his death on July 17, 1821, at which time he provides for his widow, Hannah, in a will executed on March 3 of that same year, the "use and improvement of the southerly half of my dwelling house from cellar to the garret and the bedroom chamber. . . ." His son, Thomas, received the residue of the property and reversion of the widow's thirds.³⁶ An inventory taken on August 30, 1821, described "About one acre" here with the "dwelling house, corn barn and all other buildings thereon. . . ."³⁷ The son, Thomas Mansfield, conveyed this property, described as part of "a certain Farm in Saugus where I now dwell"--one acre with dwelling house, barn, and outbuildings--³⁸ to Joseph Emes in 1832, and ultimately it became the property of Andrew A. Scott on April 1, 1860,³⁹ which undoubtedly explains why no other name is attached to it in the Atlas of 1884 where it is separated from but contiguous to other Scott property (Fig. 2).

The two halves of the house were at last reunited under a single ownership and we are now at a period when the buildings in question appear on detailed property atlases. Thus we discover from the Atlas of 1884 that there is a small outbuilding directly behind the east end of the house (Fig. 2) that photographs suggest might have been the workshop (Str. #47) and perhaps Corn Barn No. 2 (Str. #48) combined. This building disappeared at the time of the restoration. No other buildings are shown on the lot. The 1905 Atlas, however, shows not only the structure behind the house but an extension of the lean-to at the west, *and* a small rectangular outbuilding, about the right size for a "little barn," to the northwest of the house (Fig. 6). It is conceivable that the 1905 Atlas, more detailed in many respects, is the more accurate, and that the "Little Barn" (Str. #50) did indeed survive into the 20th century. To compound the question, the 1905 Atlas shows nothing directly in front of the old house, while photographs of 1915,
