# Investigation Fact Sheet

## Nabesna Mine Site

Wrangell-St. Elias National Park  
and Preserve

Spring 2011

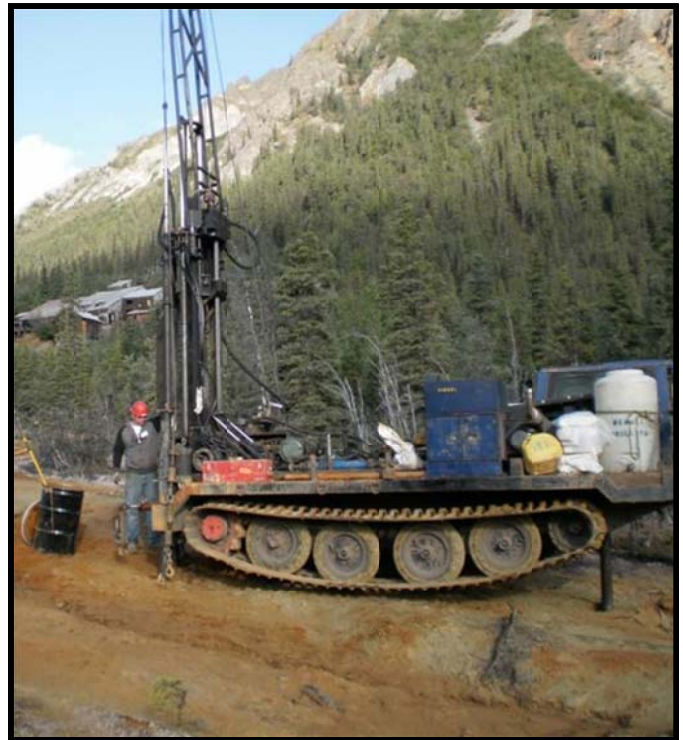
The most recent environmental investigation at the site was performed in August 2009, when samples were collected from tailings, soils, creek sediments, groundwater, and surface water. Two track-mounted rigs were used to drill borings approximately 50 feet below ground surface throughout the tailings area. Borings were analyzed to assess physical soil properties. Data will be used to determine migration patterns and depth of metals contamination beneath the tailings and to identify and evaluate remedial cleanup alternatives. Groundwater monitoring wells were installed in some borings to enable sampling and analysis of groundwater and assessment of the site's hydrogeology. PVC pipes extending from the ground mark the location of groundwater monitoring wells at the site.

Drill cuttings and soil waste, resulting from the investigation, remain on-site containerized in several 55-gallon drums. The drums are located in a small clearing on the south side of Nabesna Road near the tailings. Plans for the disposal of these drums will be incorporated into the cleanup plan for the site.

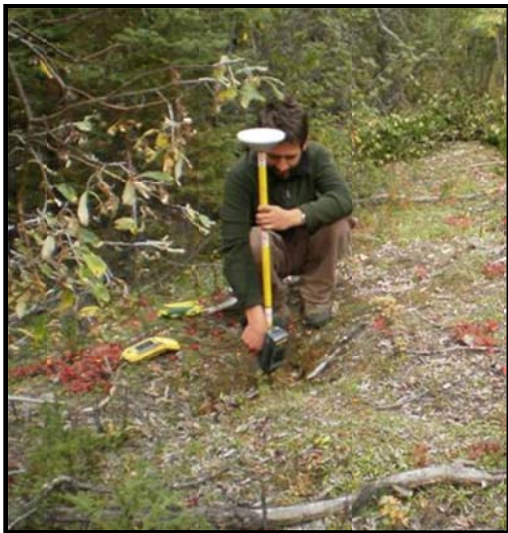
Metals (e.g., lead and arsenic) associated with mine tailings occur naturally in area soils. To establish the naturally occurring, or "background" concentrations of these metals in soils that are not impacted by the mine tailings at the site, surface soil samples were collected from slopes surrounding the mill within five quarter-acre test areas and analyzed in a laboratory. Soil samples also were collected beneath the tailings and compared to the background samples. The analysis indicated that concentrations of arsenic were elevated above background levels within the first two feet of soil beneath the tailings, but no deeper. Lead did not appear to have migrated beneath the tailings.
