# Tech Notes

## TEMPORARY PROTECTION

NUMBER 2

### Specifying Temporary Protection of Historic Interiors During Construction and Repair

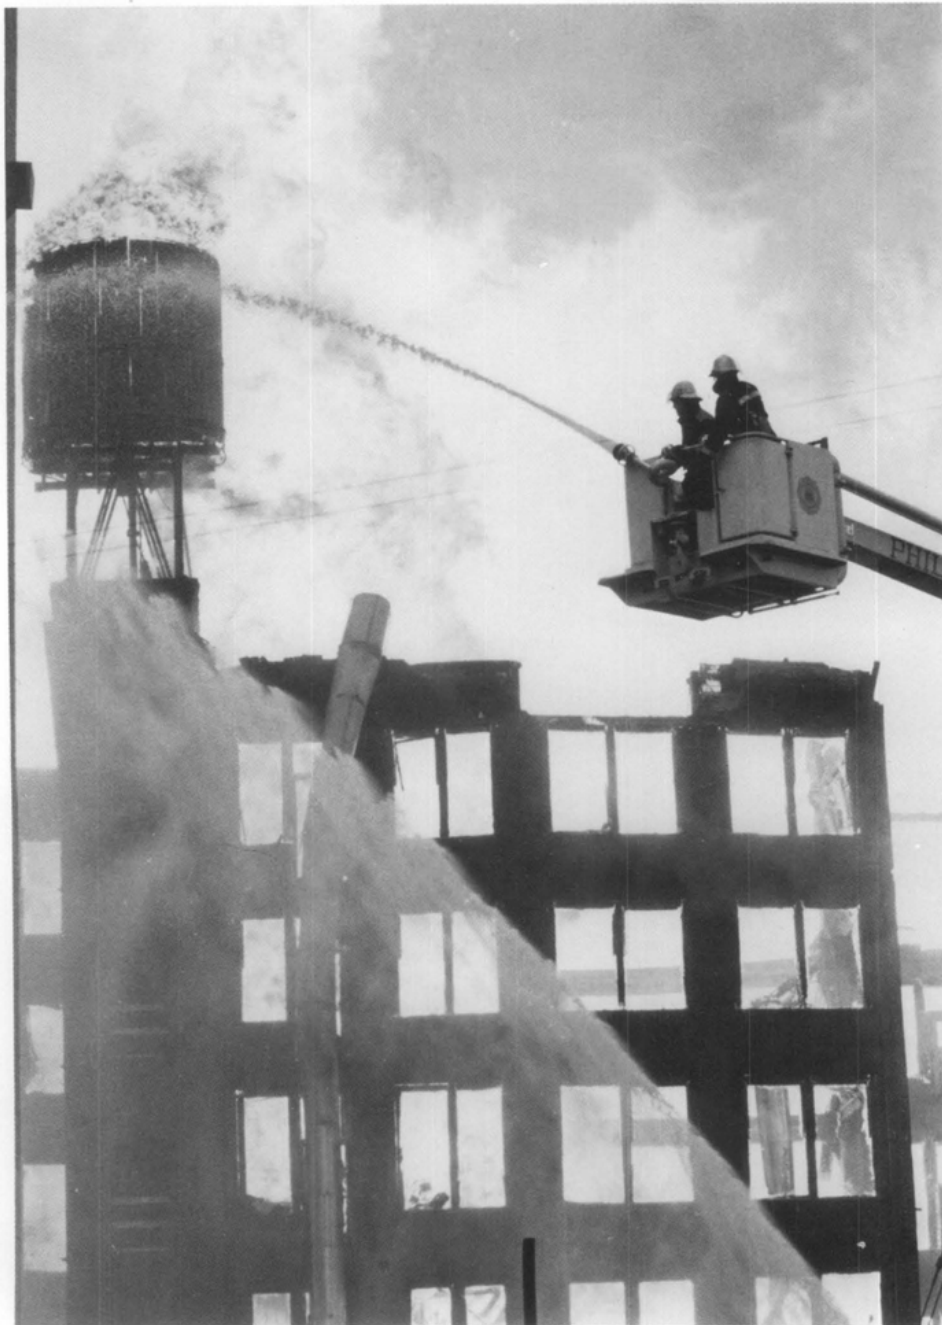
Fire poses the greatest risk of sudden catastrophic loss during construction activities in existing buildings. Just one of numerous examples is the 1985 Harrison Court fire in Philadelphia, in which a block-long National Register warehouse building undergoing rehabilitation burned to the ground (*see cover photo*). The fire was caused by sparks from cutting torches that were being used during selective interior demolition work.

Cover Photo: Urban Archives, Temple University, Philadelphia

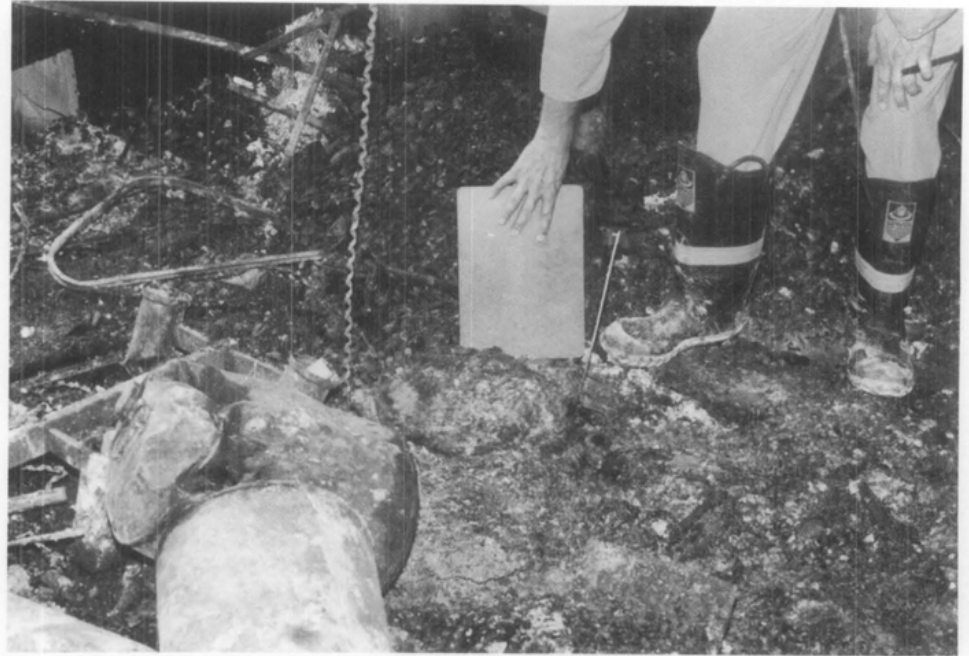
Figure 1. The spontaneous combustion of cloth rags that had been used in applying a common finishing wax caused over \$1 million damage to a historic government office building in 1991. Remains of the trash can where the rags had been stored overnight is indicated by the fireman's notepad. After the cause of the fire was determined, a standard specification provision was developed for future contracts requiring the contractor to remove all material contaminated with finishing products from the site at the end of the day.

struction activities, including new construction, NFPA 241 should be a reference standard in any selective demolition specification, and a foundation for addressing fire safety on building rehabilitation sites. Additional guidance is available in NFPA 914: *Rehabilitation and Adaptive Reuse of Historic Structures*. When these are utilized as reference standards, the historic building owner should obtain and enforce their recommendations (*see figure 1*).

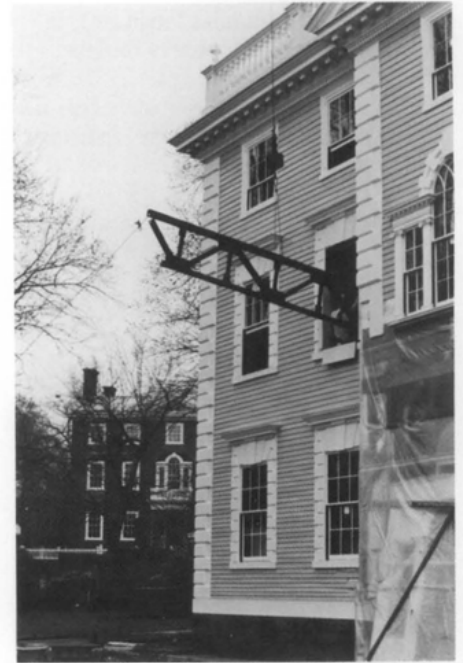
Figure 2. Because of the fire risks, open flame cutting and welding deserves careful attention both in the preparation of specifications and during the work. As much welding as possible should be done off site. For example, at the Nightingale-Brown House, several large trusses were assembled off site, then carefully hoisted through a window for installation. Photo: Irving B. Haynes and Associates.

ment. For smaller projects, the construction fireman or other designated people should be assigned the responsibility of inspecting of each cutting and welding location frequently during the day (see figure 2).

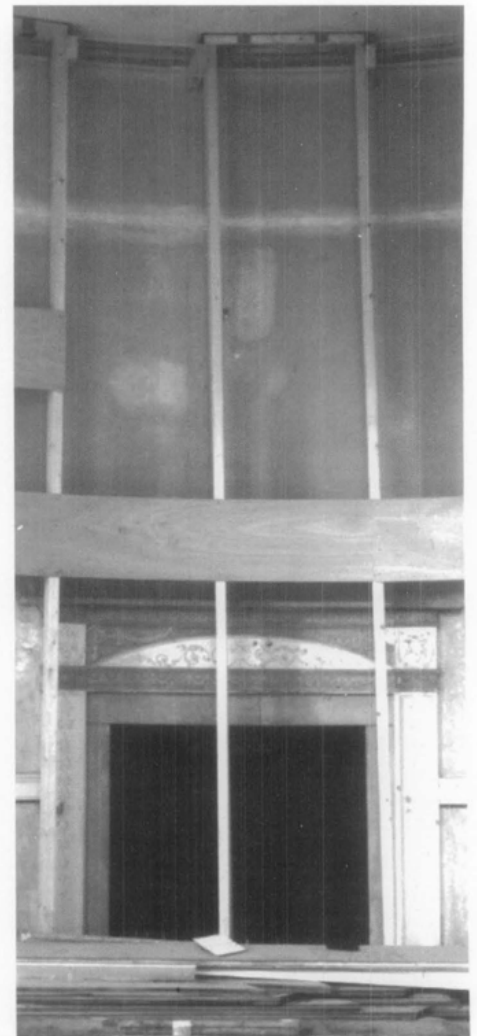
Figure 3. Vibrations generated during construction may necessitate the installation of temporary support for such fragile features as plaster ceiling cornices and soffits. Drawing: Villard Houses — courtesy of Emery Roth & Sons Architects. P.C. Photo: The Octagon, Lonnie Hovey, AIA.

Important architectural features which are easily removed should be stored off site, if possible, to protect them from vandalism, theft and damage during construction. Lighting fixtures, fireplace mantels, and interior doors are typical examples. Less movable architectural material or finishes such as wallpaper are often best retained in place but may require custom-designed protective measures developed and monitored by a conservator (see figure 3).

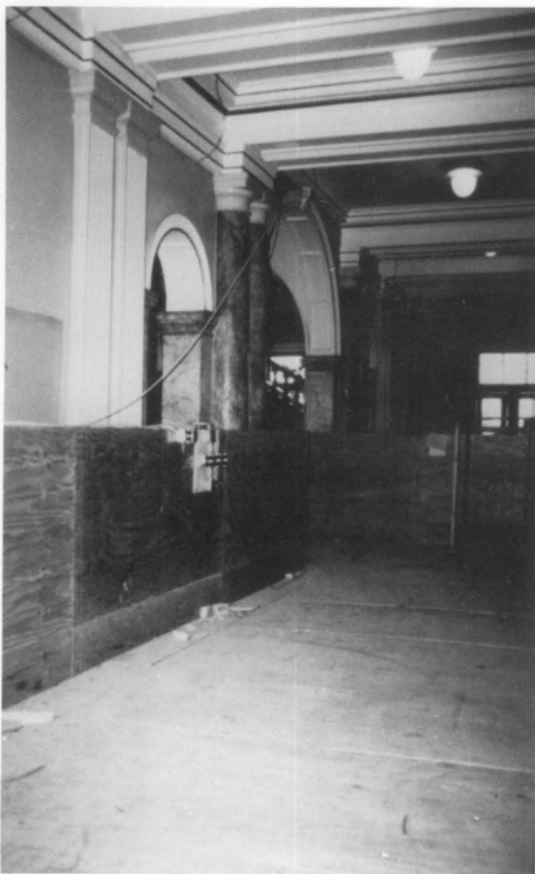
Figure 5. To provide for adequate floor protection in the New Jersey State Capitol, this area was swept clean, then covered with polyethylene sheeting to protect against spills and dirt abrasion. Fiberboard (1/2" thick) was placed over floors and the joints sealed with tape. Finally 1/2" plywood was laid with all joints taped. This floor protection system has been successful over many years of use and is recommended in major construction areas, and where tile, marble, parquet wood, or other historic flooring is involved. Photo and drawing: Ford Farewell Mills and Gatsch Architects.

dust and dirt, and spilled liquids (see figure 5). If work in, or traffic through, a particular space does not involve one or more of these risks, temporary protection may be reduced. Damage caused by abrasion can be controlled by means of protective coverings such as canvas tarps or resilient wood fiber panels. Canvas tarps should overlap and be taped at all joints. Resilient wood fiber panels should be carefully fitted with tight seams and laid continuously wall to wall. Joints should be taped to avoid displacement of the panels after setting. For added safety, resilient panels left exposed should also be fire-retardant treated to achieve a UL Class A listing for flame spread and smoke developed. Such a readily available product is N.C.F.R Homasote.

For greater protection from physical force, a layer of plywood can be applied over the Homasote panel underlayment, with joints staggered to stabilize the assembly. In this double layer assembly, the top plywood should be treated with a fire-retardant, but the underlayment need

not be. Where protection from spilled liquids is required, a layer of polyethylene sheeting should be applied between the Homasote panels and the plywood top layer. Care should be taken in planning the protection assembly to ensure that moisture from spilled liquids is not trapped against the historic flooring. Otherwise, the staining, splitting, wood-grain raising, or stone-finish destruction could potentially go undetected for months while concealed from view under the protection assembly. Care should also be taken to avoid sheet coverings such as building felt, which could potentially stain the historic flooring.

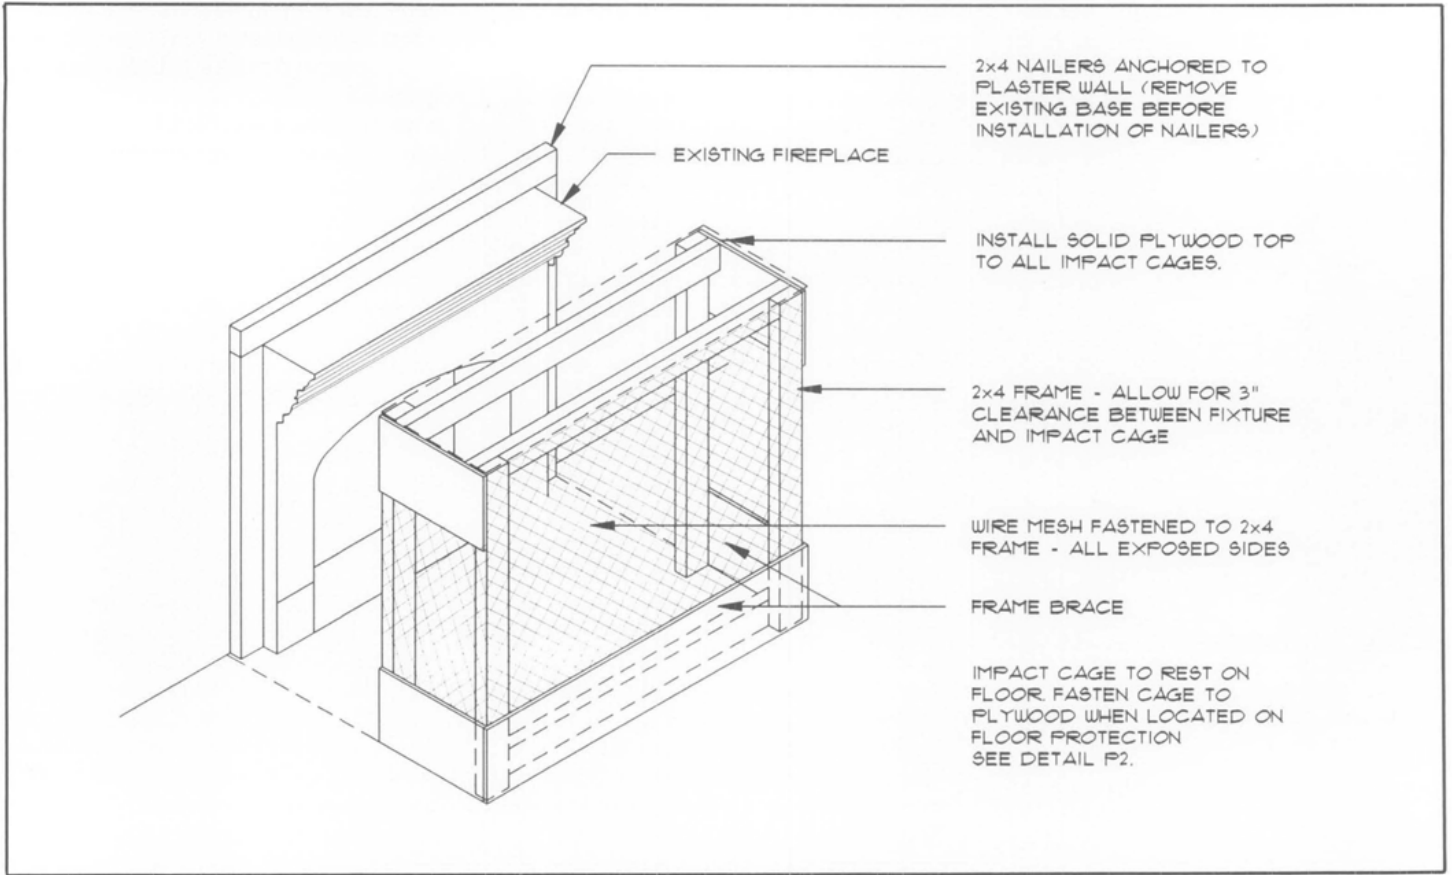
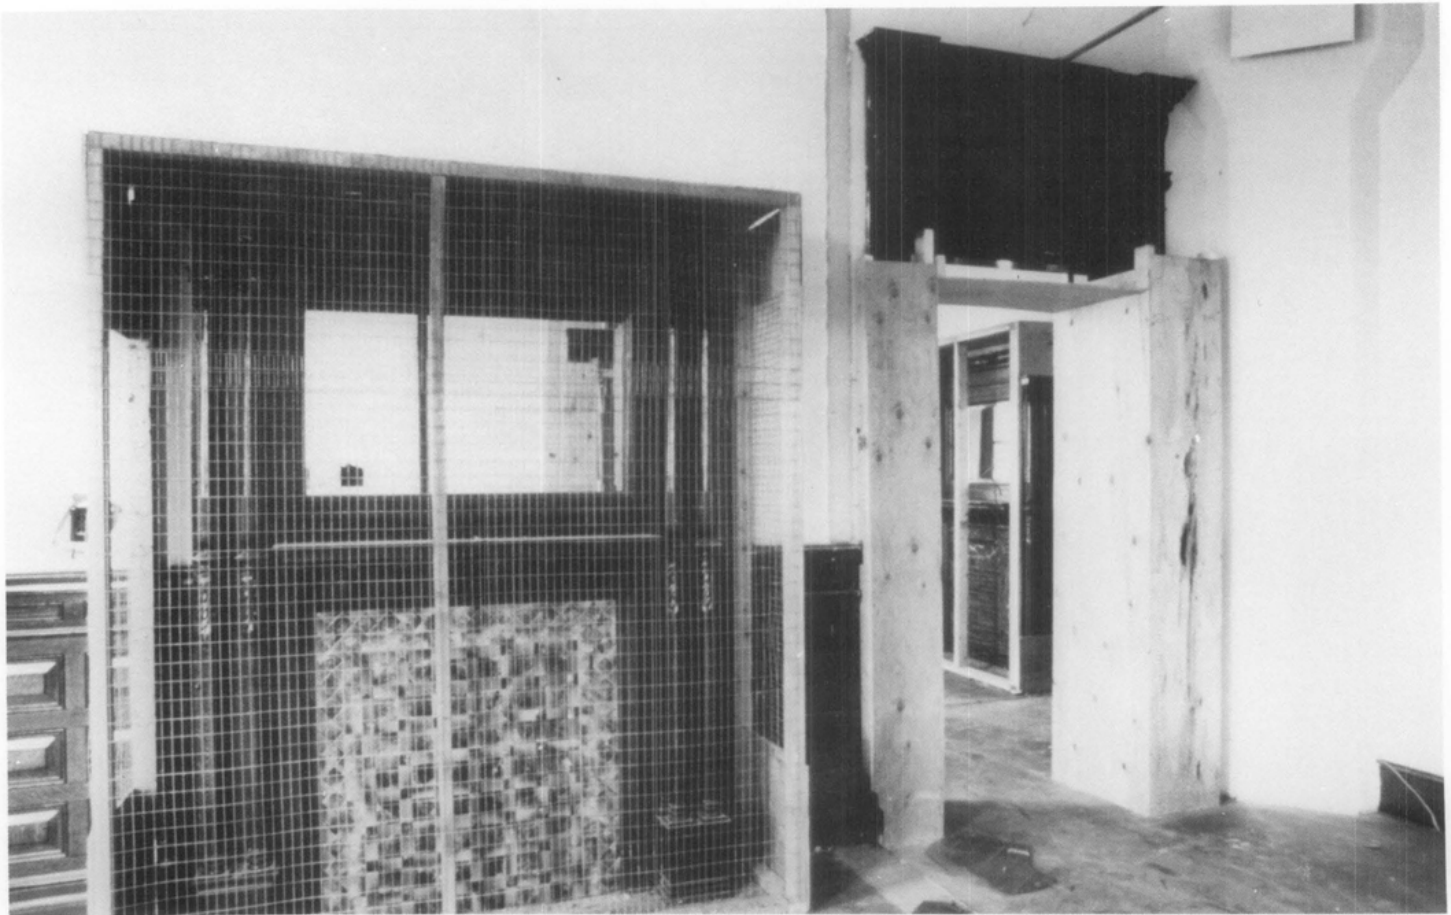
Figure 6. A self-supporting impact cage utilizing wood and wire mesh protects the fireplace. In this project, the long construction process required bidders to have visible access to features such as the fireplace. The wire mesh also facilitated monitoring during the lengthy construction. Photo and drawing: Ford Farewell Mills and Gatsch Architects.

Historic stairways, balustrades, balconies, fireplaces, door surrounds, window surrounds, and other components will also need to be protected from construction damage by combining the techniques described for floors and walls (see figure 6). Horizontal surfaces should be protected as floors, and vertical assemblies treated as walls, with the major difference being the complexity of the framing required.

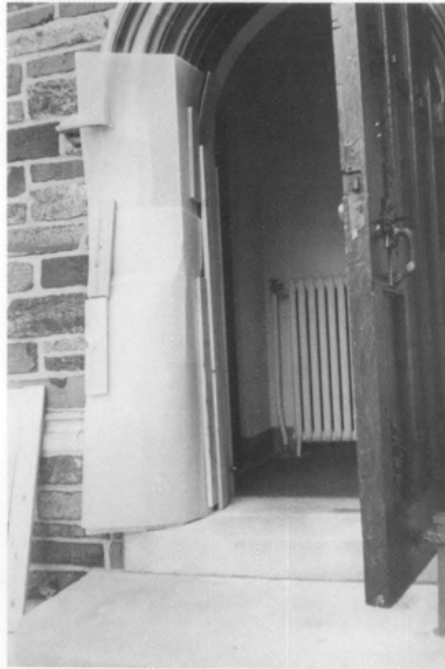
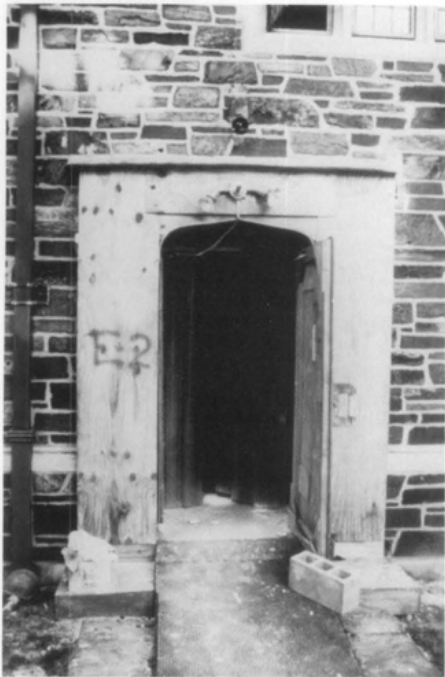
Figure 7. A contractor's solution to protecting the limestone door surround consisted of thin foam sheeting, secured with wood nailed to the masonry. This protection was rejected as inadequate by the architect, and a full plywood enclosure constructed. In the architect's solution, it should be noted that a temporary door is used while the original door is stored for safe keeping during construction. Photo: Ford Farewell Mills and Gatsch Architects.

The above notwithstanding, architects routinely specify temporary facilities including temporary utilities, temporary construction and support facilities, and security and protection services. For preservation projects, it is recommended that temporary protection of historic interiors during construction be specified in a separate Division 1 specification section entitled “Special Project Procedure” or “Restoration Project Procedures” to ensure that required provisions are not overlooked by bidders because they appear in the often lengthy Section 01500 — Temporary Facilities. Under competitive bidding circumstances, bidders logically seek to minimize the cost to the project for providing temporary facilities, including temporary protection of historic interiors. By creating a separate section in a price proposal, the bidder will be inclined to treat the “special project procedures” as an added cost rather than a part of the temporary facilities required for any alteration project. The contractor's project manager can thus anticipate making reasonable expenditures for providing specified temporary protection during construction. To ensure the adequacy of temporary protection measures in projects involving a construction manager, temporary protection is often best provided by the construction manager, who normally works for the owner on a cost-plus-fee basis (see figure 7).
