NATIONAL HISTORIC LANDMARK NOMINATION

EYRE HALL

Historic Name: Eyre Hall

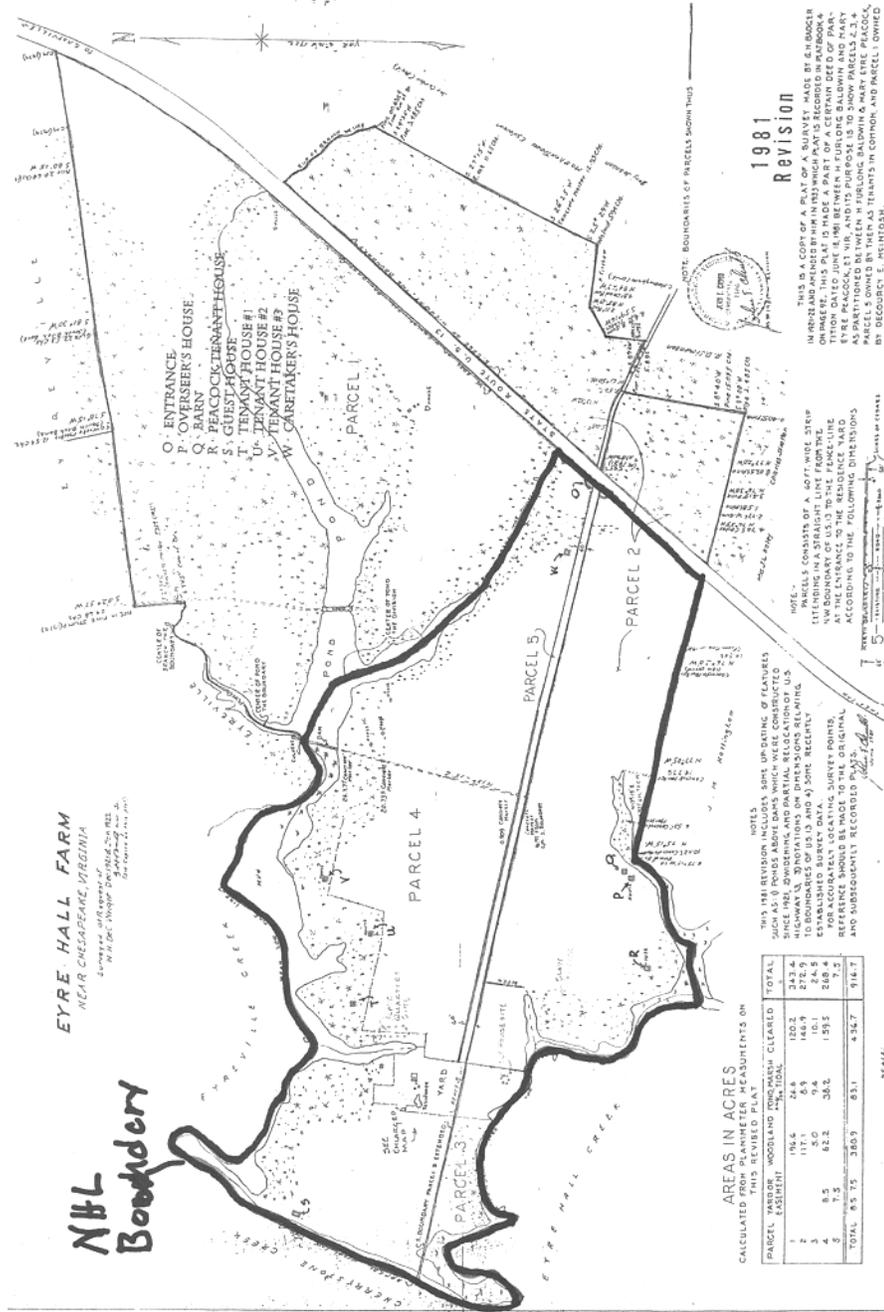
Eyre Hall, site plan and NHL boundary
Marilyn Harper, 2008

Eyre Hall plantation is located in Northampton County, Virginia, approximately 3.2 miles south of the county seat of Eastville. The property lies on the bayside of the Eastern Shore of Virginia, generally bounded by the waters of Cherrystone Creek on the west; Eyreville Creek on the north; and Eyre Hall Creek on the south. U.S. Route 13 forms the eastern boundary of the nominated property. The 467-acre tract includes eight significant contributing resources, most of which are located in the immediate vicinity of the main house, and include: a large Georgian-era frame house with Federal and twentieth-century additions, three historic outbuildings, a historic family cemetery, a large well-preserved eighteenth-century garden, and a largely intact eighteenth-century landscape, all set in an unaltered context of water and wetlands. Most of the noncontributing resources are positioned singly or in small groups at various locations around the edges of the district boundary.

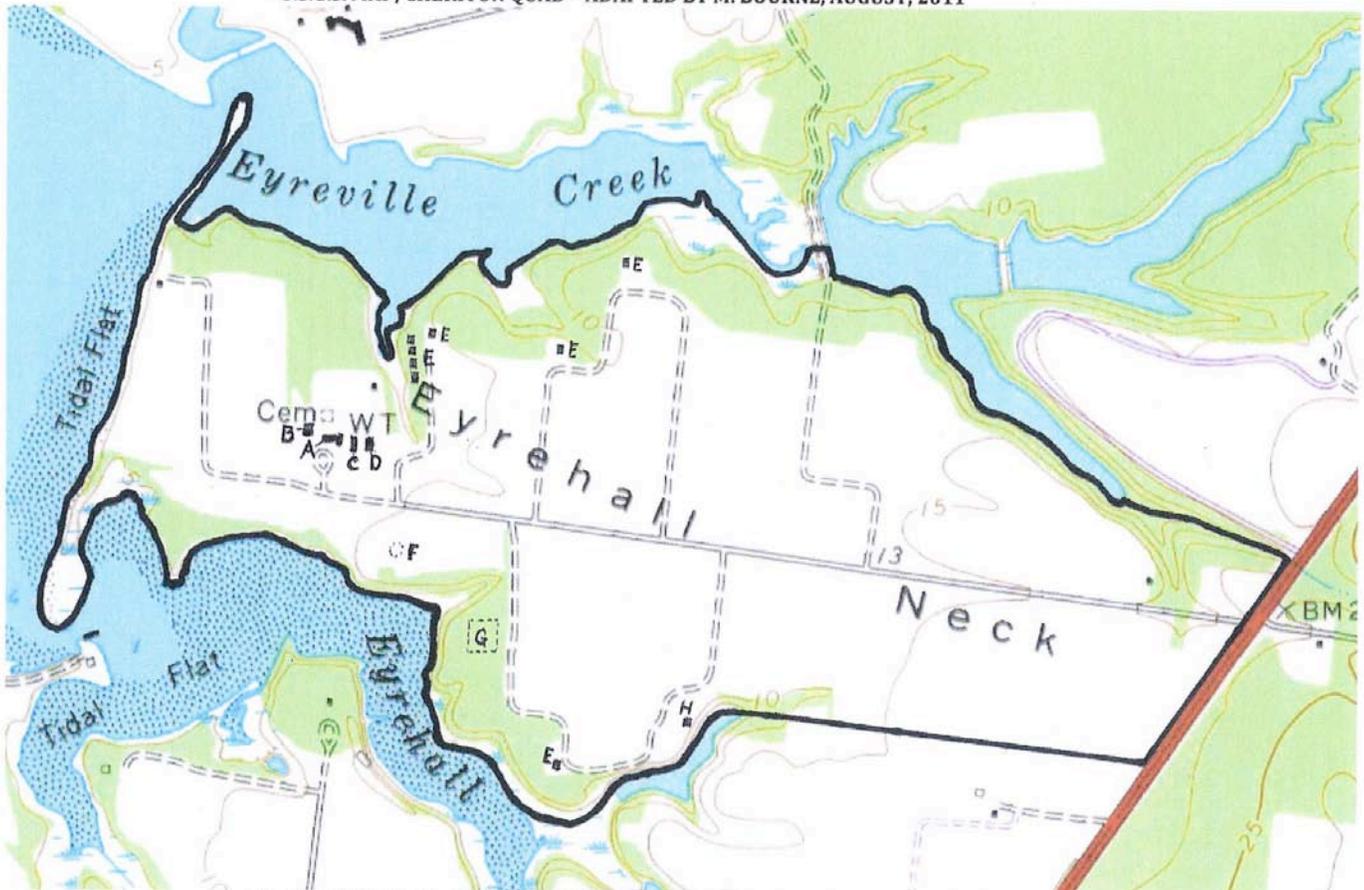
EYRE HALL – SITES PERTAINING TO SLAVERY – 1754 – 1855

- A - EYRE HALL; B - GREENHOUSE; C - KITCHEN SITE; D - KITCHEN QUARTER
- E - QUARTERS SITES; F - ROUND ICE HOUSE; G - SLAVE CEMETERY;
- H - OVERSEER'S HOUSE

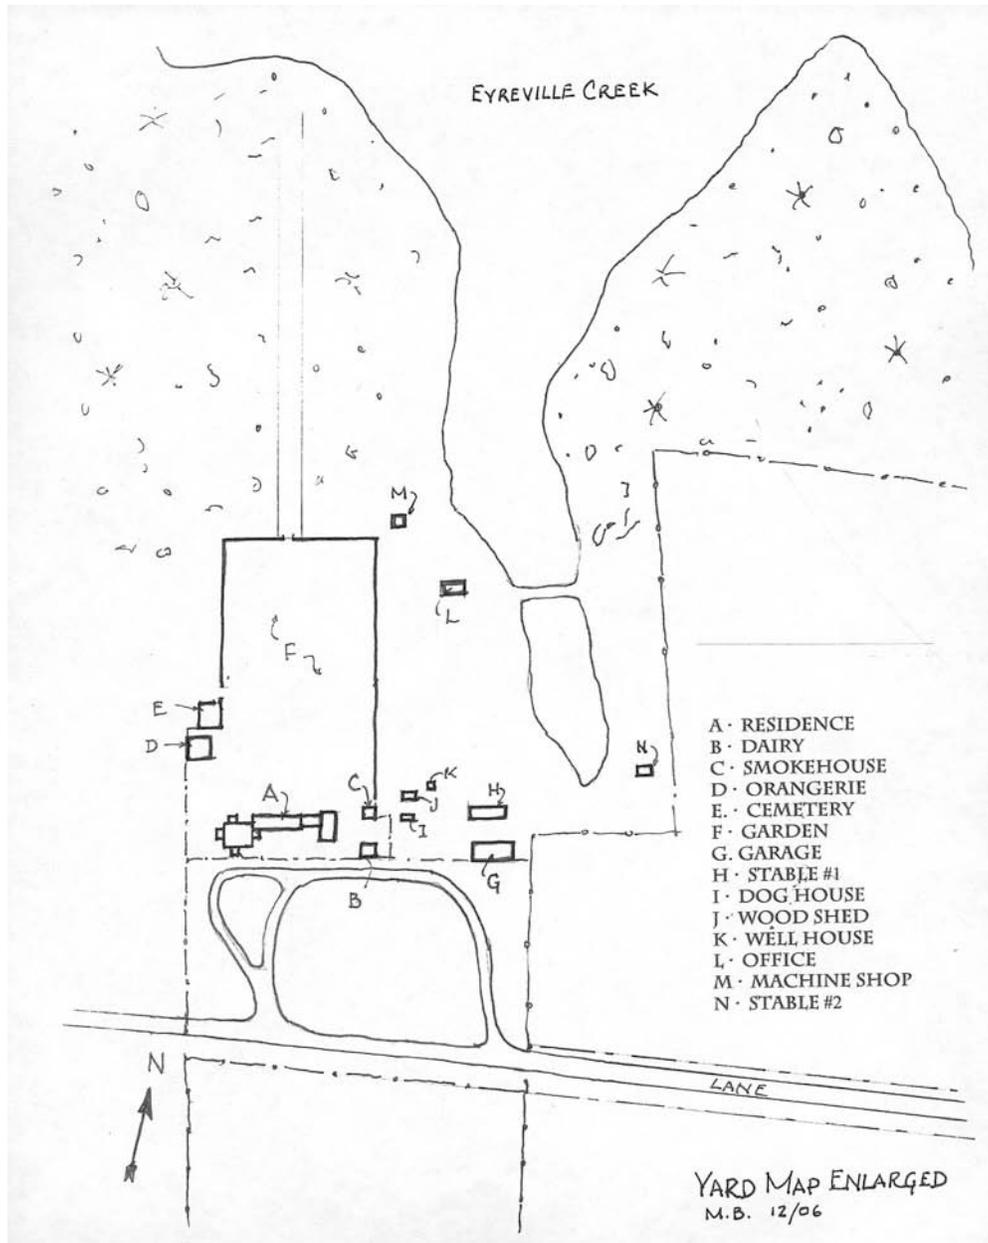
Yard Map
Michael Bourne, 2006

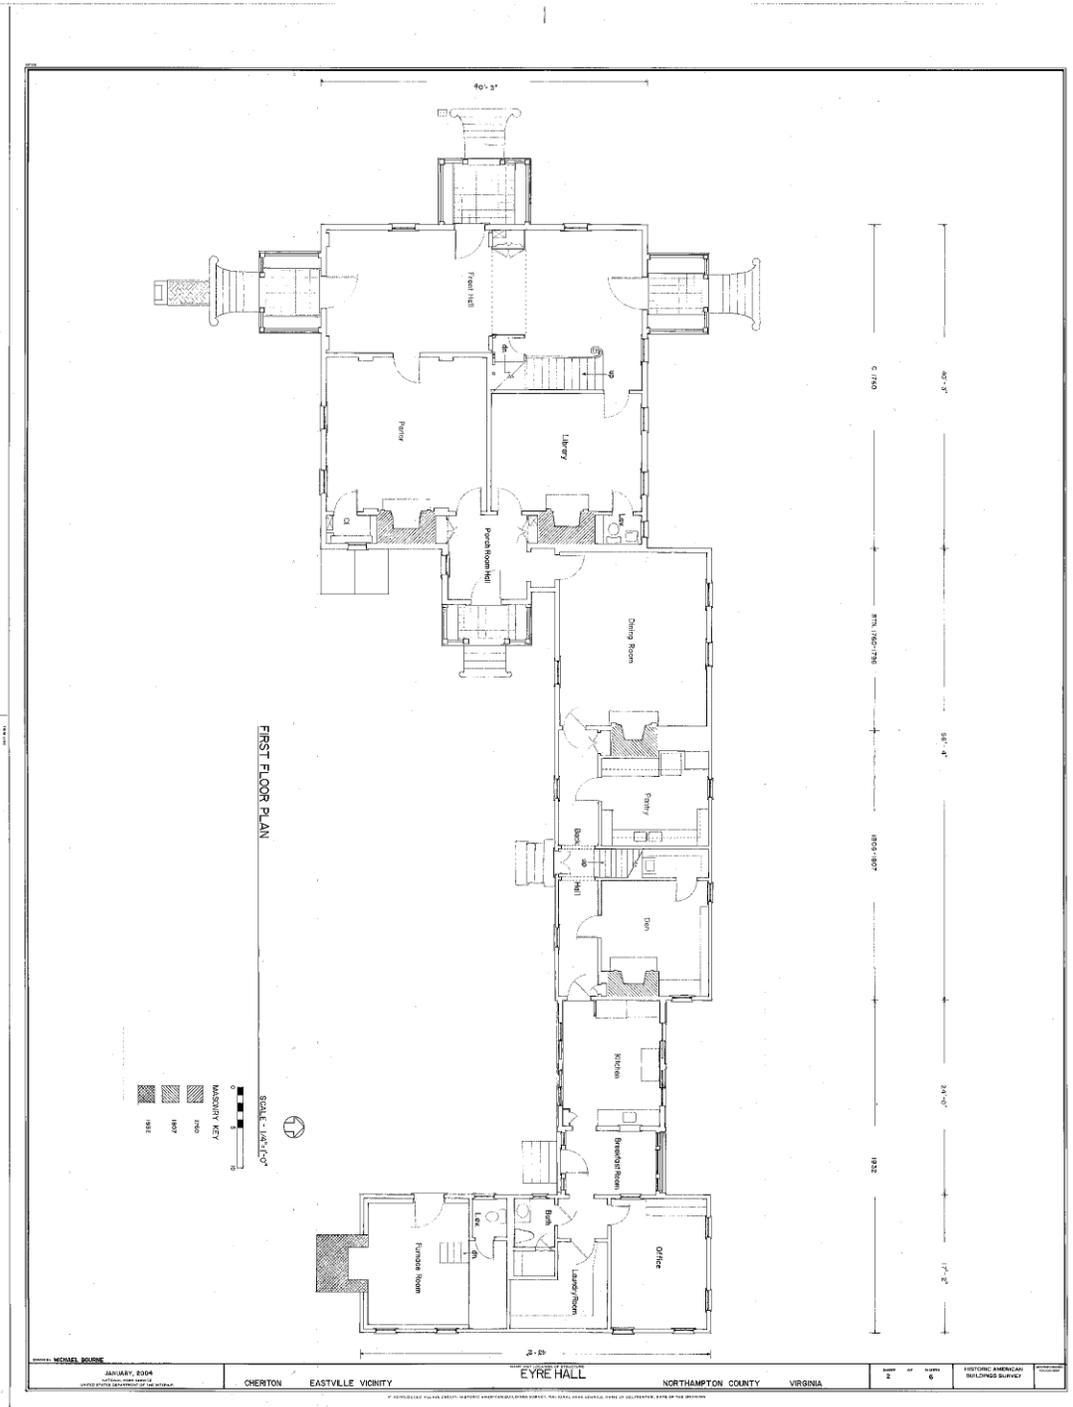
Eyre Hall, first-floor plan of house
Michael Bourne for the Historic American Buildings Survey, 2004

The first floor of the main block consists of three large rooms: a wide passage running the full depth of the house with two smaller rooms to the east. A wide elliptical arch divides the passage into a very elaborate **entry hall** and a less finely finished **stair hall**. The fully paneled entry is the most elaborately finished room in the house. Bold fluted classical pilasters rising from plain pedestals are located on the north and south walls near the corners of the room. The pilasters are exceptional in that they not only taper, but also have entasis. The five part Ionic cornice is approximately 19” deep. The heavy-fluted keystone over the south door indicates its importance as the main entrance to the house. This keystone, the keystone at the center of the arch, and the pilasters are expressed through all the elements of the cornice. The baseboard retains original marbling.

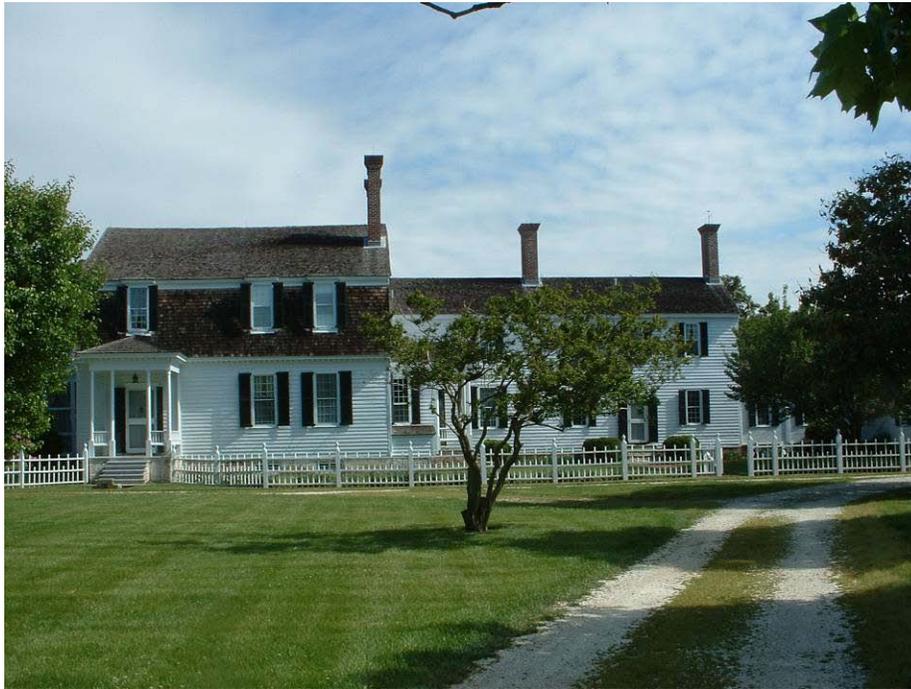
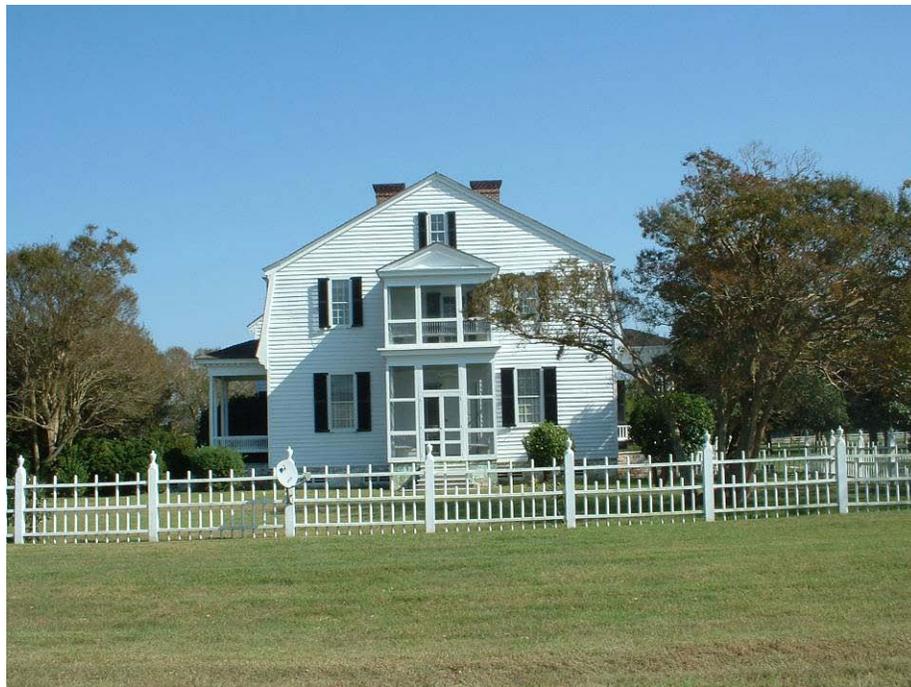
Eyre Hall, south elevation (top) and west elevation (bottom) of house Michael Bourne, 2006 and 2005

The **front (south) elevation** of the main block is divided into three bays. On the first floor the westernmost bay contains the main entrance under a one story hipped roof porch; large 9/9 sash windows fill the two bays to the east. The three bays on the second floor, set within the lower slope of the gambrel roof, contain shallow hipped roof dormers with smaller 9/9 sash windows. The cornice of the dormers is a continuation of the upper roof cornice. The entrance consists of a very large eight-panel door set into a massive frame. The lion-headed brass doorknocker was brought here in 1870 from Old Castle, the home of Margaret Parker Eyre, the second wife of Severn Eyre III.⁵ The door is protected with a recent storm/screen door. The door and the window frames are original. As is the case for most of the windows in the main block, the original Georgian window sash, with wide 1¼" muntins, was replaced with the present Federal-style sash, with slender ¾" muntins, by John Eyre in the early nineteenth century. Louvered blinds protect all openings on the first and second floor. Windows with original iron bars fill the two eastern bays in the brick foundation.

The south porch rests on a solid brick foundation and is reached by a short flight of steps. Two pairs of slender turned Doric columns support the low-pitched hip roof, with corresponding half columns against the wall. The porch cornice does not align with the main cornice and differs from it in profile. A balustrade of turned Doric colonettes encloses the porch and forms the backs of two benches flanking the door. The porch floor is covered with square white and gray marble pavers set in a gray marble surround. The marble steps have molded edges and flare outward as they descend to the lowest step, which is finished with volutes. There is a marble carriage step a few feet in front of the steps.

The **west elevation** is divided into three bays. The two end bays contain 9/9 light Federal windows. The doors in the middle bays on the first and second floors are slightly off-center, but this asymmetry is disguised by the symmetrical placement of the two-story portico. Because the west elevation is a gable, it rises a full two and one-half stories high. The sash of the single small attic window at the third floor level was not replaced in the early nineteenth century and retains the original wide muntins. Very boldly shaped bargeboards cover the eaves of the lower slope of the roof and the ends of the cornices. The foundations, weatherboard, and windows have the same details as the south façade. Four original cellar windows are symmetrically placed in the foundation. The west portico is supported on a brick half vault that differs from the foundations of the other porches and appears to date to the original construction. The west portico resembles the south porch in materials and details; the second floor columns are considerably shorter than the first, reflecting the lower ceiling heights of the second story inside the house. Full cornices are located between the first and second floor of the portico and define the pedimented gable; the tympanum is filled with beaded shiplap boards.

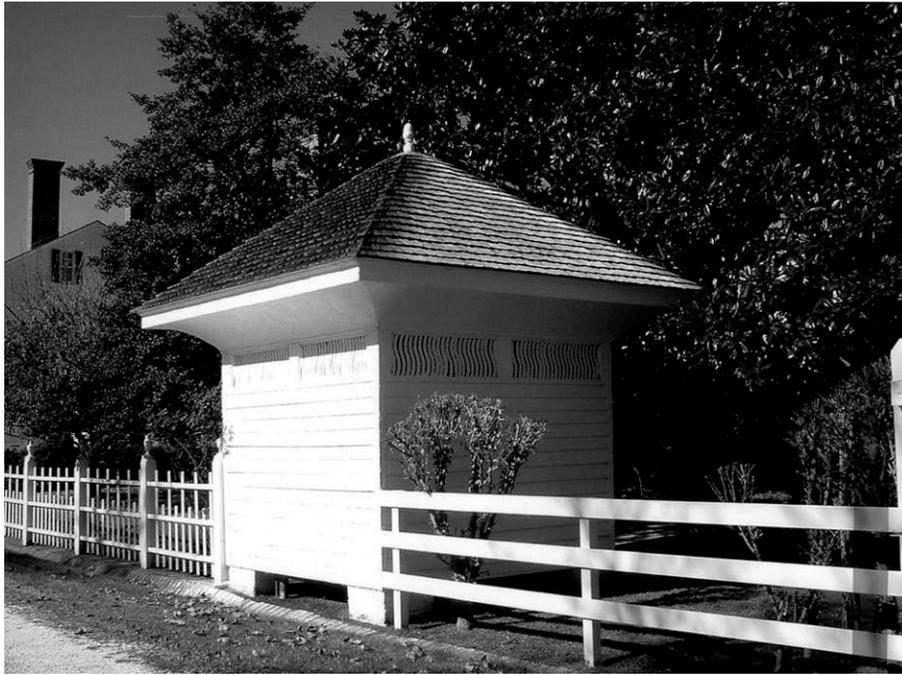
Dairy, looking northwest
Michael Bourne, 2004

Dendrochronology suggests that the frame dairy, measuring 10' square, was built ca. 1759 and moved to its present location ca. 1807.¹⁶ The north (front) elevation stands on a continuous brick foundation, while brick piers support the back of the building. Beaded weatherboard covers the lower part of the walls. Vents with vertical closely-set strigil-shaped slats fill the area between the weatherboard and the plaster cove cornice. There is a turned finial at the center of the hipped roof. A millstone step on the north side leads to a reproduction paneled door dating from the 1930s but set in the original frame and hung on original cross garnet hinges.

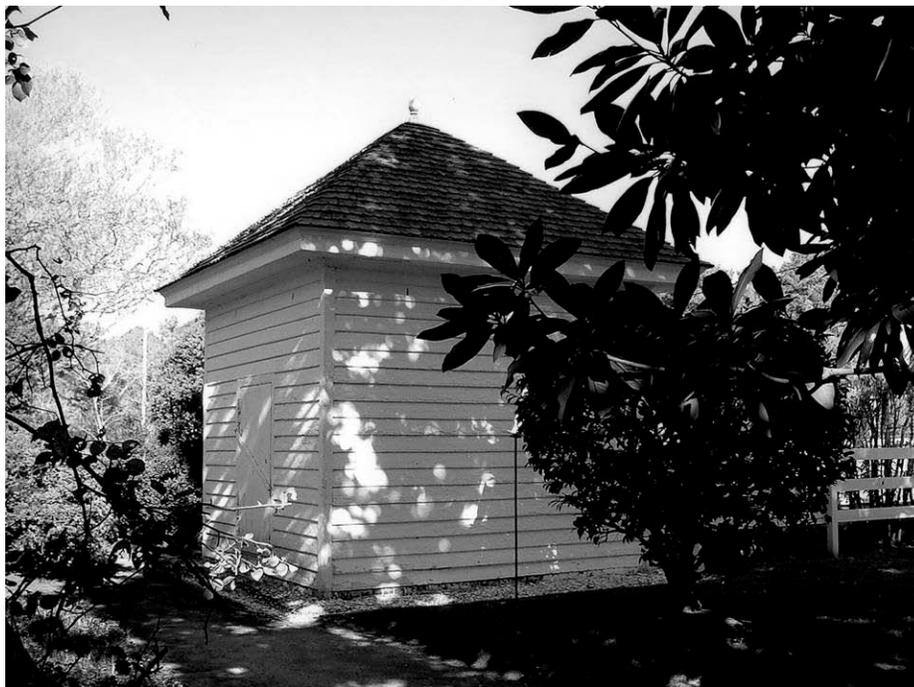
Smoke house, looking northeast
Michael Bourne, 2004

The frame smokehouse stands about 58' to the north of the dairy, with which it is aligned. According to the dendrochronology report, this building dates to 1807; it is identified on the insurance policy of that year as a “pantry.” It measures about 12' square and stands on a low brick foundation. The walls are beaded weatherboard, but many coats of whitewash have obscured the detail. A wide, board-and-batten door centered on the west elevation is secured inside by a wood box lock and outside by a diagonal iron bar and staple. Slits cut into the soffit and the second weatherboard below the cornice allowed smoke to escape. The roof, like that of the dairy, is pyramidal.

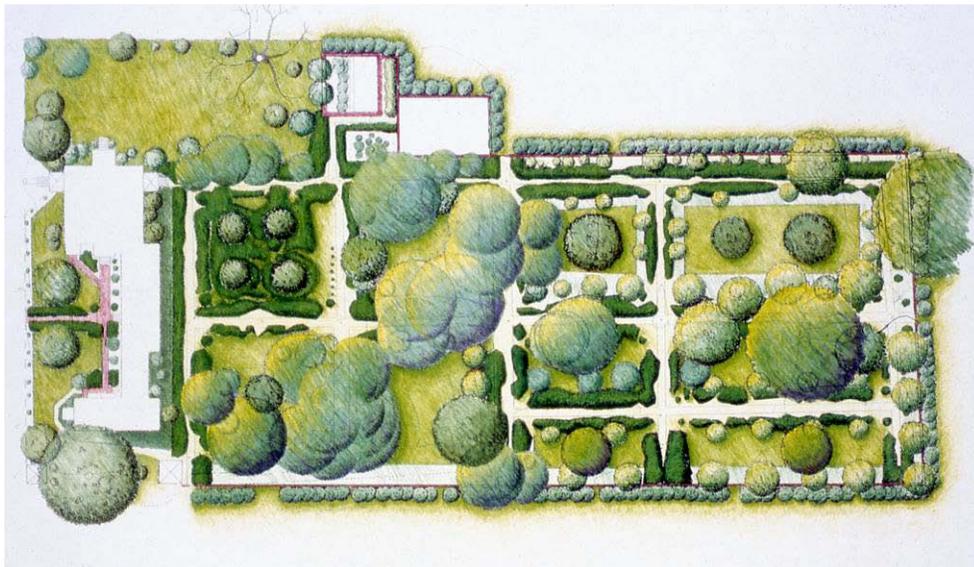
Eyre Hall gardens, schematic plan
Darrin R. Alfred for the Garden Club of Virginia, 1997
