# National Register of Historic Places Registration Form

historic name Schoolhouse No. 5

Schoolhouse No. 5  
Hamden Vicinity, Delaware County, New York

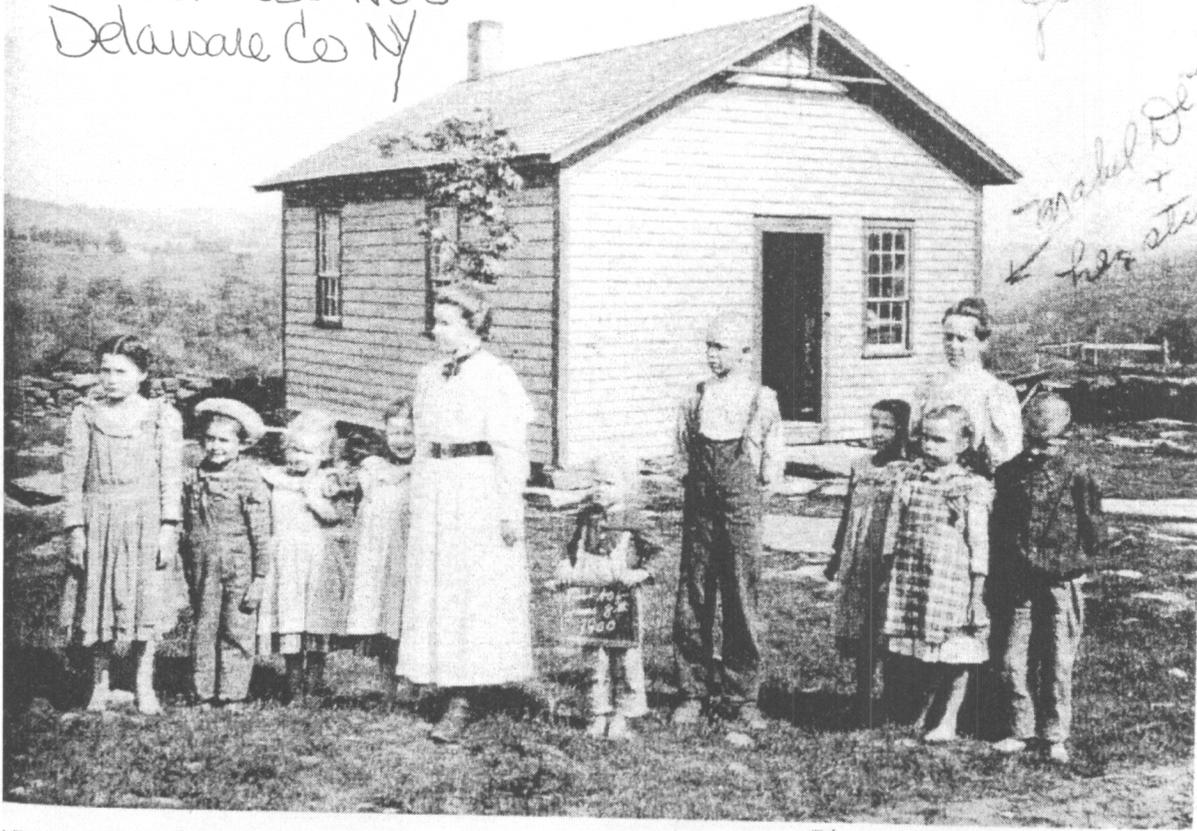
C1900

later part of the nineteenth century. All these features are consistent with a mid-nineteenth century construction date. In the absence of further evidence, this photo appears to show the exterior of the building as it was constructed in the late 1850s.

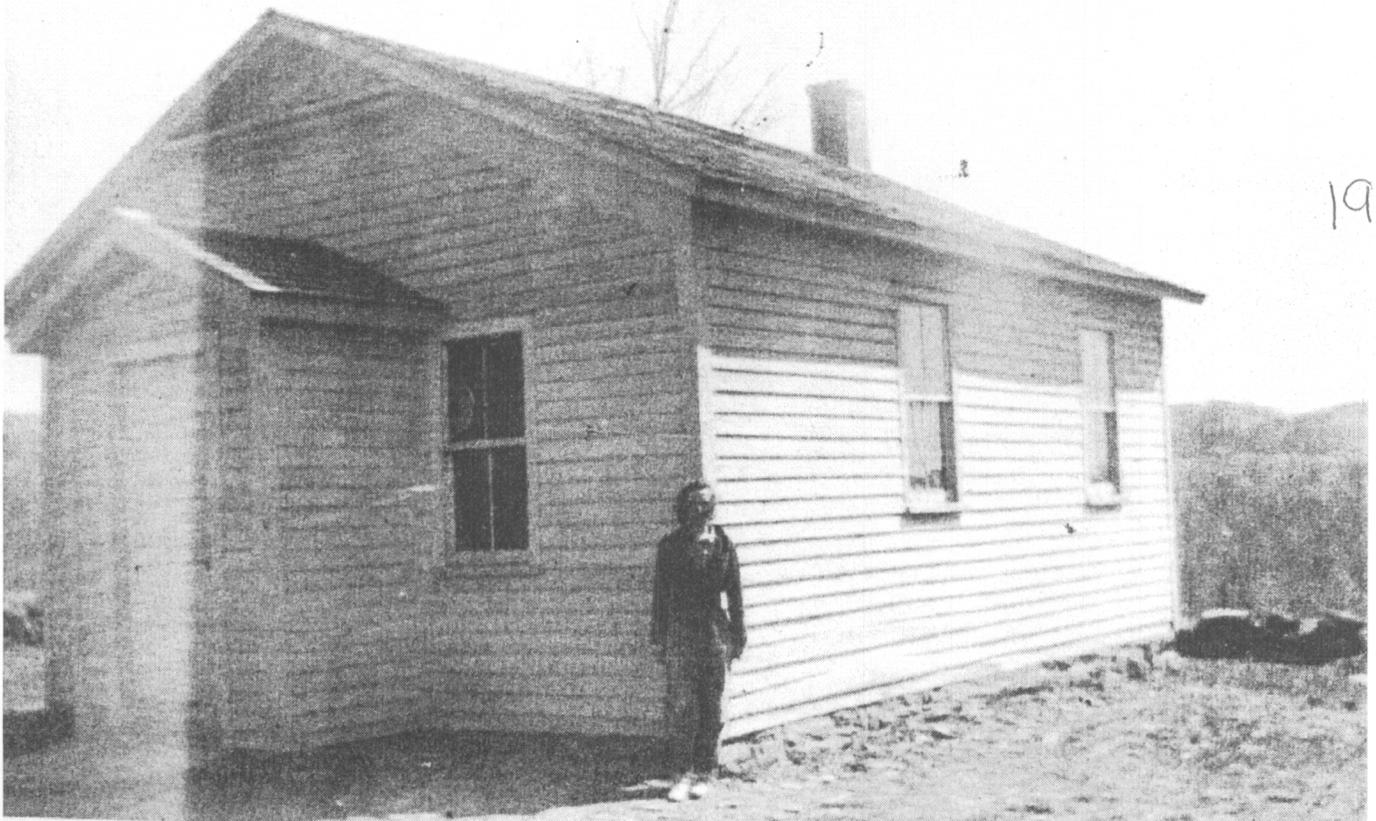
Wilda Shackelton in front of District No. 5(J), Dunk Hill School - April 24, 1937

In 1936, a report on Schoolhouse No. 5 revealed the building to be in "very dilapidated condition." The report stated that "Mr. George Tweedie, who was trustee that year, reconditioned the whole building that year and made it habitable for school purposes." While we have no record of what these changes entailed, a photo taken in 1937 shows the building with two-over-two replacement sash windows and a small wood-frame vestibule. Since photos reveal that the windows were changed between 1900 and 1937, it is possible that these were among the changes made by Mr. Tweedie. If so, the windows may have been salvaged from another building, as two-over-two sash would have been old fashioned at that late date. Nevertheless, the replacement of windows and the addition of vestibules were typical changes for this building type.

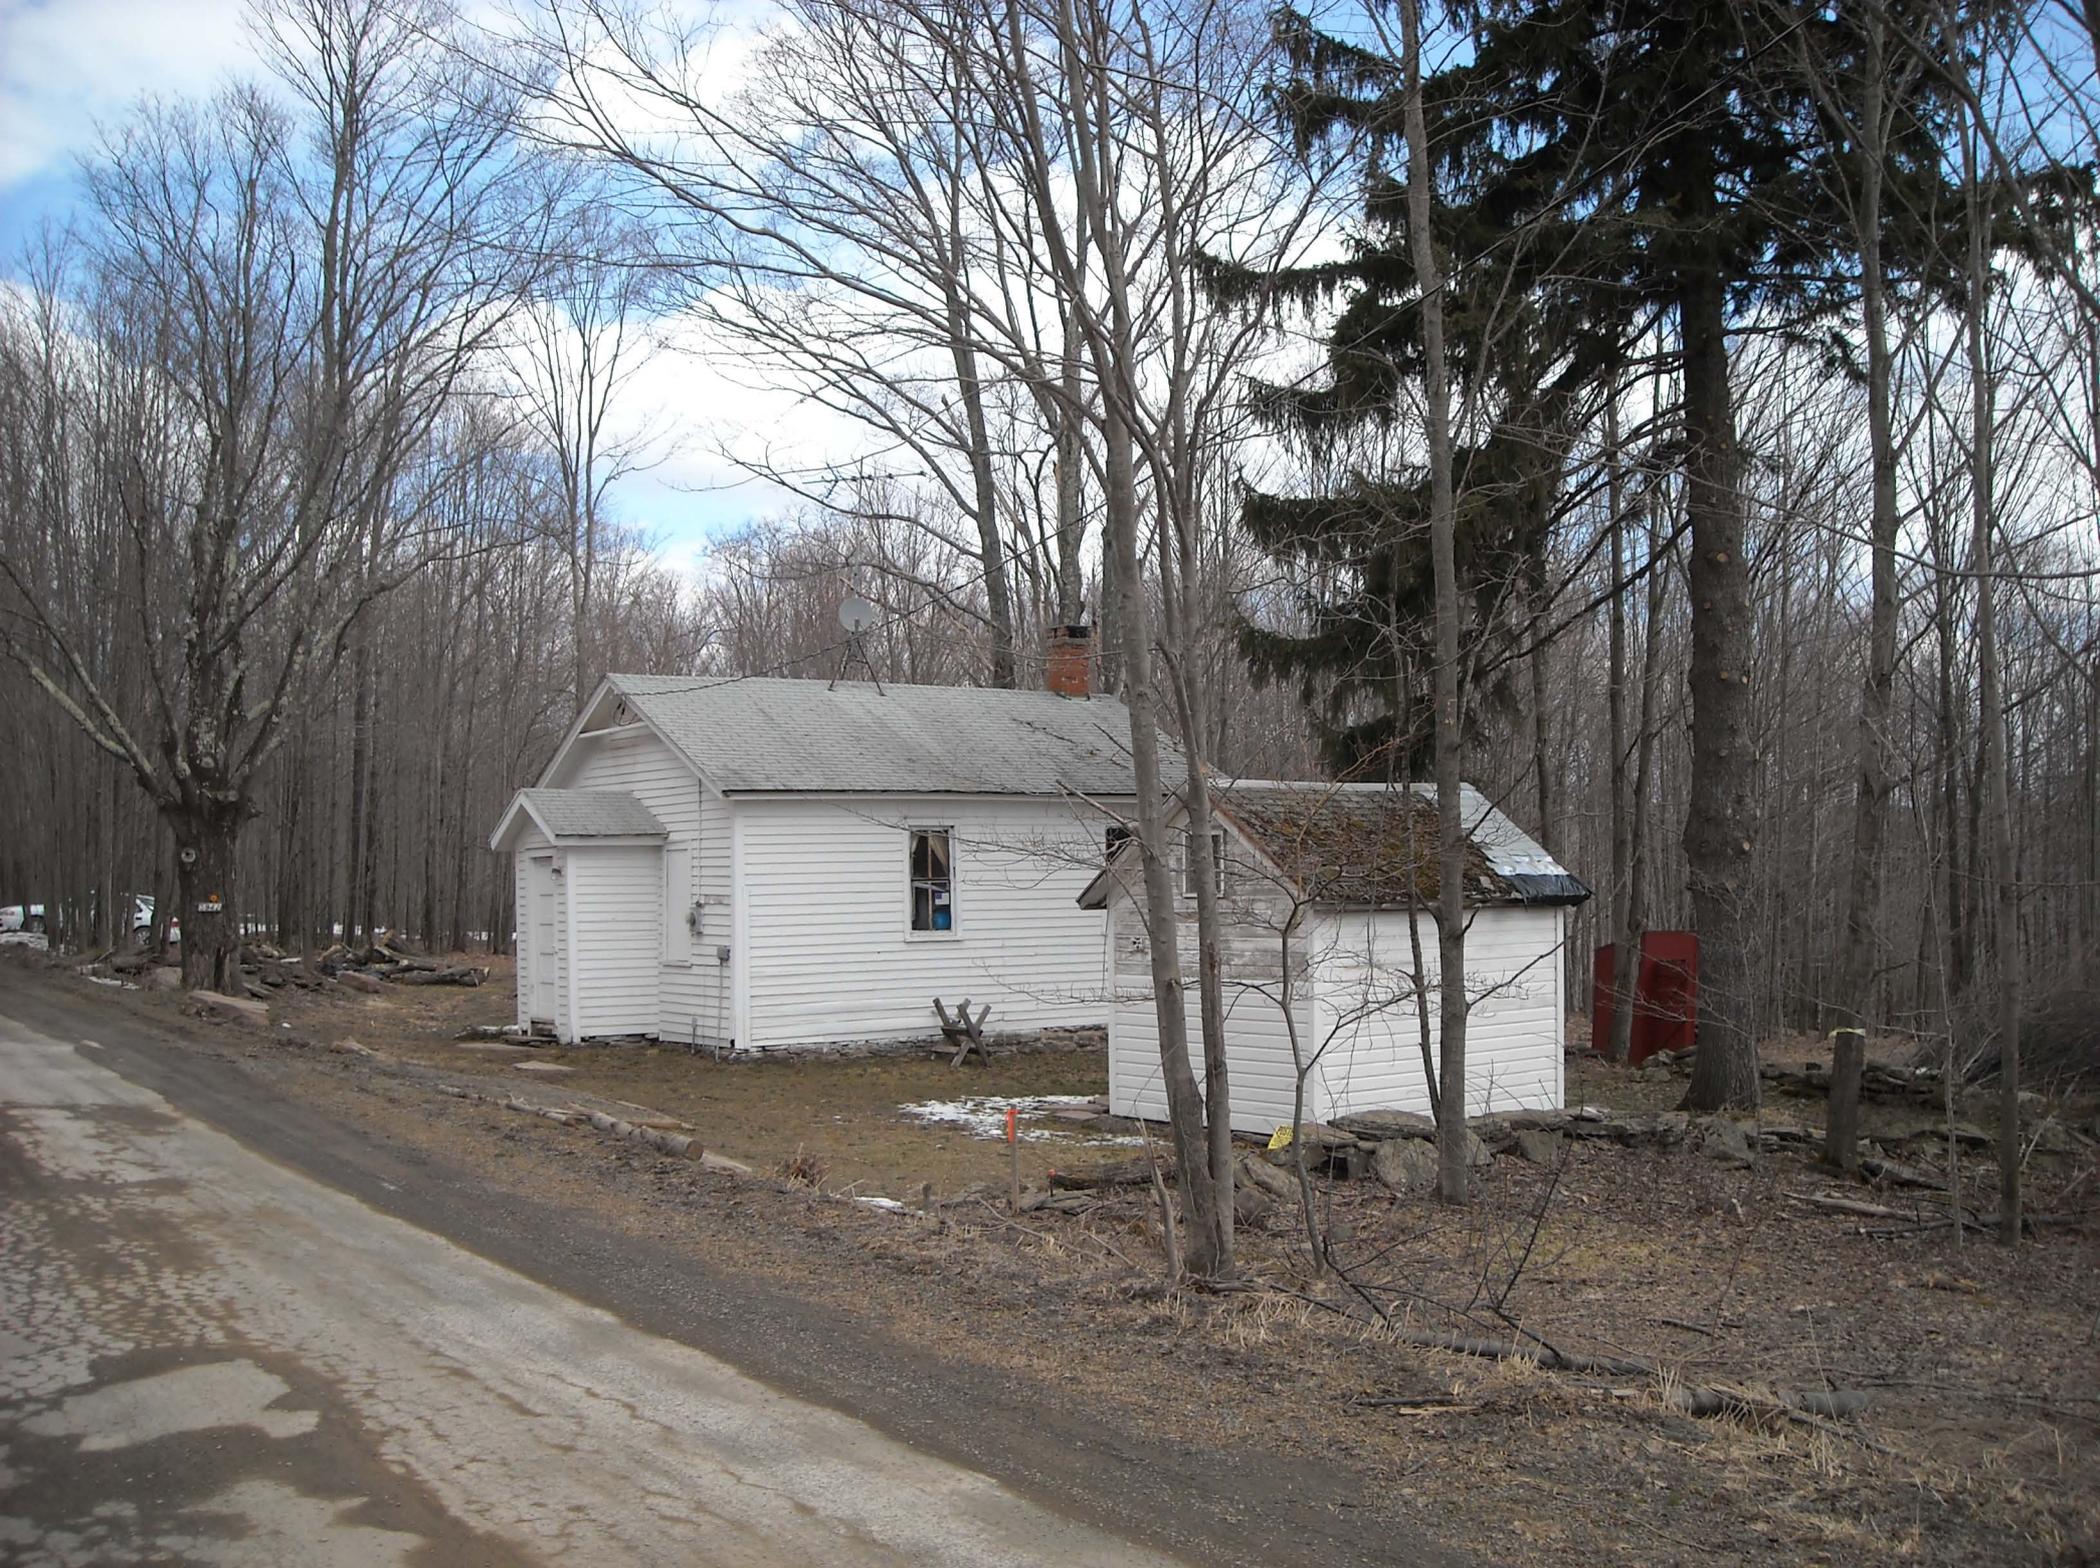
1. school, woodshed and site, looking southwest
2. school and woodshed, looking northeast
3. façade, looking east
4. rear elevation, looking northwest
5. interior
6. interior, stove
