Grasslands Not Badlands: Arid Grassland Restoration in Big Bend National Park

**By: Christina Rinas,
Park Ranger and Biological Science Technician**

Grasslands Not Badlands: Current Restoration Efforts

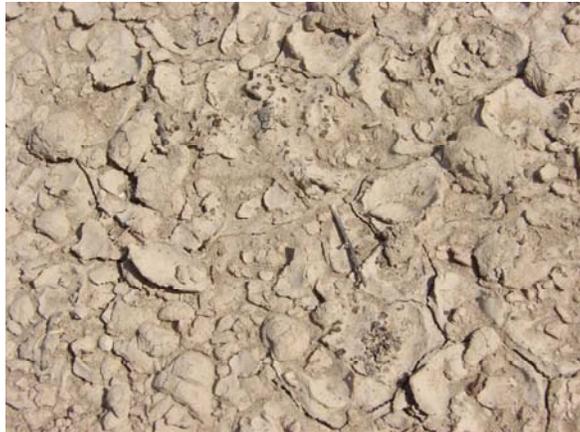
Biological soil crust at Harte Ranch.

Soils vary from region to region--at Harte Ranch the soils are fertile but fragile and particularly sensitive to disturbance. Soil erosion most likely began with El Nino winters in the late 1800s and early 1900s, and was aggravated by the loss of grass cover due to the building of water holding and diversion structures that altered surfaced water flow, and subsequent grazing of the land. It is estimated that between 1996 and 2002 Harte Ranch lost a foot of soil surface. The results have been an ever widening system of gullies and accelerated soil erosion that is altering and diminishing grassland habitat located within the entire watershed.

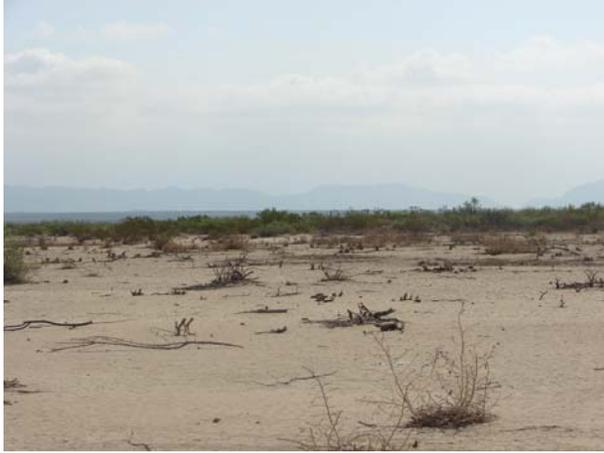
Soil erosion at Harte Ranch has resulted in tracts of land where even the hardest plants like creosote cannot survive.

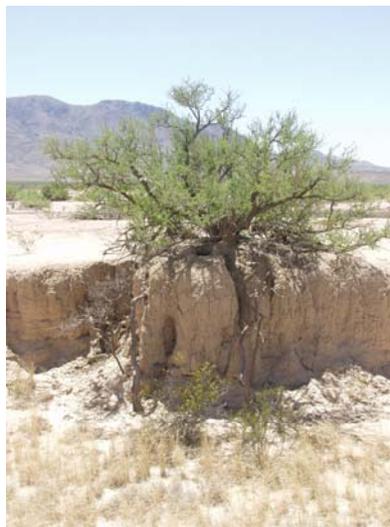
A mesquite tree growing near a gully at Harte Ranch. Accelerated soil erosion has exposed the roots of the tree.

Gullies are a common feature of arid Southwestern landscapes; they are channels that have been cut into the soil by moving water, and were probably widened and deepened by cycles of wet and dry periods that began in the late 1880s and lasted through the mid 1990s. Unusually heavy rainfalls associated with El Nino that cause flooding serve to widen and deepen these gullies. When followed by periods of extreme dryness the water table in the ground drops, reducing vegetation cover, and making soil even more susceptible to erosion. These climatic patterns have played a role in forming gullies in many areas of the southwest, and could be a contributor to the expansion of gullies at Harte Ranch. With each major rainstorm topsoil is washed into gullies, and is then deposited throughout the watershed and eventually into the river. These sediment loads have a high salt content, and threaten recovering grasslands downstream by changing the chemistry of the river.

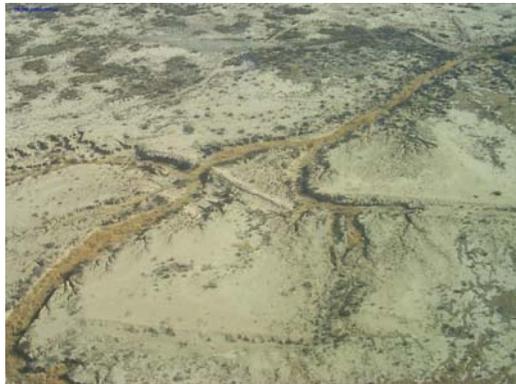
A large man-made diversion at Harte Ranch. Structures like this have altered the natural drainage patterns of the land.

The building of water retaining structures prior to the establishment of the park and subsequent grazing of the land have resulted in a loss of vegetative cover, and set the stage for destructive soil erosion. Over 140 water retaining structures, such as stock ponds and diversion, have been mapped at Harte Ranch. These structures have changed the way the water naturally flows across the land by channeling water, giving it more erosive force in certain areas, and depriving other areas of vital irrigation, resulting in loss of vegetative cover. With no protective cover, raindrops hit the exposed soil and drive the finest grains into the pore spaces between the larger grains. Once impacted, the concentration of fine grains, seals the surface, and creates a physical crust; a thin layer of the soil surface that restricts water infiltration and air movement in the soil, limiting vegetation growth. With infiltration severely reduced, water runs off the surface and carries soil into gully systems.

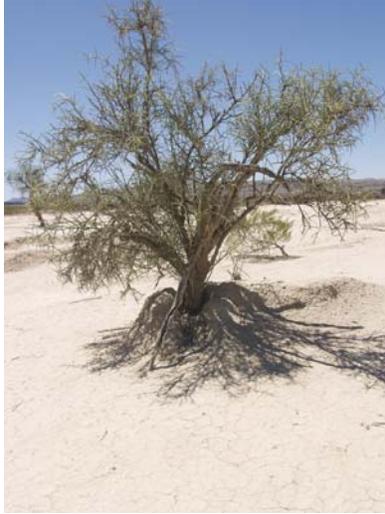
Exposed roots of an allthorn bush at Harte Ranch.

Soil loss has drastically altered the grasslands community. Shrubs like creosote and mesquite now dominate the landscape with only a smattering of tobosa grass in between. The shrubs are left in an unhealthy condition as soil loss exposes the plant's base, including roots, leaving the plant on a pedestal of soil.

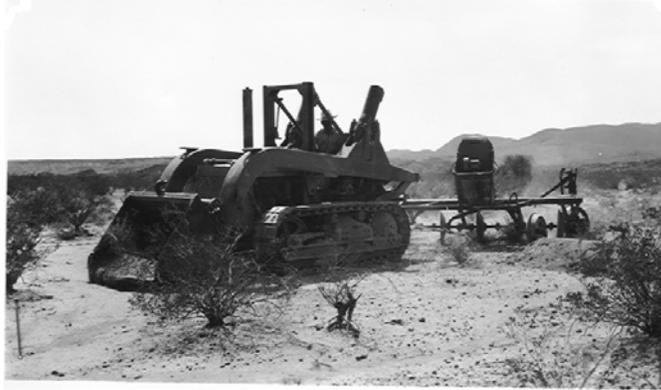
The Soil Conservation Service restoring the grassland at Tornillo Flats in the 1950s.

After the establishment of the park in 1944 it was hoped that the grasslands would recover. The grasslands in the Chisos foothills began recovering within a number of years, but the hotter and drier lowlands were not as quick to recover. In the 1950's the NPS along with the Soil Conservation Service attempted to restore the grasslands at Tornillo Flat, located south of Harte Ranch. They built structures at the bottoms of gullies to prevent further erosion, and contoured and pitted the land, adding native grass seeds to increase grass cover. It is hard to judge the success of the SCS effort because little is known about original project goals. Surveys of the area indicate mixed results; grass continues to grow in the pits, but overall vegetation cover has not increased, and unfortunately soil erosion continues today in the Tornillo Flats area. It was realized that restoration of grassland ecosystems is more complex than originally thought.

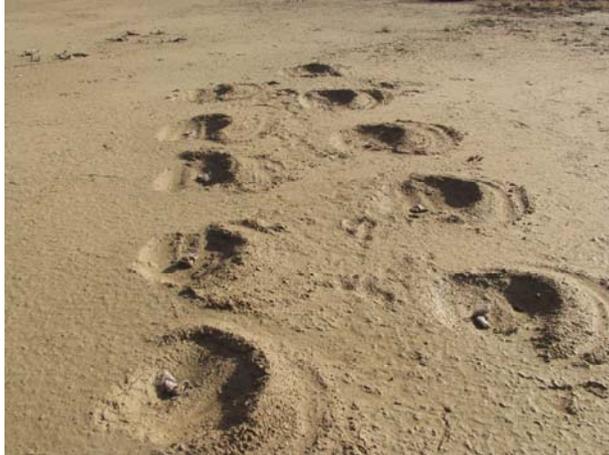
NPS staff tried micropits in an attempt to restore hydrologic function. These pits filled in after several rains.

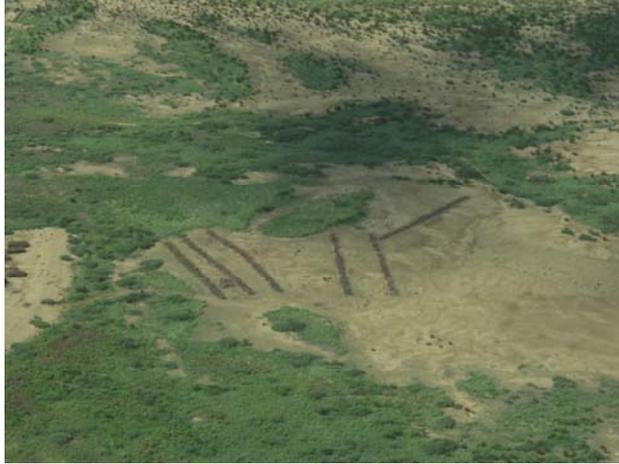
**Aerial view of a restoration site at Harte Ranch.
Grasses and forbs are planted on level contours to catch water.**

A total of 325 acres of the most severely eroded areas were targeted for restoration. Strips that will be planted with native grass and forb seeds are plotted to mimic the natural vegetation pattern of the land. After the strips have been plotted, loads of brush are staged along the strips. The brush is collected from other park projects such as exotic plant removal and fuel reduction activities.

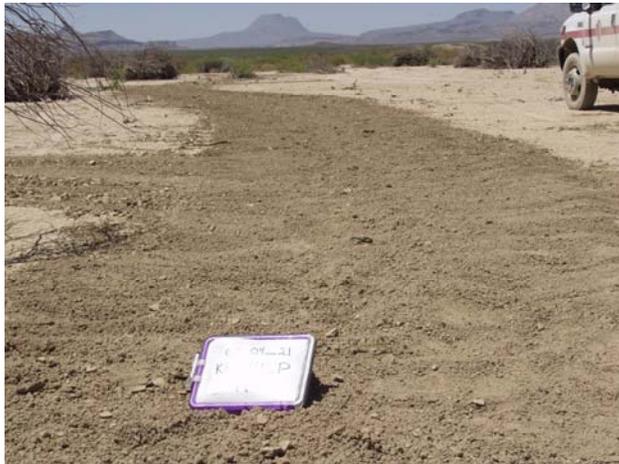
A vegetation strip that has just be tilled.

Once the brush is staged it is time to till the soil. A disc plow is used to till strips that are 8 feet wide and up to 500 feet in length, and are arranged along level contours. This arrangement allows the strips to interest water runoff and increases infiltration. The tilling breaks up the physical crust and allows roots and water to penetrate the soil.

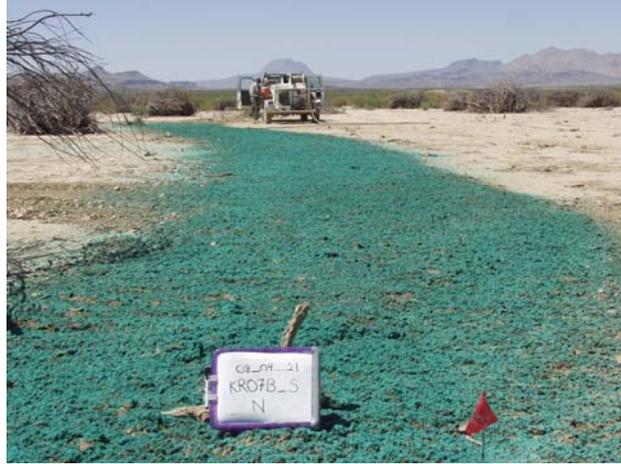
A vegetation strip that has just been planted; hydromulcher pictured in background.

Immediately following plowing the strips are planted with a mixture of mulch, seed, tackifier, and water sprayed from a gas powered hydromulcher. The mulch aids in seed growth and the tackifier, a glue that binds the seeds and mulch to the soil, prevents wind and animals from carrying the seeds away. A non-toxic dye that eventually fades allows workers to see where they have planted.

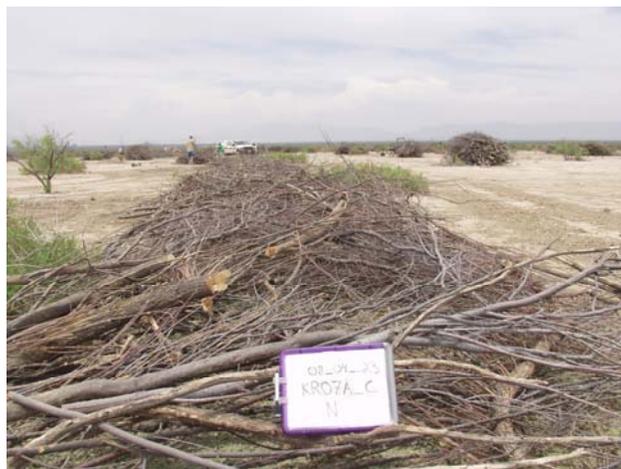
A completed vegetation strip.

The vegetation strips mimic the natural patterns of shrubs and grasses in arid grasslands; they slow the overland flow of rain water, and act as a sink for the water to penetrate into the soil, rather than run off into gully systems.

Once the strips are planted they are covered with brush and left to await the rains. The brush is critical to the success of the grass. It slows the velocity of rain drops and decreases further soil erosion. Most importantly, the brush shades the seeds and lowers soil temperatures, providing the necessary environment for the successful establishment of grasses.

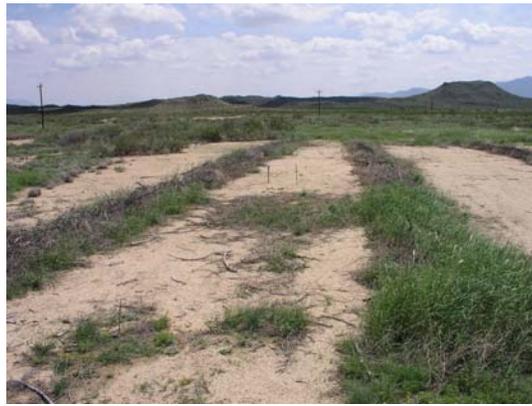
Grasses are growing each year with the spring and summer rains. Here grass has even begun to grow outside of planted areas.
