**APPENDIX C:
HISTORIC RESOURCE INVENTORY AND
EVALUATION REPORT**

**Historical Resources Inventory and
Evaluation Report
Channel Islands Telecommunications Project**

**San Miguel, Santa Barbara, Santa Cruz, and Santa Rosa Islands, Channel
Islands National Park,
Santa Barbara County, California**

November 2012

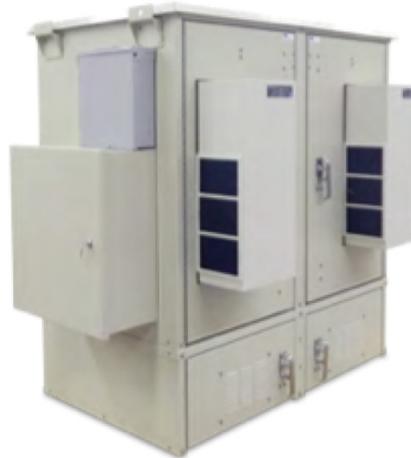
Ground-Mounted Equipment Cabinet

- One or more Global System for Mobile Communication (GSM) wireless phones
- A ground-mounted equipment cabinet that would measure approximately 69 inches tall, 72 inches wide, and 44 inches deep, painted a cream color, that would not require a foundation but would be placed on a 5-foot by 3-foot patch of cleared and level ground

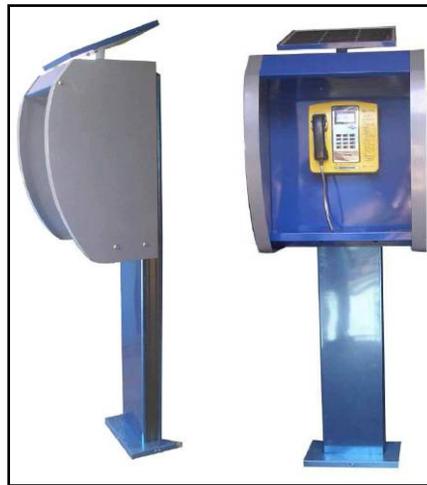
Standalone GSM Payphone

GSM wireless phones could be placed anywhere within the signal radius of the proposed telecommunication equipment. The signal radius would vary according to topography and other conditions at each proposed location, but would generally be within an approximately 0.5-mile radius around the telecommunication equipment. One or more solar-powered GSM payphones would be installed at a majority of the project locations with the exception of locations 9, 11, and 14. These payphones may be wall-mounted on existing structures, or where use of existing structures is not practical or feasible, GSM payphones may be mounted on new poles inserted in the ground, as shown below.

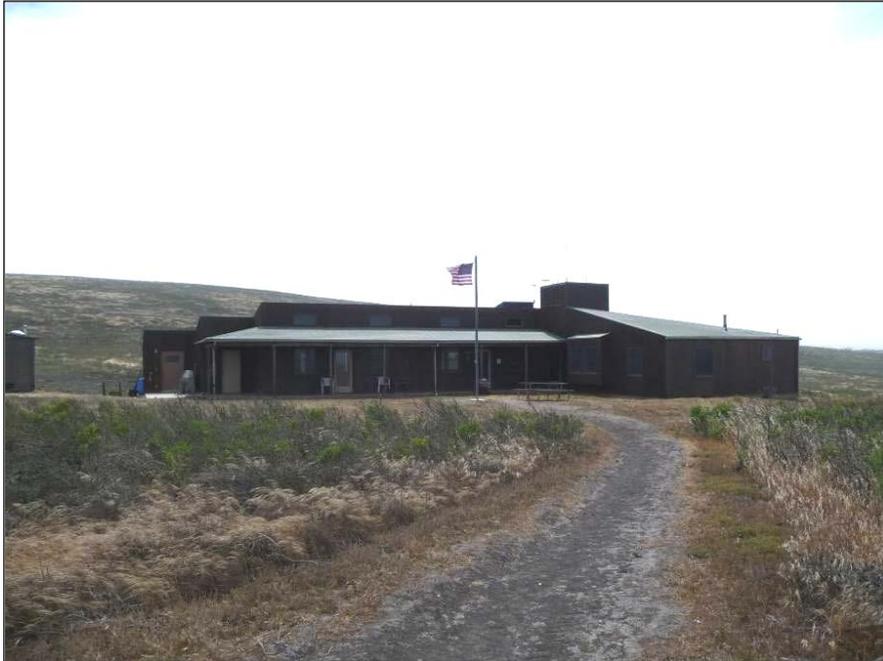
Built in 1996 and occupied the following year, the building is an example of restrained, minimalist Shed design. It is roughly L-shaped in plan, rests on a board-formed concrete perimeter foundation, and has a compound roof form. The roofs lack eaves and are sheathed with composition shingles. The long wing of the “ell” is oriented along a roughly east-west axis and has a shed roof; the east end of this wing is progressively stepped back giving the roof a “sawtooth” appearance. A hipped awning roof supported by wood posts shelters a concrete porch that runs along the main façade, which is located on the north side of the long wing. Doors on this façade are a combination of flush and glazed wood single personnel doors. The short wing of the “ell” extends north from the west end of the building and has a hipped roof. A square-plan, flat-roof tower located at the junction of the two wings rises slightly above the level of the roof. The building’s walls are clad with vertical groove wood panel siding, and windows throughout consist of one-over-one aluminum sliding sash, several of which (on the main façade) are topped by transom lights (**Photograph 2**). Surrounding the main ranger station building are three, small appurtenant wood frame structures: a shed roof outhouse on the southeast end of the building; a fox building with a gable roof, plywood siding, and vinyl sash windows, located on the south

Photograph 2. San Miguel Island Ranger Station, facing southwest.
(JRP Historical Consulting, LLC)

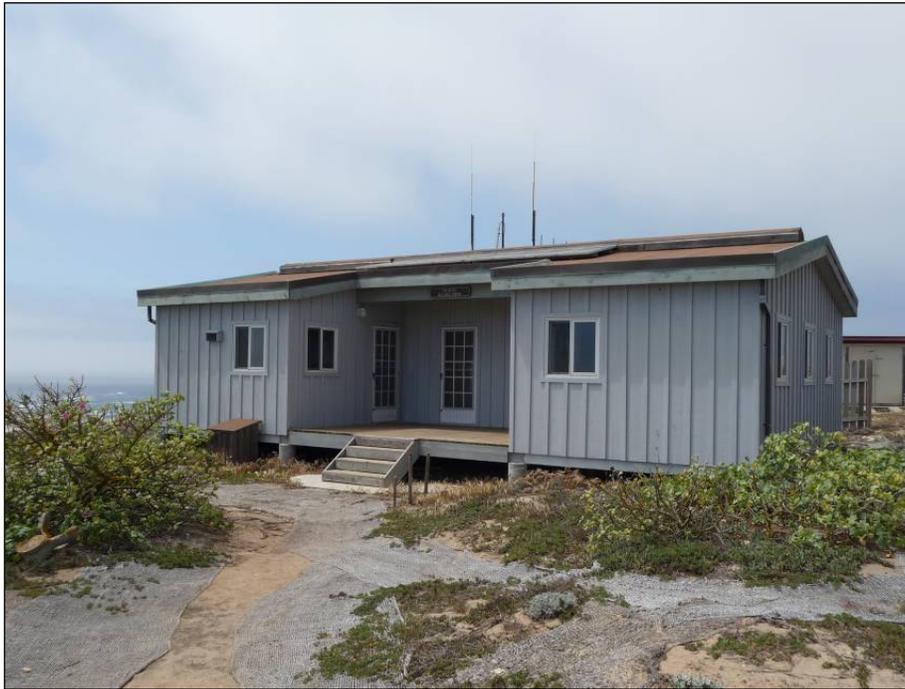
The research station, built in 2004, is a remote complex consisting of the main research and bunkhouse building, a tool shed, and two other small plywood outbuildings. The main building, which replaced an earlier modular structure originally installed on the site in 1969, is U-shaped in plan and rests on a concrete pier foundation (**Photograph 4**). The inside of the “U” faces south and has an elevated wood frame porch accessed by four wood steps. Four multiple-light glazed doors open to the porch. Other fenestration consists of vinyl sliding windows, located on all sides except the rear (north side). The building has a shallow gable roof with narrow boxed eaves and rolled tarpaper sheathing, and the walls are clad with plywood board-and-batten siding. The tool shed, located just north of the research station, is a prefabricated structure with double doors a shed roof (**Photograph 5**).

Photograph 4. San Miguel Island Marine Mammal Research Station, facing northwest.
(JRP Historical Consulting, LLC)

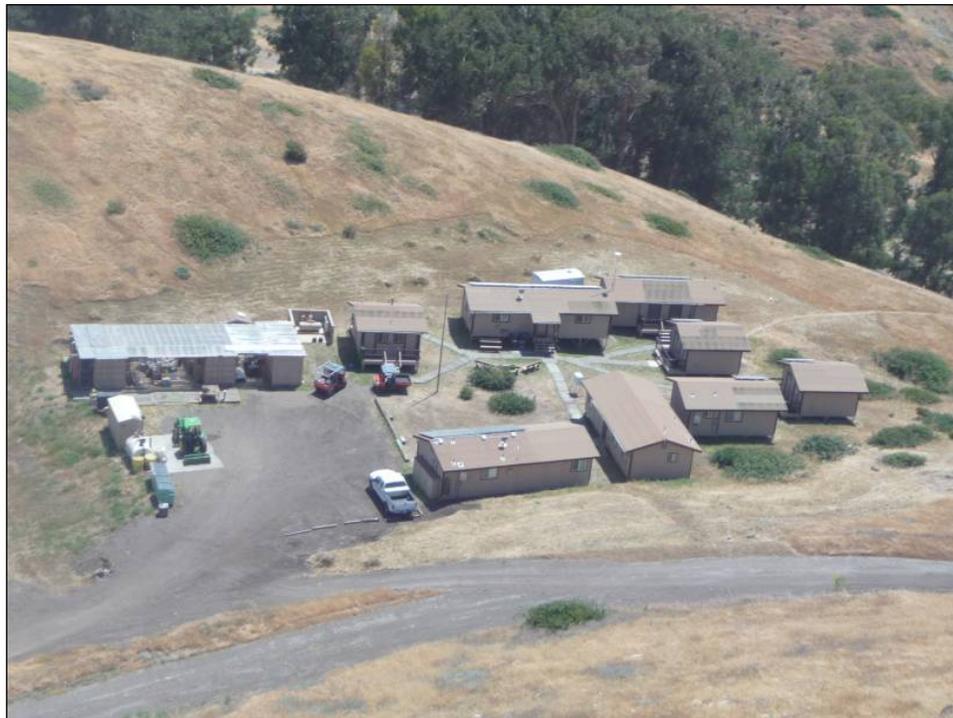
Scorpion Housing consists of nine NPS buildings and structures erected between 1999 and 2001: two staff residences, four bunkhouses, a bathroom facility, a kitchen, and a storage structure. The NPS buildings and structures are organized in a “U” shape with the open end of the “U” (facing east) leading to a gravel access road. Except for the storage structure, all of the buildings and structures are roughly rectangular in plan; rest on three-foot high concrete pillars; have side gable roof forms; and have wood frame personnel doors and sliding aluminum throughout. Three parallel Conex boxes covered by a flat aluminum roof comprise the storage area. The staff residences are approximately 640 square feet in size, and each has a bathroom and kitchen. The bunkhouses were constructed in style similar to the residences. Each has two rooms that open to a shared wooden porch. The bathroom facility has four rooms – three rooms with a toilet, sink, and shower, and one room for storage. It has two porches, one to the north and one to the south. The kitchen is approximately the same size as the staff residences. It has a small stoop, and is divided into four rooms – a cooking area, storage area, living room / office, and foyer. A rack of solar panels are mounted on the roofs of three of the bunkhouses (**Photograph 6**).

Photograph 6. Scorpion Housing Area from the air, facing south.
(JRP Historical Consulting, LLC)

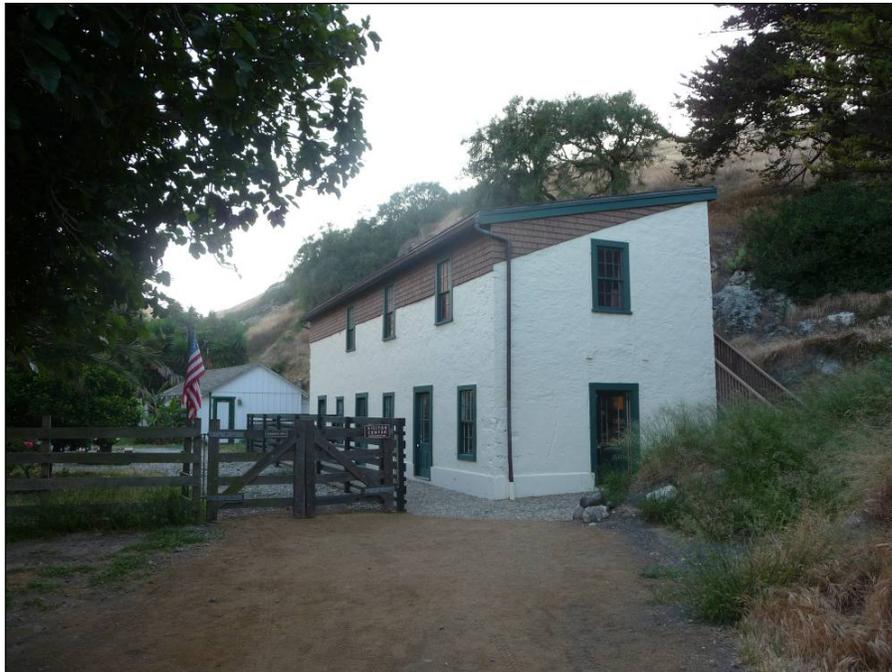
A Historic Structures Report (2002) provides a comprehensive study of the Scorpion Ranch House (Adobe), the principal contributing building in the cluster (**Photograph 7**).⁸ Briefly, the ranch house, built in 1886, is two-story adobe and unreinforced rubble-wall masonry building. The building has a rectangular plan that measures 51 feet by 18 feet four inches. It has a shed roof and walls that are 20 inches thick and composed of local stone, adobe bricks, mortar covered with stucco, and limestone quoins. Windows – a combination of original and replacement – are wood frame throughout. The building rests on a stone and mortar foundation.

Photograph 7. Scorpion Ranch House, view facing southwest;
non-contributing kitchen building is visible at left.
(JRP Historical Consulting, LLC)

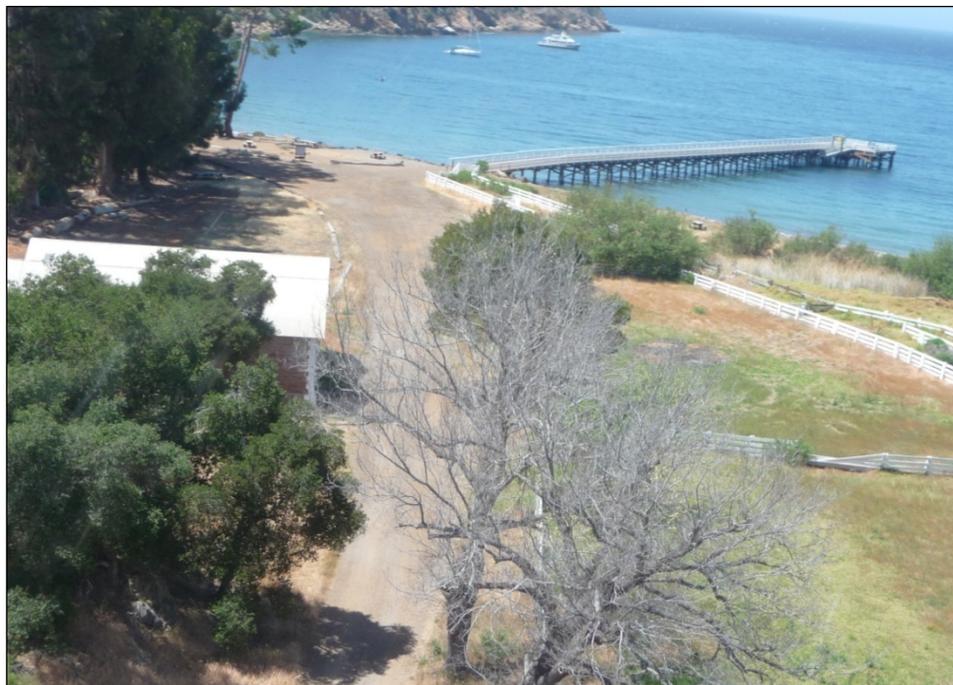
Focused APE #7 is within the contributing Prisoners Harbor Cluster (Prisoners Harbor Day Use Area), one of Santa Cruz Island's principal anchorages (**Figures 6 and 14**).¹⁰ Prisoners Harbor Cluster contributing elements include a masonry warehouse and scale house (**Photographs 10 and 11**). The warehouse, built in 1887, measures 54 feet by 45 feet and rests on a mortared rubble foundation. It has parallel twin front gable roofs and is built of native island brick and stone. There are two arched door openings on the main (northeast) side. The scale house, built after 1918, is wood frame structure with a rectangular plan. It has a corrugated metal roof and open sides.

Non-contributing elements include the pier, kiosk, and picnic area on the west end of the cluster; an NPS restroom building on the east side of the warehouse; and the parking area on the east end of the cluster, at the junction of Navy Road.

Photograph 10. Aerial view of Prisoners Harbor cluster, facing west. The contributing masonry warehouse is visible at left; the beach area and pier are non-contributing elements of the cluster, and the corral fencing has been removed since this photograph was taken in 2009.

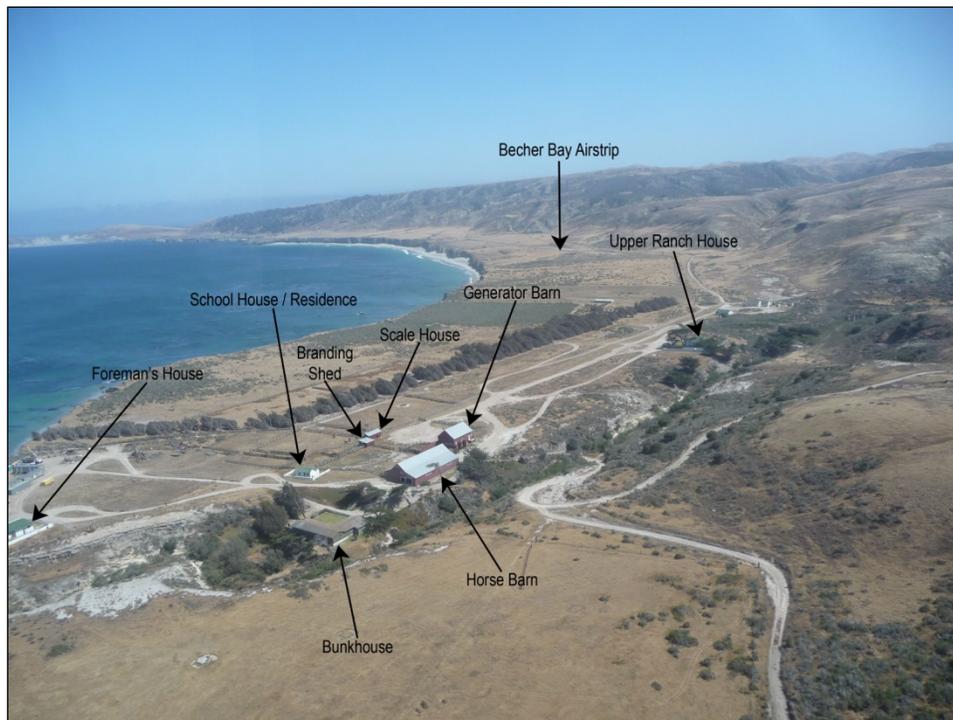
Focused APE #11 is located within the Santa Rosa Island Main Ranch Cluster, which contributes to the National Register-eligible Santa Rosa Island Ranching District (**Figures 7 and 16**). Contributing elements of the district include the Upper Ranch House and outbuildings, horse barn, generator barn, schoolhouse and residence, foreman's house and outbuildings, scale house, branding shed, eucalyptus tree row, and the airstrip at Bechers Bay (**Photograph 17**).

Photograph 17. Aerial view of the historic Main Ranch Cluster (Focused APE #11) showing principal buildings, facing southeast. All identified elements except for the bunkhouse contribute to the historic district.
(JRP Historical Consulting, LLC)

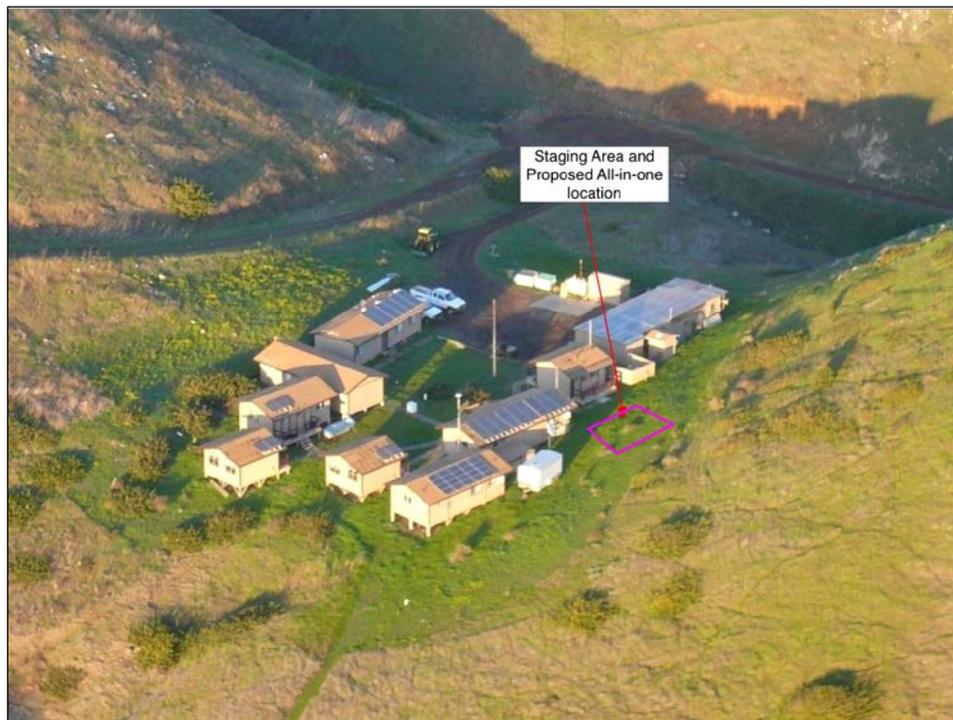
Proposed activities within Focused APE #5 include equipment installations within the Scorpion Housing Area, an NPS-developed, **non-contributing** cluster. Under the proposed project, an all-in-one telecommunications unit would be placed within an 8-foot by 8-foot area in or near the housing area, such as at the proposed location shown below (**Exhibit 1**). The unit will be surrounded by fencing that is compatible with any existing fencing in the vicinity. Additionally, a GSM payphone will be wall mounted on the exterior or placed within the kitchen building.

Exhibit 1. Proposed location of all-in-one unit at Scorpion Housing Area.
(Channel Islands Telephone Company)

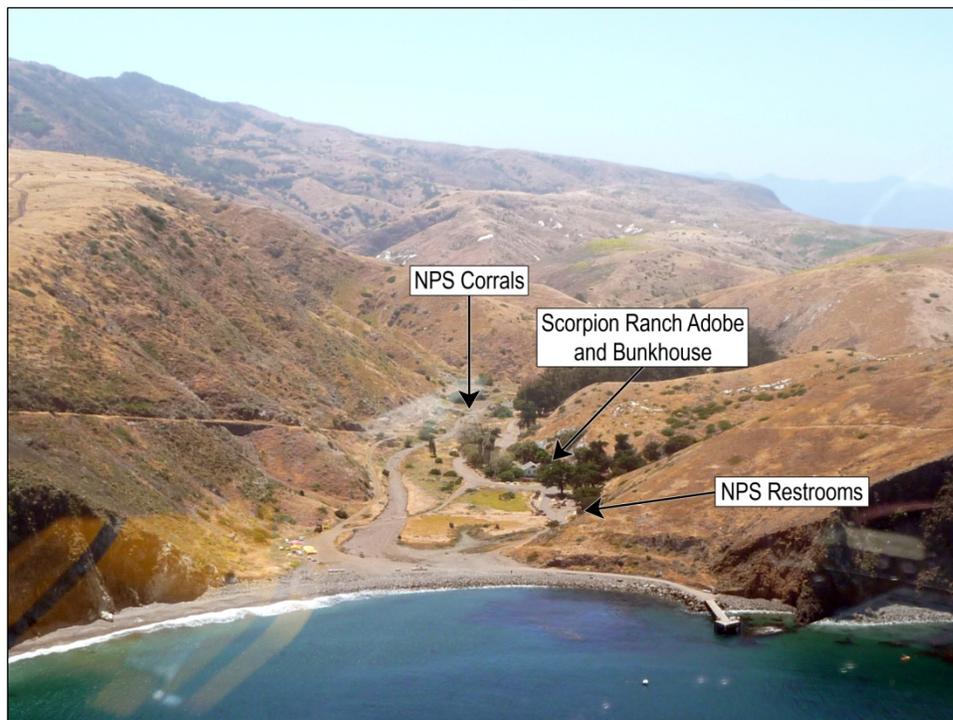
Proposed activities within Focused APE #6 include equipment installations within the **contributing** Scorpion Ranch cluster. Under the proposed project, an all-in-one telecommunications unit would be placed in an 8-foot by 8-foot area within the non-contributing corral west of the main ranch building. The unit will be surrounded by fencing that is compatible with the existing corral fencing. Additionally, a freestanding GSM payphone will be installed near the corral or adjacent to a non-contributing NPS restroom building on the east end of the complex (see **Exhibit 3** and **Figure 13**).

Exhibit 3. Aerial overview of Scorpion Ranch, facing west toward the contributing Ranch House and Bunkhouse. The restroom building and corrals are non-contributing features.
(JRP Historical Consulting, LLC)

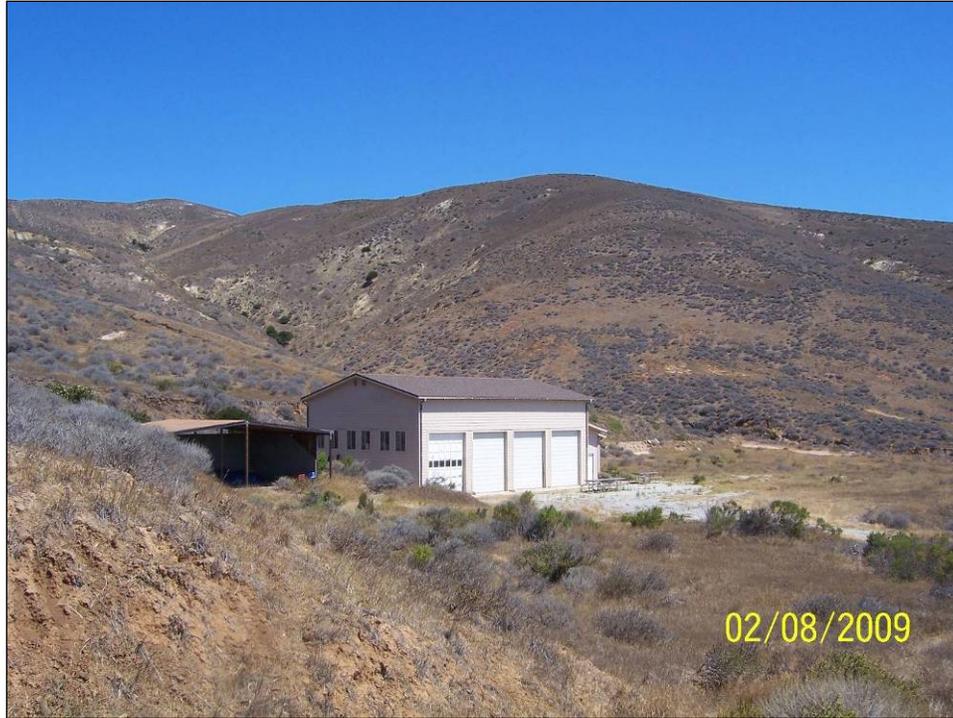
Exhibit 18. Vehicle maintenance shed at Johnson’s Lee, surrounded on all sides by high hills and not visible from any contributing clusters, view facing northeast. The all-in-one unit would be placed on the ground behind the building.

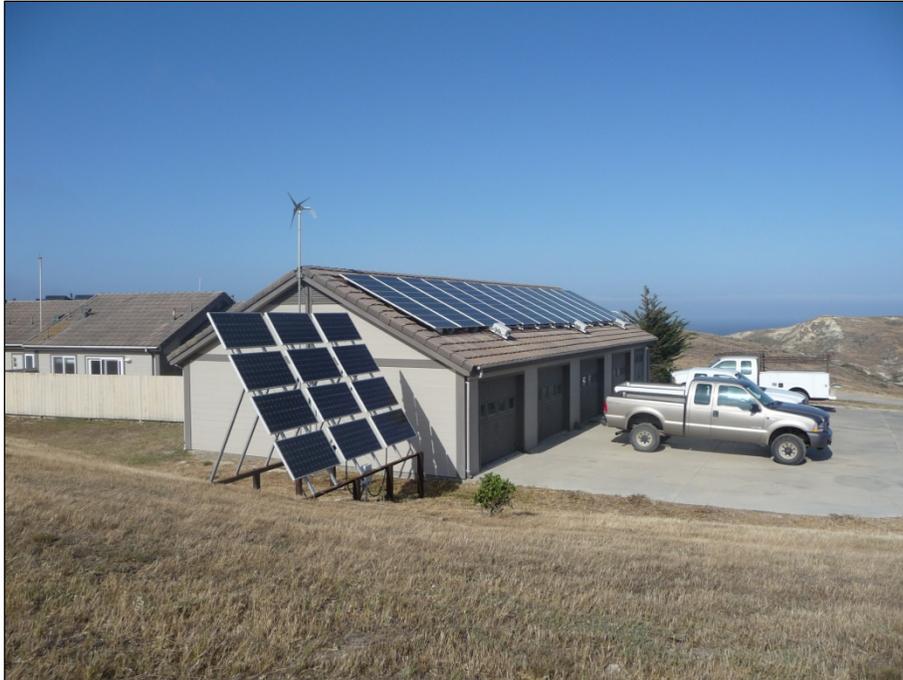
Exhibit 20. Proposed installation site for the payphone, mounted on the garage building wall next to the solar panel array. View facing east toward Main Ranch cluster, located along the shoreline and not visible from Focused APE #16.
(JRP Historical Consulting, LLC)

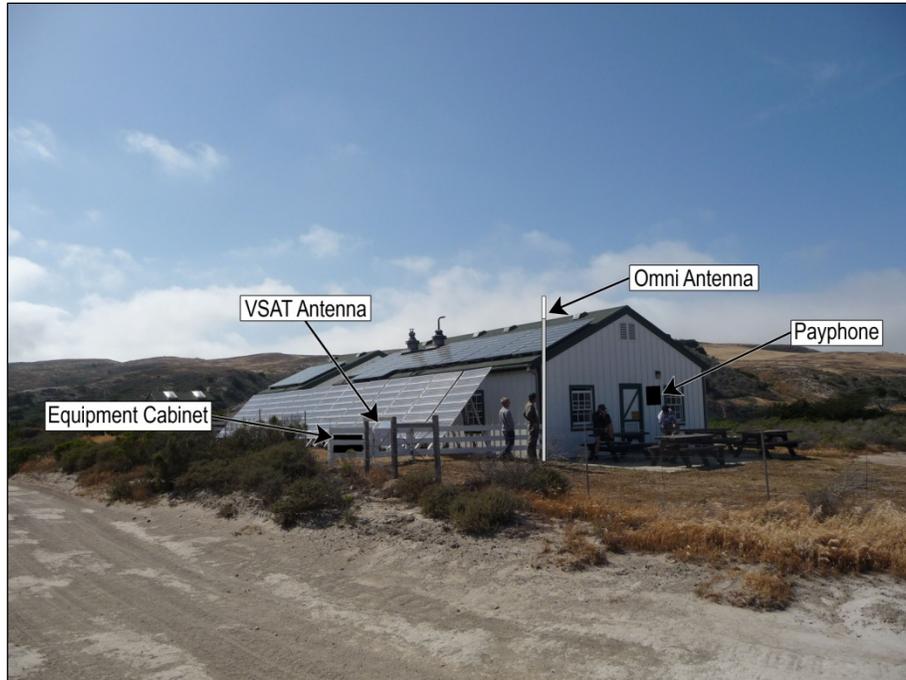
Exhibit 21. Simulated view of proposed telecommunication equipment at generator complex, facing northwest.
(JRP Historical Consulting, LLC)

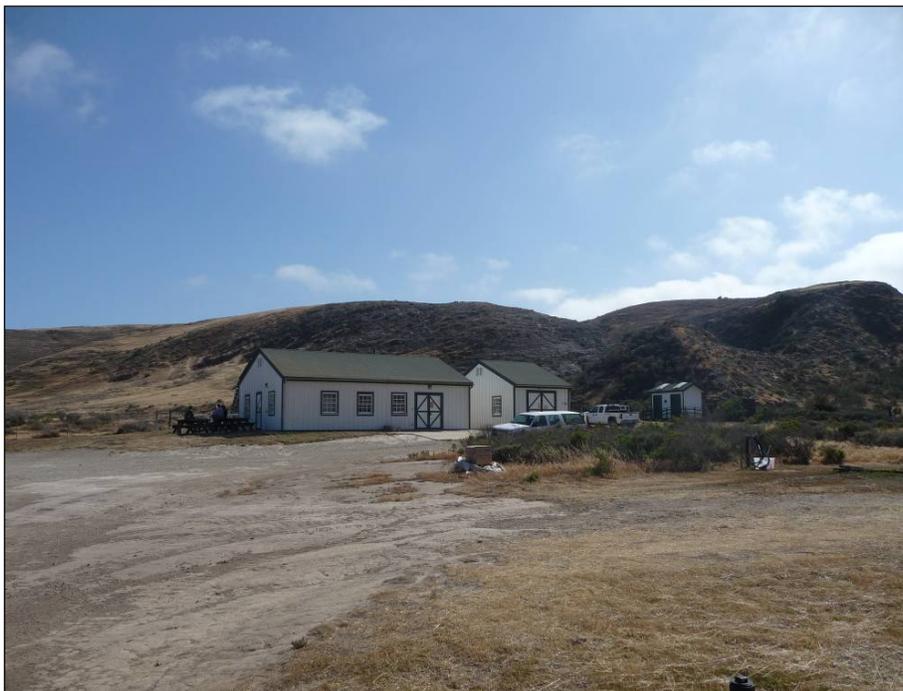
Exhibit 23. View toward the generator complex from the non-contributing World War II-era shed, facing south. The VSAT dish and equipment cabinet would be installed behind the generator building (at left), and the payphone and omni-directional antenna would be installed on the east (left) side of the building.
(JRP Historical Consulting, LLC)
