CRM

VOLUME 16 • NO. 4

Thematic Issue

A Reality Check for Our Nation's Parks

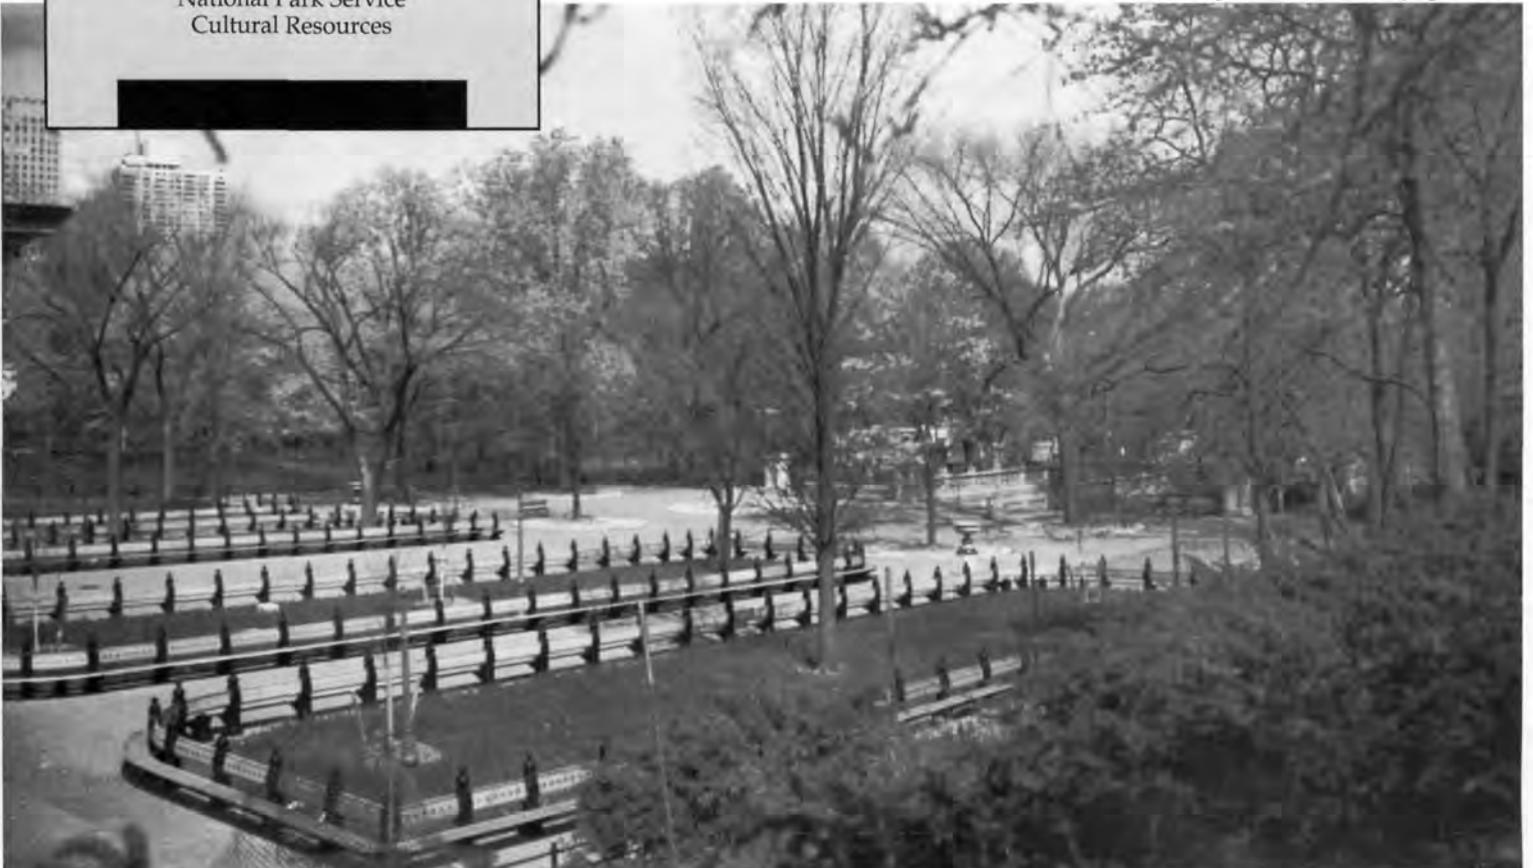
Fig. 1. New seating along Central Park's Concert Ground at the Mall. Could this "more agreeable product" be characterized as a "synthetically created environment?" Is this a trend? Is this good preservation? Photo by the author.

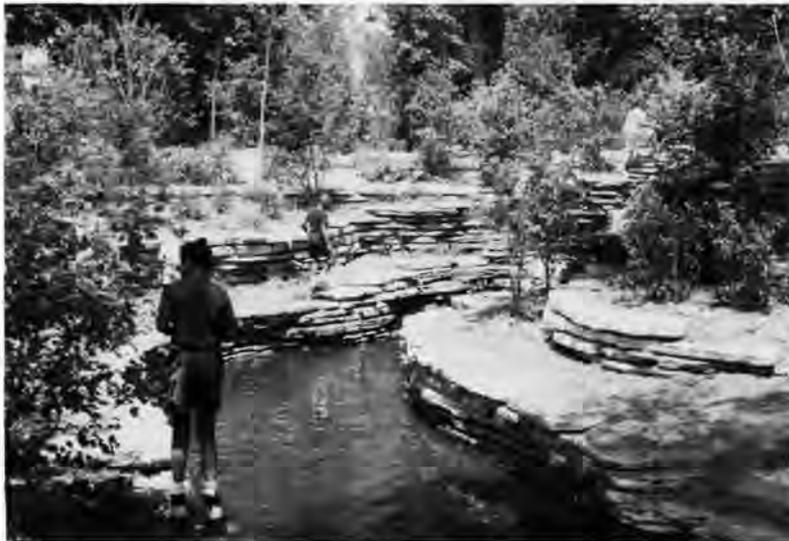
Fig. 2. Recent rehabilitation work in Columbus Park included the waterfall, cascades, rocky brook and associated landscape for this popular Prairie feature in Jens Jensen's most extant and authenticated park in Chicago. Photo by the author.

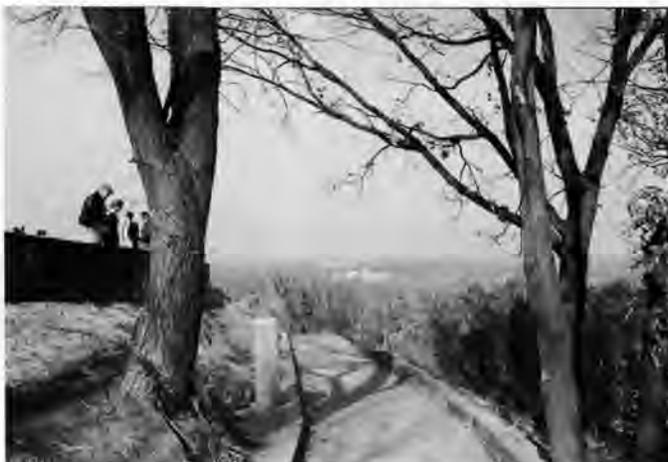
Fig. 4. In an effort to provide access up Iroquois Park's hill, this standard 1980s project resulted in a degradation to geology and historic fabric. More recent efforts at Louisville's Olmsted Park Conservancy recognize this shortcoming and aims to provide hill access along the historic woodland route in a rehabilitation treatment project proposal.

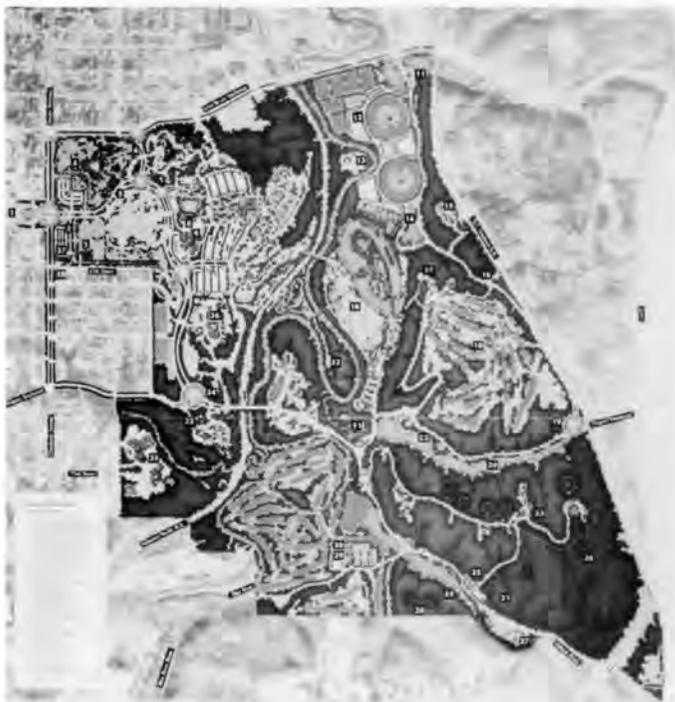
Fig. 3. *Master Plan for Swope Park as adopted by the Kansas City, Missouri, Board of Parks and Recreation Commissioners, March 19, 1991. Howard Needles Tammen and Bergendoff, Kansas City, MO. Courtesy HNTB.*

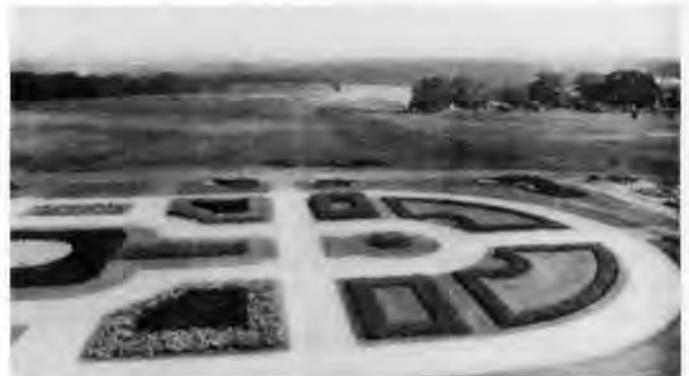
Fig. 4. *Detail of "Swope Park, Part of Sunken Garden and Golf Links," Report of the Board of Park Commissioners of Kansas City, Missouri, April 16, 1906. Courtesy the Office of the Board of the Park Commissioners.*

Plans to rehabilitate (and in some cases restore) the majority of the park's existing features have already been considered. Vistas will be restored, shelters will be restored or rehabilitated and Kessler's historic gardens, such as a Sunken Garden in Swope Park (figure 4) will be researched, and a rehabilitation plan generated from available documentation. Most important, the historic research and existing conditions inventory undertaken coupled with later evaluation will help us to make difficult choices regarding the future management, treatment and interpretation of the parks.

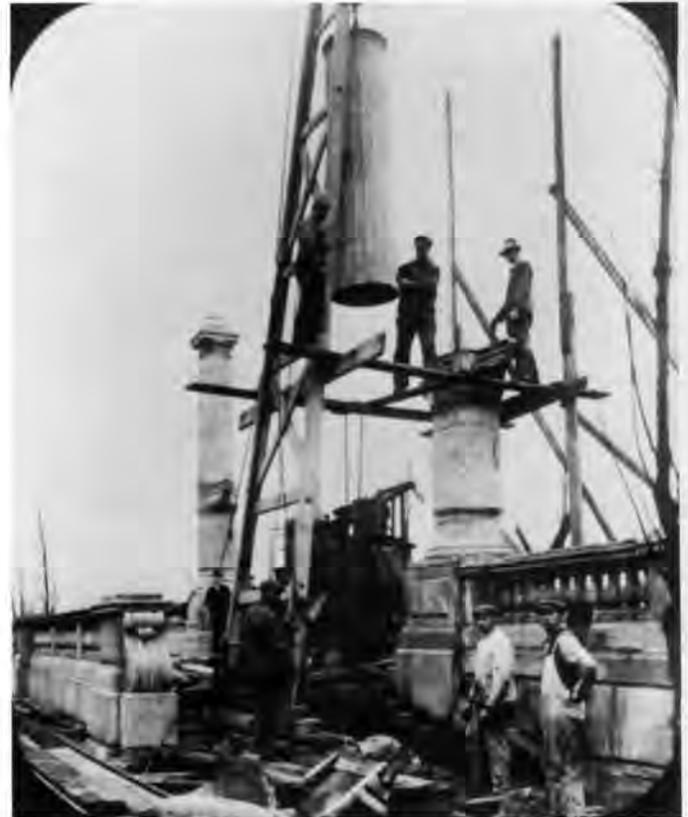
Fig. 2. Construction of balustrades, rostral columns, and other ornamental concrete in grant park, 1916. Courtesy Art Institute of Chicago.

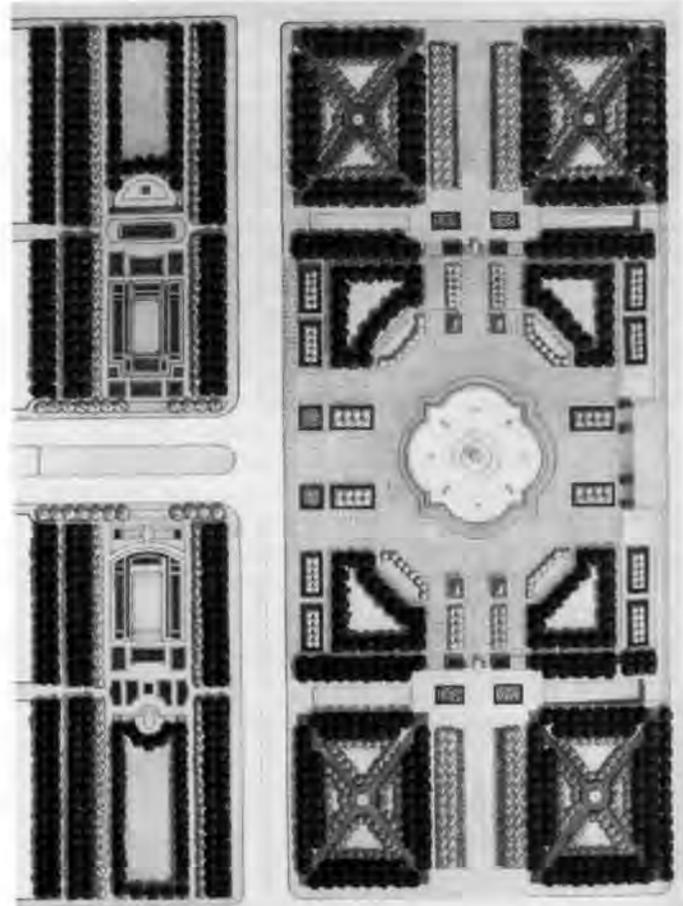
Fig. 6. Historic template drawing, central section of Grant Park: Fountain Table and Court of Presidents. Courtesy Chicago Park District, Office for Research and Planning.

In order to better illustrate the template concept, the Fountain Table and Court of Presidents, which is one of the most historically significant areas of the landscape, provides an example. This area's prominence and importance of its lakefront views became apparent early in the park's history when Ward launched his campaign to keep Grant Park open and free of buildings. Though Burnham's plan for a neoclassical museum building on this site was not implemented, his vision of this as the formal focal point of the landscape was realized. Plans by Edward H. Bennett and in-house South Park Commission designers between 1922 and 1929 guided the original construction of the area. As there is not a comprehensive plan that was fully implemented, the series of plans was analyzed and implemented aspects were documented.

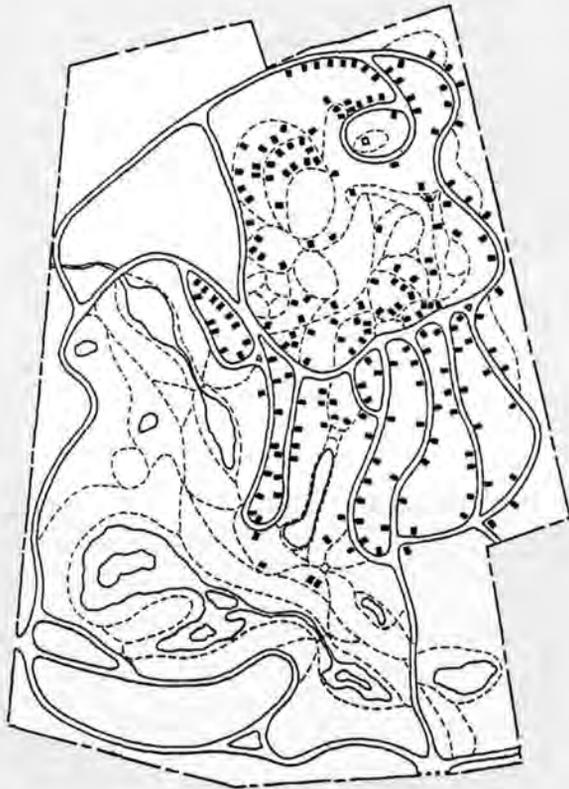
Fig. 1. Graphic depiction of the distribution of burial lots, 1831. Illustration by the author.

Mount Auburn Cemetery, established near Boston in 1831, was the first landscaped rural cemetery in America and a model for the generation of cemeteries which followed (figure 1). It had a profound influence on 19th century attitudes about death and bur-

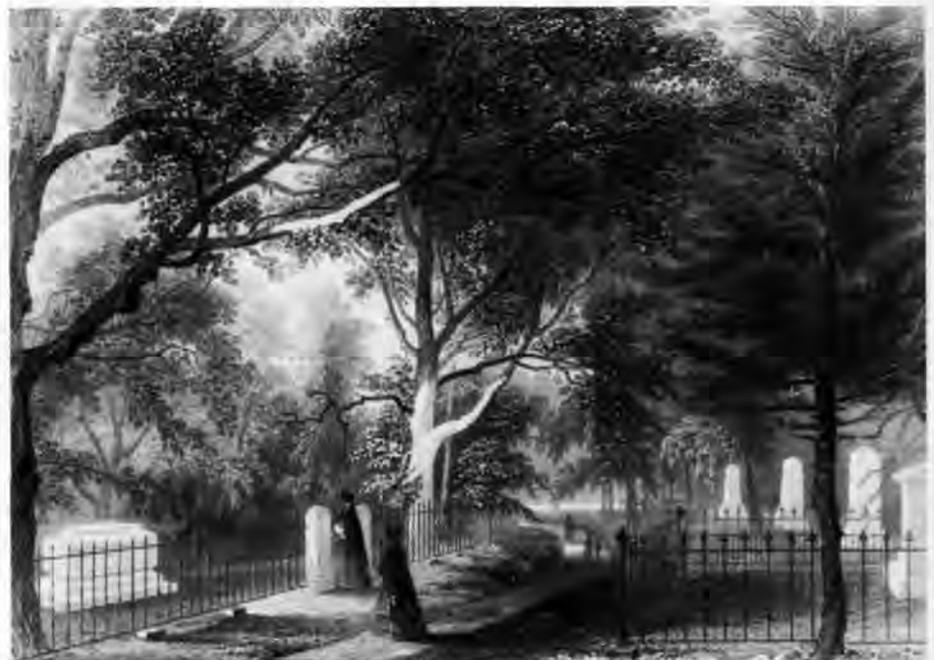
Fig. 3. The naturalistic period as evoked in the 1847 engraving by James Smillie. Courtesy Mount Auburn Cemetery.

cally with complex topography and naturally occurring plant associations (figure 3). The ornamental landscape (the remaining 60%) included areas developed later which exhibited more gardenesque or formal landscape characteristics with limited trees, large areas of turf and bedding plants (figure 4). Within each of these zones, a number of sub-zones were delineated. This approach, although often called "restoration" because it uses plant palette and massing appropriate to the historic period, is more accurately characterized as sympathetic rehabilitation because it is a modern interpretation of what existed rather than a literal copying. Factors such as existing conditions and maintenance influenced the design as well as purely historical considerations.

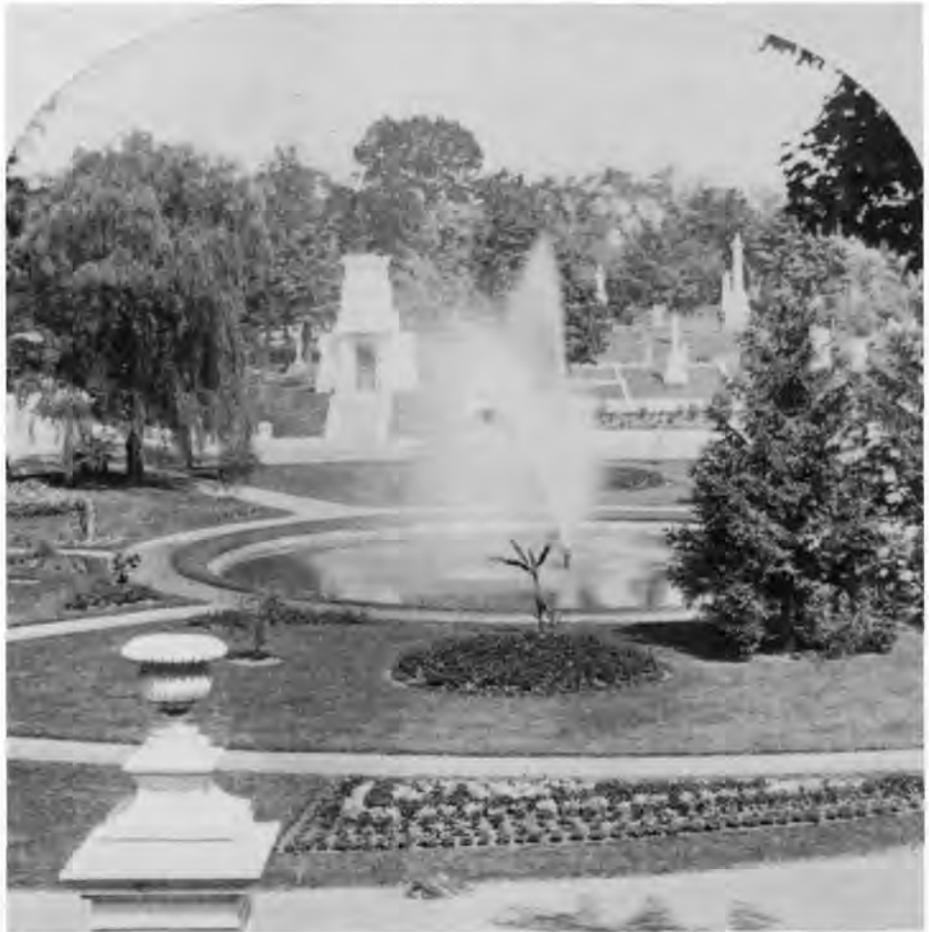
Fig. 4. The ornamental period as illustrated in an 1870 stereoscopic view, complete with circular fountain, fine turf, bedding plants and scattered trees. Courtesy Mount Auburn Cemetery.

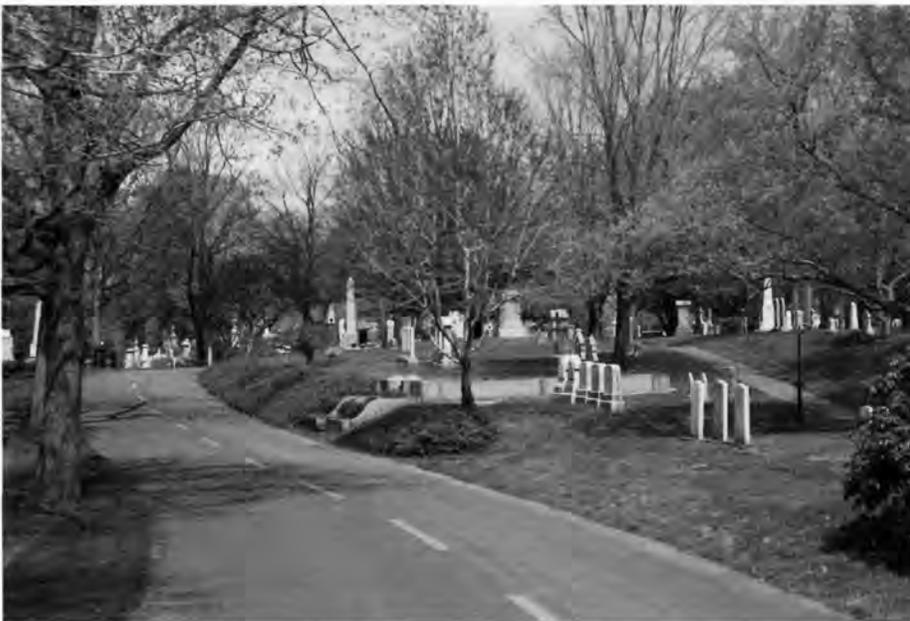
Fig. 5. Dashed green line along drive interprets the historic core of the cemetery. Photo by Charles A. Birnbaum.

Another example illustrates the way in which a proposed action was true to the ideals of the cemetery, even though it meant a physical change. Central to Mount Auburn's purpose is its role as a public institution, designed to inspire and instruct visitors. However, orientation within the cemetery has always been difficult because of the complex and winding road system. In the 19th century, when visitors toured by carriage, a map provided sufficient guidance. Today visitors in automobiles move at a greater speed. Green lines were recently painted on the pavement to direct visitors along designated interpretive tour routes (figure 5). While some have perceived this as an intrusion, most visitors welcome the guidance provided by the green lines. The lines and accompanying interpretive map allow them to move more easily through the

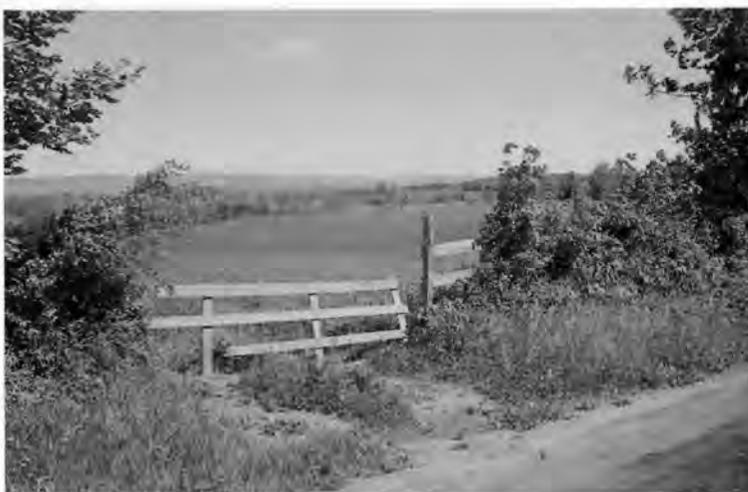
Fig. 4. The relationships of road, field, hedgerow and viewshed are important to the character of the historic landscape in Waterford. Photo by the author.

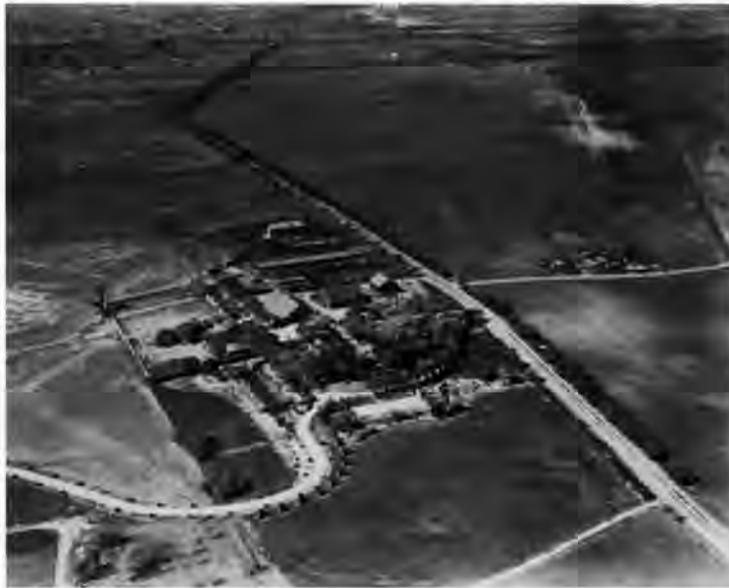
Fig. 1. Aerial view of Rancho Los Alamitos, c. 1936. Courtesy Rancho Los Alamitos Foundation.

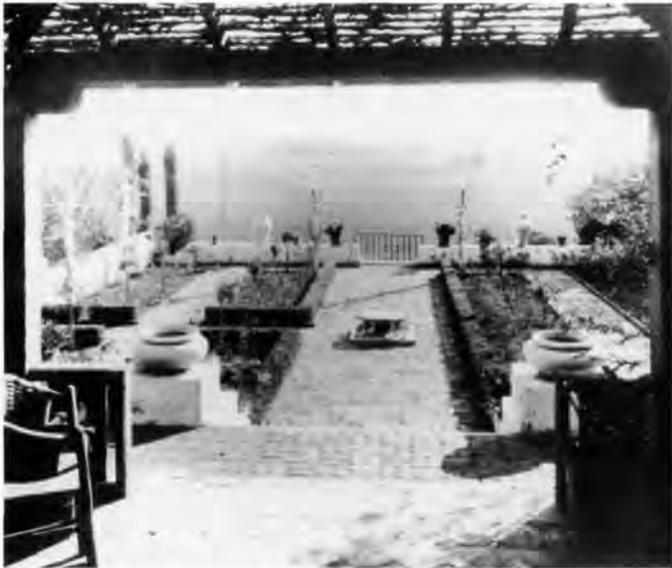
Fig. 3. William Caywood photo of Rose Garden, looking south. Design attributed to Florence Yoch, c. 1925. Courtesy Rancho Los Alamitos Foundation.

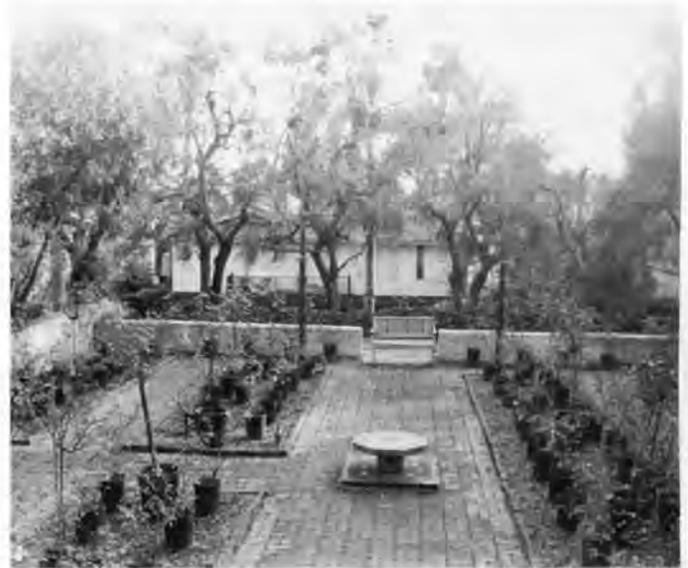
Fig. 4. Rose Garden, 1993. Photo by Janet Brown Becker.

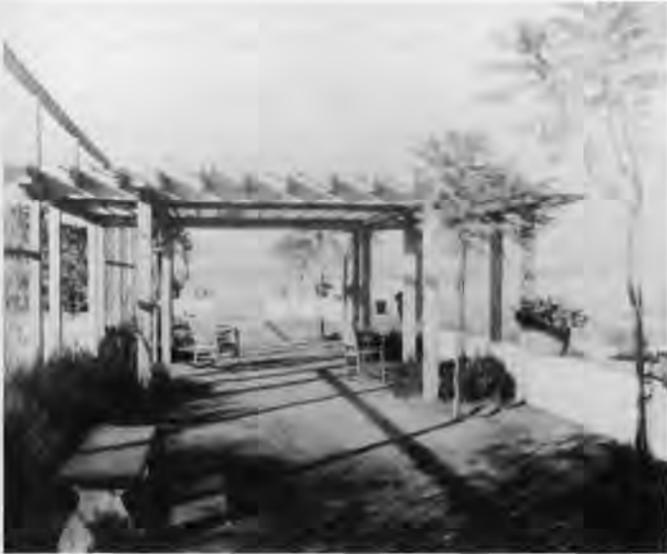
Fig. 5. William Caywood Photo of Jacaranda Walk, c. 1936. Courtesy Rancho Los Alamitos Foundation.

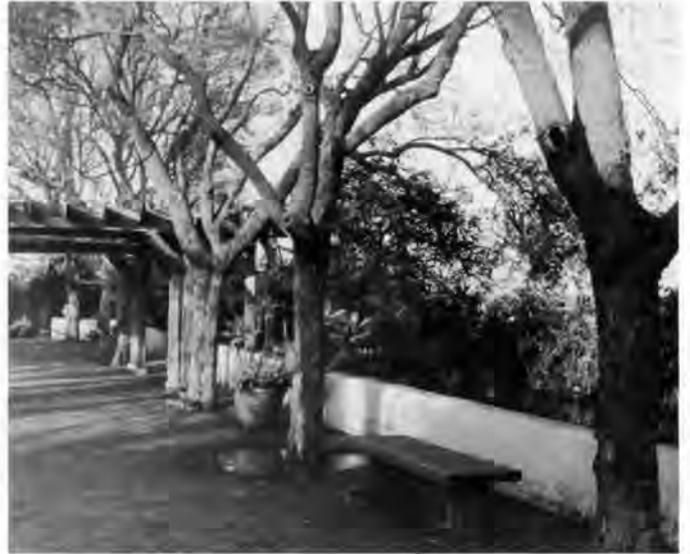
Fig. 6. Jacaranda Walk, 1993. Photo by Janet Brown Becker.

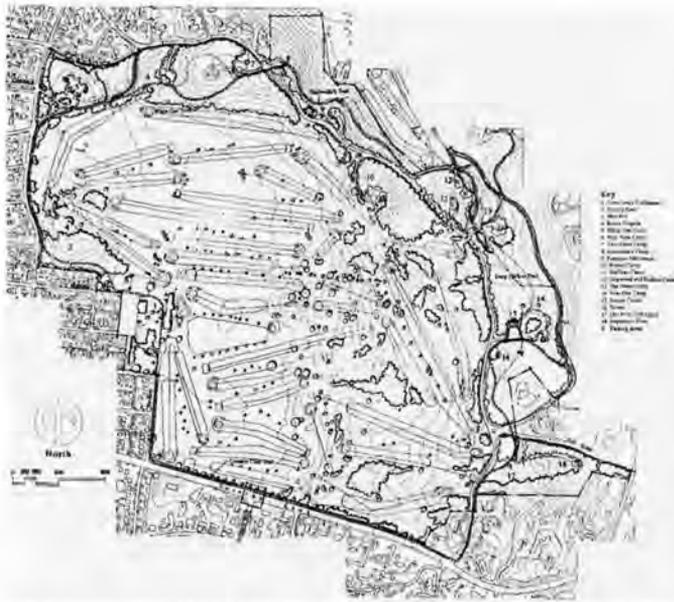
Fig. 1. Preservation Master Plan for Hills and Dales Park, City of Dayton, Ohio. Vernon and Cairns, Ball State University, Department of Landscape Architecture, 1992.

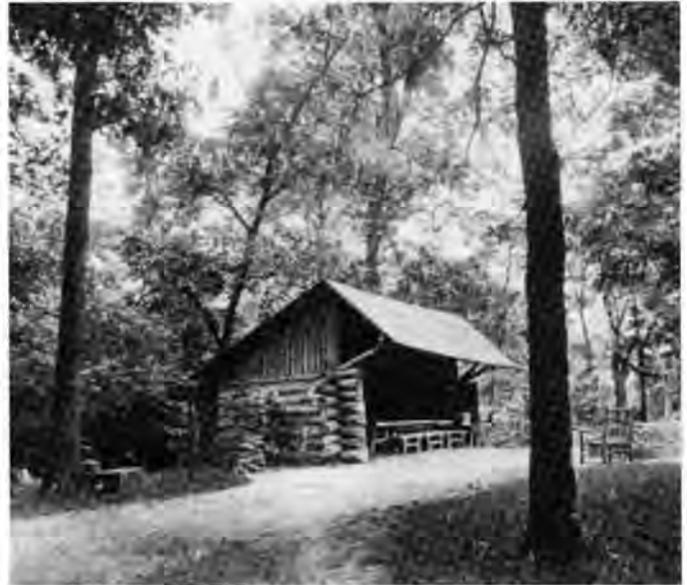
Fig. 3. Typical picnic camp, ca. 1915. Courtesy City of Dayton.

4. The existence of the picnic camps as integral components of the park landscape (figure 3).
5. The strong distinction between the wooded Hills and the meadow landscape of Dales.
6. Traditional patterns of driving, riding, and hiking with various features/sections extant.
7. New Deal landscape details comprised the primary detailed landscape evident in the park: stone and brick detailing still contributed significantly to the rustic character of the park. However, the park's

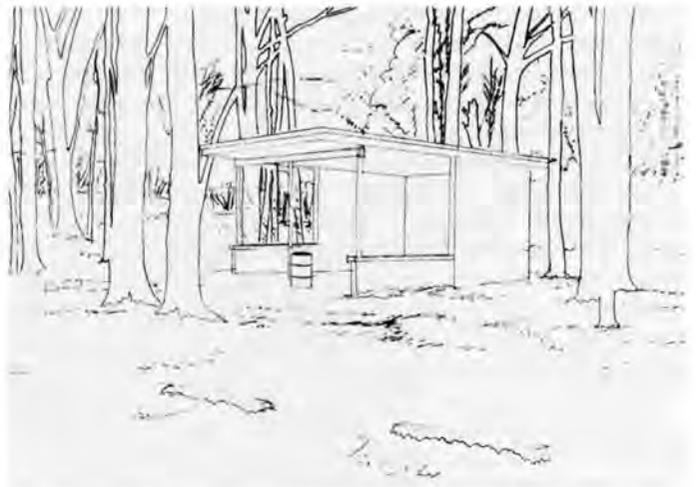
Fig. 4. Incompatible 1960s campsite structure. Vernon and Cairns, Ball State University, Department of Landscape Architecture, 1992.

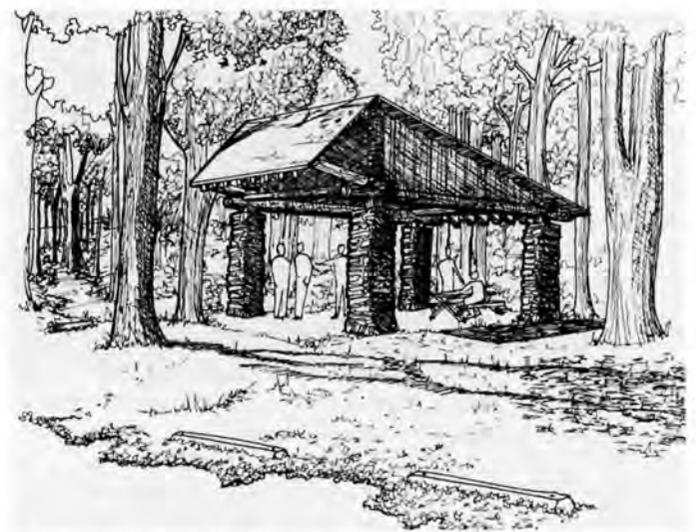
Fig. 5. Proposed campsite. Vernon and Cairns, Ball State University, Department of Landscape Architecture, 1992.

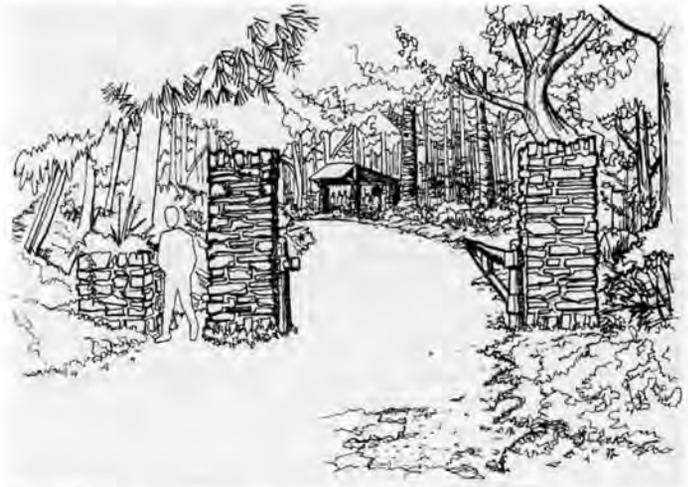
Fig. 7. Proposed entrance with new campsite (midground). Vernon and Cairns, Ball State University, Department of Landscape Architecture, 1992.

ows with panoramas, vistas, and campsites: these features could be rehabilitated. While nature study was an historic intent of the park, invasive species and lack of interpretive facilities leave little opportunity for this. Thus the proposal suggested that the largest of the 1960s shelters be removed and replaced by a Nature Study Center. Concept Three accepted that the historic campsites and pergola were gone and provided modern-but-historically-sympathetic ways of regaining these features (figures 6 and 7). Again, historic fabric would be retained and repaired. Overall, this concept plan suggests ways in which the park could better respond to today’s users and site context, while remaining faithful to the Olmsted-Patterson intents—specifically the intent that the park be a place to experience nature. This plan also promoted the Olmsted’s “homes in the park” concept, while preserving the privacy of those local residents who live on private lots bordering the park. Most importantly, the concept rejoined the severed segments of the park.

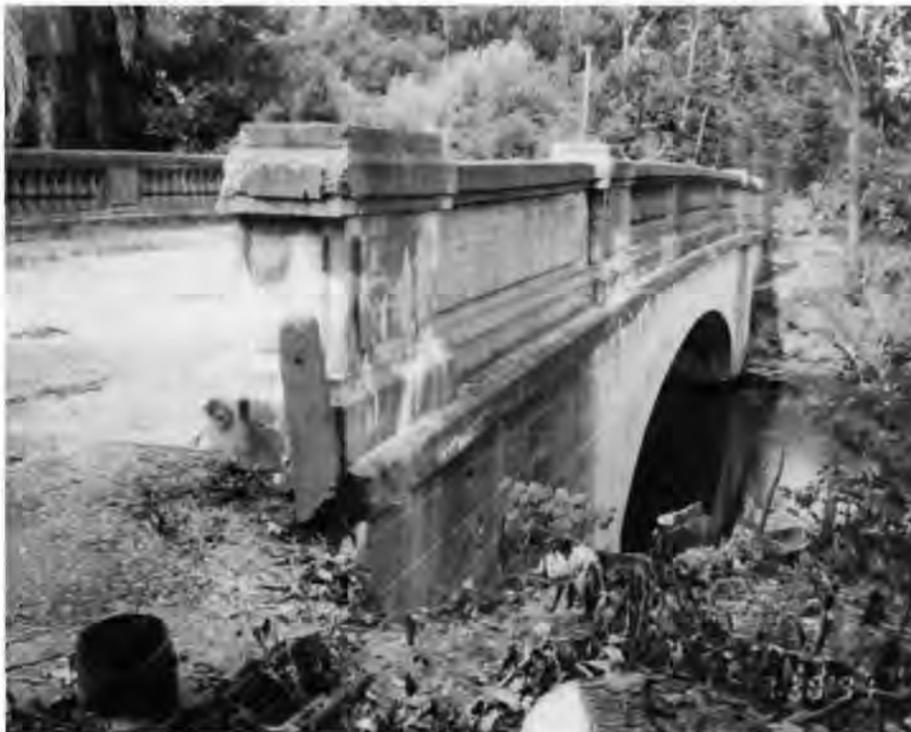
Fig. 1. Deterioration of deck, parapet wall and efflorescence. Photos by LANDSCAPES.

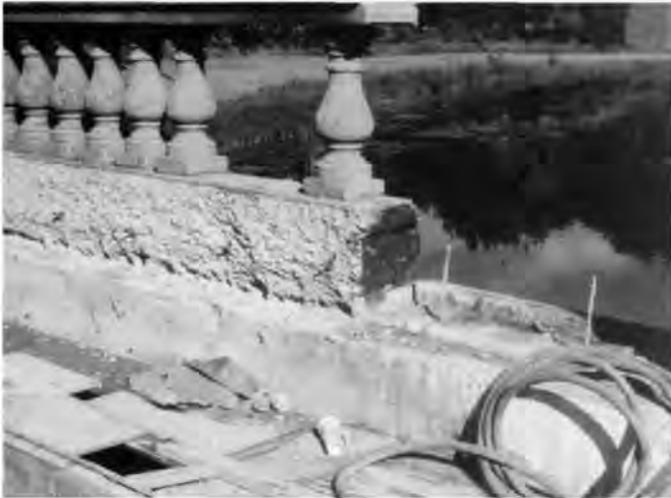
Fig. 2. Removal of unconsolidated concrete and portion of parapet in section of lost balustrade. Photo by LANDSCAPES.

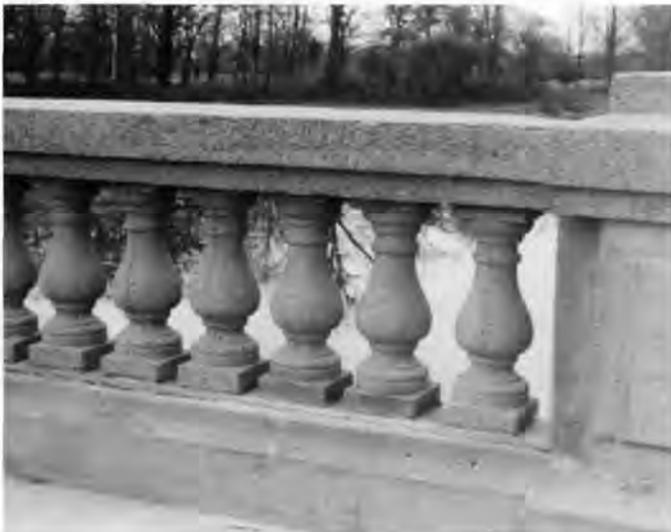
Fig. 3. Detail of completed balustrade and portion of parapet wall—same view as Fig. 1, before construction. Photo by LANDSCAPES.

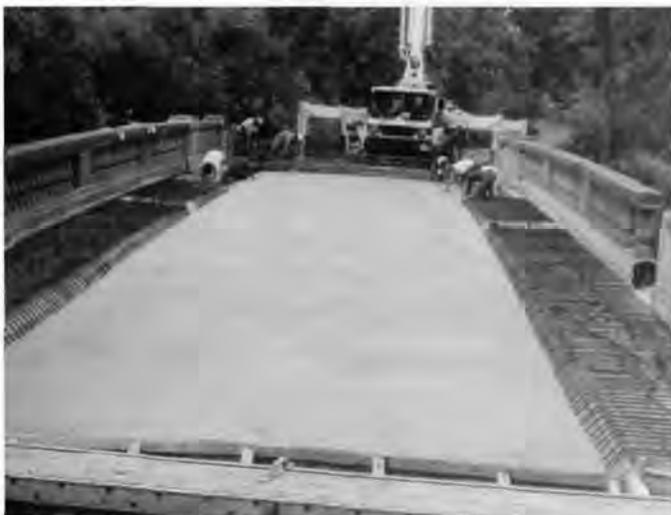
Fig. 4. Deck pouring underway with the rebar for new sidewalks in place. Photo by LANDSCAPES.

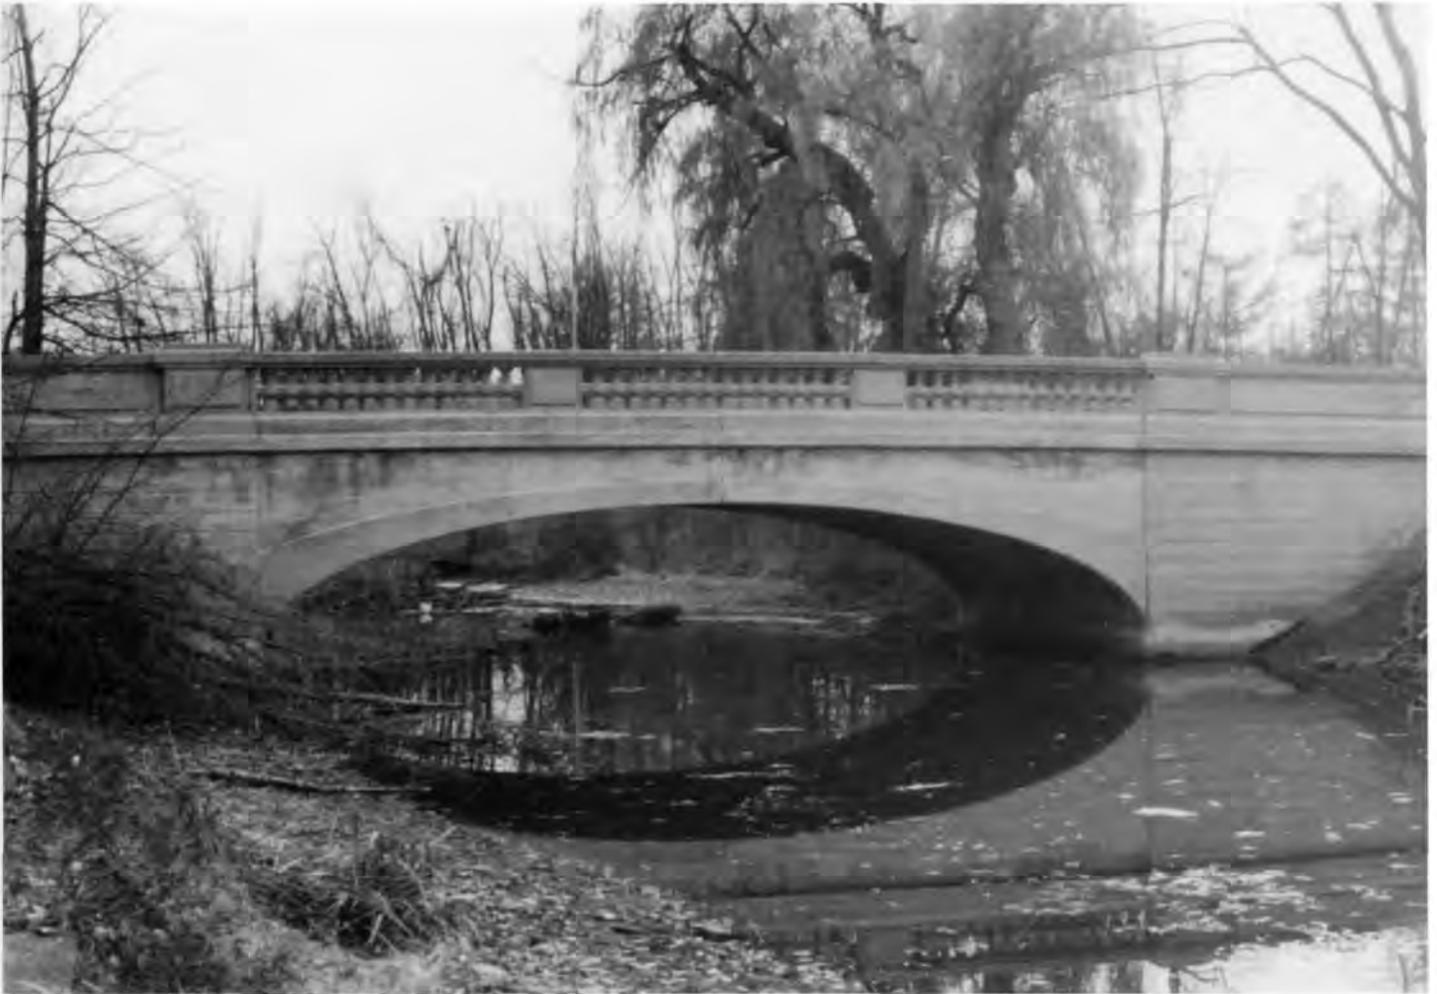
Fig. 5. Finished view. Although some remnants of earlier stains are still visible, new construction blends with original. Photo by LANDSCAPES.

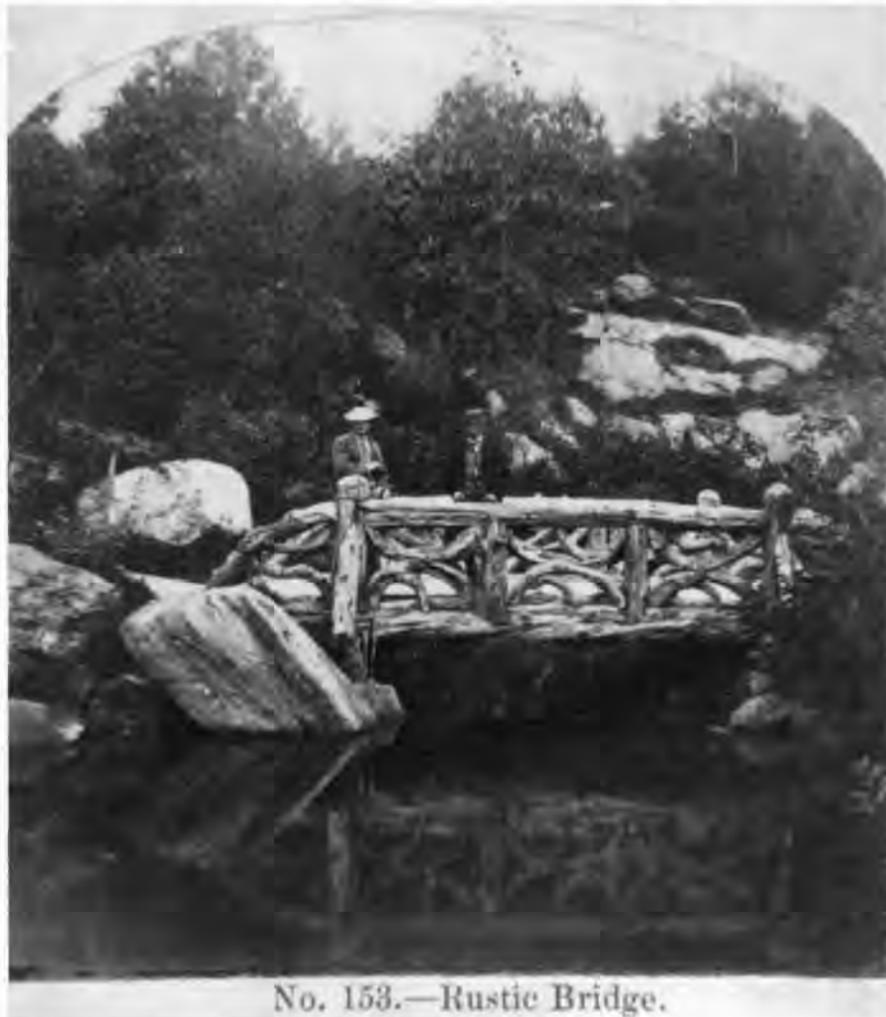
Fig. 1. Stereoscopic view of a rustic bridge in Central Park, ca 1890s.

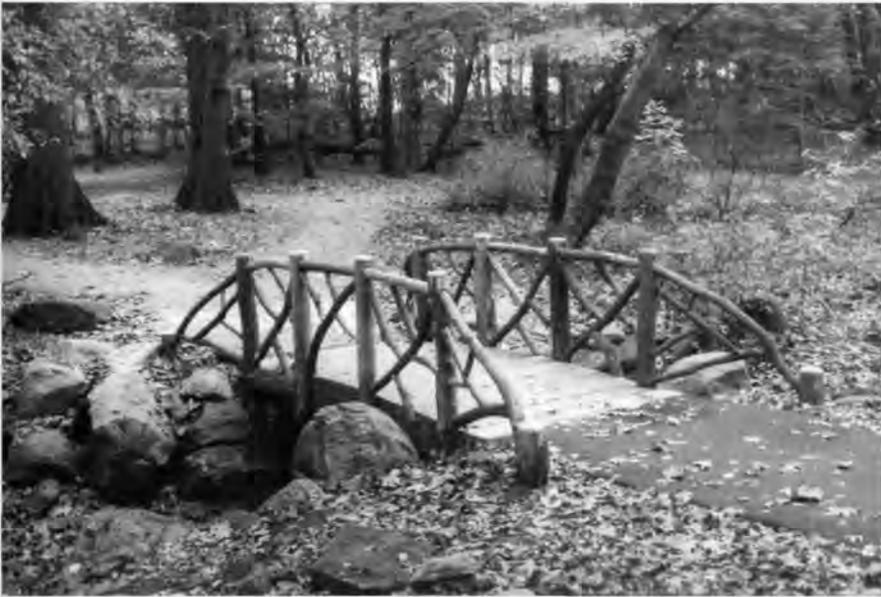
Fig. 2. Rehabilitated rustic bridge in the Upper Park's Ramble, 1980s.

enjoy the landscape. Rehabilitation of the park's circulation system required the replacement of the park's rustic architectural features.

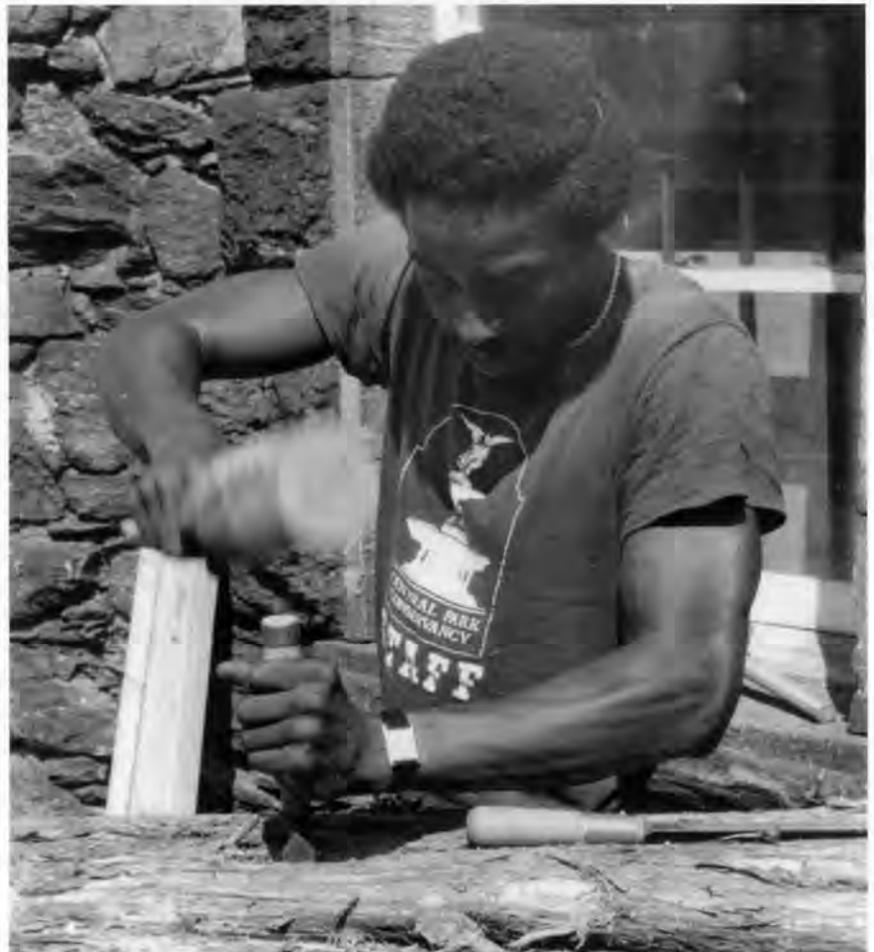
Fig. 3. Central Park Conservancy staff illustrating rustic carpentry technique.

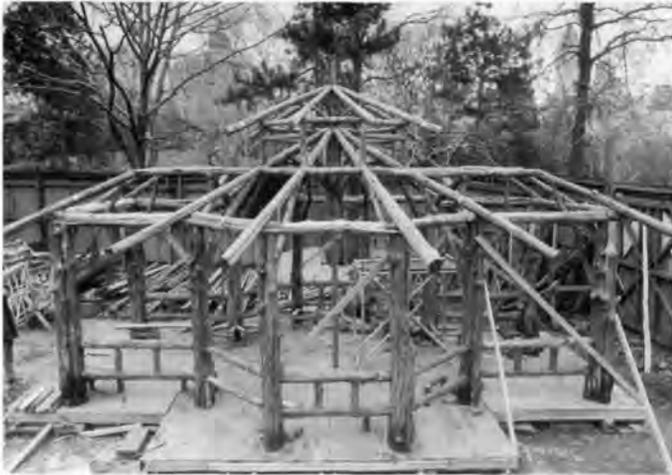
Fig. 4. The Dene rustic shelter under construction in the Ramble Compound, winter 1983. Photo by Calvin Wilson.

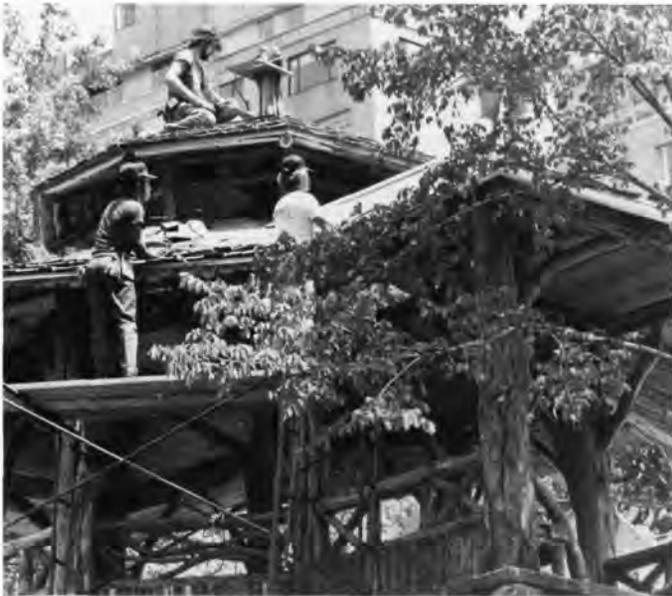
Fig. 5. The Dene rustic shelter in-place at 67th Street along Fifth Avenue, May 1984. Central Park Yearbook photo, 1984.

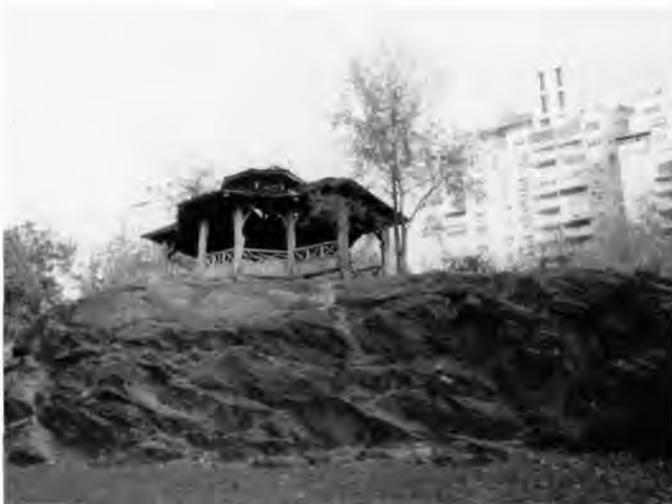
Fig. 6. Completed shelter, late 1980s.

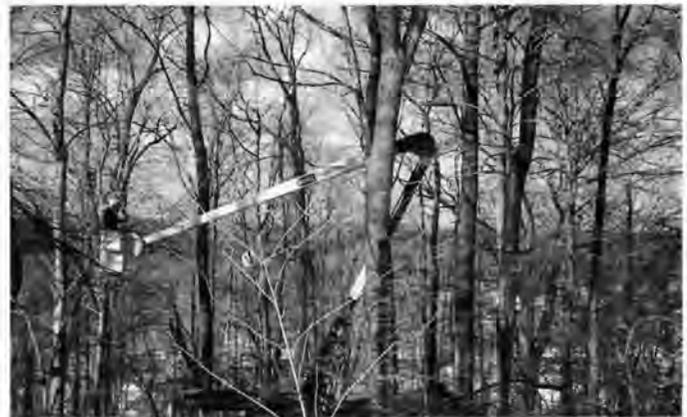
Fig. 2. Two of the three bucket trucks flagging the control limits and direction of a vista toward the Cuyahoga River Valley, as determined in historical research by Child Associates. Notice that both near and far objects can be seen through the deciduous trees in winter as compared to Fig. 3.

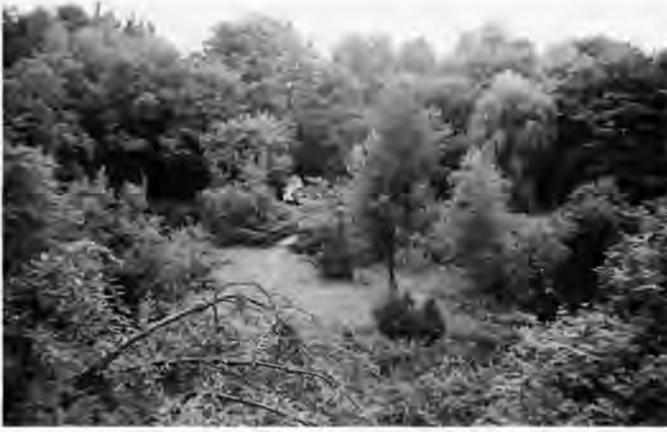
Fig. 3. Restoration of the vista from the Birch Allee and Tea House Pavilion, proceeding through the lagoon area toward dense woods of both planted and natural growth.

of the vista center line was established from within the Allee. Once an opening was cut through the woods, the distant visual intrusions could be studied by moving away from the vista center line. The last trees that were in the vista were two large old oaks that did not show up in the historic photographs, but some branches now hid unsightly condominium buildings about two miles away.

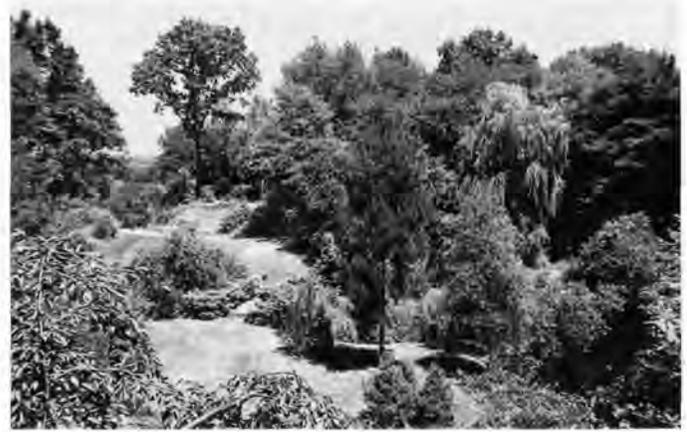
Fig. 4. Vista from the Birch Allee and Tea House Pavilion upon completion of project work.

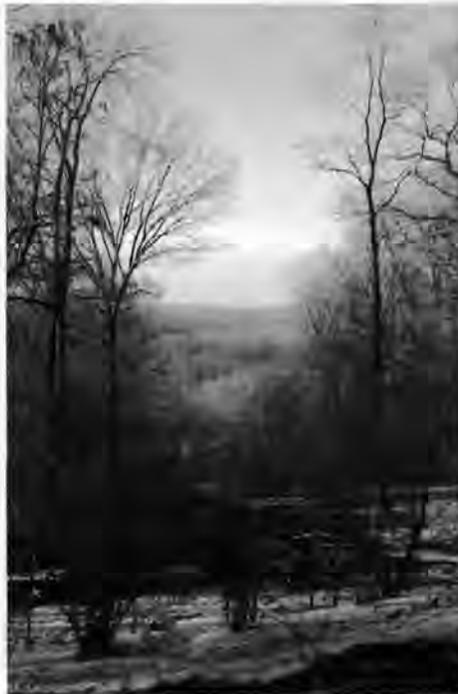
Fig. 5. Natural edges of a vista after final pruning. Tall Oxydendron frame the left side with seed pods, which in fall are yellow against reddish leaves. The fence framework of the tennis court and the logs from the locusts not yet hauled away can barely be seen in the shadows.

The oaks actually form a "roof" to this vista that would not have existed during the construction of Stan Hywet. The fact that Manning, a noted landscape architect with extensive plant material knowledge saved these oaks (prior to his own practice he served as the superintendent of planting with Olmsted, Olmsted & Eliot) was interpreted to mean he knew their crowns would grow together and limit the size of the vista. This "roof" actually has several benefits. It cuts down the amount of bright sky seen and also focuses attention on the rolling wooded hills below the distant horizon.

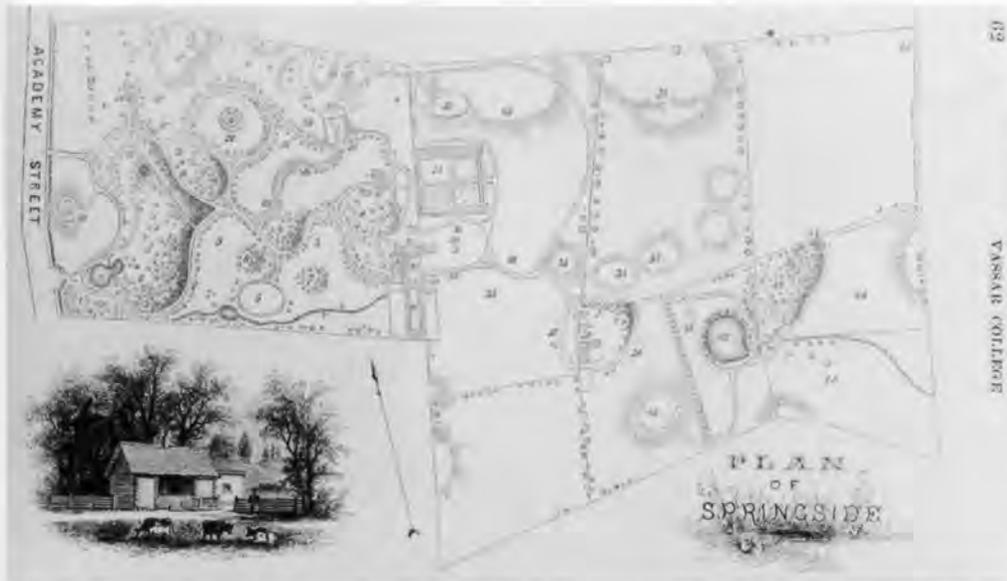
Fig. 2. Plan of Springside. "Vassar College and its Founder," Benson-Lossing Plan, 1867. Courtesy Vassar College Library.

and paths, as well as serving as the feature tree of Matthew Vassar's spinneys (figure 2). Springside is an introverted landscape, views are contained, rather than being oriented out over "borrowed" landscapes. In the *Guidelines for the Treatment of Historic Landscapes*, the importance of maintaining these complex visual relationships in historic landscapes is well stated:

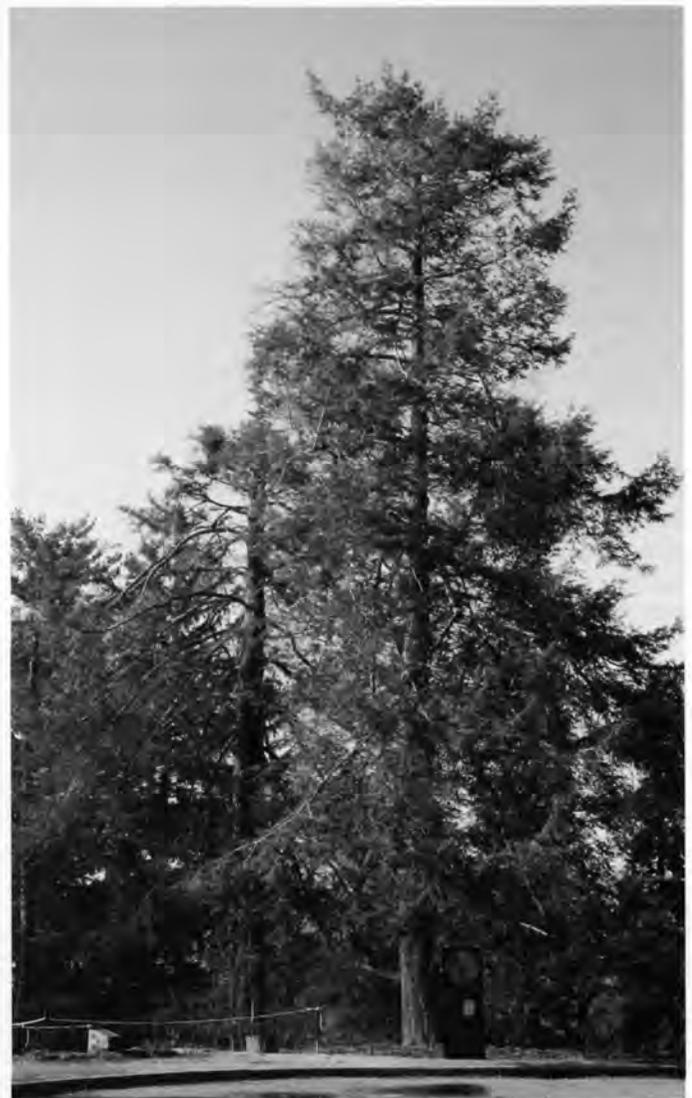
Fig. 3. A sentinel stand of hemlocks in a field at Washington Irving's Sunnyside. Photo by the author.

⁸ Frazer Pehmoeller, Historic Hudson Valley's Director of Historic Landscapes and Horticulture, has authenticated the age of the eastern hemlocks at Sunnyside through ring counts of storm-damaged trees.
