CRM

VOLUME 16 • NO. 4

Thematic Issue

A Reality Check for Our Nation's Parks

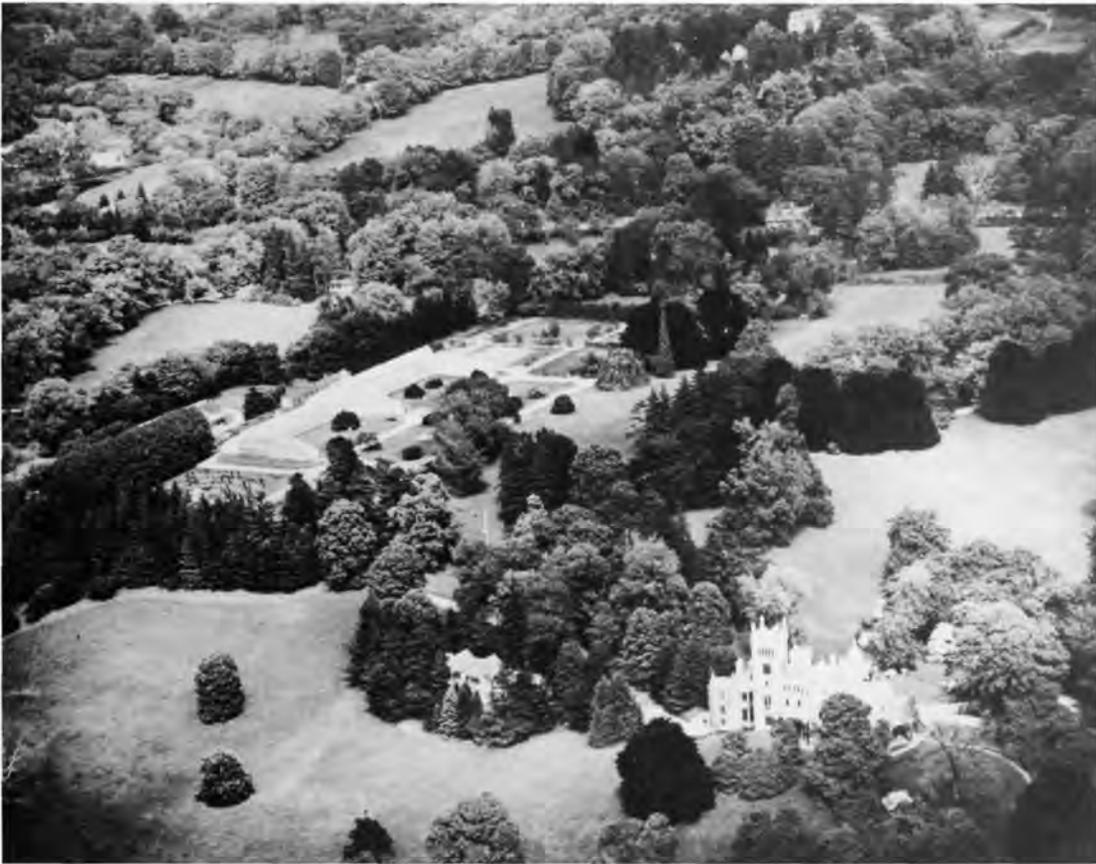
Fig. 4. Aerial view of Lyndhurst. A clear illustration of the impact on the spatial composition and visual relationships within the designed landscape should the hemlocks demise. Courtesy the National Trust for Historic Preservation.

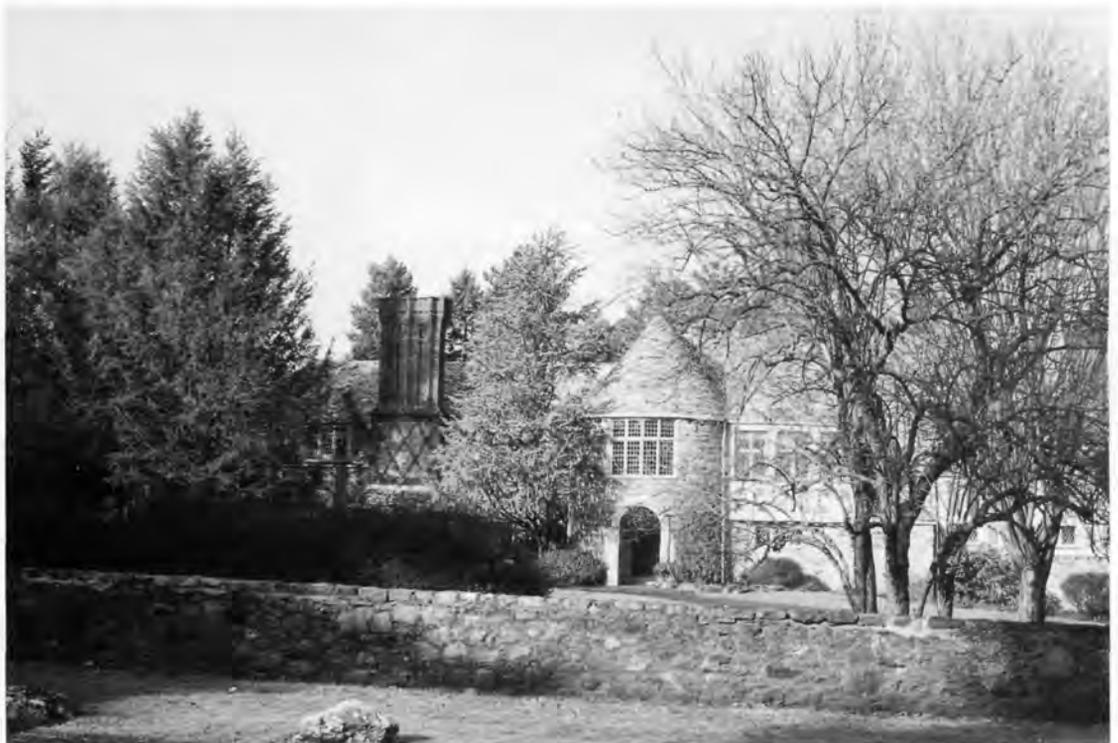
Fig. 5. A healthy screen of hemlocks by the president's house at Sarah Lawrence College. Photo by the author.

students and faculty living on campus (figure 5).¹¹ Quick-growing and able to thrive in even the shadiest of sites, the eastern hemlock was considered relatively trouble-free and the ideal specimen for establishing the bounds of enclosure on a wide variety of properties. From a design perspective, the eastern hemlock has long been regarded as one of the best ornamental evergreens, and always first on the list when designing gardens. Careful treatment of this species (or rehabilitation through plantings of hardier trees) is essential to preserving beauty and also a much needed sense of enclosure on residential landscapes and campuses.

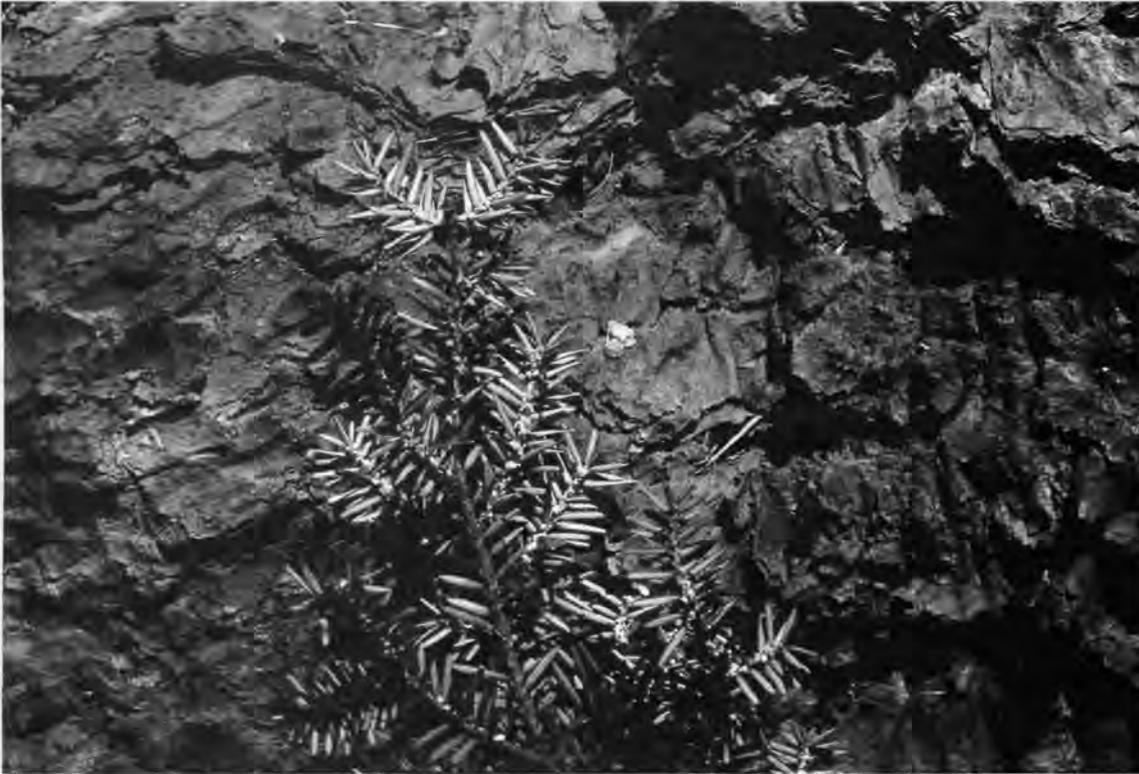
Fig. 6. A branch of the eastern hemlock with a heavy infestation of hemlock woolly adelgid. Courtesy SaveATree.

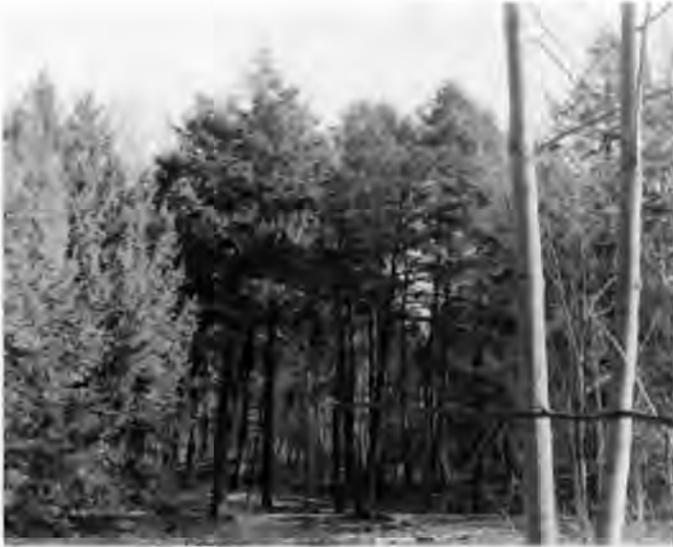
Fig. 7. Recent photo of hemlocks at risk at Springside. Photo by Sarah Ilchman.

Horticultural oil has proven the most successful treatment for mature hemlocks on historic sites, such as at Sunnyside, Lyndhurst, and Sarah Lawrence College. Unfortunately, the arborists may have arrived too late to save the trees at Springside; many of the mature specimens are overrun with adelgid, what little foliage remains is of a grayish cast (figure 7, page 42). The managers face difficult and costly decisions regarding the tragic number of trees which are now in such a weakened and dangerous state that they warrant immediate
